Union Smelting Works, Weir Quay, Devon

Archaeological recording 2009-2010

Client	Bill Horner, Historic Environment, Devon County Council
Report Number	2012R044
Date	May 2012
Status	Final
Report author	Colin Buck
Checked by	JN
Approved by	AY

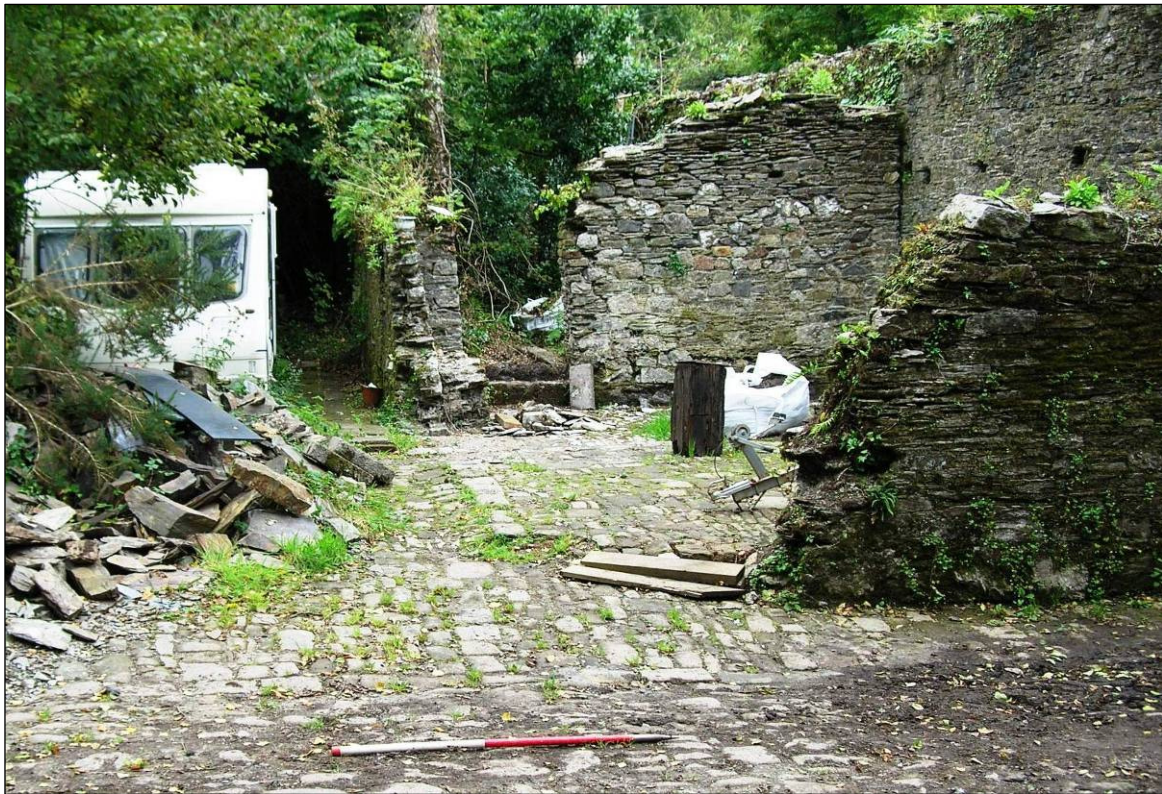
The outbuildings (or stores) were constructed against the tall south boundary wall (adjacent to the road - see Figure 3). The repair works consisted of repointing and preparing the top of the boundary wall to receive a wall plate to secure a mono-pitch roof to the store buildings within the smelter complex. A small amount of initial rebuilding was done in cement and subsequently following guidance from the WDBC Conservation Officer, lime mortar was used throughout with the sand colour chosen to reflect what was originally used (see Figure 4 below). The original extent and position for each wall was retained. The cement repointing was recessed then the walls repointed to nearly flush with the lime tan coloured finish.

Figure 3 Photograph (from west) of the outbuildings (Sites 26 and 33) before works
© CC HE Projects 30/9/2008

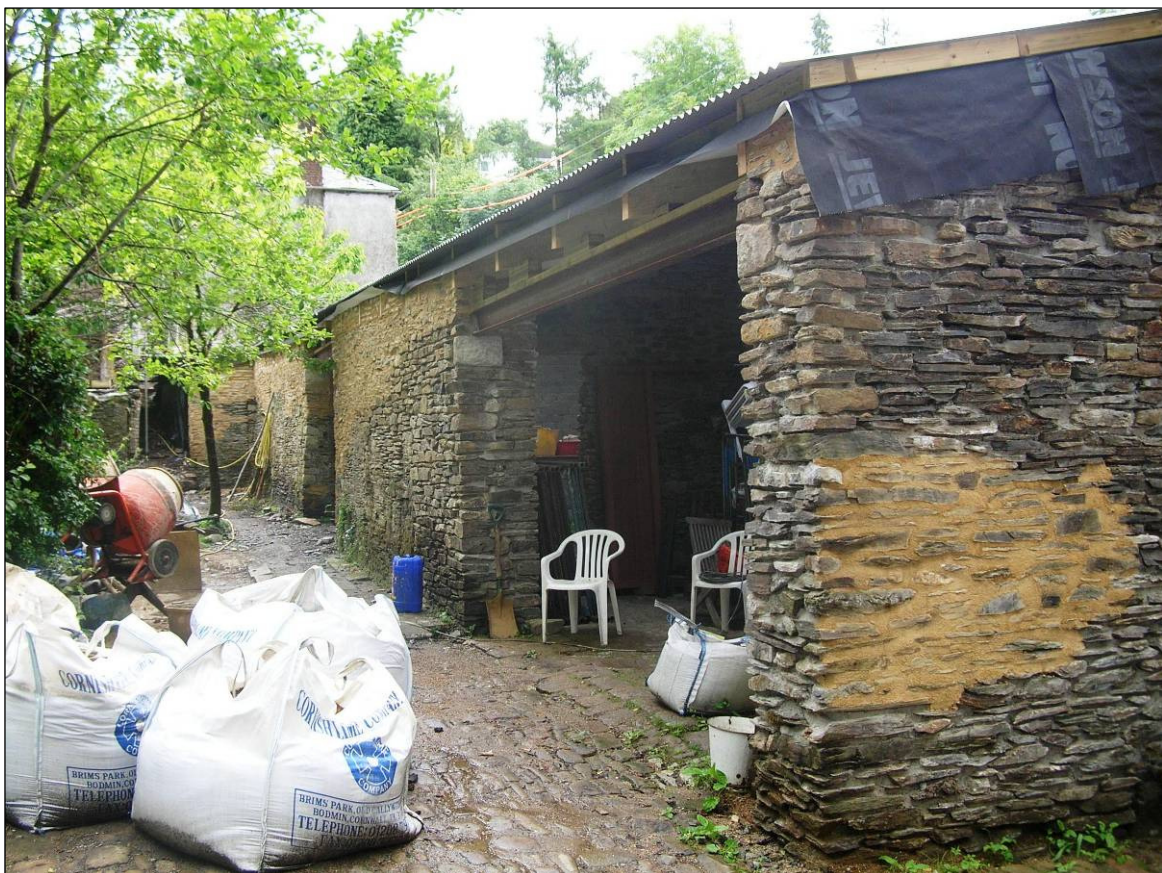
Figure 4 Photograph (from west) of the outbuildings (Sites 26 and 33) during works
(repointing shown in places) © CC HE Projects 24/7/2009

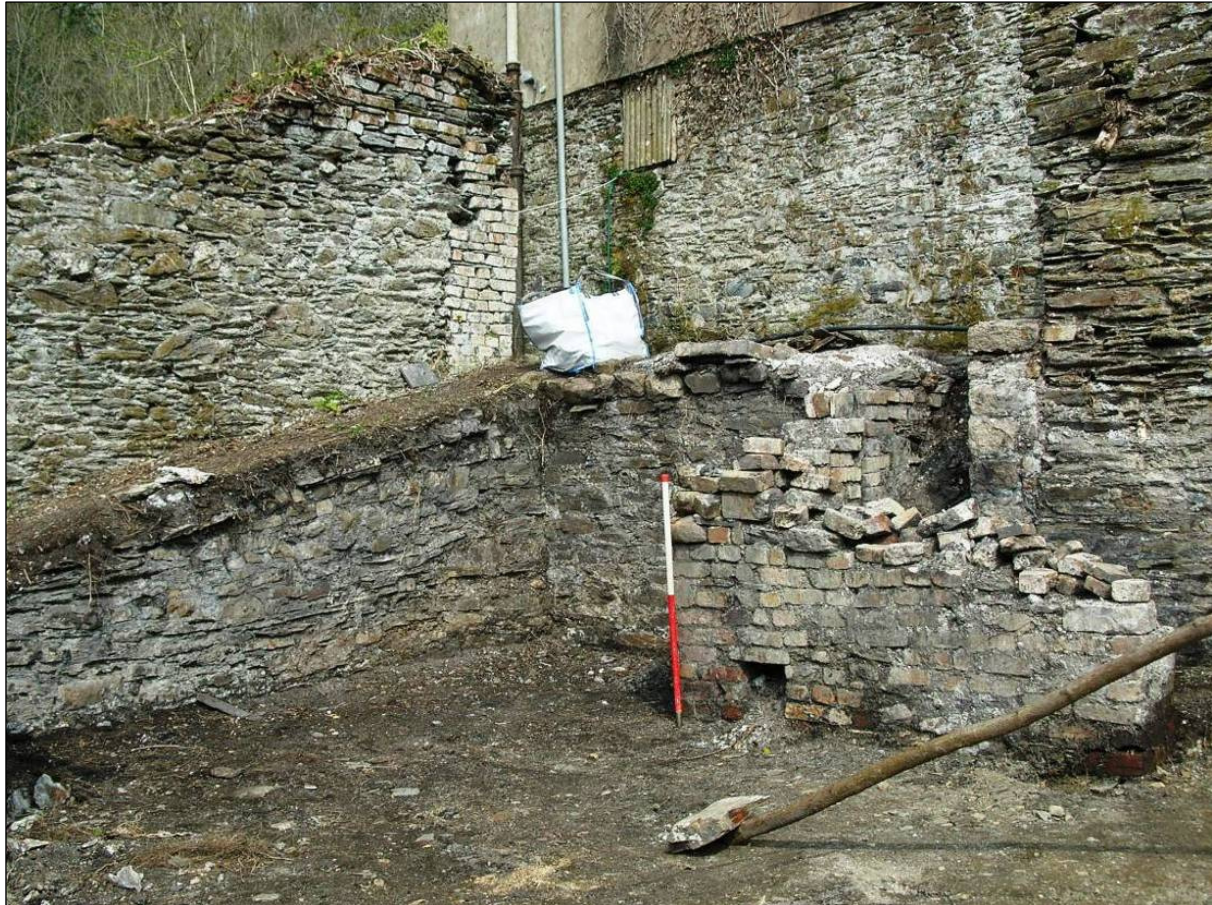
during clearance of rubble build-up, a brick feature was revealed. This was surveyed and photographed before it was removed (see Figure 2 survey plan drawn on to the site inventory plan). The brick feature appears to have been built of old smelter fire bricks, and was 'L' shaped. It extended up the adjacent retaining wall, and had a small opening at its base (see Figure 5). Its function is puzzling, but it may have been related to some chimneys shown on the 1880 OS map (Buck 2008, Figures 6 and 17).

Figure 5 Photograph (from west) of the revealed brick feature (within Site 26) after clearance works (before repointing) © CC HE Projects 3/4/2009

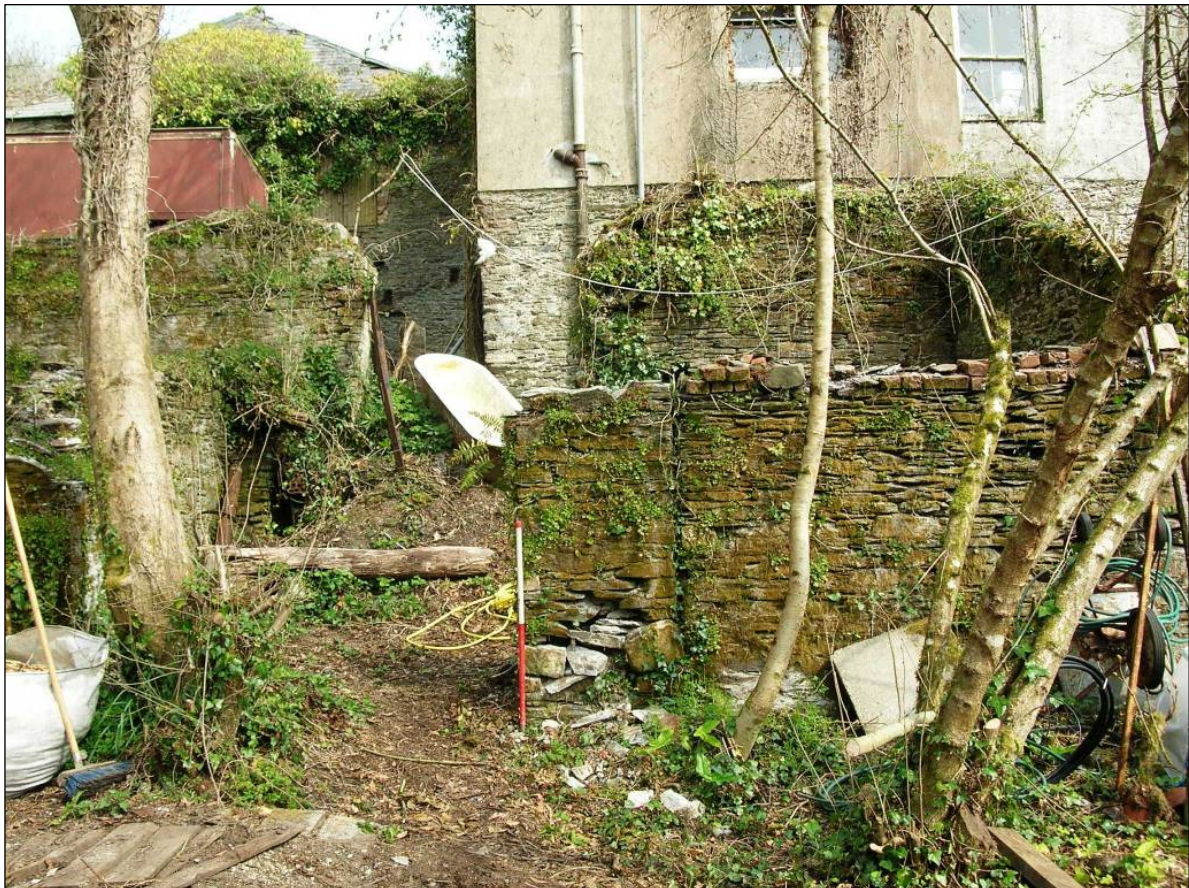
Site 25: the store was originally constructed against the tall west (coal store) boundary wall (adjacent to the smelter - see Figure 2). It may originally have had two wide openings in its west wall, but subsequently the southern one was infilled with stone. The repair work consisted of partial rebuild of the north and south gable walls, and repointing and preparing the walls to take a new timber and slate roof (see Figure 7). The remainder of the walls were completely repointed with lime mortar following the original extent and position for each wall.

Figure 6 Photograph (from west) of Site 25 before works © CC HE Projects 3/4/09

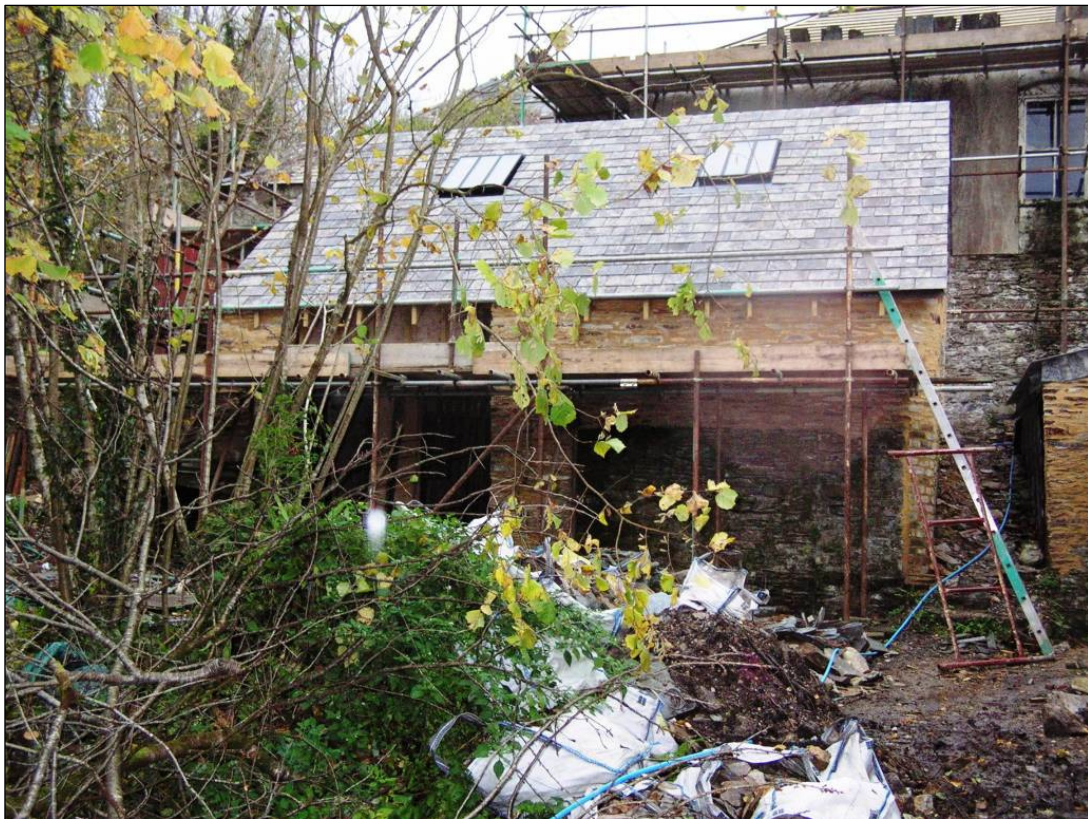
Figure 7 Photograph (from west) of Site 25 with new roof © CC HE Projects 14/11/09

The east wall was mostly rebuilt with stone (to match existing) and re-used bricks as quoin stones. The existing doorway was utilised and the WDBC Conservation Officers instructions followed to make new single entrance door resemble the original double entrance door. This also provides access directly into the newly constructed first floor (given the height differential of the adjacent smelter building 'west' yard ground level compared to the lower yard ground level). The new pitched roof was constructed of slate, with slate fascias (Figure 7).

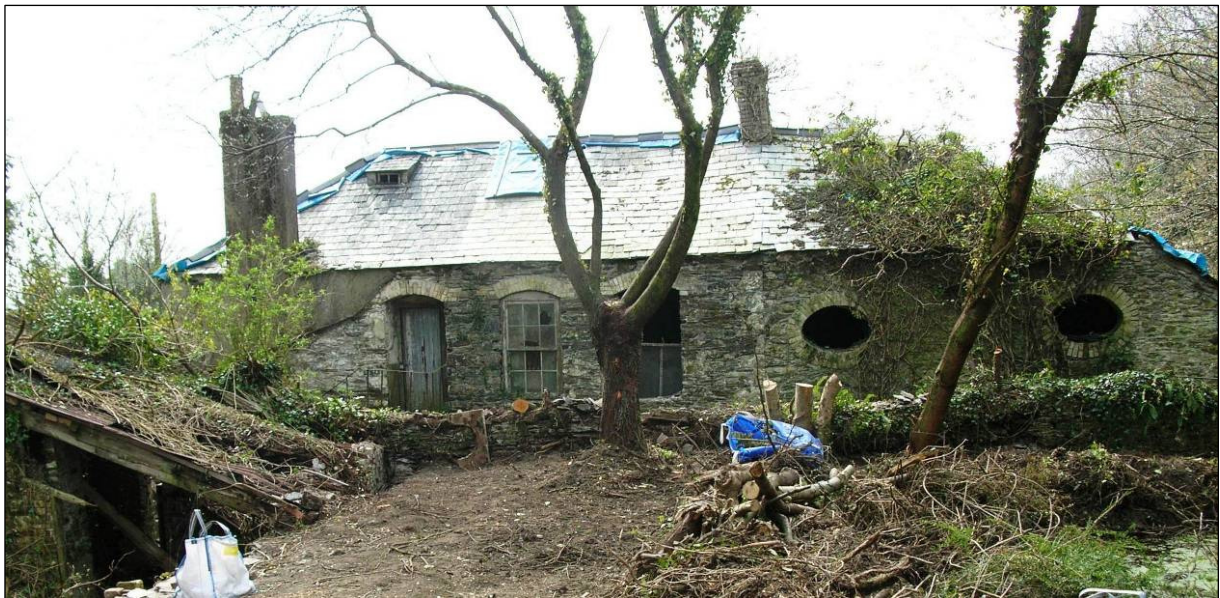
Figure 8 is a view of the building (and Smelter building) from the east at the start of works in early April 2009. From April 2009 the hipped roof and timbers were all removed, as was the east wall from the doorway (including the two window openings). These would have had internal timber joists and the external brick arched headers (as seen in Figure 8). The original first floor walls that remained included the north (originally gable), wall (with inbuilt Cornish range), the south wall (with window opening) and the west wall (with two windows).

Figure 8 Photograph (from east) of Site 41 at the start of works

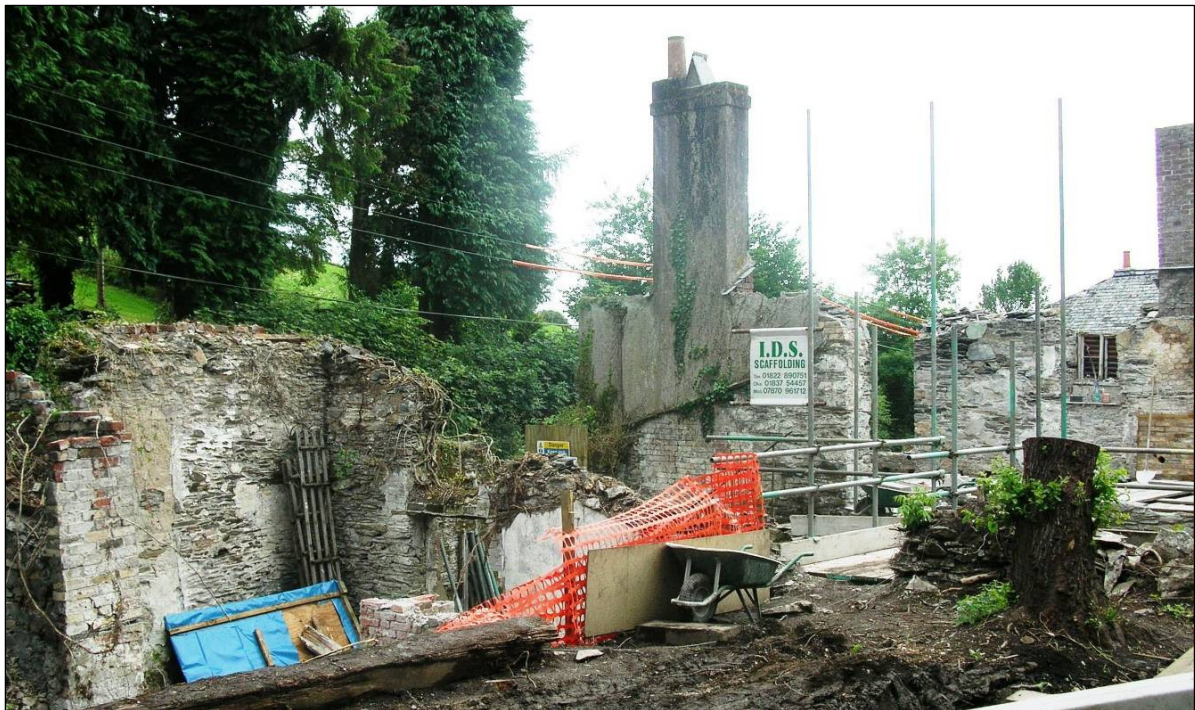
Figure 9 shows the site after the masonry to the east wall had been removed, and after the reinforced concrete floor had been installed. Note the east wall south (rendered) chimney was unaffected by the works, although the other two brick chimneys were rebuilt. The section of east wall that had been removed was rebuilt (with the same stone), as were the original brick arch headers and new internal timber lintels. The west wall window lintels were also rebuilt. The roof was rebuilt with new timbers throughout (see Figure 14), and re-slated (see Figure 10) with new rooflights/vents. All internal walls were repointed and lined with a damp proofing membrane, followed by 150mm of insulation, plaster board and a final skim. On the ground floor, a new doorway was formed between the original Assay room (Site 14), and the original Tin Store (Site 15).

Figure 9 Photograph (from east) of Site 41 during rebuilding works

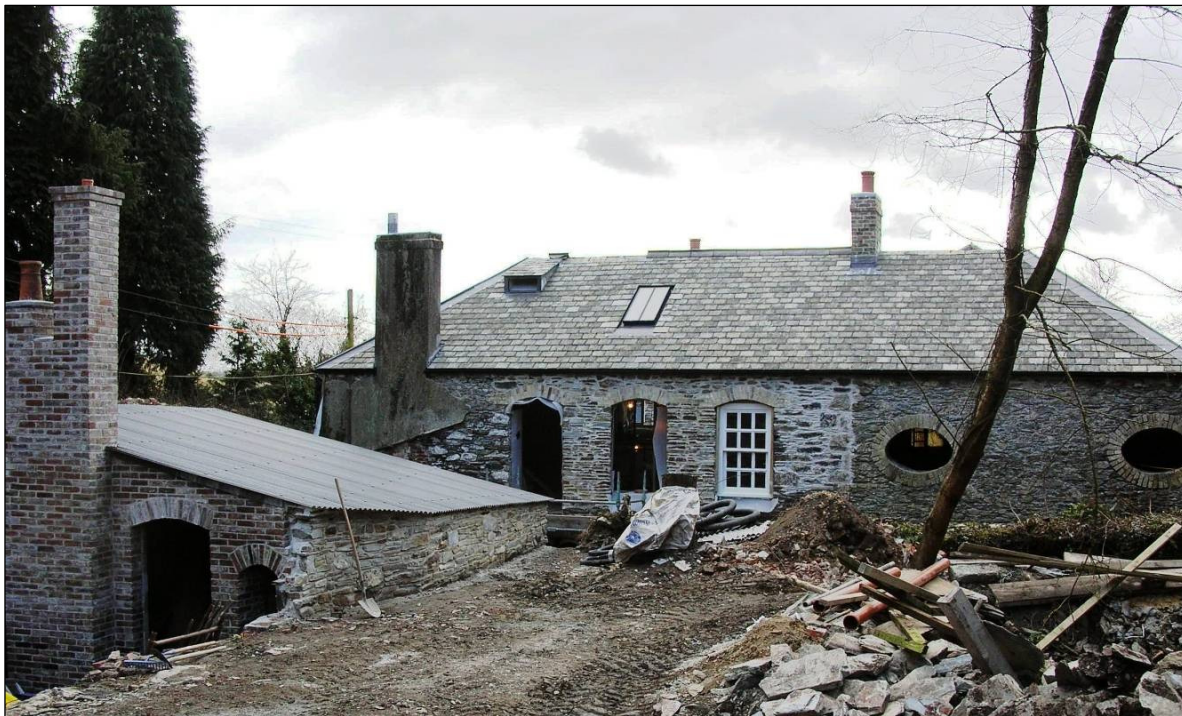
Figure 10 Photograph (from east) of Site 41 after major repair/building works

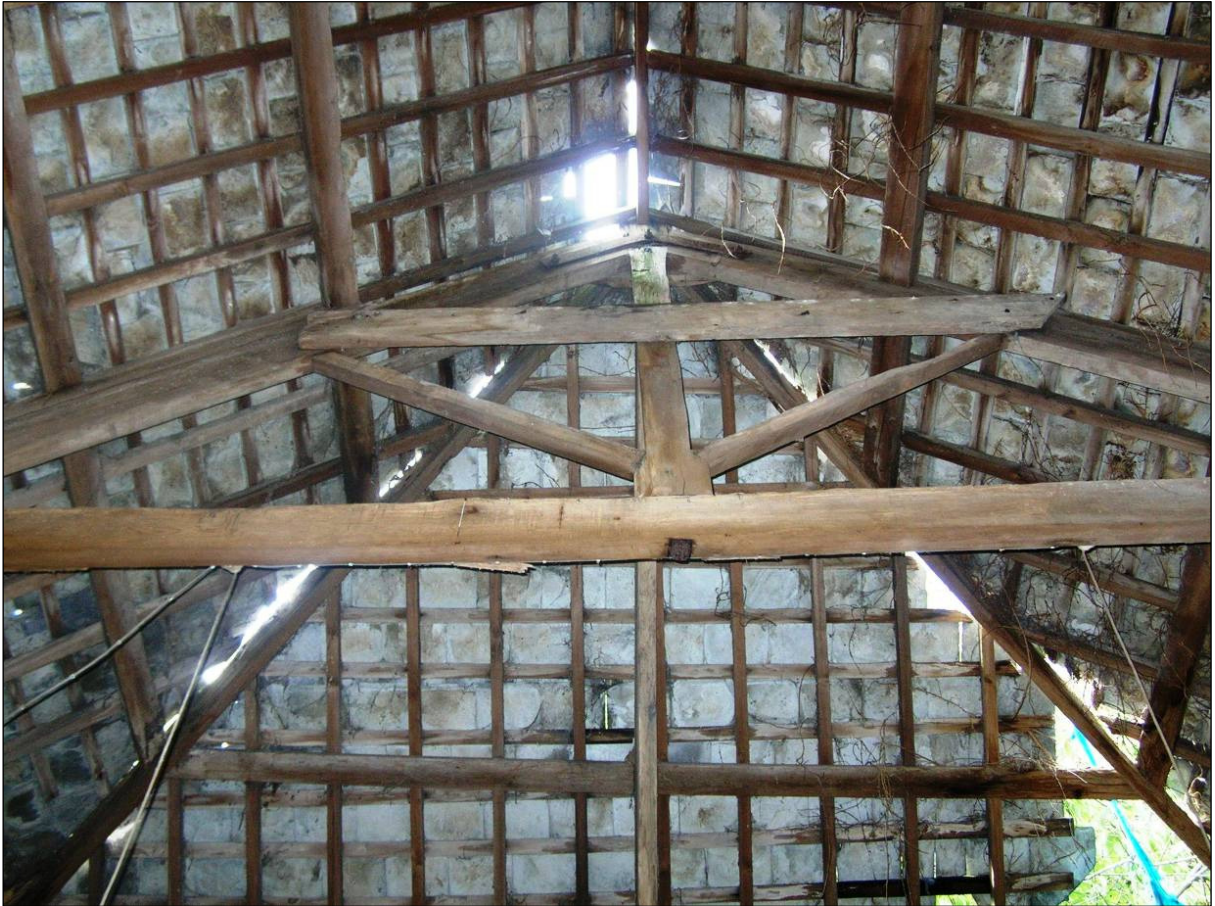
Figures 11 and 12 are internal views of the main smelter roof prior to works. The worsening deterioration of the hip joint lead flashing has had its effect on roof timbers since its construction (between 1865 and 1883). Of high structural significance however, was the condition of the main large (valley) timber spanning (north-south) across the east side of the smelter, which carried the new extended section of roof (adjoining the original eastern section of roof) via an upright steel (reused rising main pipe), above which was sited a wide lead valley for water run-off (See Figs 11 and 12).

Figure 11 Photograph (looking north upwards) of Site 16 (Smelter roof 'A' frame truss) before major roof rebuilding works © CC HE Projects 14/7/2009

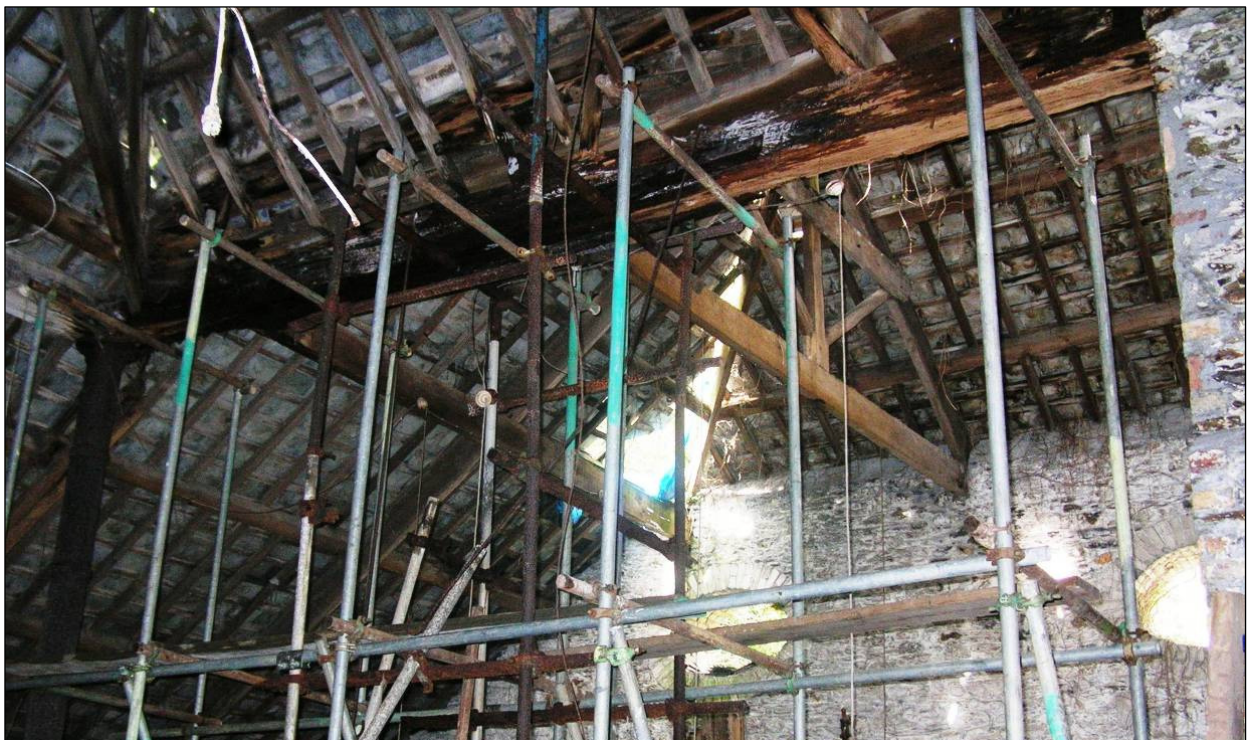
Figure 12 shows that the lead valley flashing above the timber had failed years ago, and as a result the wet timber had deteriorated. This had necessitated the construction of temporary supporting scaffolding (by the former owner Eric Moss). As a major priority the new site owners (Geoff Moss), commissioned the contractors working on the Assay/Managers House rebuild (Nick Fell Partnership), to undertake the additional works of replacing the large timber beam and re-roofing the east end of the smelter building (at the same time as re-roofing the Assay/Managers House, see Figure 14).

Figure 12 Photograph (looking north east upwards) of Site 16 (Smelter roof/wet main valley timber) before roof rebuilding works © CC HE Projects 14/7/2009

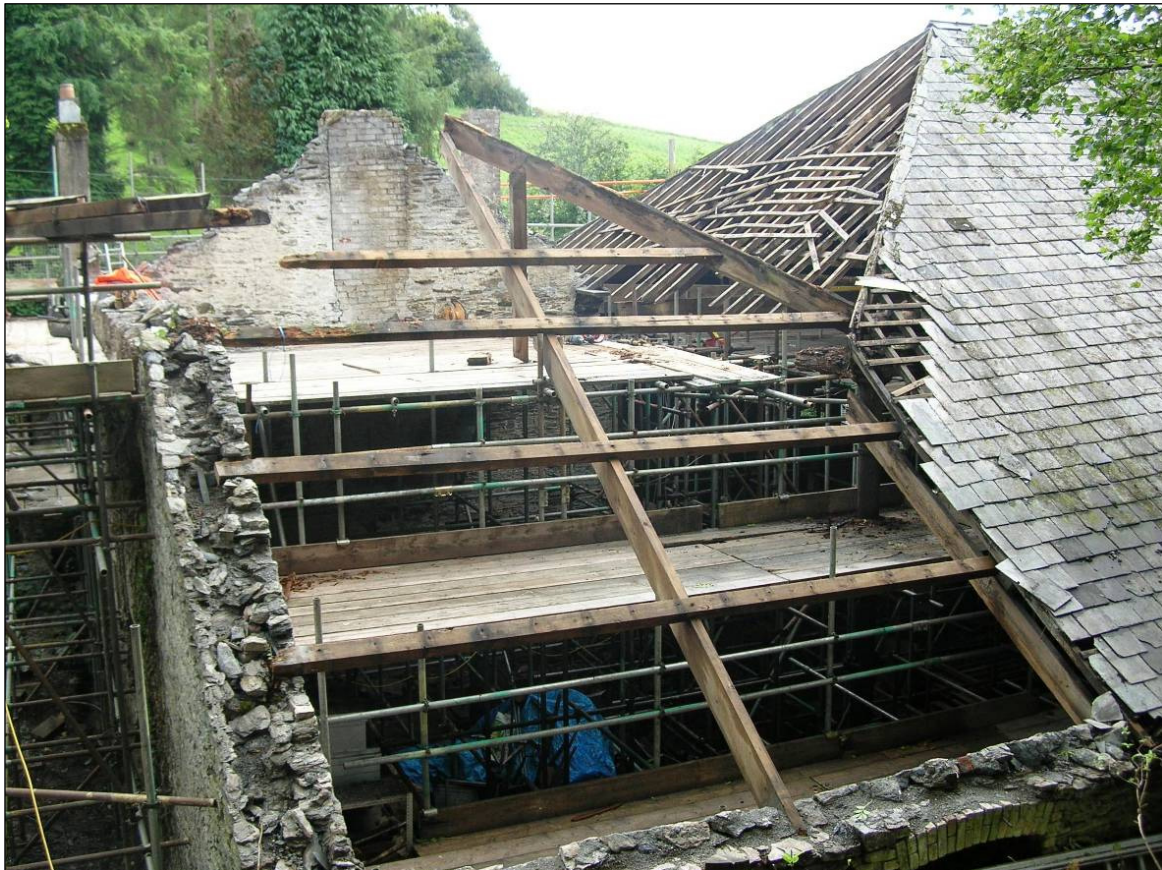
Figure 13 shows the main smelter roof with a few remaining main timbers of the extension. Figure 14 in comparison shows a view of the roof structure before it was re-slated (including some second hand and re-used slates). Between taking these photographs, the new large main valley beam was craned into place and then the new rafters, purlins and hip rafters rebuilt. Figure 15 shows in detail the newly installed main valley beam, the new rafters, purlins and 'A' frame scarf repair. Figure 16 provides a view (looking upwards from the smelter floor), of the new bat 'floor' and roof space, which needed to be built to protect and allow to thrive a protective species of bat. This new floor was built from the house gable wall, on the horizontal section of the main 'A' frame truss rafter and a new 12" x 3" beam (replacing a rotted smaller equivalent). Figure 17 is a view (looking south) of the newly rebuilt roof, new lead valley, and newly rebuilt hipped section of the main smelter roof.

Figure 13 Photograph (looking south) of Site 41 (Smelter roof) during major roof rebuilding works © CC HE Projects 25/8/2009

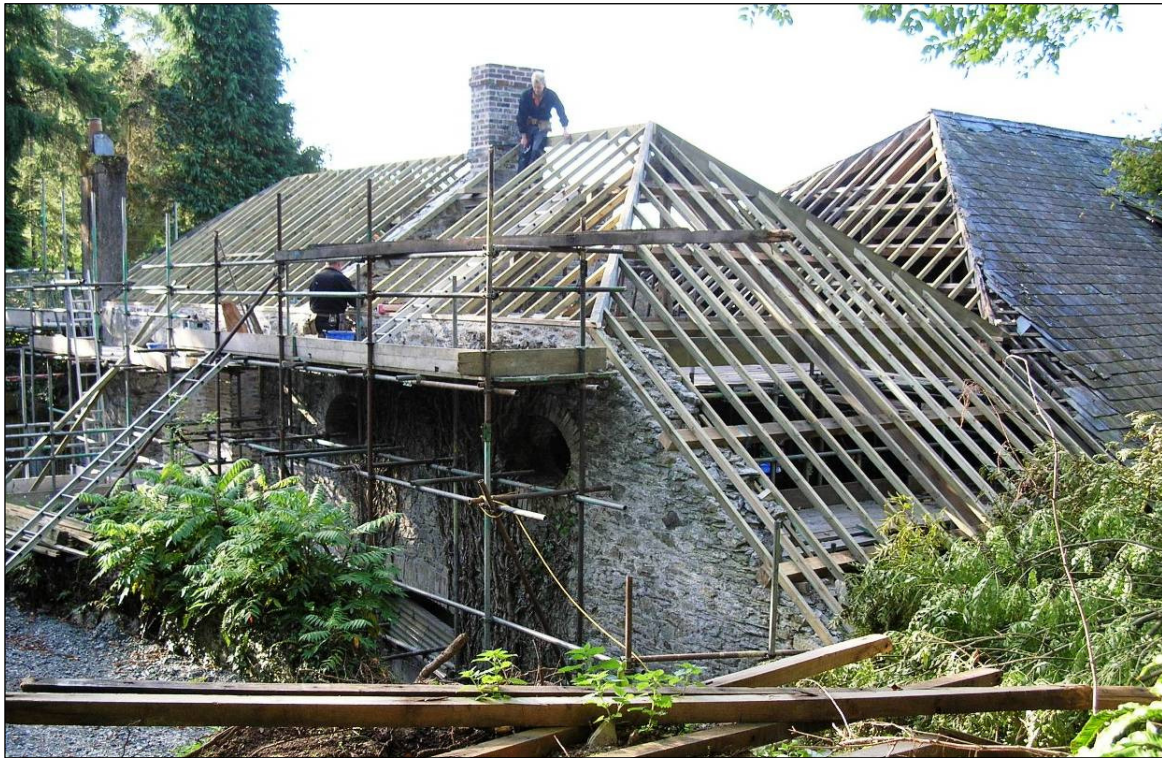
Figure 14 Photograph (looking south) of Site 41 (Smelter roof) during major roof rebuilding works © CC HE Projects 25/9/2009

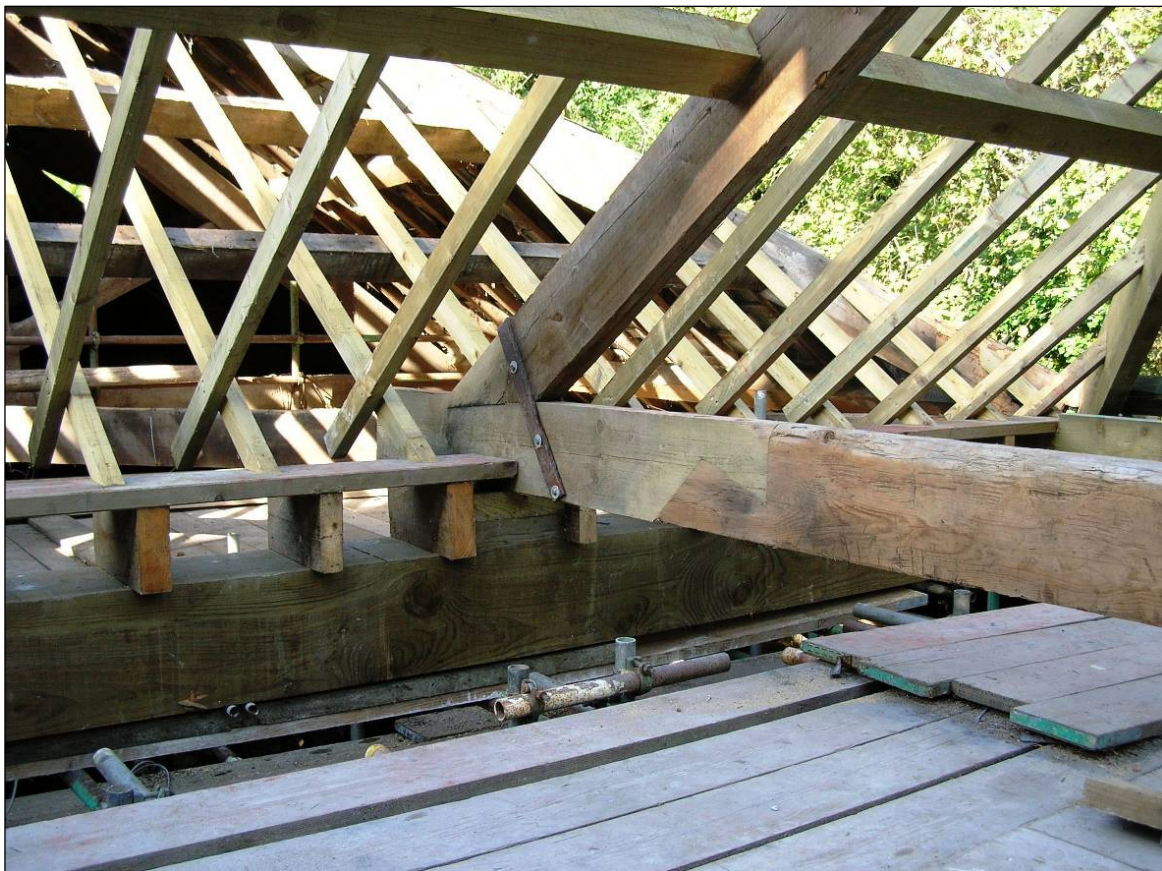
Figure 15 Photograph (looking west) of Site 41 (Smelter roof valley timber/re-scarfed 'A' frame truss) during roof rebuilding works © CC HE Projects 25/9/2009

The main 'A' frame truss rafter had serious cracks at each end which needed to be re-scarfed and bolted with plates (see Figure 15). The timbers that could not be re-used were removed; some large timbers were scarfed and/or repaired and then re-fitted back on the roof. However, all of the battens and smaller rafters were replaced, as well as a number of purlins.

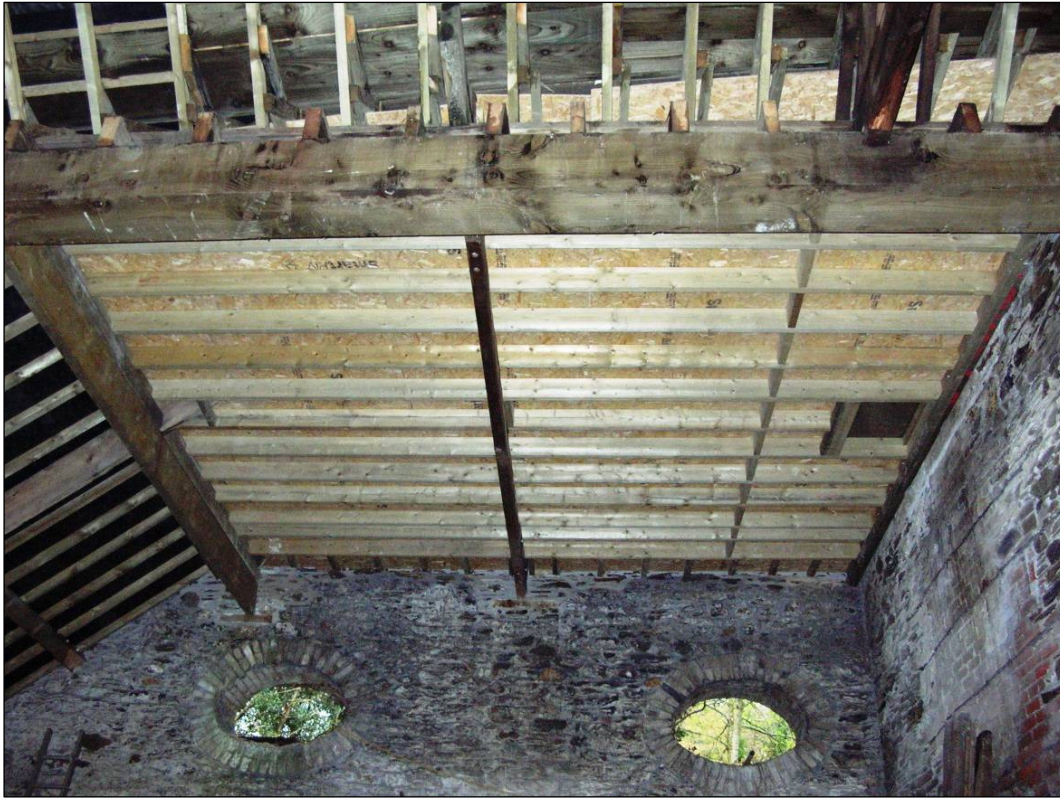
Figure 16 Photograph (looking east) of Site 41 (Smelter bat floor) during major roof rebuilding works © CC HE Projects 18/11/2009

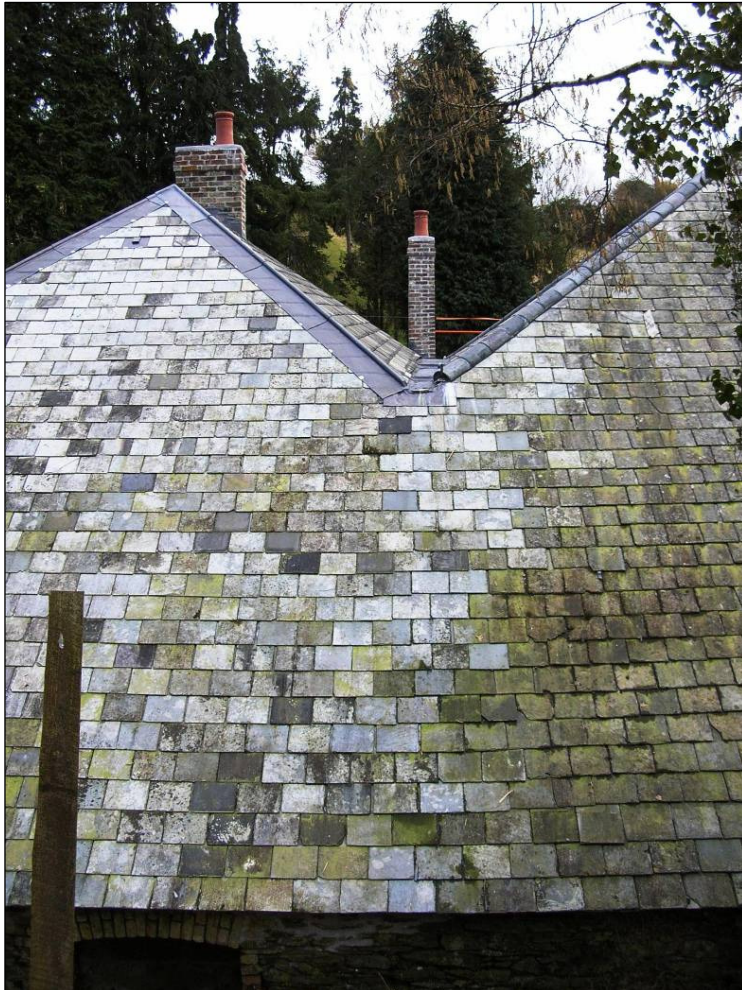
Figure 17 Photograph (looking south) of the newly built roof and lead valley after major roof rebuilding works. The curved roof tiles are temporary, to protect the main smelter roof ridge until the roof is re-slatted. © CC HE Projects 12/3/2010

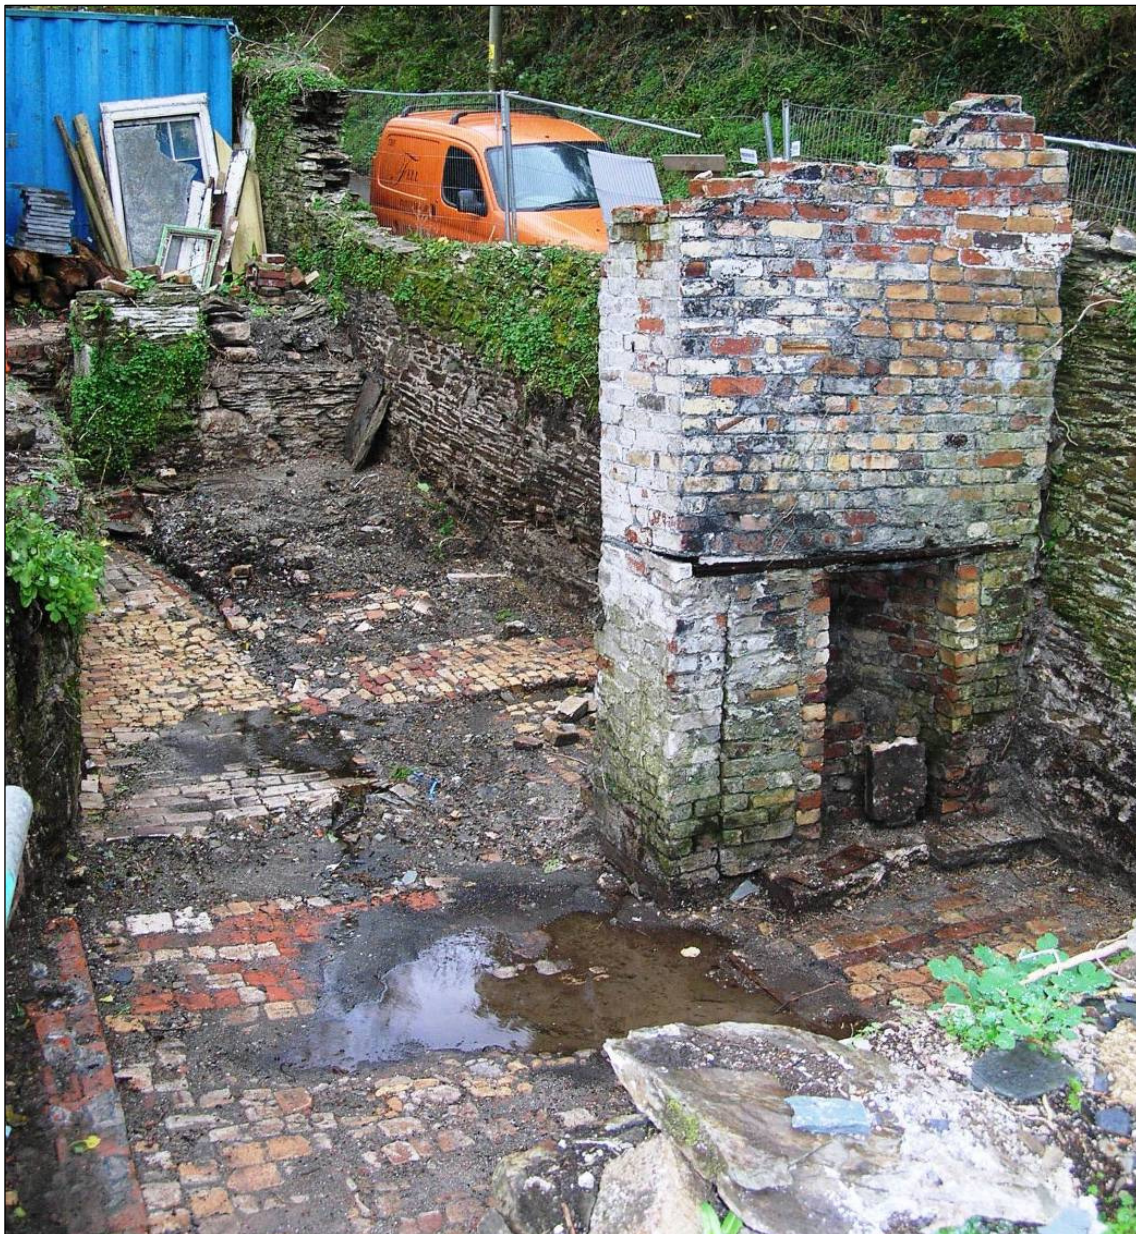
Figure 18 shows the site looking eastwards after clearance of the roof remnants, obscuring vegetation and rubble. The photograph was taken after a rain shower revealing floored and tiled surfaces. In addition, Figure 9 shows the masonry walls and doorway (west and south sides). Figure 19 is a hand measured survey plan (27/11/2009) of Sites 8 and 9 – with three elevations of the brick chimney flue (see A-C), as this site was to be removed and rebuilt. The remainder of the masonry walls were retained and possibly added to where the wall tops had been reduced. In terms of site analysis, the area in front of the steps (east end of survey area) appears to have always served as a yard area with a brick and tiled floor. However the c 1870s plan (Buck 2008, Figures 5 and 10), shows another small rectangular building near/around the chimney flue, which is not replicated on either the 1884 or 1907 OS maps (which only show the chimney). However, the possible building foundation trench (east and north wall) may be discernable at ground level. This feature appears to pre-date the open plan layout shown on the 1884 OS map.

Figure 18 Photograph (looking east) of Sites 8 & 9 (Outhouses) after roof removal and prior to major rebuilding and groundworks © CC HE Projects 18/11/2009

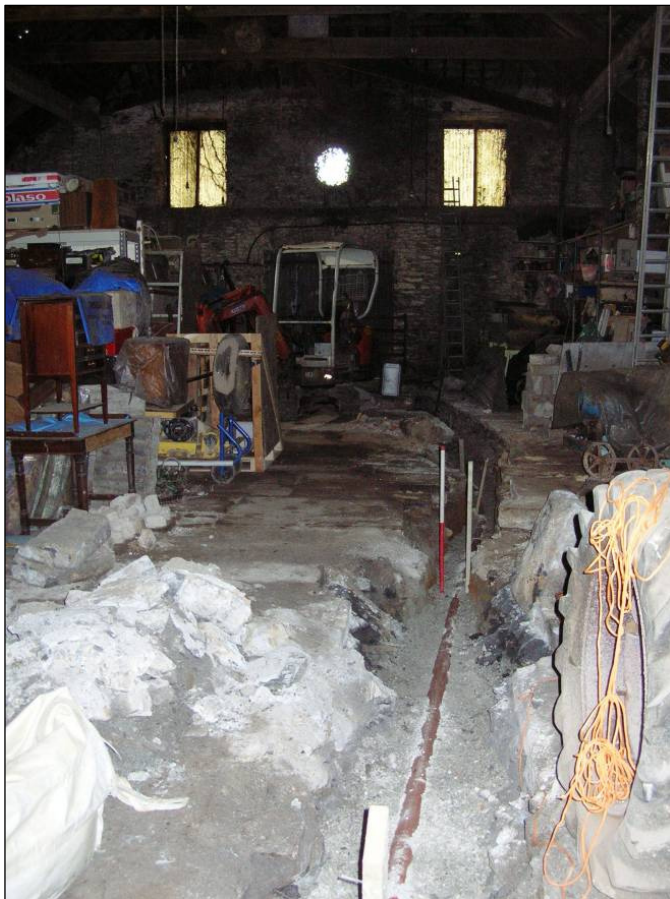
Figure 20 Photograph (looking west) of the excavated and partially infilled service trench across the former tin smelter floor © CC HE Projects 19/5/2010

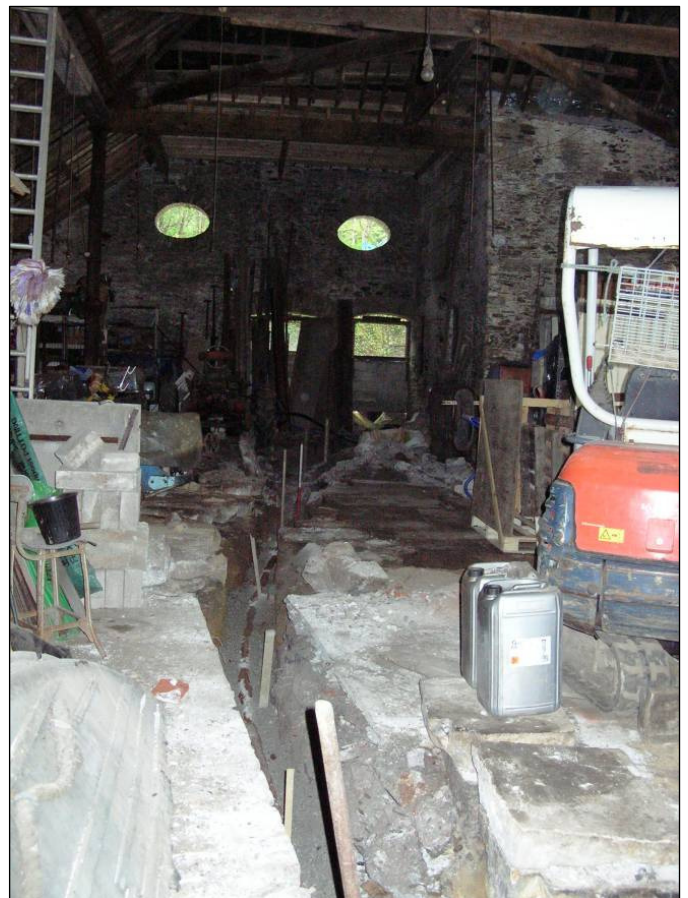
Figure 21 Photograph (looking east) of the excavated and partially infilled service trench across the former tin smelter floor © CC HE Projects 19/5/2010

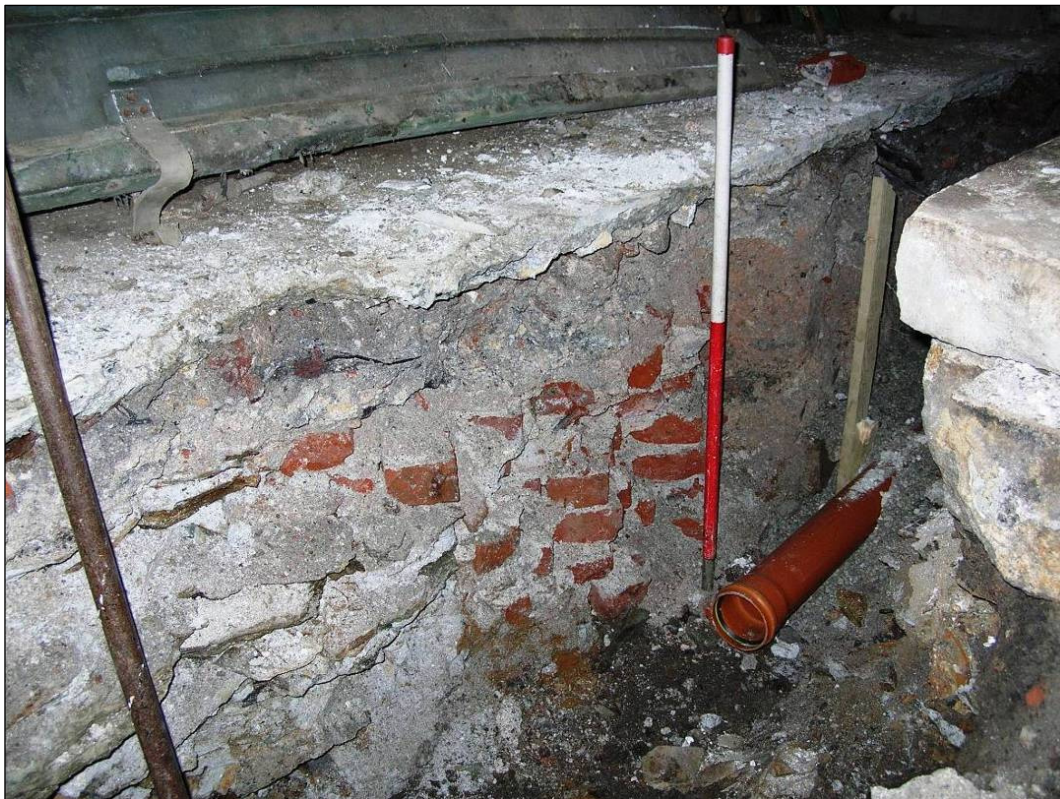
Given the limited width exposure of brick, it may be below ground remnants of the vertical chimney (Figure 2, Site 17) attached to the Smelter furnace (Site 18), or perhaps part of the side of the furnace itself still remaining in situ. The trench, after section C, bends to the north side of the wide opening in the Smelter west wall (see Figure 20). In section D granite slabs were recorded in the northern trench section and these rested on dumped infill comprising mixed black ash/earth, un-burnt coal, and burnt clinker slag waste.

Figure 22 Photograph (looking north) of Section C © CC HE Projects 19/5/2010

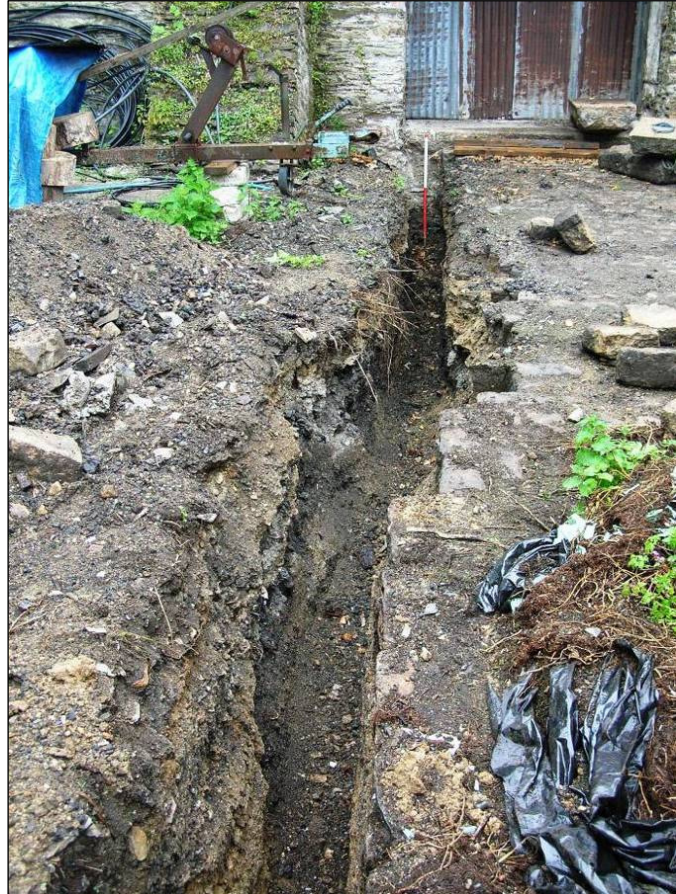
Figure 23 Photograph (looking east) of the excavated service trench across the former coal yard
© CC HE Projects 19/5/2010

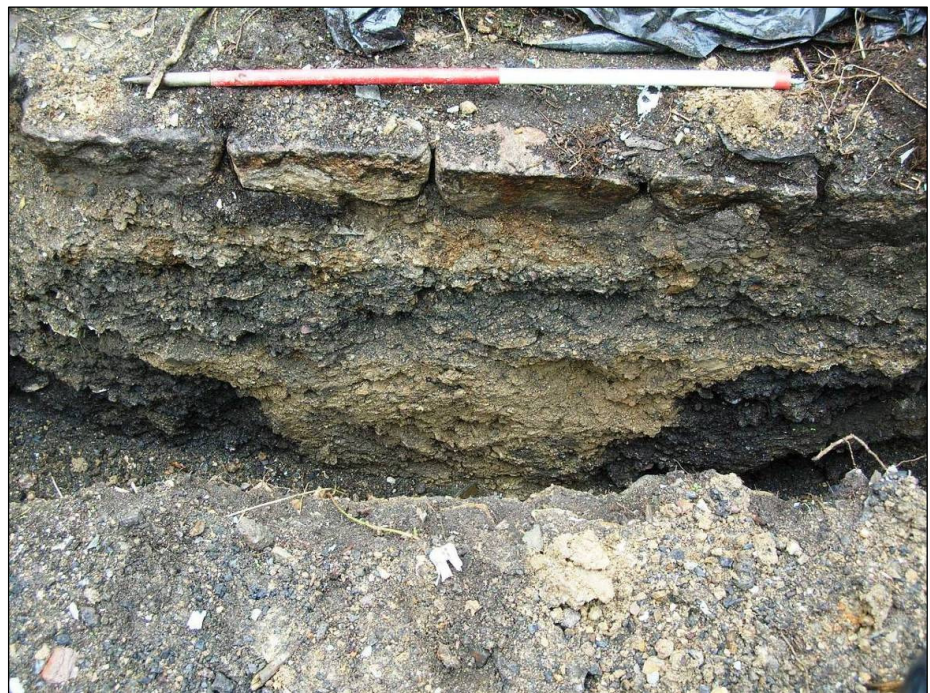
Figure 24 Photograph (looking north) of Section E © CC HE Projects 19/5/2010

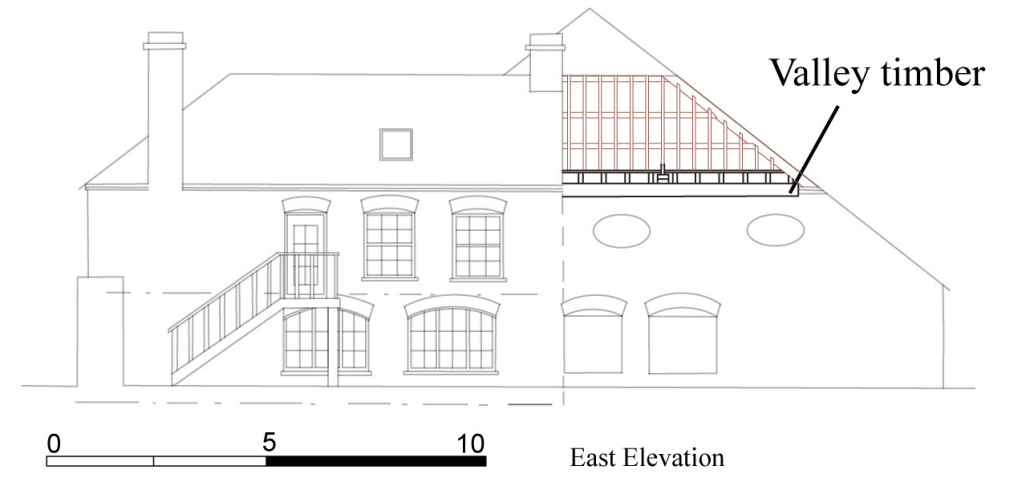
Appendix 1. Measured survey plan and elevations of the Smelter House roof timbers. (Rafters Purlins and A frame shown)

Retained structural roof timbers
(some timbers repaired and re-scarfed)
