Porthmeor Stamps, Zennor, Cornwall

Archaeological recording of the spalling floor walling prior to works

Client	The National Trust
Report Number	2012R012
Date	17 December 2012
Status	Final
Report author	Adam Sharpe BA MifA
Checked by	Andy Jones, MA MifA
Approved by	Andrew Young, HE Projects Officer

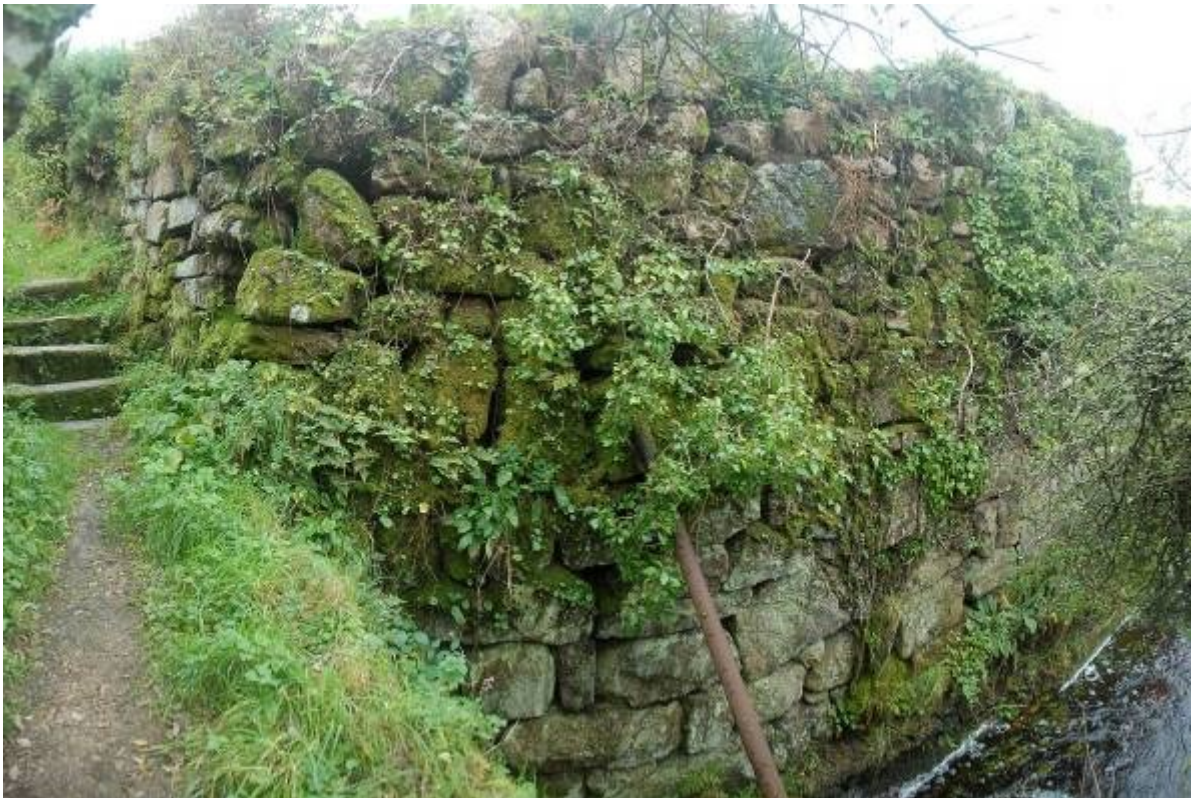
Cover illustration

A composite digital image of the northern section of the spalling floor walling at Porthmeor, showing its poor condition prior to works.

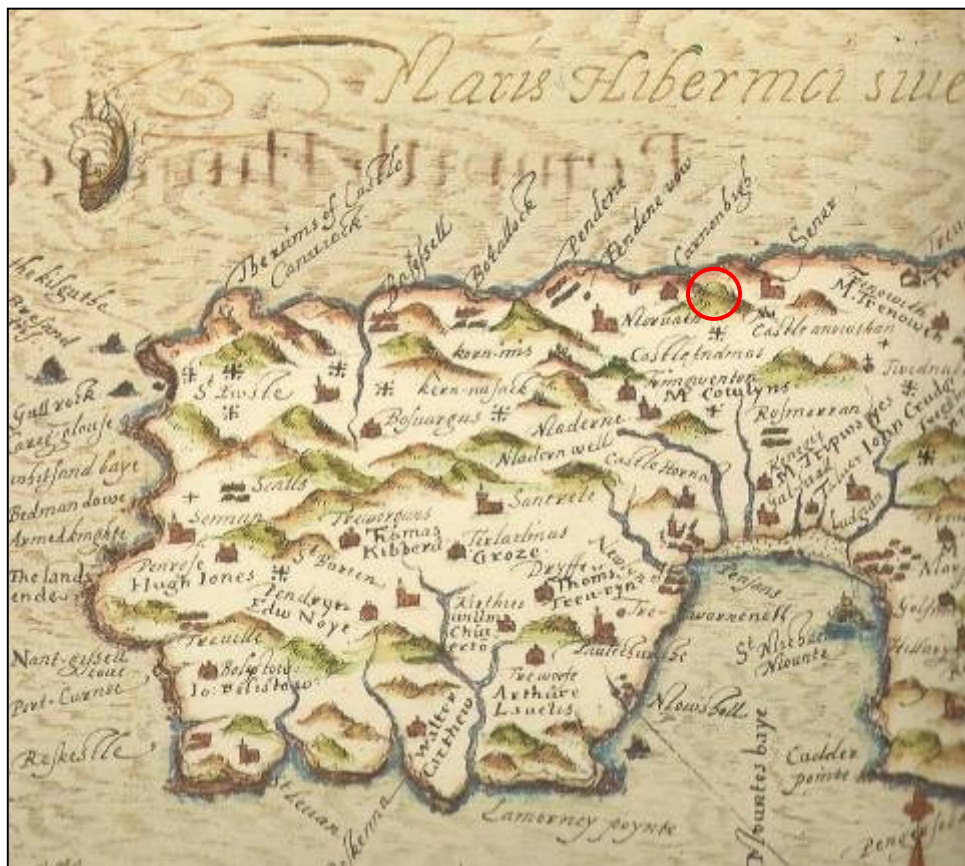
Fig 4. Norden's 1724 map of Cornwall (mapped circa 1600), showing the location of Porthmeor. The crosses surrounded by dots are Norden's symbol for active mines.

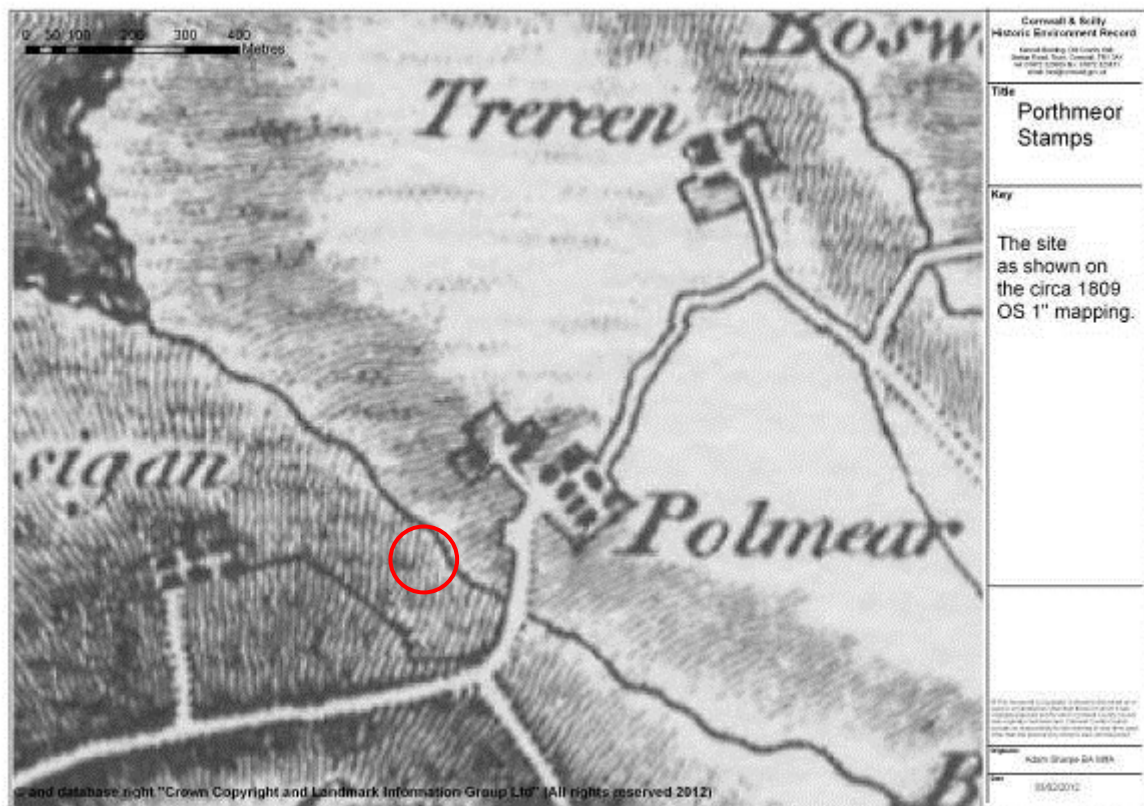
Fig 6. An extract from the 1809 Ordnance Survey 1st Edition 1" to the mile mapping, which omits the documented mills on the Porthmeor Stream.

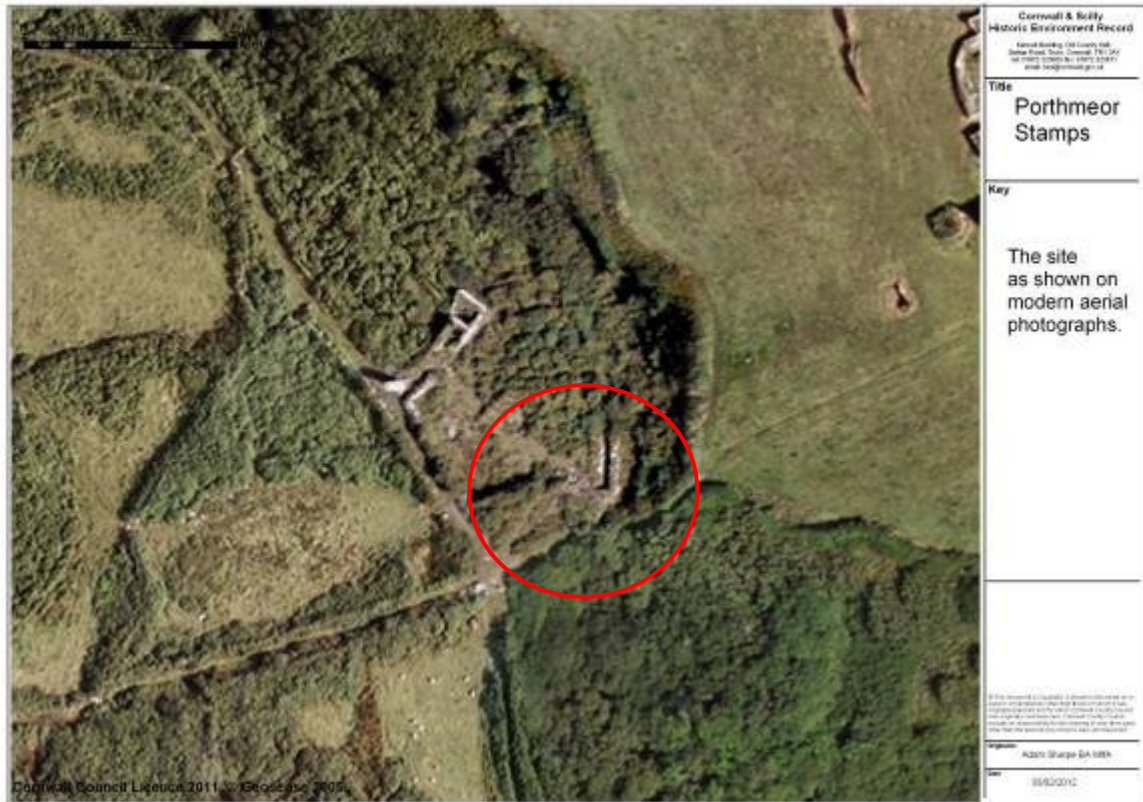
Fig 11. A 2005 Cornwall County Council aerial photograph of Porthmeor Stamps, showing the scrub which had grown up over much of the site. The wheelpit and spalling floor are just right of centre in this image within the red circle.

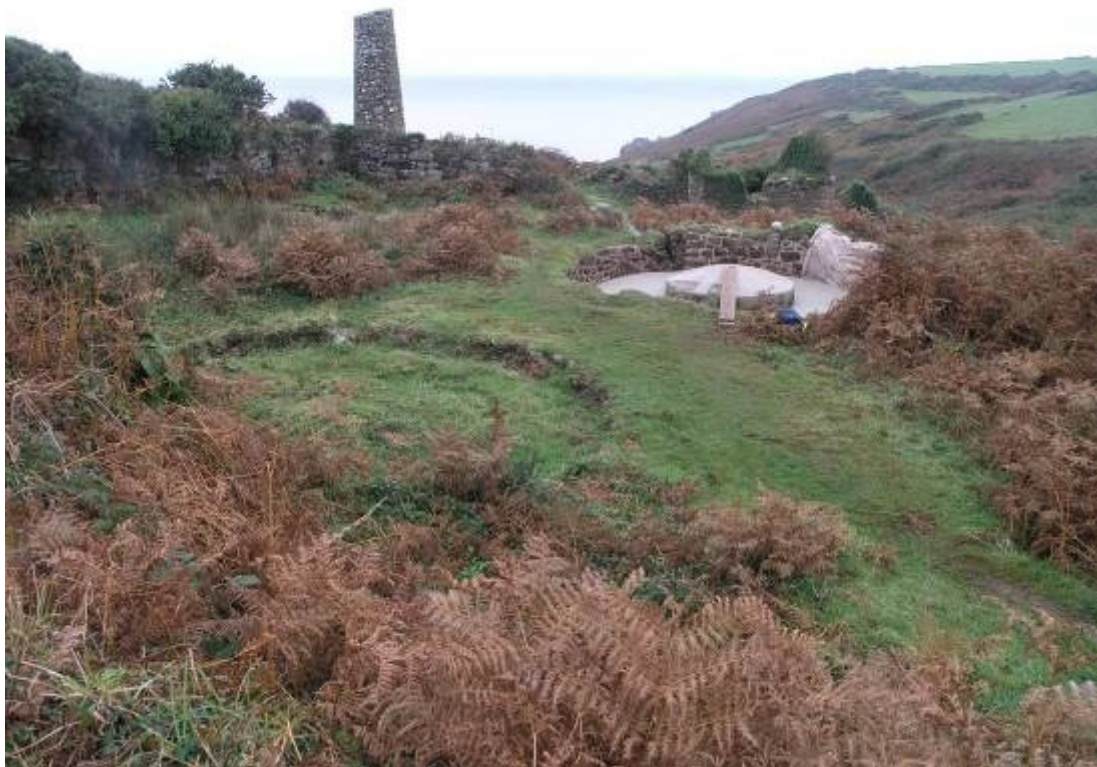
Fig 12. A view over the Porthmeor Stamps dressing floor in 2005 during the conservation of one of its buddles.

One of the buddles on the dressing floor was consolidated in 2005 as part of the St. Just Environmental Enhancement Works project (Fig 12), as this feature had suffered malicious damage in 2003, resulting in its concrete facings being badly damaged.

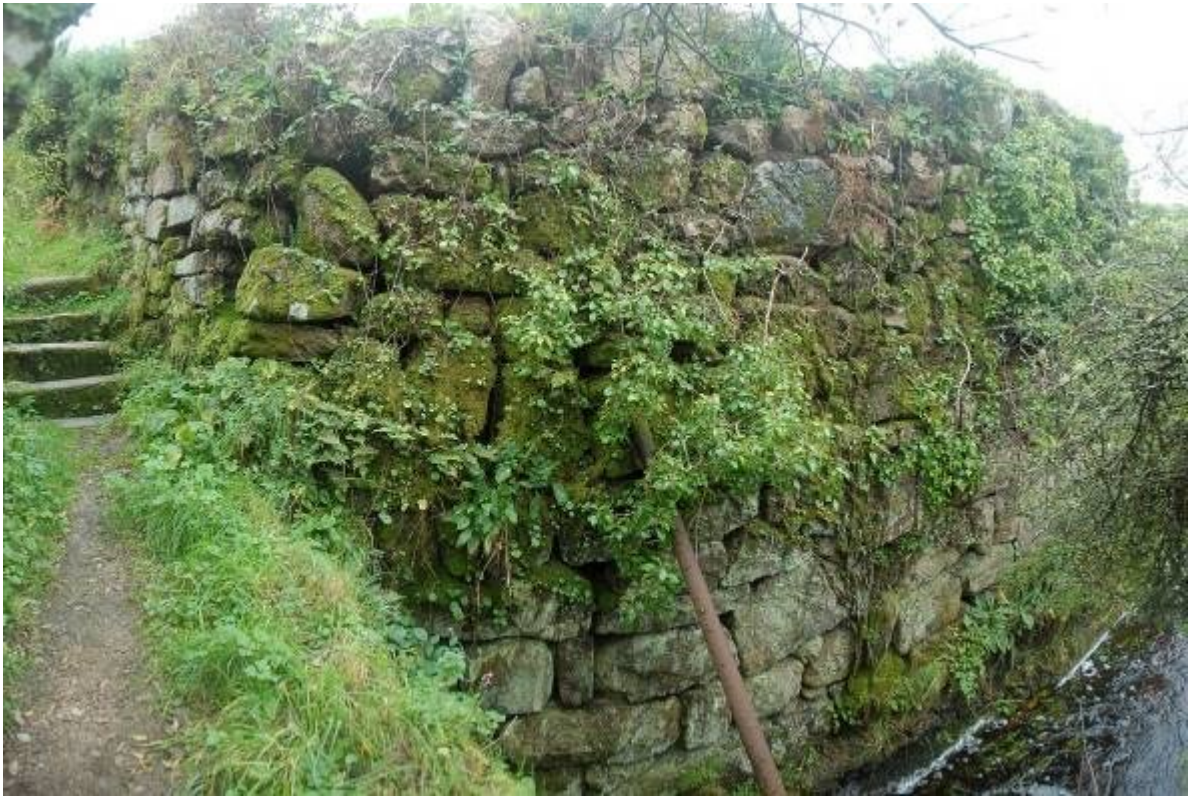
Fig 14. A composite image of the revetment walling to the spalling floor from the north-east showing the Penwith type stile on the Church Path (left) and the steel prop installed in 1987.

Evidence for the repair works carried out by the NT MSC Team in 1987 takes the form of a single surviving, very rusty tubular steel strut diagonally set so as to pick up the southern end of the walling just above its midpoint. A further collapsed strut lies in the stream, having originally supported the wall a little to the north of the surviving strut. A mass concrete facing at the foot of the wall also may also date to this attempt to consolidate the wall, or may be a feature created during the 1920s reworking in order

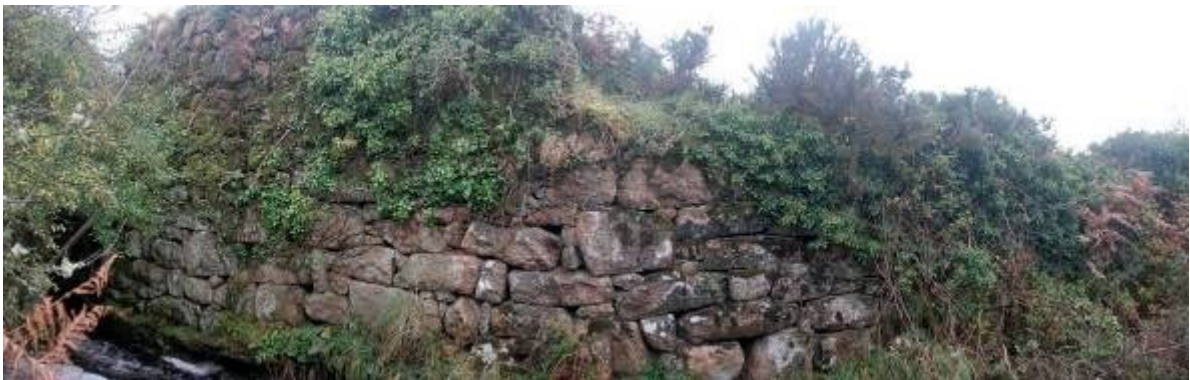
Fig 15. A composite image of the walling of the spalling floor (left) and wheelpit (right) from the east prior to vegetation removal in the winter of 2011/12.

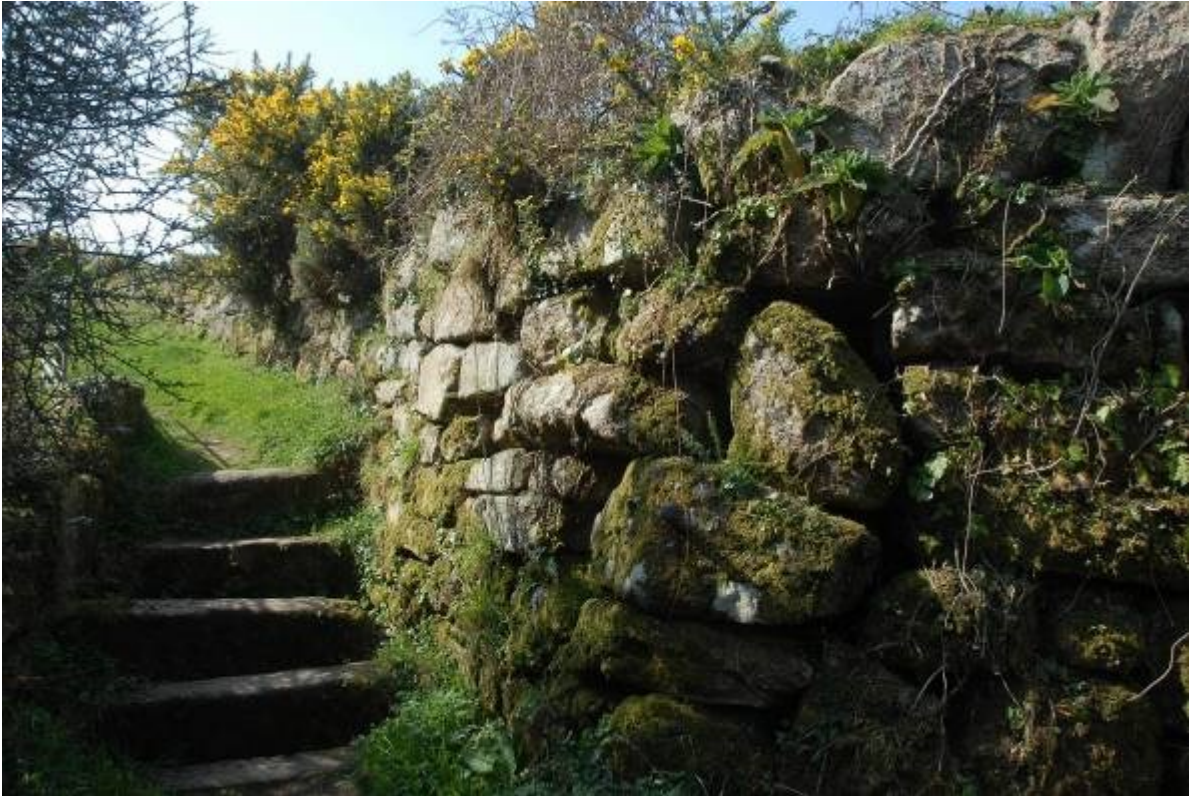
Stone movement caused by a combination of poor original build and loss of bedding soil is most apparent at the southern corner of the wall where it returns to the west. Significant voids and clearly dislodged stones are common in this area, which has the appearance of being on the verge of collapse in its upper half. The opening up of joints between stones through movement provides pathways for enhanced water ingress and the potential for further bedding soil to wash out, accelerating this process.

Fig 16. Looking west along the Church Path, showing the West Penwith stile and the poor condition of the corner of the spalling floor walling at this point.

Whilst the wheelpit walling is essentially stable and does not require conservation works such as pointing at this stage, sections of the spalling floor walling, particularly at its southern end, will require major works which will, of necessity, entail their dismantling

and reconstruction. The present survey should be used to guide this work, though it is recommended that any stones to be removed and replaced should be numbered and photographed in advance of the work taking place. Some stones forming the top course of the wall near its centre have been lost, and should be reinstated, as should those forming the top courses of the wall flanking the Church Path near its eastern end, and those lost or dislodged at its western end.

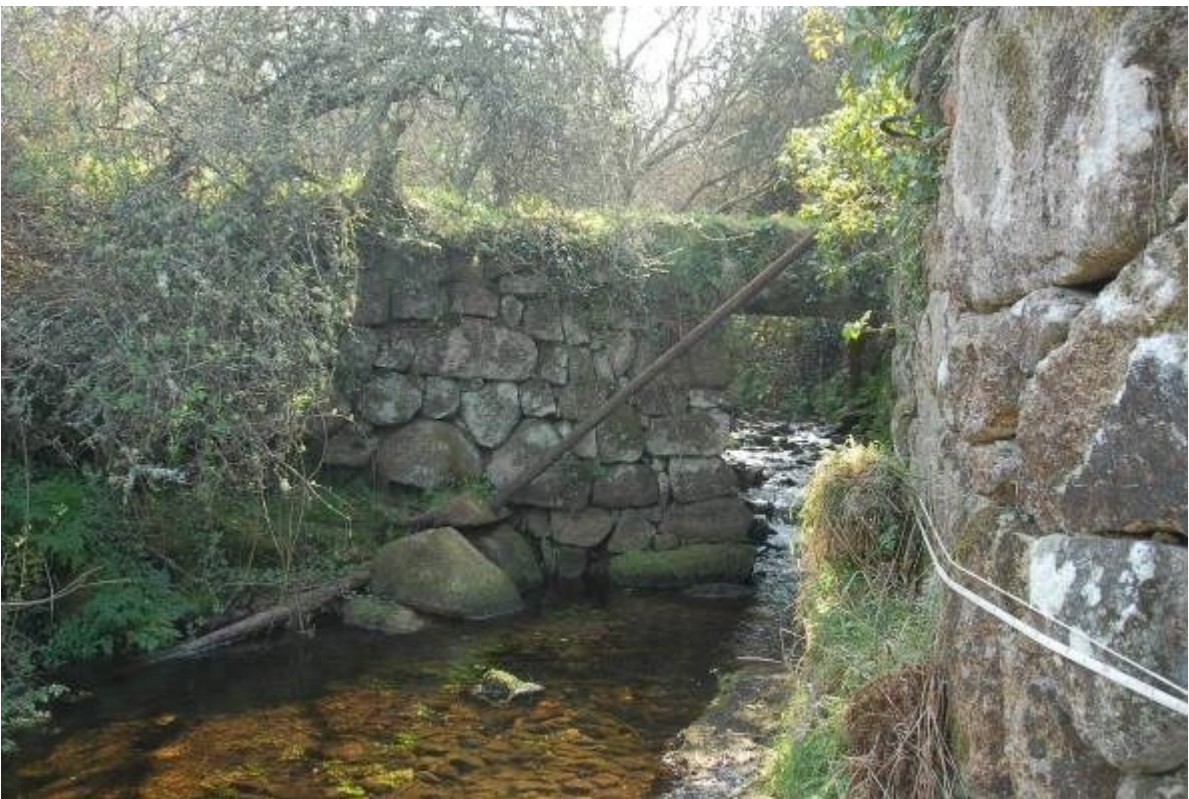
Fig 17. Looking south along the course of the stream showing the masonry buttress for the Church Path bridge and the tubular steel struts installed in the 1980s (one has now fallen into the stream).

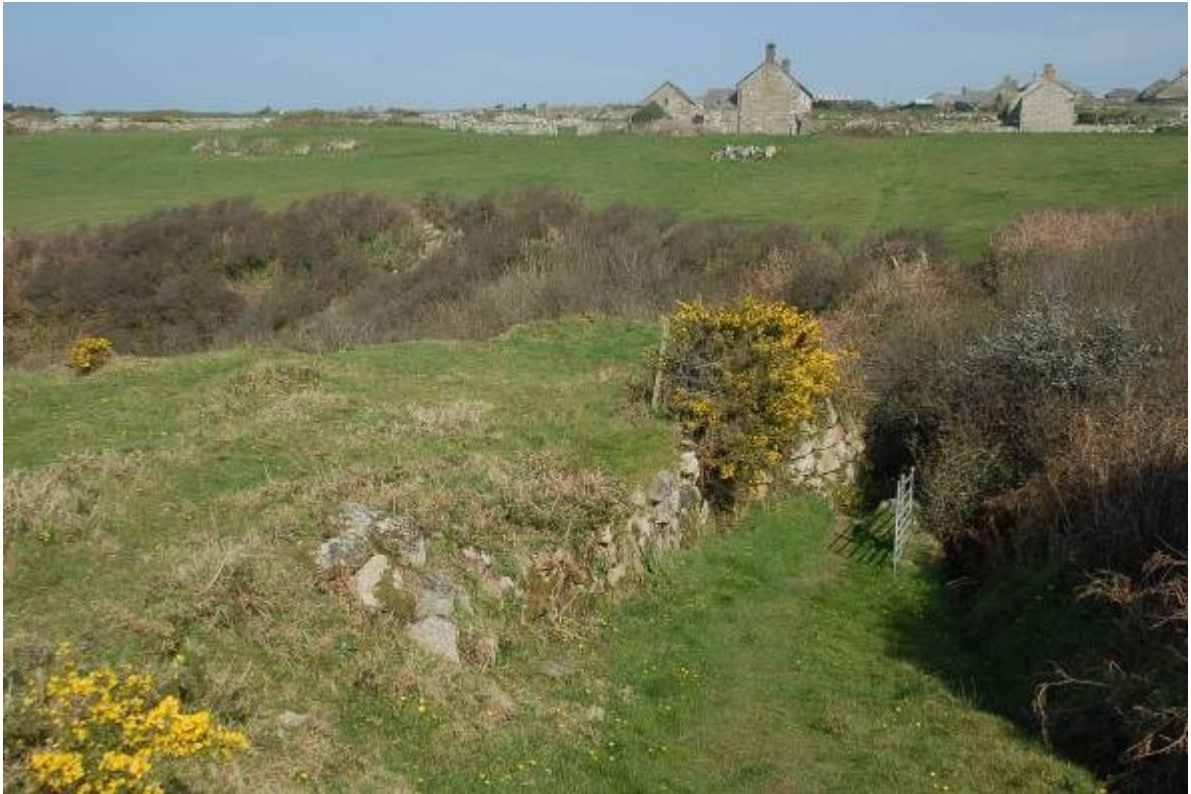
Fig 18. Looking east down the Zennor Church Path, with the spalling floor on its northern side.

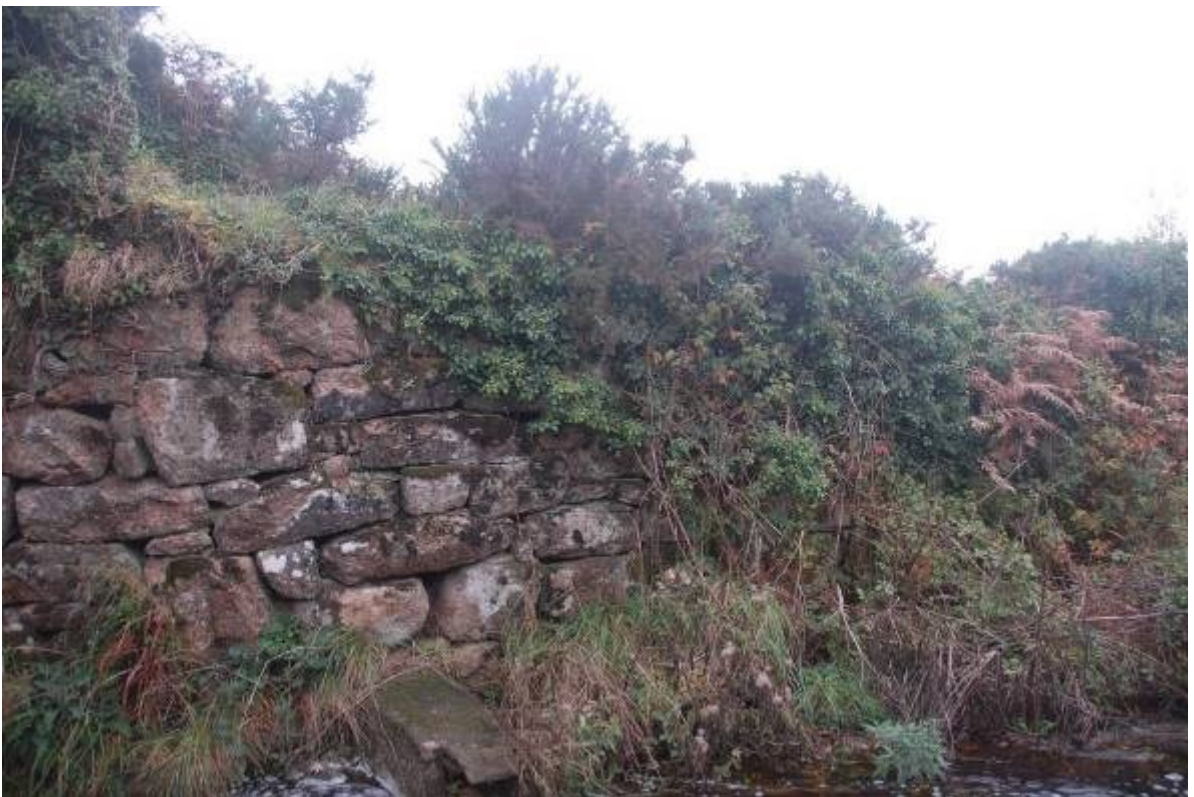
Fig 19. Looking across the stream to the wheelpit walling prior to the clearance of some of the obscuring vegetation. The concrete dam is just left of centre at the base of the wall.

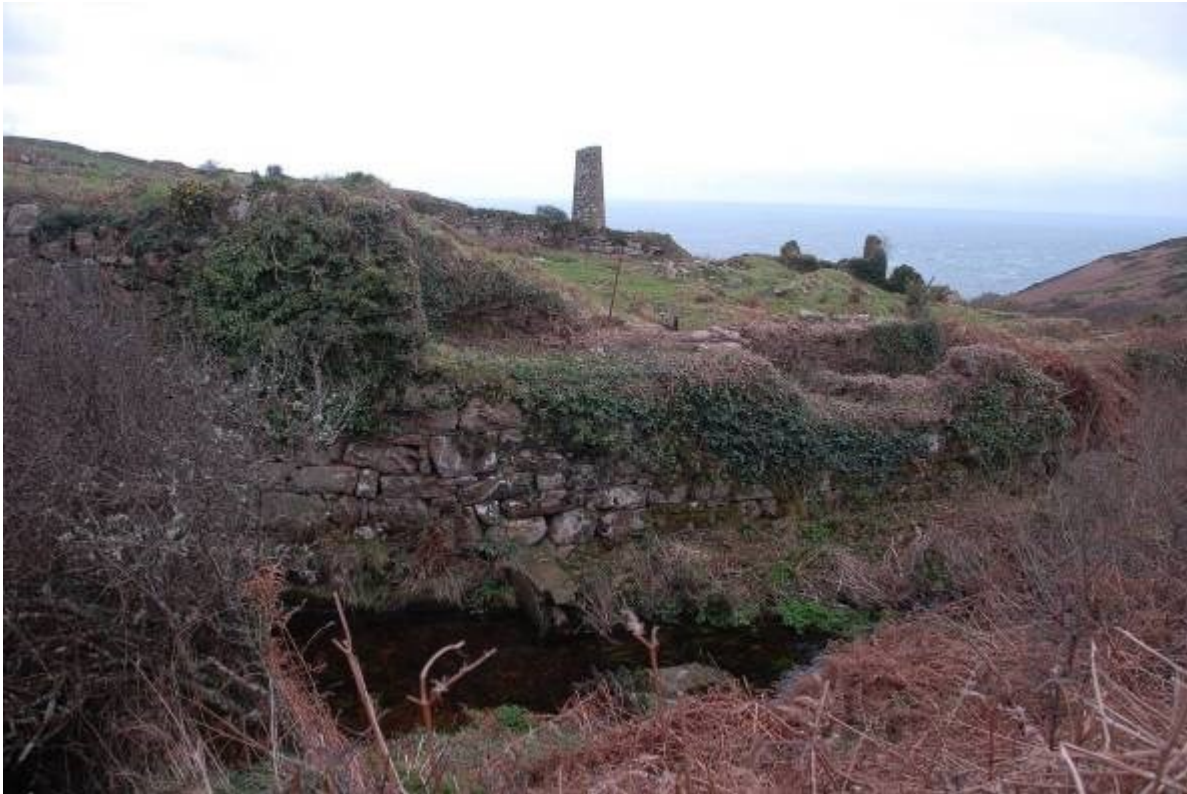
Fig 20. The spalling floor and wheelpit walling from the east following the removal of some of the obscuring vegetation by NT volunteer Rangers.

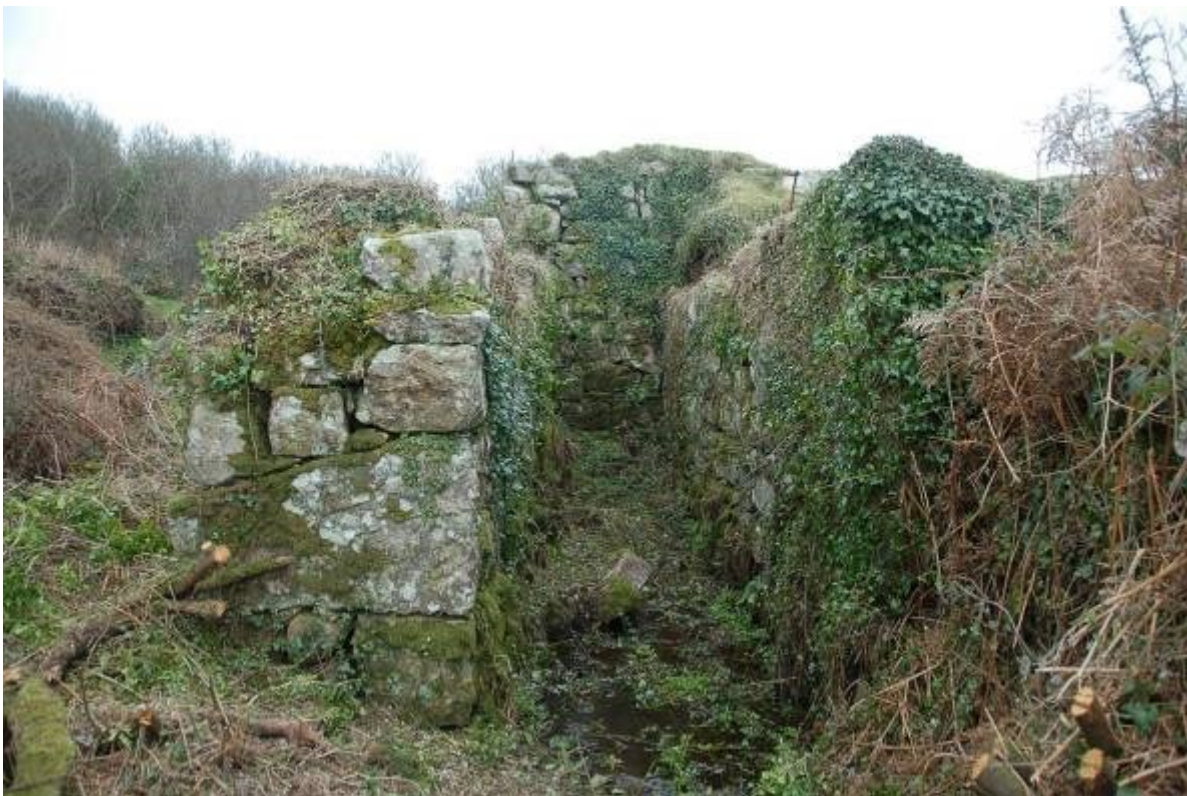
The eastern section of walling defining the eastern wall of the wheelpit is integral with that of the spalling floor wall, rises to 2.6m above the stream water level and has a more or less level upper surface at its southern end, though has clearly lost some of its stone topping to the north. Being double faced, it has not had to withstand the pressure of embanked soil like the spalling floor walling, though did have to support the weight of the water wheel, and resist the dynamic forces which the wheel would have exerted on it when in use. Both faces of the wall are vertical, and again, have been constructed of roughly shaped and coursed granite masonry. The wheelpit measures 10.6m long x 1.8m wide internally – on the large side for a Zennor wheelpit – and would have (just) accommodated the documented 32' diameter wheel. The internal walls of the wheelpit are currently 2.6m high, though, as mentioned above, the base of the wheelpit is currently infilled, probably to a depth of about 2.0m. The pit is open-ended to the north, discharging to a partly-backfilled tailrace leading northwards to the stream, the western side of which is formed by a partly-revetted earth slope forming the edge of the dressing floors, the eastern side by a low earth bank.

Fig 21. The interior of the wheelpit from the north following vegetation clearance.

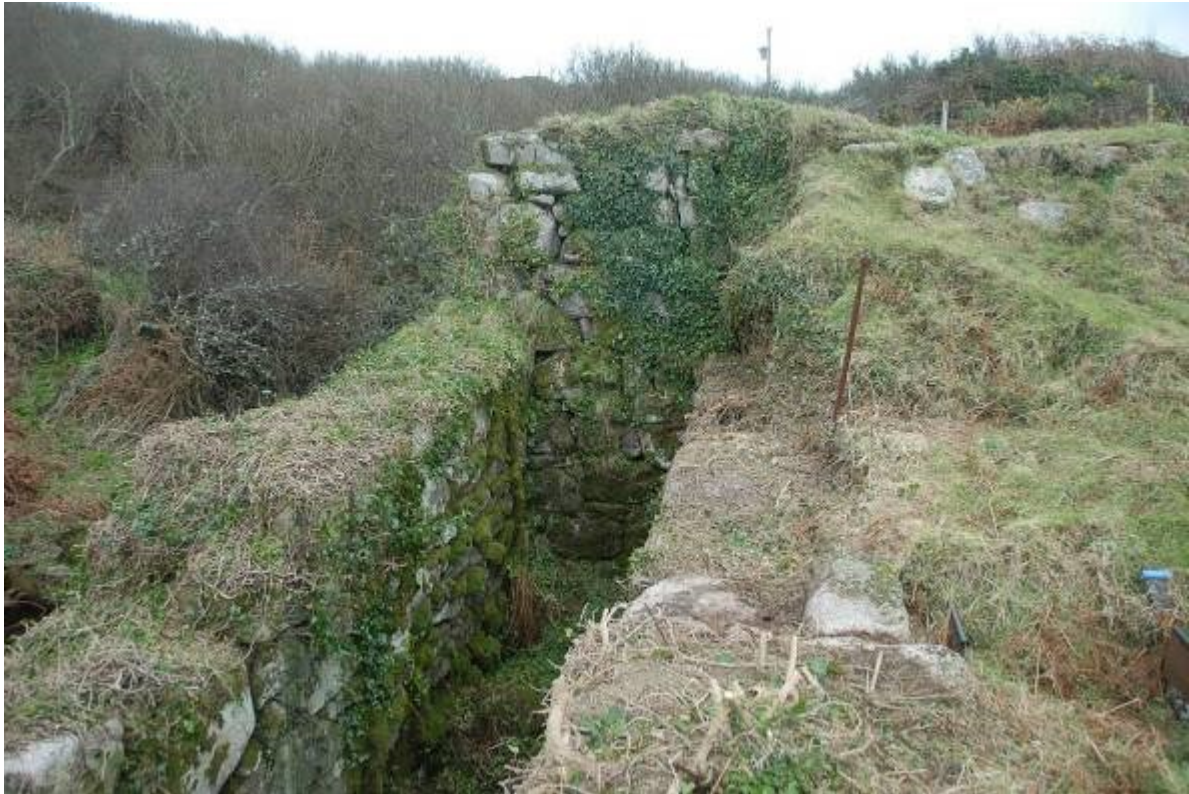
Fig 22. An overview of the wheelpit looking back towards the spalling floor. One of the stamps hold down bolts survives just to the rear of the location of the waterwheel axle.

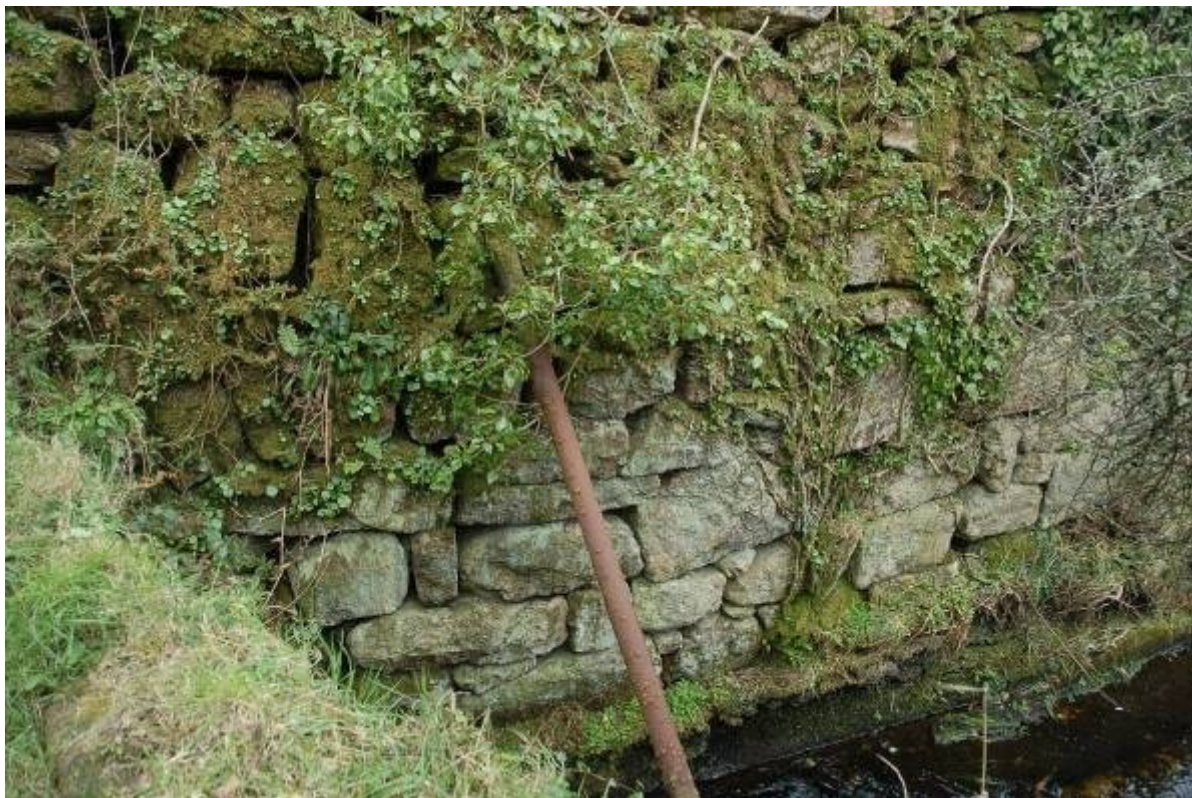
The clapper bridge over the stream which carries the Zennor Church Path is made up of three substantial granite slabs topped with soil retained by two lines of edging stones. These slabs have been tied into the lower courses of the spalling floor walling, and are supported on barely coursed substantial pieces of roughly-shaped granite which have, in places, major voids between them. Whilst the upper faces of the bridge slabs are more or less level (though covered with the thick layer of compacted soil), the undersides are uneven, and have been packed up with smaller stones to level up their top surfaces.

Fig 23. The lower section of the spalling floor wall adjacent to the bridge, showing the more open jointed and partly dislodged masonry in the upper part of the wall, the surviving steel strut, and the band of mass concrete along the foot of the wall.

The mass concrete at the base of the wall has, as mentioned above, been undermined by the flash flood, and water appears to be making its way underneath it, and under the wall stones, potentially continuing to wash out earth fills and contributing to ongoing destabilisation. The existing concrete will need to be broken away and replaced; the replacement concrete will probably need to be securely pinned into bedrock using stainless steel reinforcing bars and grouted into the basal courses of the wall.
