Clinnick culvert, A38 Glynn Valley, Cornwall

Archaeological assessment

Report No
2012R026

Clinnick culvert, A38 Glynn Valley,
Cornwall: Archaeological assessment

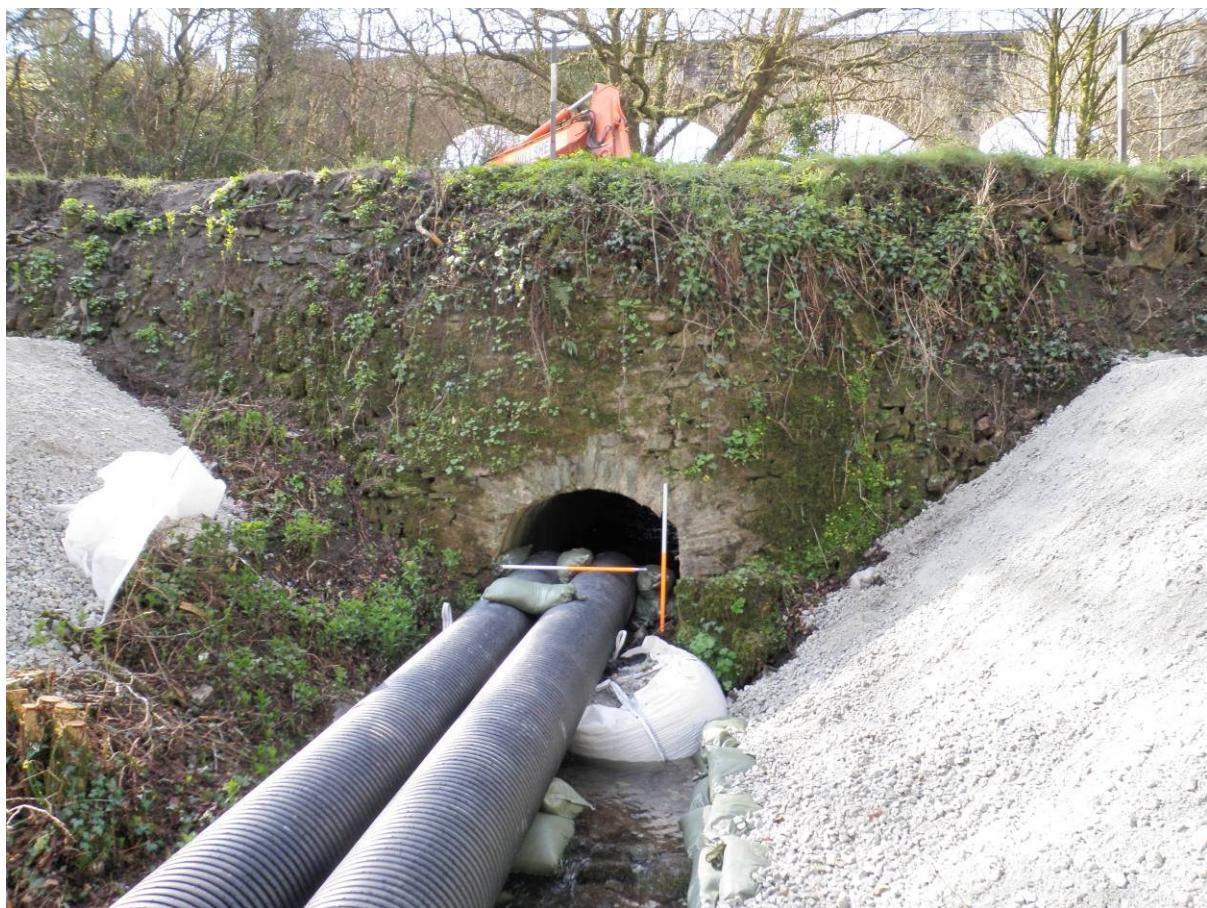
Front cover: north portal of Clinnick culvert

Clinnick culvert and its associated causeway carries the A38 road over a stream flowing northwards into the River Fowey. It comprises a straight tunnel spanning the full width of the road. The tunnel is built of slate rubble stone, probably locally quarried, and its

portal is built as a slate shallow arch 1.4m wide and 0.9m high at the centre. The imposts of the arch are 0.6m above a concrete invert, the latter presumably added to prevent potential scour damage to the stream bed during high rainfall.

The masonry above the culvert portal is horizontally-laid slate rubble, originally bedded in lime mortar. Within the culvert the mortar has been replaced with cement-based material.

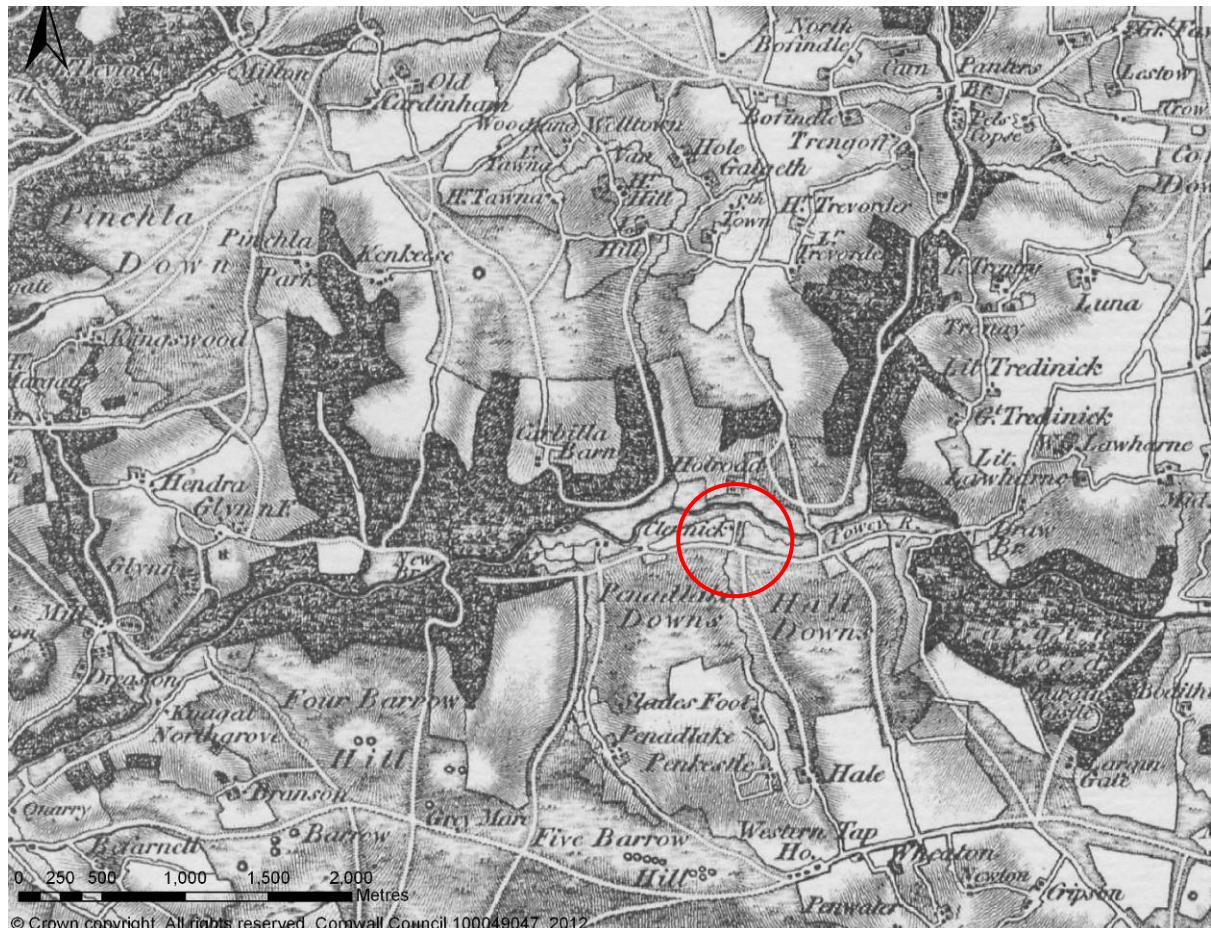
Fig 2 Extract from Thomas Martyn's 1748 map of Cornwall

Thomas Martyn's 1748 map of Cornwall (Fig 2) shows the farmstead of Clennick (sic) with an unfenced road running E-W along the valley to its south. This stretch of road, running westwards from Drawbridge (where the Halfway House public house is sited) and connecting with the trackways over Taphouse Ridge, appears to have been forded over the streams. The c1809 OS map (Fig 3) also shows this road. The remainder of the road in the Glynn Valley, such as the stretch close to what is now Bodmin Parkway station, running eastward towards Bellasize, was not then constructed. Similarly the part of the Glynn Valley road by Twowatersfoot was not in existence in the early 19th century.

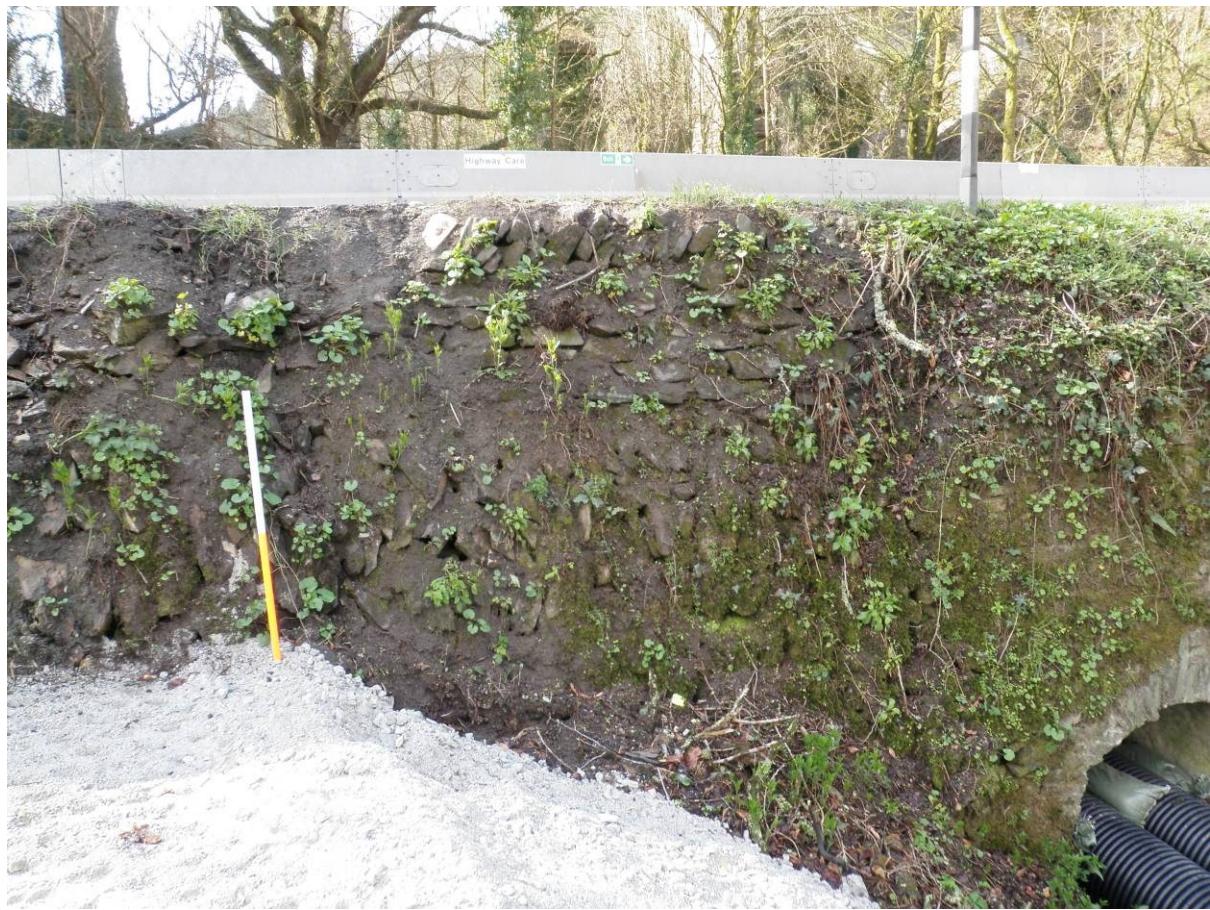
Fig 9 Revetment of the causeway east of the culvert

The road is now carried on an embankment/causeway that rises above the level of the masonry portal of the culvert. On each side of the culvert portal, the retaining wall supporting the causeway is built of un-mortared vertically-laid slate rubble. This masonry now shows much sign of failure, including bulges and loss of facing particularly west of the culvert. On the east side of the culvert portal the higher levels of retaining wall contain horizontally-laid slate rubble with two courses of herring-bone pattern above. This may be either a repair or represents the remainder of an earlier parapet hedge, the southern side of which is now infilled with the modern raised roadway.

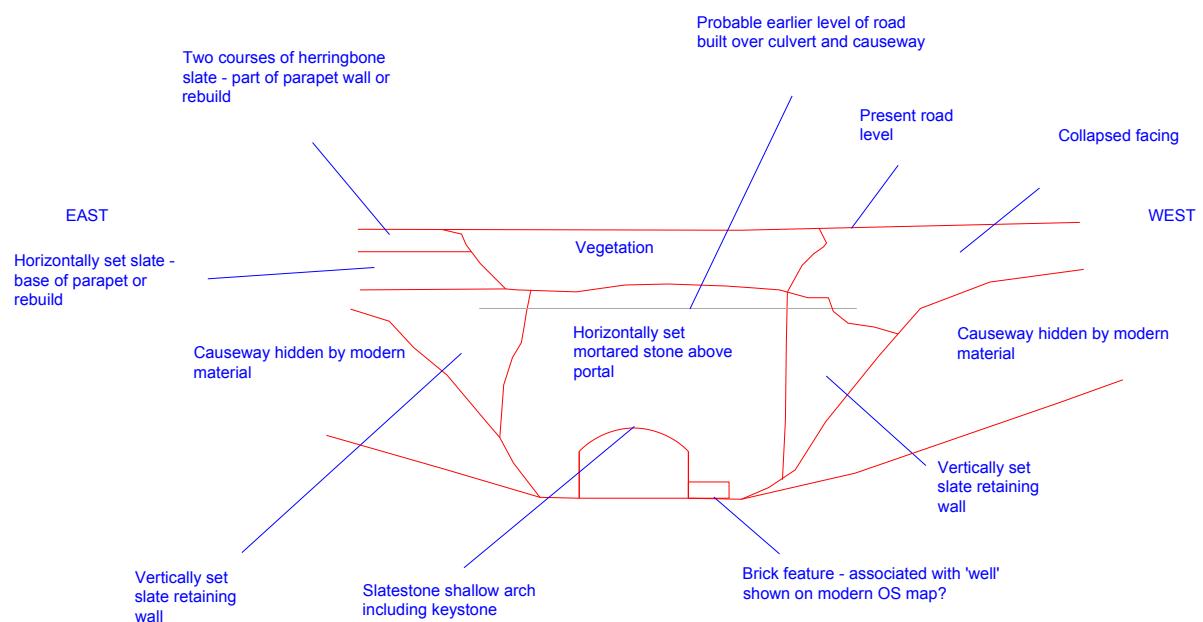
Fig 10 Sketch of the northern portal, with related features

A well is marked north of the culvert on the modern OS mapping (Fig 6); this is not shown on the early large scale OS surveys (Figs 4 and 5). A single skin red brick-built structure adjoining the west side of the culvert portal may be associated.
