# **Royal Cornwall Infirmary, Truro Cornwall**

## **Archaeological recording**

<b>Client</b>	<b>Linden Homes</b>
<b>Report Number</b>	<b>2012R035</b>
<b>Date</b>	<b>May 2012</b>
<b>Status</b>	<b>Final</b>
<b>Report author(s)</b>	<b>Jo Sturgess</b>
<b>Checked by</b>	<b>Nigel Thomas</b>
<b>Approved by</b>	<b>Andy Jones</b>

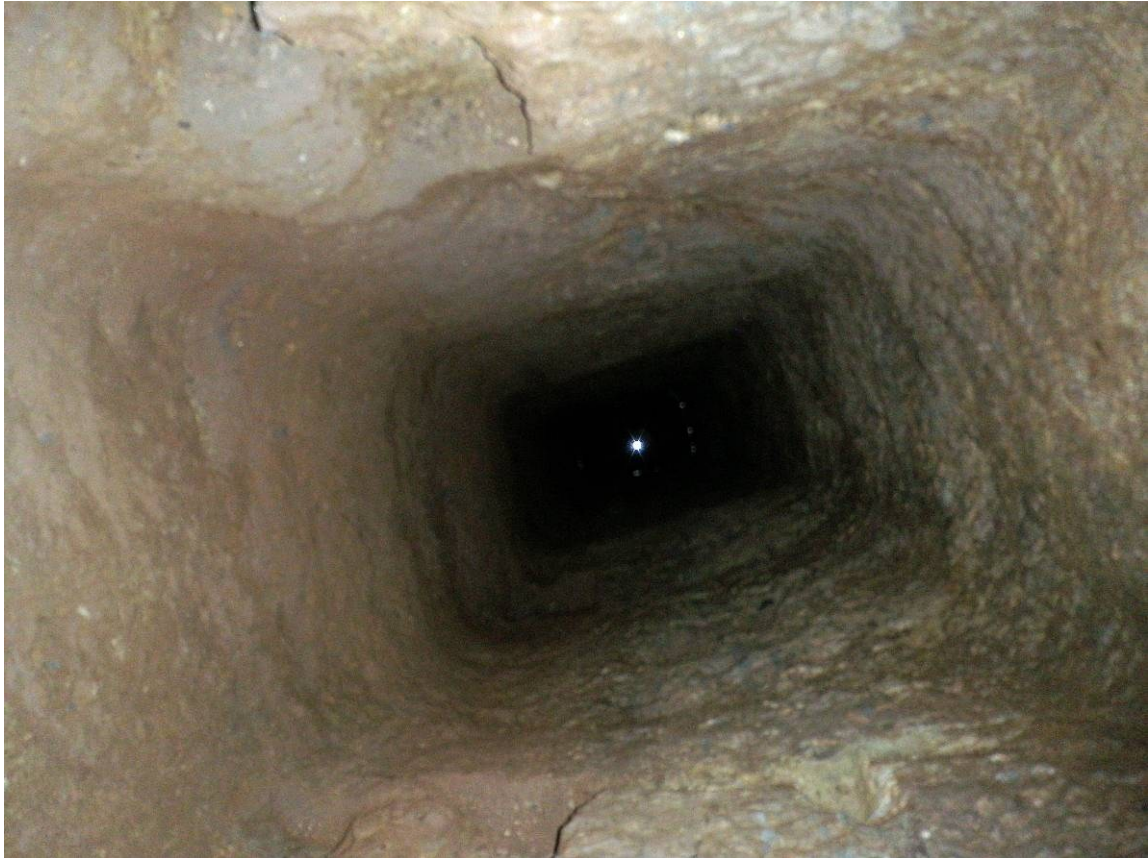
The well (Fig 9), located to the north-west of the centre of the room adjacent to a fireplace in the north-west wall, comprised an un-lined, sub-rectangular shaft with rounded corners cut through the slate bedrock to a depth of at least 17m. The shaft was aligned roughly north-south and did not match the alignment of the building, suggesting that it may have been present before the construction of the Infirmary. It measured approximately 1m north-south by 0.6m east-west except in the top metre where the opening widened into an irregular cut measuring approximately 2m north-south by 1m east-west. It seems likely that the irregular cut at the top of the shaft was caused by the removal of a well head structure (probably a hand pump at a later date). Cut into the east and west sides of the top half of the shaft were a series of rounded sockets which may have originally supported timber staged platforms used either

during construction or to ease lifting of buckets during use. Alternatively they may have supported timber lining in the upper section of well. The top of the water lies at 13.5m below the floor surface and appears deep turquoise in colour.

*Fig 9 View down the well*

The well is almost certainly earlier than the infirmary building in a constructional sense since its alignment is not square with the building. The sinking of the well shaft probably took place before the building was erected around it. The well is, however, likely to have been used throughout most of the history of the building's use and is conveniently located close to the former kitchen within the service area of the building. The discovery of a lead pipe feeding into the well suggests that at some point the top was covered and a hand pump installed.

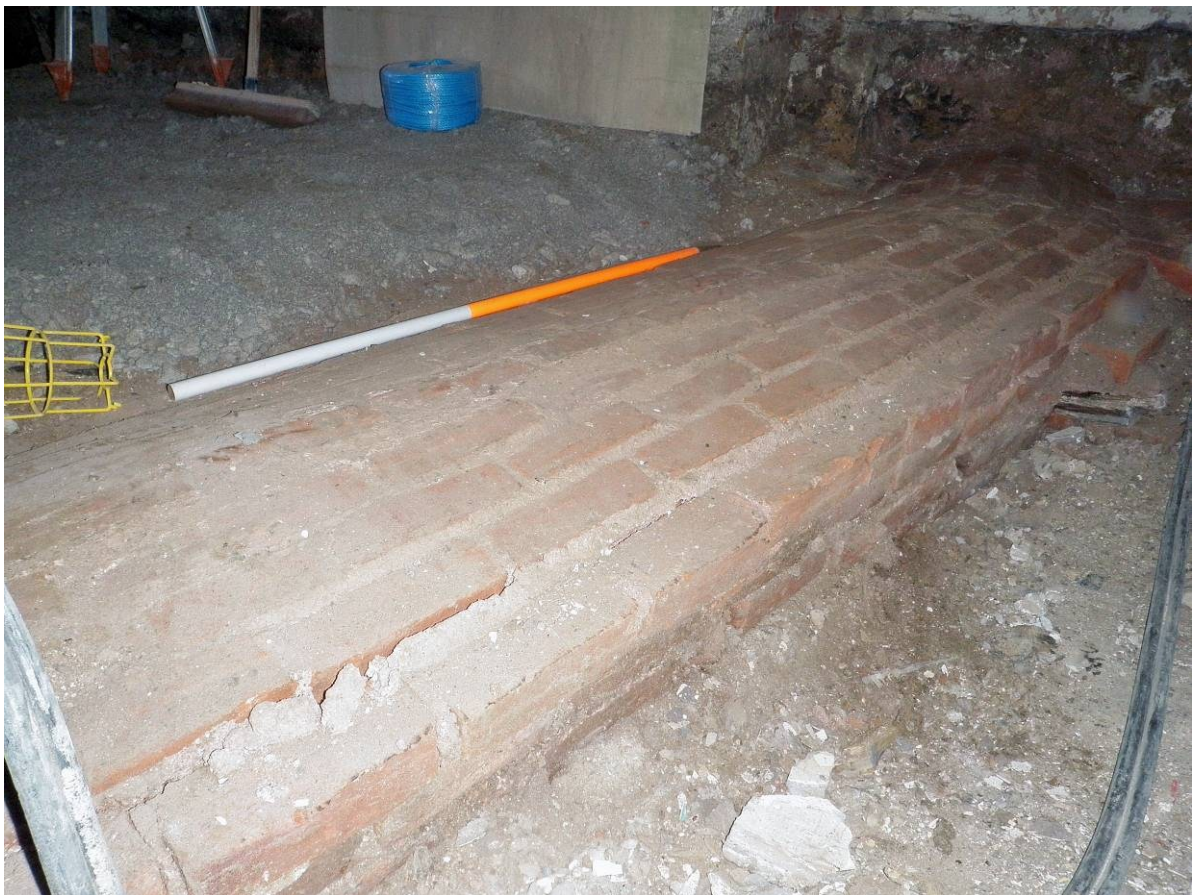
At the time of the site visit the top of the culvert, located below the floor level in a former kitchen, had been exposed and cleaned by the building contractors (Figs 10 and 11). This feature was aligned approximately north-south crossing the length of the room and entering through a doorway in the south-east wall and exiting through a doorway in the north-west wall where it could be seen continuing through into the next room although had been truncated close to the door opening by later ground disturbance. The culvert was set in a trench dug through the slate bedrock measuring 0.78m wide by 0.78m with vertical sides and a flat base. The cut was lined on the base and sides with red brick bonded with lime mortar and capped on the top with arched, stretcher bond brickwork also bonded with lime mortar. Each brick measured 0.23m x 0.08m x 0.07m. The culvert sloped down gently from south to north and internally was filled almost to the top with a layer of mid greyish brown silty clay containing frequent small shillet fragments and occasional flecks/small fragments of coal.

*Fig 10 Brick culvert looking north-west*

The brick culvert is a later, inserted feature (19<sup>th</sup> century) and has no association with the well. It is clear that it was constructed after the part of the building in which it is located, since it has been designed to pass through existing door openings. This part of the building appears to have been constructed at some point between 1831 and 1848 (Figs 3 and 4) although Symons map of Truro dated 1831 may not be wholly accurate and this south-west range is more likely to be part of the original build. The original extent of the culvert to the south-east and north-west is unknown but it was presumably inserted to drain water (either external surface water or waste water from a wash room) under the building from the south-east side leading out to the north-west.

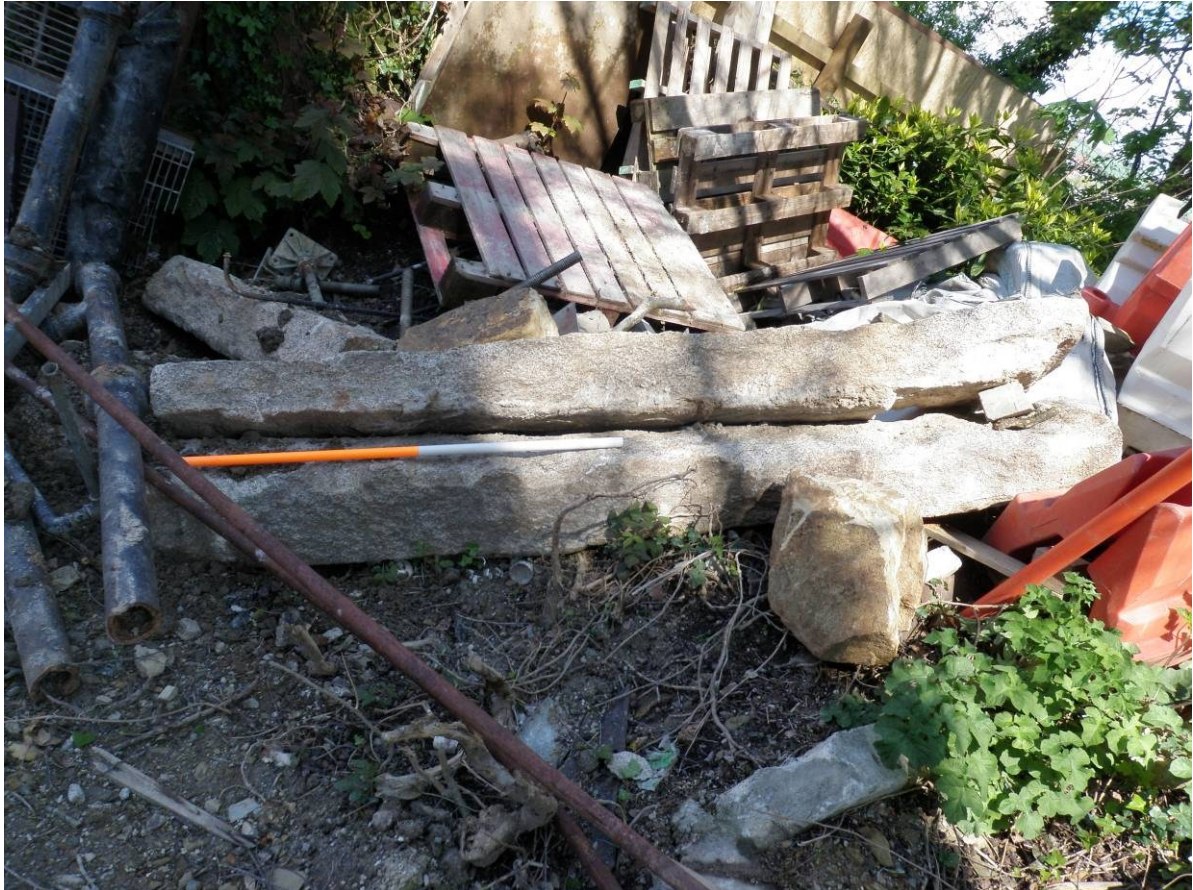
When the floor was removed in the room containing the well three large reused granite posts or lintels were revealed covering top of the well opening (Fig 13). A lead pipe was also noted feeding into the opening. Due to safety concerns the posts/lintels and lead pipe were removed and the well was capped with a concrete slab prior to the site visit. The granite posts/lintels were later found to be 18<sup>th</sup> century or earlier evidenced by wedge splitting quarry marks (Fig 13).

*Fig 13 Reused granite pillars/lintels found covering the well. Wedge splitting marks indicate a pre 1800 date.*
