South West Coast Path Project, South Hams, Devon Archaeological recording

South West Coast Path Project
Archaeological impact assessments of
sites at Burgh Island, Torcross and West Soar,
South Hams, Devon

Client	South West Coast Path Project Team (Jo Kiddell)
Report Number	2014R001
Date	January 2014
Status	Final
Report author	Colin Buck
Checked by	Andy Jones
Approved by	Andrew Young

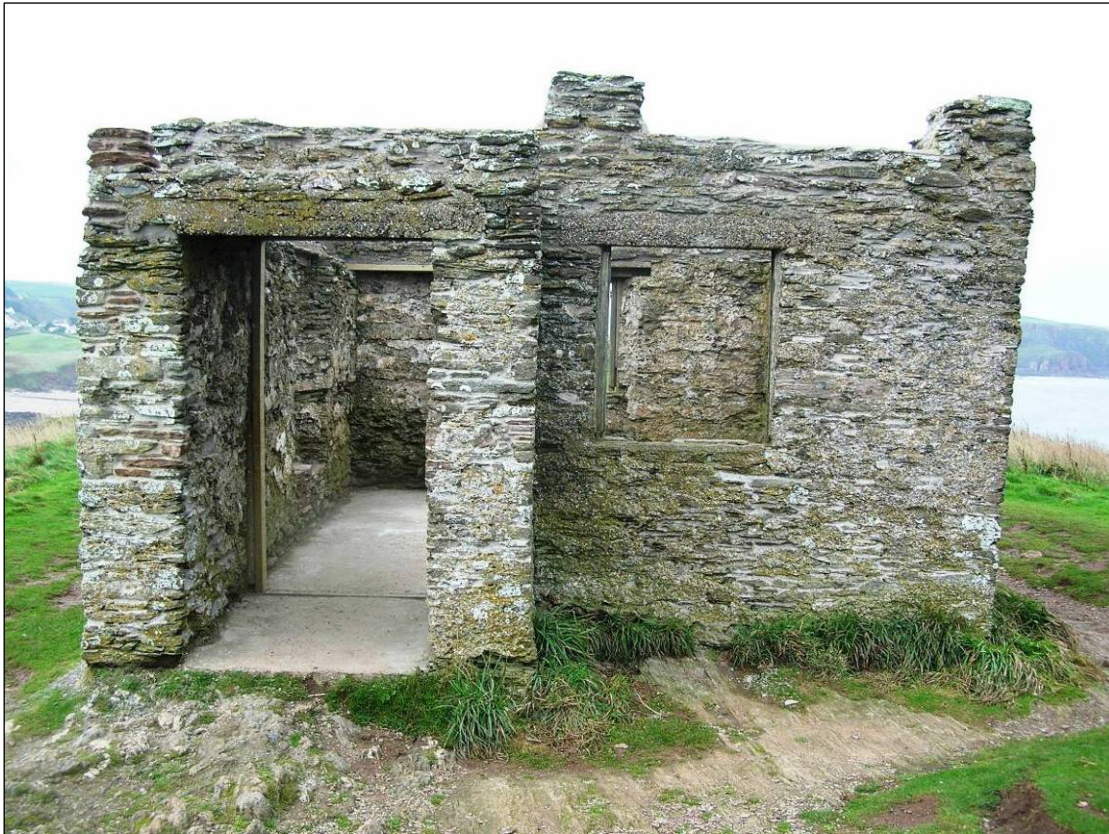
Figure 2 External view (from the west) of the Huer's observation building after works showing porch and windows © HE Projects, CC 24/10/2013.

Work on this building fell into three categories: Lime repointing, cement and concrete repairs and timber repairs (replacement). The extent of the lime repointing can be seen with reference to the 'after works' images shown in Figures 2 and 3 (and see front cover), whilst the internal and external elevational 'as-built' surveys are also indicative. Generally speaking, the western side of the building needed more repointing than its eastern equivalent, and the exterior to a greater extent than the interior. Given the greater degree of weathering on the west side, the external eastern elevation still had evidence of the original 'lime rendering'.

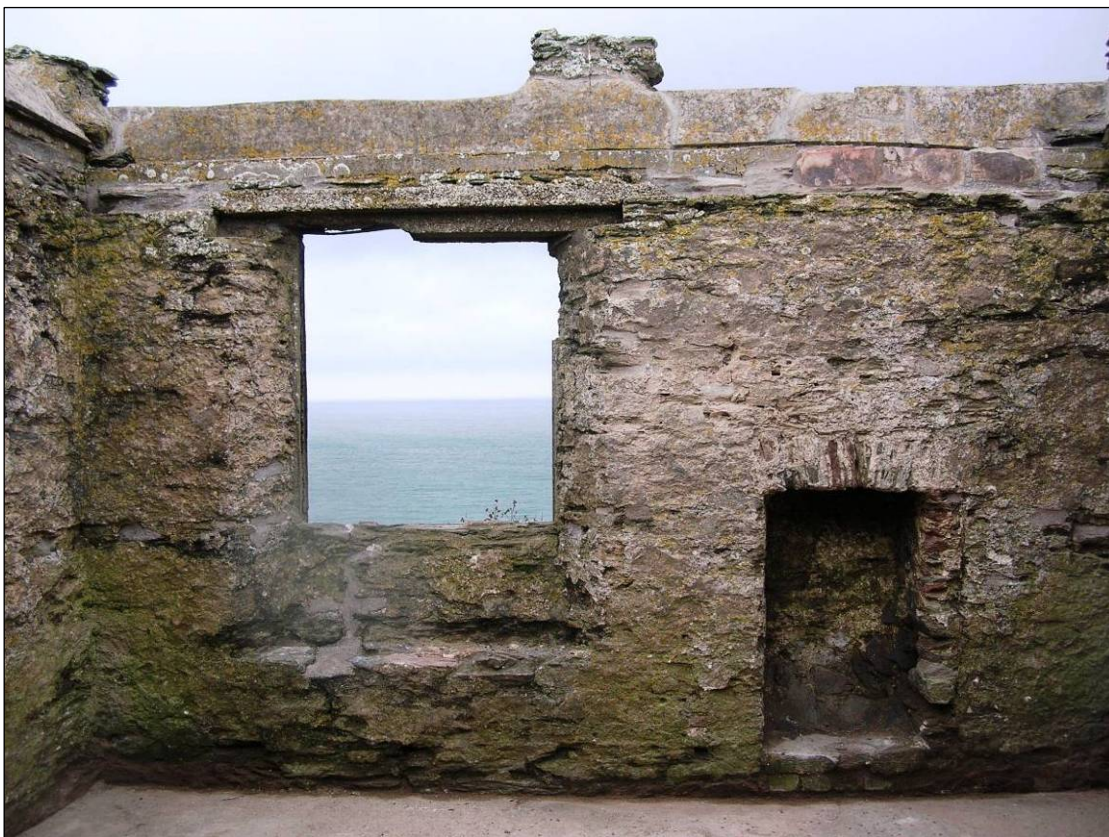
Figure 3 Internal view (from the north) of the Huer's observation building after works showing fireplace, window and WWII roof line © HE Projects, CC 24/10/2013.

On the internal West Elevation, some of the stonework above the existing lintel with the blocked up door has become detached. Consequently, it was agreed that a new timber lintel will be installed and the stonework replaced. This is shown on the attached revised Drawing No.B7607/03A. The soffit to the concrete slab over the door entrance on the West Elevation has deteriorated. It was agreed that this area will need to be broken out and repaired using the concrete repair system. This is also identified on revised Drawing No.B7607/03A' (Knevitt email dated 17/9/2013).

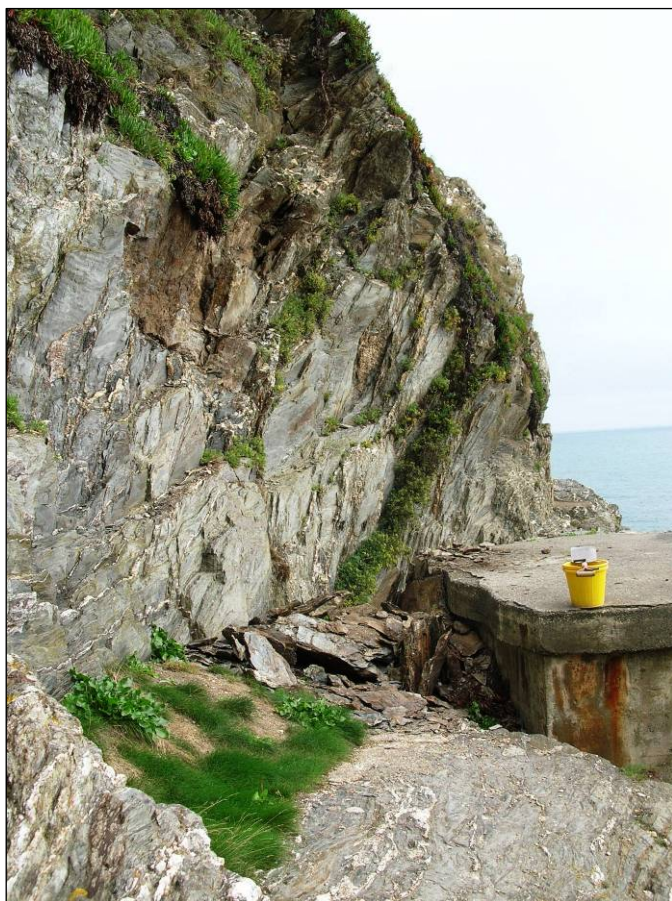
Figure 7 Image (from the west) of the Outflow pillbox rock face collapse
© HE Projects, CC 7/10/2013.

Preparatory works were undertaken during the first week of October 2013. This included the pointing of a mortar panel on the south side. On the 7th October the mortar panel was photographed during a site visit, but during a night of the weekend before the visit – sections of the near vertical rock face immediately north of the pillbox collapsed onto the ground obscuring the entrance and its north elevation. Given the instability of the rock face, the SWCPT agreed with the recommendation that it was no longer safe for the contractors to undertake further works to this site. Images reproduced as Figures 7 and 8 show the nature and extent of the rock face collapse, whilst Figure 9 is a reproduction of the survey plan and elevation of the pillbox.

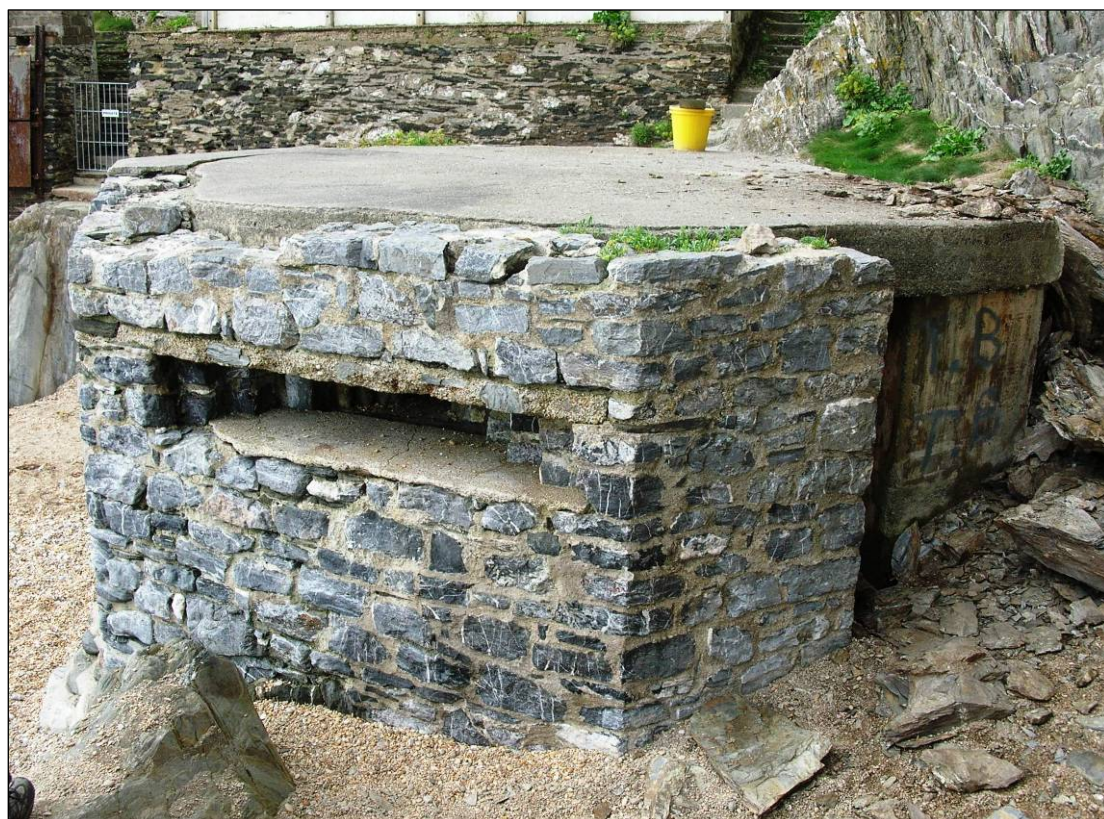
Figure 8 Image (from the east) of the Outflow pillbox rock face collapse © HE Projects,
CC 7/10/2013.

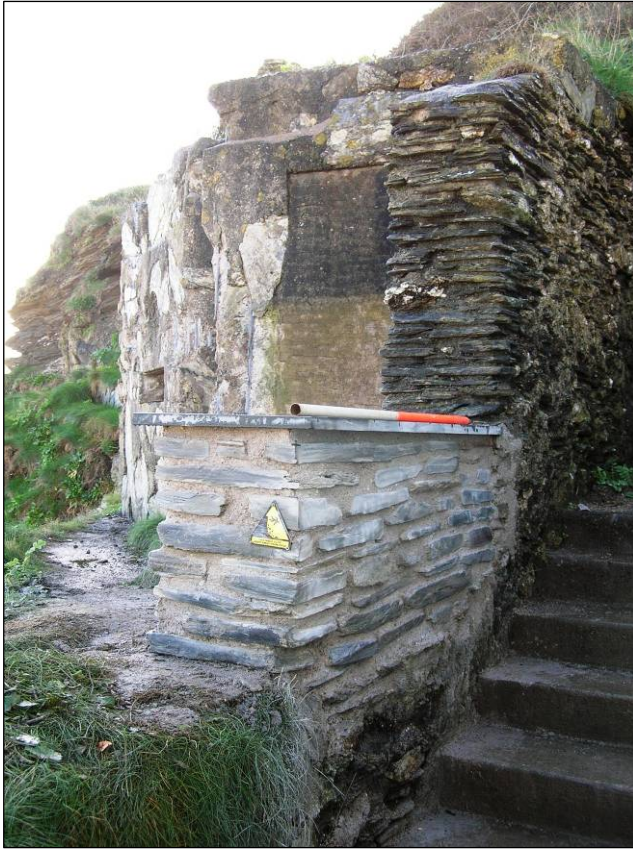
Figure 10 Image (from the north) of the Hotel pillbox repairs and new wall © HE Projects, CC 14/11/2013.

pillbox and the beach below. The HBC suggested that the new walling reflect the style and character of the adjacent (thin slatestone) walling, and that a similar stone was available from Millhill stone quarry near Tavistock. The new stone wall is 0.5m high, 1.2m long, was erected by 14/11/13 and can be seen in Figure 10.

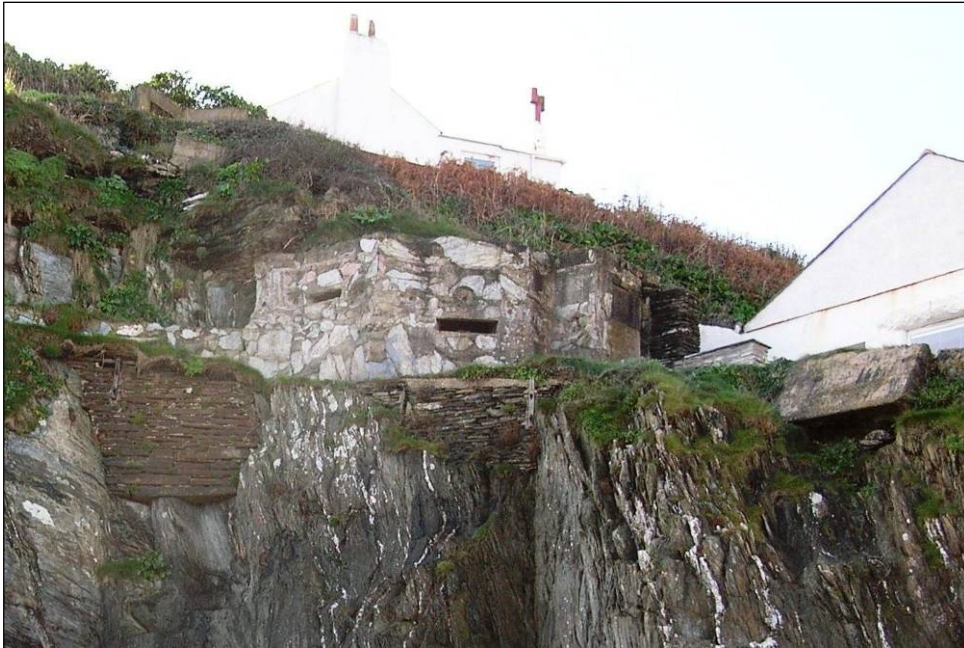
Figure 11 Image (from the south) of the Hotel pillbox works and new wall. The Mortar bunker can be seen top left © HE Projects, CC 14/11/2013.

Minimal conservation works were necessary for this WWII building. Generally, concrete/cement had been mixed with beach pebbles to form lintels with additional iron reinforcing bars. Through time these have been progressively rusting, causing the concrete lintels to split in places. The impact also of ordnance holes (presumably from WWII US beach landing training events), has, in places, through the impact hole, revealed the iron reinforcement. At an early stage it was decided to arrest this process by using 'paint on products' rather than replacing the entire lintels, etc. The concrete treatment used was Fosroc Nitocote SN502, and the reinforcement treatment was Fosroc Nitoprime Zincrich. These materials were painted directly onto the de-laminating iron structural reinforcement. Figure 12 shows the nature and extent of the conservation works although the new section of wall is not shown on plan.

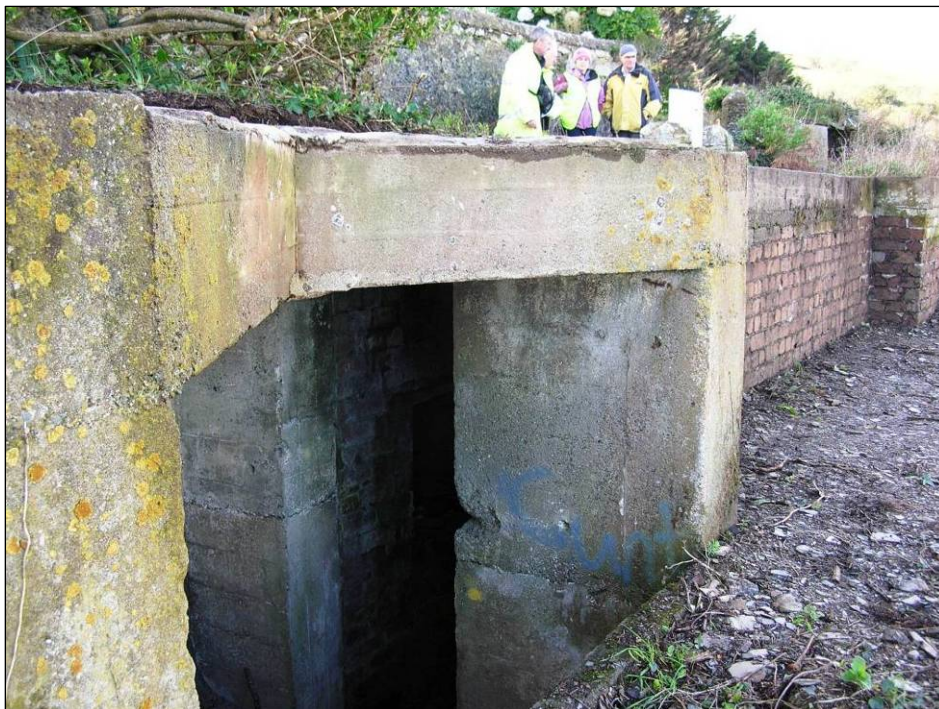
Figure 13 Image (from the east) of the mortar bunker firing point and north side vegetation clearance © HE Projects CC 14/11/2013.

In order to enable the site to be more visible from the adjacent coastal footpath, vegetation and earth clearance from the flat concrete roof of the mortar and ammunition bunker structure was undertaken and some adjacent bushes reduced in height (see front cover image). In addition, as part of longer term site management, vegetation was removed along the north side of the structure, revealing the original sides of the building (see Figs 13 and 14).

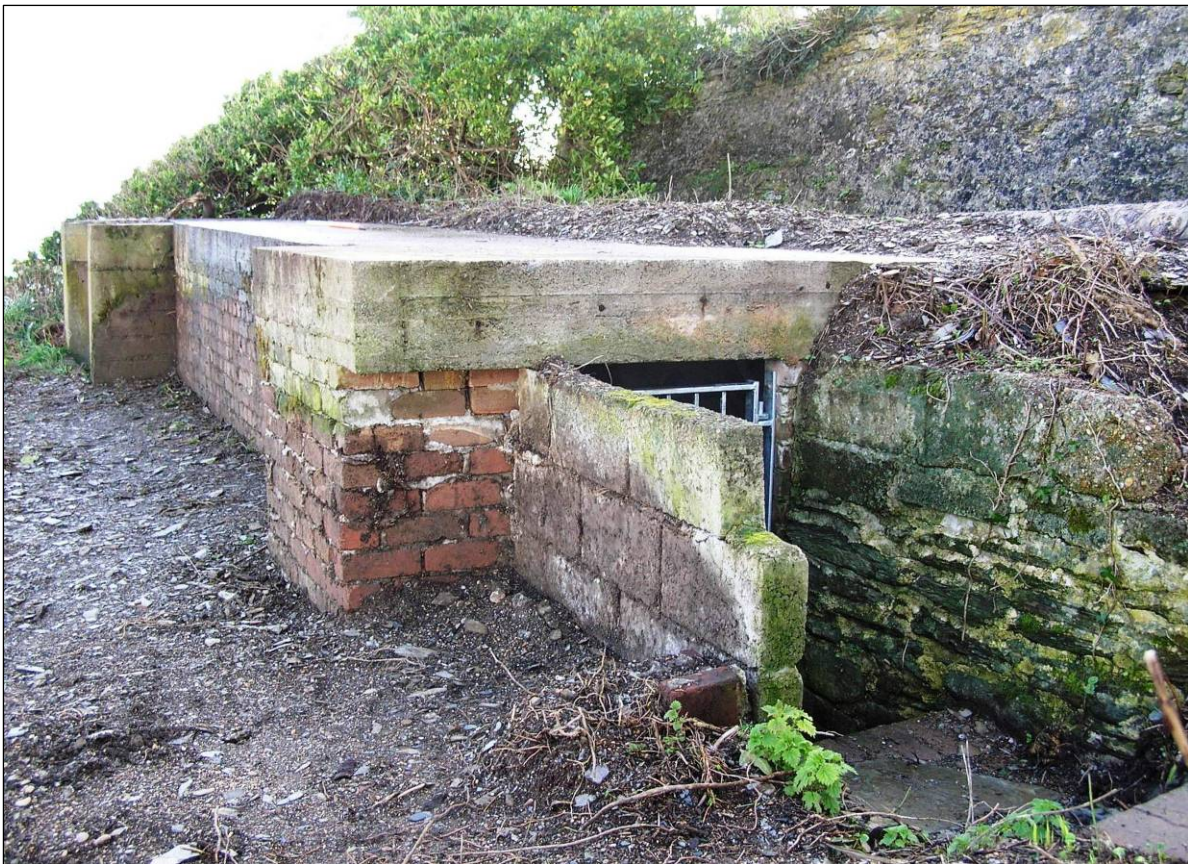
Figure 14 Image (from the west) of the mortar bunker firing point and north side vegetation clearance © HE Projects CC 14/11/2013.

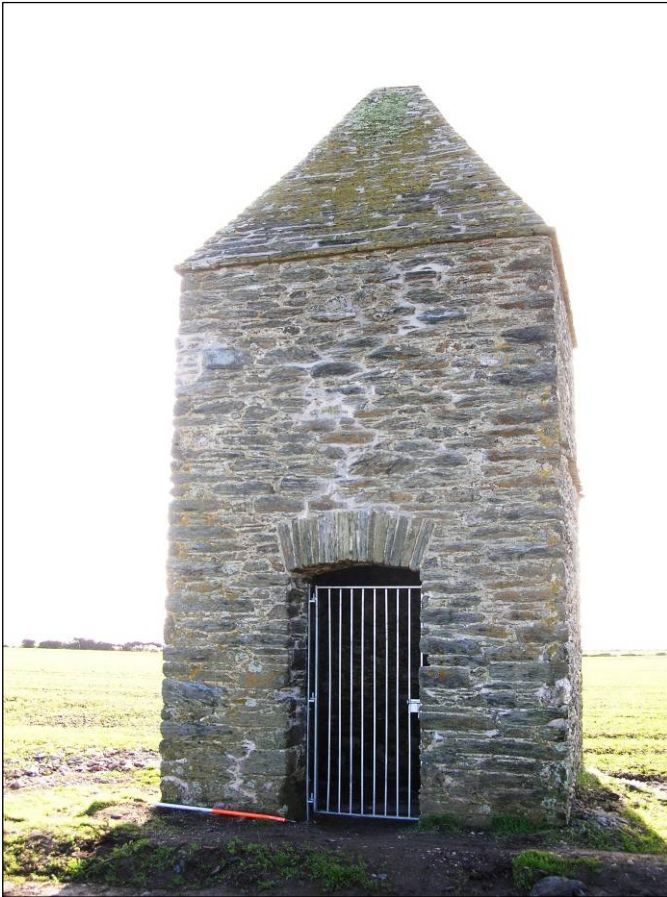
Figure 16 Image of the north side of West Soar Admiralty signal station. New grilled door added © HE Projects CC 14/11/2013.

Externally patch repointing was necessary at all elevations (see Figs 16 to 19) including the stone roof, and internally, a small amount of repointing necessary – especially within cracks in the north and west elevations. A 6mm stainless steel tie bar system was used to stitch the crack in places, as well as stone. The building was scaffolded during the repointing works, and during repointing another piece of ordnance found within the masonry – which again was removed by the MOD Ordnance Team.

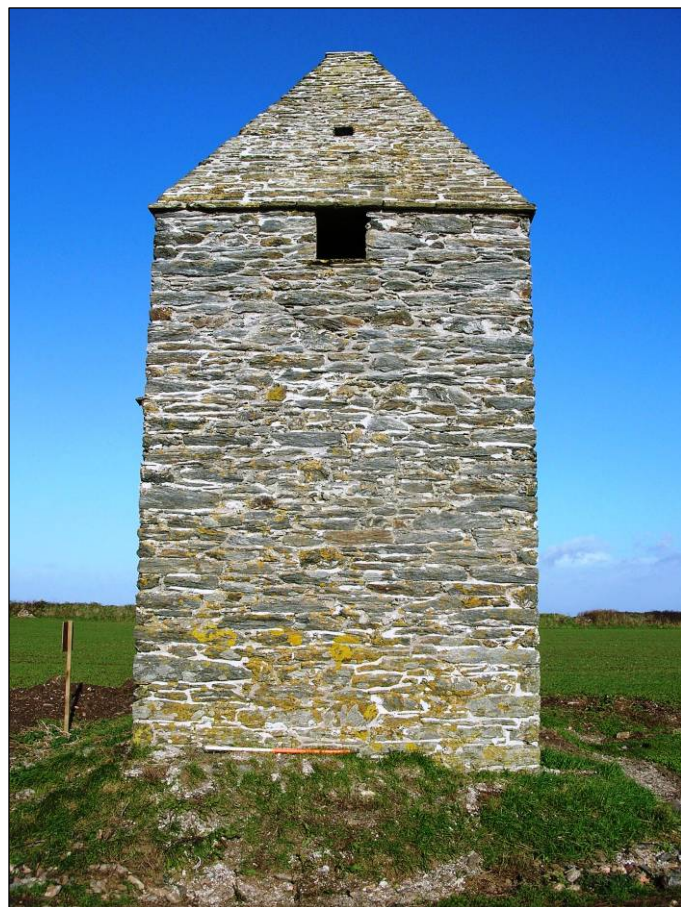
Figure 17 Image of the south side of West Soar Admiralty signal station. Extent of repointing and binocular opening with sight opening evident © HE Projects CC 14/11/2013.

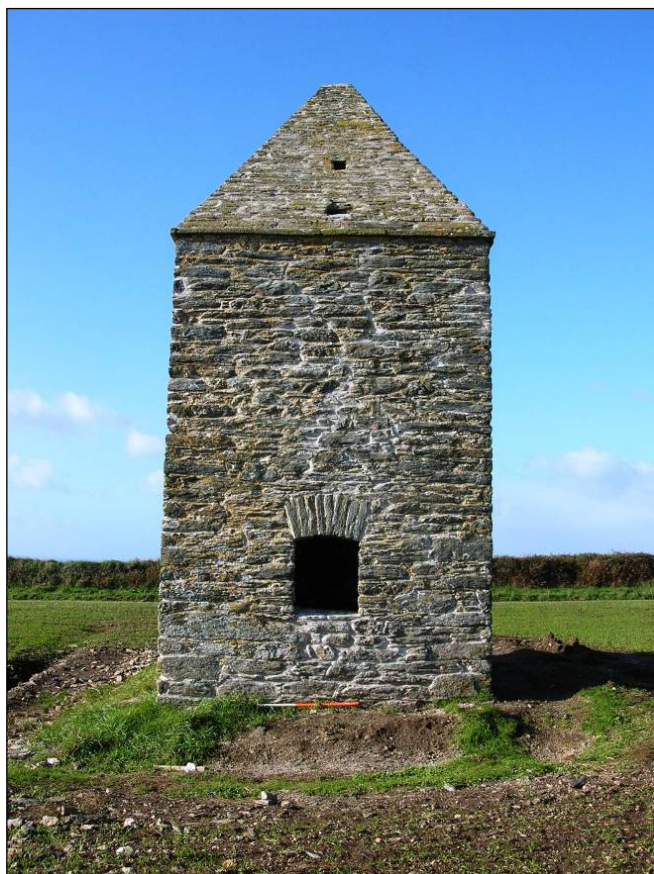
Figure 18 Image of the east side of West Soar Admiralty signal station. Window opening evident © HE Projects CC 14/11/2013.

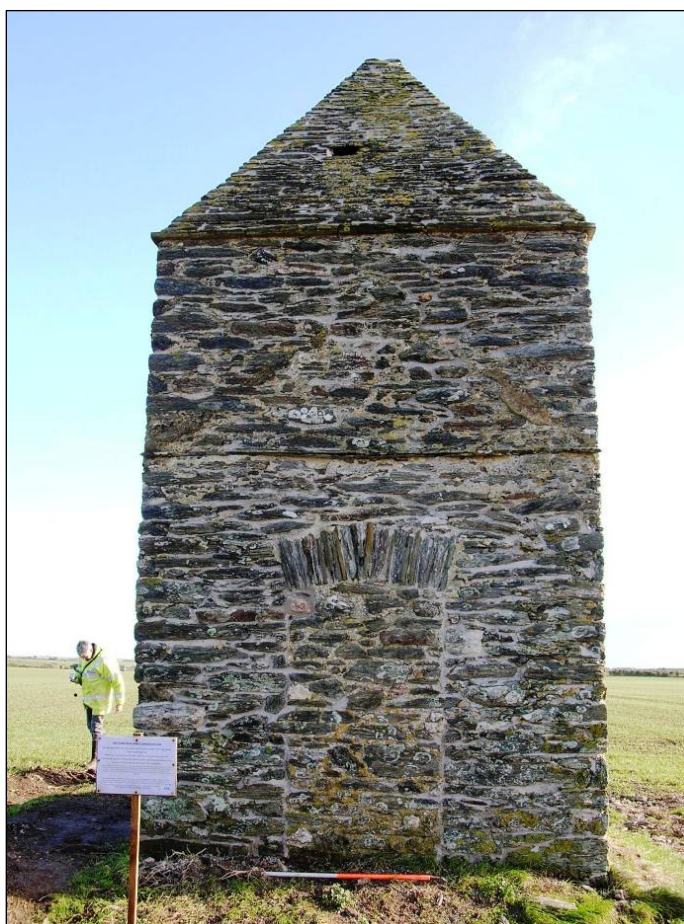
Figure 19 Image of the west side of West Soar Admiralty signal station. High percentage of repointing necessary and two phases of former junction with residential block visible © HE Projects CC 14/11/2013.
