Reeve Barns, Week St Mary, Cornwall

Historic building record

Client	Mr T Colwill
Report Number	2012R036
Date	May 2012
Status	Final
Report author(s)	Eric Berry and Jo Sturgess
Checked by	Nigel Thomas
Approved by	Andy Jones

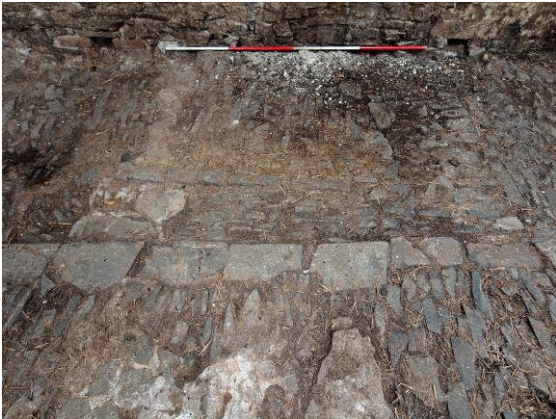
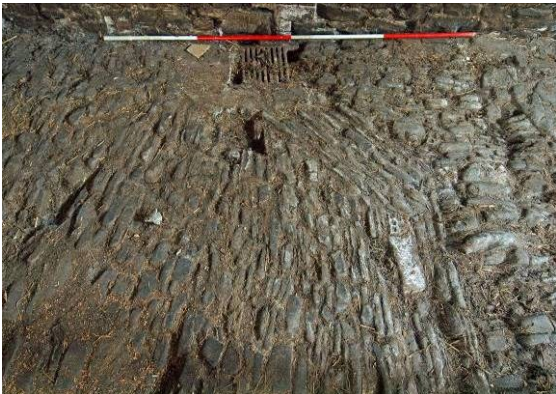
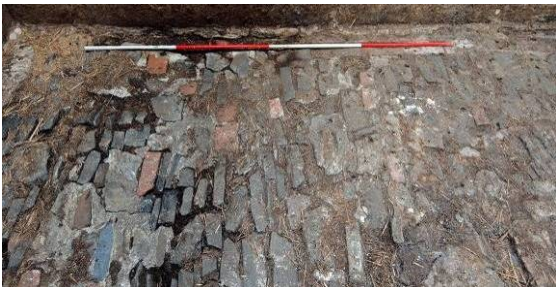
Fig 59 Building 3 (shippon), floor detail

Fig 60 Building 3 (shippon), floor detail

Fig 61 Building 3 (shippon), floor detail

Building 3 has a symmetrical plan as originally designed. The layout of original cobbled flooring proves that Building 3 was designed to function as a shippon with a wide central through-passage, a split feeding passage to its south-east side, and a split open drain running along its north-west side. The rear (north-west) wall of Building 3 is the partition wall with Building 5. As well as its central wide doorway (reduced in width at some time) there are four other regularly-spaced doorways, one of which has been fitted with a brick arch in relatively recent times. All of these doorways (now within a party wall shared with Building 4) must relate to dung removal.
