Wheal Rose Stamps, Cot Valley, St. Just, Cornwall

Archaeological recording of the dressing floors prior to works

Client	The National Trust
Report Number	2012R013
Date	31 November 2012
Status	2nd Draft
Report author	Adam Sharpe BA MIfA
Checked by	Andrew Young MIfA, HE Projects Officer
Approved by

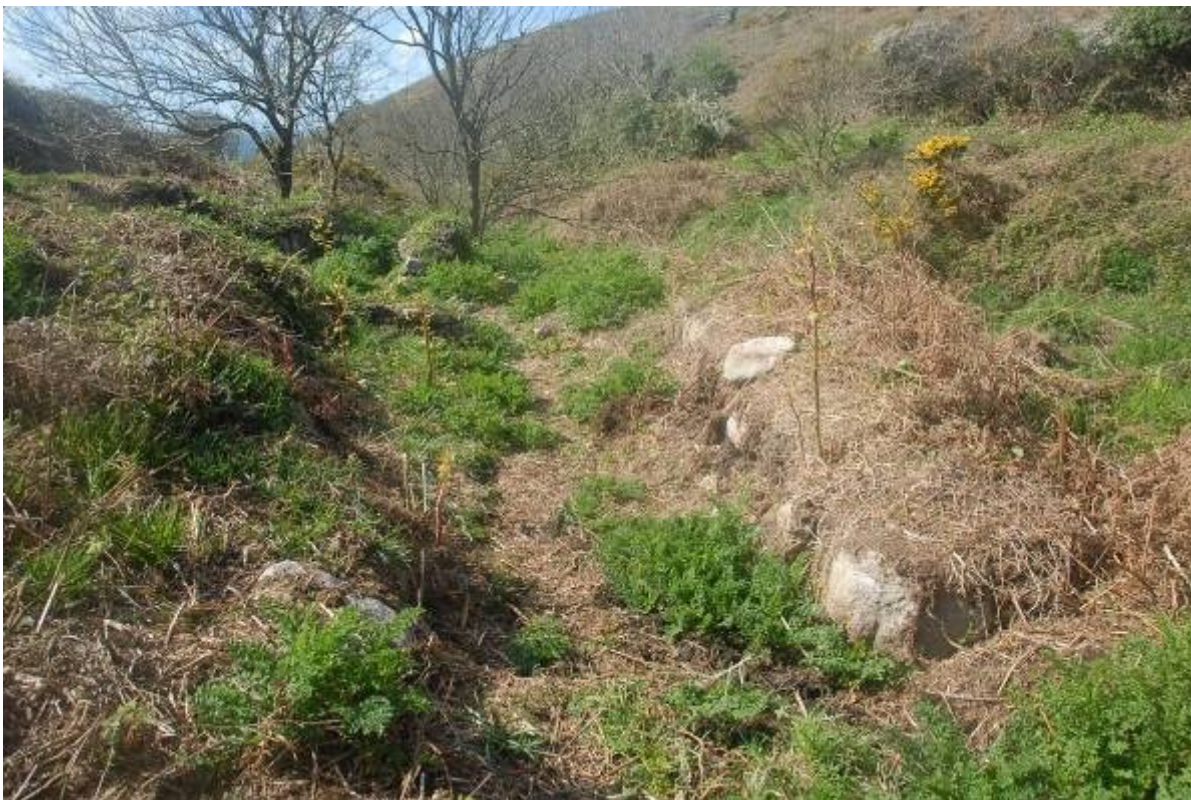
Fig 22. One of the former reservoir ponds just to the east of the Little Stamps site in mid-April 2012. Note the vigorous Japanese knotweed growth in this part of the valley.

The Wheal Rose Stamps site and its surroundings occupy one of the areas of the Cot Valley which, despite many years of attention from the National Trust, still remains infested with Japanese knotweed. Much of this is to be found in damper areas adjacent to the stream, though it is also found near the buddle yard, on the site of the former reservoir, in the levelled yard to the east, in the reservoir ponds to the west of Wheal Rose Stamps and in the Little Stamps site. This is likely to continue to be treated by stem injection with Glyphosate on an annual basis by the National Trust.

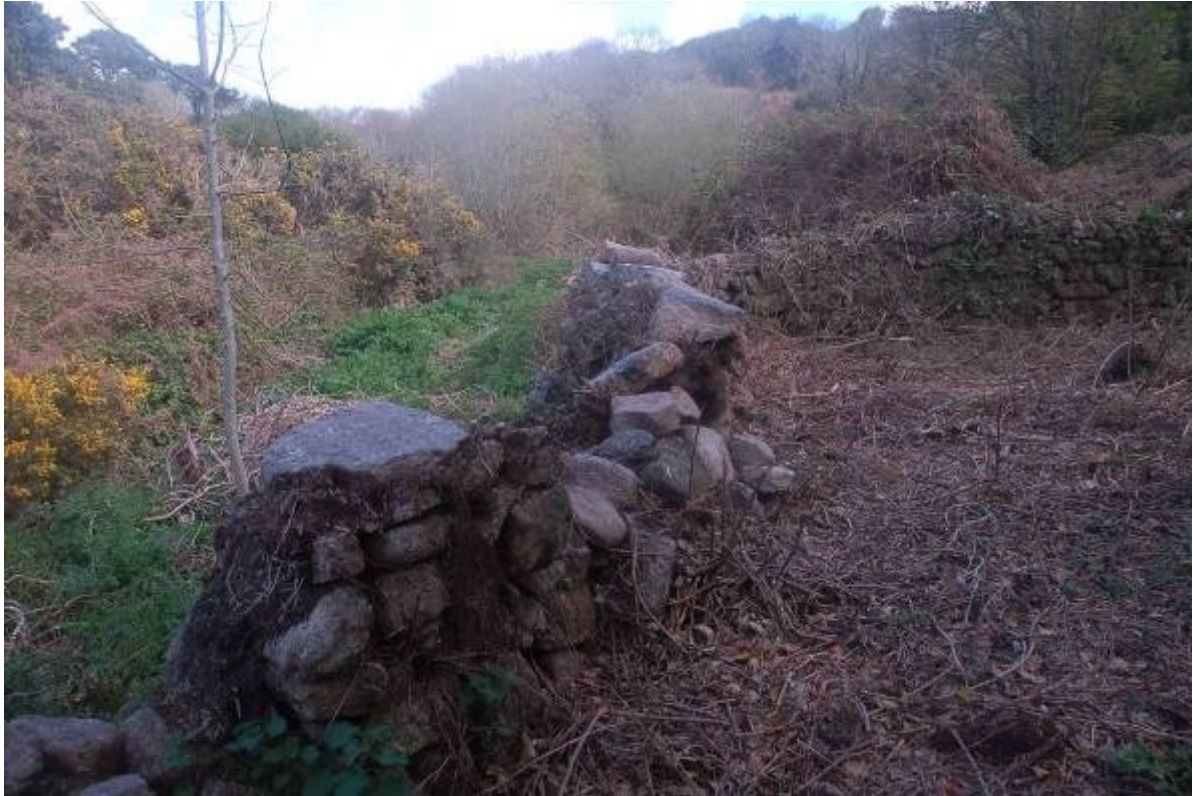
Fig 23. The yard wall at the eastern end of the survey area. Its poor state is clearly evident in this view.

Much of the walling here is in very poor condition and is likely to collapse in the relatively near future. Nevertheless, it is a feature of some interest, and, if a path route

It is suggested that the National Trust consider this site as a potential volunteer repair project entailing taking down and rebuilding unstable stretches of the walling. The levelled area to its rear, if kept clear of brambles and gorse, would provide a pleasant glade amongst the trees in this area. Given the high density of the saplings in this general area, thought should be given to some selective thinning.

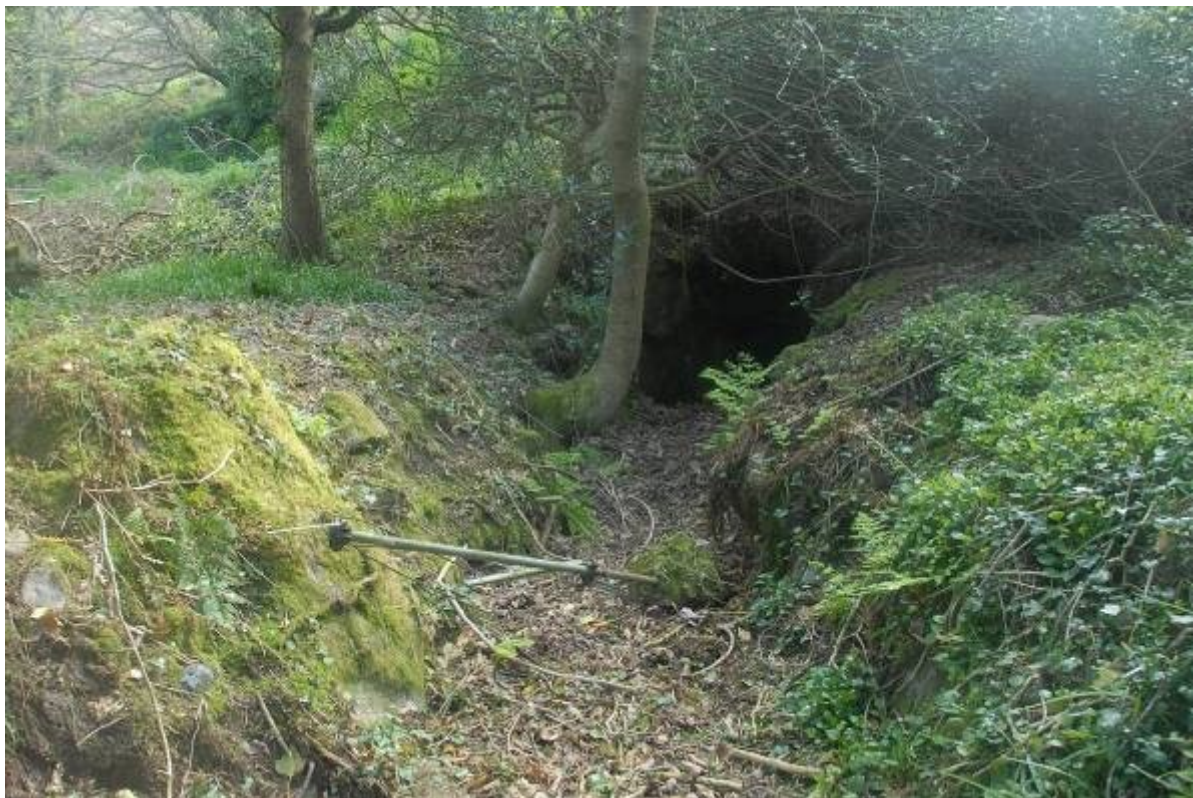
Although open, silting of the adit lobby has caused water to back up within the adit almost up to its roof. Domestic rubbish has also been dumped into the mouth of the adit, and as a result, no survey of its interior and extent was possible. The adit is not shown on any OS mapping.

Fig 24. The adit portal and lobby near the eastern end of the site, together with an example of the rubbish which litters most of the site.

Rubbish within and around the mill complex should be removed from the site and disposed of. Accumulated leaf litter and garden waste should be removed from within the mill, the buddle house and the spalling floor where this currently obscures floor detail. Any features revealed during this process should be recorded by an archaeologist and added to the 2012 survey. Some of the rubble resulting from wall collapses may also need to be cleared, for example from within the wheelpit. Local residents should be dissuaded from dumping any further garden waste over the bank adjacent to the road. Removal of bracken litter and rhizomes from the buddle yard would probably enhance its interpretation and reduce future vegetation management requirements. Japanese knotweed growing on and adjacent to the site are the subject of an ongoing eradication programme being carried out by the National Trust.

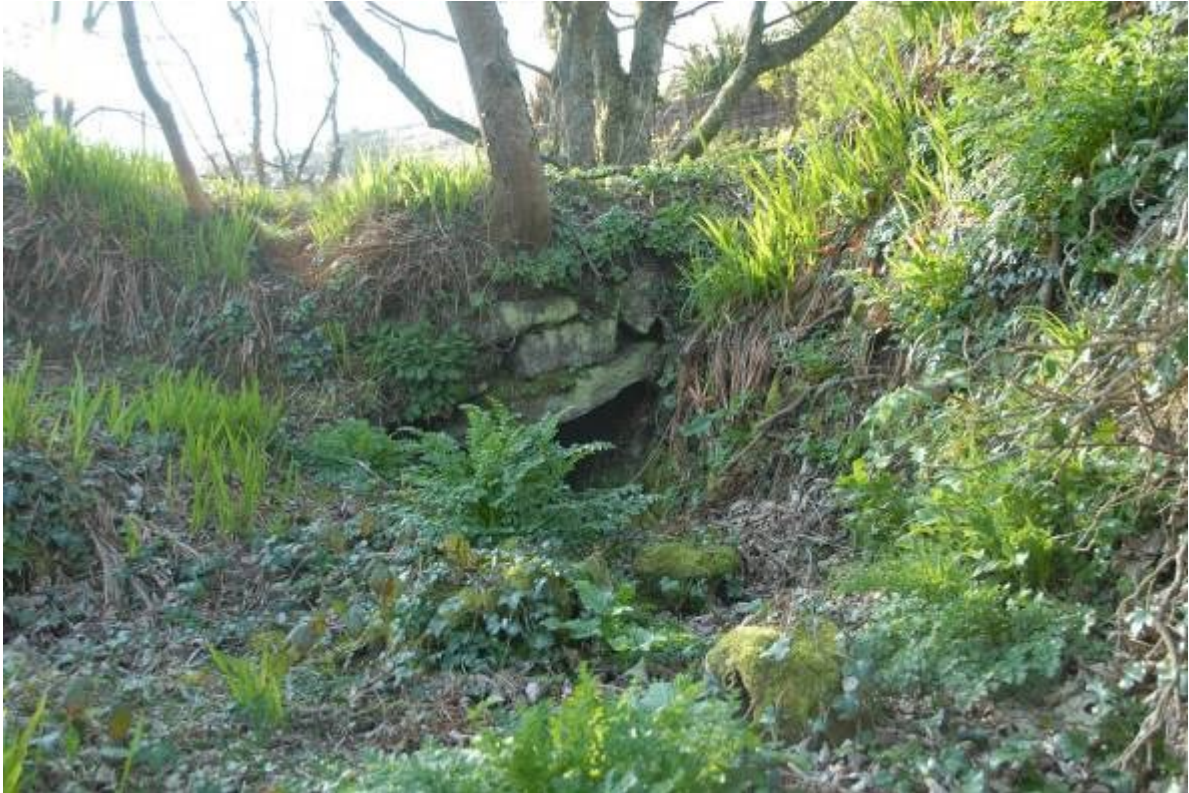
Fig 25. The western end of the bridge over the Wheal Rose Stamps top leat, showing the trees whose roots are beginning to damage this feature.

It is recommended that a number of semi-mature sycamores within and immediately adjacent to the mill complex should be felled and stump treated to prevent any further root damage to its masonry or catastrophic damage to its walls should they fall. Care will need to be taken during the felling to ensure that no damage is done to the nearby structures. A substantial buddleia at the eastern end of the buddle yard should also be removed, and consideration should be given to the clearance of bramble and other scrub obscuring the low-level tank adjacent to the west of the buddle yard. Woody material which has already been cleared and stacked on site should be burned. A programme of annual cutting should be instituted to prevent woody regrowth and to ensure that the site and its features remain visible and accessible following the building works programme. It is recommended that trees adjacent to the site are examined to see whether a case can be made for a requirement for further felling and clearance. It

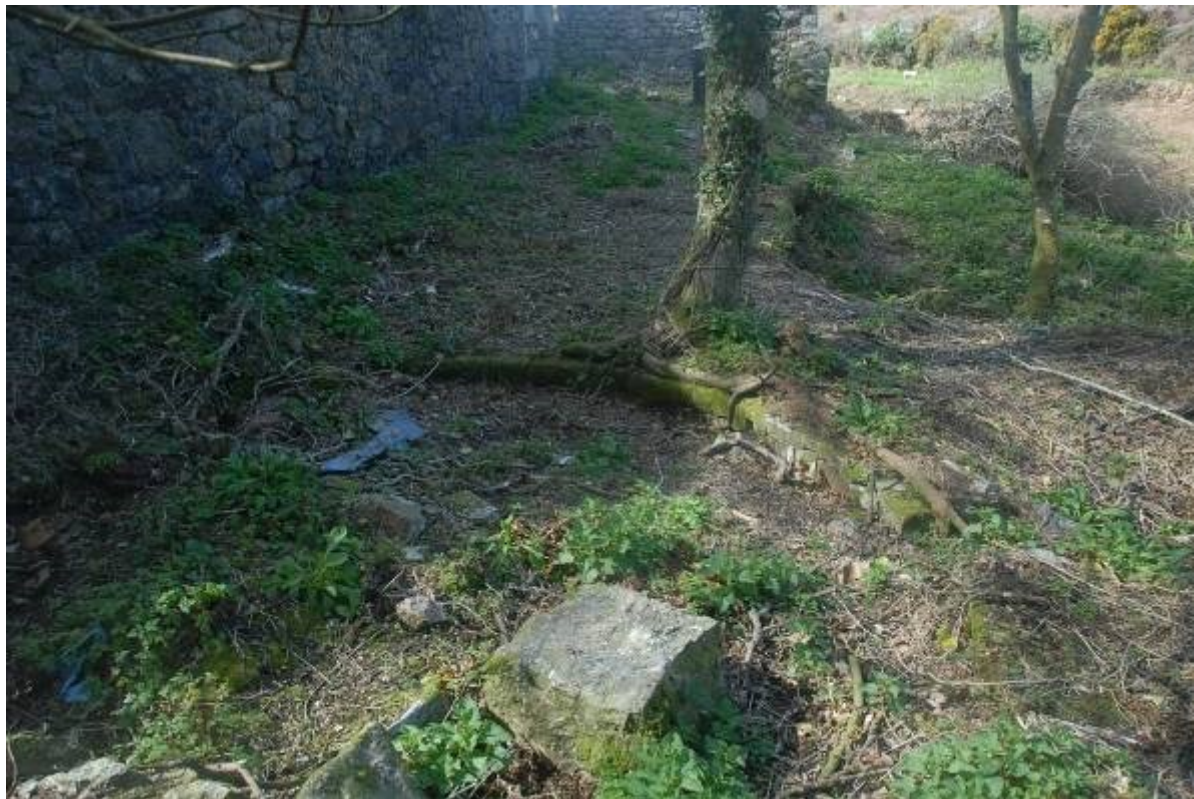
Fig 28. A late concrete faced buddle in the eastern part of the buddle building. Tree roots threaten to break up this feature.

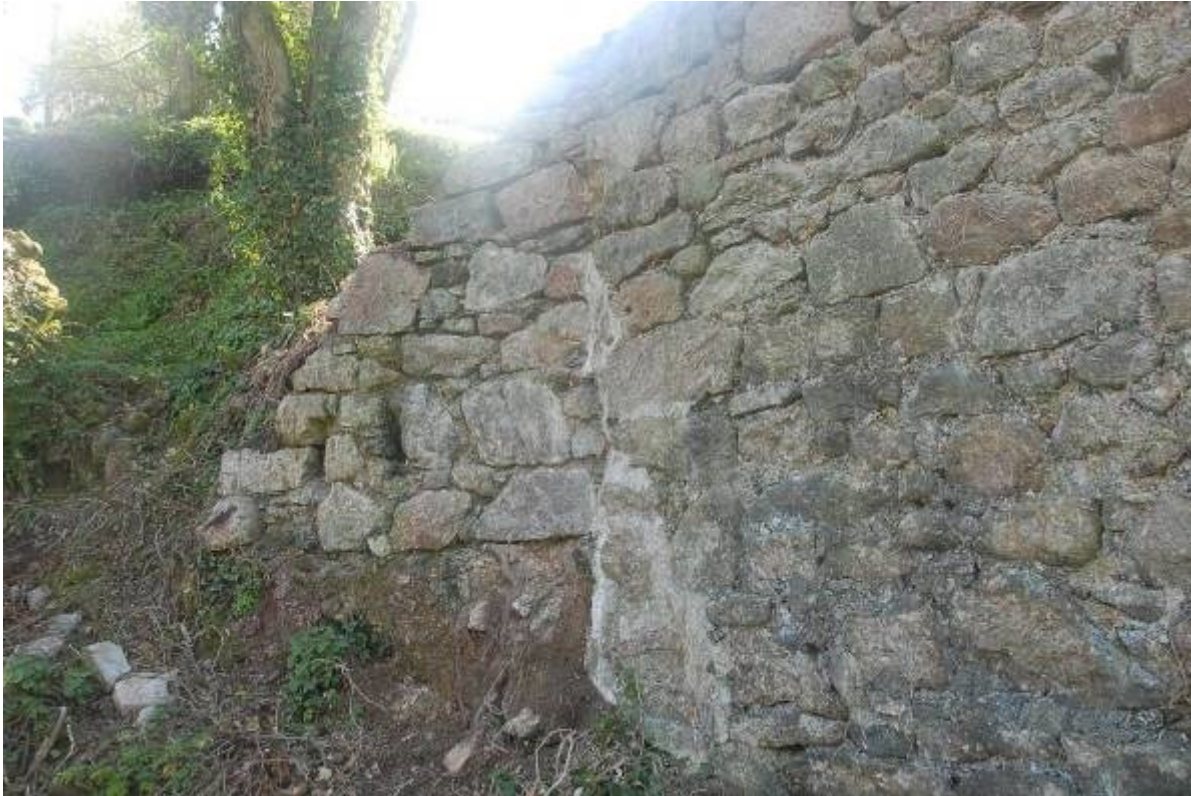
The southern wall of the buddle building is 10.7m long, 3.5m high to the north but only a metre or so high to the south (against the spalling floor), and is less robustly constructed than the mill, which it abuts at its western end. The eastern end of the south wall has been extended by 6.3m in slightly less formally-laid masonry (possibly reflecting a pre-1877 extension), the wall line curving slightly to the north in this section. An area of substantial collapse here is the result of root infiltration by a mature sycamore growing immediately behind the wall line. The formerly gabled eastern wall now survives only in a low and fragmentary form, whilst the northern wall has been robbed away completely. No physical evidence for the line of the wall shown in the 1920s photograph could be found; this area is, however, covered in leaf litter and rubbish, and if the early 20th century wall was of timber construction, it might now be represented only by a line of corroded bolts.

Fig 29. The eastern end of the southern wall of the buddle building, showing the earth foundation of this section. Root growth associated with the tree in the upper left of this view has already caused the collapse of a section of walling.

Within the eastern end of the buddle house, the walling forming its southern side was seen not to be founded on solid ground, but to have been built up from a cut into the earth bank behind. This may need to be underpinned (preferably utilising a masonry wall) to prevent any further collapse of this structure. The collapse to the section of wall immediately to the east of this was caused by the root action of a semi-mature sycamore which had become established immediately behind the wall. Further significant damage to the walling is likely to result if this sycamore is not felled and its roots killed off. The 4.0m diameter dumb buddle should be cleared out and, if required, repaired in concrete. Any roots in, on and running through this feature should be killed off to prevent further damage and the adjacent sycamore felled.

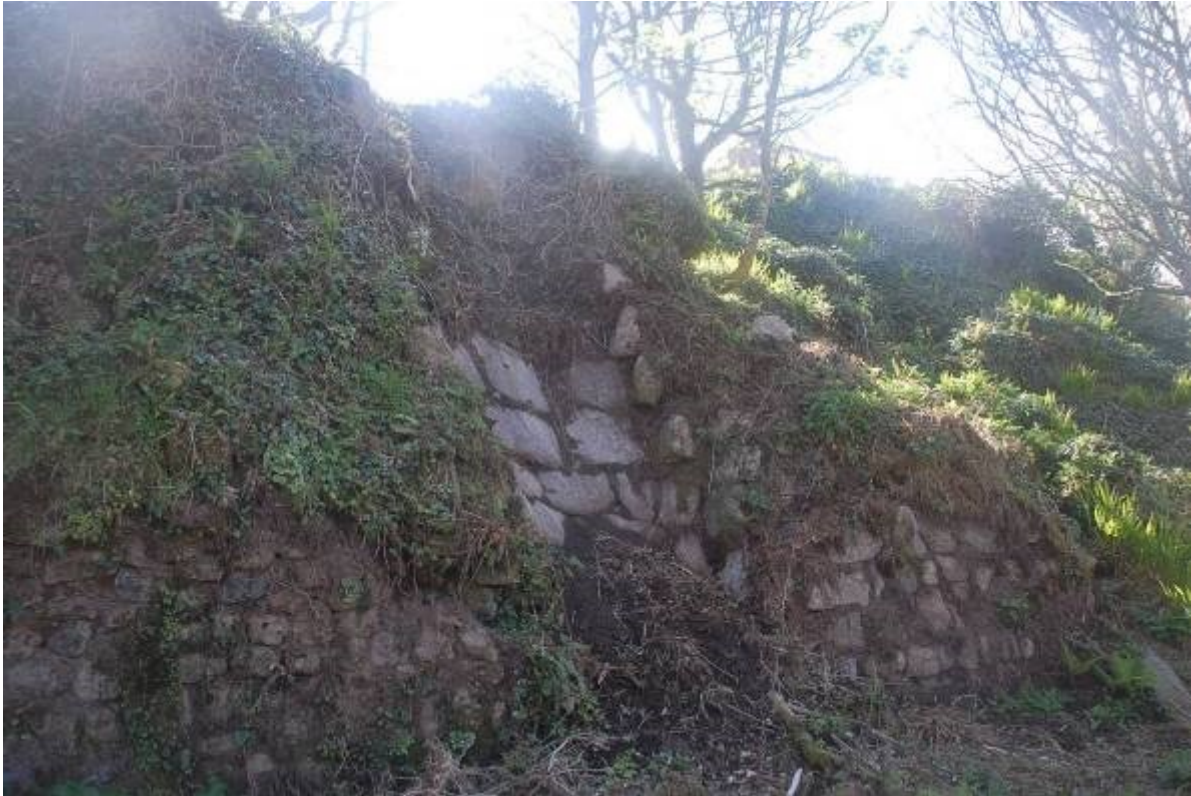
Immediately to the south of the buddle building, a levelled platform set above it would probably have been used for spalling (breaking up) larger pieces of ore, which would have been delivered to this area of the site via a 6.2m long, 1.8m wide stone-faced chute revetting the bank below a platformed area adjacent to the nearby track. Earth and leaf litter covers the surface of this spalling floor, obscuring any original hard surfacing, but with the removal of some of the material covering this area, some apparently deliberately-laid granite surfacing was partially revealed. A photograph which probably dates to the early decades of the 20th century suggests that this original

The original granite-faced chute shows signs of hard wear, the ore sliding down it having hollowed and polished it. One detail which emerged during the survey is that the constructors of this feature took particular care to ensure that large pieces of ore slid down the chute did not dislodge the cheek stones which defined its edges; these were offset slightly from each other so that there was no possibility of pieces of ore catching the upper corners of the stones.

Fig 33. The stone-faced ore chute and its retaining walls at the rear of the spalling floor.

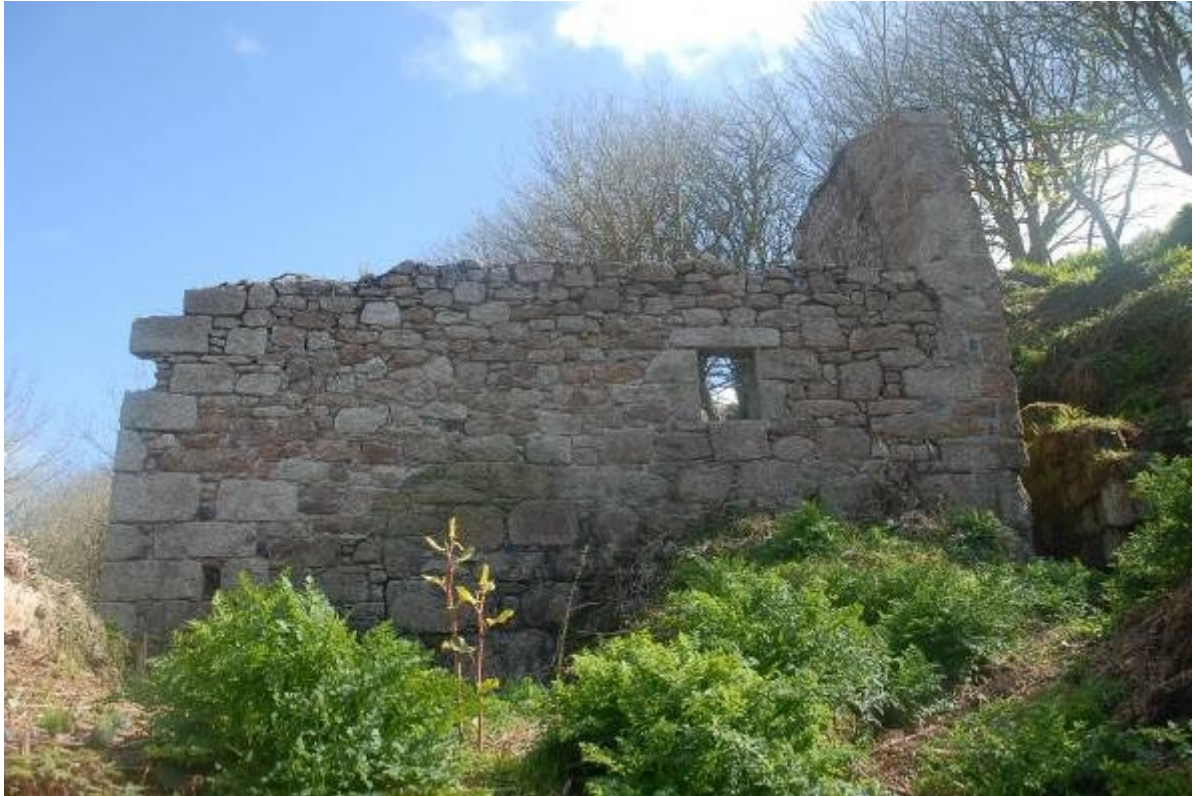
Fig 35. The western wall of the stamping mill. The original northern corner of the mil is clearly visible as the vertical line of quoins in the lower half of the wall just to the left of centre in this view.

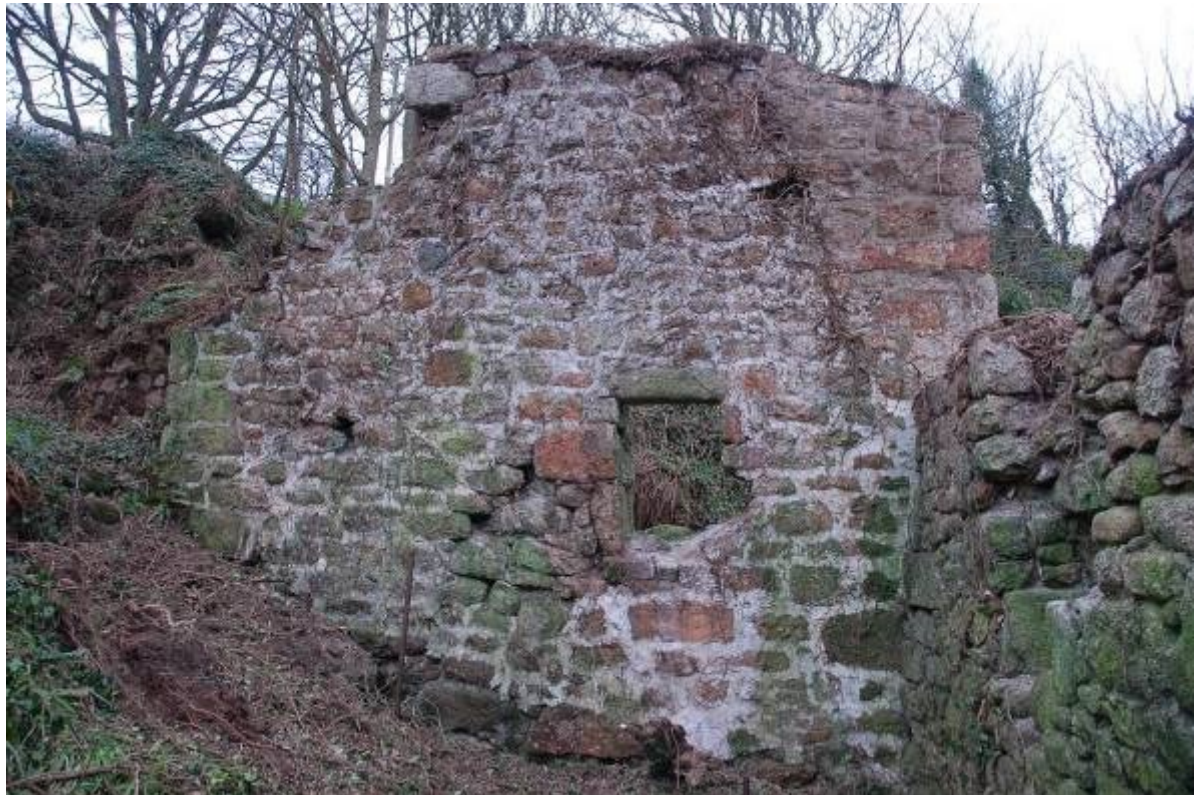
The wheelpit is 6.2m long and 0.8m wide, so would have accommodated a wheel of about 17 foot diameter, whose axle passed through a 0.8m x 0.7m rectangular opening in the wall to a set of perhaps six or eight stamps (in two groups) aligned south-north. Ore was fed to these stamps down a full width chute from the east, the mill walling here being only half height, suggesting that the upper part of the wall was wholly or partially open to the adjacent spalling floor. A pair of iron bolts inside the southern wall of the building probably supported a substantial timber trestle on which one end of the stamps axle bearing would have been sited, whilst originally paired pieces of iron plate protruding from the ground to the north of the stamps would have framed a timber construction of unknown function, possibly a launder. The only surviving window in the building is in the centre of the original part of the western elevation; this measures 0.7m x 0.6m.

Fig 36. The wheelpit wall of the stamping mill. The axle opening is clearly visible. The stamps would have been at right angles to the wall and to the left of the opening. Note the difference in heights of the wheelpit wall and those to its left and right.

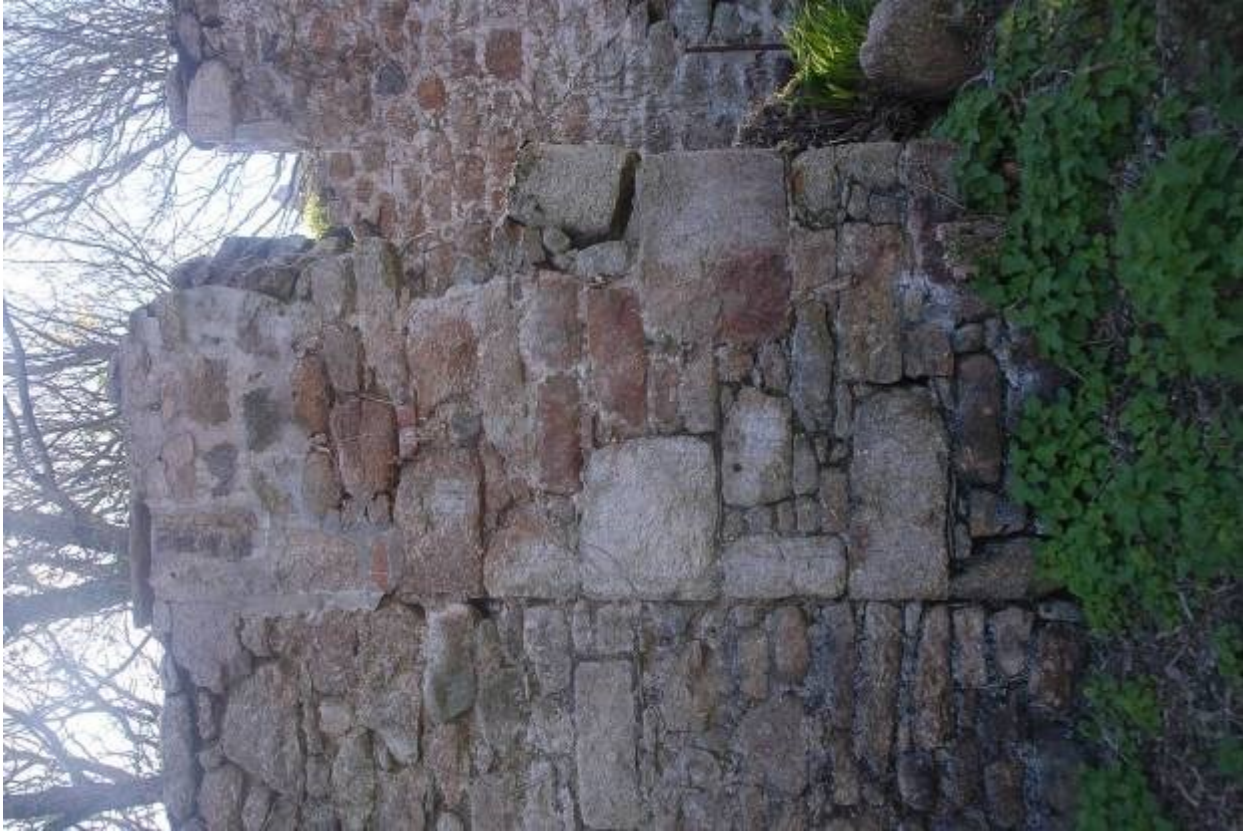
Fig 38. The junction between the stamping mill (right) and the buddle building (left), showing that the stamping mill predates the buddle building.

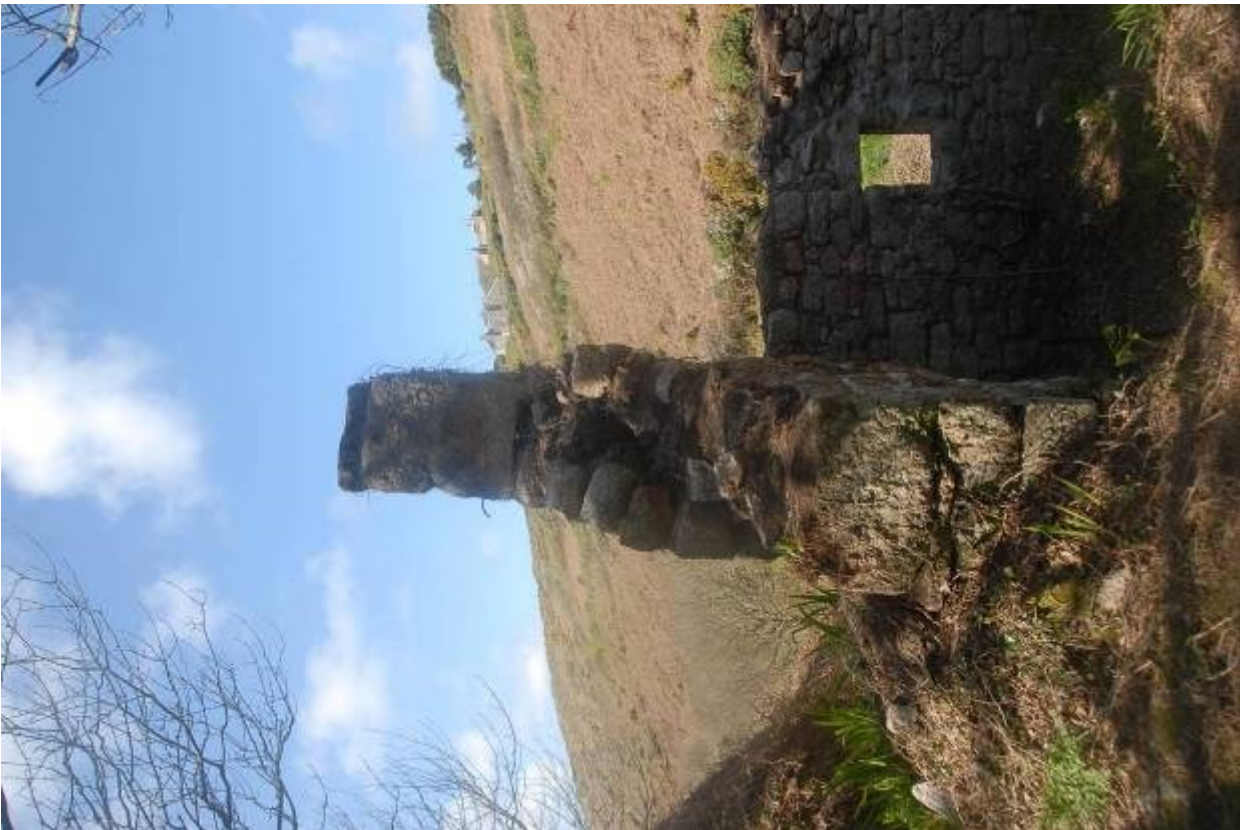
Fig 37. The poor condition of the eastern end of the southern wall of the stamping mill.

Now that the ivy has been cleared from the mill and buddle house, it should be possible to draw up a detailed set of specifications for the consolidation and repair of these buildings and their associated structures. This should be based on the use of a hydraulic lime mortar incorporating a range of aggregates which will provide a reasonable match to the existing pointing, and should be designed for a minimum of 30 year life without major maintenance. Any existing degraded or detached pointing should be dug out to a depth of at least 50mm, and all areas of cement-based repair pointing should be removed. All wall head stonework should be re-laid in lime mortar. A new oak lintel will be required on the southern face of the wheelpit wall above its axle opening. Fallen or loose stones should be re-set, particularly above the axle opening and above the window in the western wall of the mill on its internal elevation. Where walls have broken ends resulting from stone robbing or collapse, these should be pointed to prevent water ingress – some fallen masonry may need to be reinstated to ensure the long-term stability of sections of the walling of the mill and buddle shed.

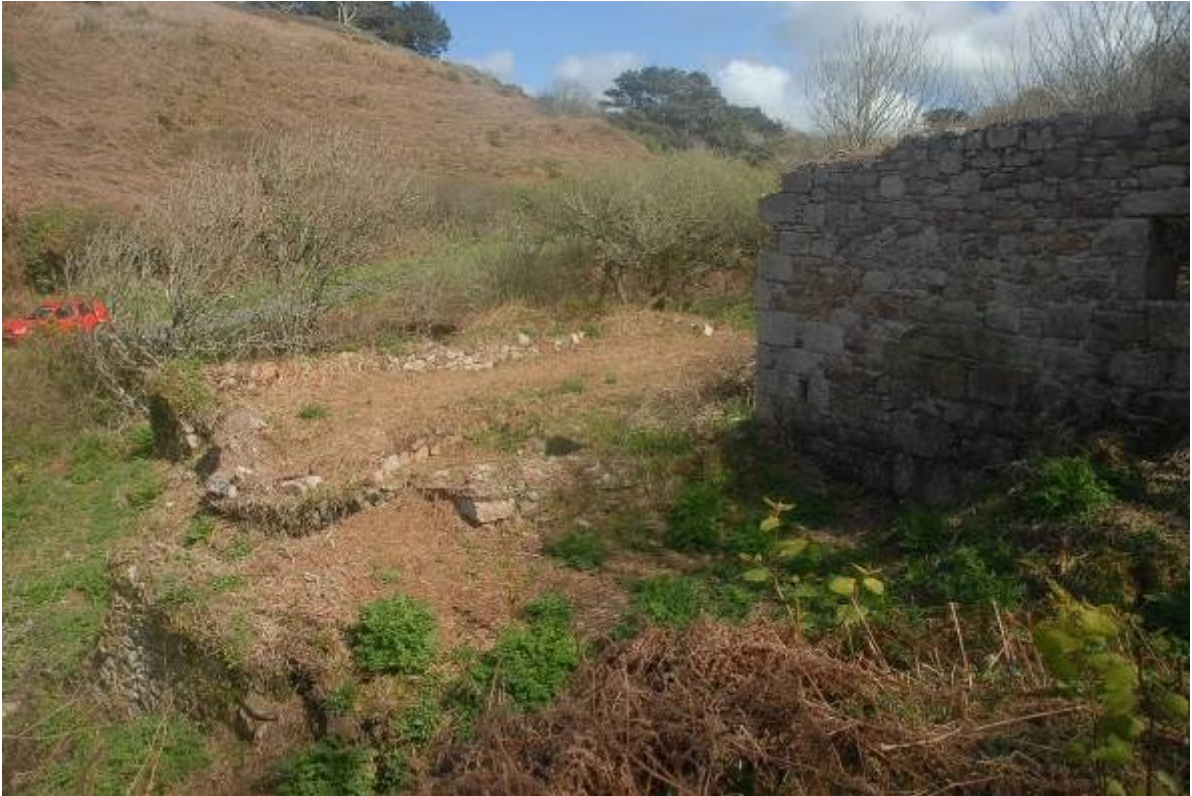
Fig 39. The buddle yard to the north of the stamping mill. The buddle wheelpit is sited on its western end (left of centre in this view).

The buddle yard wall facings and the walls surrounding the buddle wheelpit should be cleared of any remnant ivy and their pointing inspected and, if necessary replaced or repaired. Scrub or small trees which have taken root in their wall heads should be killed off and the top courses of masonry re-laid in lime mortar. Sections of loose or fallen stonework should be rebuilt where they are currently causing instability or are likely to cause this in the future, particularly at the wall ends and where an informal path currently crosses it. Bracken litter should be cleared from the buddle edges and bases and the condition of the masonry inspected. Where required, this should be repointed in lime mortar and lost masonry reinstated where fallen stones can be identified. The concrete faced buddle centre at the east end of the part of the site which apparently dates to the last phase of working on the site has become so badly damaged that is probably beyond repair.

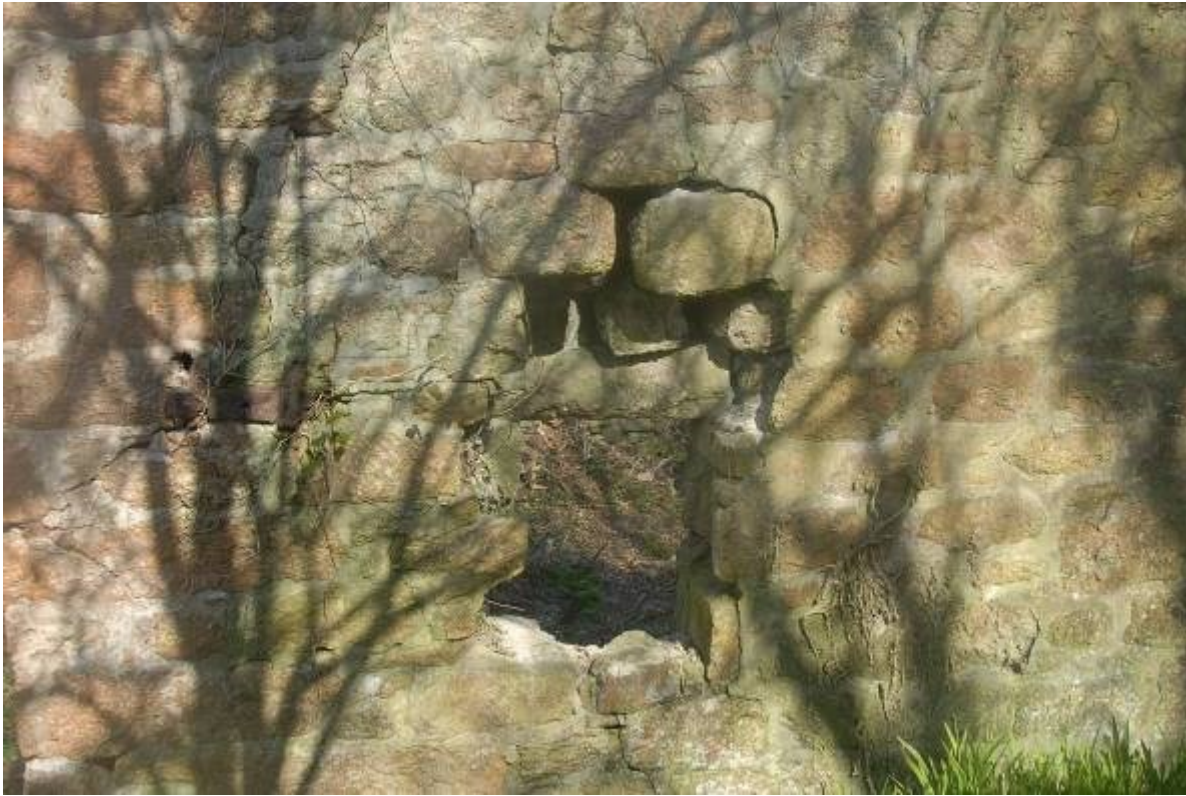
Fig 41. Stone loss from the southern face of the stamps wheelpit wall due to a lost lintel over the axle opening will need to be made good.

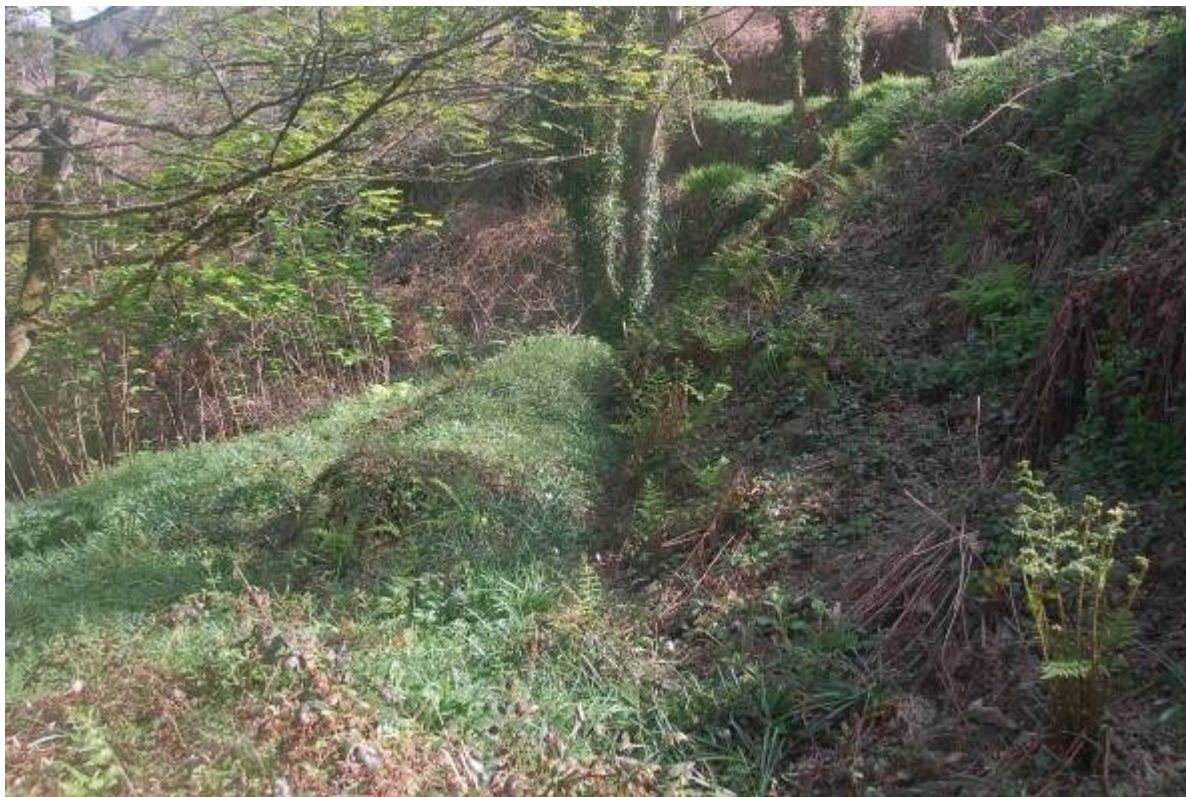
Fig 42. A part of the course of the possibly early lower leat to the east of Wheal Rose Stamps. The upper leat which fed the stamps is immediately upslope, and, with sections of other leat to the west, could potentially form the basis for a path network down through the valley.

The middle leat, fed by the tailrace of the Wheal Rose Stamps wheel, is in good condition, and as a trial, its banks were strimmed by the St. Just NT Ranger to establish whether it had the potential to form a path which could link Wheal Rose stamps to the public footpath running from Cot Lodge down to Pen Nanven. It was concluded that if a short flight of timber-revetted steps were constructed at its western end, this would be a practicable proposal.
