No. 2 The Square, Chacewater, Cornwall

Archaeological watching brief and historic building record

Client	Dr Anthony Bradley
Report Number	2012R049
Date	July 2012
Status	Final
Report author(s)	Jo Sturgess
Checked by	Nigel Thomas
Approved by	Andy Jones

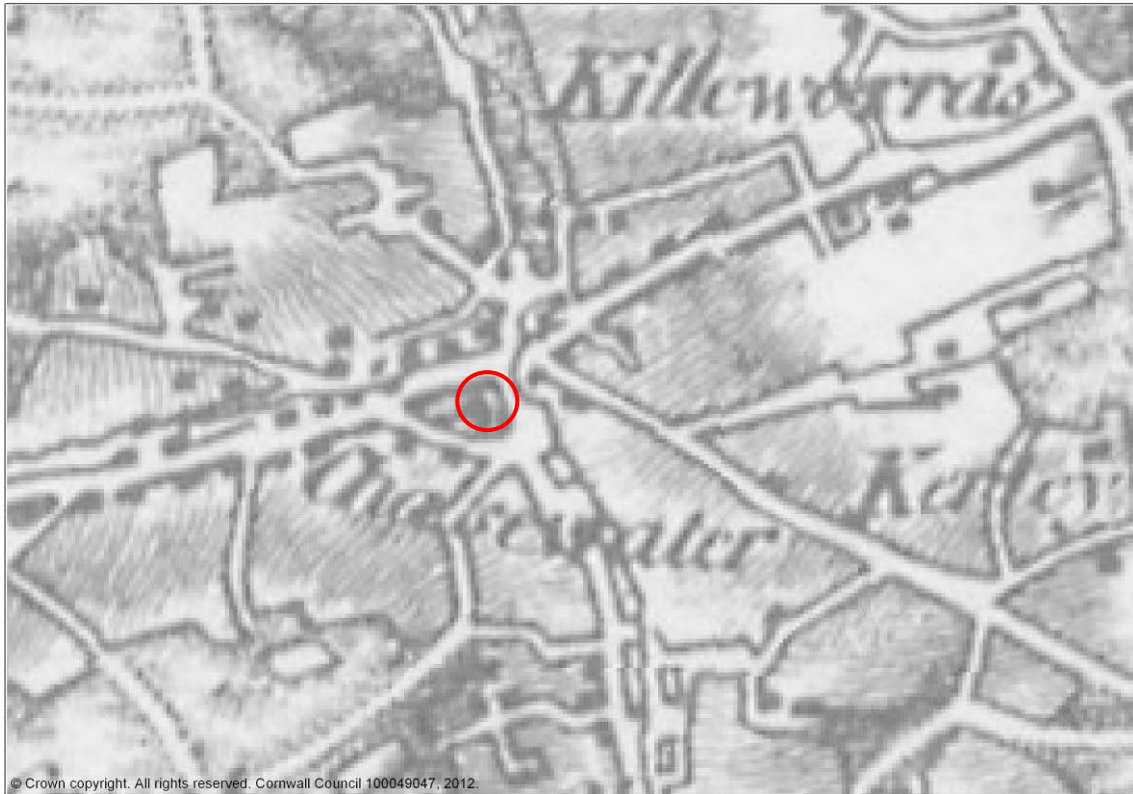
drawing (Fig 3). The settlement at this date is shown as 'Chacewater' and the c1809 map indicates a well-established centre focused around The Square and stretching east-west along Fore Street more or less to its modern extent. Buildings are shown on this map in the area of The Square but it is not detailed enough to pin-point exact structures.

Fig 3 OS Surveyor's drawing c1809

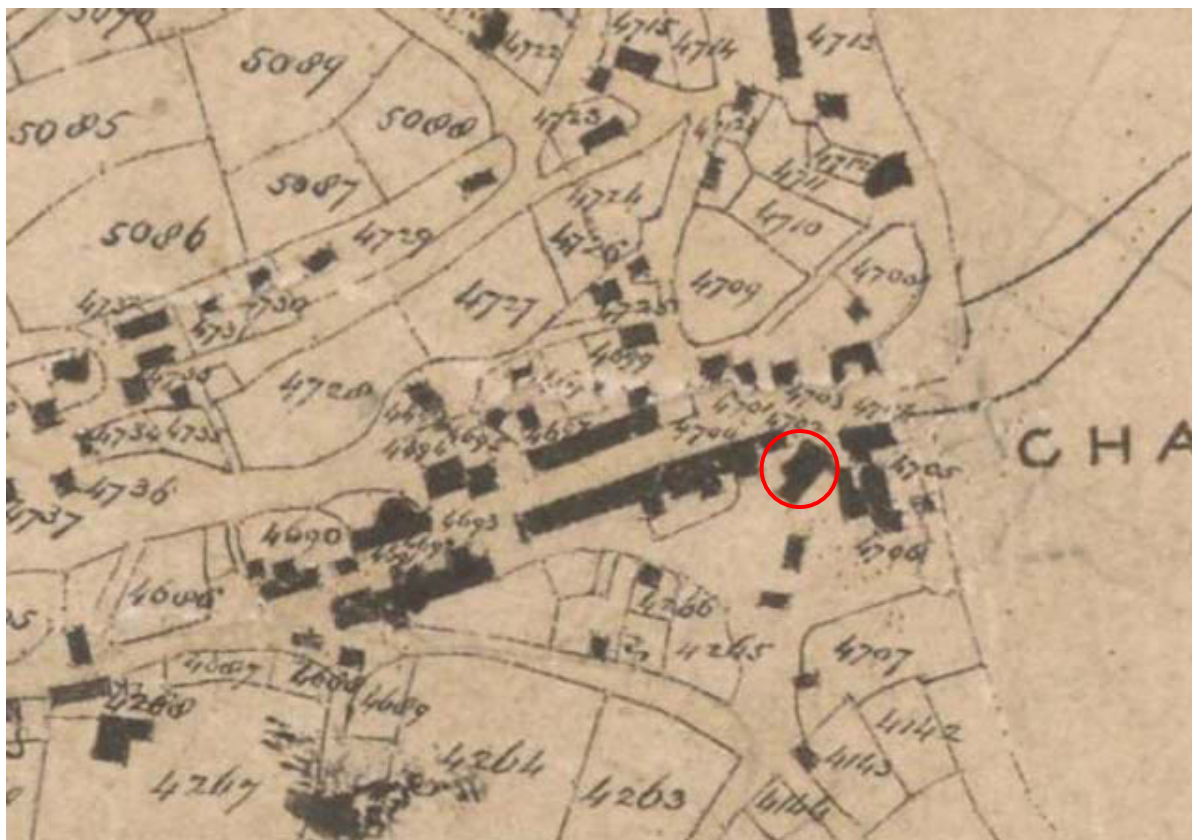
The Tithe map of c1840 (Fig 4) is the earliest map to show the plan of No.2 The Square. It appears at this date to stand alone with its existing service wing extension to the rear already added and with further extensions to the rear within the present backyard. The accompanying Apportionment lists a group listing for the houses in this area. It lists the owner as the Earl of Falmouth and records 'houses' leased by James Tyacke and occupied by Mark Richards.

Fig 4 Tithe Map, c1840

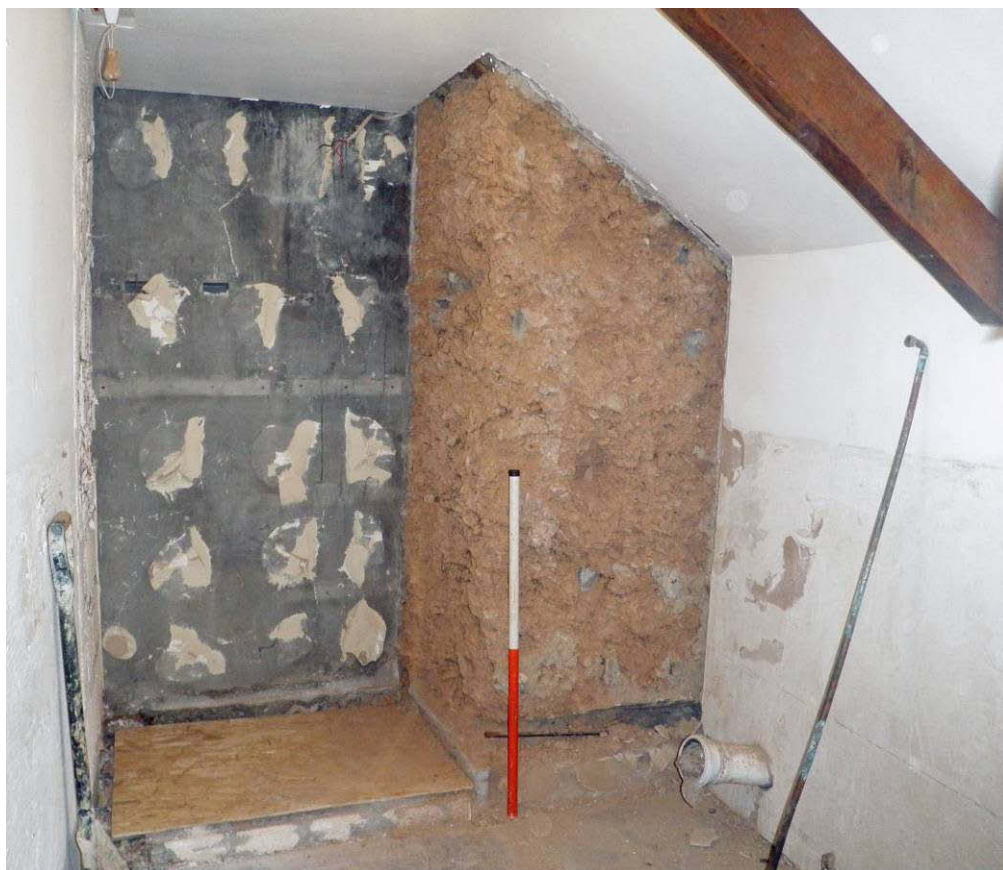
The removal of the plasterboard covering the feature revealed that it was constructed from cob, comprising mid orange/brown silty clay with frequent shillet fragments and moderate chopped straw pieces. It was square in plan, reaching from floor to ceiling and protruded into the room space by 0.7m. During the demolition of the feature it became clear that it was not the remains of a chimney breast but part of the original south-east gable end wall with a maximum recorded width of 0.8m (see Figs 7 and 8). The area of former wall to the north-east of it within the bathroom had clearly already been removed to allow for the insertion of a shower, and at an earlier date (second half of the 20th century) the ground floor gable end wall within the rear service room had also been removed and a concrete slab inserted at first floor level to support the cob wall on the first floor.

Fig 7 Remaining section of cob wall in bathroom before removal

The watching brief undertaken in the house focused on the removal of a feature in the south-west corner of the house at first floor level within the existing bathroom (Figs 2, 7, 8 and 13). An earlier inspection of this feature by an independent surveyor (whose opinion had been supported by the Conservation Officer) had noted that it may have been a chimney breast servicing the room below where the lower part had been removed and the stack above roof level may also have been removed.

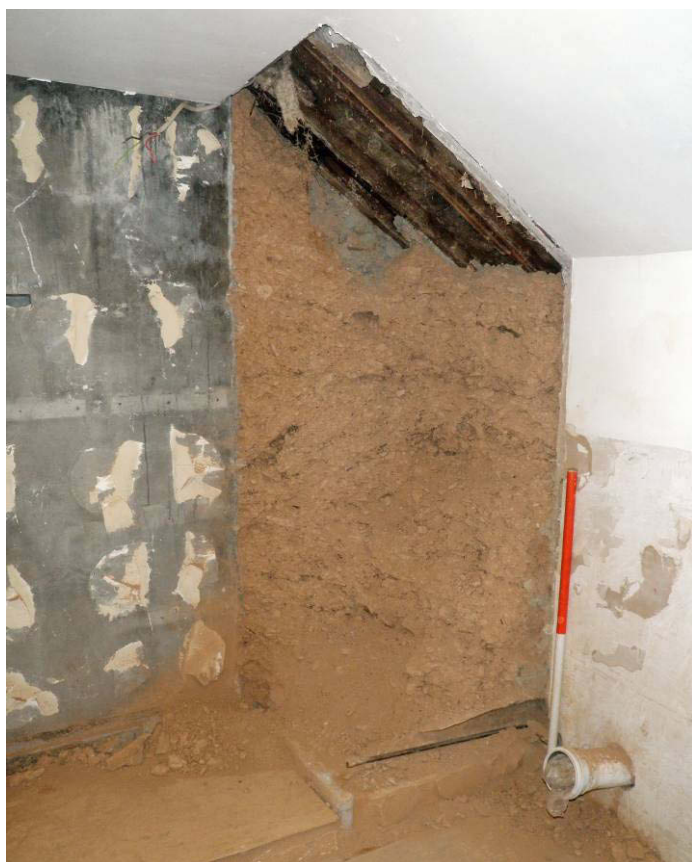
Fig 8 Corner of bathroom during removal of cob wall

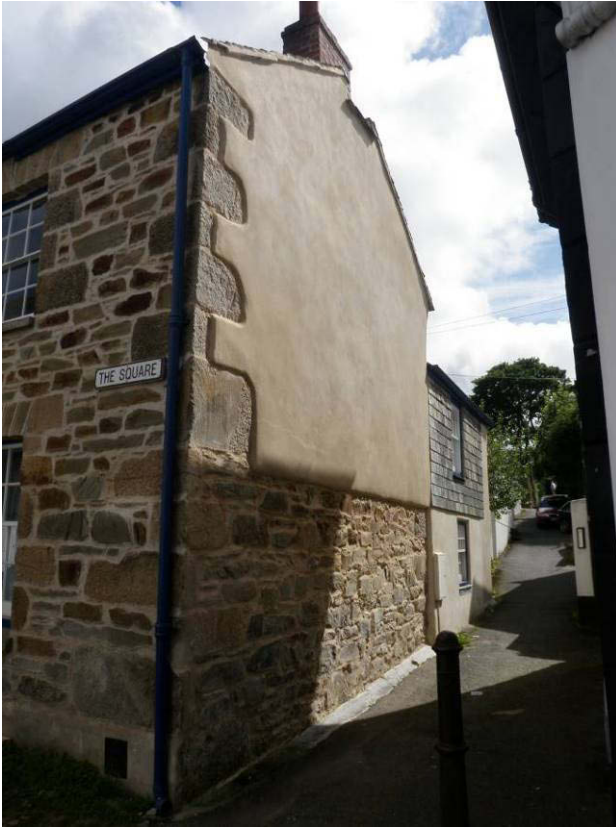
Fig 9 North-west external elevation showing stone masonry at ground floor level and cob at first floor level, also service wing extension to the rear

A brief inspection of the other areas in the house where plaster had been removed combined with what was visible of the rest of the building enabled a cursory phased development to be formed. The original building appears to have been a simple gable ended house of single room depth. This is evidenced in the northern half of the building by the survival of the original exterior rear wall (seen after removal of plaster in the hallway) which comprises masonry at ground floor level and cob at first floor level (shown in Fig 10). It seems likely that this wall was demolished in the southern half of the building when a small, two-storey, cob-built extension was added which now contains the boiler room and bathroom, although it is possible that the building was originally designed with this extra room space to the rear. The present kitchen wing with bedroom above (to the rear north) is a later extension but may still have been added as early as the 18th or early 19th century. This is evidenced by the location of the 18th century staircase (Fig 11), which appears to be *in situ*, and breaches the original rear wall of the house giving access into the first floor extension(s).

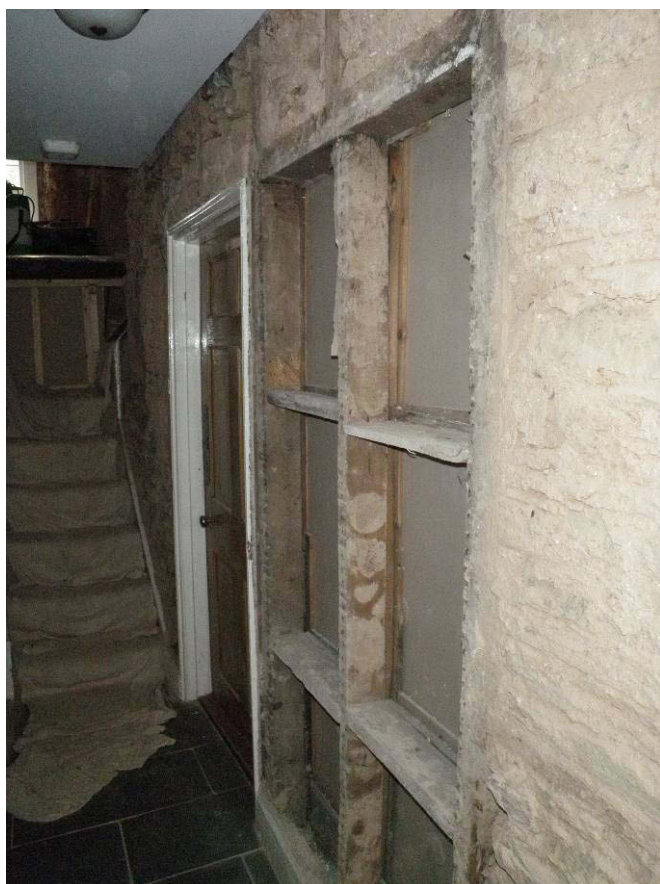
since the staircase is built up against the south partition and an earlier plastered wall face is visible behind the partitions where they butt up against the front wall either side of the front door. In the north partition wall there is a blocked door opening (Fig 12). Other alterations noted were that the window and door openings in the bathroom had been inserted at a later date.

Fig 12 Hallway and stairs
