# **Carmears tramway, Luxulyan Valley, Cornwall**

## **Archaeological recording**

2012R066

Nigel Thomas

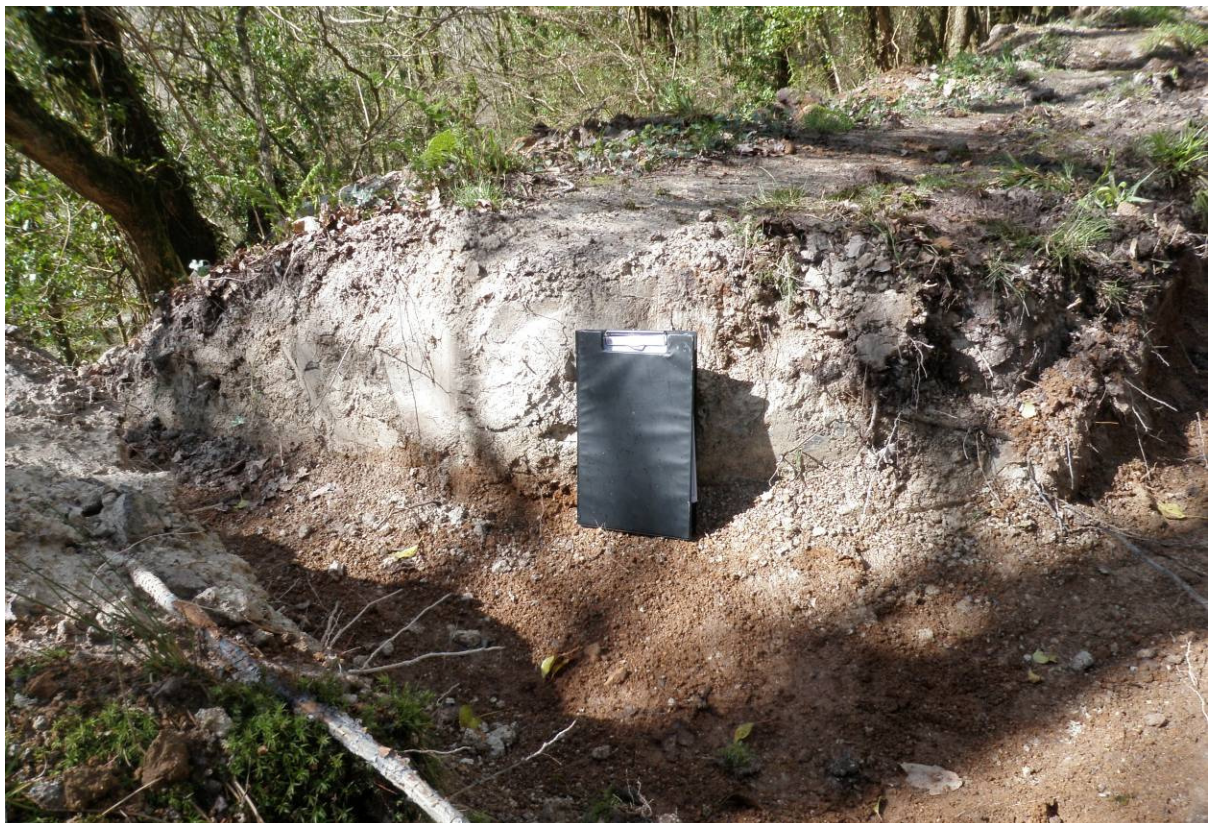
*Fig 8 Section through a pile of china clay waste, previously dumped at the side of the tramway*

The original tramway embankment of free-draining rubble (decayed granite) is clearly visible beneath the dumped material. (Scale: folder = 360mm high)

The tramway was built to standard gauge (4 feet 8½ inches) and for most of its length the track was laid upon iron brackets (or 'chairs') bolted to granite blocks or setts (Fig 13). At the outset of this study the majority of the tramway surface east of the viaduct was obscured by later silt dumping, carried out by the china clay companies undertaking periodic clearance from the leat. Clay waste was also dumped along the outside edge of the tramway, resulting in a relatively continuous bank being formed (Fig 8). This also impeded the drainage and contributed to the build up of debris on the tramway (Fig 5).

New drainage channels were cut through the outer bank, and this revealed that the bank is mostly composed of china clay waste (see Fig 8). After removal of the silt, the space between the setts was built up with clean rab, excavated from a small re-opened quarry close to the head of the incline plane (at SX 06657 56632). With the addition of the new material the tops of the granite setts were left more or less level with the surface.

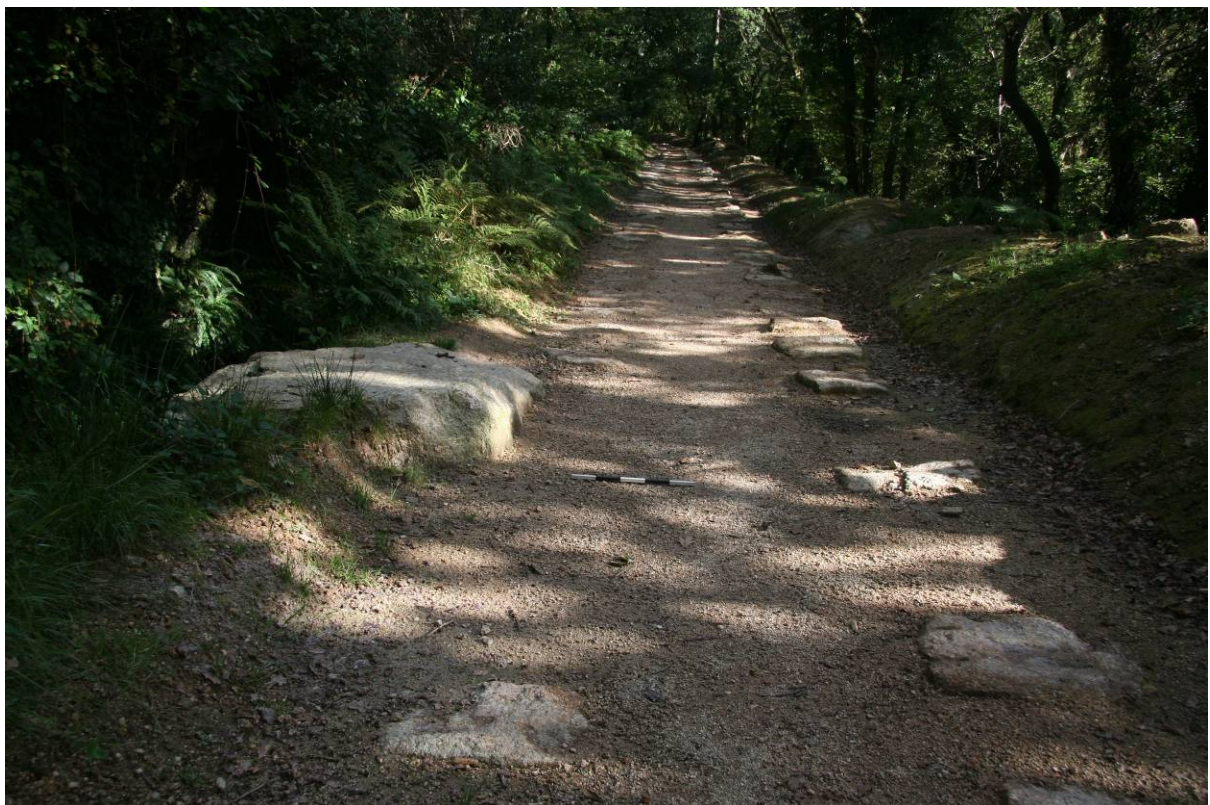
*Fig 10 A granite boulder lying between the leat and tramway*

*This had fallen from the opposite leat bank some years previous, and was relocated here (Chris Tigg, pers comm)*

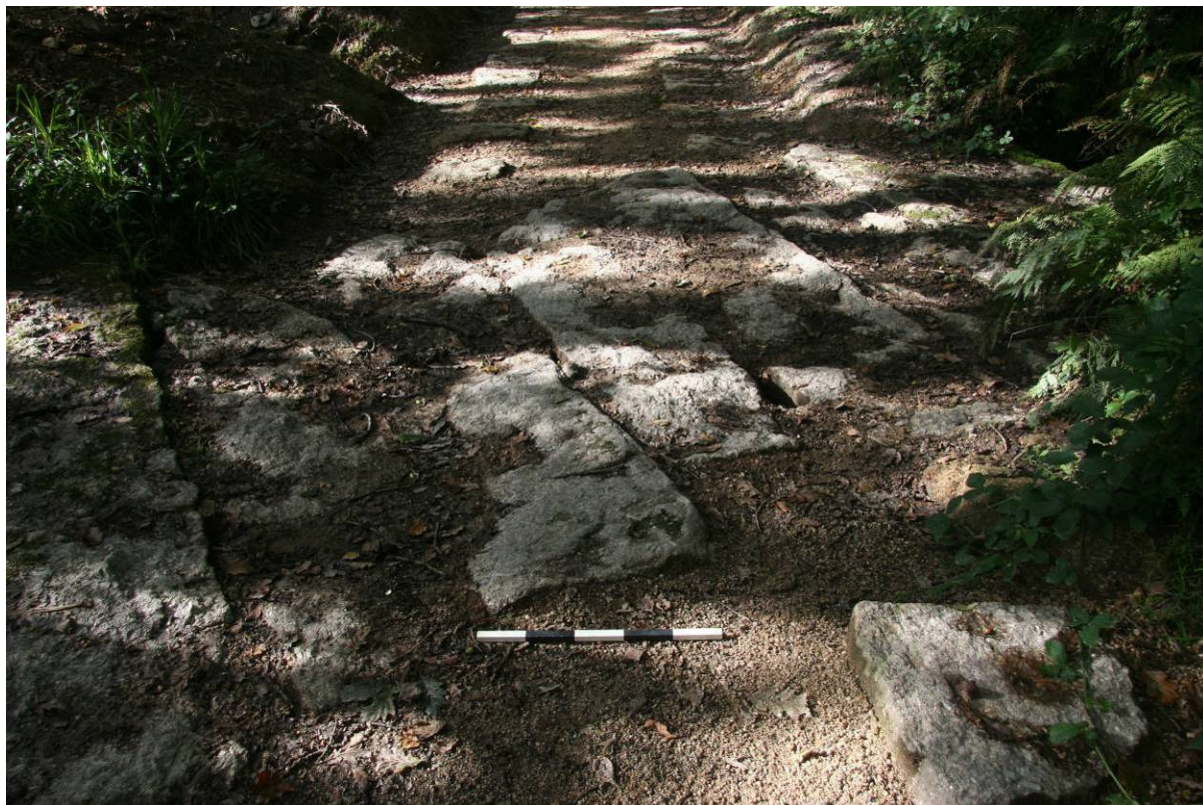
*Fig 11 Tramway carried on a granite lintel bridge over the course of the Carmears leat*

In three places the tramway crosses the Carmears leat by single span granite lintel bridges. The upper surfaces of the granites have been trimmed and rectangular depressions or shallow cut-outs can be seen, to carry the iron chairs to secure the rails (Fig 11). This echoes a similar system on the Treffry viaduct itself, where the tramway is carried directly on granite lintels covering the line of the aqueduct channel (Fig 12).

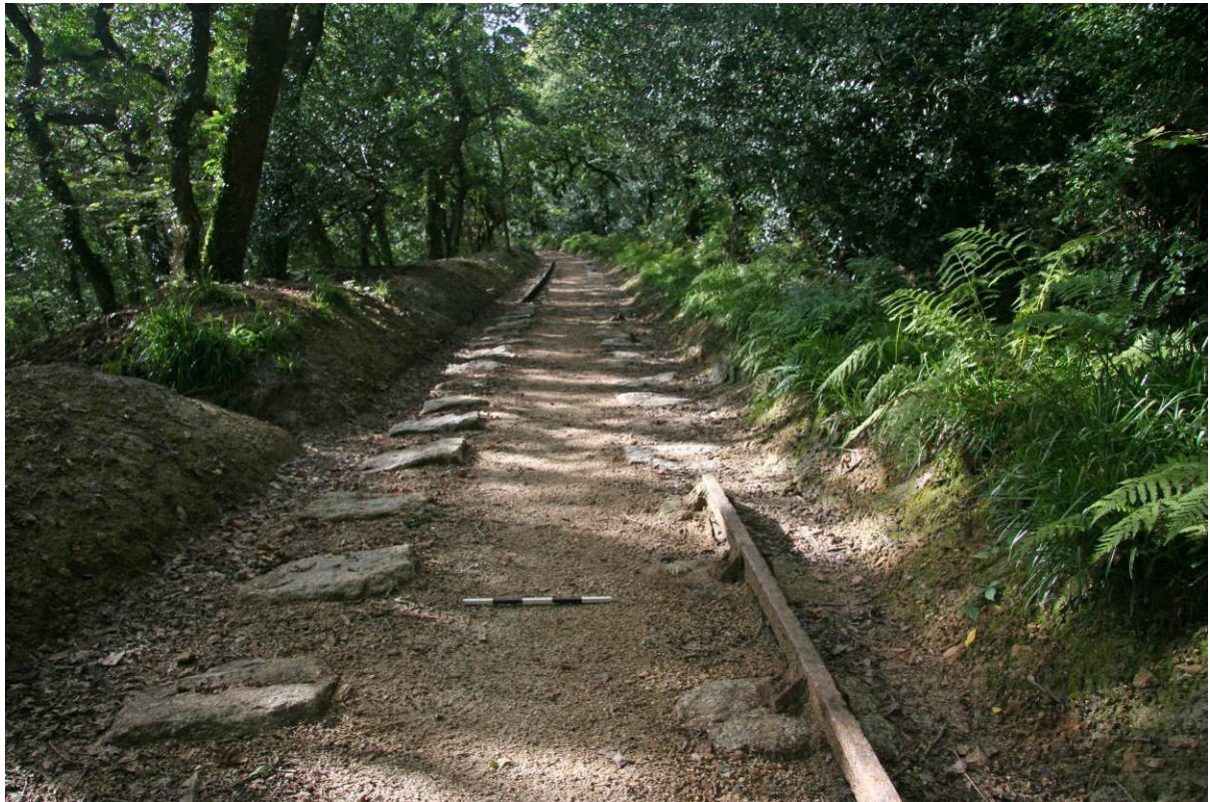
*Fig 14 Sections of surviving rails within a completed section of conserved tramway*

The contractor's programme included machine excavation of silt and debris from the tramway surface and exposure of the tops of the granite setts, remaining iron chairs and surviving sections of rail (see Fig 14). This work revealed that the tramway embankment was originally constructed of rab (decayed granite), which is free draining. It is likely that when the tramway was created, the rab was excavated from the hillslope, and a large proportion may have been overburden brought from the nearby quarries.

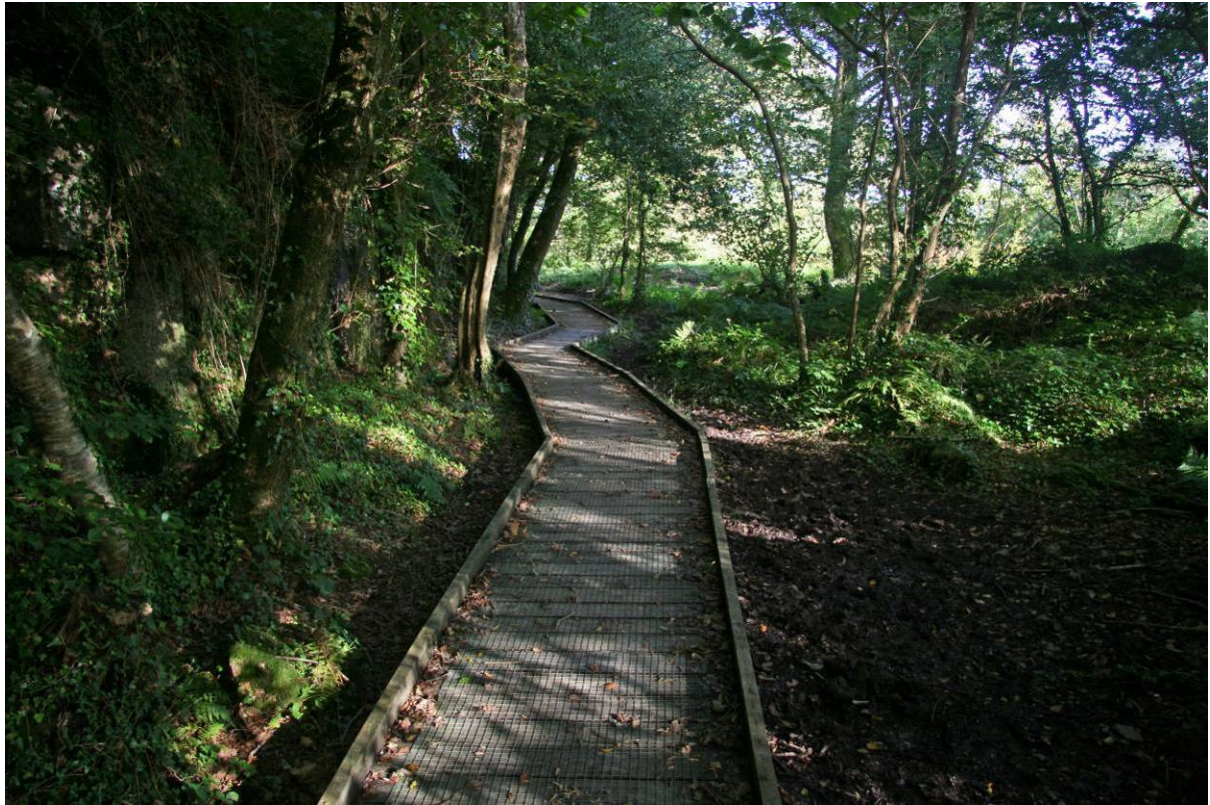
*Fig 15 The western end of the tramway is partly covered by a boardwalk, designed to raise the footpath above wet ground below the adjacent cliff*

To the east of the loop the tramway has been levelled into the slope by quarrying away part of a low granite cliff. As there is considerable wet ground at the foot of the cliff and the surface of the tramway is mostly obscured by mud, a modern boardwalk has been installed to raise the level of the footpath (Figs 15 and 16). In this area the leat runs south of the tramway, the channel running beneath a granite lintel bridge. Between the tramway and the leat the ground has been considerably disturbed since the time the tramway became derelict, with many overgrown dumped heaps of earth and stone.

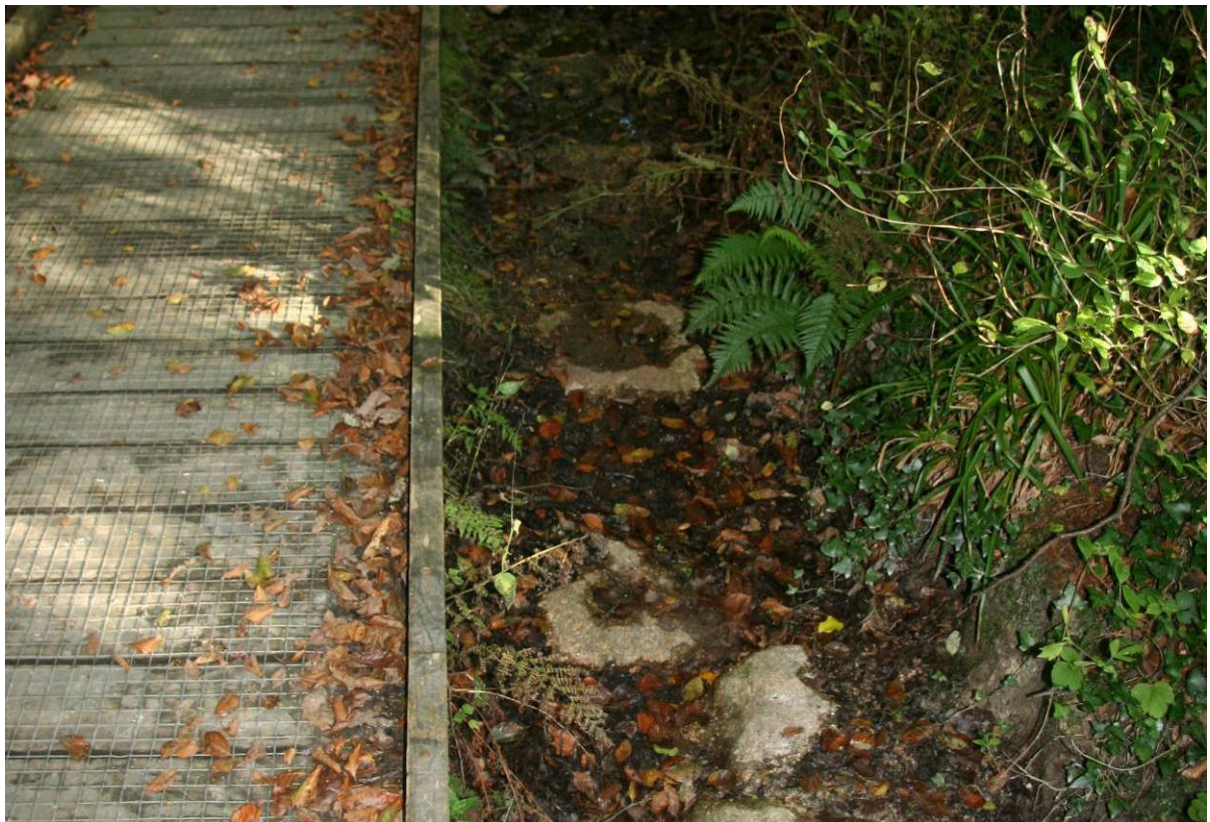
*Fig 16 A line of granite setts visible below the boardwalk*

*The original line of tramway setts is probably still extant throughout this section, although now mostly covered with debris*

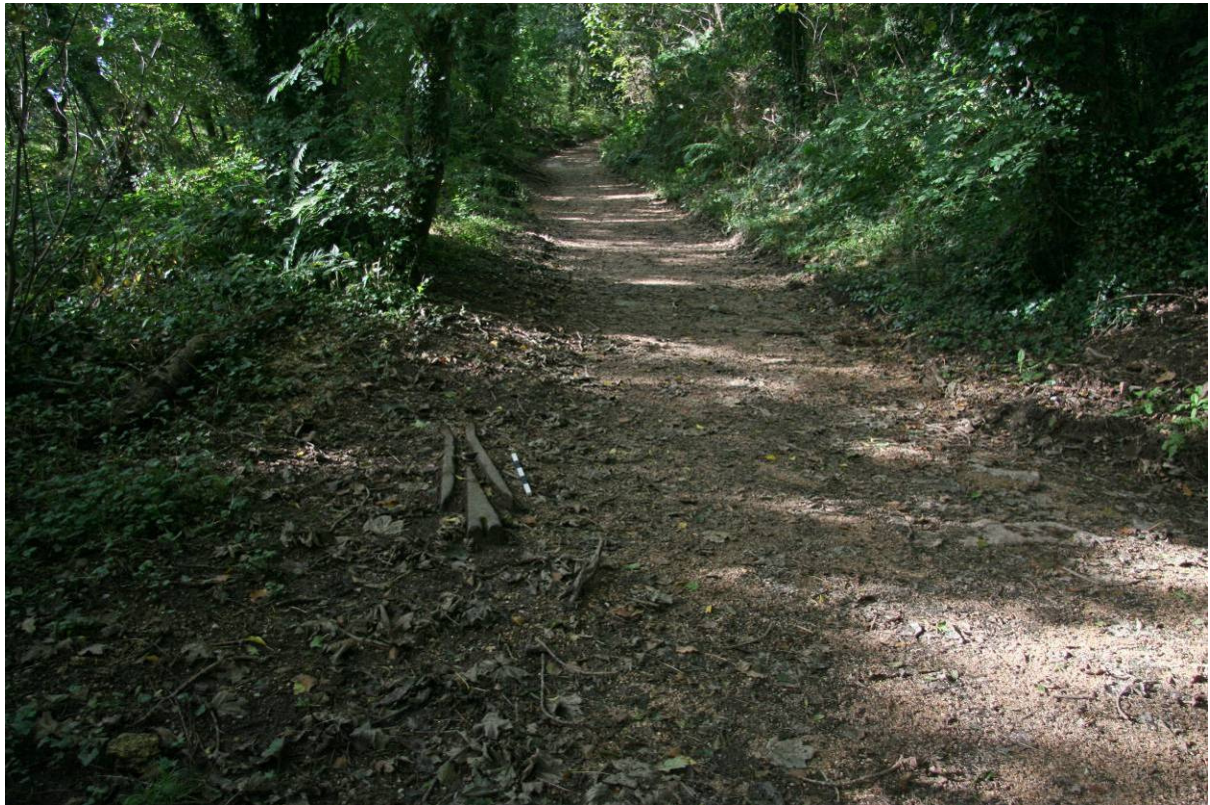
*Fig 17 A turnout rail (points) displaced and abandoned beside the tramway*

The part of the tramway closer to the water wheel pit was particularly disturbed at the commencement of the project. Many granite setts have been dug up from this area in the past and several are now scattered around the former marshalling area. Part of an extant turnout (points) rail is a remainder of the track from this section. As the rail is situated adjacent to the line of the main track and appears to be at the wrong level, it is unlikely to be *in situ* (Fig 17). Another piece of turnout rail is extant; this is located on

*There were originally two lines at the eastern end of the tramway, above the incline plane*

The survival of the two turnout rails is interesting, as it strongly suggests that the rails were taken up to be reused elsewhere, whereas the turnout sections were not required and left behind. If the rails had been destined for scrap then all useful and accessible sections will have been removed.

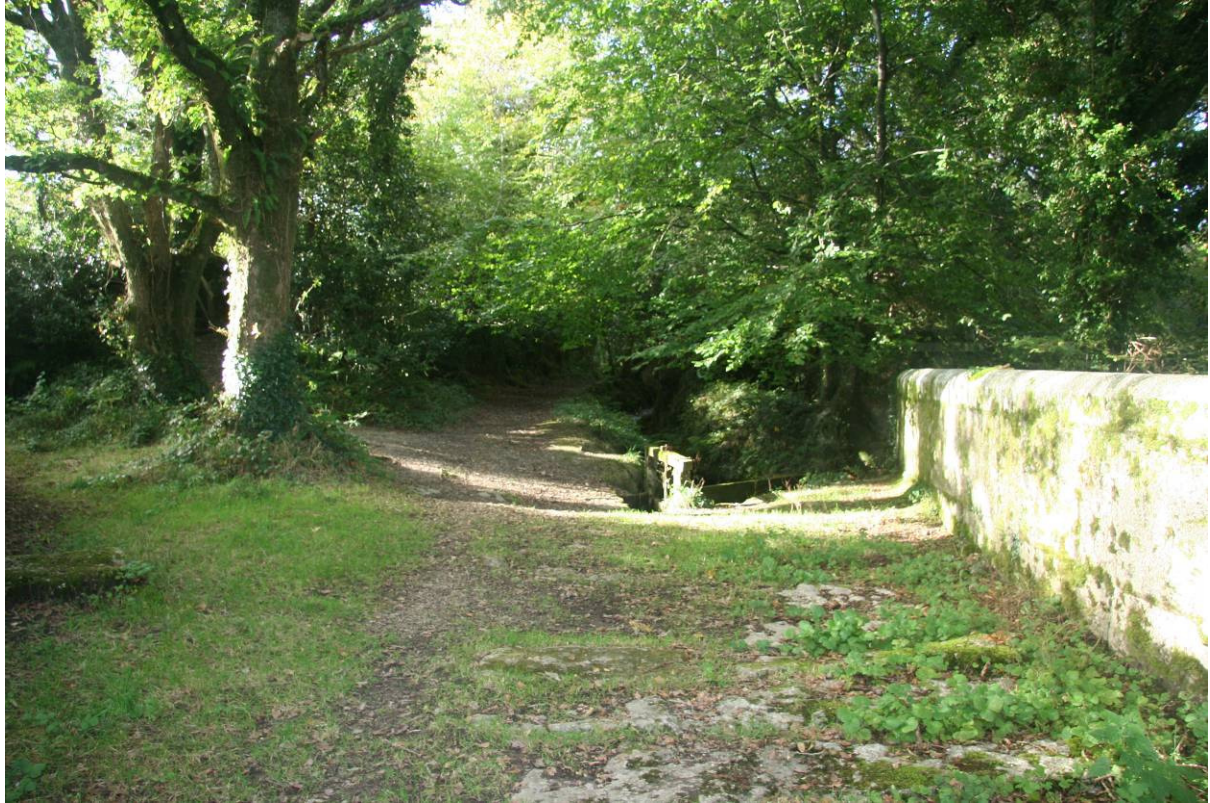
*Fig 23 The continuation of the tramway at the western end of the Treffry viaduct*

*Beyond the sluice gate the tramway route is now at a higher level; this is due to later dumping from the leat, which has masked the original surface*
