New Mills, Launceston, Cornwall

Historic building record

Client	Mr and Mrs R Ball
Report Number	2012R085
Date	December 2012
Status	Draft/2nd draft/Final
Report author(s)	Nigel Thomas
Checked by	Jacky Nowakowski
Approved by

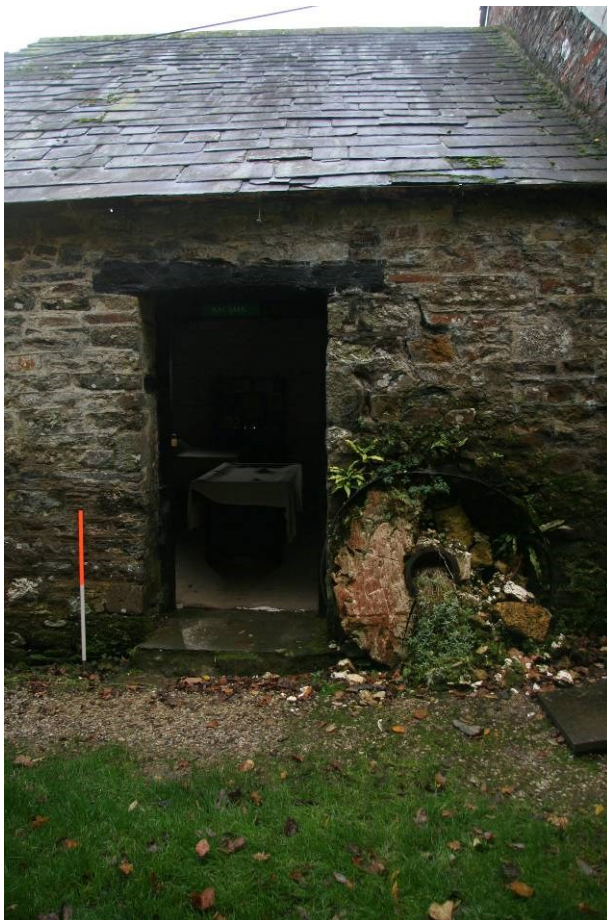
Fig 12 Rear doorway into the loft/barn above the shippon

Note the older style stone jambs and timber lintel, and a broken discarded millstone to right

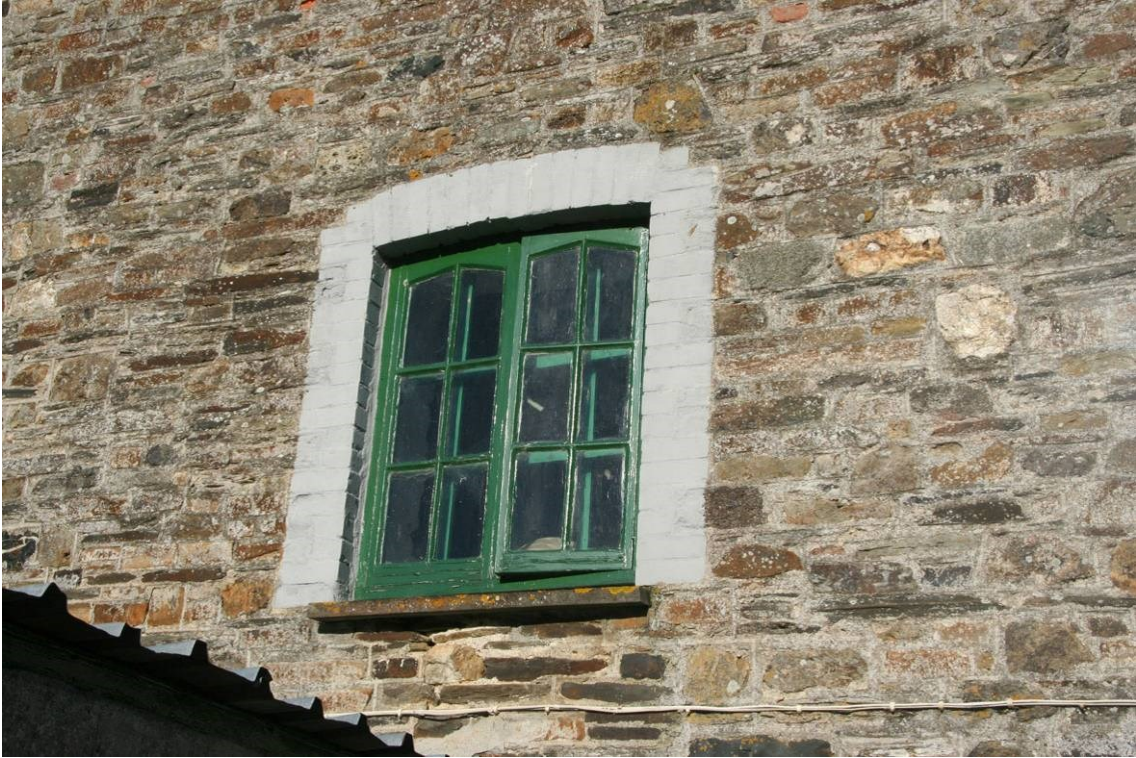
Fig 13 Upper floor window of mill, probably original to the 1905 reconstruction

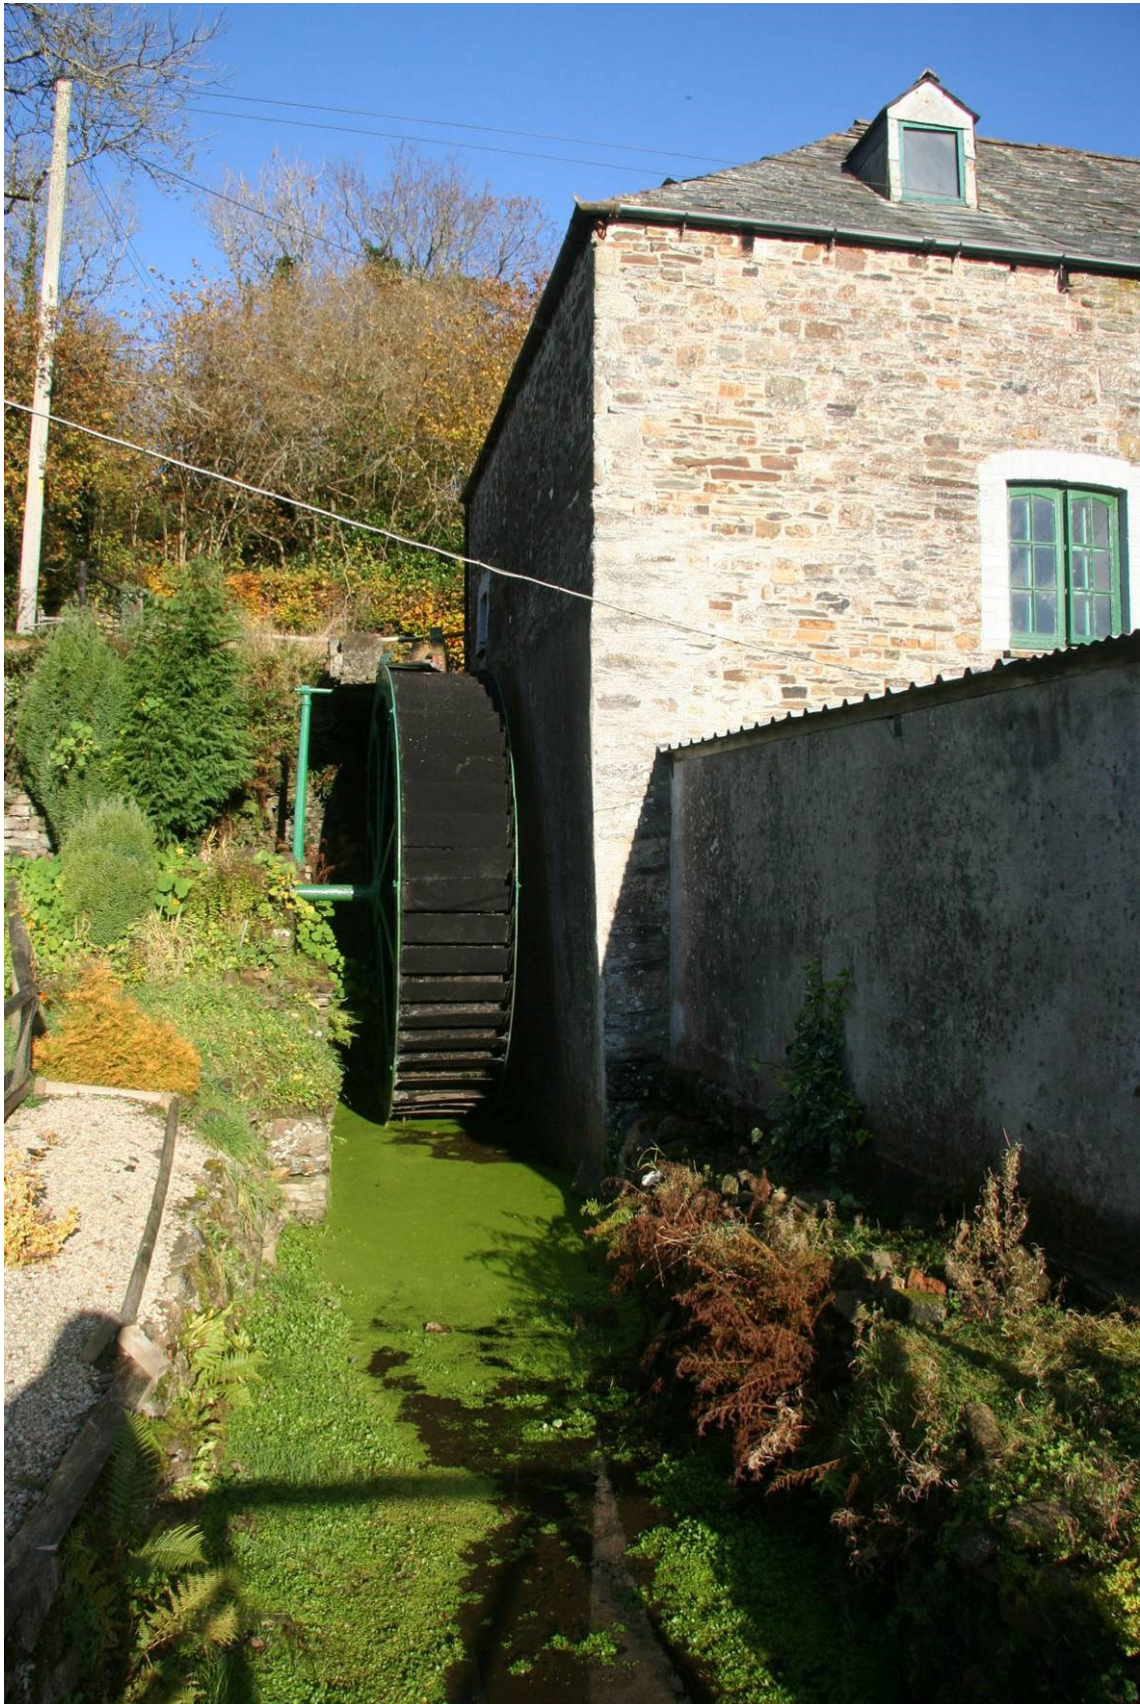
Fig 15 Waterwheel, wheel-pit and tailrace

The overshot iron waterwheel, made by T Coombe and Son of Launceston, is 4.2m (13.77 feet) diameter and 0.8m (2.62 feet) wide. The shrouds of the wheel bear the name of the maker and also a date of 1905 (Fig 17). The wheel is fed from a short concrete launder, presumably a replacement for an earlier wooden example. Although still operational, the wheel has abundant patching to the buckets. The wheel-pit now appears slightly silted and feeds into a shallow tailrace that allows water to return to the river. A brick-arched bridge with low granite parapets carries the mill and farm access track over the tailrace.

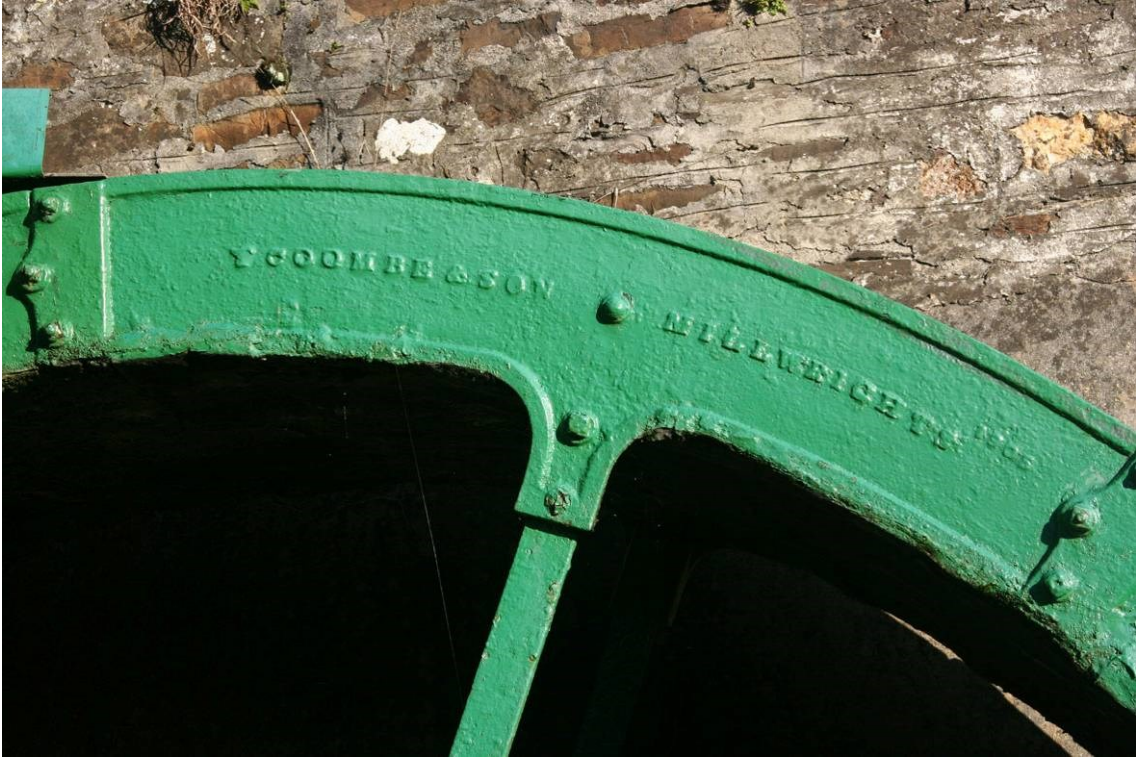
Fig 16 Waterwheel shroud, embossed 'T COOMBE & SON MILLWRIGHTS 1905'

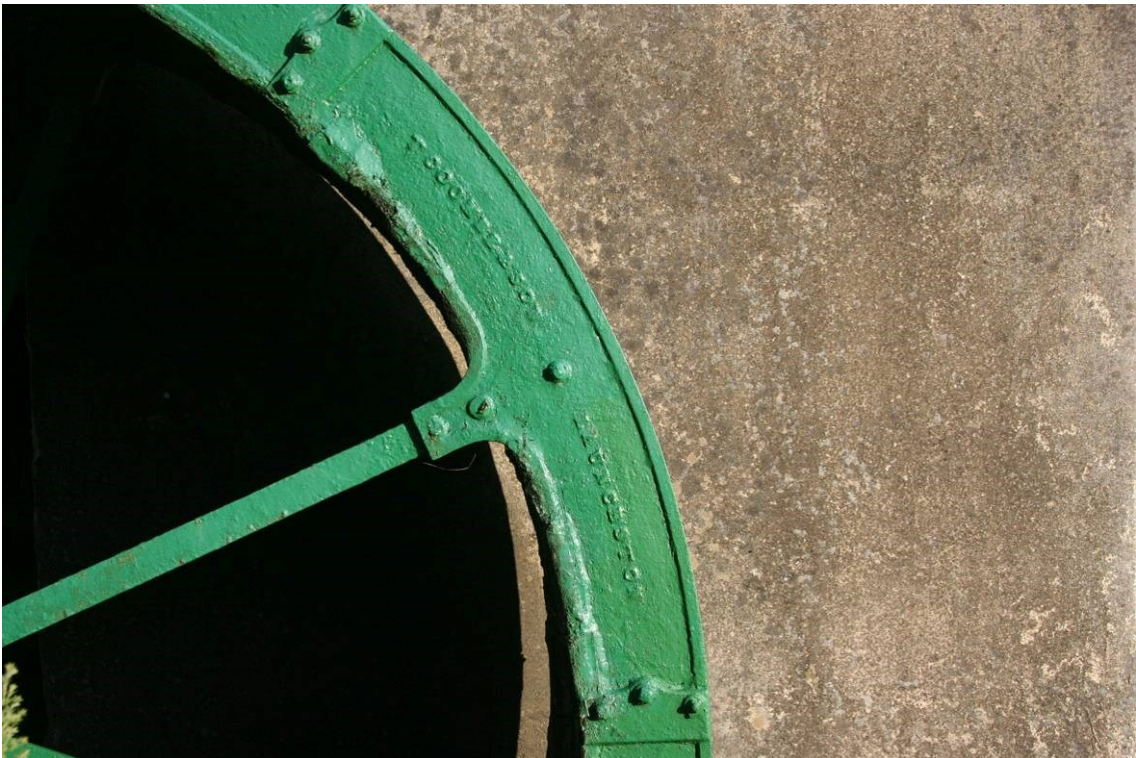
Fig 17 Waterwheel shroud, embossed 'T COOMBE & SON LAUNCESTON'

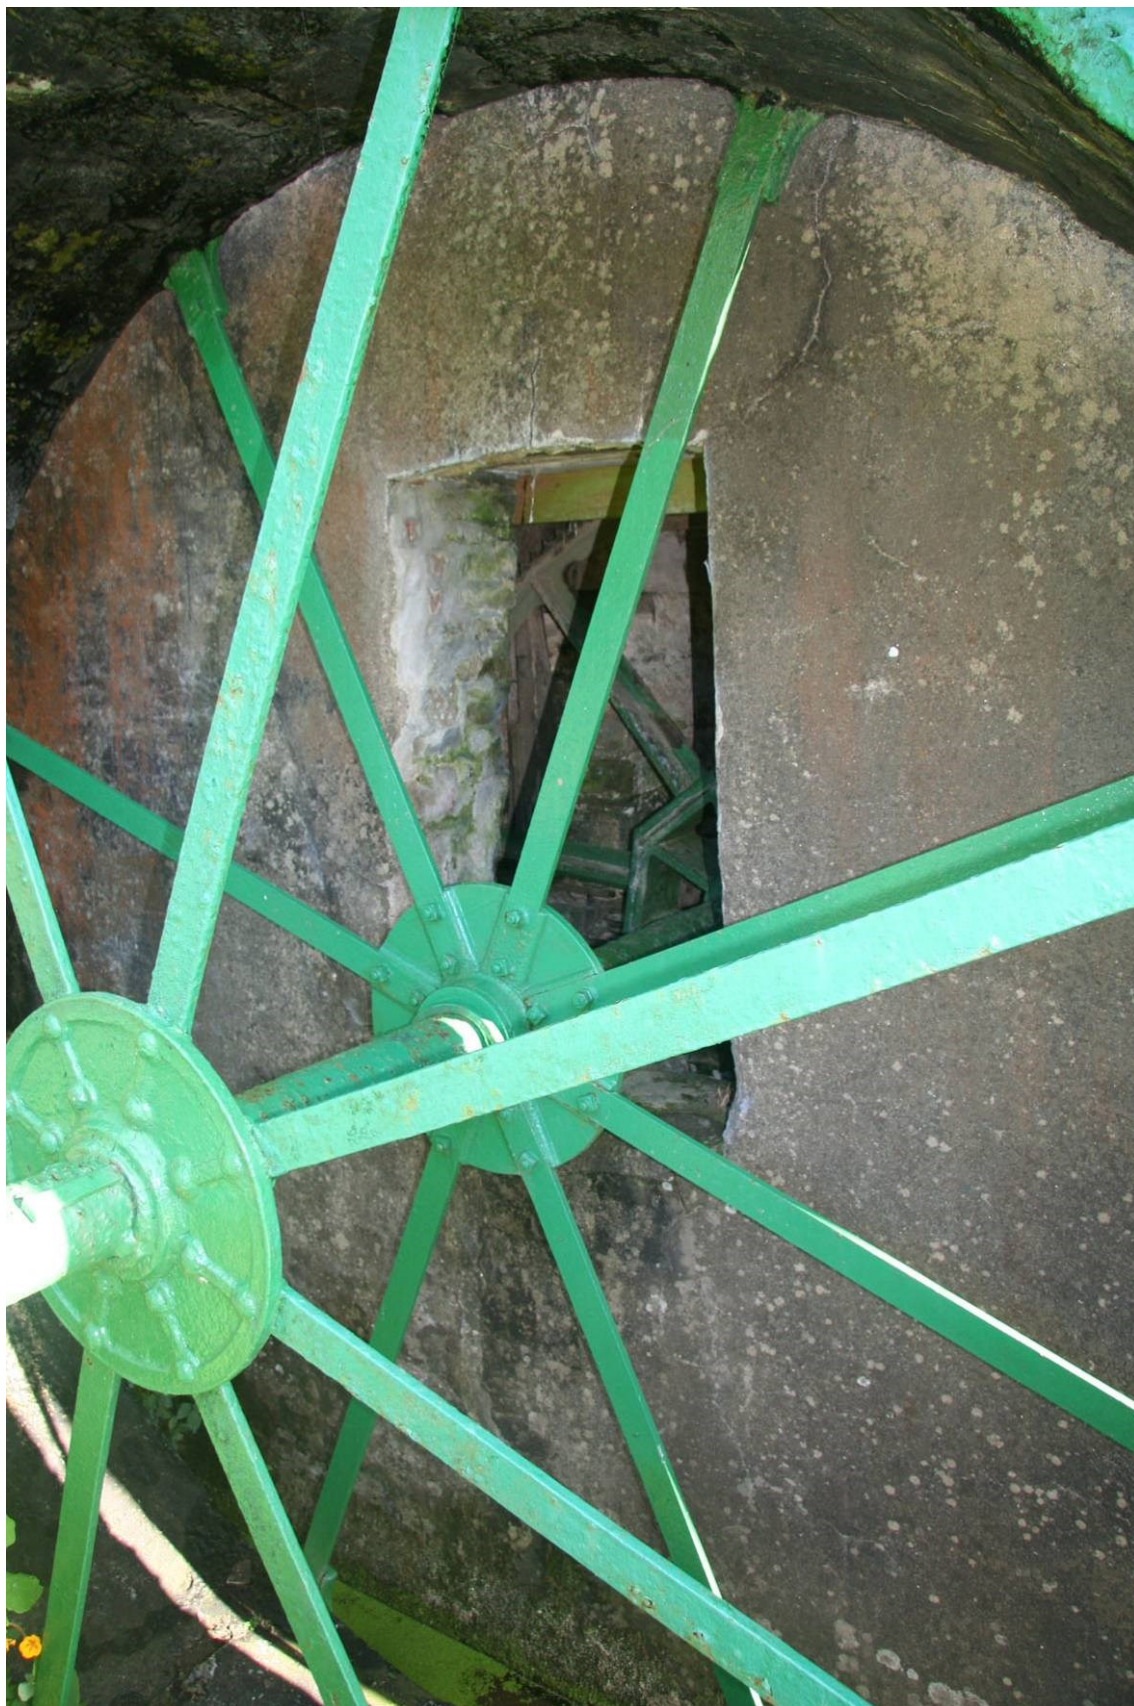
Fig 18 View of wheel hubs and spokes, with pit-wheel inside

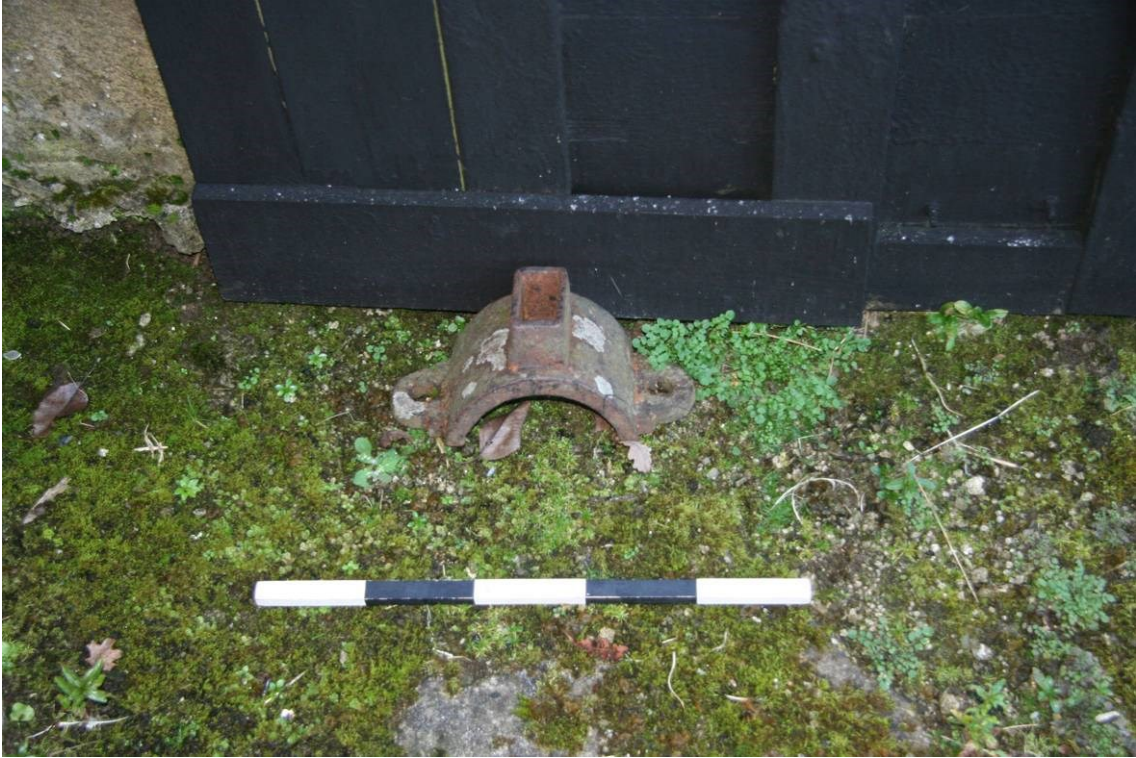
Fig 19 A displaced top casting of an axle bearing

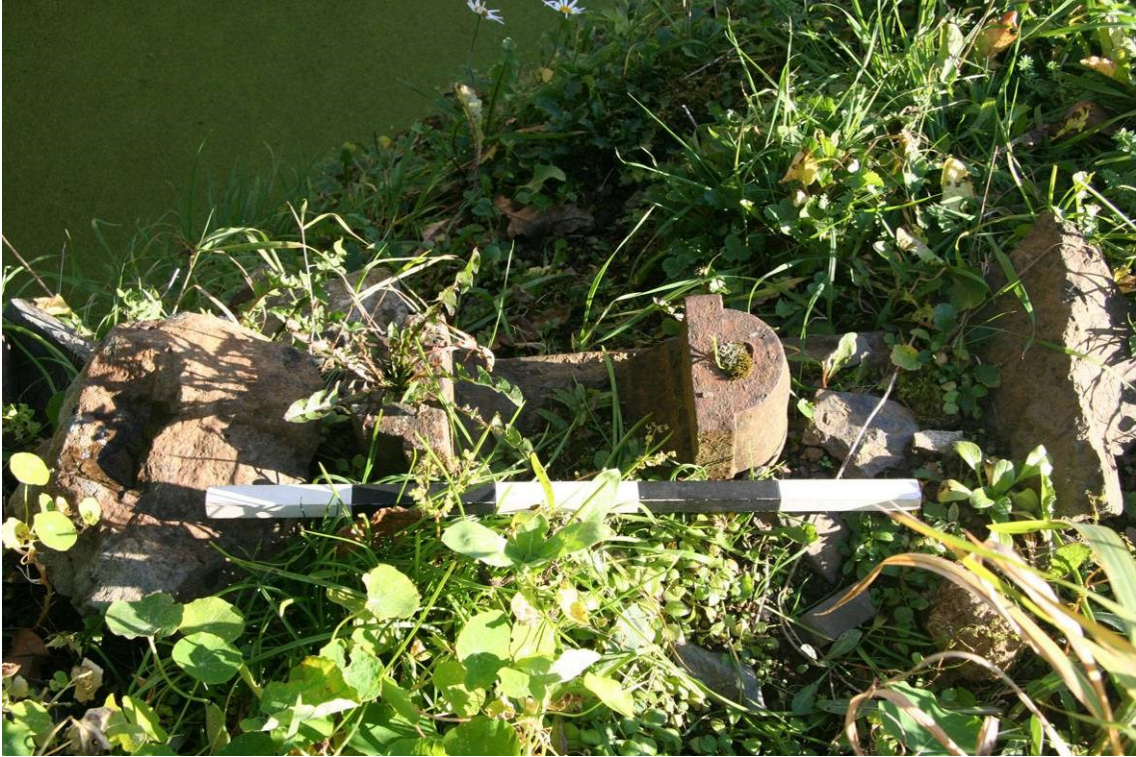
Fig 20 Displaced bottom casting of an axle bearing

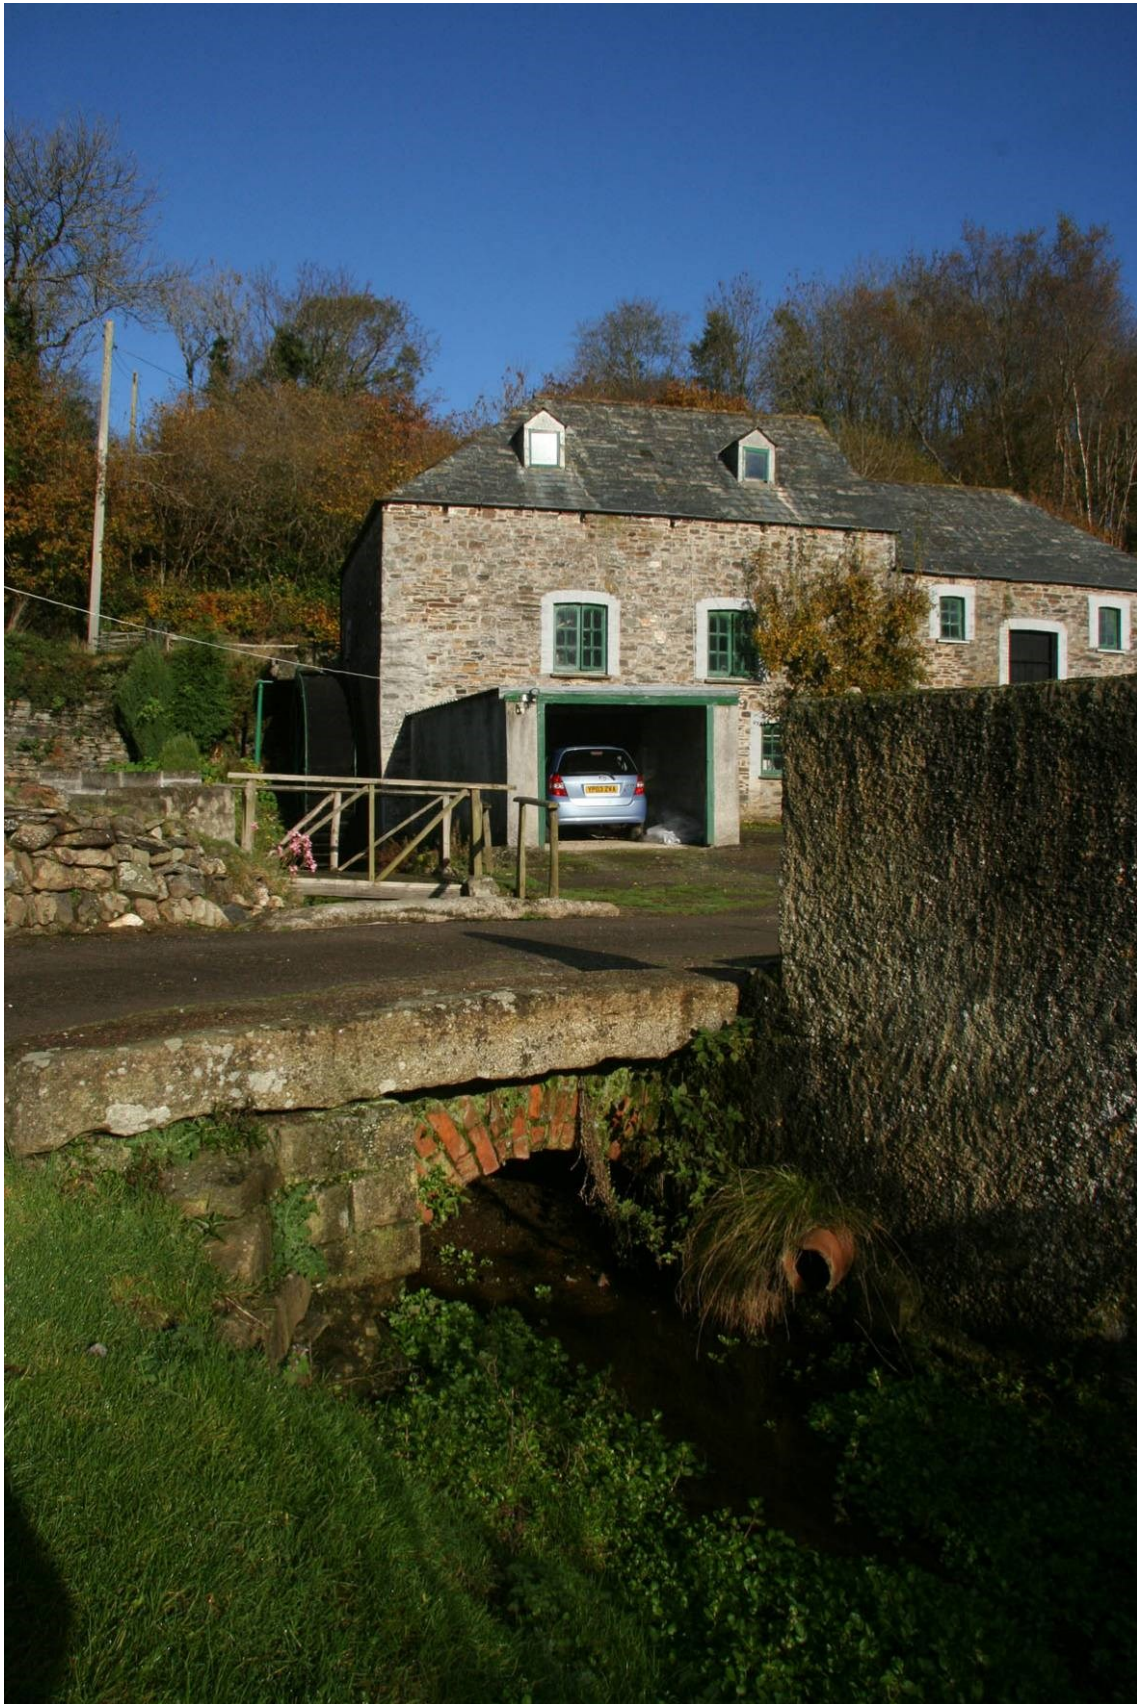
Fig 21 A brick arched bridge carries the mill access track over the tailrace channel

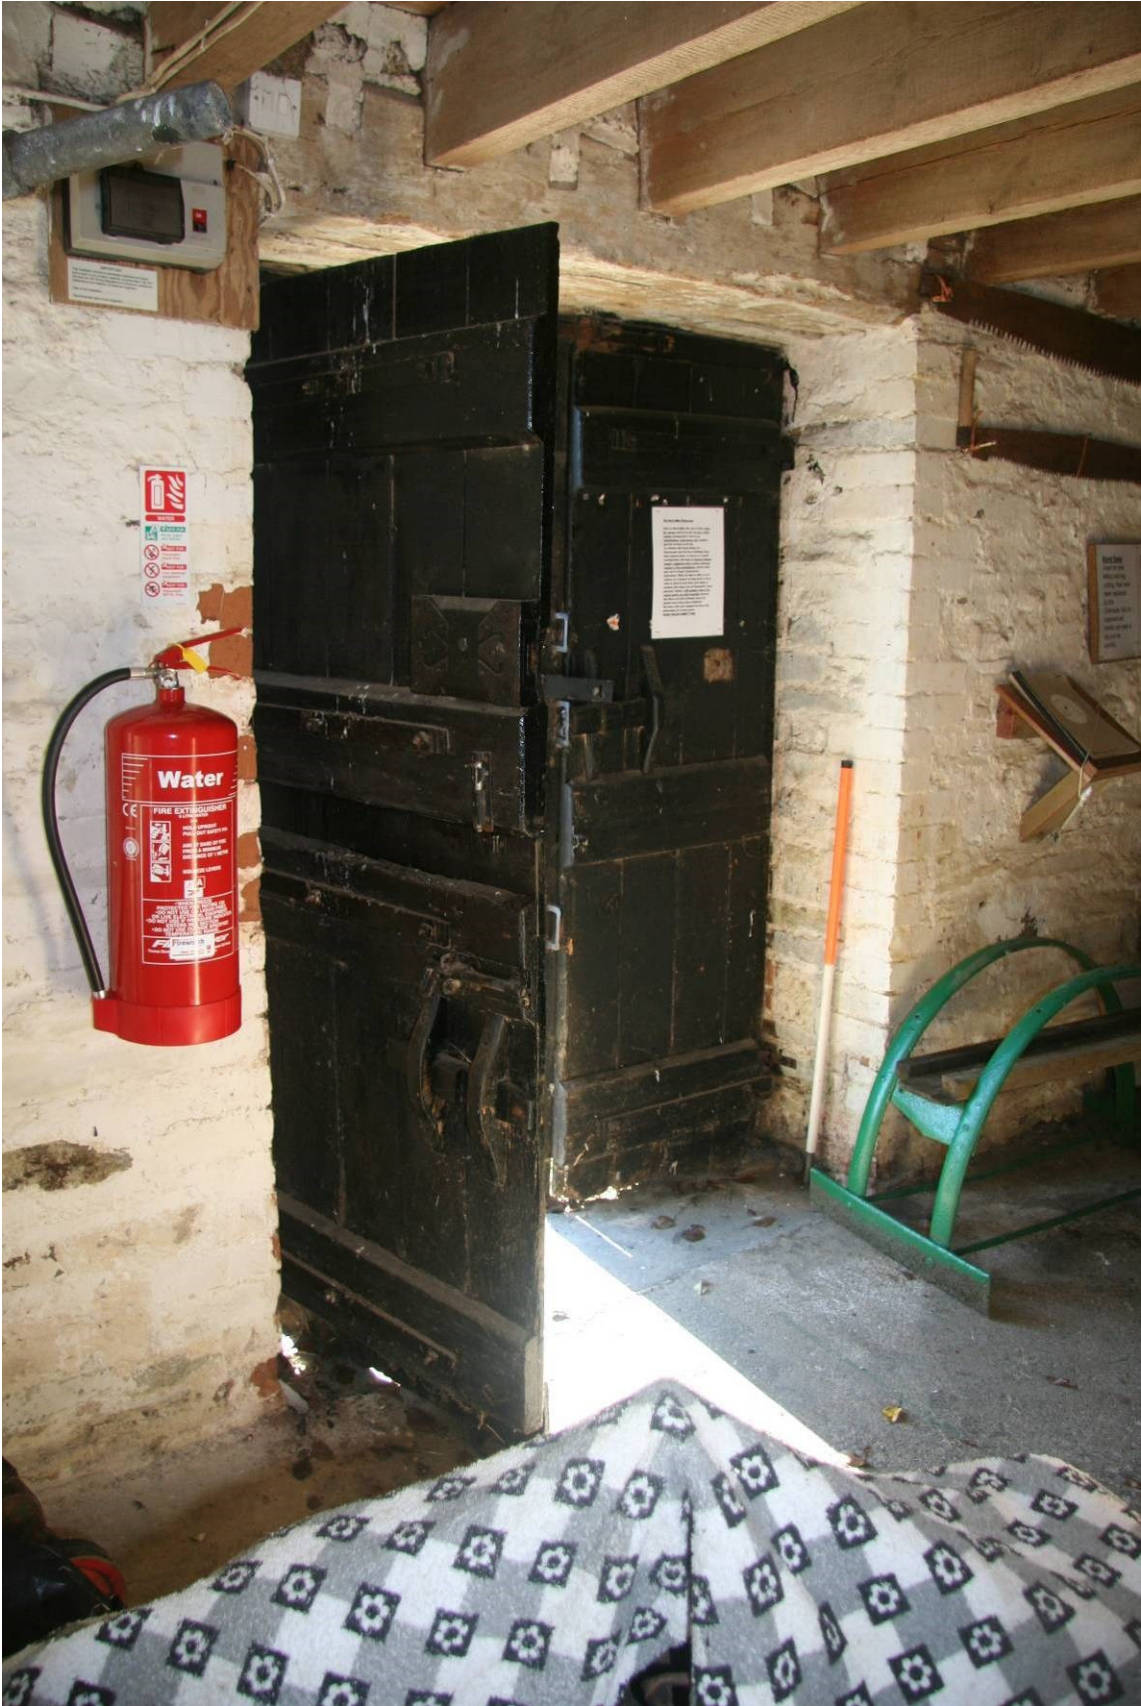
Fig 22 The main entrance of the mill, with a split door in the foreground showing latch and lock detail

Note also the reused timber lintel above the doorway

loft/barn above the shippon has single casements, as does the loosebox. All doors are now painted with heavy tar-based paint. The door into the mill has a traditional double door, the east side also being a split (stable-door) type (Fig 22). It retains all its old lock and latch fittings. The shippon door has vertical slots in the upper part and may have originally had a similar sliding shutter behind ('hit and miss' ventilator).

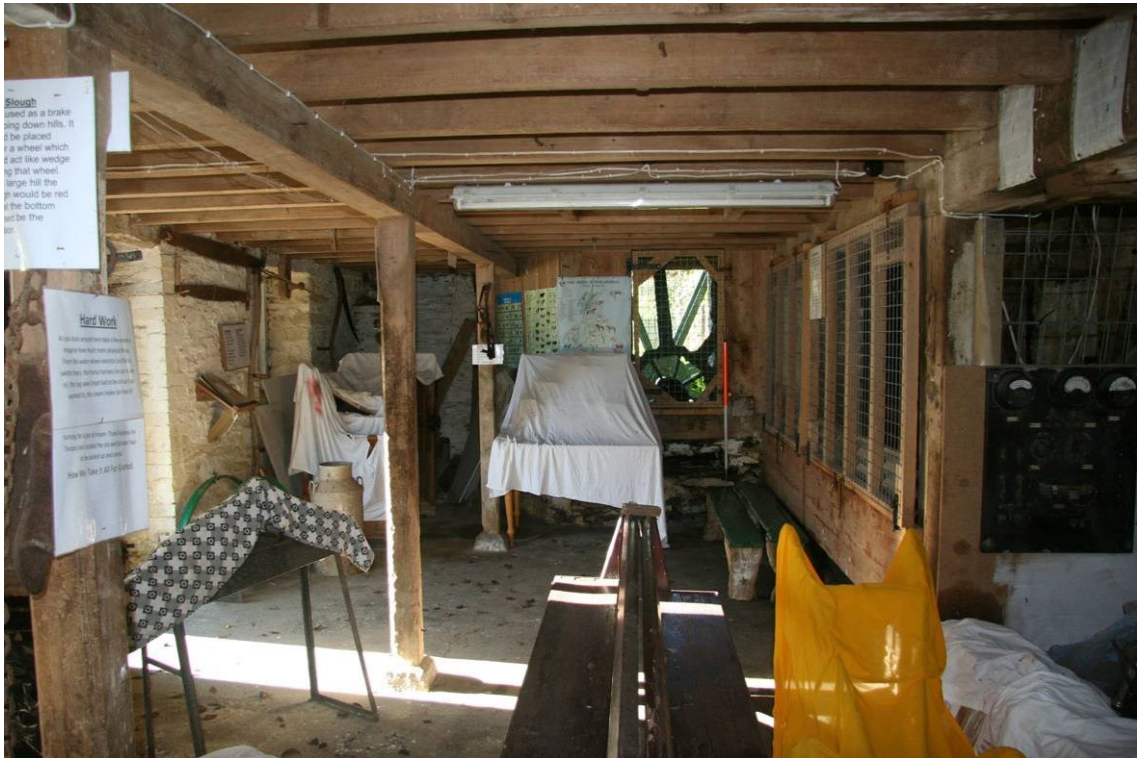
Fig 23 The ground floor of the mill, looking towards the pit-wheel

A countershaft supplying drive to an electrical generator is behind the screen to the right

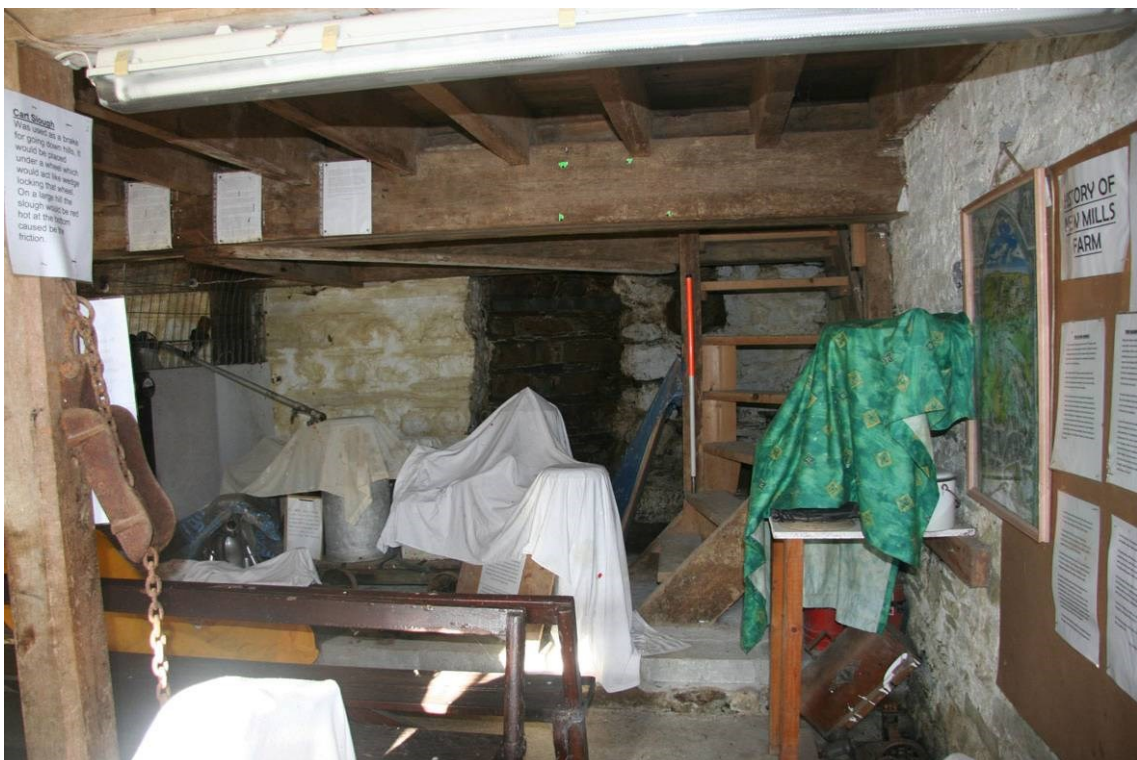
Fig 24 Ground floor of the mill, showing winder stairs to the stones floor *(on the right)*

A narrow winder stair, with some treads more recently replaced) leads up to the stones or milling floor at the northeast corner.

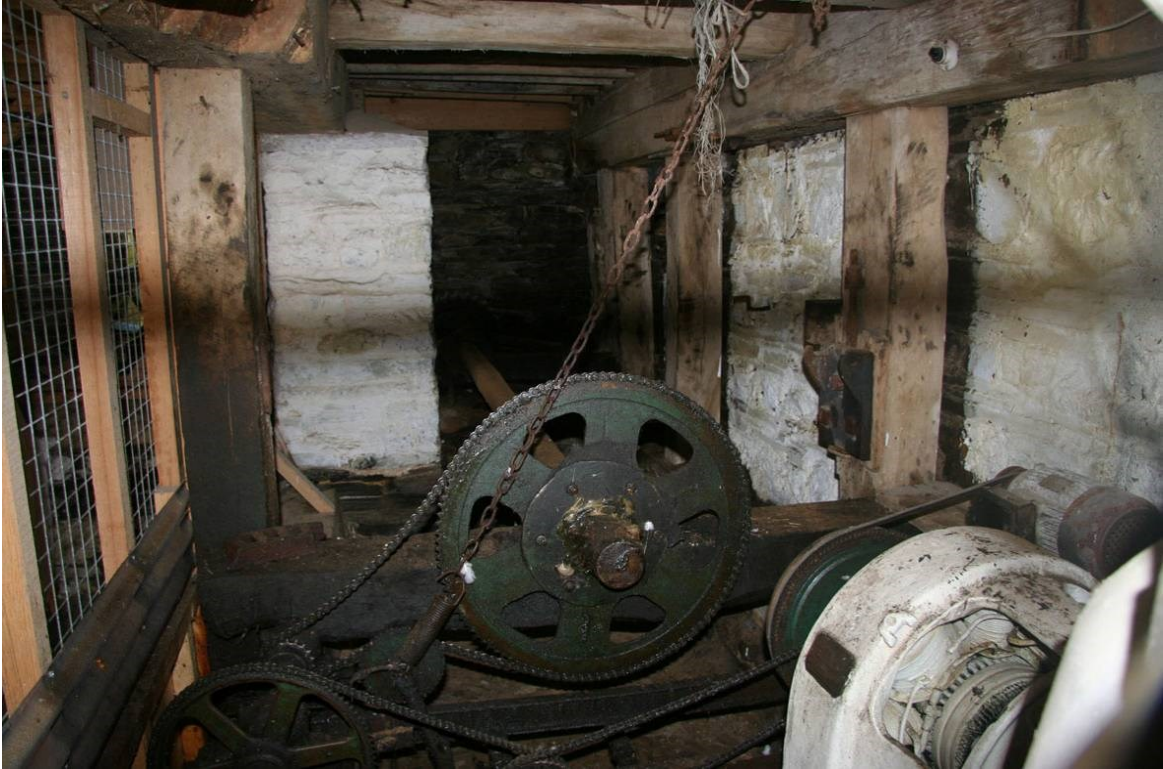
Fig 25 The end of the countershaft (centre), now driving a dynamo via chains and sprockets

A vacuum pump for a milking machine is also connected to this drive

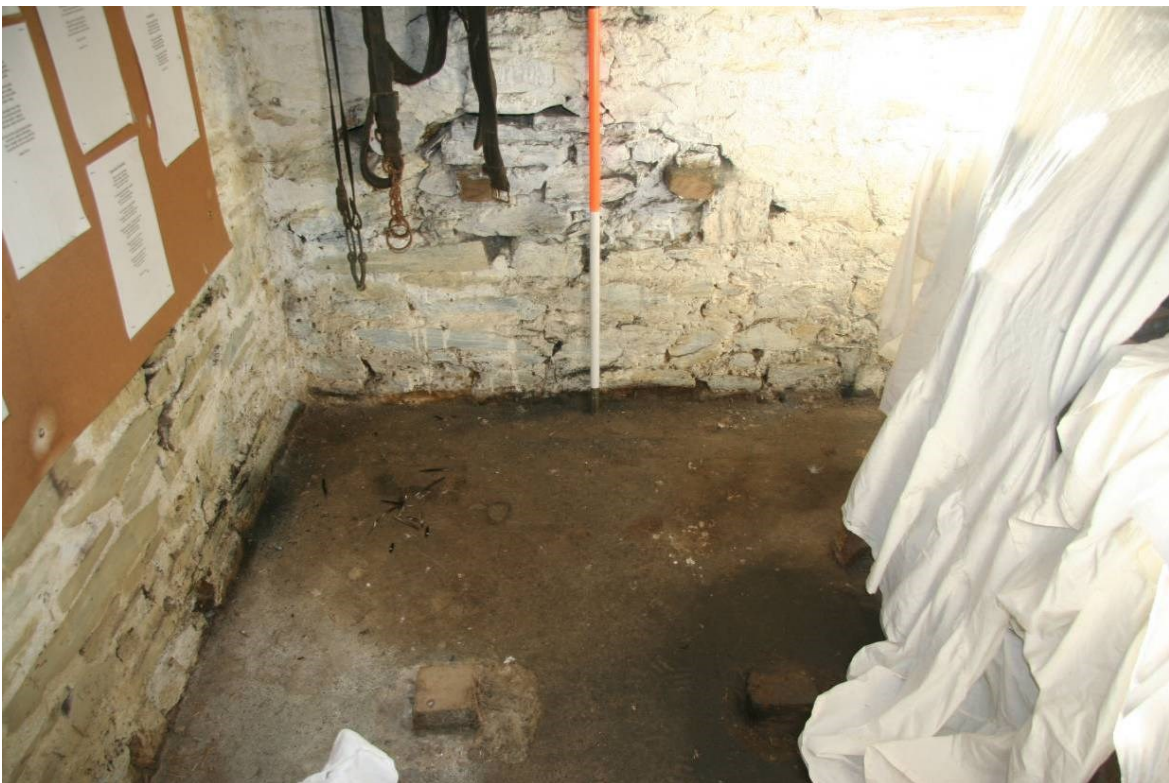
Fig 26 Traces of an inserted foundation for a bench or similar feature, attached to the floor and wall in the south east corner of the mill

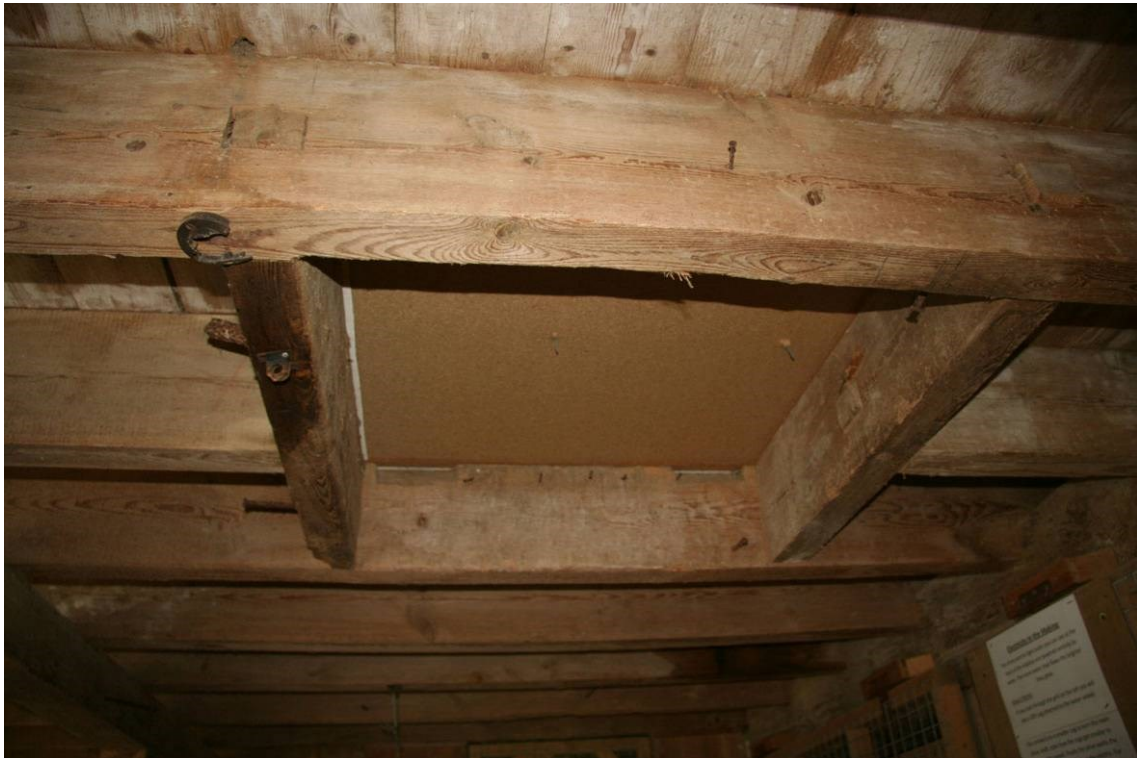
*Fig 27 Sack hoist hatch between the ground and first floors
Note the shallow cut-outs for the hinges of the trapdoors*

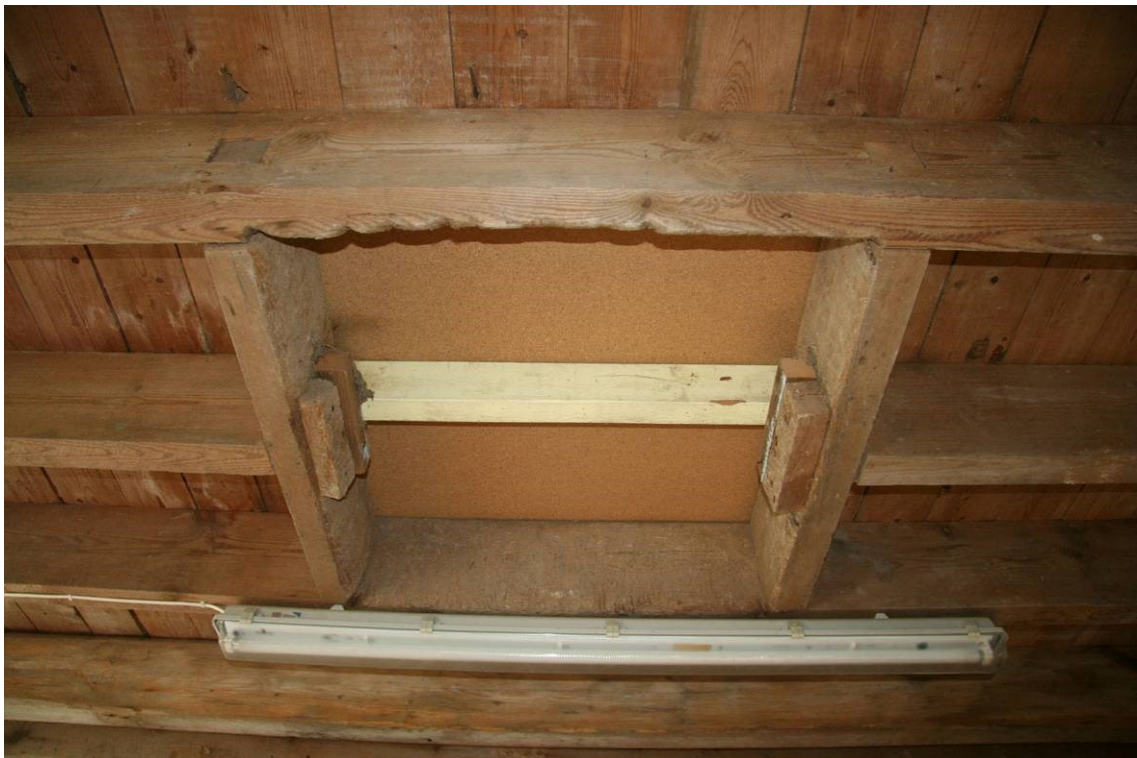
*Fig 28 Sack hoist hatch between the first floor and loft level
Note the wear on the floor joists caused by the ropes when the hoist was in use*

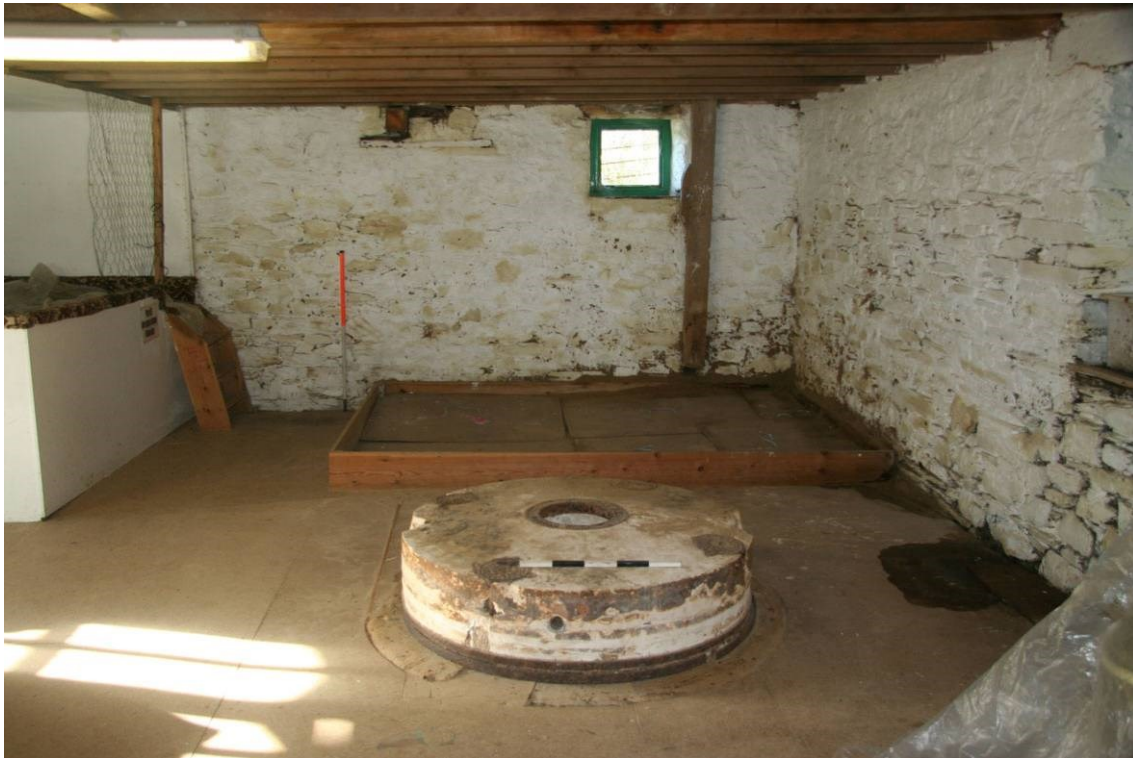
Fig 29 The single surviving set of millstones on the first floor, now without wooden covers (compare with a more complete example in Fig 31)

The small window to the rear was for observing and controlling the water level in the leat outside. The vertical timber supported a control for a sluice

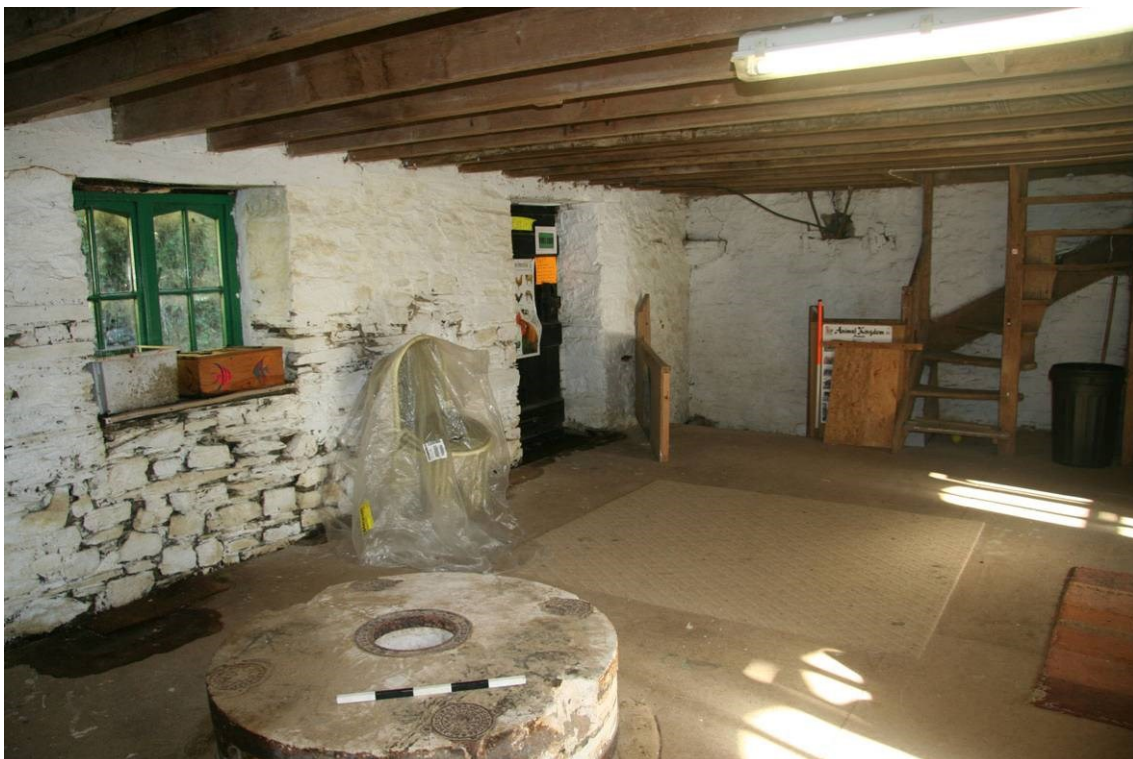
*Fig 30 View of the first floor with original winder stairs to the loft at the rear
A second pair of millstones was once sited in the position of the square mat*

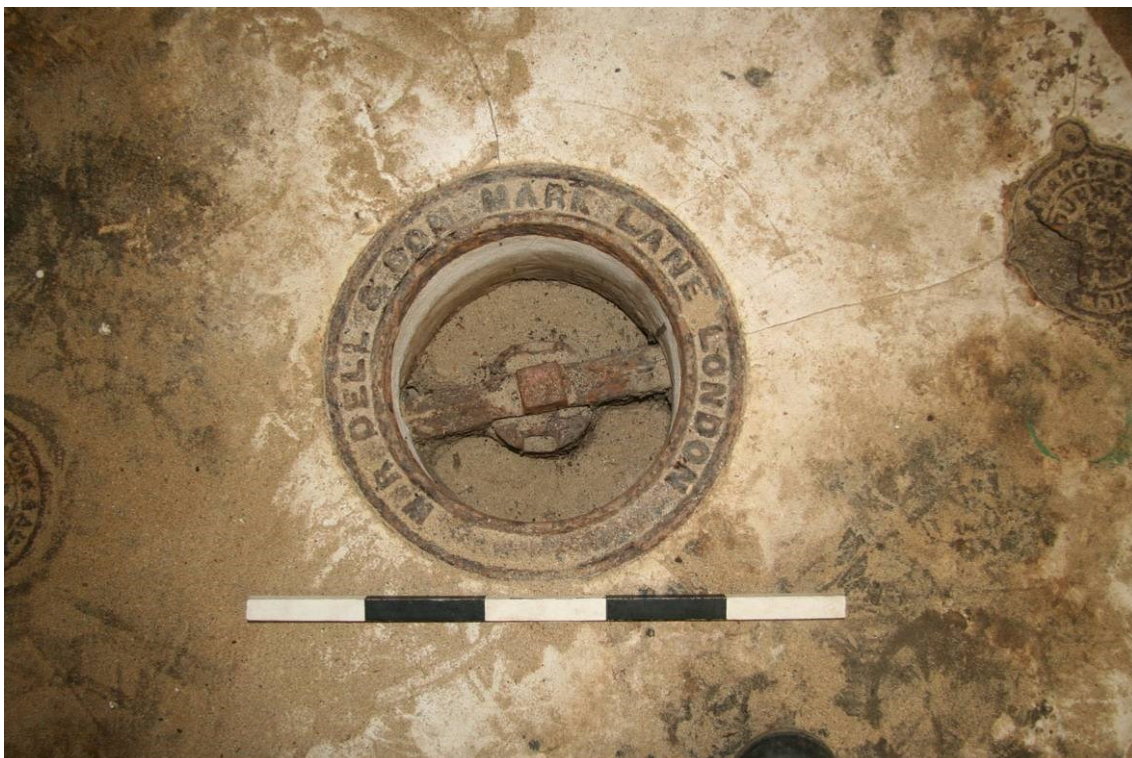
Fig 32 Casting at the centre of the New Mills millstone

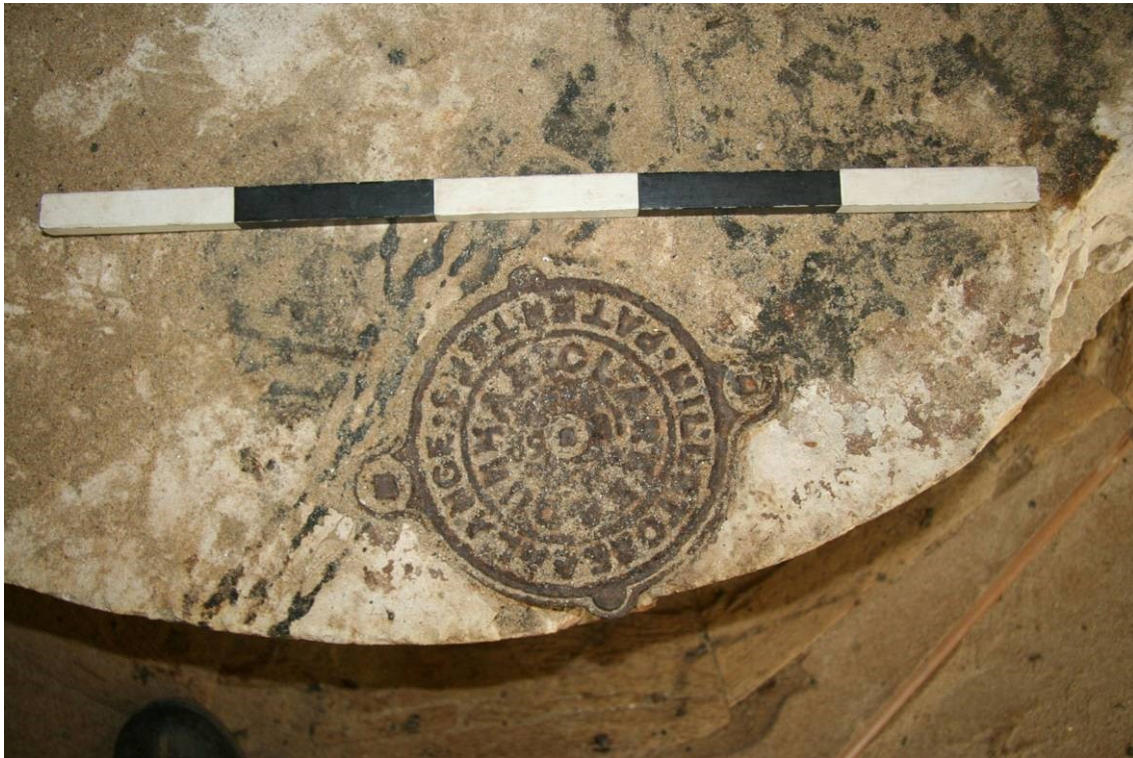
Fig 33 Casting in the edge of the millstone

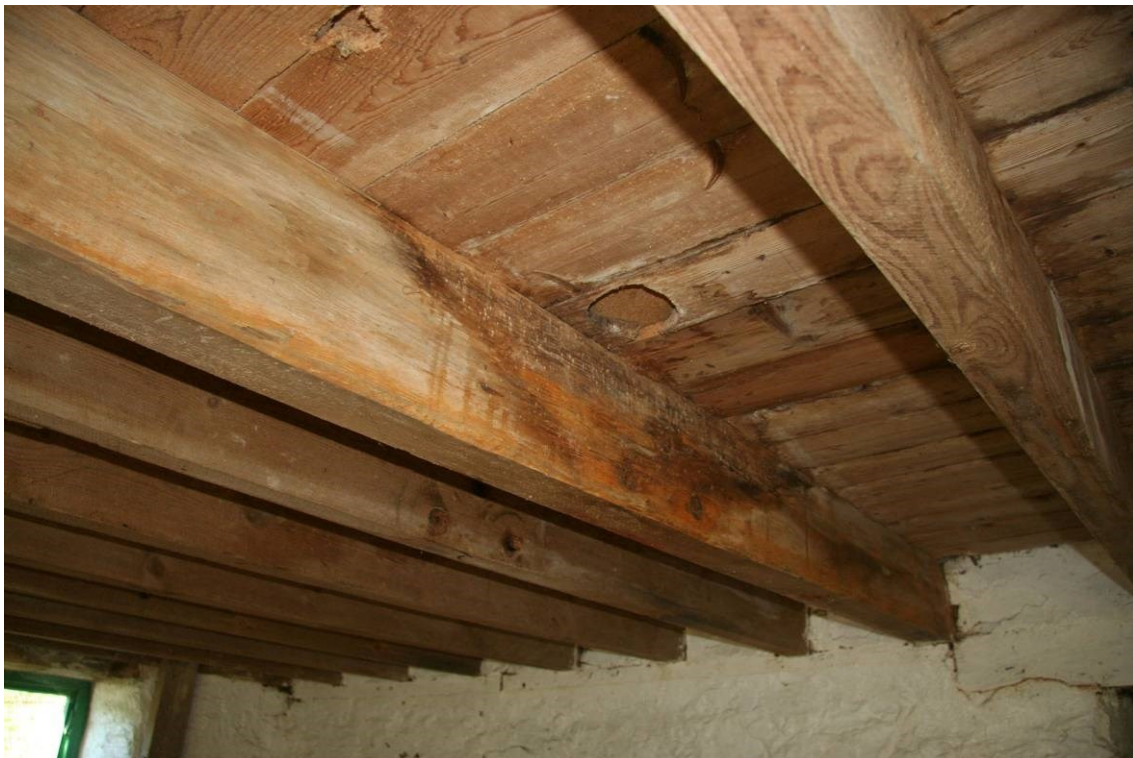
Fig 34 Hole in the loft floor where grain was once channelled into a hopper above the millstone
