New Mills, Launceston, Cornwall

Historic building record

Client	Mr and Mrs R Ball
Report Number	2012R085
Date	December 2012
Status	Draft/2nd draft/Final
Report author(s)	Nigel Thomas
Checked by	Jacky Nowakowski
Approved by

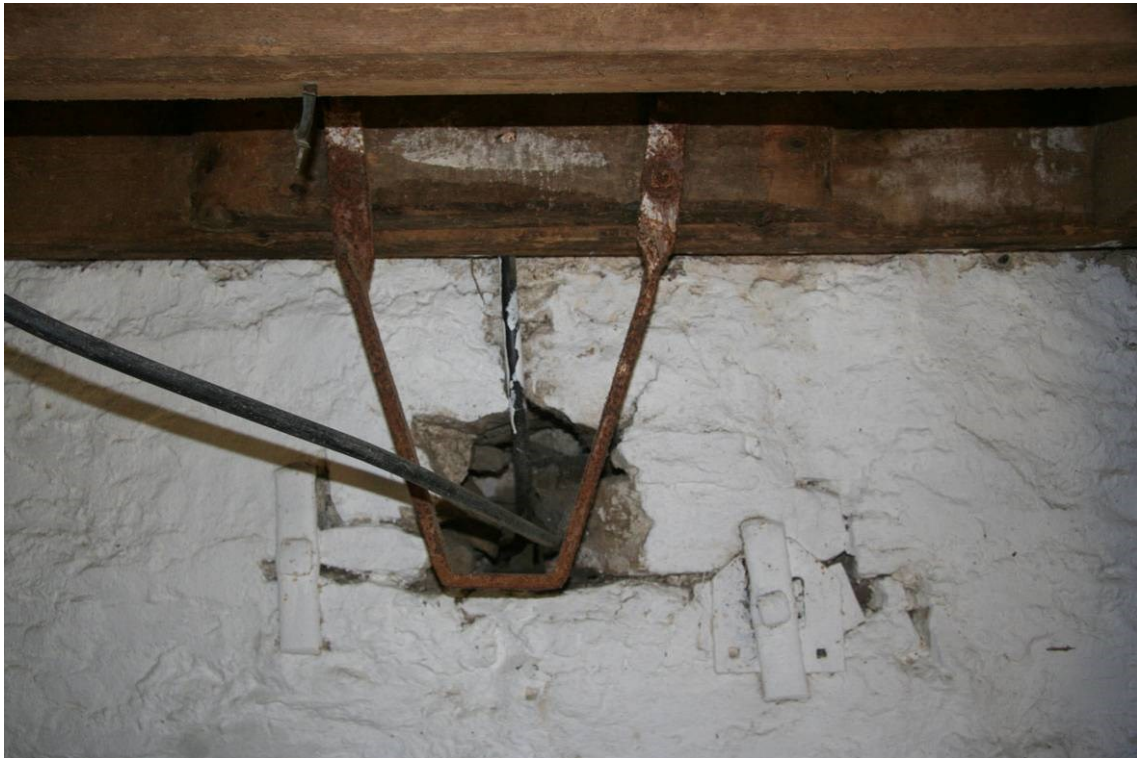
Fig 35 Axle support bracket (and hole through the wall) for line shafting to subsidiary machinery

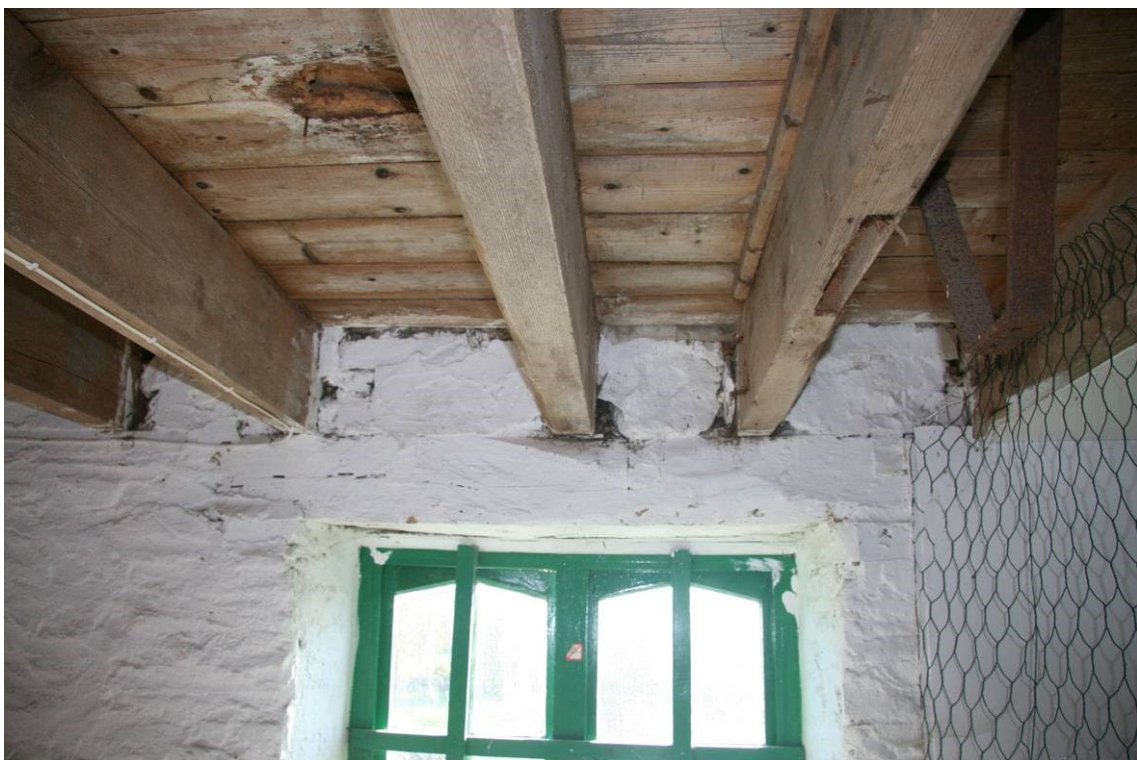
*Fig 36 Another axle support bracket on the south side of the first floor
This part of the mill probably once contained cleaning/grading machines*

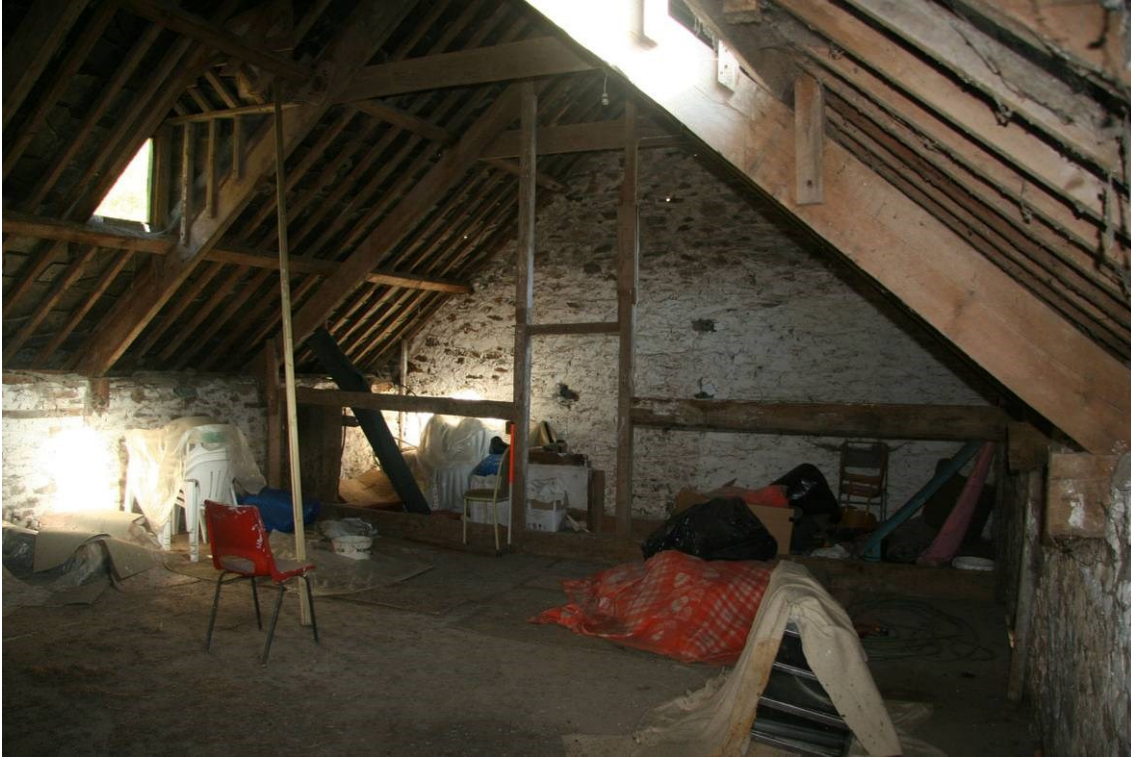
Fig 37 The mill loft, lit by three dormer windows

Grain once arrived here via a sack hoist situated above the middle of the room. The remainder of the space was probably given over to grain storage, the walls most likely originally lined with timber to prevent contamination

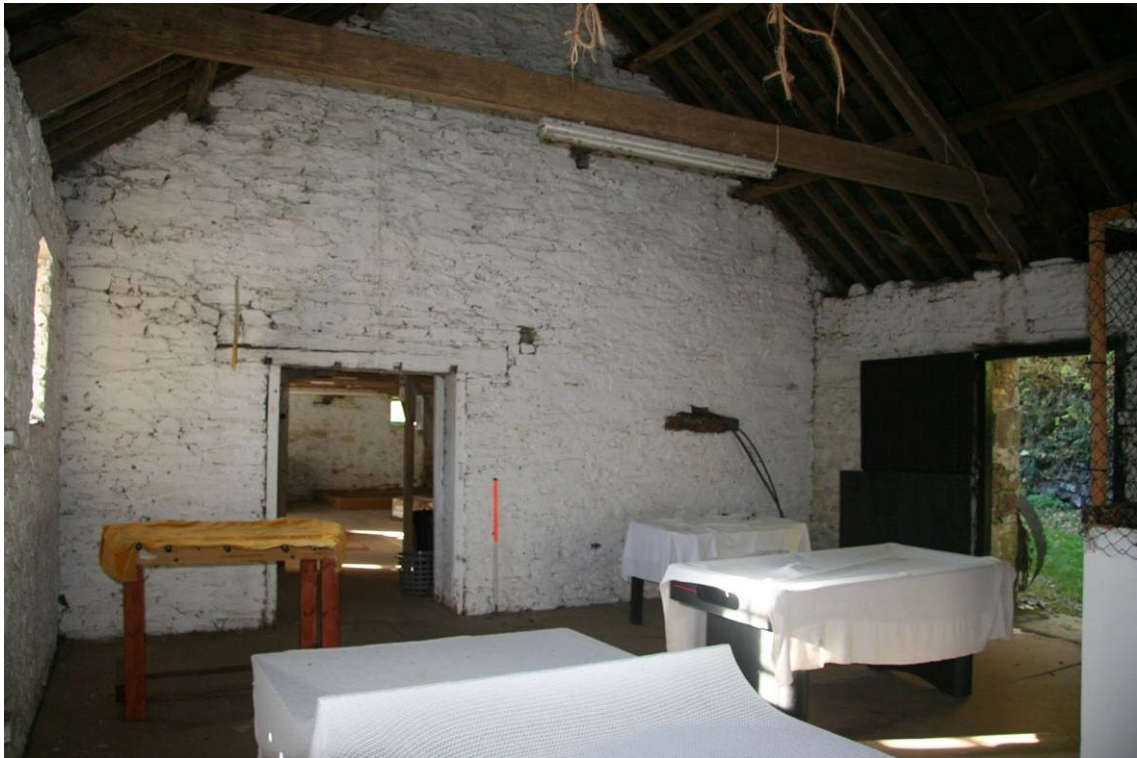
Fig 39 The loft/barn above the shippon

Note the timber lintel above the doorway leading into the first floor of the mill. This has clearly been reused from an earlier stage of the mill's development, showing mortises from former joists

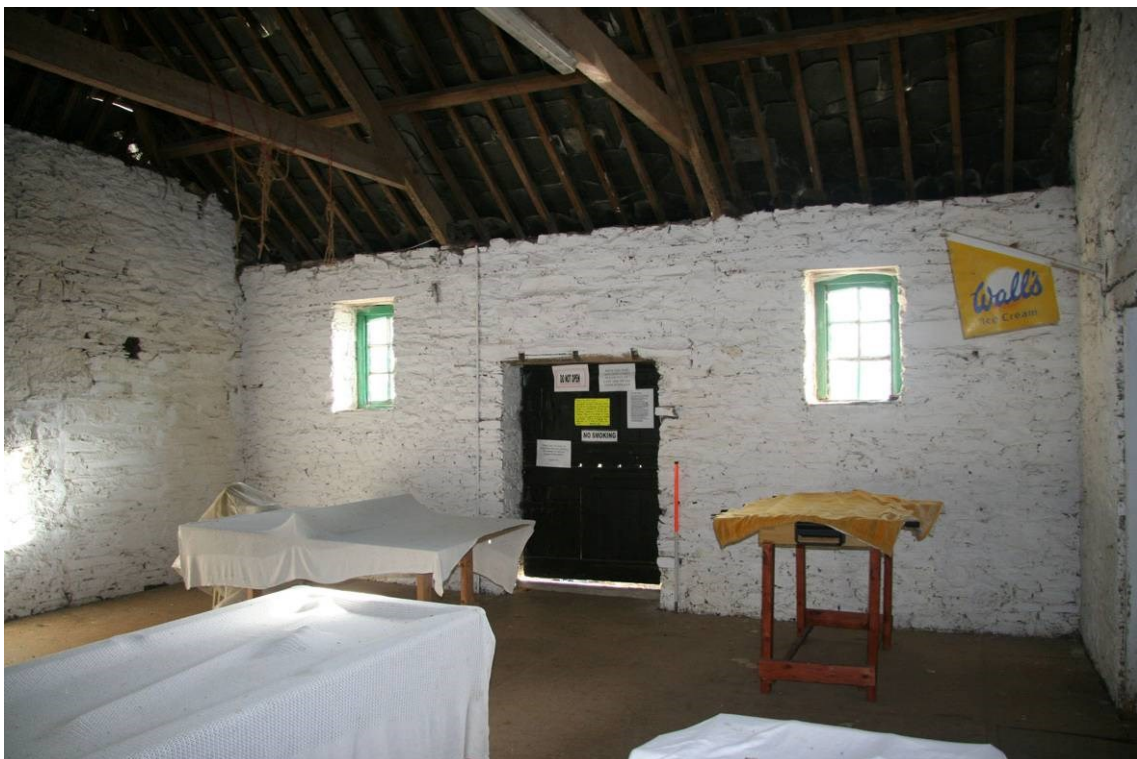
Fig 40 Another view of the loft/barn above the shippon

The large space with a wide loading door to the front (and another door at the rear) suggests this space may have also been used for threshing and winnowing

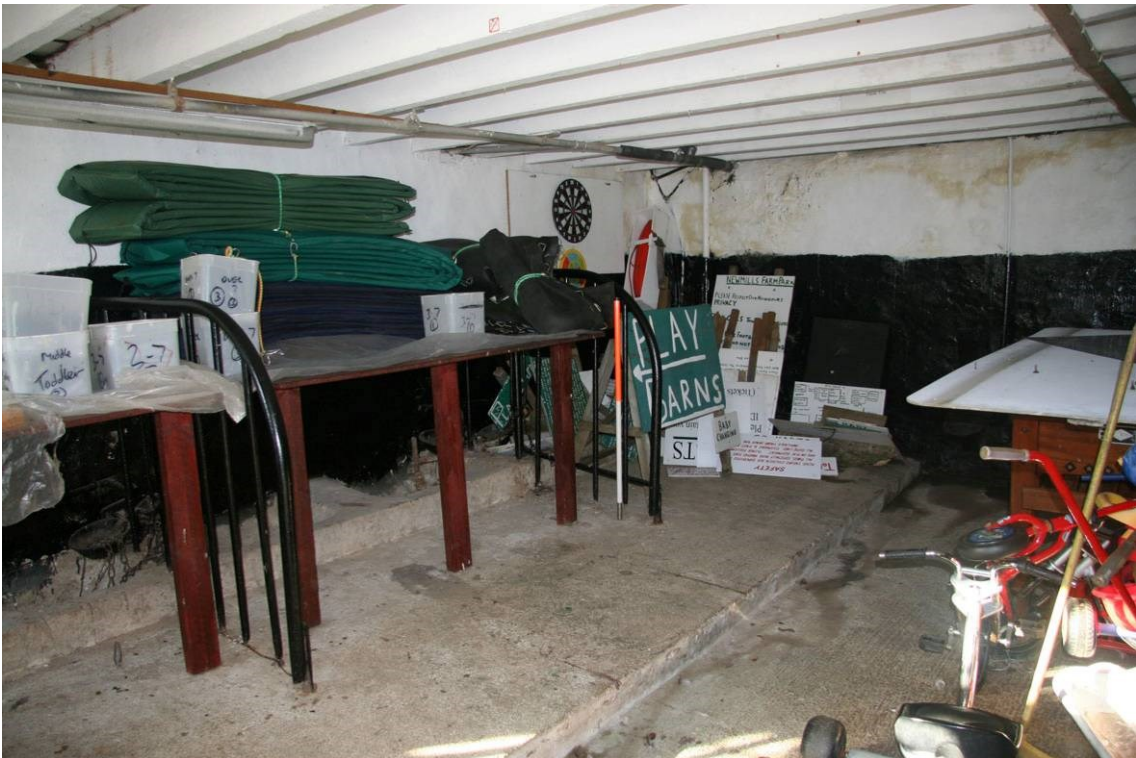
Fig 42 Ground floor of the main shippon, showing the 20th century steel bays and feed troughs when the building was used as a milking parlour

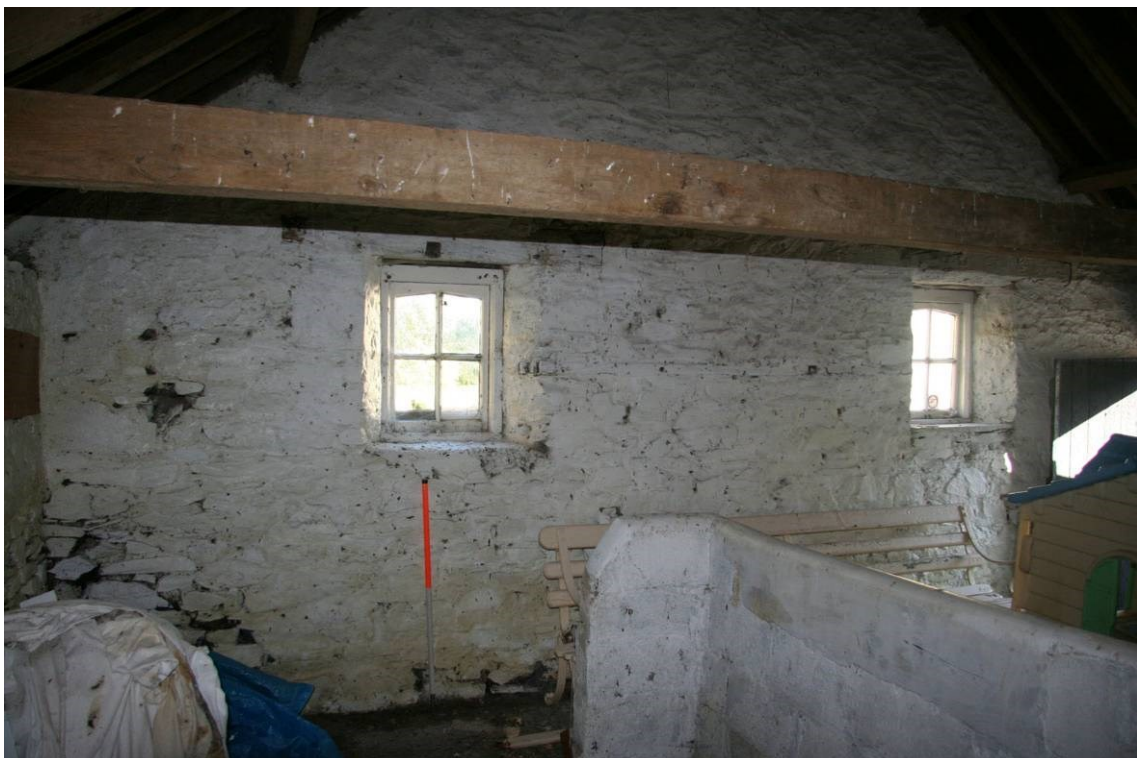
Fig 44 Subsidiary loosebox/shippon, showing reused timber lintels above the windows

The single storey loosebox at the east end is the only part of the complex which has brick quoins, and is clearly part of the 1905 rebuild of the mill (Figs 5 and 49). Both windows have reused timber as interior lintels. Its interior is relatively featureless; it has a concrete floor and concrete block-work divisions. The concrete flooring is at a higher level than the door threshold and may conceal earlier surfaces.
