King Edward Mine Camborne, Cornwall Conservation Management Plan

Conservation Management Plan

Status	This Conservation Management Plan has been adopted by Cornwall Council and King Edward Mine Ltd. See section 8.1 on page 108 for details
Client	Cornwall Council Culture Team
Report Number	2012R086
Date	March 2013
Report author	Colin Buck Dip. Arch. MIfA

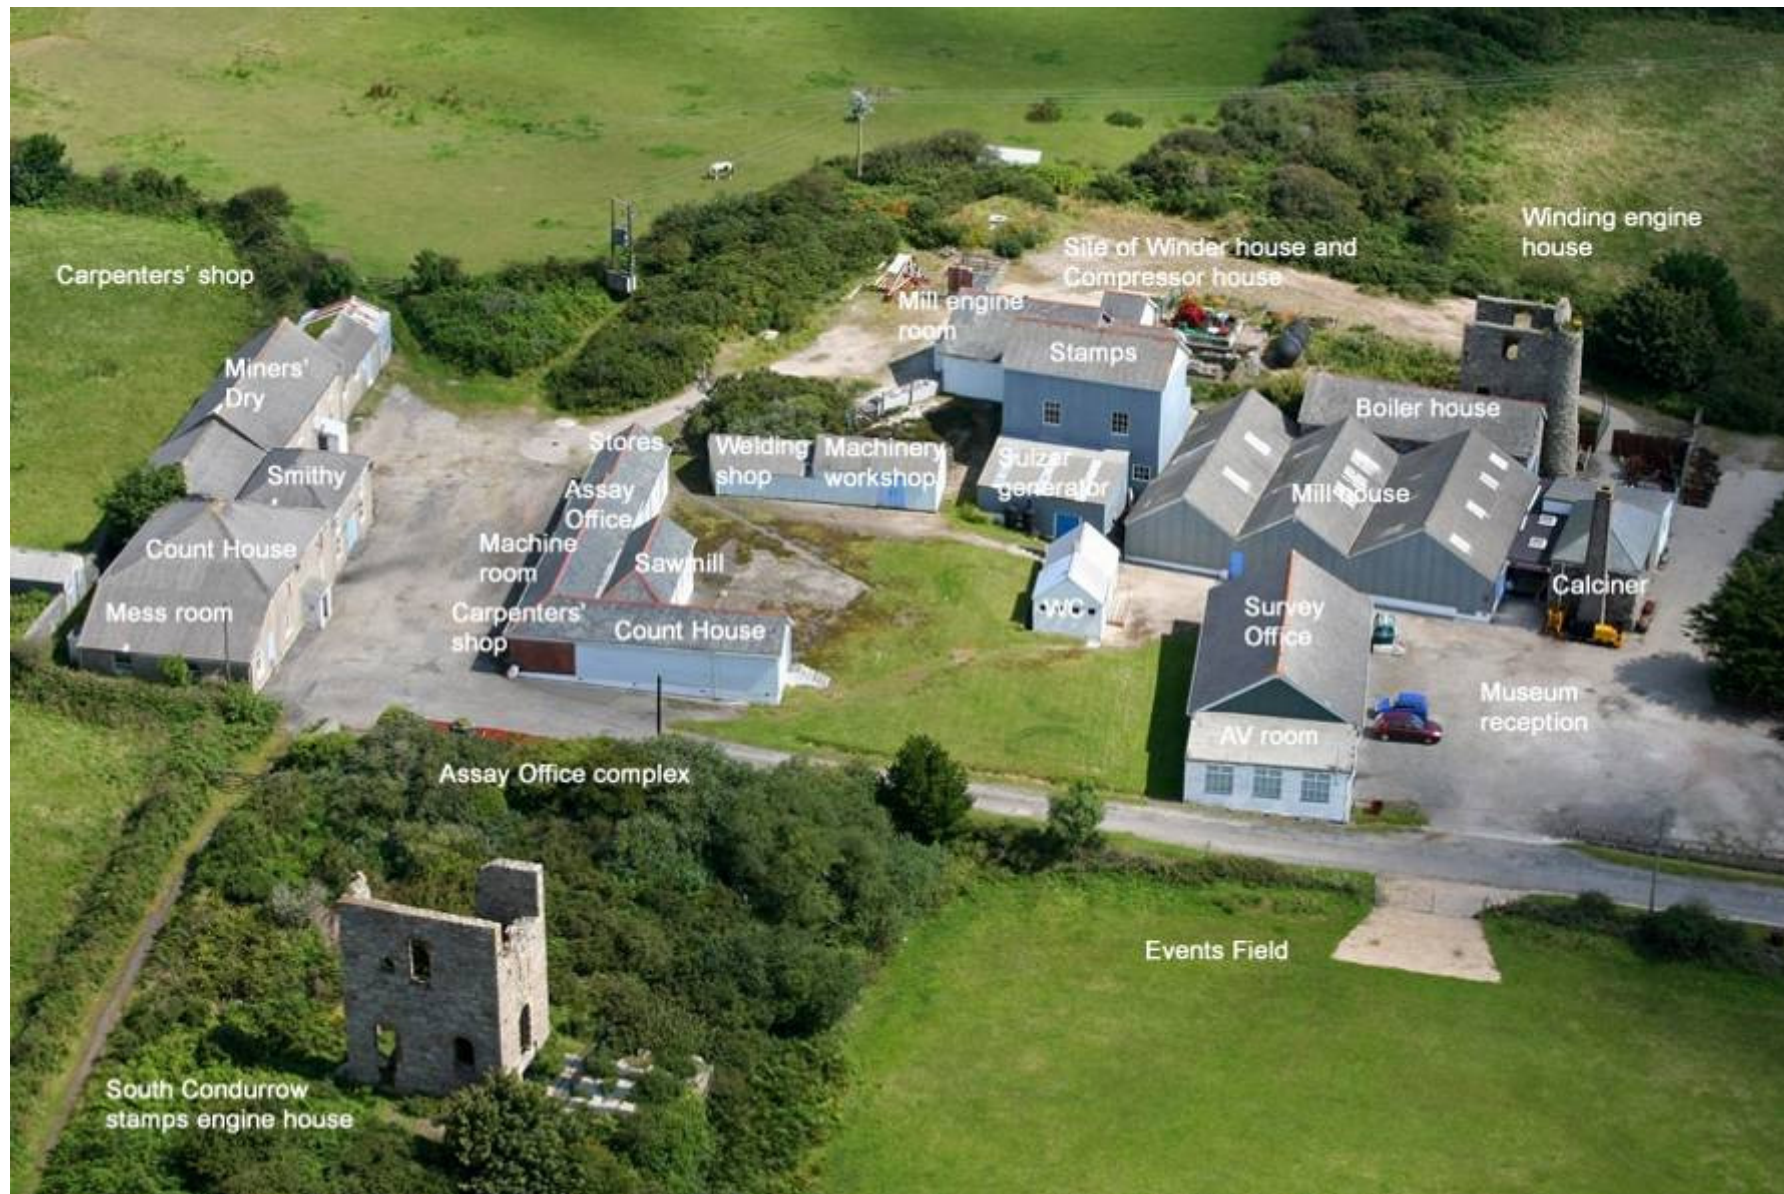
Figure 1 An HES aerial photograph (2009) of King Edward Mine with building functions labelled (before the horizontal steam engine winder and compressor house was rebuilt).

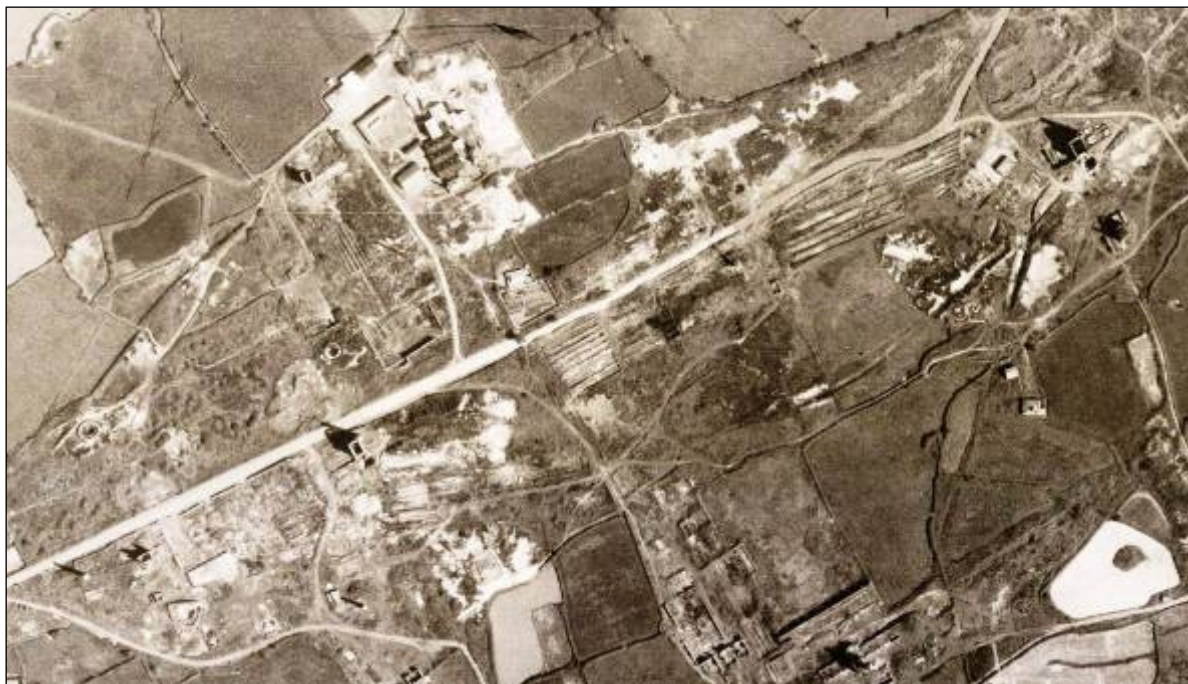
Figure 11 Reproduction of a 1946 Royal Air Force aerial photograph of the CMP area

Figure 11 shows the later earthwork remnants of mining related features shown on Figure 9, the earlier 1908 OS map, after the final closure of the Great Flat Lode mines in the 1920s. Throughout the following decades, some new buildings were added, until in 1975 most lectures were held at the new Camborne School of Mines building at Pool. However, KEM continued to be partly used for mining tuition until 2005. In 1987, volunteers decided to turn the redundant mill complex into a museum. The project was supported by the School of Mines. The volunteers, since that inception have lovingly restored and remarkably, brought back to working order much of the entire mine complex.

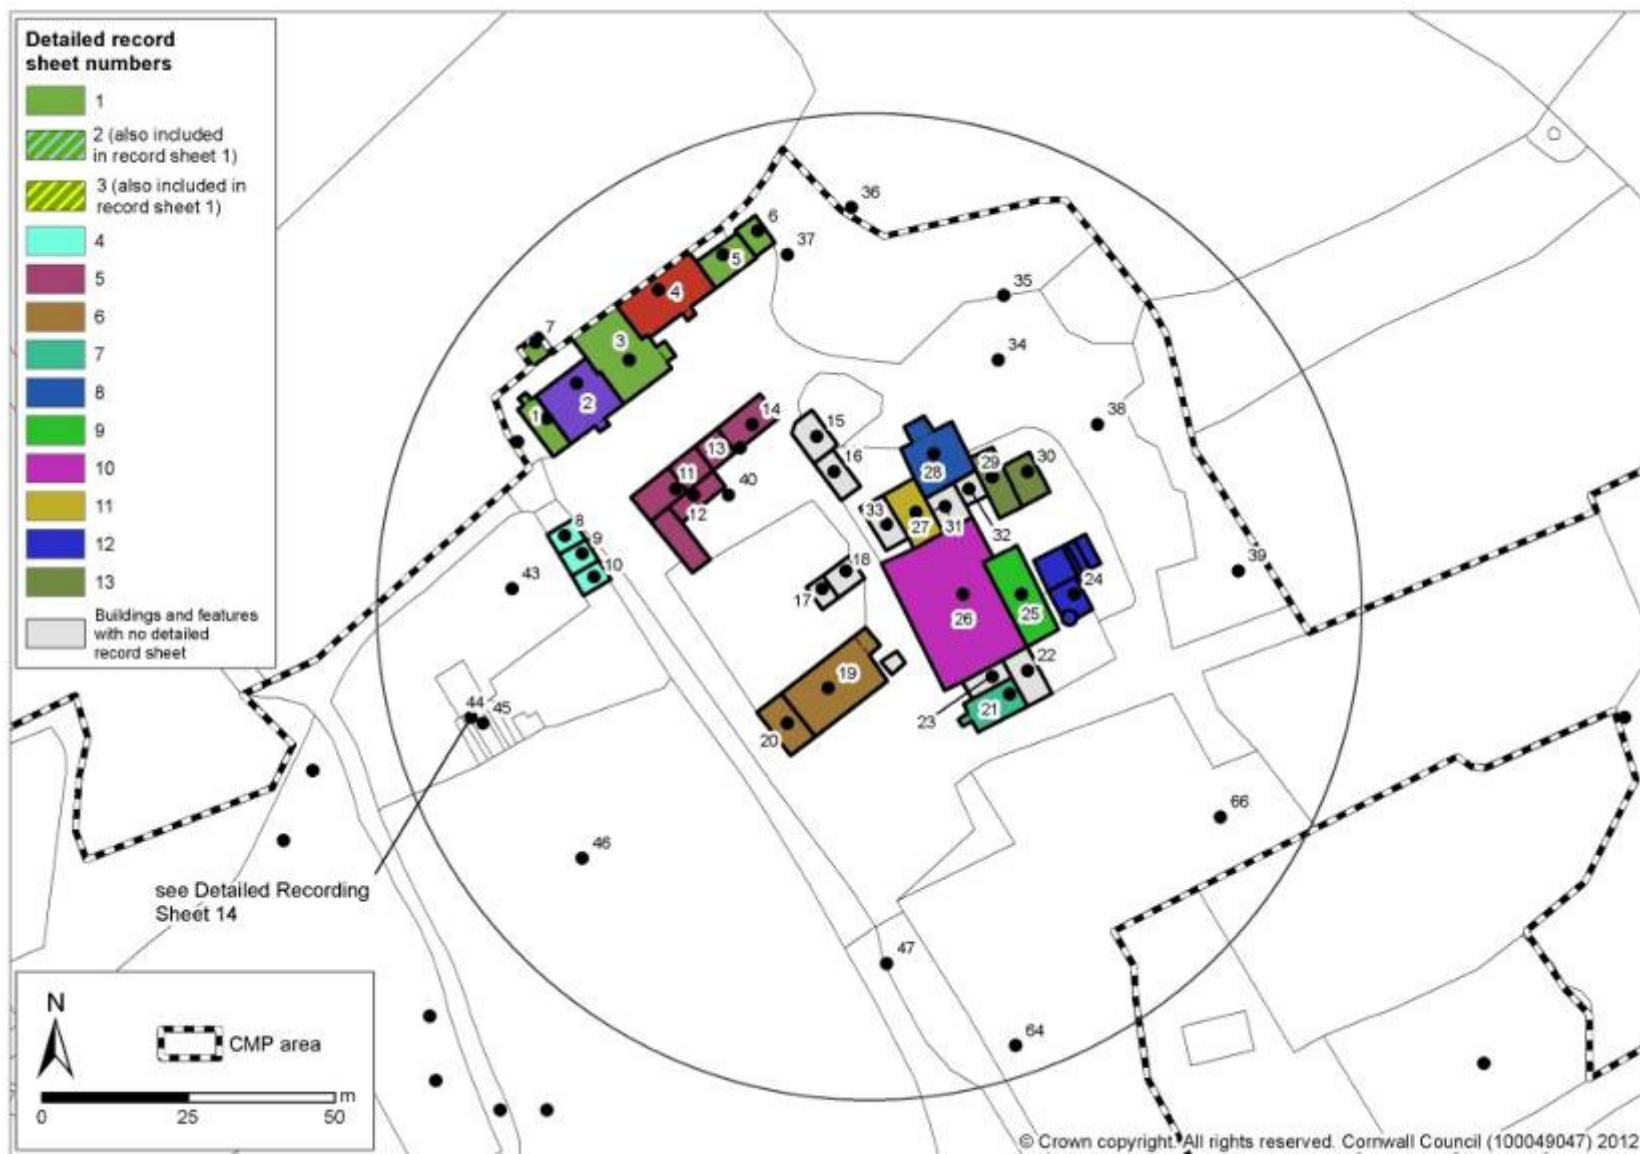
Figure 14 A core plan site inventory map of King Edward mine buildings. Refer to the Table 2 for site number description

- Site number relates to inventory list and core plan (Fig 14)
- MCO No. is the unique identifier given to each record in the HBSMR.
- LB Ref. is the National List Entry number on the National Heritage List for England
- EH HAR Register: English Heritage at Risk Register 2012
- Assess Sheet No. related to the Detail Record Sheets (No's 14 to 16 are reproduced in Appendix 10.3)
- Many unused buildings are currently used for temporary storage by Trevithick Society/KEM for a variety of items of historical interest

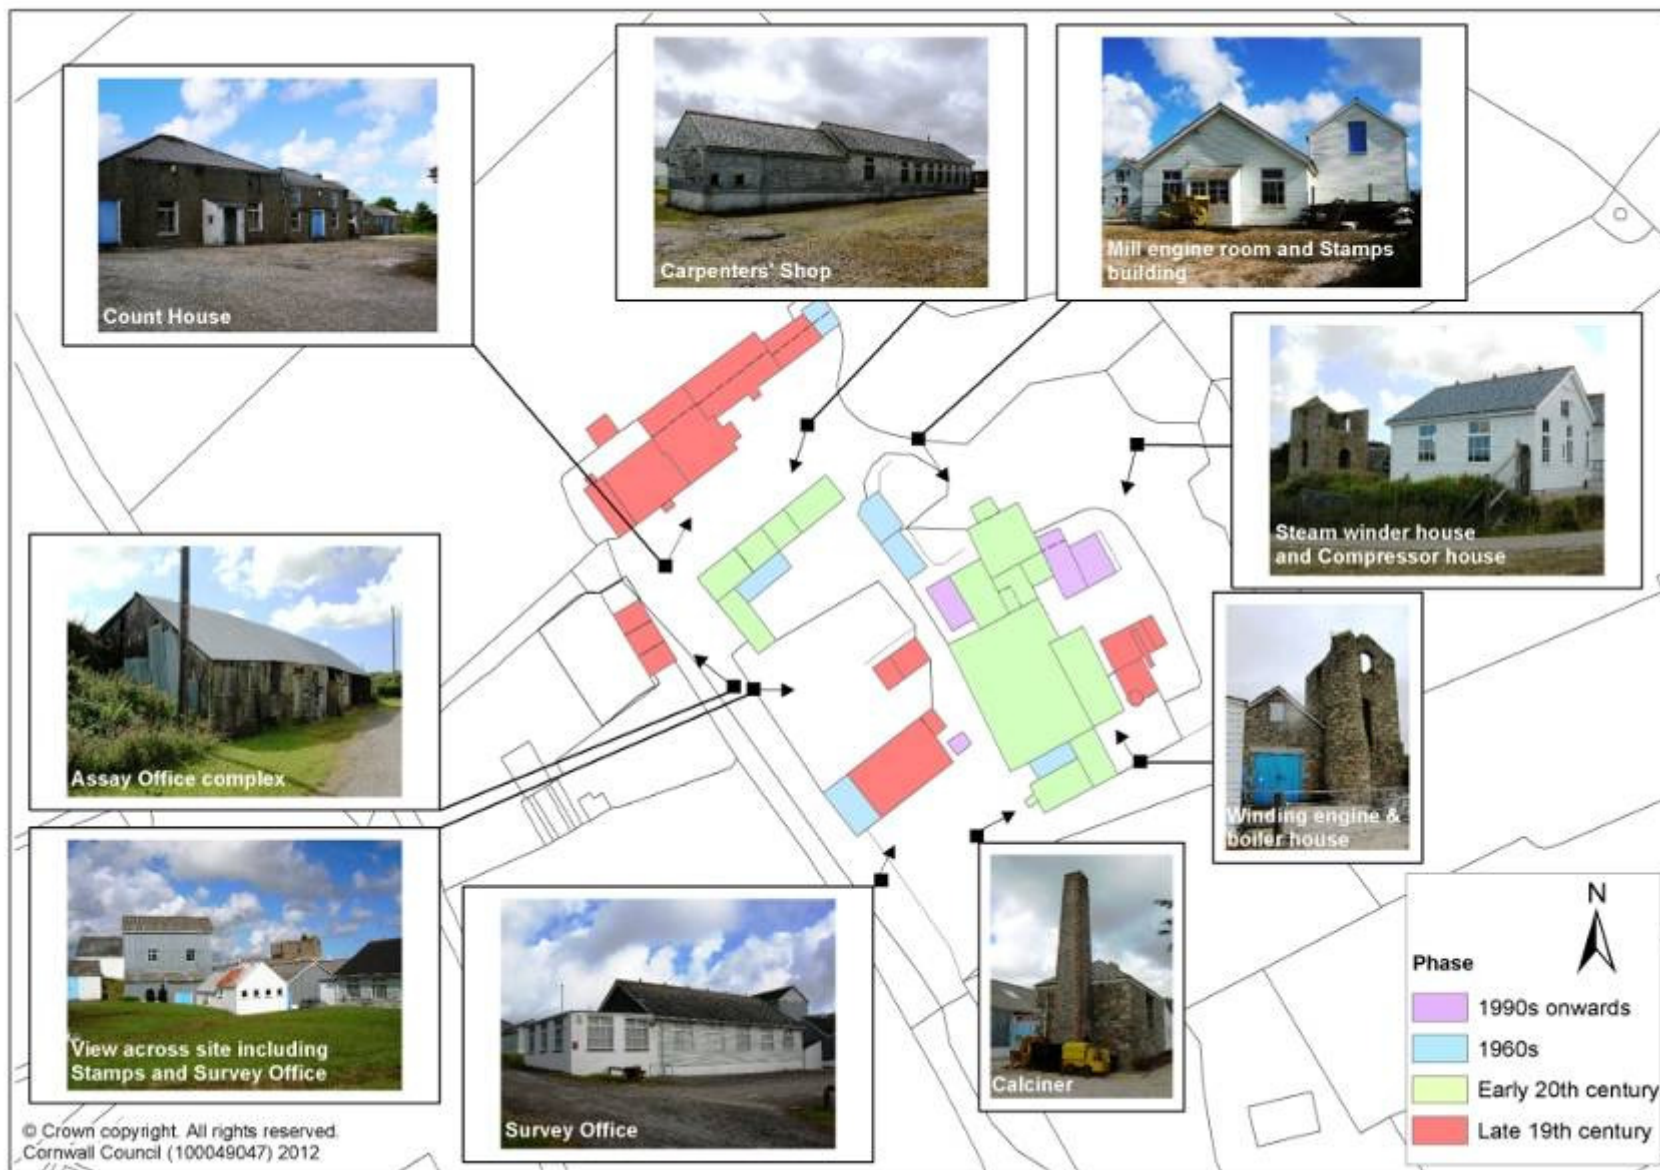
Figure 15 A plan showing existing views of King Edward Mine transposed onto a phase map of site development

Figure 8, an 1899 survey plan of the mine, labels individual buildings two years after Camborne School of Mines took over the site lease from South Condurrow Mine (with the exception of the Counthouse and Assay Complexes: Sites 1 – 10). Apart from the Counthouse and the Assay Office complexes, the main mine buildings that had been used by South Condurrow were some Carpenters buildings (Sites 36 and 37), the Drill Shop (Site 18), the Winding engine house (Site 24), and the Spalling Shed (later to be built over by the Mill: Site 26), see Figure 7 annotations. Interestingly, the square rectangular feature next to the Drill Shop appears to have been a spoil mound, possibly waste remnants from the nearby spalling floor (Site 40 – cobbled floor), only part of which appears to have been exposed.

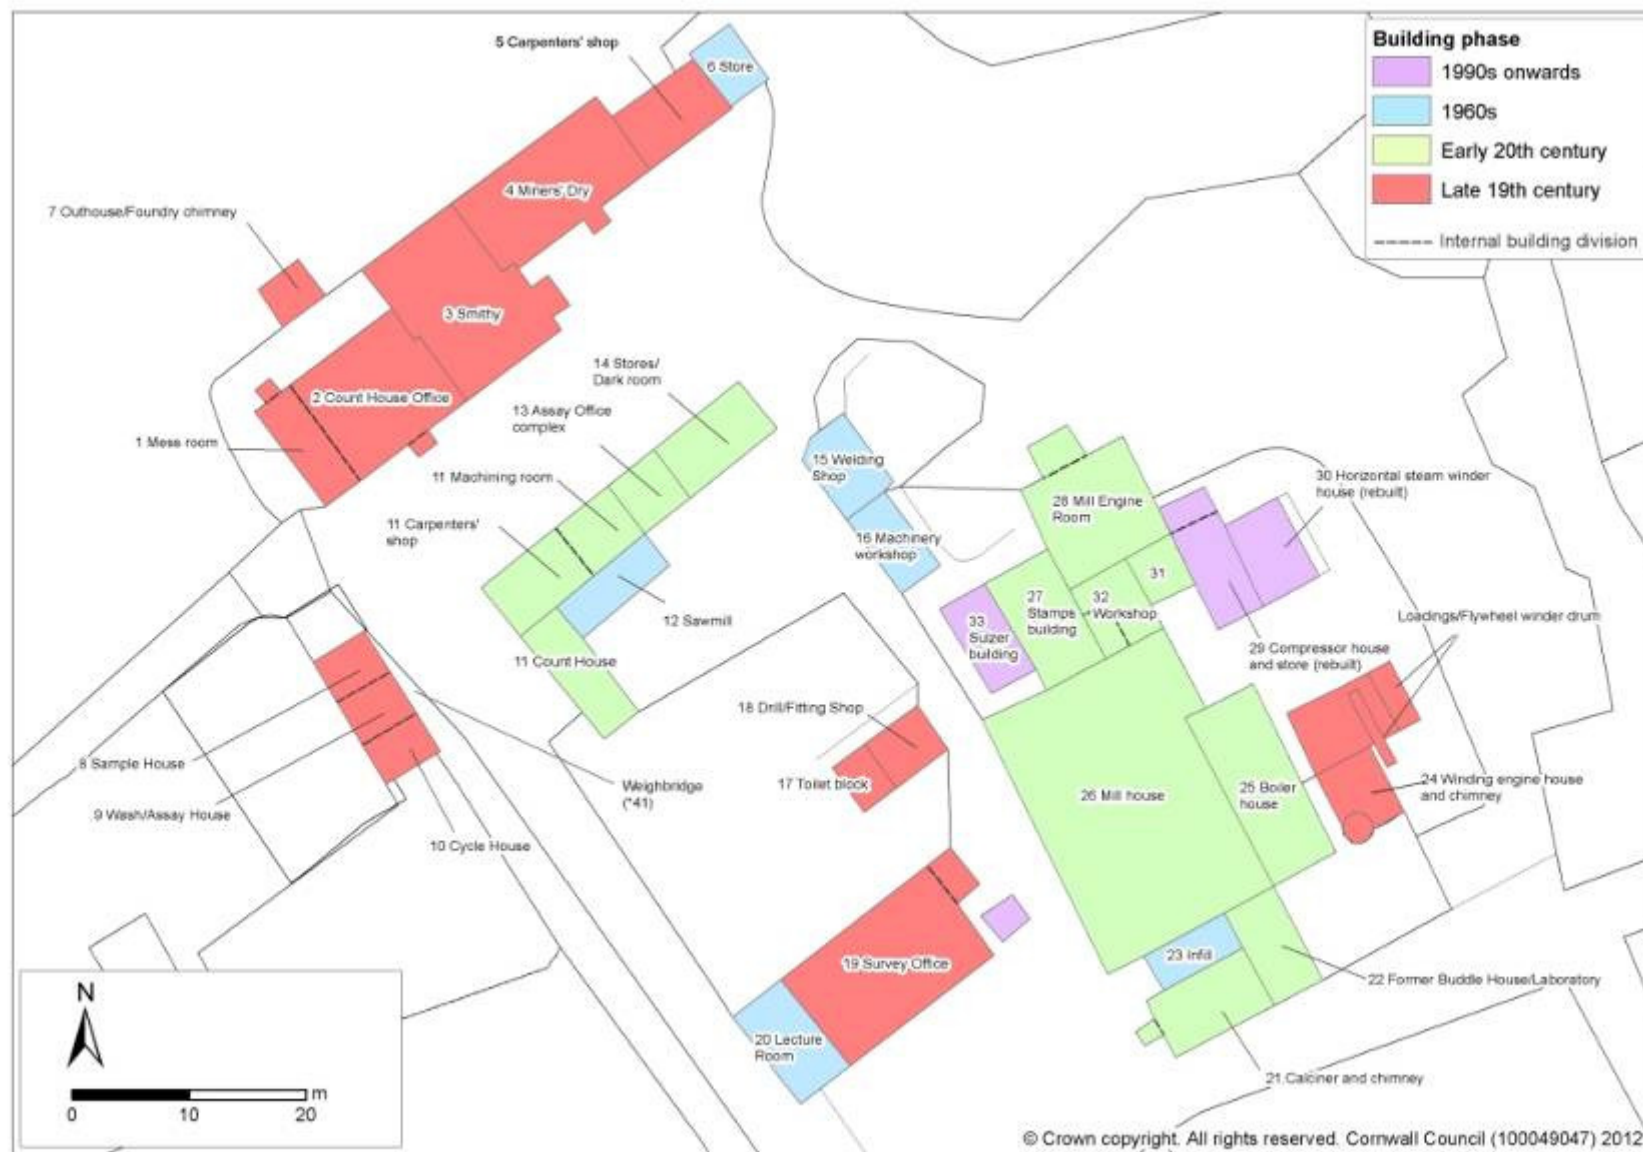
Figure 16 A map of King Edward Mine showing the main construction phases from the late 19th century to the present day

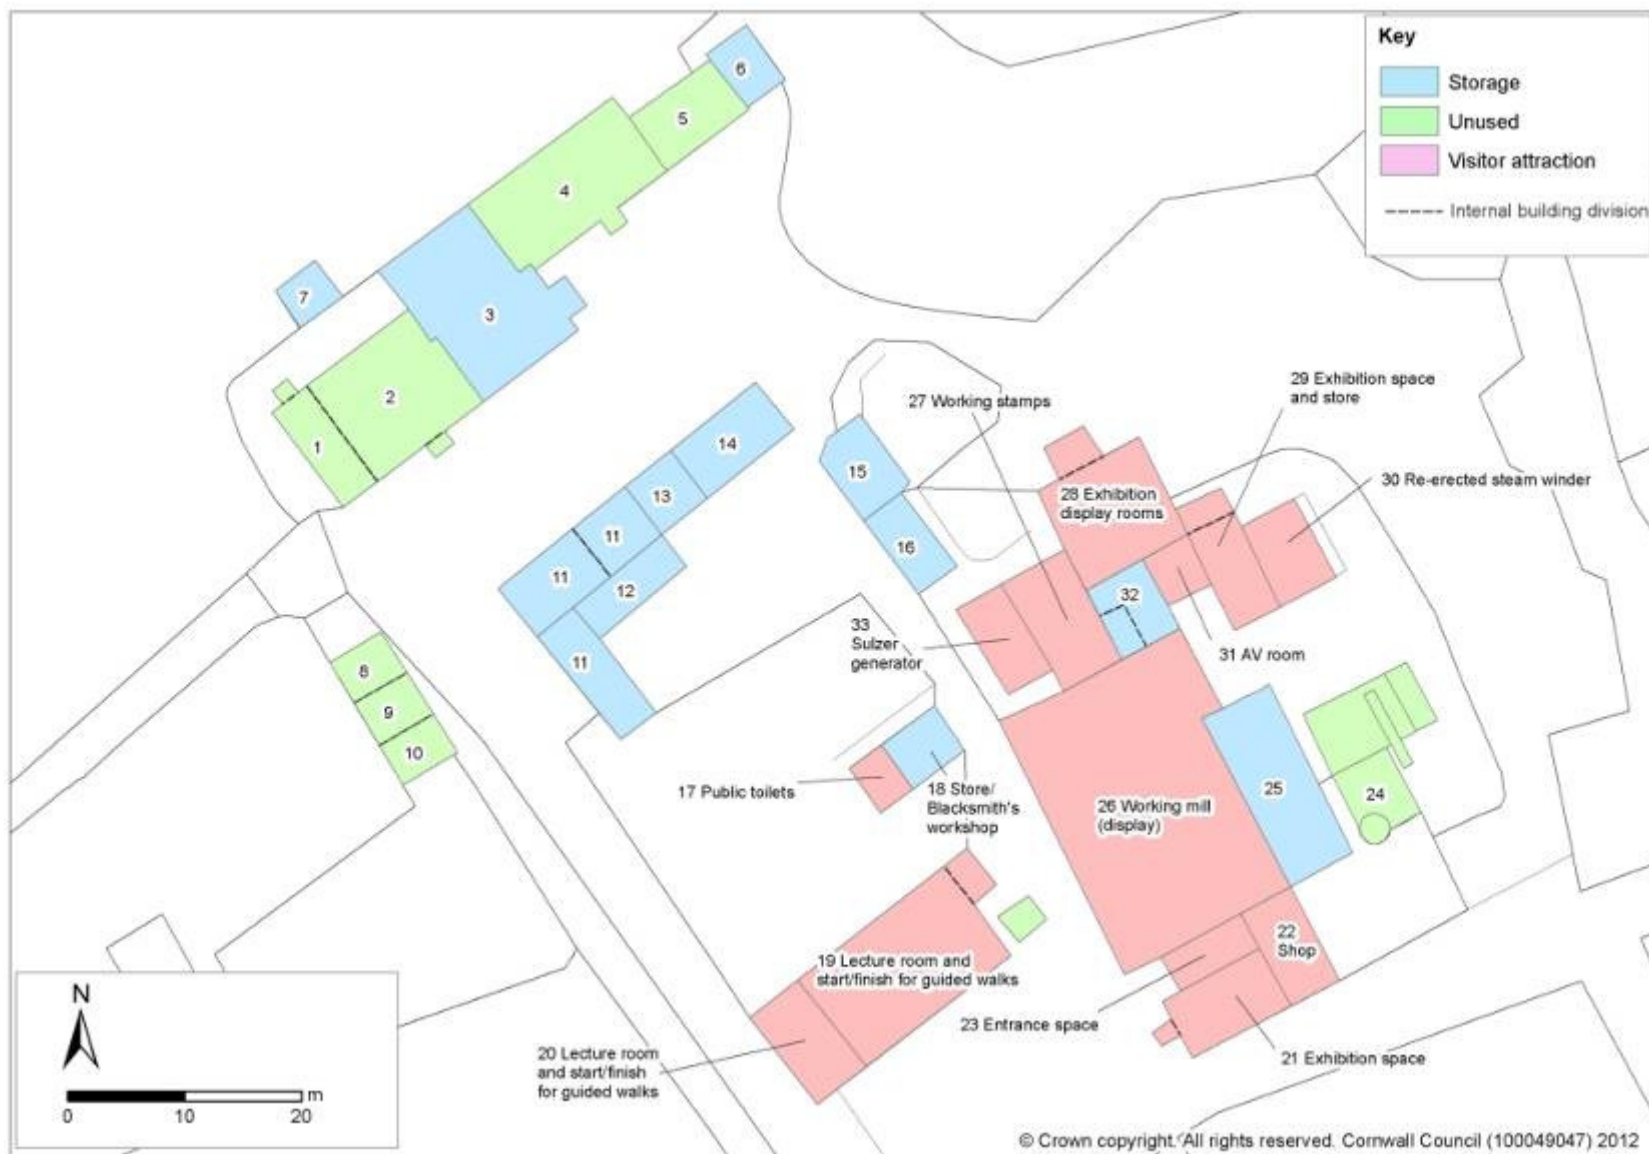
Figure 18 A plan showing the existing building functions of King Edward Mine

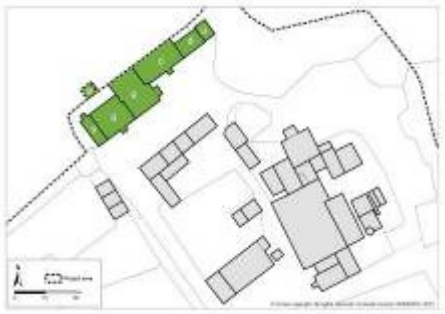
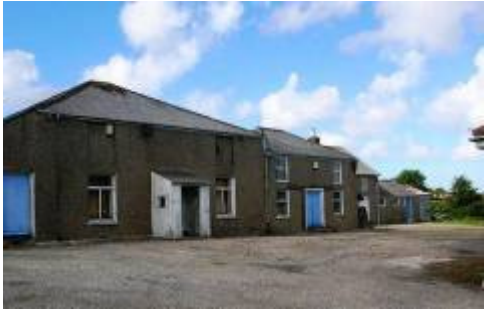
Construction materials: (walls, roof, floor, ceiling, windows, doors):	<i>External:</i> Corrugated asbestos roof sheeting replaced original slate in 1950s. Cementitious pebble dashed render over original granite quoins and stone masonry with earth rab/lime mortar. Only one original window appears to remain (Site 4), the remainder of later different 20 th century styles. Many original chimneys removed (including Counthouse, Smithy forge etc).
	<i>Internal:</i> Buildings have been unoccupied leading to damp, floors and walls. Counthouse Office has dry lining of plasterboard and painted woodchip wallpaper on some walls, covering damp lime plaster. Cement plastering in places. Many original plaster ceilings replaced. Floor joists in office collapsing. Smithy building has had major alterations (possibly 1960s). Miners Dry ceiling fully built over, walls faced with granolithic plaster (to create a wet room). Some original doors/floorboards and some dado rails.

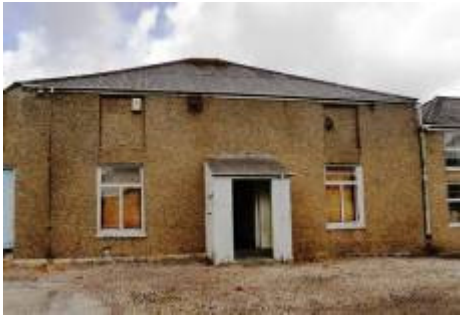
Construction materials: (walls, roof, floor, ceiling, windows, doors):	<i>External:</i> Corrugated asbestos sheeting replaced slate in 1950s. Cementitious pebble dashed render over original granite quoins and stone masonry with lime mortar. Windows are mostly 1970s replacements and other styles. Original chimneys removed. First floor windows blocked up.
	<i>Internal:</i> This building has been unoccupied leading to damp floors and walls. Office has dry lining of plasterboard and painted woodchip wallpaper on some walls, covering damp lime plaster. Cement plastering in places. Many original plaster ceilings replaced with fibreboard. Floor joists in front office collapsing (dry rot). At rear some modifications to partitions, with original staircase to first floor (storage space) removed. Some original doors/floorboards/architrave and fireplace (removed/blocked up on east side).
Build date:	Counthouse Office constructed c1864/5 as South Condurrow Mine Count House (shown in elevation on 1865 mine plan). The mine retained this complex until 1903 when it ceased operating. The lease was then sold by the Pendarves Estate to Camborne School of Mines.

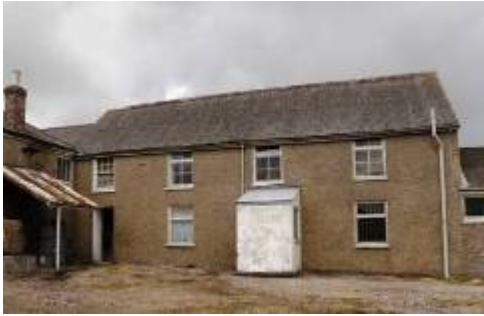
Construction materials: (walls, roof, floor, ceiling, windows, doors):	<i>External:</i> Corrugated asbestos sheeting replaced slate in 1950/60s. Cementitious pebble dashed render over original granite quoins and stone masonry with lime mortar. Only one original window appears to remain, the remaining windows of different styles.
	<i>Internal:</i> An 1899 photograph (Fig 16) shows the internal layout of the Miners' Dry at that time. The walls were lime washed, with a part open ceiling and ground floor boiler. The building now has a full ceiling and first floor with open roof joists. At ground floor the building has been re-plastered with a granolithic finish to provide a 'wet room' with showers, possibly in the 1960s/70s.
Build date:	Original Miners' Dry (Site 4) c1865-1877.

Significant features/contents:	Miners' Dry (Site 4): Original walls and (boxed in) roof joists. No visible significant original features at ground floor (masked by later re-plastering etc). It is possible that the original drains survive below ground floor level, and probably the pipes relating to the original boiler.
Original fixtures and fittings:	Most window openings appear to be original dimensions, windows mostly of later date but the window and frame at the south west corner of Miners' Dry may be original (small paned). Original fixtures and fittings appear to have been removed.
Machinery:	Not applicable.
Summary description:	Count House Complex is Listed Grade II* and now on EH Buildings at Risk Register (2012). The Count House was built first, closely followed by the remainder of the buildings in a single connected complex to serve the needs of South Condurrow Mine (1865-1896). This building provided changing facilities following underground mine student training from 1897 - 1923, and possibly later when underground training moved to Great Condurrow Mine (Beacon). An internal 1899 photograph of the Miners' Dry and description is given in Figure 17 and (Brooks 2002, 12). Externally, it appears the original slate roof was replaced in the 1950s, as well as re-rendering the external walls with cementitious pebble dash. Internally substantial changes have occurred to both floors, although the exterior walls and openings appear to have been untouched (apart from the partial blocking of a doorway to form a window).

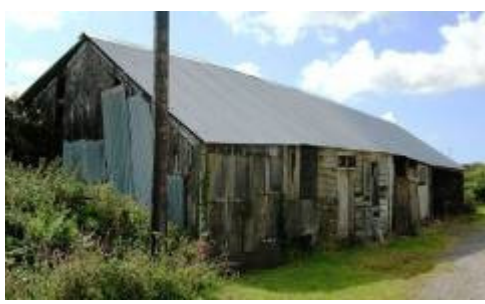
Construction materials: (walls, roof, floor, ceiling, windows, doors):	<p><i>External:</i> Photographs taken in 2011 by Purcell Miller Tritton show a rusty corrugated iron sheet roof, with various forms of rotted ship lap with tongue and grooved timber repairs. All of these are in a precarious state. Within the past year, a new corrugated iron sheet roof with some new rafters has been added by KEM – providing a degree of interior protection for water ingress. The windows are of different periods and styles, but given their condition, all need to be replaced. The north and south (original) exterior side walls are both timber ship lap on a timber frame.</p>
	<p><i>Internal:</i> Internally, the complex was divided into three rooms with varying functions through time (see site inventory Fig 14). These are separated by stone/brick lime plastered partitions, the middle section (Site 9), with remnants of a lath and plaster ceiling (possibly the original building of the three). The other two room's ceiling was open to the roof. The same middle section has a stone blocked opening, possibly a low door or window to the yard, the remains of an Assay oven, an assay hearth and adjacent, a Victorian fireplace. The original chimneys from this building have long gone.</p>

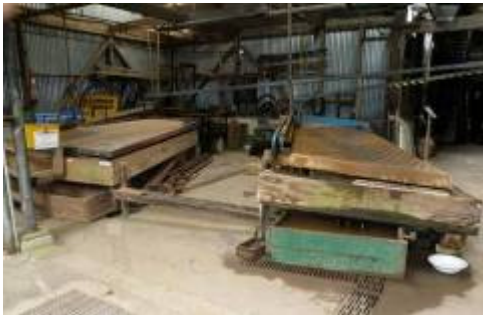
Construction materials: (walls, roof, floor, ceiling, windows, doors):	<i>External:</i> This large single storey tin dressing plant building is constructed of corrugated sheet cladding to walls supported by a timber frame and a cement fibre corrugated roof. It is rectangular in plan with a three span roof on an east-west axis, triple gabled to west and east. There is a door between the first and second gables, and internally to the south, with roof skylights.
	<i>Internal:</i> The floor is mostly concrete, to site tin dressing machinery: This includes a Dipper wheel, a Frue Vanner, a Cornish Round Frame, A Buddle, Rag Frames, Slime Tables, Kieve Tossing and packing gear, Flotation Cell, and Sand Table. Internally, the building is open on its north side where it adjoins the stamps, creating a far larger building than it appears externally.
Build date:	The dressing floor was erected 1902–1904 on the former site

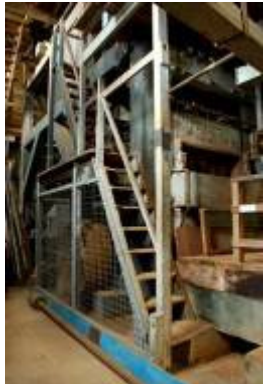
Construction materials: (walls, roof, floor, ceiling, windows, doors):	<i>External:</i> This tall double storey building to site the Californian Stamps is constructed of corrugated sheet cladding to walls supported by a timber frame and a cement fibre corrugated roof. It is rectangular in plan with a single pitched roof. There are two windows on the west side, one on the south side and one on the east side. The north side opening is blocked with timber, formerly the opening for the overhead tramway from Engine Shaft headgear.
	<i>Internal:</i> The building is built around the massive timber frame to support the five head of stamps. The book on King Edward Mine (Brooks & Watton 2002, Plate 44), shows a photograph of the stamps building being erected around the already constructed stamps. To allow safe public access from the Mill Engine Room (Site 28), timber stairs have been constructed down to the Mill floor.

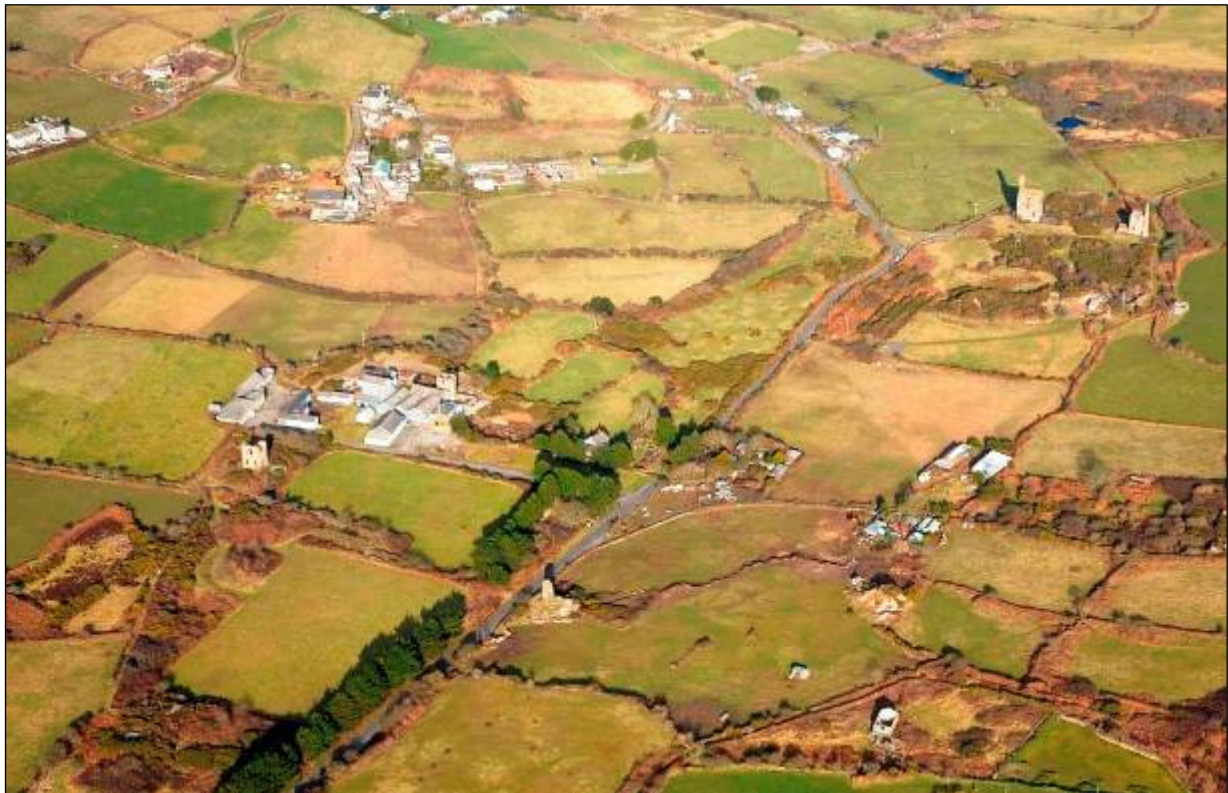
Figure 23 Historic Environment aerial photograph of the CMP area (CC F71-015) shows the extent of fields, hedges, gorse and rough ground obscuring spoil heaps and possibly mine shafts.

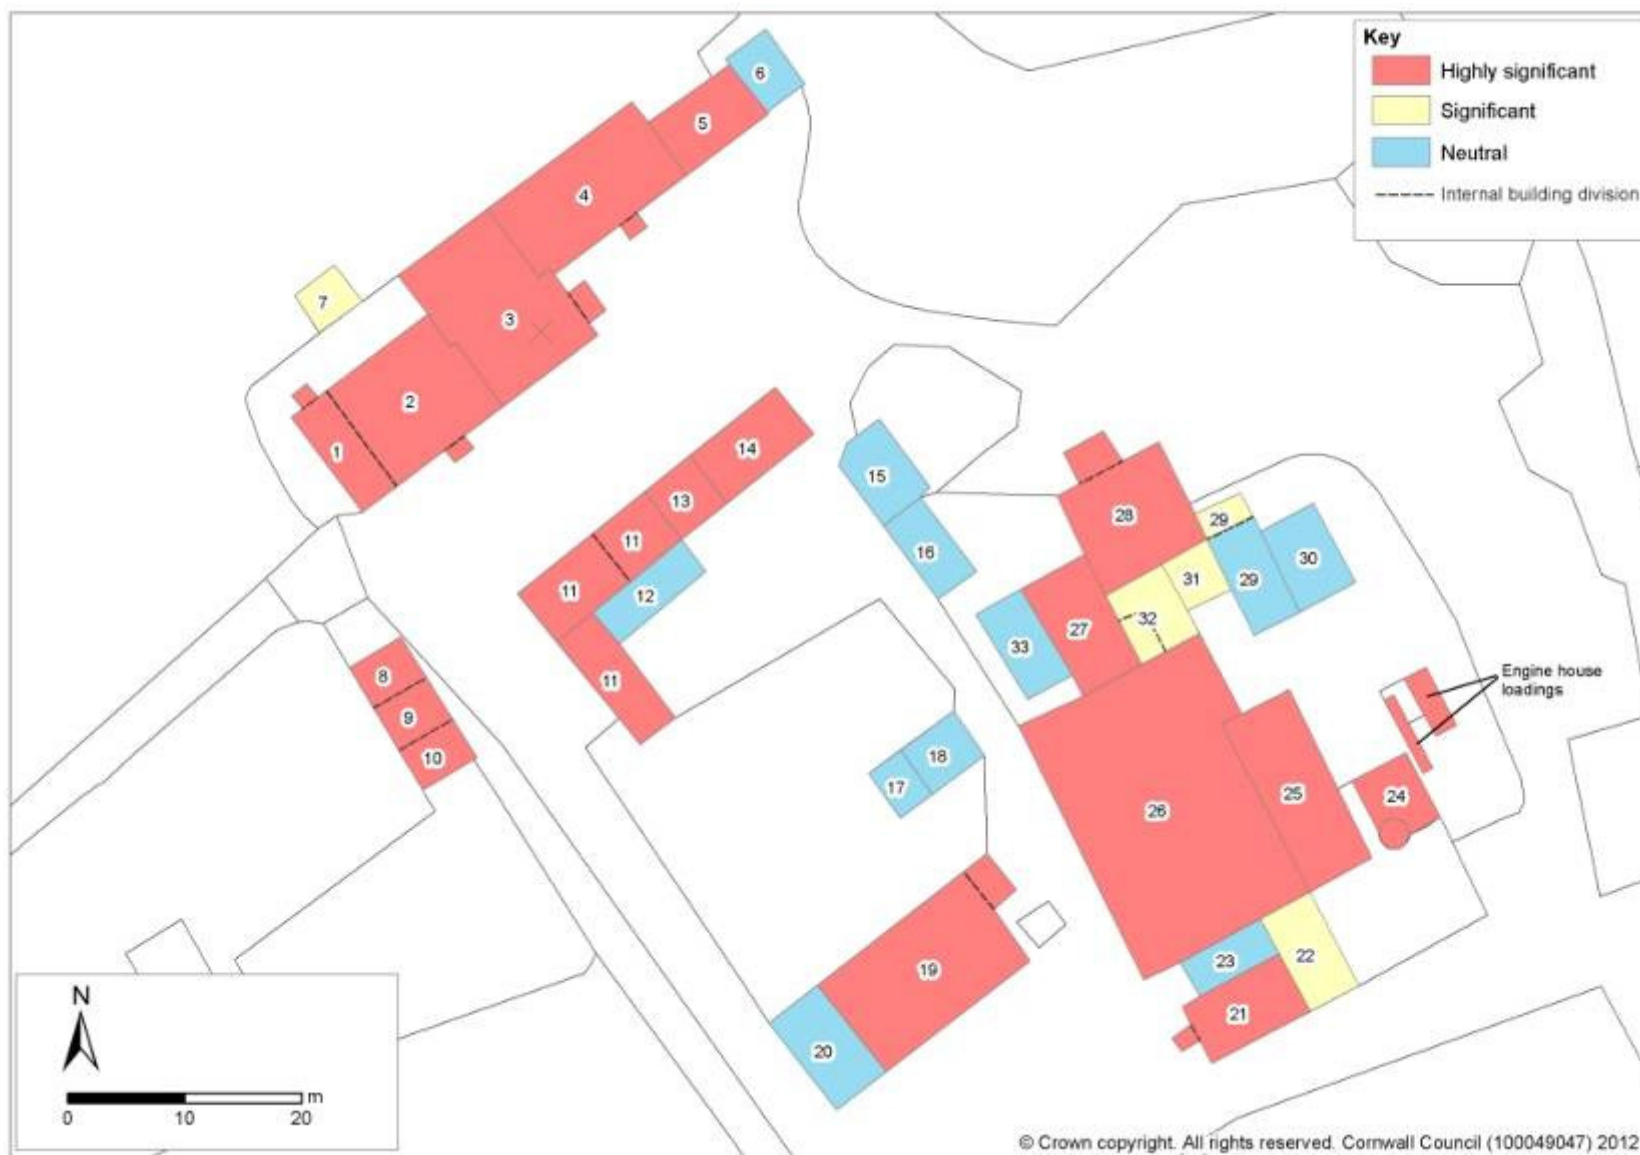
Figure 25 King Edward Mine core plan of comparative significant sites

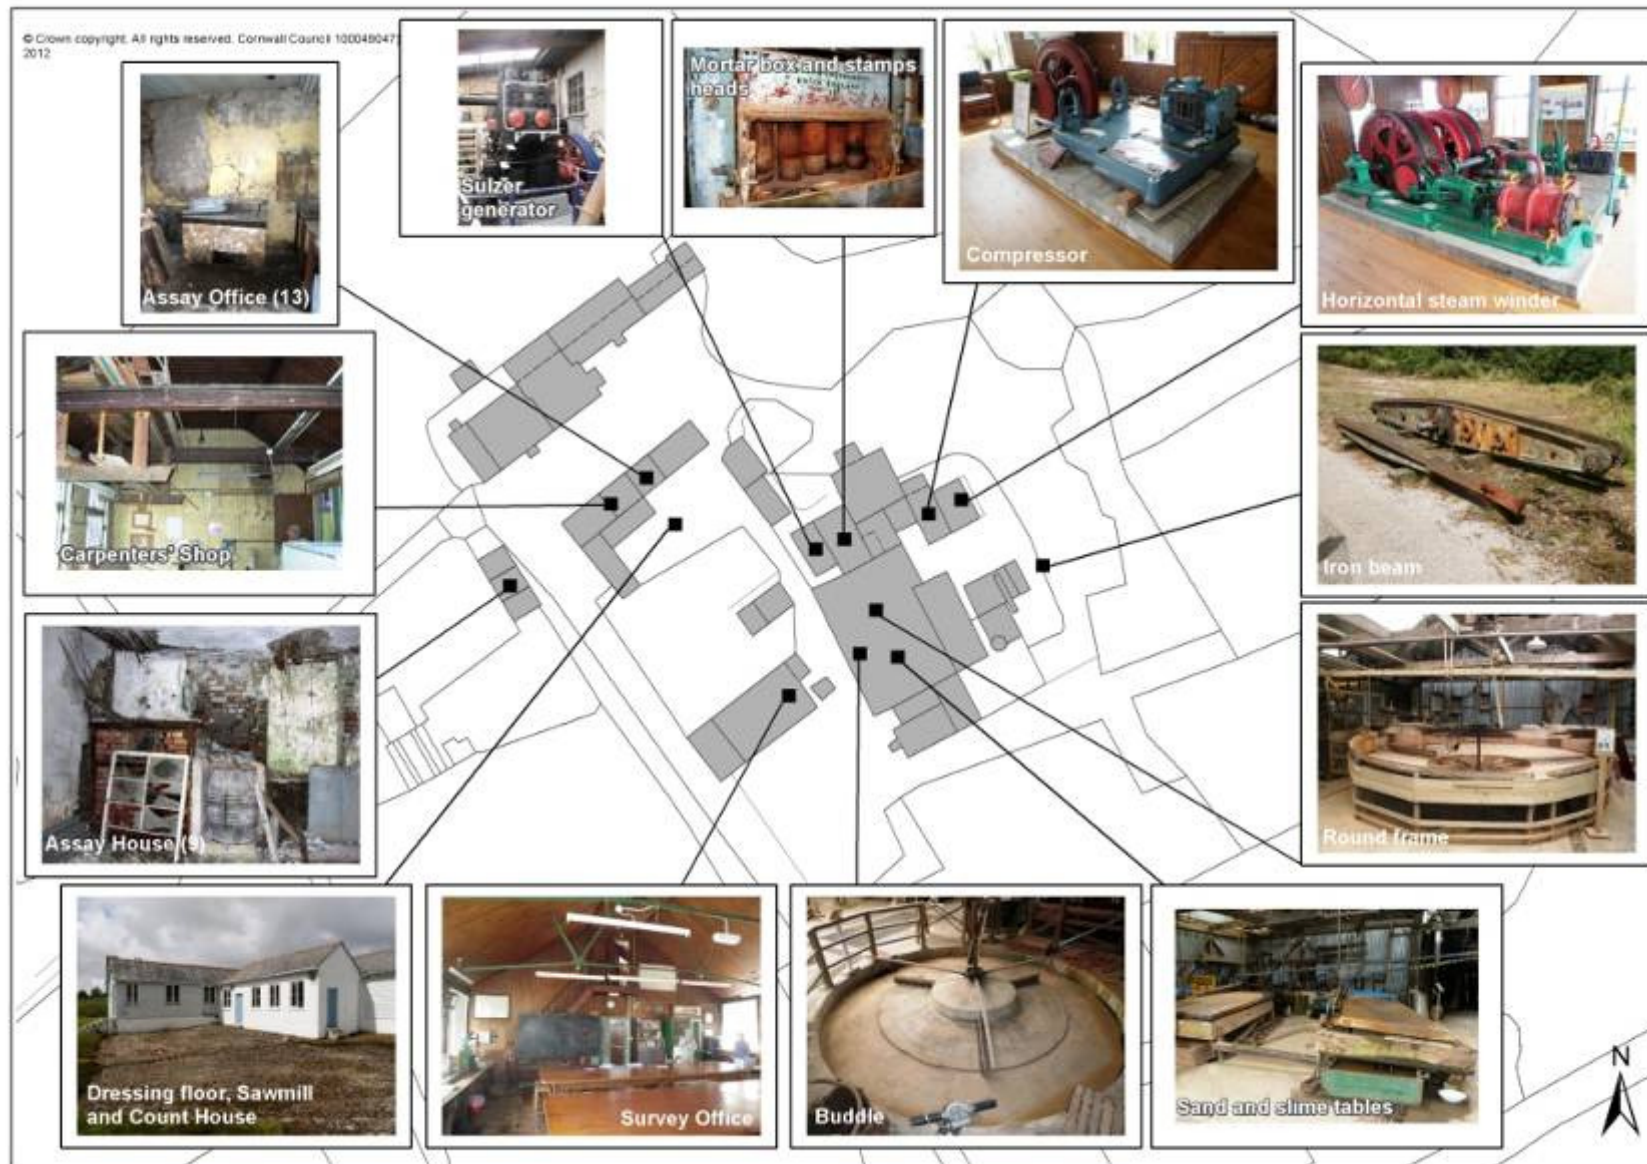
Figure 26 King Edward Mine core plan of images of significant KEM/Trevithick Society artefacts and their location

Figure 26 is a core plan map showing images of King Edward Mine/Trevithick Society significant artefacts. It should be noted that much of the tin-dressing equipment shown in these images is of international significance, as is the group value of such a collection - all of which is in working order.

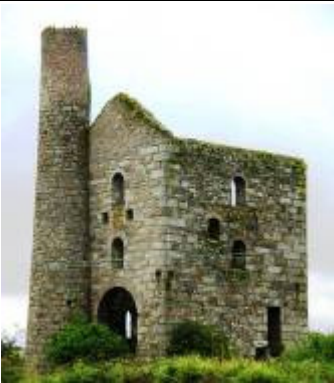
Construction materials: (walls, roof, floor, ceilings, windows etc):	<p><i>External:</i> The walls are constructed of un-coursed granite rubble with granite quoins. The roof is no longer extant, presumably either collapsed through neglect or removed when the steam engine was sold in 1922. (See Appendix 10.2). The walls were partially repointed in 1993, but its mainly granite and coursed granite construction with arched windows have also preserved this building and kept it in a relatively good condition. However, vegetation is now growing out of its top and sides, with ivy growing up the attached chimney. There are two windows in each of the east and west elevations, and the main girder opening. The boiler house doorway is on the west side – the boiler house has gone, although there are extant remains below ground level (Buck 1999b). The upper brick section of the chimney is missing (and may be crumbling and distorting – it was hit by lightning not long after it was built). Fortescue's Shaft, since closure has been used by South West Water as an emergency reservoir – but its use has been discontinued. The shaft is now fenced and internally obscured by vegetation.</p>

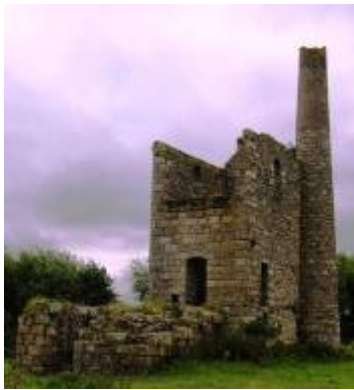
Construction materials: (walls, roof, floor, ceilings, windows etc):	<p><i>External:</i> The walls are constructed of un-coursed granite rubble with granite quoins. The roof is no longer extant, presumably either collapsed through neglect or removed when the steam engine was sold in 1922. (See Appendix 10.2). The walls were partially repointed in 1993, but it's mainly granite and coursed granite construction with arched windows have also preserved this building and kept it in a relatively good condition. However, vegetation is now growing out of its top and sides, with ivy growing up walls. There is one window in each of the east and west elevations, and the main girder opening is bricked up externally. The boiler house doorway is on the west side – the boiler house has gone, although there are likely to be remains below ground level. The upper brick section of the chimney is partly missing (and now crumbling and distorting).</p>

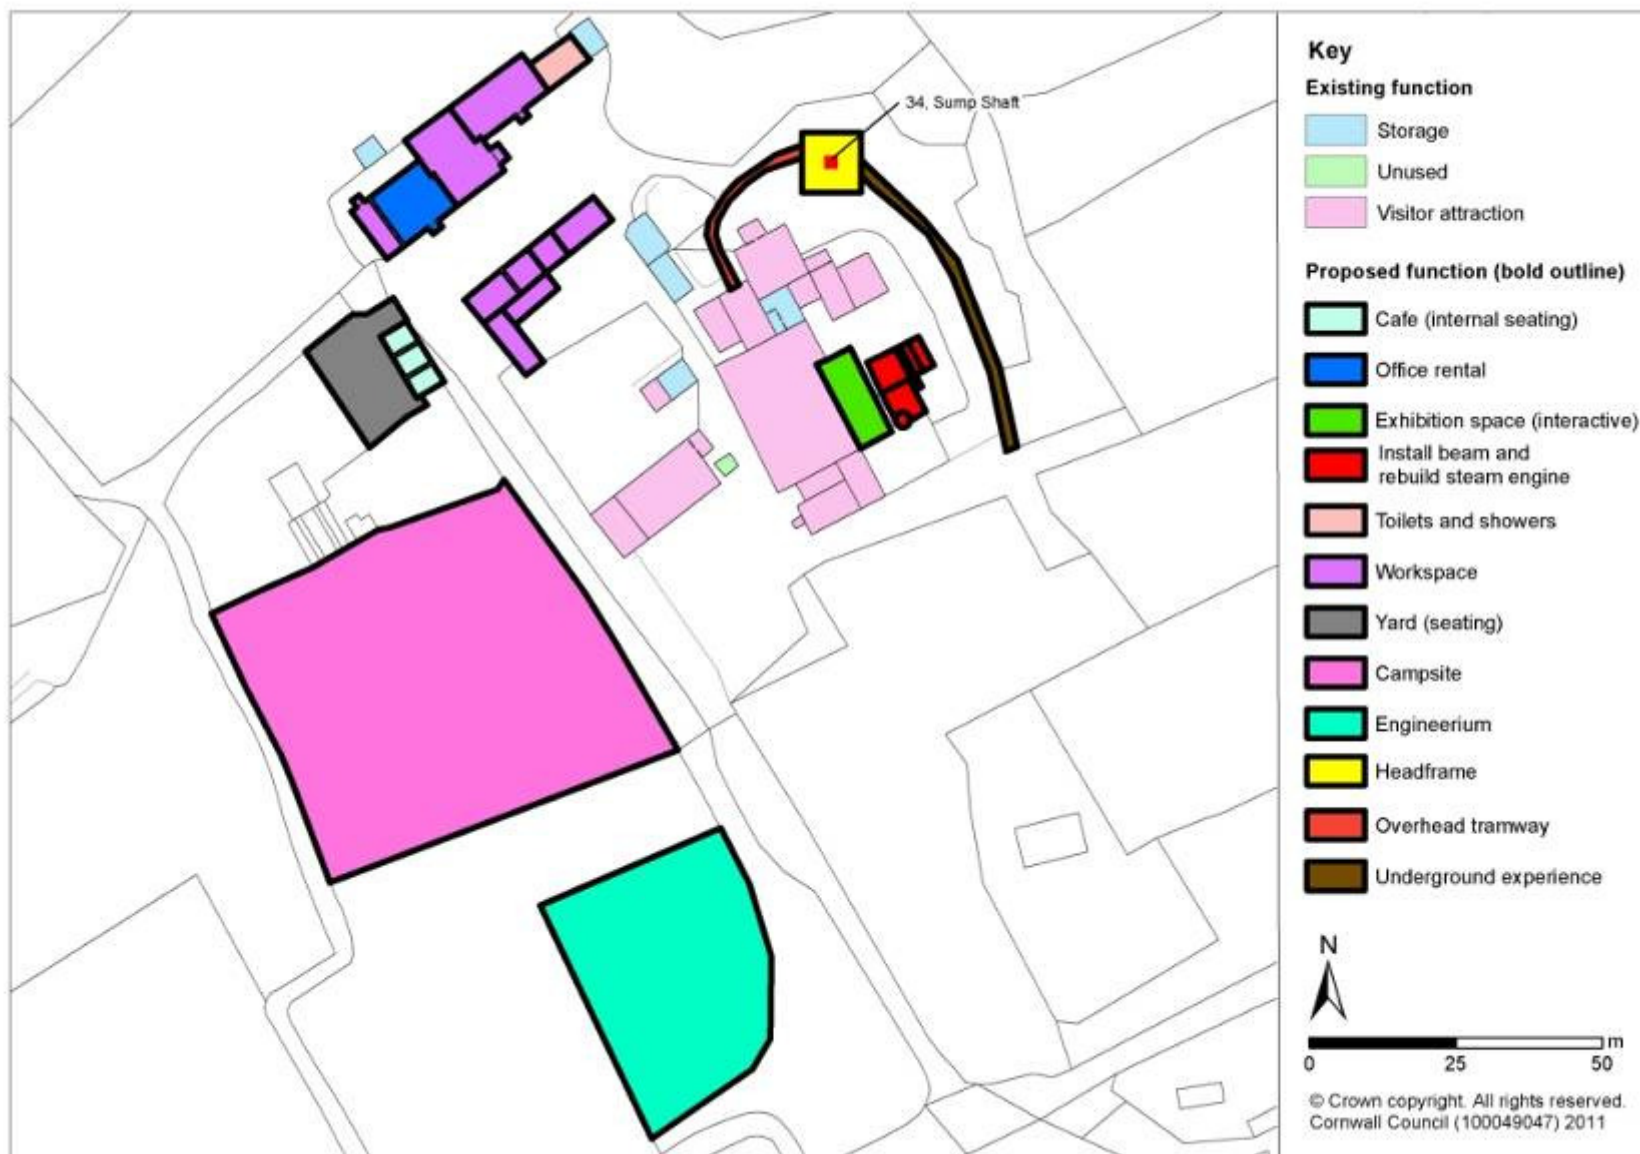
Figure 27 King Edward Mine plan of proposed changes of functional use and provisional future projects (2012)
