Report No: 2013R005

Manor Tannery, Grampound, Cornwall

Watching Brief and Historic Building Record

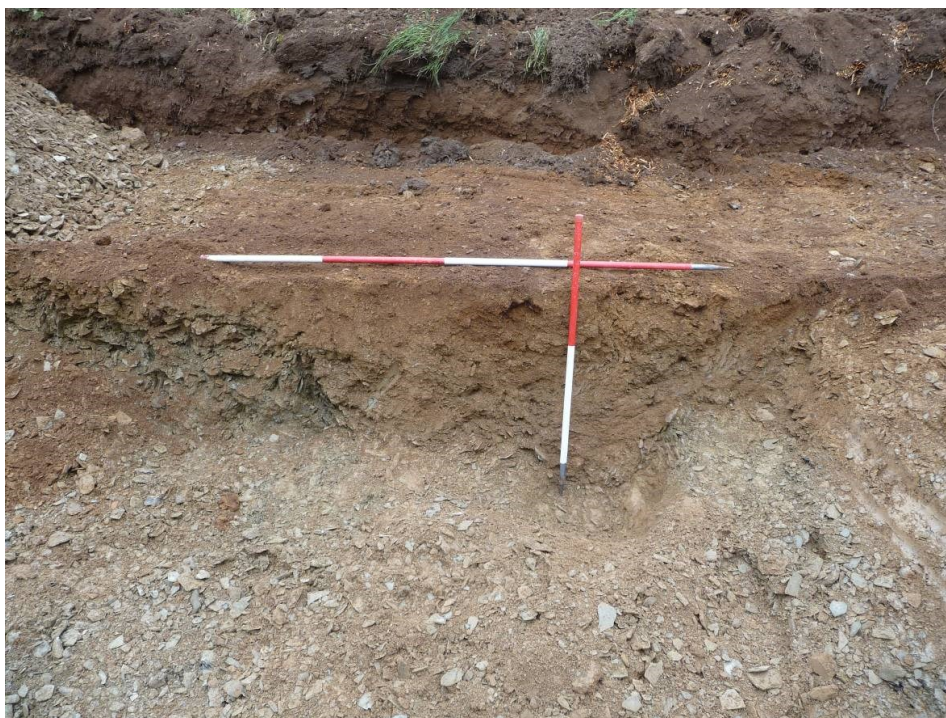
Fig 11 Section through ditch [102]

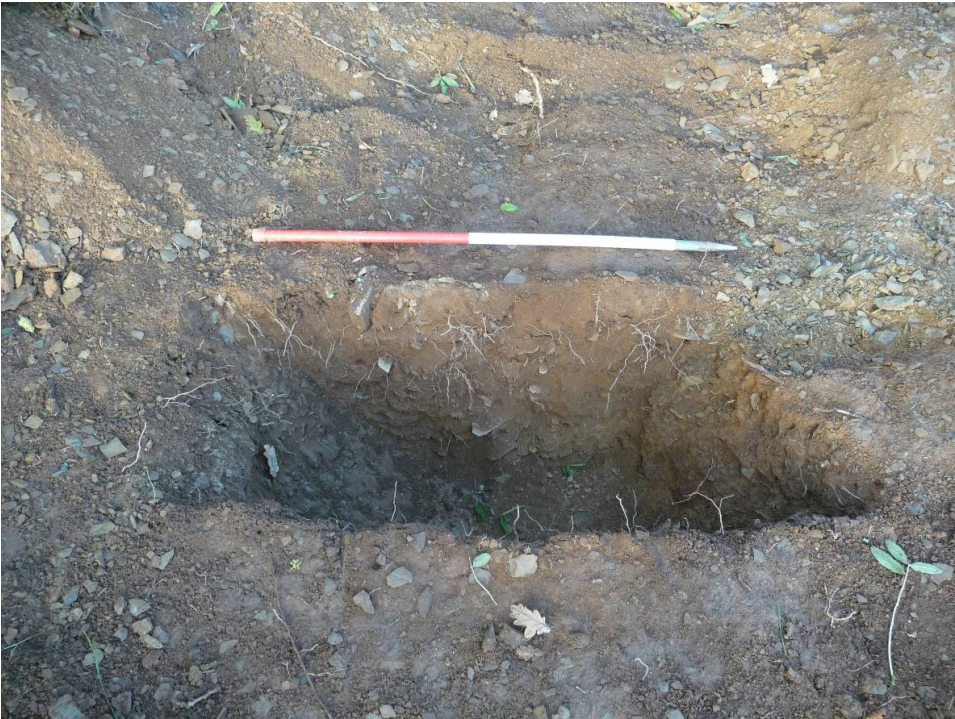
Fig 12 Section through ditch [106]

A ditch [106] was recorded in the south-eastern part of the field running roughly west to east (Fig 12). This was 'ditch B' recorded by the geophysical survey (GSB Ref 2011/49). This ditch was 1.2m wide and had an asymmetrical U-shaped profile 0.5m deep with the northern side being the steeper. Two fills were recorded. The primary fill (108) was a red-brown silty clay with numerous shillet fragments and some stones up to 0.3m in size. This deposit was up to 0.2m thick. It was overlain by up to 0.35m of red-brown loose silty clay with frequent small shillet fragments (107). No artefacts were recovered.

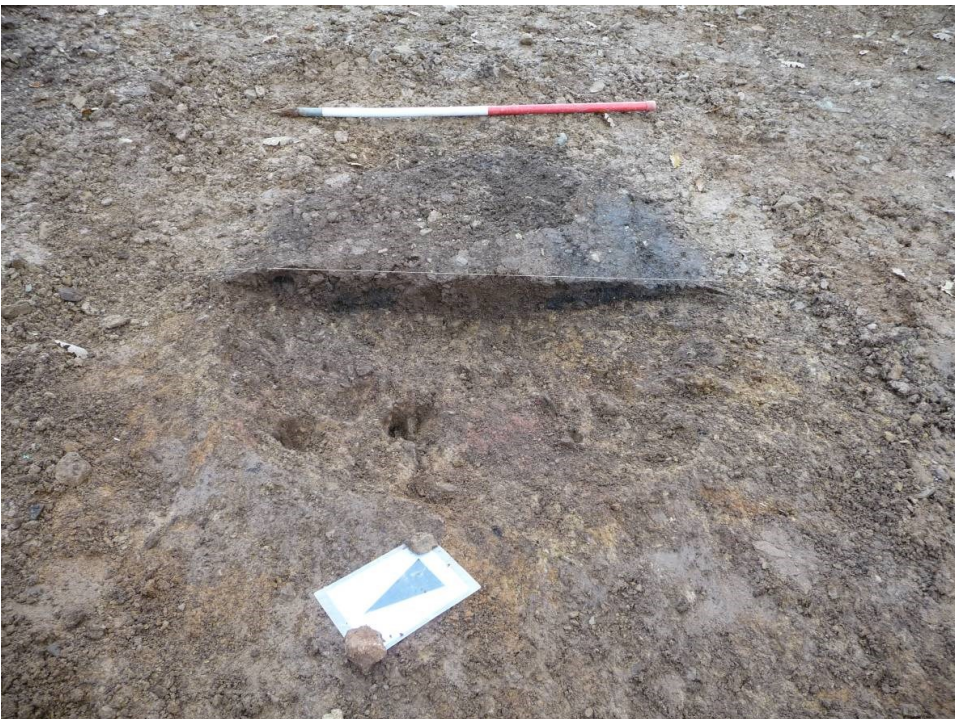
Fig 13 Section through burnt pit [110]

Some 22m from the north-west field boundary, and 15m from the south-west hedge boundary a sub-circular shaped pit was recorded [110] (Fig 13). This had a diameter of 1.1m and a shallow concave profile that reached a depth of 0.15m. The sides were steeper to the north while the base was uneven, with two possible root holes c0.1m in diameter. The bedrock at the base of the cut had been reddened indicating that burning had occurred *in situ*. Two fills were recorded. The primary fill (112) consisted of black-brown charcoal rich silty clay with some larger fragments of charcoal, and burnt clay. This primary fill appeared as a bowl-shaped hollow and was filled by a reddish-brown silty clay containing a few stones (111). No artefacts were recovered from either of the fills.

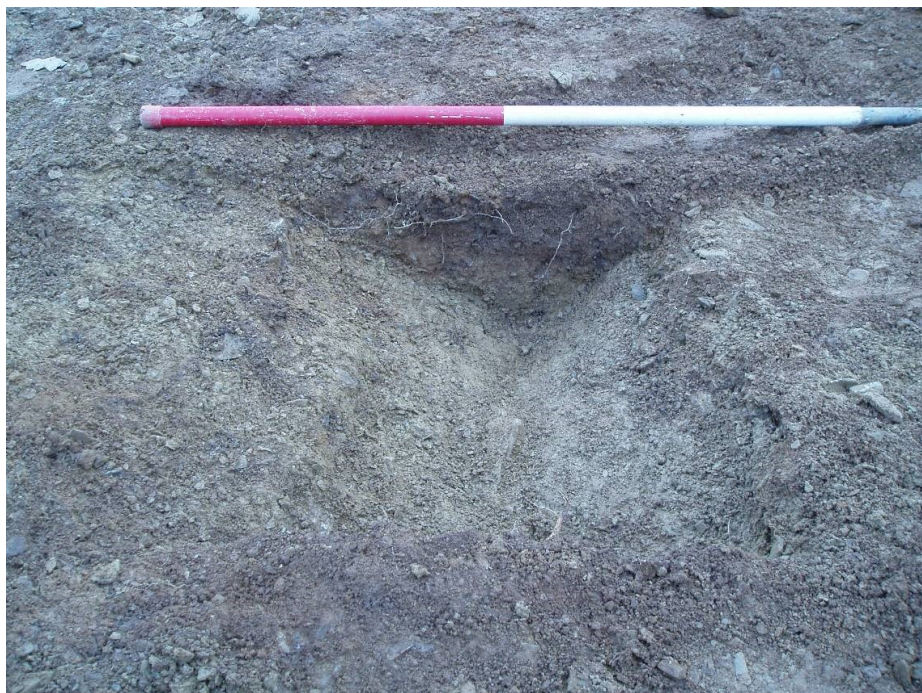
Fig 14 Section (slot 3) through ditch [113]

A small ditch [113] (Fig 14) was recorded running from north-west to south-east across the western side of the field running parallel with, and some 12m from the south-west field boundary. Four sections were cut across this ditch which varied in nature along its length. The first section at the north-west end of the ditch had an asymmetric U-shaped profile some 0.8m wide and 0.25m deep and was filled with yellow-brown silty clay with numerous shillet fragments (114). In the second section the ditch was 0.5m wide and had a flat bottom reaching a depth of 0.25m. Two fills were noted, a primary fill of tightly packed fragmented shillet in a grey-brown silty clay (115) up to 0.15m deep, overlain by up to 0.1m of (114). In the third section the ditch had a V-shaped profile, 0.55m wide and was 0.2m deep. Two fills were recorded. The primary fill (117) consisted of yellow-brown silty clay up to 0.1m thick which contained one sherd of medieval pottery and was overlain by up to 0.1m of dark red-brown silty clay with a few shillet fragments (116). Finally in the last section to the south-east the ditch was steep-sided with an irregular flattish bottom 0.7m wide and 0.45m deep. The primary fill up to 0.3m thick was (117) overlain by 0.15m of dark yellow-brown silty clay (124).

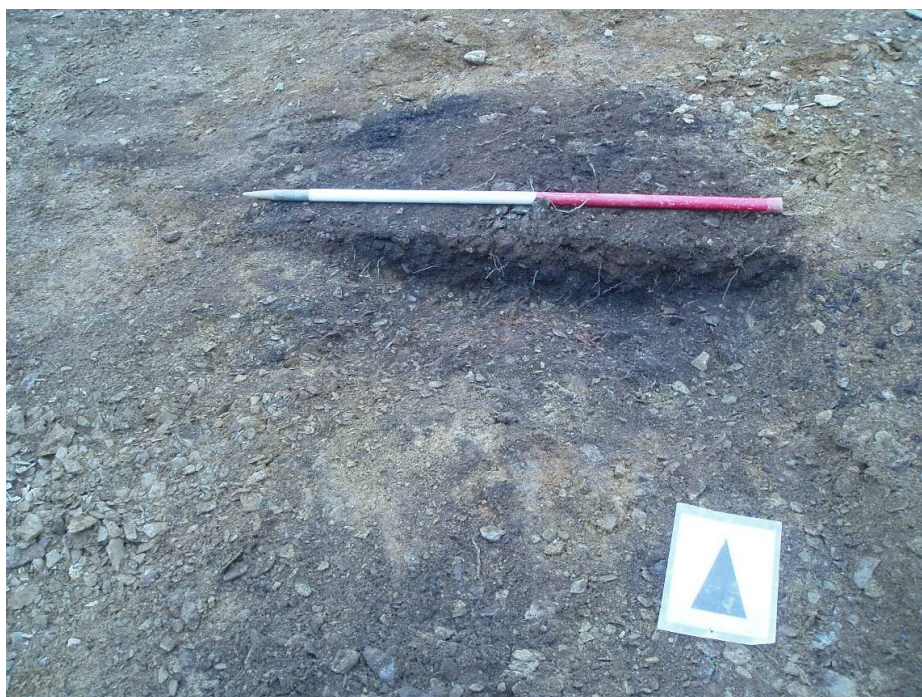
Fig 15 Section through burnt pit [118]

Close to the centre of, and some 4m from the eastern field boundary a sub-circular bowl shaped pit [118] was recorded (Fig 15). It had a diameter of roughly 1.1m and reached a depth of 0.15m. It was steep-sided on its north side, and shallow to the south. It was filled with dark reddish brown silty clay with numerous charcoal fragments (119). The basal bedrock had been reddened by heat showing that burning had occurred *in situ*. No artefacts were recovered.

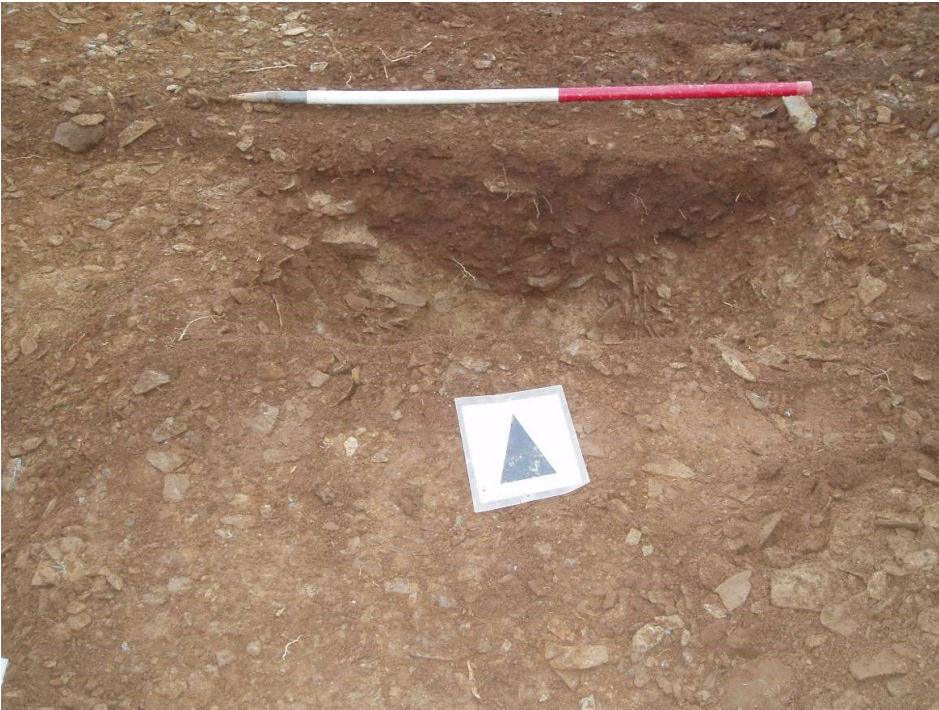
Fig 16 Section through ditch [120]

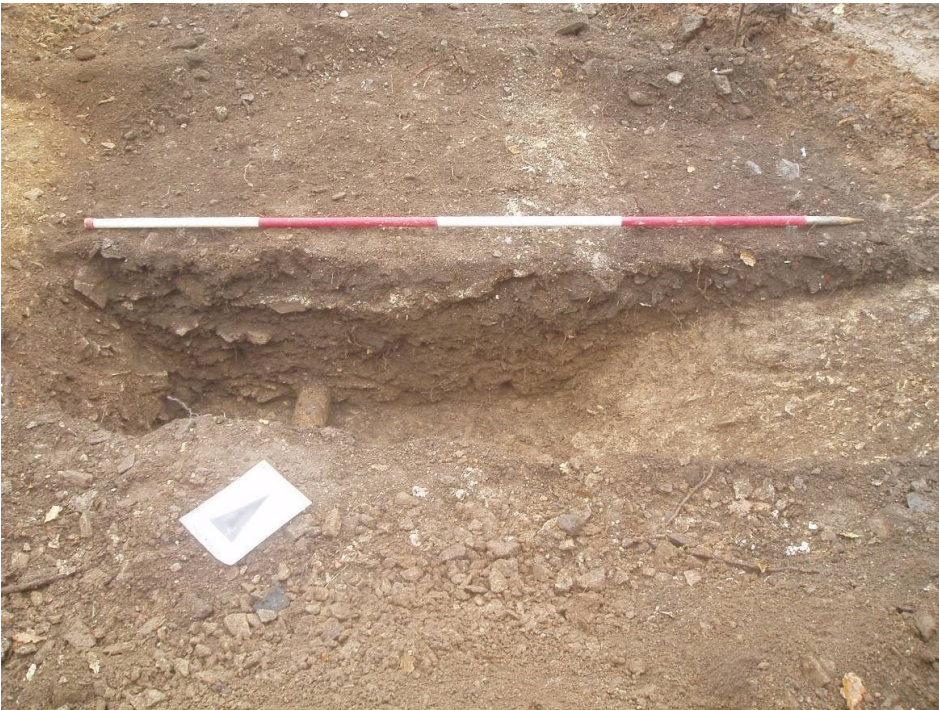
Fig 17 Section through ditch [126]

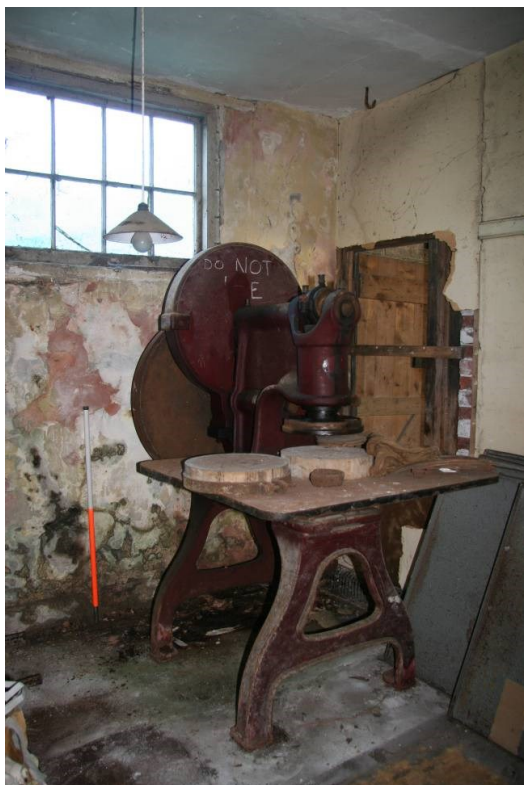
Fig 29 Machine on ground floor of Building 1

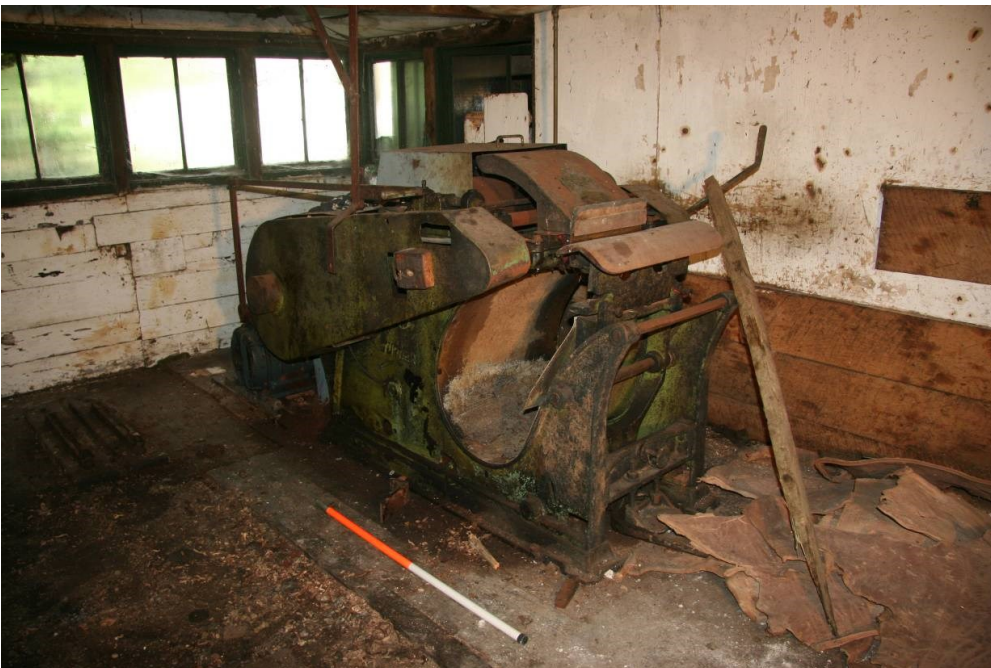
Fig 35 Building 4, machine on first floor looking north-east

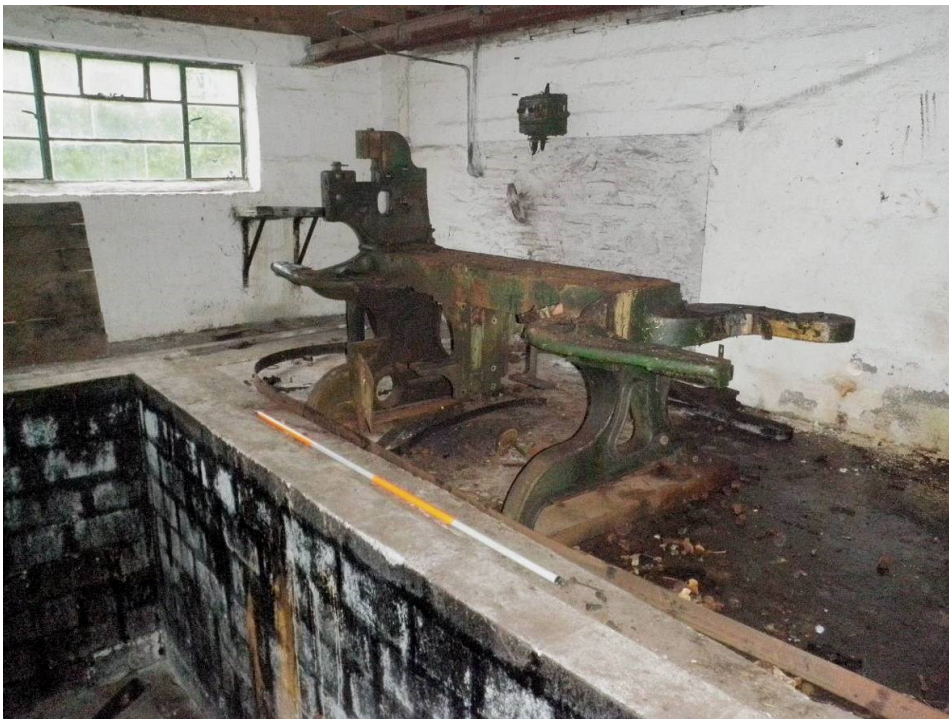
Fig 39 Building 5, machine on ground floor looking north-west

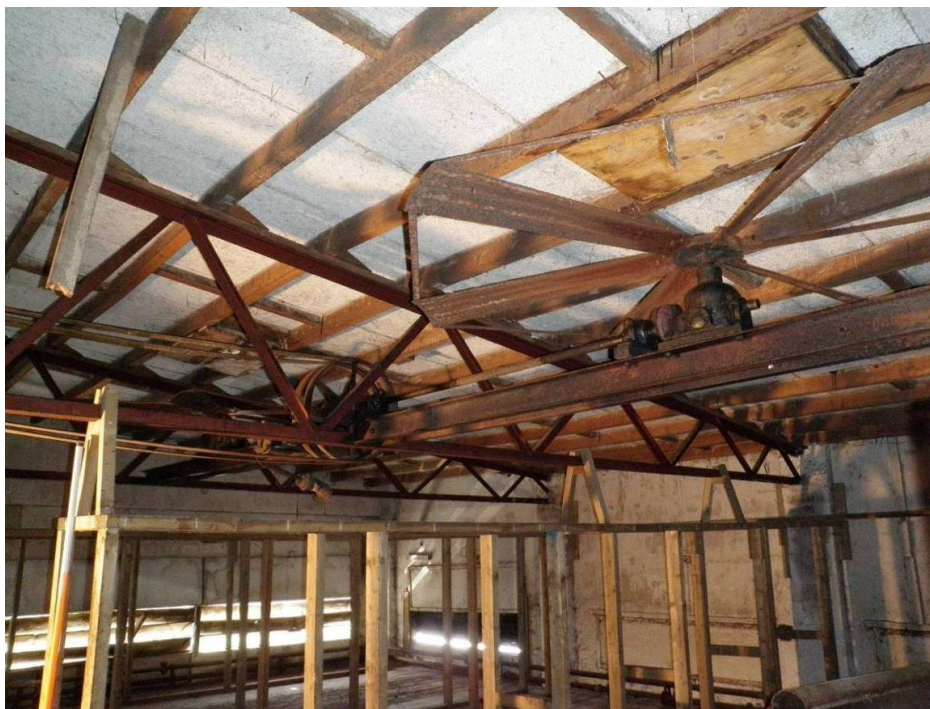
Fig 40 Building 5, first floor interior showing drying loft fan, drive wheels and belts looking north-west

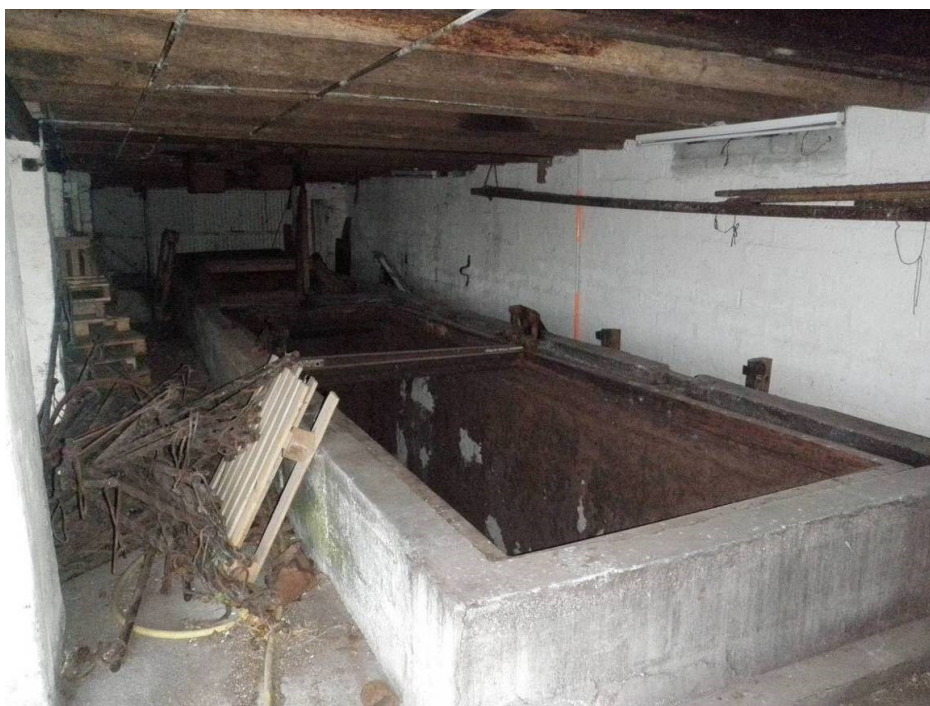
Fig 41 Building 6, ground floor interior looking north-east showing tanning pits with rockers

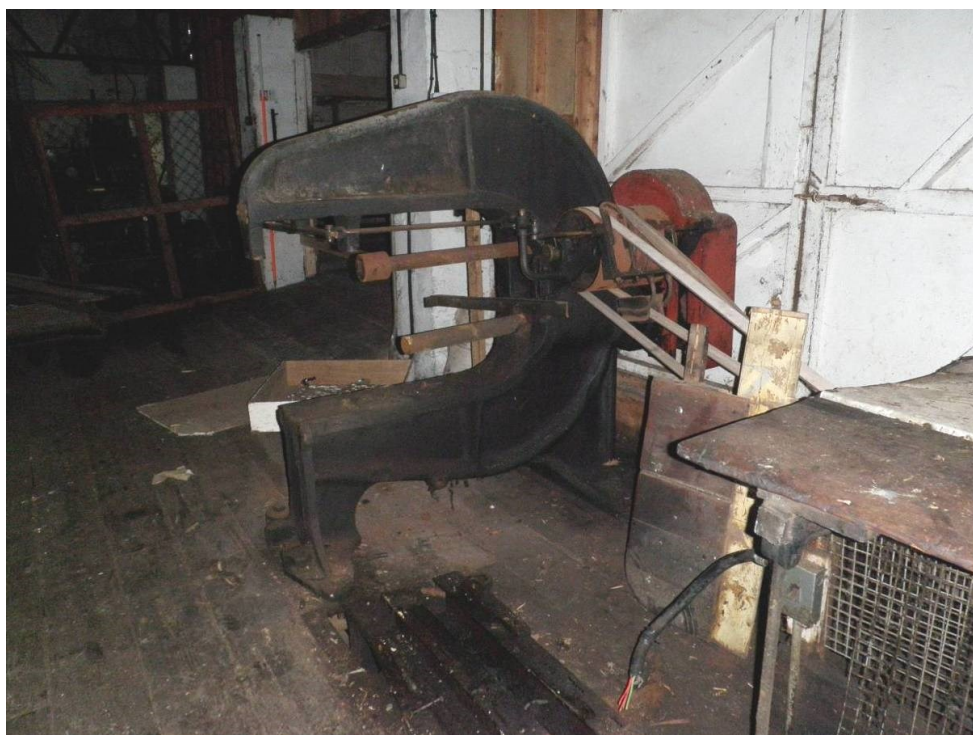
Fig 44 Building 6, electric motor driven machine on first looking south-west

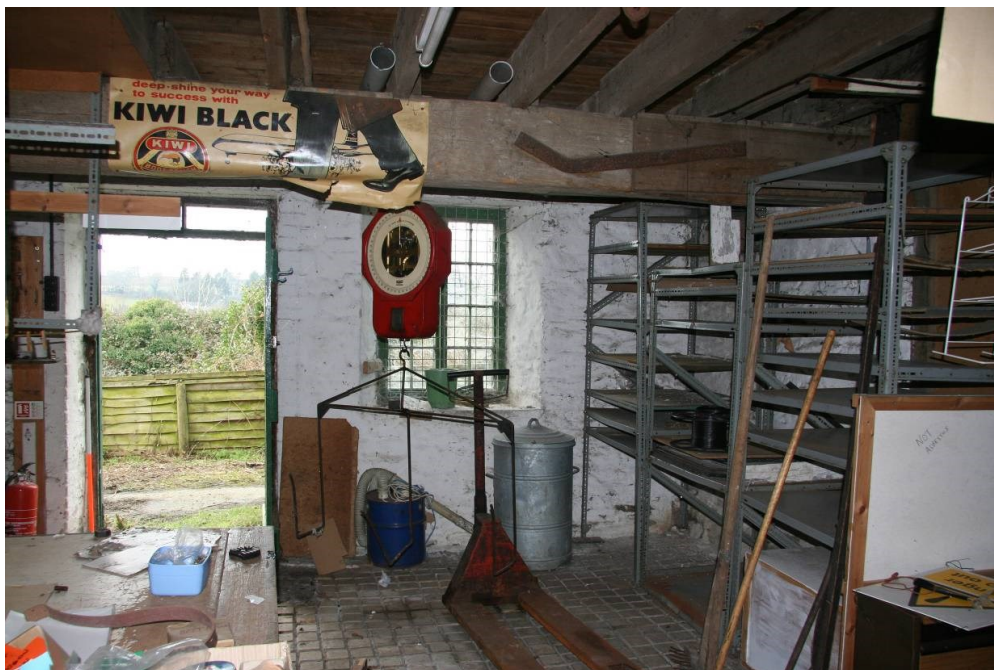
Internally the ground floor (Fig 49) has a square block tiled floor with a central drainage channel (now infilled) and stone blocks showing the locations of the former stall divisions, a typical stable floor. After use as a stable the ground floor was converted for use as a sales/workshop space and the dividing wall between buildings 7a and 7b was removed forming a single large room within the two buildings. There is a very large timber beam running the length of building 7a from north to south supporting the first floor in the western half of the building. This appears to be reused and is not related to the building's purpose. It has a cut-out for a bracket which is reminiscent of a horse engine gearing support. The first floor (Fig 50) originally served as a hayloft but was later converted for use as storage for finished hides and is now open to the first floor of building 7b forming a single large room space. It has a timber boarded floor and an inserted hardboard ceiling. Along the rear (east) wall there is timber racking for storage of hides and finished products and there are also two work benches in the room.

Fig 49 Building 7a, ground floor interior looking west

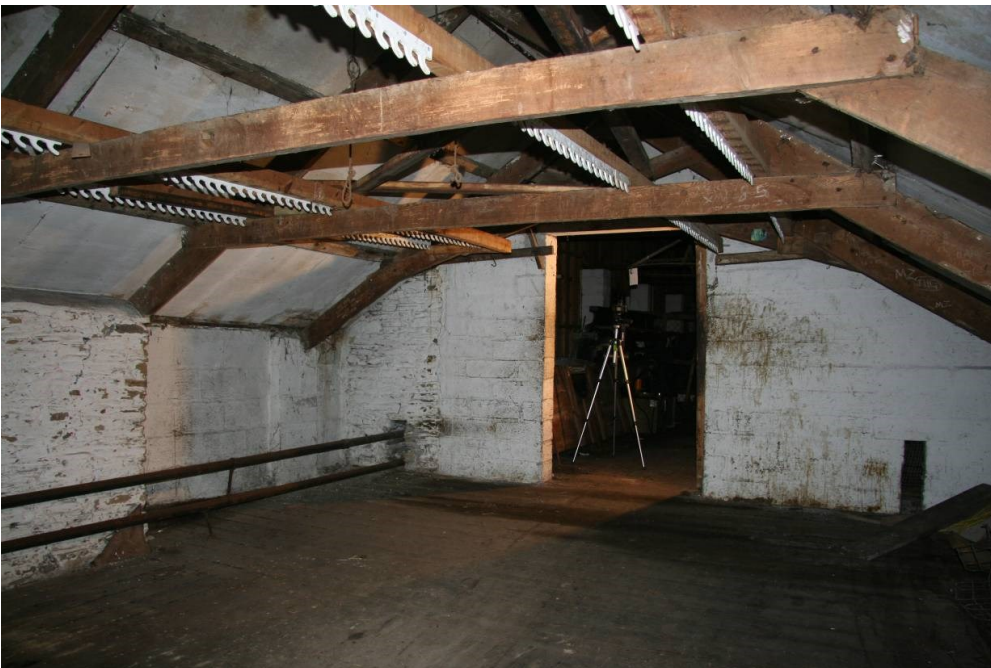
Internally the ground floor has a concrete floor surface and there is a blocked original doorway in the south wall which was once the main entrance to the building. The first floor (Fig 51) has served as a heated drying loft with hangers suspended from the ceiling. It has a timber boarded floor and there is an inserted door opening in the south wall giving access to building 7b. This has been fitted with a heavy duty fire door labelled 'Malter and Platt'.

Internally the loft (Fig 51) has a timber boarded floor and it is open to the first floor of building 7c. At the north end there is a door opening through to building 6 which has been fitted with a heavy duty fire door labelled 'Malter and Platt'.

Fig 51 Buildings 7c and 7d, first floor interior looking north-west

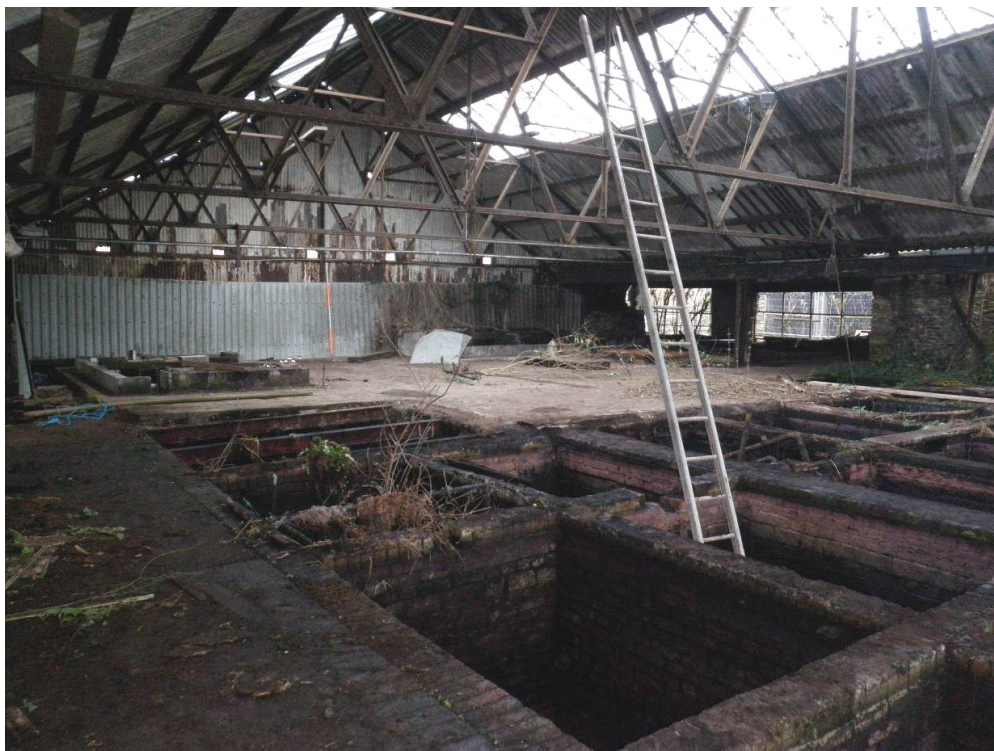
Internally the floor is concrete. There is a pair of tanning mixing pits in the north-east corner and in the north-west corner there is a machinery plinth (machine now removed). To the south of this there are 24 tanning pits of different grouping and sizes and all lined with brickwork (Figs 53 and 54).

Fig 53 Building 8a, interior looking north-east

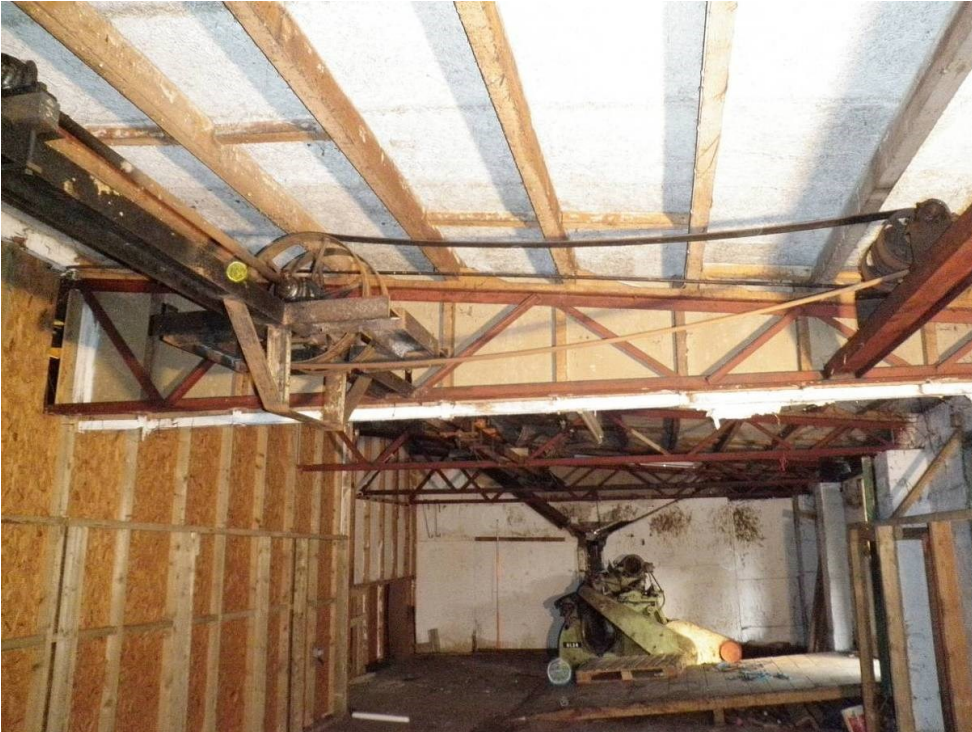
Fig 55 Building 8b, interior looking north, showing machine and drive belts

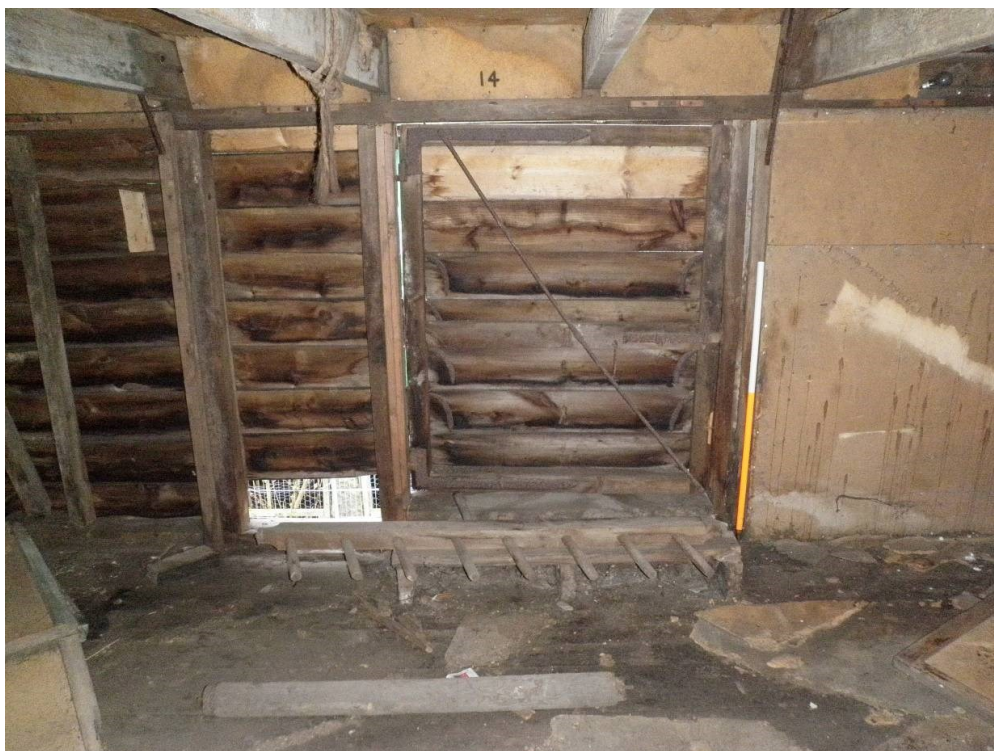
Fig 61 Building 9a, first floor interior showing adjustable louvered opening

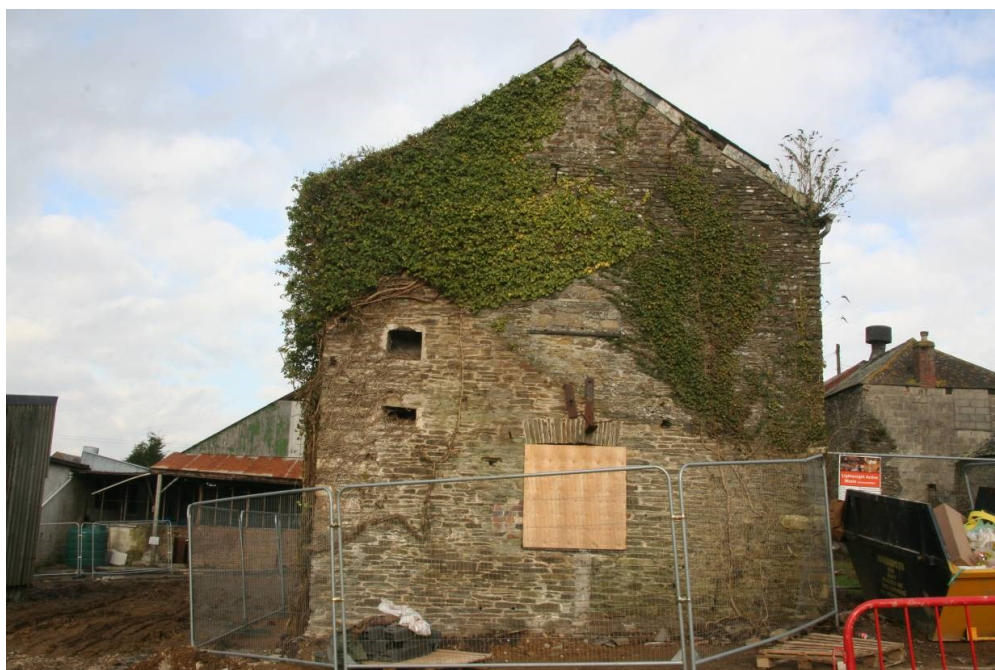
Fig 68 Building 11a, south elevation

The ghosting of a roofline and slots towards the left indicate a former shed which contained an engine

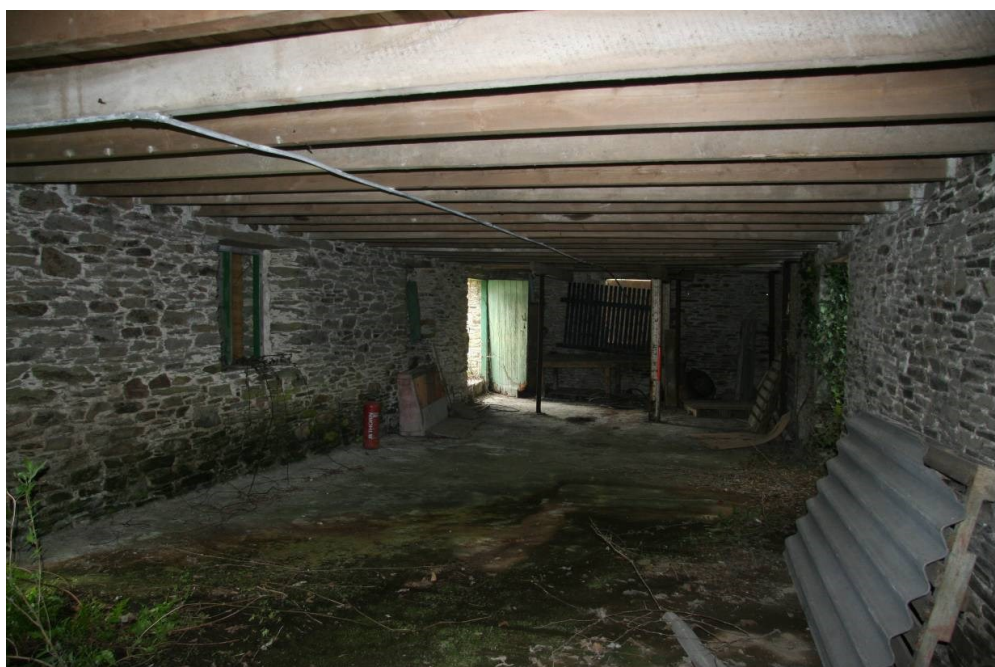
Fig 69 Building 11a, ground floor interior looking south

The interior of the building (Fig 69) was replaced following a fire in the 1920s but a small area of the original first floor structure survives at the south end of the building (Jones 2001). Both the ground floor and first floor are single open room spaces although the ground floor was originally divided in two, with a small room at the south end divided from the larger room by a stud partition wall evidenced by sockets for timber supports in the floor and a line of plugs in the south wall. The original first floor structure, located in the south-west corner, has a large reused timber beam (likely to be a bearing beam from a horse engine house) supporting the floor above (probably where there was once machinery). In the west half of the south wall there is a blocked opening for a drive shaft. The larger ground floor room to the north had a central support beam (now removed) holding the floor above running from north to south and held by props (the prop sockets are visible in the floor). The ground floor now has a concrete surface and at the north end there are remains of oak bark chippings. The first floor is accessed via an external staircase on the west side of building 11b although originally there was an internal staircase at the south end of the building (Jones 2001). At the time of the site visit the collapse of the first floor in building 11b meant that the first floor could not be accessed. The ground floor and first floor latterly were used as storage areas for oak bark and Valonia. The tie beams of the trusses have been worn where hides have been hung to dry (Jones 2001).

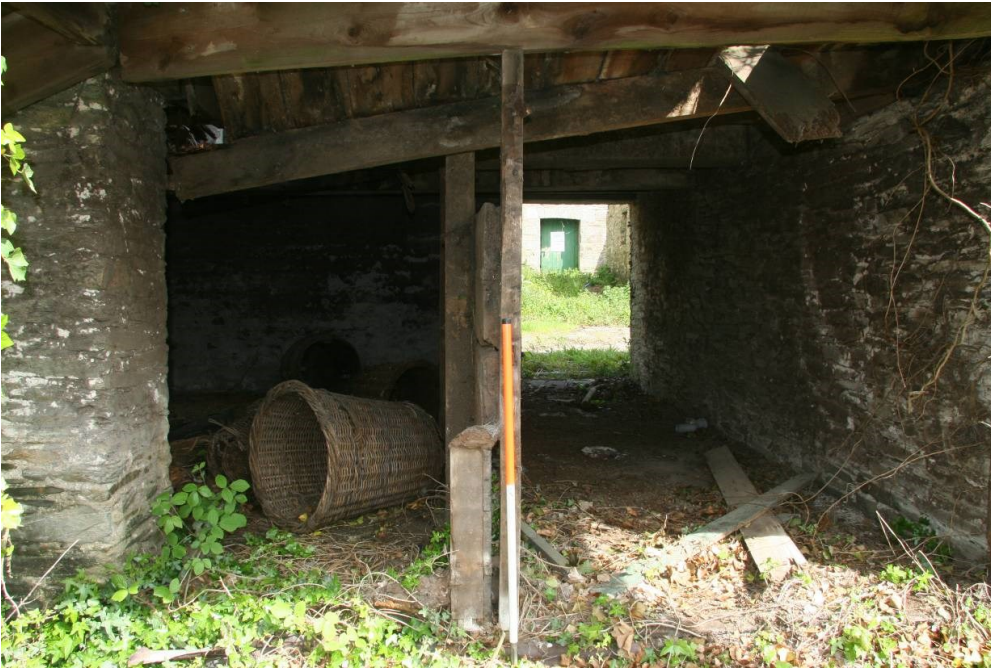
Fig 70 Building 11b, ground floor interior looking east

The ground floor (Figs 70, 72 and 73) is divided into two spaces by a half-height, timber planked partition. This was designed so that the milled oak bark would fall from the floor above into the northern half of the building and the milled Valonia would fall into the southern half of the building. Lying on the concrete floor surface was milled Valonia in the southern half and milled oak bark in the northern half along with several large wicker baskets used to transport the milled materials to the tanning pits. The mills (now removed), located on the first floor, were supported on two large timber beams (now collapsed) aligned north-south in the centre of the building. Curved recesses in the timbers immediately below the two mills indicated the bearings and point at which the milled material fell to the ground (Fig 73). Either side of the recesses there were large iron bolts to hold the mills in position. At the time of the site visit the first floor could not be access because of its partial collapse, although bundles of oak bark were visible on the remaining floor surface.

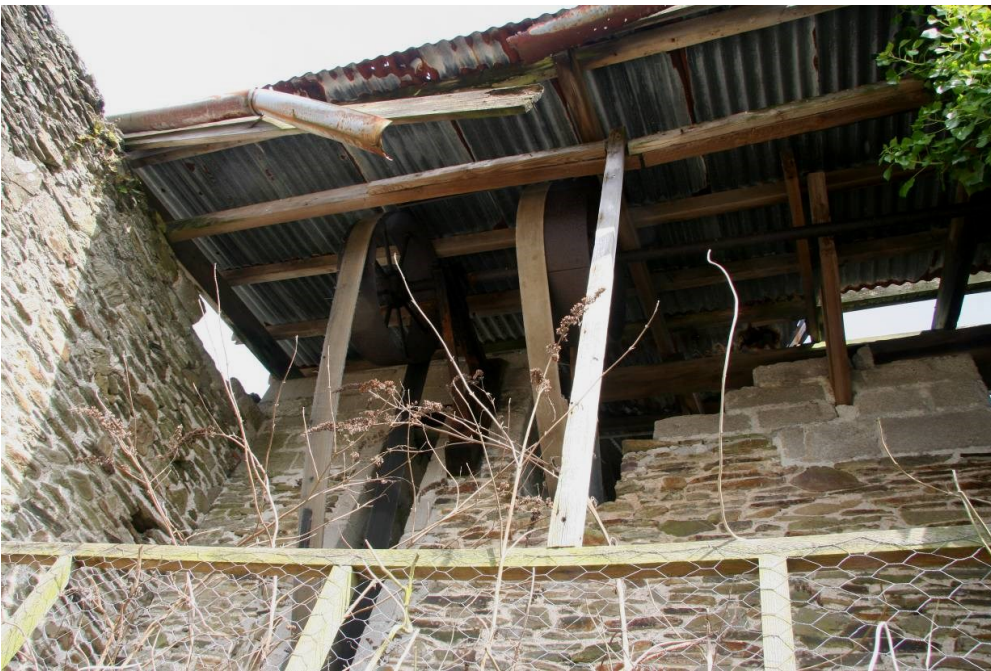
Fig 71 Building 11b, west elevation showing wheel and belt drives for mills

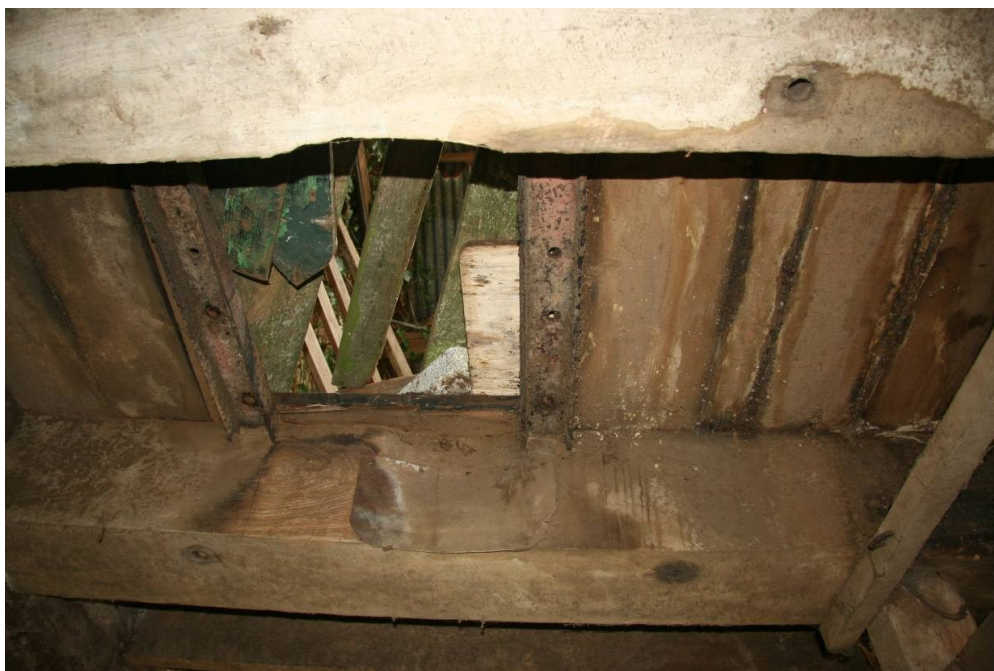
Fig 73 Building 11b, hatchway in first floor and worn beams associated with former Valonia mill above

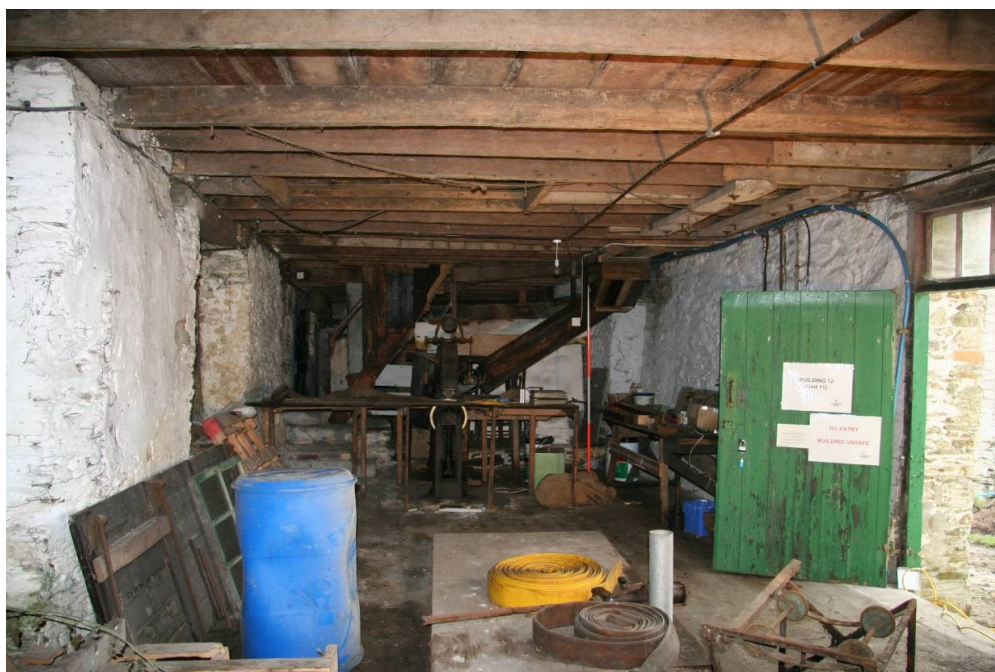
Fig 77 Building 12b, ground floor interior looking south

Internally on the ground floor there is a concrete surface at the north end and a timber planked floor at the south end. A machine with electric motor is located at the north end and there is a complete rolling machine (labelled Huxham and Brown, Exeter, England, Figs 77 and 78) at the south end powered by a belt drive from an electric motor (all *in situ*). There is a trap door above the centre of the room, probably used for hides from the loft above. The first floor is a single open drying loft (Fig 79) with access via door openings through to building 10 and 12a.

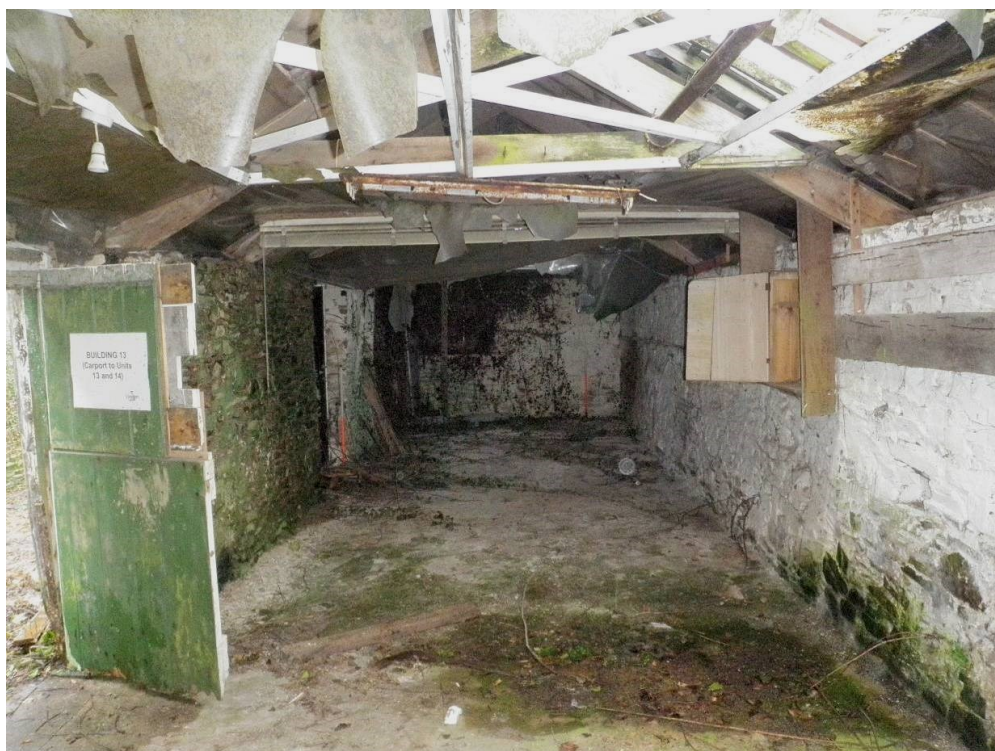
Fig 81 Building 13, interior looking south

Internally there is a concrete floor and the walls are lime-washed (Fig 81). All the windows have reveals and there is evidence of a removed east-west partition that once divided the interior in half.

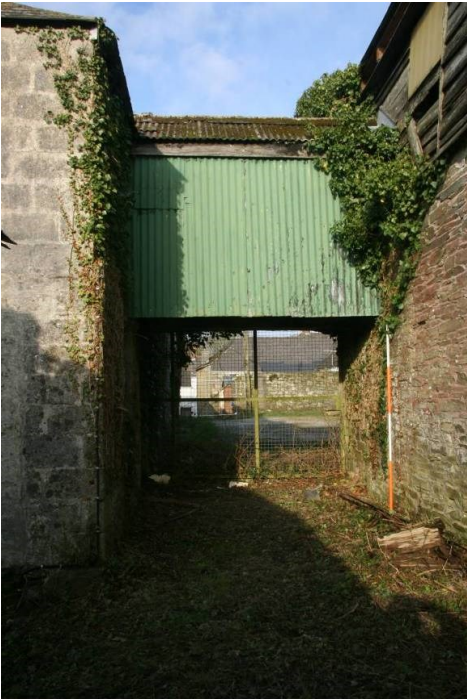
Fig 82 Aerial walkway between buildings 12 and 14 looking north

masonry of building 12a. At first floor level the wall is now concrete blockwork rendered with concrete (replacement of probable timber louvered walls) and an aerial walkway has been inserted in the northern half giving access between the first floor levels of buildings 12 and 14 (Fig 82).

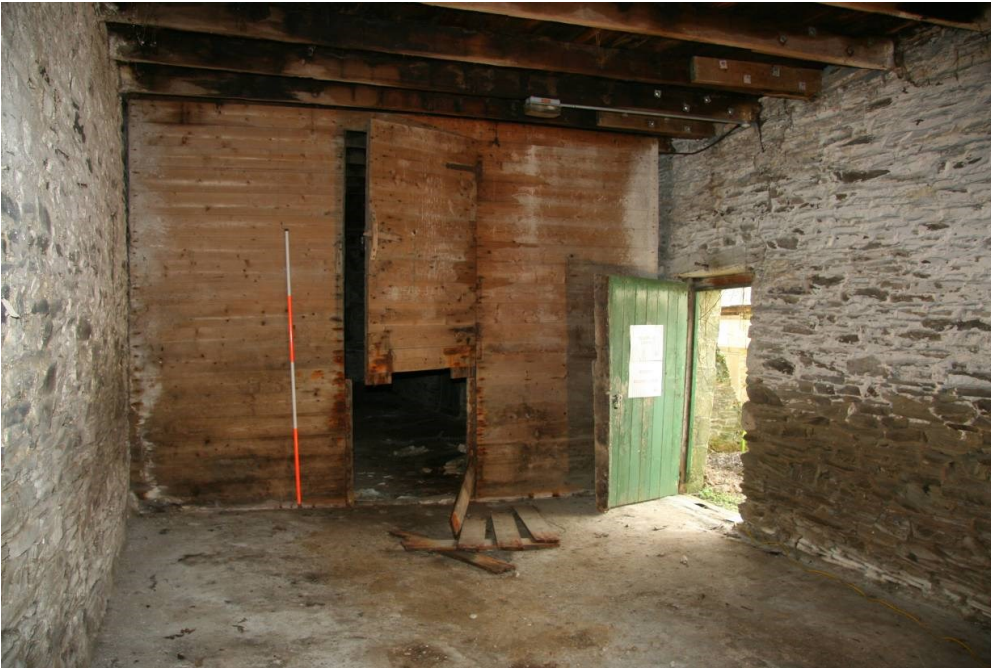
Fig 86 Building 14, ground floor interior of northern room looking south

Internally the ground floor has been divided into two room spaces by a timber partition (Fig 86). This partition has a central tall hatch opening with a split door whose base is 1m above ground level. The floor surface in both the north and south rooms is concrete. The north (smaller) room (Fig 86) has lime-washed walls above 1.5m up from the floor surface. The lower part of the wall is bare stone. The larger southern room (Fig 87) does not have lime-washed walls. There are wooden racks along the east wall and in the south gable a window opening is visible, blocked by the later external buttress. The original function of the ground floor is not known but it seems likely that the unlit southern room served as an oak bark store and the smaller northern room served as a receptacle for milled bark derived from a mill located on the floor above. At first floor level there is a single open room space (Fig 88). This room was originally probably a drying loft with an oak bark mill installed at the north end. It has a timber planked floor and the timber louvered walls are original. An opening through to an aerial walkway between buildings 12a and 14 has been inserted at the north end of the west wall (Fig 82). There is also a door opening in the north gable giving access to a flight of external steps (now removed).

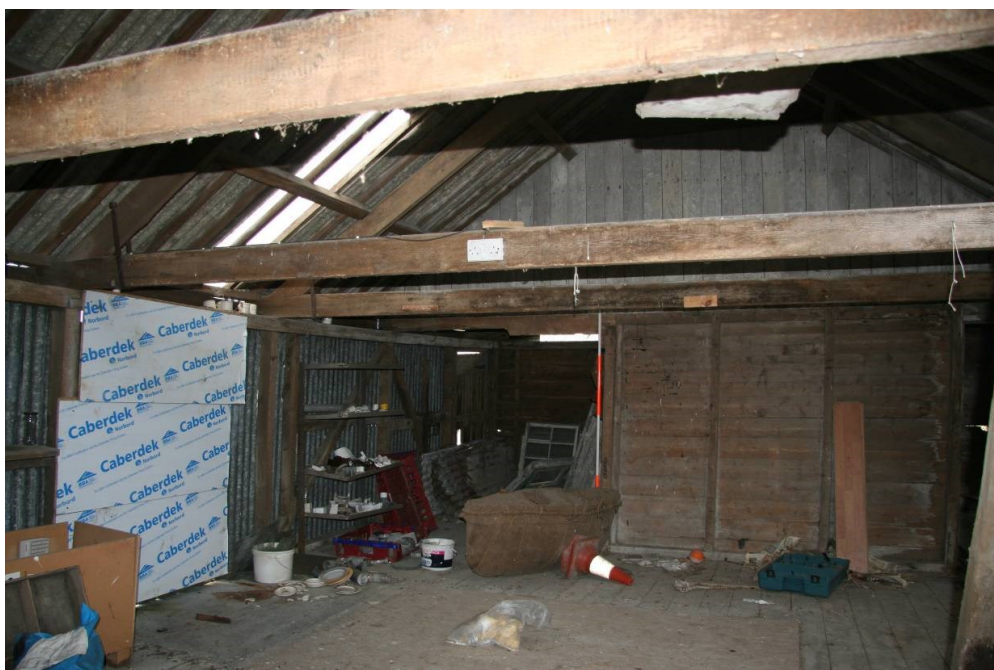
Fig 92 First floor interior of Building 15, looking N

Internally there is a concrete floor in both the north and south ends of the ground floor. The north half of the ground floor is divided into two room spaces by a timber partition wall. In the smaller, open-fronted, southern room a vehicle inspection pit has been inserted (possibly reusing a former tanning pit). The northern room (Fig 91) has been converted for use as a workshop/store and at the north-east corner there is a staircase leading to a first floor landing/gallery (a small room enclosing the stairs screened from the rest of the first floor room space by timber planked partition walls). The stairwell sides of the planked partitions enclosing the landing are decorated with pasted up illustrations taken from 19th century periodicals. The rest of the first floor is likely to have originally functioned as a drying loft (Fig 92). The roof trusses are original tie beam trusses.

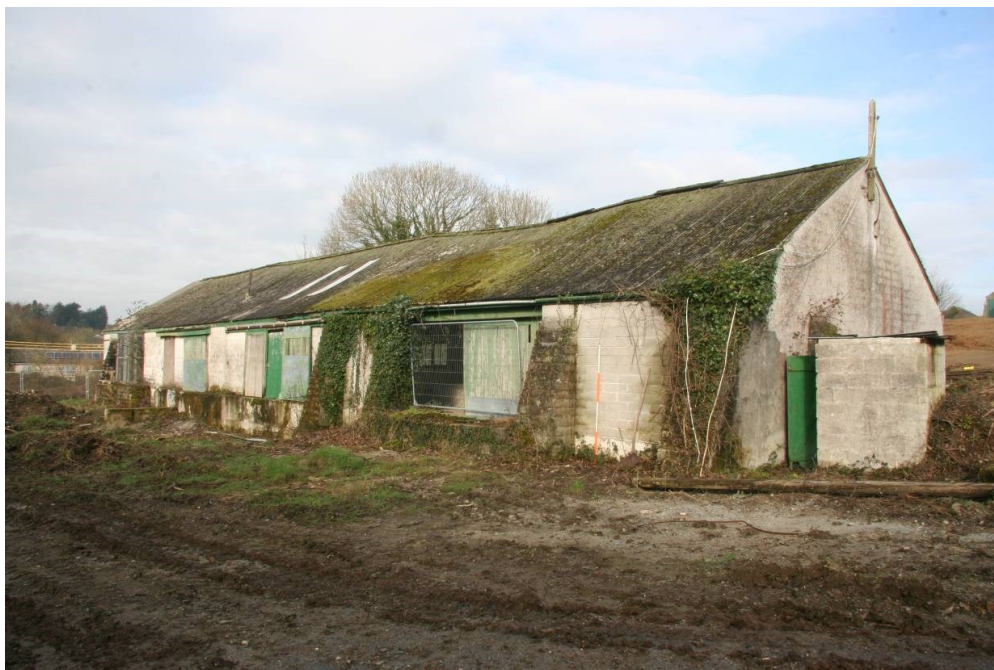
Fig 93 Exterior of Building 18 (20th century limes shed), looking NW

The front (south) elevation (Fig 93) is supported by a series of concrete buttresses and has four wide, sliding, double loading and ventilation door openings evenly spaced along its length. Three of the door openings retain their original braced timber doors. The north elevation has two original window openings and the two gable ends are blind.
