Report No: 2013R005

Manor Tannery, Grampound, Cornwall

Watching Brief and Historic Building Record

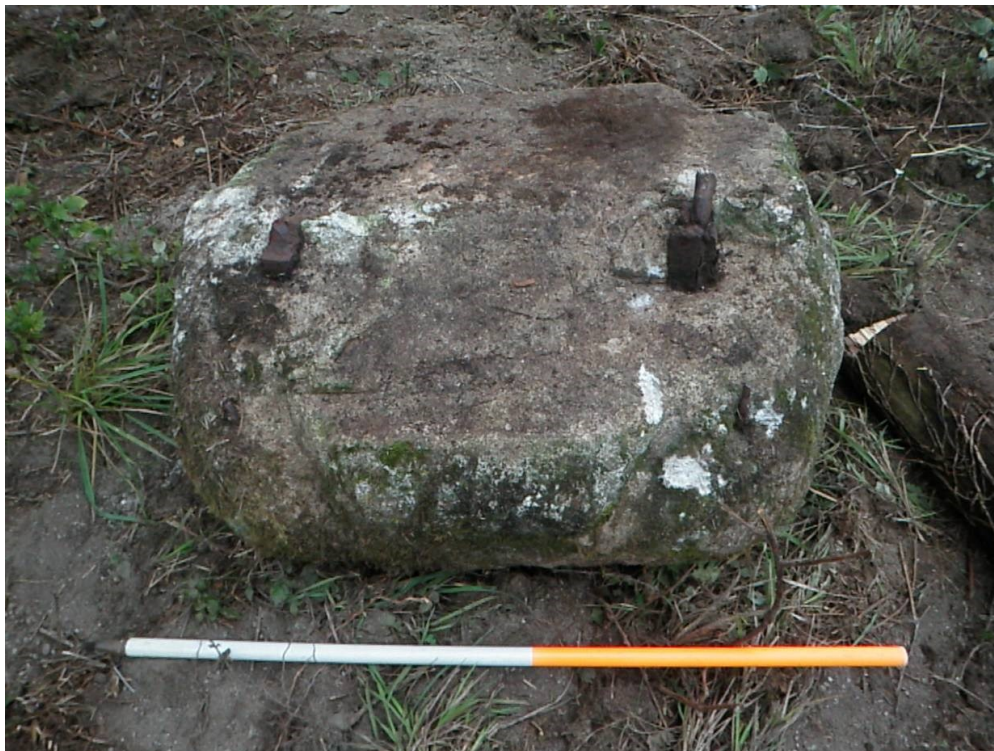
Fig 96 Possible stay to support the drive shaft uncovered at the eastern end of Building
