Porthcressa Regeneration Project St Mary's, Isles of Scilly

Building recording and archaeological watching brief

Client	Kier Construction – Western & Wales
Report Number	2013R022
Date	15/04/2013
Status	Final
Report author(s)	Charles Johns and Jo Sturgess
Checked by	Andy Jones
Approved by	Andrew Young

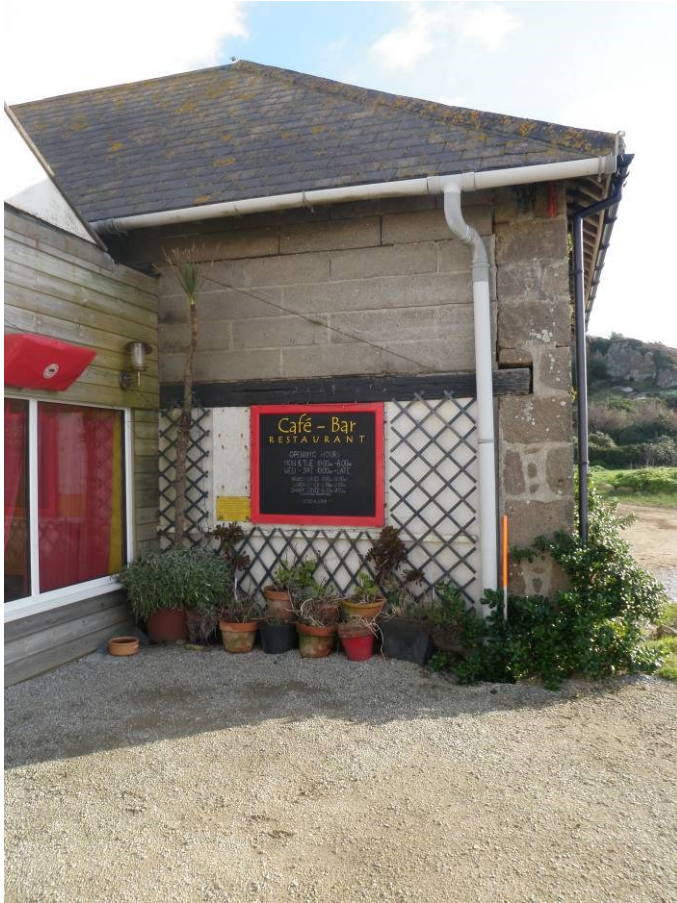
Fig 12 West elevation of south extension to Building 1 (former lifeboat station)

The 1923 extension was built in granite rubble to match the existing building, with a vertical window facing south and a chimney on the eastern roof (since removed) for the operation of the hot water treatment of bulbs. There is a wide blocked door opening at

ground floor level in the west elevation with timber lintel over and matching wide, blocked opening at first floor level (Fig 12).

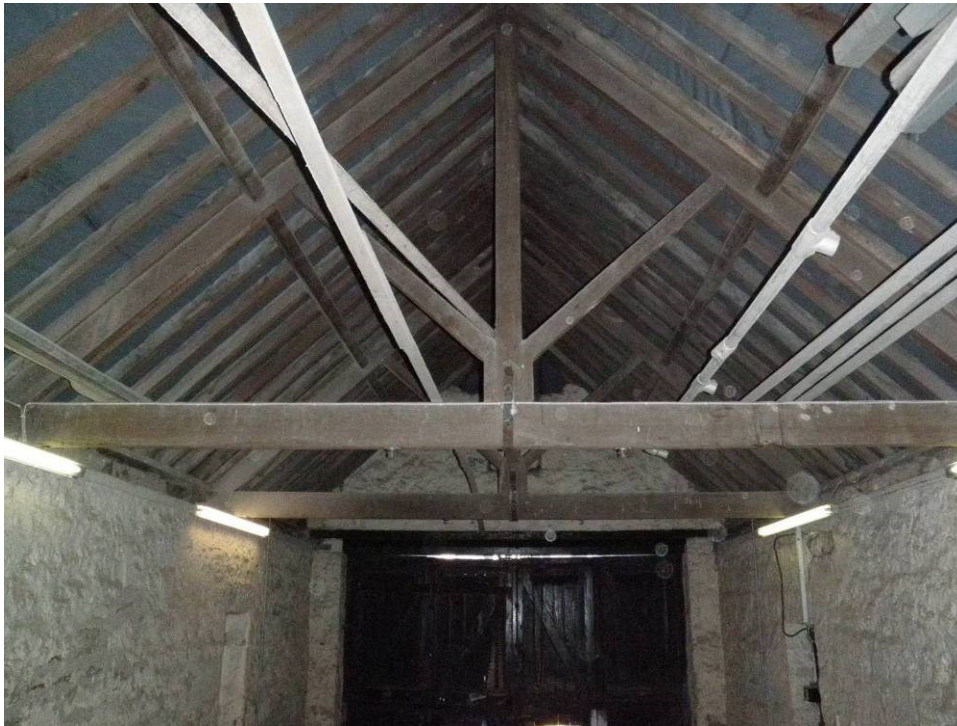
Fig 13 Interior of Building 1 (former lifeboat station) looking north showing king post trusses

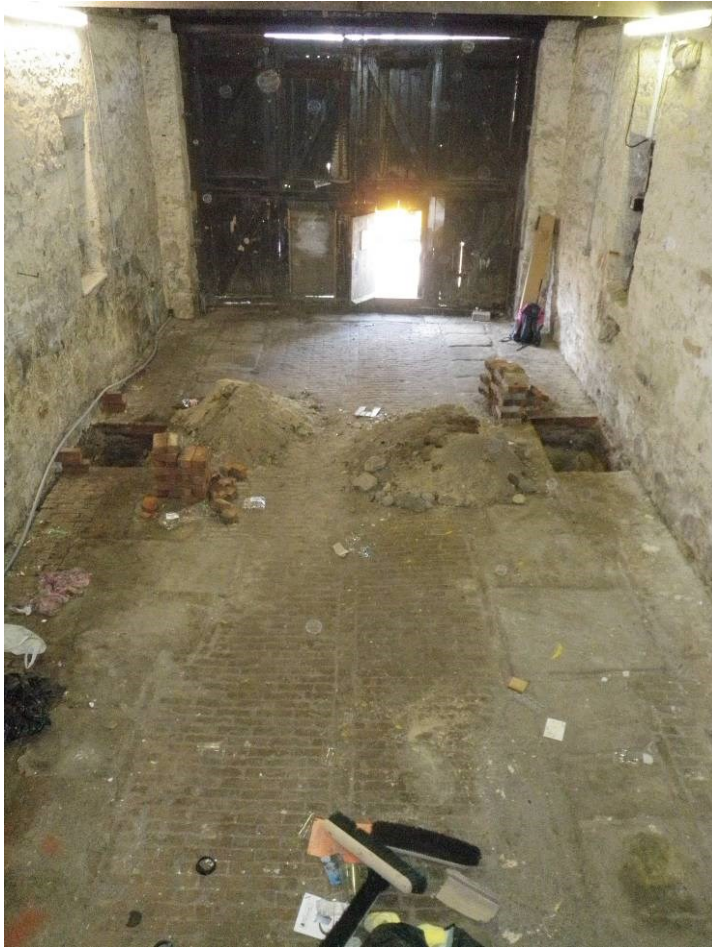
Fig 14 Interior of Building 1 (former lifeboat station) looking north showing original brick floor with granite wheel runs

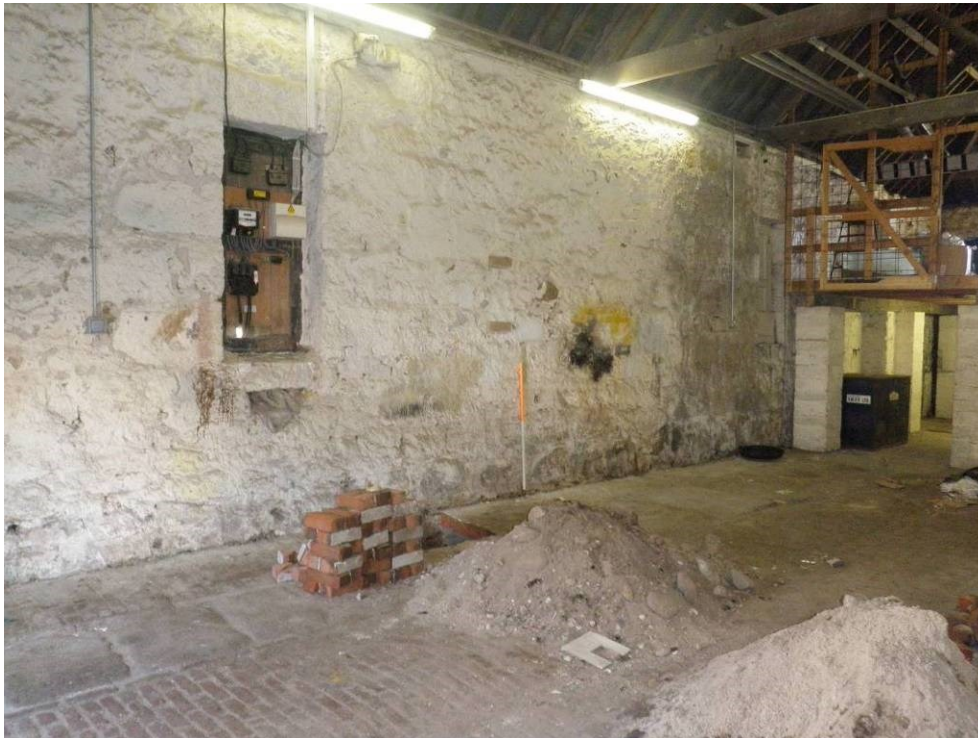
Fig 15 Interior of Building 1 (former lifeboat station) looking south-east showing blocked window opening in east wall

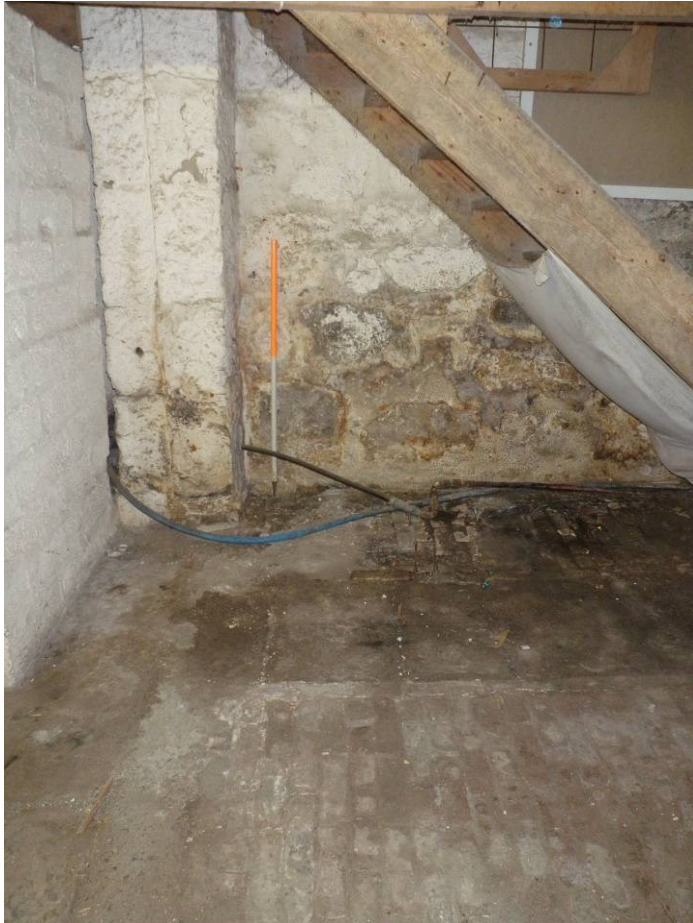
Fig 16 Interior of Building 1 (former lifeboat station) looking west showing door jamb at the south end of the original building where the later extension has been added

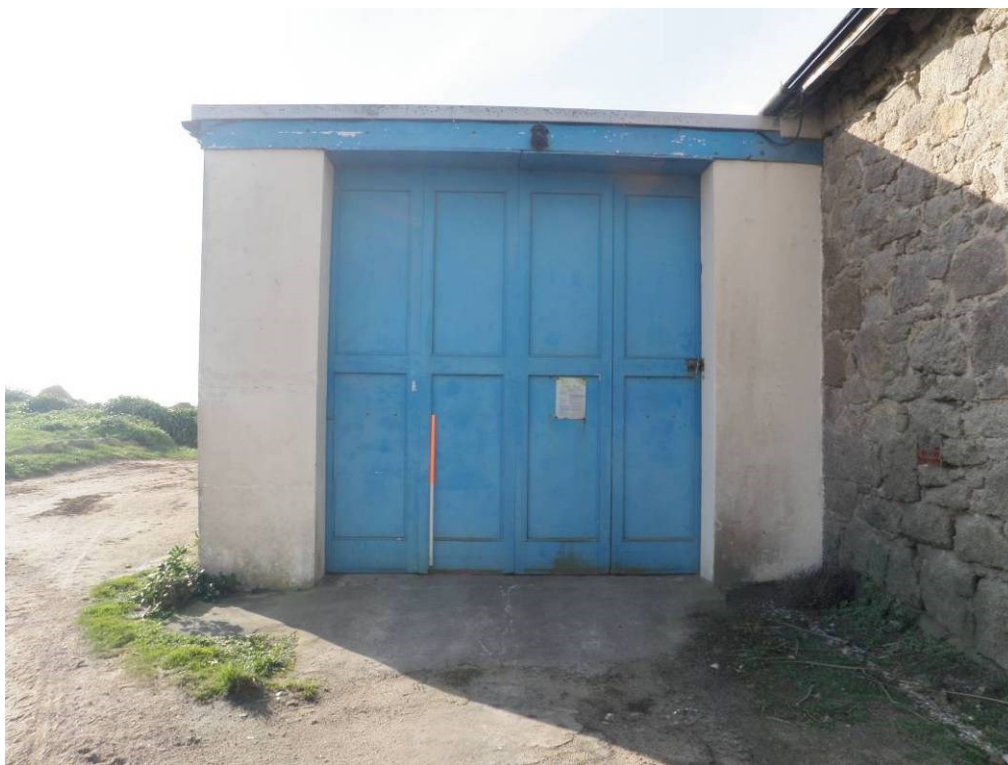
Fig 17 North elevation of Building 1a (former bus garage)

Adjoining the lifeboat house / bulb treating station to the east is a flat roofed, cement rendered garage. This building was built in the post-war period and replaced a mono-pitch roofed structure which previously stood on the site. It functioned originally as 'Katie's bus garage' but has recently been used for storage. It has wide double doors in its north elevation and metal framed windows in both the west and south elevations.

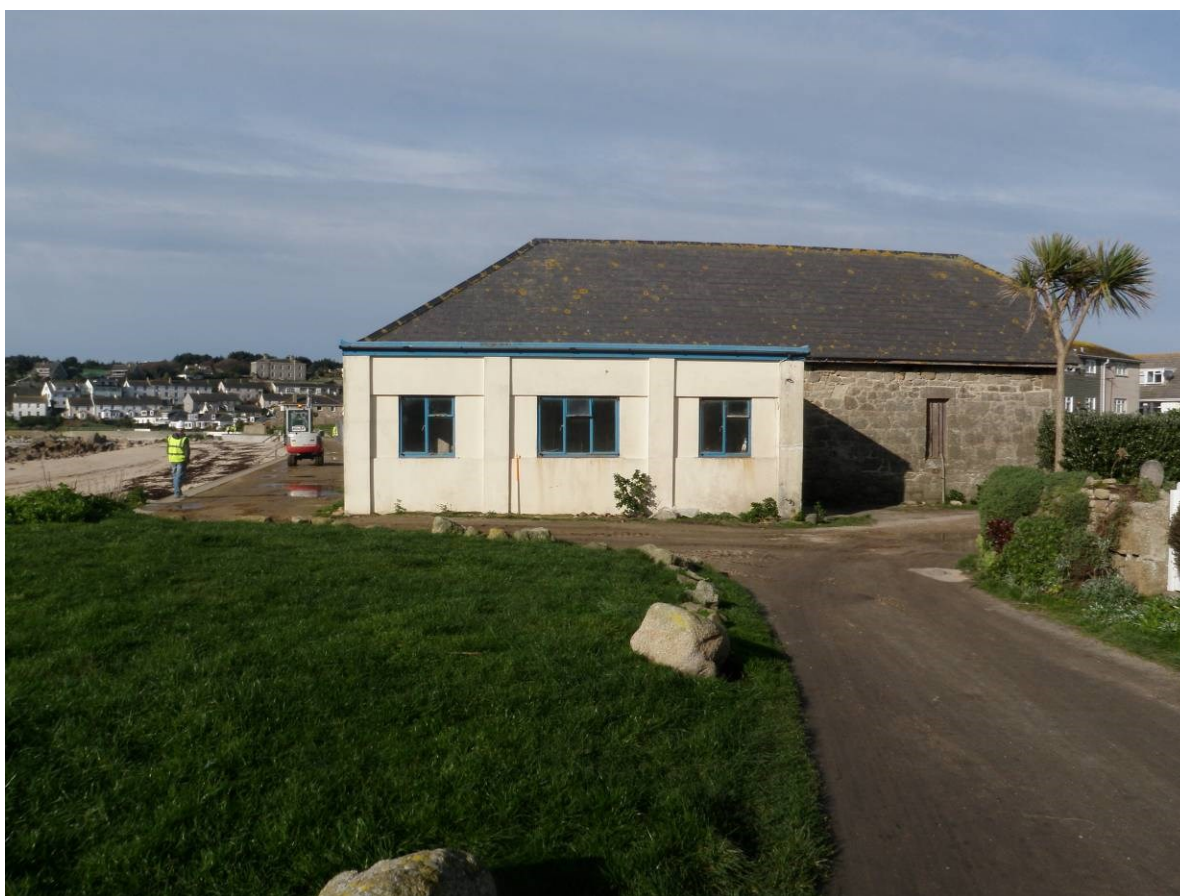
Fig 18 East elevation of Building 1a (former bus garage) with building 1 behind

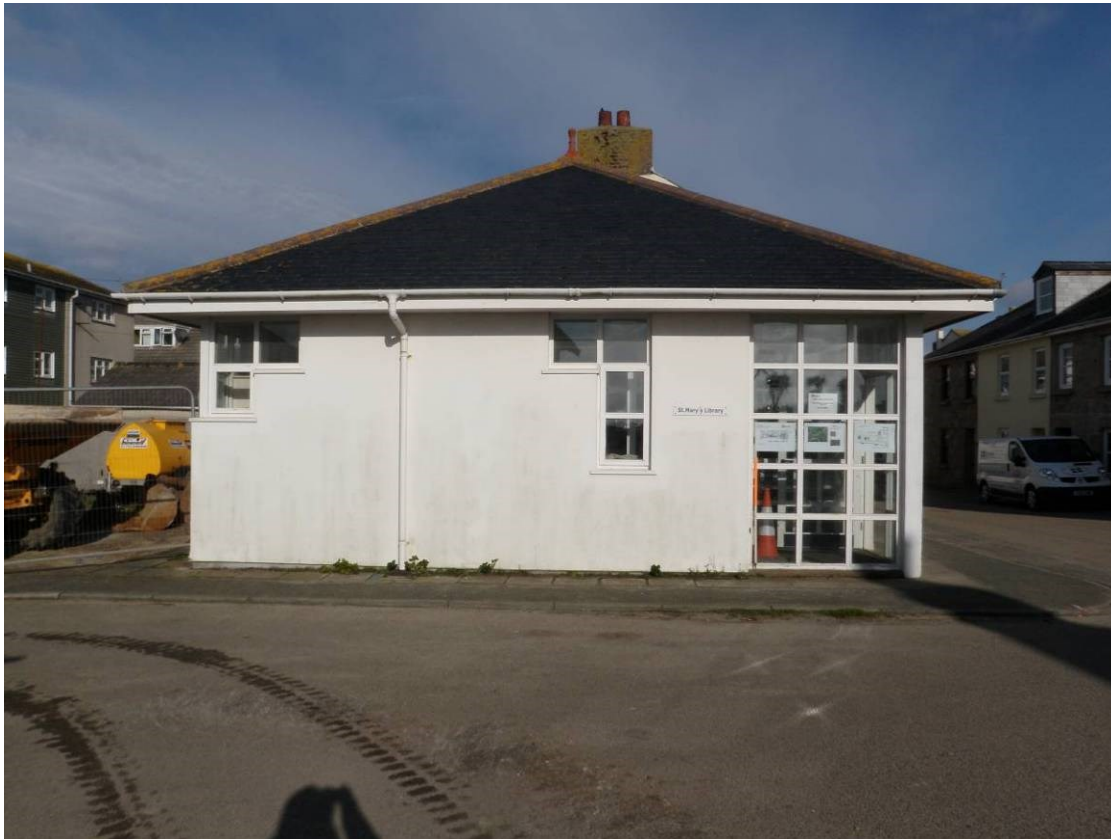
Fig 19 South elevation of Building 2 (St Mary's Library)

This building originally functioned as a DHSS office until it was adapted for use as a library. It is an entirely modern structure and has been built on land which is shown as undeveloped on the 1889-91 and 1909 OS maps (Figs 5 and 6). It is a single storey building with a pyramid hip roof which has a slate covering with ceramic ridge tiles and a central finial. The walls are concrete block-built and the openings all have timber frames. There are door openings in both the north and east walls. Internally the space is divided into two large rooms and a third smaller toilet and washroom in the north-west corner. All the internal surfaces and fittings are modern.

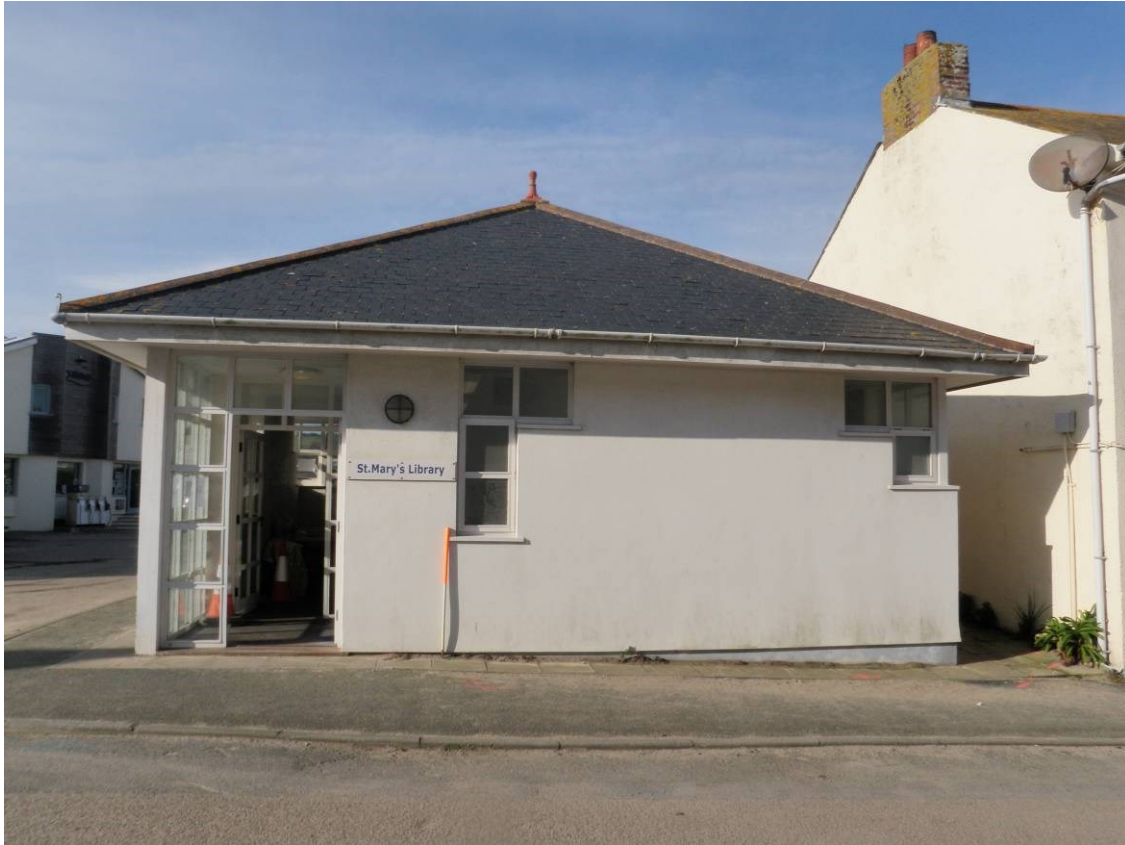
Fig 20 East elevation of Building 2 (St Mary's Library)

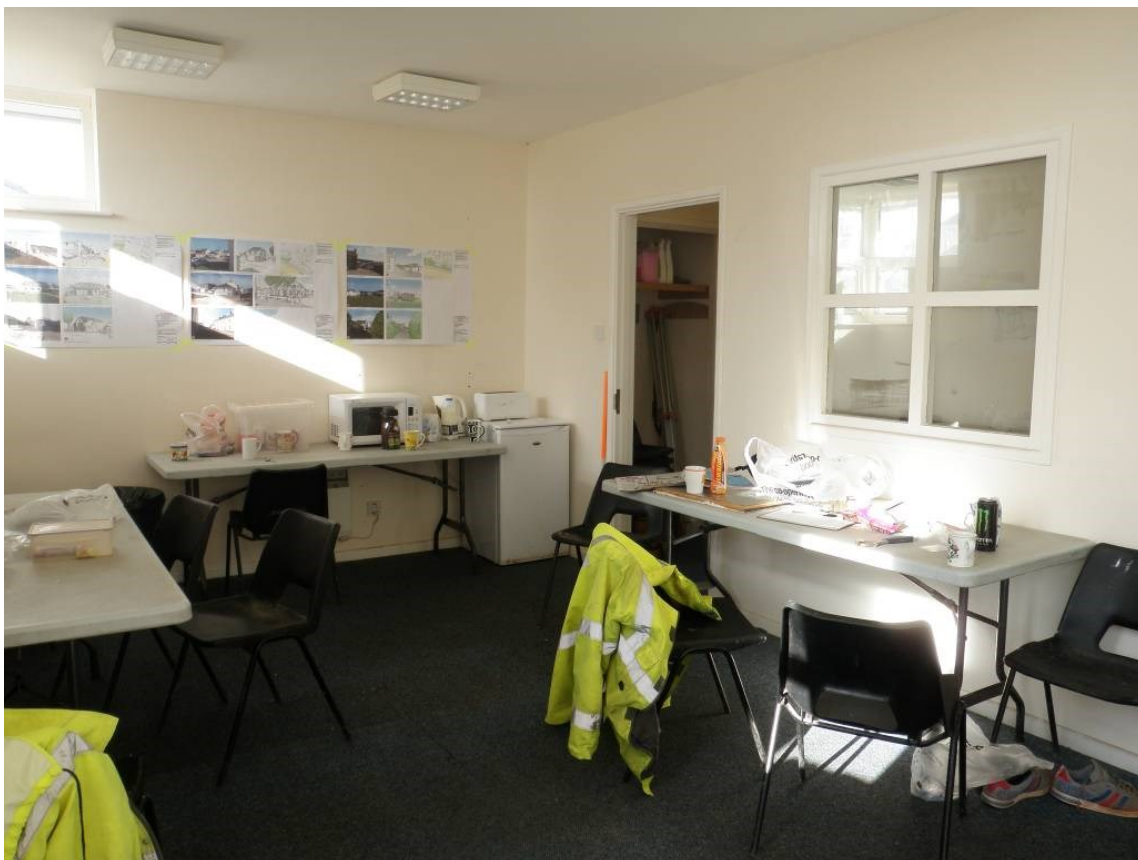
Fig 21 Interior of southern room of Building 2 (St Mary's Library) looking north-west

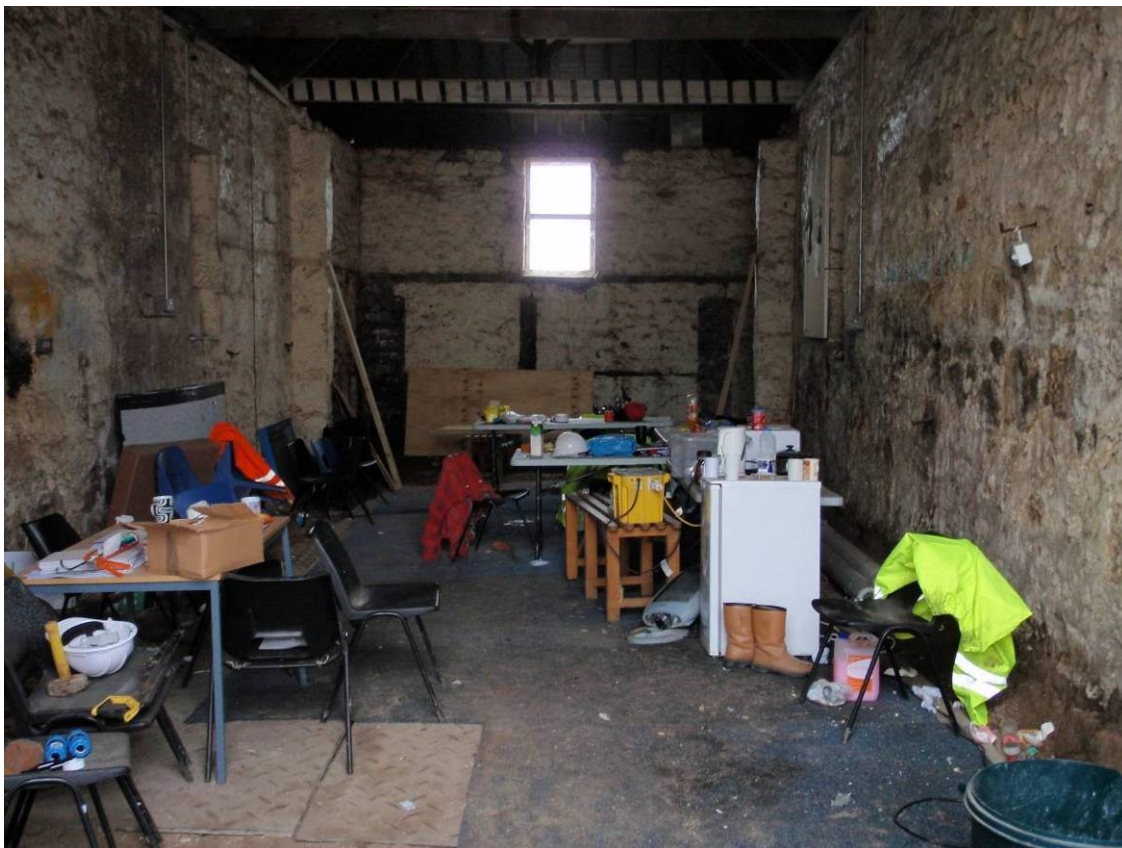
Fig 27 Interior of the old lifeboat station after removal of the existing floor (Building 1)

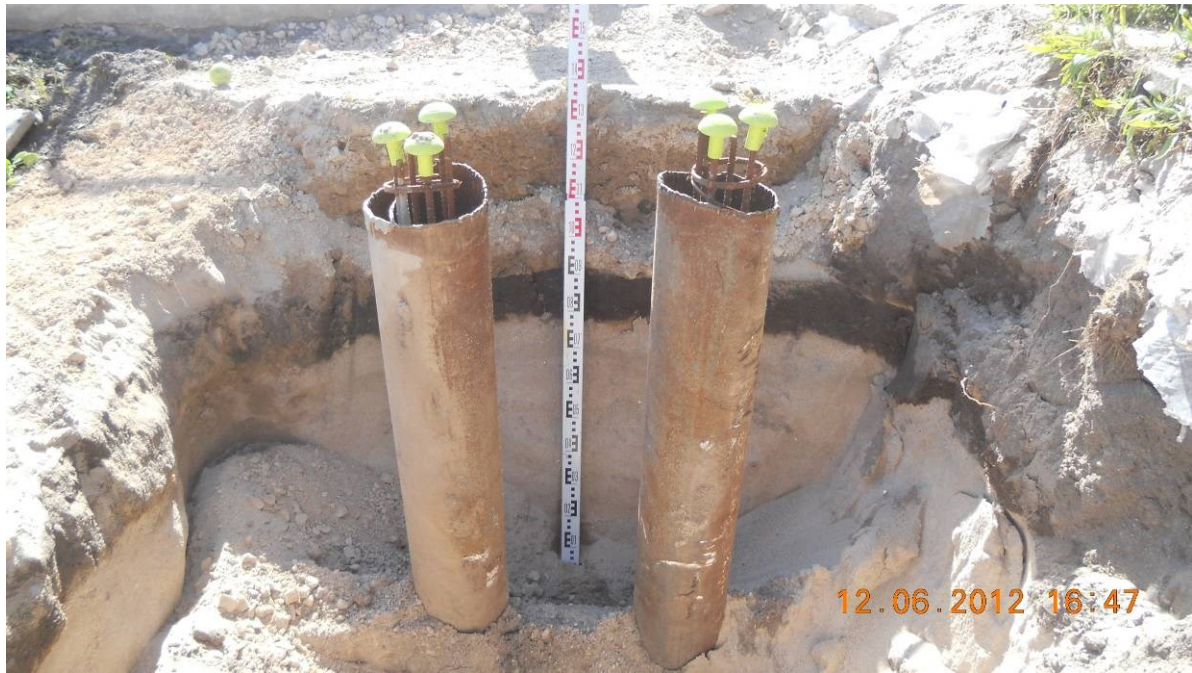
Excavations on this site commenced in the week beginning 11 June 2012, digging to depth of 1.4m and revealing only sand. No features or finds of archaeological interest were found (Fig 29).

Fig 29 Lot 2, site of former library (Building 2)

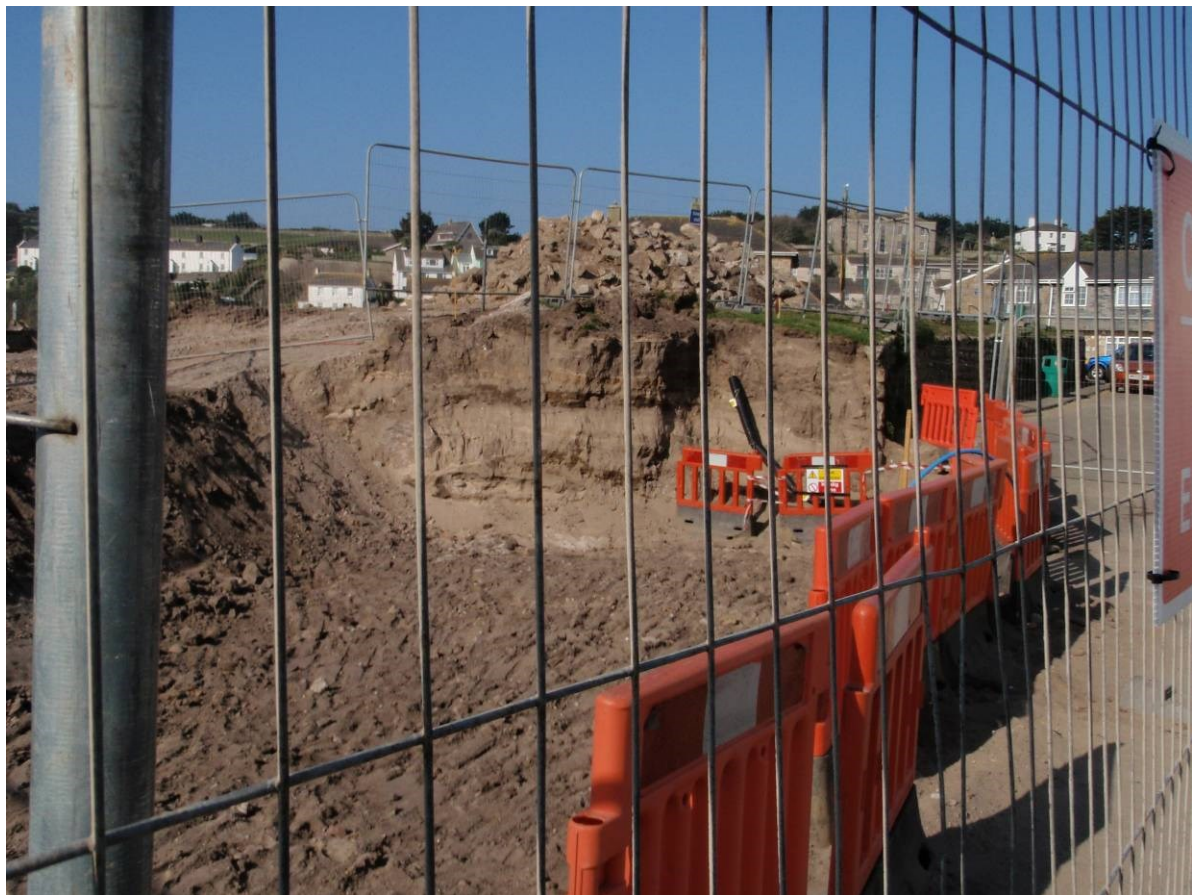
The excavations were through layers of redeposited sand. Nothing of archaeological interest was found, although the site had clearly been used as a backfill storage area. Excavations were completed on 5 March 2013 (Fig 30).

Fig 30 Amenity area (Lot 3), site of former shelter and toilet block (Building 3)

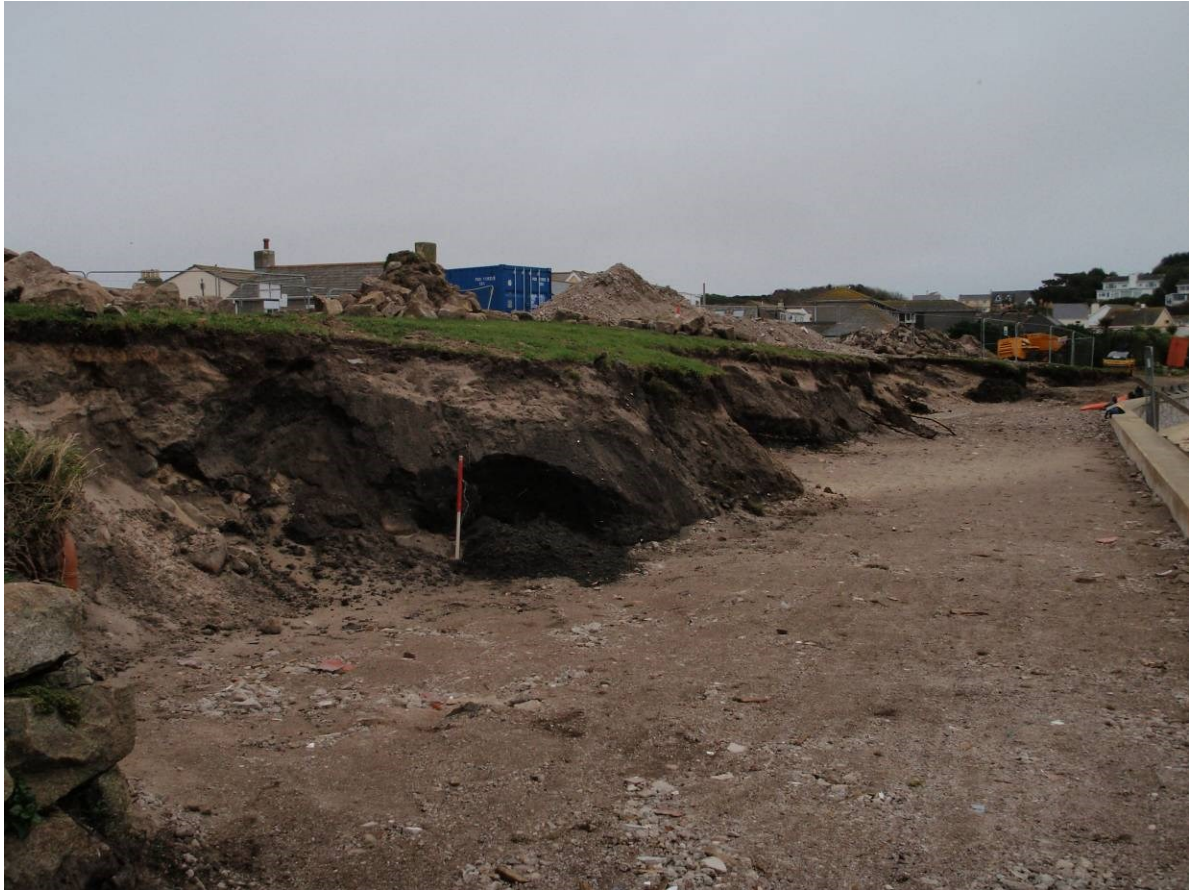
Fig 31 General landscaping works (Lot 4) on Porthcressa Bank showing modern made up ground

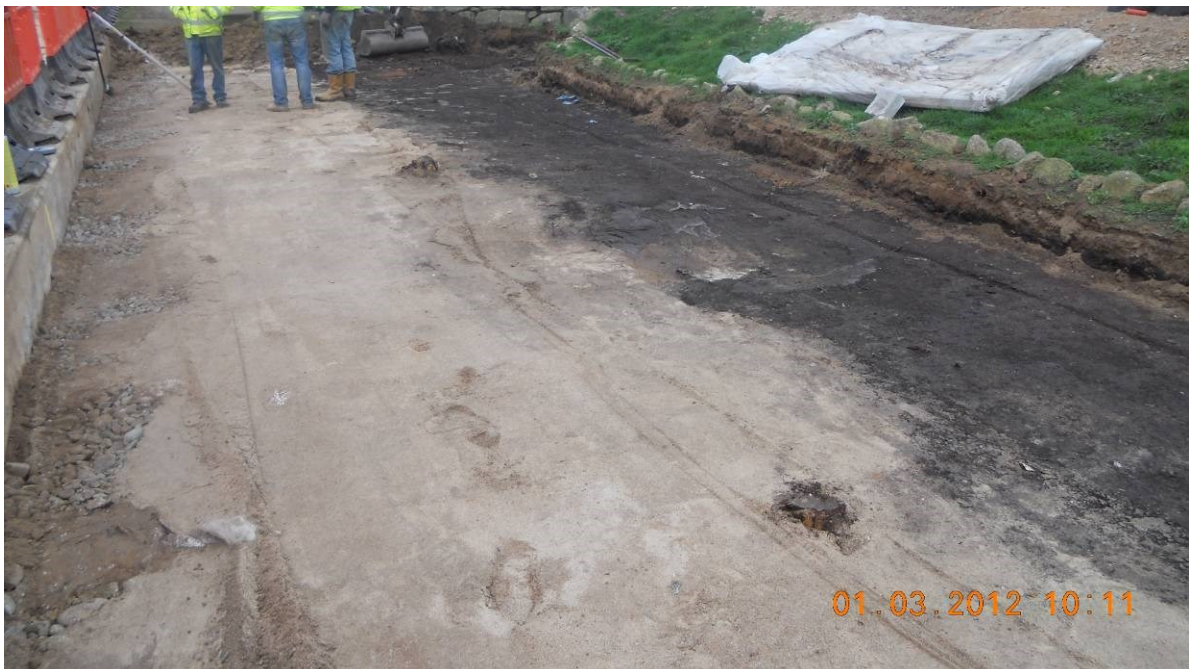
Fig 32 Tops of wooden posts associated with 1960s shuttering

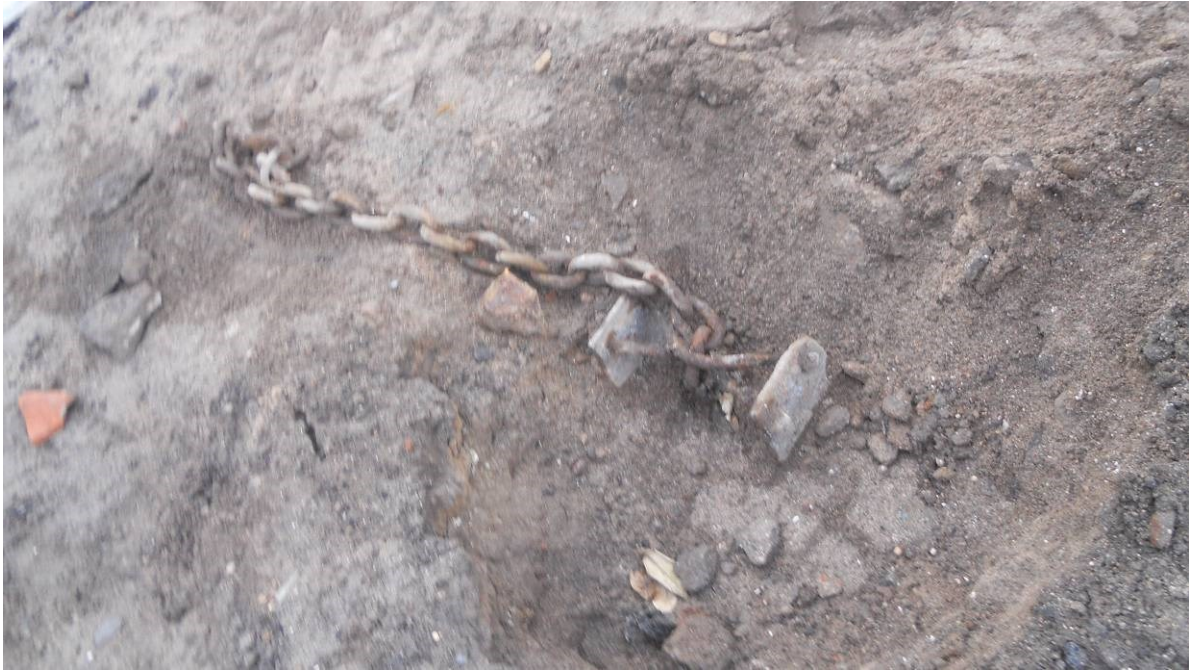
The existing tarmac was removed and excavations undertaken to a depth of approximately 0.4m through rubble and sand for the new surfacing works in the Porthcressa Square in October 2012. A length of chain fixed to a bracket was uncovered but this was not attached to anything, and was not retained (Fig 33).

Fig 33 Chain and bracket uncovered during resurfacing work at Porthcressa Square

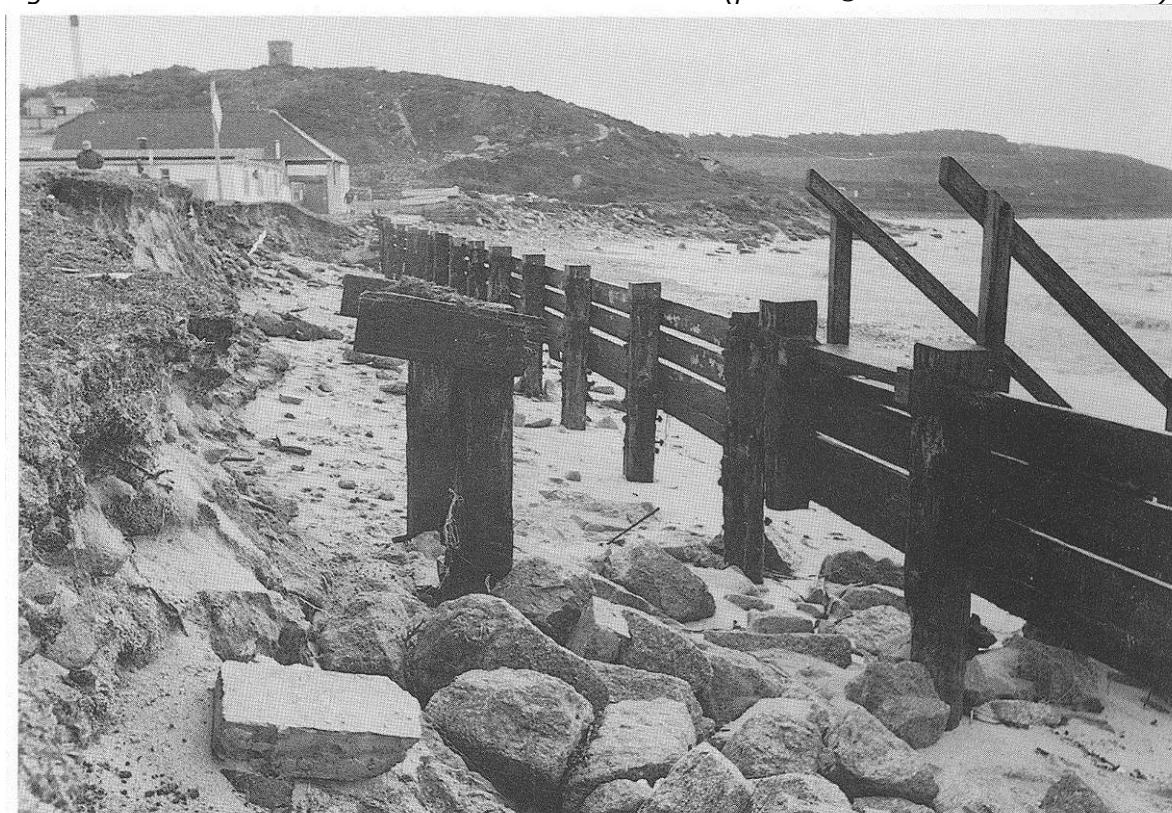
Further severe gales in the winter of 1989/90 also caused much damage. Porthcressa beach took the full force of the wind and sea, a good deal of the beach and a vast amount of the bank behind the barrier boards were washed away (Gibson *nd*, 45, 47). Figure 35 shows the extent of the damage and also the form of the 1964/65 shuttering; it is likely to be the tops of these wooden uprights that were revealed below the surface of the sea-front parade.

Fig 35 Damage at Porthcressa beach caused by the 1989/90 storms (© Gibson Collection)

Urgent remedial works were undertaken by the Council of the Isles of Scilly at that time, but the general state of dilapidation and damage caused by the event greatly increased the risk of breaching in similar storm conditions and so in 1994/95 a concrete wall was constructed in front of the existing bulkhead as a defence along the seafront (Fig 36) and the damaged area re-landscaped (cf Landmark Environmental Consultants, 1994).

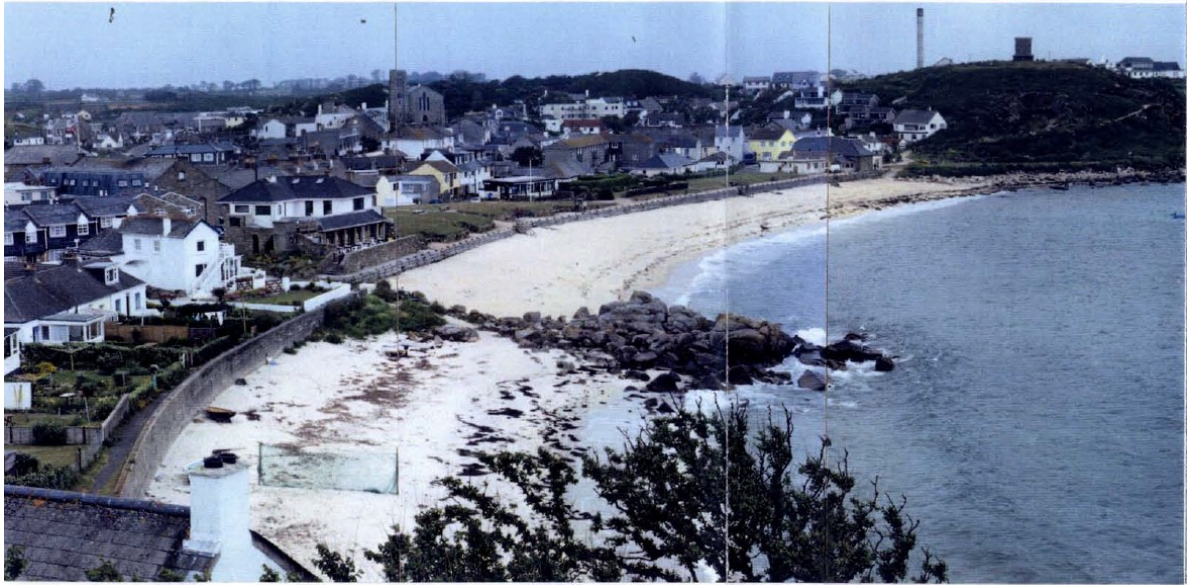
Fig 36 Porthcressa in 1994, showing the repaired timber bulkhead (photo: Landmark Environmental Consultants)
