Cross Channel Improvements, Pentewan, Cornwall

Archaeological Watching Brief

Client	Environment Agency
Report Number	2013R049
Date	July 2013
Status	Final
Report author(s)	S R Taylor
Checked by	Andy Jones
Approved by	Andrew Young

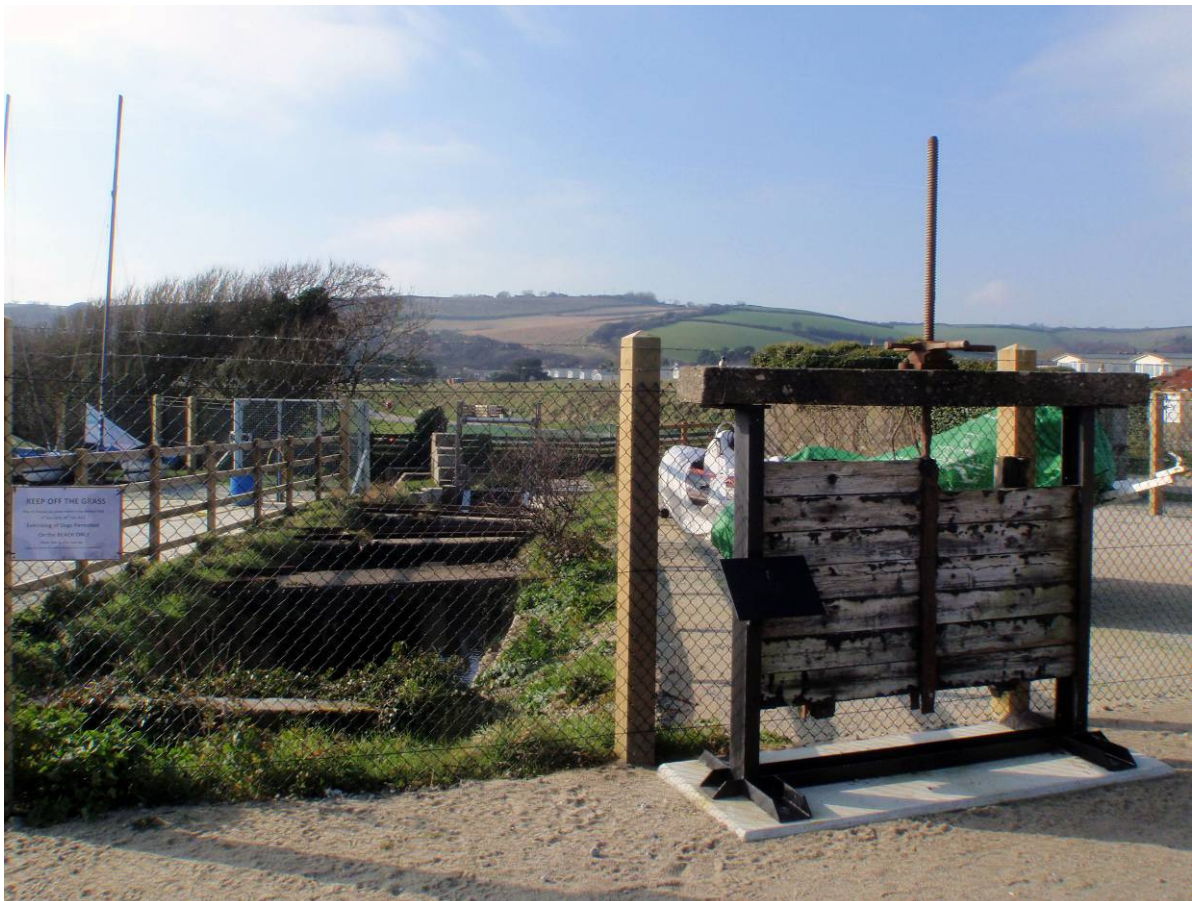
Cover illustration

The removed wooden penstock now displayed over the new cross channel. Some of the concrete beams that formerly carried rails across the channel are visible on the left.

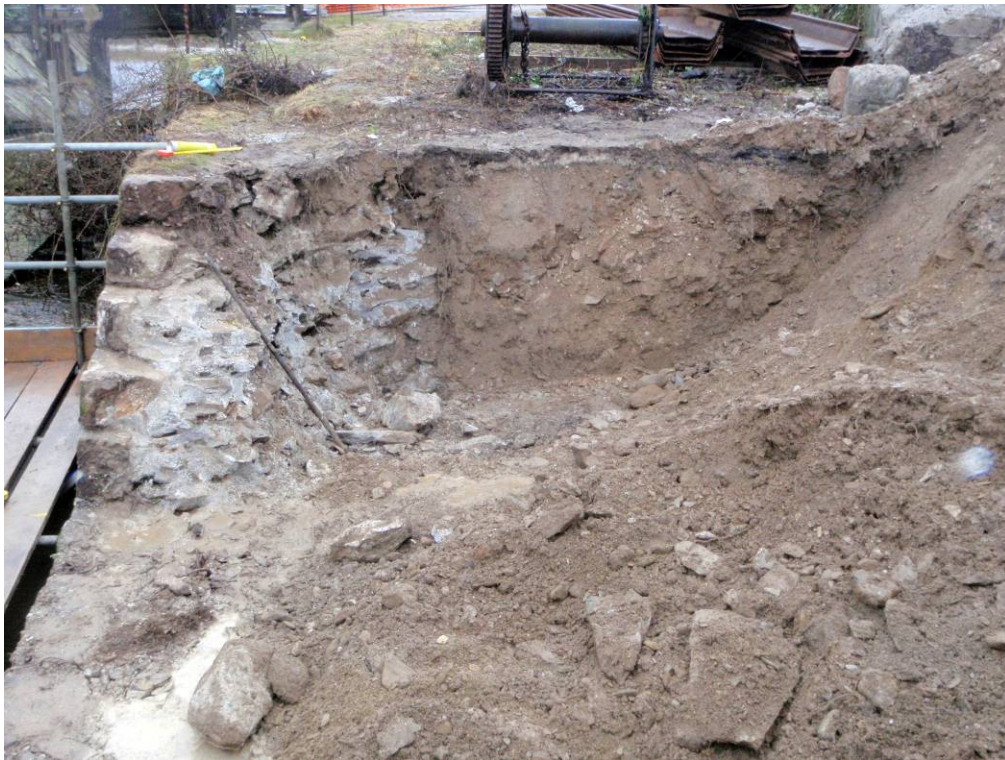
The harbour wall, **1**, is constructed of Pentewan Stone, dressed on the outer face and the joins but rough on the interior, where it faces a rubble core of killas backed by an inner facing of flat-laid killas, **2** (Fig 4). The core was consolidated by concrete of beach sand origins. The wall comprises six courses of stone to a height of 1.92m facing the harbour.

*Fig 4 Section through harbour wall **1** and rubble core and face **2***

The present harbour wall **1** is likely to belong to the period of improvements of 1818-1826. No earlier structural elements were identified during this project and, although it seems likely that this part of the harbour's edge has not moved since the original construction of the harbour basin in 1744 (since it lies along the southern edge of the channel near the mouth of the basin), earlier features must have been removed by the improvement works.

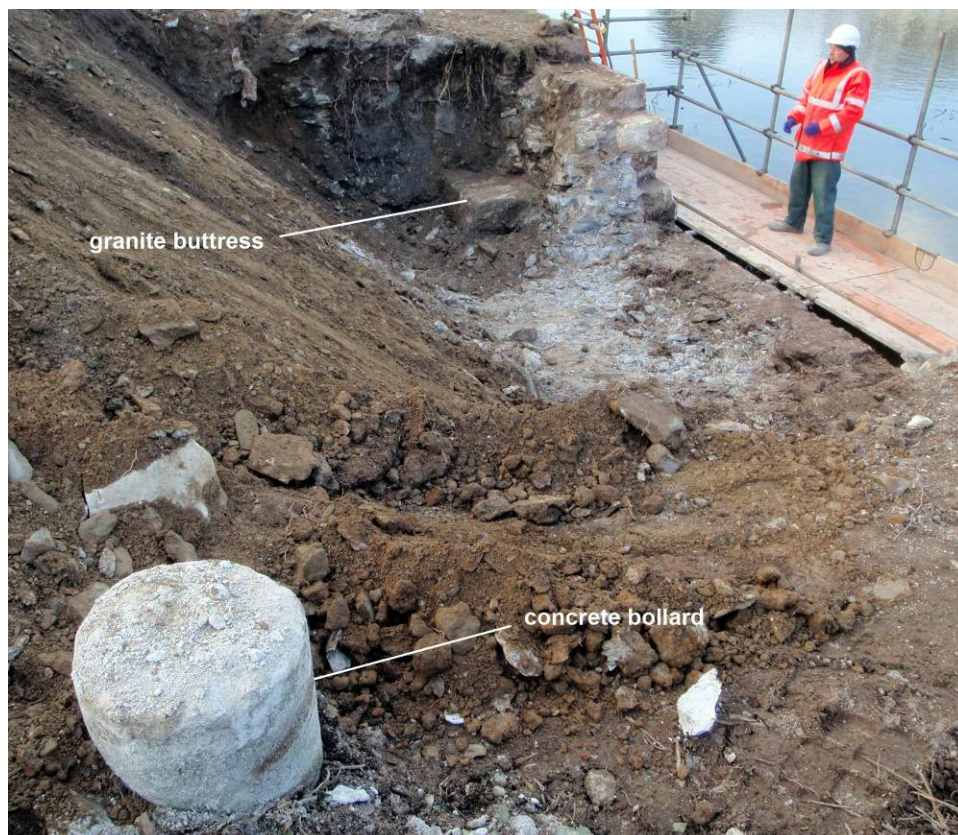
Set against the back of the wall were two large dressed granite boulders, **5**, the smaller one a broken fragment of a larger object, the other whole (Fig 5). The smaller boulder was 1m by 0.7m by 0.35m and featured a circular cutaway on one corner, presumably forming part of a collar when joined with other blocks. It was also drilled with a hole. The larger block was 1.3m by 0.73m by 0.6m. The stones appeared to be buttressing the harbour wall. They were set in deposits of clay intercalated with sand, (**4**), possibly derived from dredging the harbour. Finds from this material included shrapnel, in the form of a nosecone, from a World War II bomb (see Appendix B). This deposit was sealed by a thin dark clay, (**3**), containing water-worn pebbles.

*Fig 5 Section through harbour wall **1** and rubble core and face **2** showing granite buttress **5** and concrete mooring bollard*

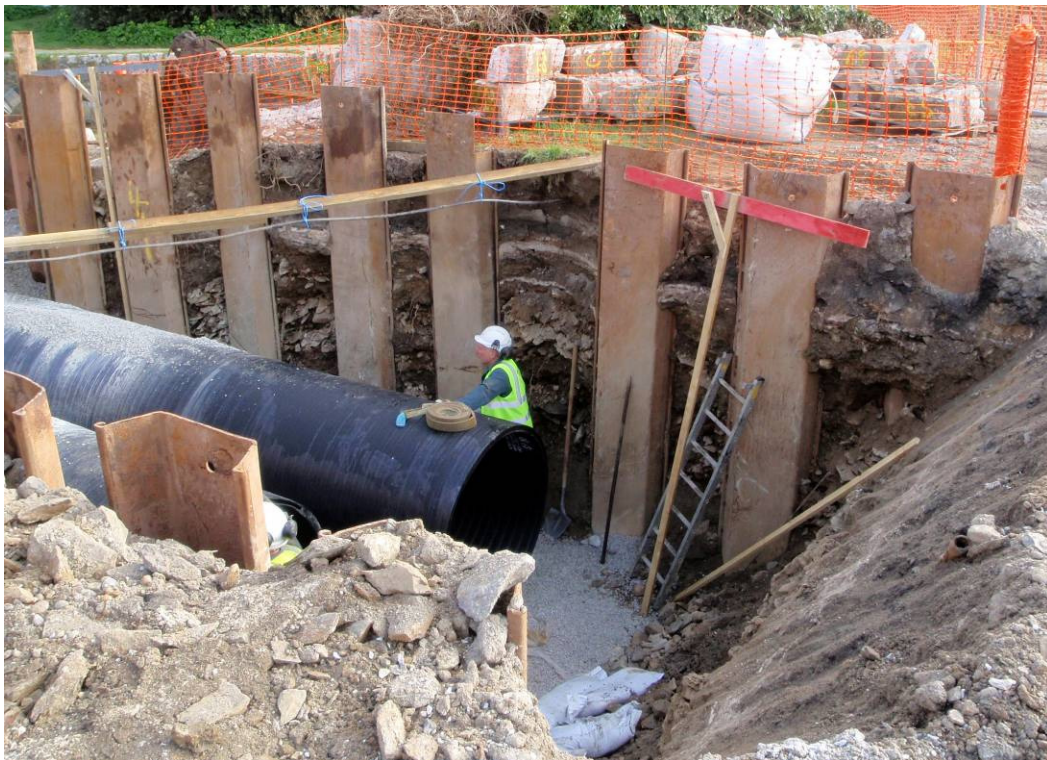
Above deposit **(11)** for the bulk of the section to the south east of wall **28** was a sequence of deposits (Fig 6) representing track beds for two to three phases of tramway/railway lines, **29** (the earliest), **25**, and **24** (the latest). The earliest tracked sequence comprised (sequentially – earliest to latest) deposits **(15)**, a sand, **(17)**, a white clay containing black lenses, **(14)**, a compact clay with an iron pan base, **(13)**, a grey clay, and **(12)**, a sandy clay upon which sleepers/rails **29** sat. Of these deposits **(13)**, **(14)**, and **(17)** may represent earlier track beds from which the rails have been removed.

Fig 6 Section through some of the track bed deposits at the middle of the trench

The first track bed sequence, represented by layers **(13)**, **(14)**, **(15)**, and **(17)**, is likely to date to the enlargement of facilities and conversion to steam power in the period 1870-2. The OS 25 inch map of 1881-2 (Fig 3) shows two parallel lines running along the southern edge of the harbour before converging on the beach, representing the growth in the export of beach sand for building at this time. The same layout is

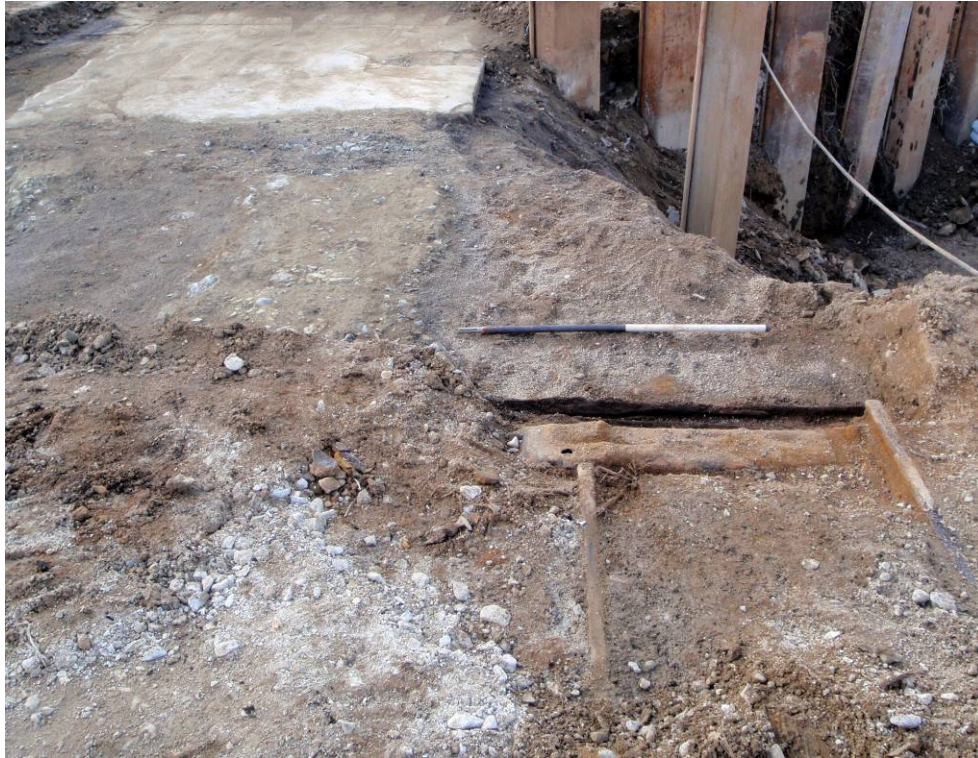
*Fig 7 Railway tracks **24**, hollow steel sleeper **30**, with wooden sleeper **25** visible beyond (facing west, 1m scale)*

Deposit **(12)** was truncated towards the south east of the trench and partially replaced by a different sequence of tracked deposits, **(20)**, a dark sandy clay, and **(8)/(18)**, a compact white sand. Sat on this deposit were wooden sleepers **25**, overlain by hollow steel sleepers **30** and railway lines **24** (Fig 7).

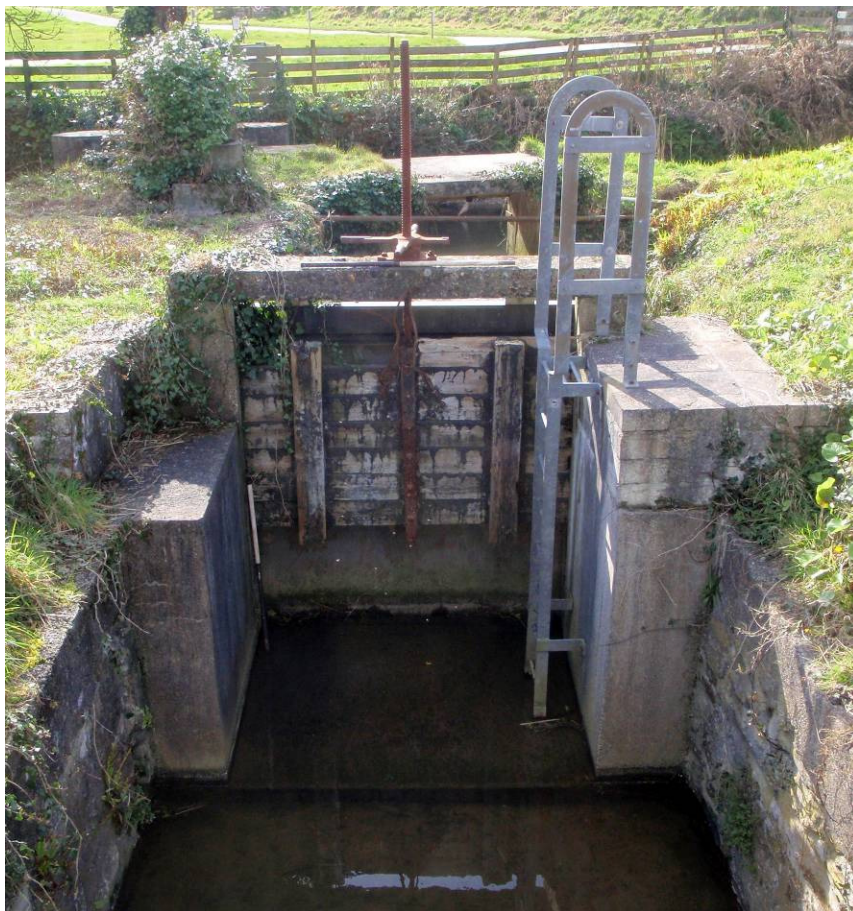
A photographic record of the original wooden penstock at the mouth of the original cross channel was made prior to its removal. The record was made with black and white negative film (HER ref GBP2246) in a Pentax K1000 SLR camera. The record was supplemented with digital shots taken with an Olympus SW 1030 compact camera, some of which are reproduced below (Figs 8-10).

Fig 8 Wooden penstock prior to removal, facing south (1m scale)

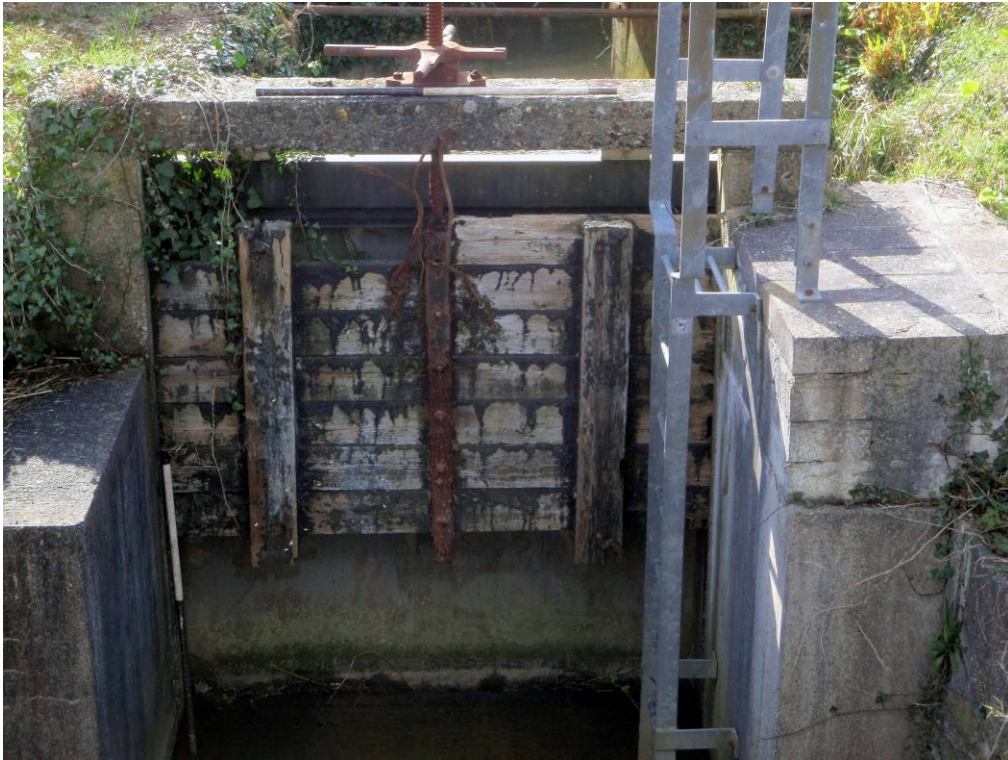
Fig 9 Detail of penstock and mechanism, facing south (1m scale)

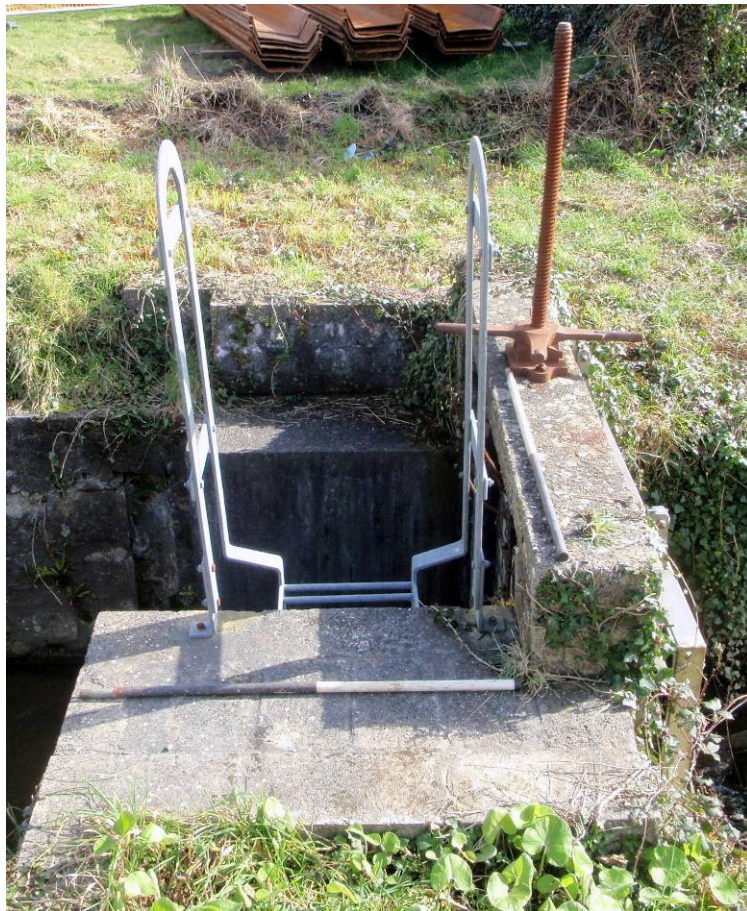
Fig 10 Penstock mechanism facing east (1m scale)

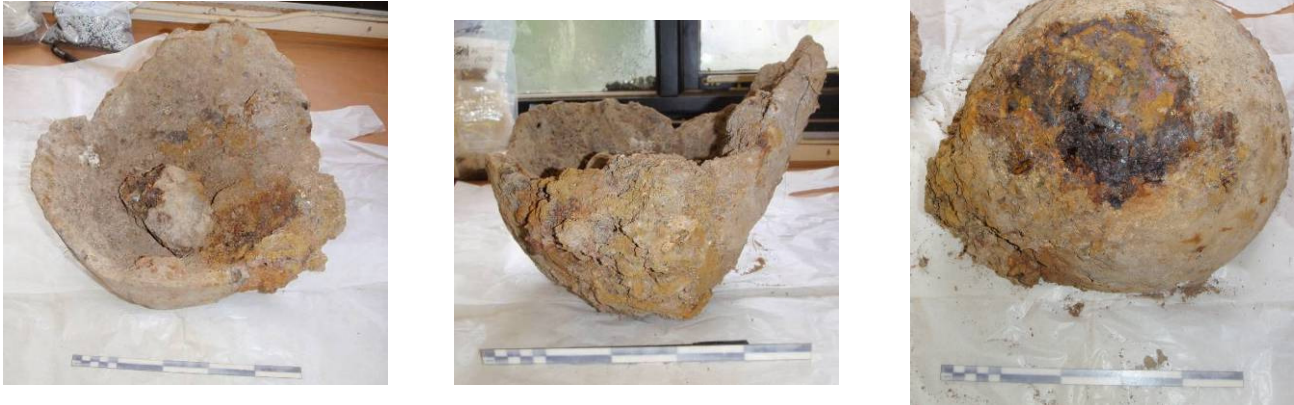
Lab Number:	Object Name: Possible shrapnel	Material: Ferrous	Period/ C20 date
Source: HE - Pentewan Harbour (2012015)	Object Identification Number: (museum accession no./site name context number)		Copy to client:
Photos:	X-rays:	Samples:	Previous Treatment: NA
Date Started: 21.12.2012	Date Completed: 21.12.2012	Conserved By: Laura Ratcliffe	
Description: <p>A single piece of ferrous material forming a bowl shape with flared sides and jagged broken edge. It looks very like the nose of a bomb, and therefore shrapnel. 320mm in diameter at the open end 242mm deep from tip to top 20mm thick at the thickest point. There is damage and concretion so the thickness varies at this stage.</p>

Condition: Major Structural: Only a part of the object remains, the exposed broken edges being jagged Accretions: There is concrete and sand adherent to the object and trapped within corrosion as surface concretion. Chemical: The ferrous material has corroded, fusing with sand and forming concretions inside and outside of the item. There are piece of mineralised wood within the conglomerate in the interior of the piece and what appears to be bits of mortar which is consistent with it having been built within the harbour wall for a time. The aggressive nature of the corrosion suggests high moisture and chloride presence, consistent with a harbour side location. The weight of the object suggests that below the iron oxide layer on the surface of the object, (Fe ₂ O ₃ .nH ₂ O & FeO(OH).FeOH ₃), a substantial amount of metallic material remains.

Mechanical removal of the loose and bulky concretion down to the remains of the surface on the interior and exterior of the object for identification.

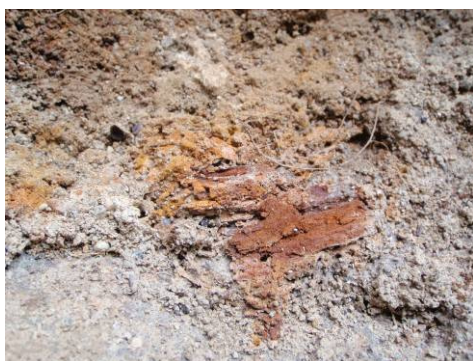
Not all of the concretion came away from the interior surface, which is quite deteriorated.

Mineralised wood within the interior

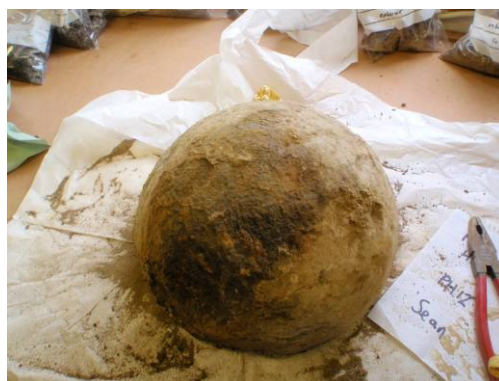
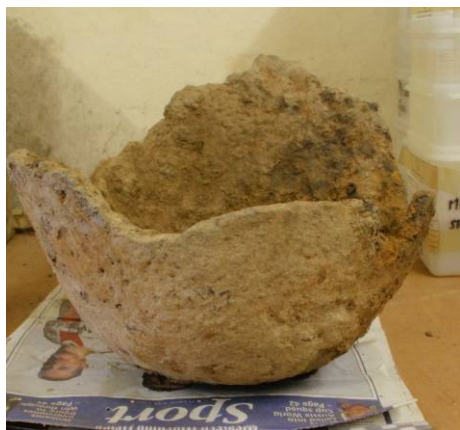
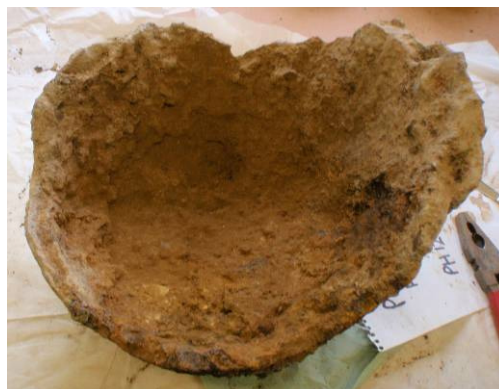
A thin veneer of concrete residue is present over most areas of original surface, removal of this and the heavily compacted concretion remaining inside the object would be best done with an air abrasive machine for a very clean surface. I am not sure if it is however necessary for ID or whether the basic mechanical clean will be enough. It looks very much like the nose of a bomb, although there are no markings or paint layers visible at this time.

Keep from getting wet or damp to avoid further corrosion.
