# **Former railway buildings, Grampound Road, Cornwall**

## **Historic Building Record**

<b>Client</b>	<b>Mr Steve Soper</b>
<b>Report Number</b>	<b>2013R044</b>
<b>Date</b>	<b>June 2013</b>
<b>Status</b>	<b>Final</b>
<b>Report author(s)</b>	<b>Nigel Thomas</b>
<b>Checked by</b>	<b>Andy Jones</b>
<b>Approved by</b>	<b>Andrew Young</b>

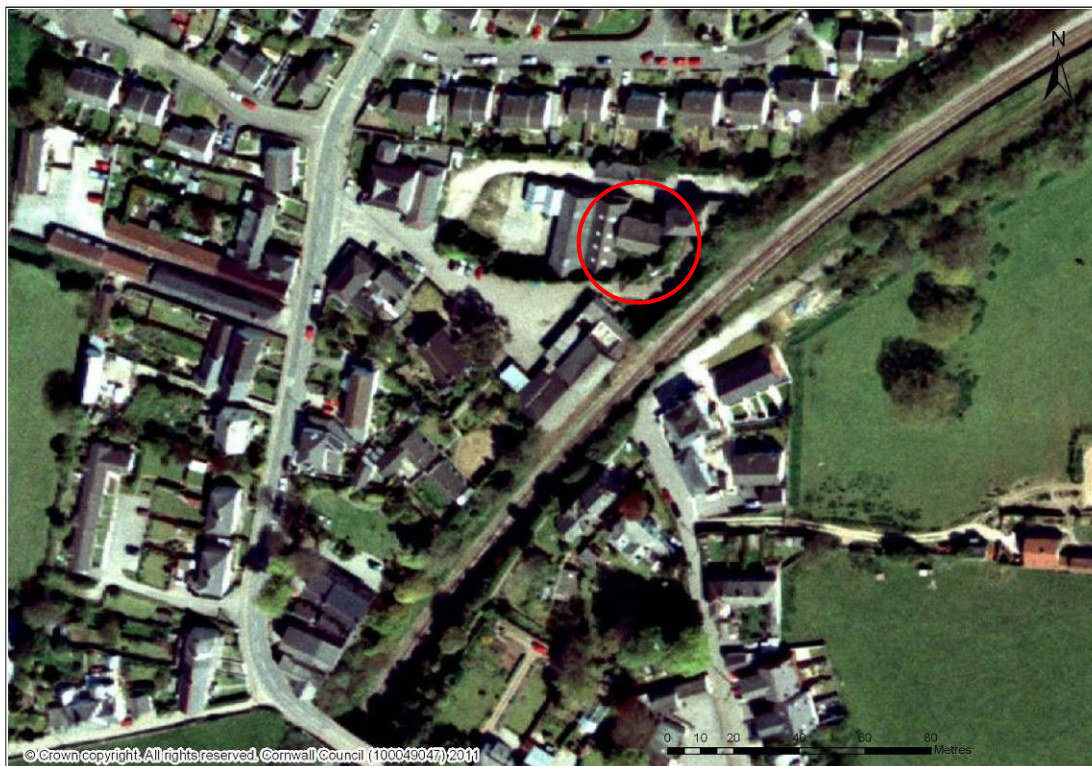
Fig 6 Air photo of Grampound Road 2000

taking place for construction of a housing estate between 2000 and 2005 (compare Figs 6 and 7). This has left the two subject buildings remaining, plus other former railway buildings immediately to the east and north.

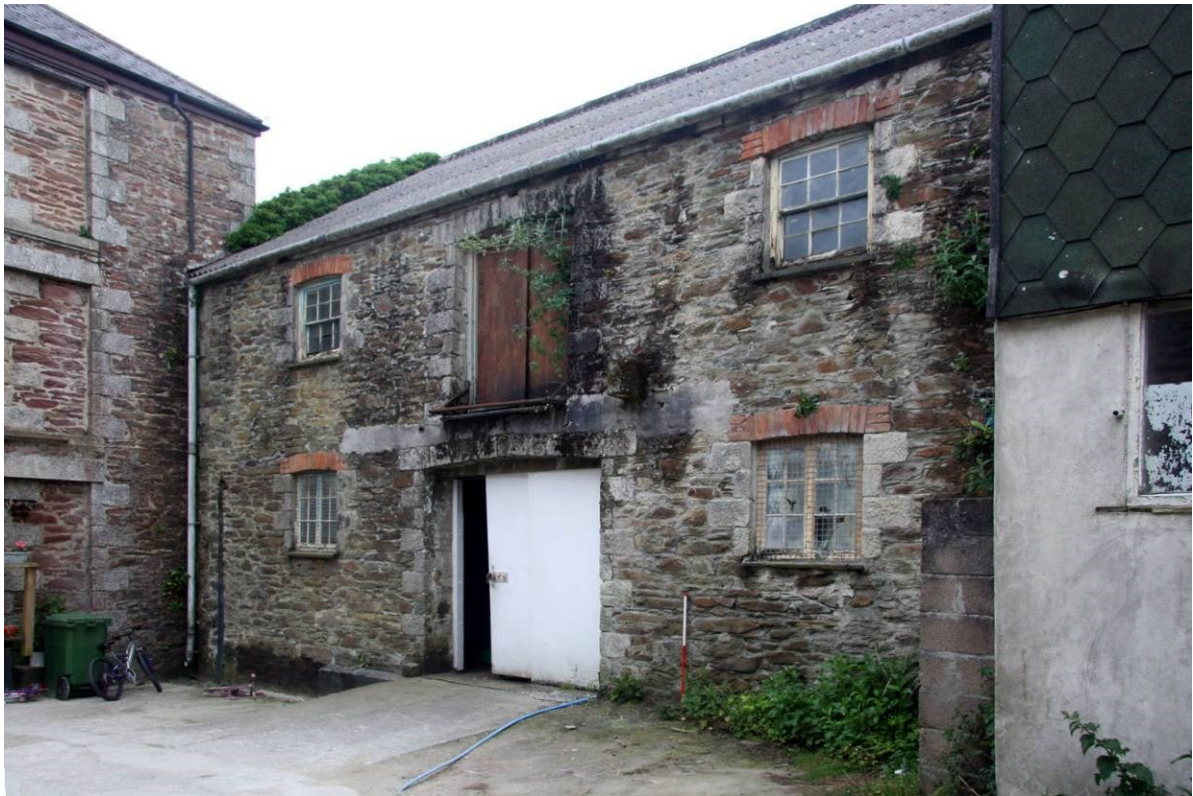
*Fig 9 Front elevation of Building 1, viewed from the north west*

Building 1 is a rectangular two-storey double fronted structure with central loading doors to each floor (Figs 9 and 12). There are also loading doors serving the upper floor in the rear (south) wall (Fig 11). Each floor is lit by a pair of original windows in the front (north) wall; on the ground floor these are 12-pane casements, with 12-pane sash windows on the first floor. In its original form the building also had a doorway at the south east corner, and small windows in both gable ends.

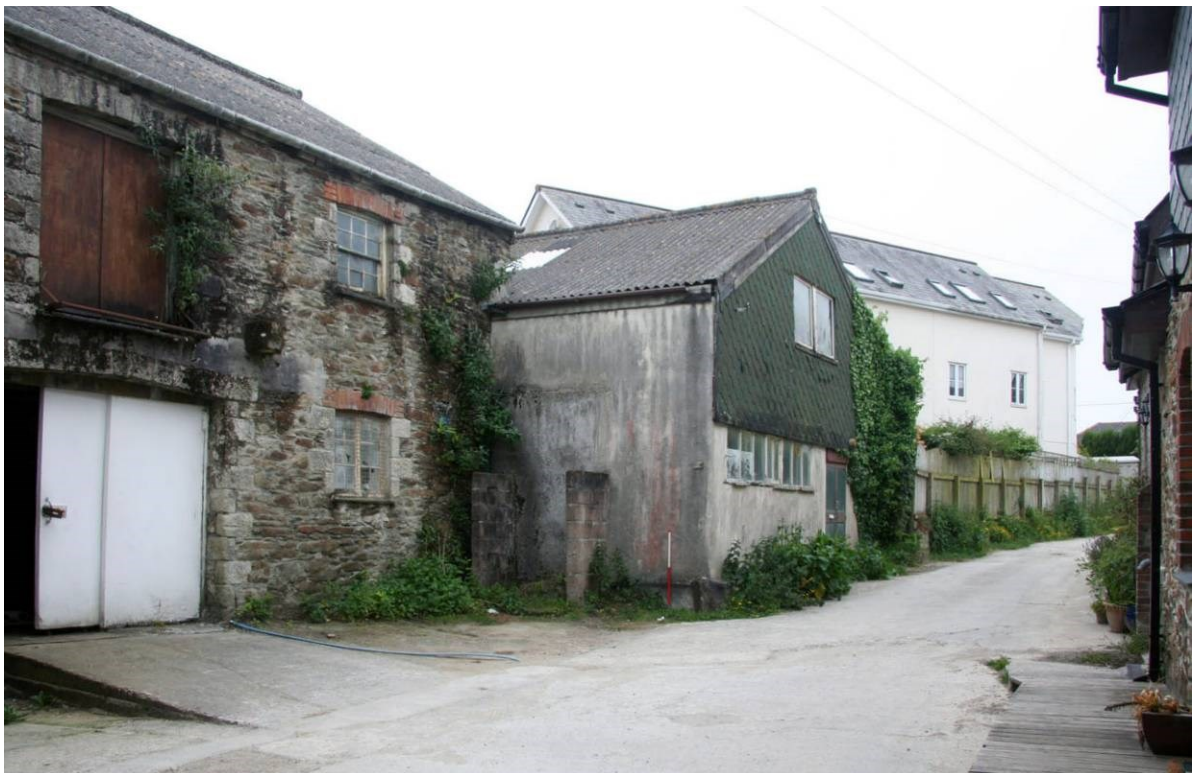
*Fig 10 The frontage of Building 2 (right of centre)*

*The modern houses behind have been built on the sites of further railway buildings and an associated yard*

Building 2 is a sub-rectangular two-storey structure oriented north-south, with the north gable providing a frontage on a narrow lane (Fig 10). This part also projects forward of Building 1. The rear of Building 2 (Fig 14) is angled, to allow clearance for a former railway siding (the latter is visible on historic maps, see Figs 4 and 5). The building is set into the slope, so that the exterior ground level at the rear (south) end is at the first floor height of the interior.

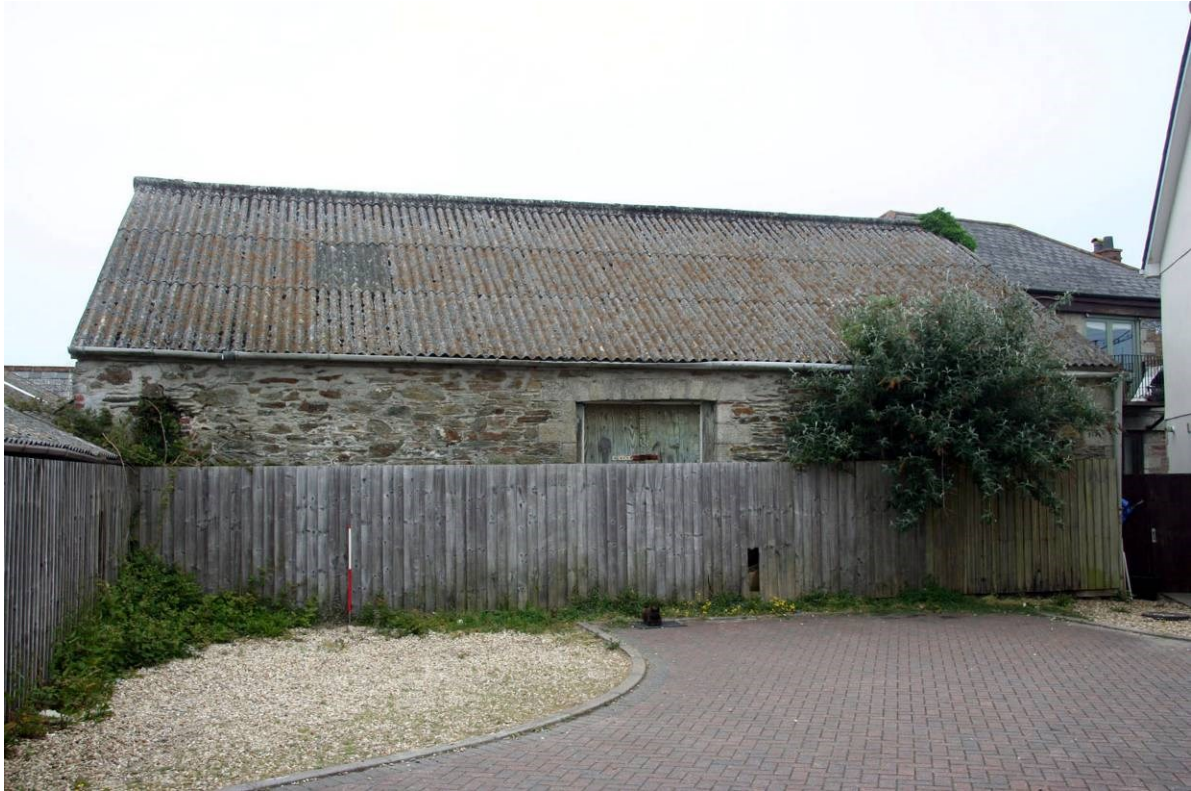
*Fig 11 The rear of Building 1 showing central loading doors into the upper floor  
An inserted window lies behind the bush to the right, and at extreme left is a slot (now infilled) for a belt drive*

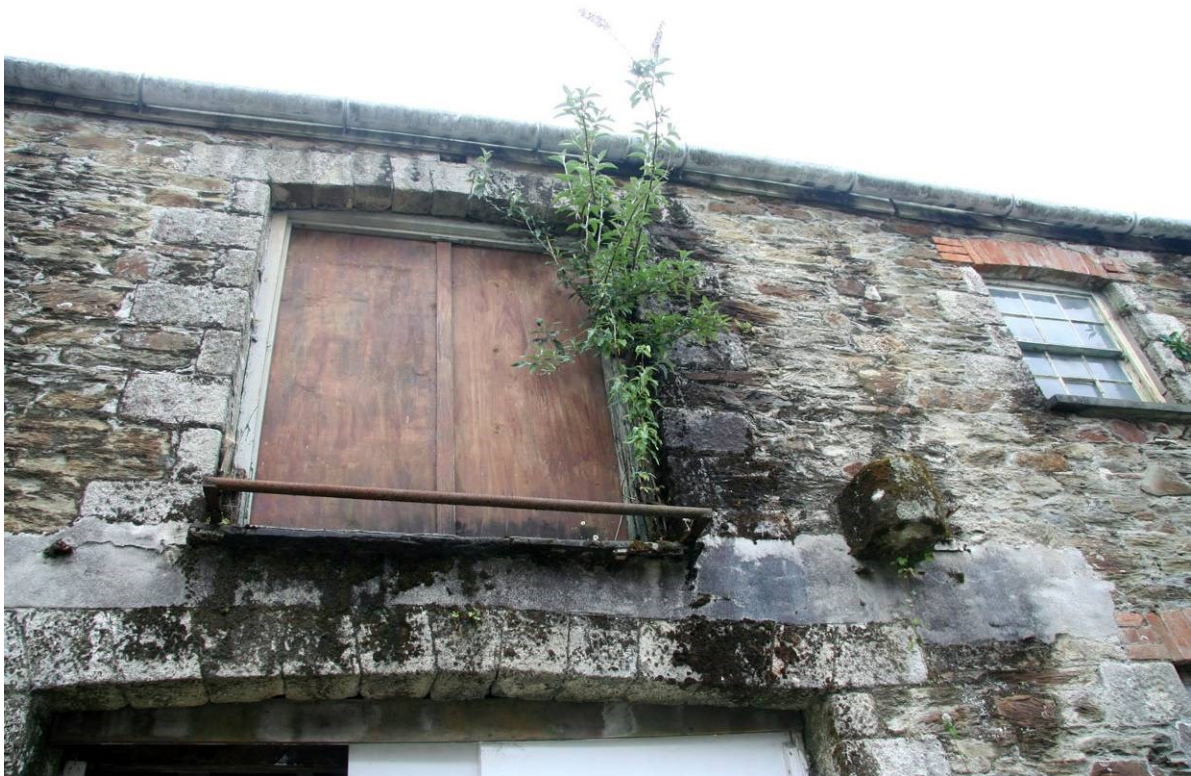
*Fig 12 The front loading doors on Building 1  
Note the projecting corbel to the right, probably to support a loading crane, and a slot for an overhead loading beam above the keystone of the upper arch*

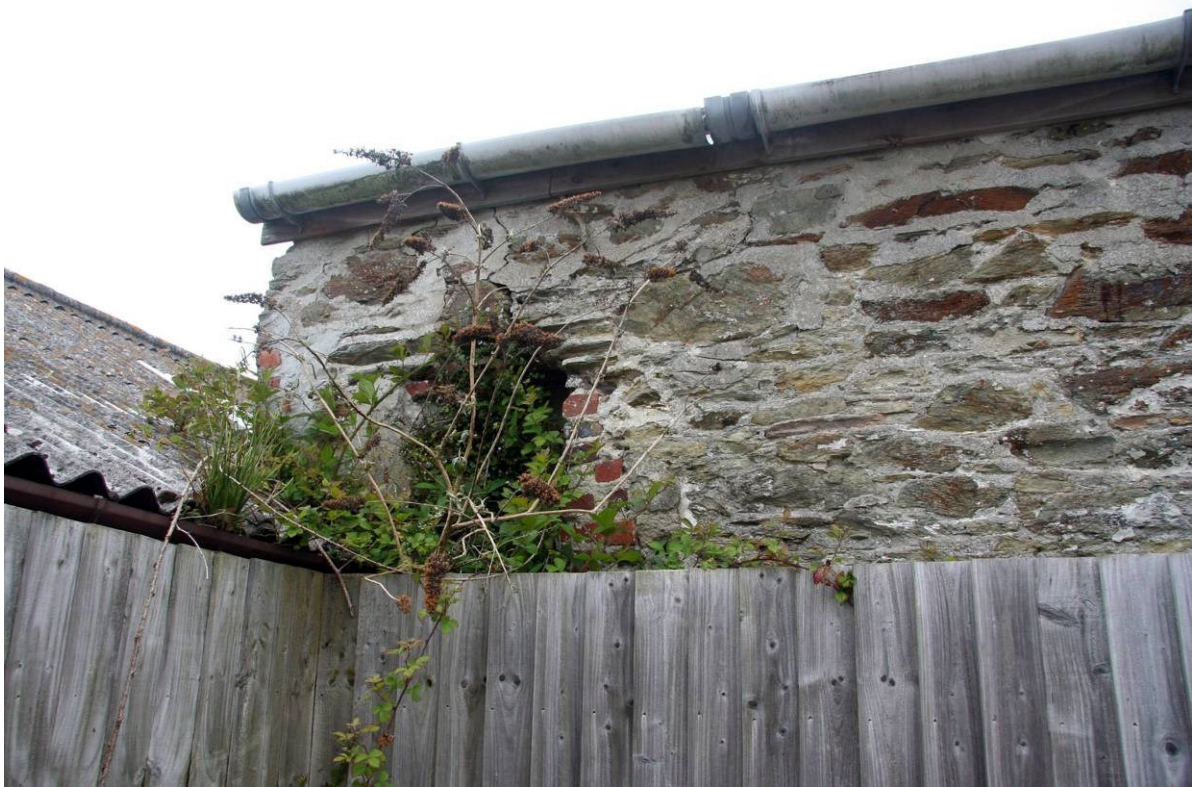
*Fig 13 An inserted (and subsequently infilled) slot for a belt drive to machinery inside the building*

Other additional features on the upper storey include an inserted window in the south wall (close to the south-east corner) and a slot for a belt drive (near the south-west corner, Fig 13).

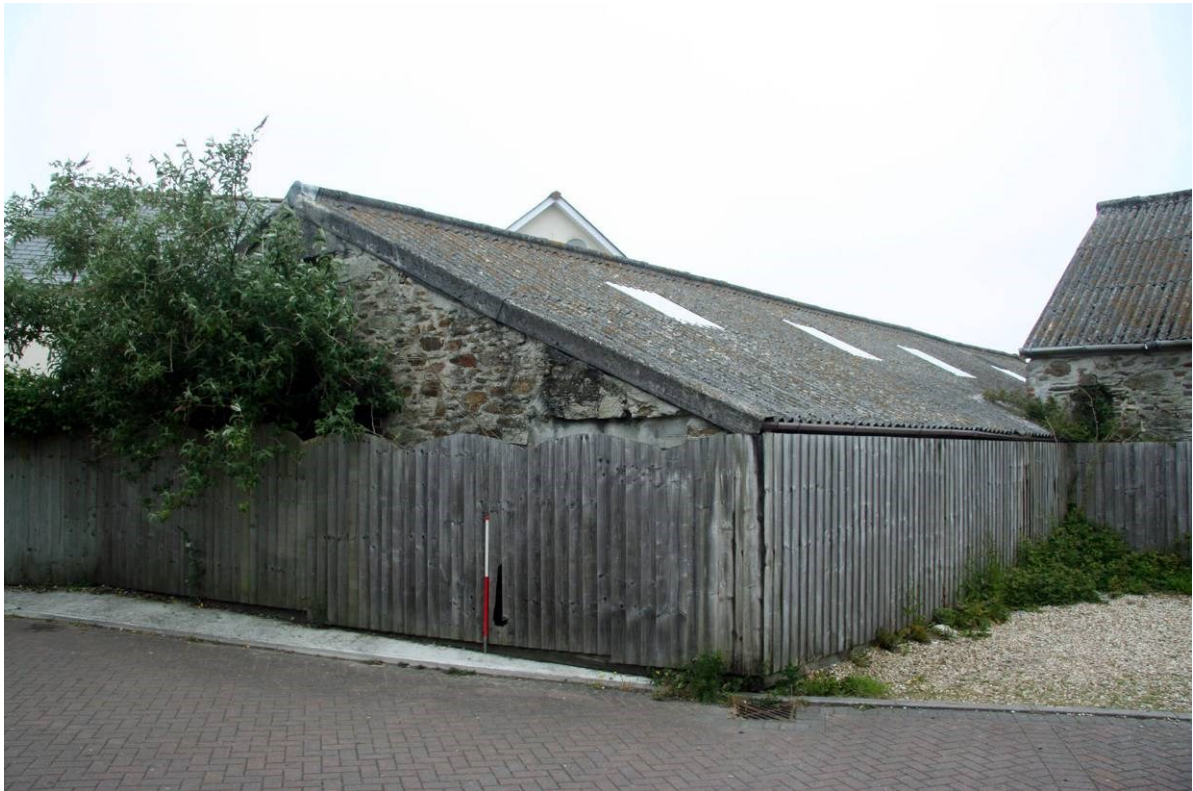
*Fig 14 The rear gable of Building 2*

*Loading doorways and windows are just visible above the modern fence and within the bushes*

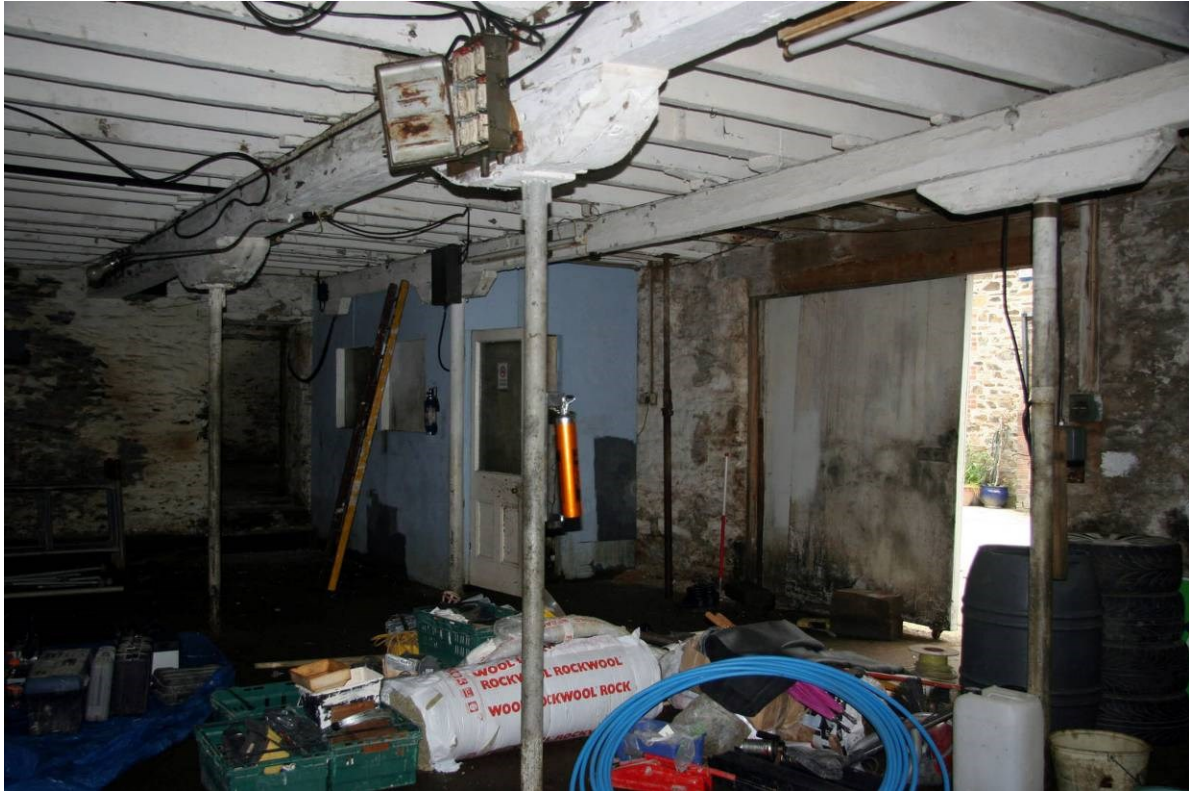
*Fig 15 The ground floor of Building 1*

*Steel piers supporting the upper floor are probably all replacements. The larger beam (left) appears to be original, with two other outer beams added to strengthen the floor.*

The wooden plank upper floor is supported on sawn joists and (probably originally) a single longitudinal principal beam beneath, the beam propped at intervals on steel piers. The steel piers appear to be replacements, and two other outer longitudinal beams of lighter section may also be additions to the original floor (Fig 15).

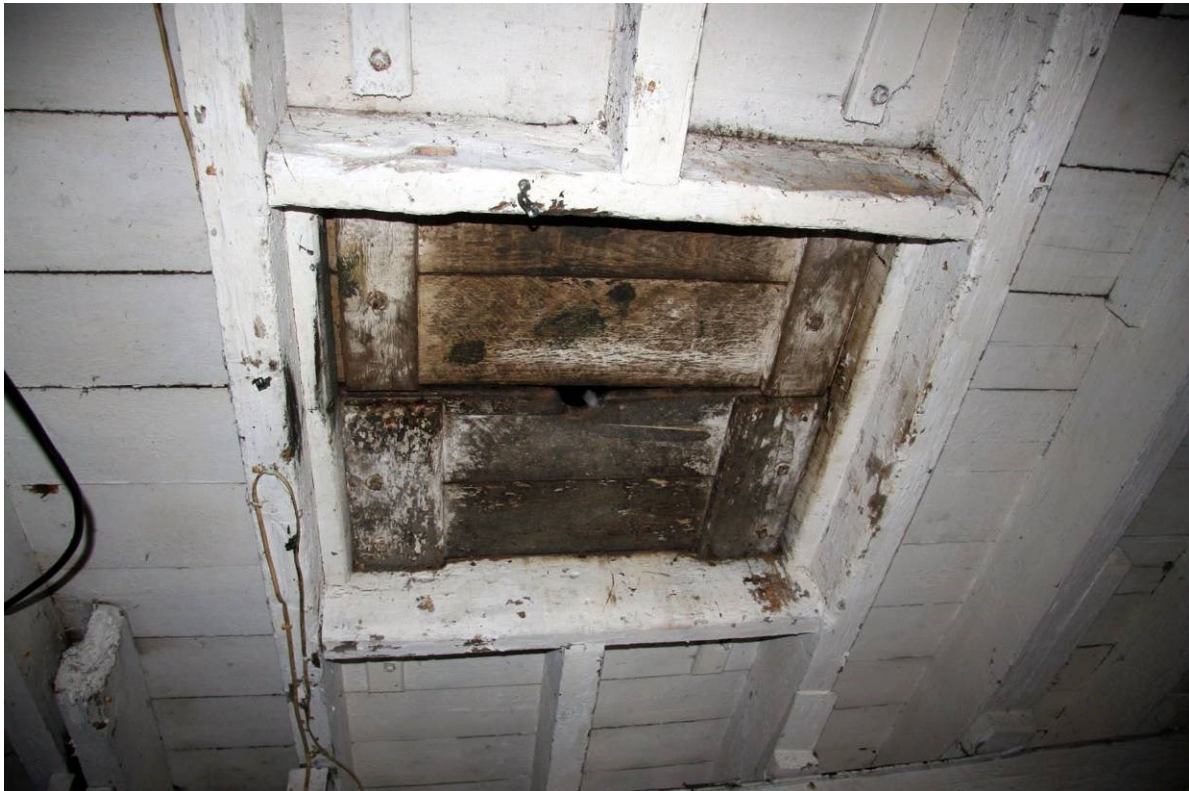
*Fig 16 Trapdoor associated with a sack hoist, viewed from beneath*

Near the centre of the floor is a double trapdoor with hinged flaps, similar to those often seen in corn mills (Figs 16 and 24). This feature appears to be original to the build of the floor and was evidently associated with a sack hoist. Although there are no remains of any machinery, a recess for a bearing in the west gable (with a large grease stain on the wall beneath, see Figs 18 and 20), plus grease stains on the majority of the roof trusses are convincing evidence for machinery driven by belts from line shafting (Fig 17). It appears the roof trusses were slightly adapted to accommodate these additions as empty mortises are traces of missing diagonal struts from the king-posts. Rectangular patches in the timber floor are likely locations for machinery (Fig 25).

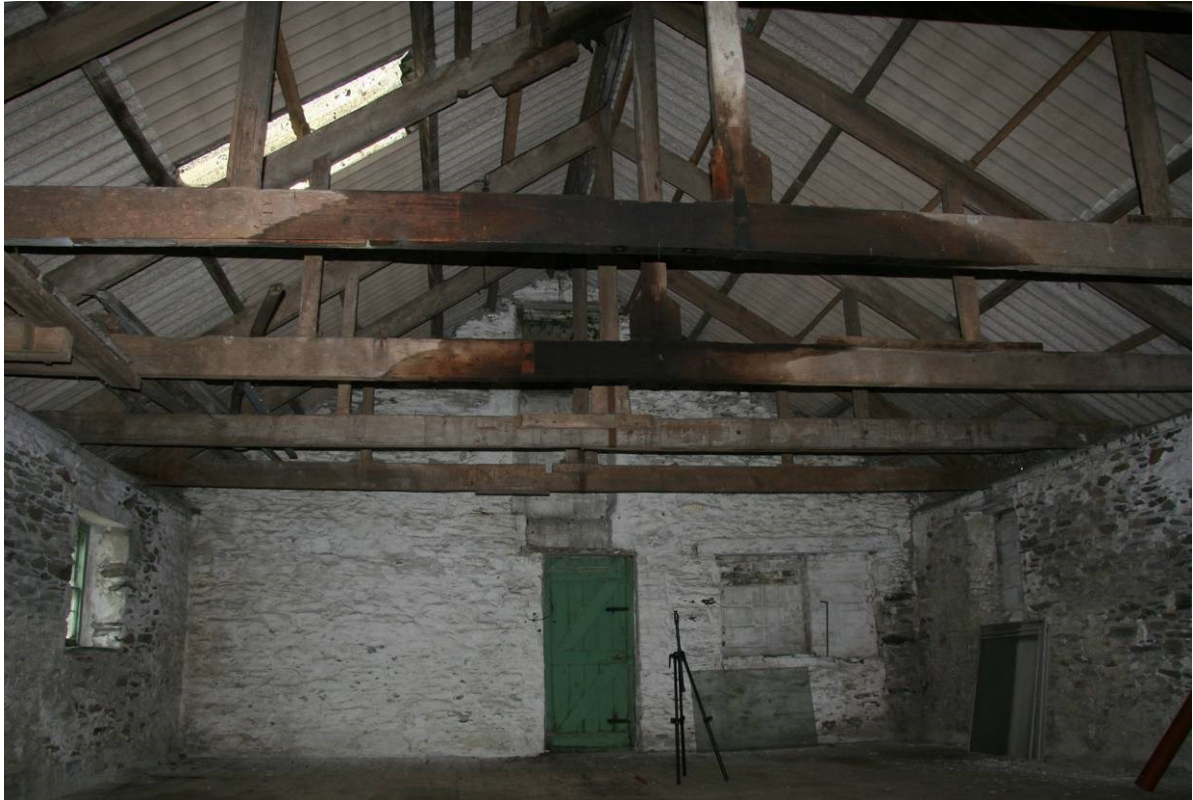
*Fig 17 The upper floor of Building 1, looking east*

*A wide doorway towards the right has been blocked and replaced by a narrower more central door. The gable window above has been deepened and subsequently blocked*

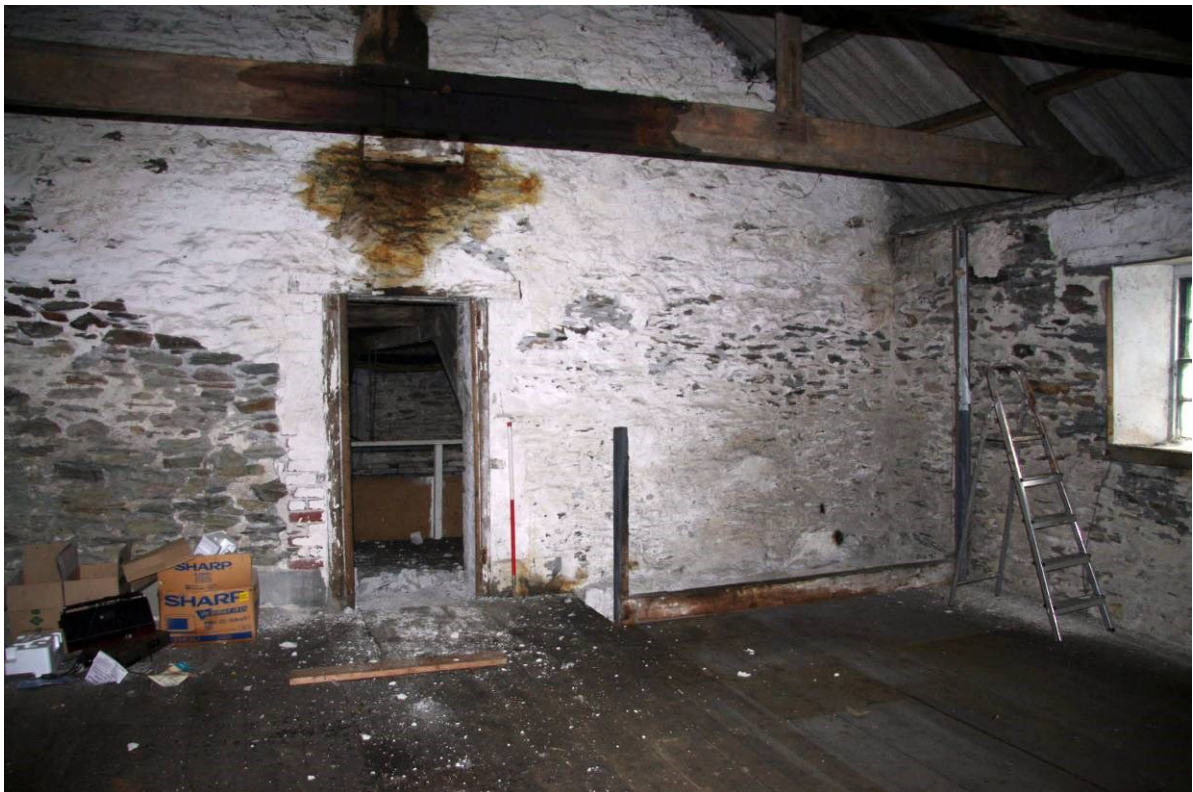
*Fig 18 The north eastern corner of Building 1, with former stairs to the right*

*The doorway is an addition, made to connect with the first floor of Building 2*

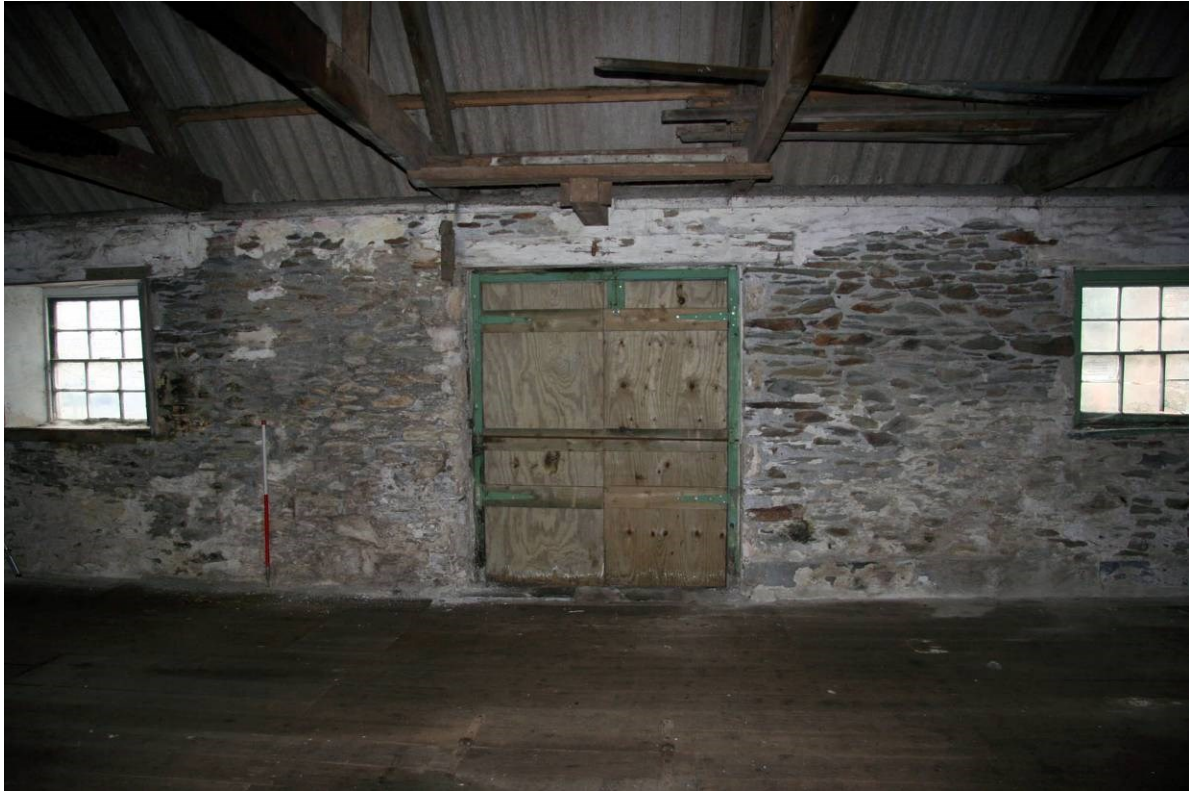
*Fig 19 View towards the front wall on the upper floor of Building 1*

*Note the remains of a timber beam above the loading doorway; this would once have supported an external pulley for bringing goods in or out of the building*

Other evidence of loading arrangements include remains of a timber beam central to the upper loading doorway, which would have projected from the opening and supported a pulley for hoisting sacks (Fig 19).

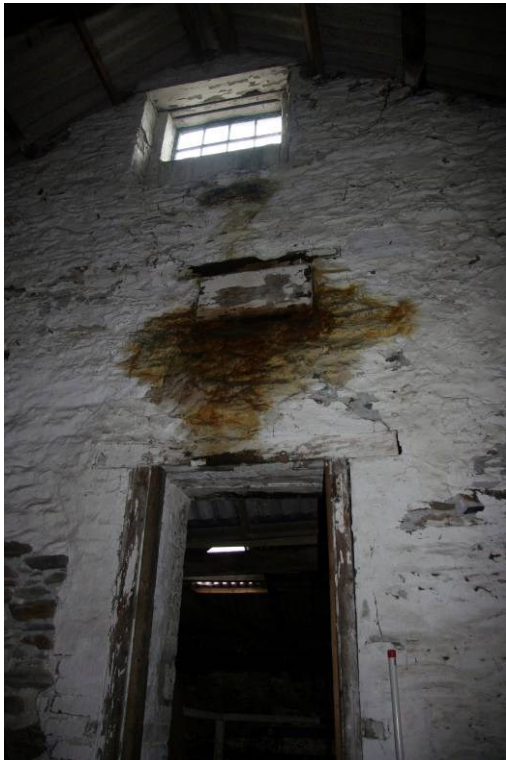
*Fig 20 Features in the west gable wall of Building 1*

*Note an original gable window, an infilled bearing recess (with grease stain below) which once supported line shafting, and the doorway to Building 2*

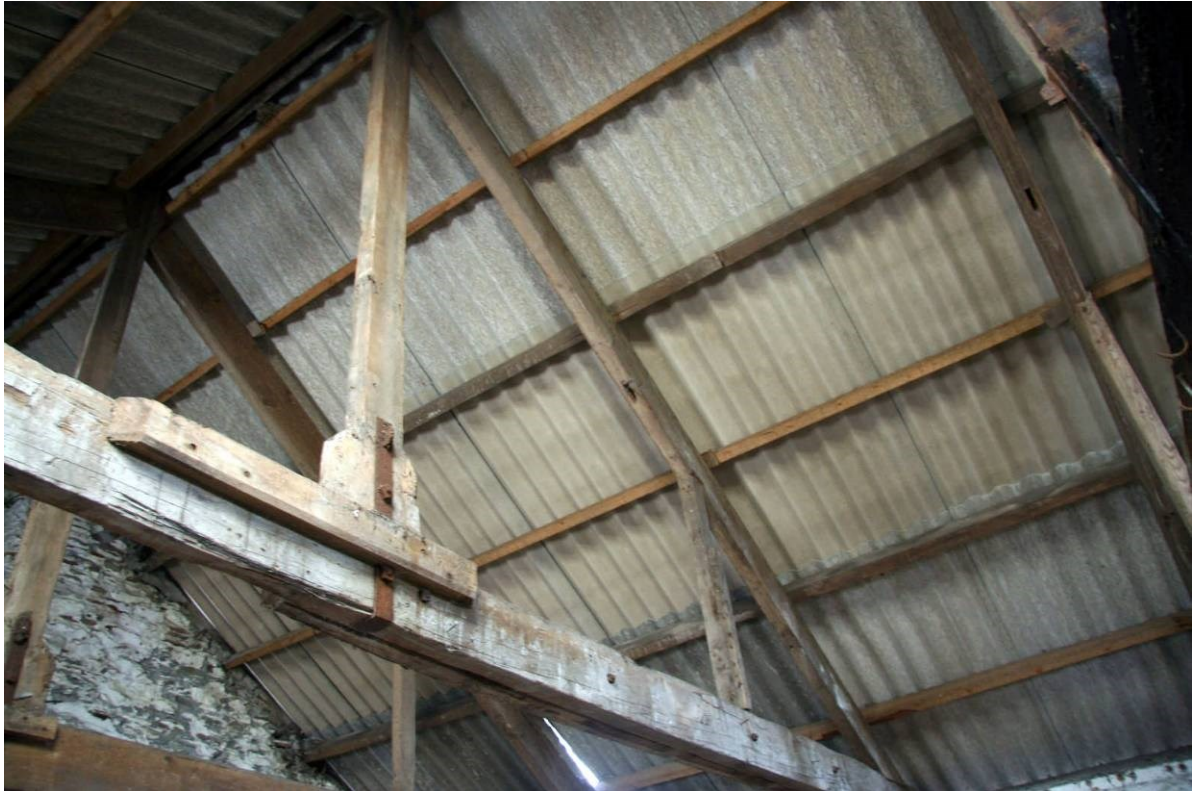
*Fig 21 The roof structure of Building 1*

*Original king post trusses have had their diagonal struts removed (note underside empty mortises). The earlier darker purlins have been supplemented with newer timber when the roof covering was renewed*

King-post trusses are used to support the roof of Building 1, which is divided into 7 bays. Empty mortises indicate that diagonal struts have been removed from the roof trusses; this appears to relate to later installation of line shafting to provide belt drive to machinery (Fig 21). The present roof is of corrugated asbestos sheets, probably replacing slate. The original purlins are still extant and these have been supplemented with additional horizontal timbers to support the present roof covering.

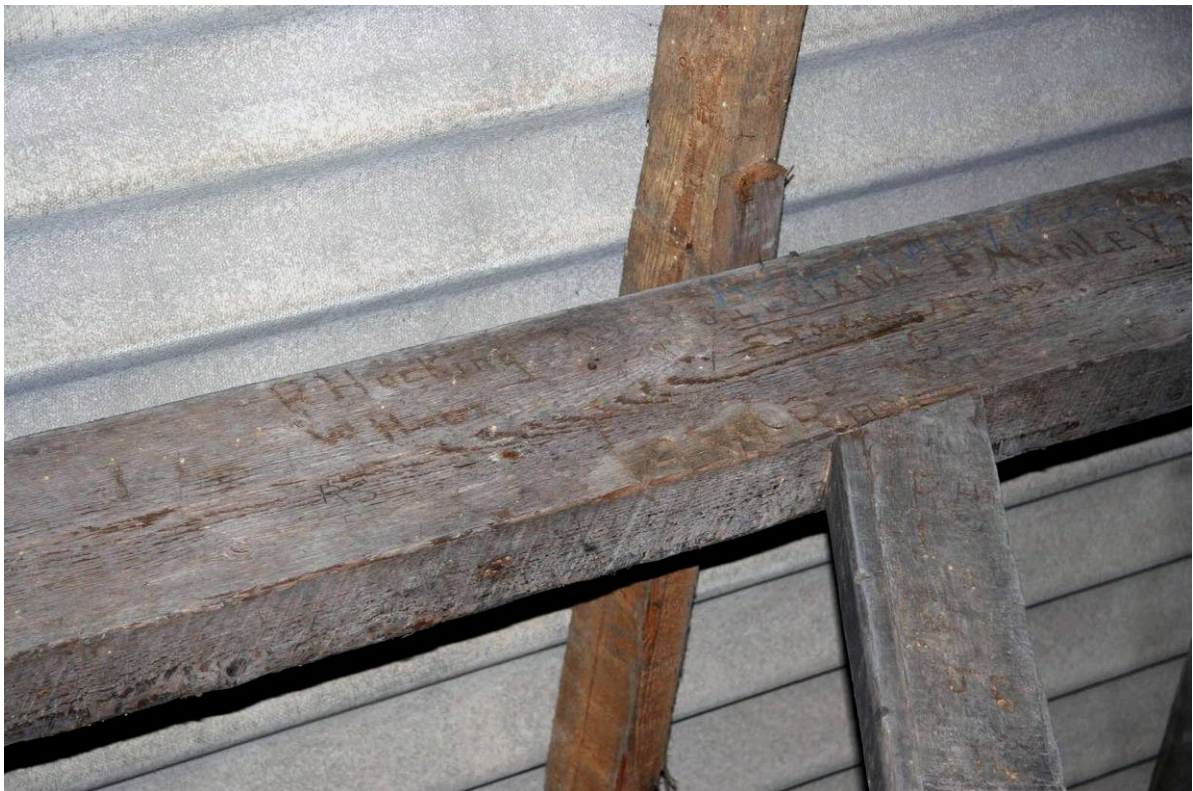
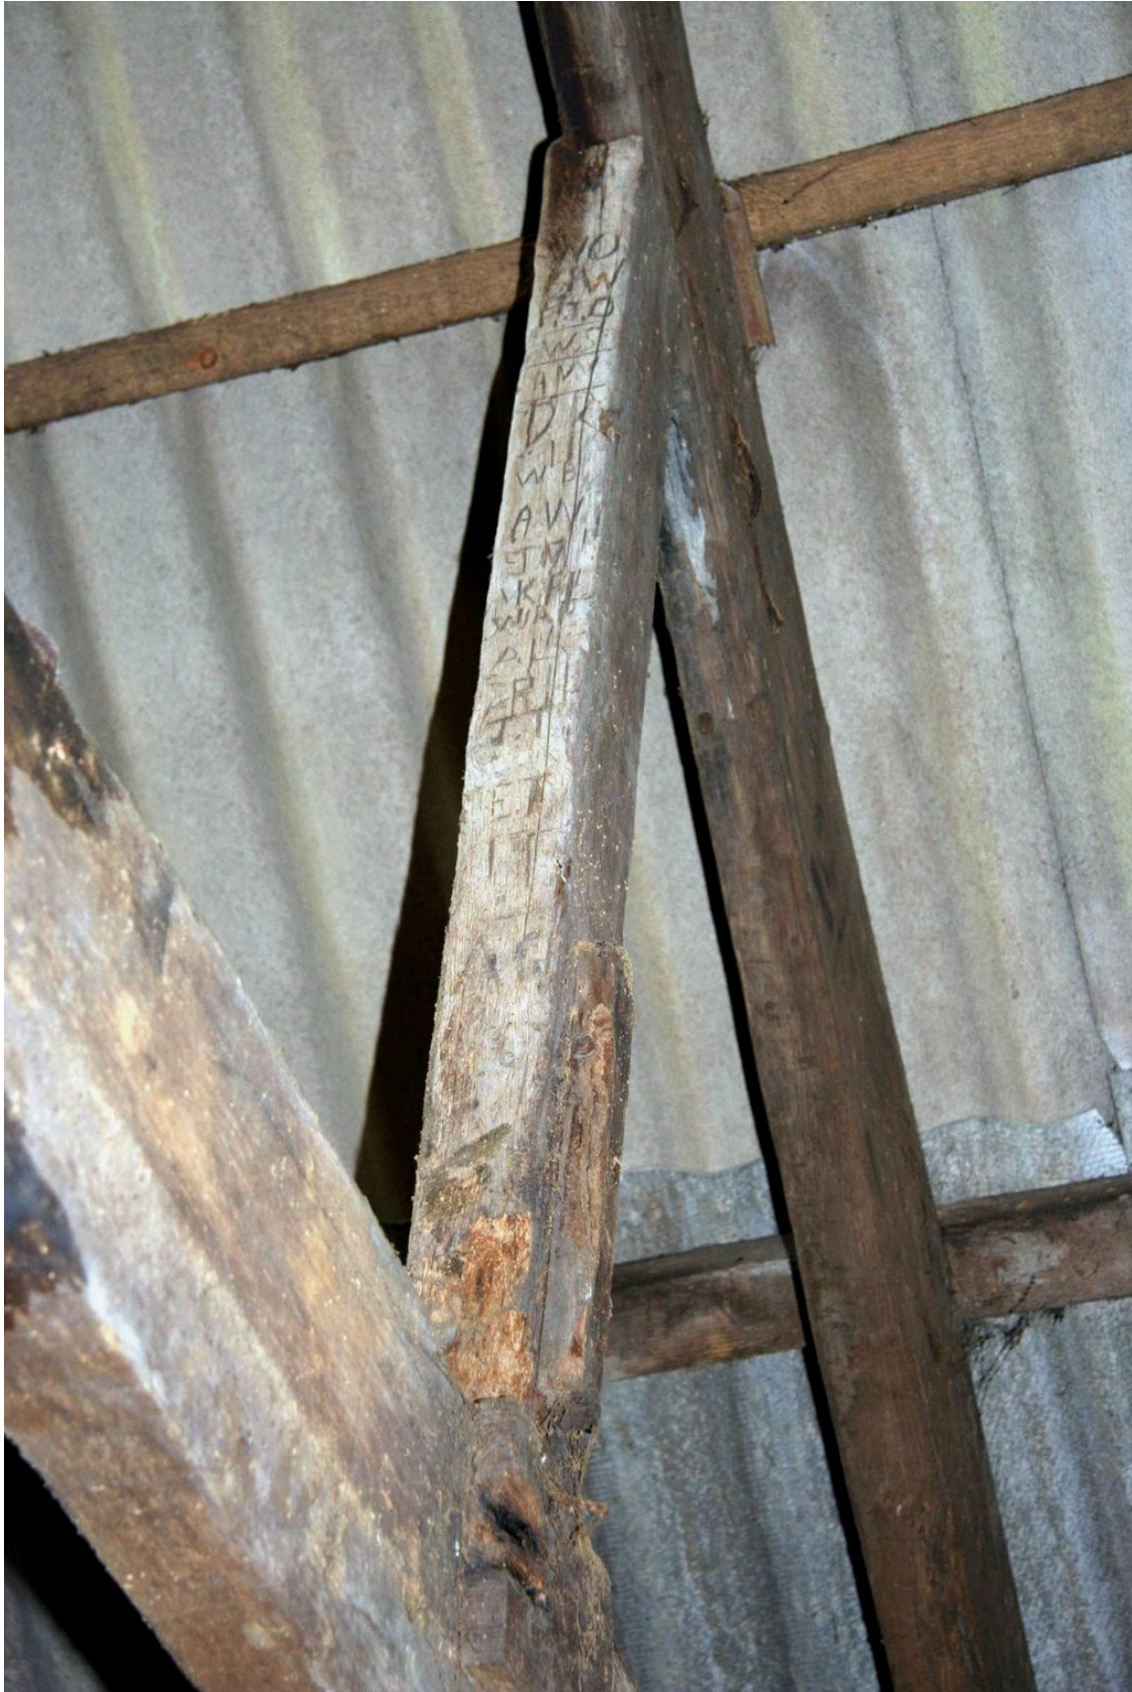
*Fig 22 Graffiti on a roof truss in Building 1*

*Fig 23 Graffiti on a roof truss in Building 1*

*It appears this was periodically added by individuals who were oiling the line shaft bearings mounted in the roof structure*

Graffiti showing on two roof trusses was probably added by individuals who were asked to oil the line-shaft bearings (Figs 22 and 23).

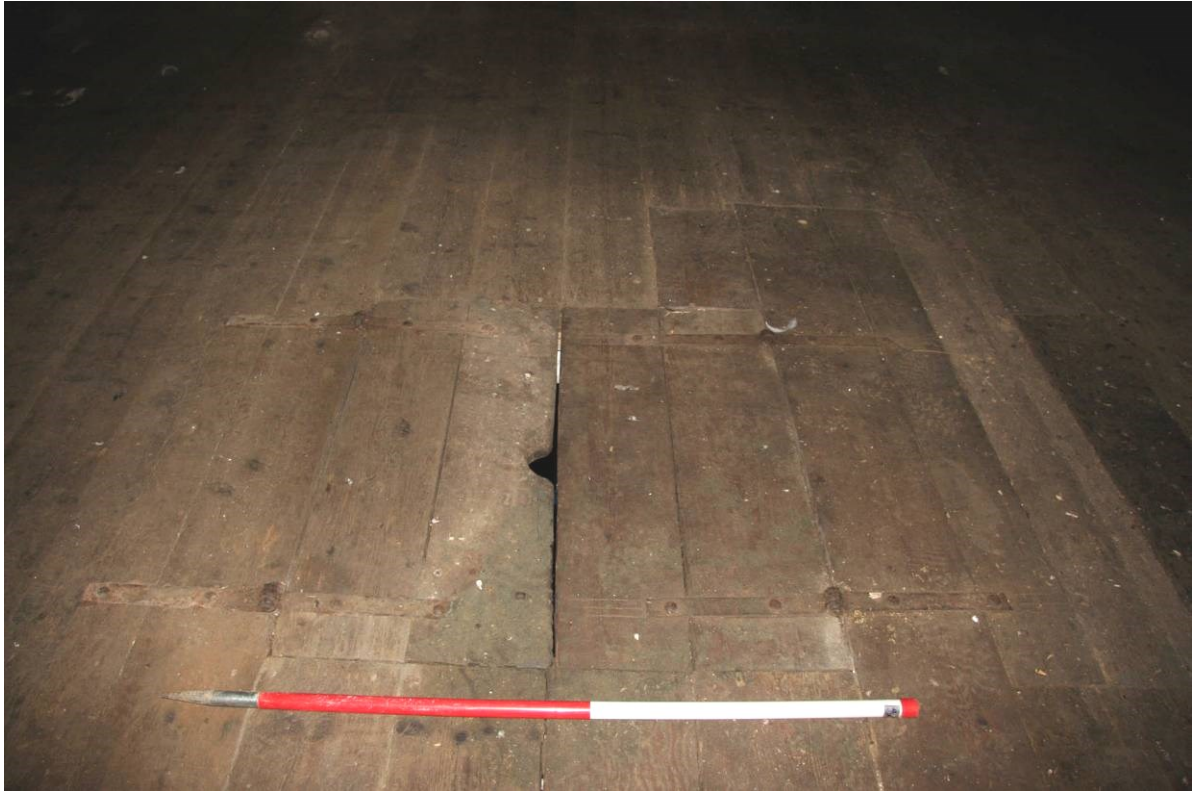
*Fig 24 The trapdoor associated with a sack hoist, as seen in the planking of the upper floor*

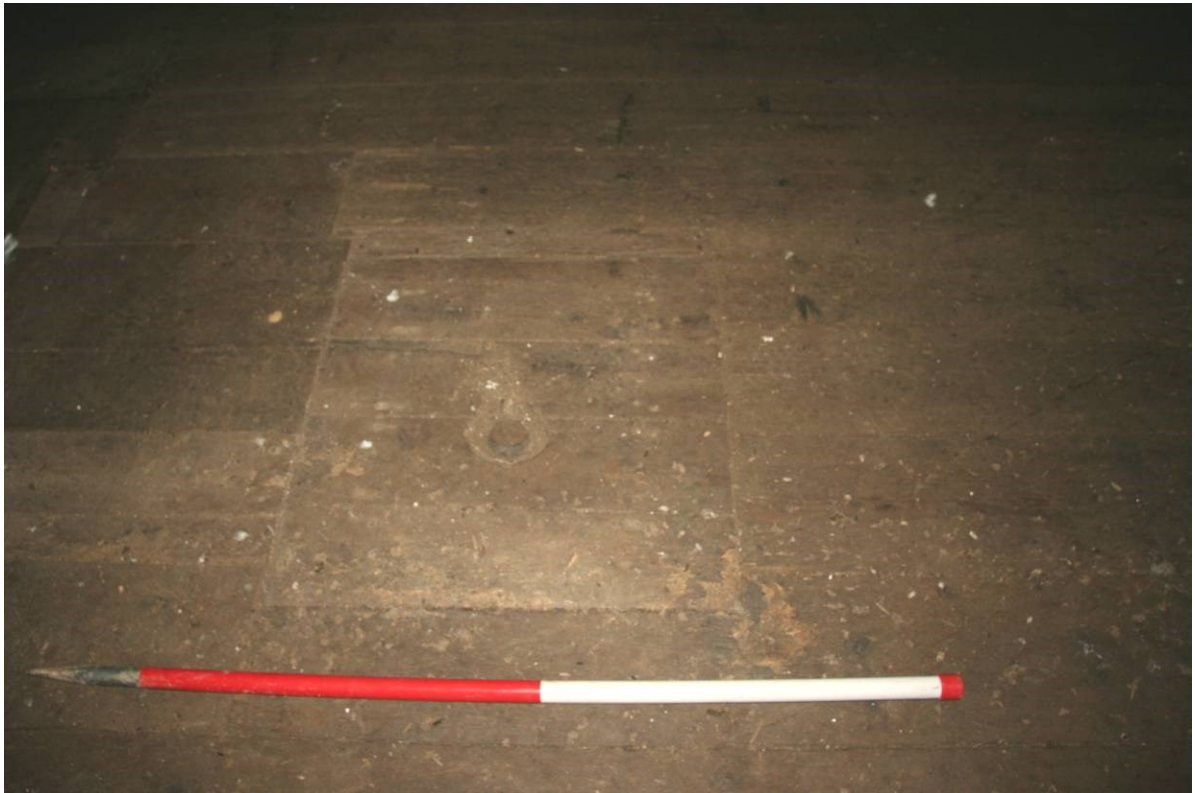
*Fig 25 Irregularities in the upper floor planking probably represent footings for machinery and /or chutes to the ground floor level*

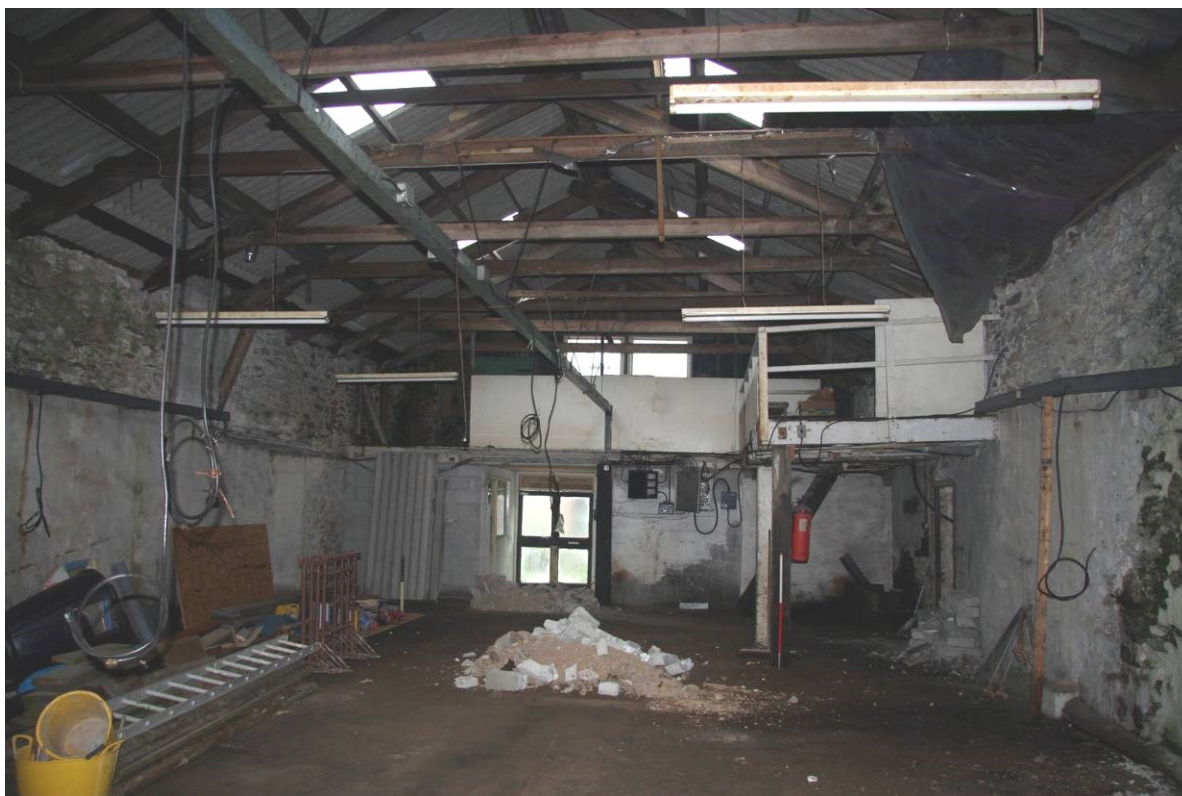
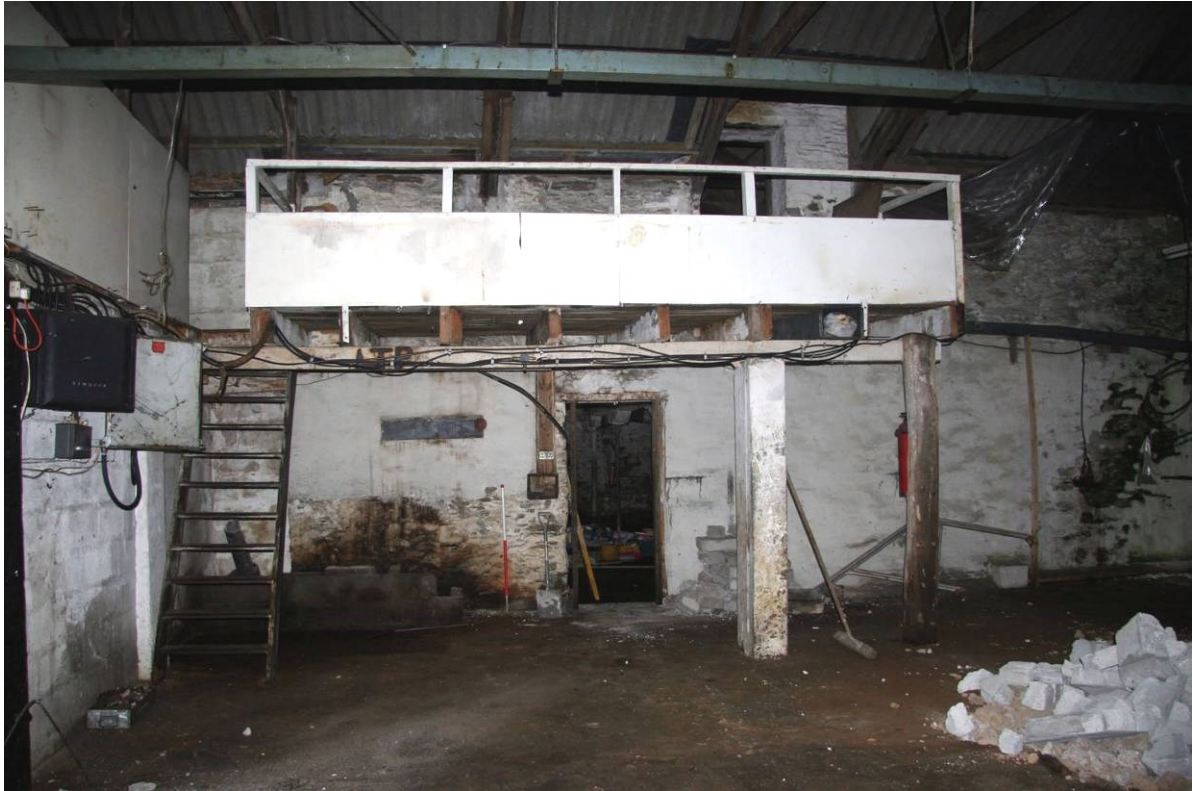
*Fig 26 Interior of Building 2, looking north*

*Fig 28 Interior of Building 2, looking east, showing remains of upper floor and stair access*

The ground floor front of the building has been divided (with block-work partitions) to become a short entrance passage with a small office to the west side and toilets to the east. This area supports a surviving width of the upper floor. A short wooden stair leads to a platform which provides a link to a first floor doorway into Building 1 (Figs 26 and 28).

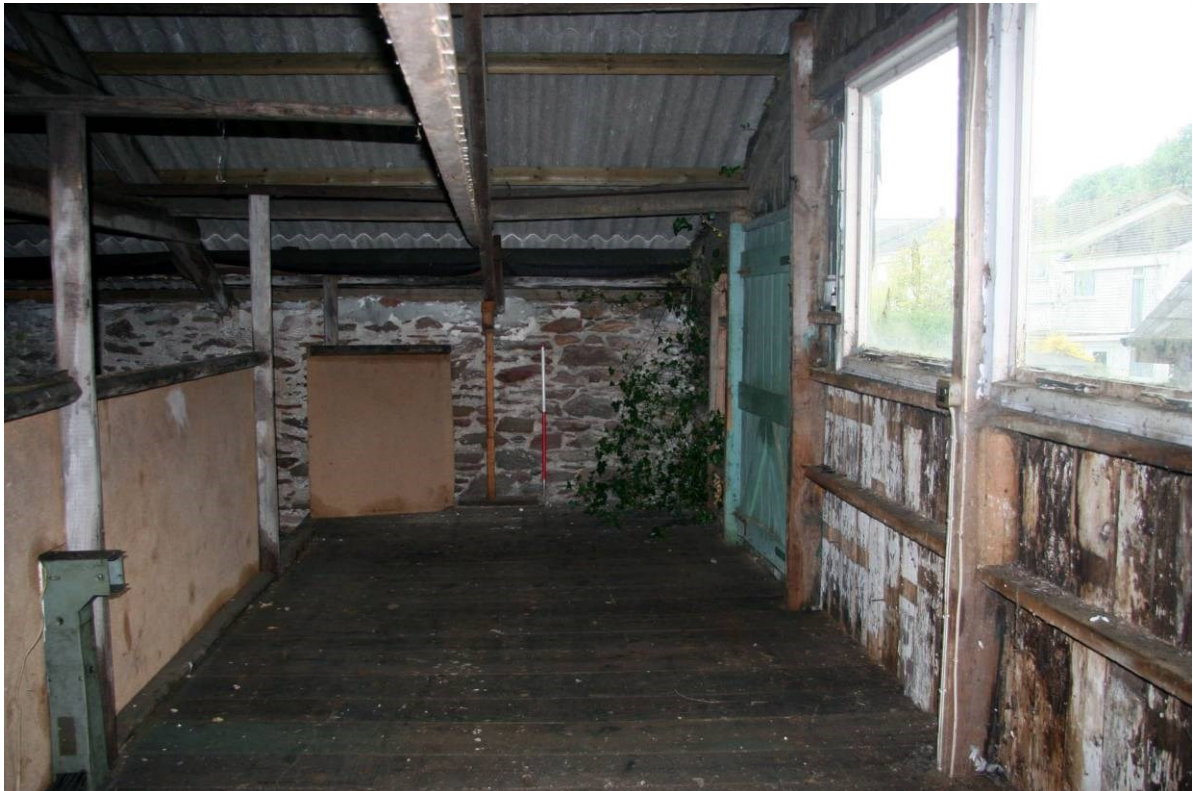
*Fig 29 Surviving area of upper floor at north end of Building 2*

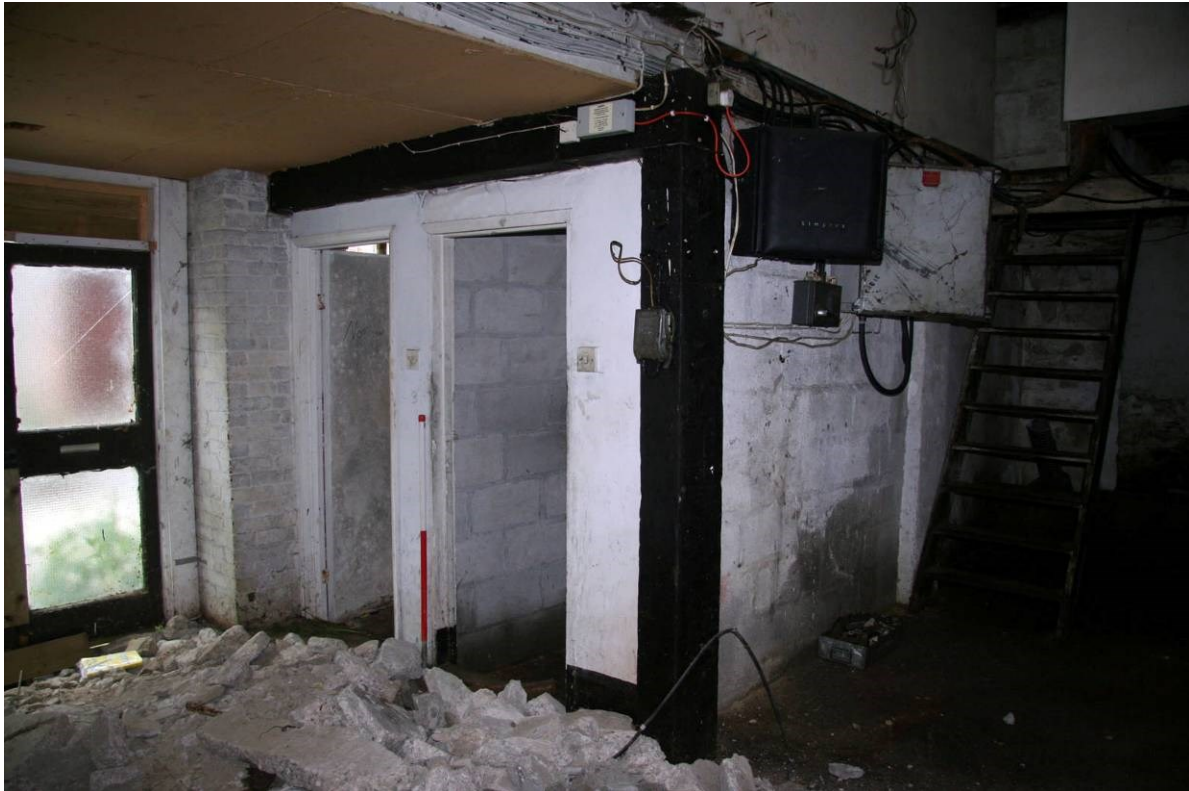
*Fig 30 The upper floor of Building 2 was originally supported on central piers running the length of the building; a brick pier survives at the front of the building (towards left) and the horizontal black painted timber running into the pier is a truncated fragment of a principal floor beam*

*The vertical timber (right of centre) is a reused element, placed here to support the remaining part of the upper floor*
