Middle Penpethy farm buildings, Tintagel, Cornwall

Historic building record

Client	Mr Stephen Brown
Report Number	2013R043
Date	June 2013
Status	Final
Report author(s)	Nigel Thomas
Checked by	Andy Jones
Approved by	Andrew Young

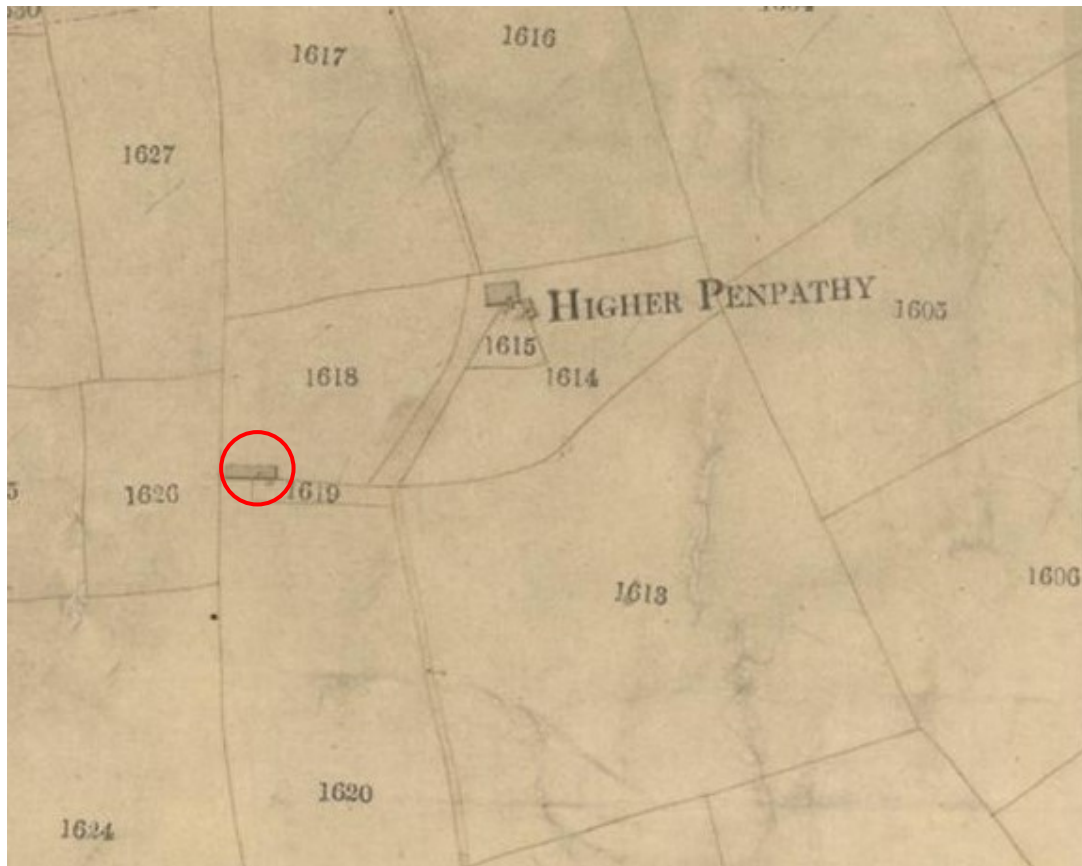
Fig 3 Extract from the Lanteglos-by-Camelford Tithe map, surveyed 1841

The subject building range is first shown on the Lanteglos-by-Camelford Tithe Map surveyed in 1841 (Fig 3). The First Edition 25 Inch OS map shows that the buildings faced a small yard on the north side and another square enclosure to the south was probably a mowhay (rickyard) (Fig 4). By c1907 the building range had been extended westwards towards the hedge with the addition of Building 3 (Fig 5). Another small rectangular building had also been added on the south side of the approach lane.

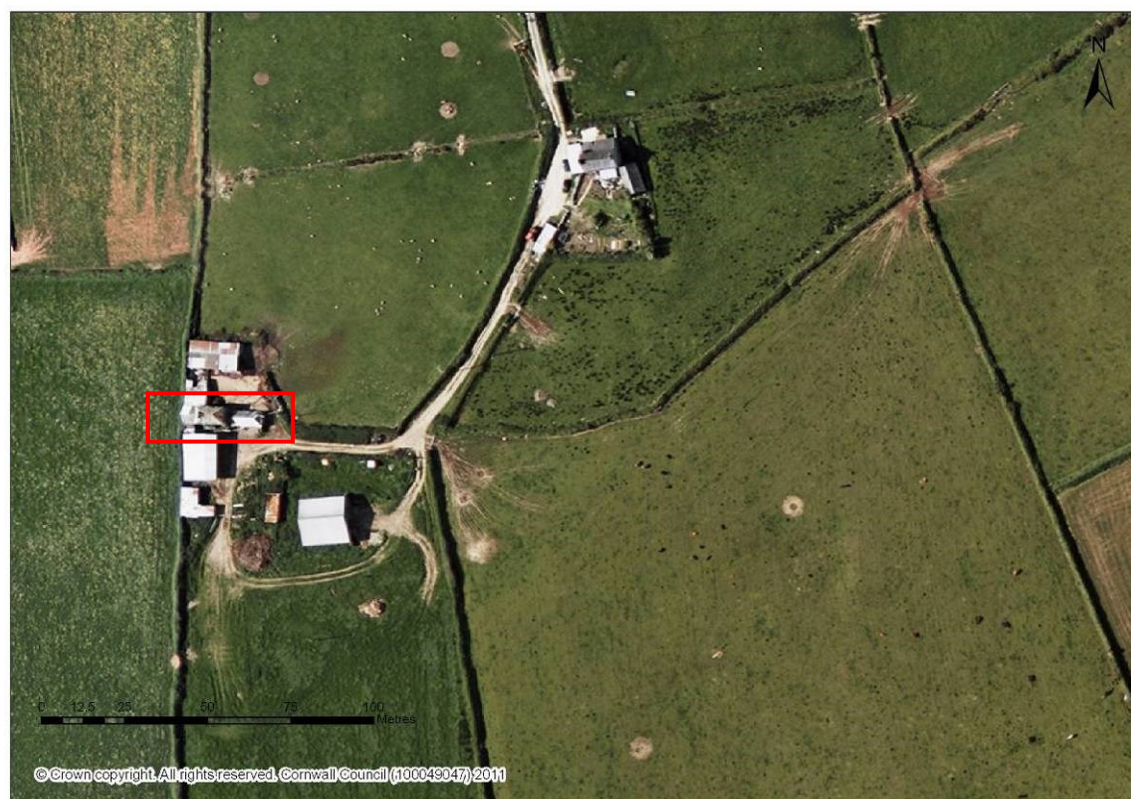
In more recent times corrugated iron sheds have been built adjoining the older stone buildings; these are now disused and in collapsing condition. The building adjacent to the lane mapped in c1907 is no longer extant. Pole barns immediately south of the older range and a larger agricultural building in the enclosure to the southeast are the modern replacements for the older structures (Fig 6).

Fig 6 Air photograph of Middle Penpethy, taken in 2005
The subject building range is highlighted

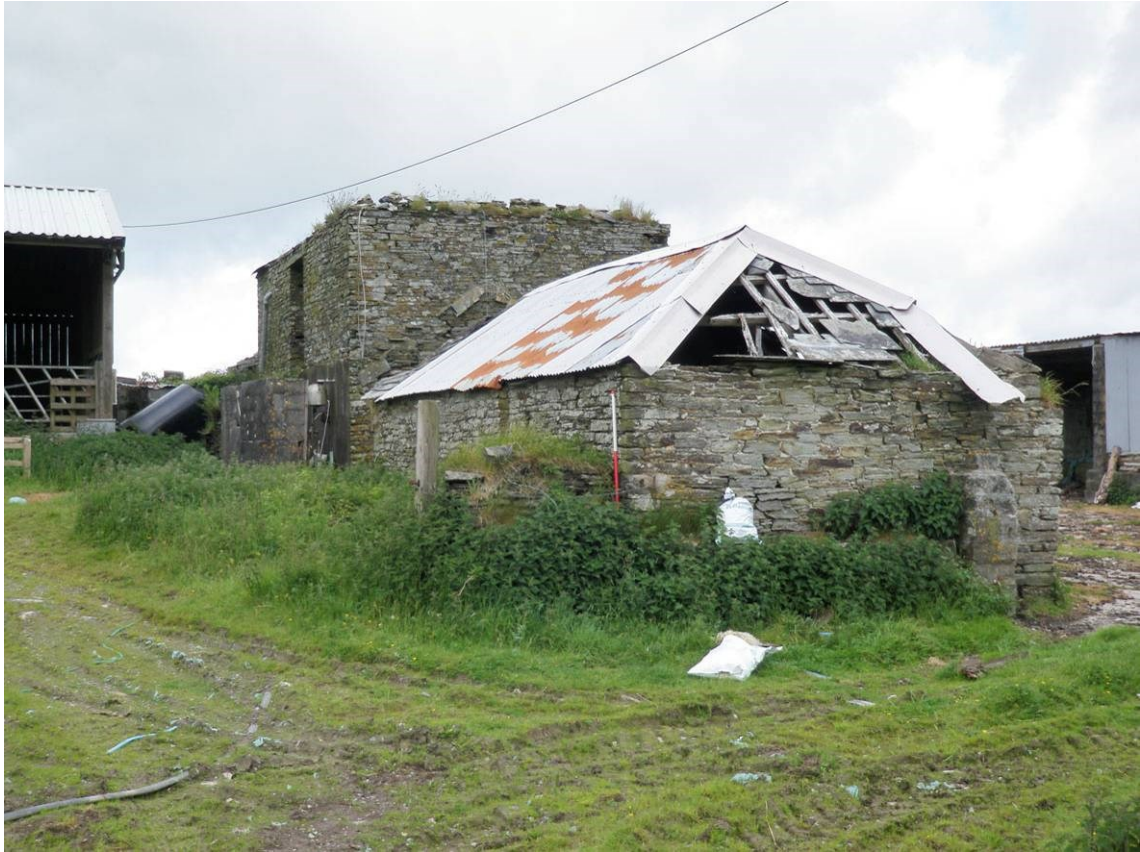
Fig 7 View of the farm buildings from the southwest

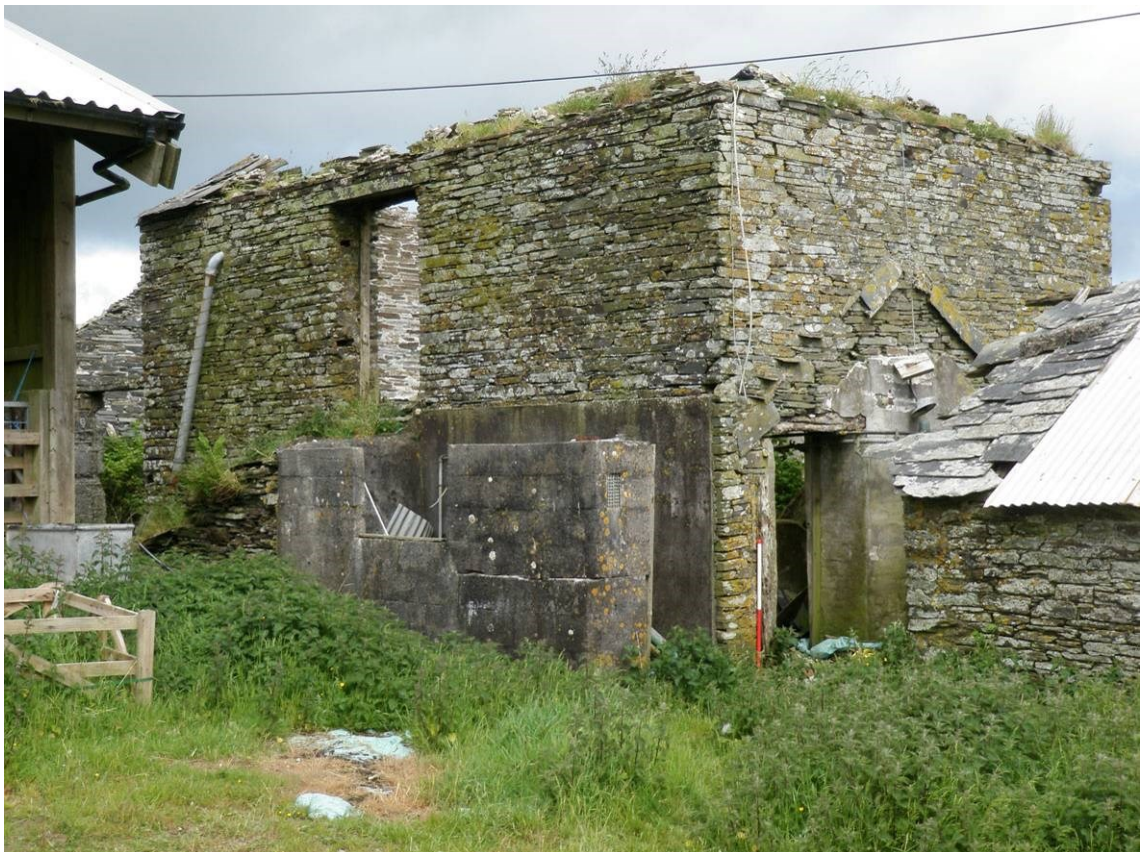
Fig 8 Building 1, viewed from the southwest

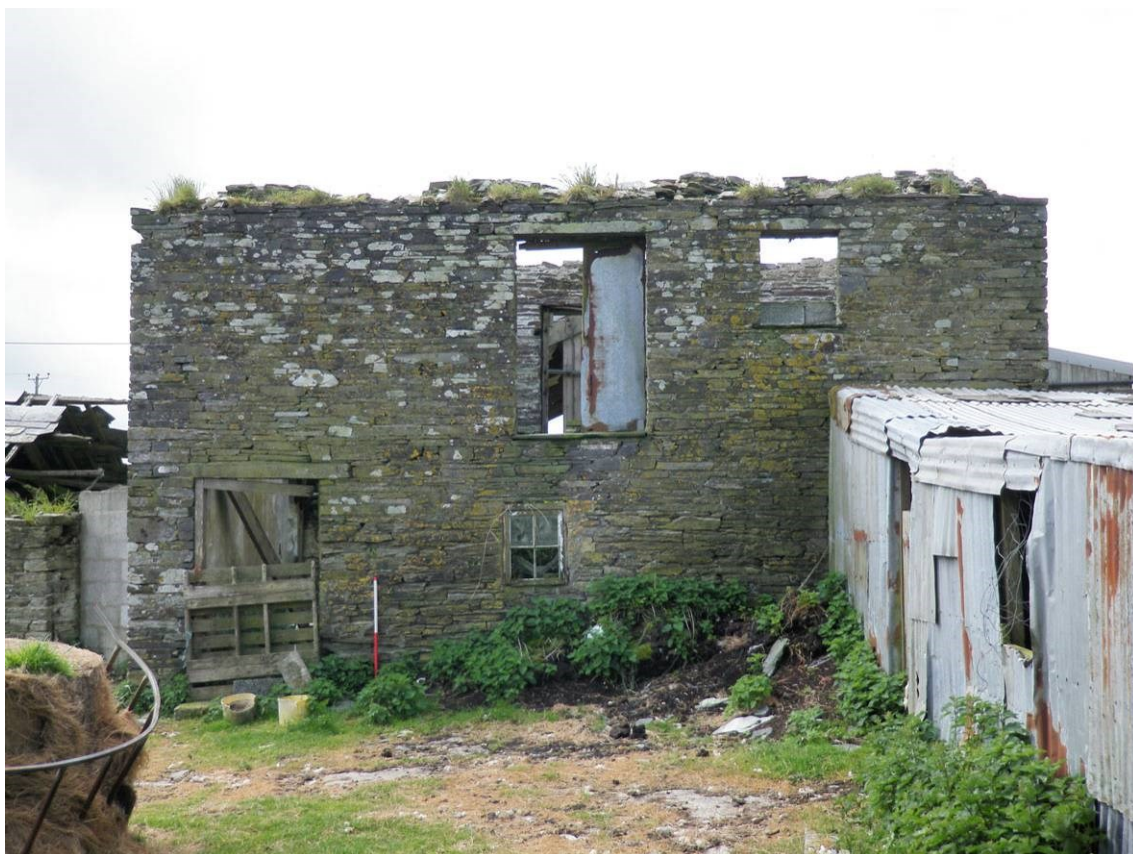
On the ground floor two doorways in the north wall (one at each end) provided access for livestock. Interestingly the western doorway is lower/smaller, perhaps designed for pigs or sheep, whilst the other doorway was for cattle. A feeding passage runs along the length (and to the rear) of the building with doorways at either end; the interior has remains of concrete cow stalls towards the eastern end.

A single ventilation slit exists in the south wall towards the western end (i.e. behind the feed passage). A ground floor window in the north wall appears to be an insertion, or may represent widening of an earlier slit ventilator.

Fig 9 The north side of Building 1

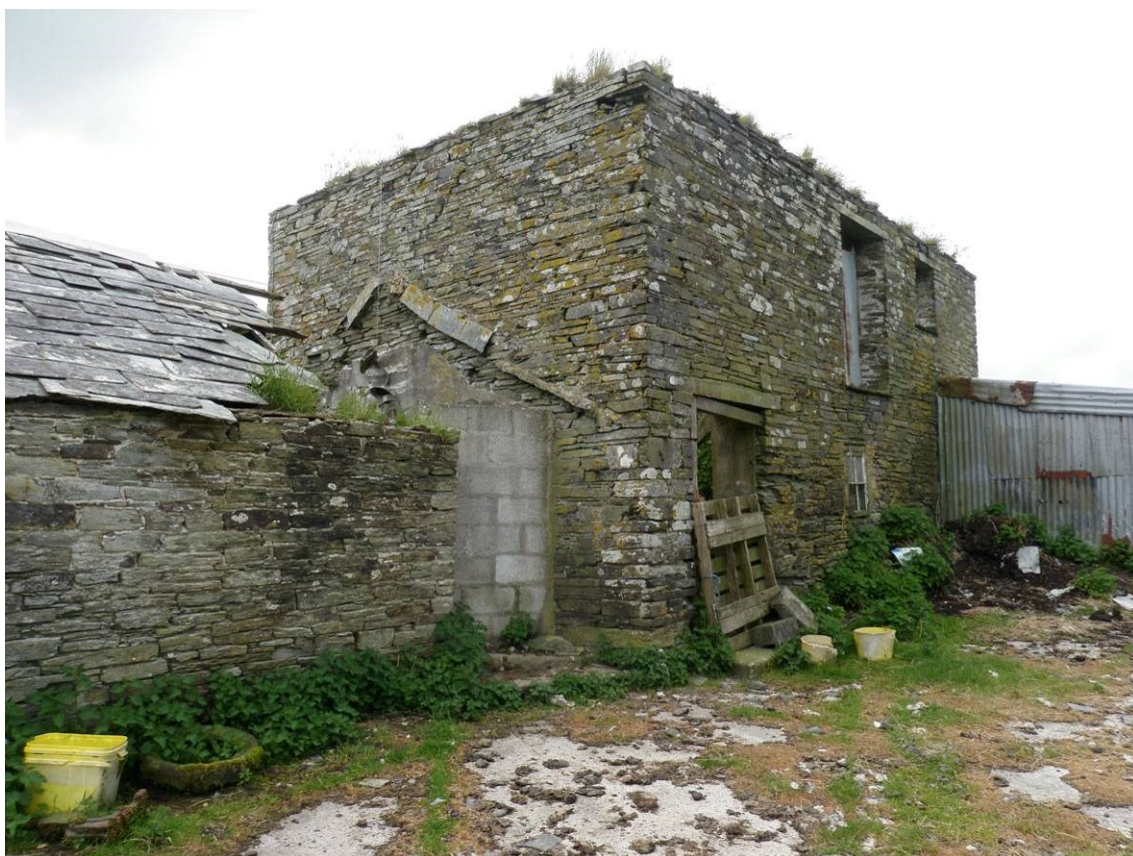
Fig 10 Buildings 1 and 2, viewed from the northeast

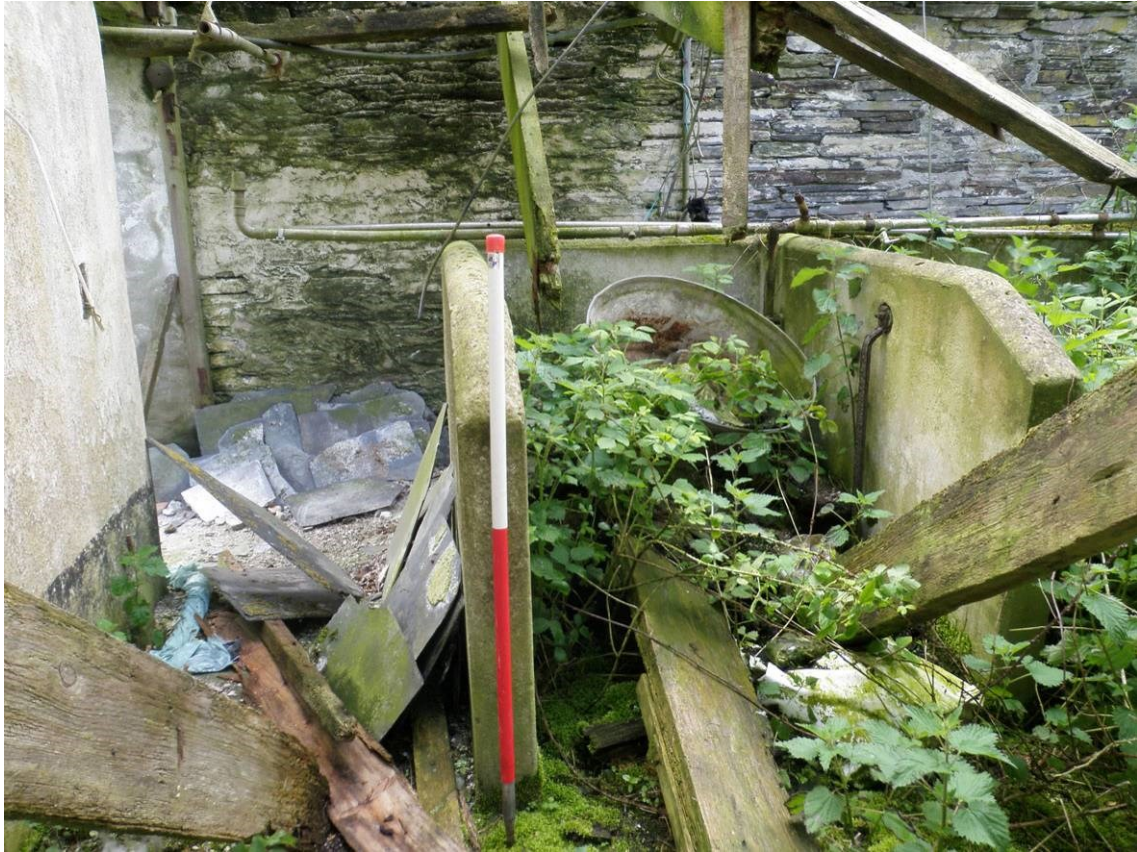
Although its walls appear sound the building was in very poor condition when visited as the roof and upper floor had long since tumbled in. The floor and surroundings were littered with fallen roof slates.

Building 1 has no gable ends and originally had a roof that was hipped at both ends, probably to reduce wind resistance in this upland location. The roof structure was simple nailed A-frames supporting purlins, rafters and a covering of rag slates.

Some fallen floor joists remain; these once supported a wooden upper floor. Fragments of a rough timber skirting for the upper floor are still in place.

Fig 11 Interior (ground floor) of Building 1, showing concrete stalls and collapsed floor and roof timbers

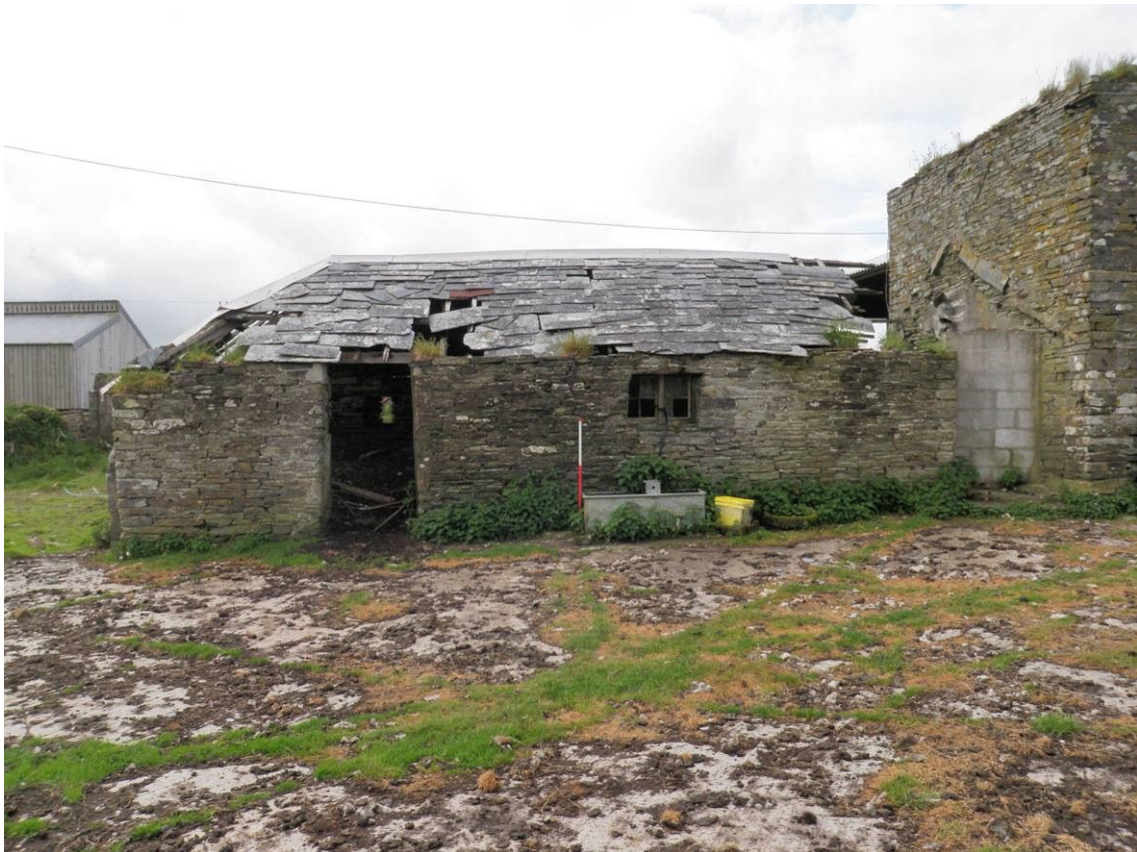
Building 2 is a single storey rectangular structure, slightly longer in plan than Building 1 but a little narrower. The only original access is at the west end where there are two opposing doorways, one facing the yard on the north side, and a widened doorway to the south. Originally this building had two windows in its north wall. One is extant but has been widened to the east side. The other window at the east end has been converted to a doorway. Two ventilator slits pierced the south wall; the westernmost one has since been blocked.

Like Building 1, this structure is also of finely jointed slate masonry, bedded in lime mortar. The roof is still partly extant; it has small simple A-frame trusses supporting a rag slate covering. The original hipped east end survives. A portion of the roof on the south side has been replaced with corrugated sheeting. The rag slated covering originally adjoining Building 1 has collapsed. On the north side the roofline once extended forward slightly to cover the angled entrance doorway.

Fig 12 Building 2 viewed from the north

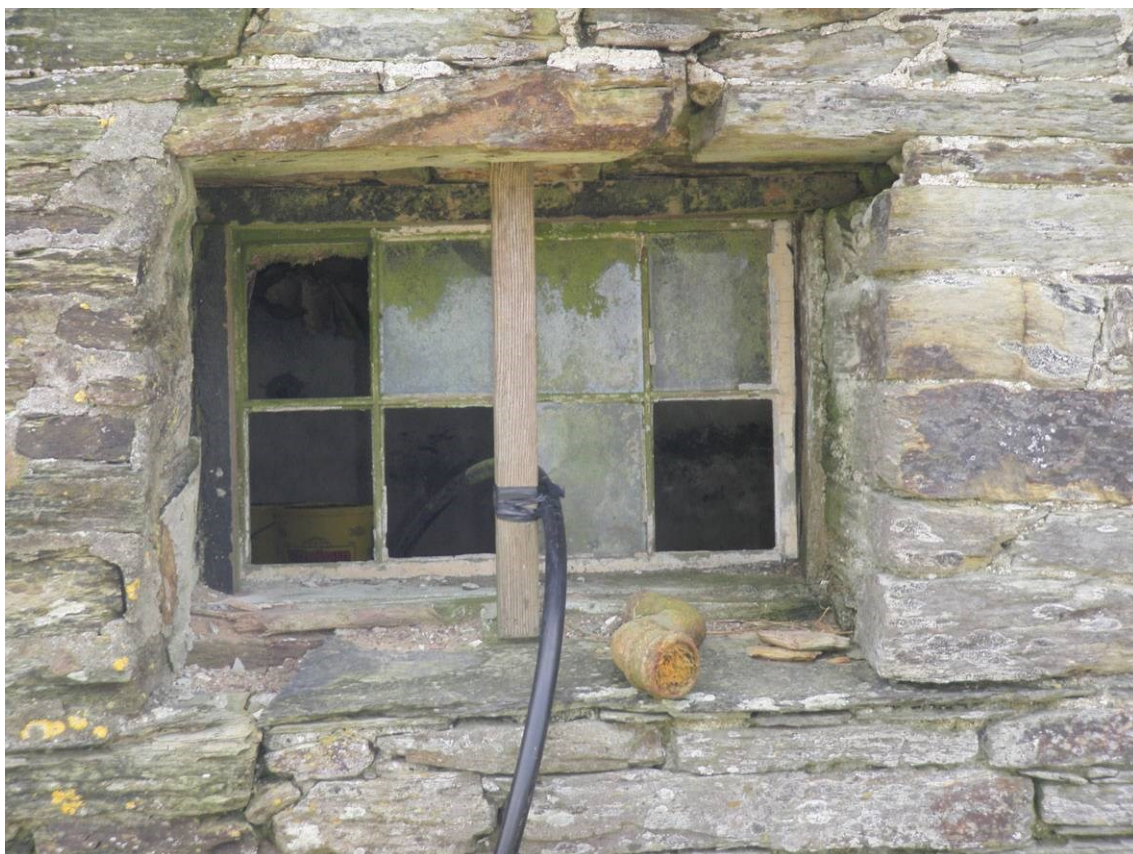
Fig 13 Window in north wall of Building 2, widened to left side

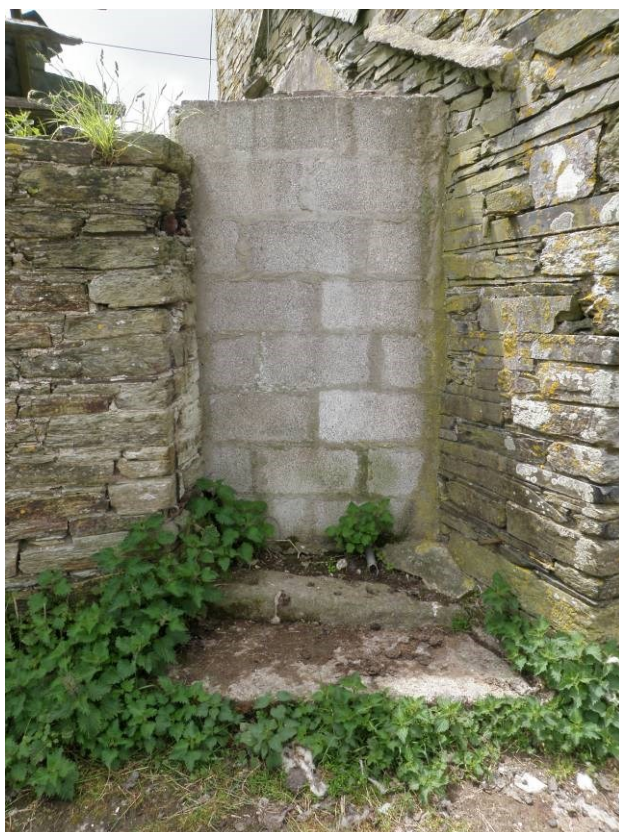
The original north doorway facing the yard has interesting chamfer detail, and an angled granite step forming the threshold has wedge marks. The doorway itself has since been in-filled with concrete block-work.

marks on this stone indicate that it was sourced before 1800 (the approximate date when invention of tare-and-feather granite splitting superseded wedge splitting). It is possible, however that this stone was reused by the time it was incorporated into the construction of Building 2. The general style of the buildings suggests they were built in the first decades of the 19th century, and may therefore be approximately contemporary with Middle Penpethy farmhouse.

Fig 14 Doorway with chamfered slate jamb and granite threshold

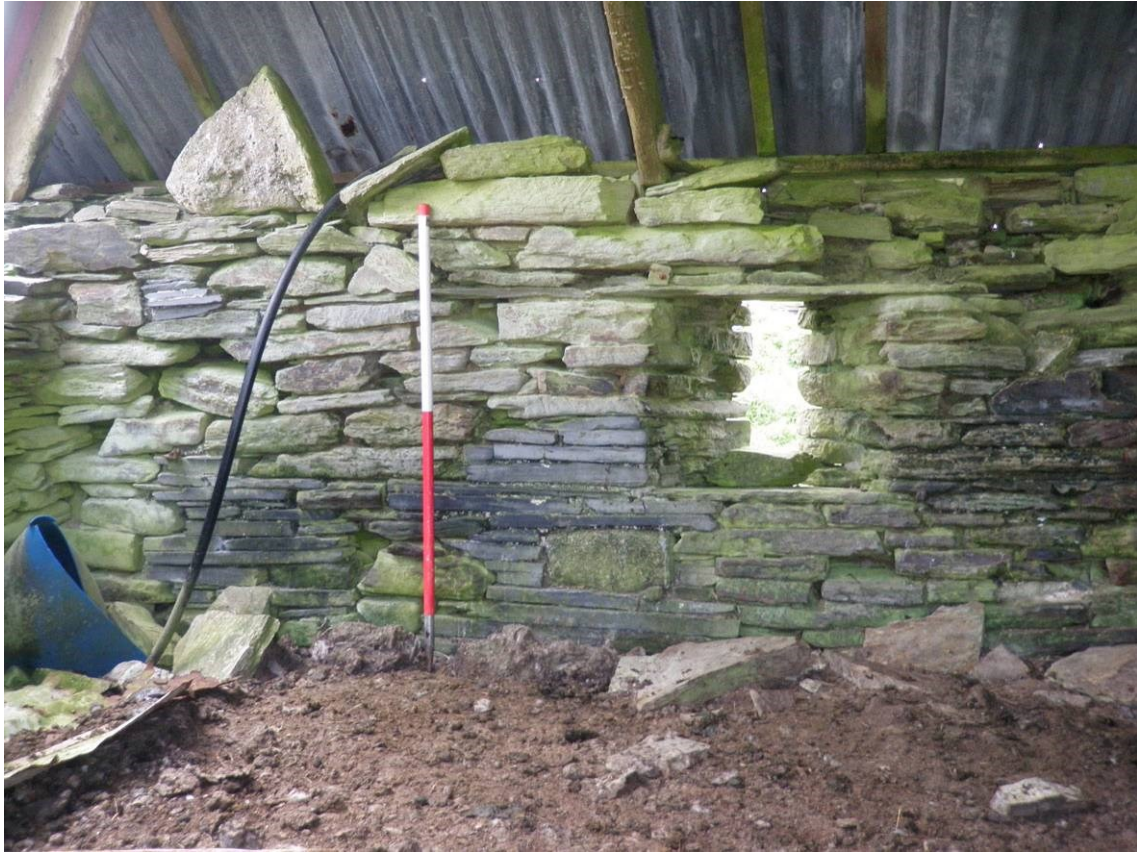
Fig 15 Original slit ventilator in east end of Building 2

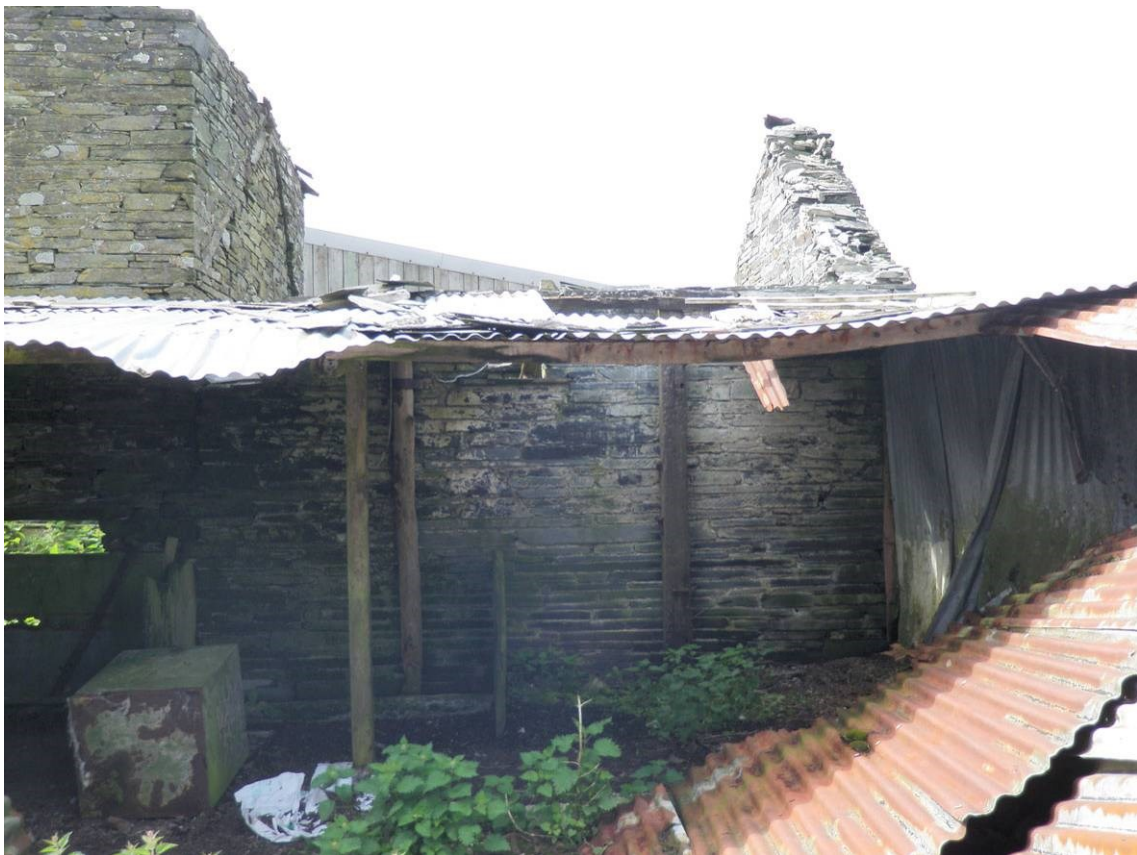
Building 3 has an almost square plan and clearly abuts the west end of Building 1. The only original openings are two small ventilators/windows under the roofline close to the northeast corner. Unlike the other buildings in the range this has its original doorway in the south wall. This doorway has been narrowed by insertion of a pier of block-work. The only other doorway is a connection to the feeding passage in Building 1.

Fig 16 Exterior of Building 3 viewed from the north, partially masked by collapsed 20th century sheds

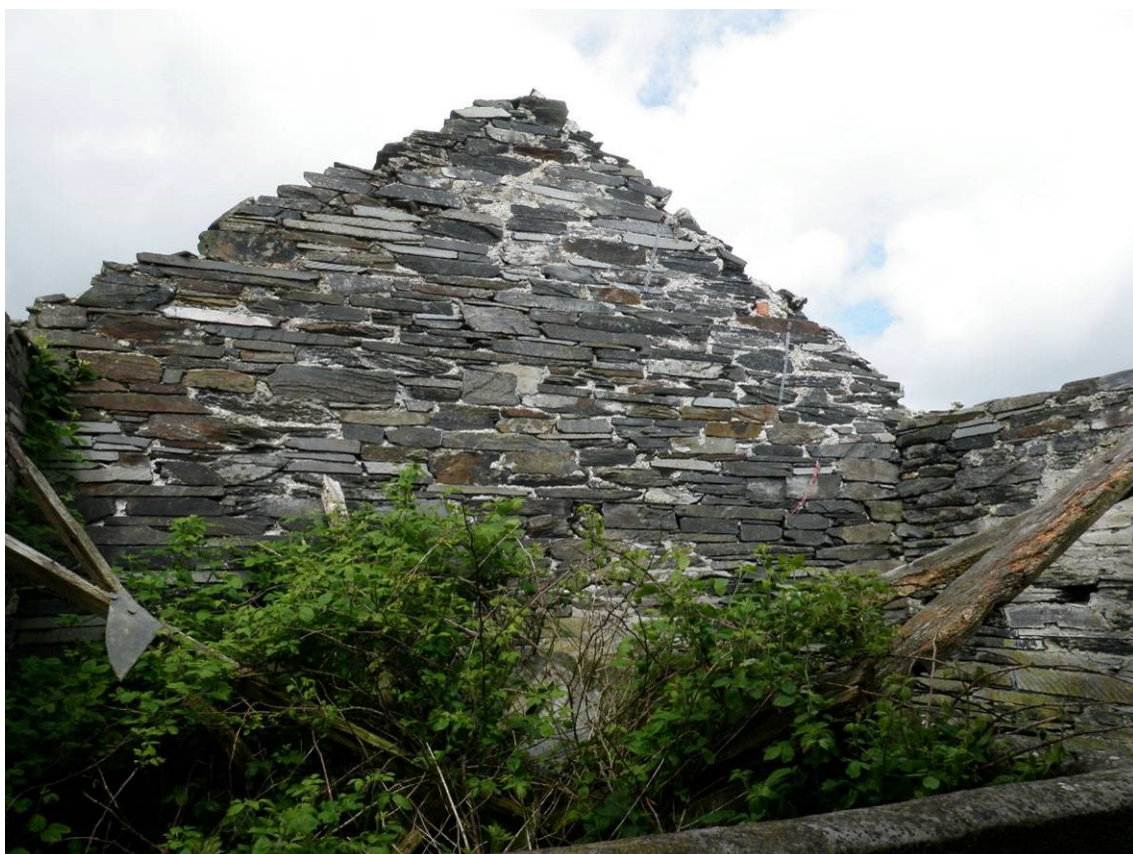
Building 3 is built of finely jointed semi-coursed bluish slate rubble. Several of the stones on the interior face have stone saw marks, typical of more recent slate quarried around Tintagel.

This building has also lost its roof; the roof was different from the two earlier buildings in that it had a gable at the west end.

Fig 17 Interior and gable wall of Building 3

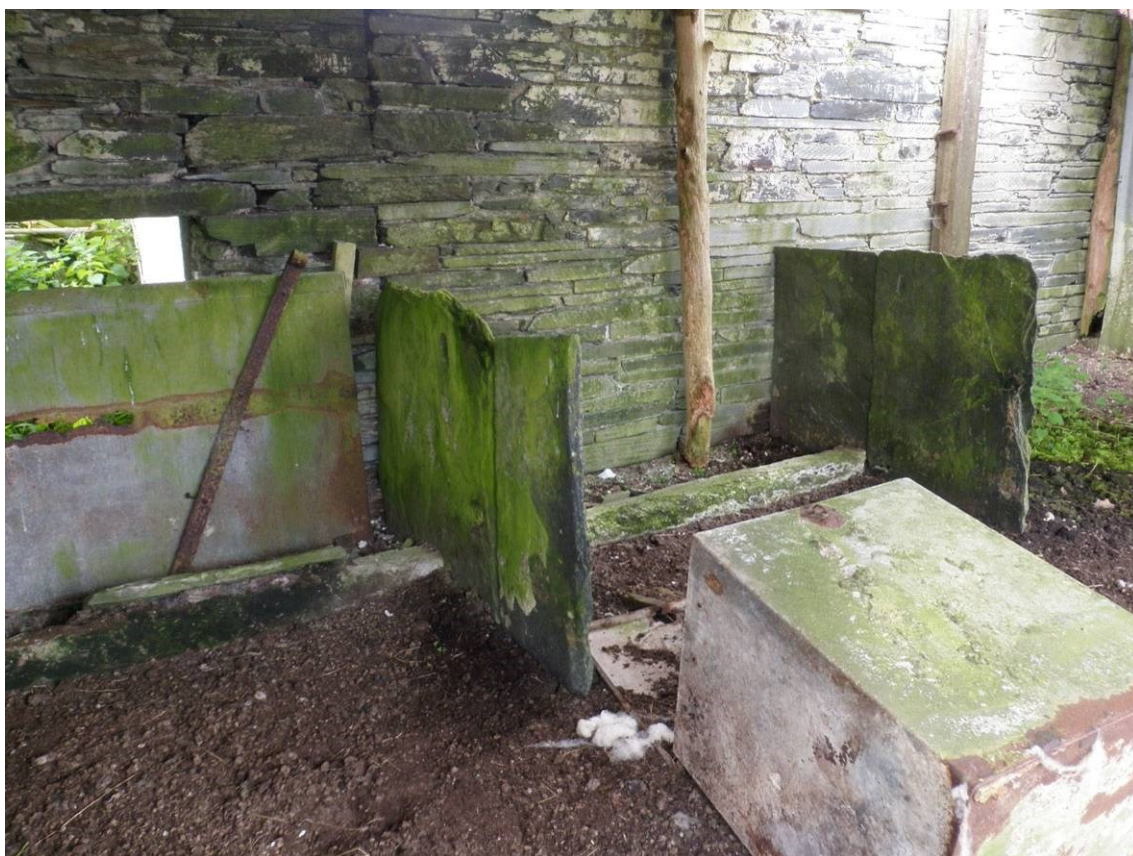
Fig 18 Slate divisions between stalls in 20th century shed adjoining Building 3

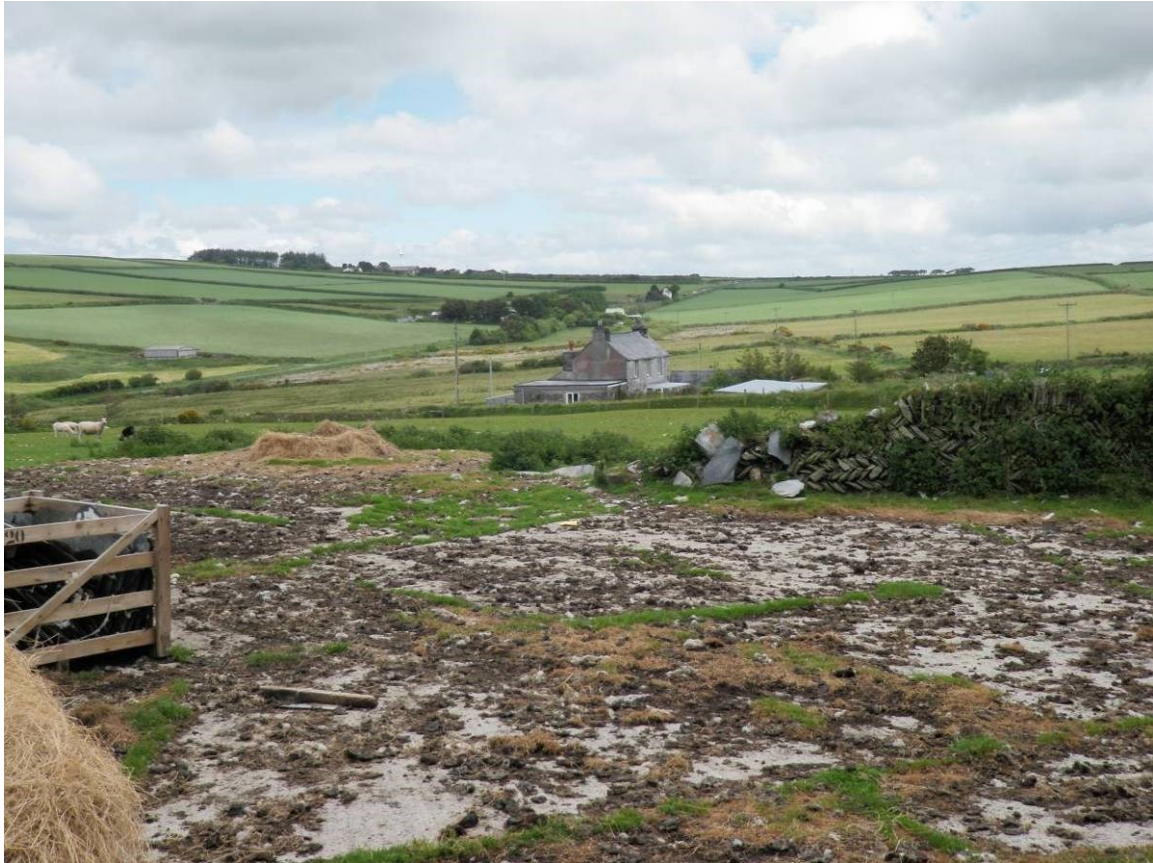
In terms of historic landscape character the farm appears to be in Recently Enclosed Land (land enclosed since the medieval period from former rough ground), being a small farmhouse set in fields with predominantly straight hedges (Fig 19) and with its principal buildings and yard sited over 100m upslope to the southwest.

Fig 19 Context: Penpethy farmhouse, viewed from the farmyard
