Ennor Castle, St Mary's, Isles of Scilly

NHLE 1014994

Conservation Management Plan

Client	Phil and Anthea Roberts
Report Number	2013R034
Date	17 November 2014
Status	Final
Report authors	Adam Sharpe and Charles Johns
Checked by	Andrew Young, HE Projects Officer, Consultees
Approved by	Andrew Young, HE Projects Officer

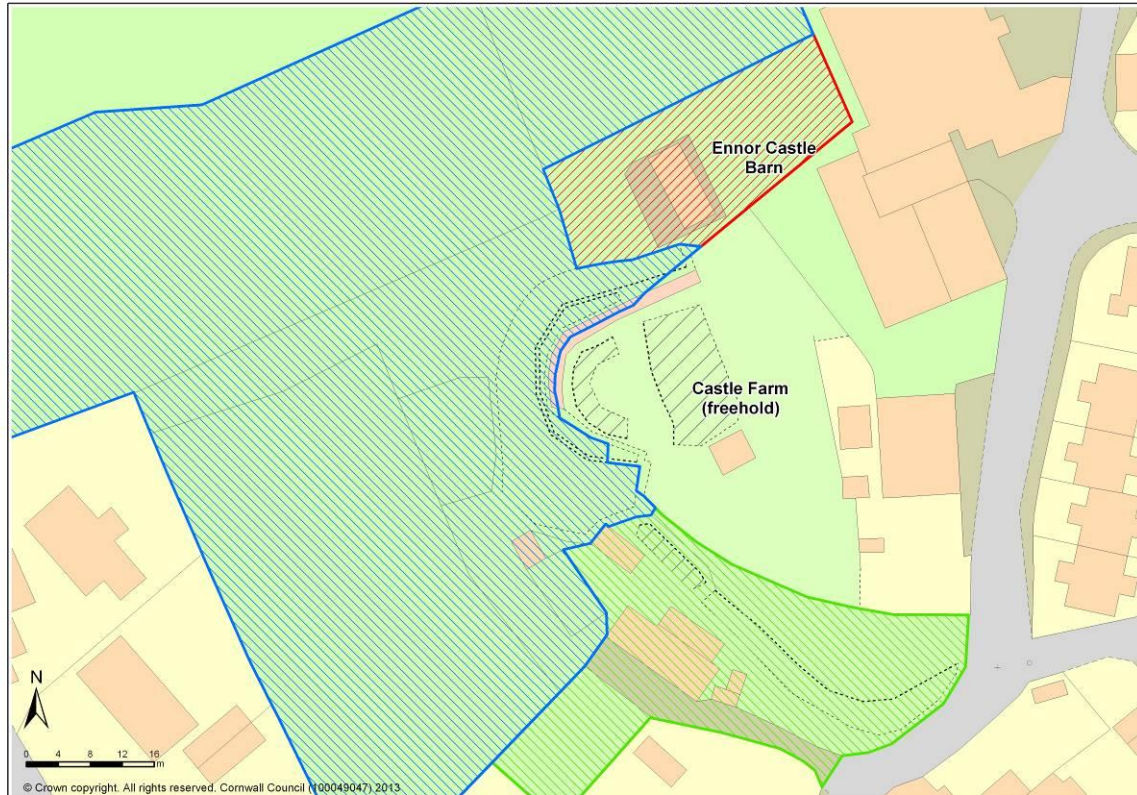
Fig 2 Land ownerships and tenancies at Ennor Castle. Red/Blue hatch — Ennor Castle Barn and extent of area covered by the HLS agreement. Green hatch — Duchy tenancy to the south. Unshaded — Castle Farm (freehold) to the east

See Figure 2 for extents of land blocks and Figures 57 to 60 for general recommendations and Appendix 1 for detailed specifications.

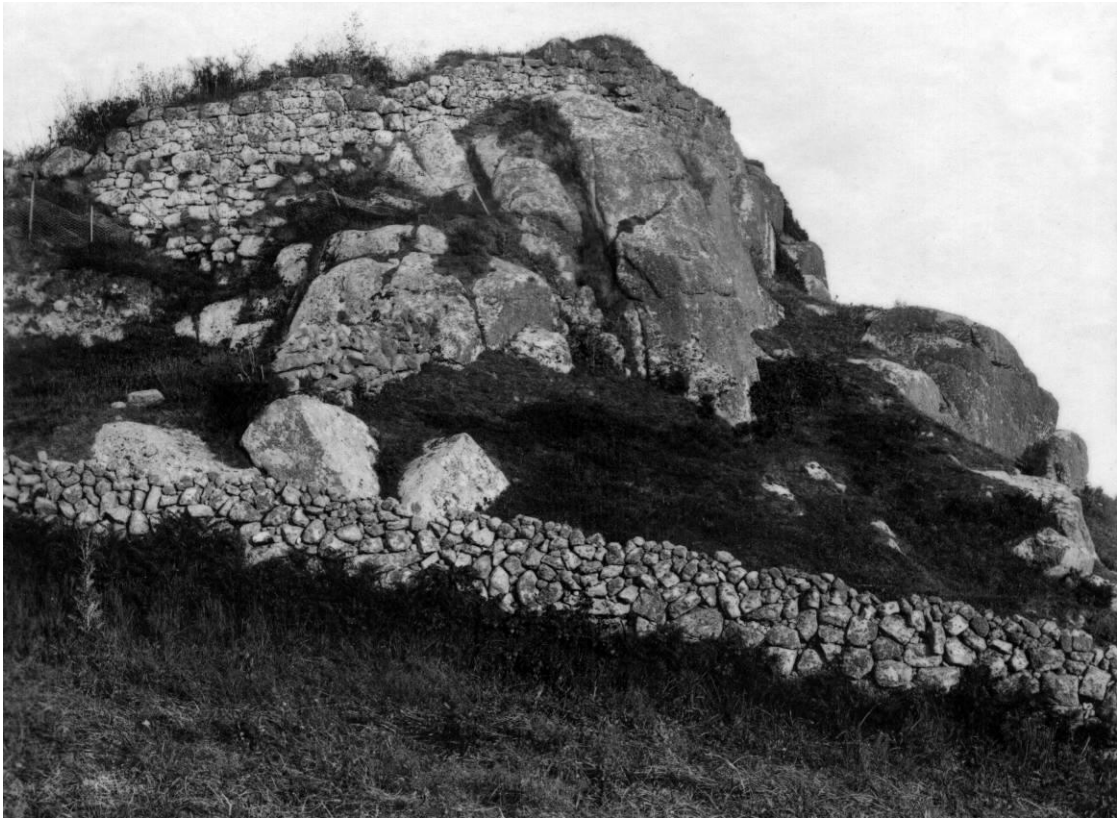
Fig 9 A late 19th century Gibson view of the Ennor Castle site from the west clearly showing the remains of the castle walling, and the absence of trees on the site (Image supplied by kind permission of the Isles of Scilly Museum)

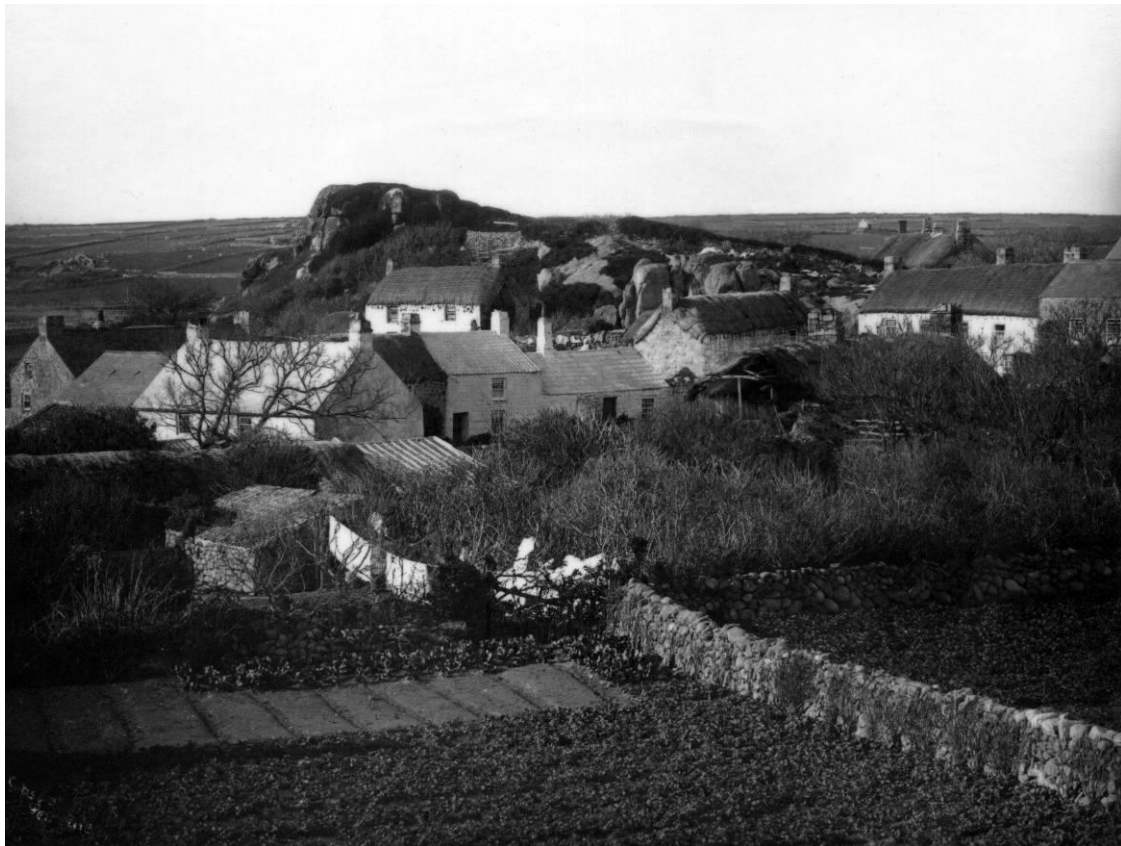
Fig 10 A late 19th century view of Ennor Castle seen across Old Town from the south east, showing the former prominence of the site within this locality. (Image supplied by kind permission of the Isles of Scilly Museum)

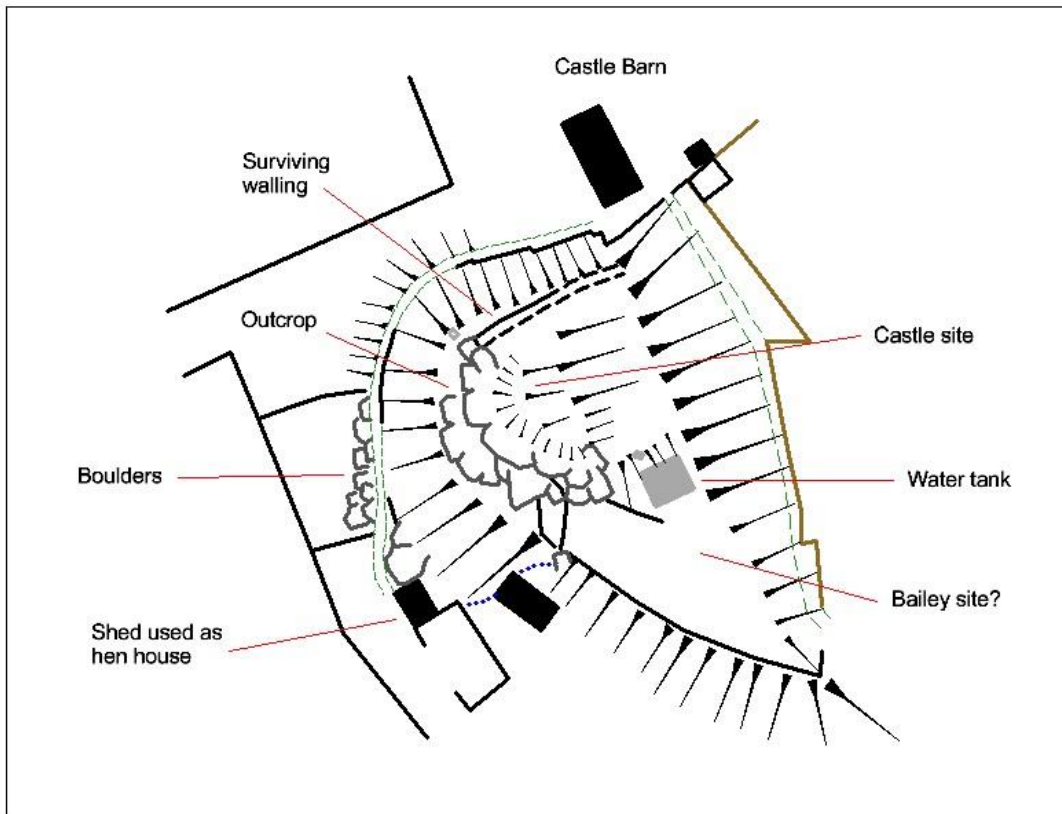
Fig 13 Sketch survey of the Ennor Castle site and its immediate context by HE Projects February 2013. Grey outline – rock outcrops, Black lines – walls, Green dash – paths, Brown – wicket fencing, Blue dots – fence line. Hachures show the slope directions

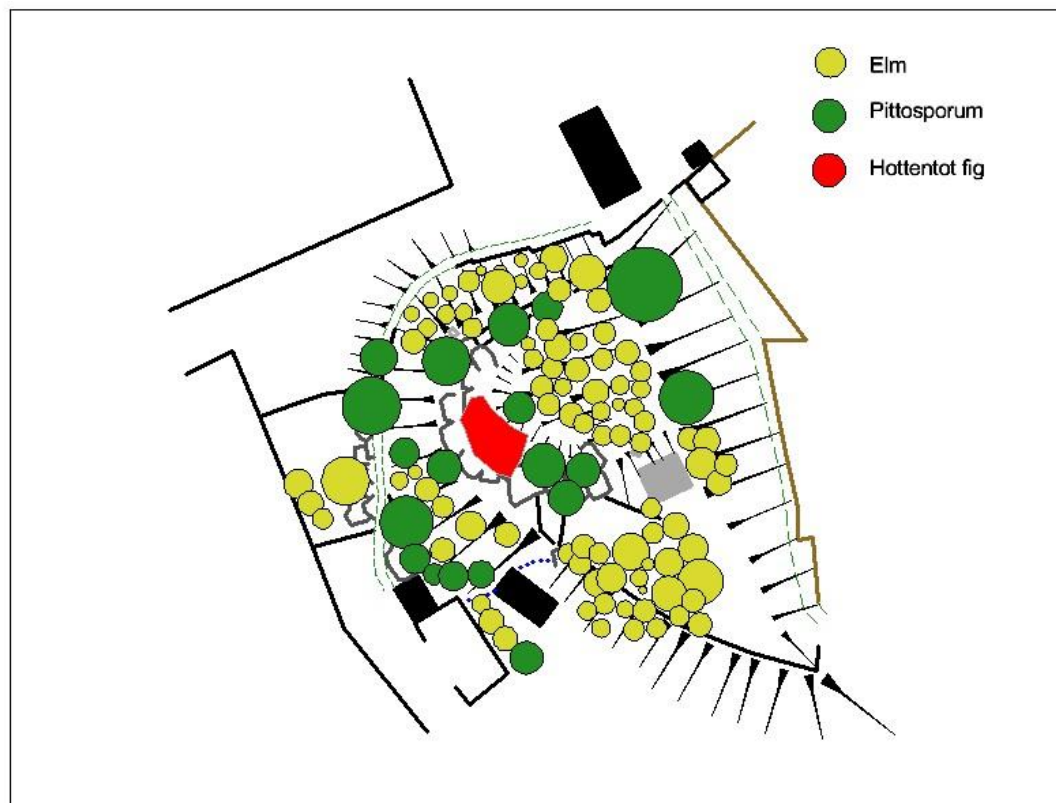
Fig 14 February 2013 sketch survey of the extents of tree cover on the castle mound

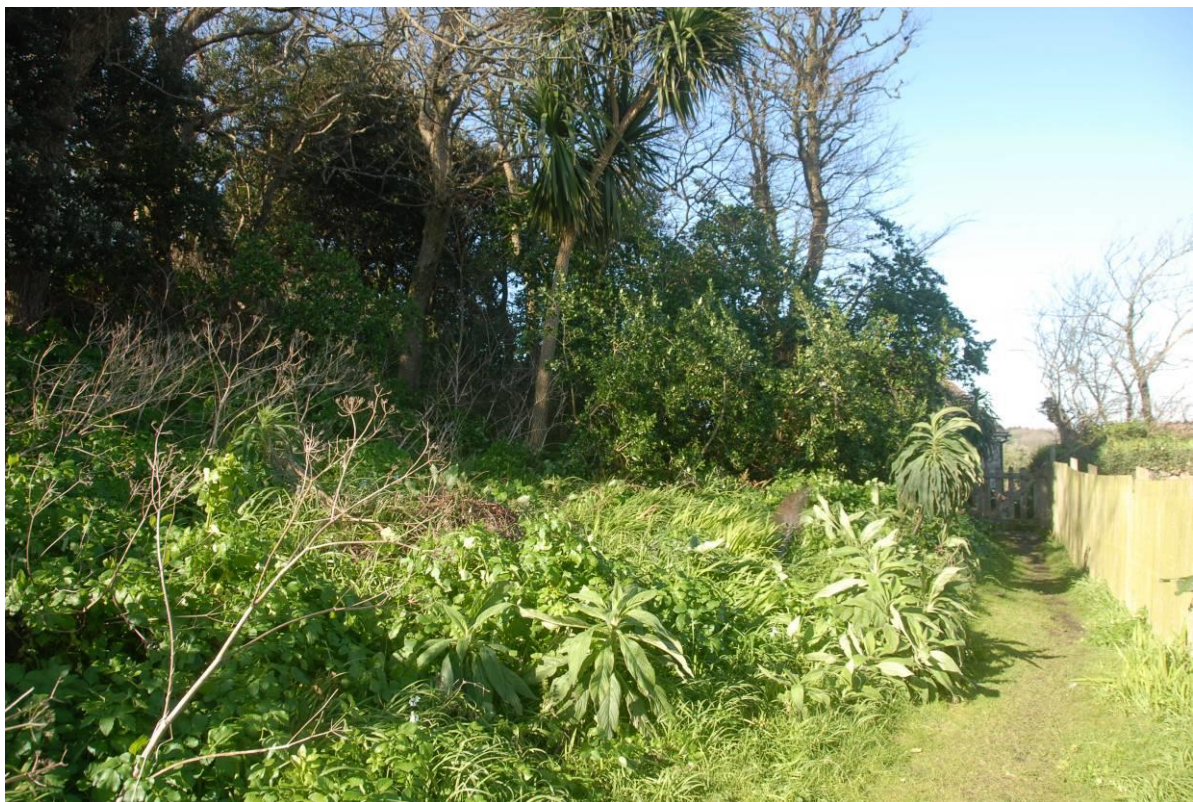
Fig 16 The access to Ennor Castle Barn from the south. The overgrown castle mound is to the left in this view. Note the *Echium pininana*, *Pittosporum* and palm tree

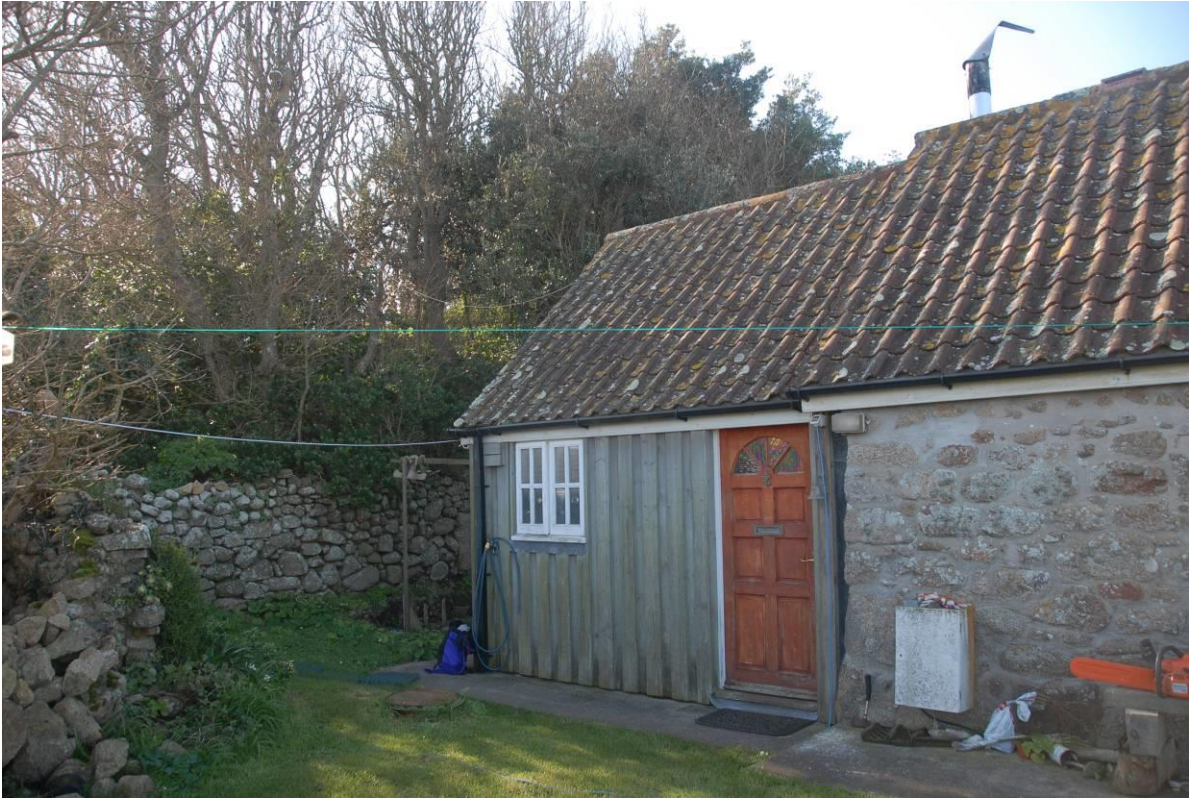
Fig 18 Ennor Castle Barn, with the northern flanks of Ennor Castle immediately behind to the left

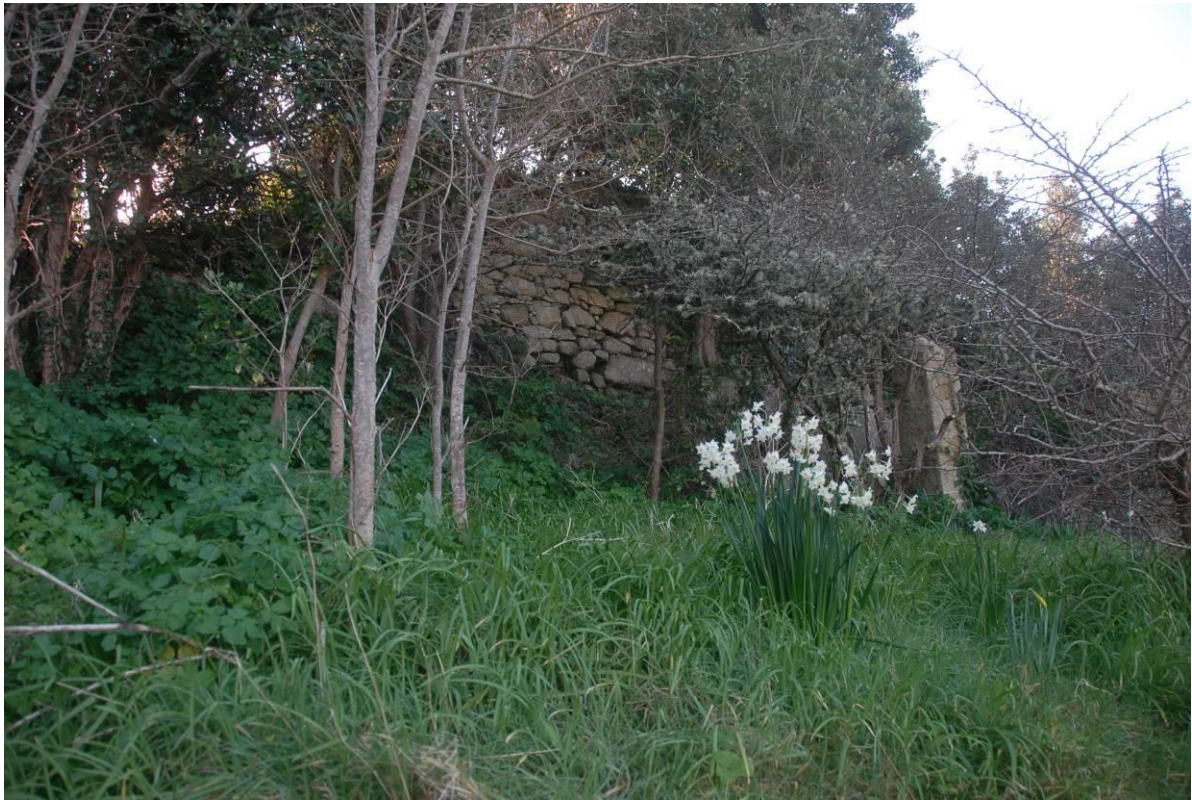
Fig 19 The surviving walling on the northern side of the castle mound

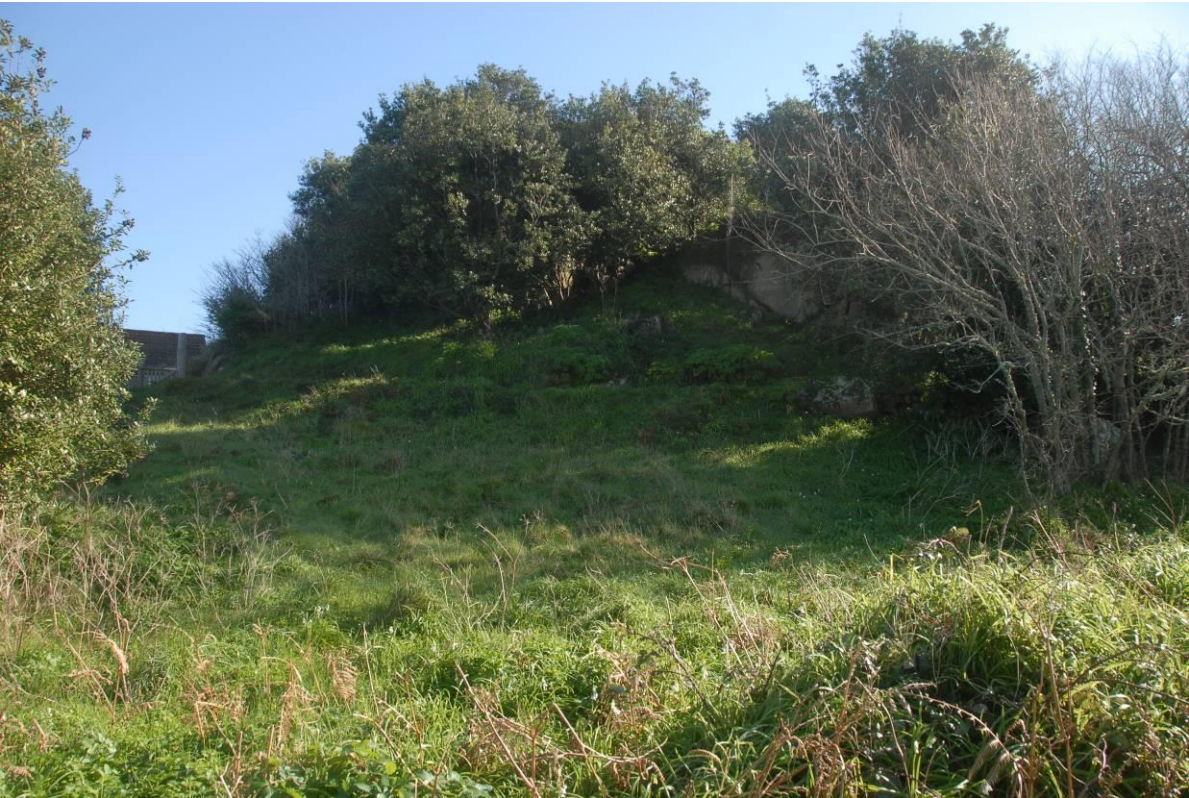
Fig 21 The north-western elevation of the castle mound

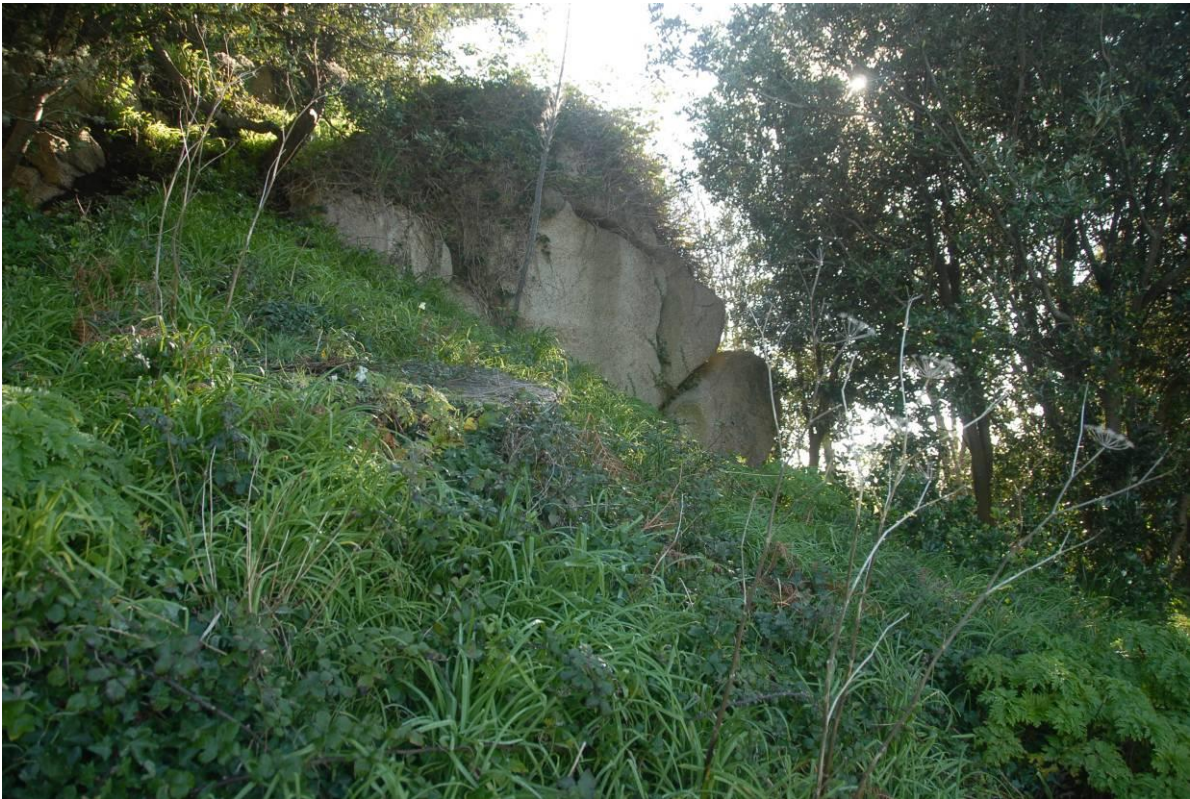
Fig 22 The north-western corner of the castle mound, showing the prominent rock outcrop

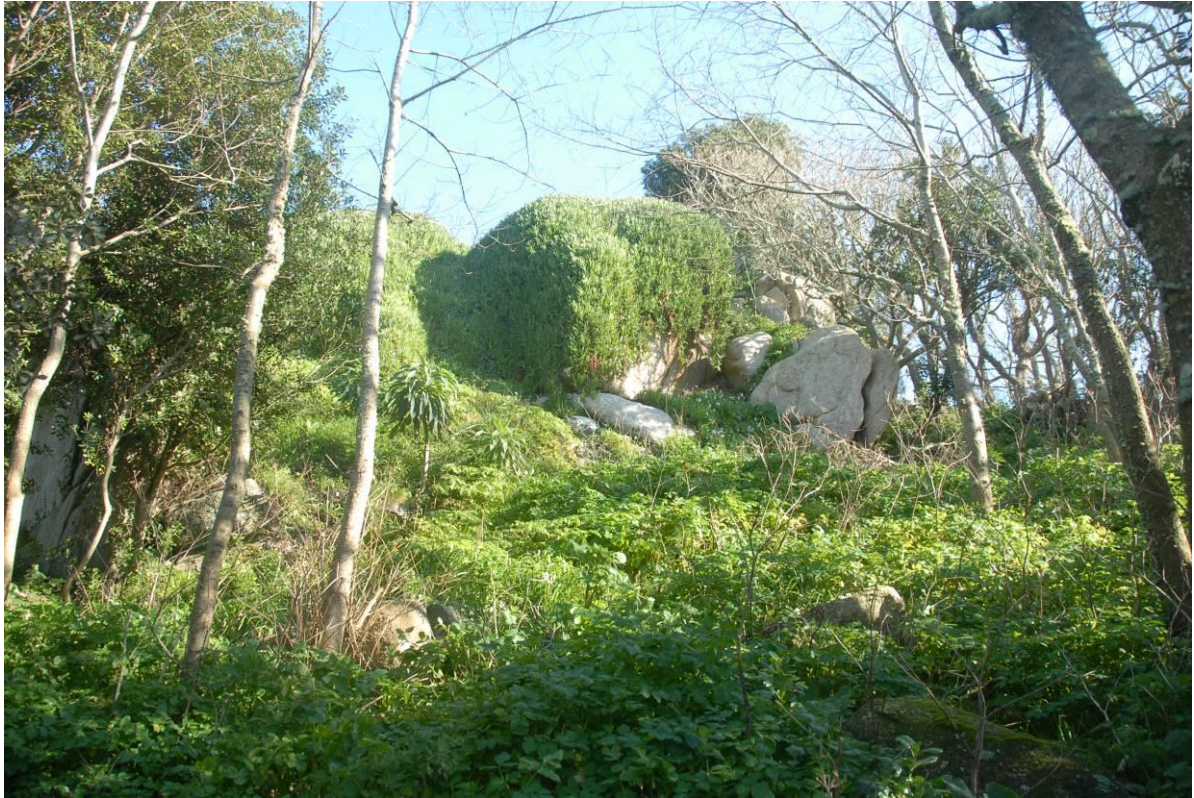
Fig 23 The Hottentot Fig blanketed west-facing granite outcrop formerly surmounted by the shell keep

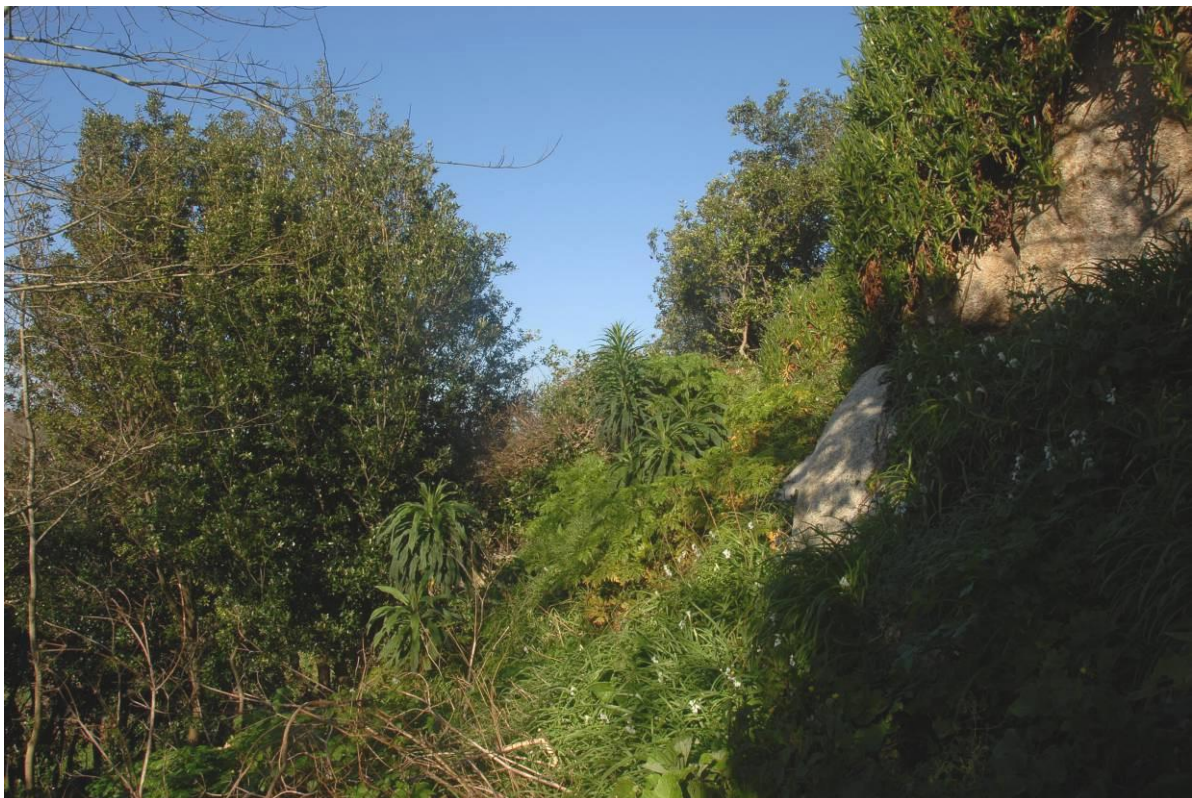
Fig 24 The south-western corner of the castle mound, looking north. Note the Hottentot Fig, Echium pininana, Pittosporum and Three Cornered Leek

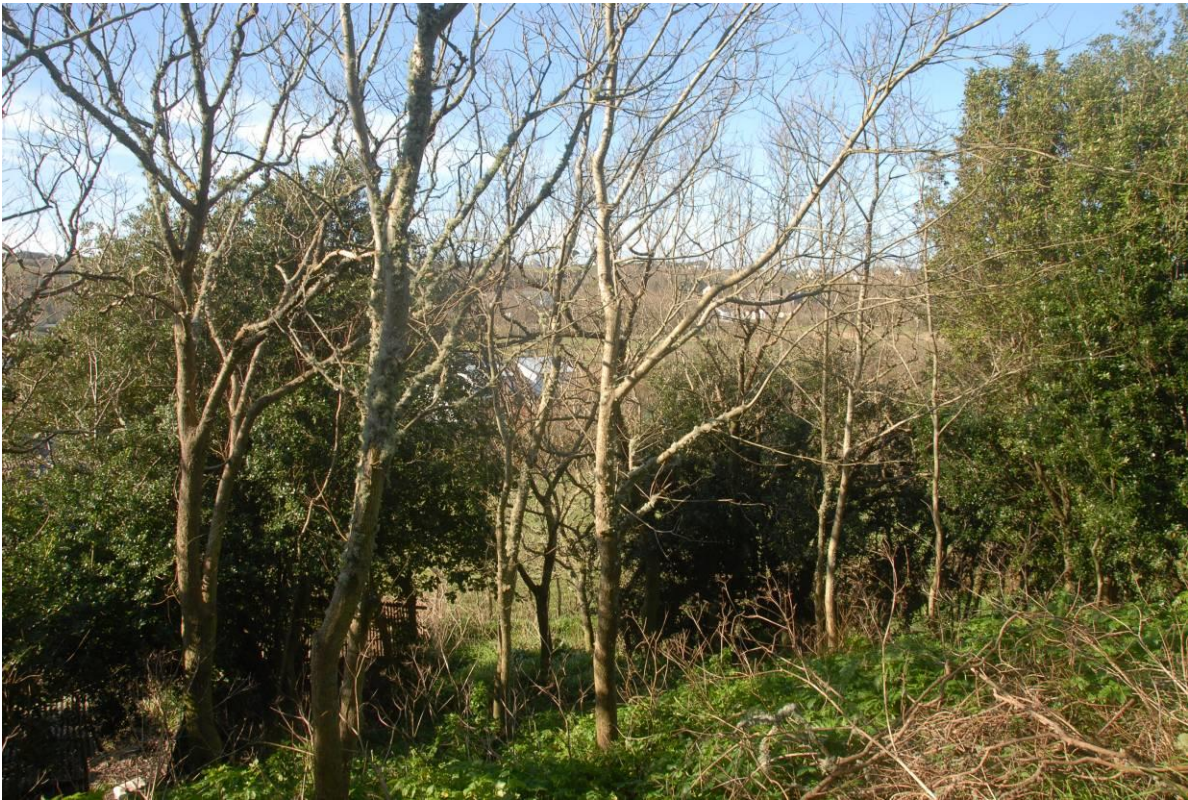
Fig 25 Trees and bushes blocking views north west from the lower flanks of the castle mound

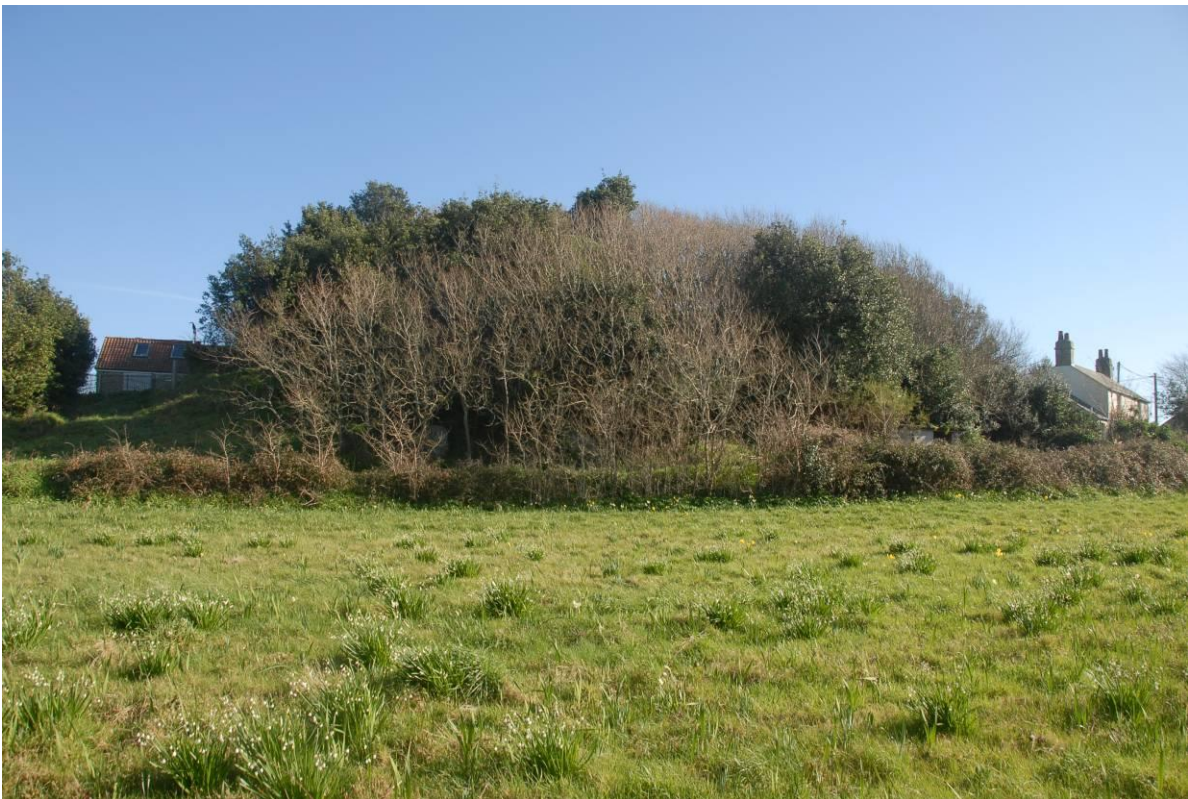
Fig 26 The castle mound from the fields immediately to its south west, emphasising the degree to which trees entirely mask the castle site

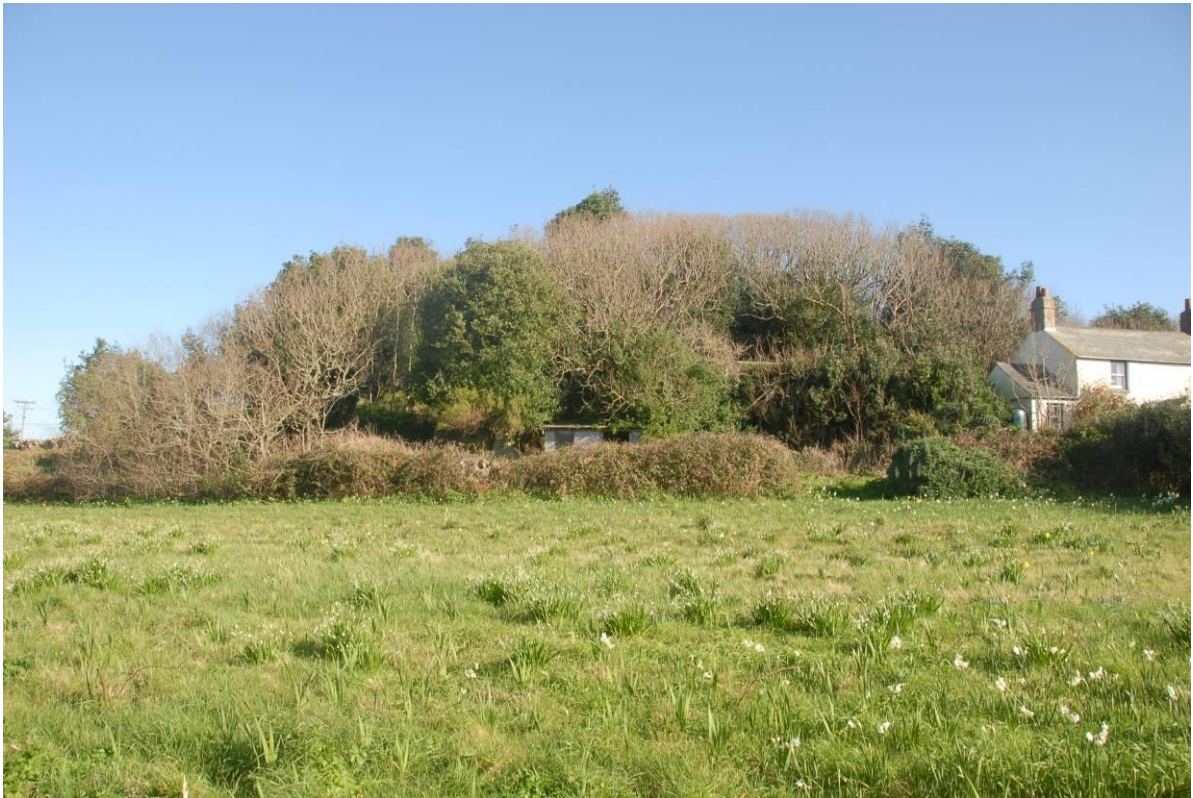
Fig 27 A view of the castle mound from the south west, again showing the degree of tree cover on the castle site

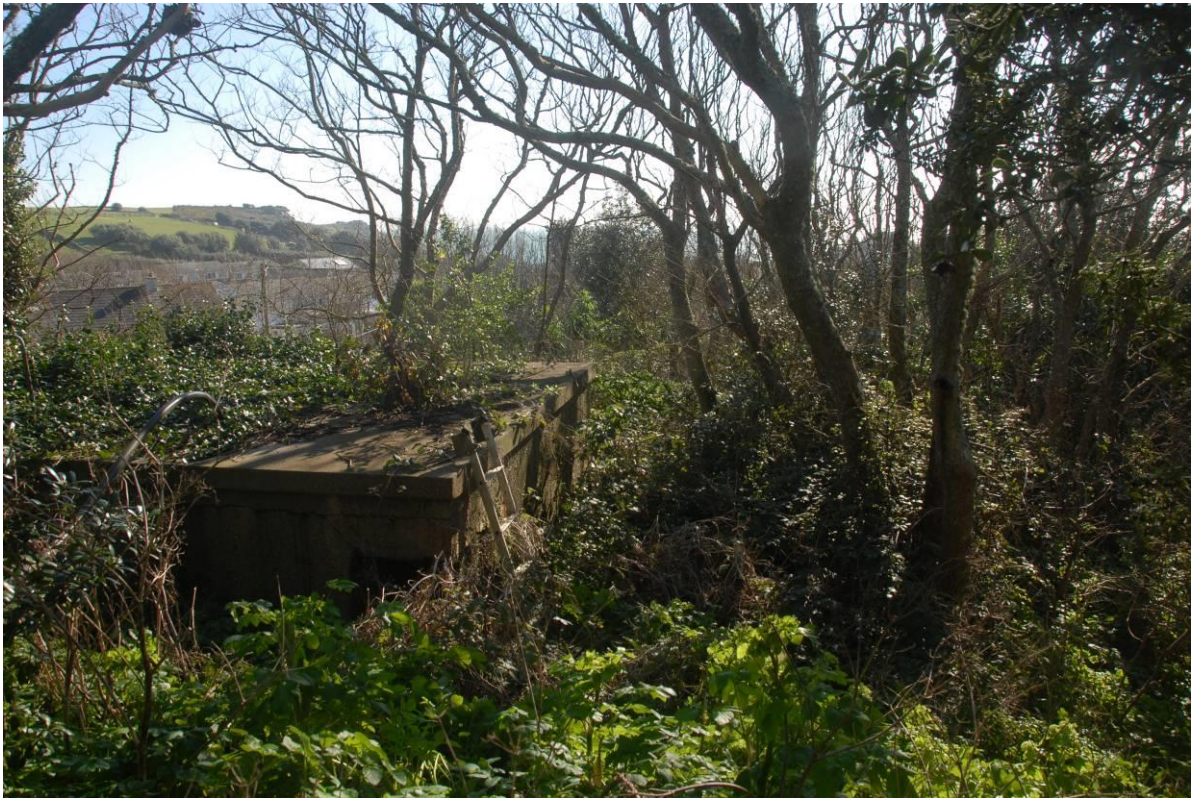
Fig 31 The concrete water tank on top of the castle mound

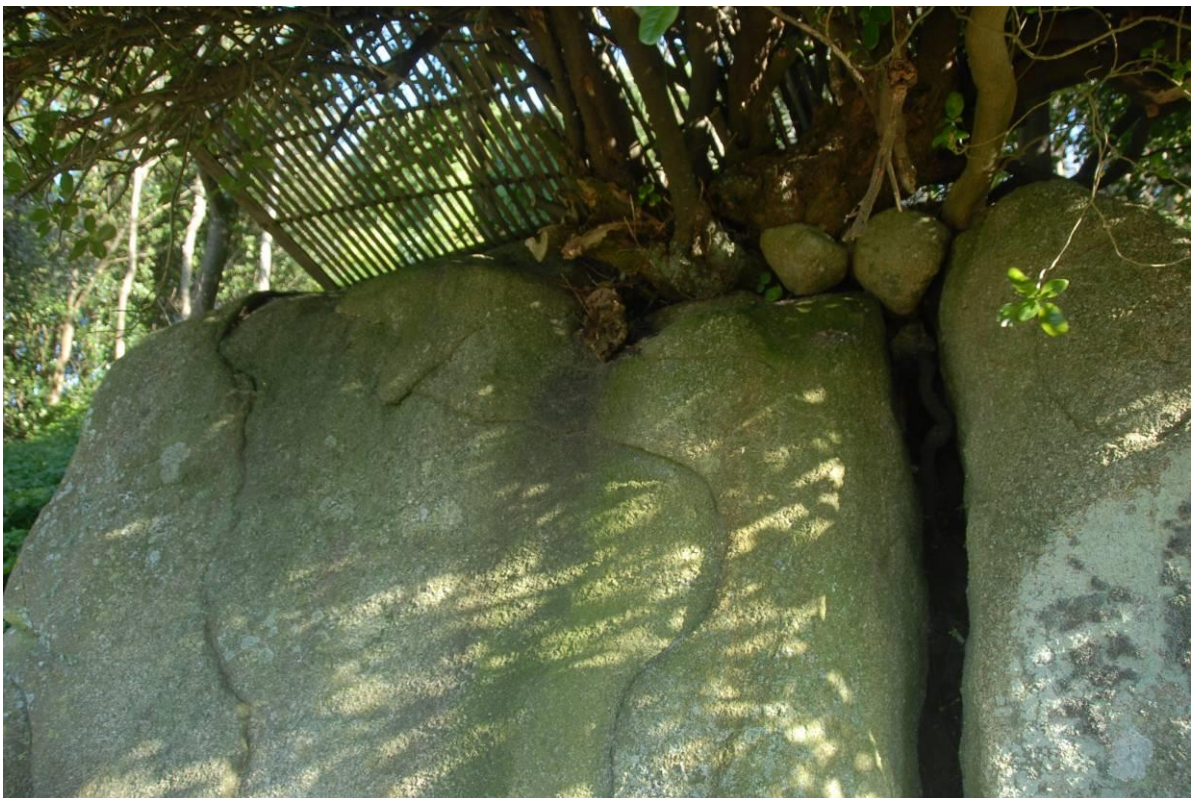
Fig 32 The roots of a Tamarisk which have taken hold in a boulder on site

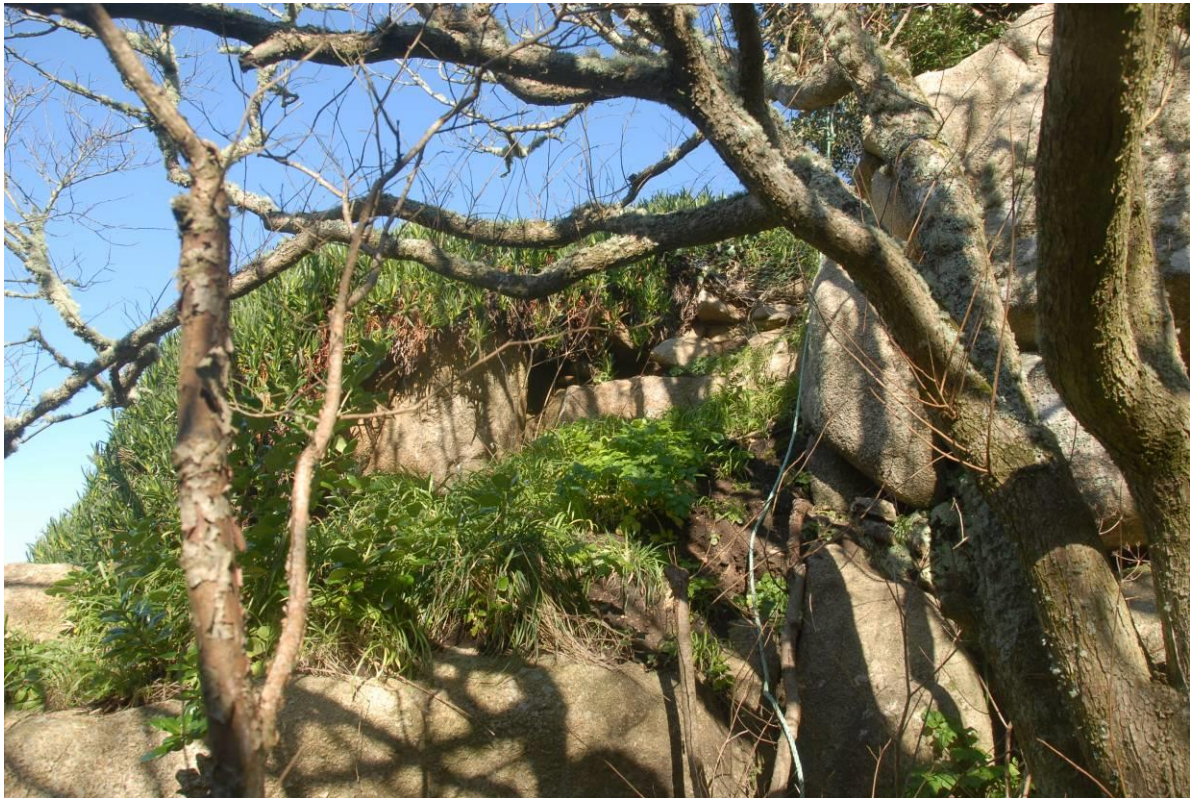
Fig 33 Hints of revetting masonry were found at this location on the upper southern corner of the granite outcrop

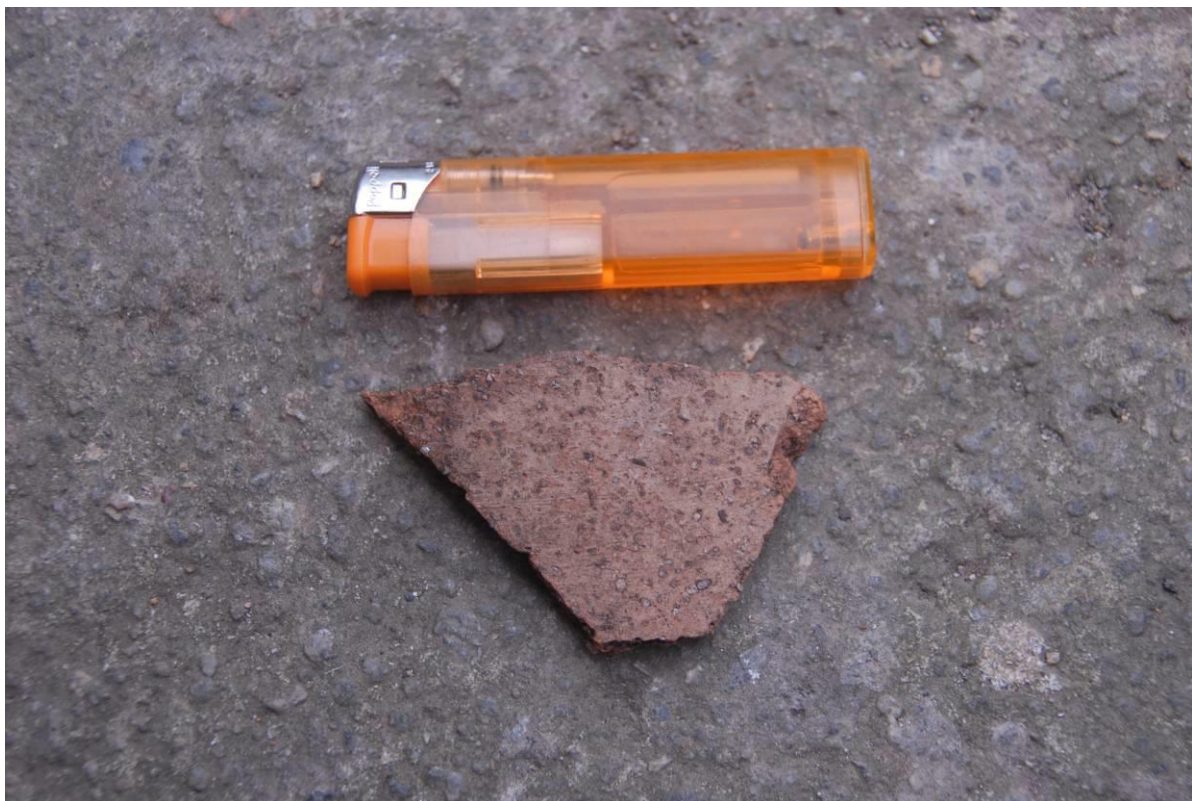
Fig 34 A sherd of medieval pottery found at the surface immediately below the granite outcrop on the south western side of the castle mound

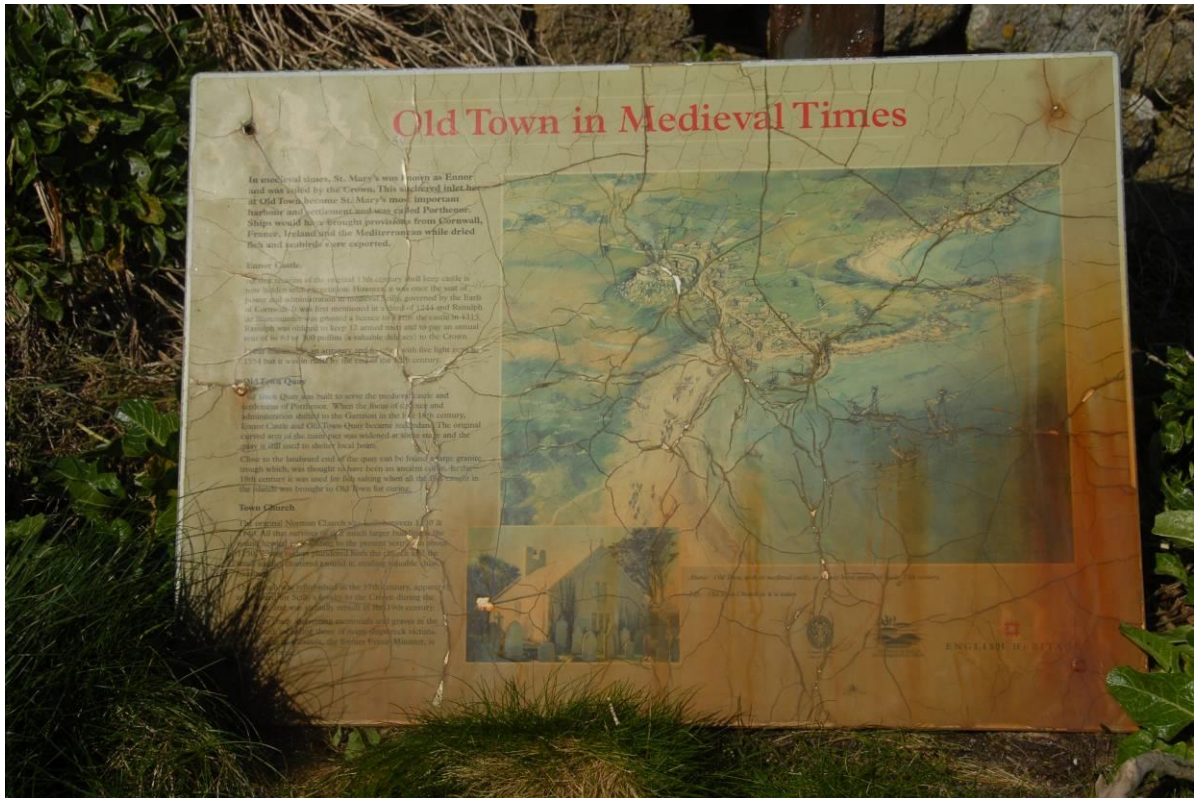
Fig 39 The time-expired interpretation board near the church at Old Town

Fig 60 Other works proposed in the landscape around Ennor Castle — Phase 2 replacement of interpretation board

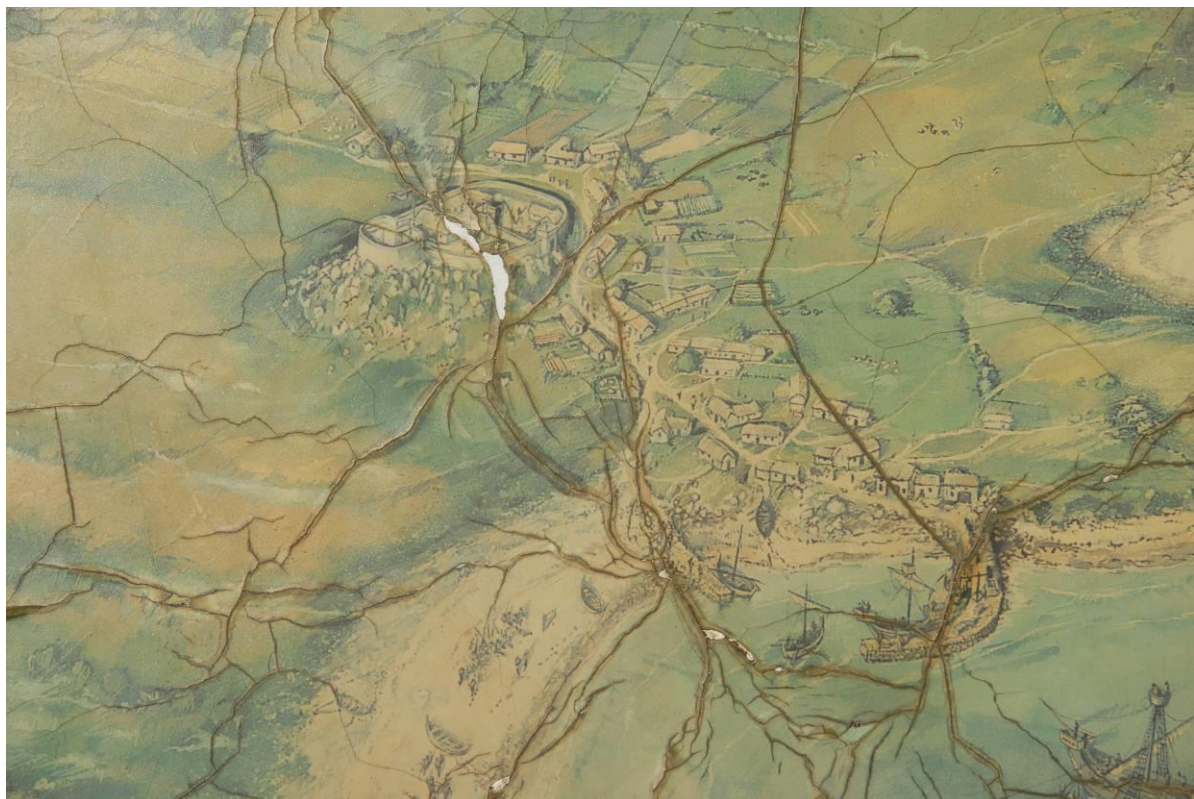
Fig 40 Detail of the interpretation board, showing a reconstruction of the castle, settlement, quay and landing place at Old Town

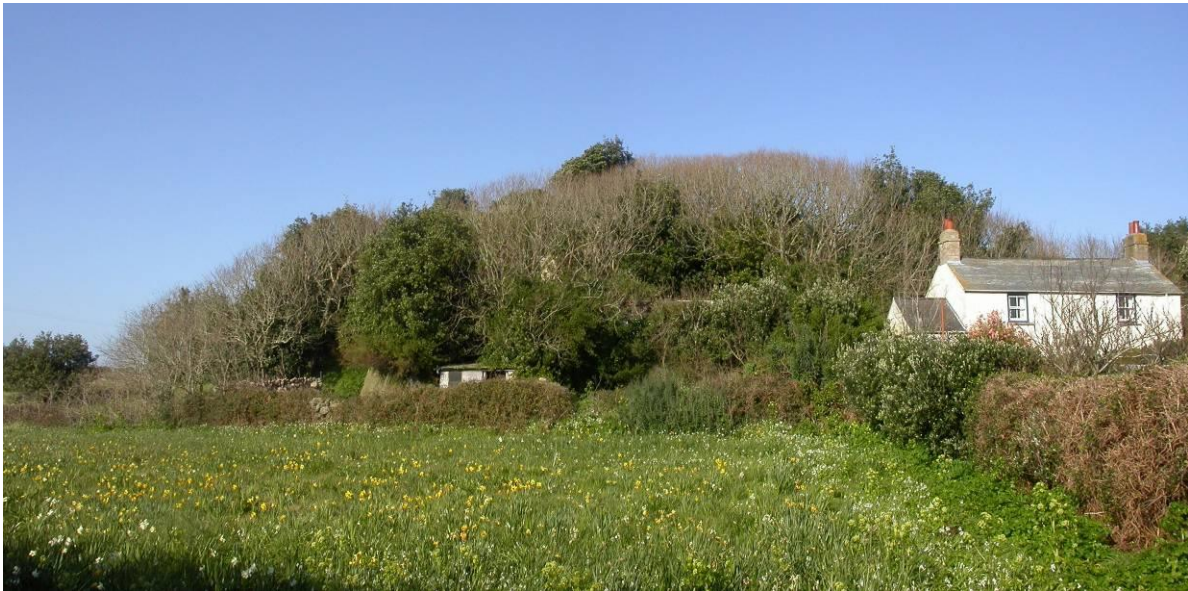
Fig 44 A composite image of the site's west-facing boundary, showing its most visible side, which would benefit considerably from conservation management

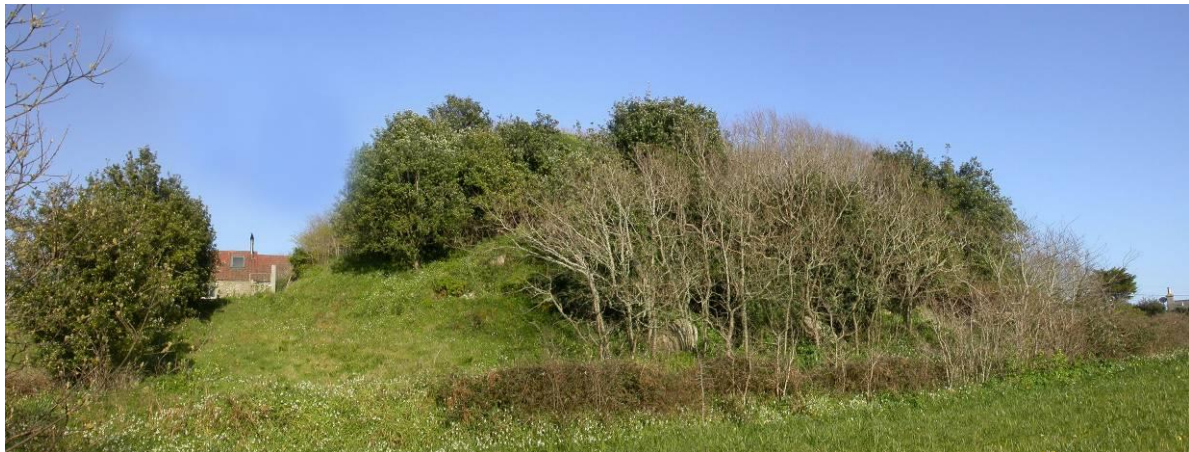
Fig 45 A composite view of the site from the north west

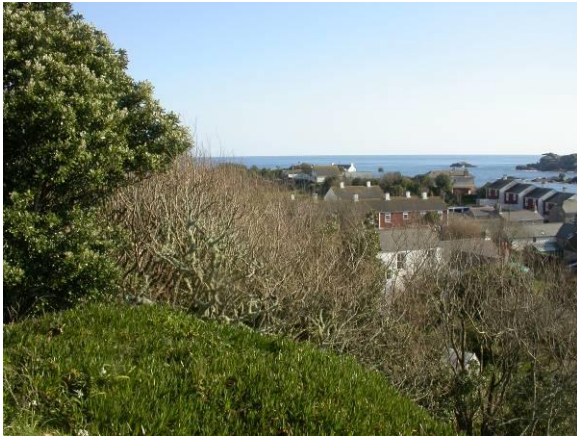
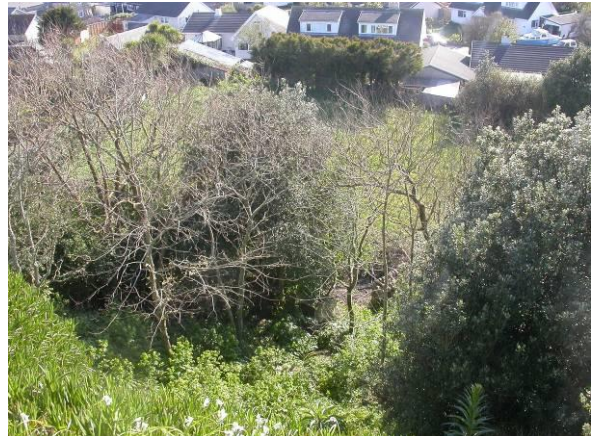
Fig 47 Views out to the south and west from the summit of the castle mound

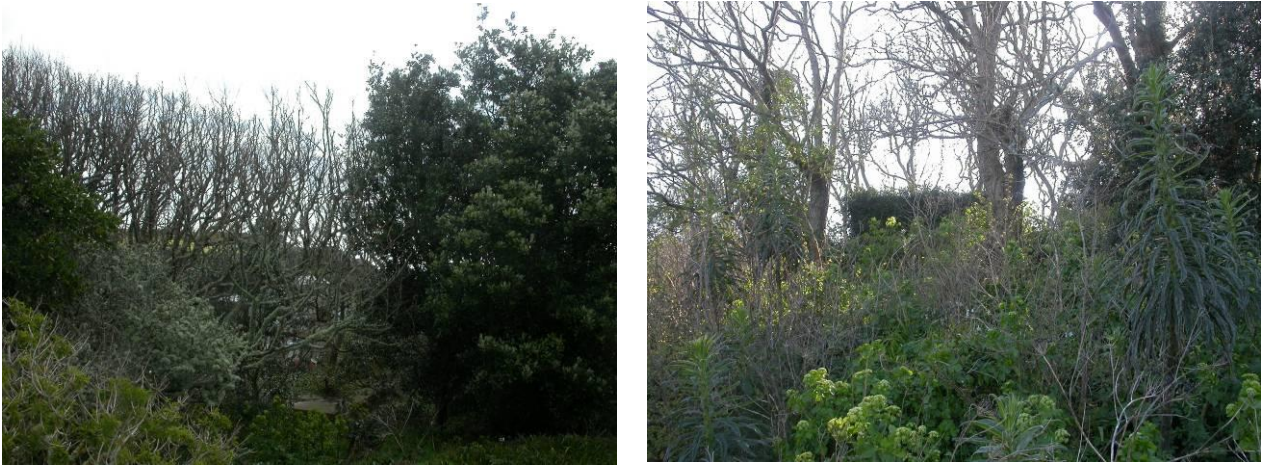
Fig 49 Left; the view looking north off the castle mound summit showing mixed deciduous trees (elm, elder and hawthorn) and non-native evergreens (Coprosma and Pittosporum). Right; the east facing slope showing woodland and understorey including abundant elm suckers and Echim pininana, together with the water tank
