Ennor Castle, St Mary's, Isles of Scilly

NHLE 1014994

Conservation Management Plan

Client	Phil and Anthea Roberts
Report Number	2013R034
Date	17 November 2014
Status	Final
Report authors	Adam Sharpe and Charles Johns
Checked by	Andrew Young, HE Projects Officer, Consultees
Approved by	Andrew Young, HE Projects Officer

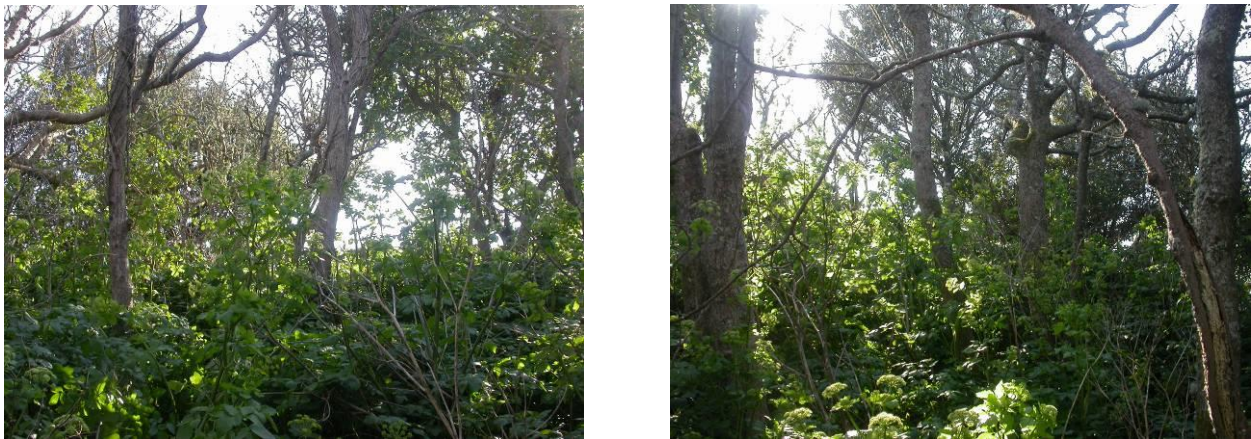
Fig 50 Two views of the area to the east of the summit of the castle mound, showing woodland and understorey, including very abundant elm suckers

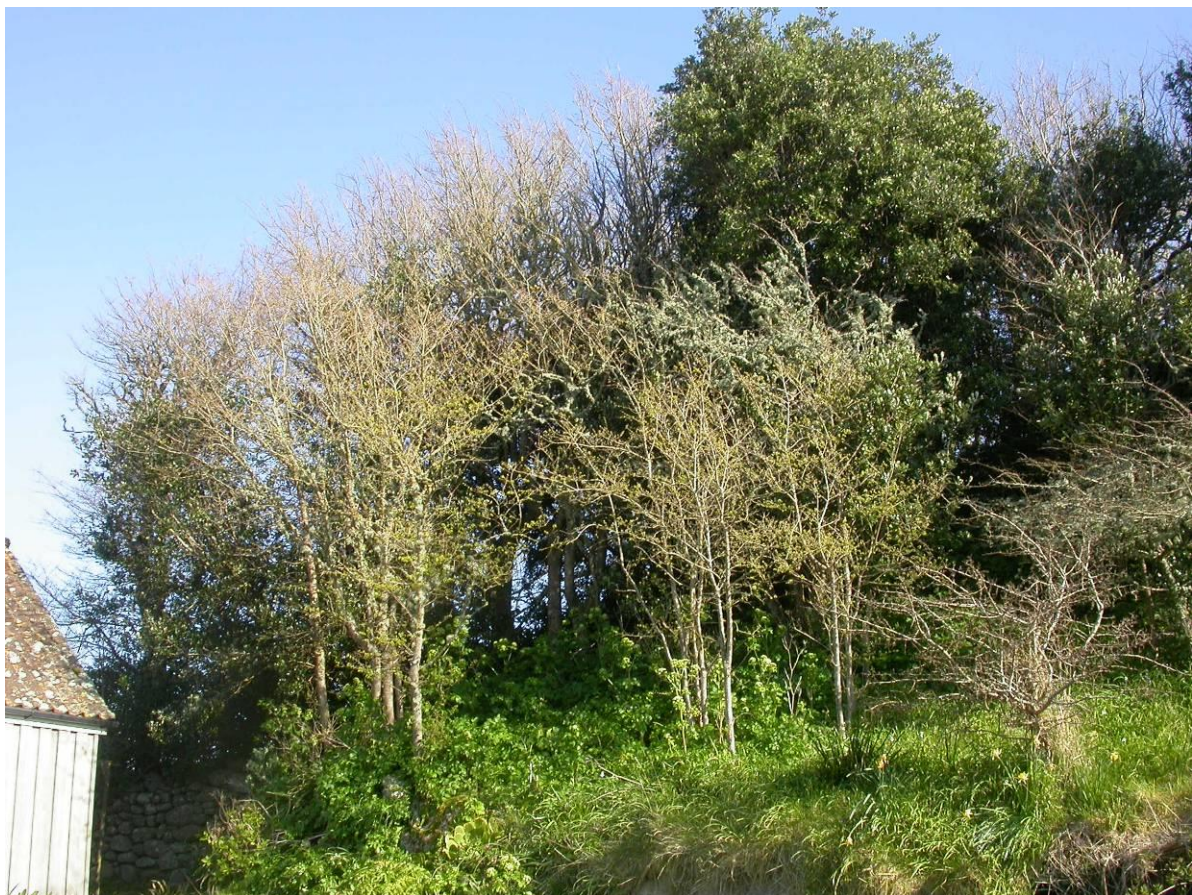
Fig 52 The area of the castle mound adjacent to Ennor Castle Barn showing elm suckers, hawthorns and Pittosporum on the slopes of the mound

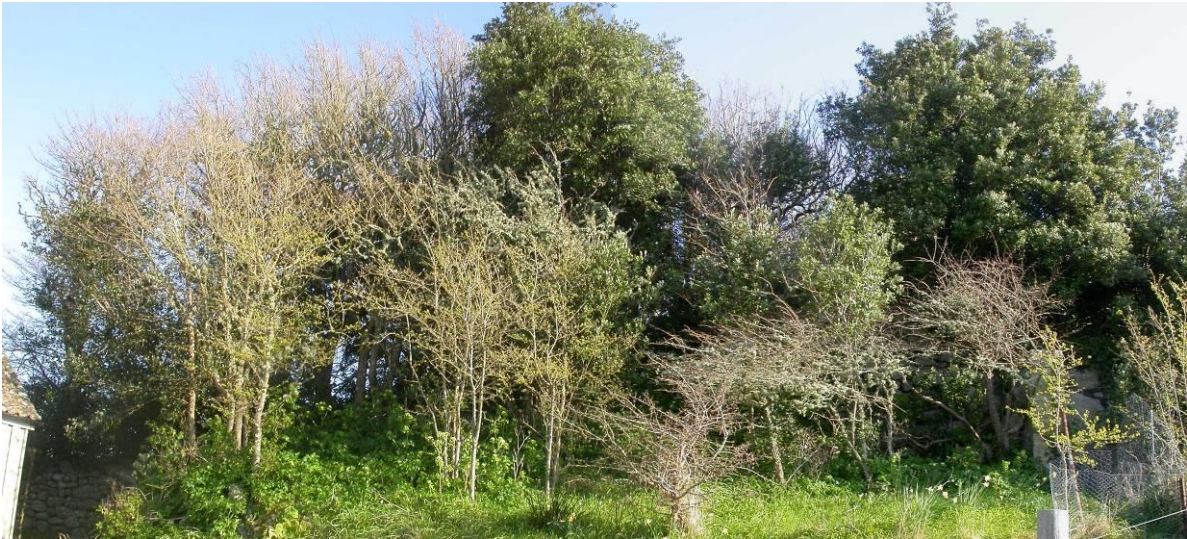
Fig 53 The northern elevation of the castle mound, showing how hawthorn, elm suckers and Pittosporum completely obscure the surviving castle walling

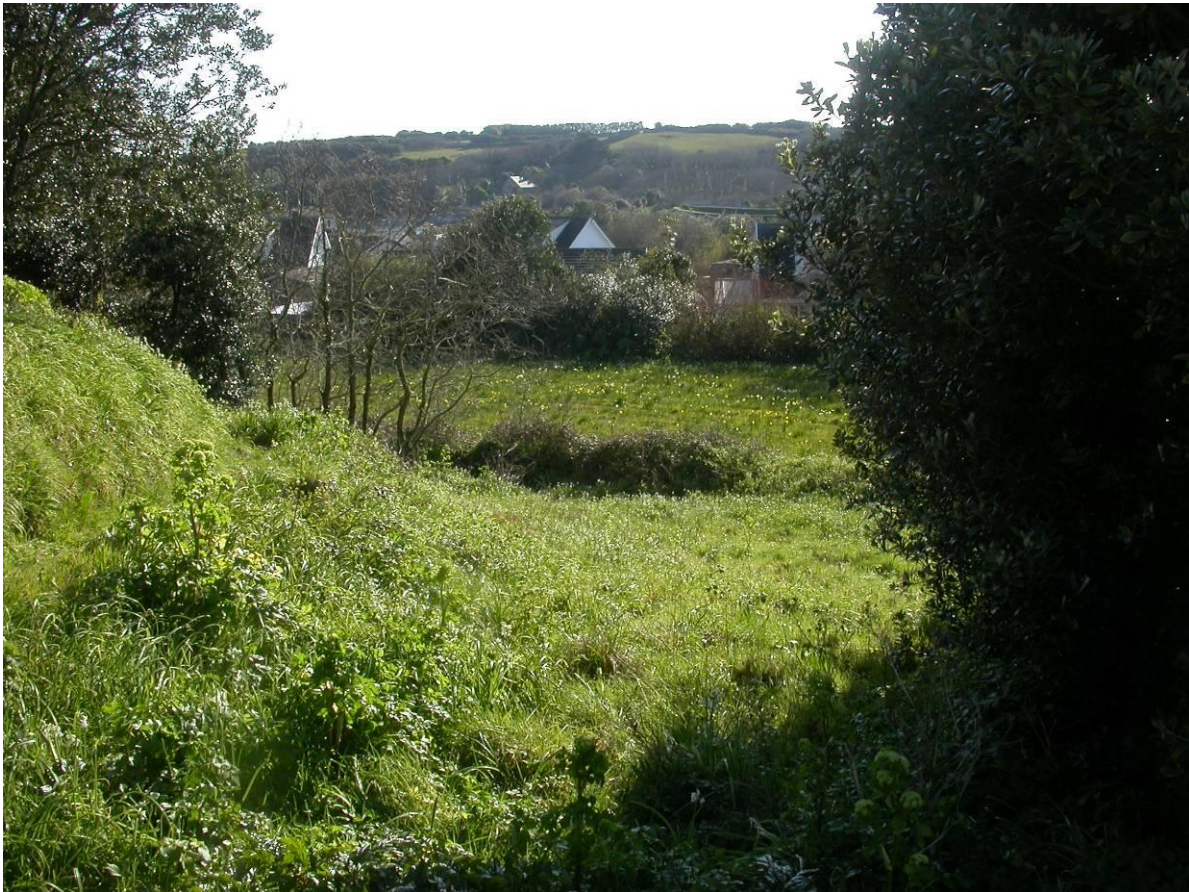
Fig 54 Neutral grassland adjacent to Ennor Castle Barn showing boundary hedge. Habitats here merge with previously cultivated land

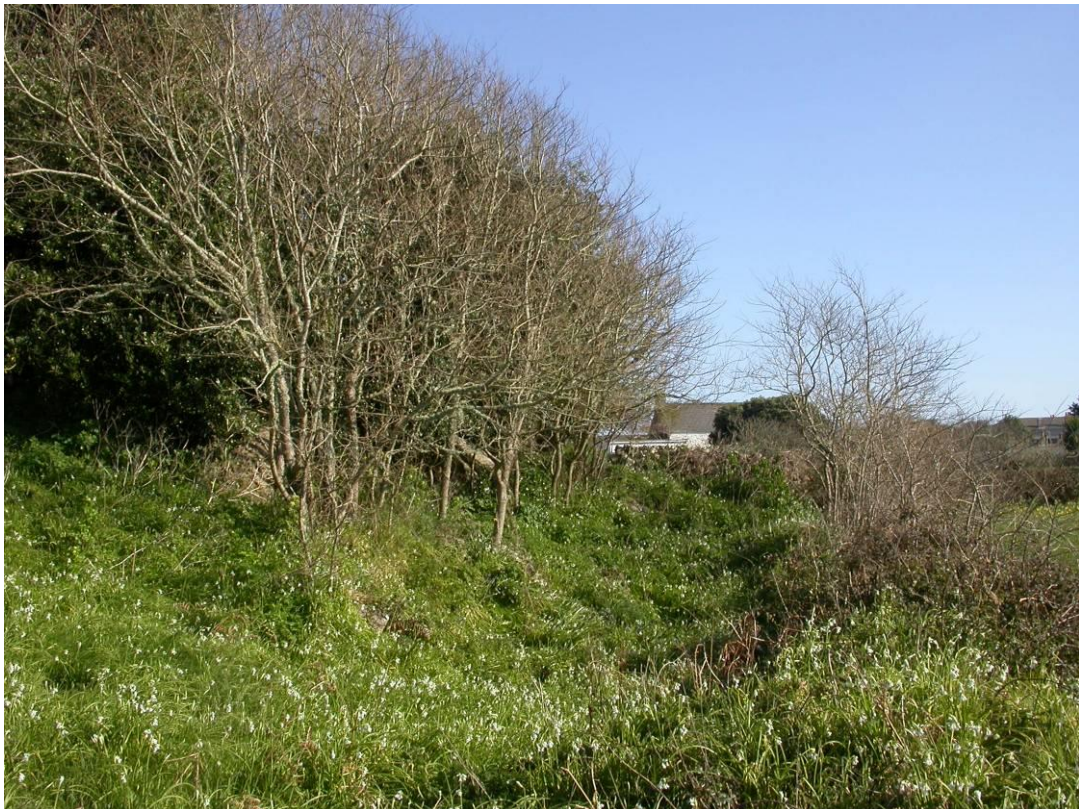
Fig 56 Looking south along the site boundary, the junction between habitats in the cultivated land to the south and those on the castle mound, showing increasing dominance by Three-cornered Leek
