Woolgarden farm buildings, St Clether, Cornwall

Historic building record

Client	Mrs Hazel Smith
Report Number	2013R065
Date	September 2013
Status	Final
Report author(s)	Eric Berry and Nigel Thomas
Checked by	Andrew Jones
Approved by	Andrew Young

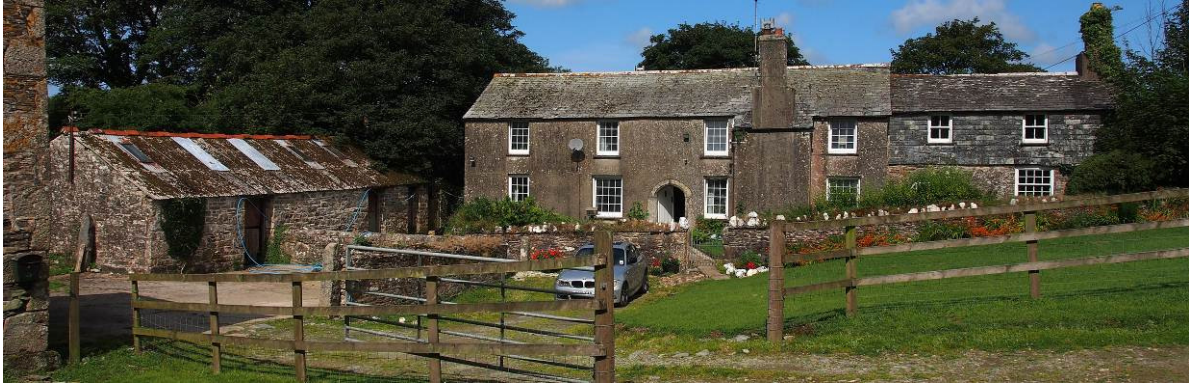
Fig 9 Context: the 17th century Woolgarden farmhouse and 19th century outbuilding

The date of the farmstead is much older. The present farmhouse is possibly late 16th century or early 17th century based on its 4-centred arched moulded granite doorway. A round-arched chamfered granite doorway with the head of the doorway made out of one piece of granite is more difficult to date but must be 17th century or earlier. A well-house (Fig 28) in the forecourt of the farmhouse is evidence for the siting of the farmstead next to a good fresh water supply.

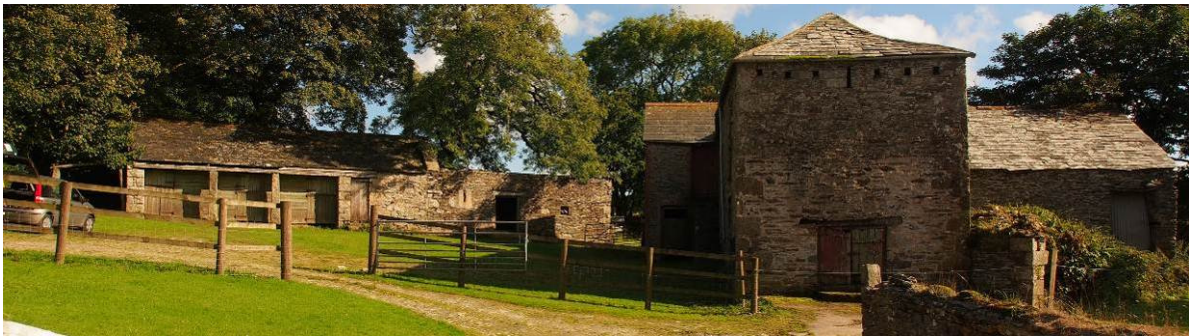
Fig 10 Subject buildings from NW: Barn 1 (right) and Barn 2 (left)

The NNE end elevation (Figs 10 and 24) faces the farmhouse. There is a central slit ventilator under the eaves and a series of pigeon holes to either side. The only other opening is a wide central ground-floor doorway opening (Fig 25) with a low level timber lintel over. The opening has a pair of very old planked doors with old iron door furniture. The right-hand part of the door-frame has internally a series of mortise slots from its original use as the stile of a field gate.

The NNW part elevation (Fig 10) faces the farmhouse. The barn steps located to the right of this walling have been reused to also give access to a loading/access doorway into the upper floor of the extension. Left of the steps and adjoining the left-hand corner of the building is a doorway spanned by a brick segmental arch. This doorway gives access to the ground floor of the extension from the farmyard.

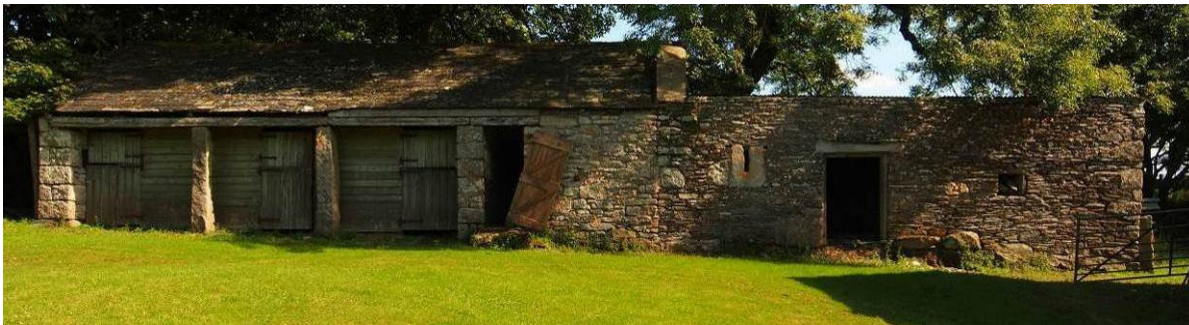
Fig 11 Barn 2: early 20th century cartshed (left) and early 19th century barn (right)

The NW (front) elevation (Figs 11 and 12) is divided into three phase elements. At far left there is the narrow open end of a phase 3 lean-to. Phase 2 right of this is the 3-bay open front of a cartshed plus a stable/loose-box front with a doorway to its left. At far right is the original probable cow-house. This has a doorway left of centre plus a small window opening towards the left that has been reduced in size and a smaller window opening central between the doorway and the right-hand corner. The wall has been underpinned for much of its length following slight lowering of the yard level possibly caused by tractor-powered yard cleaning. Adjoining the west corner of the building is a granite monolith gate-pier, one of two relating to a gateway into the farmyard, the other post adjoining the SE corner of the early 20th century 2-storey extension to Building range 2.

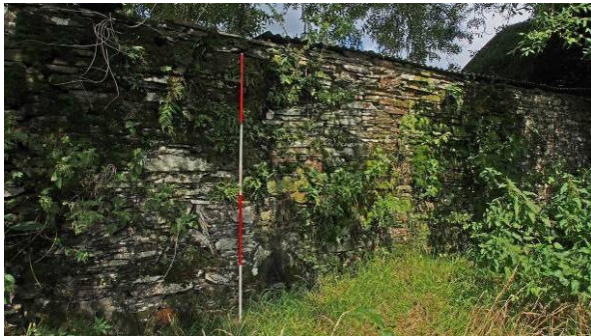
Fig 13 Barn 2 from south

The rear (SE) elevation of the phase 1 building (Fig 13) has been reduced in height when the roof was altered. The only openings are three triangular ventilators formed with slatestone.

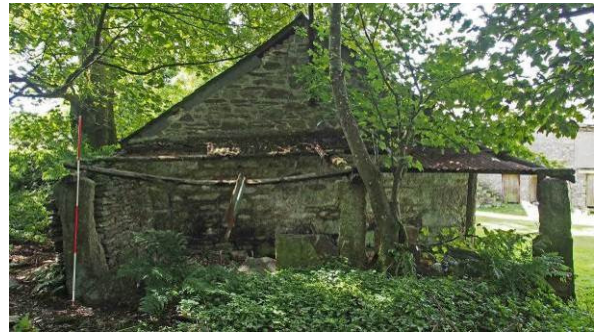
Fig 17 Lean-to from NE

The implement shed at the NE end of the overall building (Fig 17) has a 1-bay open front. The NE side is carried on three granite monoliths (2 bays) with a low wall of slate monoliths between the granite posts. A timber wall-plate carries the edge of the roof.

The phase 3 cartshed (Fig 17) has the remains of a rough-timbered roof comprising principal timbers and purlins.

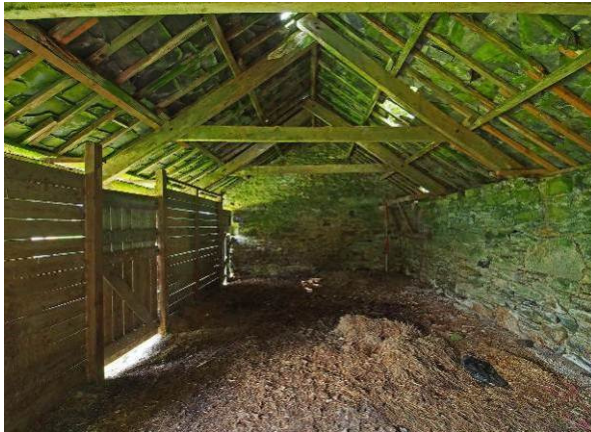
Fig 14 Cartshed interior from SW

The phase 2 cartshed (Fig 14) has a keeping place in its NE wall near the front. A rough opening high up in the SW wall enabled communication with the adjoining loft above the stable-loose box. A modern timber-framed structure with horizontal boarding has been built set-back from the original granite posts of the open front. The original 4-bay roof structure survives, the collars and apices fastened with iron bolts.

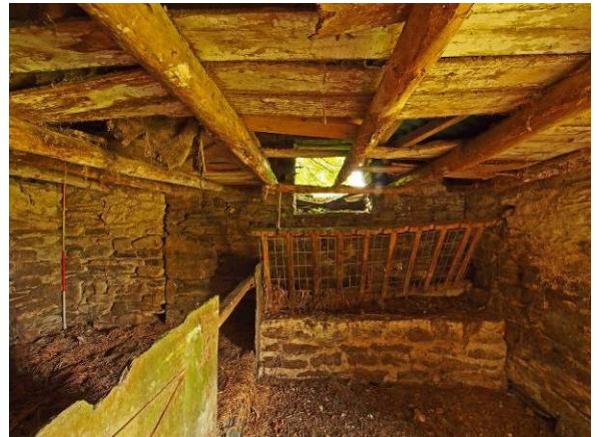
Fig 18 Early 20th century stable interior

The original NE gable end (Fig 18) retains a central loading doorway and is now the party wall with the phase 2 stable/loose box.

The phase 2 stables/loose box has a low slate-slab partition between the front and rear parts of the building and an old hay rack built over a stone base to its SW wall within the front part. There is a hay or straw-storage loft above with rough boards supported on pole joists that run along the length of the building. An original loading doorway belonging to the phase-1 part of the building (Fig 18) is visible between the floors. The original 2-bay roof structure with A-frame trusses survives above.

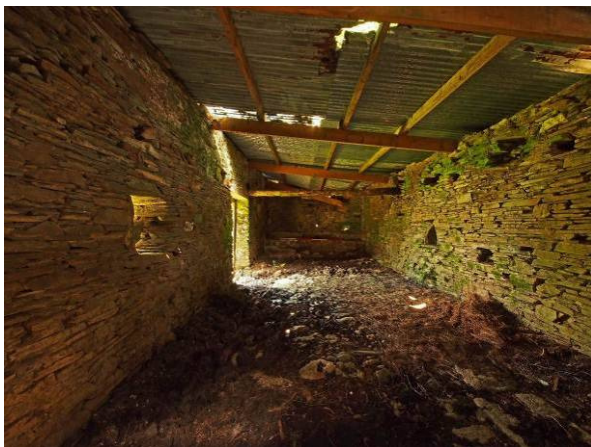
Fig 15 Barn 2 interior from SW

The phase 1 building interior (Figs 15 and 19) has a cobbled floor with evidence for a trough base against the rear wall and a drain parallel to the front wall. There are rough-hewn timbers that formerly carried some sort of loft floor. A large probable beam socket (Fig 20) in the front wall has no similar beam socket opposite in the rear wall. Three triangular vents in the rear wall are each constructed from three pieces of slatestone (Fig 16).

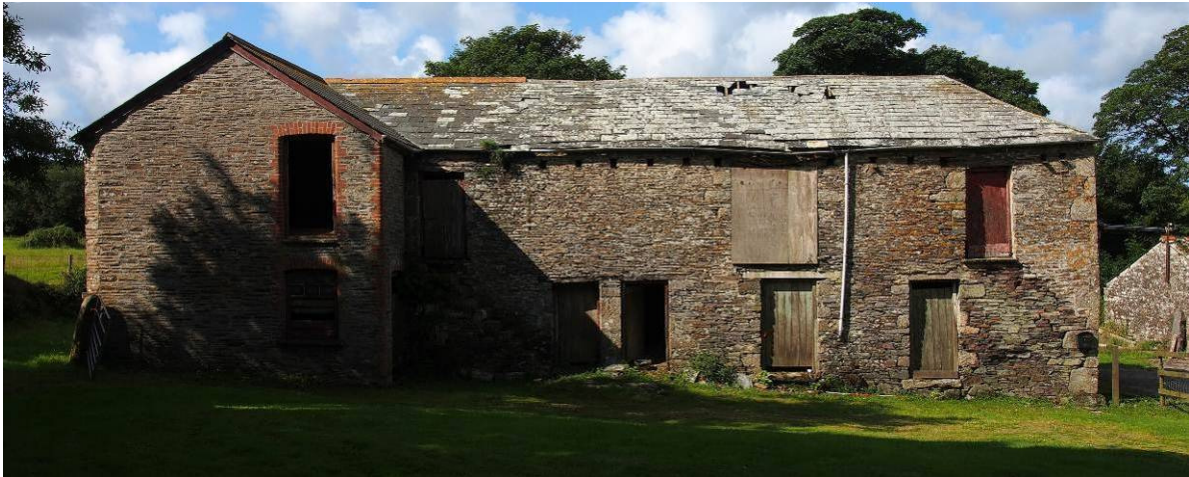
Fig 21 Barn 1, extended to the left in the early 20th century

The original barn has an ENE front (Fig 21) with an irregular disposition of openings related to the function of the various parts of the building. At far left is a straight flight of stone steps built against the front wall and leading up to a loading/access doorway to the loft. Immediately right of the steps on the ground floor is a pair of doorways. The left-hand doorway provides access to the loose box; the other doorway was designed as access to a feeding passage. Right of centre to the front is a slightly wider doorway that was designed for animal access to the central aisle between rows of stalls. Above this doorway and wider to its left is the wide front doorway of the threshing floor. Towards the right of the front is a further narrow doorway that was designed to give access to another feeding passage at the northern end of the cow-house. At first-floor level at far right is a loading doorway with original planked and ledged door, the doorway designed for loading sacks of grain into or from the granary part of the loft. Much of the masonry near the right-hand corner of the building has no pointing mortar. Masonry above this has later pointing. The walling in this general area has been the subject of some structural movement and the difference in the character of the wall surfaces is probably as a result of attempts to rectify or stabilise the movement. Under the eaves is a series of pigeon holes.

The ENE elevation (Fig 21) has two openings towards the right: a loading doorway at first-floor level and an original window opening at ground-floor level. Each opening is spanned by a segmental brick arch. The window is original and has a 6-pane top-light and adjustable wooden louvers below. The masonry of the left-hand corner of the extension is chamfered, most likely associated with a gateway close to the building.

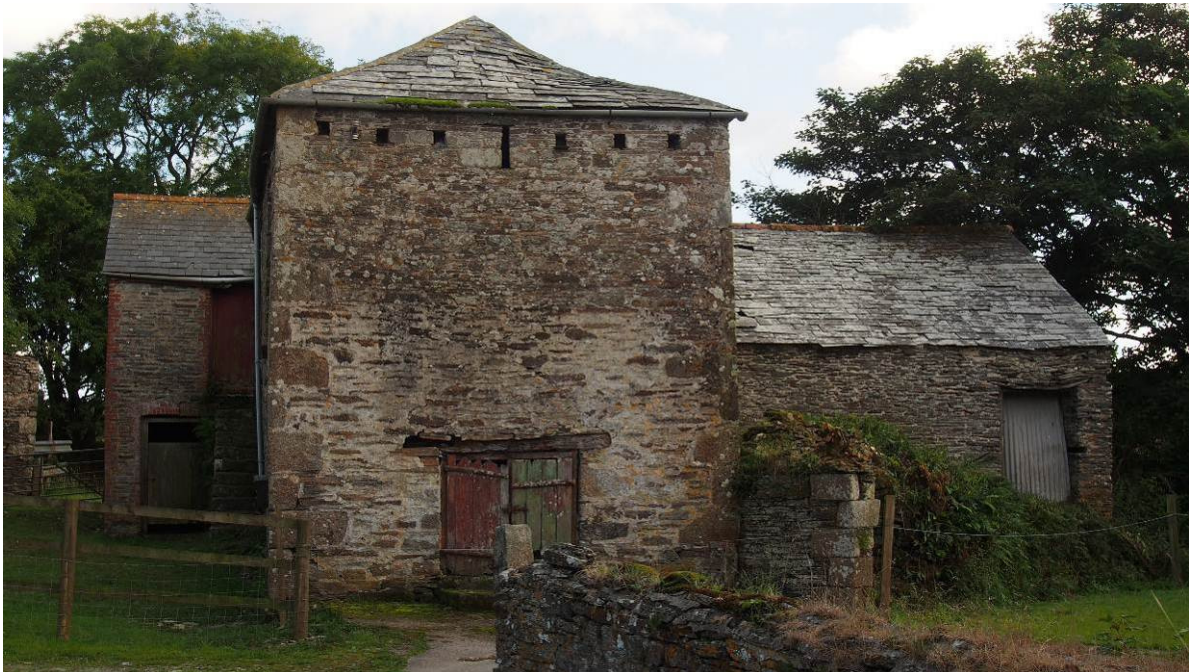
Fig 22 Barn 1 NNW end with goose-house doorway, and horse-engine house on right

The NNW elevation of the horse-engine house (Figs 22 and 24) has a blocked doorway at far left and another doorway at far right with a failed timber lintel above, each doorway relating to phase 2 of the horse-engine house.

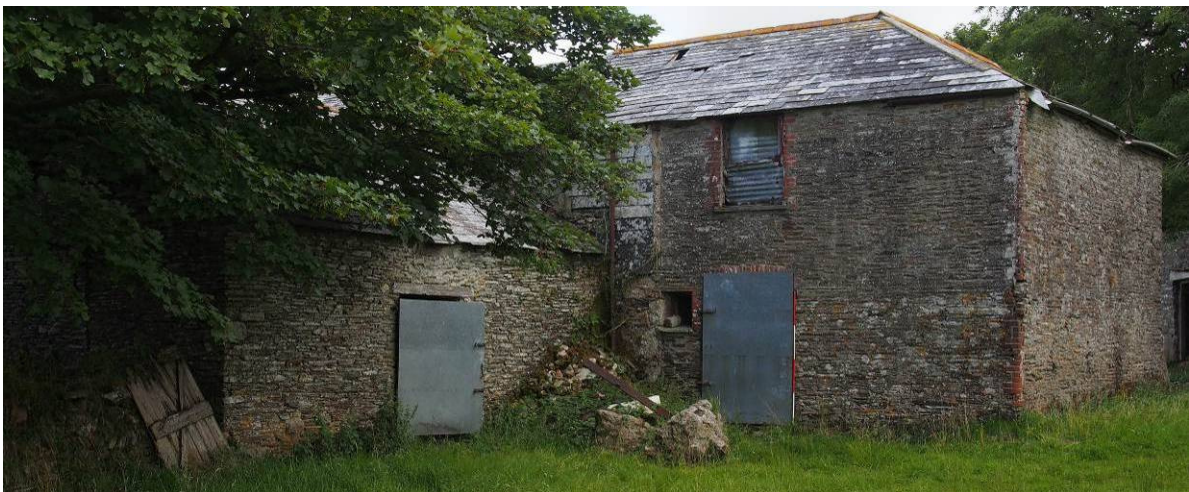
Fig 23 Horse-engine house (left) and extension to Barn 1 (right) from SW

The SSE elevation (generally phase 2 of the horse-engine house) (Fig 23) has a central doorway that is the result of some alteration. It has an internally-splayed jamb to the right (possibly originally relating to a window opening and a rebuilt jamb to the left). A probable reused timber spans the opening and there is an internal timber at a higher level that suggests a former opening of slightly different width.

The SSE elevation (Fig 23) has no original openings but there are five holes cut into the wall, perhaps as intended ventilation holes but never finished. A cement infill to the left-hand corner may be the repair of a socket cut for a former extension. The corner is built from brick lower down and slate-rubble above. The right-hand corner is chamfered.

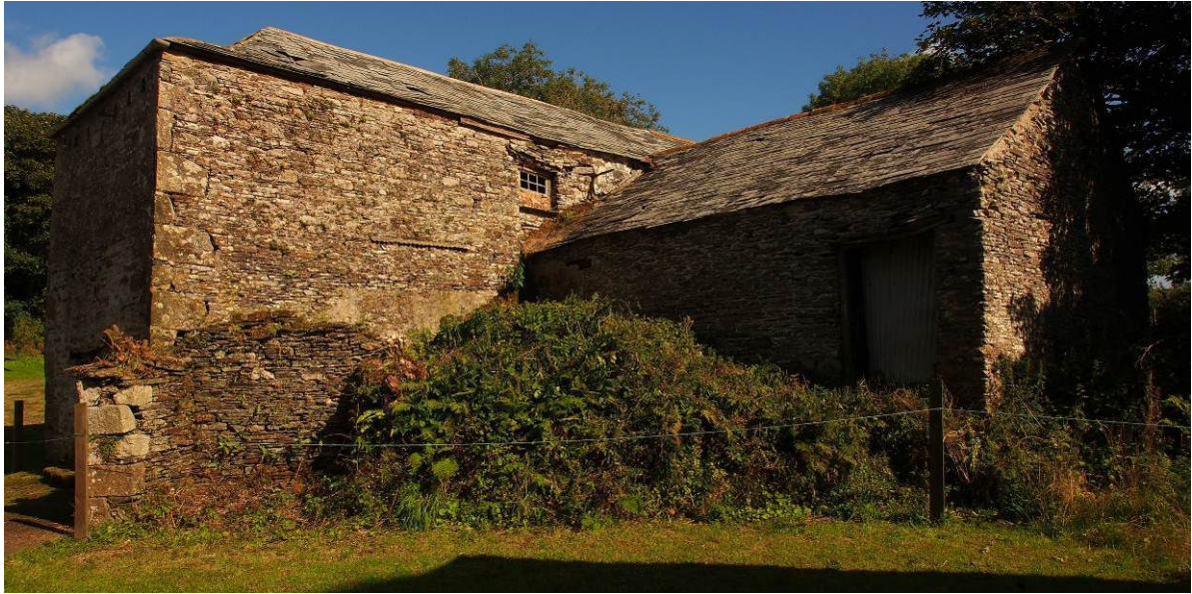
Fig 24 Barn 1 and adjoining horse-engine house from NW

The rear elevation (Fig 24) has only one original opening, the wide threshing-floor doorway that is located directly opposite to the threshing-floor doorway of the front elevation. Built in front of the lower part of the doorway and to the right almost to the original right-hand corner of the rear of the barn is a horse-engine house built at right angles with the ridge-line of its gable-ended roof rising partly into the roof of the barn. The rear doorway (Fig 27) was partly in-filled probably when the horse-engine house was added. A reused window casement has been inserted to the top left-hand corner of the former doorway. The lintel above the doorway has failed and the masonry below the eave slumped. There are remains of slatehanging to either side of where the horse-engine house adjoins the rear of the barn. At far left some walling of a former single-storey building (Fig 26) survives adjoining the barn at an angle. This structure is not part of the subject group.

The horse-engine house has three external elevations. The original beam-bearing wall survives central to the WSW elevation (Fig 24) and retains its central beam socket. At either side of the bearing wall, and partly above, the original open sided part of the elevation has been in-filled with solid masonry except for a blocked former vent or window opening high up on the left.

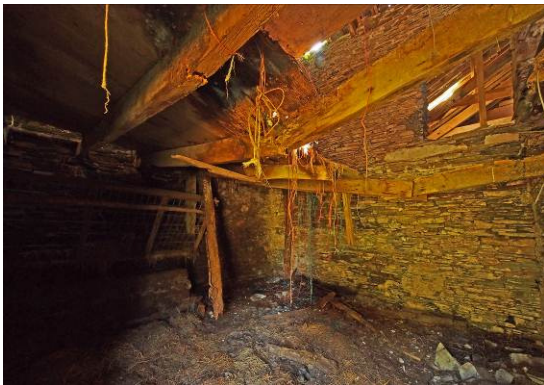
Fig 31 Loose-box interior from SSE

SSE of the cow-house is a loose-box (Fig 31) that has a hay rack to its SSE wall and a through-wall keeping-place to its opposite wall.

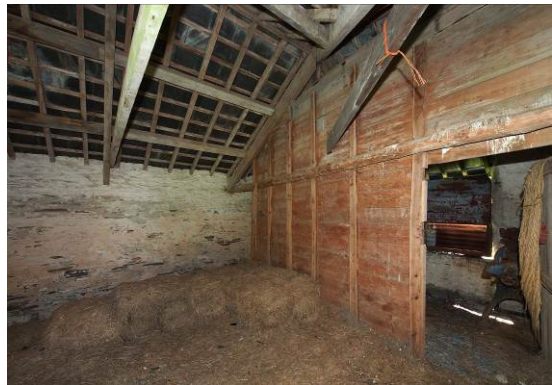
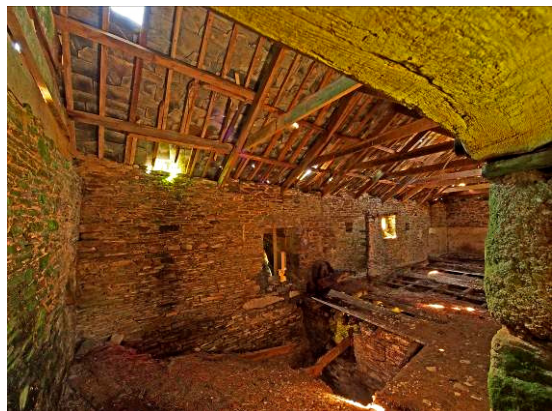
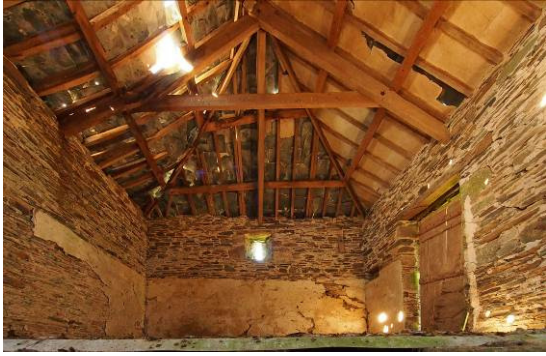
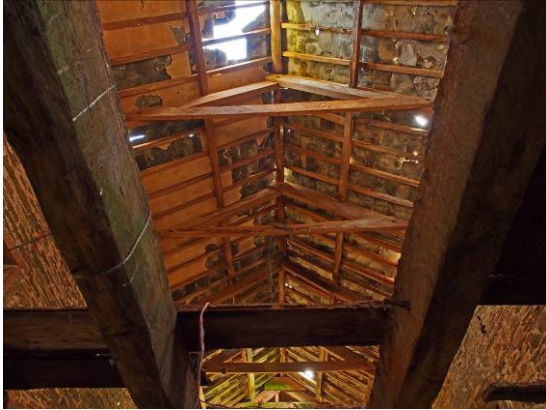
The barn loft is now one large space but may have once been partially subdivided with wooden partitions (Figs 35-38). The loft was inaccessible at the time of inspection (due to rotten/collapsing wooden floors) except for what could be observed from the cow-house and loose box below, and from a gap over the door at the top of the steps. The loft has its original 6-bay roof structure with A-frame trusses with the joints fastened with iron bolts. At the NNW end the walls are partly plastered probably for former use as a granary.

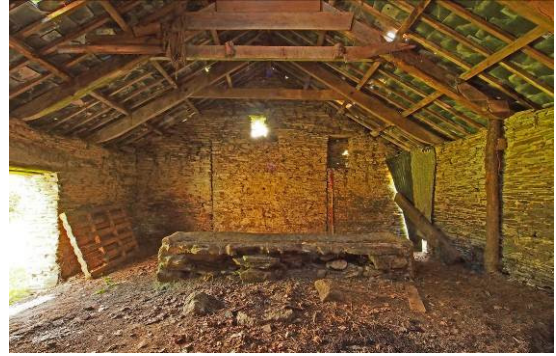
Fig 41 Horse-engine house from ENE.

The beam socket for the original horse-engine is visible in the centre of the far wall. The melior (bearing) stone is in the centre of the floor in front of a later trough

Horse-engine houses needed considerable ventilation when in use and were normally open-sided. This example seems to have been later enclosed by walling to convert it to animal accommodation

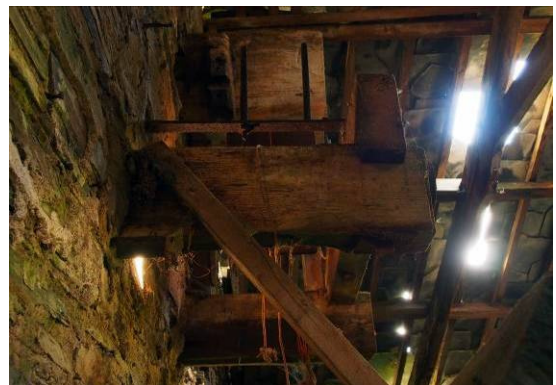
Fig 43 Belt-drive clutch remains attached to barn wall within horse-engine house
