Stowe Barton garden wall Kilkhampton, Cornwall

Archaeological watching brief

Client	Cormac Consultancy
Report Number	2013R087
Date	December 2013
Status	Final
Report author(s)	Nigel Thomas
Checked by	Jacky Nowakowski
Approved by	Andrew Young

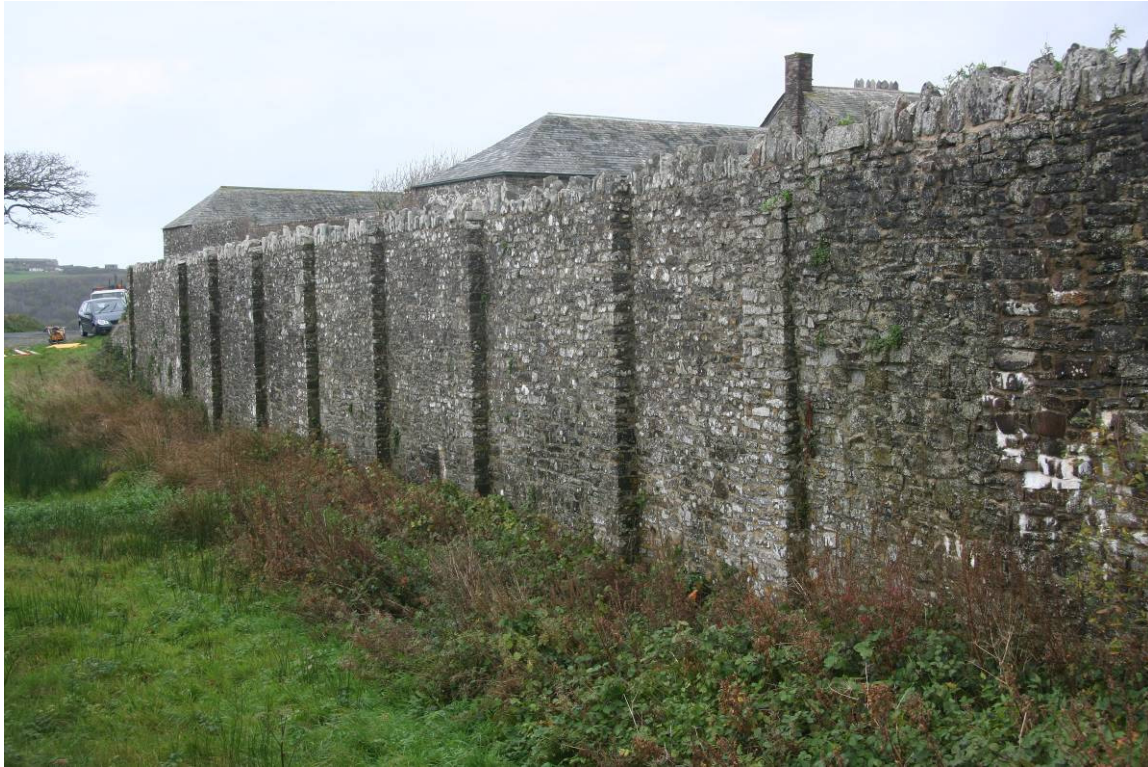
Fig 9 Detail of the carriage wash wall

The buttressed part appears to be a rebuild as a roofed building was mapped here in the late 19th century; the masonry at extreme right of the photo leans outward and appears to be earlier walling with a replacement coping

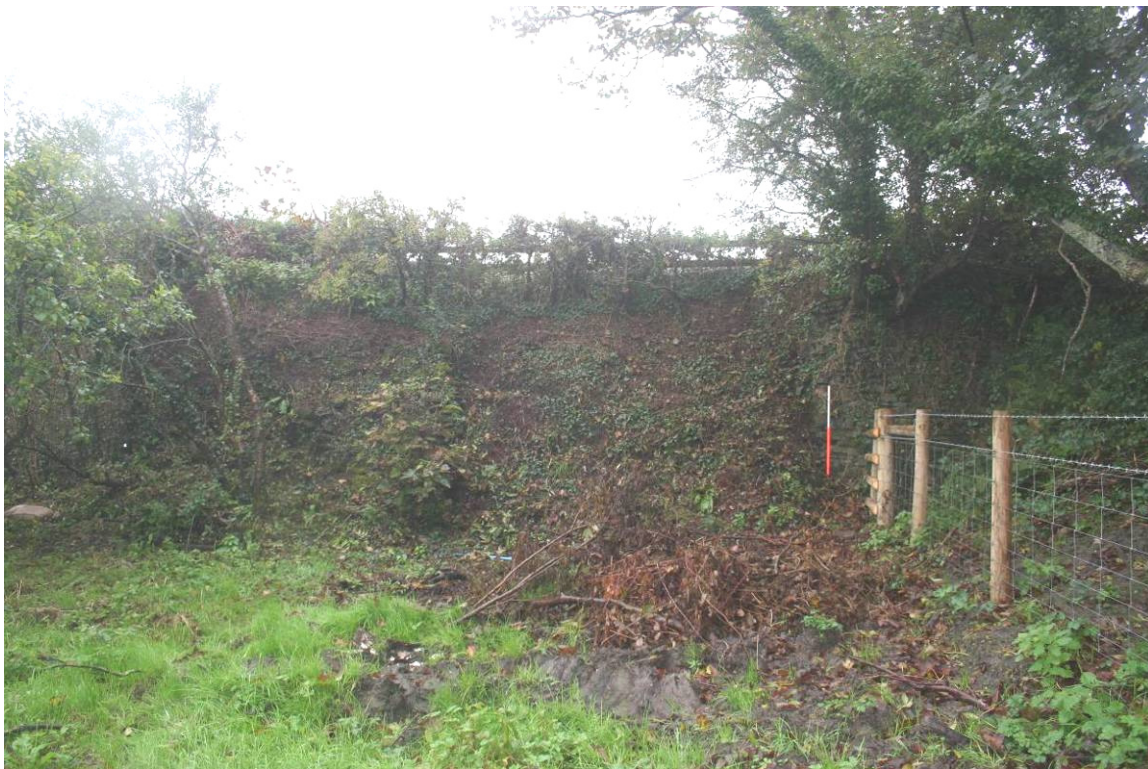
Fig 10 South end of garden wall in 2009; collapsed section in centre, wall fragment and hint of a return to the right (beneath trees)

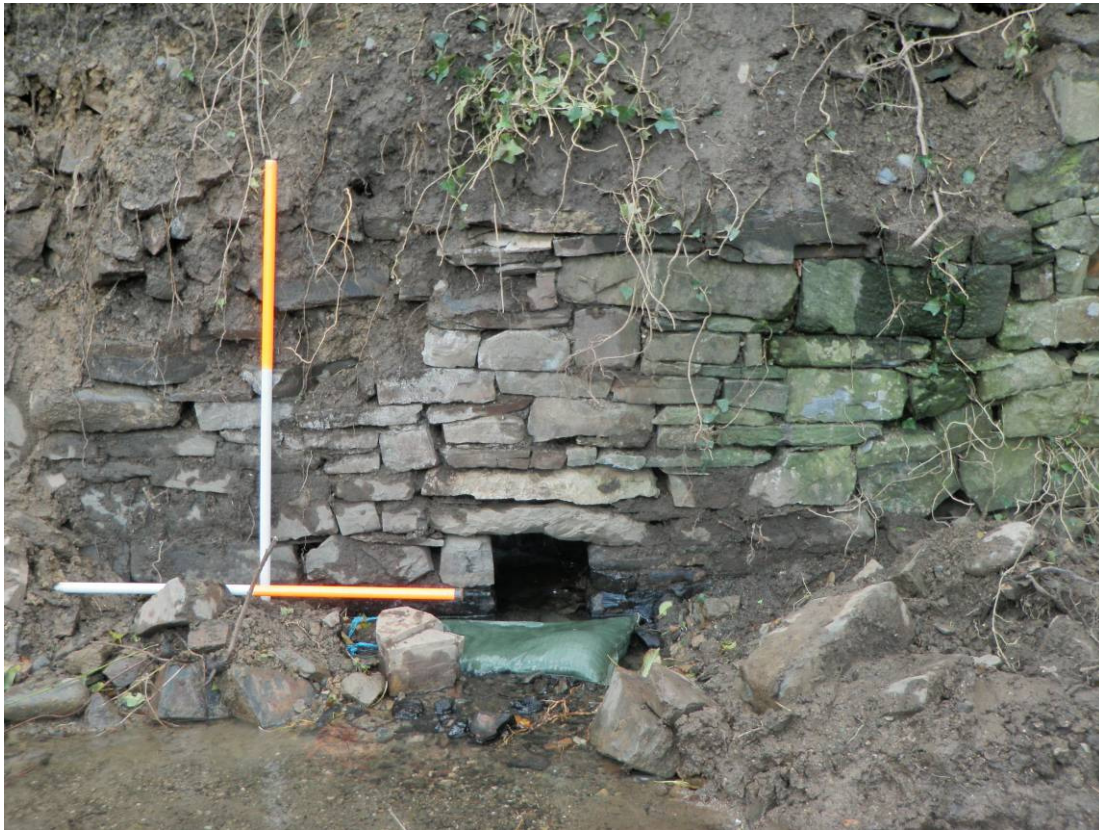
Fig 13 Stone facing around the exit of the culvert

At the northern area of collapsed wall, accumulated debris was removed by machine. This revealed a blocked exit to a stone-lined culvert built at the level of the foundation of the wall. The culvert still carries a steady flow of water and this is likely to have originally supplied ponds and other features within the orchard (Fig 13). Blocking of this culvert is likely to have substantially contributed to the failure and collapse of the wall

in this part of the garden. Although the culvert exit is at foundation level of the garden wall, it was noted to rise steeply inside (beyond the first half metre or so).

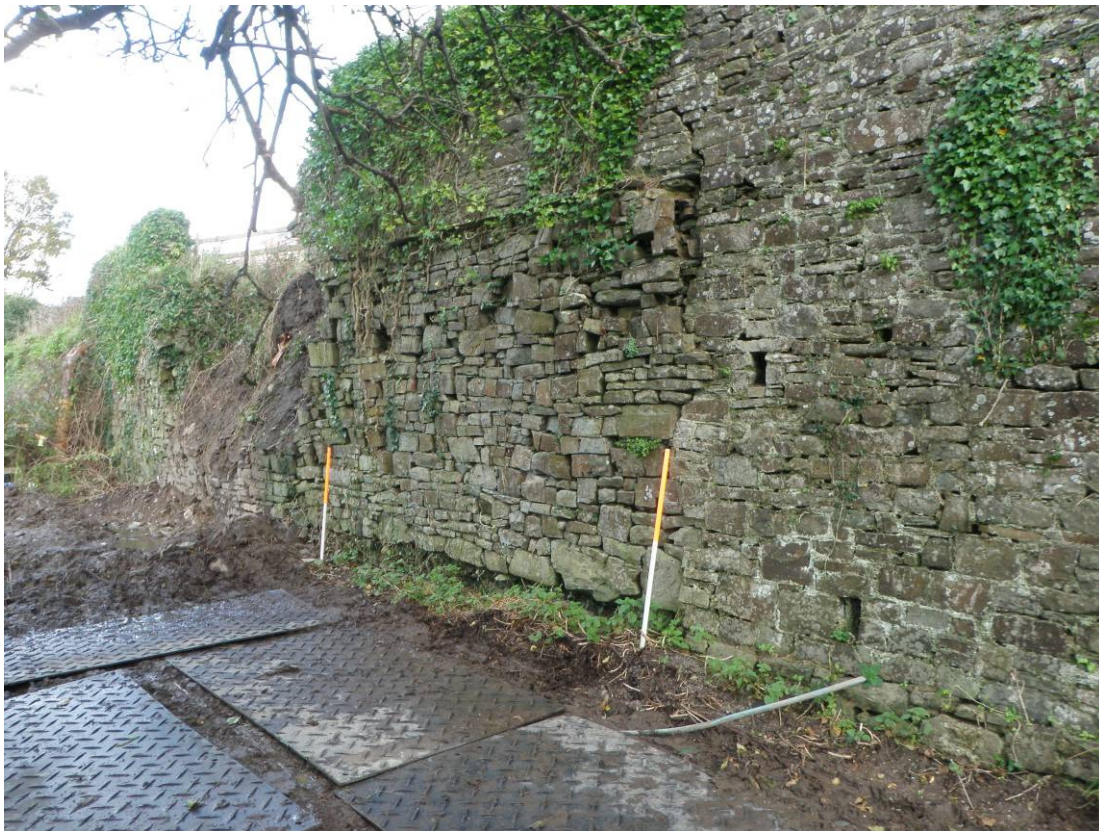
Fig 14 The site of a former lean-to building

Note the vertical, un-mortared walling at the back of the structure, in contrast with the battered face of the garden wall

Traces of a lean-to roof, although noted during the survey in 2009, became much clearer in 2013 due to removal of vegetation and tree branches (Figs 14 and 15). A rectangular area of un-mortared stone masonry below the former roofline is built vertically, whereas the surrounding masonry of the garden wall is built to a slight batter (in order to support the roadway behind). The former roofline was represented by a line of slates forming a flashing on top of the un-mortared masonry. It seems likely this represents traces of a former summerhouse or similar decorative feature. Its vertical un-mortared rear masonry may have originally been covered by panelling or other decorative elements, long since removed.

There is no indication of any joist holes supporting its roof (except possible hints at the ends of the slate flashing), which suggests that the former roof was lightweight and most likely supported on a horizontal timber. There is also no evidence of other walls abutting the rear wall, suggesting this was a pillared, probably open-fronted structure, perhaps built of wood.

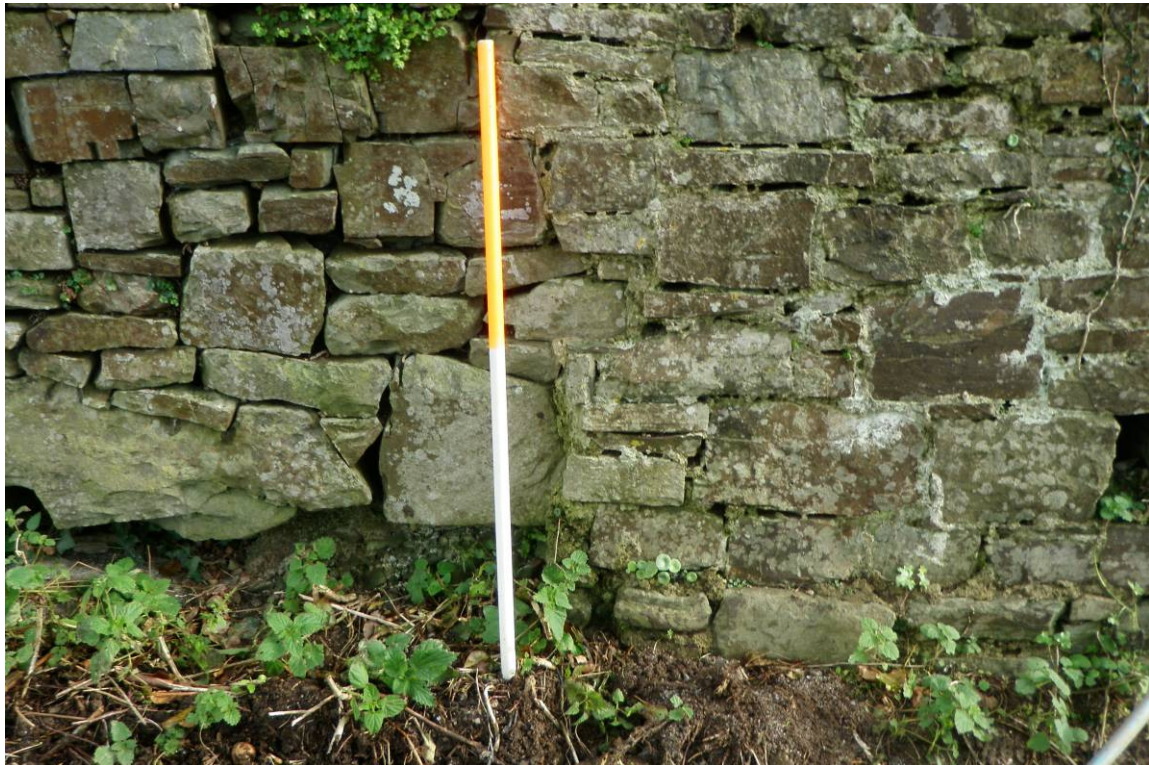
Fig 15 Joint between the wall face of the former lean-to (left) and the garden wall (right)

Note that there is no foundation/base of the lean-to wall; this may have been a decorative bench/dressed feature that has since been removed

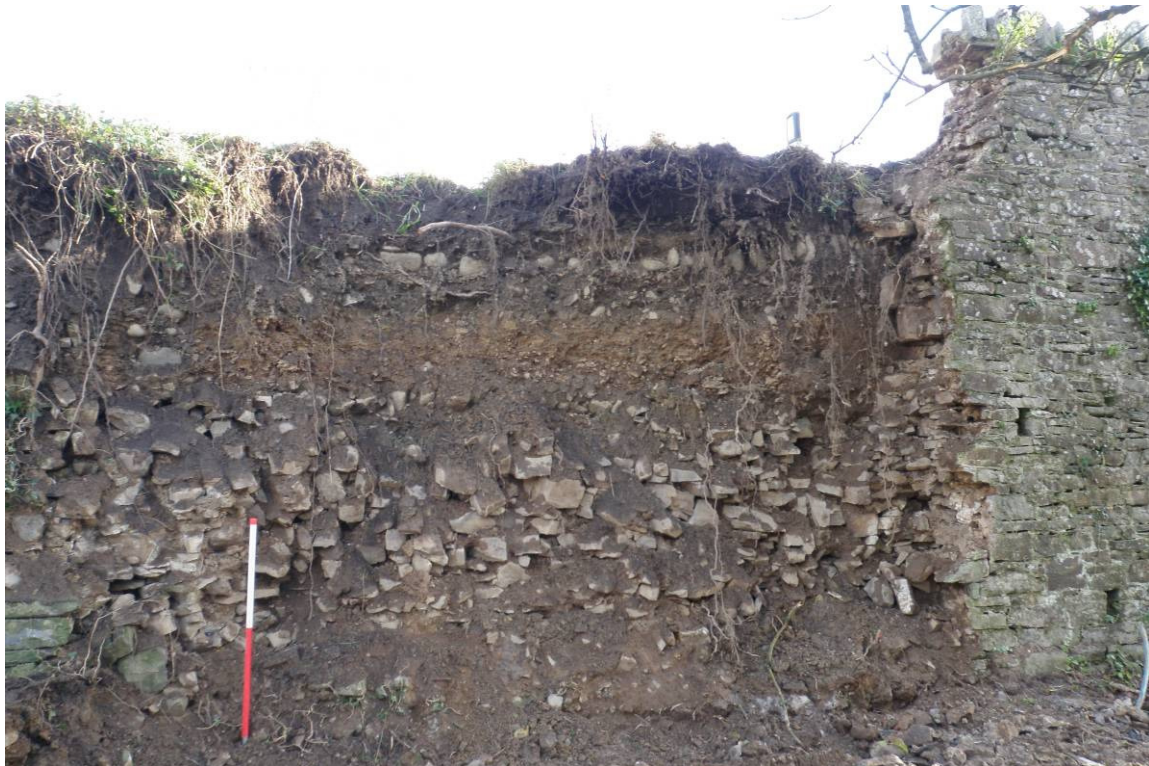
Fig 16 Part of the stratigraphy exposed after demolition of the lean-to wall face

Cobbles are visible towards the top of the section; another line of cobbles is just visible above the rubble behind the retaining wall. The wall is built with two faces above the line of the weep holes to the right

Demolition of the un-mortared vertical masonry and an area of unstable parapet above were unfortunately necessary in advance of rebuilding the wall in 2013. Removal of this part of the wall did however enable a better examination of the stratigraphy built up behind the structure.

Removal of the wall revealed topsoil and roots (1) and a lighter subsoil (2) above a level of cobbled surface (3). This cobbled surface, composed of river or beach pebbles, lies just beneath the level of the present road surface and is likely to represent the earlier surface of the road before modern tarmac layers were added. The rounded cobbles are also very similar in nature to a large cobbled surface between Stowe Barton farmhouse and the road. Beneath the cobbles was a layer of compacted clay and small stones 300mm thick (4). Under this was a layer of re-deposited clay (500mm in depth, (5)).

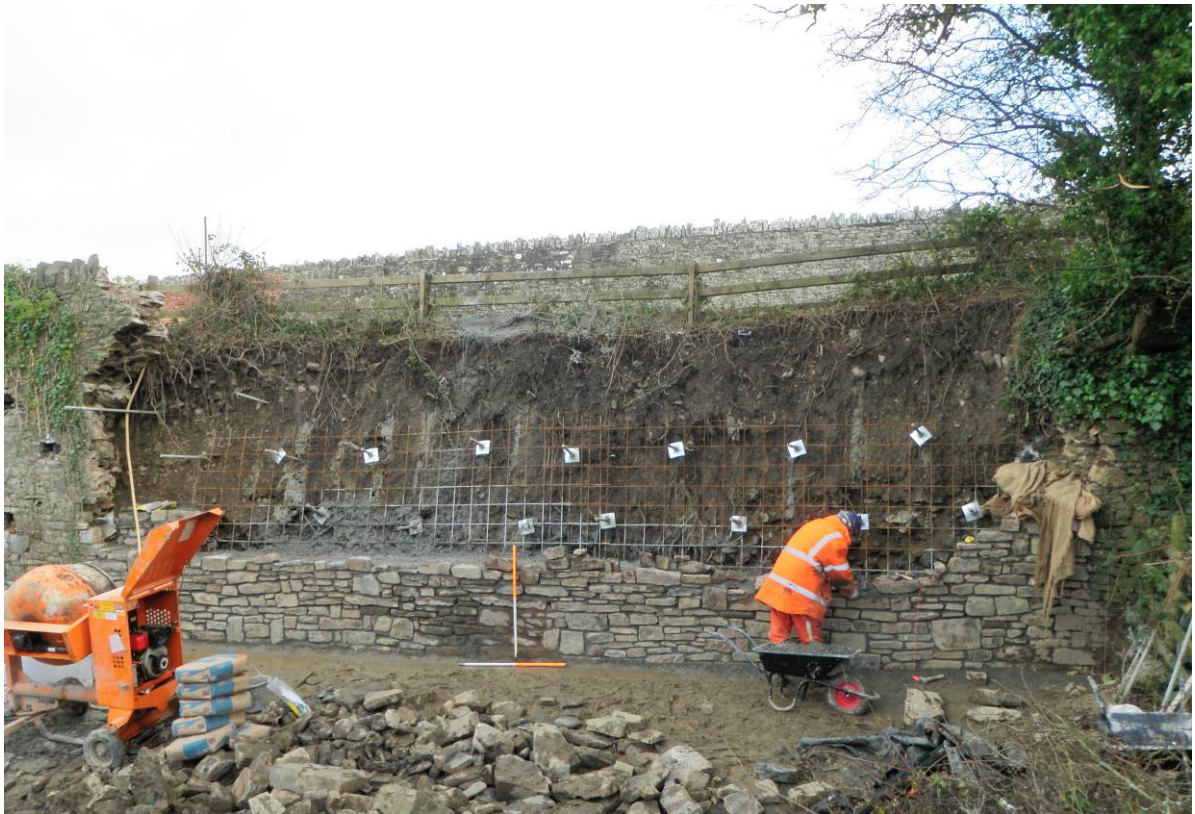
Fig 17 Rebuild of the southern collapsed section in 2013

At the time of the first site visit in November 2013 the southern collapsed area had been cleared of debris and wall construction and soil nailing (insertion of steel strengthening pins into the bank) commenced (Fig 17). Nevertheless some stratigraphy was visible including fragmentary traces of a cobbled surface. This surface equates with layer (3) in the northern section.

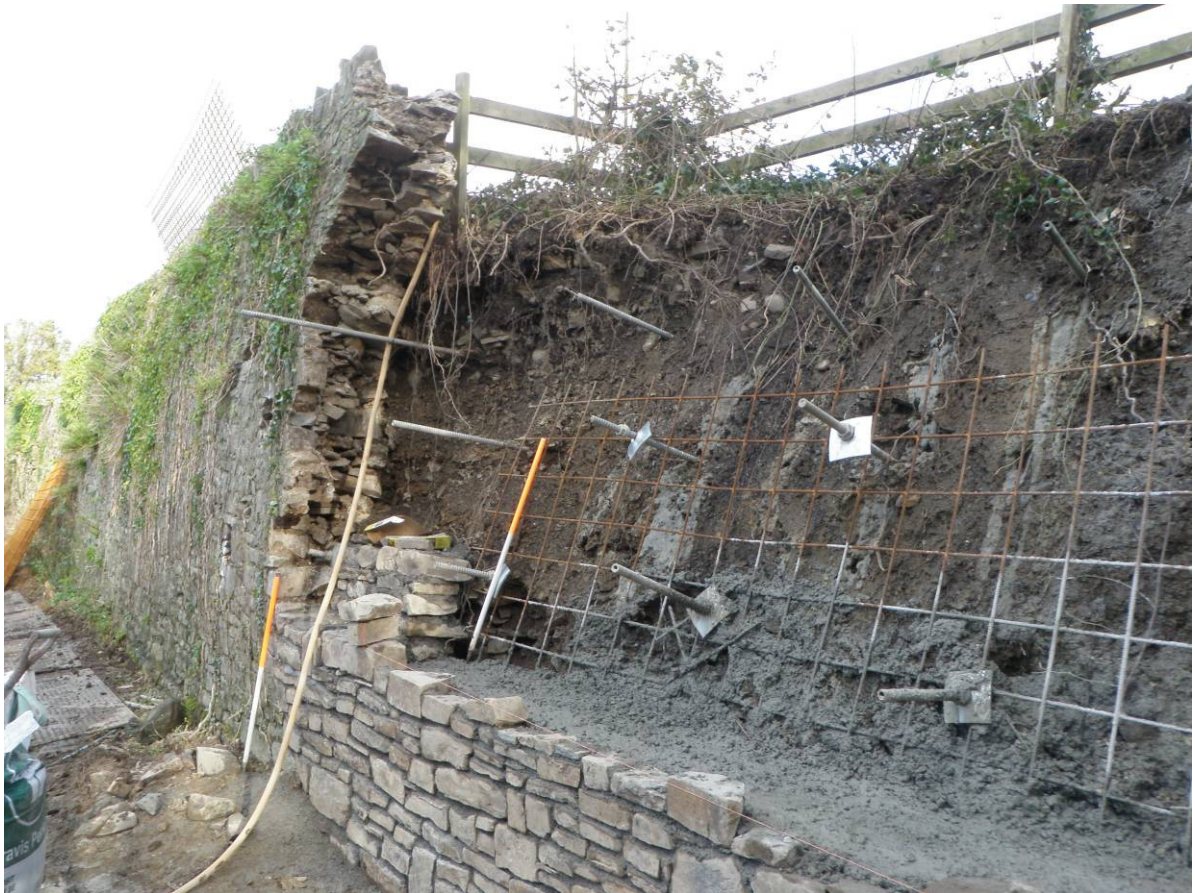
Fig 18 Stratigraphy visible behind the wall in the southern part is very similar to that in the recorded northern part
