# **Chapel Euny Well, Sancreed, Cornwall**

## **Archaeological survey and watching brief**

2013R088

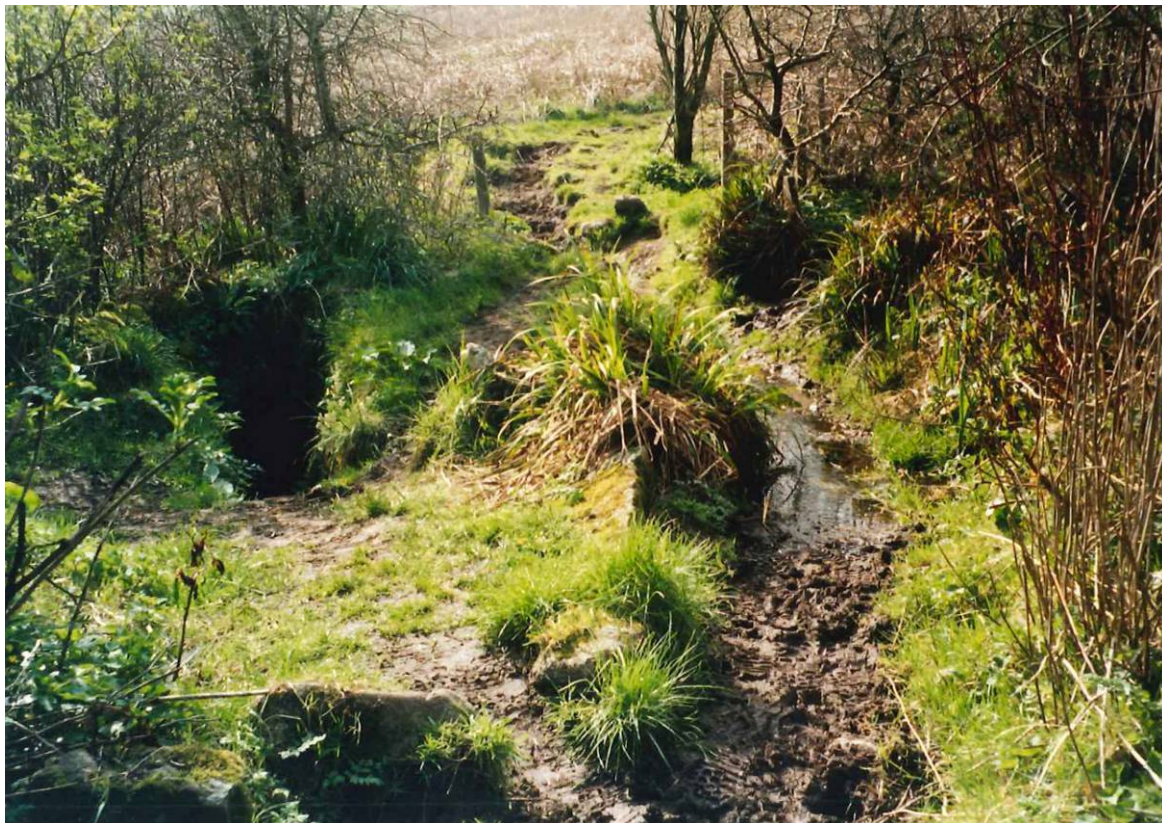
*Fig 11 Chapel Euny Well in 2002, looking west  
(photo by courtesy of Ann Preston-Jones, English Heritage)*

- Loose dressed stones on the well head are still extant but now considerably overgrown and much less recognisable than when photographed a century ago.

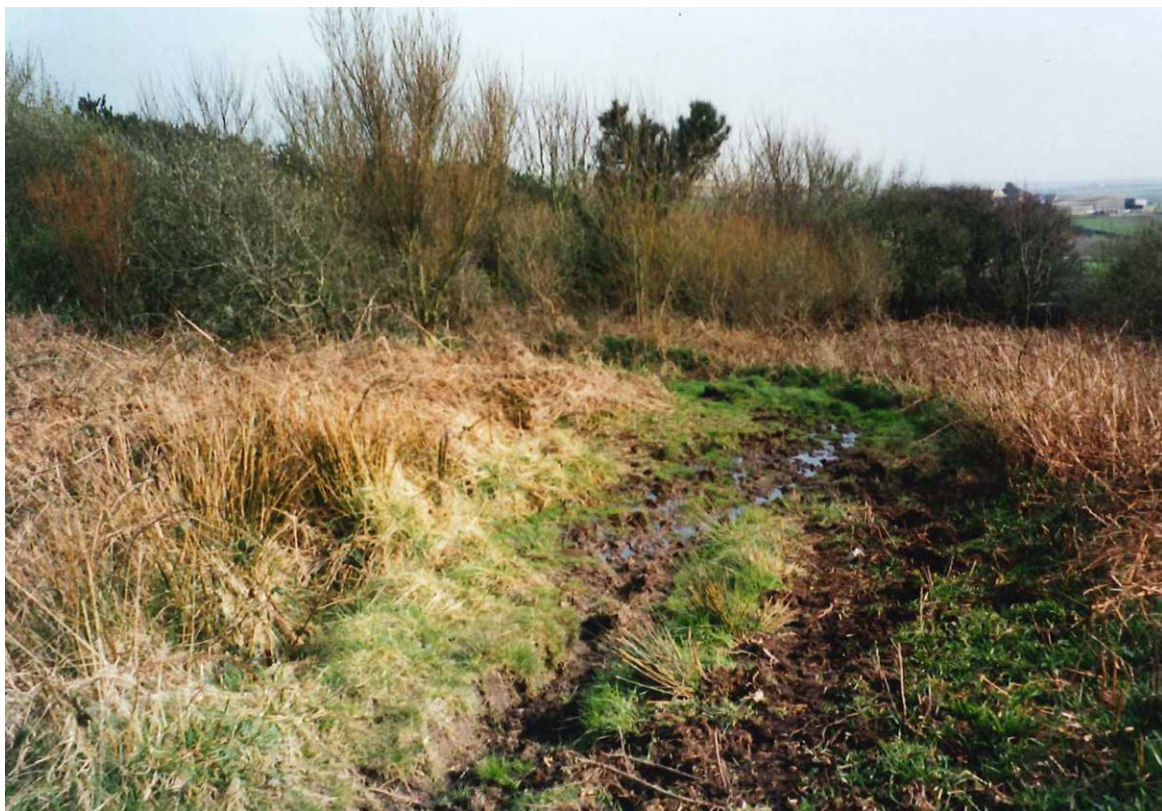
*Fig 12 The flooded and boggy footpath west of Chapel Euny Well, photographed in 2002  
(photo by courtesy of Ann Preston-Jones, English Heritage)*

For many years the bridleway had become very waterlogged and boggy to the west of the well (see Fig 12). A programme of drainage and upgrading works to the local bridleway and footpath network (the St Euny Well to Tredinney Moors project) was arranged by the West Penwith Bridleways Association. Grant funding for the work was sourced from Natural England's Paths for Communities Scheme.

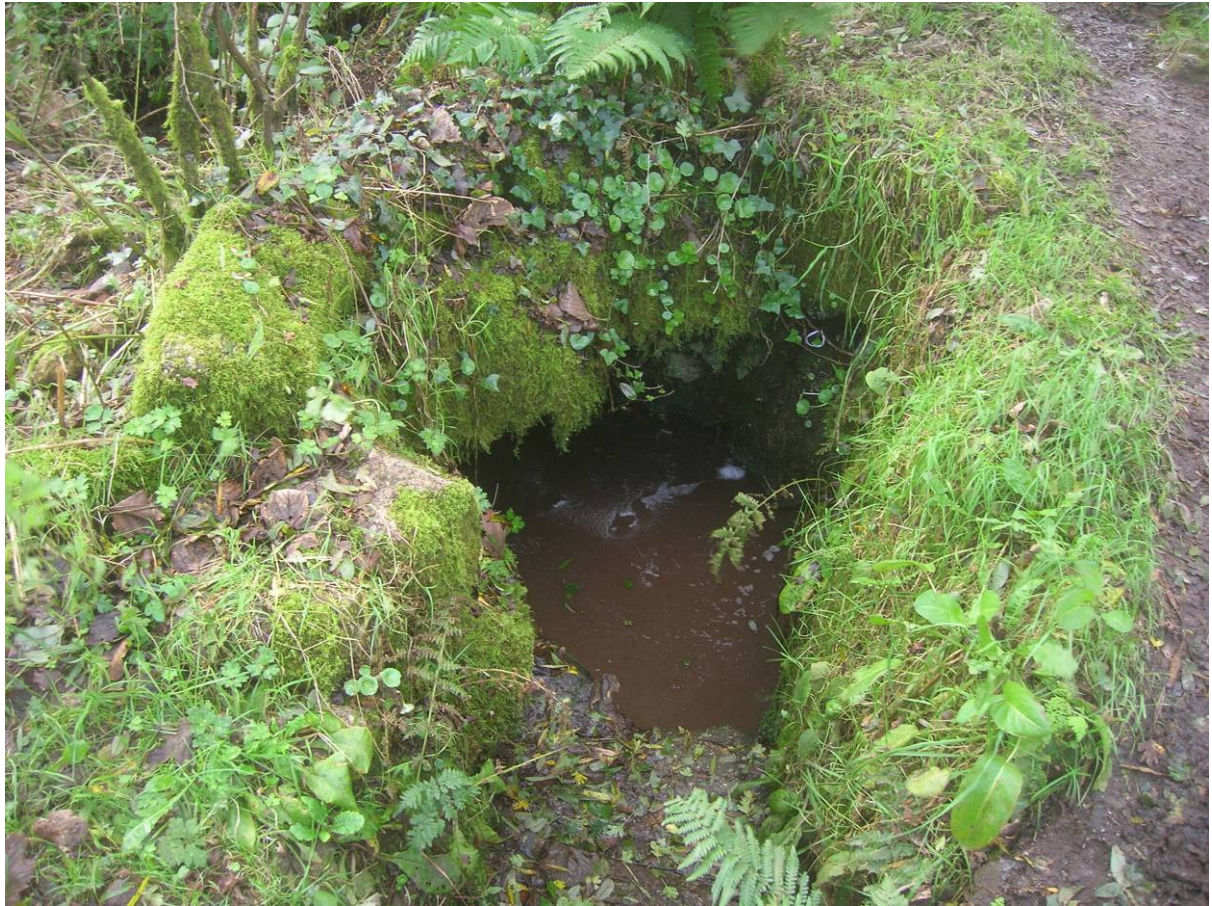
*Fig 13 The principal (south) well in 2013*

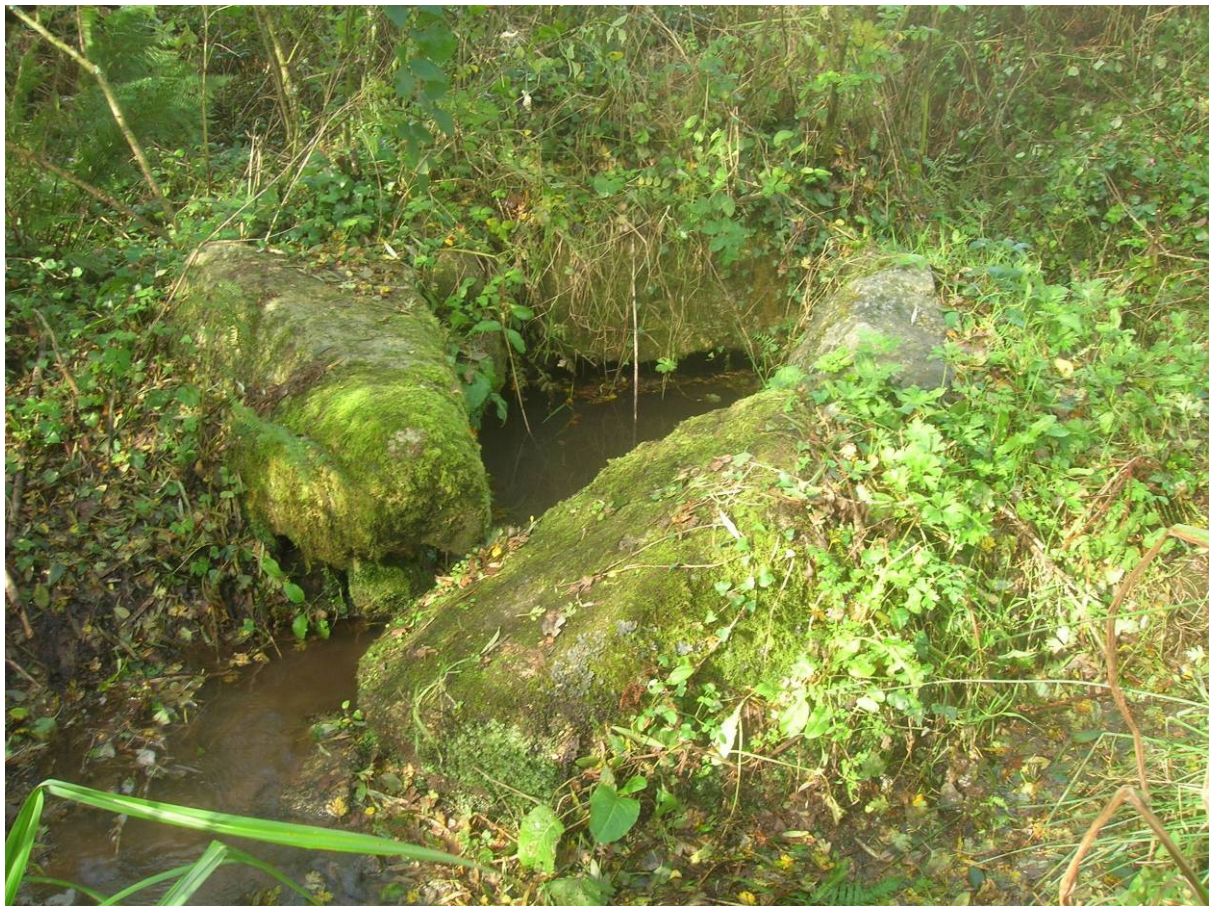
*Fig 14 The north well (2013)*

The northern well basin is not shown on early maps; it may therefore have been created in the 20<sup>th</sup> century (post-1907).

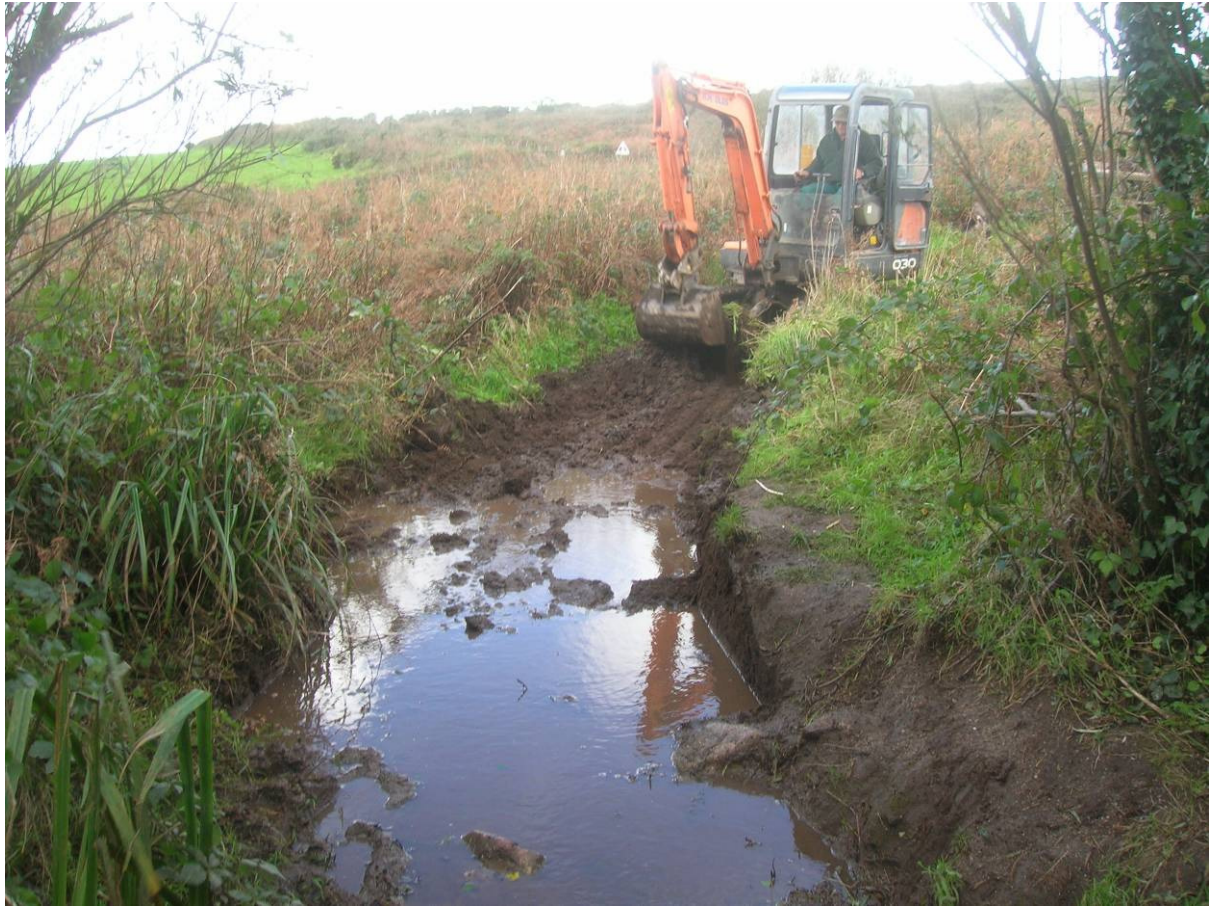
*Fig 15 Clearance of mud and debris west of the two wells*

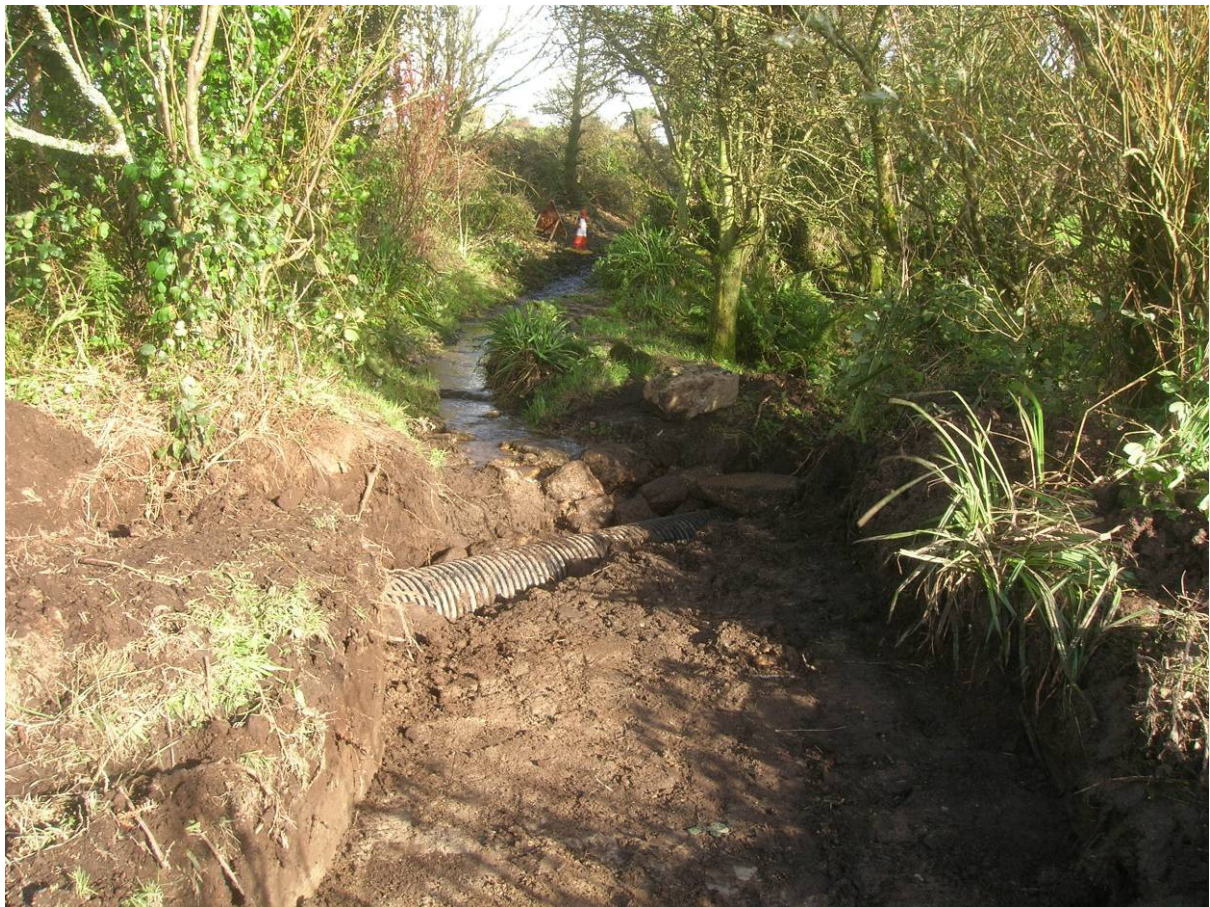
*Fig 16 Insertion of the drainpipe to drain the ground upslope from the footpath and wells*

This profile was recorded within the trench dug for the new drainage pipe and gully. This was designed to carry any water emanating from springs further up slope, and any running down the route of the trackway into the existing watercourse that currently drained water from the wells when they overflowed. This trench approximately 5m long ran roughly northwest to southeast across the line of the existing path and was approximately 0.80m wide and reached a maximum depth of approximately 0.70m. Here the soil profile comprised 0.05m of grass, roots and topsoil which overlay 0.20m of black-brown peaty loam, 0.25m of dark grey-brown clay, and 0.20m of yellow, grey-brown clay. The decayed natural granitic bedrock lay at the base of the trench. No archaeological features were recorded and no artefacts recovered.

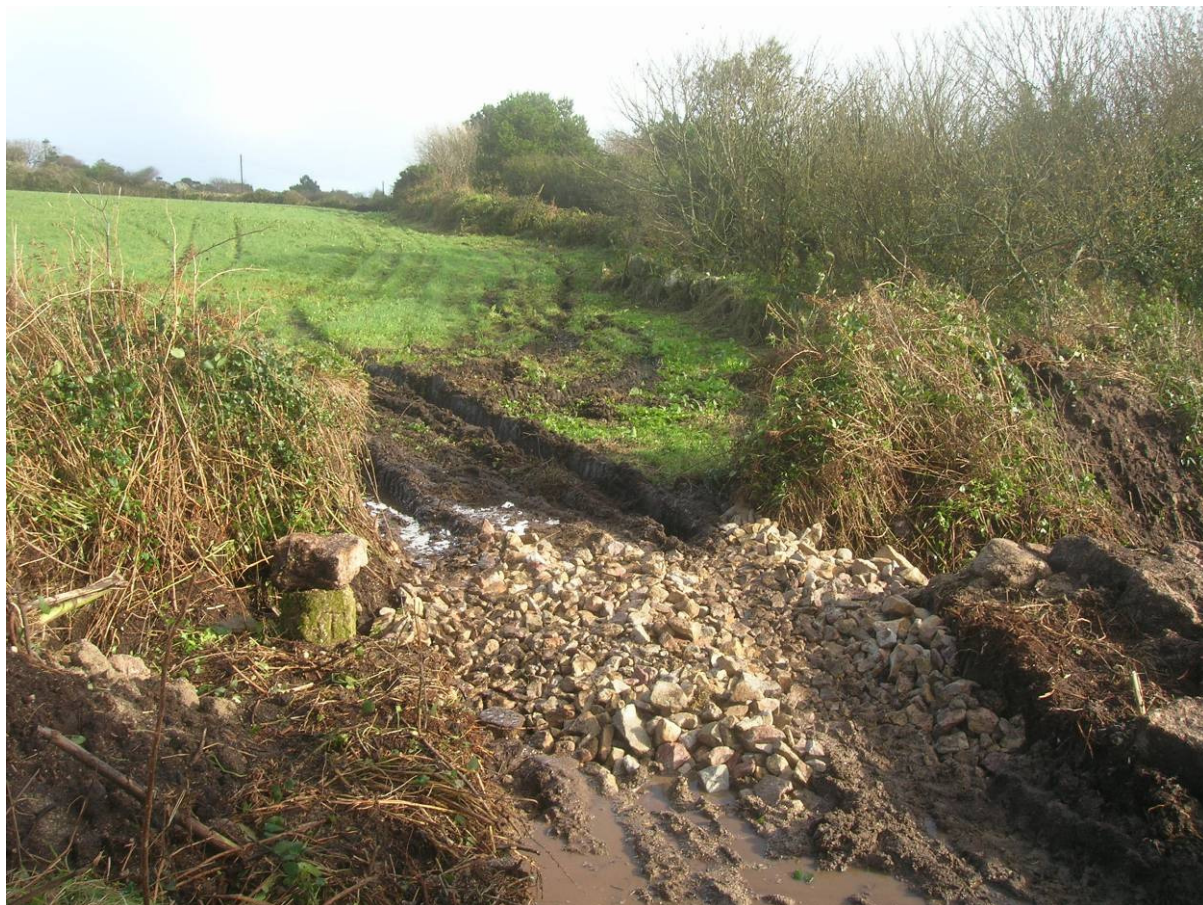
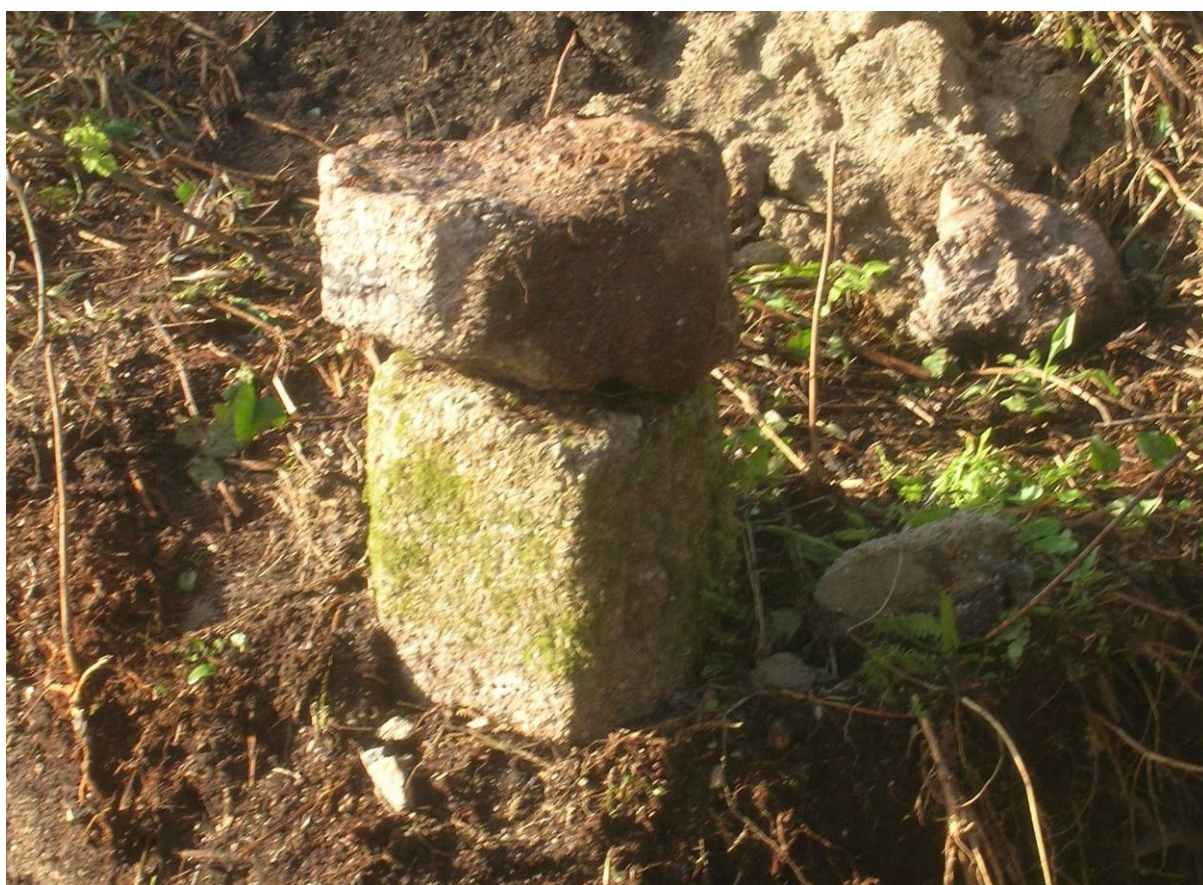
At the eastern end of the main west-to-east path leading across Tredinney Down, a small boundary stone (Figs 17 and 18) was uncovered at SW 39966 28915. Completely obscured by soil and vegetation prior to the work, the stone was a small granite pillar which measured 0.30m x 0.30m. Its full height could not be determined though about 0.25m was visible. On the western face was inscribed the letter T, while on the eastern side, the letter B. Although this stone is located on the parish boundary and is shown on the current Ordnance Survey maps this most likely represents the boundary between two properties, that of Tredinney to the west, and Brane to the east.

*Fig 17 Rediscovery of a boundary stone*

*Fig 18 Detail of boundary stone*
