# **St Breock Wind Farm Access Road, St Breock, Cornwall**

## **Archaeological Watching Brief**

<b>Client</b>	<b>Reg Power</b>
<b>Report Number</b>	<b>2013R089</b>
<b>Date</b>	<b>January 2014</b>
<b>Status</b>	<b>Final</b>
<b>Report author(s)</b>	<b>Ryan P Smith BSc (Hons) PifA</b>
<b>Checked by</b>	<b>Andy Jones Phd MifA</b>
<b>Approved by</b>	<b>Andrew Young</b>

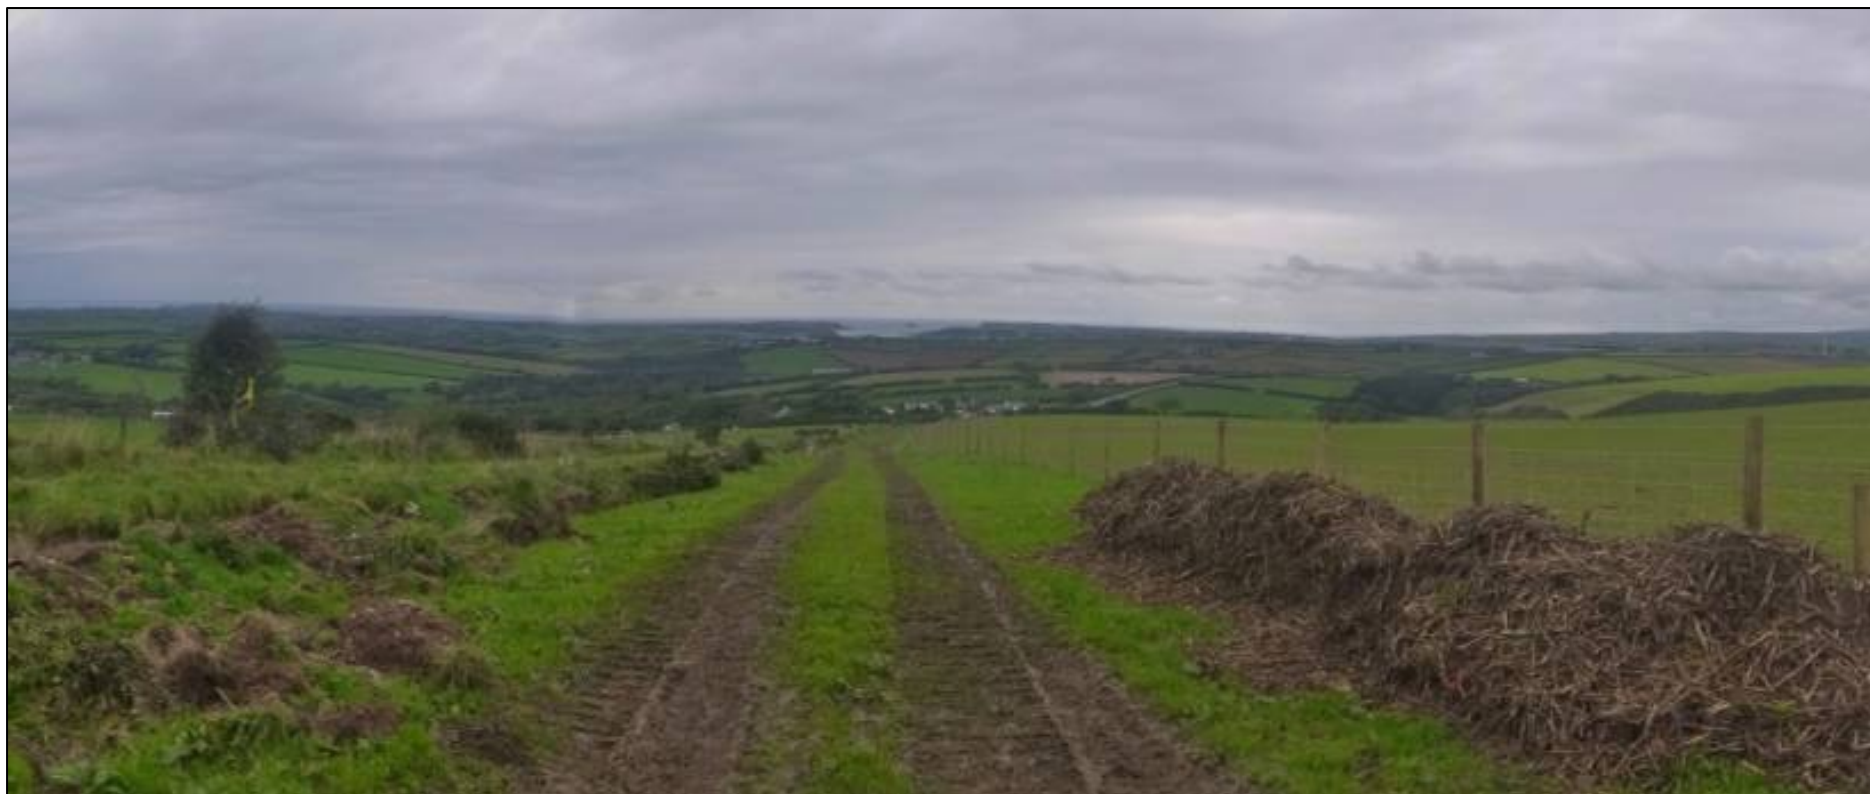
*Figure 9: View north along route of track in field 1.*

The topsoil (1101) varied in depth between 0.05m and 0.2m, consisted of mid to dark brown stony soil, stones were common, varied in sizes, irregular in form and appeared to be a mix of quartz and mud stones, the topsoil was sat directly on top of the natural material (1102). There was no secondary interface between the layers.

The natural subsoil (1102) appeared to be a yellow/red clay material with common stone inclusions. There were indications of plough marks within the surface of this

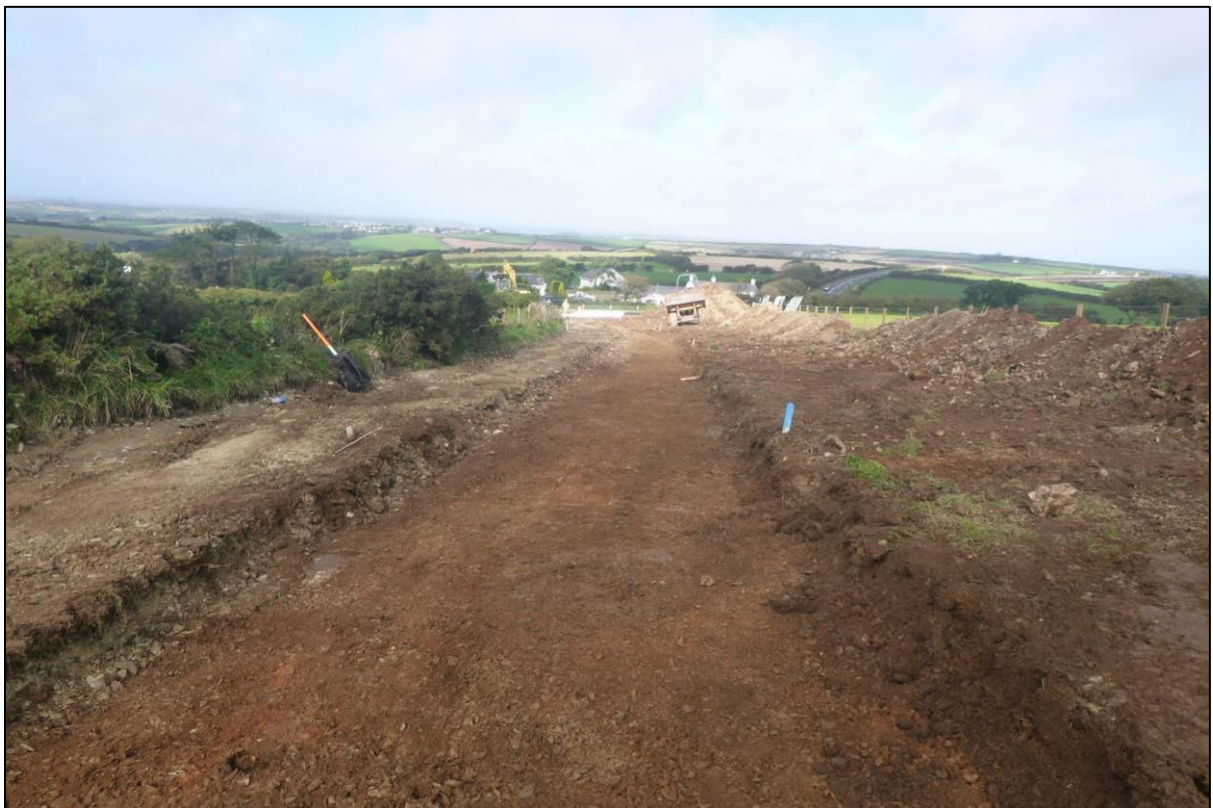
*Figure 11: Field 1, looking north along route of the new road and old track.*

During the construction material from the existing track was removed by the mechanical digger, its construction appeared to be comprised of different types of stone and it looked to have been repaired on numerous occasions in its recent past using various stones which had been imported onto site, probably from local quarries

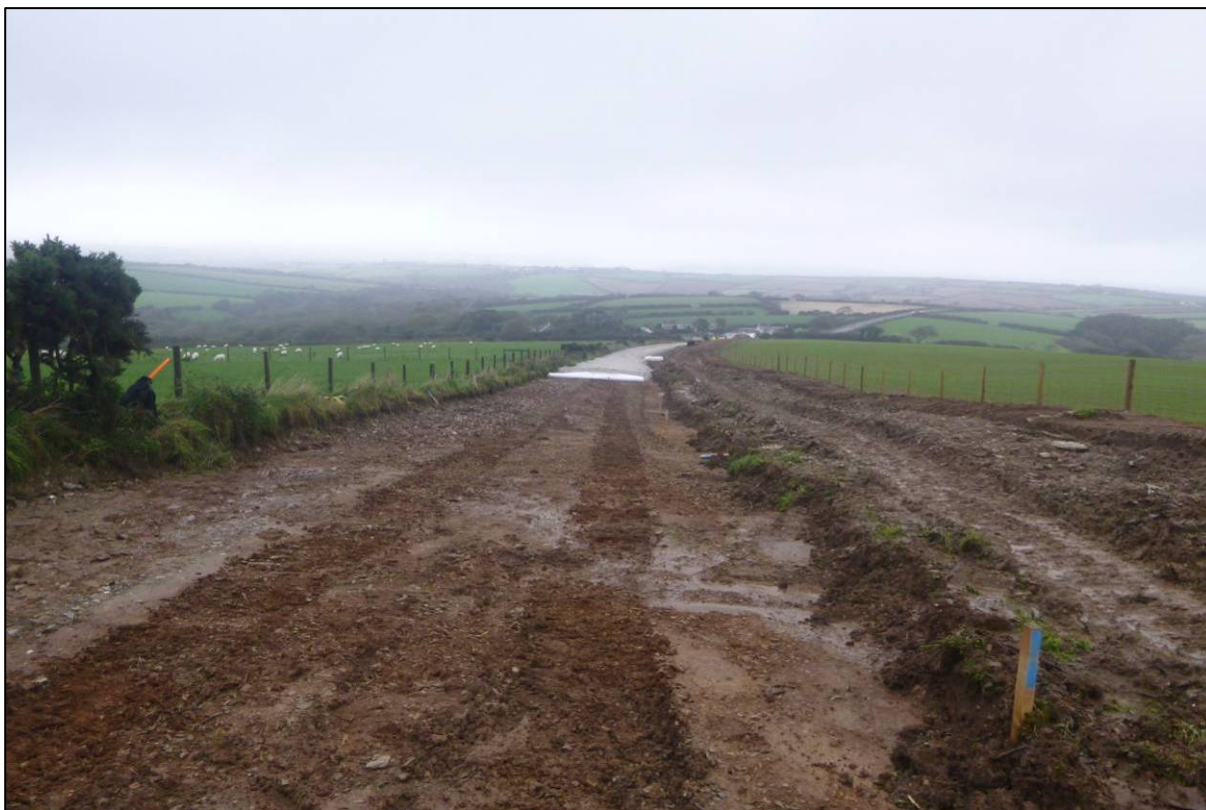
*Figure 12: Looking north from the end of field 1 after removal of topsoil.*

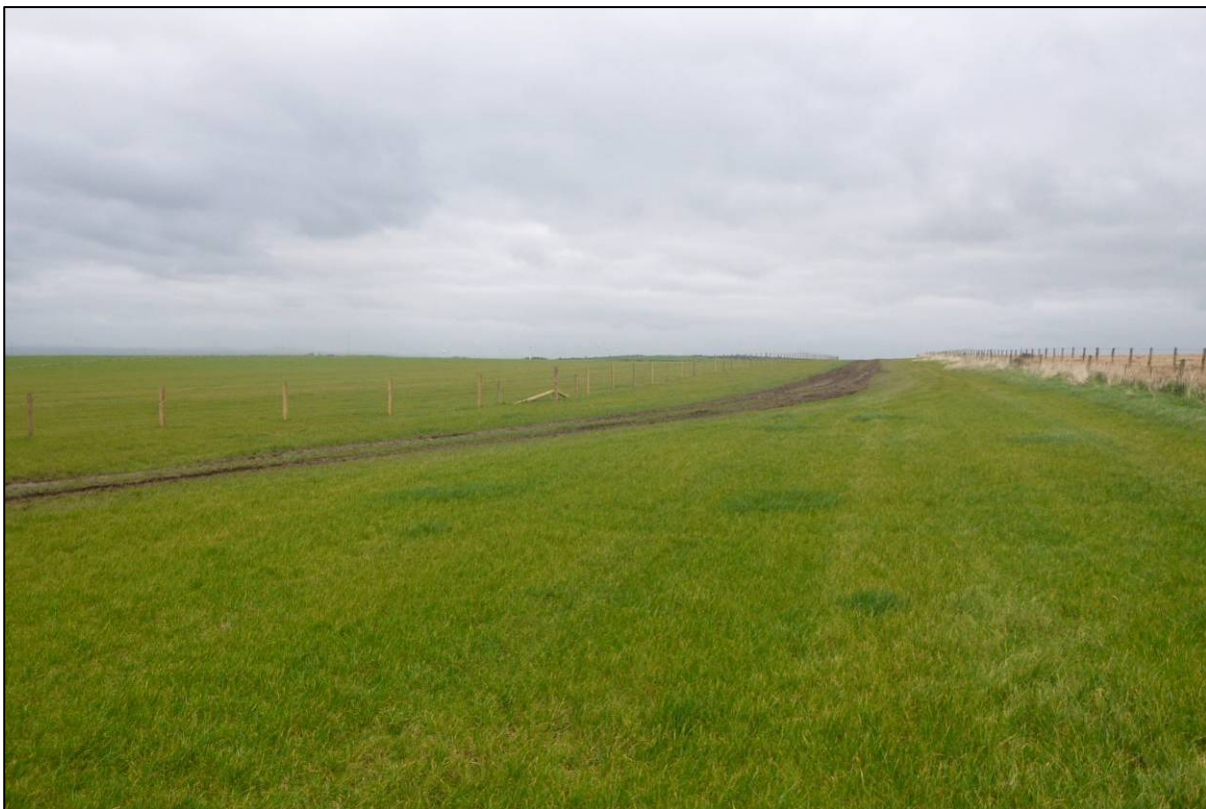
*Figure 13: Pre excavation of field 6 looking east across plateau.*

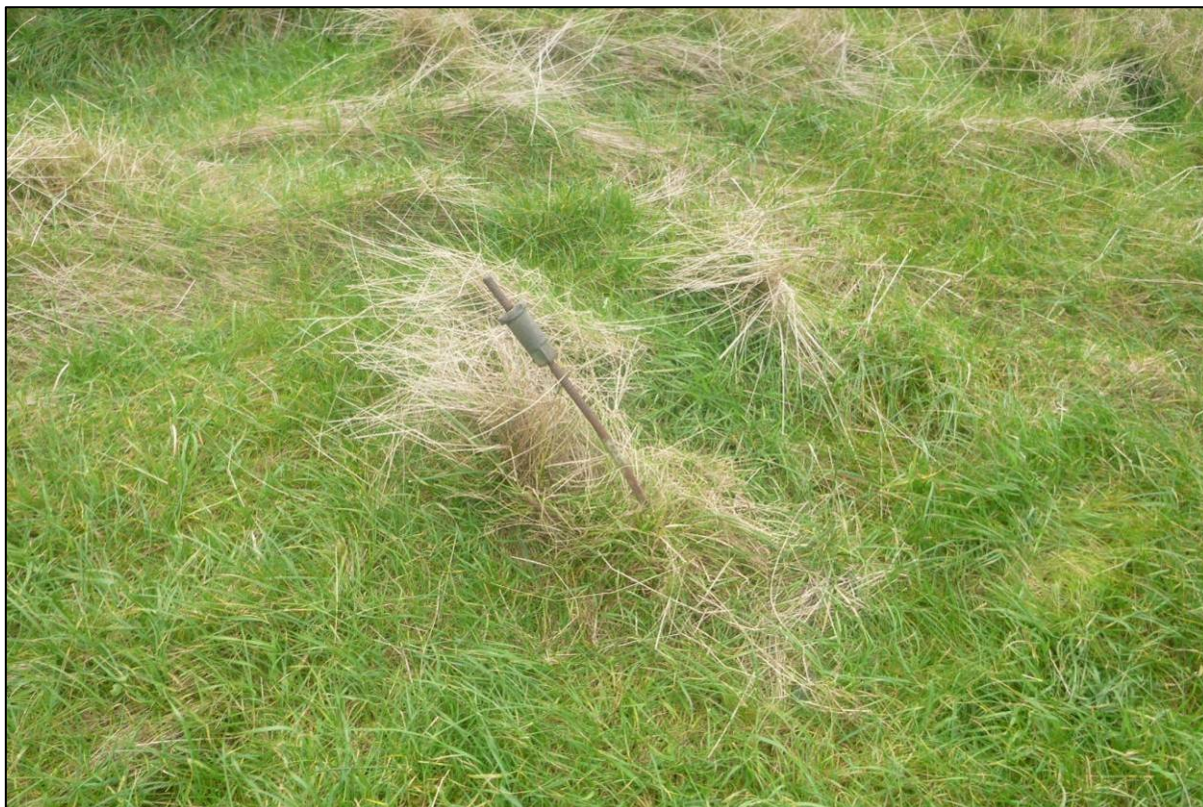
As the road began to turn east, what appeared to be a retaining wire for possibly a telegraph pole was found within the path of the track (Fig 14), a second and similar wire was observed on the south side of the perimeter fence and is possibly a second guide wire for a now defunct telegraph post. No cut or posthole was found, and it can be surmised that this was within the SSSI or perimeter fence line. A third guide wire was found within the path of the trackway (SW 95608 63188).

*Figure 14: Telegraph pole guide wire in situ (field 6).*

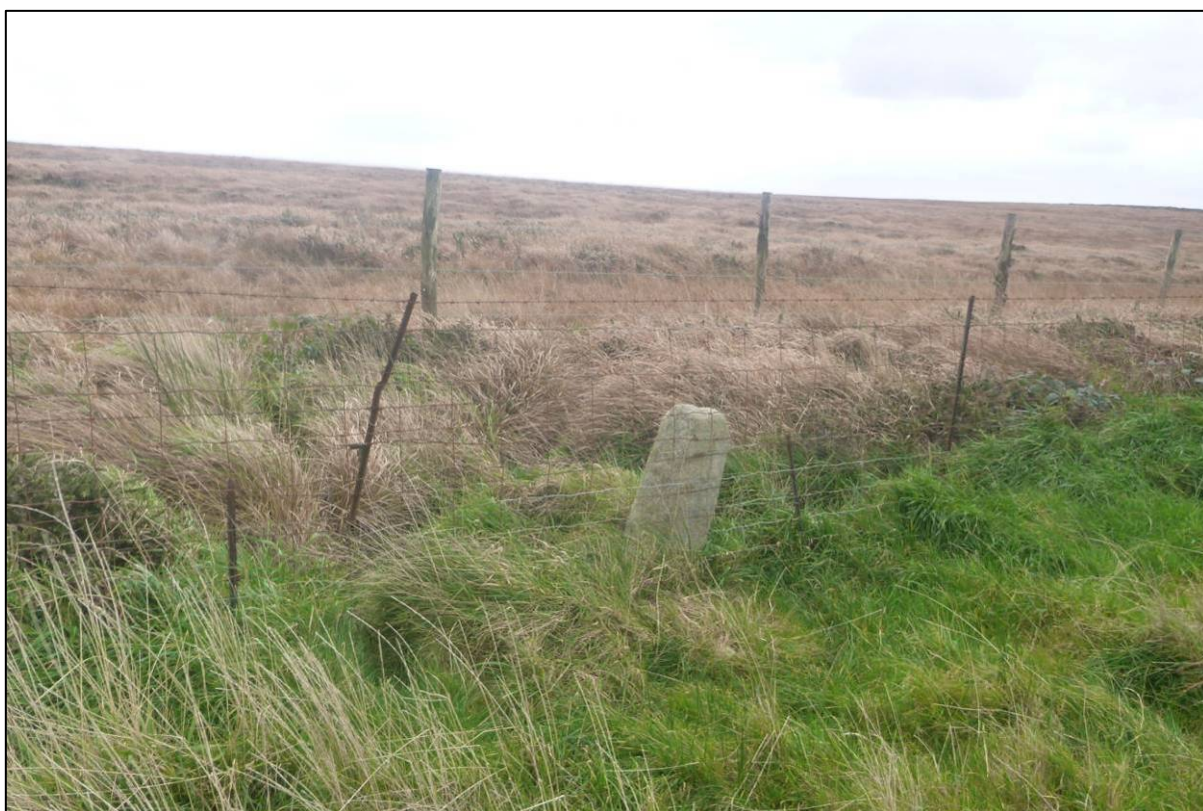
Just outside the corridor, to the south of the stripped area was an *in situ* boundary stone, which is marked on the 1:25,000 OS mapping (SW 95469 68193)(Fig 15).

*Figure 15: Boundary stone in situ (Field 6 looking SW, Rosenannon Downs fence line at the rear of image).*

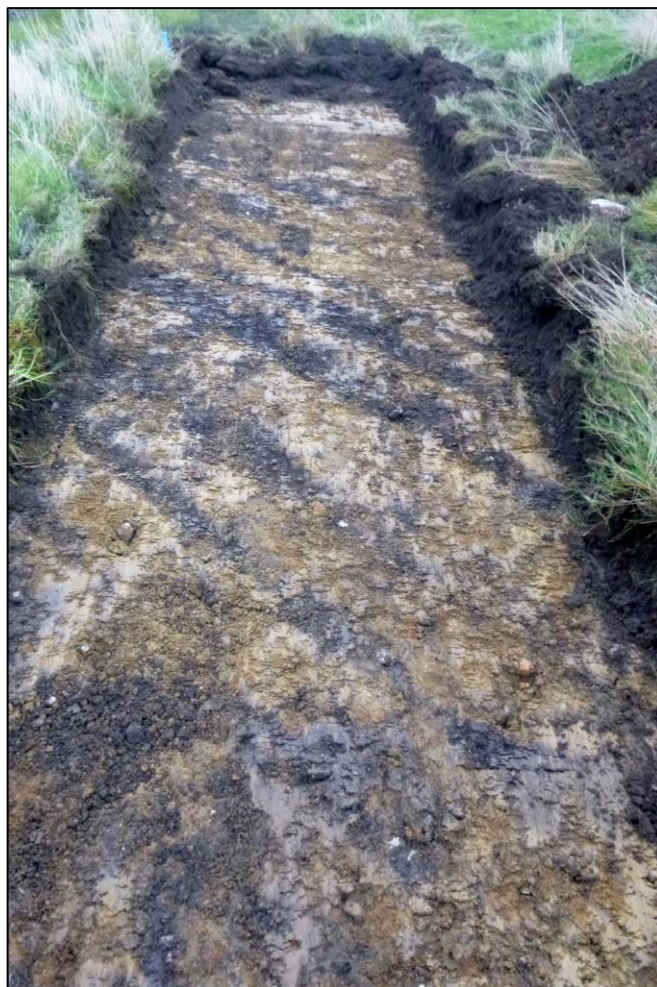
As the route of the road climbed a south easterly gentle incline to the edge of the ridge, a natural gully was observed on the west side of the field, the gully contained a single fill of dark organic material (topsoil) (601) with quartz stone inclusions, small and irregular in shape, extending across the path of the track in the direction of a natural watercourse. It was no more than 0.1m in depth and less than 0.6m in width, although the width was defined by the fill and not an actual cut. The plough furrows were more distinct (Fig 16), examination of these found they did not exceed 0.05m in depth within the surface of the natural material.

*Figure 16: Plough marks west side of field 6.*

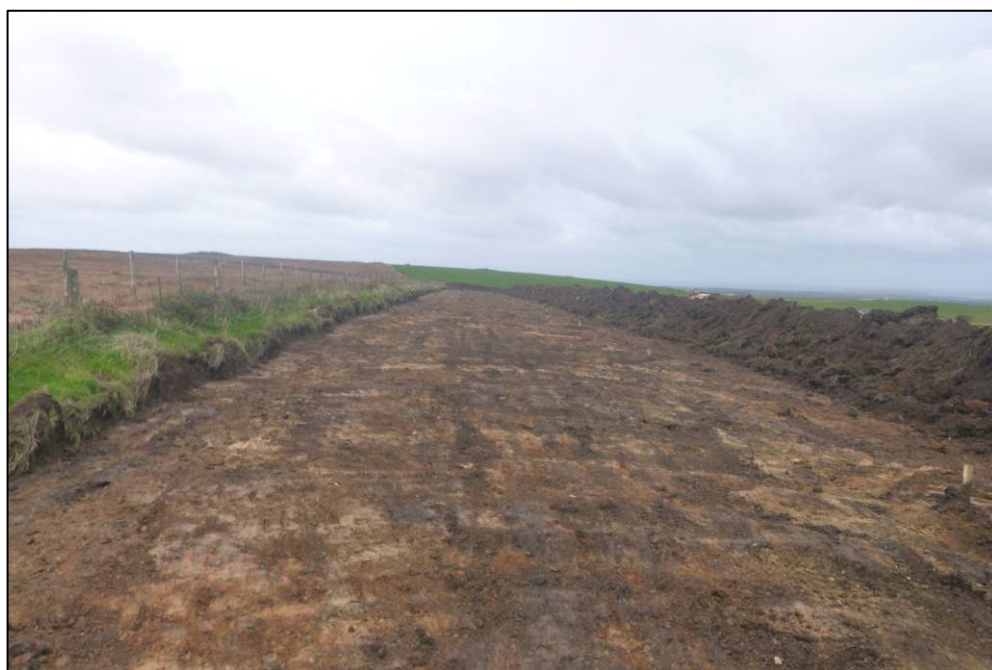
The west side of the field contained a thin layer of topsoil (601) less than 0.2m in depth. This was a darker more organic looking layer with some stone inclusions, the stone inclusions appeared to be quartz stones less than 0.01m in size irregular in shape. The depth of the topsoil varied, but never exceeded 0.2m. The underlying natural was a yellow brown clay layer (602), with common stone inclusions, predominantly quartz stones of various sizes (Fig 17).

*Figure 17: View of field 6 looking west with top soil removed, striation marks in image are from a tractor.*

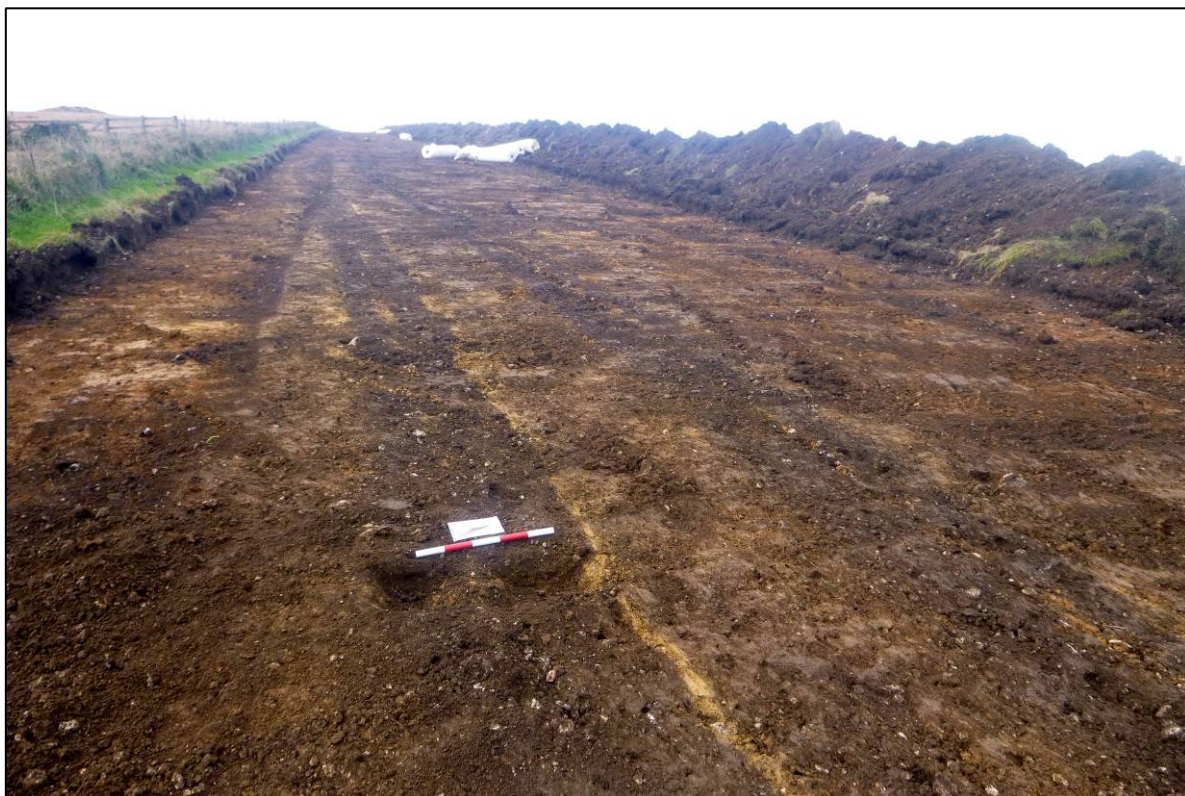
Proceeding from the edge of Field 6 on the south east side were two deep modern wheel ruts cut into the natural clay (Fig 19). They exited the old track on the south east side of the field and headed towards the west.

*Figure 19: View of heavy duty vehicle tracks impressed into natural material within field 6 (looking west).*

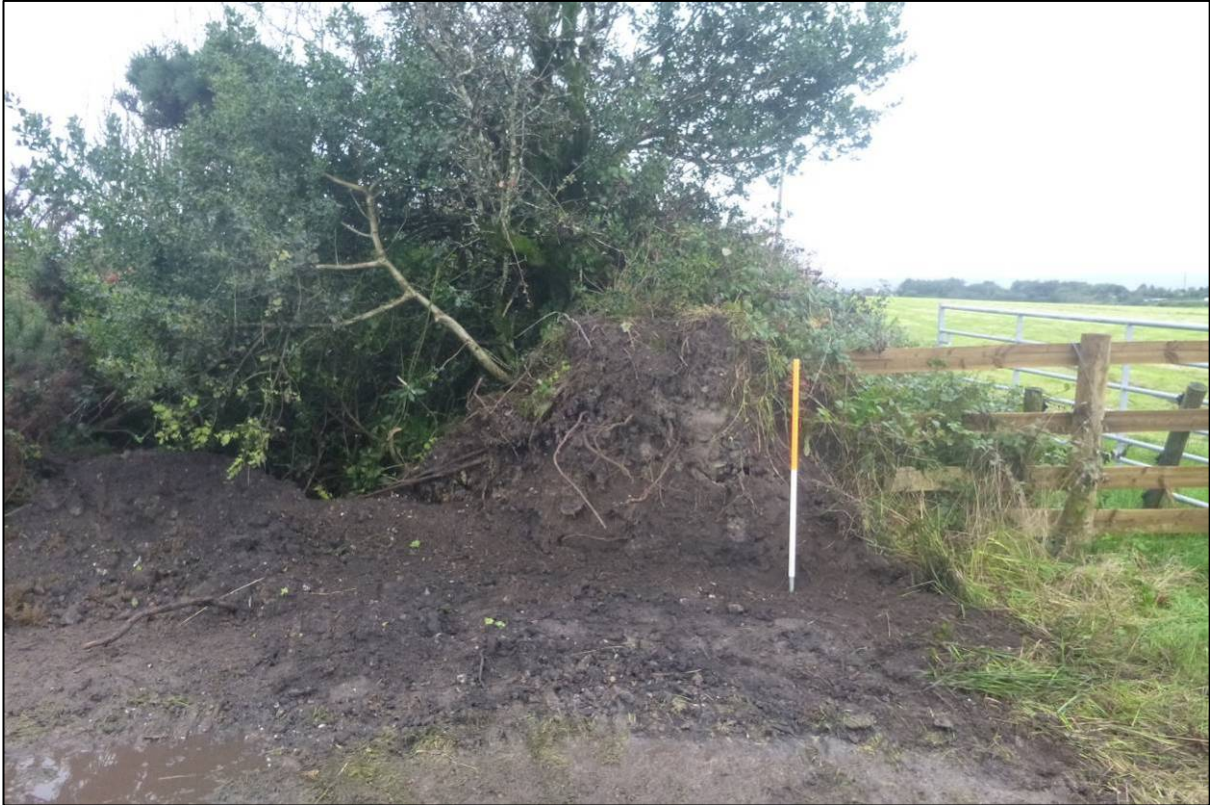
Located at SW 95974 68189 (Fig 5) between Fields 6 and 7, boundary 1, typical of a stone faced bank, is the most substantive (and established of the five recoded examples), achieving a height of around 1.2m and a spread of over 2m. The section did not display any facing stones, but these were evident away from the area of the breach undamaged by the breach. Situated adjacent to the west side of the boundary, but not recorded in section was a ditch approximately 1m deep by 1.2m wide. A track is shown on Ordnance Survey mapping running along its west side. This track appeared to be overgrown and not in constant use, although aerial imaging distinctly shows a path running along the full extent of the track. Where the breach had been made; the ditch had been filled in across the path of the new access road.

This boundary appears to be a stone faced bank containing a soil and stone core. No phasing was evident from the section recorded, however, the boundary is shown on the 1843 St Breock Tithe map.

Figure 20: View of stone faced bank (boundary 1), ditch and N-S trackway are to the left of the boundary, this is the border between fields 6 & 7 looking north.

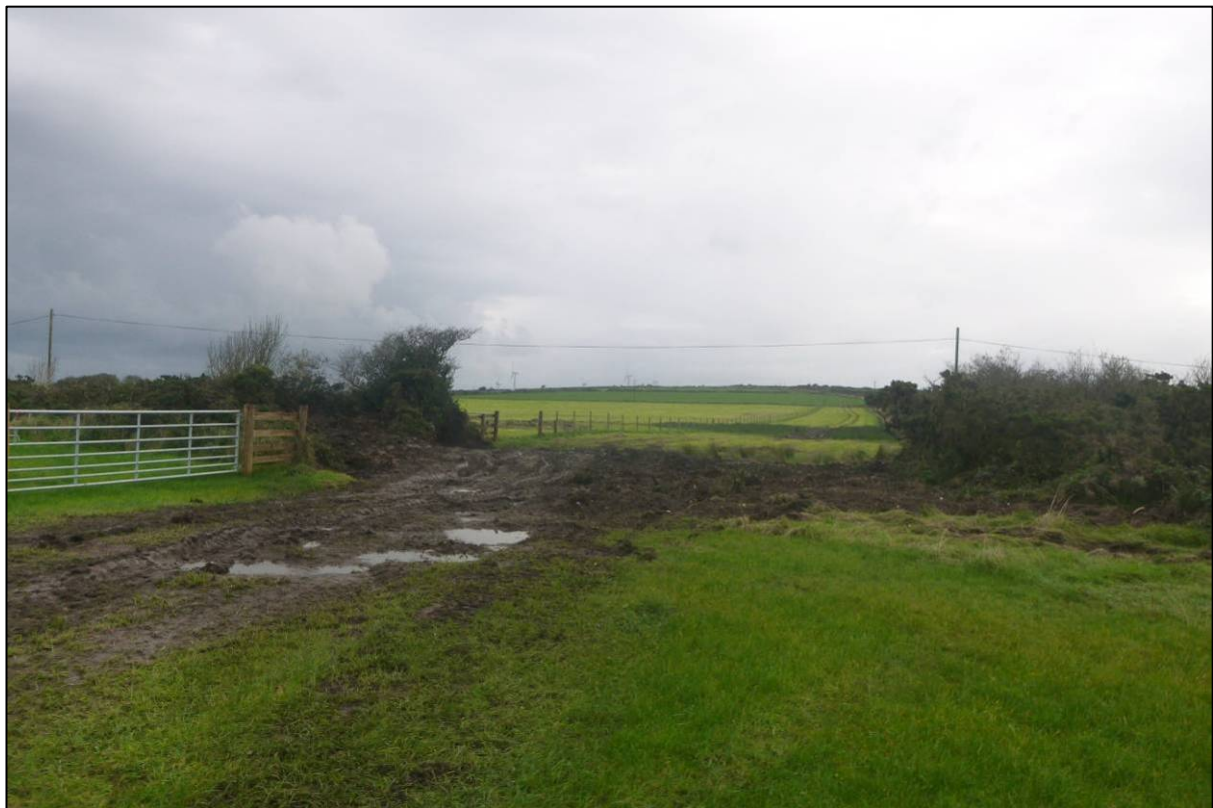
Figure 21: Looking into field 7 from field 6 showing breach in boundary 1 (looking east).

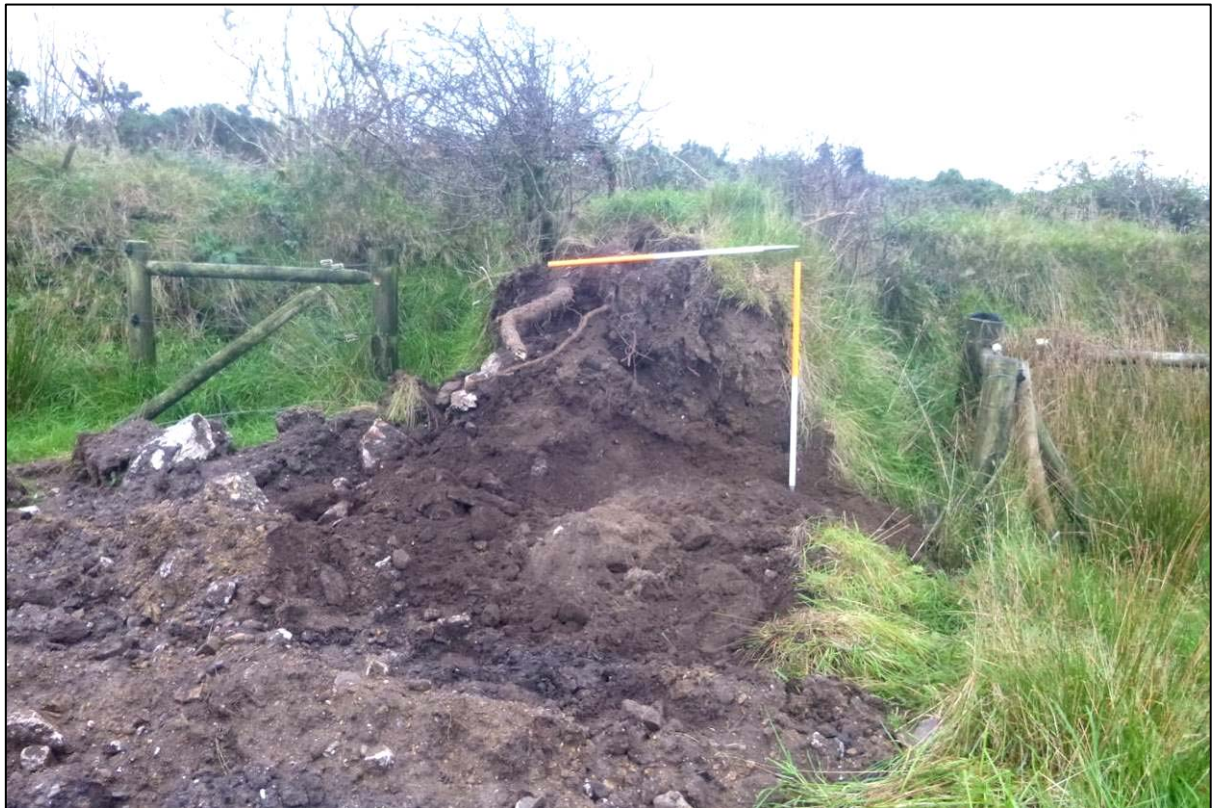
First recorded on the 1843 St Breock Tithe map, this section of the boundary is located at SW 96472 68224, between Field's 8 and 9, and measures approximately 1m high by 1.6m in width. It appears to be a stone faced bank The south face of the breach was recorded due to the damage caused during its removal. The boundary appeared to be comprised of a single layer (201) topped with a layer of grass and hawthorn was growing in close proximity, although within the section only a few large roots were present. The east side of the wall was faced with small blocks of quartz bonded together using fine soil. A thick matting of grass was present on the east side and appeared to bond the wall. An examination of the ground surface appeared to indicate that the wall was resting on the surface of an older land surface (202) and not on the natural yellow clay subsoil.

Figure 22: North facing section of stone faced bank (boundary 2), note the damage making structure unstable (looking south).

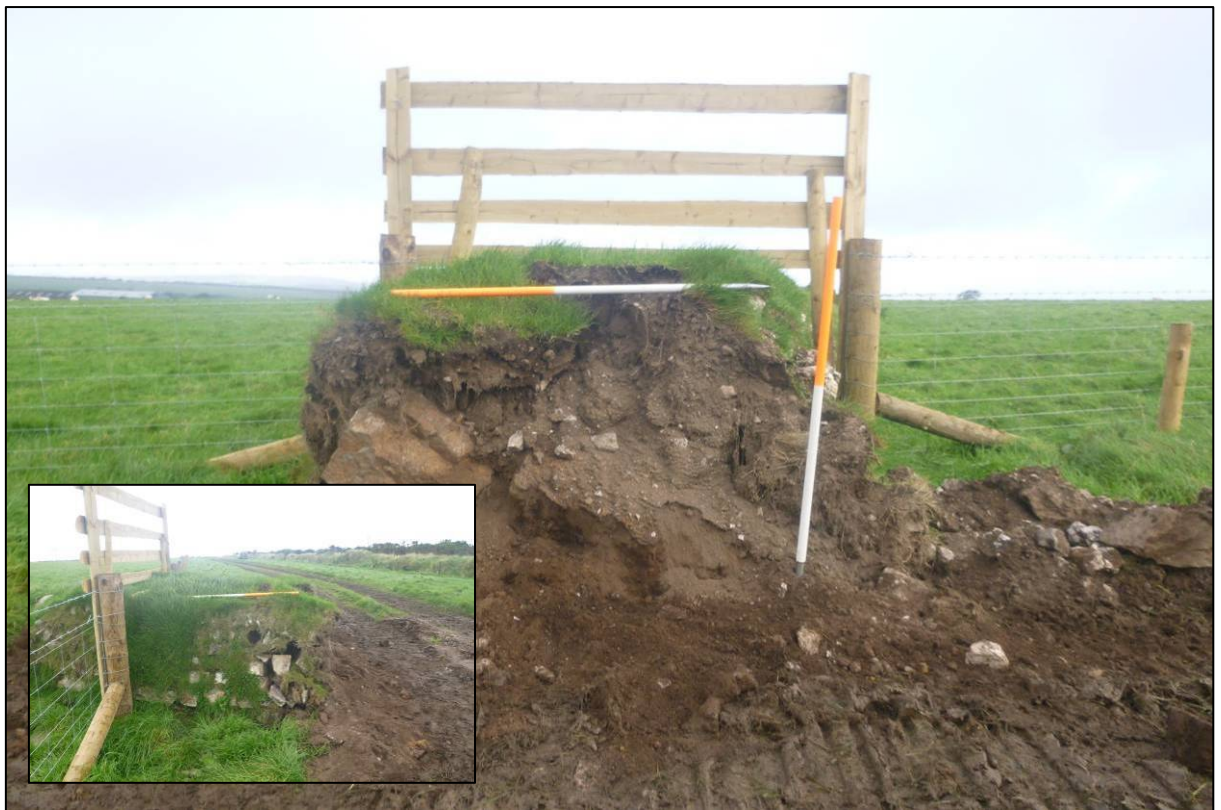
First recorded on the 1843 St Breock Tithe map, this section of what appears to be a stone faced earth wall is located at SW 96613 68277, between Field's 9 and 10, measuring approximately 1m high by 1.8m wide. Both sides of the boundary were

faced with large quartz stones, packed with silty material. The layer forming the boundary consisted of large stones and a very fine soil with small stone inclusions, predominantly quartz. The angle of the wall face was about 70 degrees and relied on the stones to maintain the shape of the wall. The stone faced wall appears to have been constructed directly upon the original topsoil (303).

Figure 23: South facing section of stone faced wall (boundary 3) (looking north). Inset image shows construction of face.

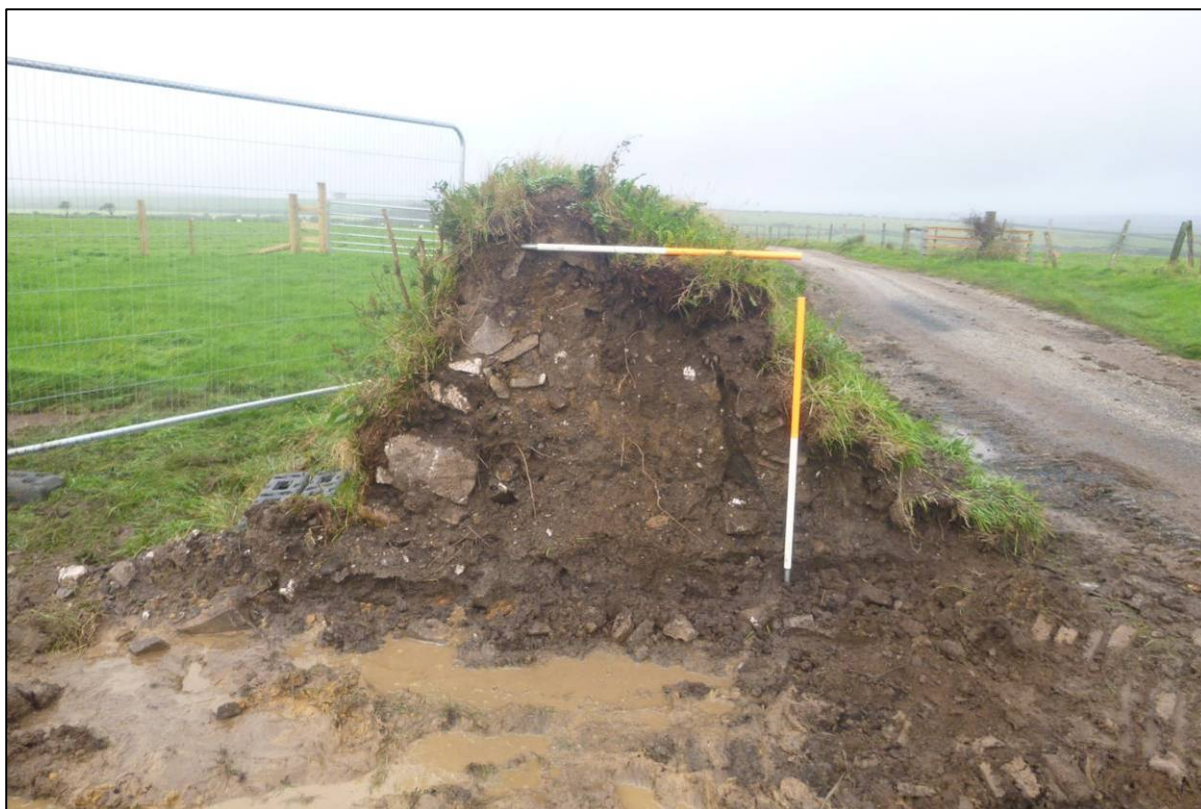
Figure 24: South facing section of stone faced bank (boundary 4) (looking north).

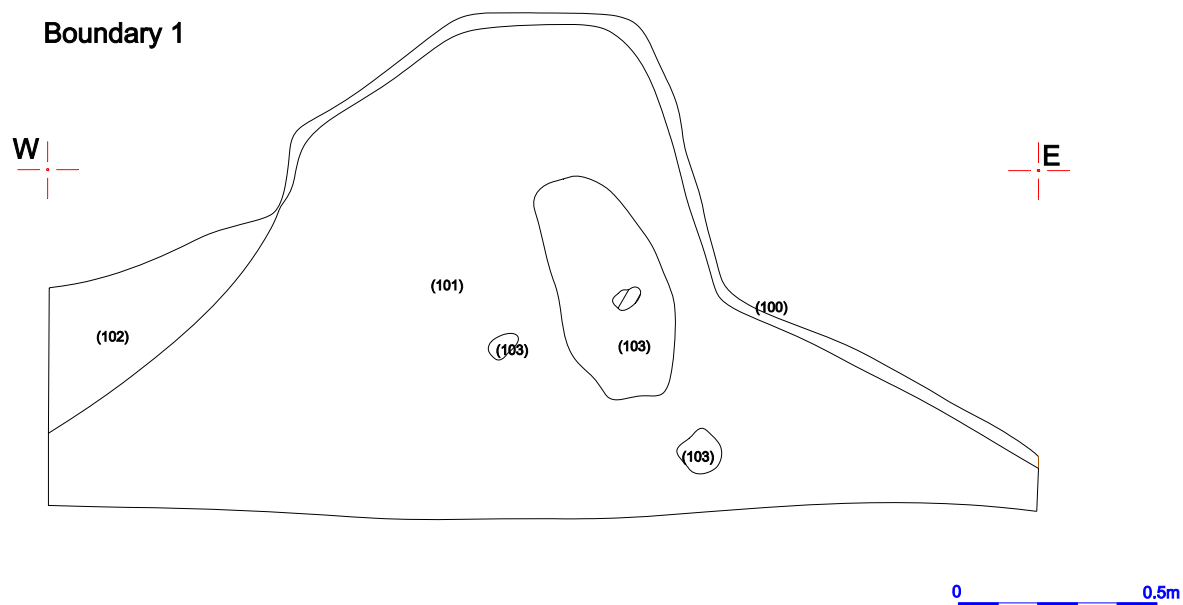
The boundary appears to have been constructed directly onto the old ground surface, which where revealed was a dark grey/black peaty/organic material, prevalent within these fields and the topsoil of the downs.

No	Description/Interpretation	Depth
(100)	Thin covering of loamy soil mixed with organic material (plants) Dark brown/grey in colour some stone inclusions, small irregular shapes, sparse, unsorted. Large roots present.	<0.05m
(101)	Fine dark grey/brown material, almost powder in form, stone inclusions (quartz) irregular shapes, unsorted, variation in colour due to drying out.	
(102)	Similar to (101) variation in colour is probably due to variation in drying rather than material content.	
(103)	Patches of light grey soil, almost powder in content, some stone inclusions, quartz, small irregular less than 0.01m in size. Some larger stones present. Probably the core material for the boundary. Lighter colour could be as a result of drying out.

Figure 26: Section through boundary 1.

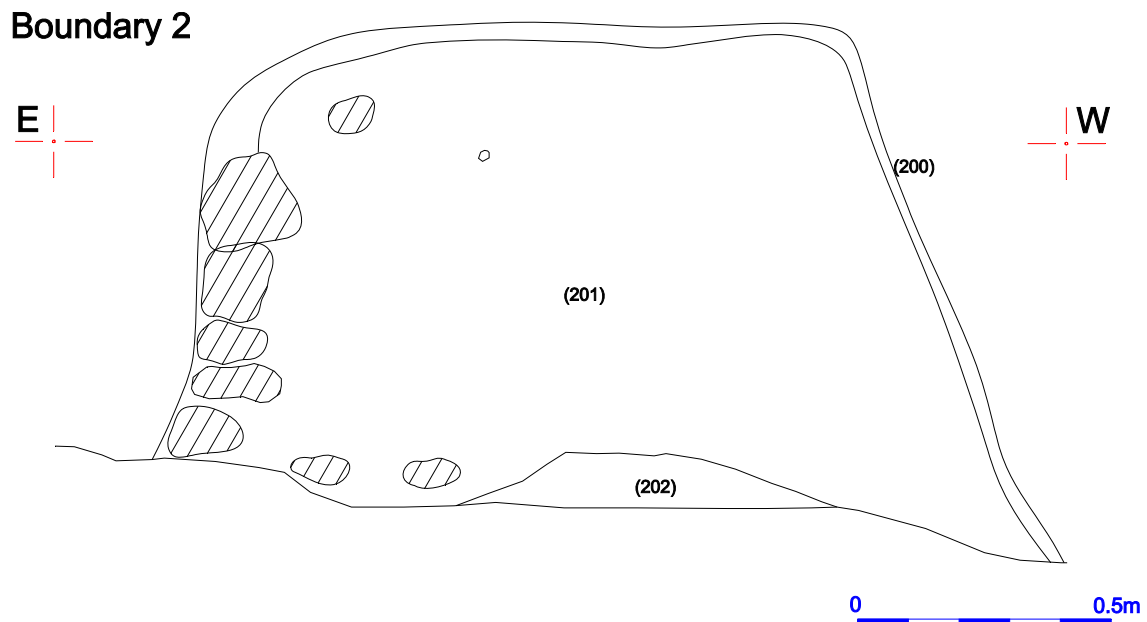
No	Description/Interpretation	Depth
(200)	Thin covering of silty soil with organic material (plants). Mid brown in colour, few stone inclusions, irregular shapes, quartz, <0.01m in size.	<0.05m
(201)	Dark brown/black silt loam, few stone inclusions, irregular shapes, <0.01m in size.	
(202)	Dark peaty soil, with quartz inclusions irregular shapes <0.02m, original ground level.	
(203)	Stone facing comprising quartz stones of various sizes.

Figure 27: Section through boundary 2.

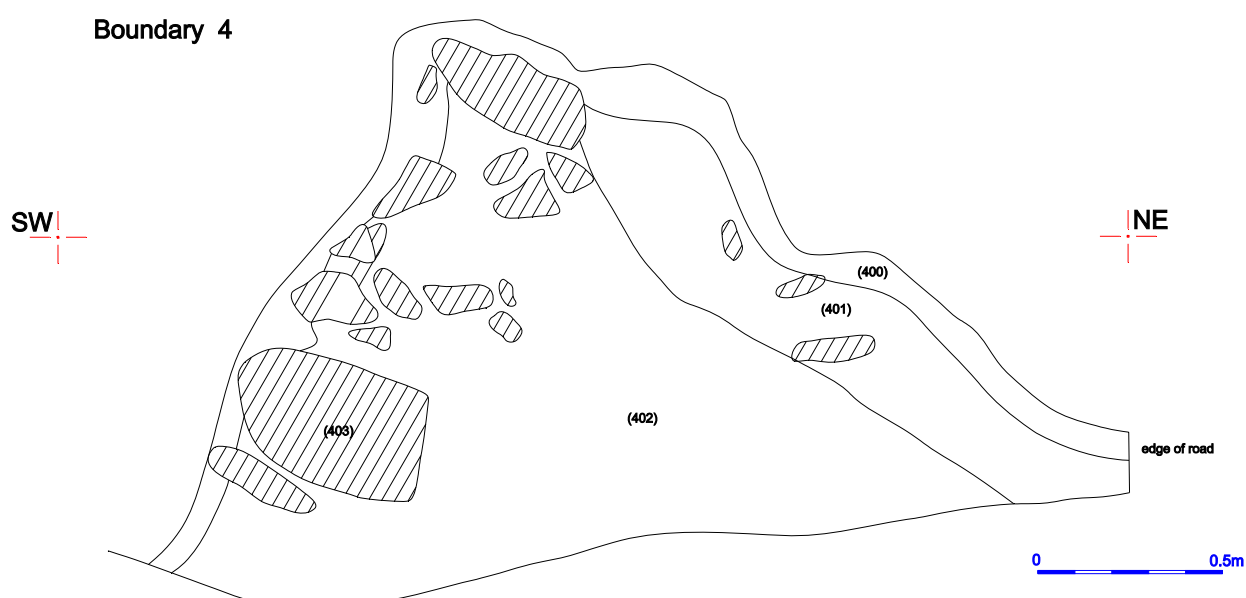
Figure 29: Section through boundary 4.
