# West Haye, Callington, Cornwall

# **Archaeological Watching Brief**

Report No	Report Name	Report Author		
2014R022	West Haye, Callington, Cornwall: Archaeological Watching Brief	C. Buck		
Event Type				
Watching Brief				
Client Organisatio	n Client Contact			
Goldbeck Constru	ction Ltd. Antje Bergmann			
Monuments (Monl	JID)			
Fieldwork dates (F	rom) (To) (Created By)	(Create Date)		
30/10/13	21/11/13 Colin Buck	7/03/14		
location (nostal a	ddress: or general location and parish)			
Location (postal address; or general location and parish) West Haye Farm, Callington, Cornwall. Site				
encompasses eight fields north west of Callington.				
(Town – for urban	sites)	(Postcode)		
(Easting) X co-ord	(Northing) Y co-ord			
SX 34490	70300			
	& CISTER.			
	$\left( \begin{array}{c} c \\ c$			
	CANISAT

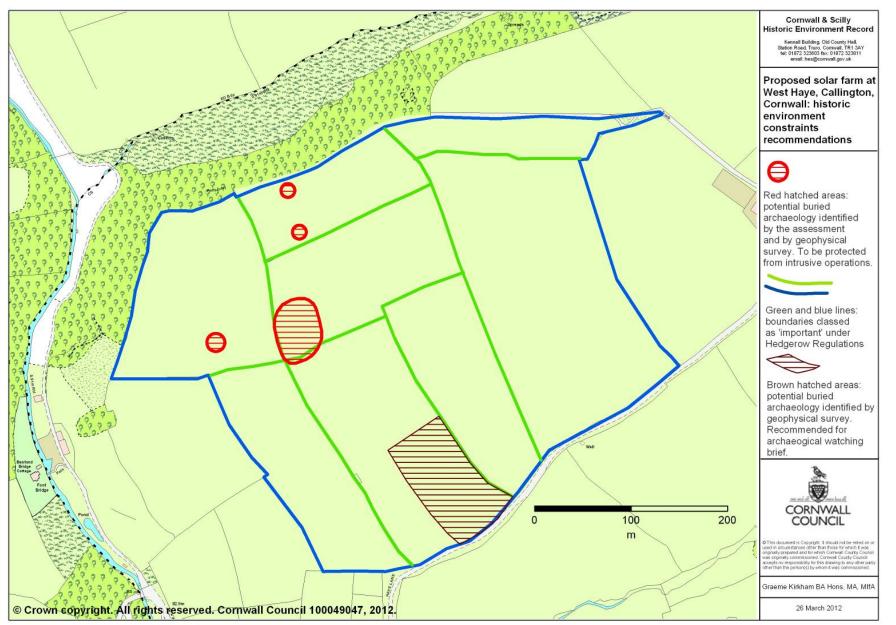
*Figure 3* Recommended historic environment constraints and mitigation (after Kirkham, 2012).

Following the geophysical surveys a report was produced which detailed archaeological constraint and mitigation areas (see Figure 3 after Kirkham 2012). This showed areas which were recommended not to be impacted upon by either solar panels or below ground cable duct trenches. The solar panel project development company accepted these constraints and redesigned the project around the archaeological features. Figure 4 is a Goldbeck Ltd. plan showing the site layout of the panels and duct trenches, whilst Figures 5-9 show the spatial impact of the deep duct trenches on the geophysical survey features. The physical impacts and archaeological features identified along the duct trenches are described in Section 5.

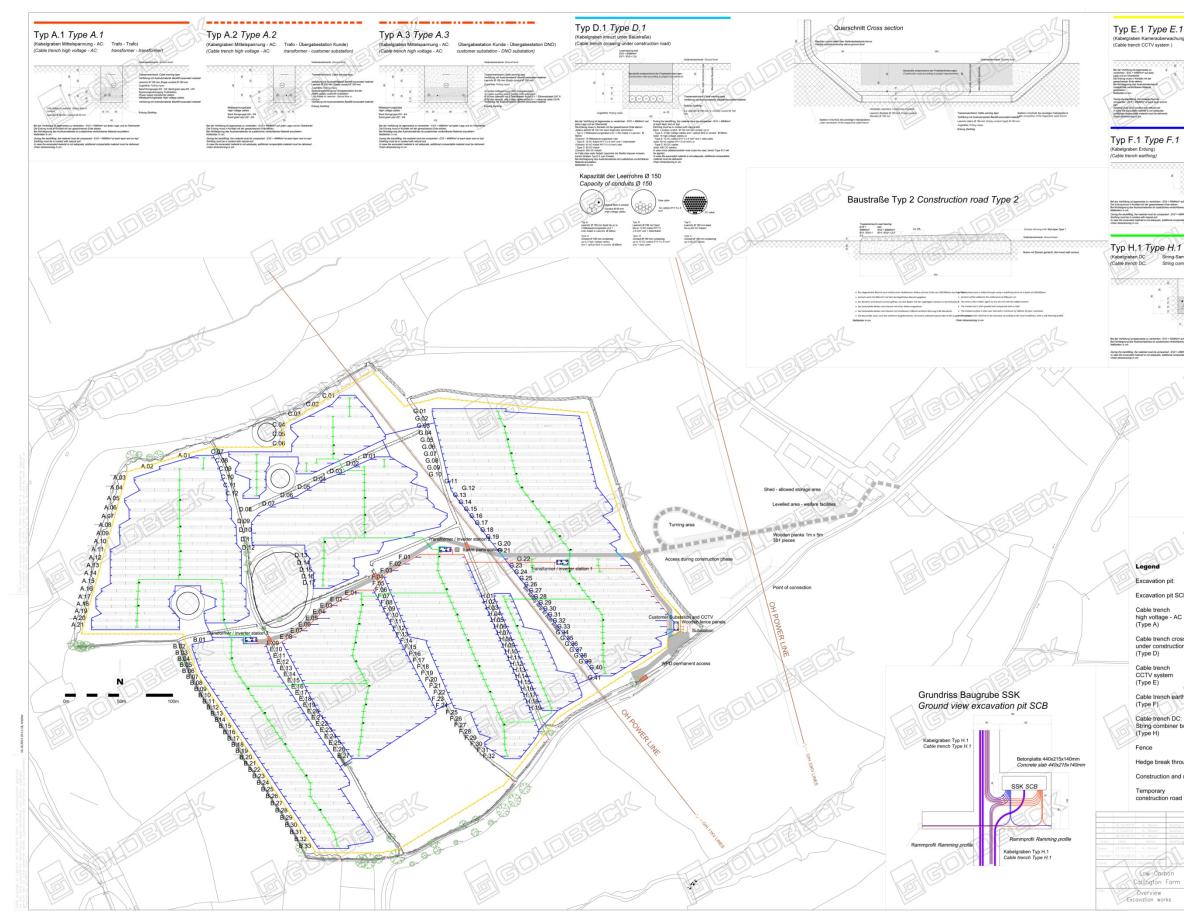
*Figure 4 Site plan showing the solar panel layout mitigating the recommended archaeological constraints resulting from geophysical survey. Plan also shows cable duct trenches and cable duct section profiles. Plan © Goldbeck Dwg. Bh0147 O1-00 'Overview Excavation works Dated 15/10/2013.*

Figure 4 shows that a buffer zone around the three anomalies in fields D and E were in fact created when designing the solar panel array for archaeological mitigation. Figure 7 (black lines) shows that the cable duct trenches went around site 5 in Field D, and did not interfere with sites 6 and 7 in Field E. In fact it appears that there was no known geophysical/archaeological impact for Field E.

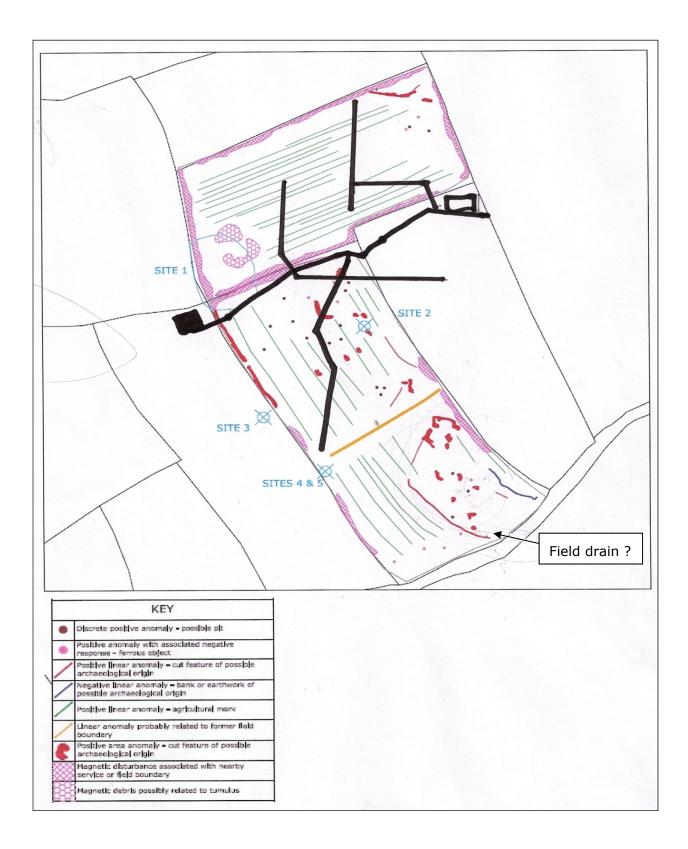
Figure 5 Geophysics data (Stratascan) for Fields A and B (see Figure 2 for site locations), with main cable and transformer duct trenches shown in black intersecting possible archaeological features.

The survey results for field A identified irregular areas of magnetic disturbance on the north-east side of the possible earthwork at site 1, but provided no indications of a ditch or other anomalies defining the feature (Fig 5; Parkes 2011). The geophysics results suggested that ploughing within the field – clearly evident elsewhere as anomalies across the remainder of the surveyed area – did not extend onto the mound. The survey also showed a possible linear feature passing approximately E-W across the north-east corner of field A. This feature was broken and showed an apparent turn to the north of its western portion.

In field B the survey interpretation (Fig 5) indicated a scatter of pit-like features and several other positive anomalies in the central and especially the northern part of the field. It also suggested the possible presence of an enclosure, possibly pre-medieval, in the south-eastern corner. A cluster of anomalies suggesting a possible sub-rectangular structure was located in the north-eastern corner of the possible enclosure accompanied by a scatter of pit-like responses (Parkes 2011).

The Geophysics data with the main cable and transformer duct trenches is shown in black on Figure 5, and appears to intersect with possible archaeological features. It can be seen from this illustration that none of the cable trenches intersected or cut significant archaeological features. Site 1, the 'mound feature' (see Fig 3) appears to be of natural origin. In conversations with the farmer, he stated that close ploughing to the foot of the mound removed clumps of bedrock, and that the site was a natural geological outcrop. This statement is perhaps substantiated by the observation that when the vertical steel posts near the foot of the mound were banged into the ground, they did not go in very far! In fact the ground bedrock west and east of the main outcrop was relatively close to surface – with only 0.2 to 0.3m depth of soil between the base of topsoil and the start of sub-bedrock shillet.

In field B the geophysical survey (Fig 5) indicated a scatter of pit-like features and several other positive anomalies in the central and especially the northern part of the field. It also suggested the possible presence of an enclosure, possibly pre-medieval, in the south-eastern corner. A cluster of anomalies suggesting a possible sub-rectangular structure was located in the north-eastern corner of the possible enclosure accompanied by a scatter of pit-like responses (Parkes 2011). The clustering of these features is interesting but identification of an enclosure remains tentative.

Archaeological mitigation for the presence of probable sub-surface archaeological features, particularly in the southern part of this field recommended that the site was not developed as part of the solar farm. This recommendation was carried out (see Fig 4). However, after having walked around the site with the farmer, and having been shown a sub-surface drain from the field feeding into a tunnel under the adjacent lane to the south of the field – it may well be the case that the 'positive linear anomaly' (Fig 5) described as a 'possible enclosure', may well in fact be a field drain.

The overlaid cable duct trenches (shown as black lines in Fig 5), intersected two 'positive area anomalies', but upon site inspection in the trench section – no archaeological features were visible – presumably the anomaly being geological. The soil profile to the lower and middle section of field B are similar to those of fields H and G (C being wetter).

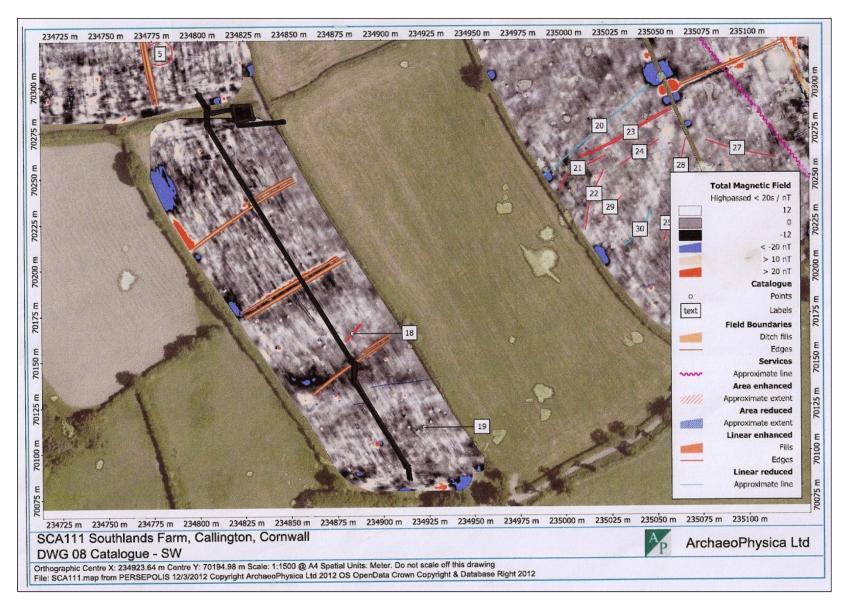
*Figure 6 Geophysics data for Field C (see Figure 2 for site locations), with main cable and transformer duct trenches shown in black intersecting possible archaeological features*

The most significant features shown in the geophysical survey (Fig 6) for this field were three double-ditched anomalies (removed Cornish hedges). The middle hedge is shown as extant in 1841 (Parkes 2010, Fig 19). The other hedges above and below the middle hedge were part of a later medieval field system. The overlaid cable duct trenches (shown as black lines in Fig 6), intersected at right angles the three sub-surface sites of the removed hedge boundaries. But upon site inspection in the trench section – no significant archaeological features were recorded.

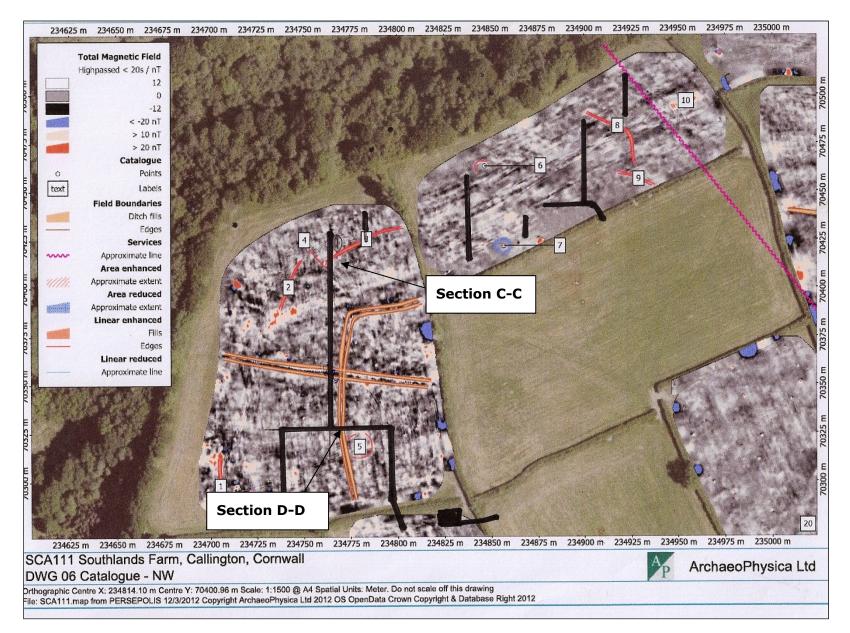
*Figure 7 Geophysics data for Fields D and E (see Figure 2 for site locations), with main cable and transformer duct trenches shown in black intersecting possible archaeological features.*

Field D in Figure 7 shows that the main cable duct trench crossed the foundations for two double ditched former field boundaries, and at the northern end of the field, the west end of feature 3 (labelled on Figure 7). 'Anomaly 9 in field E and a double-ditched anomaly (removed Cornish hedge) to the east in field G appear to align with the linear feature crossing the north-east corner of field A indicated by the Stratascan survey (Fig 5). Anomalies 2 and 4 in field D and 8 in field E could represent further elements of an earlier layout of agricultural enclosures in this area (Fig 4). A possible interpretation is that these represent a series of encroachments of land cleared for agriculture into the probable former wooded area on the lower slopes to the north' (Kirkham (2012, 8).

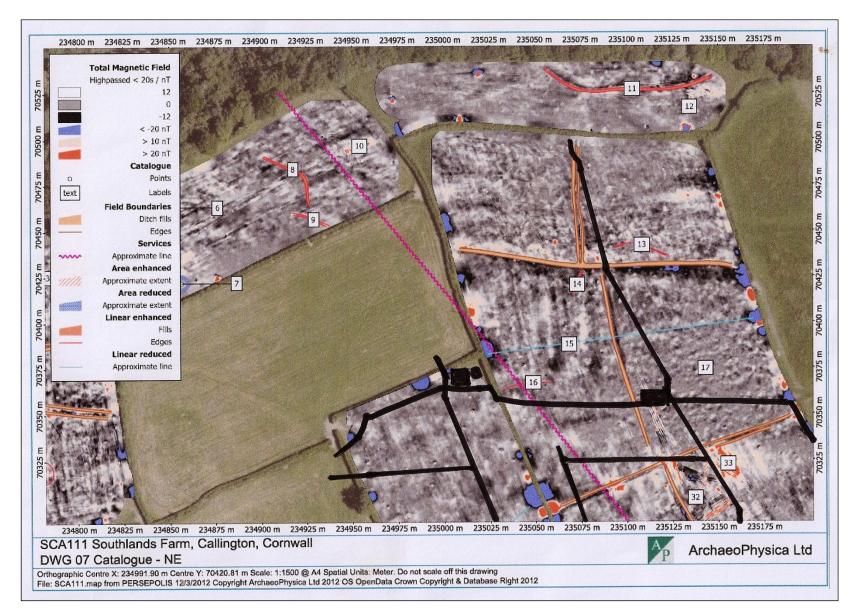
*Figure 8 Geophysics data for Fields G and H (northern sections-see Figure 2 for site locations), with main cable and transformer duct trenches shown in black intersecting possible archaeological features. Field F was not affected by solar panel installation.*

Note: **Field F** was not impacted by the solar array, although the geophysical survey was undertaken and shown on Figure 8. Kirkham (2012, 8) states: '*Anomalies 11 in field F* and 1 in field D may similarly represent historic boundaries dividing agricultural land from the former wooded area to the north and west (Figure 8)'.

Figure 8 shows the northern part of fields G and H and Figure 9 the southern parts. Field H, being located on the east side of field B, has (in its southern section - Fig 9) some geophysical linear features possibly related to those tentative 'medieval enclosure' features in the lower section of field B (see description above in Field B). The most significant features shown in the geophysical survey (Figs 8 and 9) for this field are thus described and interpreted: 'The anomaly forming the possible northern ditch of the enclosure may continue into field H to the east as either anomaly 21 or 22 identified by the ArchaeoPhysica survey; other minor linear anomalies (24, 29) occur in the same area. ... it is conceivable that both the boundary between fields B and H and the southern boundary of field B originated as the boundaries of a putative enclosure' (Kirkham 2012, 8). 'Linear anomalies 25, 26, 27 and 28 within the southern portions of fields G and H make up a pattern of two adjoining rectilinear enclosures (Fig 9). That to the north appears to be approximately 55-60m across and these boundaries would therefore fall within the broad parameters of later prehistoric rectilinear field systems identified elsewhere in Cornwall. Such an identification must be tentative, however, and other origins for these anomalies are certainly possible.... Feature 23 in field H (Fig 9) is a probable post-medieval boundary partitioning field H into smaller parcels comparable to those dividing fields B and G to east and west' (Kirkham 2012, 9).

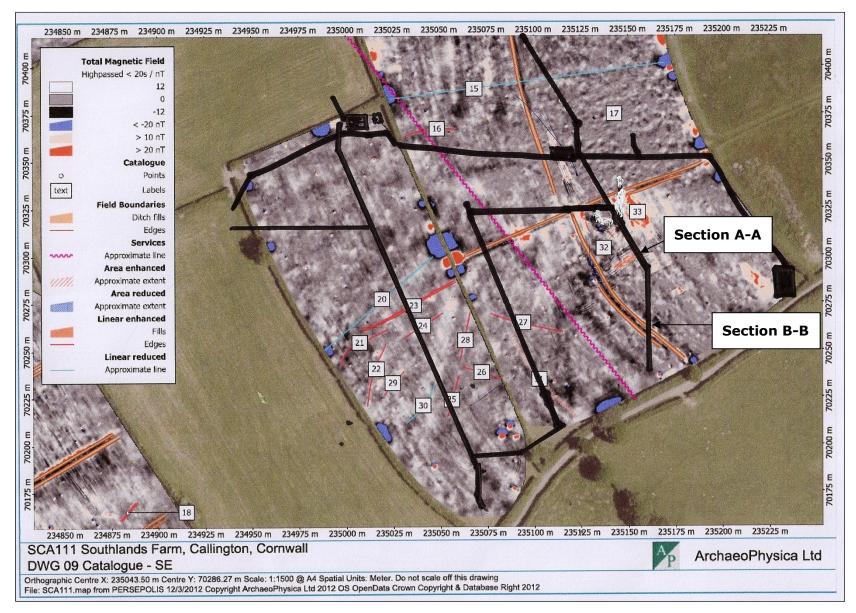
*Figure 9 Geophysics data for Fields G and H (southern sections-see Figure 2 for site locations), with main cable and transformer duct trenches shown in black intersecting possible archaeological features.*

Reference to the overlaid cable duct trenches (shown as black lines in Fig 9), intersected the following geophysical anomalies: 23 to 25, within the southern section of field H, no geophysical features were recorded for the northern section of this field which includes the site of a transformer/inverter station (Fig 9). No archaeological features were observed in these cable duct trenches. Figure 12 is an image of this field viewed from the north looking downhill to the south.

The geophysical survey results of Field G (Figs 8 and 9), mainly show the (now removed) later medieval derived field boundaries. The cable duct trenches are shown overlaid in black intersecting the former hedge boundaries in places. Sections A-A and B-B (not included within this report) were recorded at two of these intersection locations, and are atypical examples of hedge construction (see Figure 9 for section locations). There were no other archaeological features viewed in the excavated cable duct trenches.

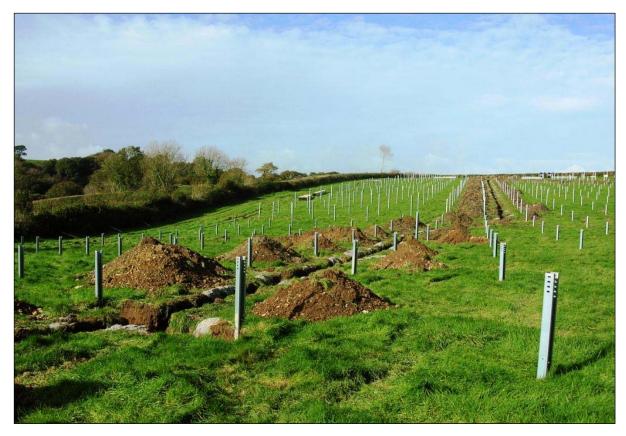
Figure 10 Image (from the south looking north) of field C after the main cable duct trenches were excavated and vertical posts forced into the ground © HE Projects, CC 5/11/2013.

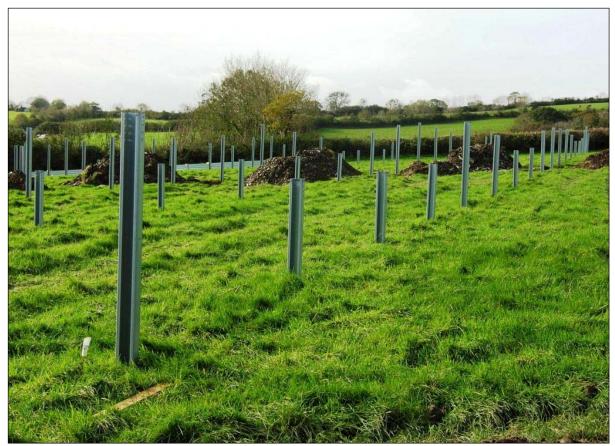
Figure 11 Image (from the south looking north) of field B showing the various depths of hard slate-stone deposits from north to south © HE Projects, CC 5/11/2013.

The average soil profile recorded in the middle and lower sections of each field during excavation of the cable duct trenches (Figs 4, 5-9), consisted of 0.05m of grass, roots and topsoil overlying 0.25m of darker brown topsoil, overlying 0.3m depth of lighter brown soil/stony subsoil, overlying 0.3m of dark blue/black slatestone to the base of the cable duct trenches which were all approximately 0.85m deep (Fig 4). The slatestone and shillet bedrock lay at the base of the deeper trenches at the lower end of the fields but higher up the fields (further to the north of the site), the slatestone generally increased in height to close to ground level – but with variations as described above (see Fig 11. The process of clearing the ground for agricultural use in prehistory, and the use of modern ploughing techniques has smoothed out the soil profile (effectively infilling between the 'peaks' of slatestone formation – see Fig 10 for 'smoothed' field bedrock level compared to Fig 11 for slatestone 'peaks').

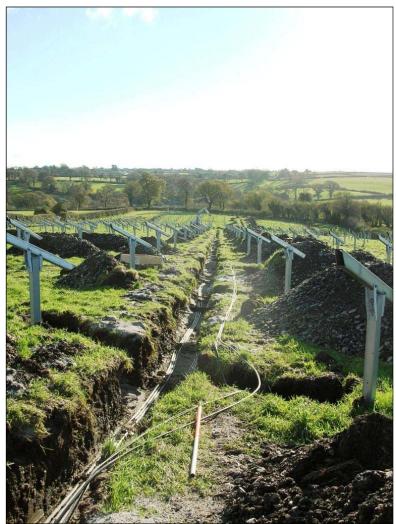
Figure 12 Image (from the north looking south) of field H showing the Type H cable duct trench with inter connecting stringer boxes and partially assemble solar panel frames © HE Projects, CC 21/11/2013.

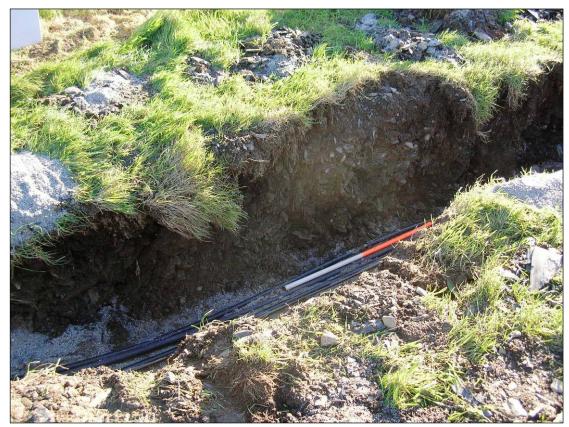
Figure 13 Image (north side) of Section D-D. See Figure 7 for site location. © HE Projects, CC 21/11/2013.

Two sections were recorded within field D, Section D-D at the intersection point between the cable duct trench and the double ditch hedge boundary, and Section C-C, the intersection point between the cable duct trench and the possible medieval enclosure boundary. Neither is reproduced within this report (as they are atypical examples), but a photograph of Section D-D is reproduced in Figure 13. GRE drawings (No. 807) for both sections have been produced and are archived in the CC HE Project GRE folders.
