# **Trelean Farm Barn D, St Erth Praze, Cornwall**

## **Historic building record**

<b>Client</b>	<b>Mr D and Mrs S Spence</b>
<b>Report Number</b>	<b>2014R038</b>
<b>Date</b>	<b>May 2014</b>
<b>Status</b>	<b>Draft/2nd draft/<b>Final</b></b>
<b>Report author(s)</b>	<b>Eric Berry and Nigel Thomas</b>
<b>Checked by</b>	<b>Andy Jones</b>
<b>Approved by</b>	<b>Andrew Young</b>

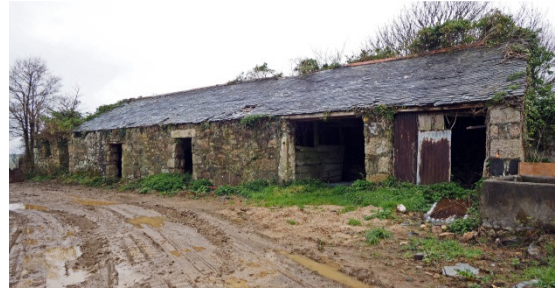
Fig 15 Barn D from SE

A pair of cartsheds (Figs 15 and 16), located at the east end of Barn D, occupy in part, the former plan space of the phase 2 building. The phase 3 scheme involved rebuilding part of the phase 2 rear wall (Figs 26 and 27) and extending it eastwards and returning

The front (south) wall has two wide cart doorways (Figs 15 and 16). The left-hand doorway is part of the phase 2 building and the quoin remains of its former gable or hipped end. This opening (which has been raised slightly) is spanned by a reused timber stained with mineral as if from former use in a mining complex. The right hand doorway is created from the part of the end wall of the phase 2 building and a new wall to the right. The phase 3 masonry incorporates quoins created from copper slag (scoria) blocks of the type that was typically cast at nearby Hayle when copper smelting was a major activity in the Copperhouse end of the town (Figs 22 and 25). The opening is spanned by a reused 17<sup>th</sup> century or earlier chamfered and stopped timber. The east end of this timber is supported on a reused ship's timber with random spacing of treenail holes.

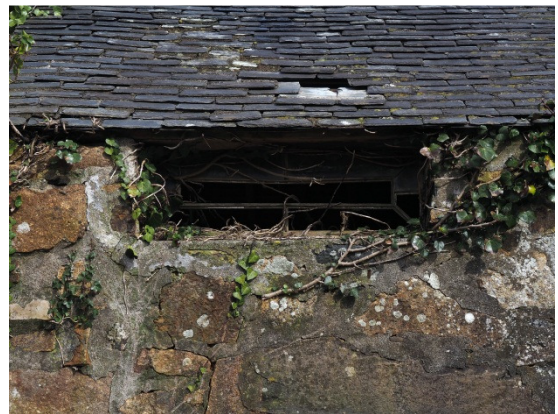
Fig 18 Barn D phase 2 reused overlight

There are no original windows but a squat opening (Fig 18) has been cut under the eaves at far left and fitted with a reused early-mid 19<sup>th</sup> century overlight with margin panes.

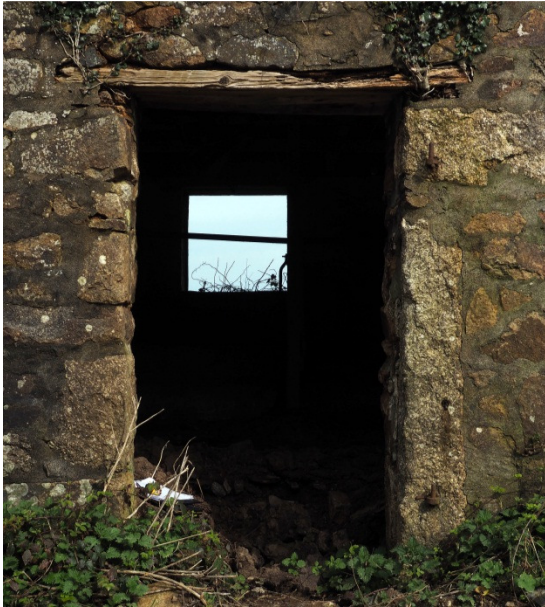
Fig 19 Barn D phase 2 doorway (with reused wedge split gatepost on right)

The front wall (Figs 19-21) has two complete original doorways (left of centre and right of centre) plus the left-hand jamb of a further probable original doorway on the right of the original length of the phase 2 cowhouse (Fig 21). At the eastern end is a single cart bay. The left-hand doorway (Fig 19) has roughly-hewn granite jamb-stones to the left-hand jamb and there is a vertically-set granite monolith forming most of the right-hand jamb. The monolith has evidence for wedge-splitting that was the method used for quarrying granite before 1800. The opening is spanned by a timber lintel. The next opening (Fig 20) is slightly taller, it has roughly-hewn granite jambs and the opening is spanned by a granite lintel. The surviving original jamb of the original right-hand doorway has a granite monolith (also with evidence for pre-1800 wedge splitting) for most of its height and this doorway was originally similar to the left-hand doorway and probably also originally spanned by a timber lintel to a similar level. This arrangement of doorways with a taller central doorway suggests that the central doorway was designed for human access and the other doorways were used as access for the cattle.

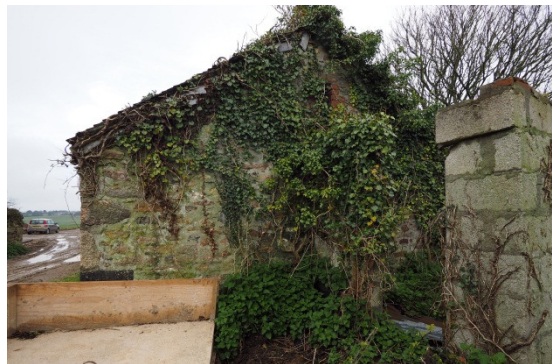
Fig 23 Barn D, E end (note gable vent)

The east gable end (Fig 23) has a gable vent with brick jambs.

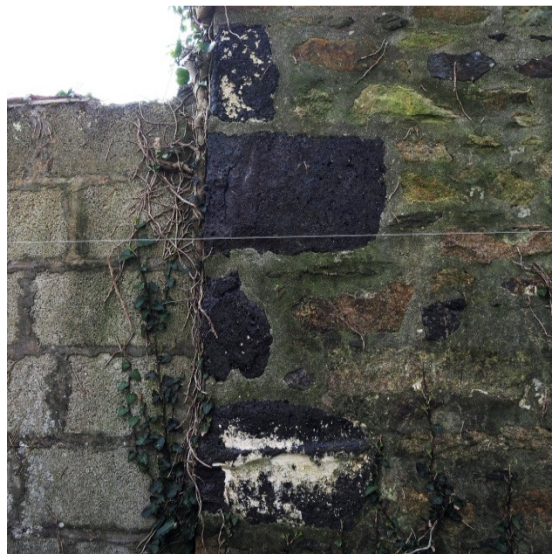
Fig 25 Barn D phase 3 NE corner (scoria blocks)

The north-east corner of the phase 3 building contains four scoria blocks used as quoins (Fig 25).

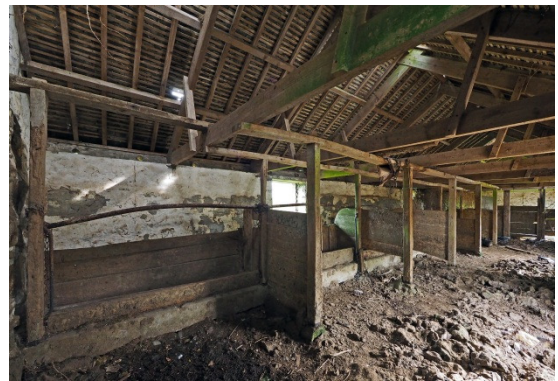
Fig 31 Barn D phase 2 interior from SW

Phase 2 is a cowhouse with eight pairs of standings (Figs 31 and 32) plus access from a feed passage and a single cart bay at the eastern end. The phase 2 building has a deeper plan depth than phase 1, the extra area at the rear used to accommodate a feed passage.

The interior (Figs 30-33) has a cobbled floor in the cowhouse part. Internal wall faces have been lime-washed.

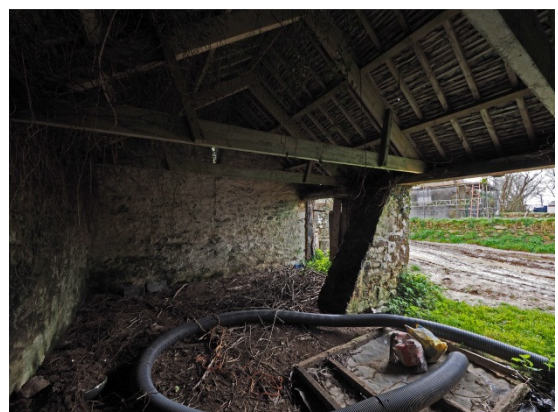
Fig 33 Barn D remains of phase 2 E wall

The right-hand jamb of the eastern cart doorway is the remains of the original end wall. This wall was mostly removed when phase 3 was added. The truncated wall (Fig 33) survives for a short length and has been made good as a sloping feature resembling a buttress.

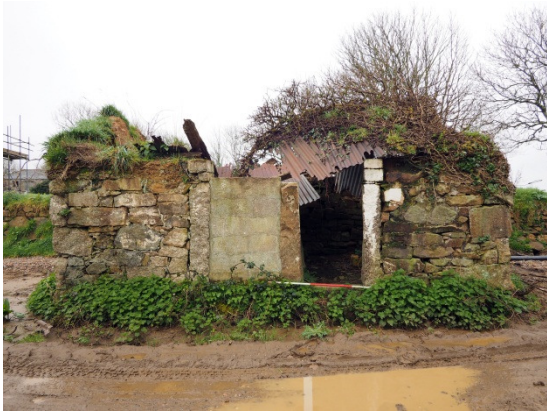
Fig 34 Pigsties N front

South of Barn D is a detached pair of pigsties (Figs 34-40 and 59). This building is in poor condition and its roof structure and corrugated-iron roof covering have mostly collapsed. The building is constructed from elvan rubble plus cob to the upper parts of the walls. Small ventilators are built into the gable ends. The north front of the building has two low doorways with a central jamb made of one massive granite monolith that also forms much of the partition wall. The floors are cobbled and there are original threshold timbers fitted into sockets in the jamb masonry. This building is therefore a very interesting example of vernacular construction. Granite jamb-stone blocks bear drill marks, characteristic of mid-19<sup>th</sup> century quarrying. This supports the historic map evidence as the building is not shown on the 1840 Tithe map and is first depicted c1880.
