Report No: 2014R050

Western Power Distribution depot, Pool, Cornwall

Archaeological Watching Brief

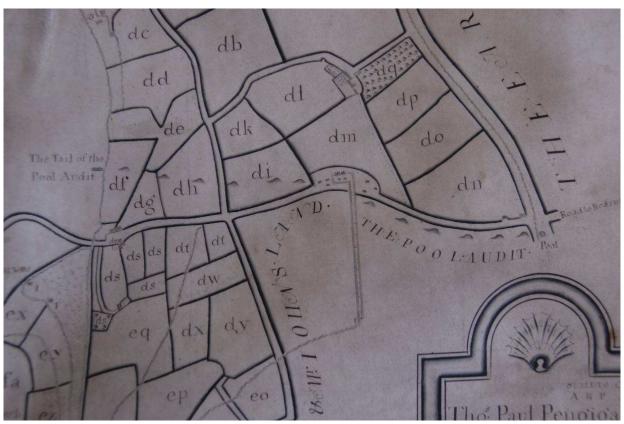
Figure 3. An extract from William Doidge's 1737 survey of the Manor of Tehidy (CRO X/101/5). The WPD site occupies Plots dk and di shown on this plan. Shaft dumps are shown in plot di along the route of Pool Adit following Reeve's Lode.

The earliest feature encountered is most likely the small outcrop shaft found in Section 29 (Figs 7, 14 and 14). This lies on the line of Reeve's Lode the line of which is shown by lode back workings marked on the 1737 map of Tehidy Manor drawn up by Doidge (Fig 3). This suggests that this feature is possibly 18th century date.

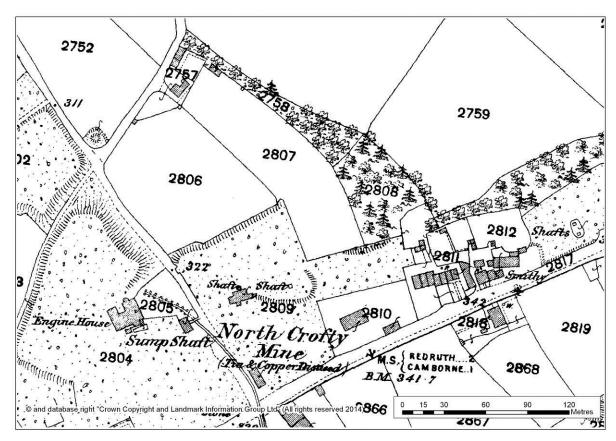
Figure 5. Ordnance Survey, c1875. 25 Inch Map First Edition.

No evidence for any buildings, (including the winding engine house associated with North Crofty Mine shown on the 1877 1st Edition OS 25" scale map) were recorded within the trenches or areas observed (Fig 5).

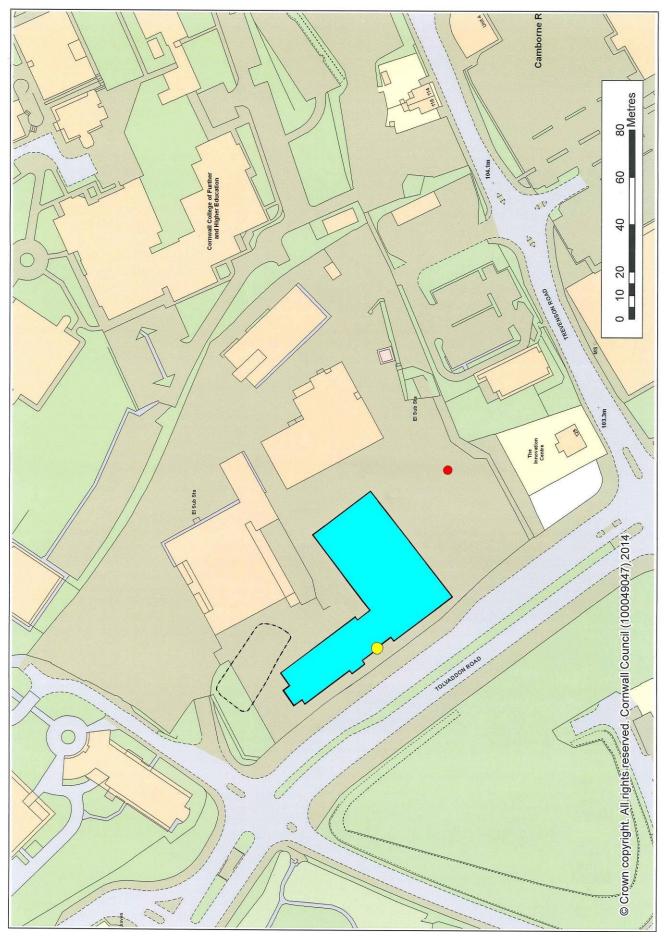
Figure 7. Site plan showing location of new building (blue) and features encountered. Outcrop shaft (yellow circle), Praed's Shaft (red circle). Attenuation tank cut (dashed lines) 20

The first phase examined the works around the footprint of the new building which is roughly L shaped with the two wings orientated roughly northwest to southeast, and northeast to southwest, the building measuring roughly $80 \, \mathrm{m} \times 60 \, \mathrm{m}$. The foundations of the new building consisted of a linear series of foundation pits connected by trenches. The pits varied in size but averaged $3 \, \mathrm{m} \times 2 \, \mathrm{m}$, reaching a maximum depth of $1.5 \, \mathrm{m}$. These were spaced at regular intervals, dependant on where they were located within the building varying between $3 \, \mathrm{m}$ and $5 \, \mathrm{m}$ apart. The trenches that connected them were $1 \, \mathrm{m}$ wide and $1 \, \mathrm{m}$ deep (Figs 7, and 8).

building footprint, and would only be overlain by the yard, it was decided the existing concrete cap would be sufficient for purpose and no further mitigation was carried out (Brian Poole, Senior Geologist, Cornwall Mining Service Ltd, pers. comm.). No evidence for any buildings or other structures in the vicinity was found (Fig 7).

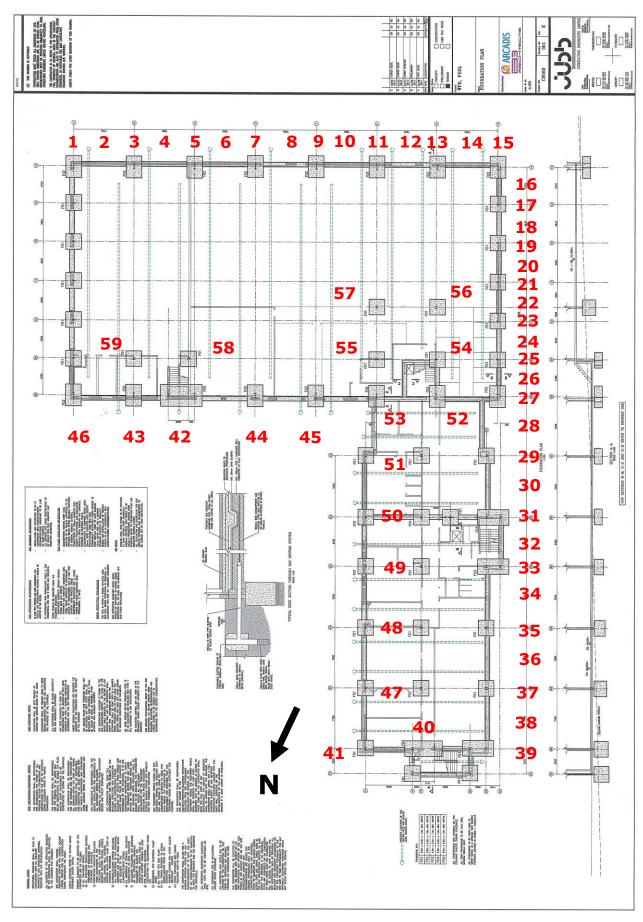
Figure 8. New building foundations plan showing location of recorded sections (red)

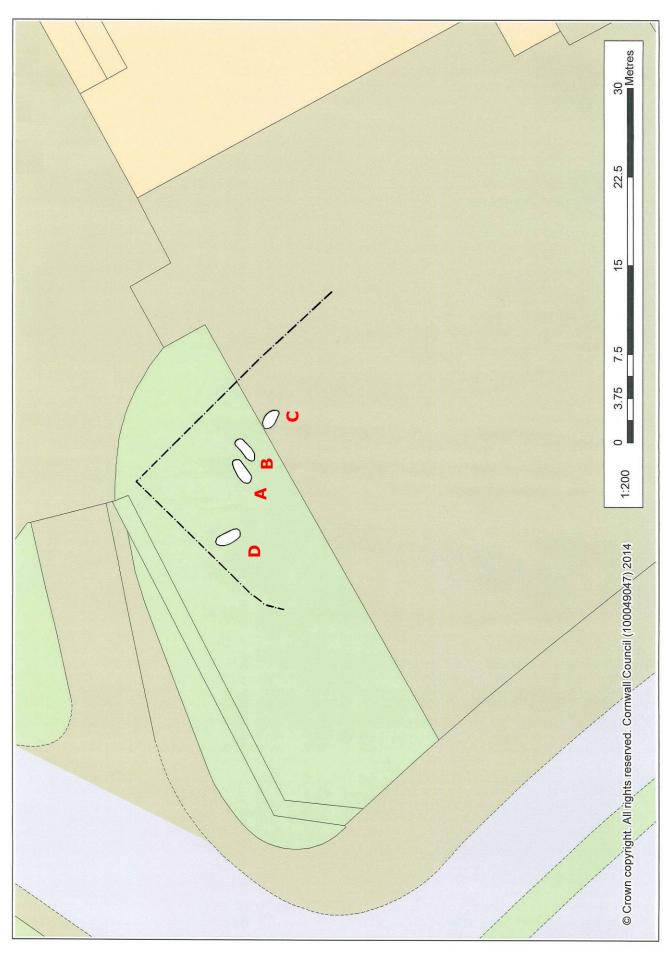
Once the base of the tank had been levelled four pits (A to D) could be seen exposed at the northwestern end (Figs 9, 18 to 21).

Figure 9. Site of attenuation tank showing location of prospecting pits encountered.

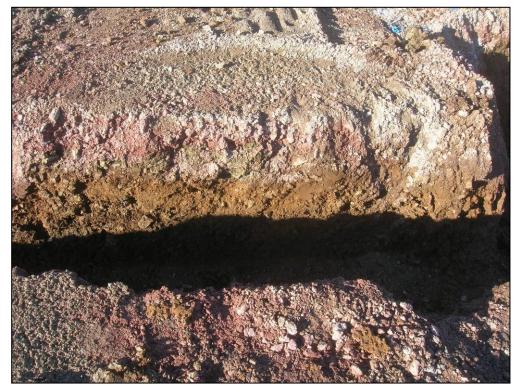
The southeastern most length of wall (Sections 1–15) was some 60m long running in a NE/SW direction (Figs 10 and 11). The general profile recorded was as follows.

- 0.05m light grey-brown clay.
- 0.20m red-brown clay.
- 0.20m grey-green, brown clay.
- 0.20m chestnut brown clay.
- 0.30m orange-brown clay with numerous stone fragments.
- 0.20m dark grey-brown clay with stone fragments.
- 0.20m red-brown clay.
- Orange, yellow-brown clay, the decayed natural bedrock (rab) lay at the base and was not bottomed.

All the layers above the rab consisted of dumped material, much of it mine waste, with the rock fragments being heavily mineralised, and often manganese stained. The layers of material had been laid down in roughly horizontal deposits, the only variations being in the thicknesses of the layers at points along the trench. No archaeological features were recorded, apart from right at the southwestern end where the section had been greatly disturbed by modern service trenching that ran parallel to the road (A 3047).

Figure 10. South eastern foundation. Section 2 showing nature of ground encountered.

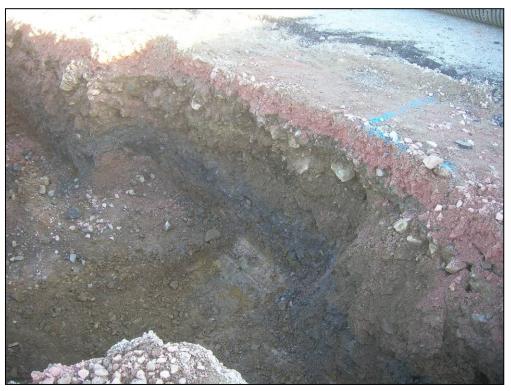
Figure 11. South eastern foundation. Section 11 looking east showing nature of ground encountered.

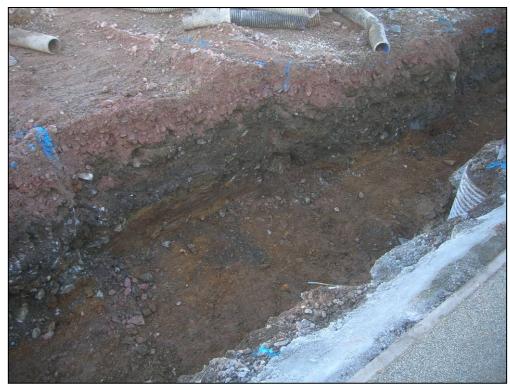
The southern part of the southwestern wall (Sections 16-27) was *circa* 30m long running in a NW/SE direction (Figs 12 and 13). The western face of the trench had been highly disturbed by modern services and associated trenches; however the general profile recorded was as follows.

- 0.10m grey-green, brown clay.
- 0.40m black, orange-brown clays with stony rubble (Heavily mineralised, and manganese stained)
- Orange, yellow-brown clay, the decayed natural bedrock (rab) lay at the base and was not bottomed.

Again all the layers recorded above the rab were of dumped material. The layers of material had been laid down in roughly horizontal deposits, the only variations being in the thicknesses of the layers at points along the trench. No archaeological features were recorded, apart from a couple of modern services including a cast iron water pipe and its associated trench that ran west to east across Section 27.

Figure 12. South western foundation. Section 24 showing nature of ground encountered.

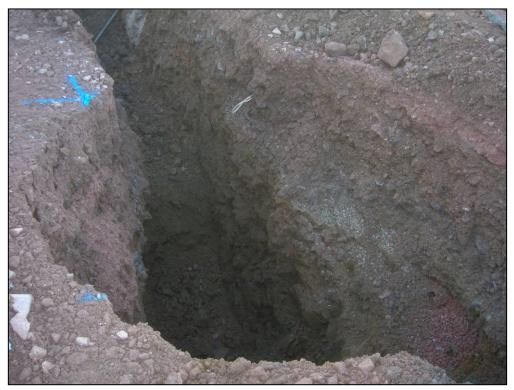
At a point 40m from the northwest corner at Section 29 a distinct mining feature was recorded (Figs 7, 13, and 14). This feature proved to be cone shaped in profile the rim being *circa* 4.3m in diameter. Cut through the dark grey-brown clay at a depth of *circa* 0.5m it passed through disturbed ground and rotten rab with solid rock being encountered at a depth of 2m. At this point the cut changed direction to become vertical, creating a shaft of circular profile some 3m in diameter. The feature was infilled with loose material and stony blocks, which were excavated to a depth of 3.0m but it was not bottomed due to the unstable nature of the fill preventing further examination. It is uncertain exactly what this feature is; it could possibly be a small outcrop shaft.

Figure 13. South western foundation. Section 29 showing outcrop shaft looking north.

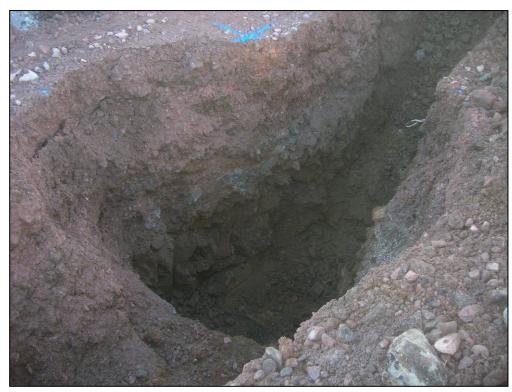
Figure 14. South western foundation. Section 29 showing outcrop shaft looking northwest.

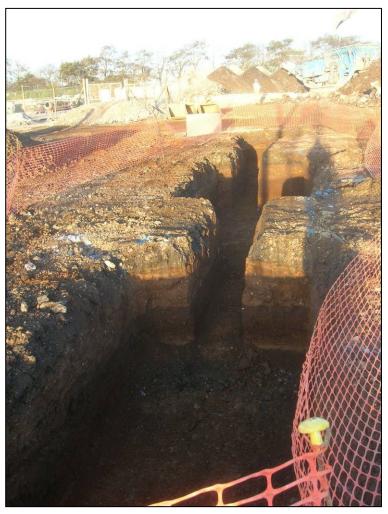
Figure 15. North western foundation. Sections 39 to 41 looking northeast showing nature of ground.

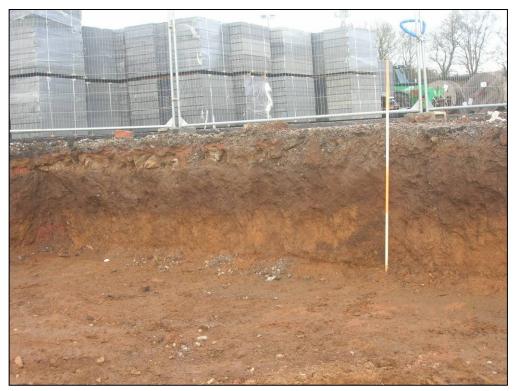
The northeastern section exhibited a similar sequence of layers (Fig 16), however towards the south the black-grey clay and cinders with some loose stone, and orange, yellow-brown clay with some brick and stone fragments layers pinch out and disappear due to the natural bedrock rising closer to the surface.

The chocolate brown clay with very few stone inclusions layer also increases in thickness to some 0.70m. Apart from some modern service pipes and cables with associated trenches recorded at the northern end of this section, no archaeological features were recorded. It appears that material forming the upper layers on the northern part of the site were brought in and dumped as levelling perhaps in preparation for this area being utilised as a yard.

Figure 16. Attenuation tank. Sample of NE section showing nature of the ground.

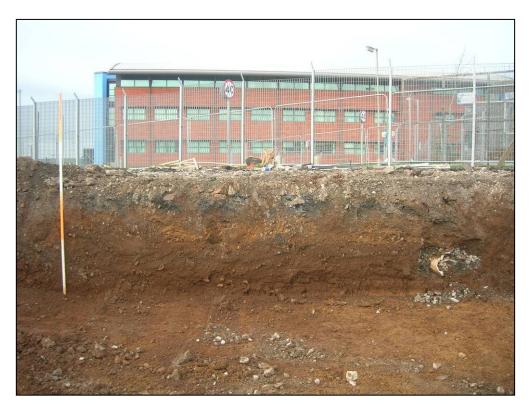
The northwestern section (Fig 17) was found to consist of the following.

- 0.05m tarmac.
- 0.10m light grey clay and stony rubble.
- 0.20m black-grey clay and cinders with some loose stone, builder's rubble and modern ceramics (not collected).
- 0.15m of orange, yellow-brown clay with some brick and stone fragments.
- 0.50m chocolate brown clay with very few stone inclusions.
- 0.5m of orange, yellow-brown clay the decayed natural bedrock that was not bottomed.

All the layers observed were horizontal in nature. Apart from a modern service pipe and associated trench, no features of archaeological interest were recorded.

Figure 17. Attenuation tank. Sample of NW section showing nature of the ground.

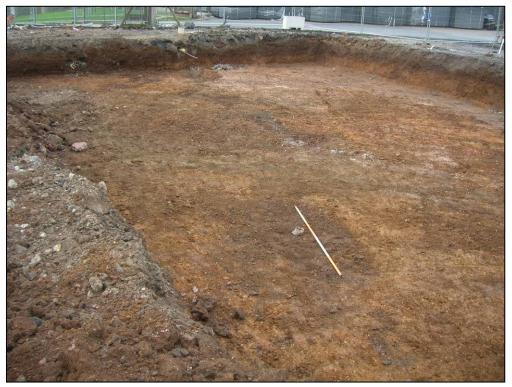
Figure 18. Attenuation tank. Over view of tank floor showing location of prospecting pits. Looking north.

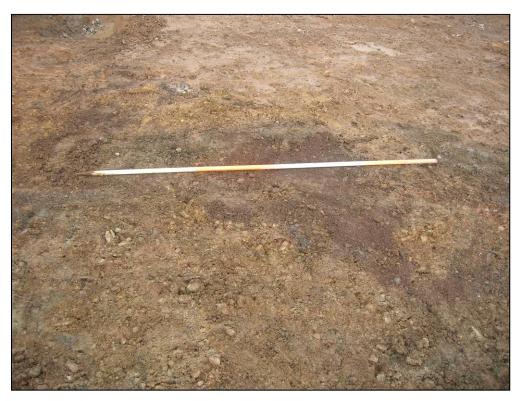
Lying some 3m southeast of Pit B this was marked by an elongated oval shaped area of disturbed ground, measuring $2m \times 1.8m$, orientated NW/SE. Infilled with dark redbrown clay with some stone fragments. This too looked like a prospecting pit. No dating evidence was obtained for this pit (Figs 9 and 19).

Figure 19. Attenuation tank. Prospecting pit C looking north.

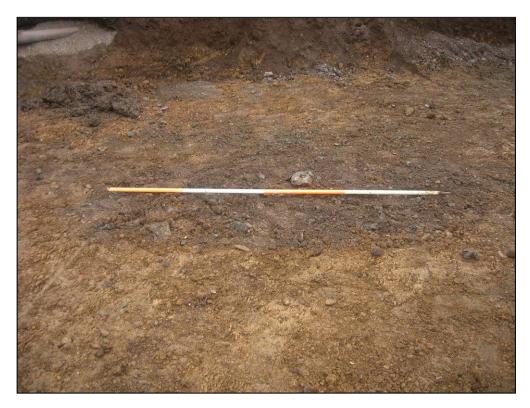
This pit lay *circa* 0.3m to the southwest of Pit A. It was again marked by an elongated oval shaped area of disturbed ground, measuring $2m \times 1.8m$, orientated SW/NE. Infilled with mixed clays including red-brown, and dark grey-brown clays with some stone fragments. This too had the appearance of being a prospecting pit. A small fragment of clay pipe stem was recovered from the surface of the fill. It had a diameter of $\emptyset = 1.8mm$ which suggests a date of *circa* 1815 (Figs 9 and 20).

Figure 20. Attenuation tank. Prospecting pit B looking south east.

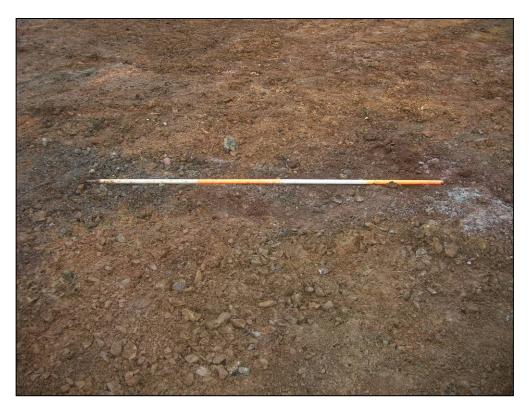
This was marked by an elongated oval (straight sided, rounded ends) shaped area of disturbed ground, measuring $2m \times 1.2m$, orientated SW/NE. The pit was infilled with dark red-brown clay with some stone fragments. This has the appearance of a prospecting pit. No dating evidence was obtained for this pit (Figs 9 and 21).

Figure 21. Attenuation tank. Prospecting pit A looking south east.

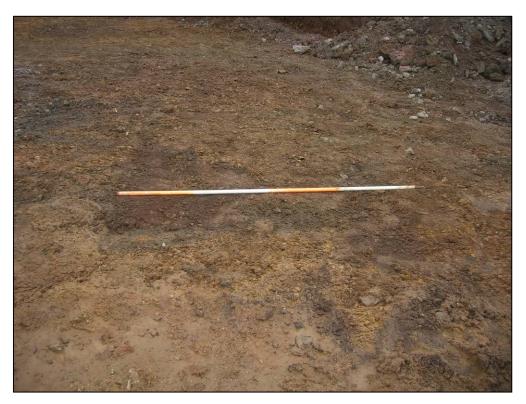
Lying circa 2m northwest of Pit A this was marked by an elongated oval shaped area of disturbed ground, measuring $2m \times 1.5m$, orientated NW/SE. Infilled with dark redbrown clay with some stone fragments. This too looked like a prospecting pit. No dating evidence was obtained for this pit (Figs 9 and 22).

Figure 22. Attenuation tank. Prospecting pit D looking west.
