Fursnewth Cross, St Cleer, Cornwall

Conservation and restoration

Client	English Heritage, Caradon Hill Area Heritage Project
Report Number	2013R051
Date	July 2014
Status	Final
Report author(s)	Ann Preston-Jones
Checked by	Jacky Nowakowski
Approved by	Andrew Young

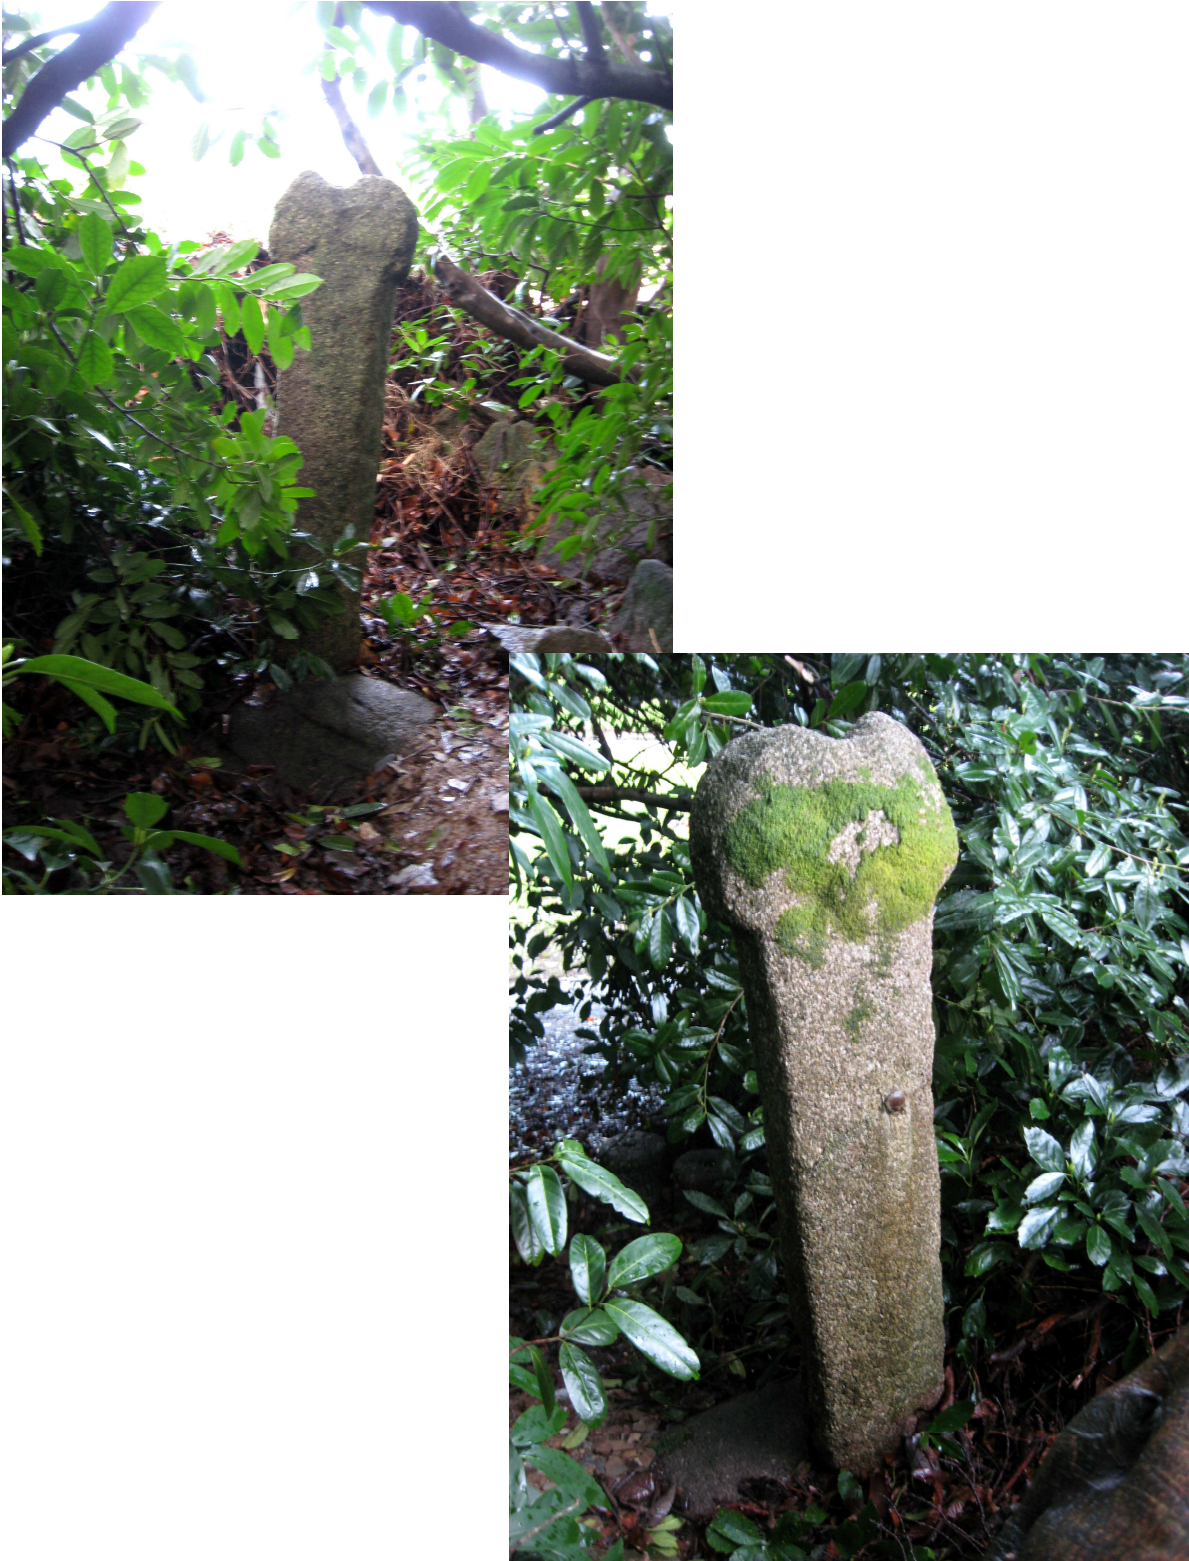
Fig 4 Cross hidden in shrubberies of Pendean, at the outset of the project

Even though it was originally intended to act as a focal feature within the garden of Pendean House, the cross had become completely overgrown and obscured beneath a large tree and laurel bushes (Fig 4). Pendean House is now a care home owned by Cornwall Council and current policy is to allow the tree and bushes to grow over and hide the cross. This was from concern that in its damaged state the cross might be a liability to children in the home, and also to protect it from any damage that they might cause. The side effect was that over recent years it had become difficult to monitor the condition of the cross so that the threats and damage to it described in this report were only discovered very recently, by Iain Rowe and Andrew Langdon on a site visit in 2011.

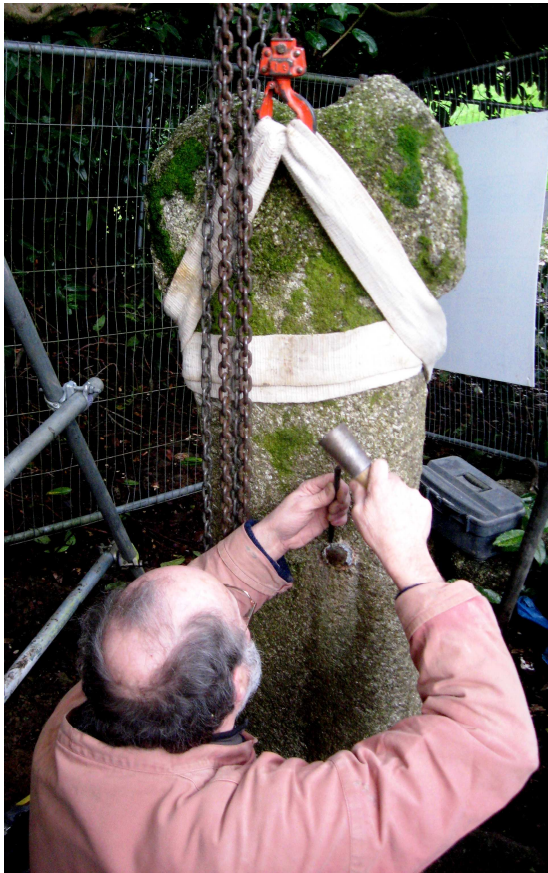
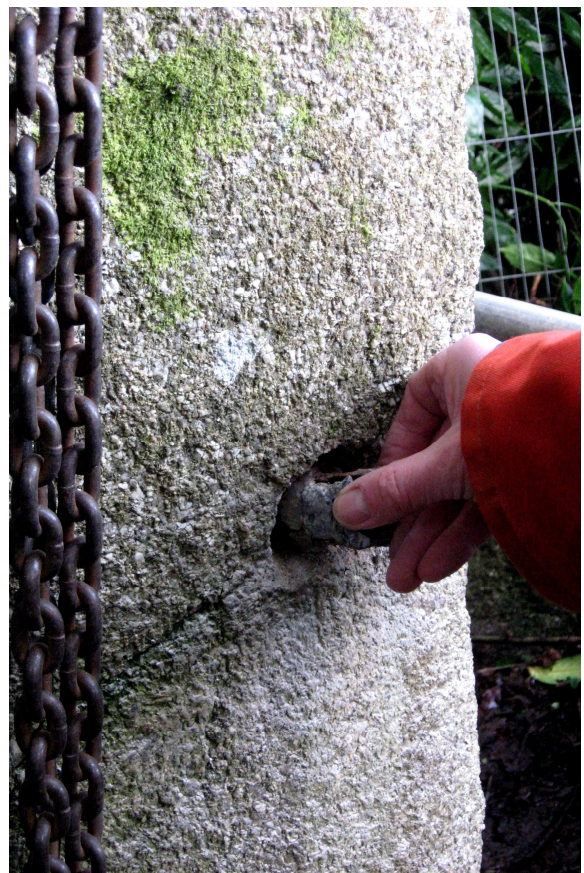
Fig 6 Lawrence Kelland removing the iron fixing from the cross-shaft

'The corroding iron gate-hanging will be removed from the cross before it causes any more damage. It is probable that to do this and to then carry out a repair, the cross will need to be broken in a controlled way. The two parts of the stone will then be drilled, ready for fixing with stainless steel pins. This work will be carried out by skilled stonework conservators.'

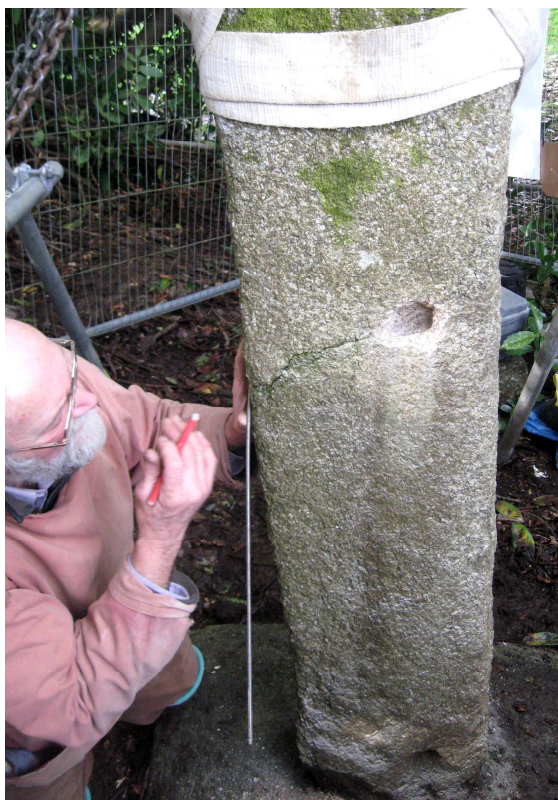
Fig 7 Measuring the cross for stainless steel dowels to tie the crack together; and drilling the shaft to take the dowels

On Thursday 31st January 2013, stonework conservators Sue and Lawrence Kelland examined the cracks in the cross-shaft and found that these could be repaired *in-situ* before the cross was taken down. The original plan had been to break the shaft at the crack, and remove the cross in two sections and later glue and pin the two sections back together again. However this revised plan was accepted as a less intrusive and far more sympathetic approach. They therefore drilled diagonal holes into the shaft across the crack, two through the face of the shaft and one across the side of the shaft. 6mm stainless steel bars were then inserted through the cracked areas and glued into position, strengthening and securing the crack.

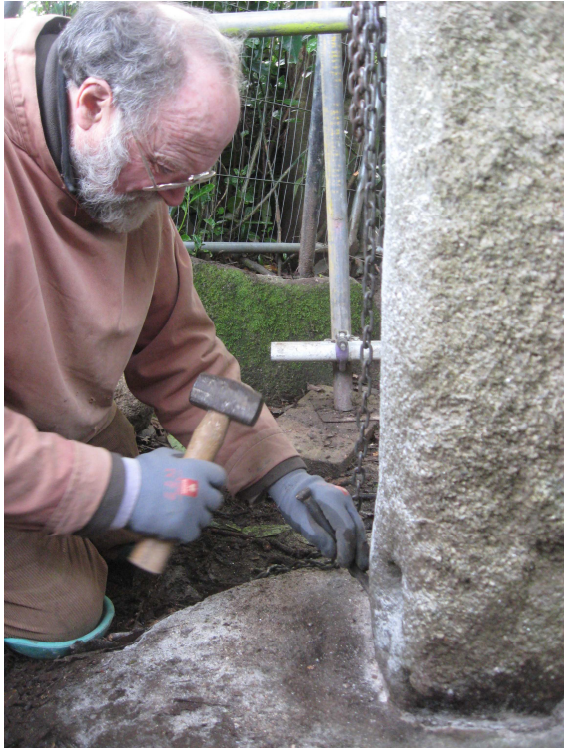
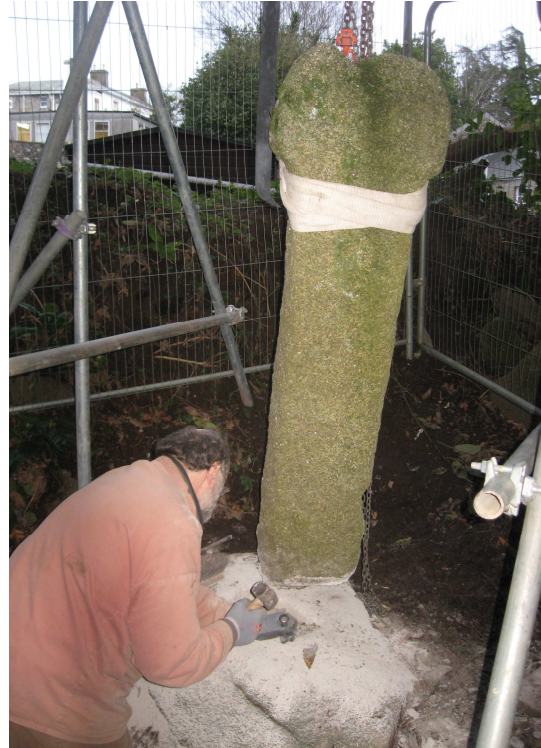
Fig 8 Lawrence Kelland chipping away the cement mortar from the base of the cross in order to remove it from its base at Pendean

Once the crack in the shaft had been secured, the weight of the monument was supported by a block and tackle from a scaffold which had been erected around the cross, and the mortar was painstakingly chipped away from the bottom of the shaft where it was fixed into the base-stone. Once loose, the cross was carefully lowered down ready for collection by Monumental Mason, Ian Piper and his team from C F Piper & Son of Bearah Tor Quarry, North Hill.

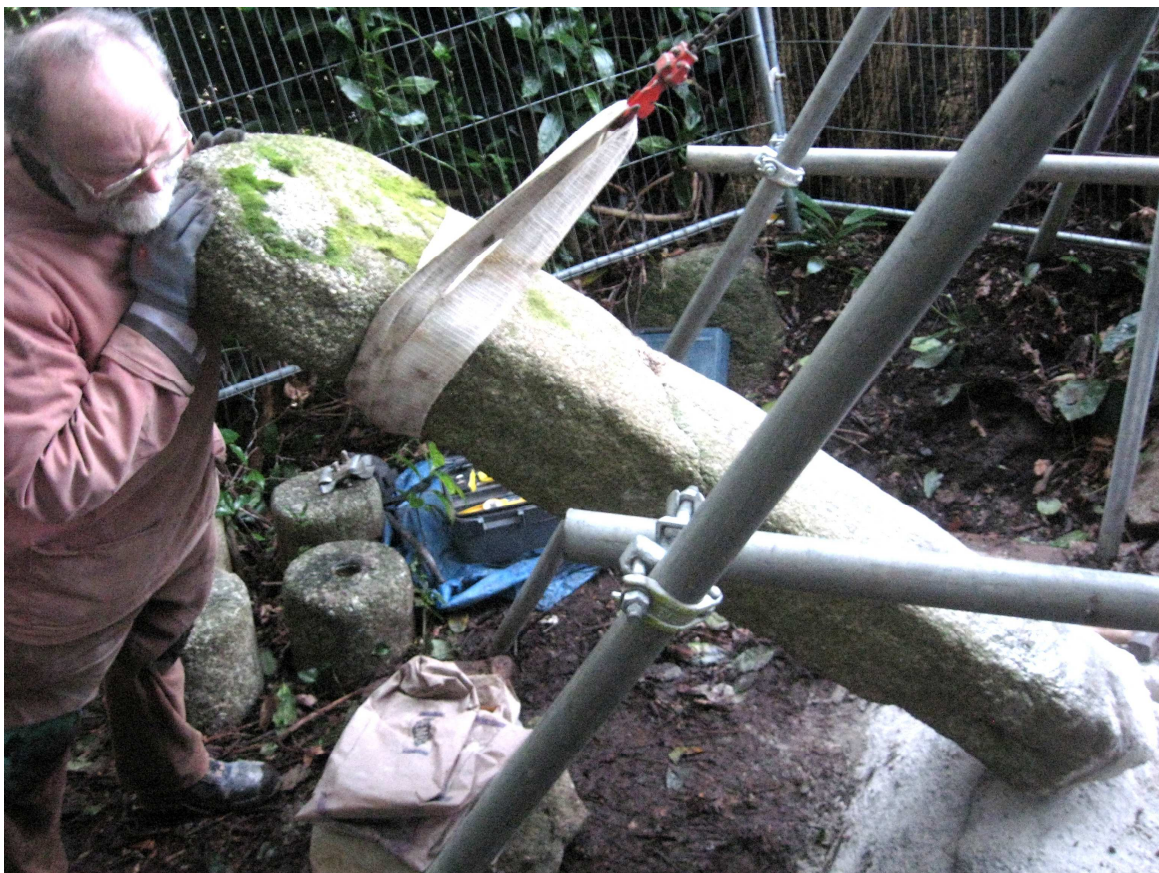
Fig 9 The cross being taken down

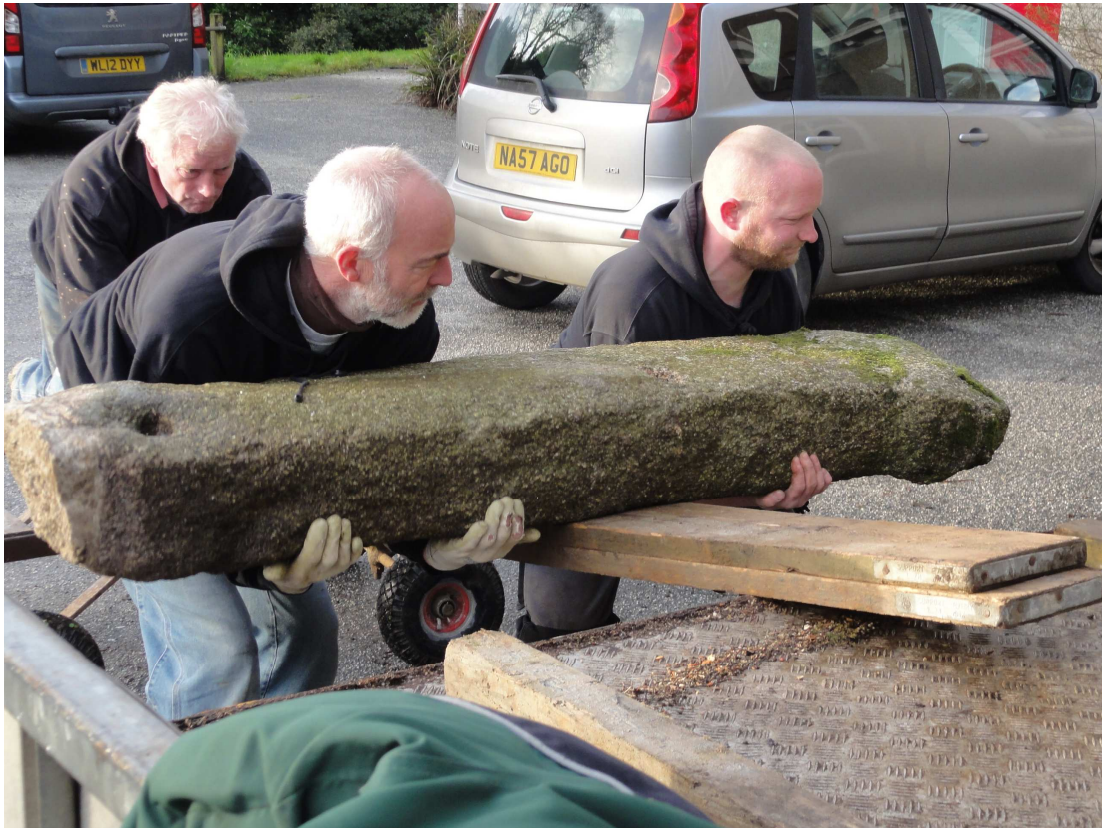
Fig 10 Ian Piper and team removing the cross from Pendean

This took place on Monday 4th February, when Ian Piper, Alex Piper and Peter Hooper collected the cross from the garden at Pendean and transported it to Bearah Tor Quarry for storage and fitting of a new base.

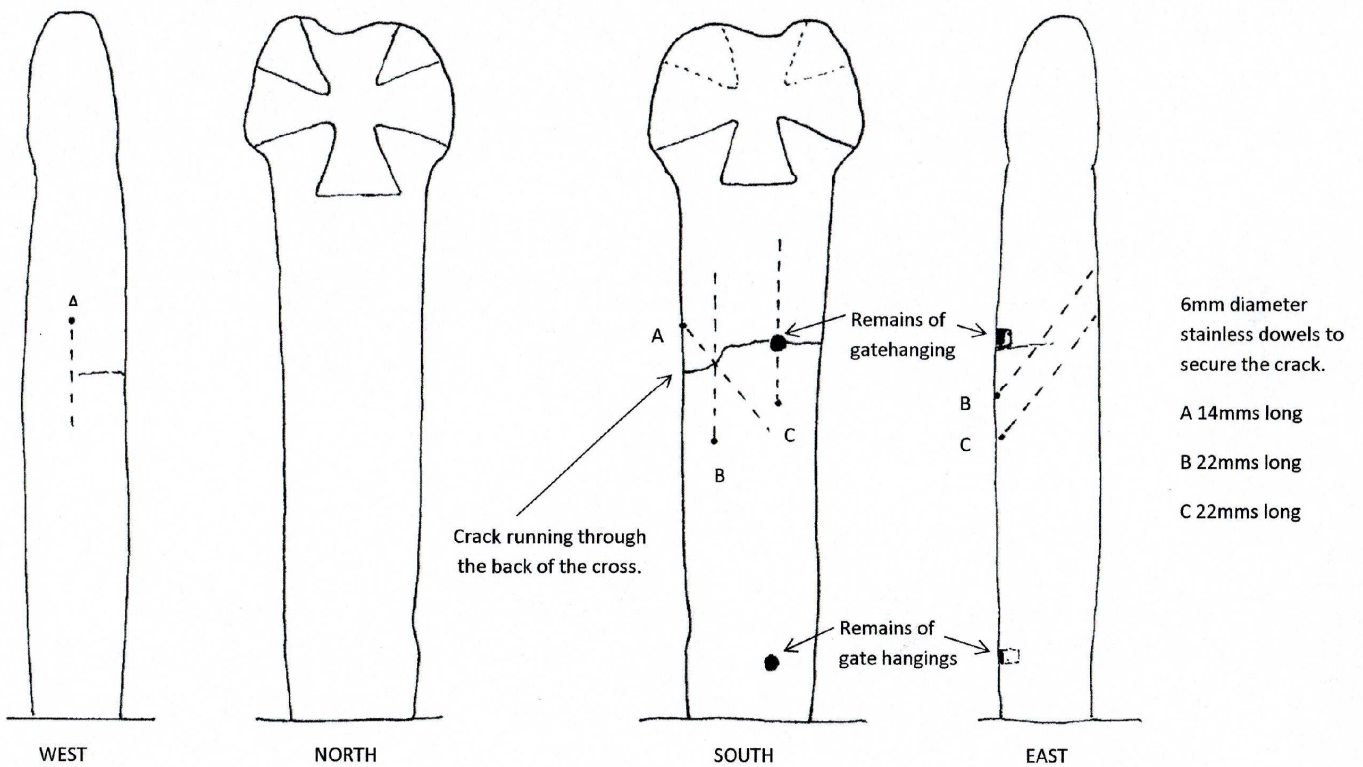
Fig 11 Sketch of the cross showing the positions of stainless steel dowels

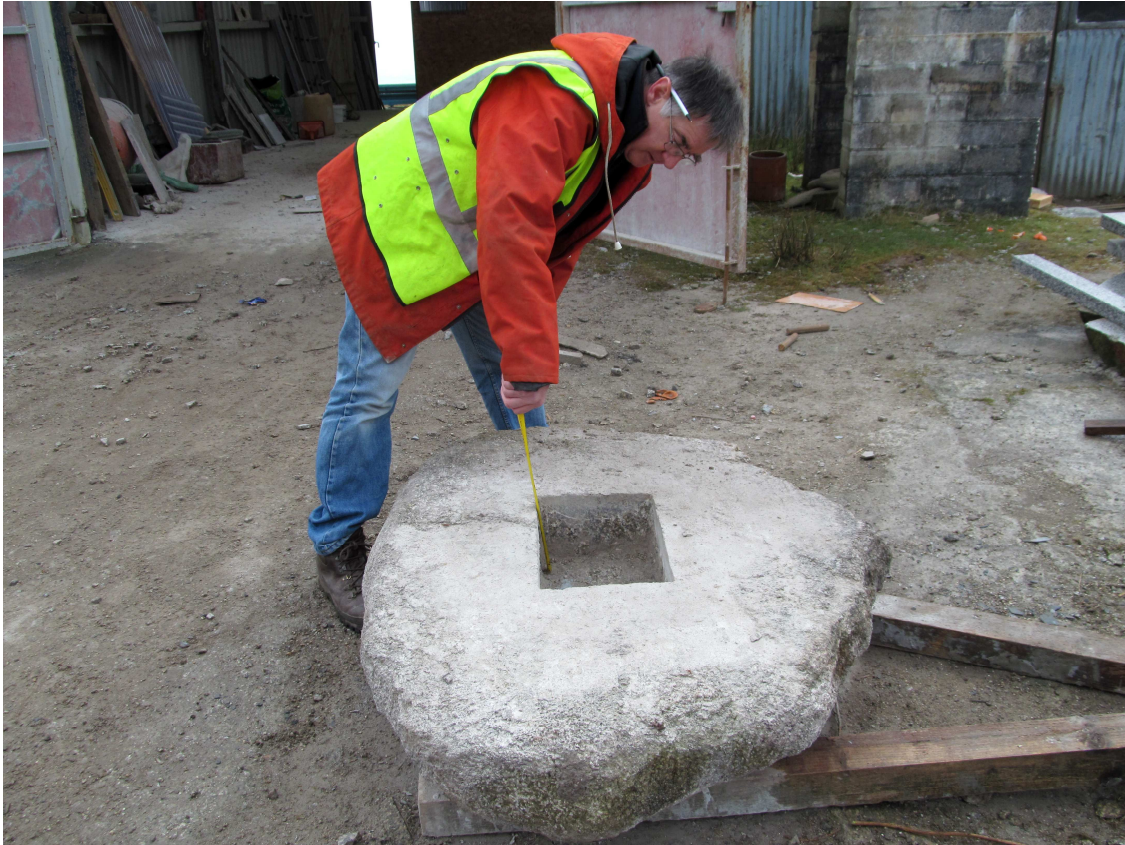
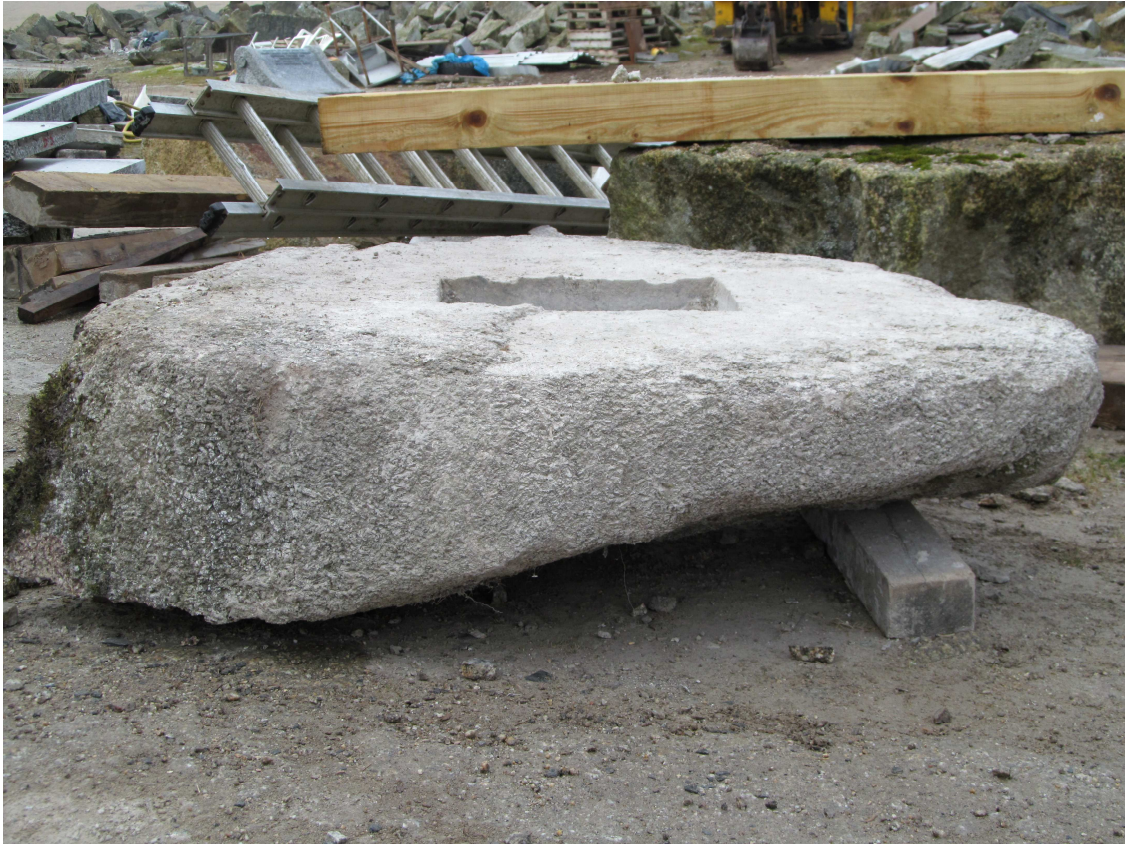
Fig 12 Checking the base-stone at Bearah Tor Quarry

A granite boulder was selected from stone at Bearah Tor Quarry for Mr Piper to fashion into a cross-base. The new base is a roughly square weathered slab of medium-grained granite just over a metre across. The top surface of the granite boulder was ideal but needed the bottom trimmed as its thickness was irregular. Once trimmed, a mortice was cut into its top large enough to support the shaft of the cross.

Dimensions of the restored cross: Base-stone 1.3M (4ft 3ins), by 1.04M (3ft 5ins), thickness varies between 0.2M (8ins) and 0.29M (11 ½ins). The mortice measures 0.37M (1ft 2 ¾ins) by 0.25M (10ins), depth 0.2M (8ins). Height of the cross above the base-stone 1.55M (5ft 1in).

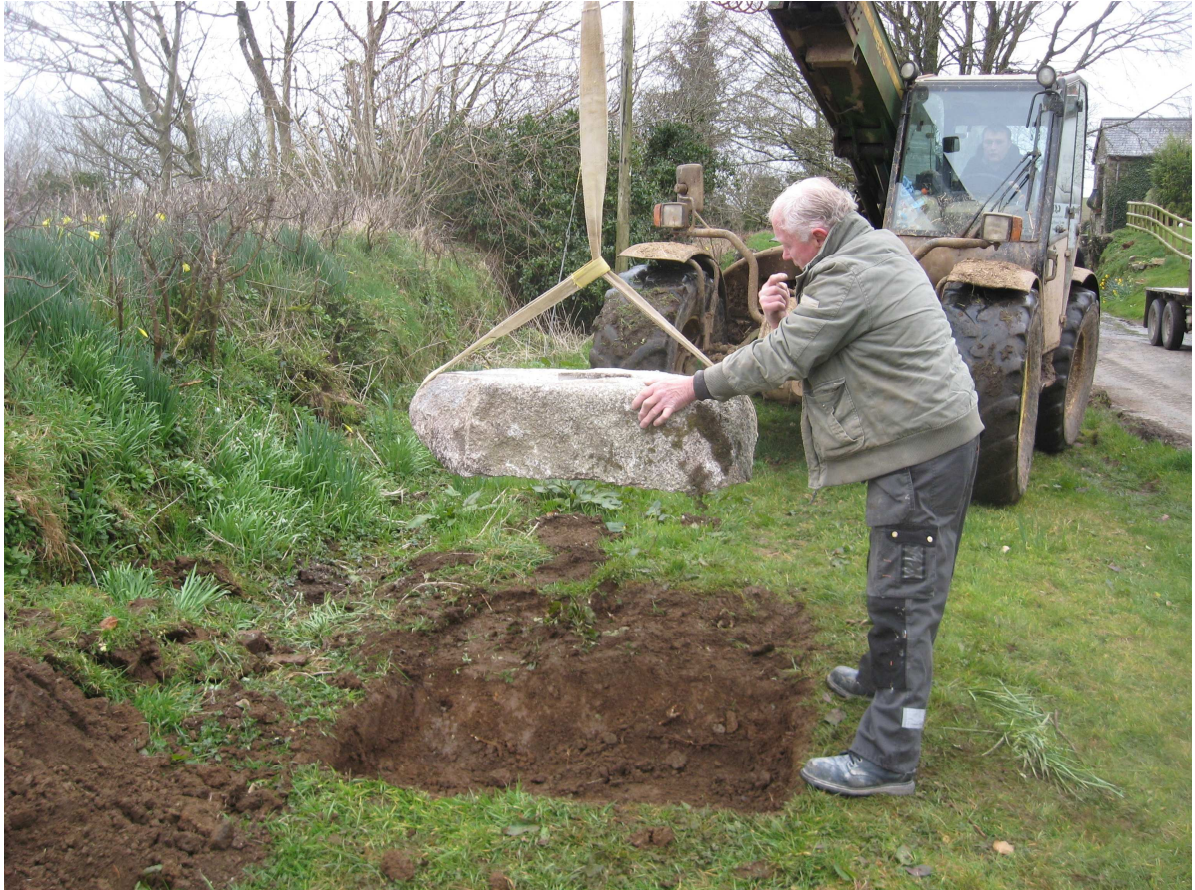
Fig 13 Ian Piper installing the base-stone at Fursnewth

On Monday 25th March, Mr Piper transported the cross, together with its base-stone back to Fursnewth. Here the base-stone was immediately set in place with the help of Toby Roger from neighbouring Trelethick Farm using a mechanical loader. Sue and Lawrence Kelland finally erected the cross on its new base on Wednesday 10th April, again with the assistance of Toby Rogers, and Andrew Langdon. The shaft was secured in the base-stone with a polyester stone resin and the joints filled in with a lime mortar coloured to match the granite. The cross was also microchipped and recorded as a deterrent against theft.

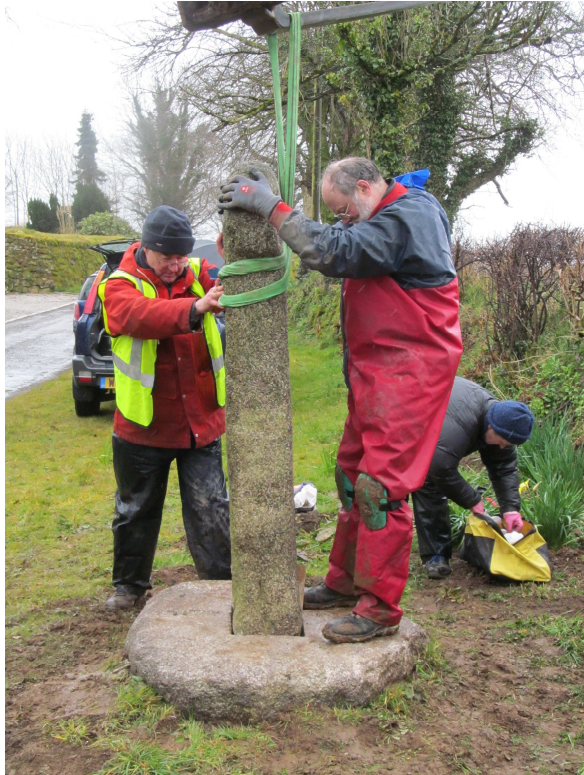
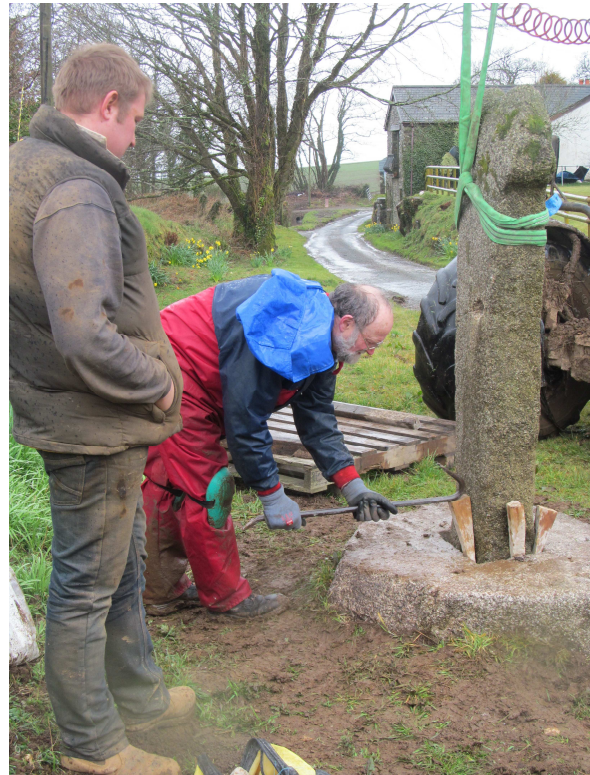
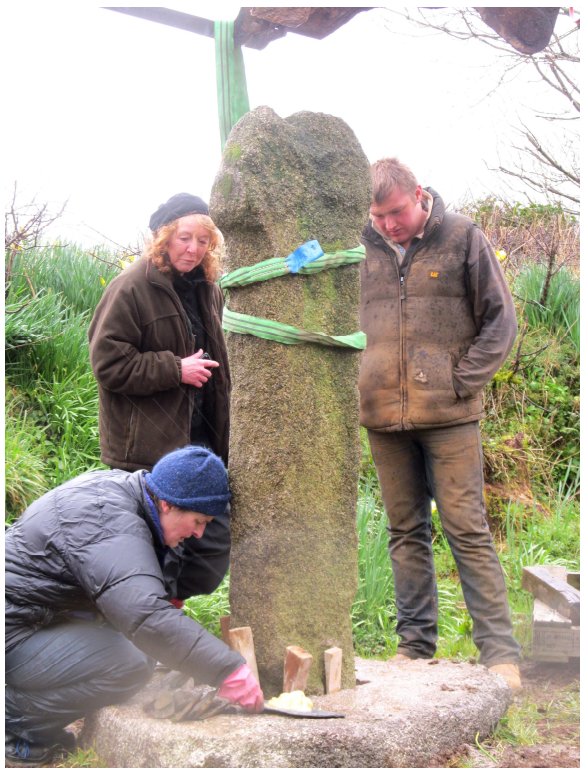
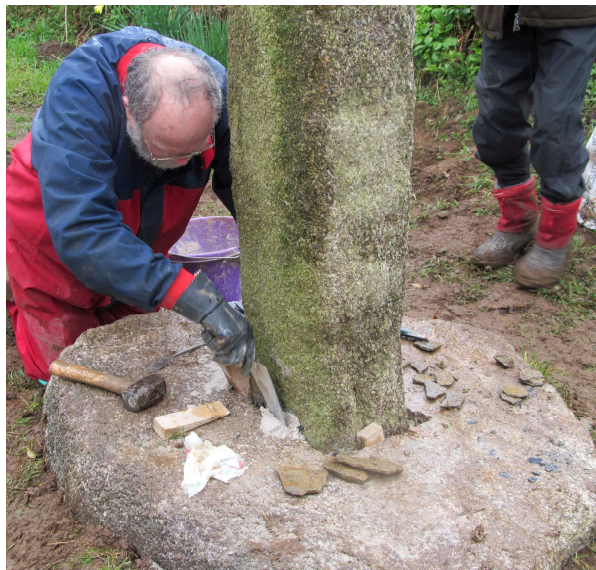
Fig 14 Restoring the cross at Fursnewth

Above left: Andrew Langdon and Lawrence Kelland setting the cross in its new base

Above right: Tractor driver Toby Roger and Lawrence Kelland securing the cross in its base

Below left: Sue Kelland fixes the stone in its base with stones and resin, watched by Angela Redman and Toby Roger

Below right: Lawrence Kelland uses lime mortar to fill the joint between the cross and the base

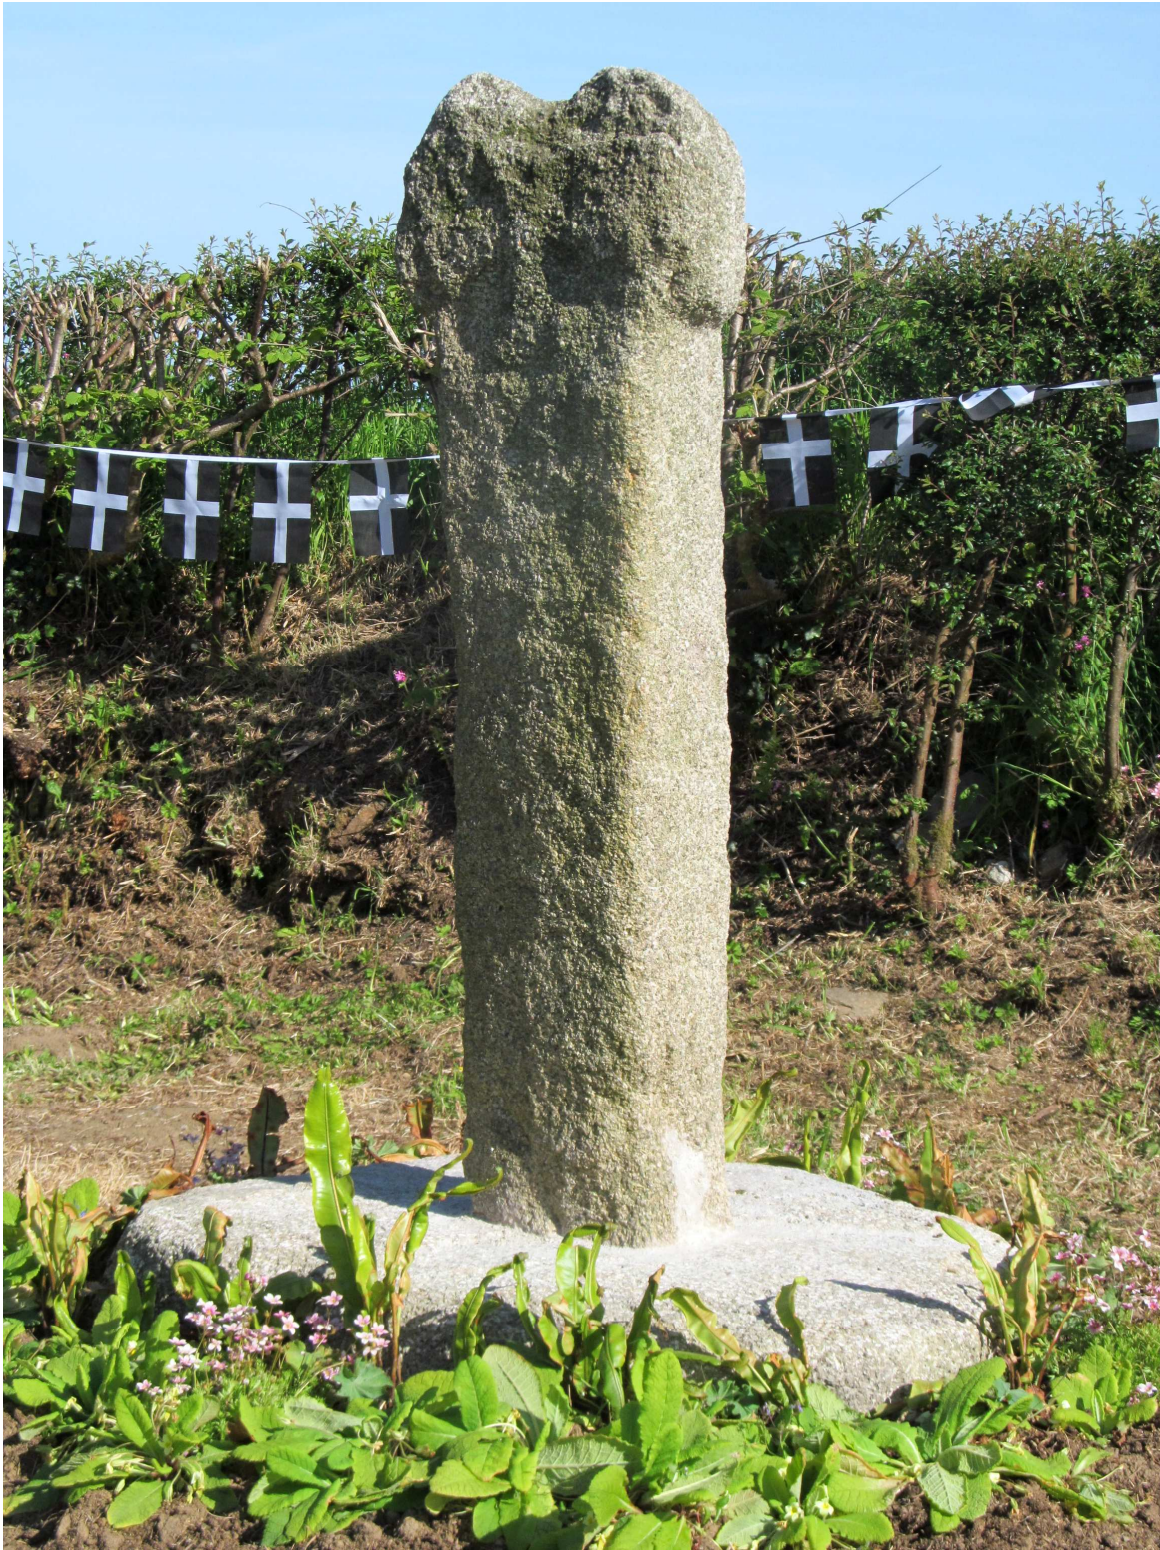
Fig 16 The restored cross

The repair to the cross was a one-off operation, resulting in consolidation of the crack and stabilisation by removal of all damaging ironwork. It should require no further action for many years, other than occasional monitoring of the condition of the mortar joint.
