Counthouse and Carpenters' Shop Complexes, King Edward Mine, Troon, Cornwall Impact assessment

**Counthouse Complex and Carpenters' Shop
Complex,
King Edward Mine, Troon, Cornwall**

Impact Assessment Report

Client	Cornwall Council Culture Team
Report Number	2013R028
Date	April 2013
Status	Final
Report author	Colin Buck

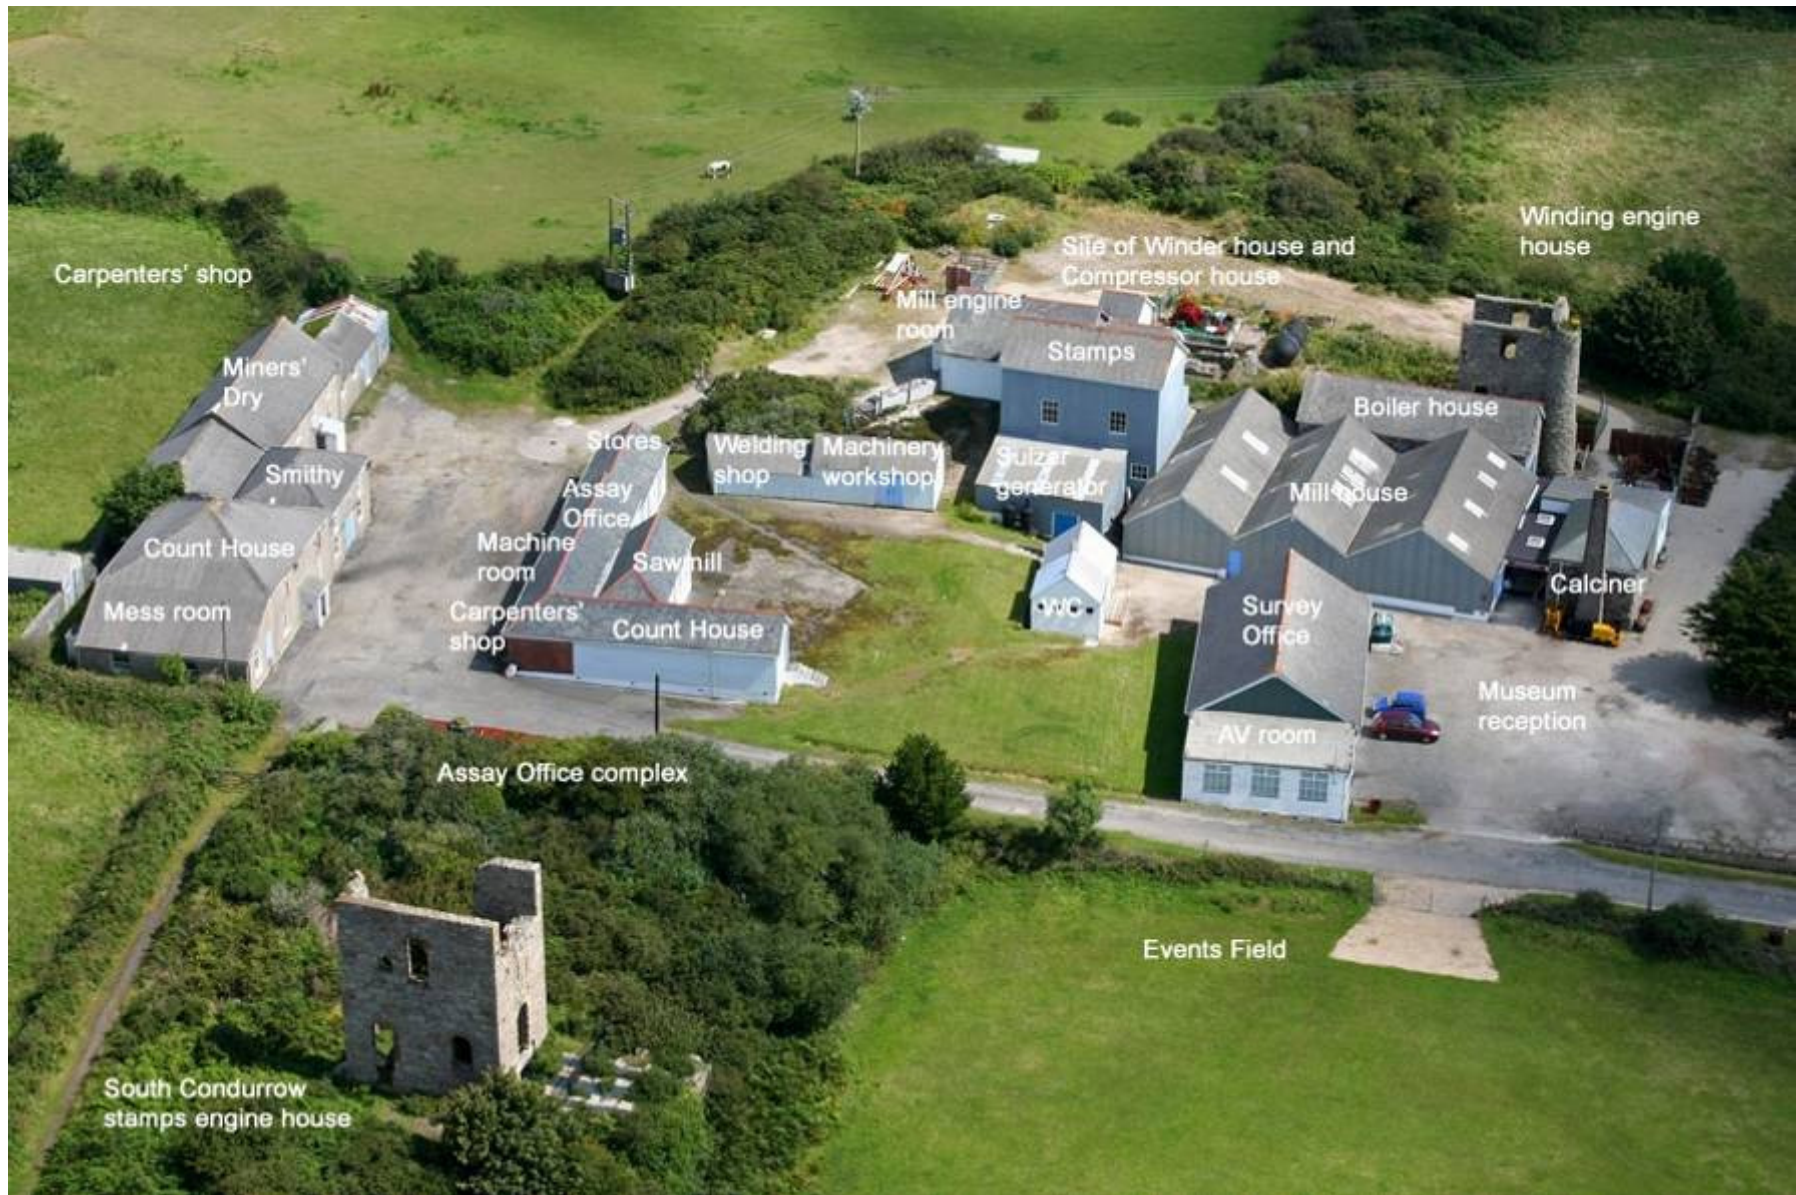
Figure 2 A HES aerial photograph (2009) of King Edward Mine with building functions labelled (before the horizontal steam engine winder and compressor house was rebuilt).

The site inventory map for the core King Edward Mine buildings is reproduced in Figure 4. This shows site numbering for every building and a cross reference to the appropriate detail record sheet given in the two sections below. The history of the phased development of each site or complex is described in each specific detail record sheet however a general summary is also given. Figure 3 is an aerial photograph of KEM with building functions labelled.

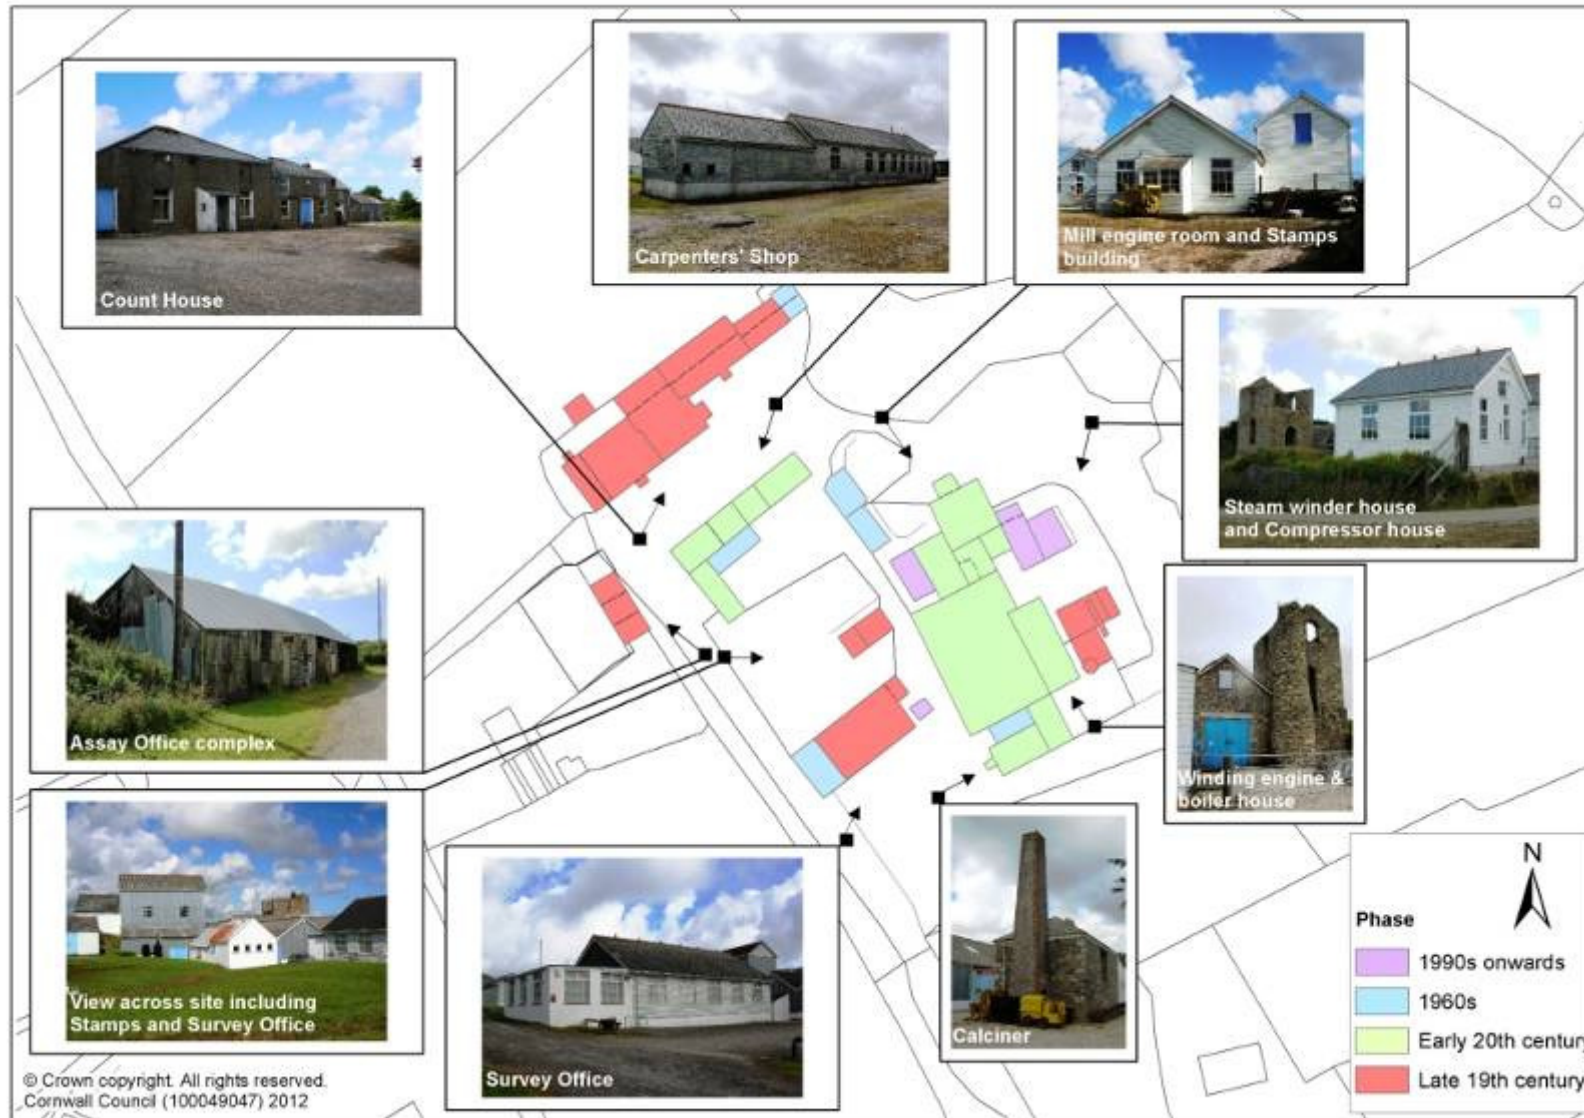
Figure 3 A plan showing existing views of King Edward Mine transposed onto a phase map of site development. Only the Counthouse and Carpenters' Shop sites are relevant to this report.

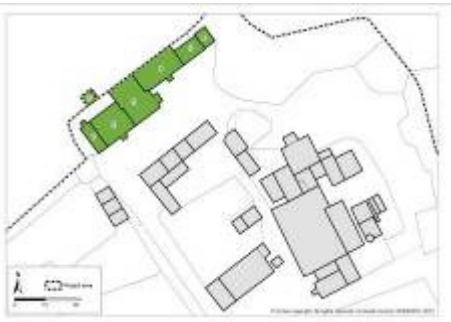
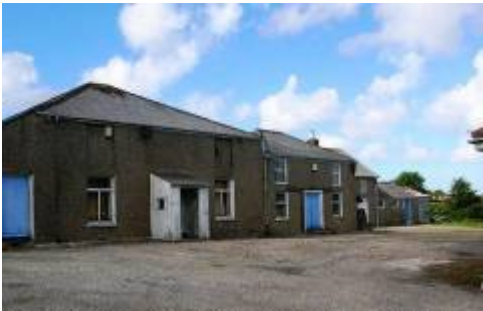
Construction materials: (walls, roof, floor, ceiling, windows, doors):	<p><i>External:</i> Corrugated asbestos roof sheeting replaced original slate in 1950s. Cementitious pebble dashed render over original granite quoins and stone masonry with earth rab/lime mortar. Only one original window appears to remain (Site 4), the remainder of later different 20th century styles. Many original chimneys removed (including Counthouse, Smithy forge etc).</p> <p><i>Internal:</i> Buildings have been unoccupied leading to damp, floors and walls. Counthouse Office has dry lining of plasterboard and painted woodchip wallpaper on some walls, covering damp lime plaster. Cement plastering in places. Many original plaster ceilings replaced. Floor joists in office collapsing. Smithy building has had major alterations (possibly 1960s). Miners Dry ceiling fully built over, walls faced with granolithic plaster (to create a wet room). Some original doors/floorboards and some dado rails.</p>

Build date:	Mess Room (Site 1) c1870s. Counthouse Office (Site 2) c1864/5. Smithy (Site 3) 1865-1877. Miners' Dry (Site 4) 1865-1877. Carpenters' Shop (Site 5) 1865-1877. Store (Site 6) 1960s. Outhouse/chimney/store (Site 6) 1865-1877.
Modification date:	Complex re-roofed (some rafters replaced with steel) in mid 1950s. Windows replaced during 20 th century, possibly twice. Internal asbestos sheeting added to some walls and some re-plastering at a similar date. Office/Mess room relatively unaltered, but the Smithy buildings have been drastically altered at various times (possibly 1960s onwards). Miners' Dry walls re-plastered and ceiling rebuilt to infill balcony (1960s onwards). Carpenters' Shop internally unrecognisable when transformed into toilets (1960s).
Original function:	South Condurrow Mine: Counthouse, Smithy, Miners' Dry and Carpenters' Shop.
Current function:	Mess Room (Site 1): Unused. Count House Office (Site 2): Unused. Smithy (Site 3): Storage of some Trevithick Society items. Miners' Dry (Site 4): Wet room (unused). Carpenters' Shop (Site 5): Male toilets. Store (Site 6): Used.

<p>the mining students. In the past, the Count House Office has suffered from damp, the walls being dry lined (twice), re-plastered and floor joists affected by damp rot. However, the Counthouse building is relatively unaltered compared to others in this complex.</p>
<p>Completeness and condition:</p>	<p>This is a rare example of a 19th century Cornish mine complex housing the Count House Office, the Smithy, the Miners' Dry and Carpenters' Shop. Internally, the Office (Site 2) and Mess room (Site 1) are the most unaltered buildings, retaining degrees of original features.</p>
<p>Significance/conservation strategy:</p>	<p>The historic group value of this complex of buildings is highly significant (these are often separate buildings). However, individually, given the extent of the 1950s and later repairs and modifications externally and internally affecting site character, each building is therefore less significant. In any future building conservation/adaptive reuse project, replacement of the asbestos roof with slate, removal of the exterior pebble dash and repointing with an appropriate mortar, and repairing floor joists where appropriate would go a long way to restoring the original character of this complex. The issue of window replacement to an agreed design (reflecting a significant period of the site) will need to be debated with conservation professionals, but a conservation philosophy would relate to minimising impacts and reflecting/mimicking original details where they have been consistently applied, for example drain gutters and downpipe details for the Counthouse (c1860s). For new Counthouse replacement windows again I feel that any decision on window style should reflect basic conservation philosophy (a compromise between the spec that was included in the Listing detail and the original form). The agreed window style should be consistently used throughout the complex. However, it is likely that internal secondary glazing may be required for change of use and to meet current building regulations.</p>

<p>EH at Risk Register 2012:</p>	<p>Count House (Site 2), Blacksmiths Shop (Site 3), and Miners' Dry (Site 4).</p>
<p>Additional requirements for future projects/any other factors affecting reuse/repair etc:</p>	<p>Given the masking of the external walls by a later cementitious pebble dash, a structural assessment of the building after removal may be necessary, to assess if there are structural remediation works that may impact the building. Internal photographic survey should be undertaken before proposed works. Re-use of original internal features (doors, architraves, (unblock fireplace) etc), is recommended. It may be appropriate to rebuild the chimneys that have been removed if funding and consent is given. The use of lime wash as an exterior finish should be considered and maintenance implications discussed.</p>

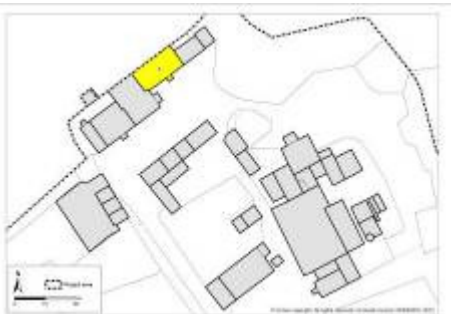
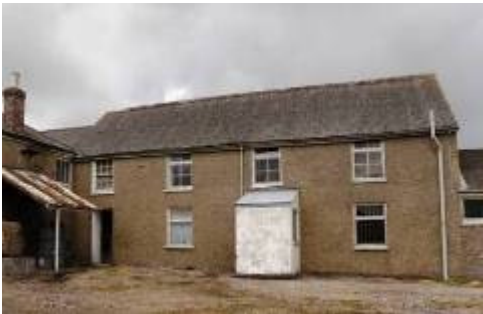
Construction materials: (walls, roof, floor, ceiling, windows, doors):	<i>External:</i> Corrugated asbestos sheeting replaced slate in 1950/60s. Cementitious pebble dashed render over original granite quoins and stone masonry with lime mortar. Only one original window appears to remain, the remaining windows of different styles.
	<i>Internal:</i> An 1899 photograph (Fig 16) shows the internal layout of the Miners' Dry at that time. The walls were lime washed, with a part open ceiling and ground floor boiler. The building now has a full ceiling and first floor with open roof joists. At ground floor the building has been re-plastered with

Completeness and condition:	This is a rare example of a 19 th century Cornish mine complex housing the Count House Office, the Smithy, the Miners' Dry and Carpenters' Shop. However, this building has been heavily modified, obscuring or destroying original details/features.
Significance/conservation	The historic group value of this complex of buildings is highly significant (as these are often separate buildings). However,

<p>strategy:</p>	<p>individually, given the extent of the 1960s repairs, modifications externally and internally that affect site character for each building is less significant. Replacement of the existing roof with slate, removal of the exterior pebble dash and repointing with lime mortar would go a long way to restoring the original external character of this complex. The issue of window replacement will need to be debated with conservation professionals (refer to Record Sheet R1). Internally, removal of the later granolithic plastered walls is not necessarily recommended – adaptive re-use of its existing form may be possible (after the washing facilities are removed), and have less impact.</p>
<p>EH at Risk Register 2012:</p>	<p>Miners' Dry (Site 4)</p>
<p>Additional requirements for proposed work/any other factors affecting reuse/repair etc:</p>	<p>Given the masking of the external walls by a later cementitious pebble dash, a structural assessment of the building after removal may be necessary, to assess if there are structural remediation works that may impact the building (including removal of wall pipes etc). The insertion of a first floor in the Miners' Dry has substantially reduced natural light levels in that space, and any decision on insertion of one or more windows in the north side of the Miners' Dry to increase natural light levels should reflect the conservation philosophy and be informed by a natural light assessment. Internal photographic survey should be undertaken before proposed works. The use of lime wash as an exterior finish should be considered and maintenance implications discussed. Internal photographic survey before proposed works should be undertaken. An impact assessment of any proposed ground floor works should be undertaken in order to preserve original pipe work (above/below ground) relating to its original function.</p>

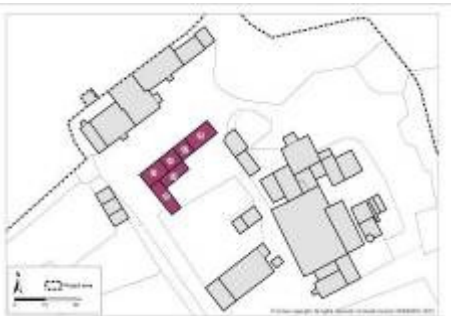
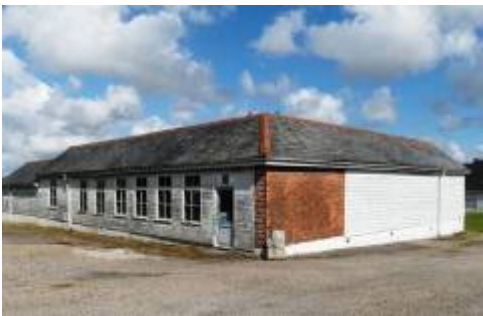
Construction materials: (walls, roof, floor, ceiling, windows, doors):	<p><i>External:</i> The roof is constructed with scantle slate; the original was replaced in c1990. It appears to be in a good condition. The side and end walls are built of horizontal boarded ship lap (with the exception of the Carpenters' Shop west wall which is constructed of brick), all of which is in dire need of redecoration, and possibly some sections replaced. The rainwater goods are plastic. The external joinery is in a reasonable to poor condition – again, some needs replacing, re-puttying and all re-decorating. Site 12, a new extension was built of concrete block, with external cement render and slate roof.</p> <p><i>Internal:</i> All the original internal partition walls are built of vertical tongue and grooved timber. However the wall between the Machine Shop and the Assay Office was built of stone, lime plastered with an inbuilt chimney flue for the Assay furnace. The ceiling was also boarded out with tongue and grooved timber under the roof joists. In the Carpenters'</p>

<p>Completeness and condition:</p>	<p>This is another rare example of a relatively untouched early 20th century mine building. It not only demonstrates period construction design, but also reflects a similar style around the mine and unusually retains a number of original features. However, this building has been in disuse for many years, its exterior timber ship lap needs to be redecorated, with some timbers and facias replaced, and guttering repainted or renewed with period equivalents. Its slate roof appears to be in a good condition. Internally, the walls and structures are in a good condition, no doubt a result of ensuring during the past century that the roof was well maintained.</p>
<p>Significance/conservation strategy:</p>	<p>The historic group value of this early 20th century complex of buildings is highly significant, as well as its contextual relationship to other buildings of a similar date and style across the site. Adaptive re-use of its existing form is recommended as long as its significant internal features are not compromised.</p>

<p>EH at Risk Register 2012:</p>	<p>Not applicable</p>
<p>Additional requirements for proposed work/any other factors affecting reuse/repair etc:</p>	<p>Given the statutory designation of these buildings it is likely to be condition of planning consent that an internal photographic survey is commissioned before any proposed works to enable adaptive re-use. Re-use of original internal features (doors/architraves/skirting boards/fireplace etc), is recommended where possible.</p>
