King Edward Mine Museum Redevelopment Project, Troon, Cornwall

Impact assessment

Impact Assessment Report

Client	Cornwall Council Culture Team
Report Number	2014R068
Date	August 2014
Status	Final
Report author	Colin Buck
Checked by	AJ
Approved by	AY

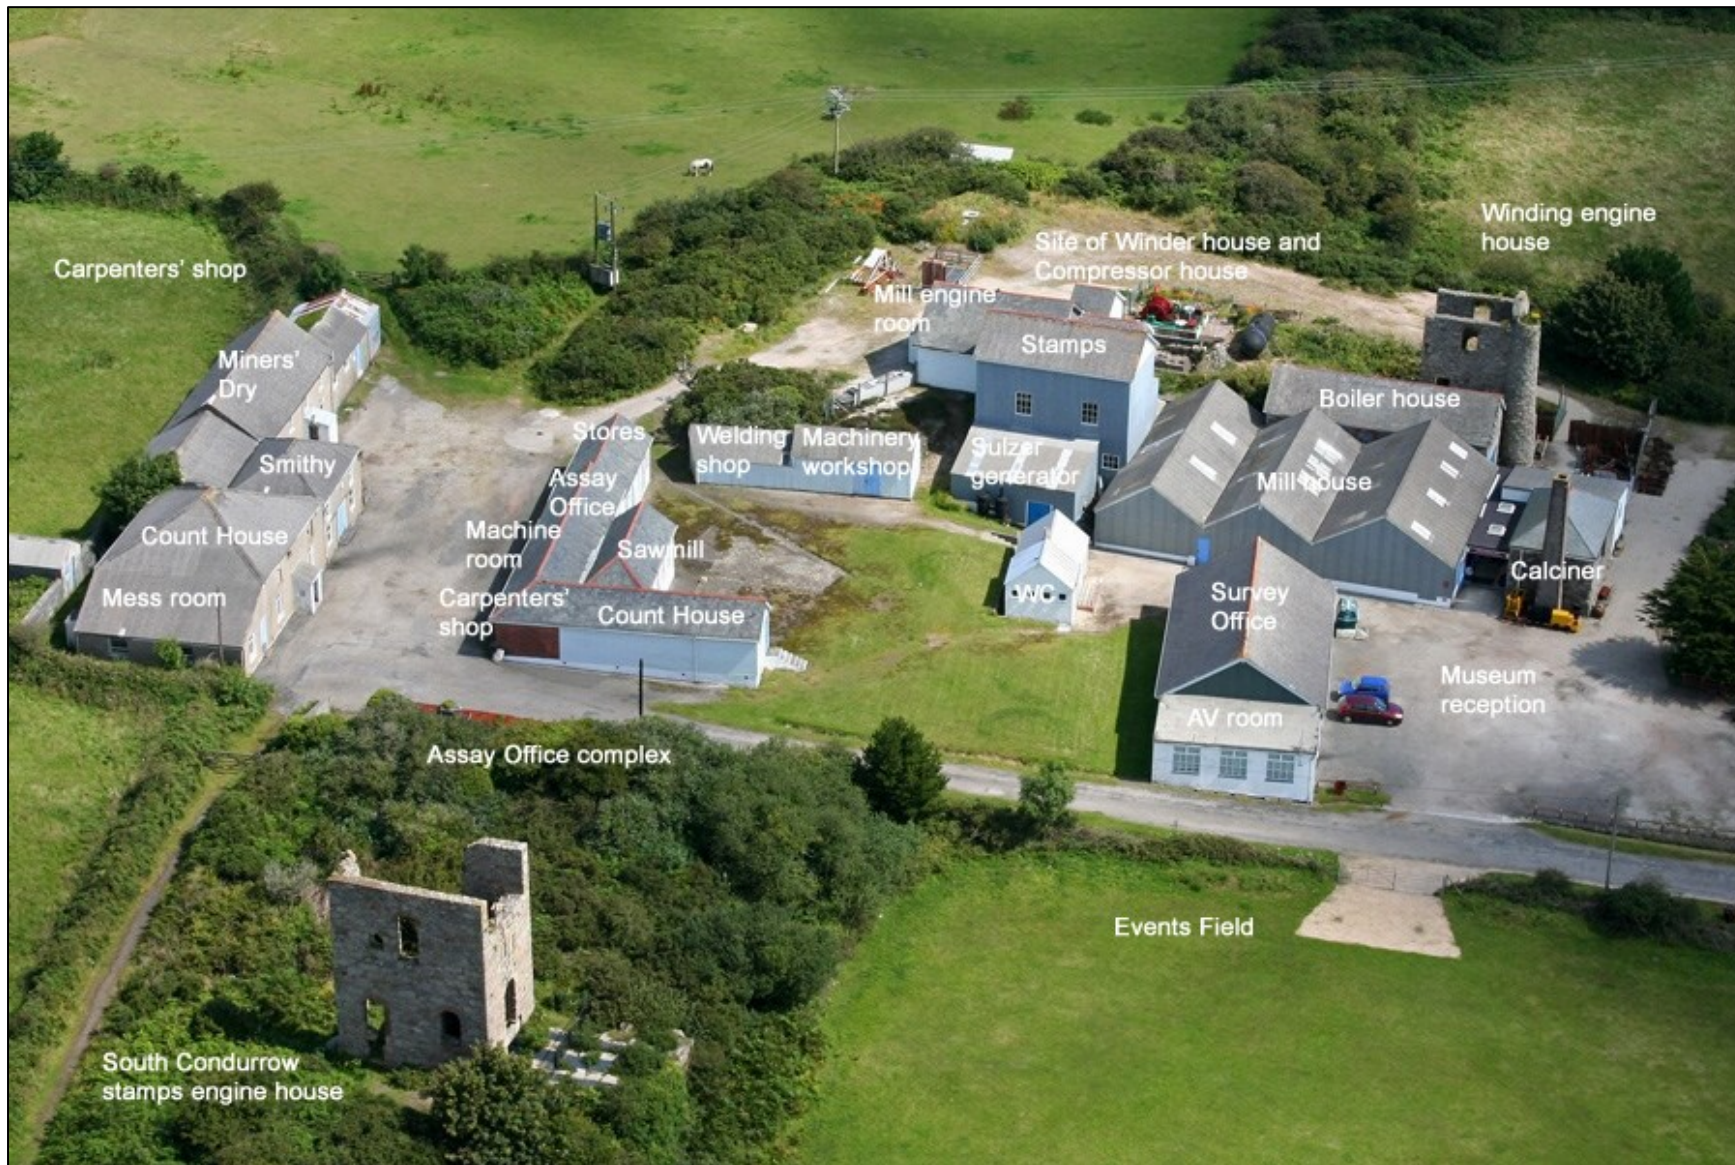
Figure 2 A HES aerial photograph (2009) of King Edward Mine with building functions labelled (before the horizontal steam engine winder and compressor house was rebuilt)

Figures 2 to 4 show the spatial relationship between the buildings that will be impacted; primarily adaption of the timber framed Assay complex to a café (with a modern extension), and adaption of the Winding Engine boiler house to create an exhibition facility, in order to increase visitor numbers and so improve sustainability. Other works include general building repairs to the mines' building fabric namely: Like for like replacement of the Mill and Stamps Roof, consolidation works and improved public access to the South Condurrow Stamps Engine house, like for like replacement of the KEM AV/meeting room and entrance flat roof, and other small insulation improvements. The King Edward Mine Conservation Management Plan (Buck 2012), contains a detailed significance and character description and a conservation philosophy (in Section 2.3), that has informed and guided the architect and design team when forming these proposals.

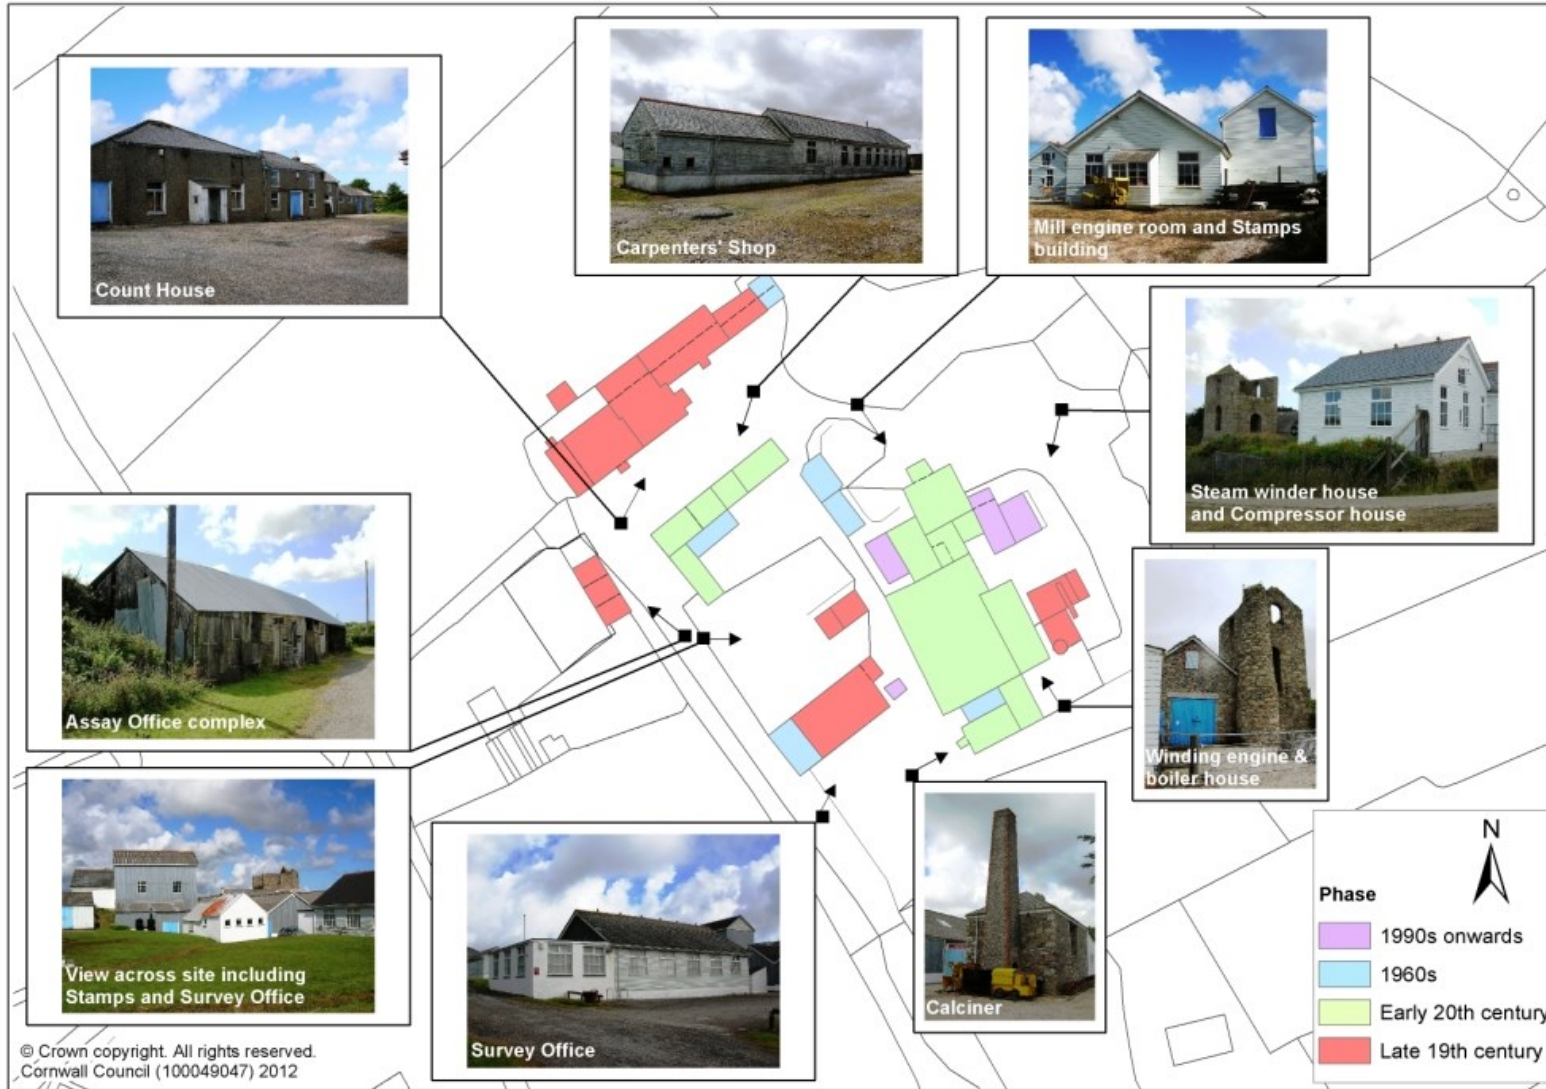
Figure 3 A plan showing existing views of King Edward Mine transposed onto a phase map of site development. Only the Assay, Boiler house, and Mill buildings are relevant to this report

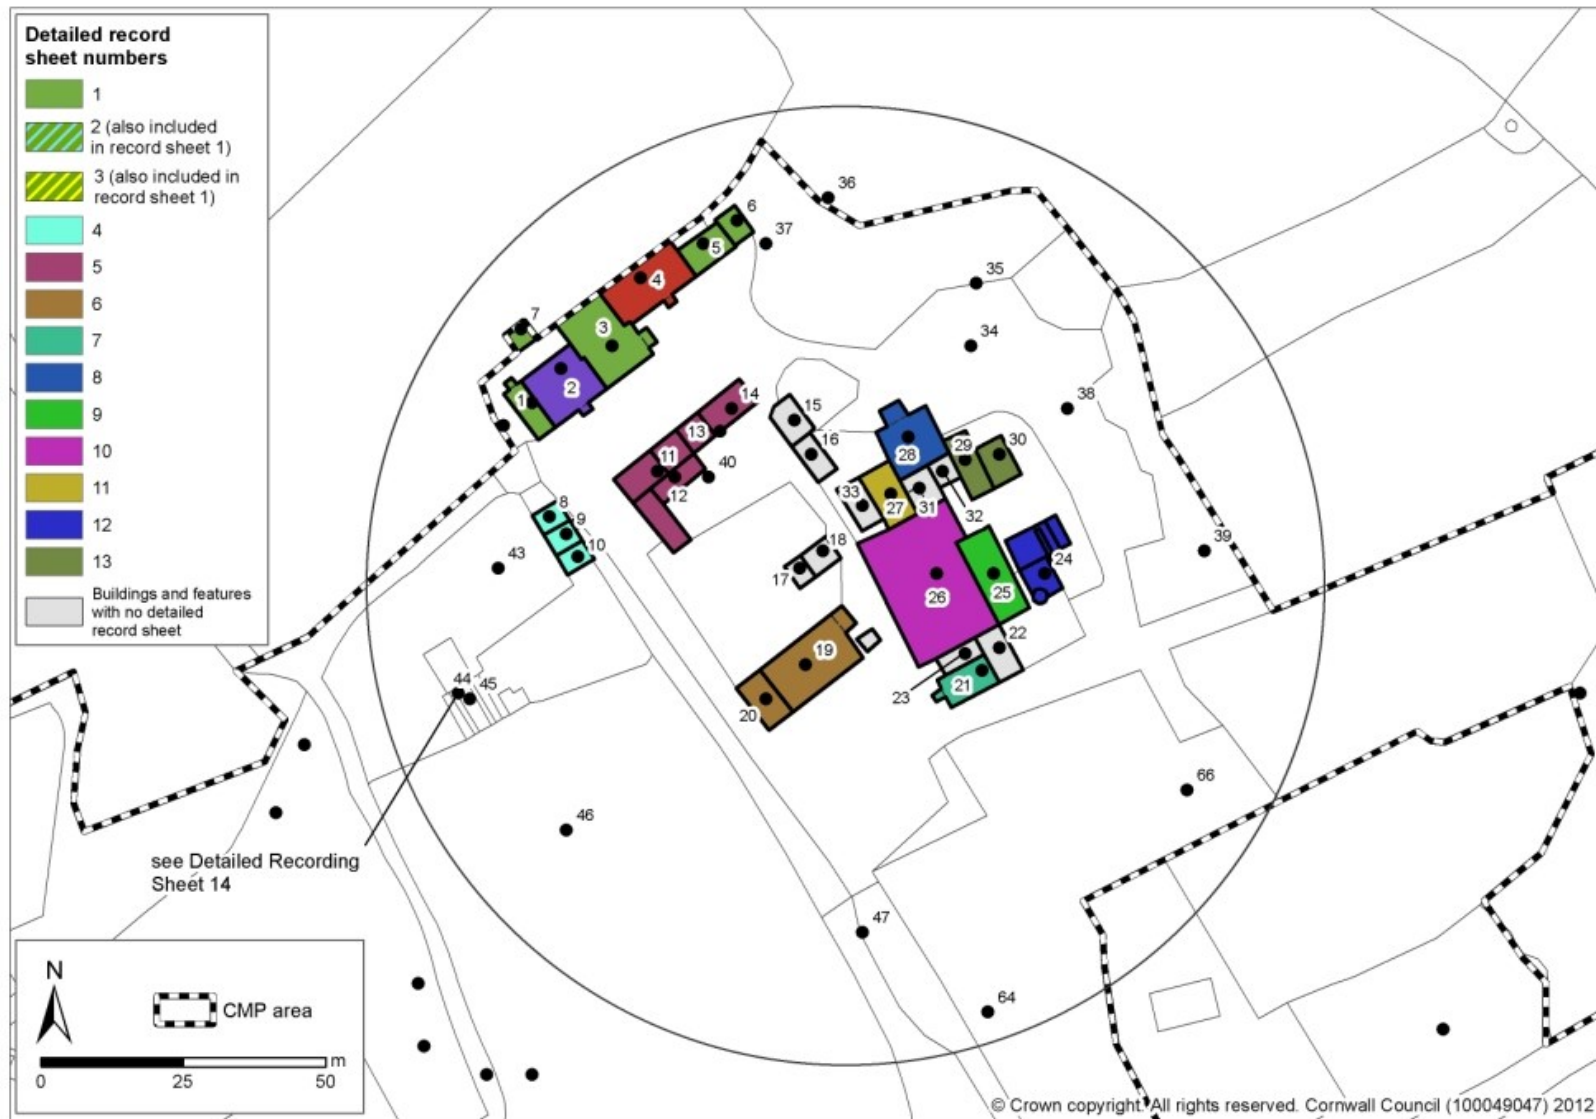
Figure 4 A core plan site inventory map of King Edward mine buildings. Refer to the Table 1 for site number descriptions

The site inventory map for the core King Edward Mine buildings is reproduced in Figure 4. This shows site numbering for every building, cross referencing to the appropriate detail record sheet given in the two sections below. The history of the phased development of each site or complex is described in each specific detail record sheet; however, a general summary is also given. Figure 3 is an aerial photograph of KEM with building functions labelled. In order to promote the sustainability of King Edward Mine in the future, it is important to understand the site's significant assets, particularly as the site has such high statutory designations and is such a significant part of the World Heritage Site; by analysing in detail all significant buildings, features, fittings, etc and in particular those sites that may be impacted by future projects, for example, adaptive reuse. This information can be given to the relevant officers and architects to enable them to mitigate negative impacts, and promote positive conservation specifications.
