Trehane House, Probus, Cornwall

Archaeological Watching Brief

Trehane House, Probus, Cornwall.
Archaeological watching brief

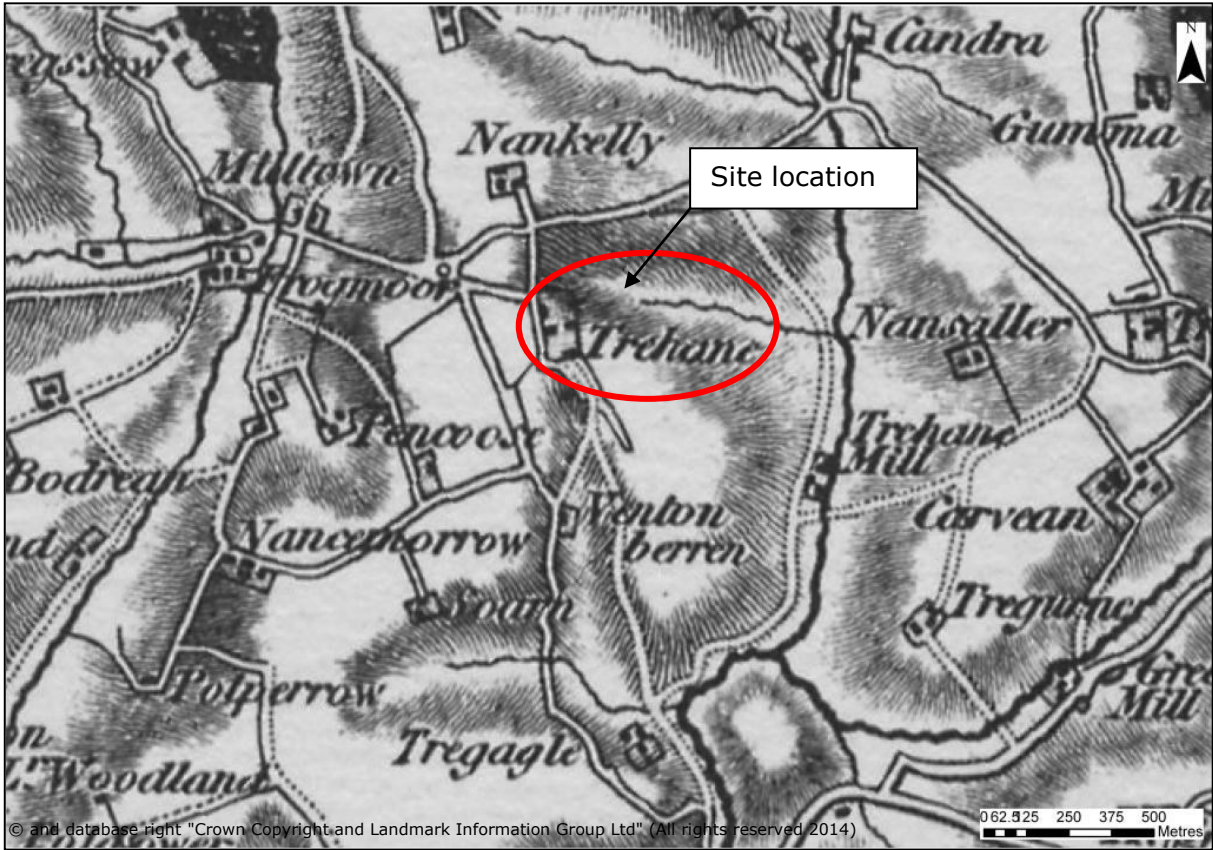
Figure 5: c1803 1st edition OS map showing the outline of Trehane and the avenue extending southeast.

shown on the 1st edition OS map (Figure 5), various out-buildings including the former coach house which was converted to a dwelling after the fire, bee boles and a privy house.

The scale of the estate warranted inclusion on both Gascoyne's and Martyn's 17th century maps with Martyn recording the owners, the Stackhouses (Figure 4). The 1803 1st edition OS map shows the avenue, tracks and the footprint of the house whilst the 1840 Tithe Map for Probus parish depicts a rectangular house apparently with porches on the south and east sides, multiple outbuildings and tracks (Figure 5 and Figure 6). The accompanying 1843 Tithe Apportionment documents the owner and occupier as the Rev William Stackhouse. In addition to the 'Mansion House Court, Road and Gardens' the apportionment records the estate as consisting of meadows, a rookery, orchards, plantations, woods and arable farmland. The extensive grounds are shown on the 1875 and 1906 OS maps with few changes between except for the addition of a probable tennis court (Figure 7).

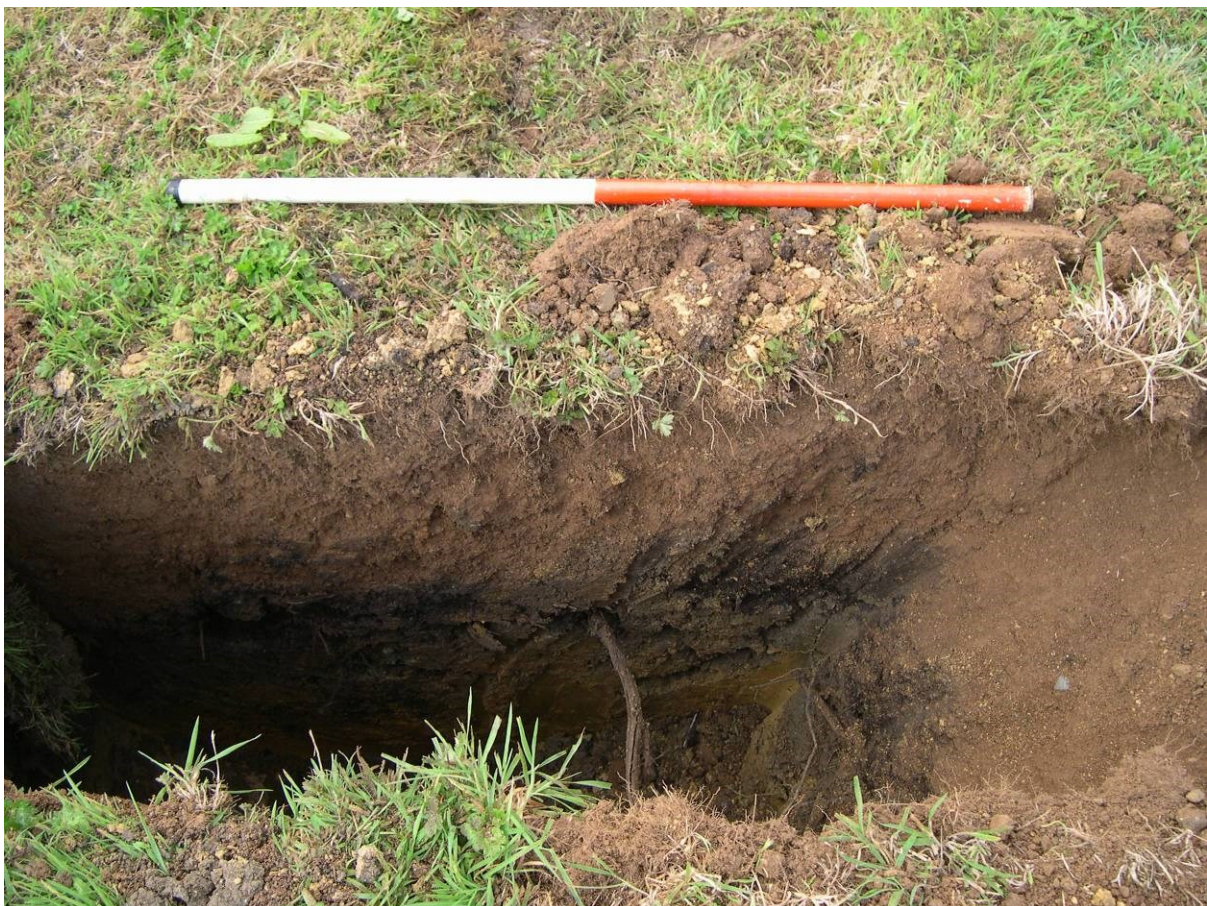
Figure 8: West facing section of Test pit 1 showing organic burnt layer below topsoil.

In test pits 1 and 2, and possibly extending into test pit 3 (Figure 8, Figure 9, and Figure 10), there was a dark black organic layer below the topsoil, around 0.9m in depth. This layer contained much evidence of burning (charcoal and remnants of burnt plant material). The evidence did not appear to reflect burnt debris associated with the house fire and seems likely to indicate a garden bonfire in this area (Figure 16). The same reddish-yellow clay subsoil visible in test pits 3 and 5 was apparent below this layer, having a depth of between 0.2m and 0.4m. Test pit 4 had no evidence of an organic layer but there were fragments of charcoal in the clay subsoil (Figure 11).

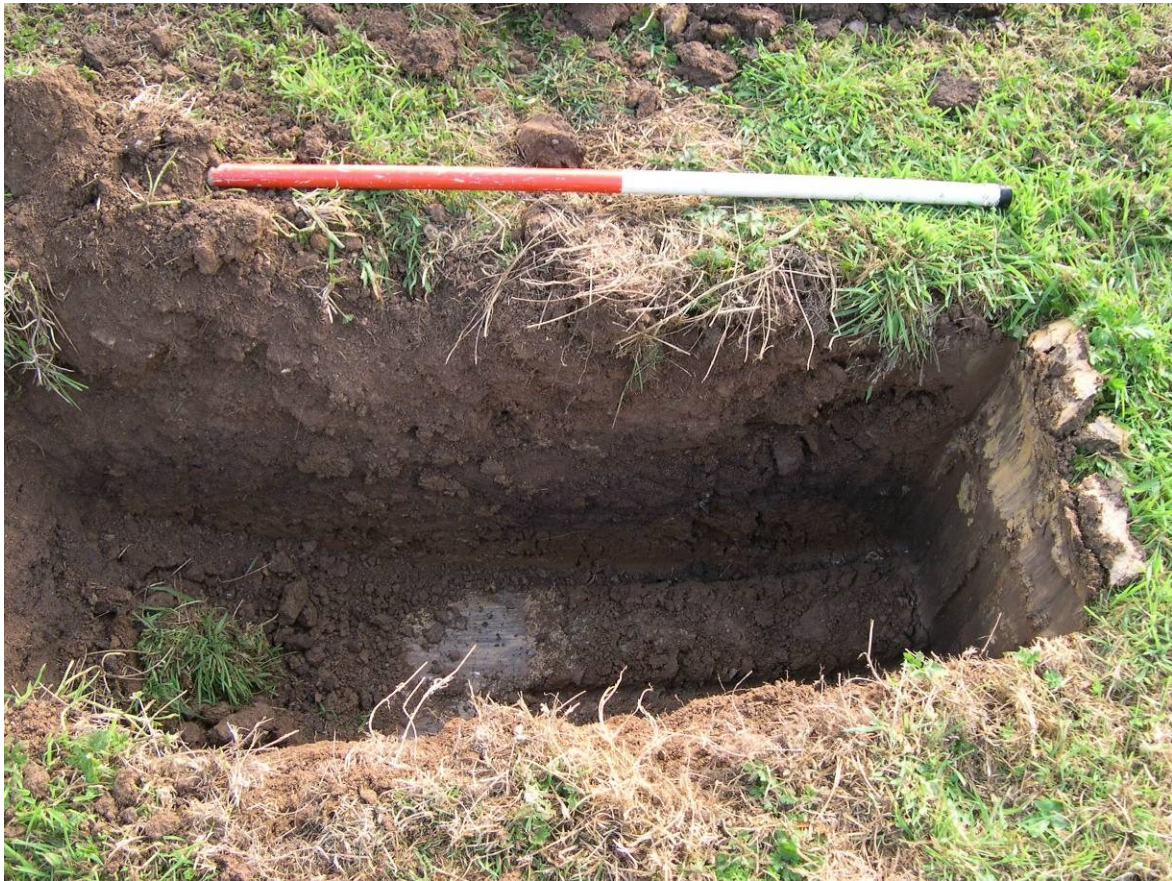
Figure 9: West facing section of Test pit 2 with organic burnt layer at the base.

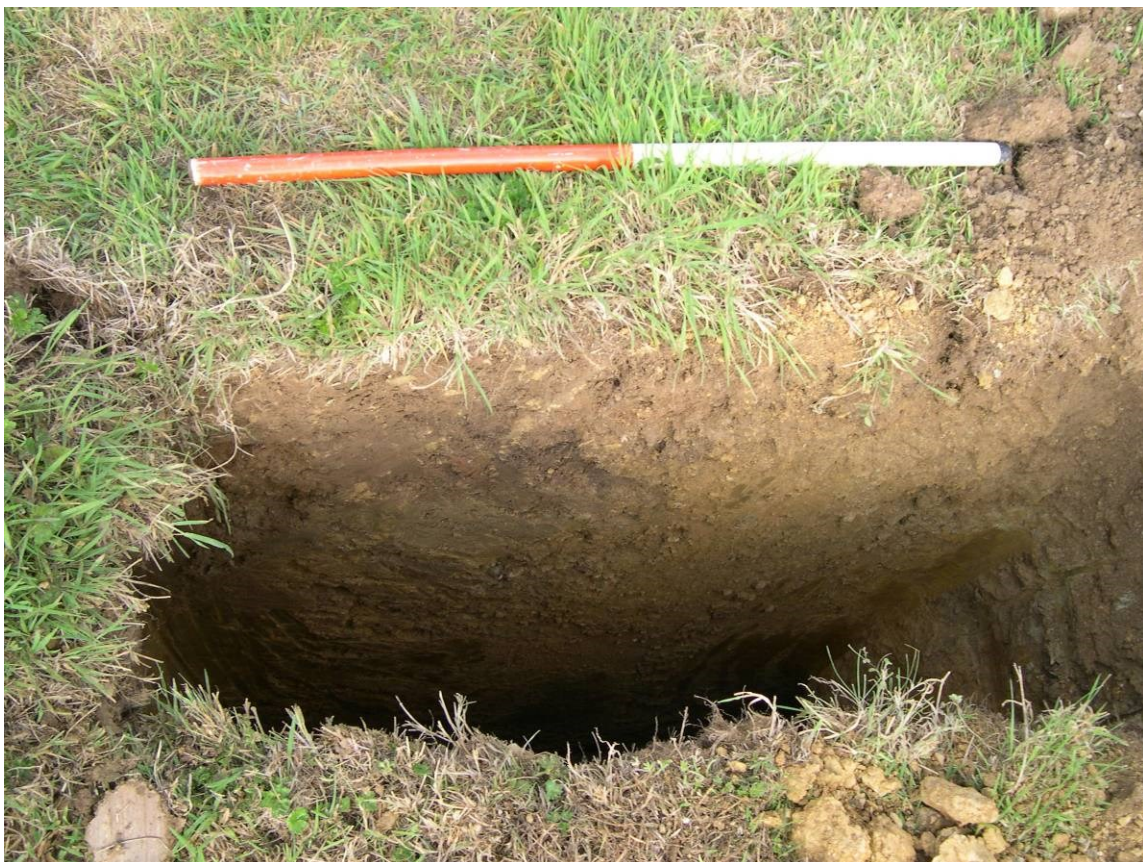
Figure 10: West facing section of Test pit 3 with dark brown lens of clay top left below topsoil – possibly the edge of the burnt layer visible in trenches 1 and 2.

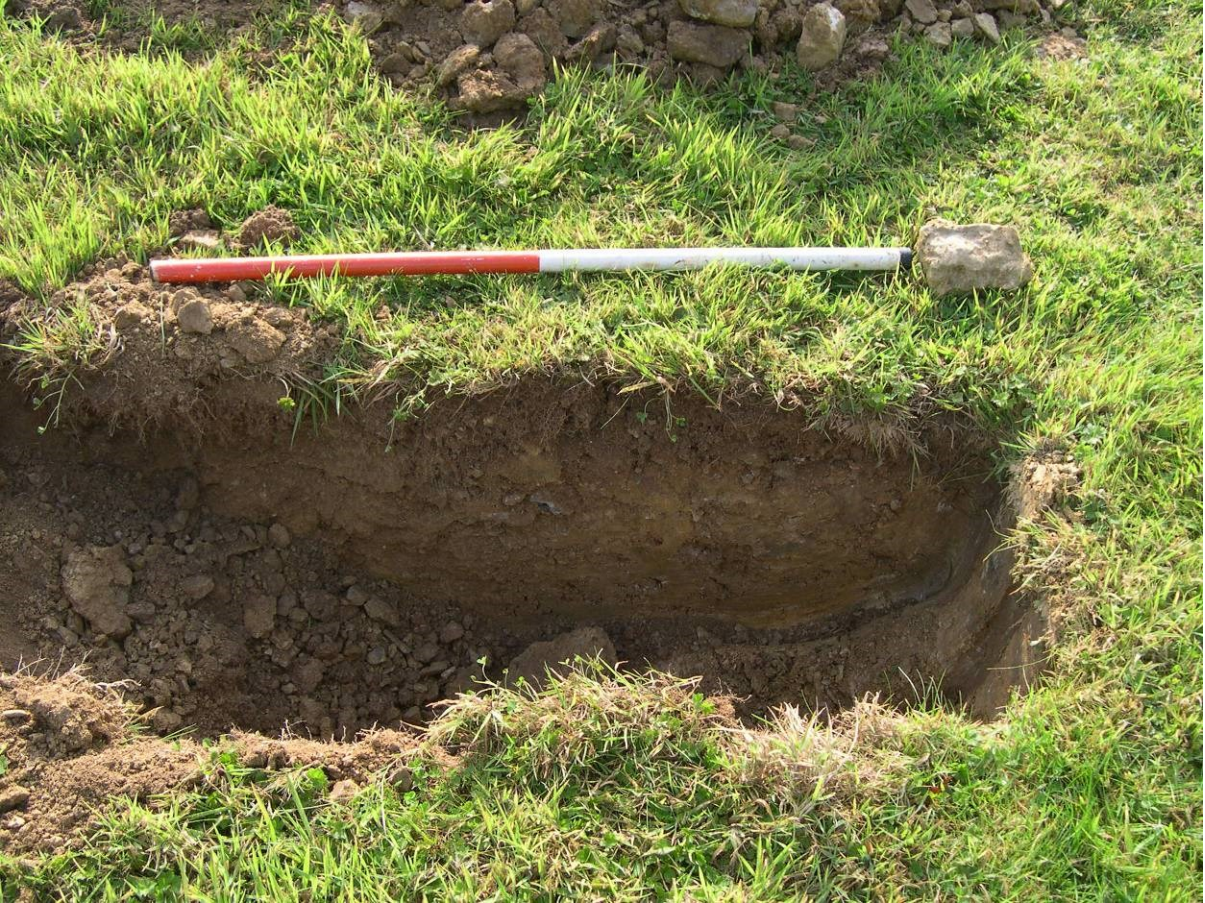
Figure 11: East facing section of Test pit 4.

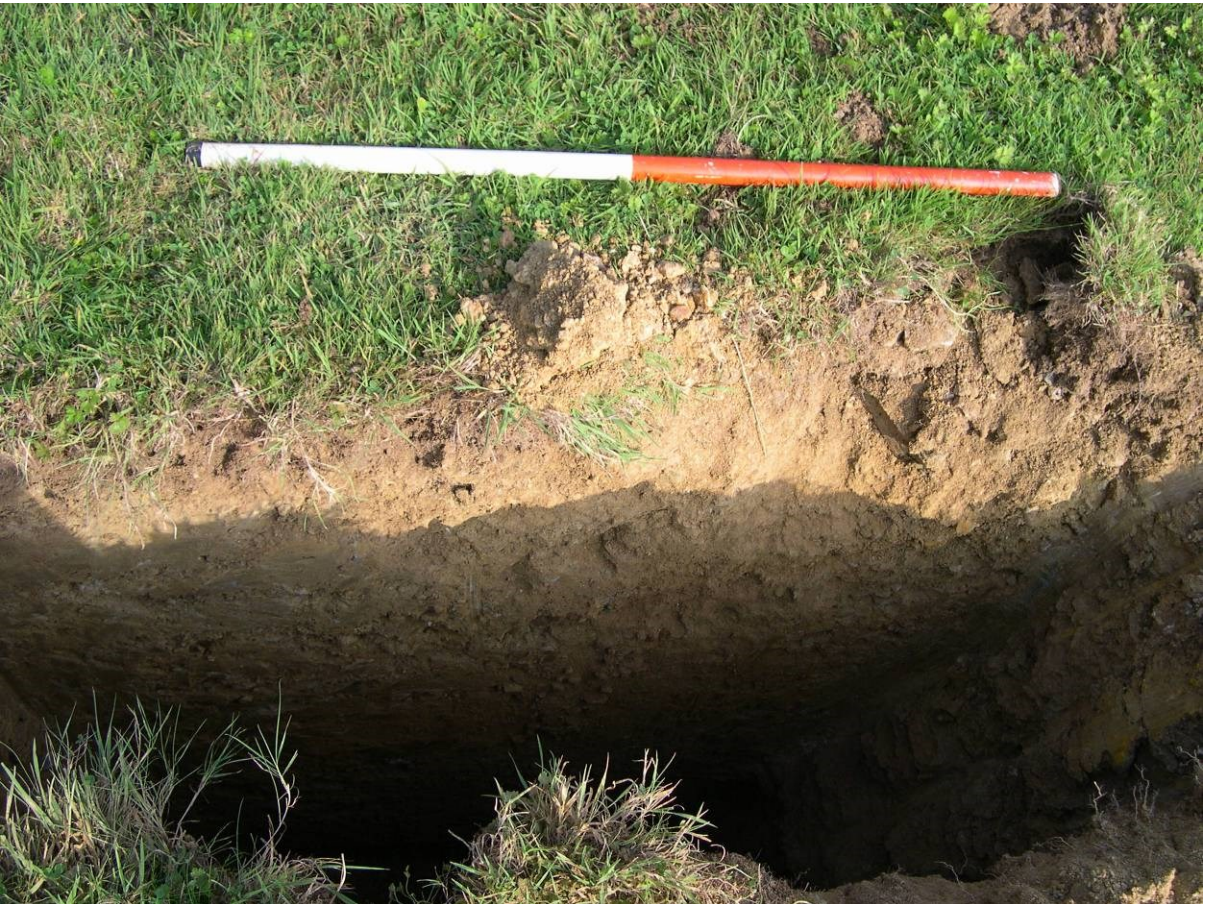
Figure 12: Southeast facing section of Test pit 5.

The geotechnical works comprised the excavation of eight test pits (Figure 2) averaging around 1.5m in length and the width of the machine bucket (approximately 0.3m). Five of the test pits were excavated to a depth of approximately 2.3m; test pits 2 and 4 were excavated to a depth of between 0.5m and 0.7m, test pit 8 to a depth of 1m. The soil profile of test pits 3 and 5 were typically around 0.3m-0.4m of topsoil, which comprised a friable dark brown loamy-clay soil. Below this was a reddish-yellow clay subsoil averaging between 0.8m and 0.9m in depth, relatively stone free or containing only small stone fragments. Underlying this was a lighter greyish yellow clay of about 1m in depth at which point the natural stony clay shillet began to emerge (Figure 10 and Figure 12).

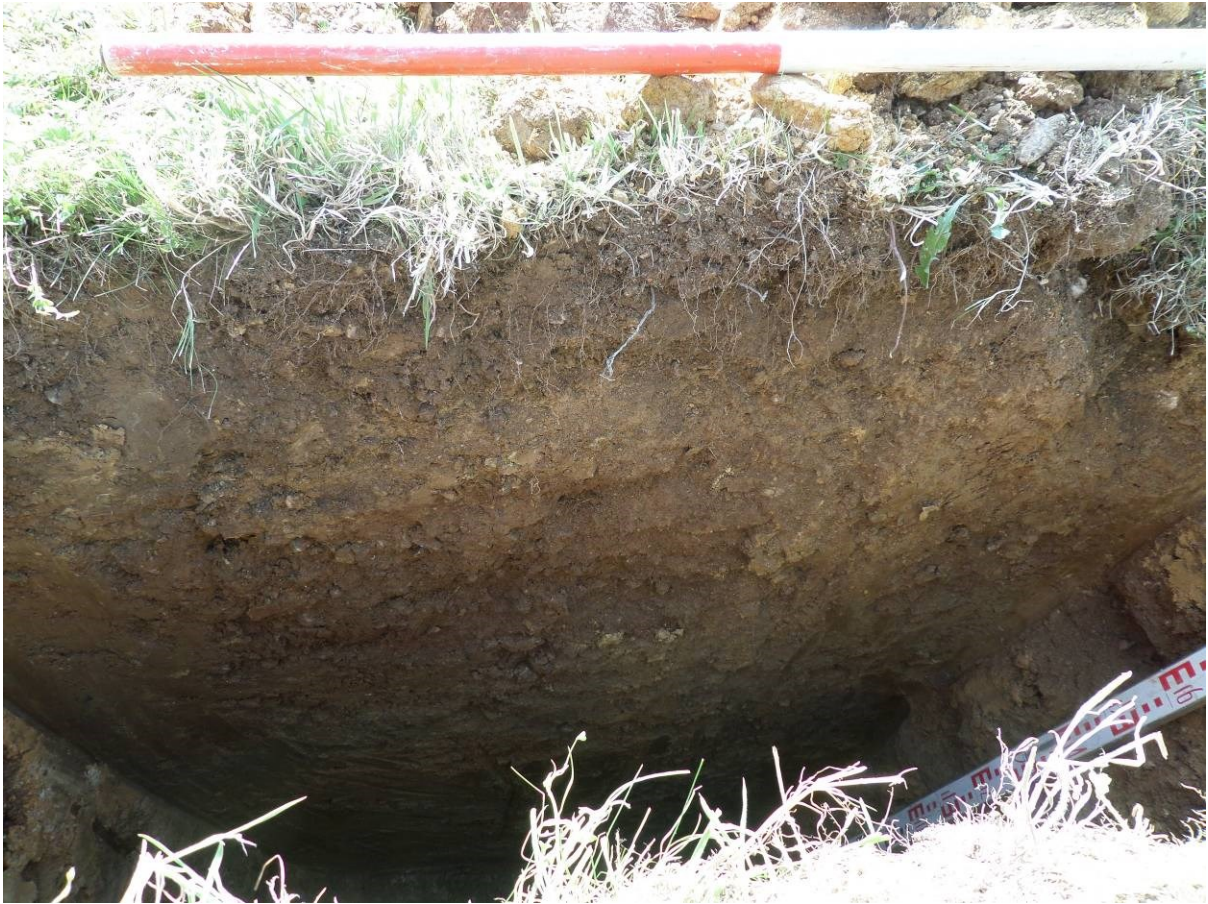
Figure 13: South facing section of Test pit 6 showing layer of possible degraded, re-deposited or older subsoil below a section of yellow clay subsoil and covering topsoil.

In test pit 6 the reddish clay subsoil appeared to have a depth of only 0.2m below the topsoil before giving way to a more friable yellowish-brown clay soil with a depth of around 0.7m (Figure 13). This may indicate a former soil surface but is probably more likely to be an area of degraded or re-deposited subsoil; there has clearly been some landscaping of the ground levels in this area, which at one point held a tennis court. Below this was the reddish-yellow clay subsoil present in test pits 3 and 5. The lower layer of lighter yellow clay and natural shillet was not visible in test pit 6.

Overall, the soil profile across the site appears to have typically comprised a shallow topsoil layer with a reddish-yellow clay subsoil. Underlying this in the southern section of the gardens was a lighter yellow, stonier, clay subsoil, which gave way to the natural clay shillet. The area of burning visible in test pits 1, 2 and possibly 3, appears to have sat within the upper subsoil and below the topsoil (Figure 8, Figure 9 and Figure 10). There appears to have been an area of degraded or redeposited subsoil in the vicinity of test pits 6 and 8 (Figure 13 and Figure 15).

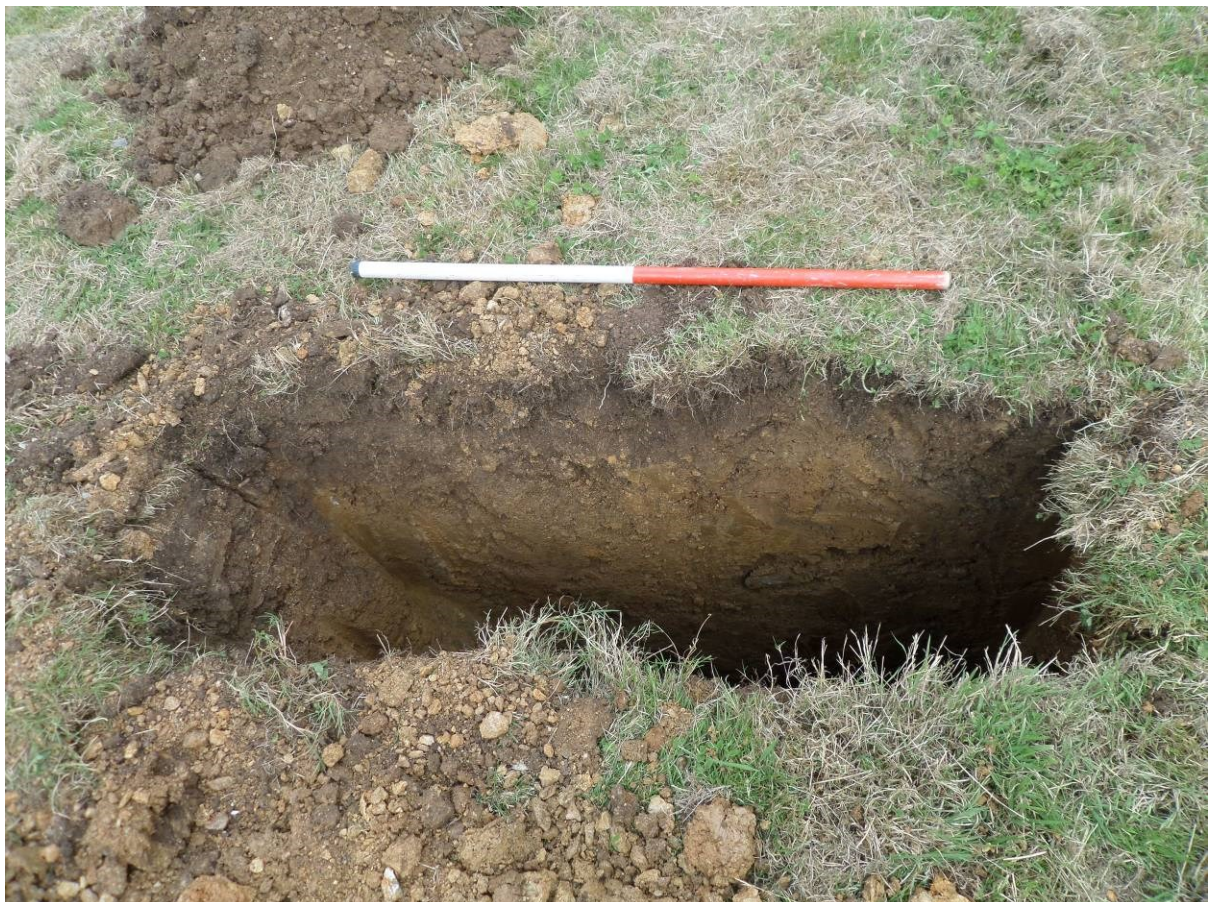
Figure 14: West facing section of Test pit 7.

Test pit 7, located to the north of the other test pits at the top of the garden slope nearest the house (Figure 2 and Figure 14), comprised a similar depth of topsoil as elsewhere on site, below which was the reddish-yellow clay subsoil, being approximately

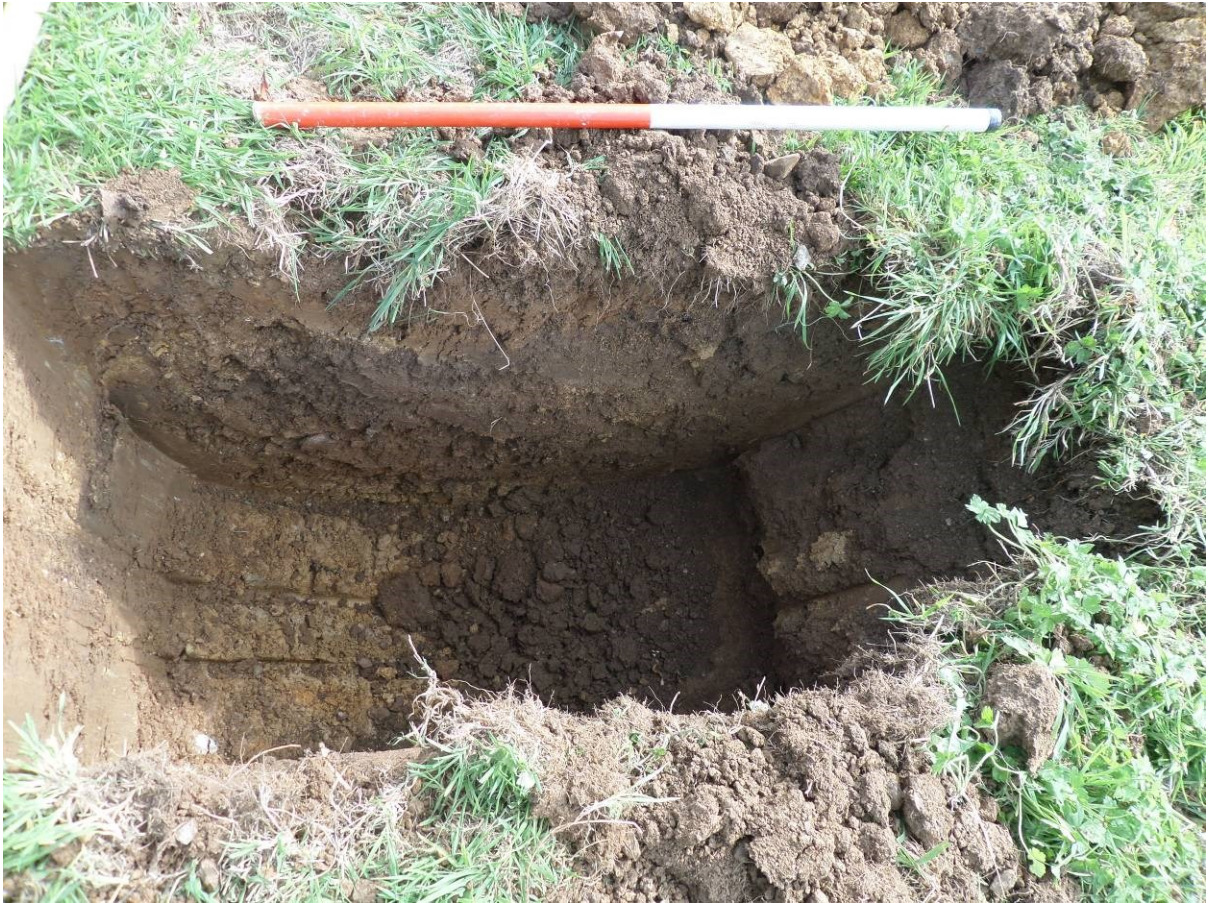
Figure 15: North facing section of Test pit 8.

Test pit 8 contained a partially visible lens of the same dark organic layer visible in test pits 1 and 2 (Figure 15). Below this, with a depth of around 0.7m, was the same friable clay soil visible in test pit 6. Below this again was the same reddish-yellow clay more typical of the subsoil layer underlying the topsoil in test pits 3 and 5.

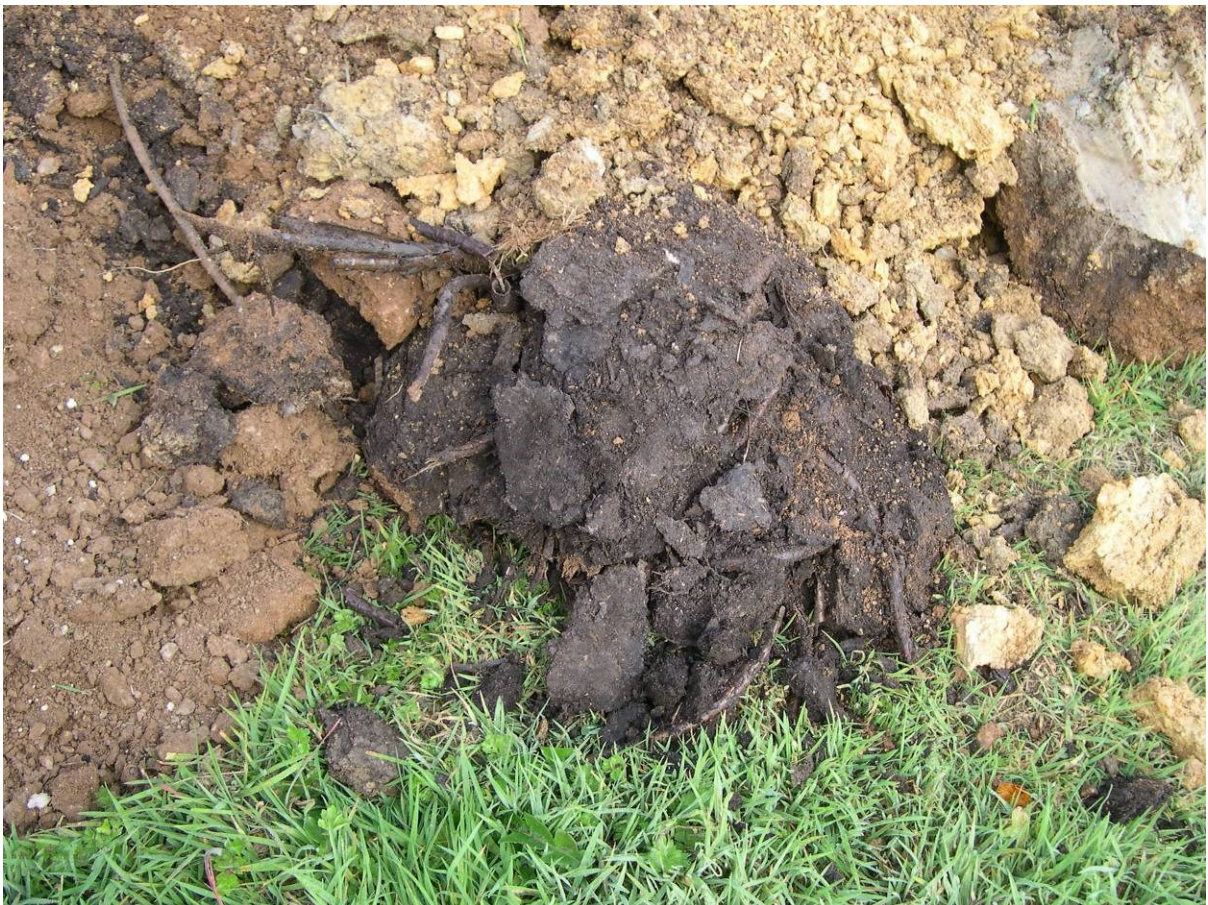
Figure 16: Burnt plant material from within the burnt organic layer in Test pit 1.

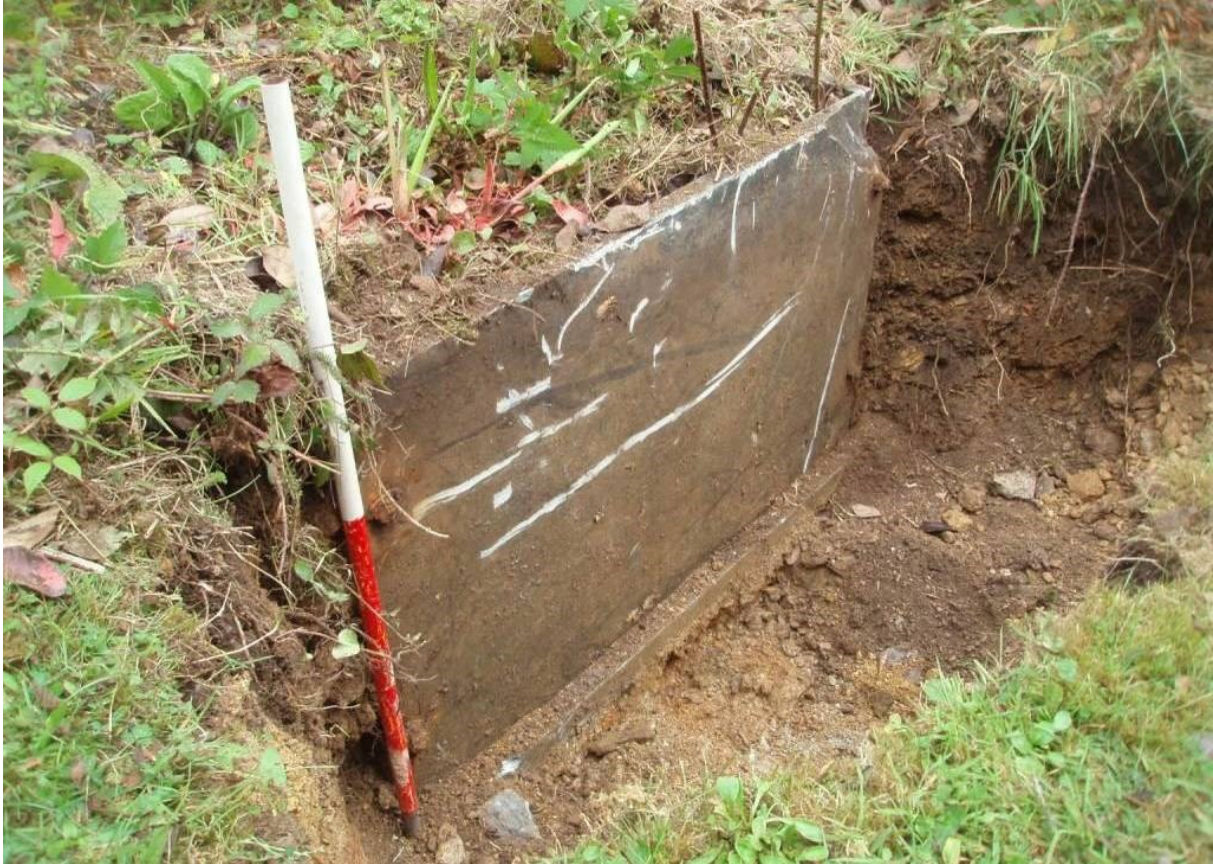
Figure 17: The slate tank found adjacent to the southwest corner of the house. Note the protruding slate base and bolts next to the scale bar and at the far end.

Close to the south-west corner of the ruined house, at the start of the trench, a slate tank was partially visible on the ground surface. This was believed by the owner to be a garden feature and was to be removed. However, on excavating the southern edge of the tank it was found to be exceptionally large; measuring 1.2m in length, 0.6m wide and 0.8m deep and was full of soil and plants (Figure 17). The tank appeared to be constructed of slate with a single slab for each side and a base. The longest sides extended beyond the end slates so that two bolts at each end, probably of iron or steel, could be passed externally through to the opposing side, holding the tank together. A form of sealant was just visible amongst the vegetation on the internal corners. Given the size and probable considerable weight of the tank it was left *in situ* and the drainage trench moved south by 0.5m to avoid it. Further works to connect the drainage trench are likely and may require the removal of the tank if it is too large to enable another trench to be excavated to one side of it. The function of the tank is not clear though it is likely it was a cistern or water tank. In records held by the owner there are references to water tanks for irrigation of the garden during the period when it was open to the public. However, these are vague handwritten notes without descriptions.

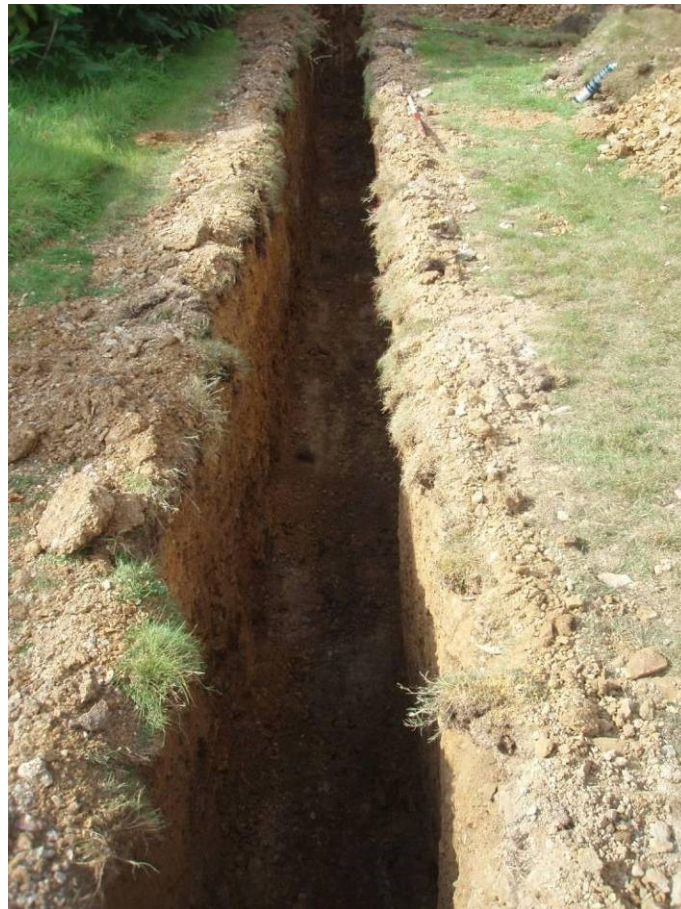
Figure 18: The excavated drainage trench. Note the shallow depth of the turf and topsoil and the gravel, visible to the sides of the trench.

A single trench approximately 15m in length, 0.5m wide and 2m deep was excavated by machine. The trench extended from the south-western corner of the ruined house in a south-easterly direction, terminating in front of the surviving porch (Figure 3 and Figure 18).

The topsoil was a maximum of 0.05m deep and was a black-brown silt with extensive grass roots. The topsoil was above a layer of quartz and granite gravel approximately 0.05m deep. Below the gravel, the natural subsoil was a dry and loose grey-yellow sandy-silt with frequent slate fragments, 'shillet,' up to 300mm in diameter.
