## **Odd Spot, Mawgan Porth, Cornwall Archaeological Assessment**

## Archaeological Assessment

<b>Client</b>	Sue Walters of Situ8 Ltd
<b>Report Number</b>	2014R083
<b>Date</b>	<b>November 2014</b>
<b>Status</b>	Final
<b>Report author</b>	<b>Ann Preston-Jones</b>
<b>Checked by</b>	<b>Adam Sharpe BA MIfA</b>
<b>Approved by</b>	<b>Andrew Young</b>

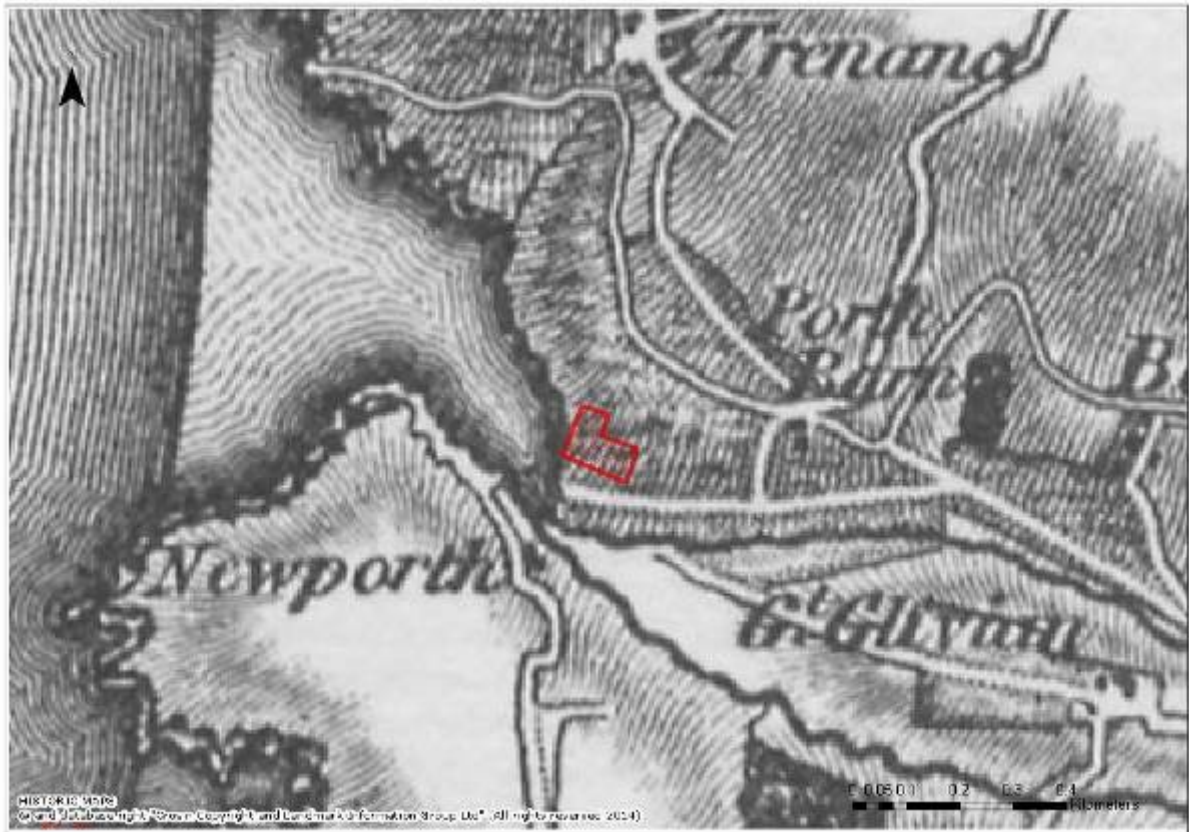
Fig 3 Extract from the OS First Edition One Inch Map c1809. The Scheduled area is shown in red cross-hatching to aid location of the assessment area (see also Fig 2).

On the 1813 OS 1<sup>st</sup> edition one-inch map, the earliest historic map examined, (Fig 3), the assessment area is shown as an open and unfenced area of rough ground, with the only settlement in the area being at Porth Barn, a few hundred metres inland. On the opposite side of the valley overlooking the beach, a house called New Porth is marked. Neither of these places is known to be of medieval origin. Apart from the Dark Age Village, the earliest settlement recorded in the vicinity is at Gluvian, a kilometre inland, this being first recorded in the thirteenth century (HER 22105). The same scenario is recorded on the Tithe Map of *circa* 1840 (Fig 4), which additionally records that this large open area (field number 29; pasture) was part of Porth Farm and was known as 'Sandy Marver'. First recorded in 1340 (Institute of Cornish Studies Place-Names Index), the name 'Marver' is derived from Cornish *\*moyl* and *\*bre*, 'smooth or round-topped hill' (Padel 1985, 30, 167), presumably in reference to the sandy, bare, short-turfed, hillslope above the Dark Age Village. The 1880 and 1907 OS 25" maps show few changes to the landscape at Mawgan Porth, though depict drainage channels in the wide flat valley bottom indicating agricultural improvement of the Menalhyl river's floodplain (Figs 5 and 6). Indeed, the impression is of a stable landscape, used to a low intensity given the sandy and exposed environment. This appears to have remained unchanged until the 20<sup>th</sup> century when development associated with the holiday industry began. It is to this development that we owe our knowledge of the Dark Age Village and its cemetery.

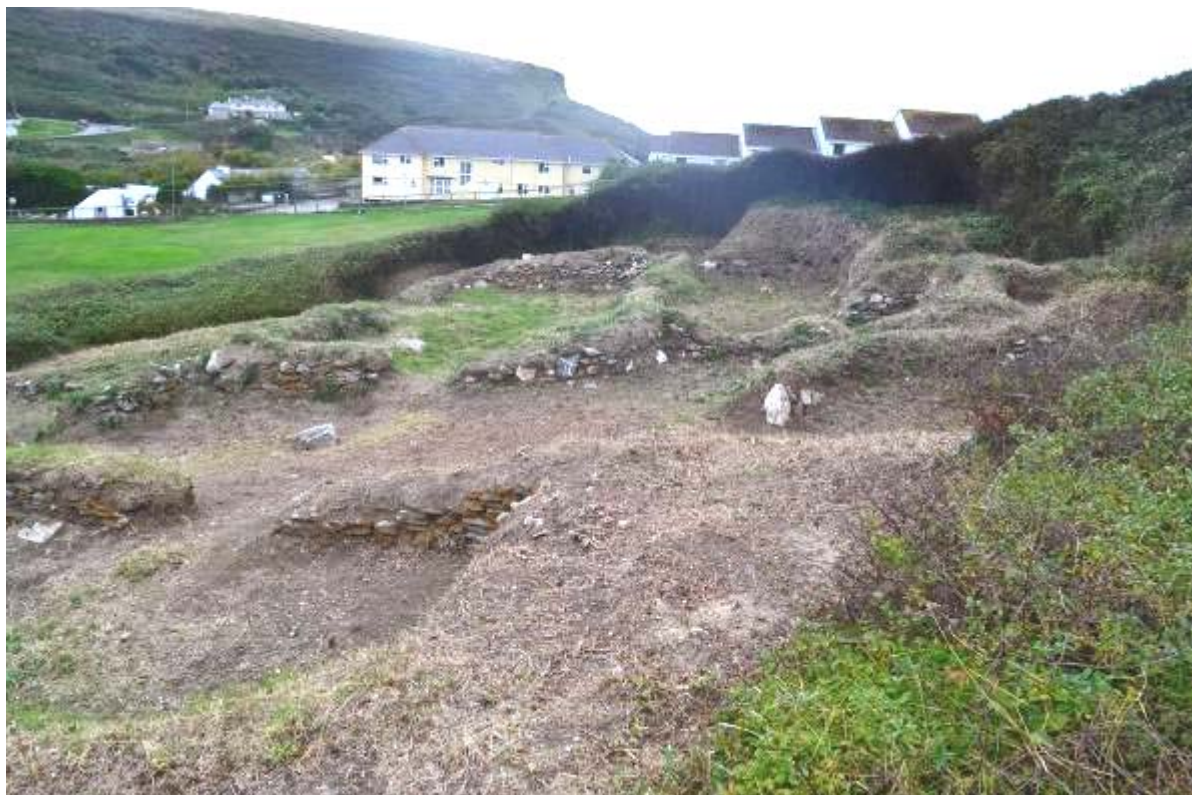
*Fig 9 The ruined buildings of the Dark Age village, recently cleared of scrub by volunteers.*

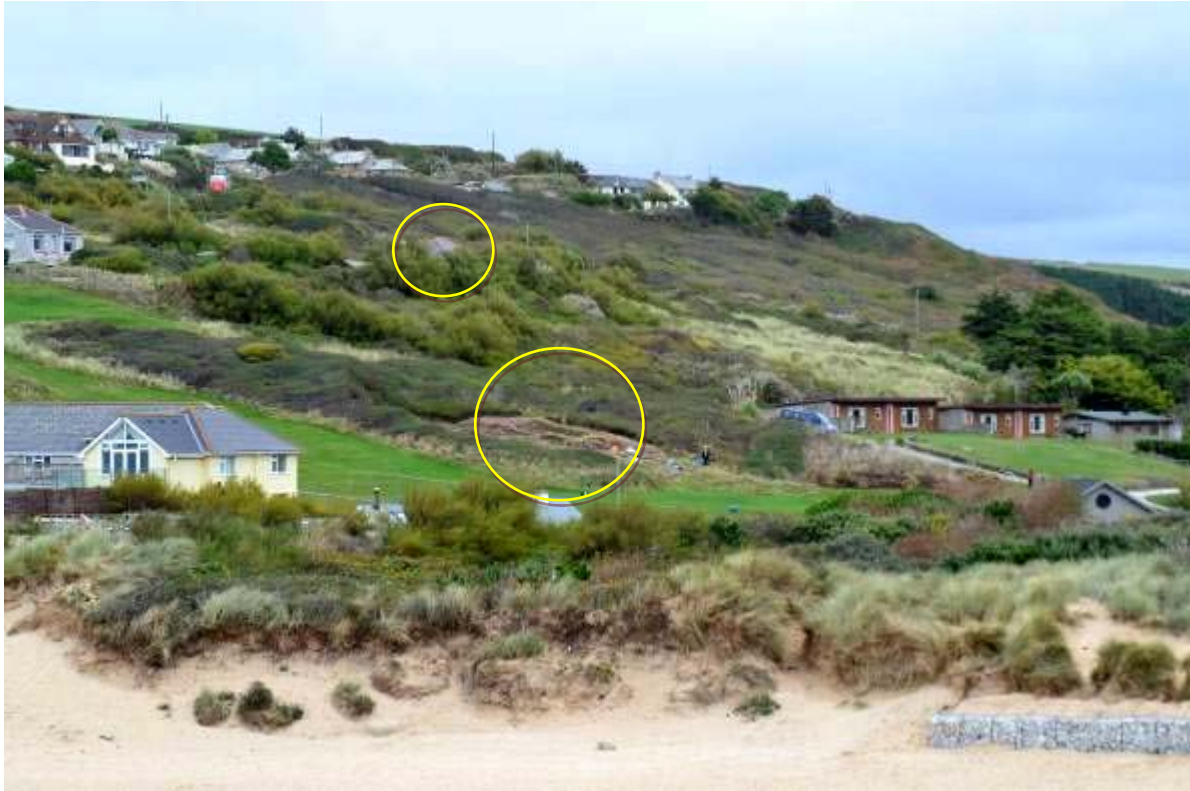
*Fig 10 View of the Scheduled Monument and Odd Spot from the south-south-west at Coastguard Cottages. Odd Spot and the Dark Age Village are circled in yellow to help to identify them.*

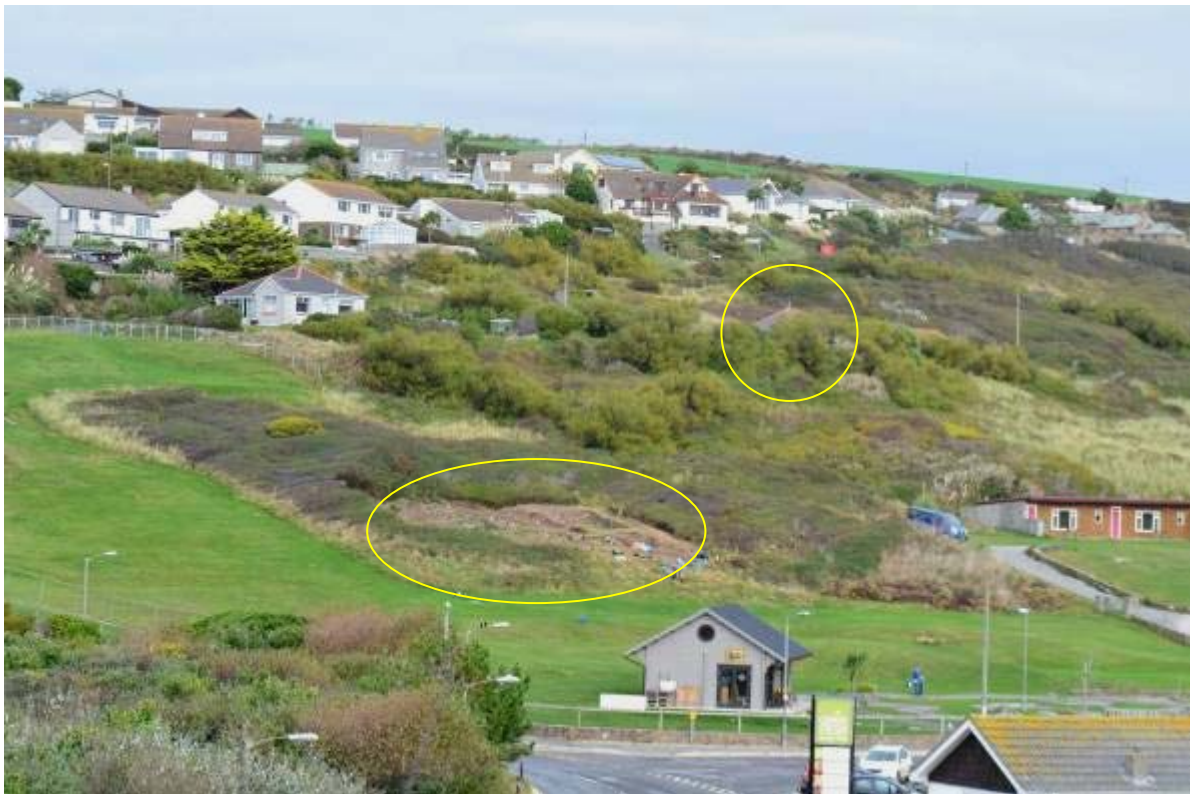
*Fig 11 View of the Scheduled Monument and Odd Spot from the south-west on the road rising up the hill towards Newquay. Odd Spot and the Dark Age Village are circled in yellow to help to identify them.*

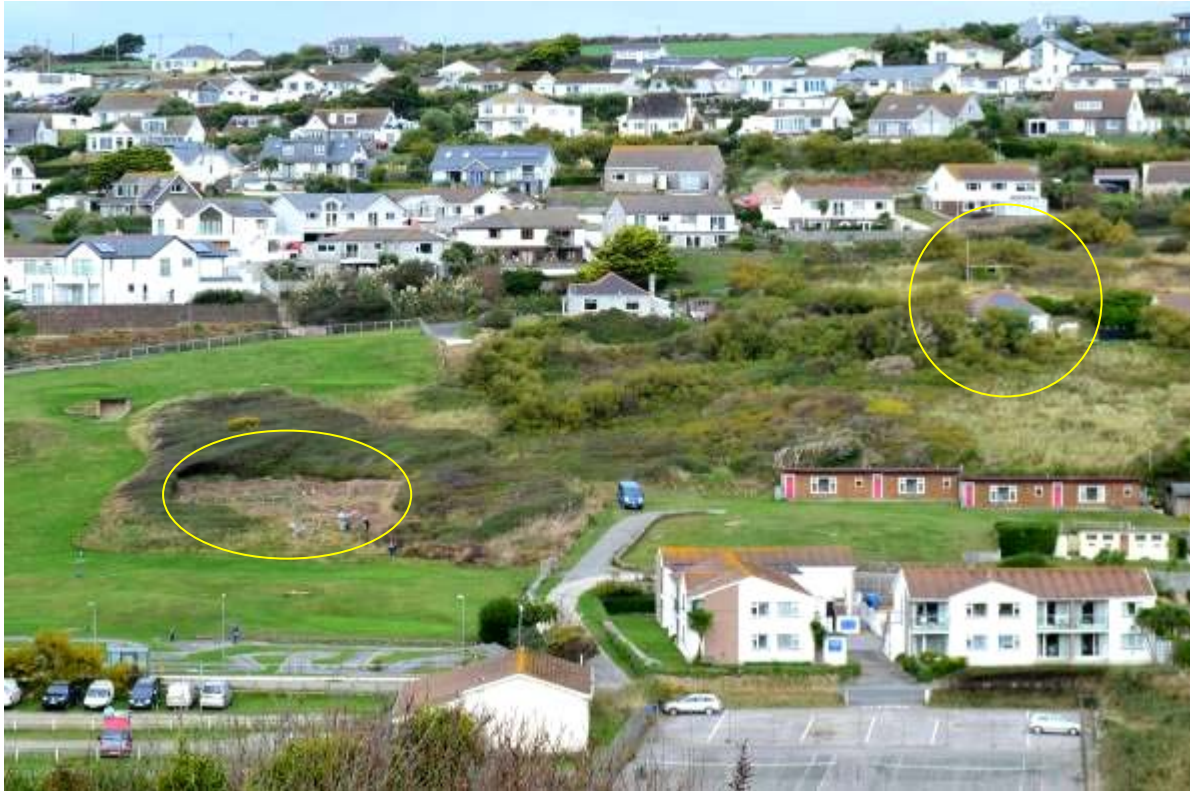
*Fig 12 View of the Scheduled Monument and Odd Spot from the south-south-west on the road rising up the hill towards Newquay. Odd Spot and the Dark Age Village are circled in yellow to help to identify them.*

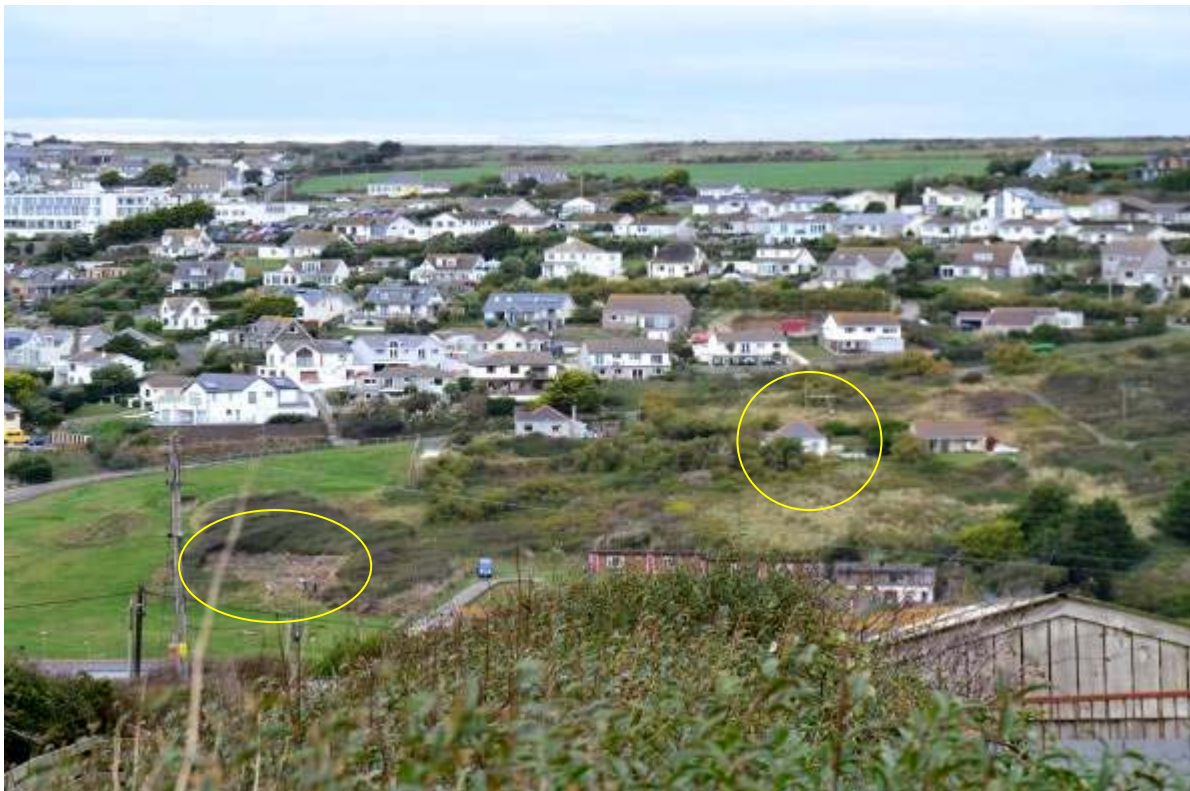
*Fig 13 View of Odd Spot and the Scheduled site from the side of the road next to Bre-Pen Farm. Odd Spot and the Dark Age Village are circled in yellow to help to identify them.*

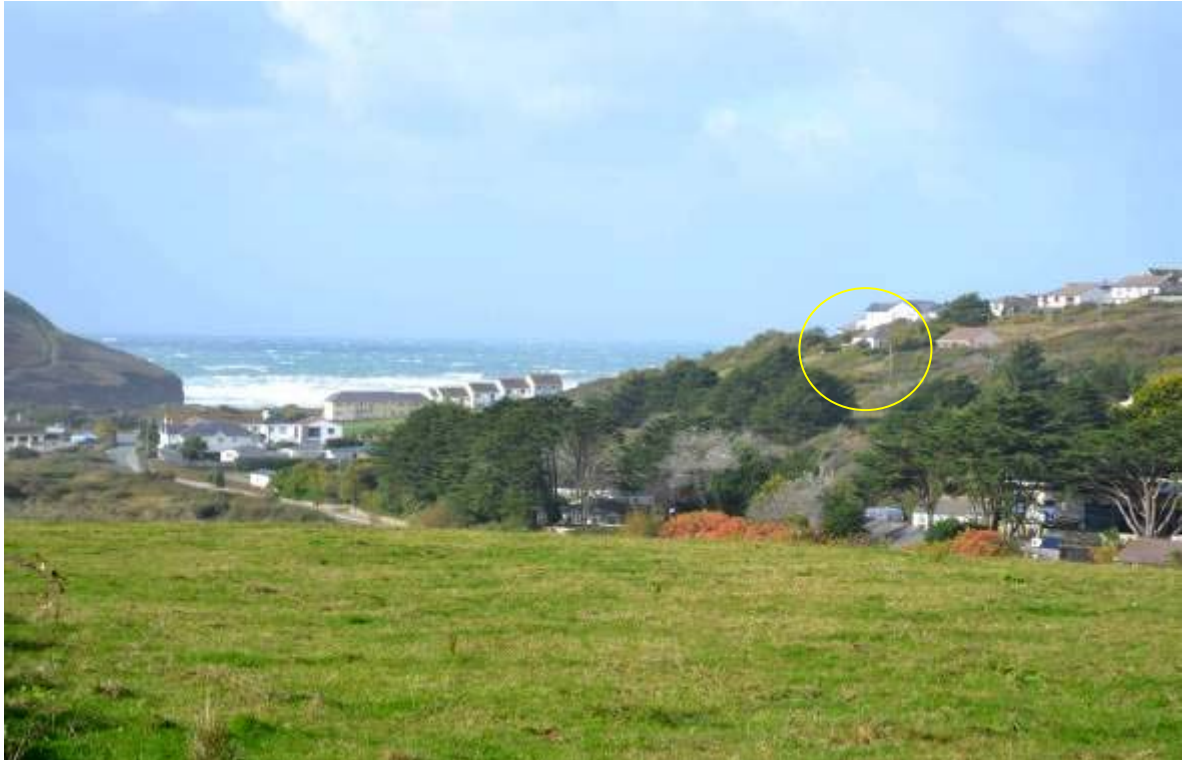
*Fig 14 A view looking towards the Scheduled site from the road to Gluvian. Odd Spot is circled in yellow; the Scheduled area is on the slope below but hidden from view by tall trees.*

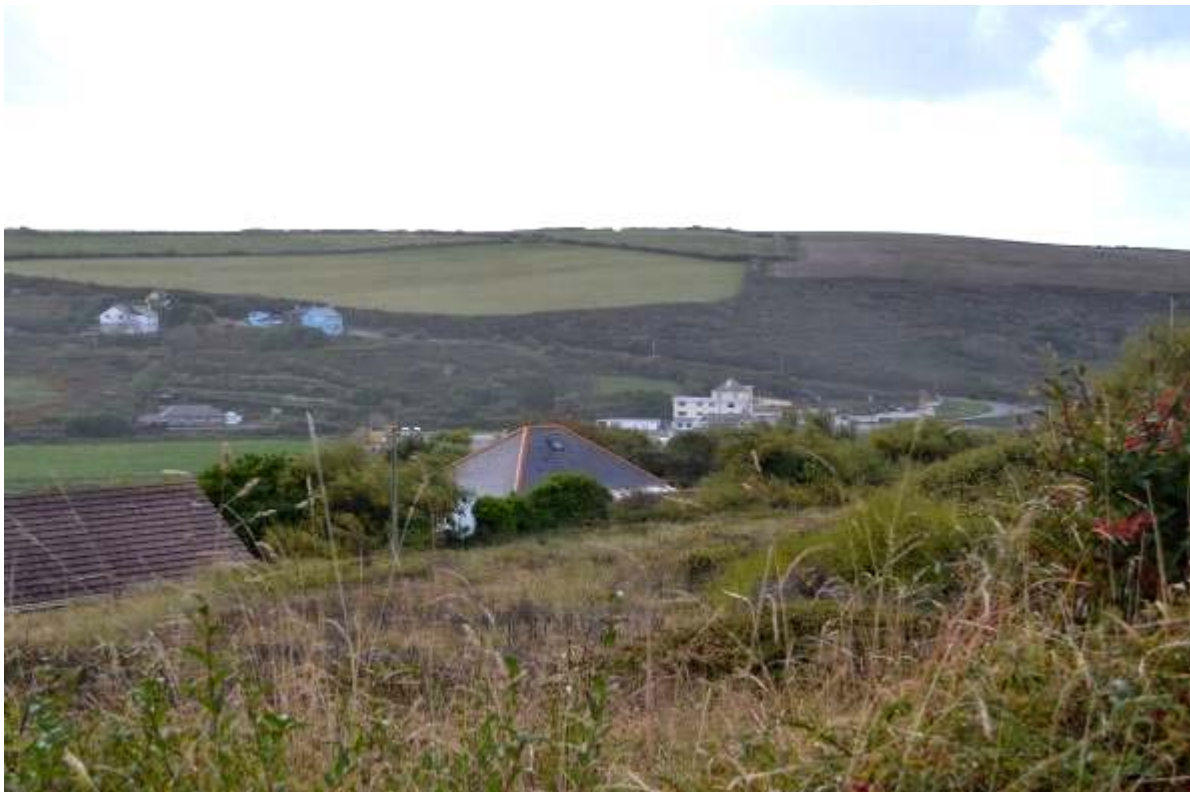
*Fig 15 Odd Spot's roof, seen from the roadside to the north, in the centre of the picture. The Scheduled area is invisible below and beyond the house from this viewpoint.*

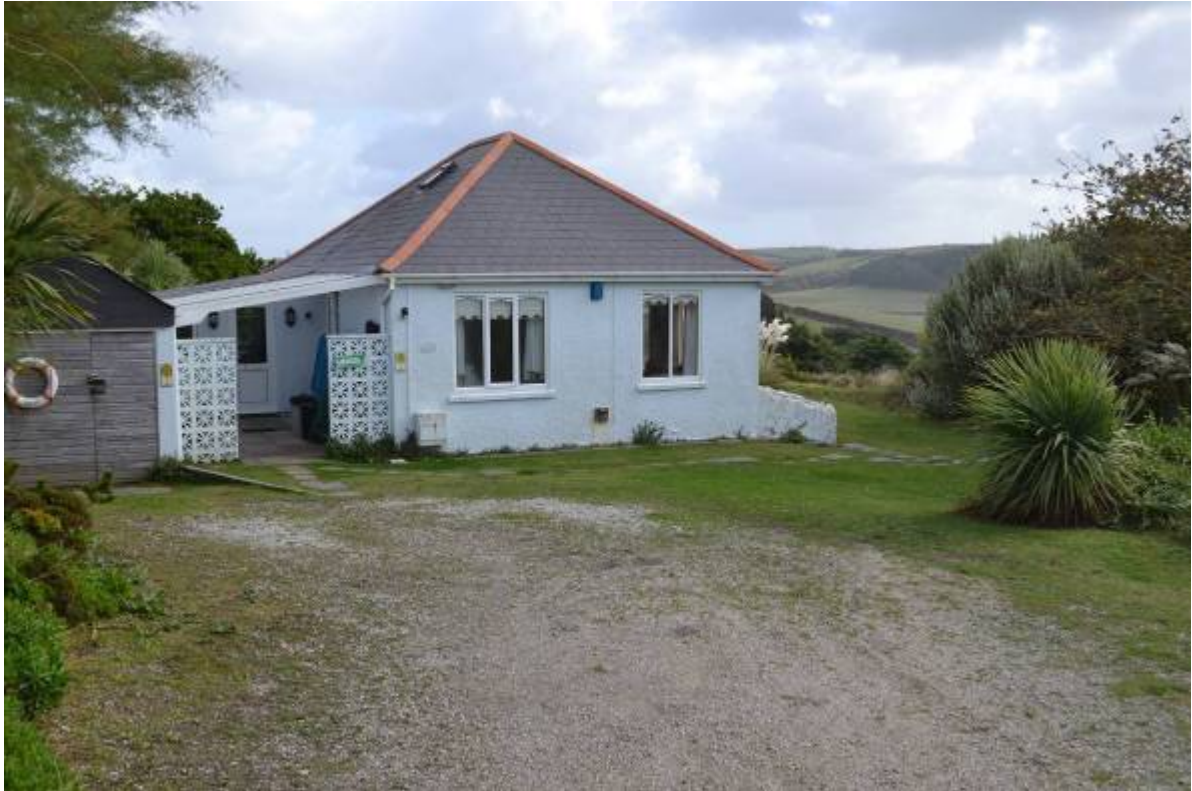
*Fig 16 The present bungalow at Odd Spot viewed from the west-north-west.*

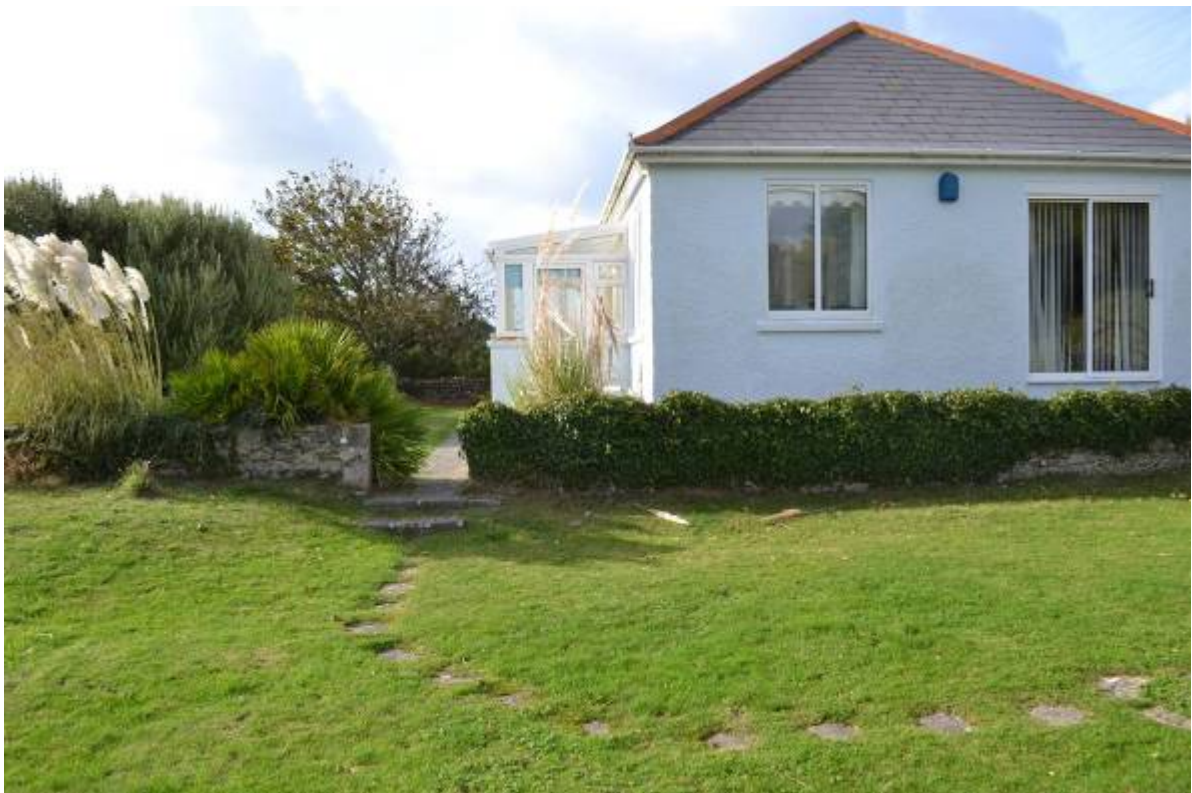
*Fig 17 The present bungalow at Odd Spot viewed from the east. Note the high tamarisk hedge framing the views.*

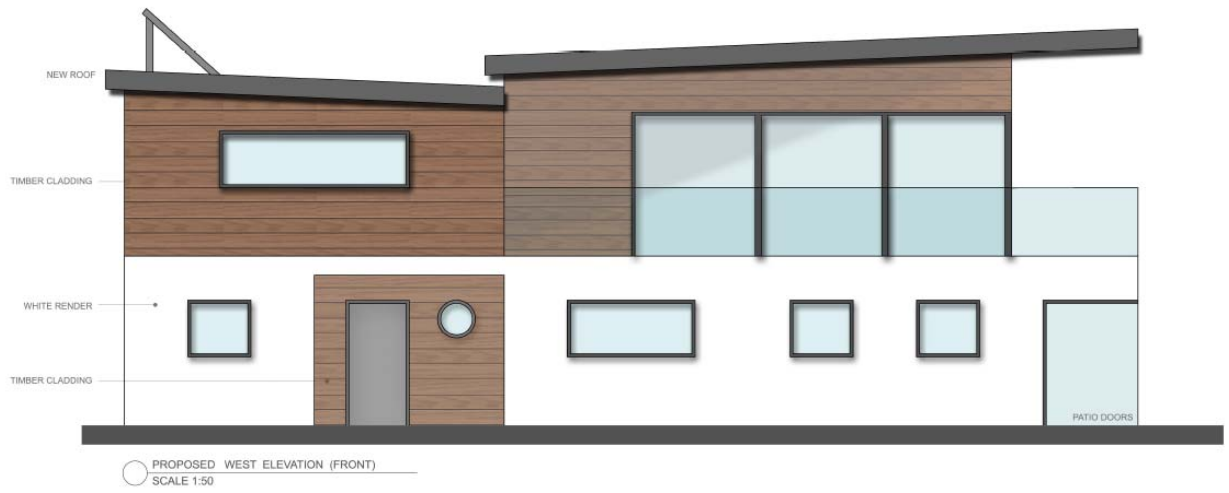
Fig 18 The proposed replacement dwelling as it would appear from the west (front).

- The proposed replacement dwelling is for a house of a modern design which is likely to be more visually prominent within the local landscape for this reason alone.

- If it is proposed to go ahead with the present design then it is recommended that the client produces a photomontage to demonstrate how it would look when constructed from the principal viewpoints identified above in section 9, that is from the south, south-south-west and south-south-east, as well as from the exposed buildings of the Dark Age Village.

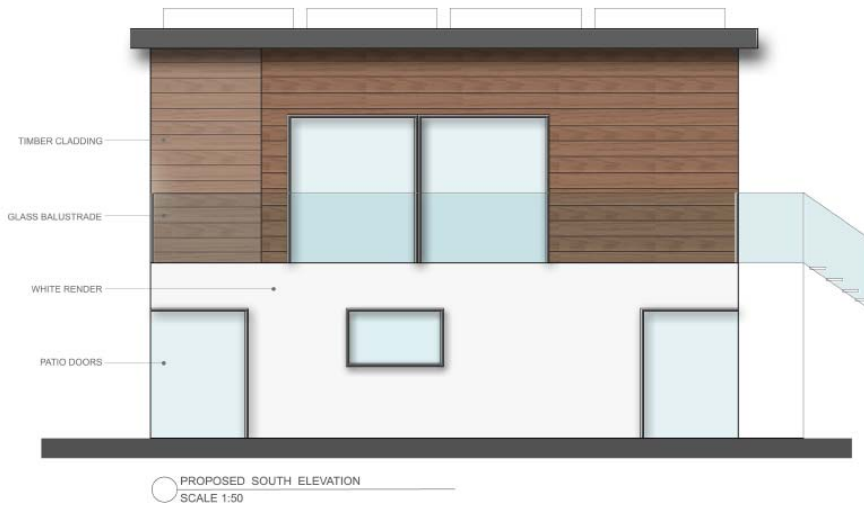
Fig 19 The proposed replacement dwelling as it would appear from the south.
