The Baulking House, Treloyhan, St Ives, Cornwall

Archaeological Assessment

Client	Christian Guild
Report Number	2015R015
Date	February 2015
Status	Final
Report author	Hayley Goacher BA (Hons) PCIfA
Checked by	Nigel Thomas BA MCIfA
Approved by	Andrew Young

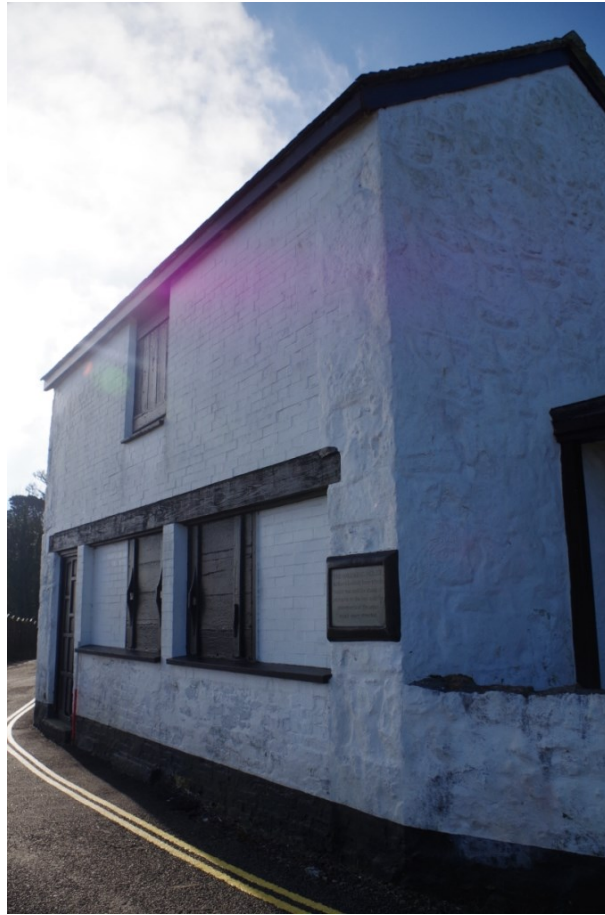
The central range is two storeys with closed sides and granite quoining on the corners (Figure 7). On the eastern, front elevation the building is accessed by a modern door which had been broken at the base just above the granite step. A second rectangular fragment of granite, similar to the threshold step at the door, protruded from the approximate centre of this elevation. The lower storey has two windows blocked by large wooden shutters that may be historical in origin. They had been relatively recently painted though there is evidence of rotting and a missing handle. These windows had relatively new wooden sills. A wooden lintel above the door and windows stretched the width of the elevation. On the upper storey of this elevation is a single central window, also with a wooden shutter. Above the lower storey window sills, the elevation is constructed of apparently modern brickwork. The upper storey of the southern elevation also has a single, central, window blocked with stone and painted white (Figure 11). No access to the interior was possible and the western, rear elevation was obscured by vegetation and only accessible via the adjoining private property and so was not inspected.

Figure 7: The central two storey cottage part of the baulking house. Note the wooden shutters, modern door and brick work across the elevation.

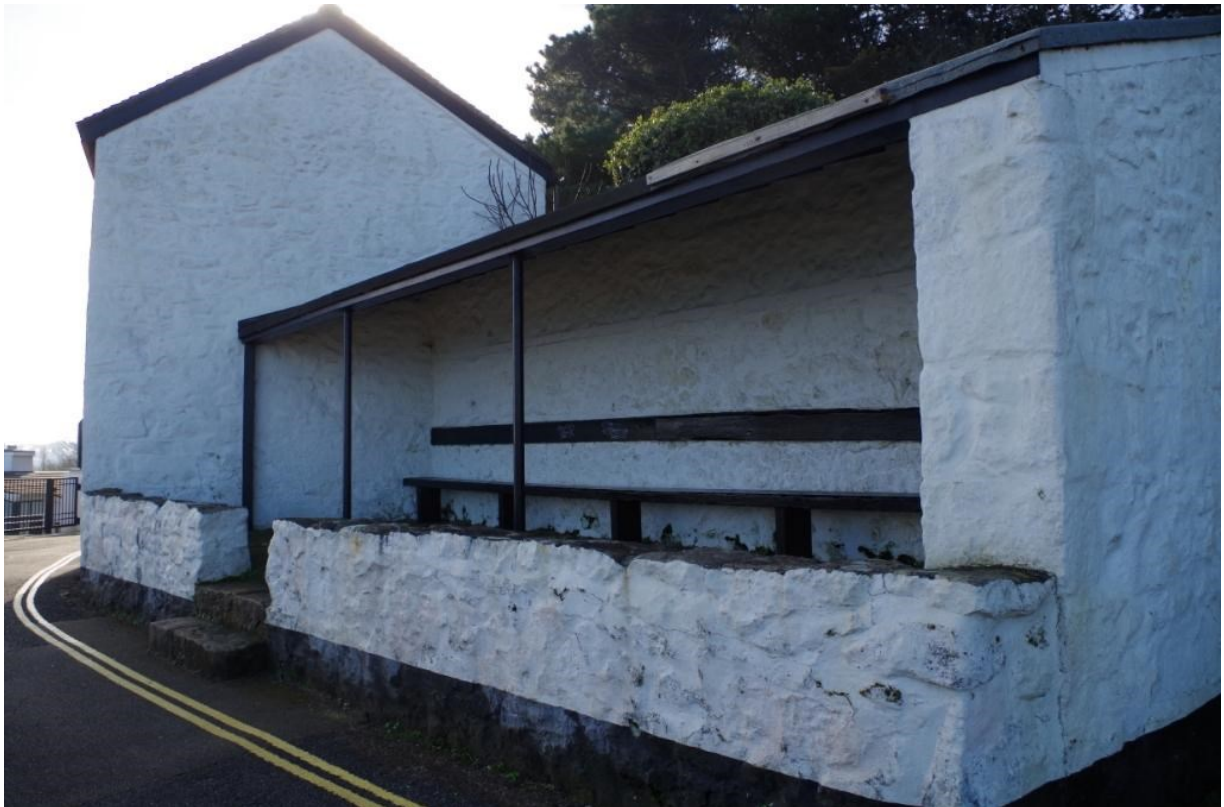
The first and third ranges, at the north and south ends of the building, are single storey, three-sided structures with the open side facing the sea (Figure 8). The roofs are mono- or skillion, pitched supported by two equidistant metal poles on the eastern edge and covered with modern asphalt. There is evidence on the roof of the northern range of a recent, aesthetically poor repair. The interior of each is accessed via two granite steps located approximately centrally through a low wall abutting the road. The interior ground surface is cobbled though the stones are beginning to be covered by moss, weeds, debris and broken glass. The rear wall supported a wooden bench and back-rest on which there was the occasional occurrence of graffiti.

Figure 8: The northern range open shelter with granite steps and benches. The graffiti on the bench and poor roof repair are just visible.

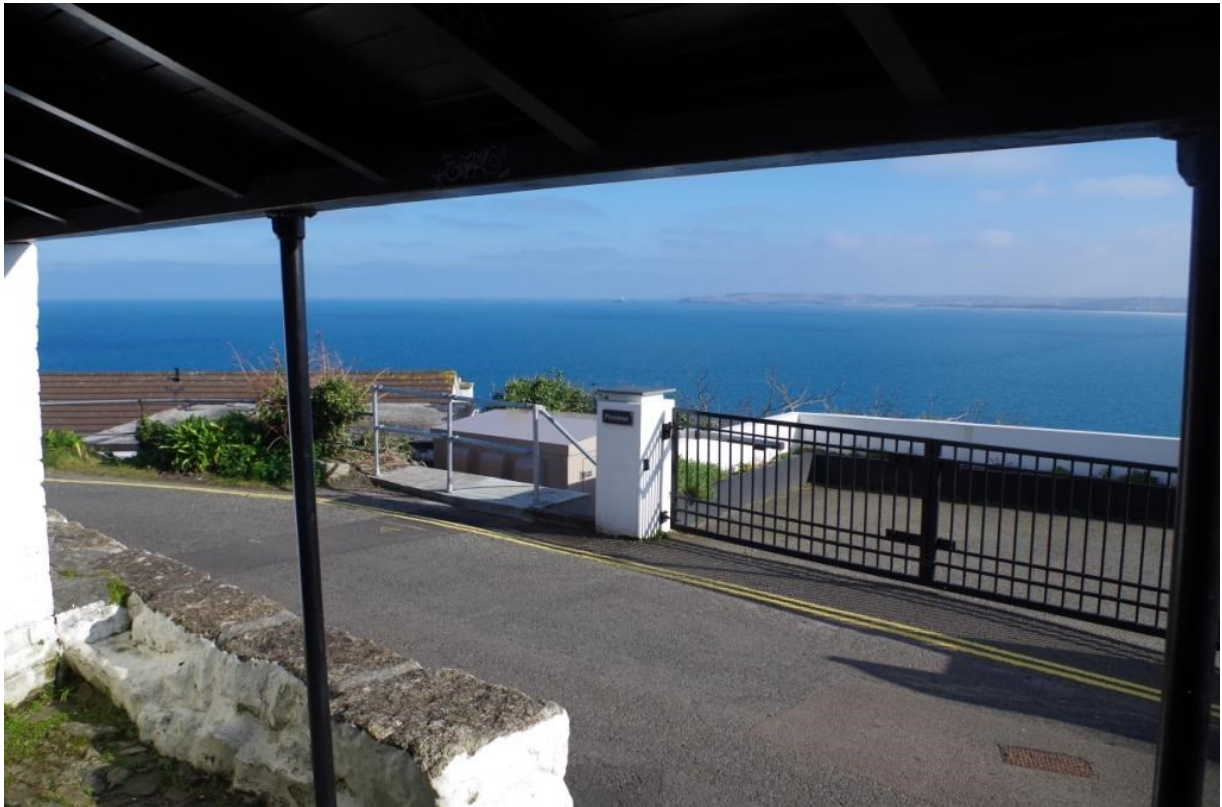
Figure 9: The view northeast across St Ives Bay to Godrevy lighthouse from the southern shelter of the baulking house now includes modern roofs and amenities.

The setting of the baulking house includes modern amenities, housing and the coastal maritime environment. The primary view from the baulking house out to sea has been largely preserved with a wide ranging view of the majority of the bay (Figure 9). Views to and from the baulking house include the houses, of varying designs having been built on individual plots, and their gardens, many of which have large features such as decorative fences or tall trees. The baulking house is most prominently viewed from approaches on Hain's Walk where its bright white appearance contrasts with the road and modern neutral coloured housing or trees that form the backdrop. From within Treloyhan Manor the baulking house is not perceived until the viewer is immediately adjacent to it due to the density of vegetation and the steeply sloping topography (Figure 13). This approach leads the viewer to the plain southern elevation. Similarly there are no views of the Manor itself from the baulking house.

As the proposed development is inland from the baulking house, appreciation of its maritime setting from the baulking house itself will not be greatly impacted as the view out to sea across the whole bay remains with minimal intrusion from the roofs of houses (Figure 9). However the maritime setting, as a result of the interaction between the huers and seine fishermen, also includes the view from sea to land. Although important, this view is now rarely accessed as a result of the demise of maritime industries and strong tides largely preventing leisure activities in the bay. In addition, the baulking house is almost completely surrounded by modern housing and views of it from the sea would include the house only as an already very small component of the modern setting. The proposed development is unlikely to significantly change this view and will not further obscure the baulking house as it will appear above and to the side of it. From Porthminster beach, another component of the maritime setting, the baulking house is already invisible as a result of modern housing and there will be no further perceivable impact to the setting from this viewpoint (Figure 12).

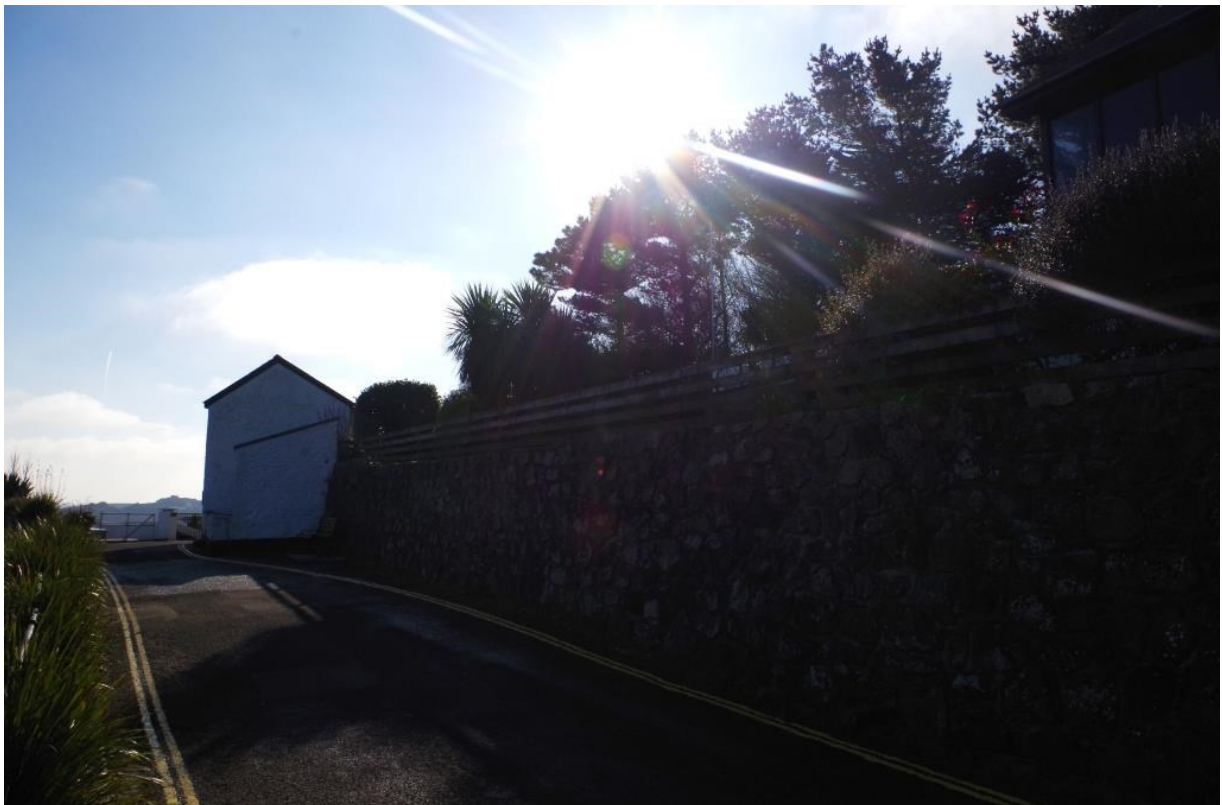
Figure 10: The view approaching the baulking house from the north along Hain's Walk. The proposed development would be right of centre within the trees and is likely to be visible from this viewpoint.

- The design and appearance of the proposed development should be particularly sensitive to the scale and aesthetics of the baulking house, particularly when viewed from Hain's Walk and from out to sea, and to respect key viewpoints in both the modern and maritime settings.

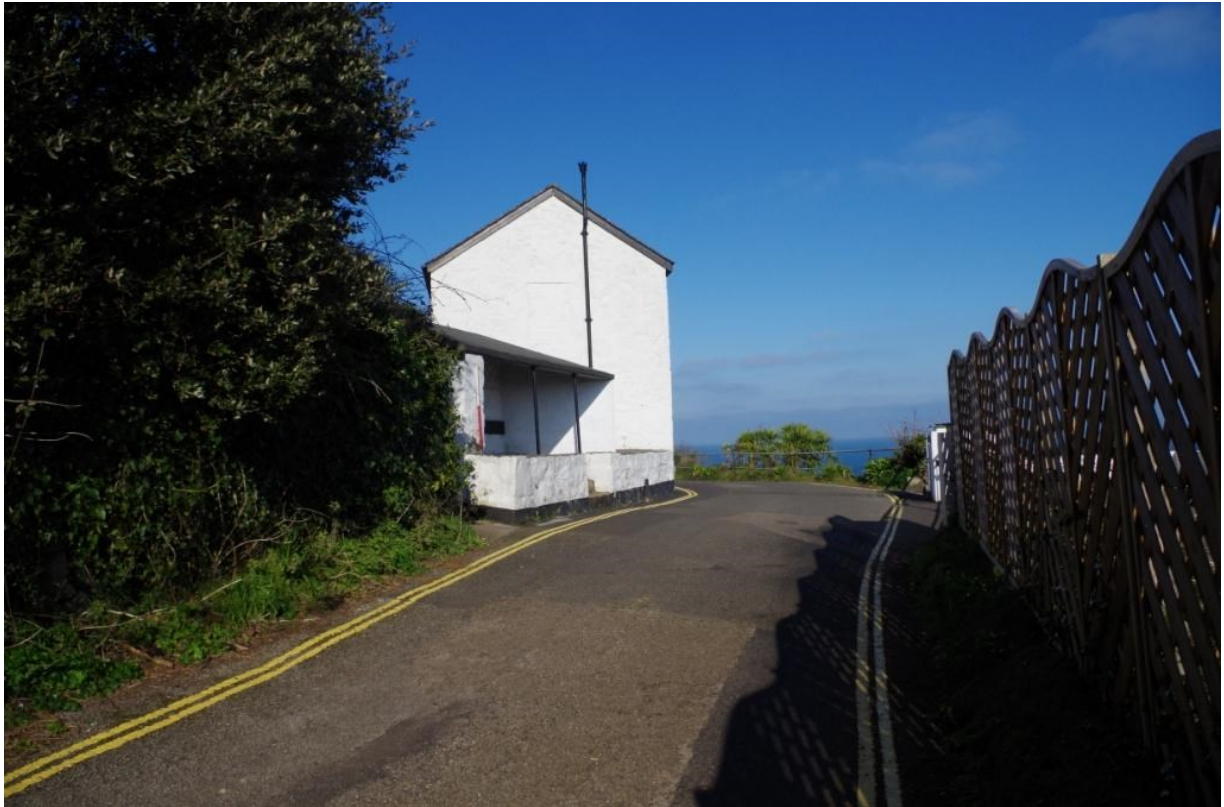
Figure 11: The view approaching the baulking house from the south along Hain's Walk. The proposed development would be out of shot behind the vegetation on the left of the image. It is possible that the proposed development would be visible from this viewpoint, depending on the density of the vegetation.

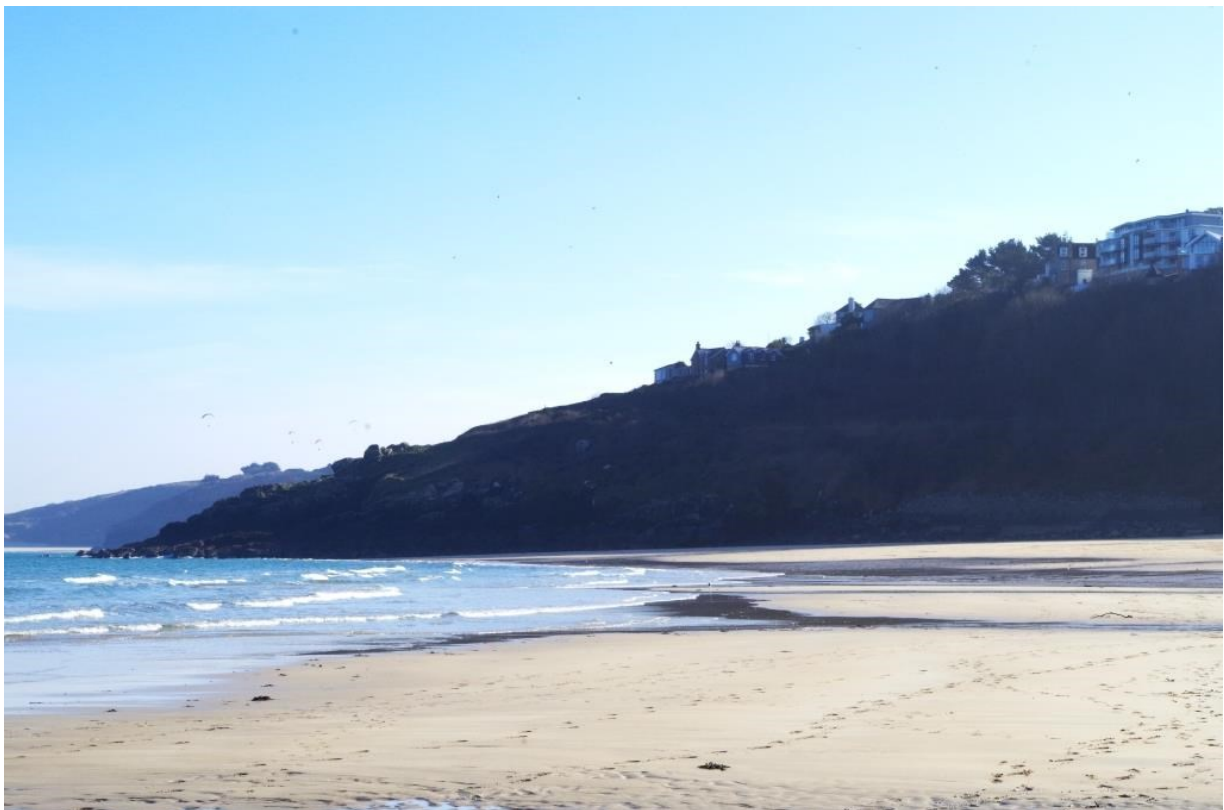
Figure 12: Porthminster Point from Porthminster beach. The baulking house is within the cluster of buildings on the slope of the point but is not distinguishable from this viewpoint.

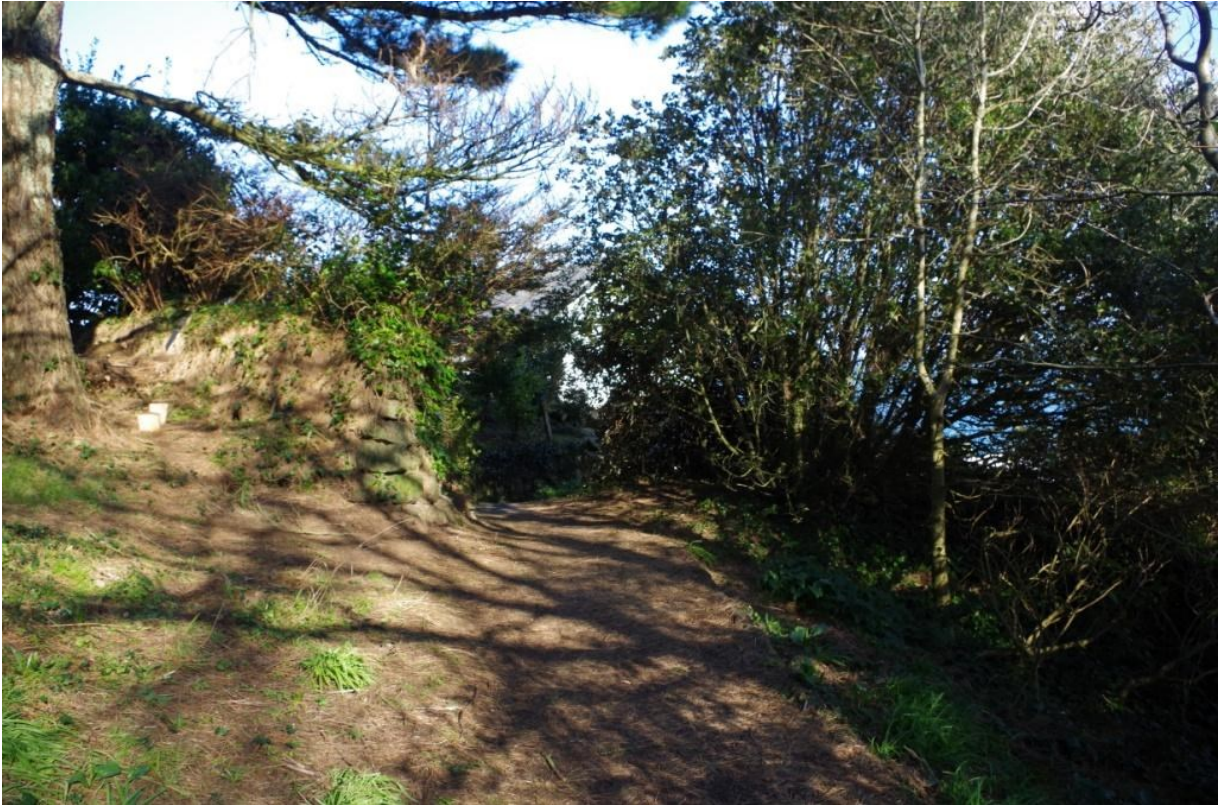
Figure 13: The pathway within Treloyhan Manor grounds adjacent to the closest proposed development to the baulking house, which is barely visible beyond the trees in the background to this image. The development plans do not indicate the removal of the trees visible in this image.
