Cubert Vicarage, Cornwall Historic building record

Cubert Vicarage, Cornwall

Historic building record

Client	Ms L Northridge
Report Number	2015R010
Date	February 2015
Status	Final Draft for consultation
Report author(s)	Catherine Parkes BA MCIfA
Checked by	Nigel Thomas BA MCIfA
Approved by	J Nowakowski

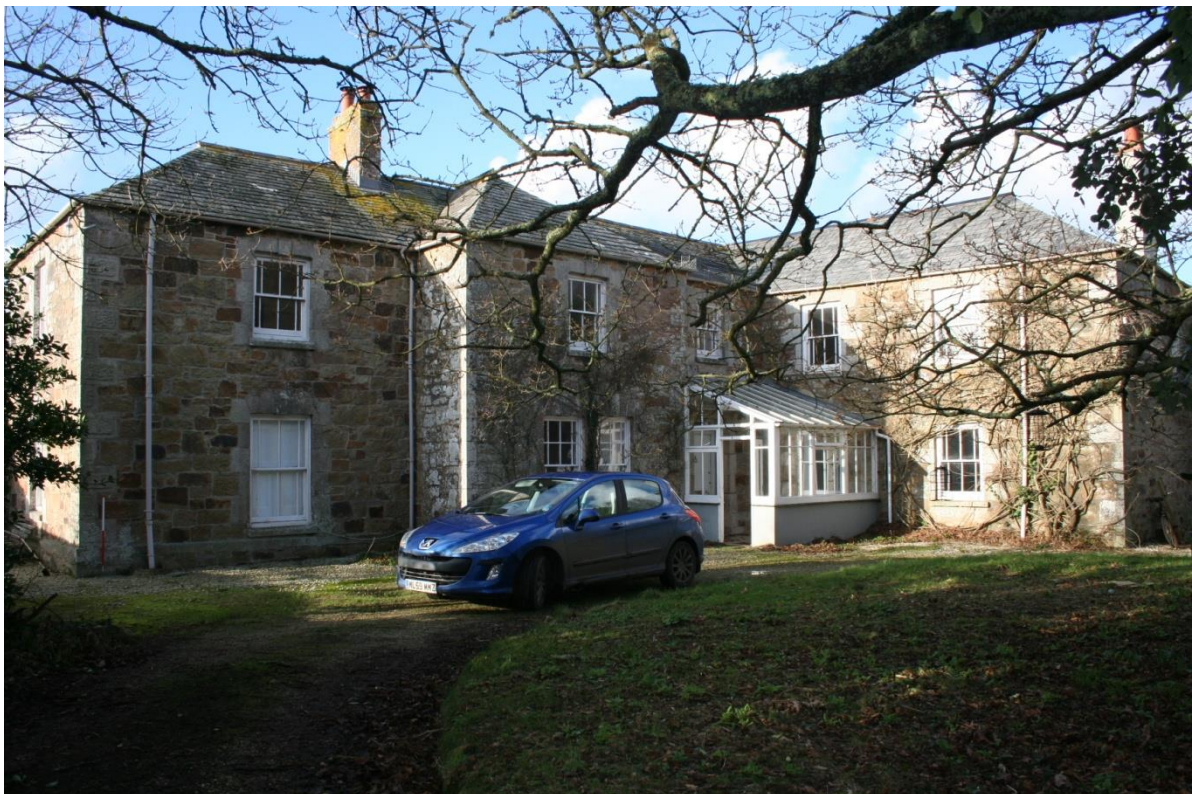
Cover illustration

Cubert Vicarage, view showing altered early 19th century vicarage (right) and new wing of the mid-19th century (left), from the carriage turning circle of the second phase in the garden on the south east.

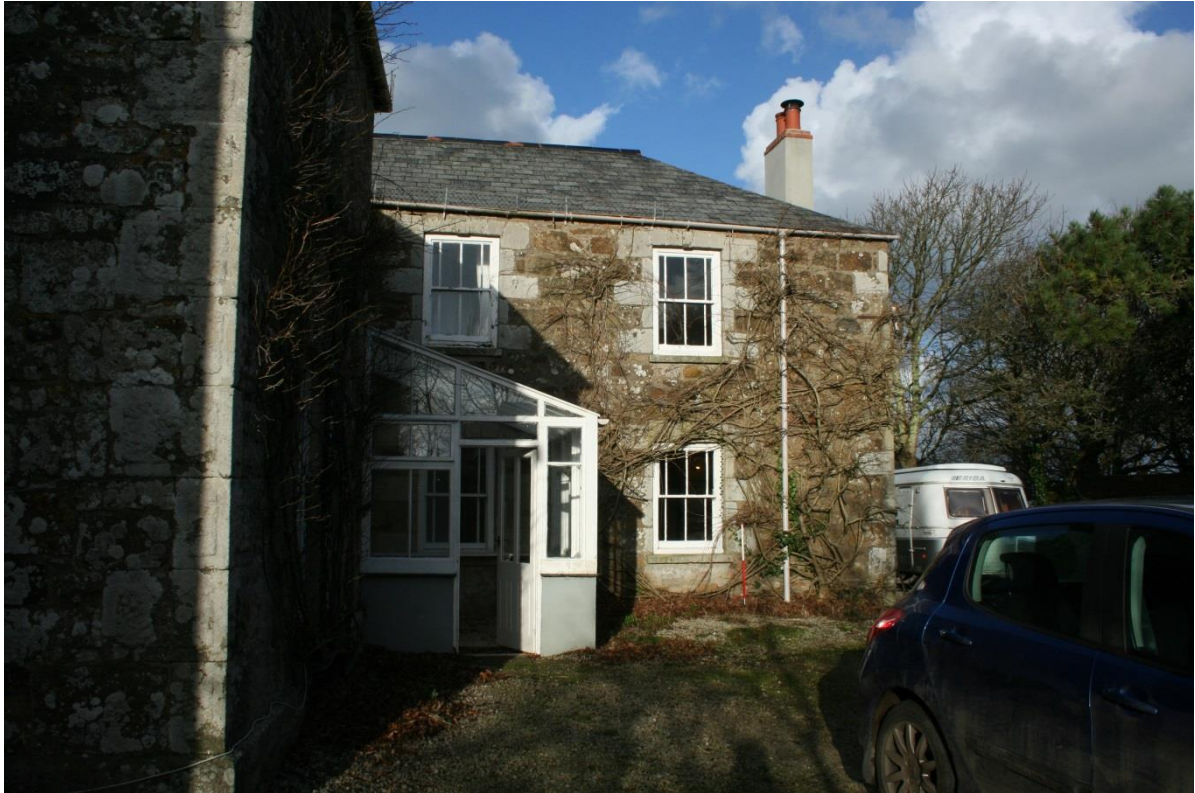
Fig 2 East half of the south front of the early house, with Victorian façade matching that of the south wing built against its west half (left), and 20C conservatory

The chamber is likely to have been lit by a window in the position of that serving the present corridor on the south (above the Conservatory in Fig 2). This window has a horned sash so was replaced or repaired in the later 19th century, and its window seat has been re-surfaced with tiles. The corridor, leading to the bedroom on its east, was taken out of the chamber in the mid-19th century.

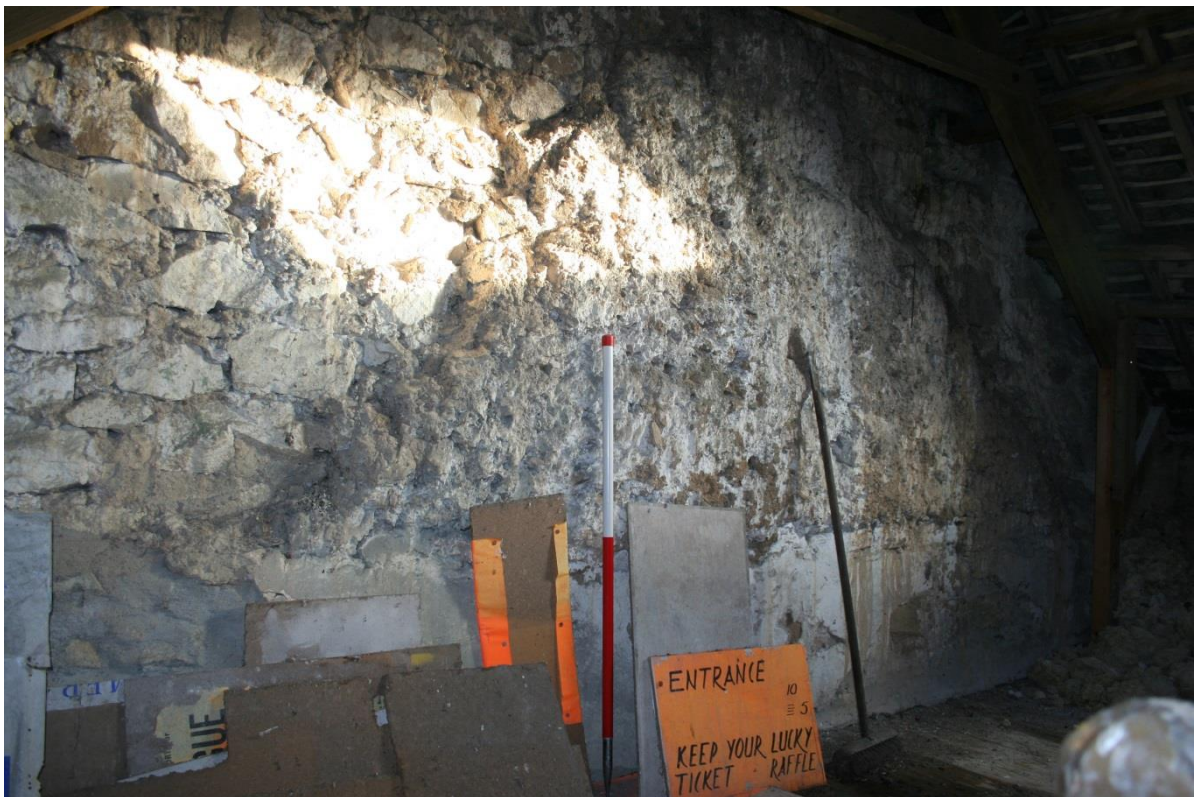
Fig 3 Upper exterior of the early Vicarage's west gable, seen from the adjoining store loft, showing cob-over-stone construction (centre), with later masonry heightening

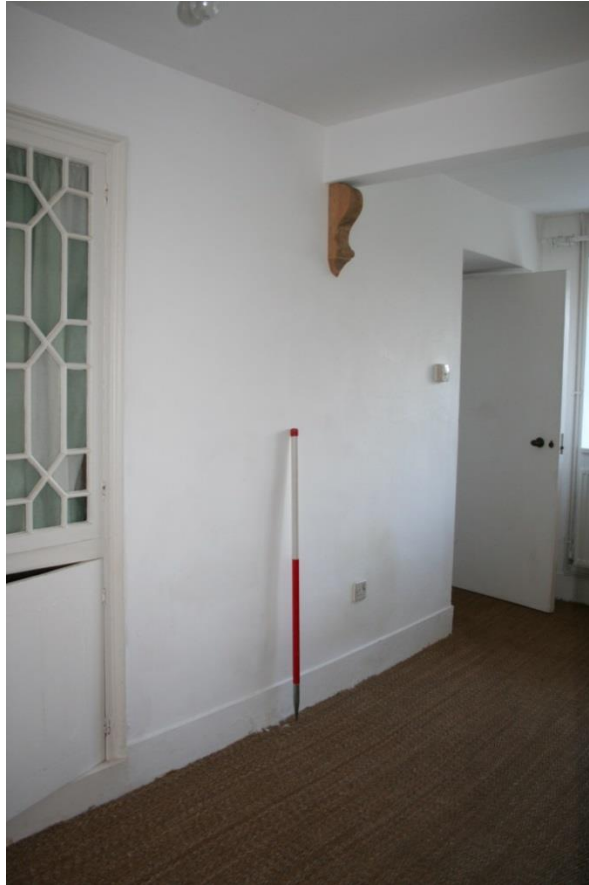
Fig 4 Probable site of a fireplace in the Parlour at the west end of the early house, between a cupboard with 19C glazing, and a modern, inserted doorway

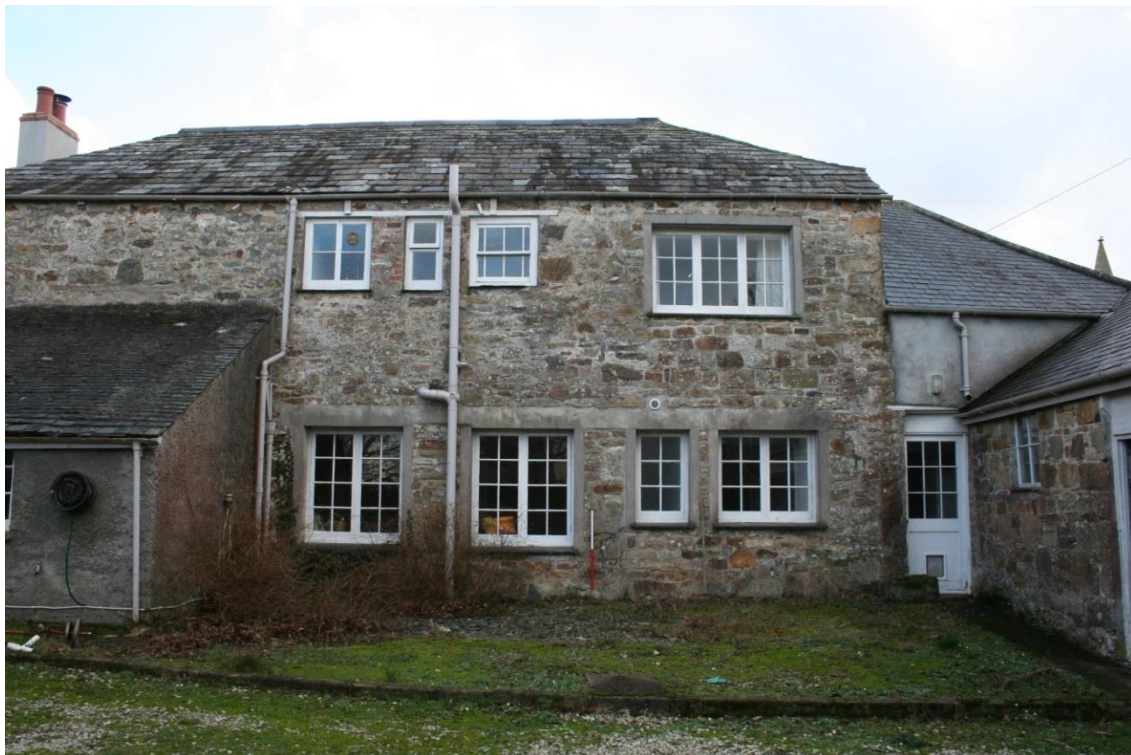
Fig 5 Rear of early range, dominated by modern openings around a Victorian window over the stairs, centre top (with kitchen lean-to, left, and Victorian stables, far right) Its western store, with secondary door later used to access a coal store, is to the right

Central chamber, now corridor with bathroom, WC and cupboard. The central bedroom probably originally had an L-shaped plan fitting around the staircase on its west. The likely site of the staircase (and its width, c1.08m) can be seen where it was covered with floorboards on decommissioning. A window now lighting a handbasin/washing area off the west chamber is likely to be in the position of the original stairway window. The character of the window there now, sash type with margin panes, indicates that it was replaced as part of works of the mid-19th century, when these stairs were retained for the use of the servants (Fig 5).

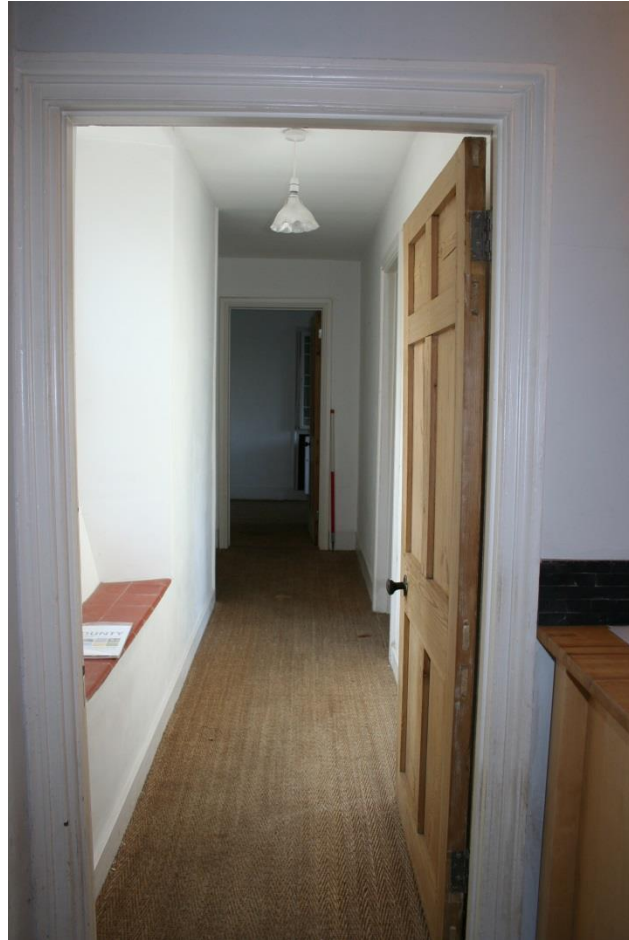
Fig 6 Service passage probably made c1850 inside south front of early house linking Kitchen (foreground) to south wing of that date (opening to left, opposite scale)

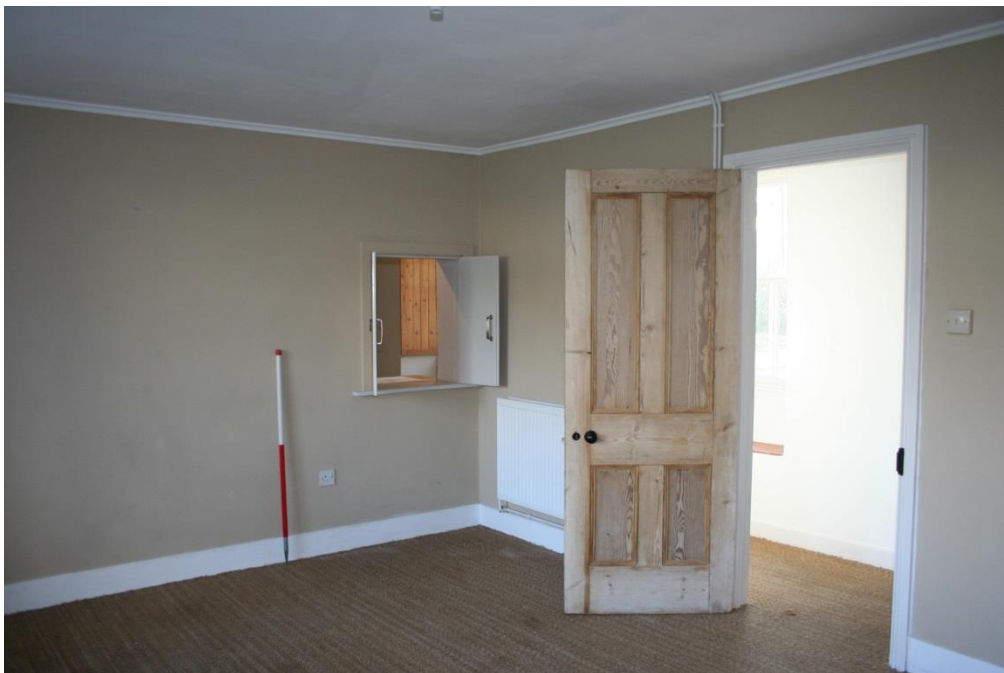
Fig 7 Probable service room of the mid-19C, later a dining room with hatch to Kitchen, made in the early Hall truncated by the service passage on its front, south side

The service room in the old Hall was made into a dining room, probably for the use of lodgers or paying guests, in the mid- to later 20th century (Fig 7). The large windows in the north wall, like those of the parlour, date from this period (Fig 5). A serving hatch from the kitchen in its south east corner may contemporary with them, or more recent, and the door from the corridor has been replaced.

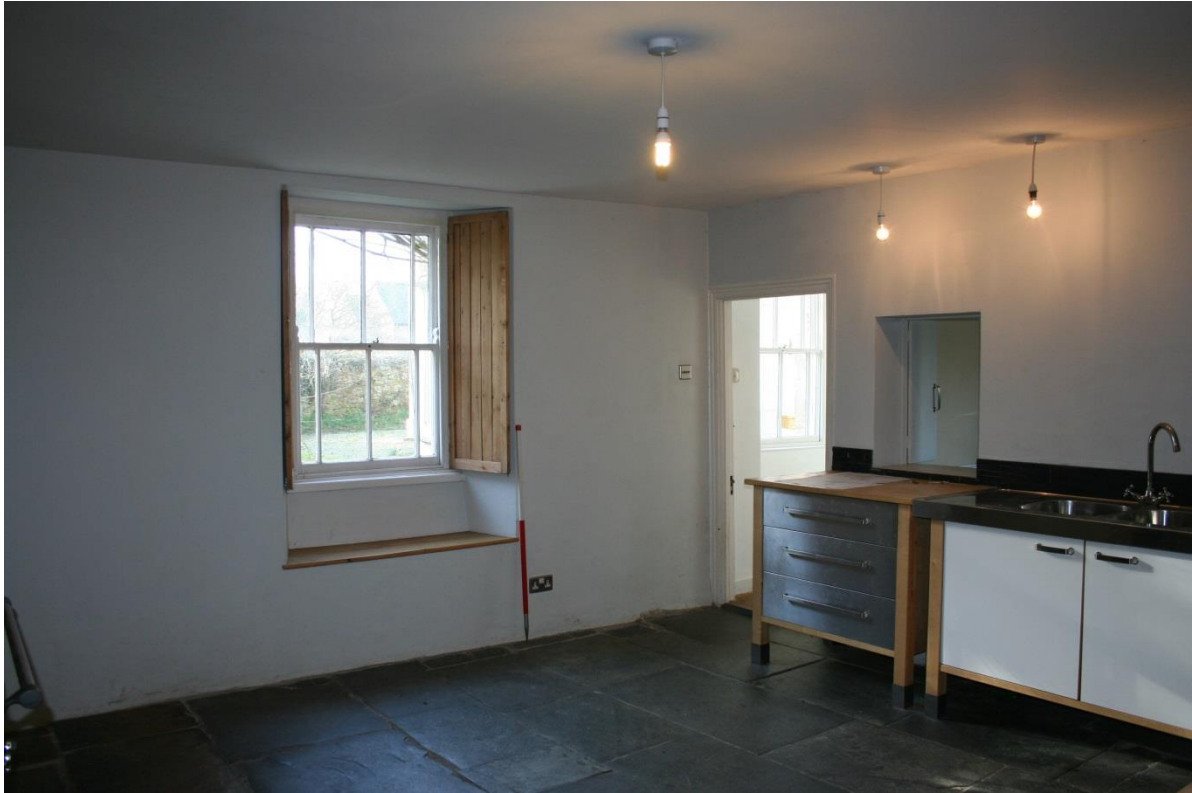
Fig 8 Early Kitchen, with service passage of c1850 beyond, showing south front with windows of c1850, slate floor probably of similar date, and 20C dining room hatch

Kitchen. The eastern room (Figs 8, 9) seems to have been a kitchen throughout the life of the Vicarage, being referred to as such in 1680. It was named the Great Parlour in 1727 but will have retained the primary, cooking role of the kitchen at that time, while other related functions may have been shifted to the lean-to on its north west, previously the flesh room (see below). The floor is slate of regular, 19th century character, with some replacement slabs. It was probably laid as part of the mid-19th century works, the floor having been 'mud', that is, clayey rab, in the 18th century.

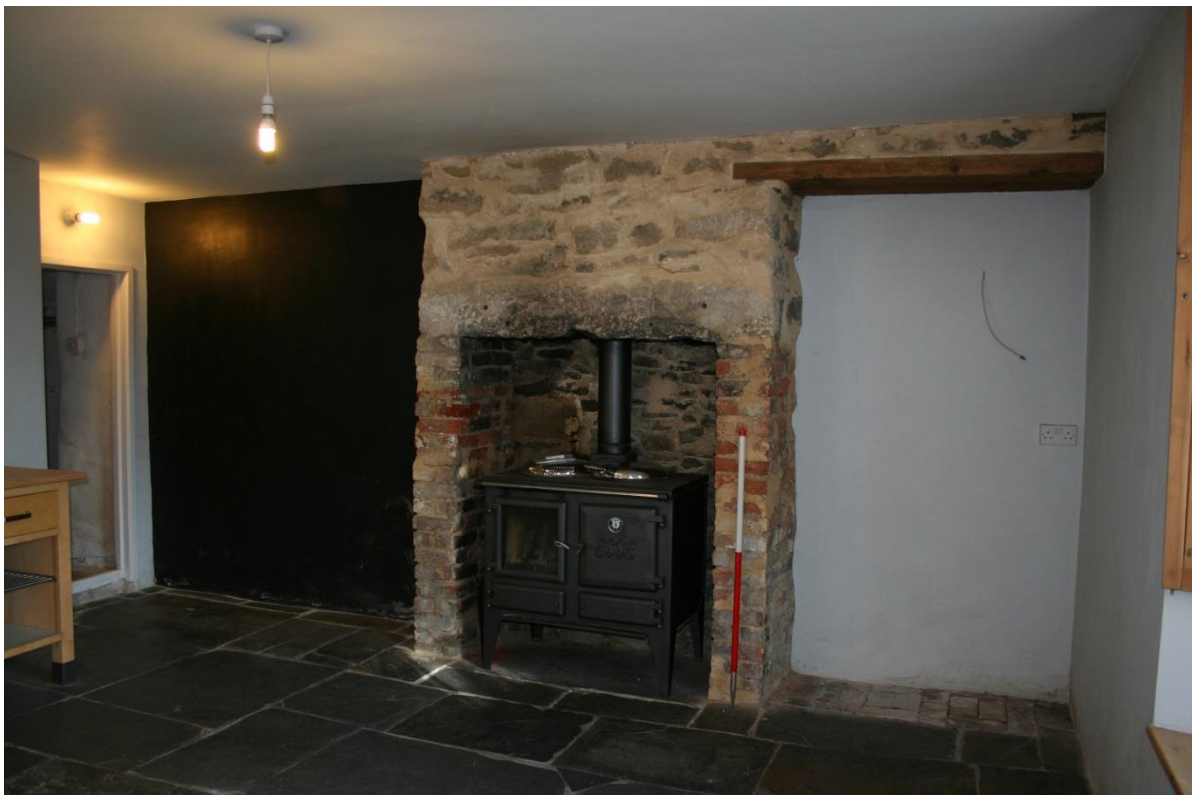
Fig 9 East end of Kitchen with doorway to dairy on north, and fireplace, rebuilt c1850, modified more recently by stripping of plaster and loss of wooden mantel shelf

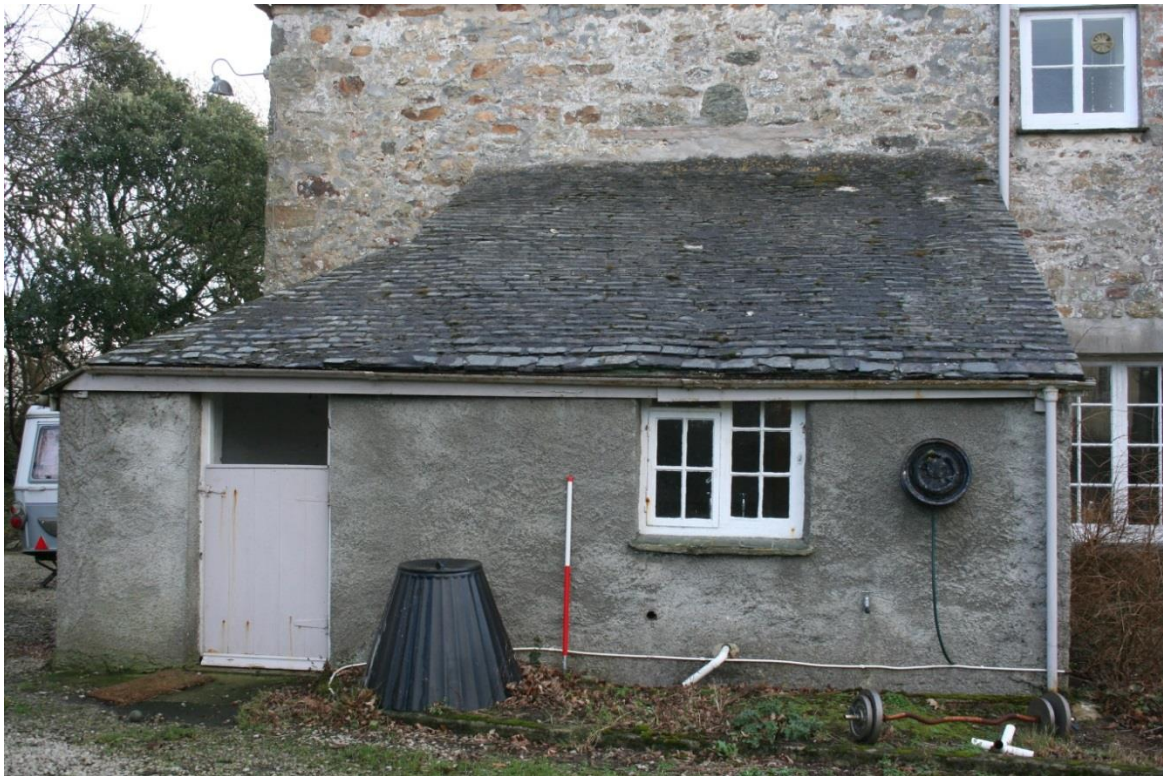
Fig 10 Kitchen lean-tos, north side, similar in length to the rear kitchen noted 1727. A mark in the wall above may be the roofline of the 17C flesh house, smaller but taller

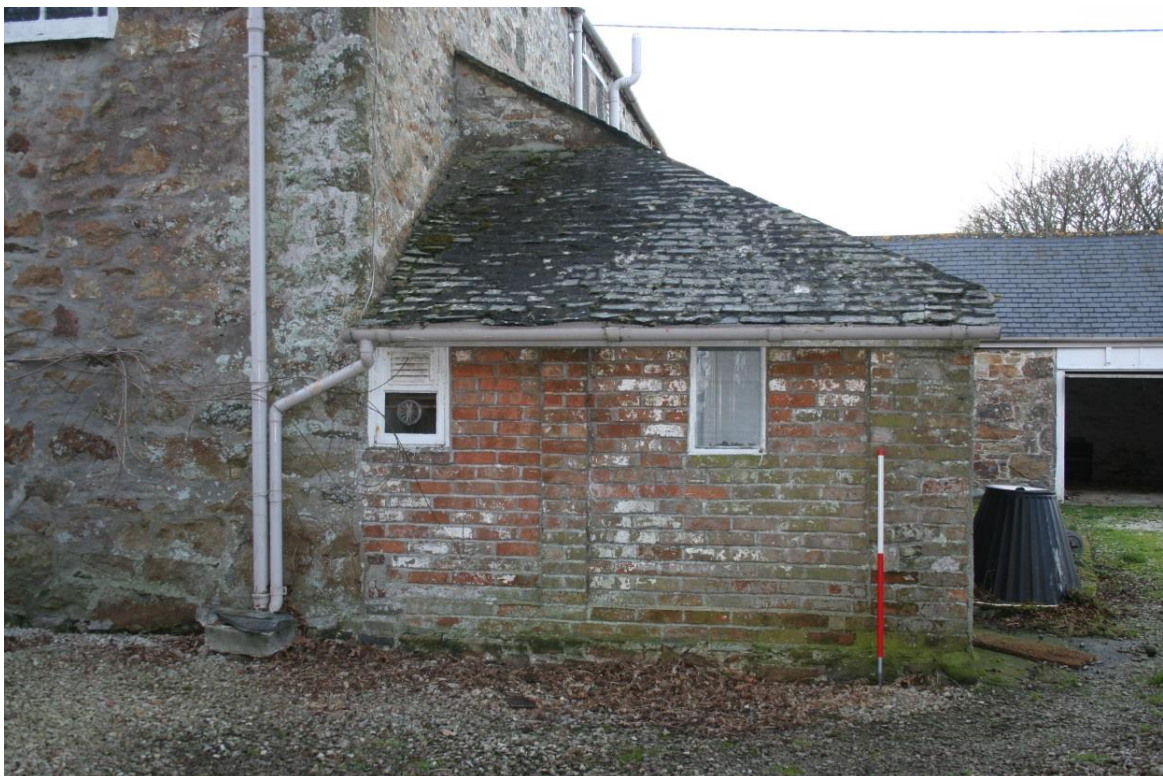
Fig 11 Lean-tos, east side, showing rebuilding in brick probably c1850 from the early Dairy (left of centre) and from the 'flesh house' previously extended around this
A 19C window in the eastern bedchamber, probably replacing an early one, can be seen, top left. The Vicar's study, noted in 17C and 18C terriers as over the dairy, may have been so in the sense that it was in the corner of the chamber lit by the window

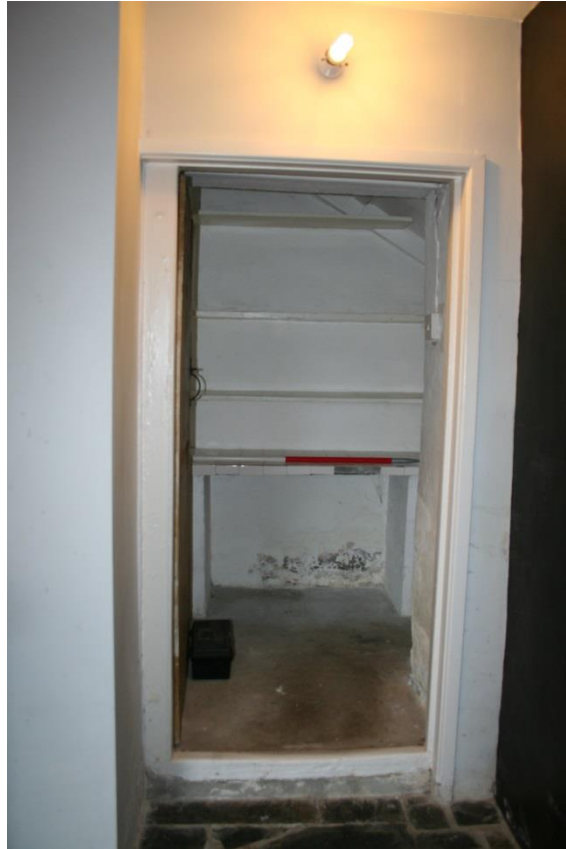
Fig 12 Interior of early Dairy on the north east of the Kitchen, with door and flooring probably of the Victorian phase, and shelving arrangements altered more recently

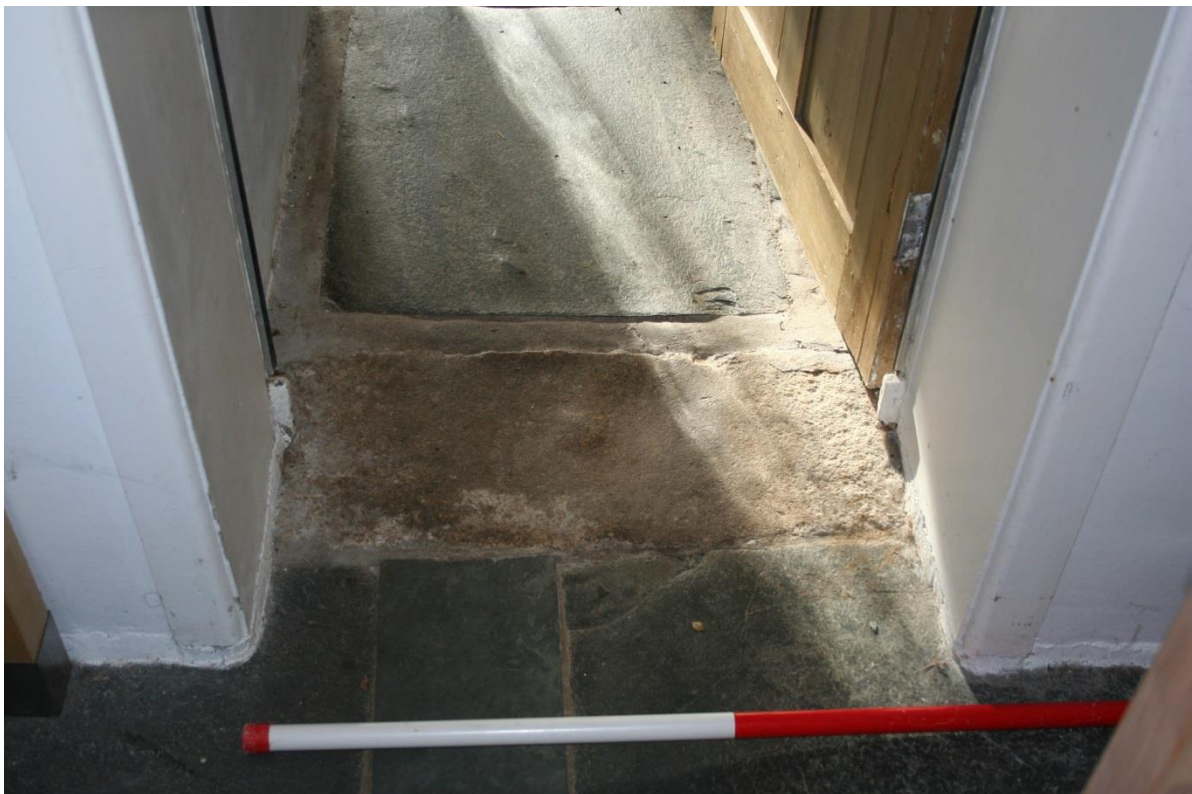
Fig 13 Threshold to Kitchen from the scullery (the [back] 'kitchen' of 1727 and 'flesh house' of 1680), showing granite slab worn in the centre with shoe sized hollows

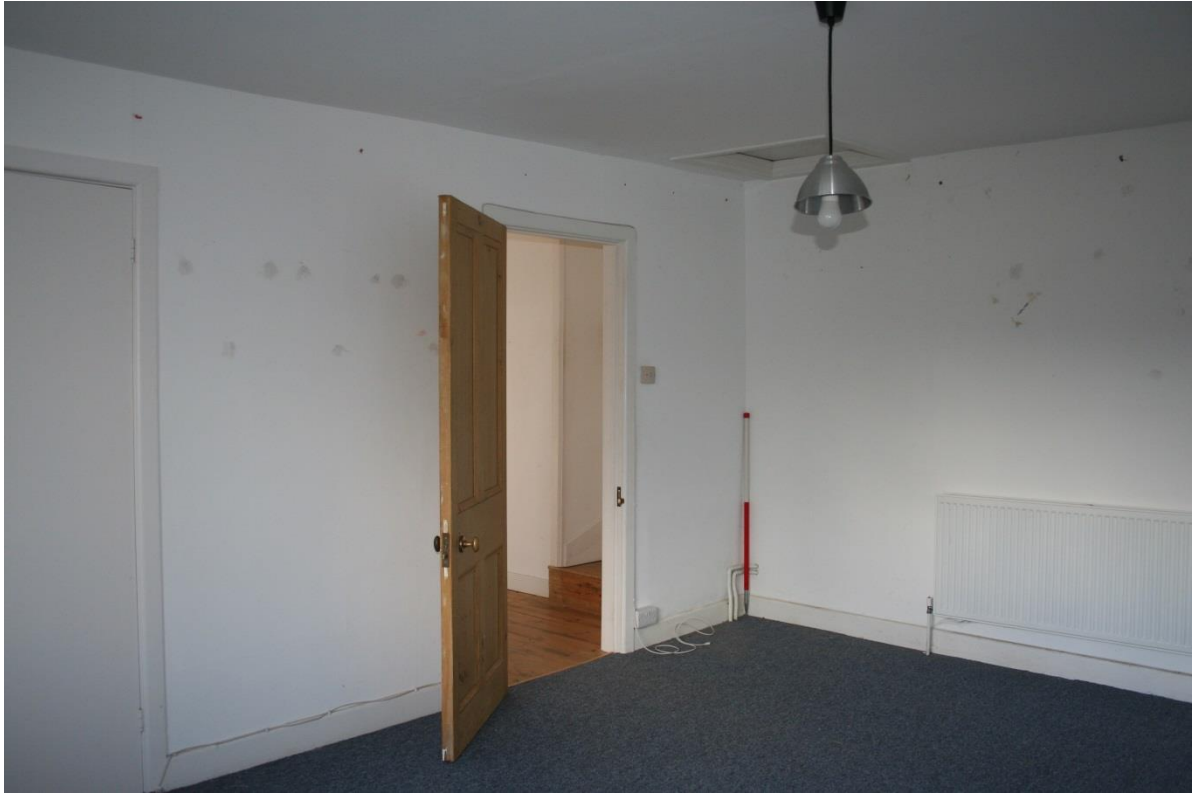
Fig 14 West chamber, with lined, thick south side likely to incorporate cob fabric of the early house front (right); the steps beyond mark the 19C link to the south wing

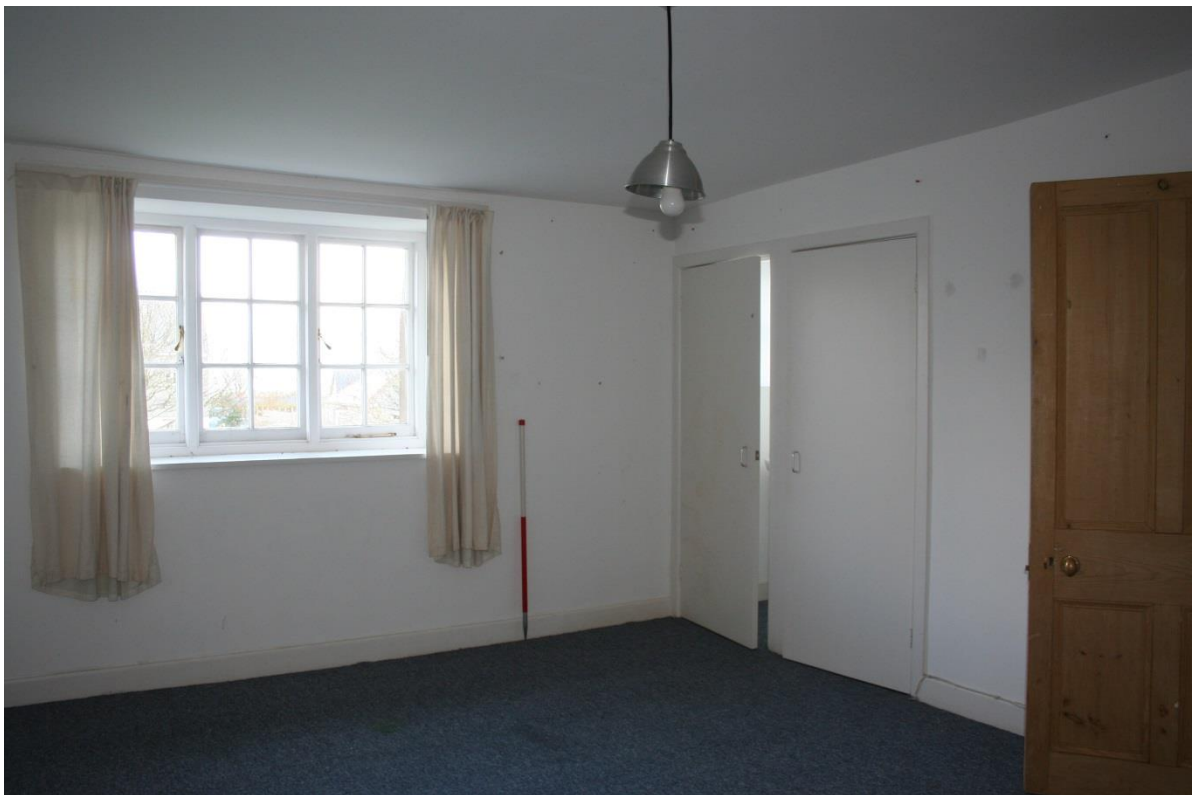
Fig 15 Early west chamber, with 20C north window, and 20C closets on the site of the original stairs to the first floor, retained as service stairs in the 19C

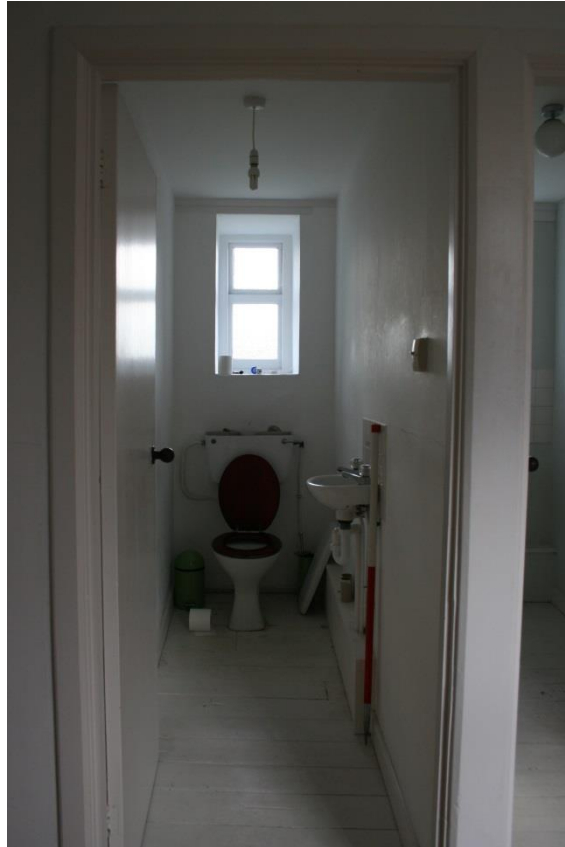
Fig 16 Site of the middle bedchamber of the early house, with south corridor of c1850, and 20C WC and bathroom off this made from a servants' bedroom of c1850

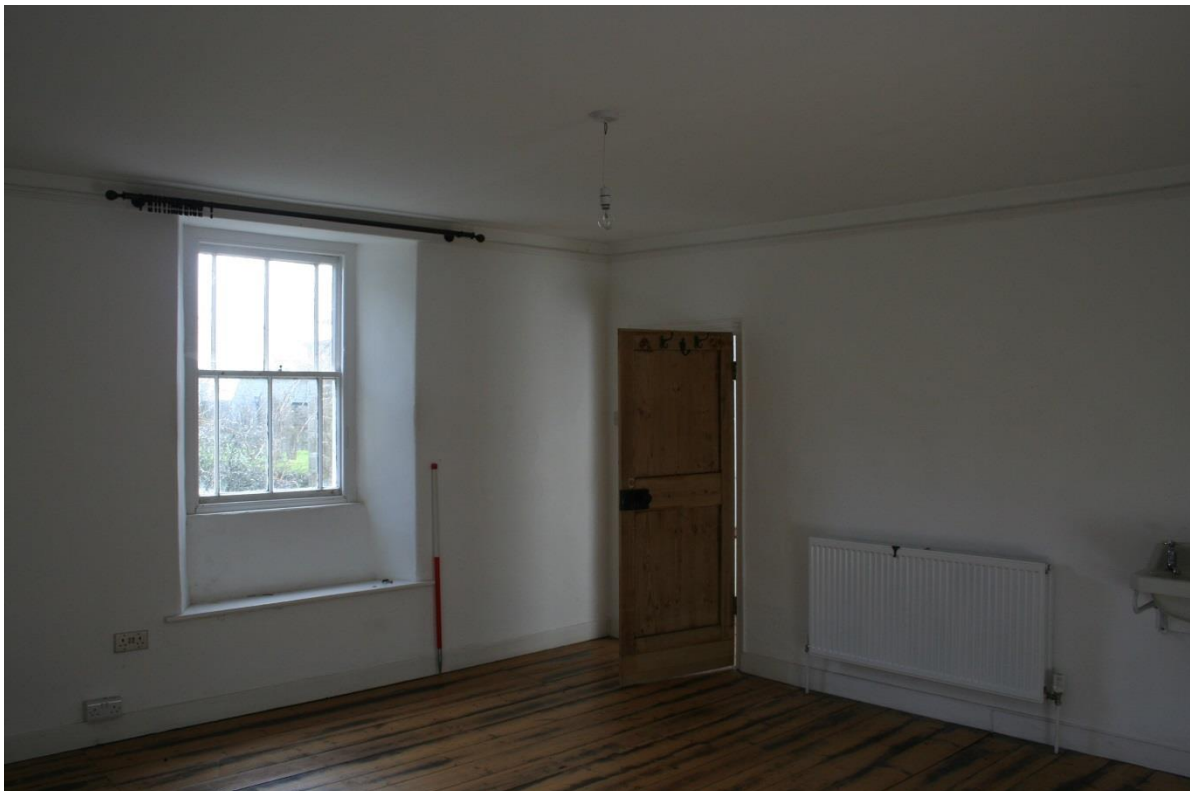
Fig 17 Larger, eastern early bedchamber, probably the Vicar's, showing the south wall rebuilt c1850 with window matching those of the south wing, and mid 20C basin

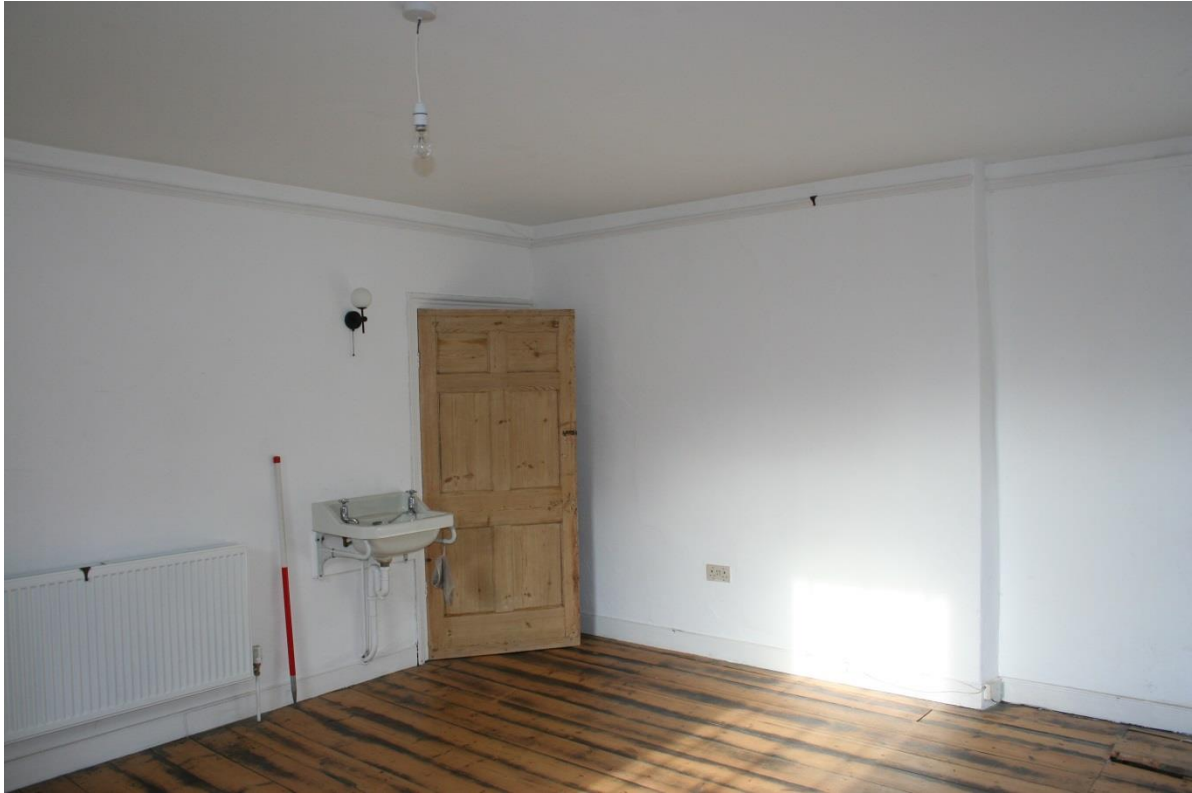
Fig 18 East chamber, with west edge of an alcove in the north wall, likely to mark the site of a study in the corner with a partition at this edge and a window on the east

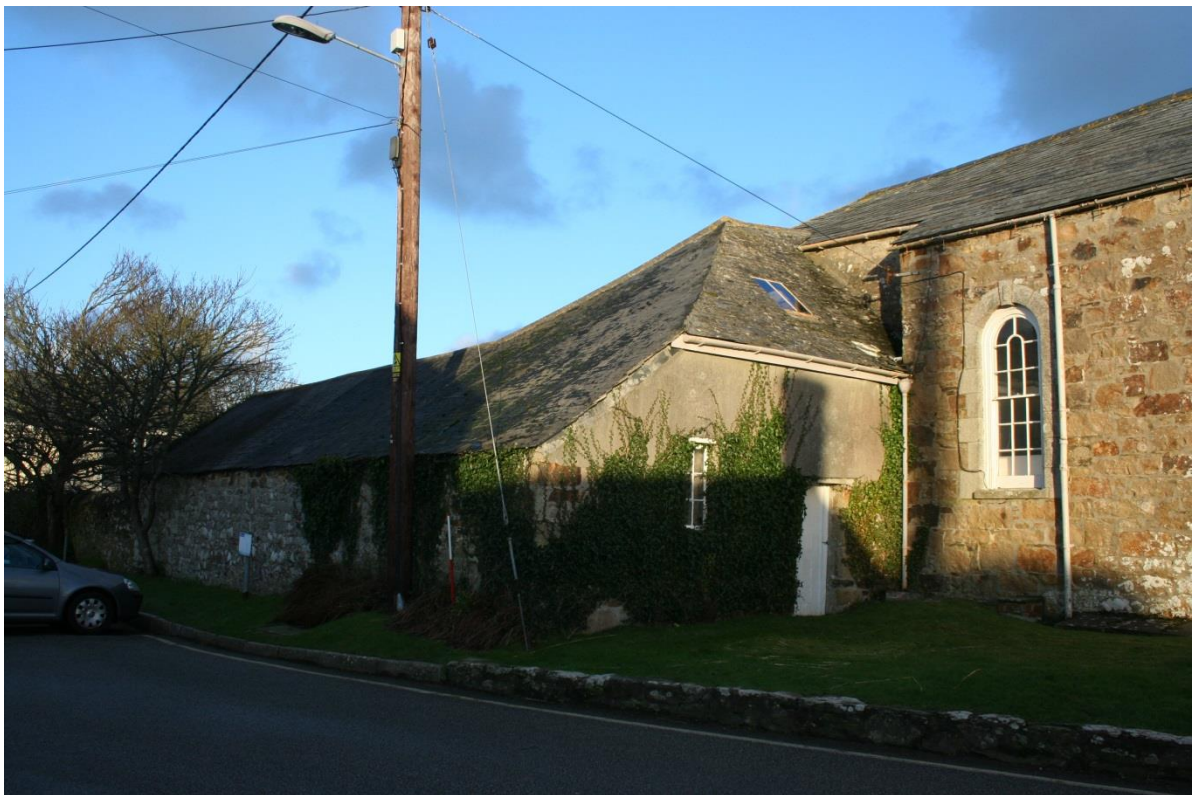
Fig 19 Lean-to store with loft under a hipped scantle slate roof on the west of the early house (centre), flanked by the mid-19C south wing (right) and stable range (left)

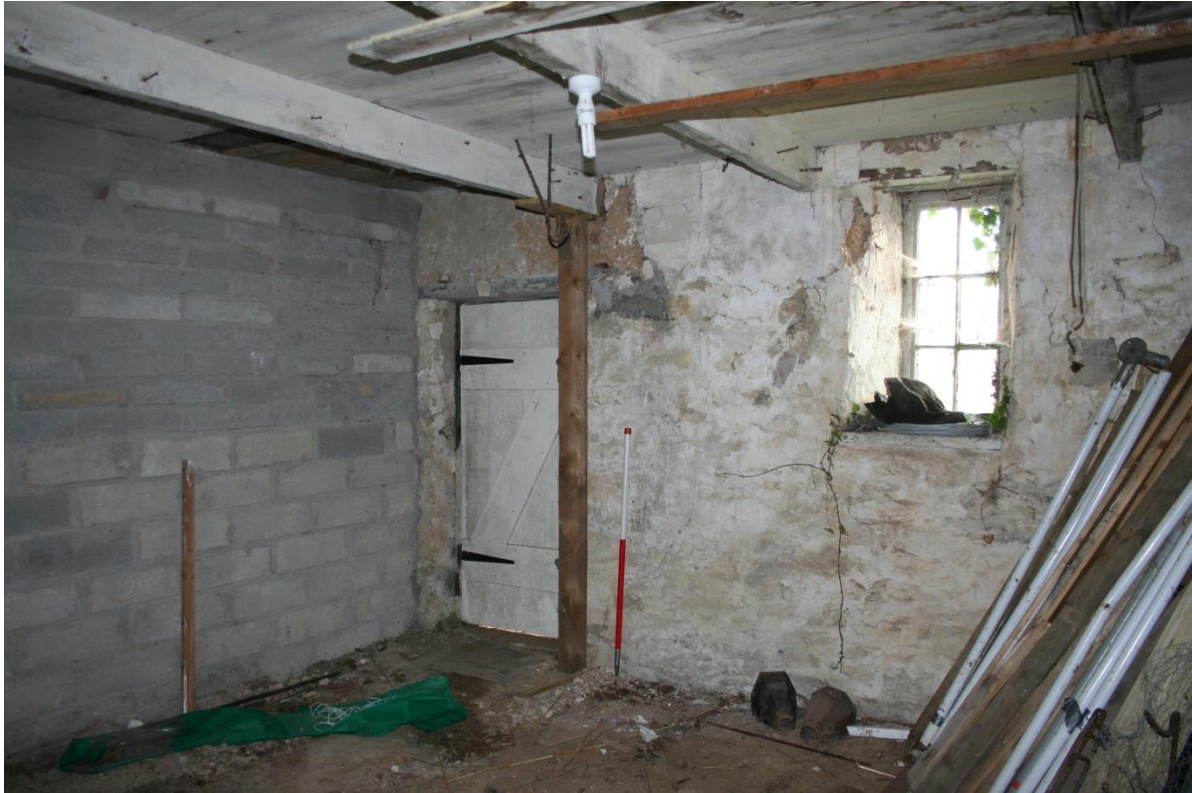
Fig 20 Western Store, showing cob fabric above door level, and rab floor as noted in the house in 1727 (under derelict later boards), and 20C wall to coal store (left)

The openings have modest proportions and a plain style with timber lintels (Figs 20, 42, 47). There are opposing doorways in its north and south walls, now beside the concrete east wall, originally east of centre. The doorway on the south has a worn granite threshold slab and a replacement door of simple design. The south wall also has a window west of the doorway, with internal splay, expanding from 44cm to 68cm in width, and six pane window, possibly 19th century with more recent glass.

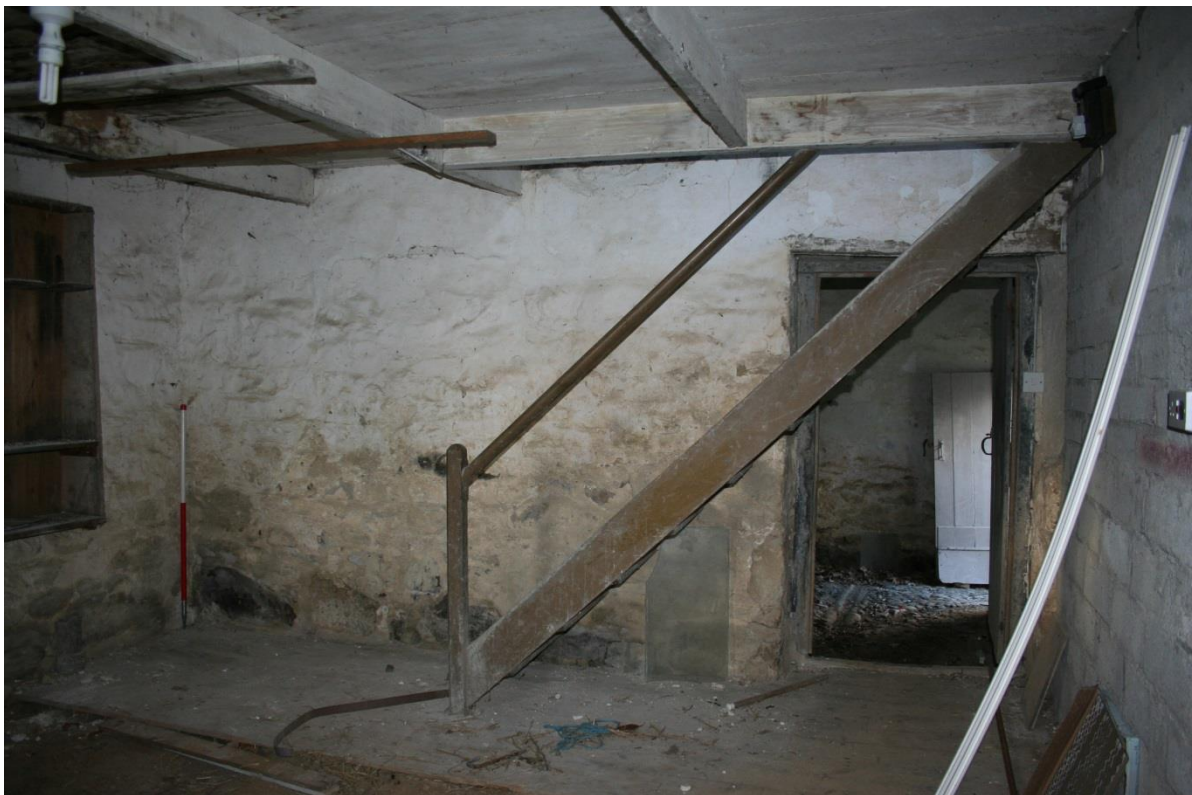
Fig 21 Western store with north door, used c1850 to link it to the new stable wing, beyond, behind secondary stair to loft; note also rack fixed to the west wall (left)

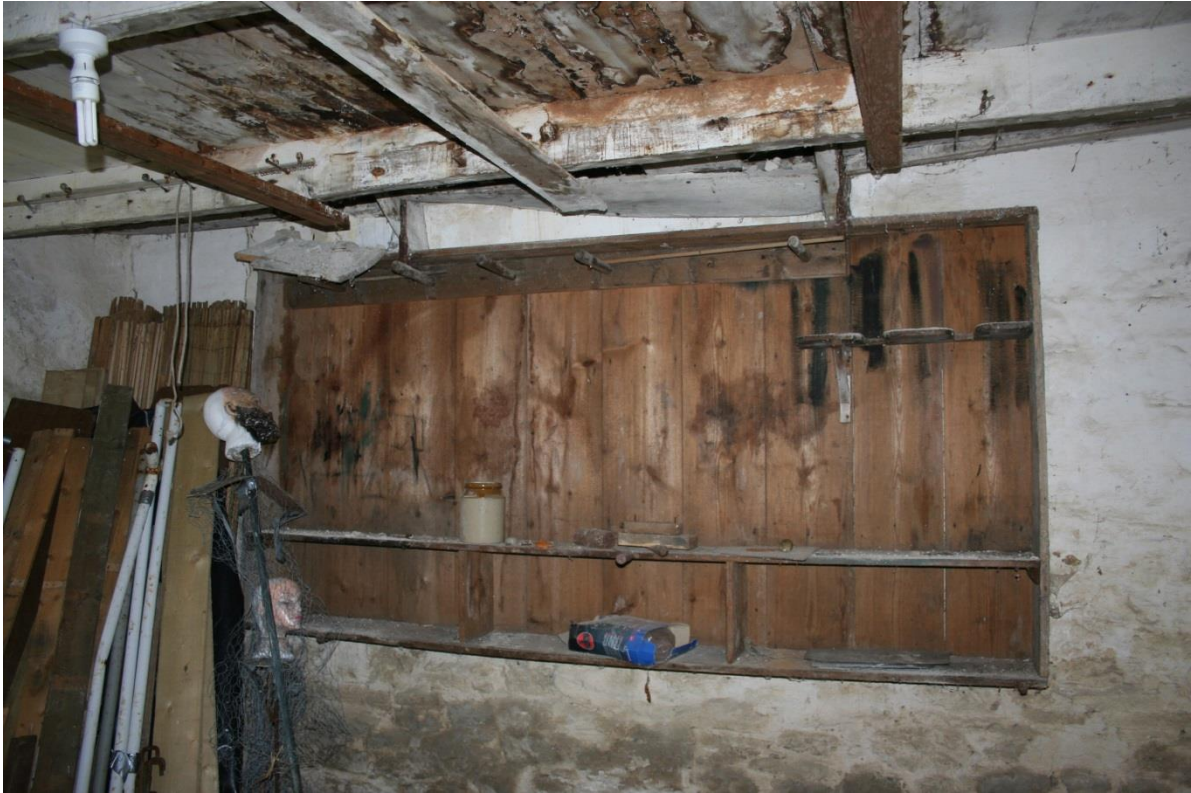
Fig 22 Rack on the west wall of the western store with pegs and shelves, possibly for equipment used in the stable and carriage house range built on to the north c1850

The north part of the west wall has a wide rack, 2.72m across, fastened 68cm off the floor (Fig 22). This has a back of planks c11 inches wide, and sides presumably designed to prevent damage to the contents in the potentially busy working space. It may have been provided, in or after the mid-19th century phase of improvements, for tack or other stable equipment. Extending across four fifths of the top of this fixture, within its frame, is a board with 6 long (26cm) round section wooden pegs, and also, to the right (north) side and at a lower level, a bracket 68cm long projecting 19cm with two rounded slots 6cm wide and 13cm deep. Above the bottom of the frame which forms a shelf is another shelf; this is 91cm below the row of pegs which may therefore have accommodated long pieces of tack such as looped-up reins or traces.

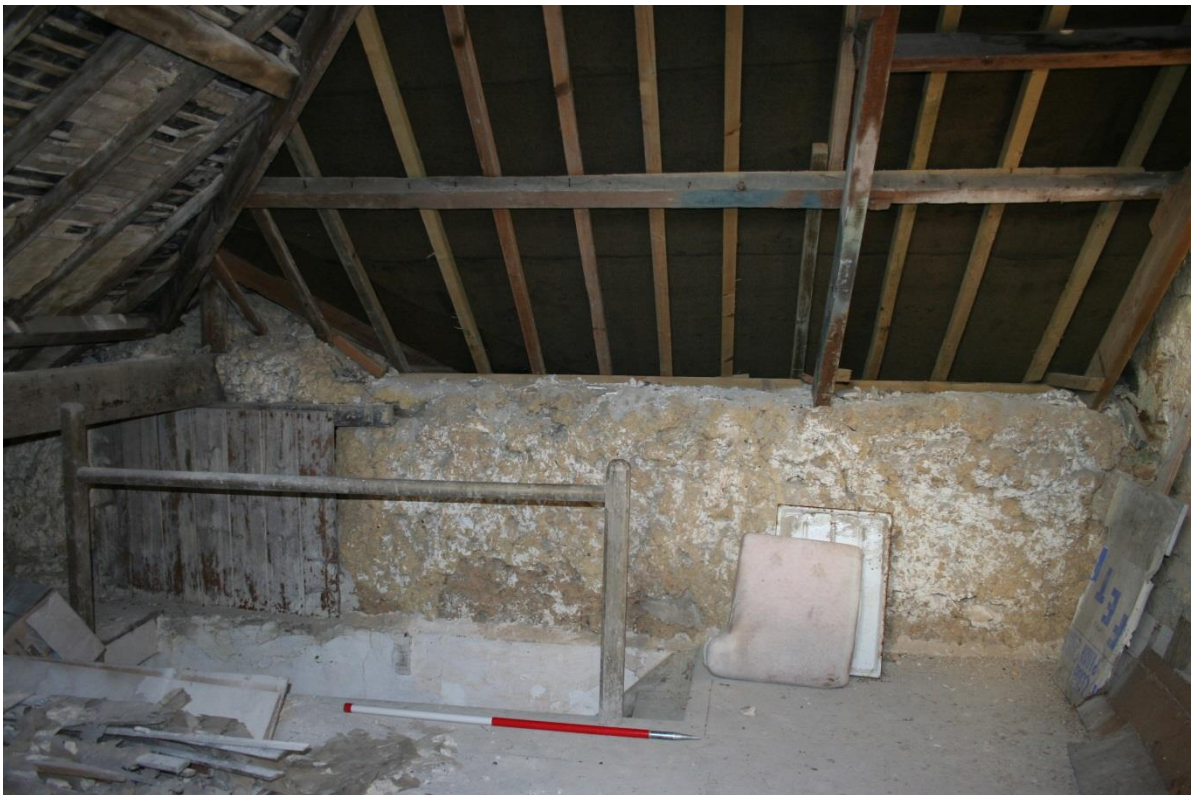
Fig 23 North side of loft in the western store, with limewashed cob walls, window (boarded up), secondary staircase, and church fete signboards of the later 20C

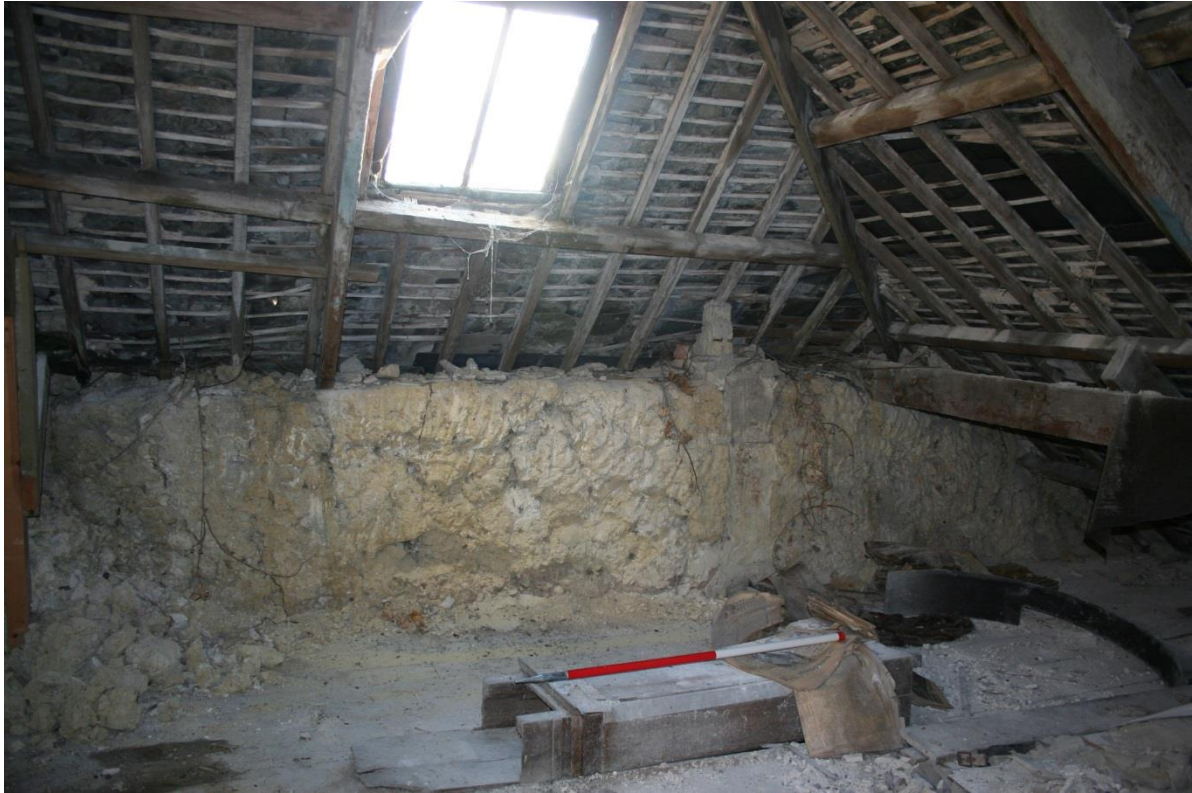
Fig 24 South side of loft in the western store, showing torched scantle slate hipped roof, broad floorboards, and abandoned clock case (with a newspaper of 1976!)
