Cubert Vicarage, Cornwall Historic building record

Cubert Vicarage, Cornwall

Historic building record

Client	Ms L Northridge
Report Number	2015R010
Date	February 2015
Status	Final Draft for consultation
Report author(s)	Catherine Parkes BA MCIfA
Checked by	Nigel Thomas BA MCIfA
Approved by	J Nowakowski

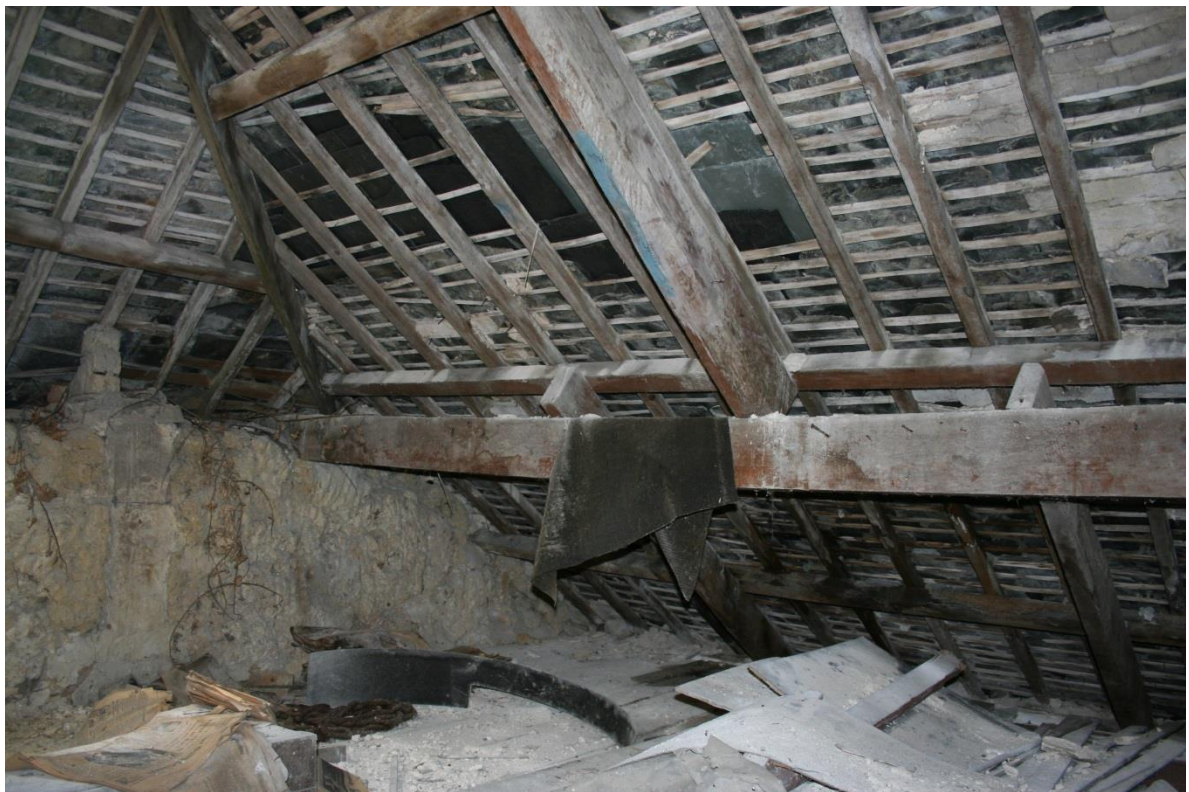
Fig 25 Detail of the roof over the south west corner of the loft of the western store, showing many laths missing or displaced, and potential for unstable timbers

It should be noted that it has not been possible to inspect the roof structure in the loft closely, because both it and the loft floor appear potentially unstable in places.

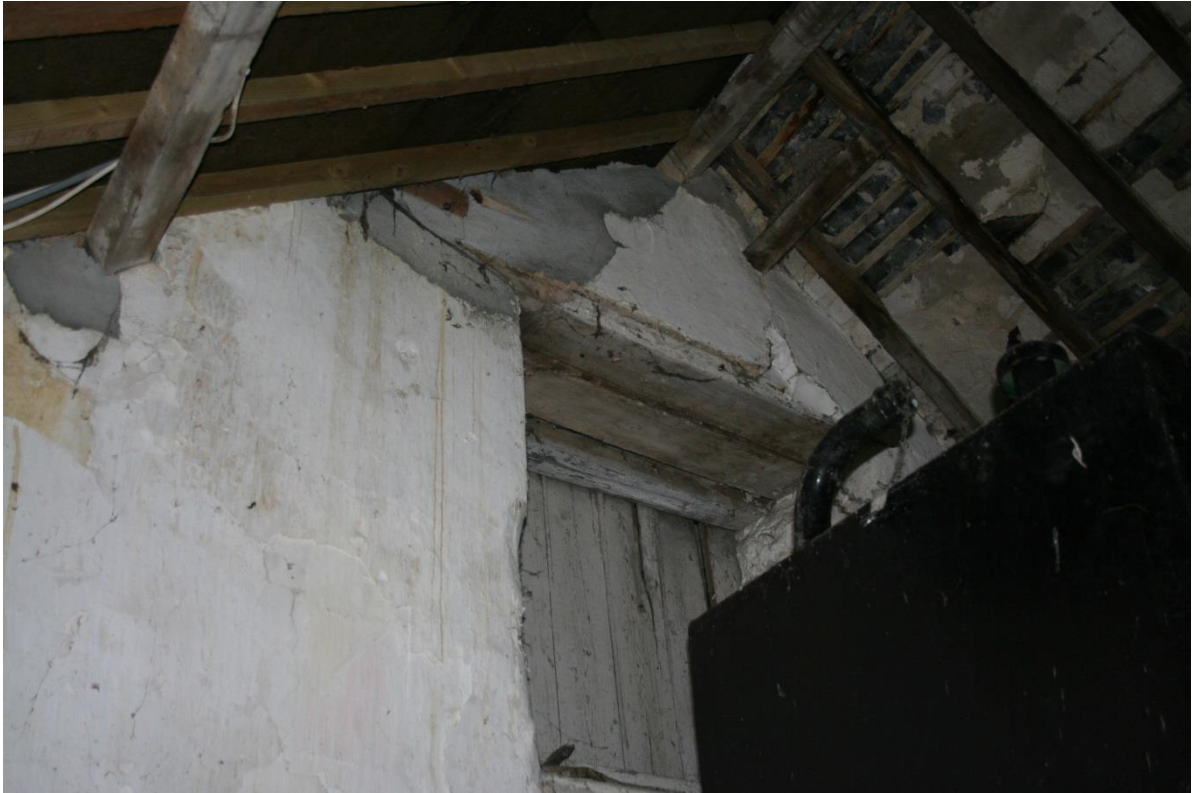
Fig 26 North window of loft over western store, originally opening to the rear court, seen from the stable built against the store c1850 with later oil tank in it (right)

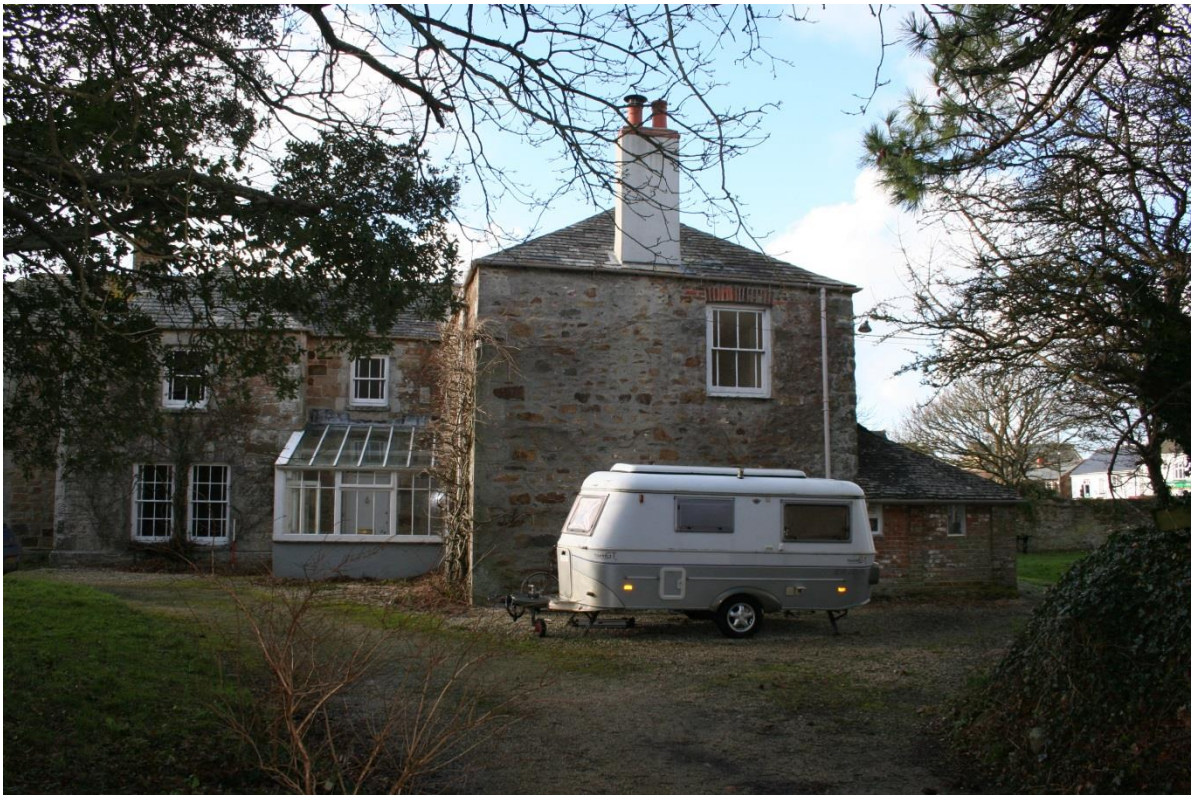
Fig 27 East side, showing how c1850 only some of the style used for the new front, left, and applied to the earlier south front (centre, facing left), was extended to the rear

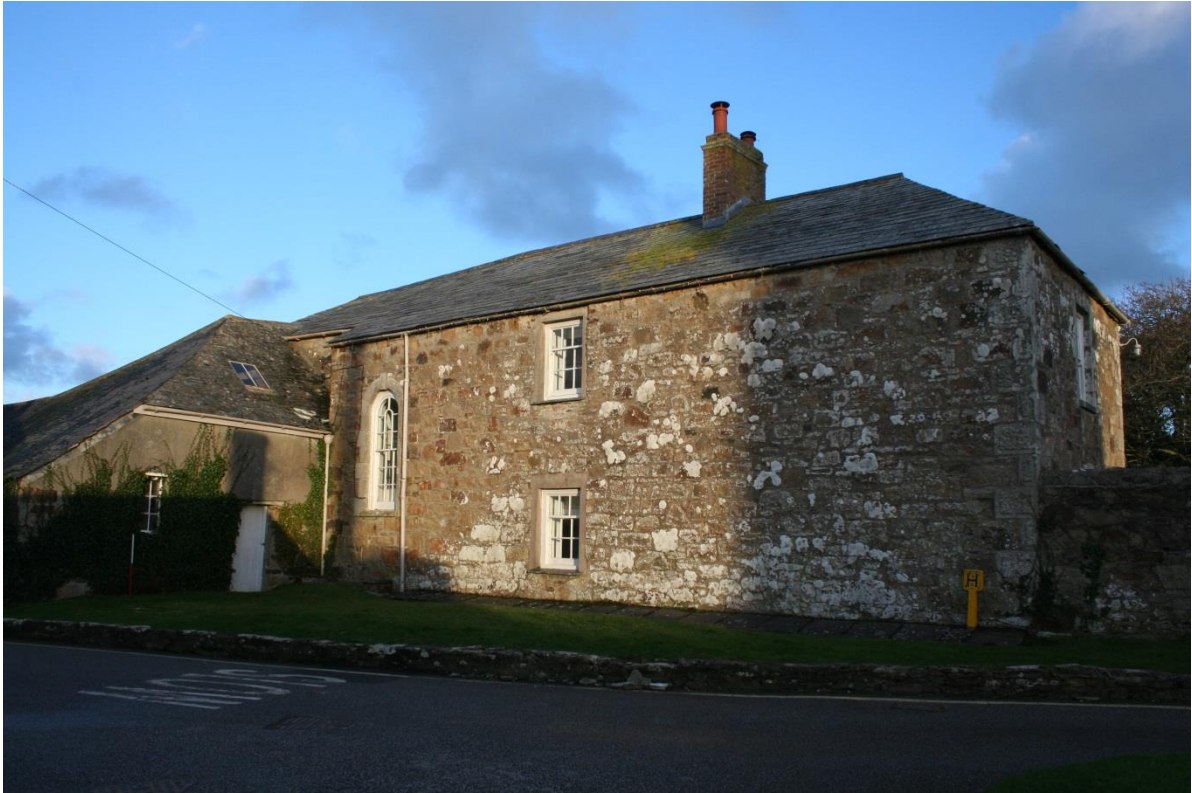
Fig 28 Plainer side of the Victorian wing, facing the churchtown on the west. The Vicar's bedroom was probably that to the south with a window facing the church (right)

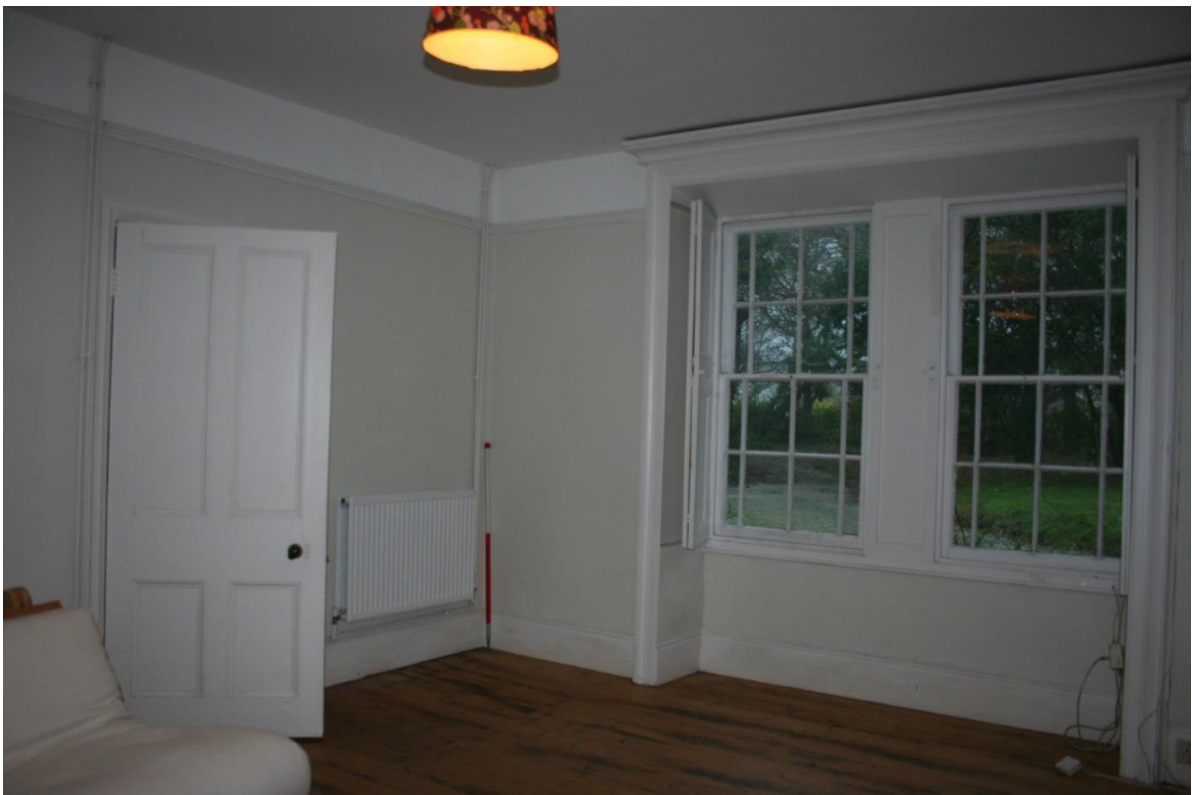
Fig 29 Principal reception room in the south wing of c1850 with particularly large windows facing the grounds on the east laid out with a carriage drive at that time

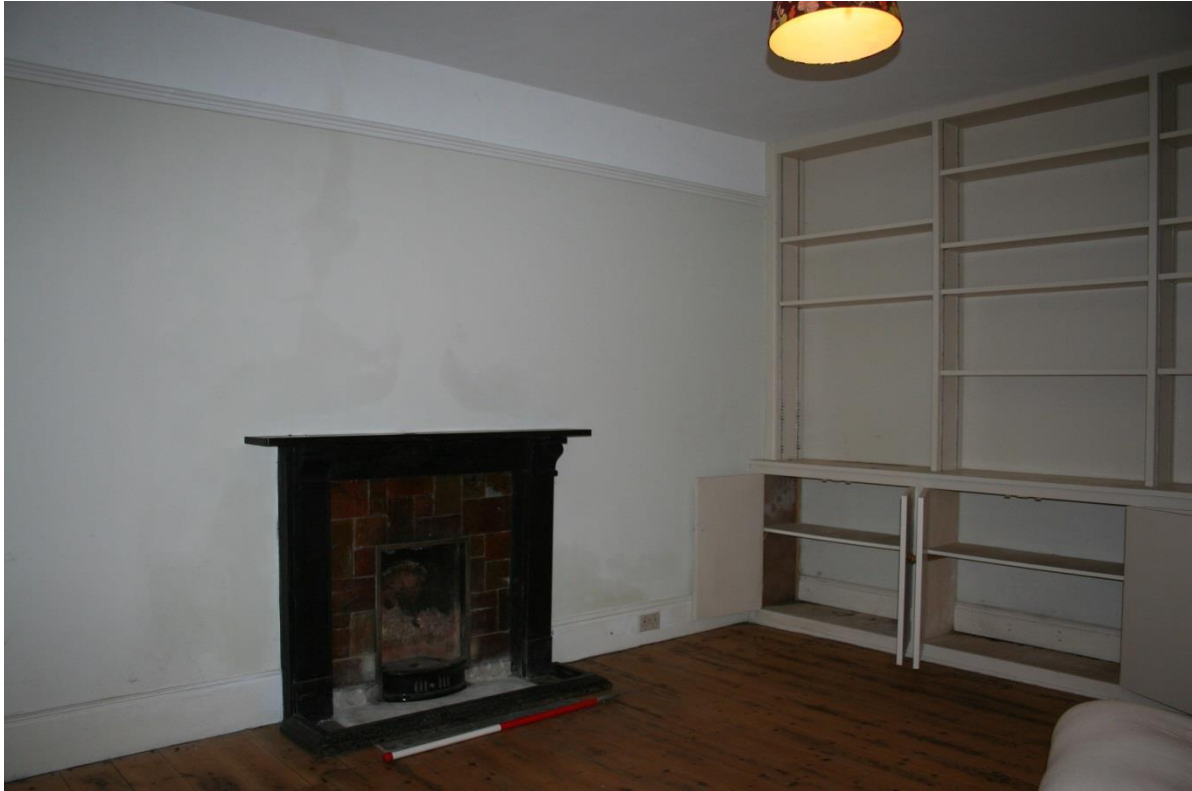
Fig 30 Fireplace, part altered, on the south in the main reception room of c1850. A second doorway probably lies behind the shelving on the west (out of shot)

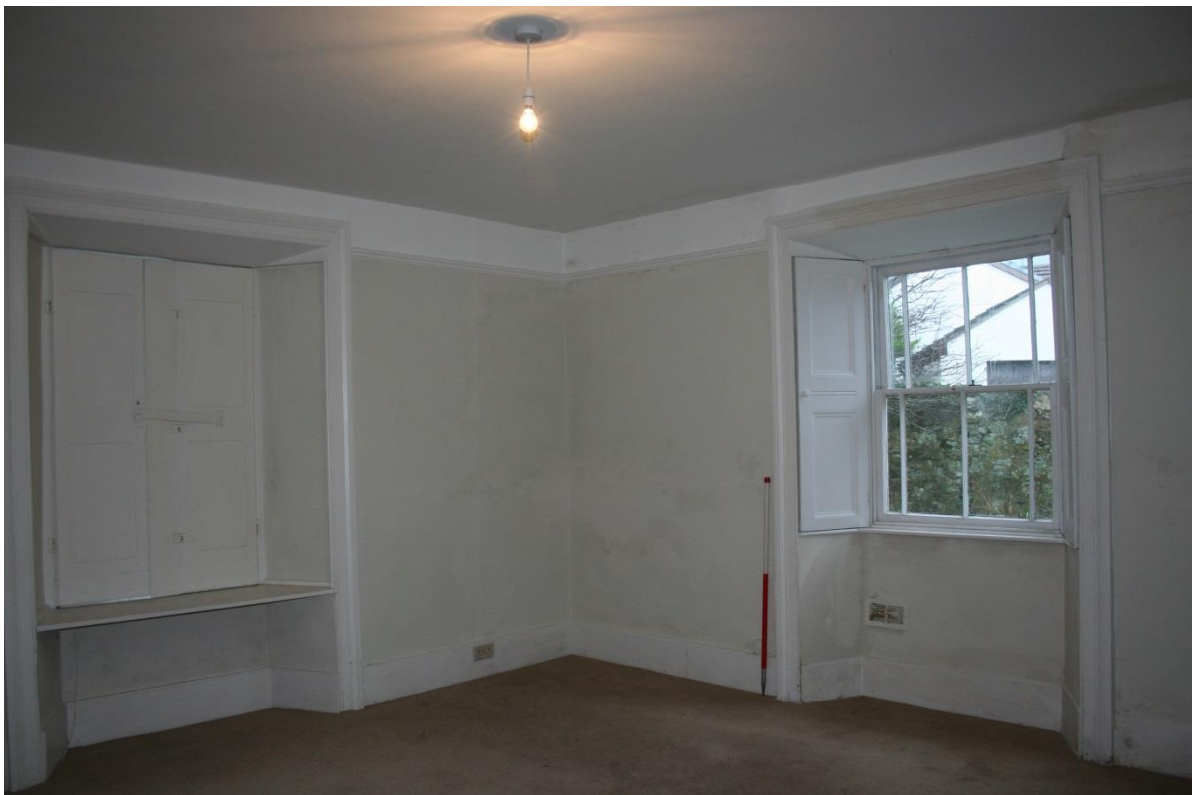
Fig 31 Drawing room at the south end of the Victorian wing, with windows facing the Vicarage grounds on the east (left) and the boundary of its glebe farmland (right)

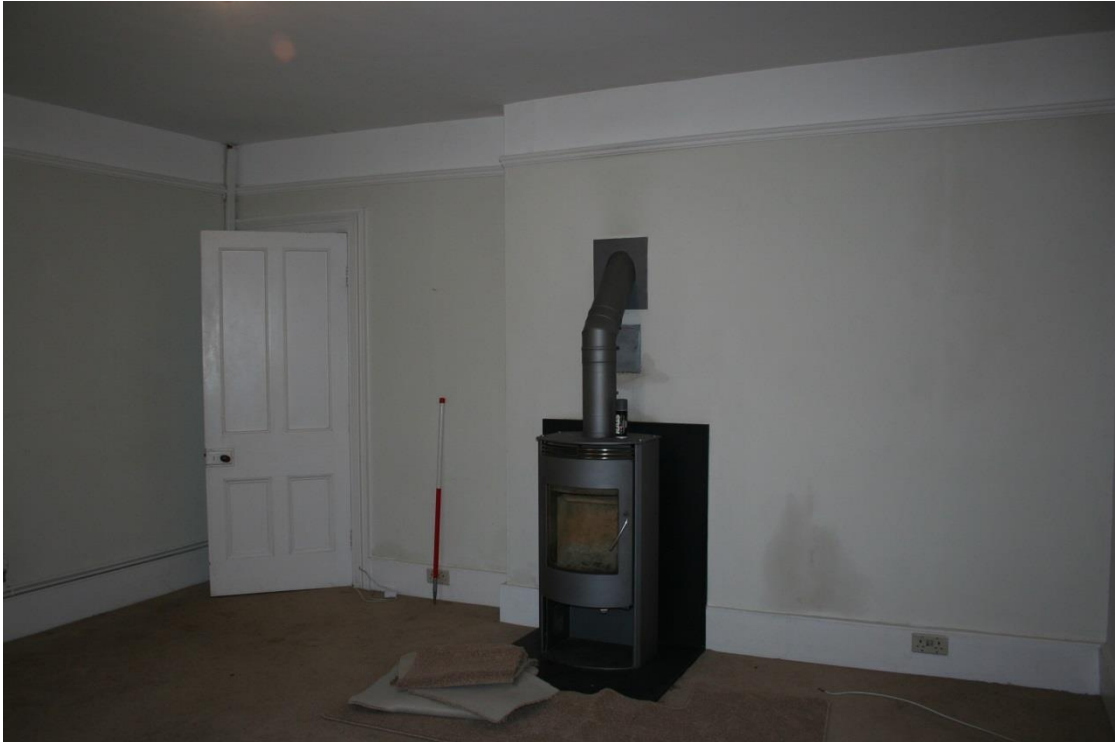
Fig 32 North wall of drawing room of c1850, with doorway giving access from the passage down the rear, west side of the south wing, and stove by a blocked fireplace

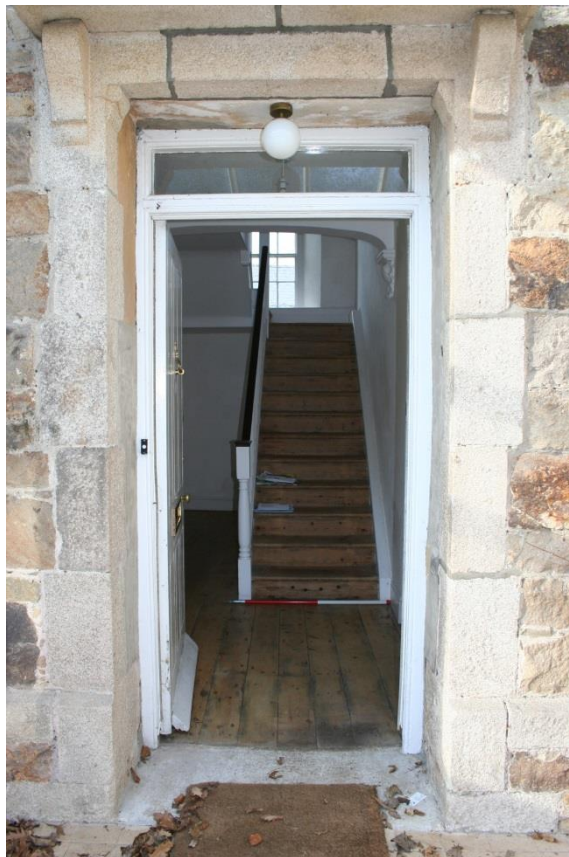
Fig 33 Doorway to the entrance hall and stairs of the Victorian south wing, with distinctive granite surround and good survival of original wood- and plasterwork

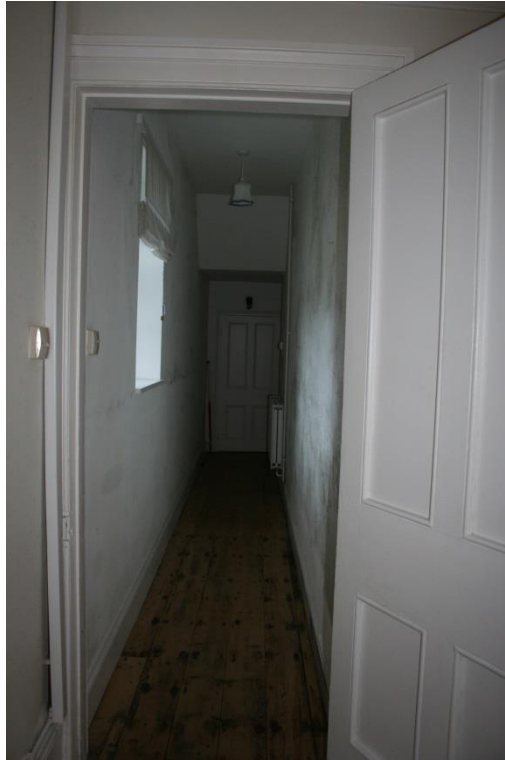
Fig 34 Drawing room passage, squeezed by the dining room (right), so showing how provision of rather grand reception space was prioritised in the new wing of c1850

A blocked opening on the east (right) of the passage by the far end of the part shown here probably marks a doorway which would have allowed the family and guests to cut out some of this rather dark and unattractive route, including the turn by the stairs

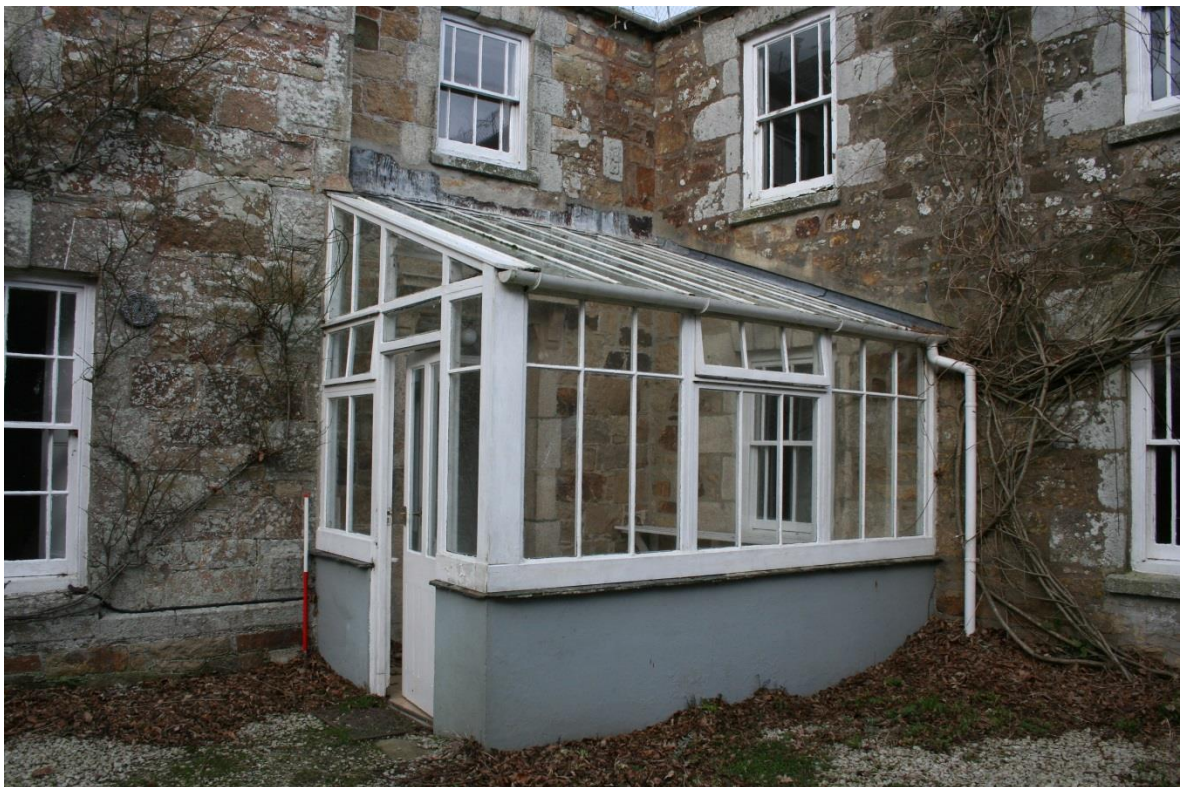
Fig 35 Conservatory at the main entrance, between the early house (right) and the wing of c1850 (left), with some early-mid 20C woodwork and a more recent roof

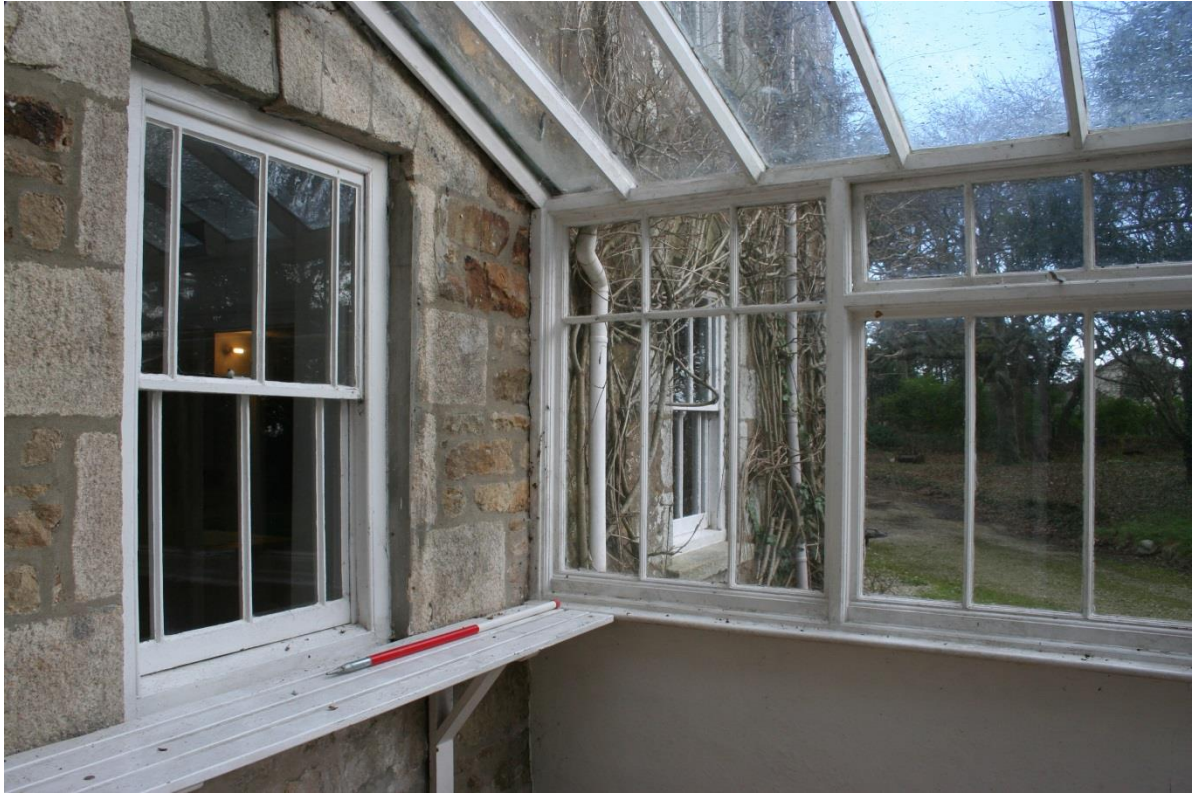
Fig 36 Interior of Conservatory, also showing detail of one of the mid-19C windows, this one lighting the service passage inserted within the south front of the early house

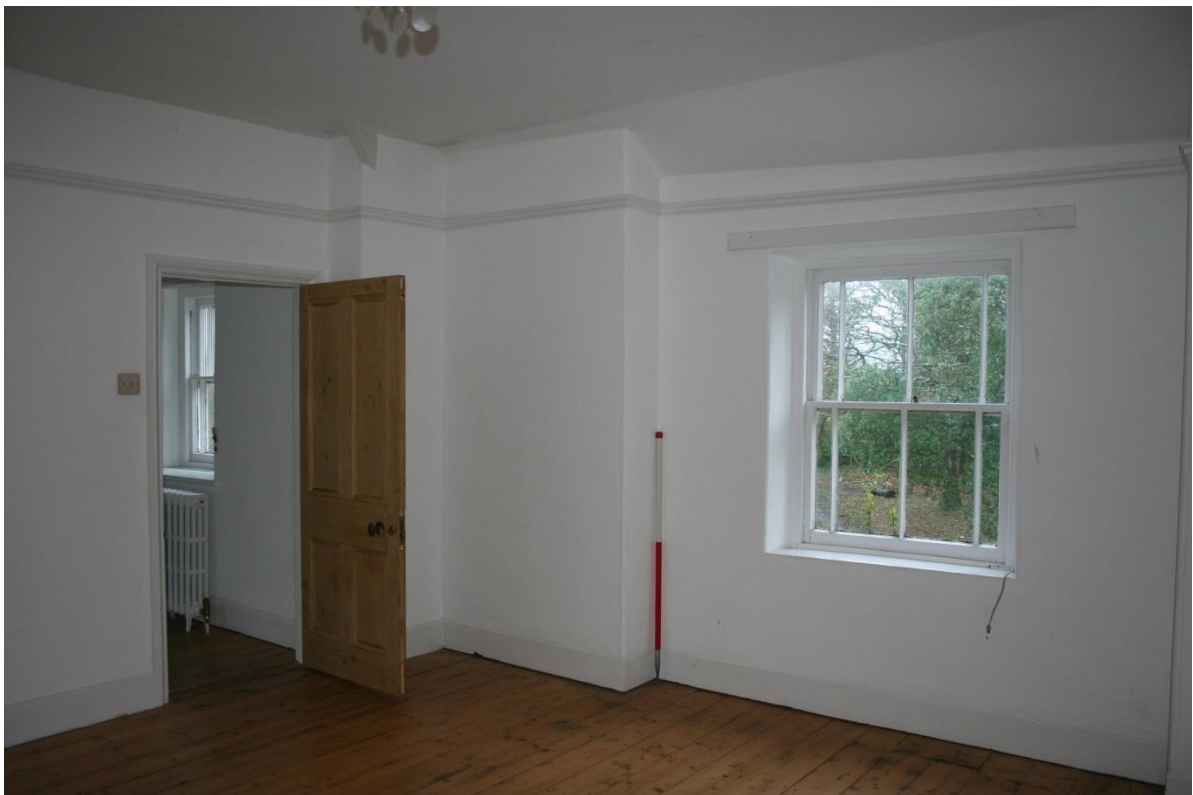
Fig 37 Second best bedroom in the south wing, with view over the grounds on the east

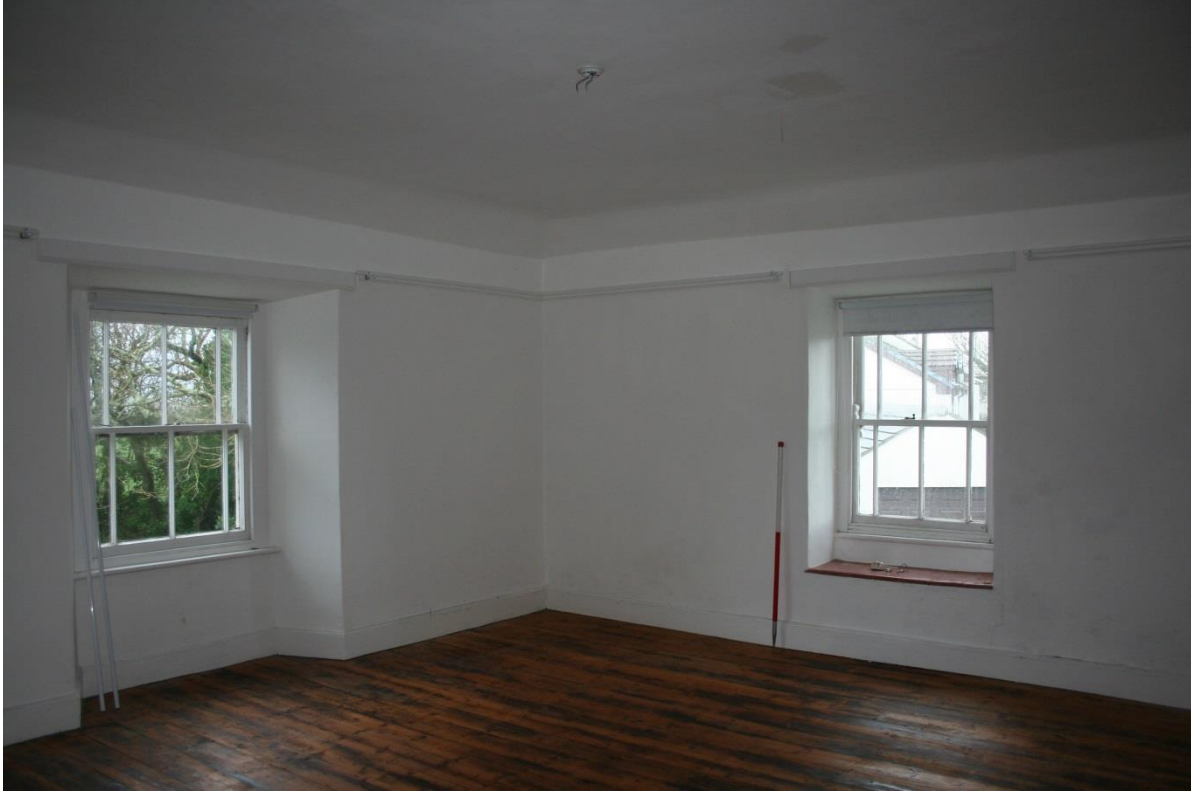
Fig 38 South end bedroom in the south wing, probably that of the Vicar, with window facing the Church as well as one over the garden

South bedroom. This bedroom may have been designed for the Vicar's use, as it had a window on the south, Church side as well as on the east (Figs 38, 55). The south window has horned sashes so is repaired or replaced, and has modern tiles on its window seat. The west window appears original but has no shutters. There is a modern brick and pine fireplace in the north wall, with original hearthstone.

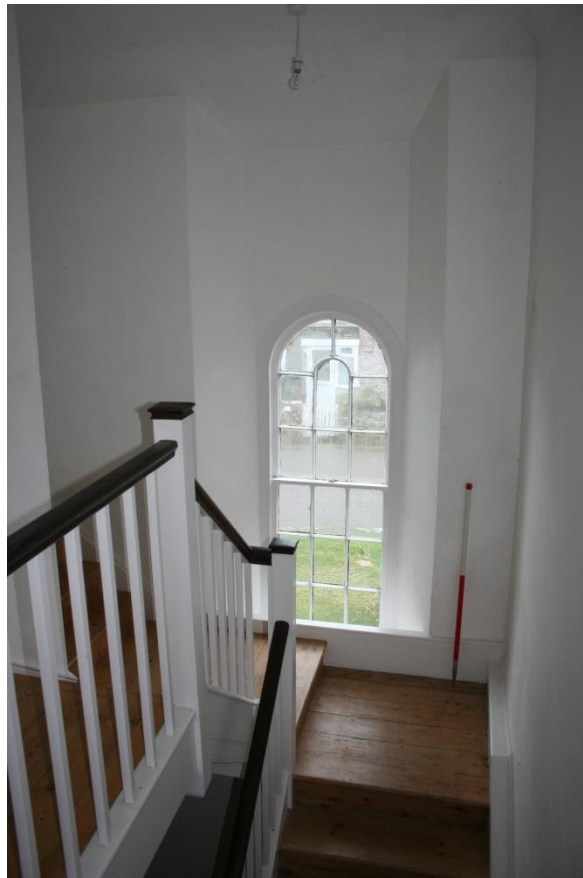
Fig 39 Spacious, well-lit stairway of c1850 rises against the west part of the south front of the early house (right), probably part cob and containing blocked window/s

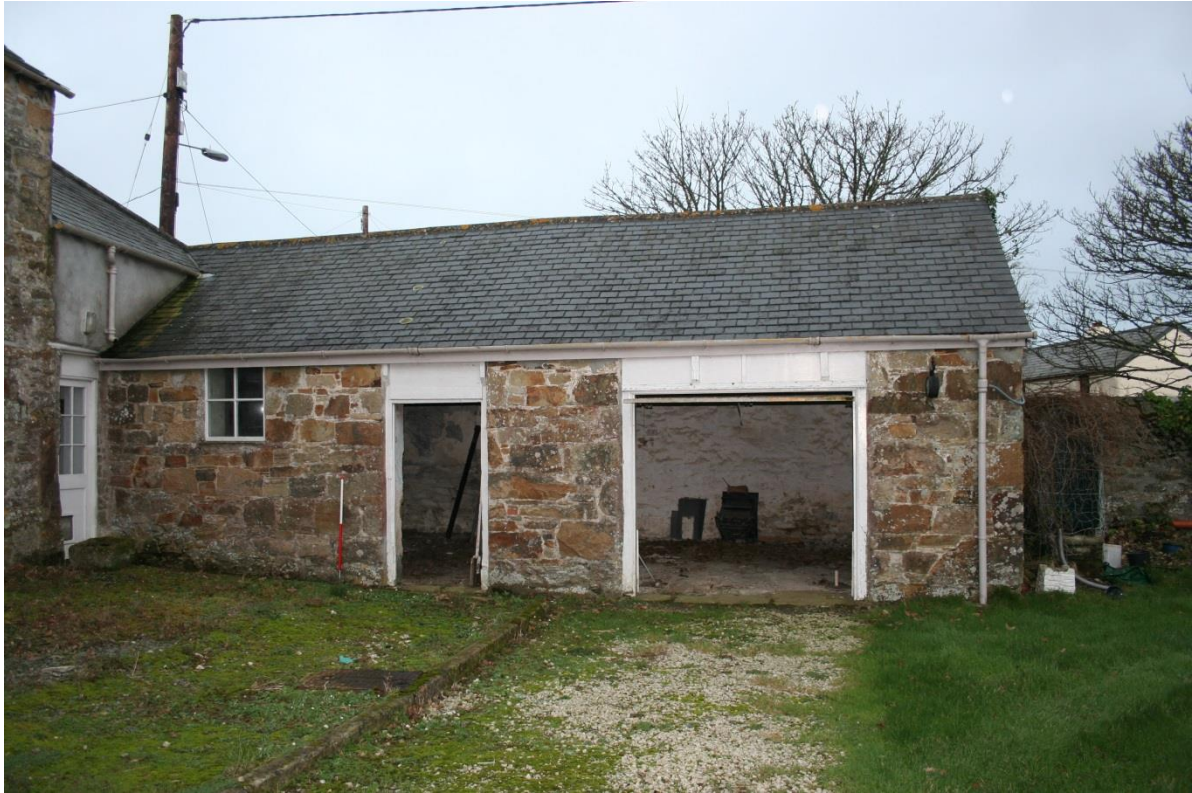
Fig 40 West front of Stable (left) and Carriage House (right) of c1850, with face of local stone resembling that of the contemporary south and east facades of the house

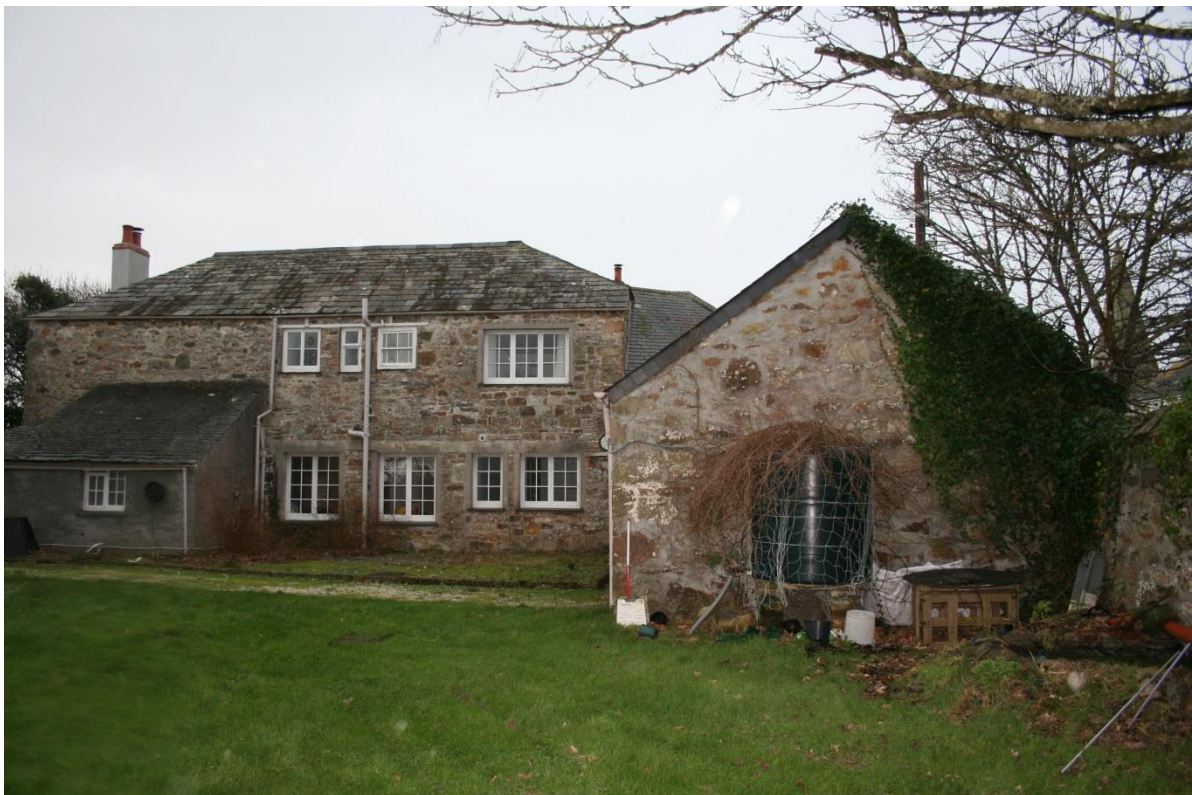
Fig 41 Carriage House and Stable wing and early, east-west range of the house, from the rear (north). Other buildings formerly stood north of the Carriage House (right)

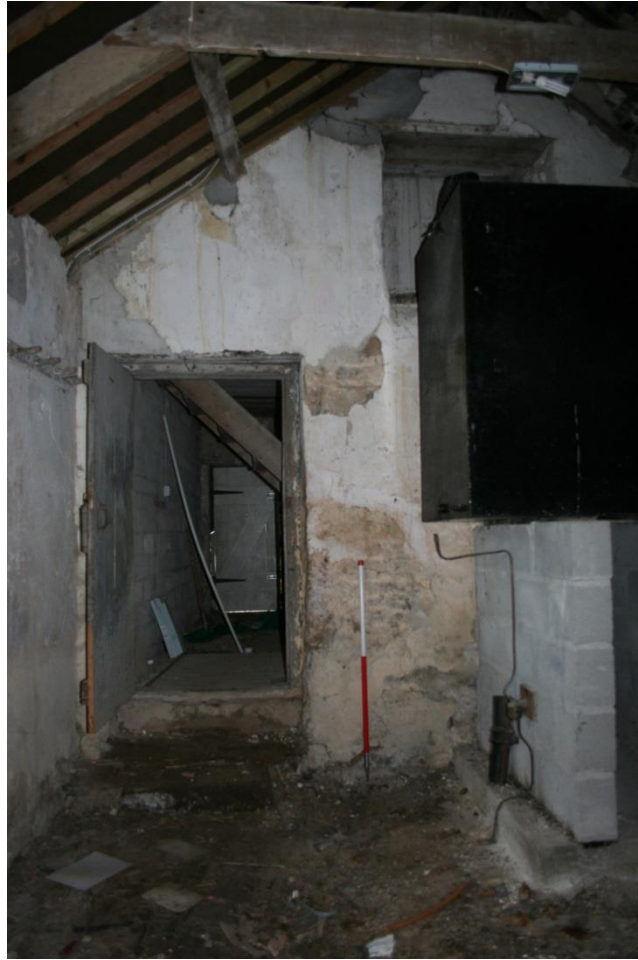
Fig 42 View from the Stable south to the Store it was built against, which probably served it as a harness and feed room; the modern oil tank occupies the south stall

The openings have modest proportions and a plain style with timber lintels (Figs 20, 42, 47). There are opposing doorways in its north and south walls, now beside the concrete east wall, originally east of centre. The doorway on the south has a worn granite threshold slab and a replacement door of simple design. The south wall also has a window west of the doorway, with internal splay, expanding from 44cm to 68cm in width, and six pane window, possibly 19th century with more recent glass.

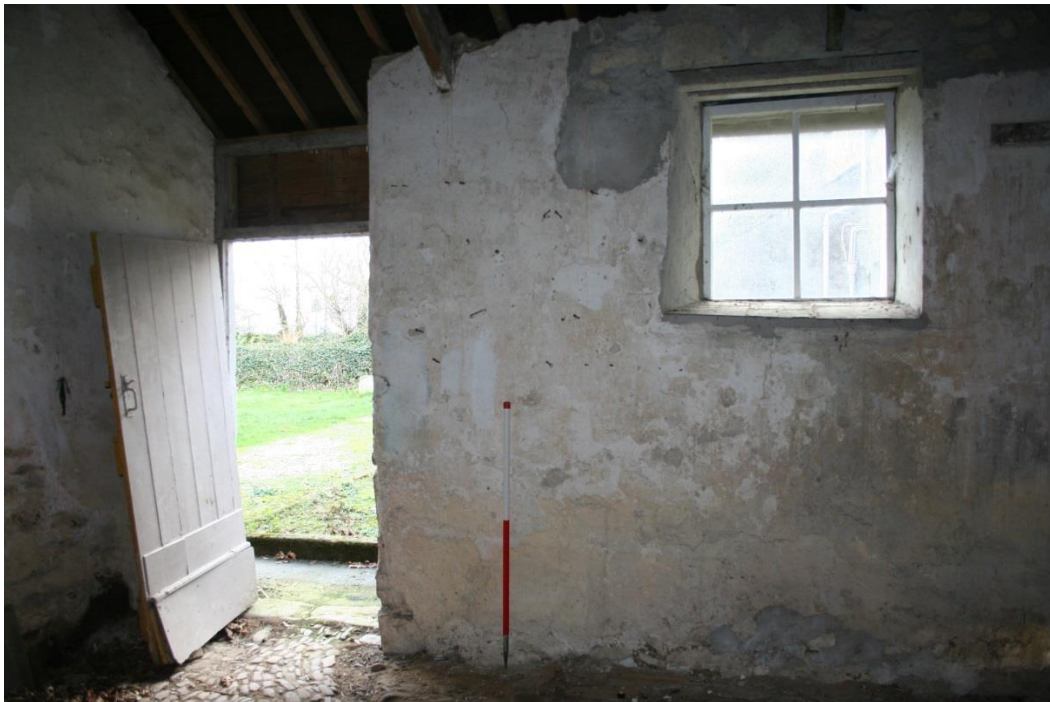
Fig 43 Door on east of Stable, possibly replacing a taller one, and passage with window and peg rack (far right) which gave access to stalls behind and harness room to right

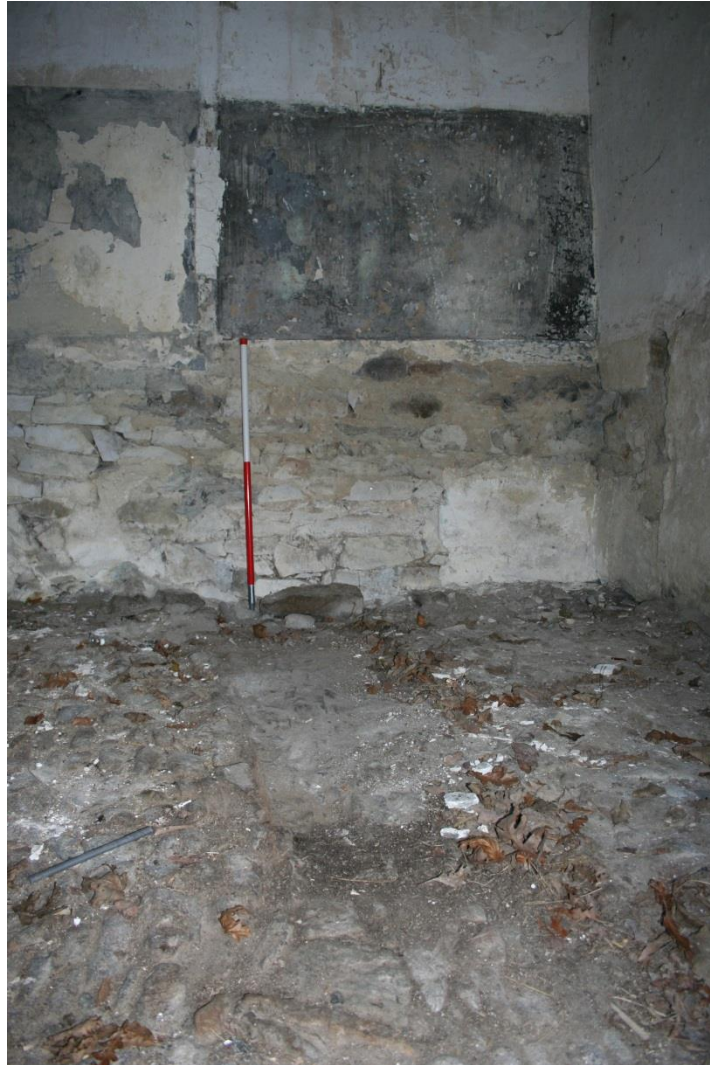
Fig 44 North stall of Stable, looking west to the 'head' end, with traces of stall partition, boarding, and varying wall finishes, and cobbled floor, here very well-preserved

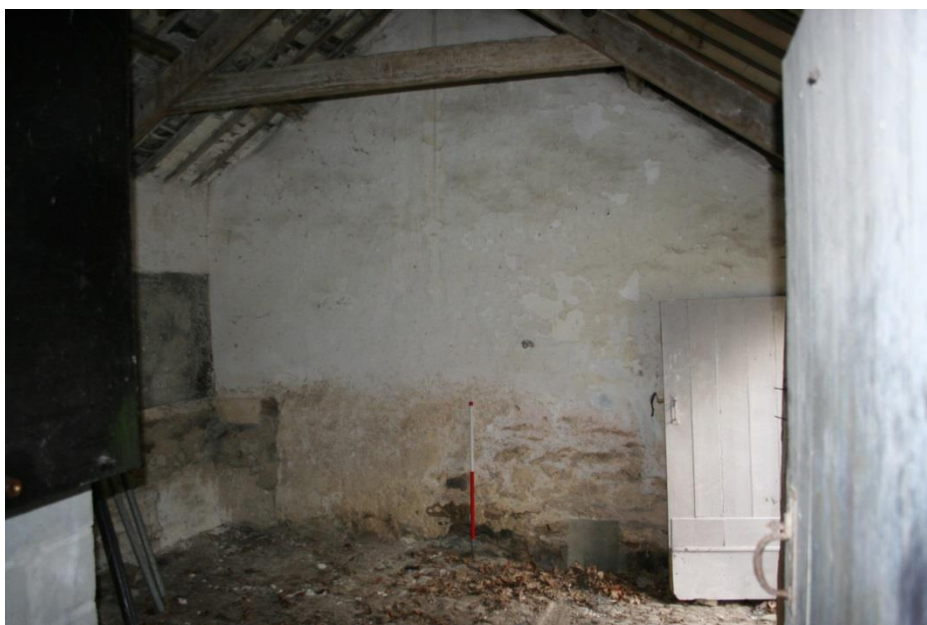
Fig 45 North stall of Stable from the south, showing torched scattle slate roof with the headroom needed for horses, and the fall of the cobbled floor necessary to drain it

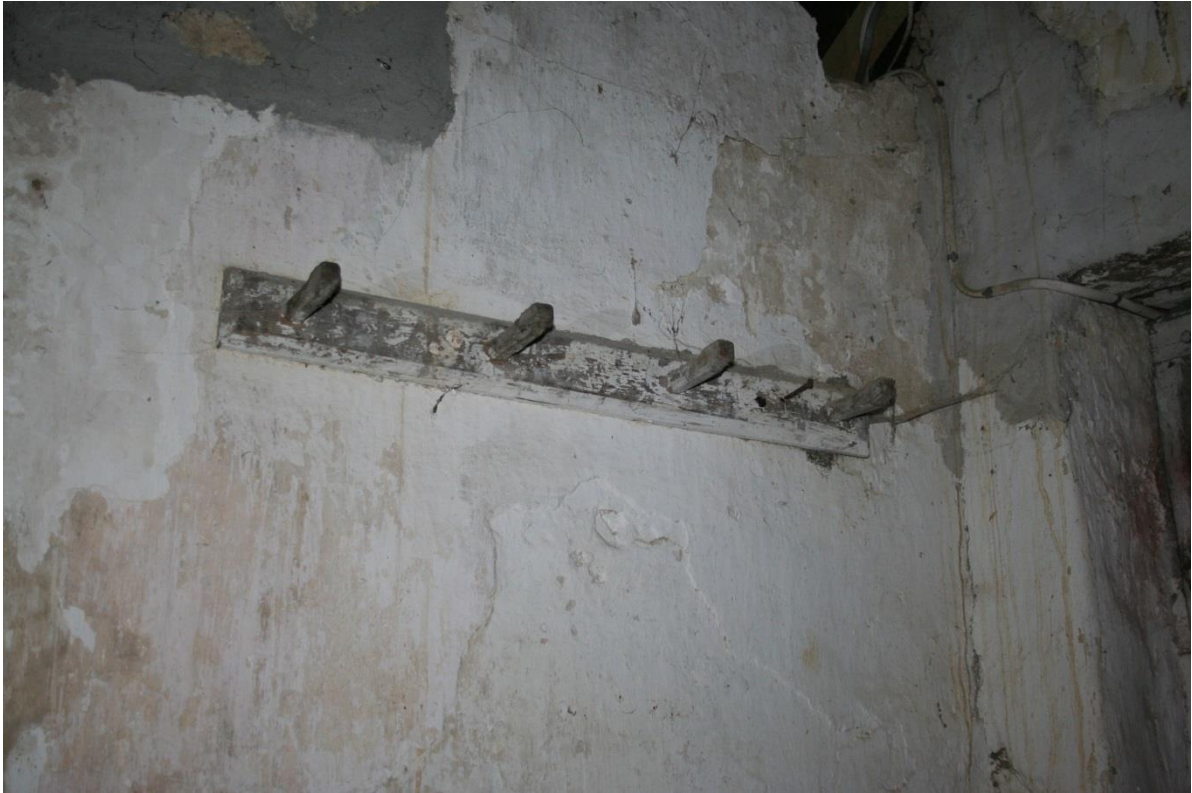
Fig 46 Wooden rack with pegs for horses' bridles or similar tack, fixed on the wall of the Stable passage behind the stalls, at the south (harness room) end of the east wall

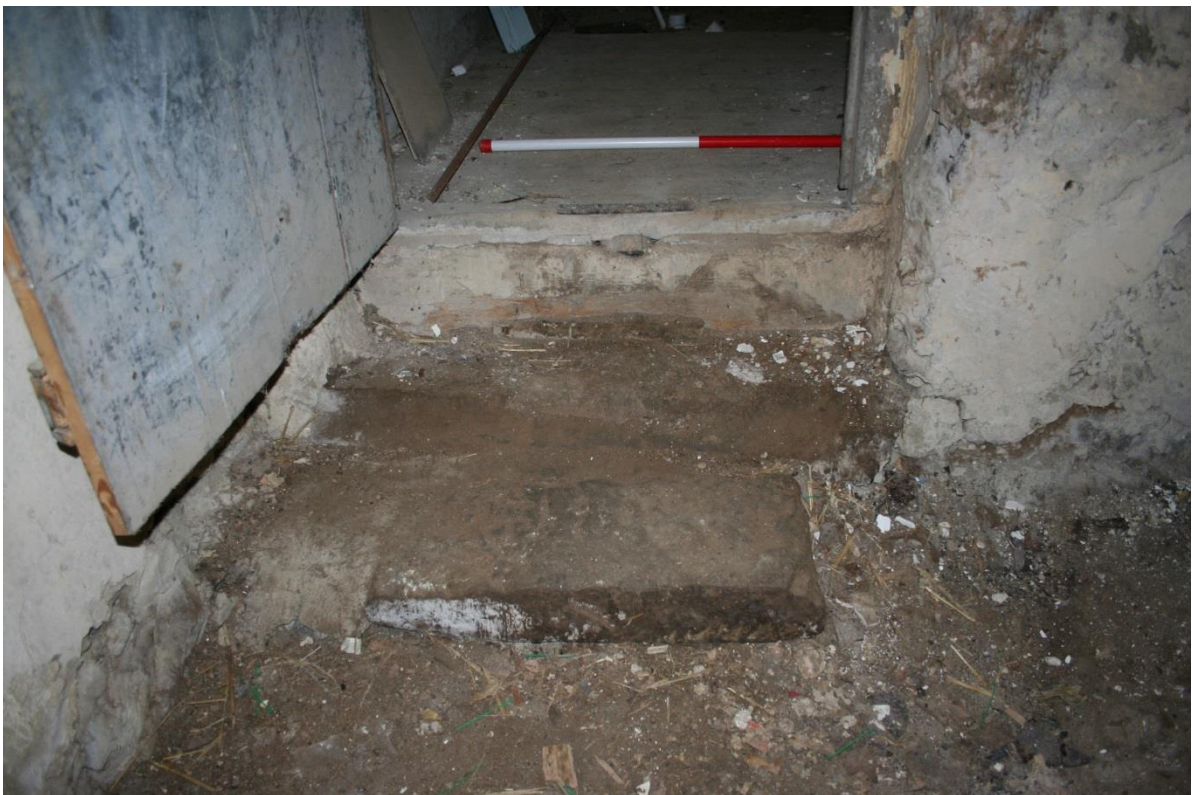
Fig 47 Steps of worked stone, the lower one oddly sized so perhaps re-used, linking the later Stable with the Store on its south, probably its harness room

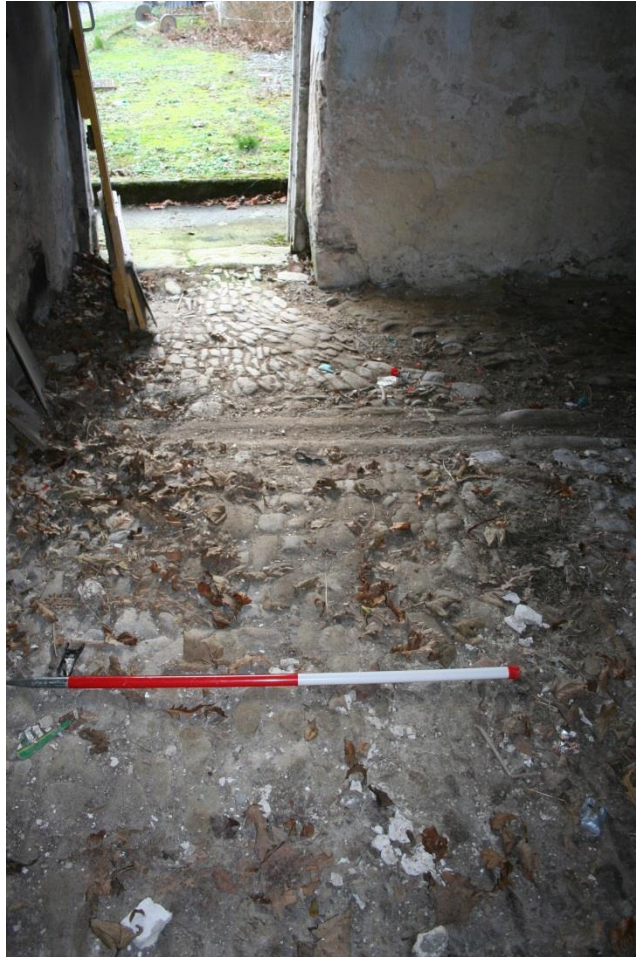
Fig 48 View from north stall across passage to east door of Stable, showing near-intact cobbling laid to fall to a drainage channel at the passage, and to curve to the door

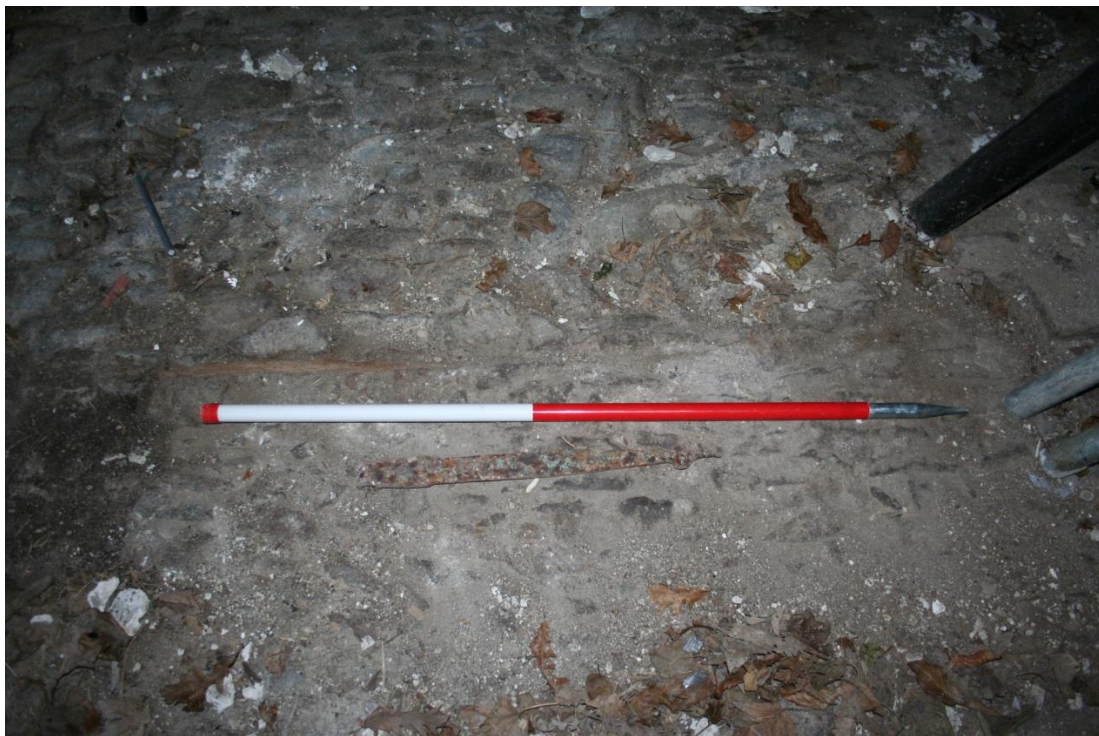
Fig 49 Detail of stable floor, with above the scale, traces of the partition between the north and central stalls; and below the scale, a loose iron door hinge (looking south)

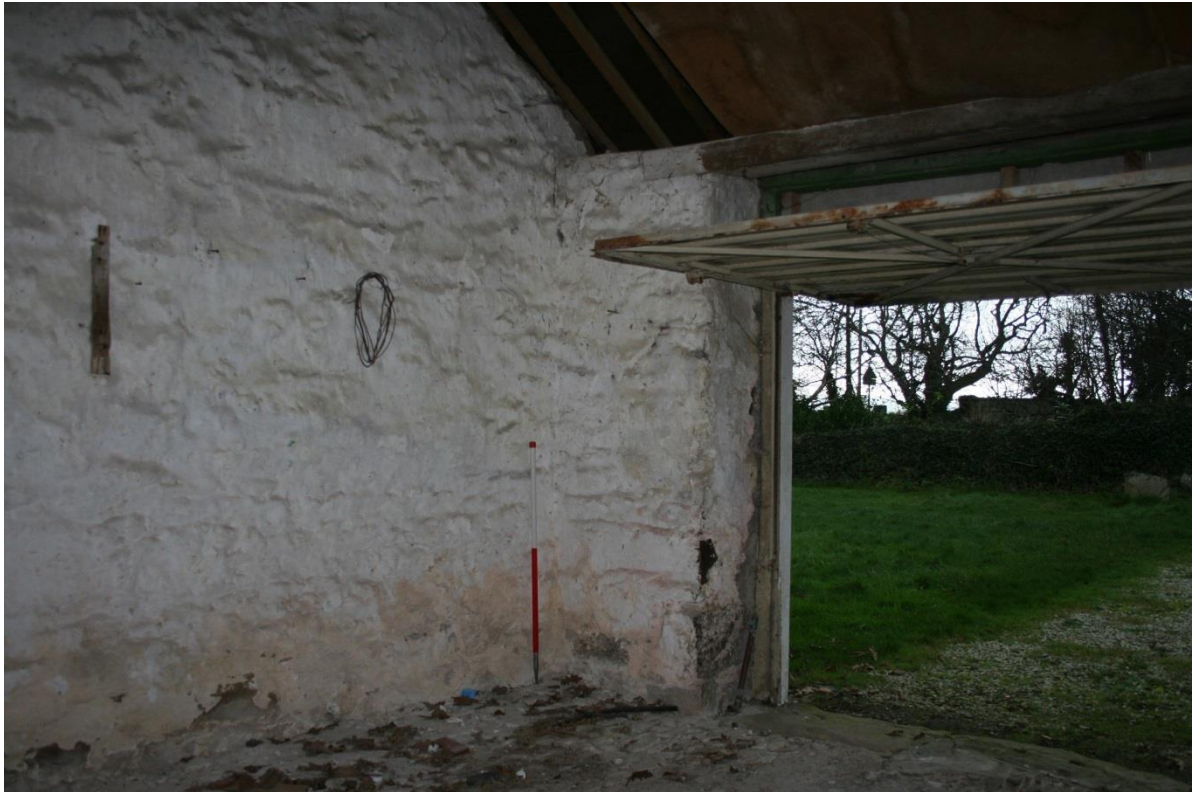
Fig 50 Carriage House showing large square doorway on the east, with modern door

- **In the Stable and Carriage House**; agreement of a scheme to avoid or minimise damage should the oil tank in the Stable be removed; retention of the cobbled flooring; restoration of scantle slate roofing; retention of the Stable's board doors and the peg rack; replacement of the Carriage House modern garage door with double doors.
