Cubert Vicarage, Cornwall Historic building record

Cubert Vicarage, Cornwall

Historic building record

Client	Ms L Northridge
Report Number	2015R010
Date	February 2015
Status	Final Draft for consultation
Report author(s)	Catherine Parkes BA MCIfA
Checked by	Nigel Thomas BA MCIfA
Approved by	J Nowakowski

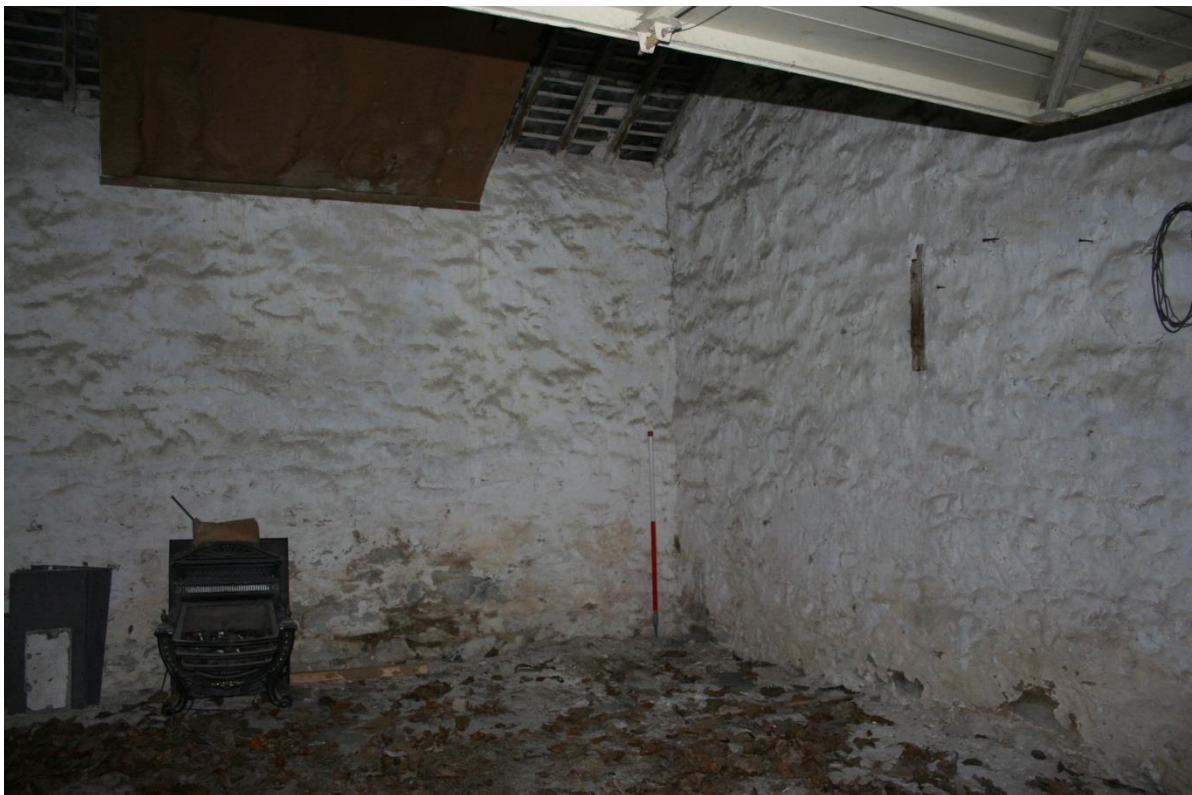
Fig 51 Rear, west side of Carriage House, showing plain whitewashed rubble stone walls, torched roof of scantle slate with some later boarding, and cobbled floor

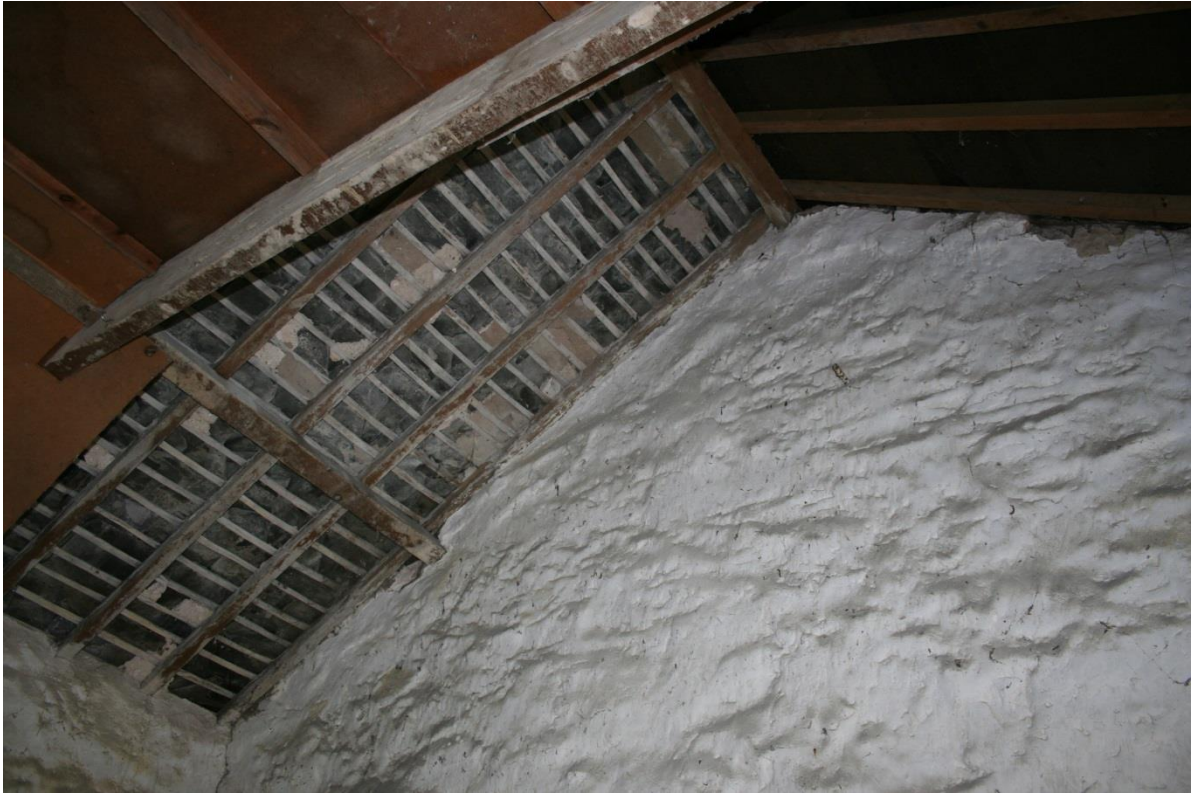
Fig 52 Detail of traditional roofing work at north end of west side of Carriage House

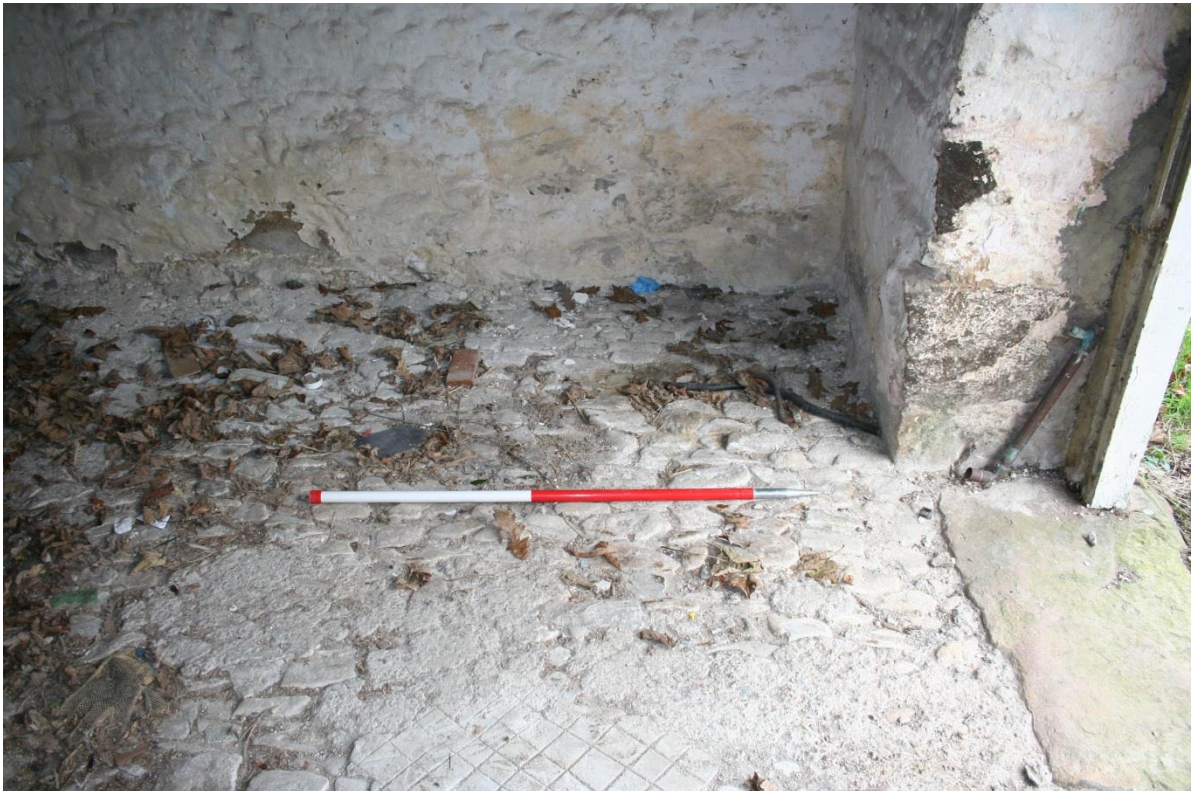
Fig 53 Floor in north east corner of Carriage House showing cobbling with wear patterns and limited modern repair, and one of the irregular threshold slabs of local stone

- **In the Stable and Carriage House**; agreement of a scheme to avoid or minimise damage should the oil tank in the Stable be removed; retention of the cobbled flooring; restoration of scantle slate roofing; retention of the Stable's board doors and the peg rack; replacement of the Carriage House modern garage door with double doors.

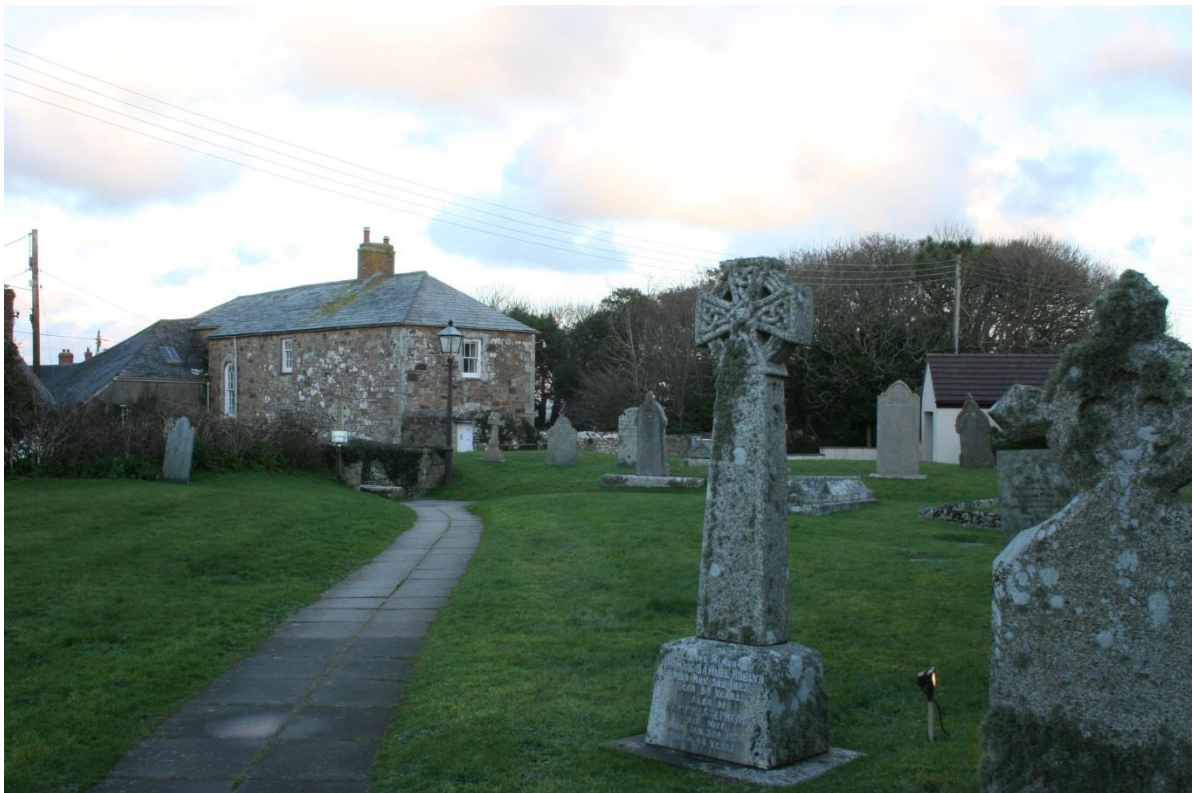
Fig 55 View from Church to Vicarage showing the plainer public side of the prominent Victorian wing, with the upper south end window possibly in the Vicar's bedroom
The clump of trees to the east (right) of the house originates from ornamental planting, shown on the 1880 map, in the carriage turning circle serving the Victorian house

South bedroom. This bedroom may have been designed for the Vicar's use, as it had a window on the south, Church side as well as on the east (Figs 38, 55). The south window has horned sashes so is repaired or replaced, and has modern tiles on its window seat. The west window appears original but has no shutters. There is a modern brick and pine fireplace in the north wall, with original hearthstone.

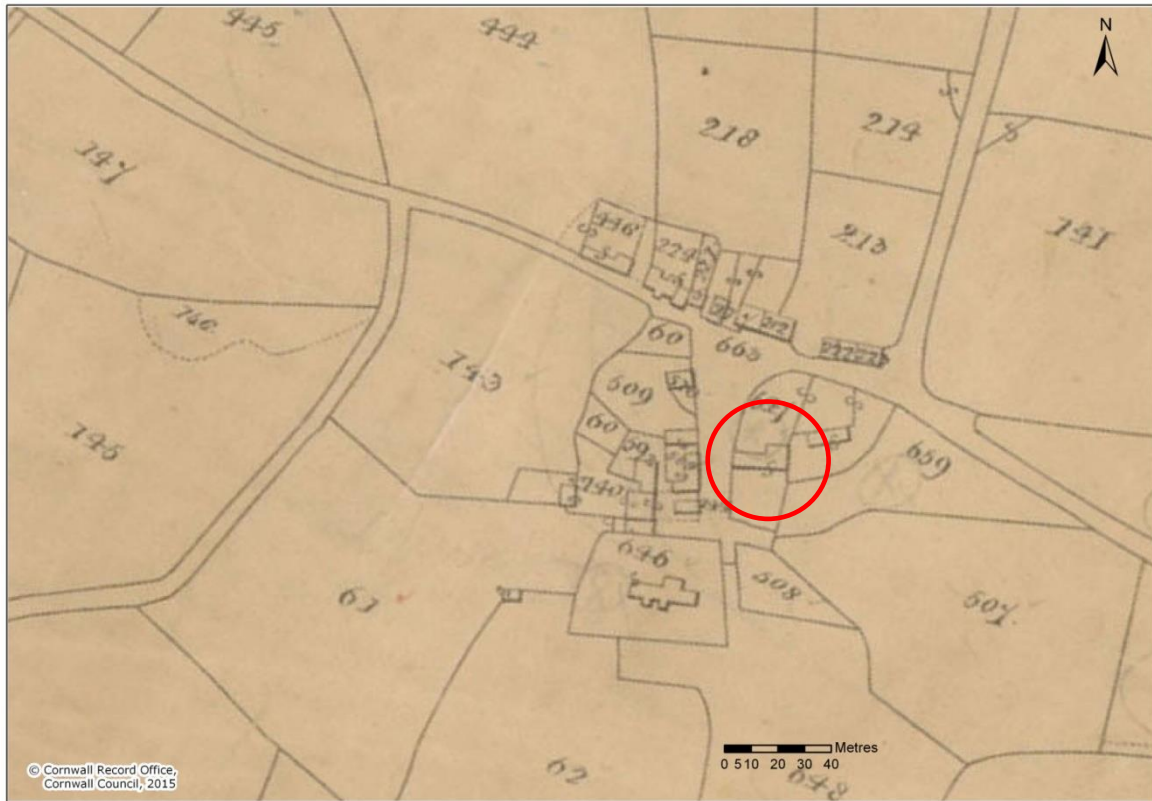
Fig 56 Cubert churchtown, with the early 19th century Vicarage (numbered 647), on the parish tithe apportionment survey of 1840

Cubert Church was struck by lightning and 'considerably damaged' in April 1848, and as a result was restored and improved by 1852 to designs by prominent architect George Edmund Street (*ibid*). It may be, then, that the Vicarage was rebuilt at around the same time as the Church, though there is not known if the Church architect or his firm had any involvement in it. A quarry west of Churchtown, already there when the tithe survey was made in 1840, was considerably enlarged by 1880 (compare Figs 56, 57), so this could have been a source of stone for Vicarage and/or the Church.

The Vicarage is mainly built of an orange-brown or orange-grey local stone, with lime mortar containing charcoal specks. One possible source of this local stone is an old quarry west of Churchtown (Section 5, and Figs 56, 57). The Listing documentation (Appendix I) describes the fabric as granite, but this stone (Cornish, but not occurring locally) is used for architectural details, as noted below, not for walling.

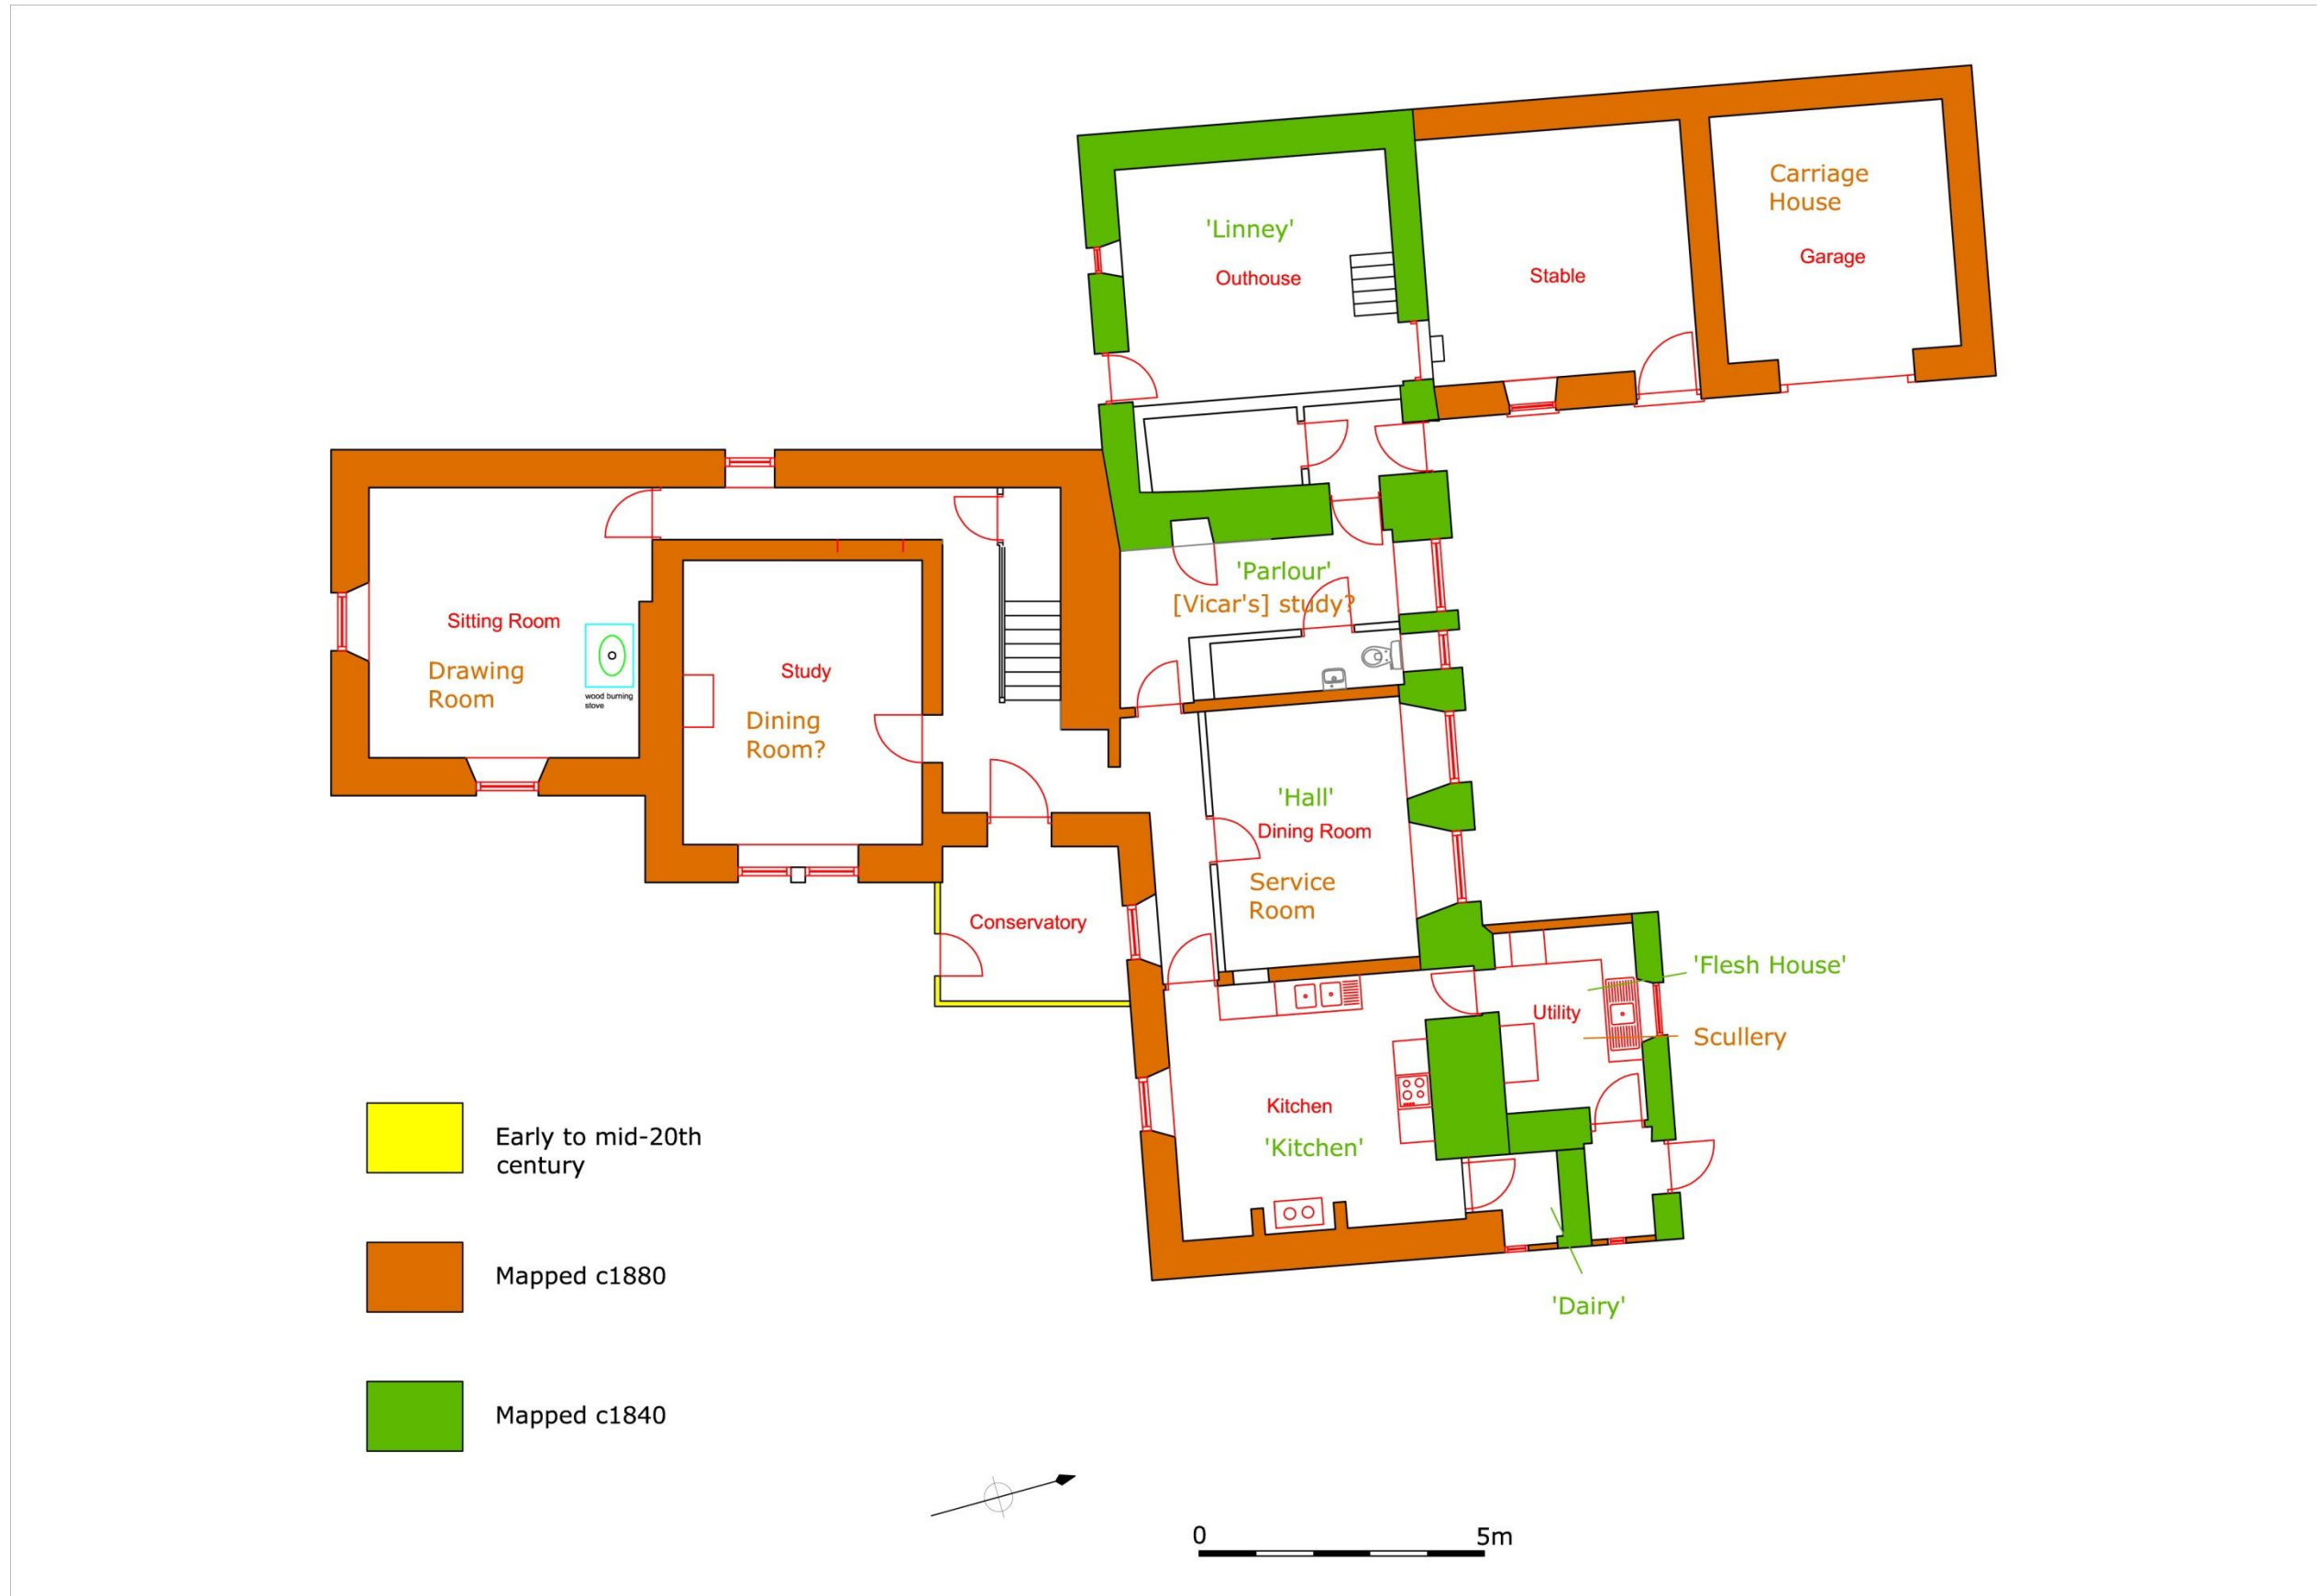
Fig 60 Ground floor plan, showing main phases of development of surviving fabric, with historic room names quoted from terriers or suggested by the assessment

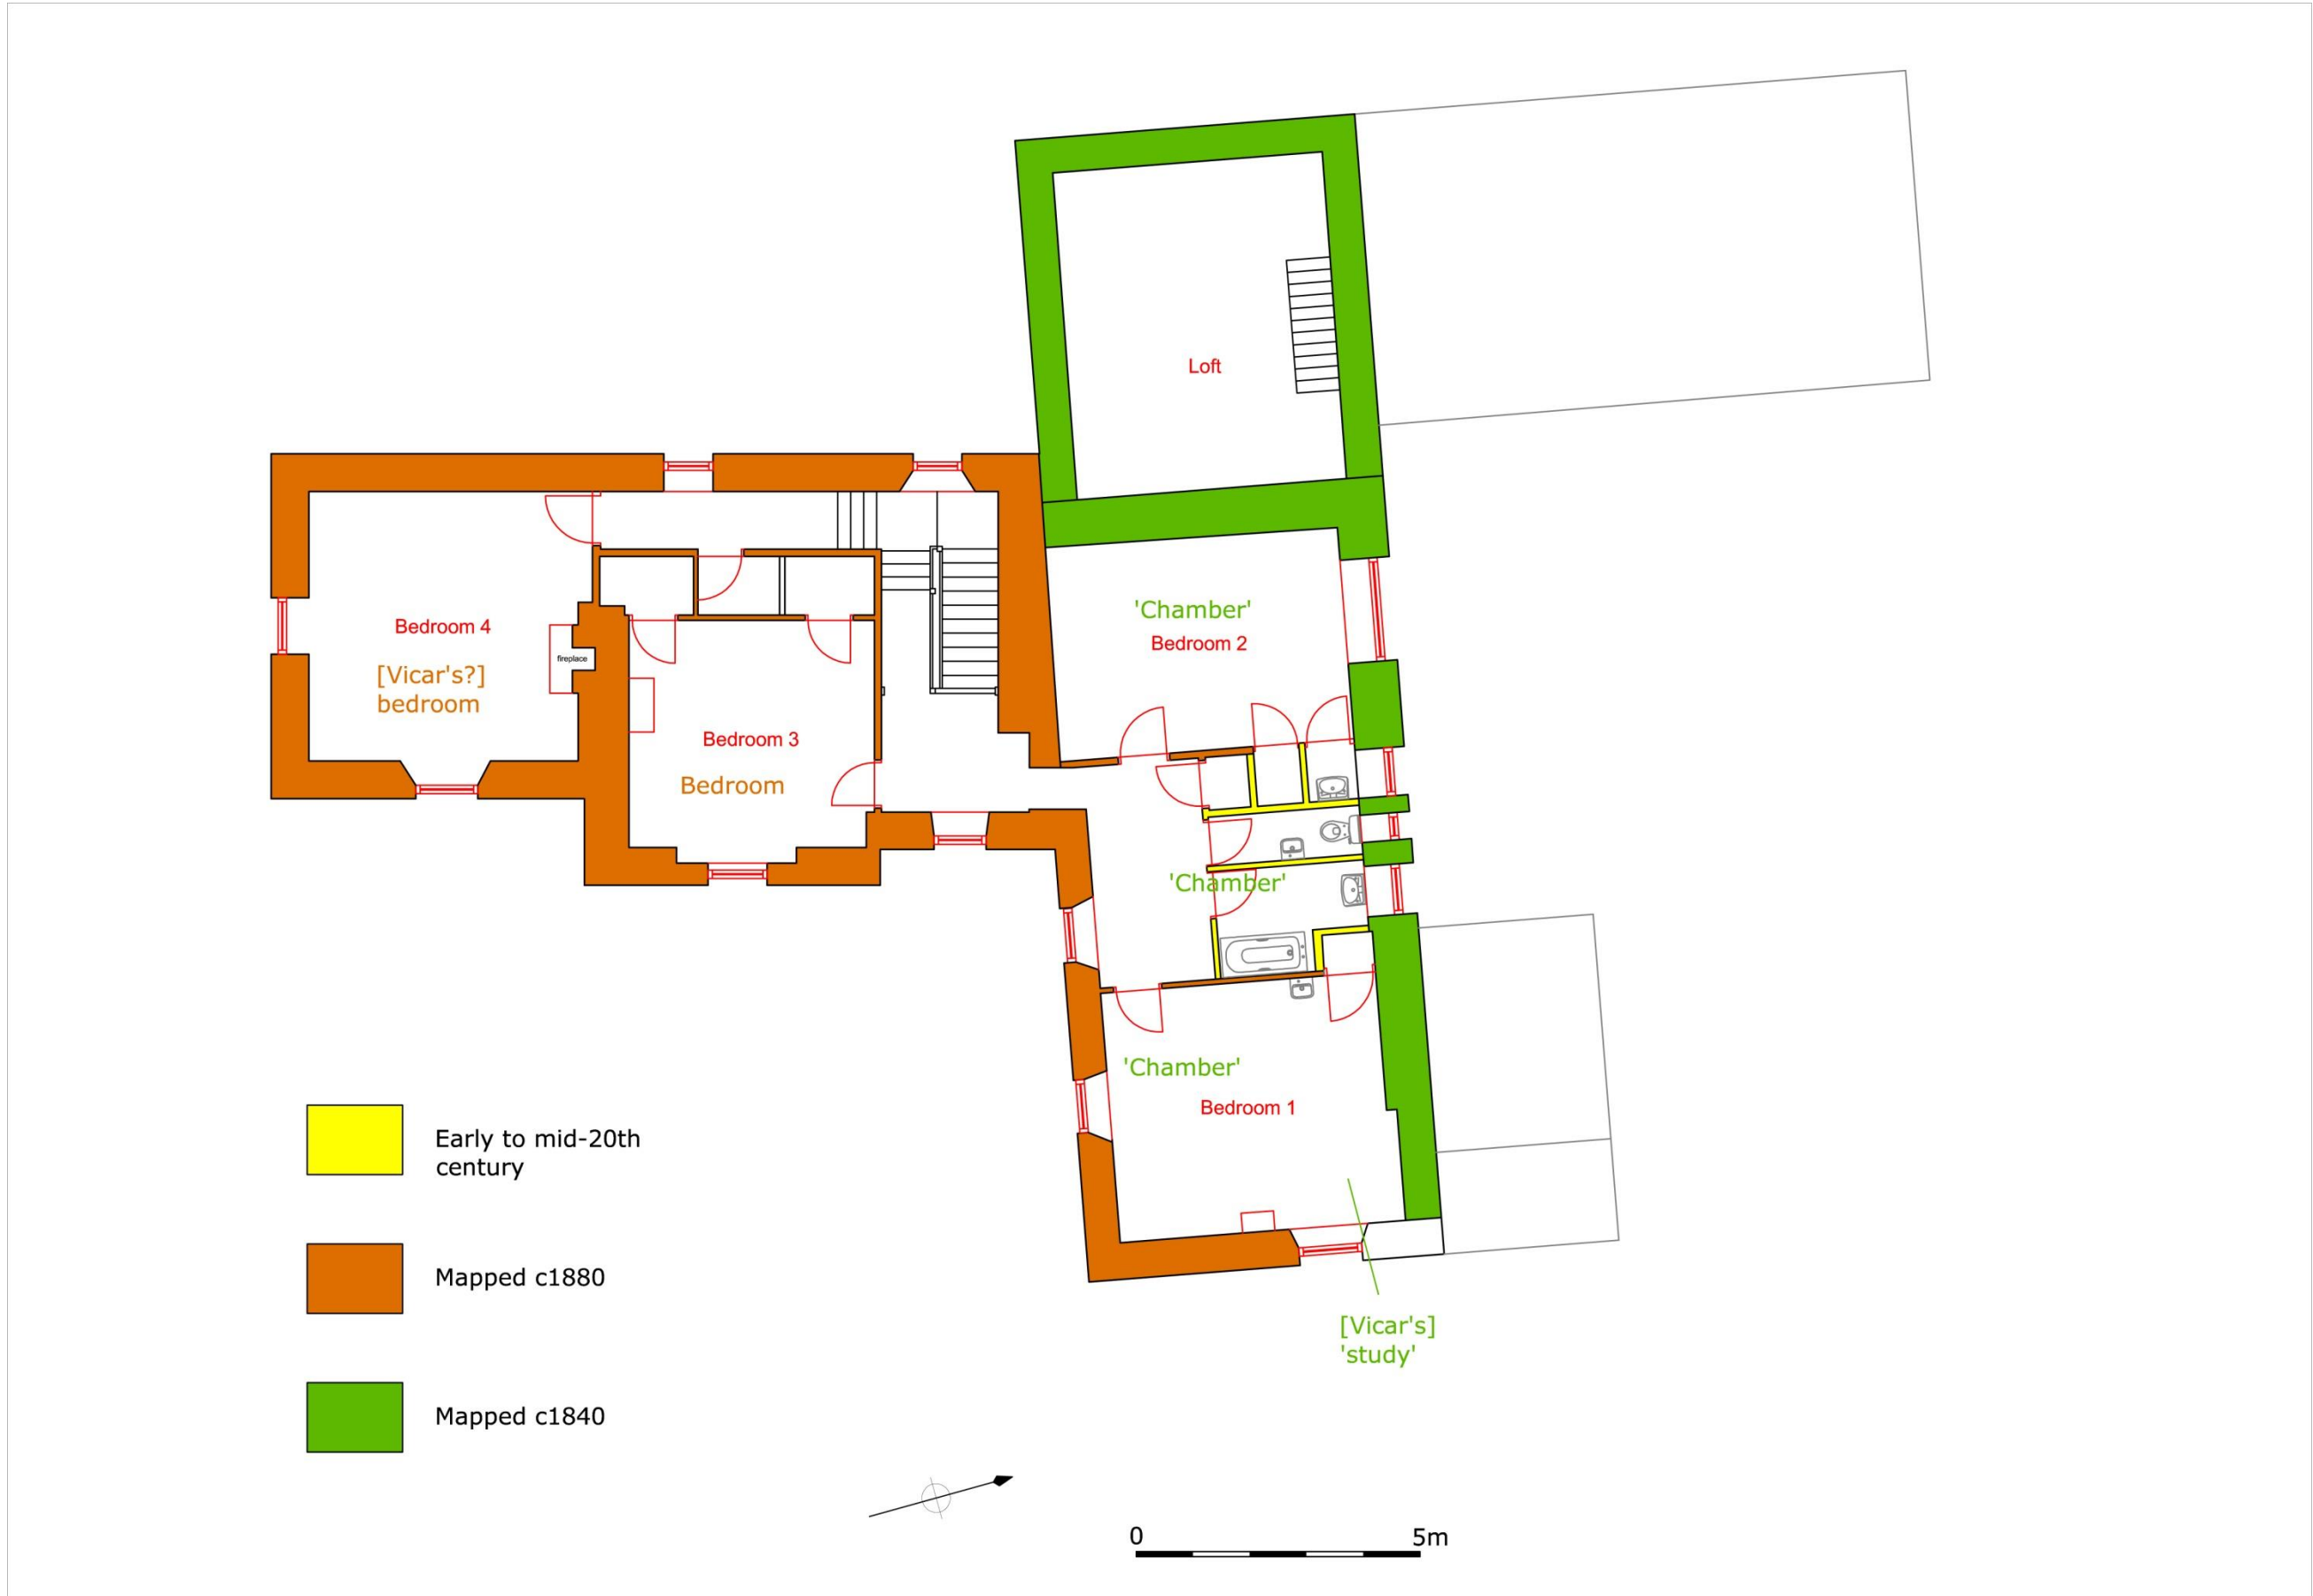
Fig 61 First floor plan, showing main phases of development of surviving fabric, with historic room names quoted from terriers or suggested by the assessment
