The Cider House, Godolphin, Cornwall

Historic Building Record

Client	The National Trust
Report Number	2015R016
Date	March 2015
Status	Final
Report author(s)	Jo Sturgess
Checked by	Nigel Thomas
Approved by	Andy Jones

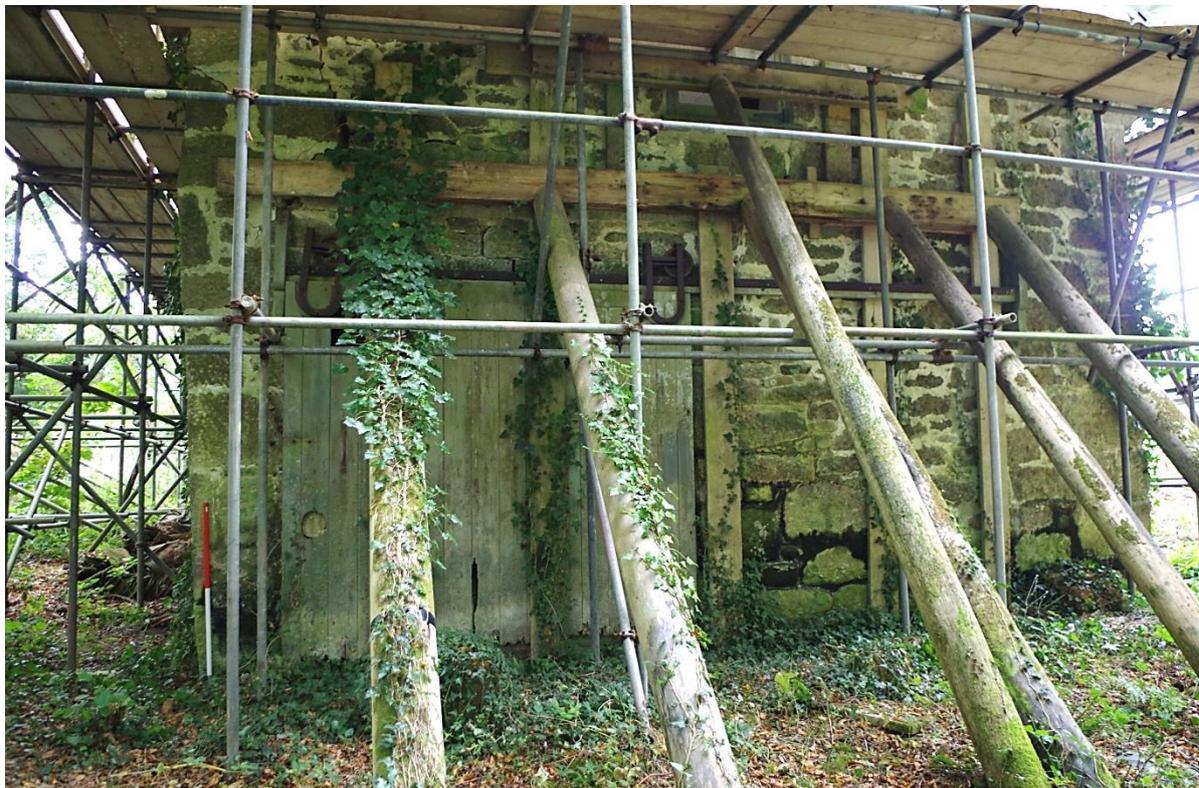
Fig 8 Exterior north elevation

The wall of this elevation stands approximately 4.3m high and is part of the phase 2 build which includes a centrally set window at first floor level and door opening at ground floor level to the east. The window opening now has a late 19th or early 20th century replacement, two-light wooden casement window with three panes in each light. The door opening was widened to the west during phase 3 by approximately 0.6m and is now 2.52m wide with a sliding timber door supported on an iron rail mounted on timber brackets. At the same time as the widening a new granite lintel was inserted which has weakened the eastern quoin above it causing it to lean outwards. The stonework of the rebuilt western door jamb protrudes from the face of the original 18th century masonry to the west. At the top of the western quoin there is a kneeler stone and towards the base of this quoin is a granite block with wedge splitting marks indicative of 18th century quarrying/stone masonry. Just above it and set in the quoin is an iron pintle. The whole elevation has been heavily repointed with a white cement mortar.

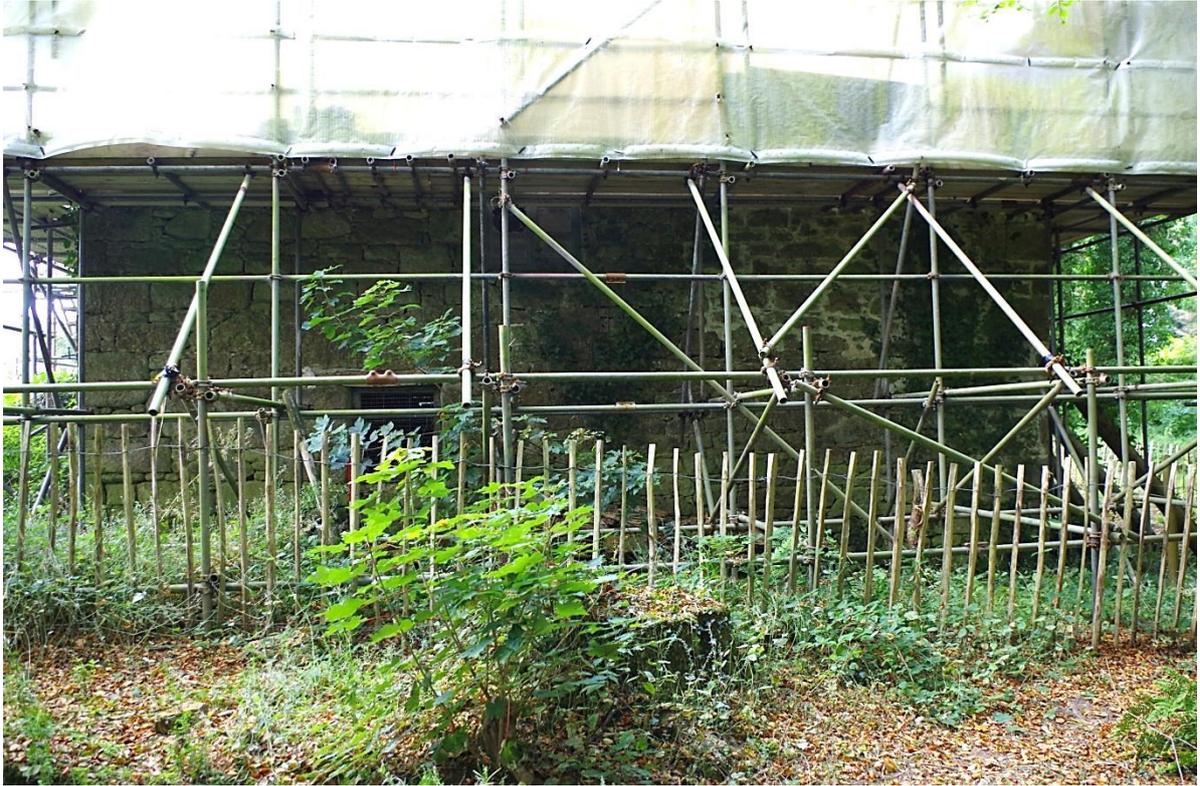
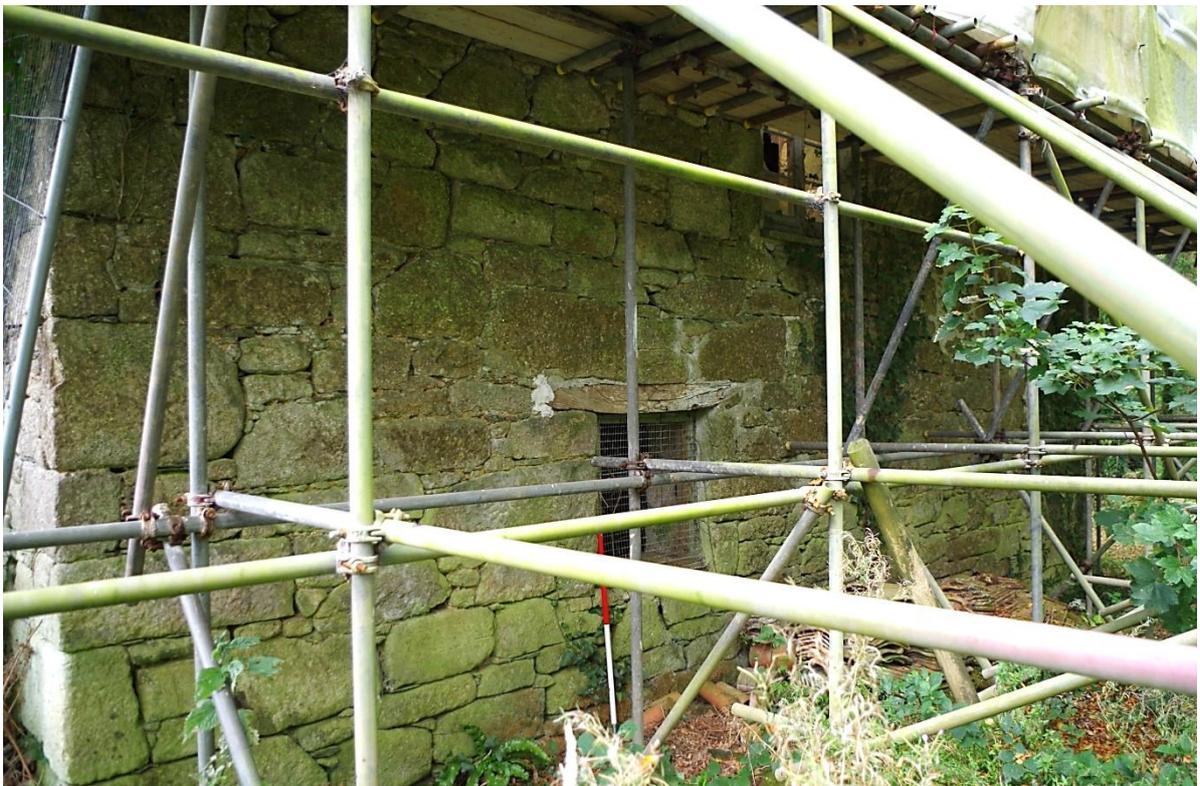
Fig 9 Exterior east elevation

This is the rear elevation of the cider house (in relation to the principal house), that faces into the wood. The wall stands 4.3m high at the north end and 3.6m high at the south end where the ground slopes upwards. The elevation contains two original (phase 2) window openings, one at ground floor level in the southern half and the other at first floor level just to the south of centre. Both have timber lintels and granite jambs. The first floor window is a replacement late 19th or early 20th century casement window matching that in the north elevation, whilst the ground floor window has the remains of a frame only. The lintel of the ground floor window opening is a replacement. Just above it to the south is a granite block with a wedge-splitting mark. The northern quoin shows clear signs of having been disturbed when the new (phase 3) door lintel was inserted in the north elevation. At this point the quoin stone has been removed and replaced with small rubble infill. A portion of the wall at the northern end has been repointed with white cement mortar but the majority remains with its original earth mortar bonding still visible.

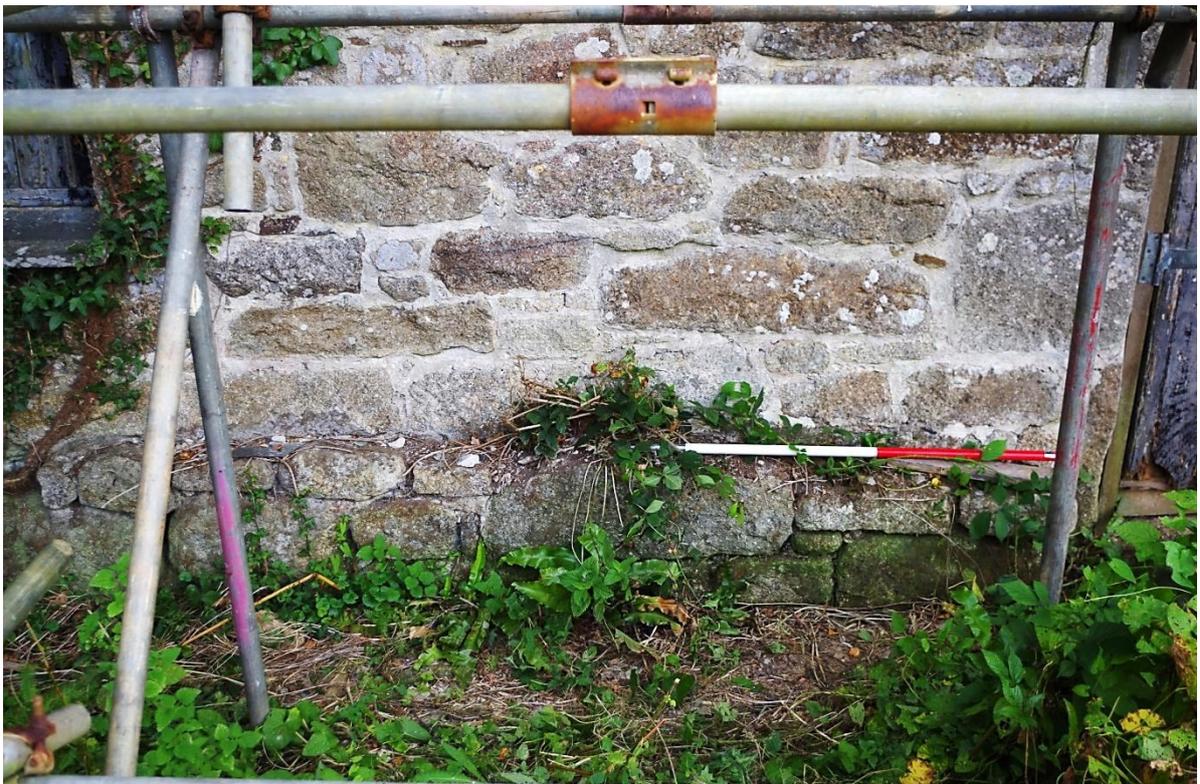
Fig 14 Protruding earlier (phase 1) walling at base of west (front) elevation

The present building is 18th century in date and is shown as a cider house on the 1786 survey. There are no architectural details to suggest that the building is any earlier than this but it does have a few fairly minor alterations and repairs dating to the 19th and 20th centuries. Evidence does survive, however, for the existence of an earlier but perhaps smaller building on the same site. In the northern half of the west wall a length of walling associated with this earlier building survives as protruding footings for a length of approximately 3.8m (Fig 14).

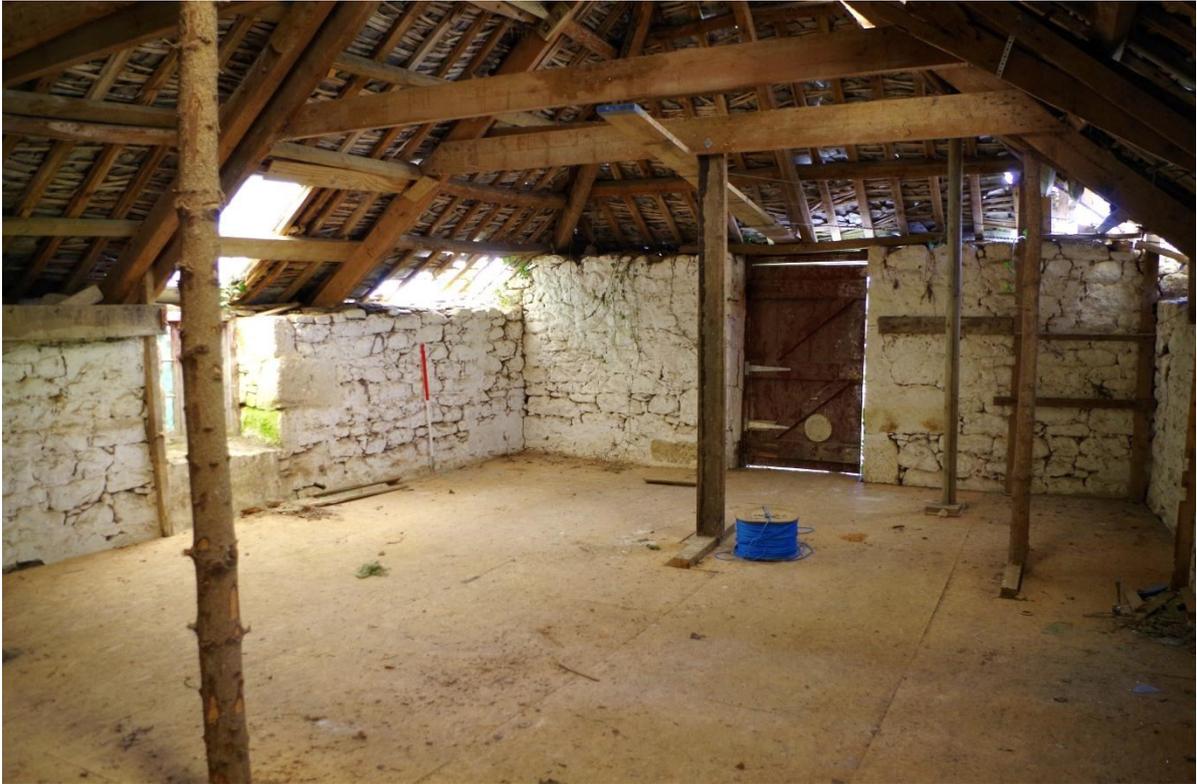
Fig 25 First floor looking south

The first floor also comprises a single room designed as an apple store. It measures 5.7m in width by 8.2m in length with its external phase 2 access via a ramp (formally steps) leading to a door opening in the south wall. The door opening measures 1.25m in width and has a replacement concrete threshold and ledged and braced 19th or early 20th century door (Fig 25).

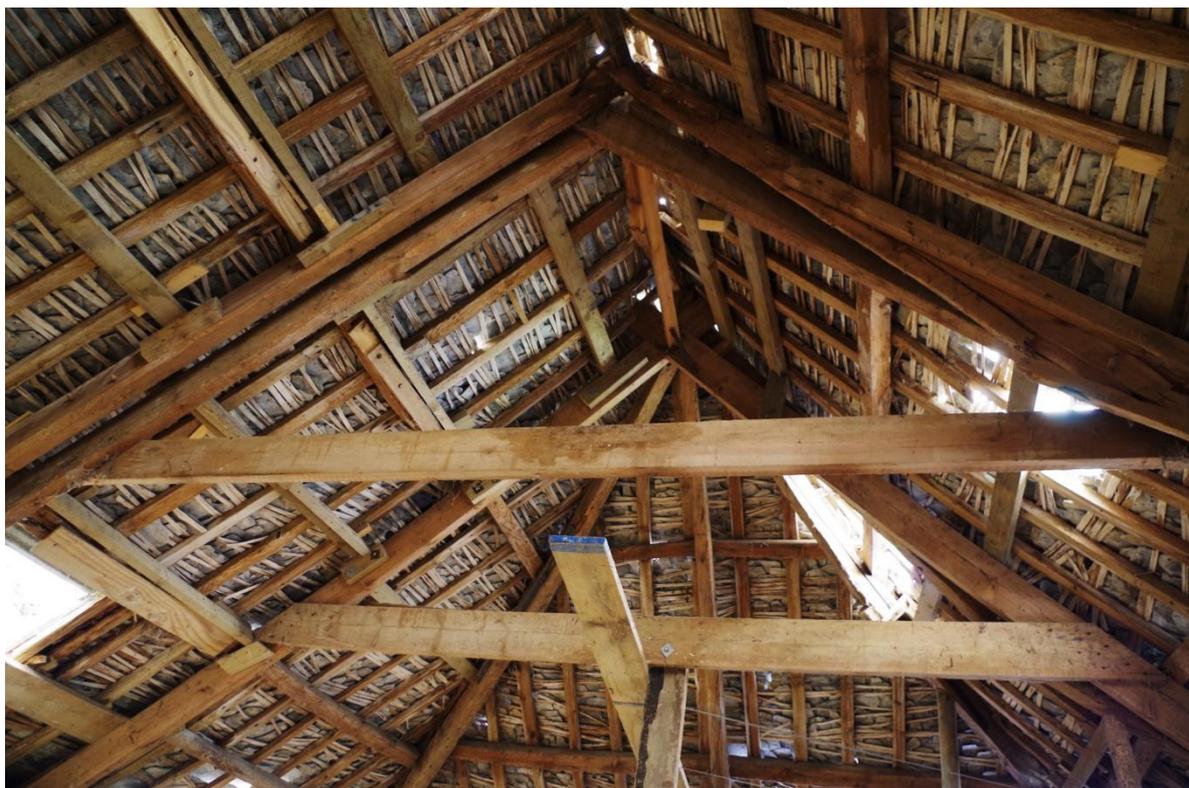
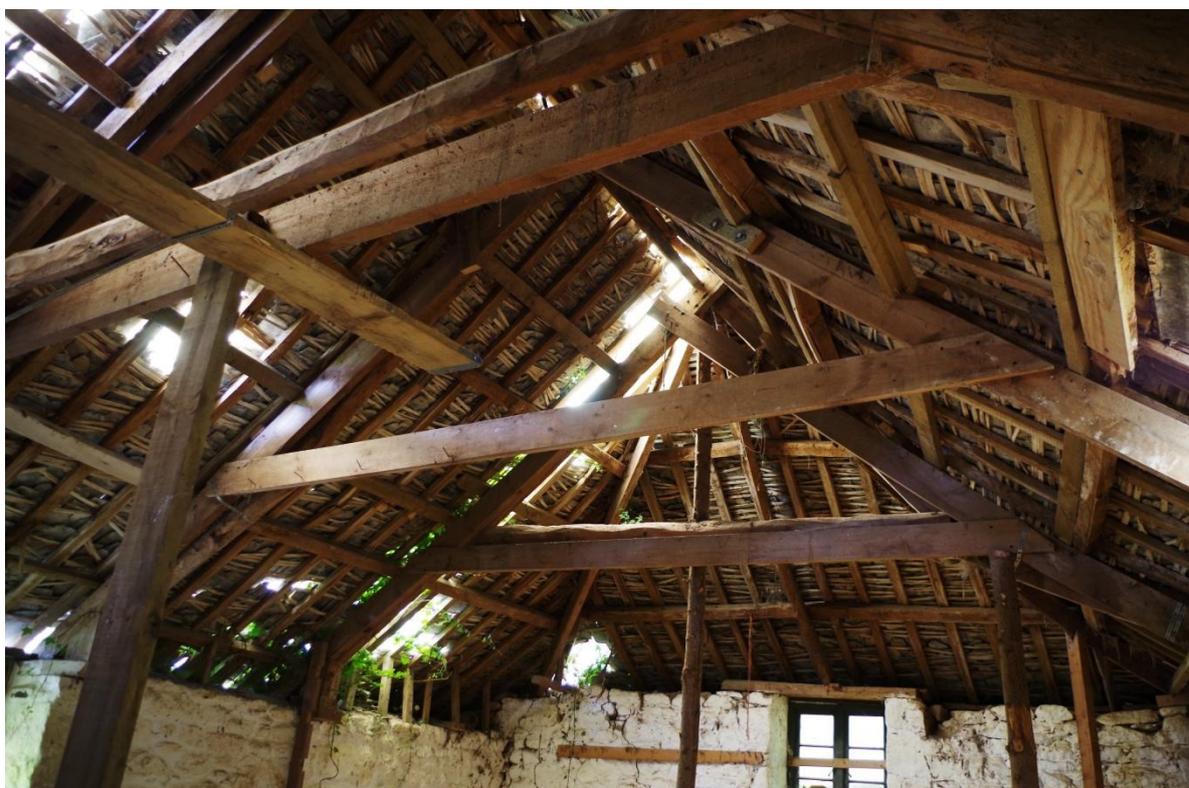
Fig 31 Roof structure looking south

The roof structure is half-hipped at both ends (see Figs 31, 32 and 36) and consists of a least two construction phases with the majority of original timbers left *in situ*. It comprises simple doubled up A-frame trusses. Each of the three early (probably original) doweled trusses has failed and been given support by the addition of a later (19th or early 20th century) nailed truss inserted up against the original. One original hip truss survives at the north end of the building but the others are later replacements (19th or early 20th century). The purlins all appear to be original and many have bowed significantly. The original wide plank wall plates also survive but are now in poor condition. The roof covering is grouted scantle slate which has already begun to slide off the structure below and the ridge tiles are an assortment of plain and crested tiles (see Figs 26-29). It seems likely that the crested tiles are original but most likely reset. In the eastern slope of the roof a late 20th century roof light has been inserted and at the north-east corner a late 20th century flue has also been inserted to serve a fire/brazier in this corner at first floor level.

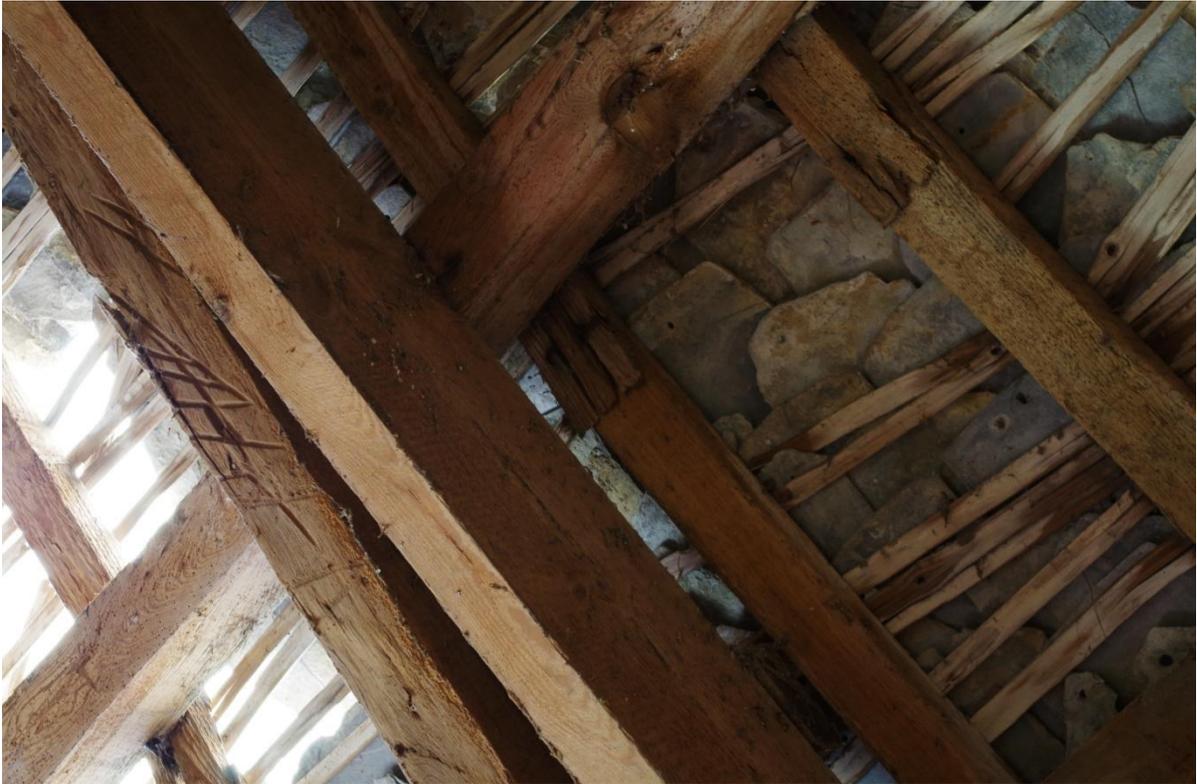
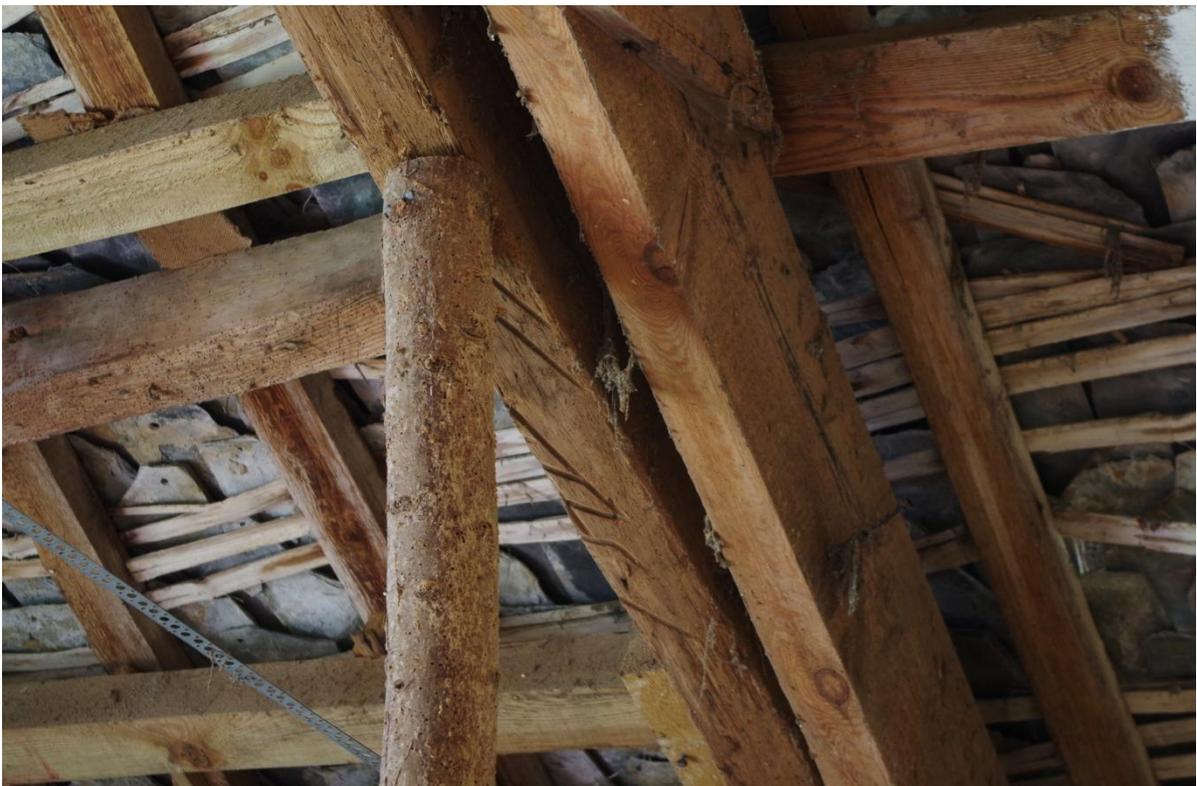
Fig 33 Carpenter's marks on early truss timber

The room is open to the roof structure above which retains many of its original phase 2 timbers including the three main A-frame, doweled trusses, one hip truss timber to the north-east and all the purlins. Roof repair and strengthening was clearly undertaken during phase 3 in the 19th century when three new lap-jointed, nailed A-frame trusses were inserted alongside the originals and the majority of the hip trusses were replaced. Many of the early truss timbers along with one or two of the later timbers have carpenter's marks (see Figs 33 and 34).

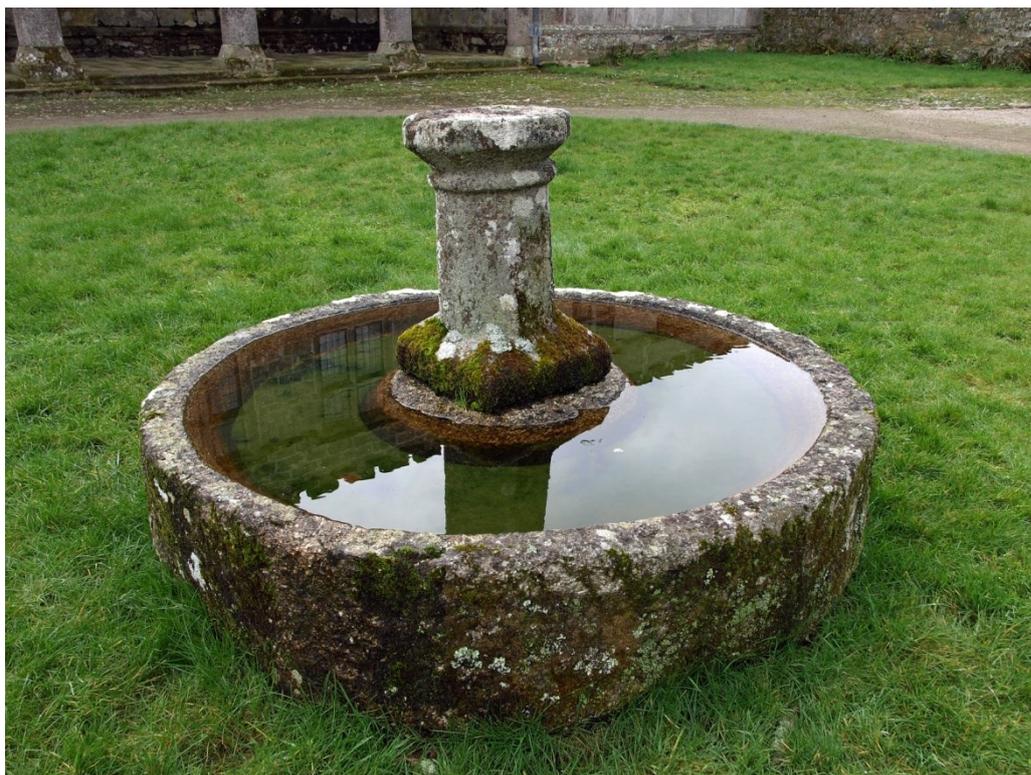
Fig 35 Cider mill base now displayed in forecourt with pedestal or possible piscina balanced on top

When the apples were ready to be processed they were passed from the apple loft to the processing room on the ground floor via a chute or trap door in the floor. The apples were almost certainly fed directly from the chute into the trough of a mill. The mill appears to have been located just to the south of the central point in the room and consisted of a large circular granite trough which held the apples and in which a smaller granite crushing wheel was set vertically. This wheel was attached via a horizontal rod to a vertical pivot at the centre of the trough. The mill was almost certainly powered by a person rather than a horse. This would have involved pushing a handle attached to the granite wheel and walking in circles around the trough crushing the apples with the weight of the turning wheel. The apples were milled in this way until they formed a pulp called pomace or pomage. The granite trough has been reused as a garden ornament and now stands in the forecourt at the front of the house with a moulded granite pedestal or possible piscina from elsewhere balanced on top of it (Fig 35).

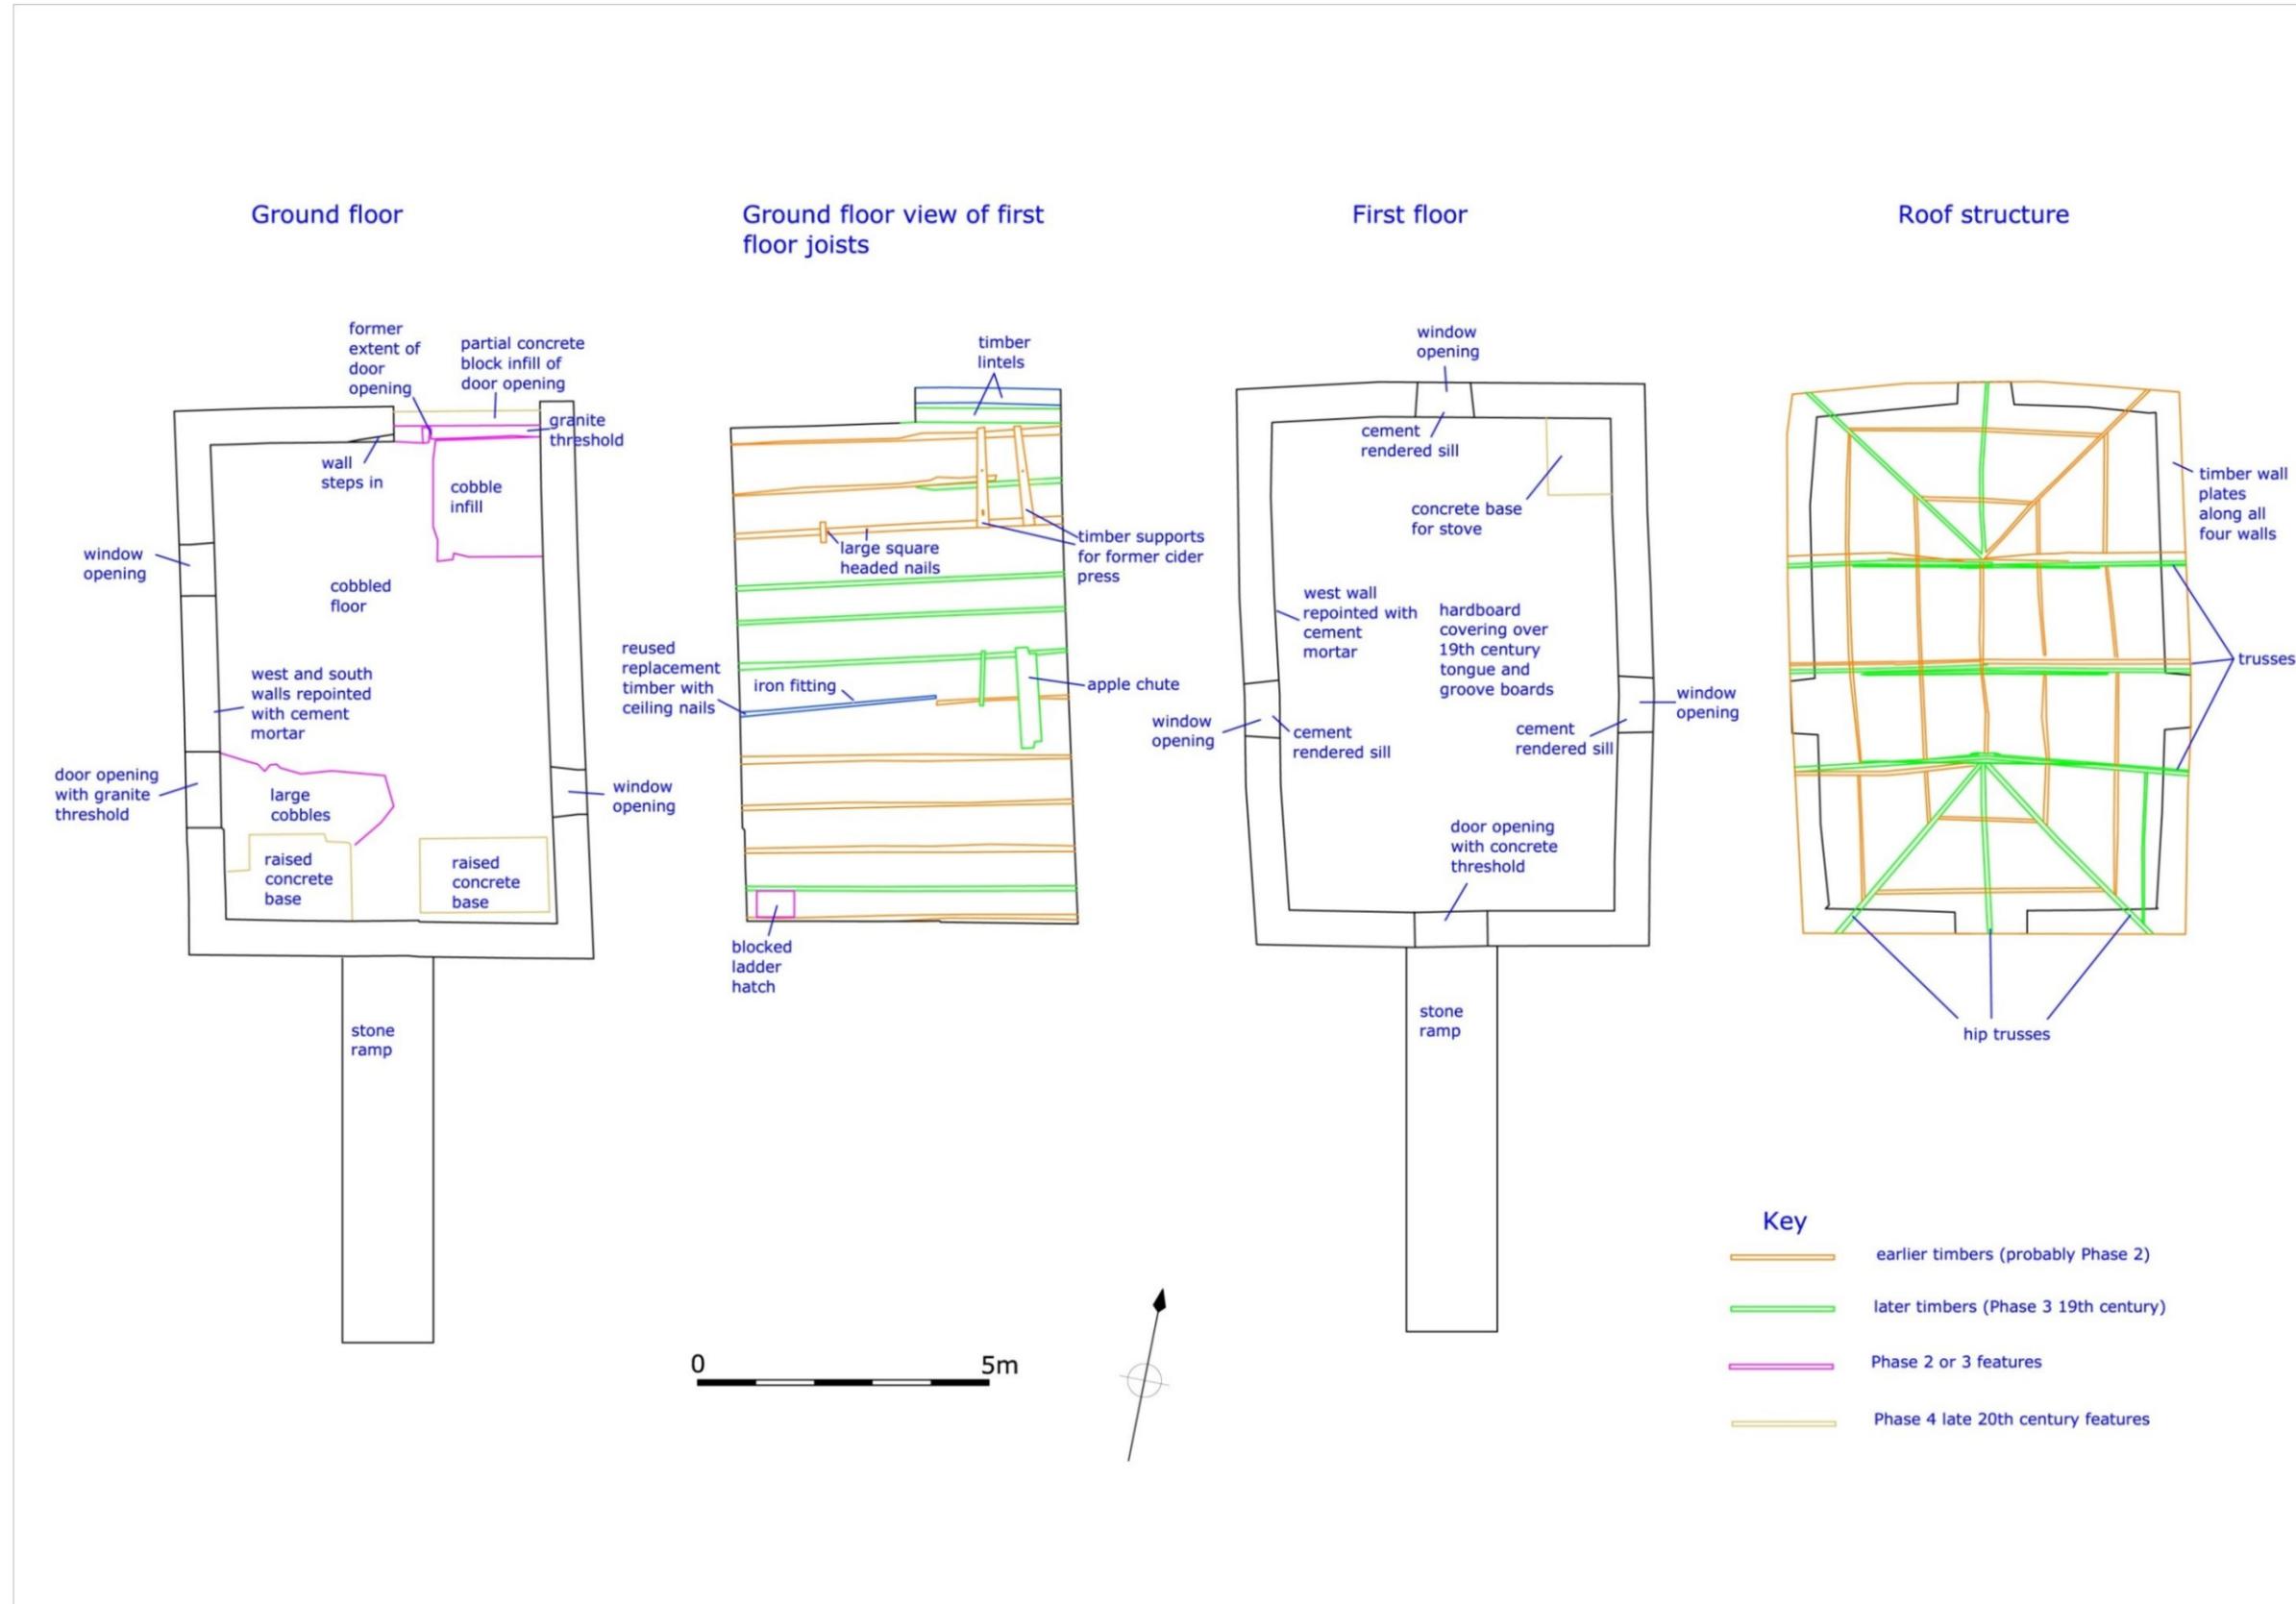
Fig 36 Floor plans and roof plan

The building is rectangular in plan measuring approximately 9.3m long by 6.9m wide externally and is aligned approximately north-south in an isolated area of former orchards to the north-west of Godolphin House. It is a two-storey structure with a single room space on the ground floor where apples were crushed and pressed and another single room at first floor level for use as an apple loft. It is built from coursed granite rubble with small granite and slate snecks between the blocks which are bonded with a pale yellowy brown earth (clay) mortar. The walls measure approximately 0.6m in width. The exterior north and west elevations have been heavily repointed with a white cement mortar. All the jambs and quoins are dressed granite but the lintels are a mix of both dressed granite and timber. Adjoining the south elevation and constructed as part of the original structure is a coursed granite rubble-built ramp (formerly steps) bonded with the same earth mortar as that used in the main building. The ramp leads to a door opening at first floor level giving access to the apple loft. It measures 1.55m in width and extends from the building for a distance of 6.6m southwards.
