DG5 Sewer repair and flood alleviation works in central Truro, Cornwall

Archaeological watching brief

Client	South West Water Ltd
Report Number	2015R003
Date	March 2015
Status	Final
Report author	Anna Lawson-Jones
Checked by	Charles Johns
Approved by	Andrew Young

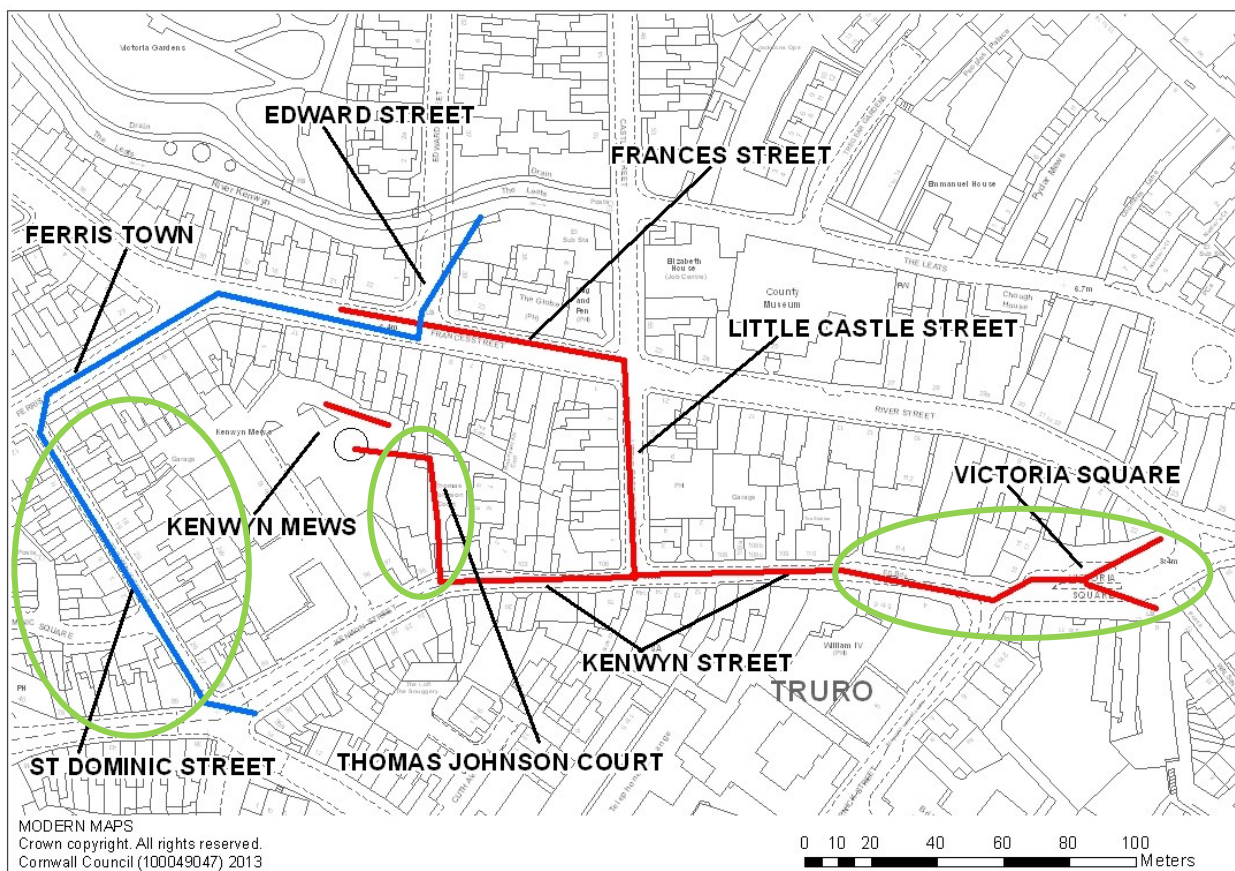
Fig 2 Site extent within Truro with all affected streets named. Blue line shows surface water pipeline, red line shows foul water pipeline, and the green ovals are areas of new or deeper pipe coursing.

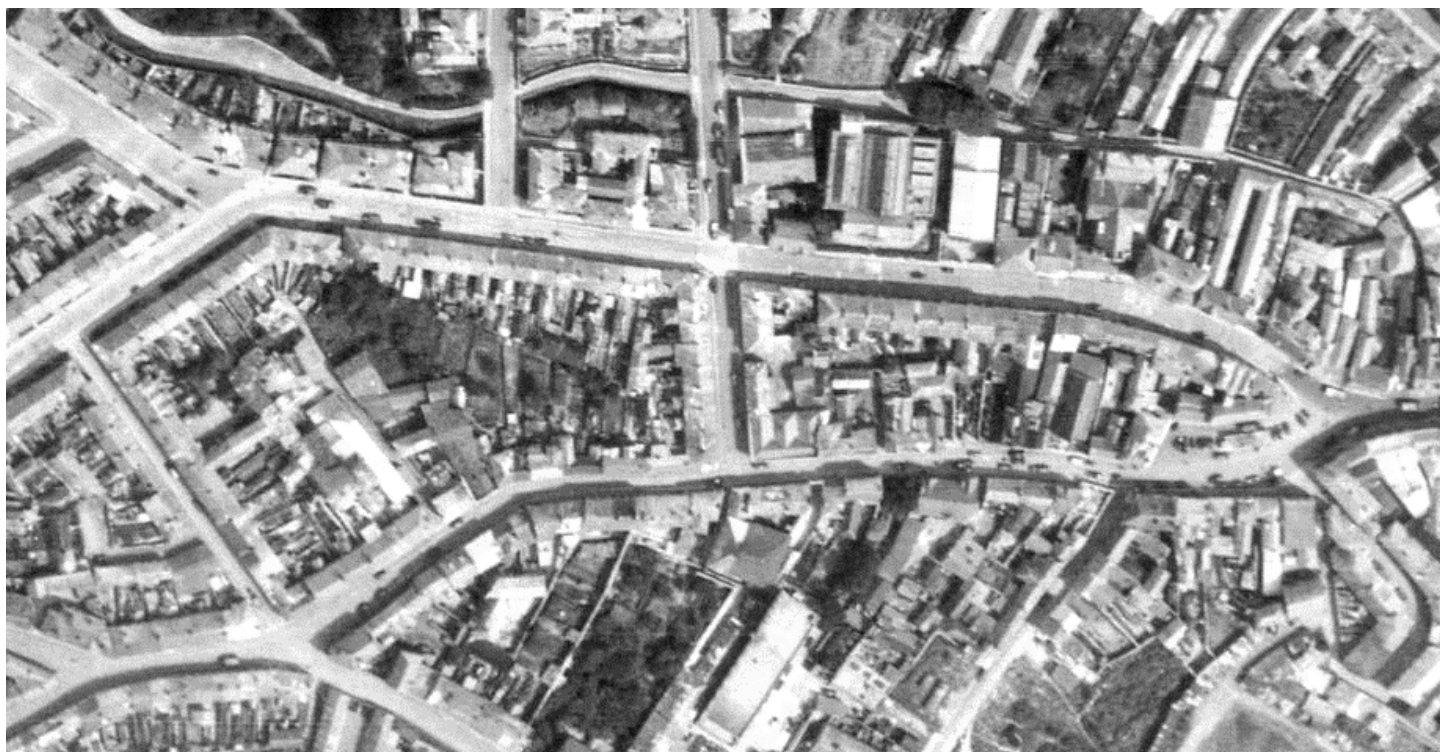
Fig 9 Second World War aerial photograph taken on 12th July 1946 (no. 4406).
Note the undeveloped area around the Friary Well site.

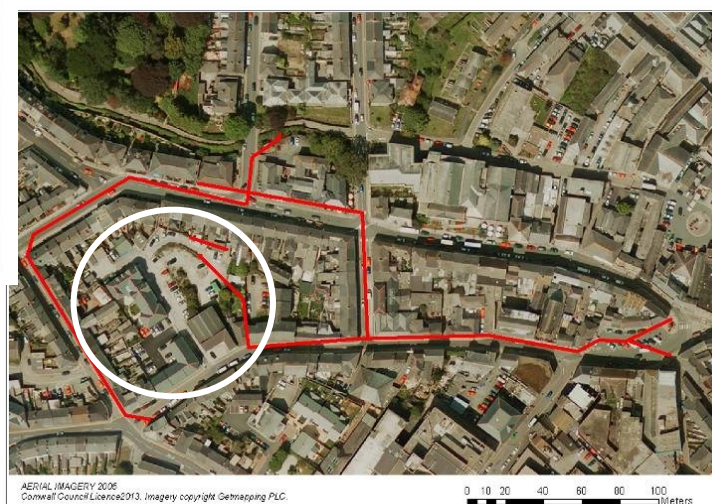
Fig 10 Aerial photographs for 2000 (top) and 2005 (bottom) showing the route of works in red and significant alterations around the Site of the Friary Well (white circle).

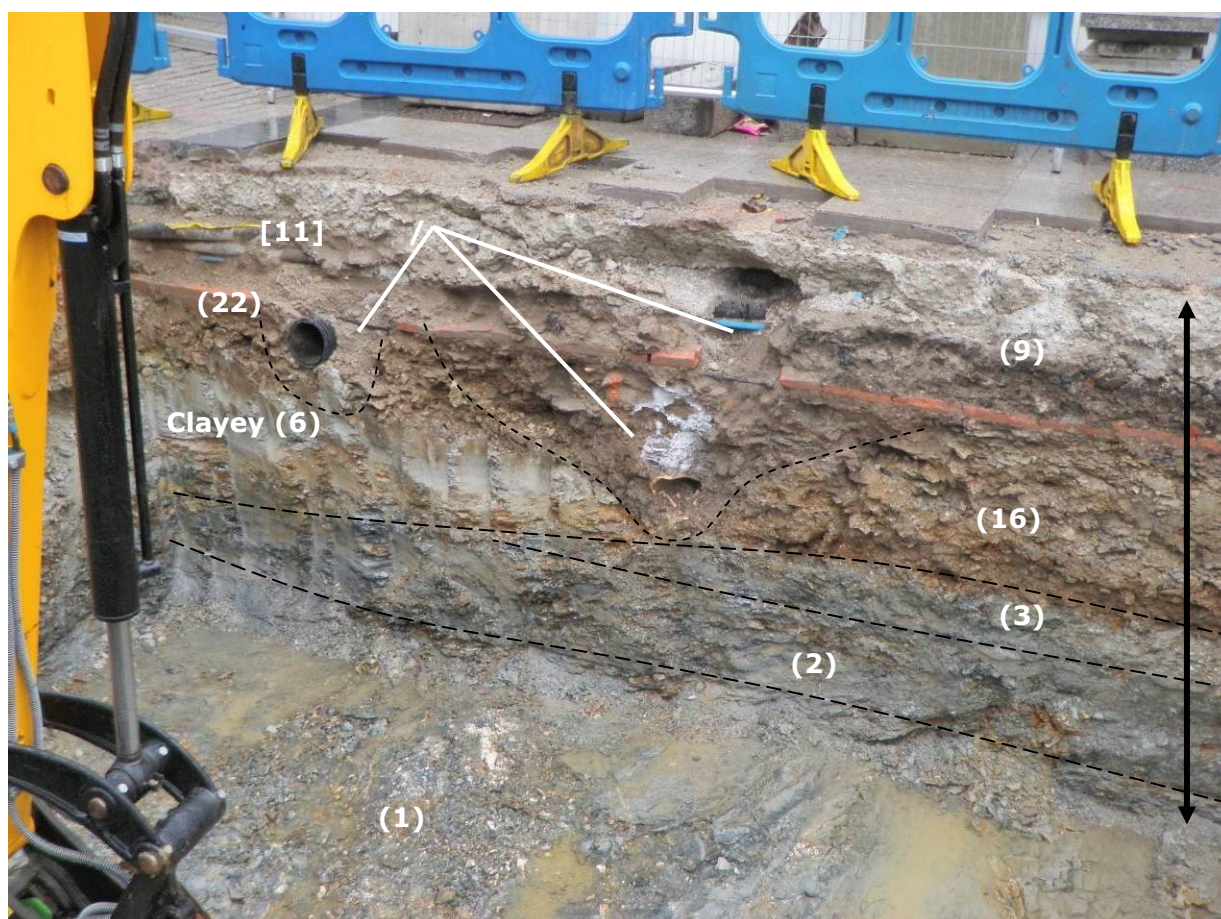
Fig 11 Looking north across the Combined Sewer Outfall (CSO) excavation, located in central Victoria Square (September 2013). The arrow is 3m long.

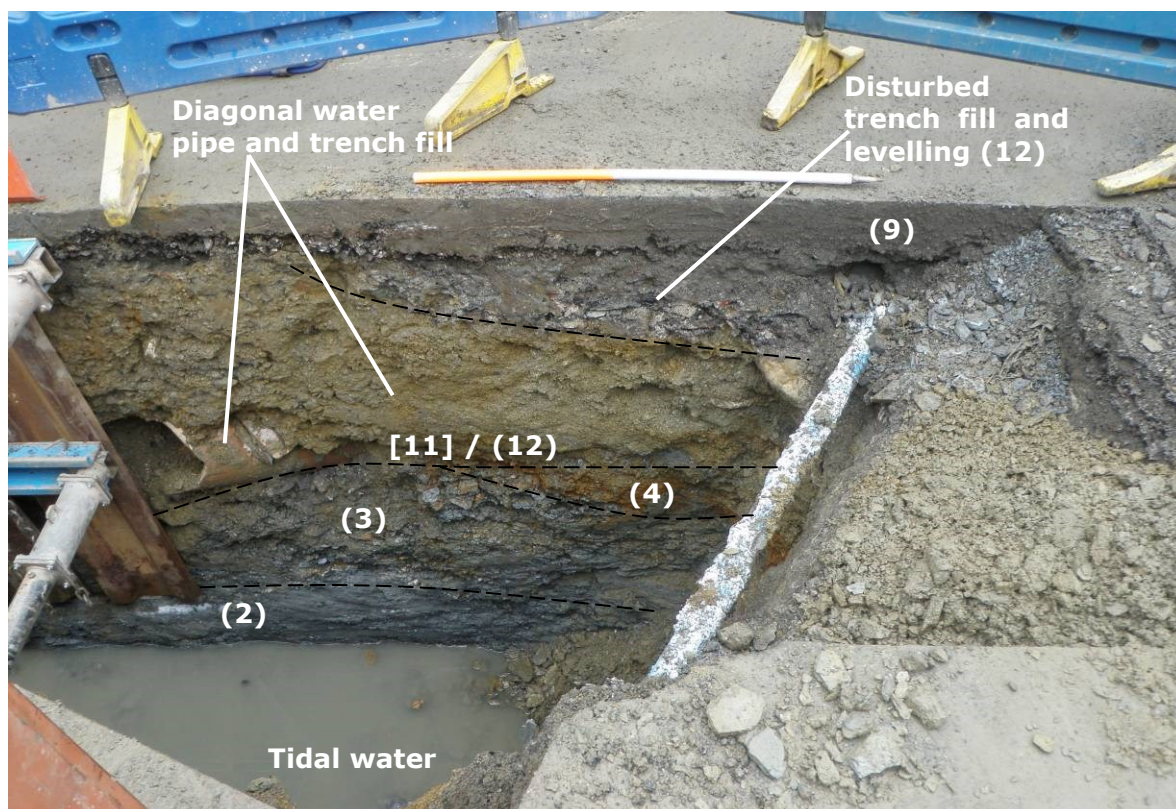
Fig 12 The eastern end of the northern trench extending east from the CSO excavation across Victoria Square. The visible section is 1.5m deep.

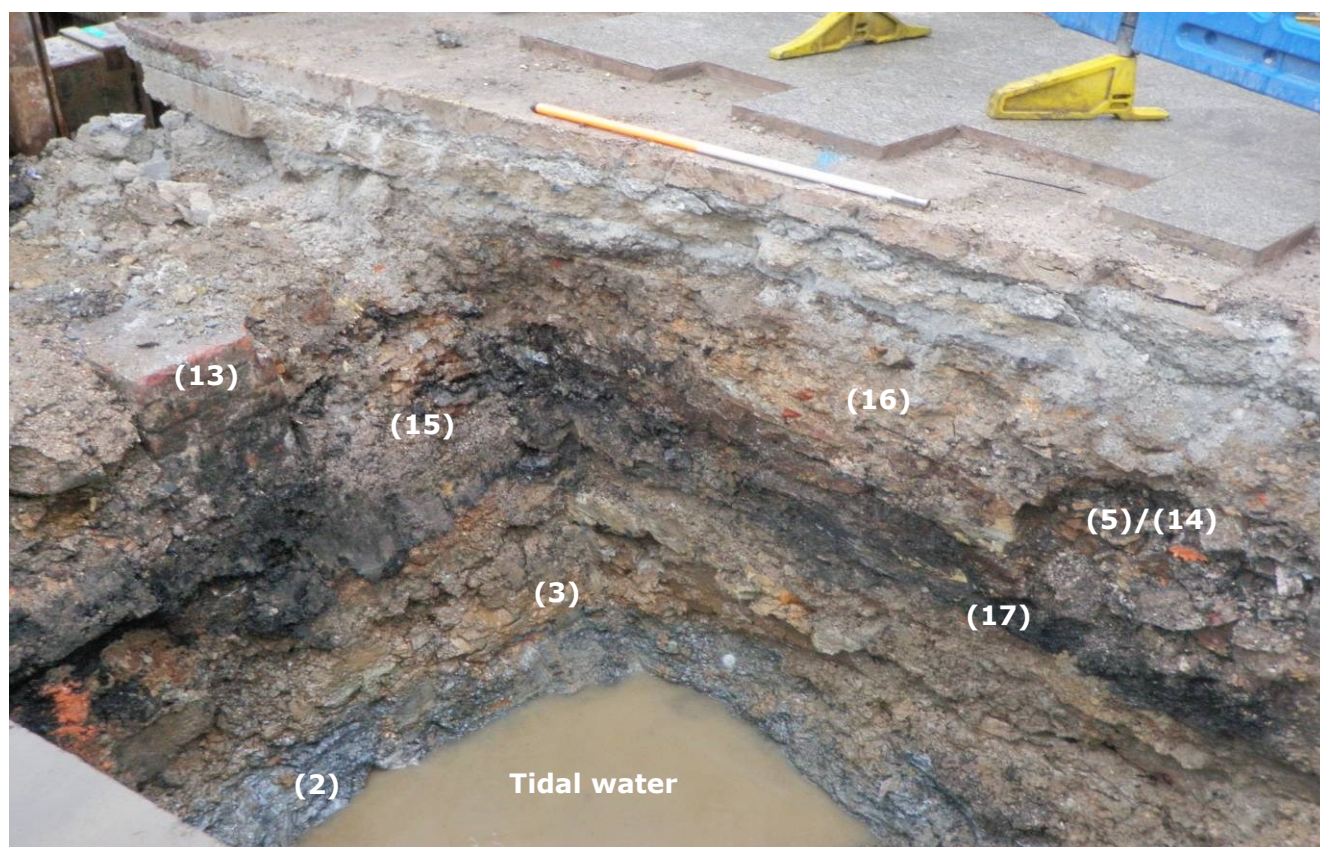
Fig 13 Looking northwest across the north eastern trench running from the CSO excavation in Victoria Square, showing crucible deposit (14). 1m ranging rod.

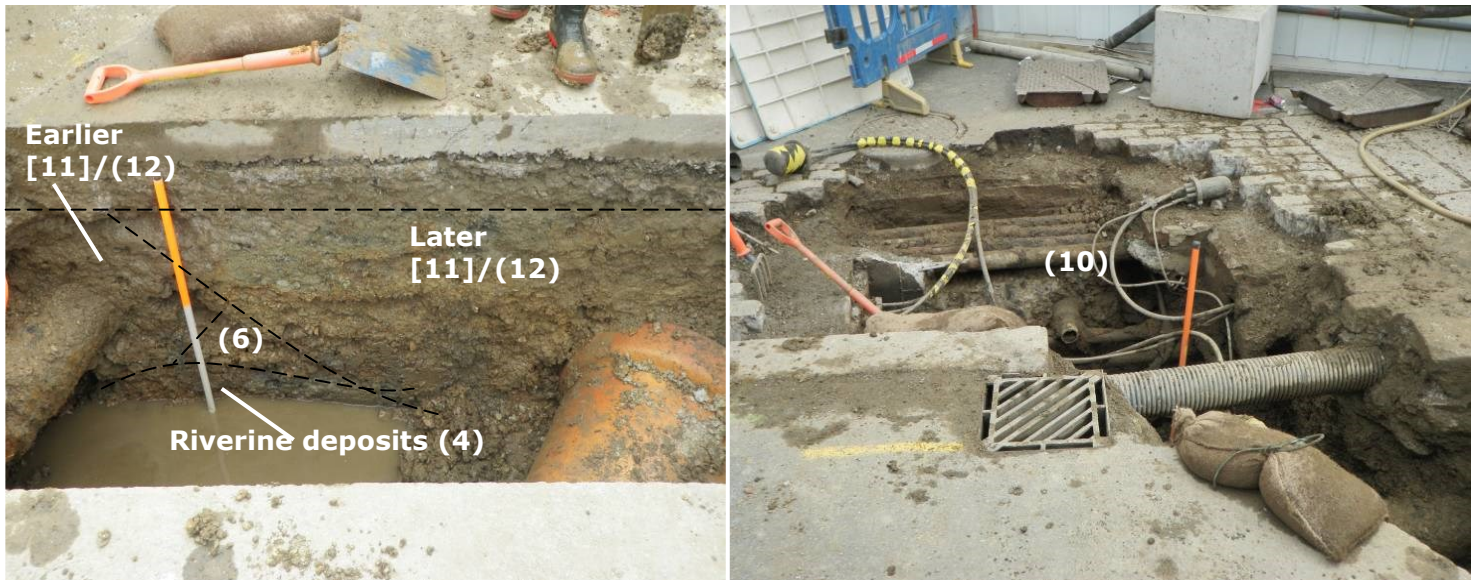
Fig 14 Two photos looking southwest and southeast across the south eastern trench running from the CSO excavation, showing substantial disturbance associated with a huge ceramic storm drain, and the eastern end of the trench where a mass of different service pipes converge.

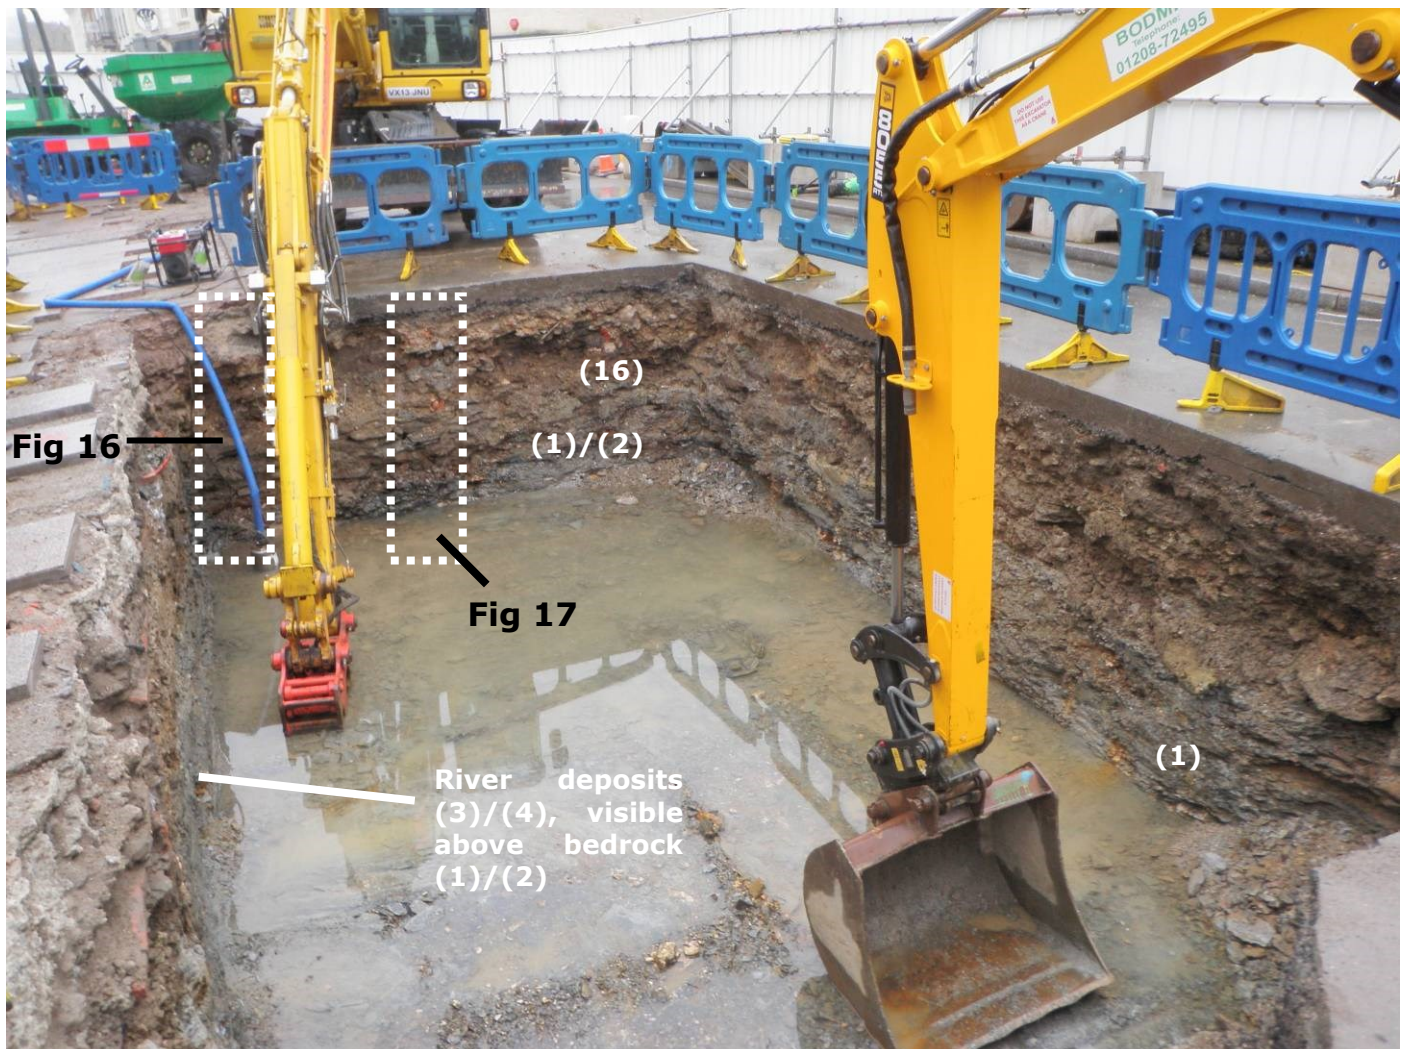
Fig 15 Looking east across the excavated CSO showing the long southern section (right side) and shorter eastern section prior to tunnelling pushing through from the east causing the approximate collapse of 0.2m of section to reveal wall fragment 18 and cut [20].

Cut [20] was recorded as an approximate 0.5m high, north to south aligned, east-facing cut through bedrock. To the near immediate west is the CSO which cut through decayed bedrock (see Fig 15 and 17). Figure 17 shows the inside of the cut to have been filled with loose, decayed shillet (**21**) which when exposed by tunnelling almost immediately slumped into the tunnel through tidal flow and instability. Context (21) was not water sorted or abraded, and as such is likely to represent dumped material associated with later infilling and build-up.

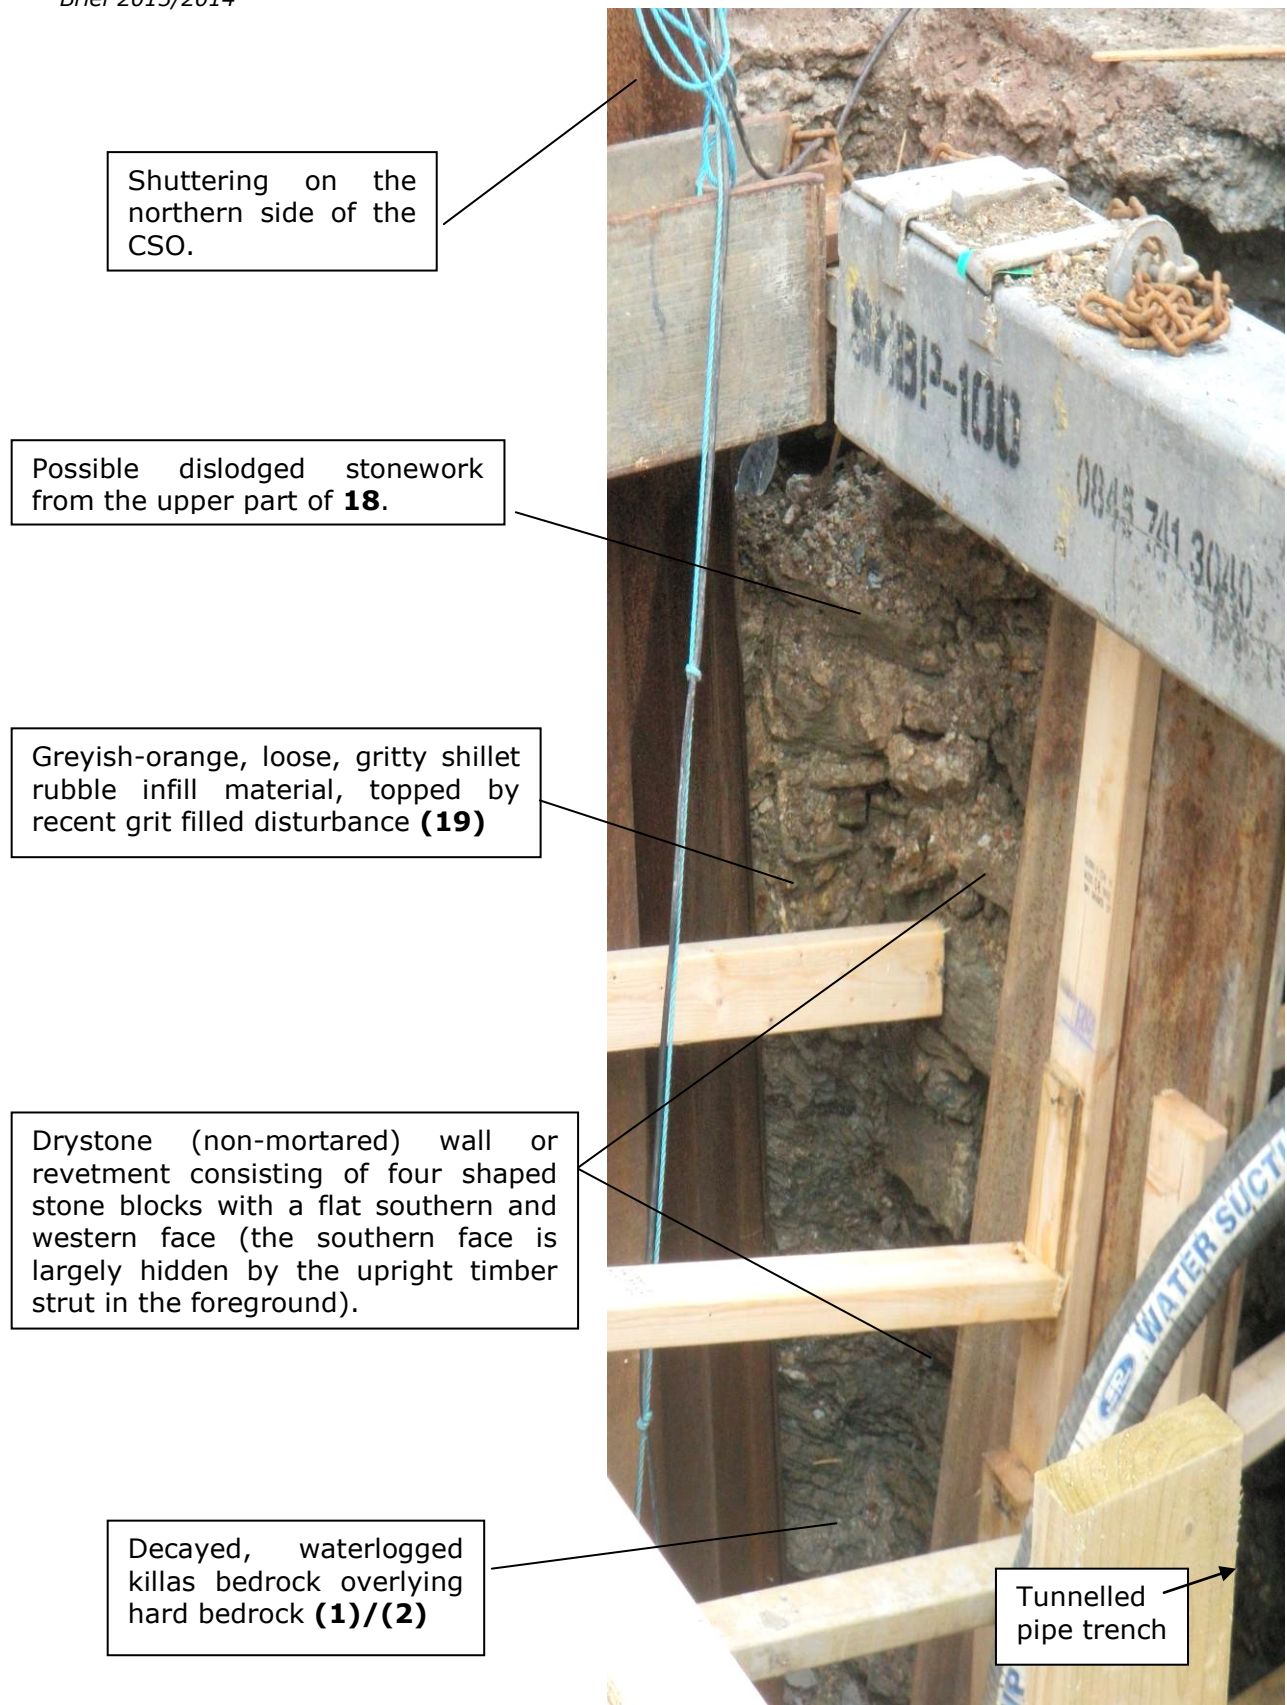
Fig 16 Fragment of drystone walling 18 revealed by the collapse of the eastern side of the CSO where trench tunnelling breached the north-east corner. A 3m depth is shown.

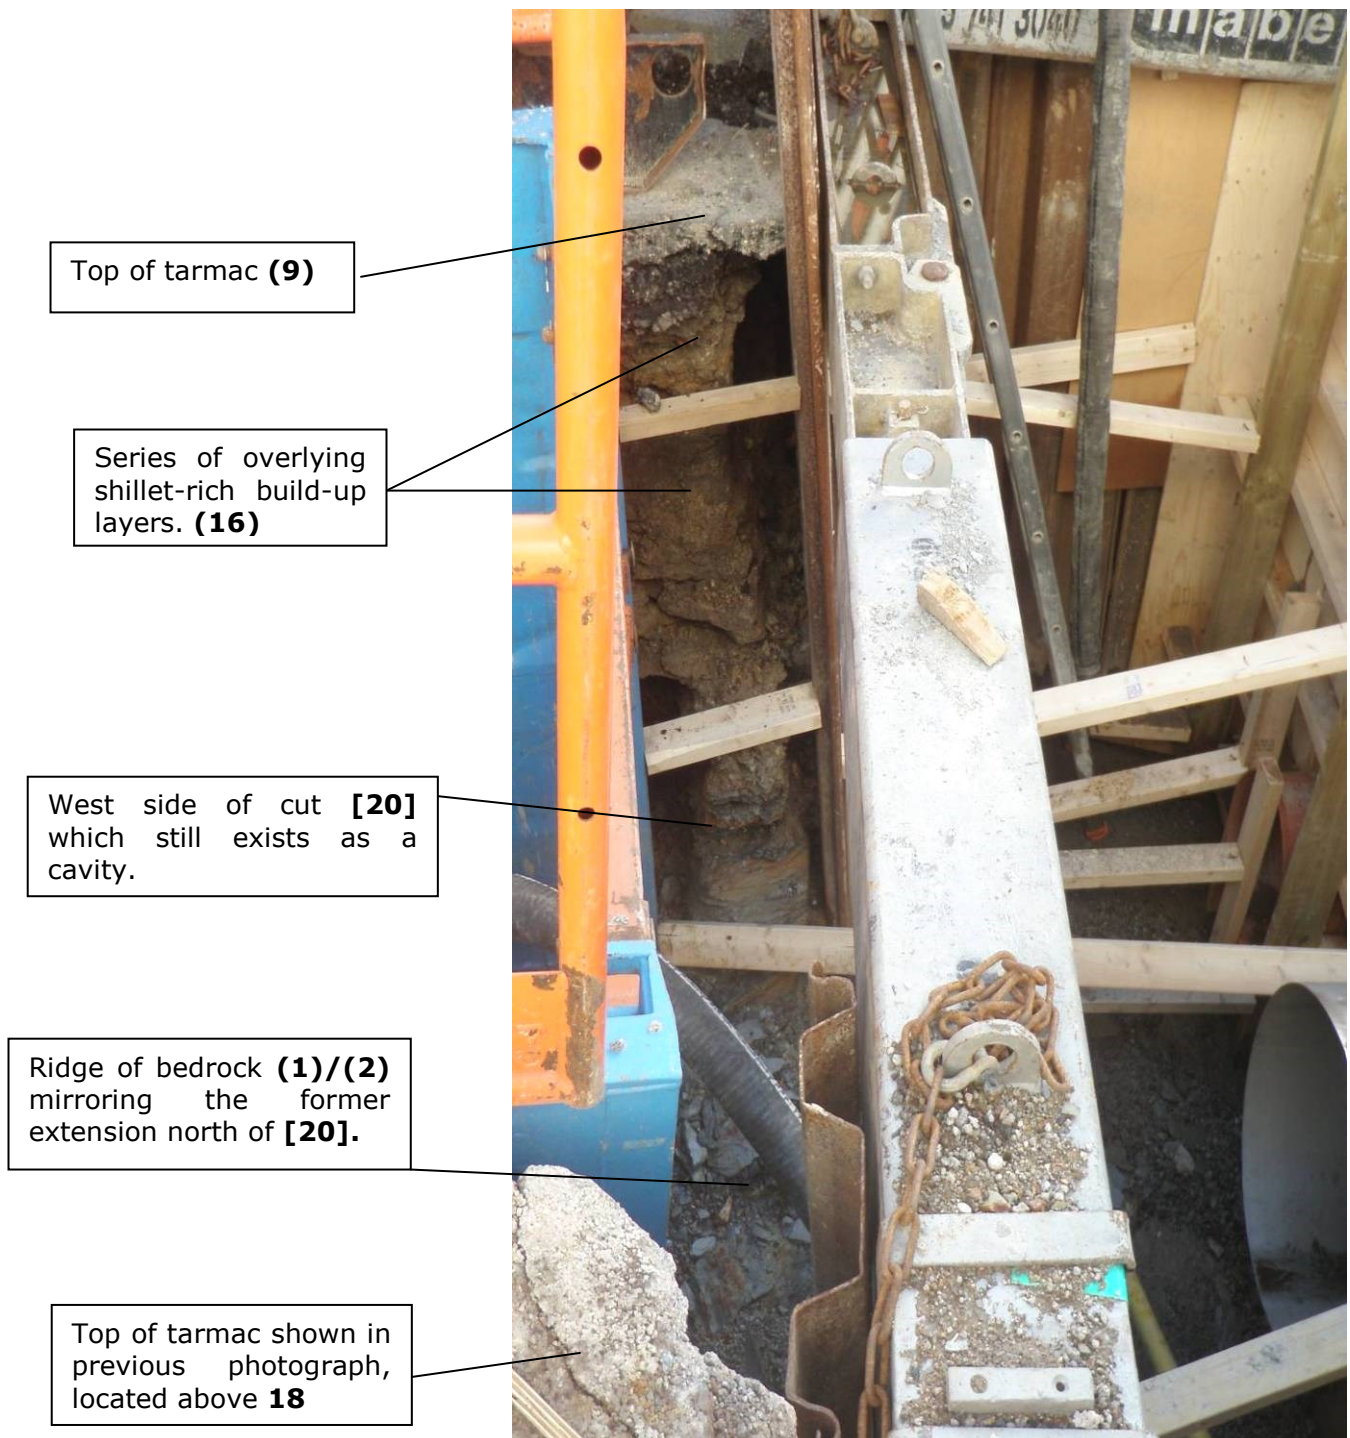
Fig 17 Looking south across cut [20], identified on the extreme eastern side of the CSO. It has been cut through by tunnelling which runs east from the CSO. 3m depth shown. The blue shuttering flanks either side of tunnelled pipe trench, while the visible pipe runs east from the CSO along the north-eastern trench.

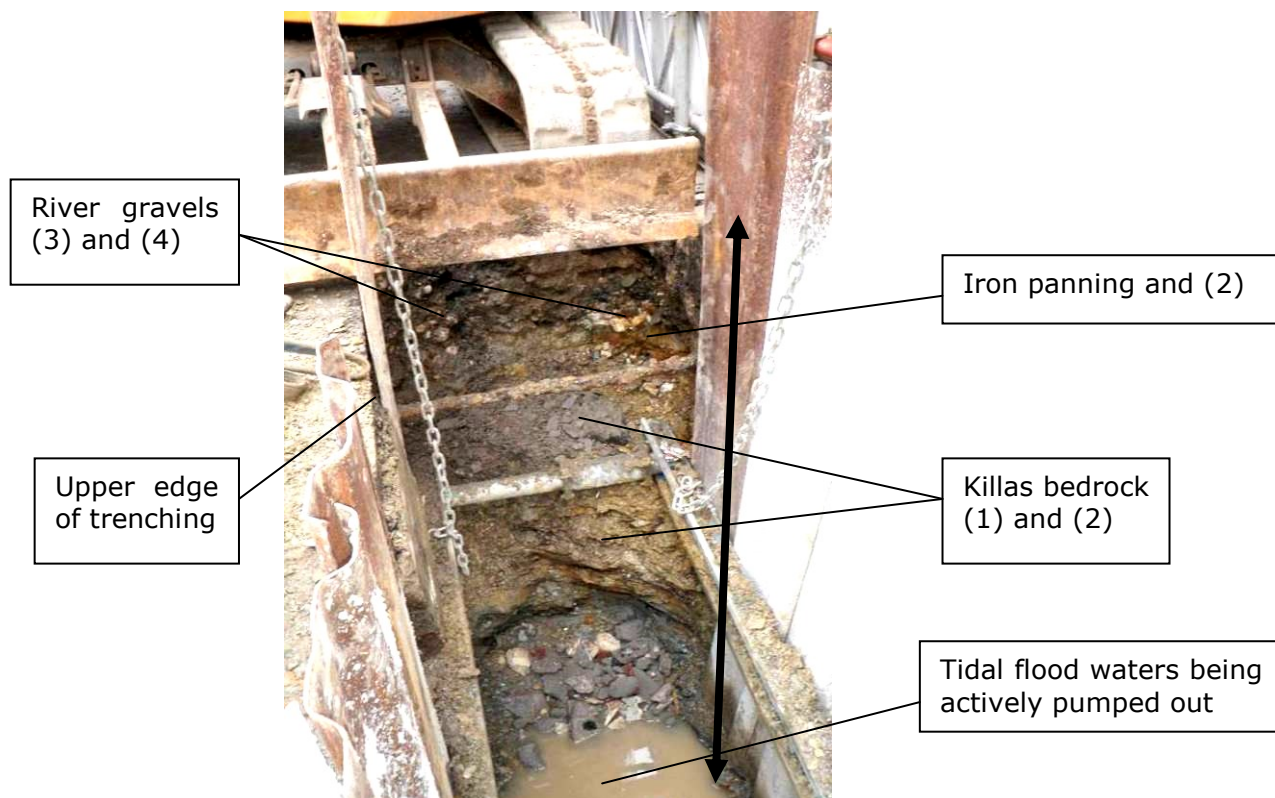
Fig 18 Looking west towards Kenwyn Street from the side of Lavenders, showing the high level of river gravel deposits. The scale arrow is 2.3m long.

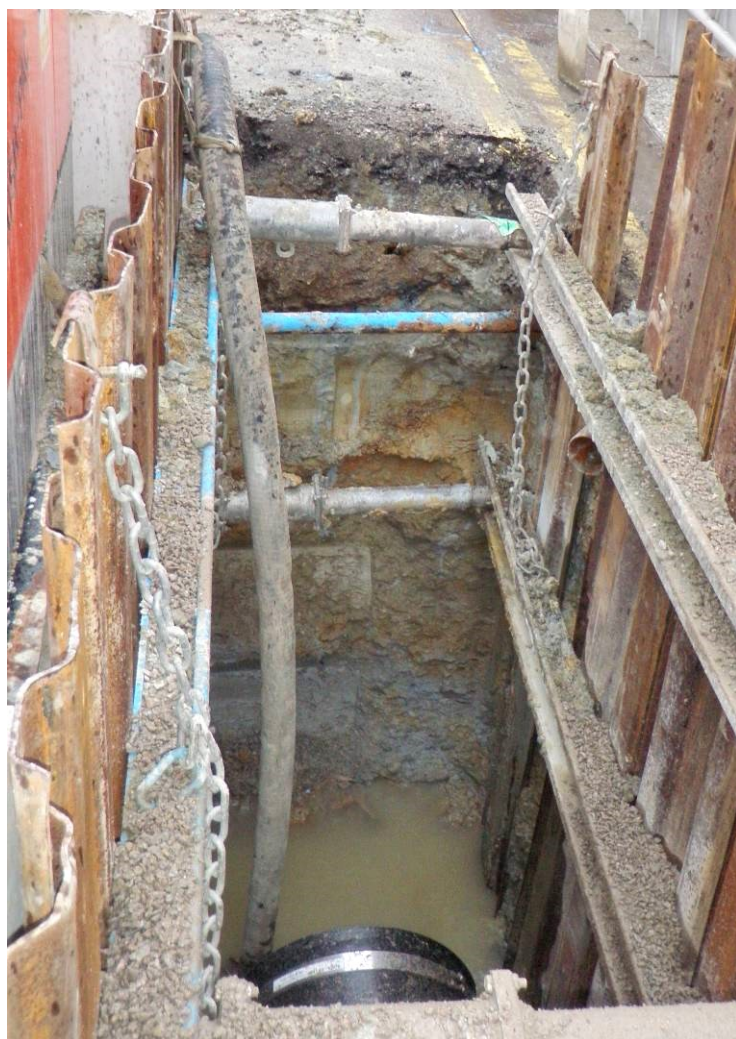
Fig 19 Looking west along part of the Lower Kenwyn Street trench located between Piero's pizza restaurant and William IV pub.

The section shows from the bottom up, gleyed blue-grey clay, brown clay shillet and then pale orange clay (all of which are naturally deposited), topped by a more recently redeposited mixed grey shillet-rubble-like deposit, a thin black burnt shillet-rich spread and a 0.4m maximum brown clay shillet topped by tarmac. The whole section measured 2.2m deep.

NOTE: No river gravels were identified beneath the grey clay, although a very similar sequence of deposits (type and colour) was recorded above river gravel in the trenching between Thomas Johnson Court and Kenwyn Mews (almost 200m to the west-north-west).

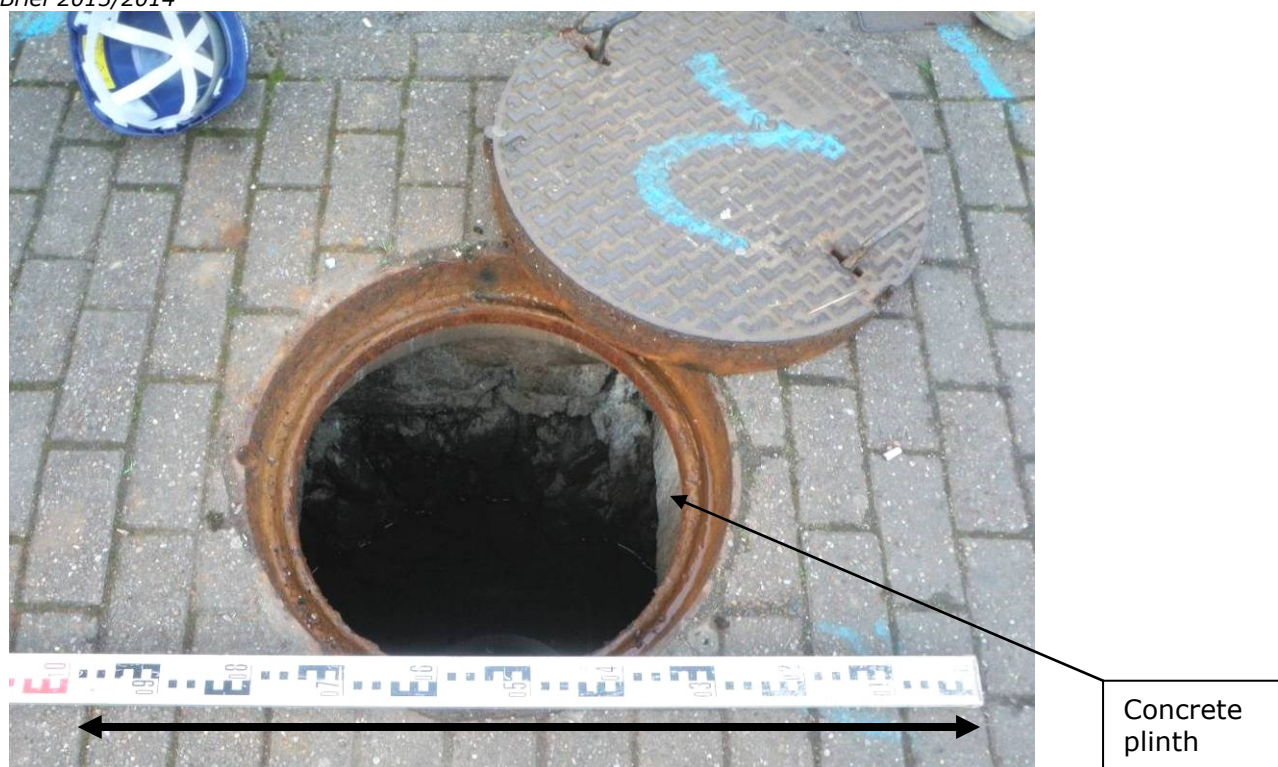
Fig 20 Looking north across the top of the well opposite The William IV on Kenwyn Street. The arrow is 1m long.

It is probable that this well is one of a number of former wells within the city, which were used to provide clean water, in preference to the increasingly foul rivers that ran through Truro. The water appeared to be very clear and fresh, with no hint of brackishness despite the proximity of tidal water. The original date of the well is unknown.

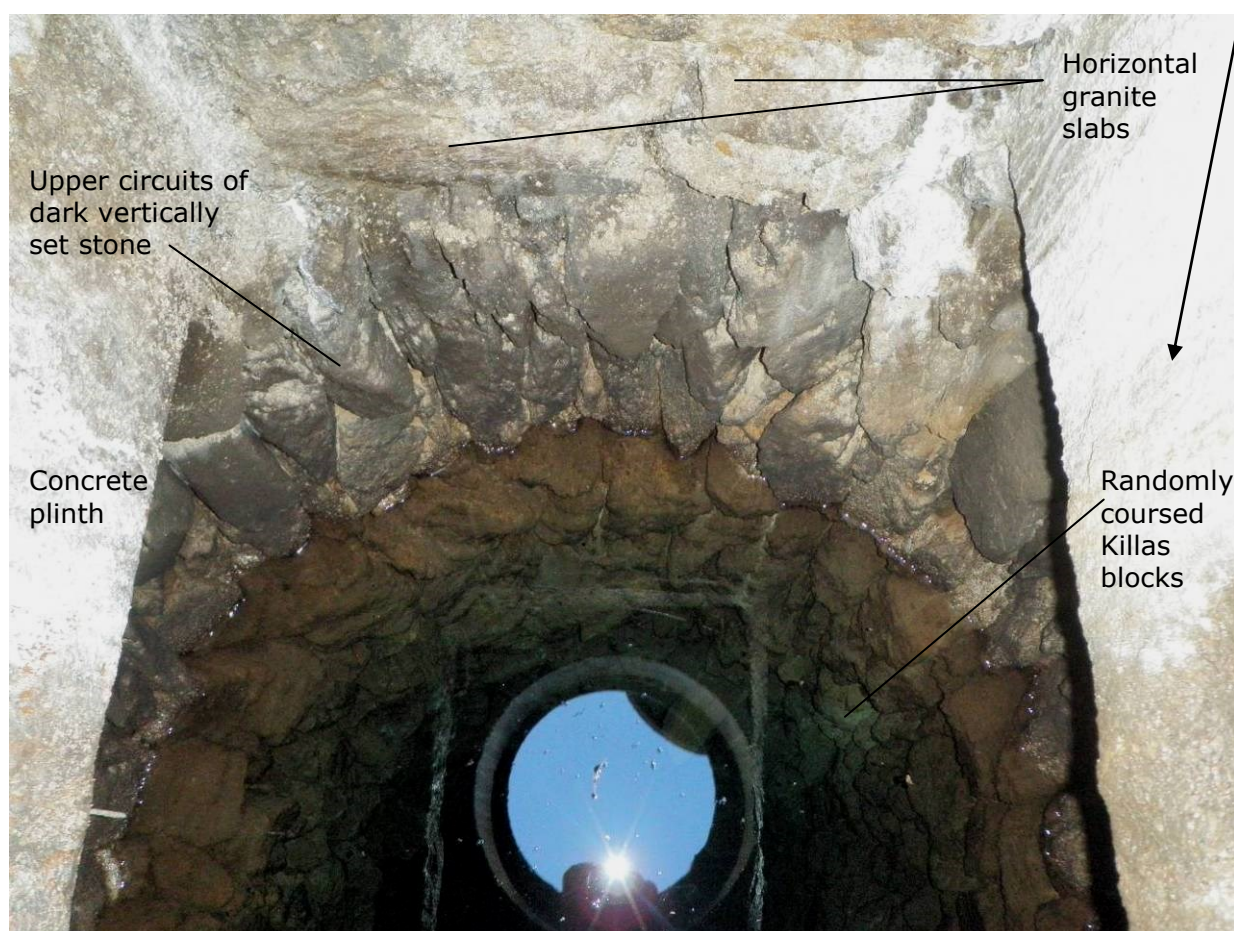
Fig 21 Looking north and down the 6m deep post-medieval well located opposite the William IV. Note the high water level c1m below current footpath.

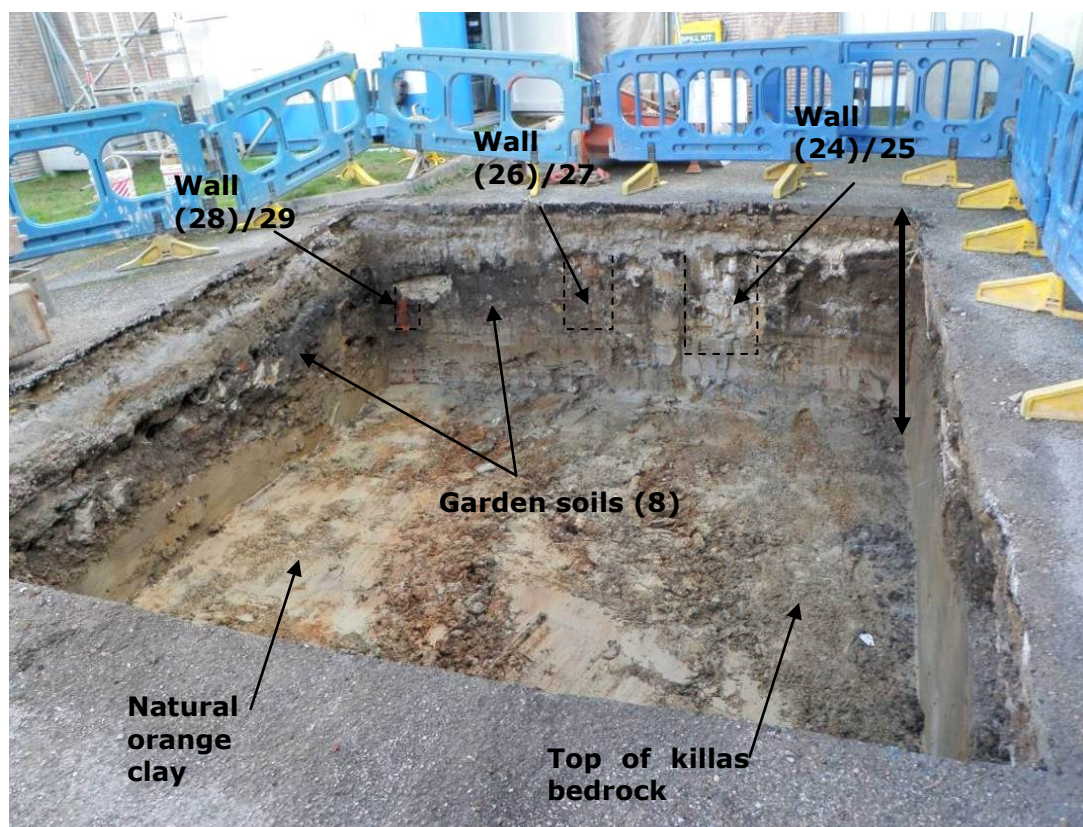
The northern pit was excavated in Thomas Johnson Court and is shown in Figure 22. Here a 0.4-0.6m deep layer of tarmac and hard core grits **(9)** overlay a 0.4-0.6m deep layer of what appeared to be deep mixed, loamy largely stone-free garden soils **(8)**, which had seen some disturbance. Their presence, close to, but off the main thoroughfare of Kenwyn Street further implies the deliberate removal of soils from beneath the early road build-up. It suggests that the eastern, lower portion of Kenwyn Street would have looked like and acted as a causewayed approach to the city during the medieval period. Walls **25, 27 and 29** were all recorded in the southern side of the pit (discussed below). All were recent (post-medieval/modern) in date. At the base of the northern pit is a diagonal line separating killas bedrock from orange clay. The orange clay was bright and dense, probably representing a natural fissure within the geology and which possibly helped dictate the course of the river?

Fig 22 Looking south across the Thomas Johnson Court pit showing modern surfacing, over garden soils, wall foundations and possibly natural fissuring which may have dictated the course of the river? The pit was subsequently deepened. Note the natural slope down from right to left of the killas bedrock as it drops down beneath the naturally redeposited orange clay. This clay may represent the upper of two naturally deposited layers (seen further to the north-west-Figure 24) infilling the former river bed. The killas here may represent the one time edge of the River Kenwyn? The arrow is 2m long.

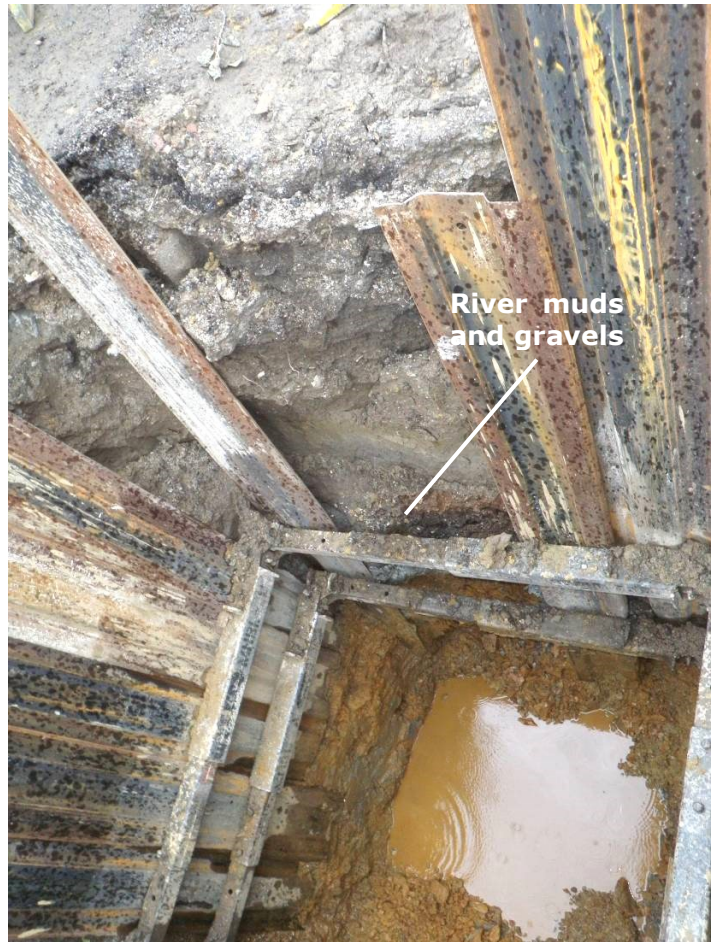
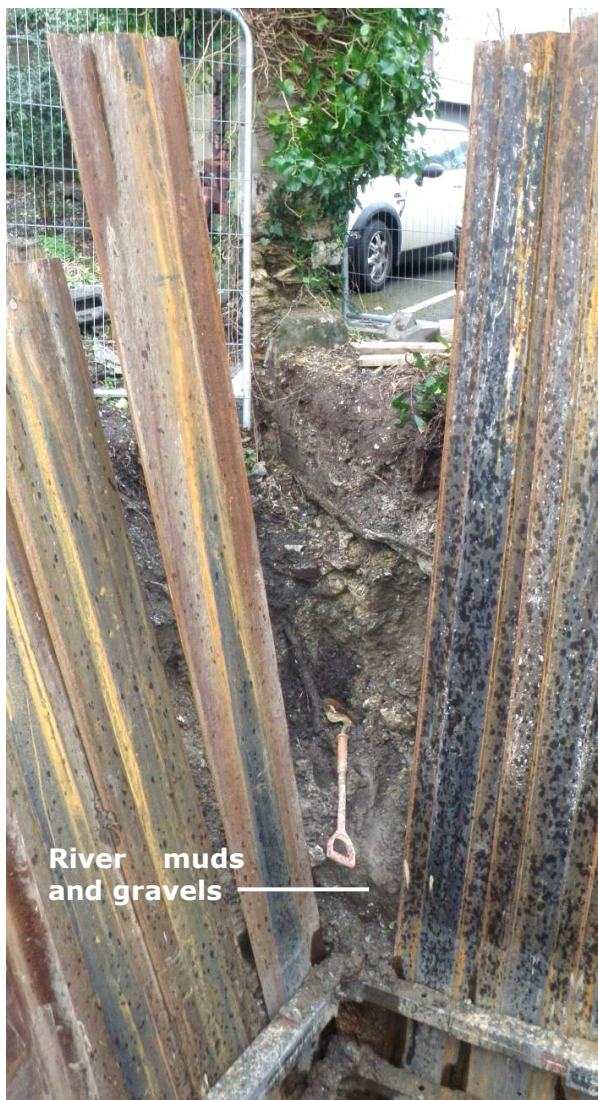
Showing from the bottom up: orange bedrock at the base, overlain by river gravels (near the horizontal bars); compact clean grey clay; pale brown silty clay; dry brown clay loam with occasional shillet possible demolition rubble, breeze blocks and white pottery; loose hard core and thin fragmented tarmac.

NOTE: these two photographs are about 3m apart.

Fig 24 Looking north-west in to Kenwyn Mews down the c5m deep trench/pit at the junction between Thomas Johnson Court and Kenwyn Mews, showing an approximate 4m deep section.

From the bottom up can be seen: orange bedrock between the horizontals; river gravels; dry pale grey silty clay with loam mixing in from above; dark grey/brown loam (see spade); un-cut shillet block wall; loose dry loam and rubble; thin concrete surface; loose loamy crushed shillet and occasional pottery; loamy ground surface.

Located some 5m to the north-west a different sequence of layers was revealed (see Fig 23 and 24). Here a 5m plus deep pit was excavated which revealed from top to bottom; thin fragmented tarmac; loose hard core; dry brown clay loam with occasional shillet and possible demolition rubble **(37)** (with breeze blocks and white pottery in its disturbed upper part); pale, un-disturbed orangey-brown silty clay **(36)**; compact clean grey clay silt **(35)**; river deposits **(3) and (4)** at an approximate 4m depth; and at the base dark reddish orange killas bedrock **(1)**. The pale orangey-brown silty clay may be associated with the more strongly orange clay seen in plan in the northern pit (Figure 22).

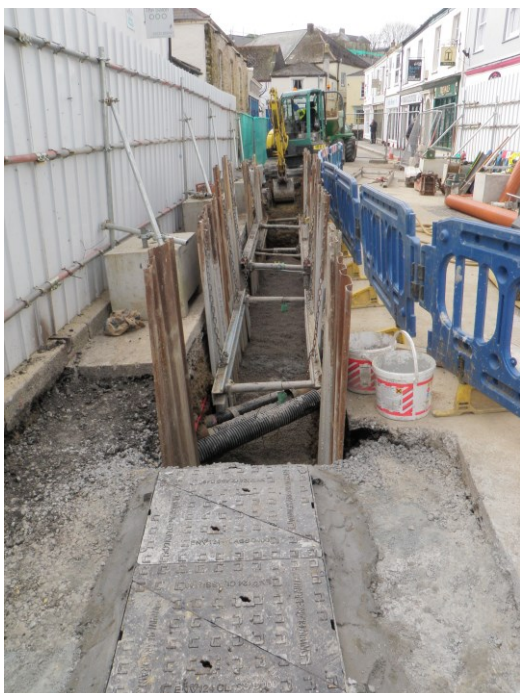
Fig 25 Looking south along Little Castle Street, showing pipe laying works in progress.

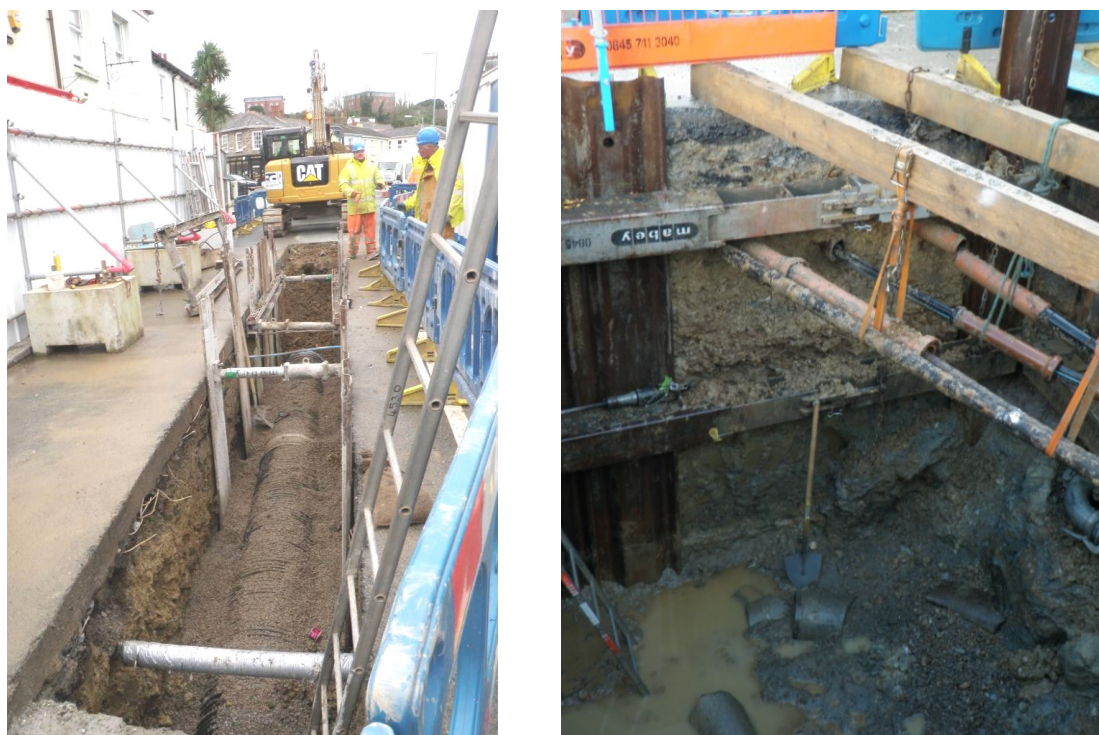
Fig 26 Left – looking west along St Frances Street, showing trenching and pipe laying in progress. Right – the north-western section of the 'launch pit', showing smashed ceramic pipes, and waterlogged deposits following heavy rain.

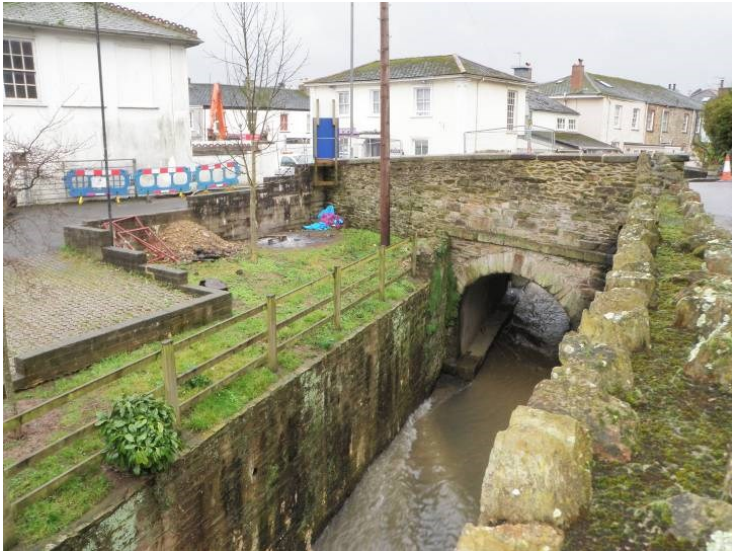
Fig 27 (left) Looking west along the River Kenwyn towards the Edward Street Bridge showing the area prior to works. The leat runs parallel to the river just to the right of the photograph.

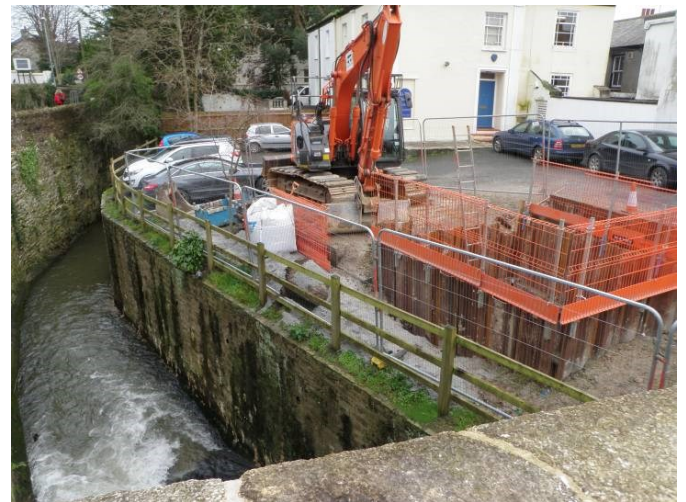
Fig 28 (right) Looking east along the River Kenwyn from the bridge, showing the large pit excavated close to the river edge, prior to tunnelling up from Frances Street and breaching of the river wall.

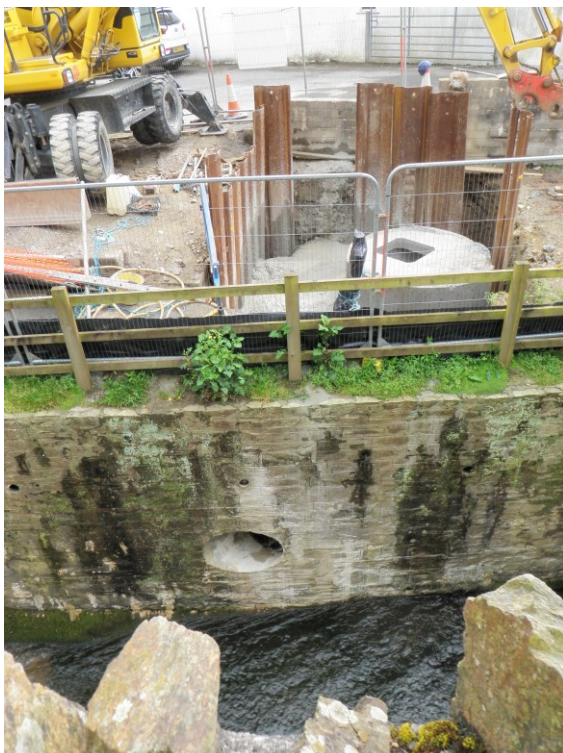
Fig 29 (left) Looking south showing the new overflow in place, prior to completion.
