DG5 Sewer repair and flood alleviation works in central Truro, Cornwall

Archaeological watching brief

Client	South West Water Ltd
Report Number	2015R003
Date	March 2015
Status	Final
Report author	Anna Lawson-Jones
Checked by	Charles Johns
Approved by	Andrew Young

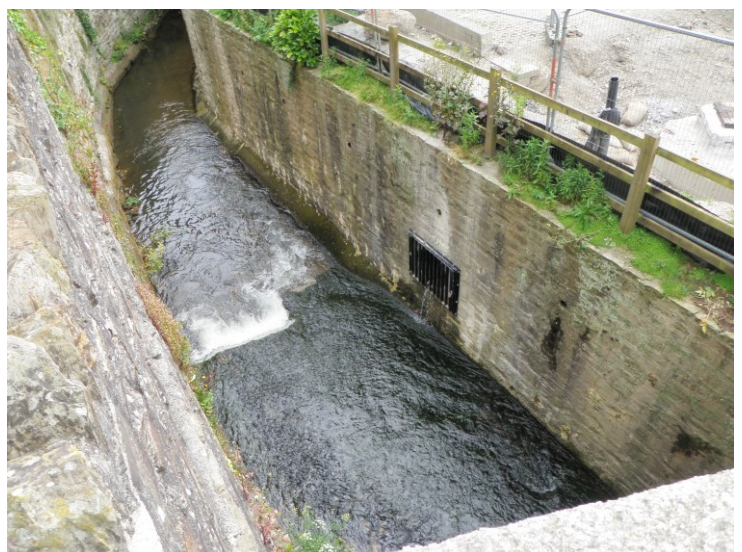
Fig 30 (right) Looking west showing the new overflow with black rectangular grill in place at the completion of works.

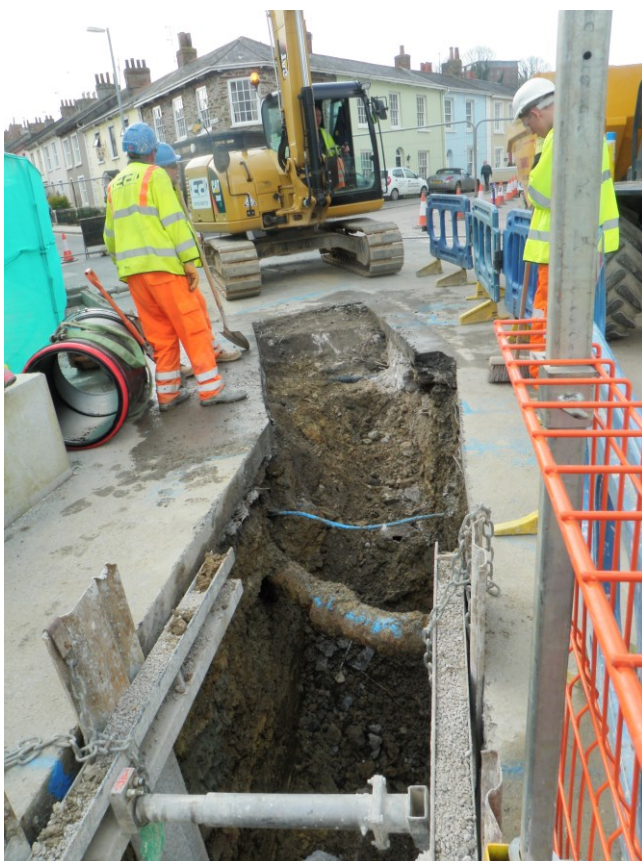
Fig 31 Looking west towards the Cheese Shop from the junction between Frances Street and Ferris Town, showing an approximate 2.8m deep trench section.

*Note: Sections seen along Ferris Town did not reveal free-running water deposits of rolled cobbles, pebbles and grits **(3)** and silts **(4)**, but did suggest pooled /flood water deposits.*

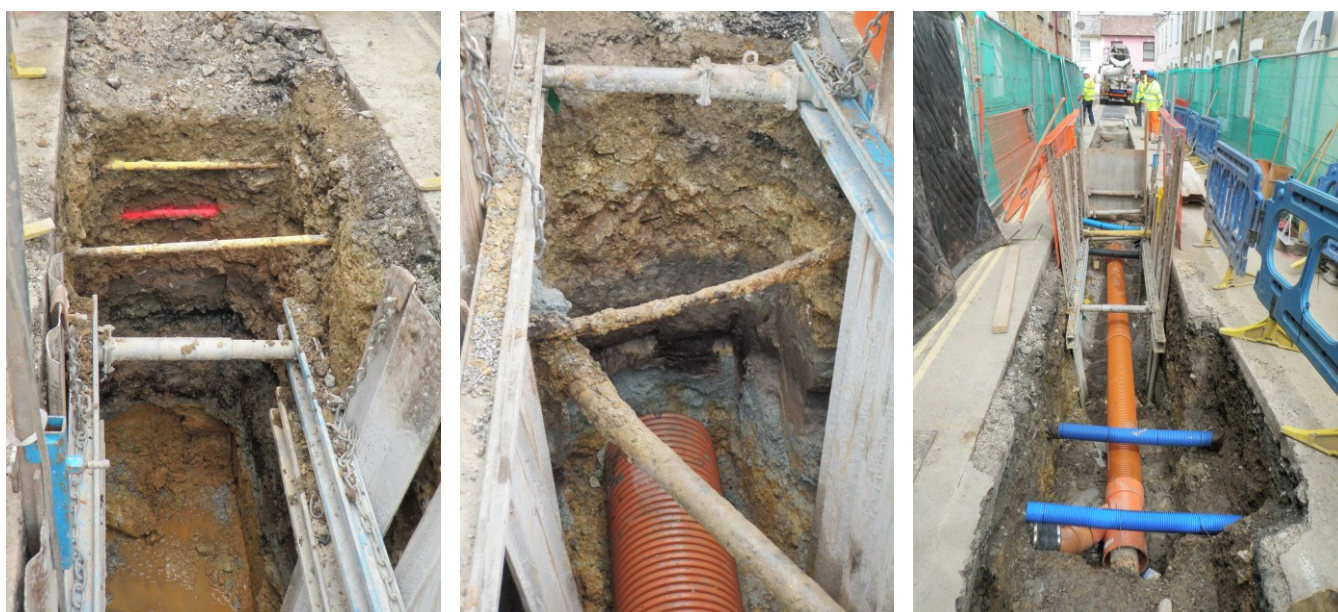
Fig 32 Left and centre - looking south-east from central St Dominick Street showing the build-up of deposits, crossing service pipes and the partially tidal water table. Right - looking north-west along St Dominick Street.

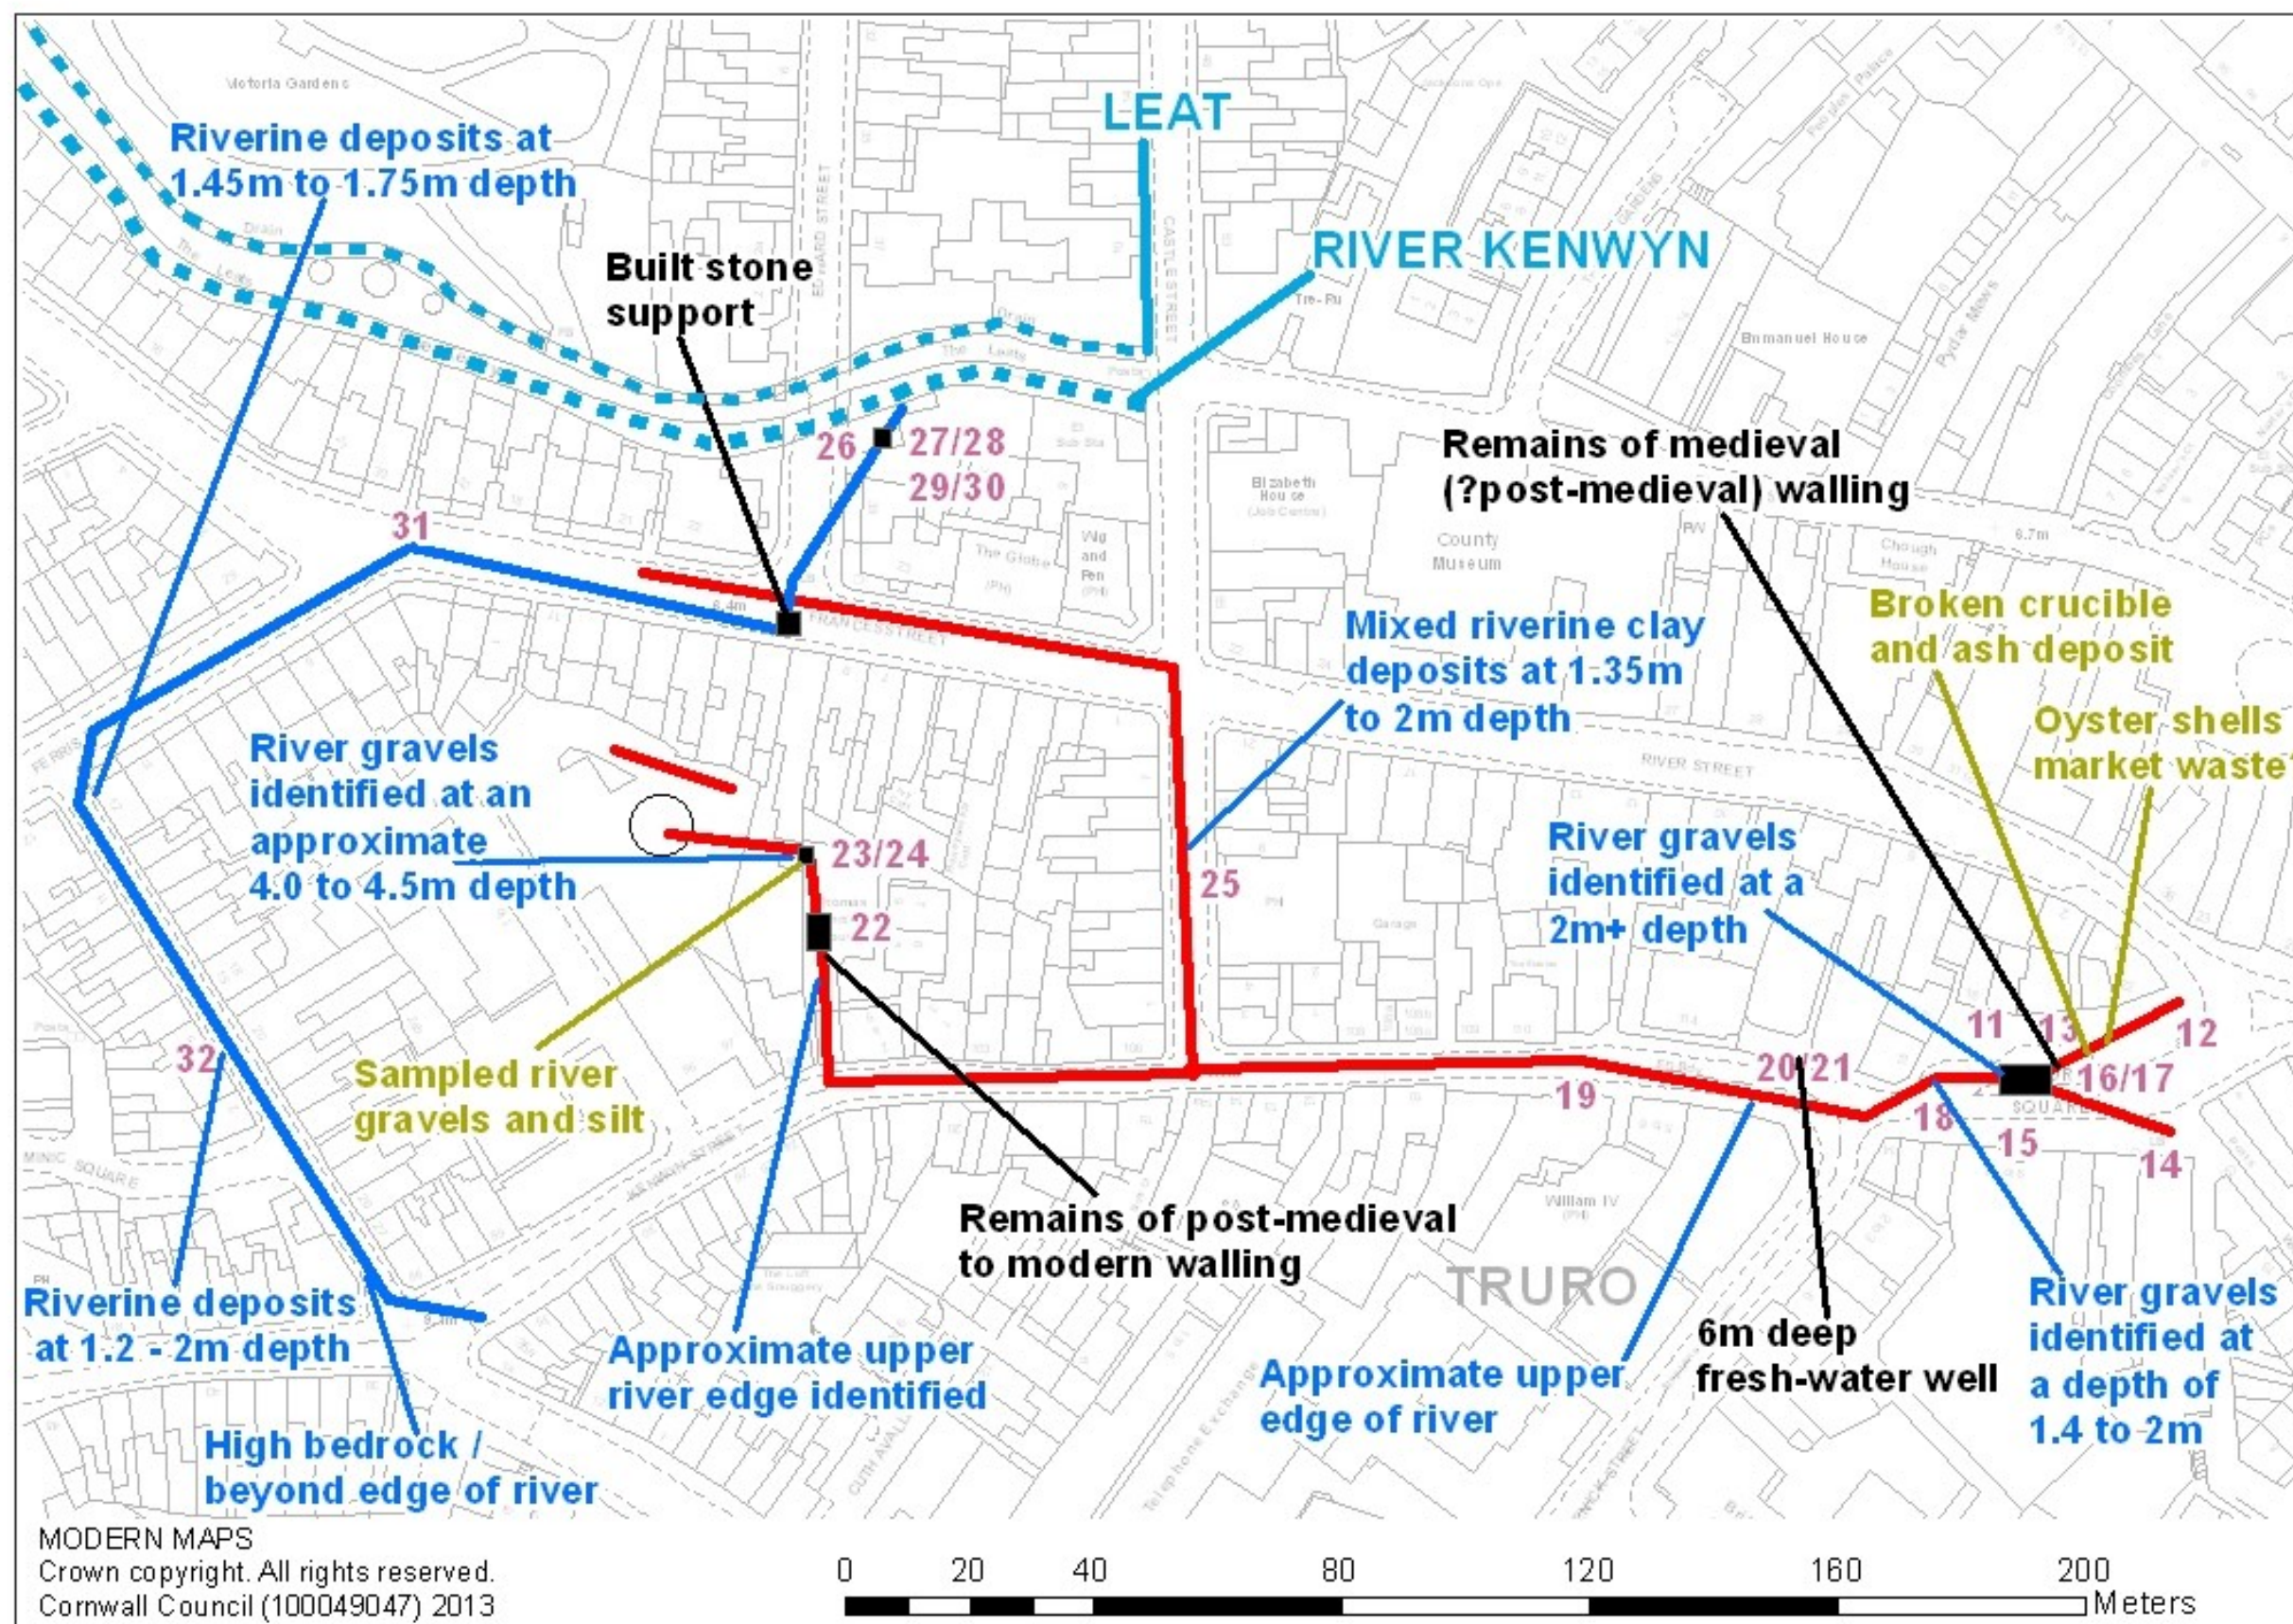
Fig 33 Map showing the site extent (also see Fig 2), significant results and new information, and the location of all photographs within the report (grey).

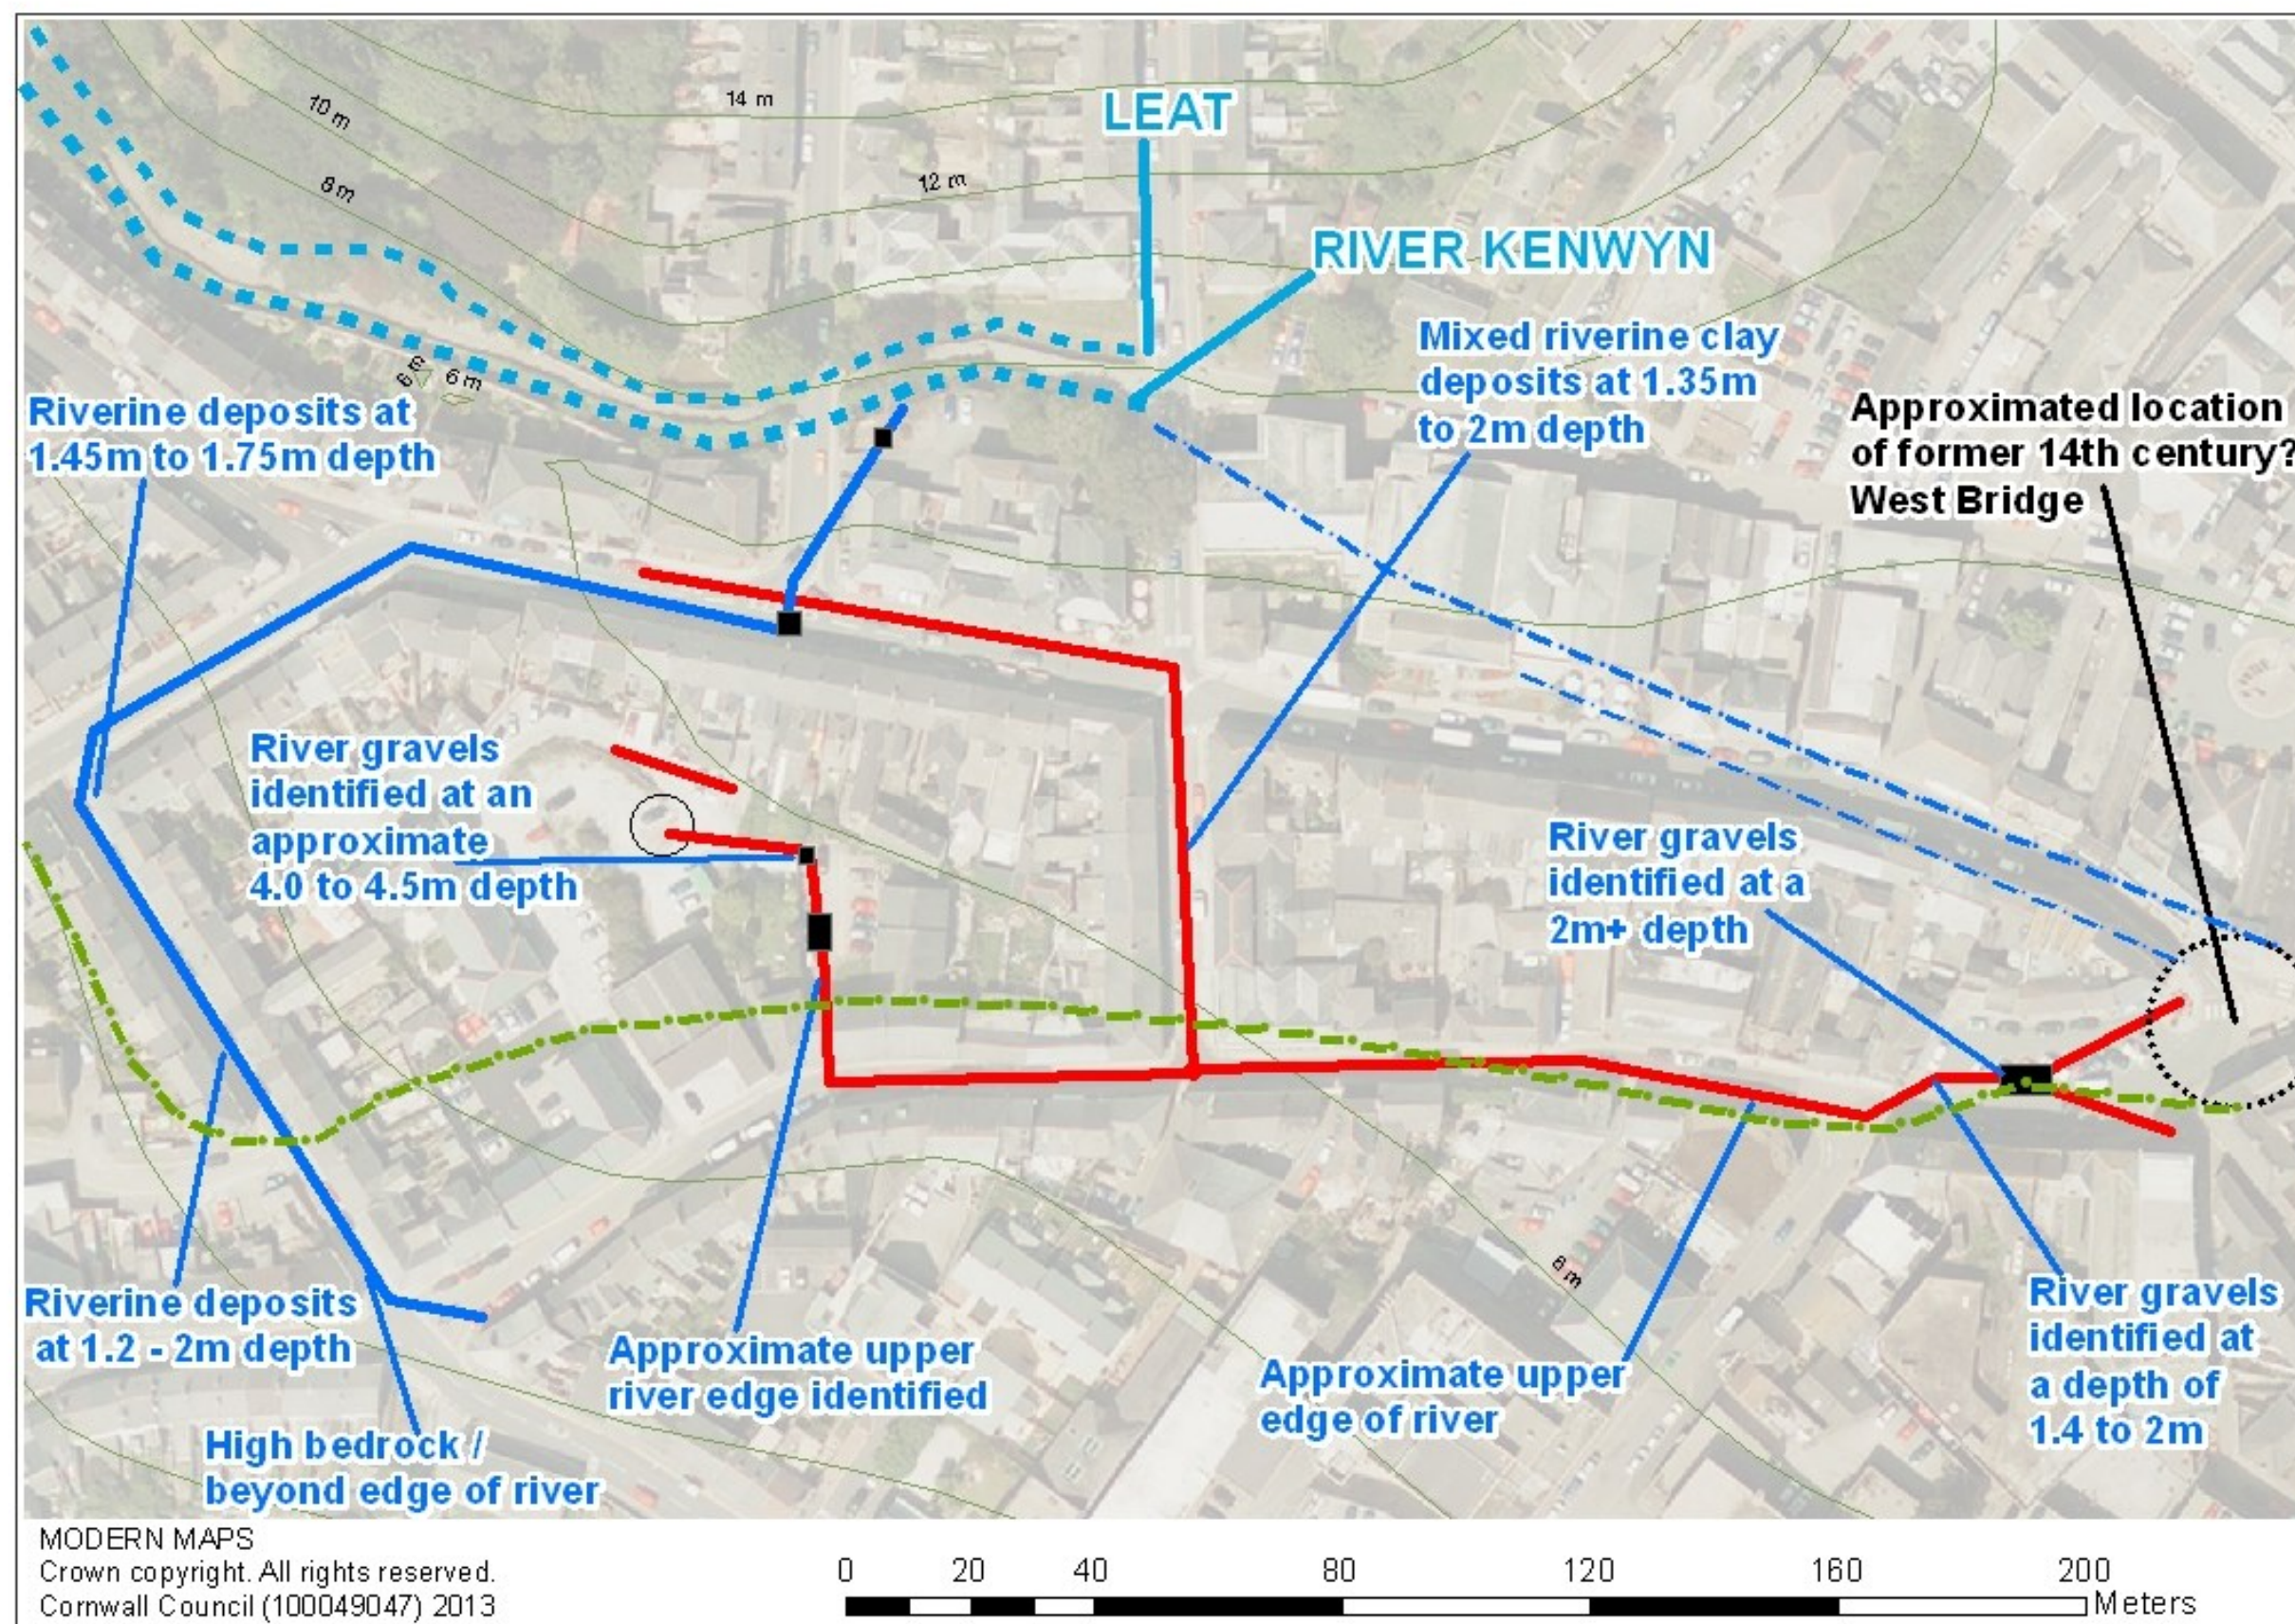
Fig 34 Showing the site extent, 2m contours (GIS layer), the approximate location of West Bridge, the conjectural southern edge of the former River Kenwyn? (green) and the approximate pre-1850 river course - see Fig 7b (blue), overlying a 2005 aerial photograph (GIS layer).

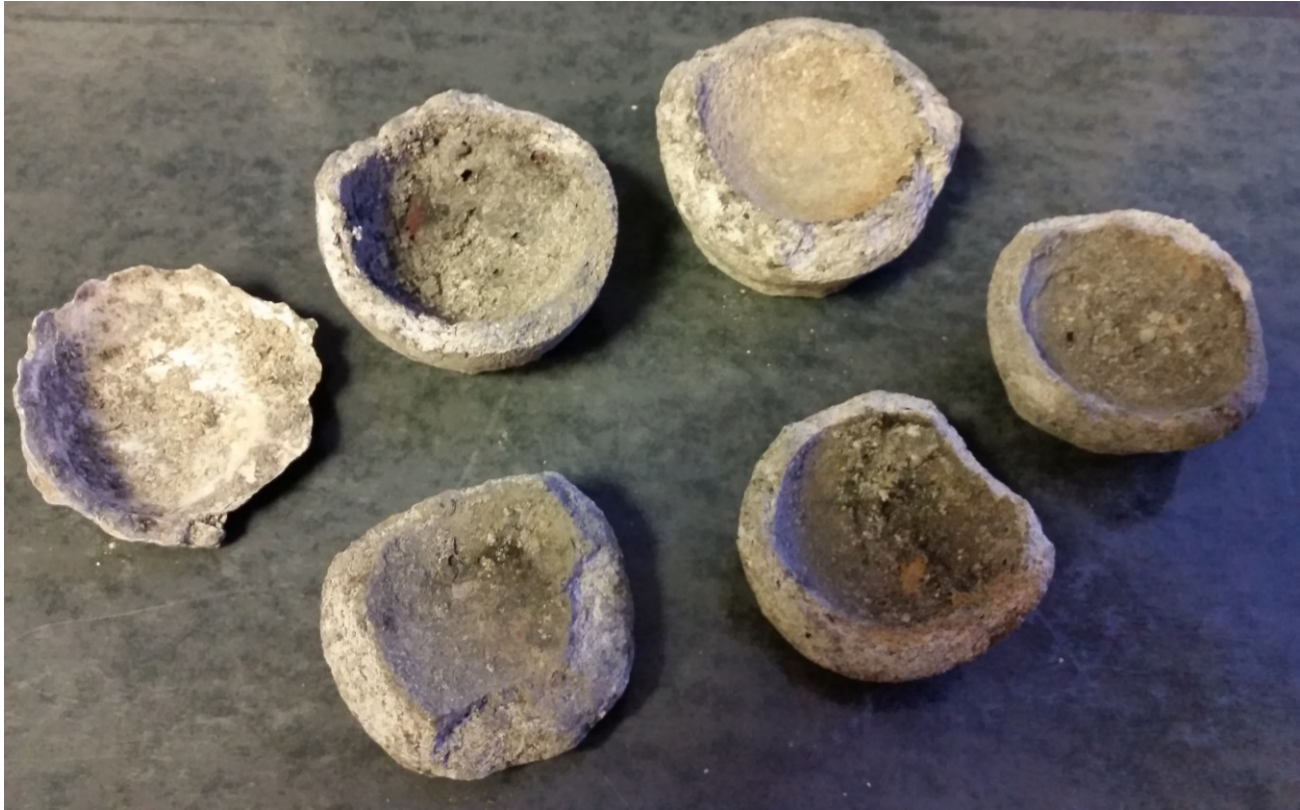
</div>	Probable 18 th century date, perhaps 1740 to 1760.	(14)	<p>Five broken crucible bases were recovered, ranging in basal diameter from 2.5 to 3.5cm. Originally they may have had an approximate 15cm height.</p> <p>Thorpe suggests that Truro-based Lake's Pottery produced these vessels. Some contain limited soft, burnt basal residues, but none show slag adhering or high temperature discolouration – despite being found in association with ashy industrial waste.</p> <p>The crucibles themselves are made from China Clay-based clay (Adam Sharpe comment).</p> <p>They have been broadly dated on the basis of their similarity to crucible remains found in conjunction with pottery and clay pipes during excavations under City Hall in Truro.</p> <p>Thorpe stated in 1997 that <i>'The crucibles, most likely used in the assaying of metallic ores (by comparing a known weight of ore, and the amount of metal derived after smelting), are unusual, and are similar to those which have been found at the crucible manufacturing and smelting site at Calenick, one of only two in Cornwall, operating between 1766 and 1851 (Tylecote 1980). With circular bases and triangular mouths (three pouring points), they will repay further investigation, especially analysis of the residues contained within them. It is possible that they were used in the nearby Coinage Hall on Boscawen Street'</i>.</p> <p><i>'Chemical analysis of the residues would give some indication of the types of ores being smelted within them, i.e. Tin or Copper ores, certainly the green/blue tinge present in many indicate the presence of copper, while red suggests Iron Oxide (pers. com. A Sharpe). Chemical analysis may also give an indication of some of the fluxes (additives) used in the smelting process and thus give an insight into the industrial processes of the period in obtaining metals from ores'</i>.</p>

<div>2</div> <div>Oyster shells (see a single example on the left side of the above photo)</div>	Medieval/post-medieval	(4)	<p>This thin, sporadic upper riverine deposit contained occasional oyster shells. Pockets of this material were found to the west and the northeast of the CSO. It is likely that these are at least in part associated with the pre 1769 Fish Market, which was held <i>'...by the West Bridge, to which boats would then have had access'</i> (Douch 1977, 50). Domestic household waste disposal may also have contributed to their presence. Bones etc would not survive the acidic waters and erosive flow of the river.</p>
