# **Congdons Bridge, St Gennys, Cornwall Archaeological Assessment**

# Congdons Bridge, St Gennys, Cornwall Archaeological Assessment

<b>Client</b>	Jonathon Darch (Cormac Solutions Ltd)
<b>Report Number</b>	2015R024
<b>Date</b>	February 2015
<b>Status</b>	Final
<b>Report author</b>	James Gossip
<b>Checked by</b>	Jo Sturgess
<b>Approved by</b>	Andy Jones

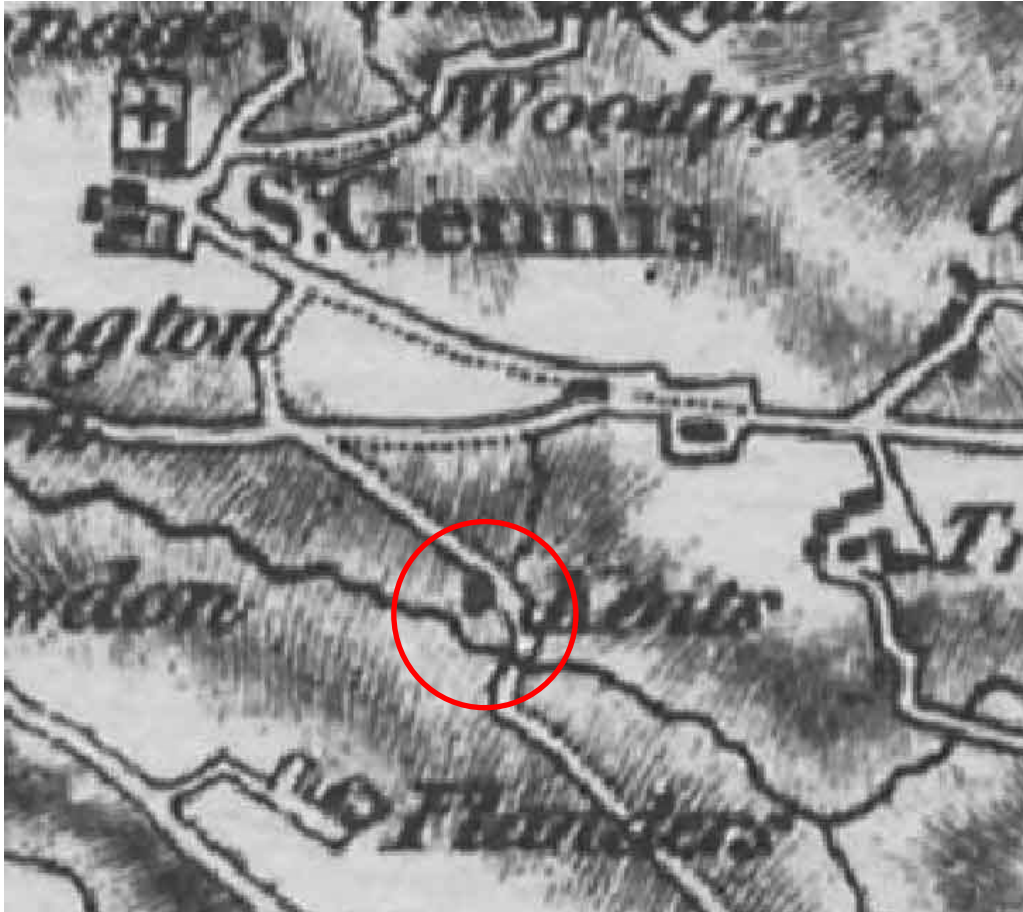
Fig 3 1813 1 inch to 1 mile Ordnance Survey showing the road, river and settlement known as 'Kents'

Neither the Gascoyne (1699) or Martyn (1748) maps are detailed enough to show the river or road in this location. The 1813 1" to 1 mile Ordnance Survey map (Fig 3) is the first to show the river and road in detail although no bridge is shown and the river runs

The settlement of Kents appears on the 1" to 1 mile Ordnance Survey of 1813 (Fig 3) 120m along the road to the north of the bridge but is not named on the 1840 Tithe Map or later Ordnance Survey maps, and at an unknown date (possibly 20th century) the place name is changed to Congdons, the name of the modern settlement (recorded on the 2009 Mastermap, Fig 2). Despite the lack of map evidence for a bridge the earliest reference to a crossing in this location appears in churchwarden's accounts of 1711 for the parish of St Gennys, for repair work where fourpence was paid for "a pole to make a raile for kent's Bridge" (Parnall 1973, 90).

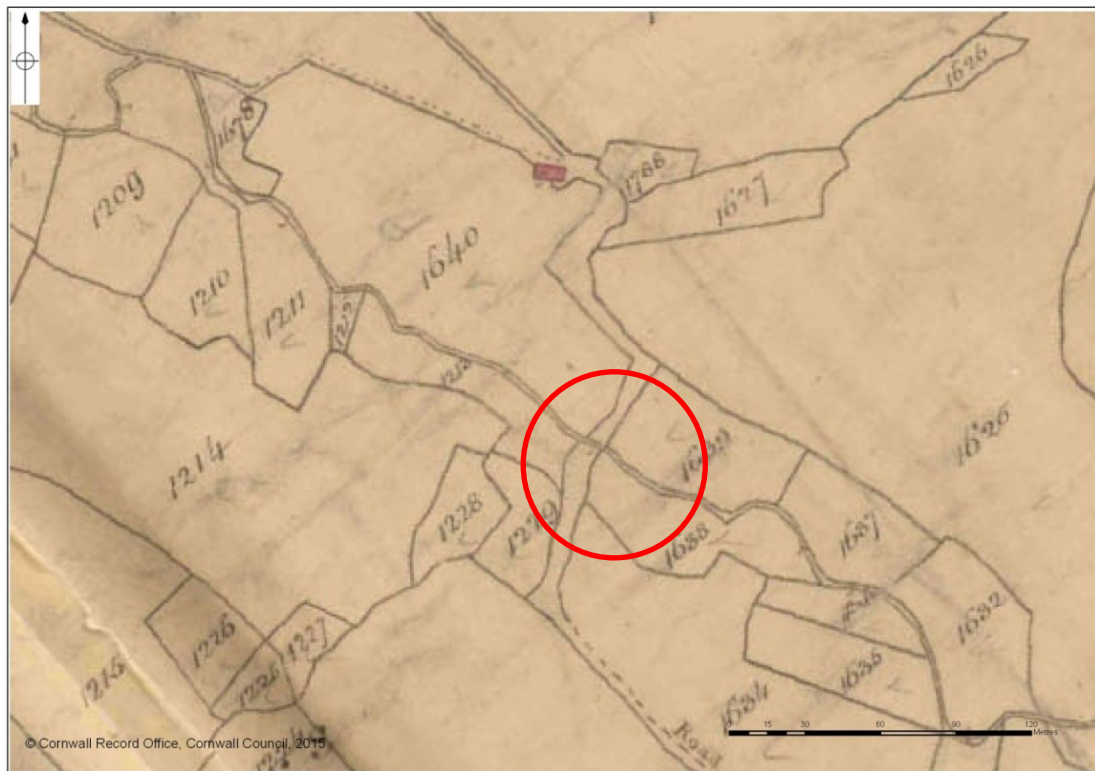
Fig 4 Tithe Map for the parish of St Gennys, c1840

across the road suggesting a ford. The 1840 Tithe Map for St Gennys (Fig 4) shows the same road layout with a possible ford crossing the river but the first map to clearly show the presence of a bridge is the 1880 First Edition Ordnance Survey (Fig 5). Both this and the 1907 second edition map (Fig 6) show a bridge spanning the river with a possible ford on the east side. There is very little apparent change between these and the modern mapping suggesting that the layout of bridge and road has changed minimally over the last 135 years. Most of the ground descends steeply to either side of the stream and whilst the river bank slopes more gradually to the east of the bridge on its south side, possibly indicating the location of a ford, this is by no means certain (and this modification of ground level may be due to the presence of a relict riverside structure – see below).

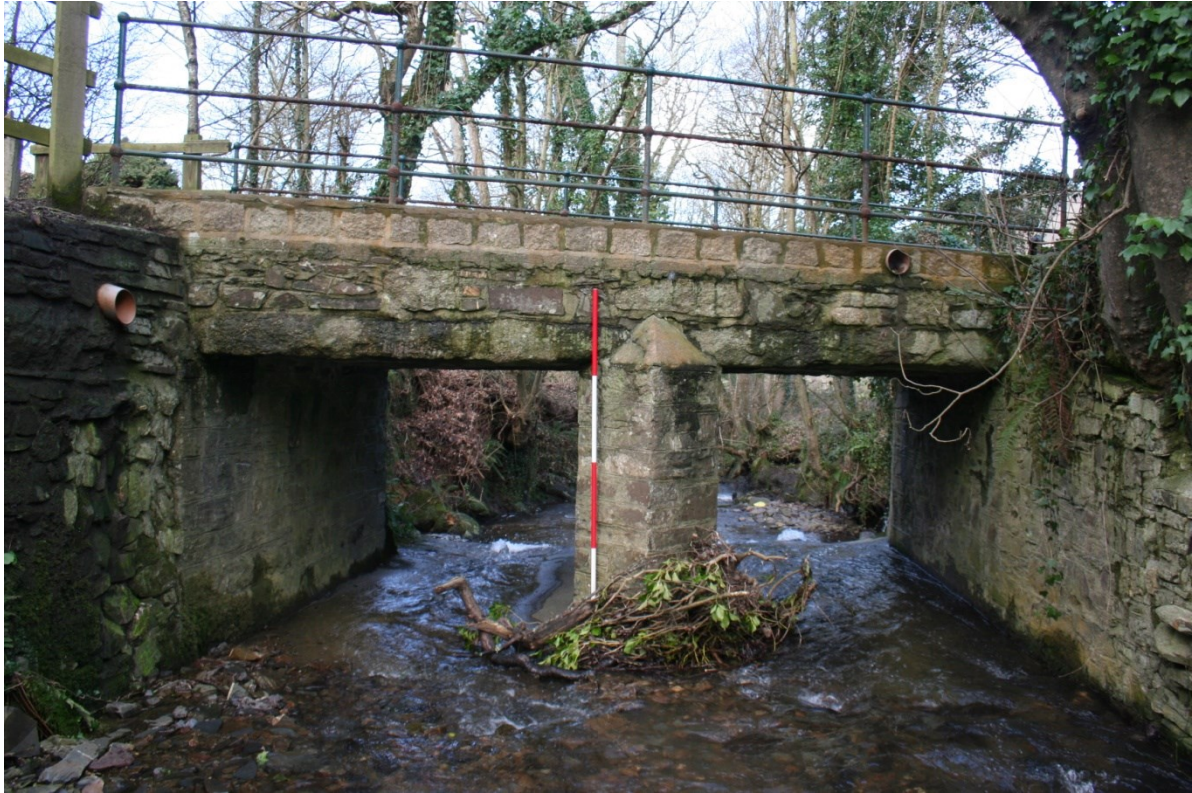
The present road bridge (Figs 7 and 8) measures approximately 3.9m in width, is 5m long between abutments and appears to have a single construction phase with no

The structure is built from a mix of killas and granite blocks and is of lintel (or beam) construction with a single simple cutwater pier and abutment walls on each of the riverbanks (Figs 7-9). The pier has a pointed end upstream and is square-ended downstream (Figs 8 and 9). Seven roughly hewn granite lintels (Figs 10 and 11) form the tops of each of the spans and show clear signs that they were quarried in the late 19<sup>th</sup> or early 20<sup>th</sup> century with many quarry drill splitting marks (approximately 2cm wide) visible. The lintels measure at least 2.15m long (the width of a span), ranging between 0.36m and 0.46m wide and 0.3m high. The cutwater pier and abutment walls have been heavily pointed with modern cement mortar incised with horizontal and vertical pointing lines.

*Fig 8 East (upstream) elevation*

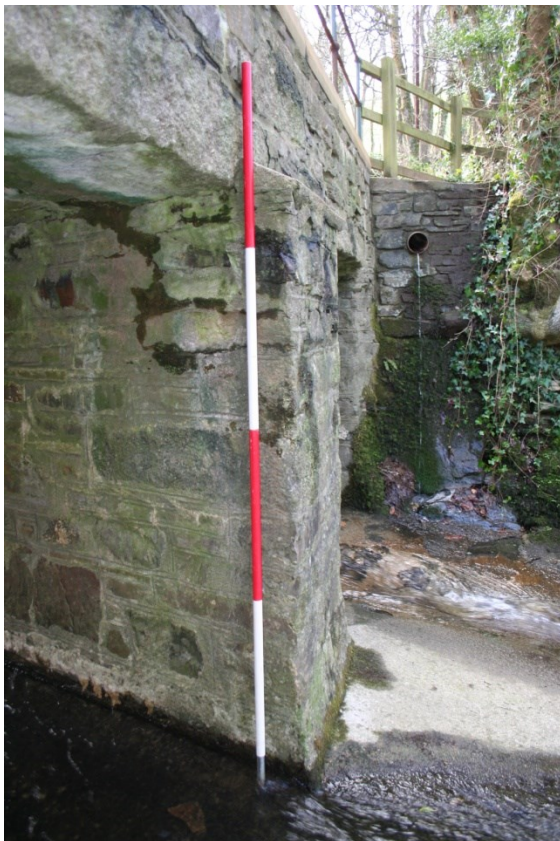
*Fig 9 West (downstream) elevation showing square end of the cutwater pier*

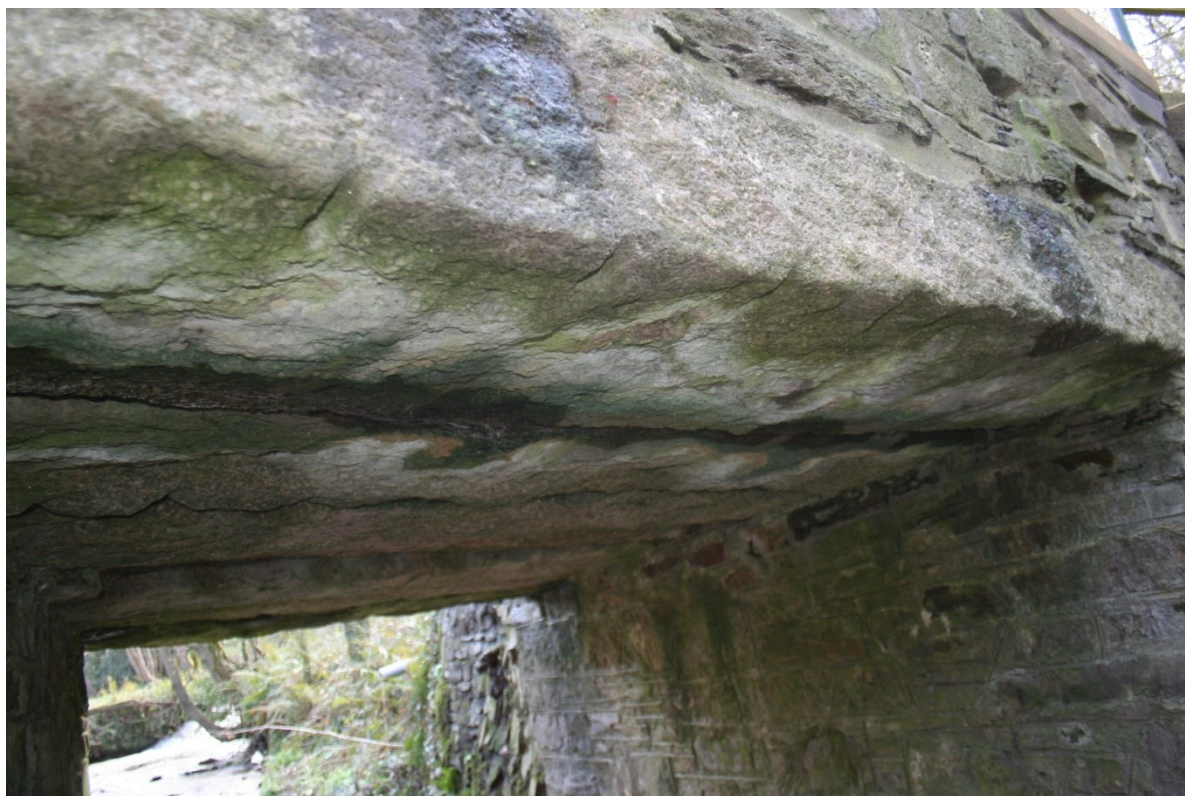
*Fig 10 West (downstream) elevation showing span lintels with quarry drill marks*

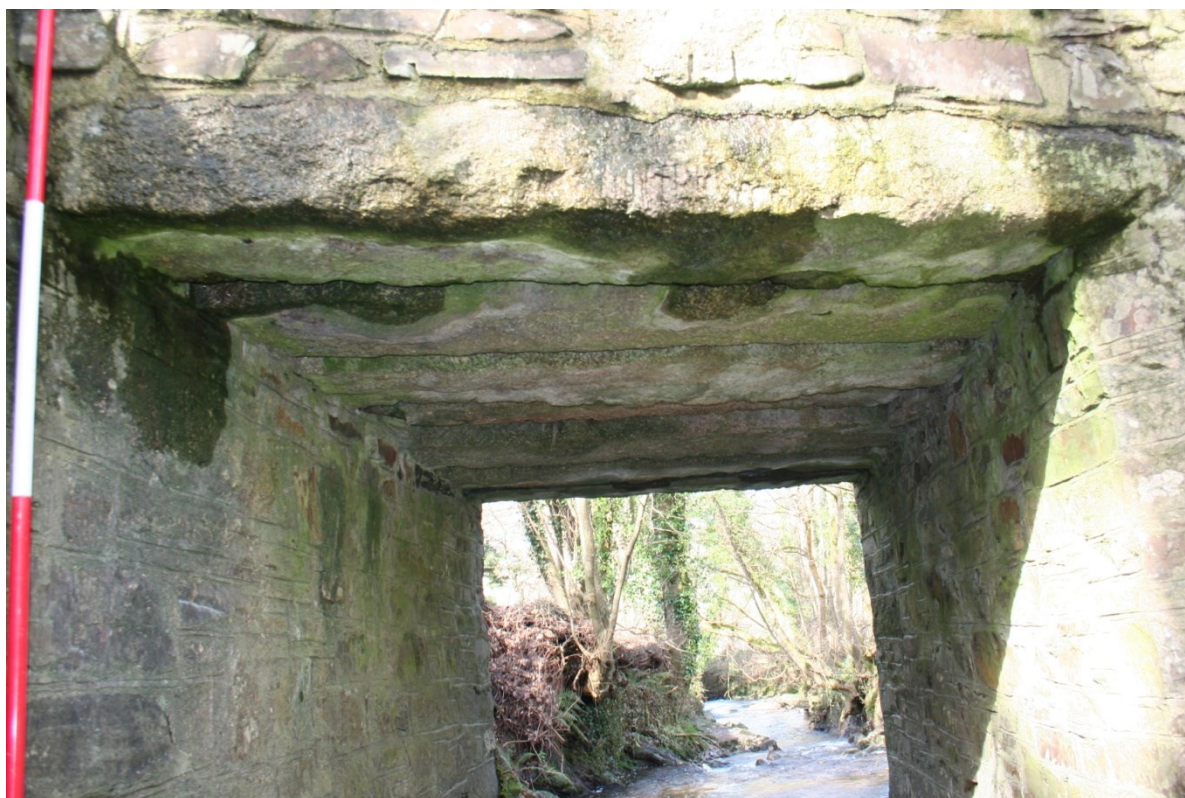
*Fig 11 East (upstream) elevation showing span lintels*

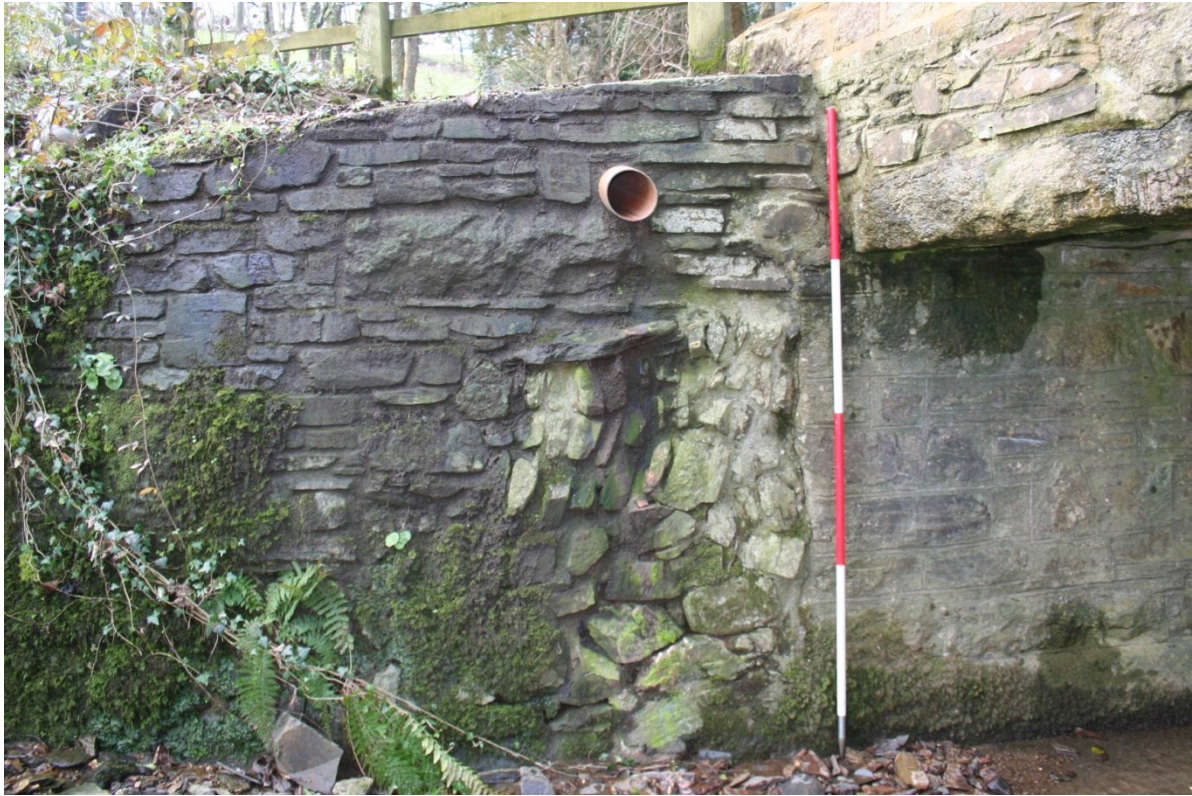
notable alterations or repairs, although fragments of earlier drystone abutment walling can be seen on both the northern and southern sides (Figs 12-14).

*Fig 12 South abutment, upstream side showing evidence or earlier abutment walling*

good condition and possibly contemporaneous with the first stone construction. If ground is disturbed to the landward side of either abutment a watching brief should be carried out by a suitably qualified archaeological contractor as these areas have the potential for elements of the earlier timber bridge or road surfaces to survive.

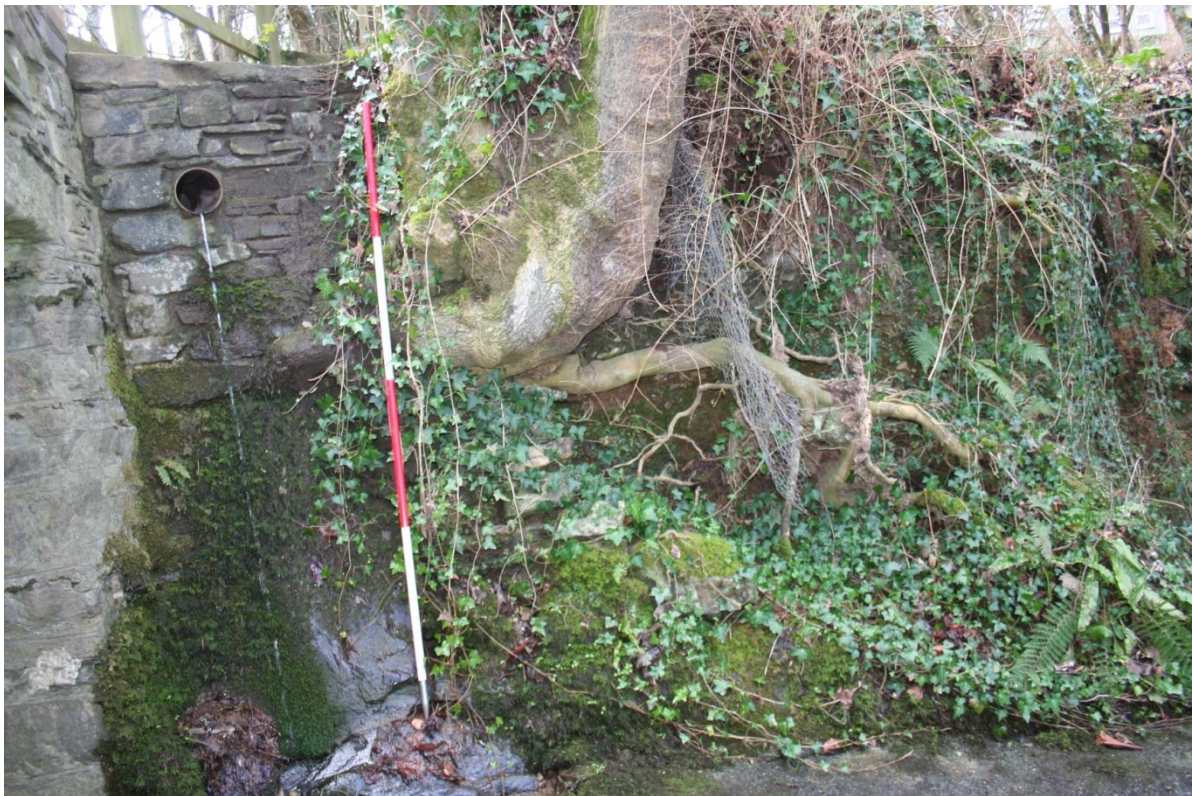
*Fig 13 South abutment, downstream side showing evidence or earlier abutment walling beneath tree roots*

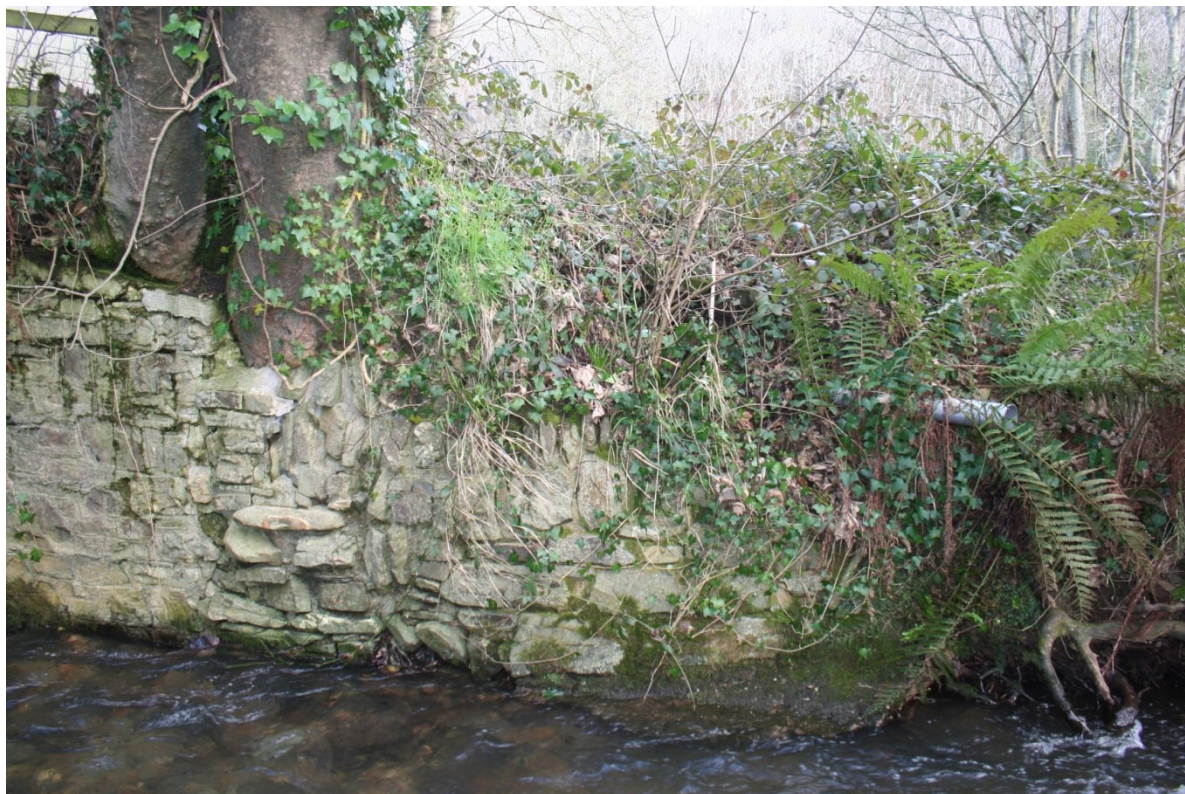
*Fig 14 North abutment, upstream side showing evidence of earlier abutment walling beneath and to east of tree roots*

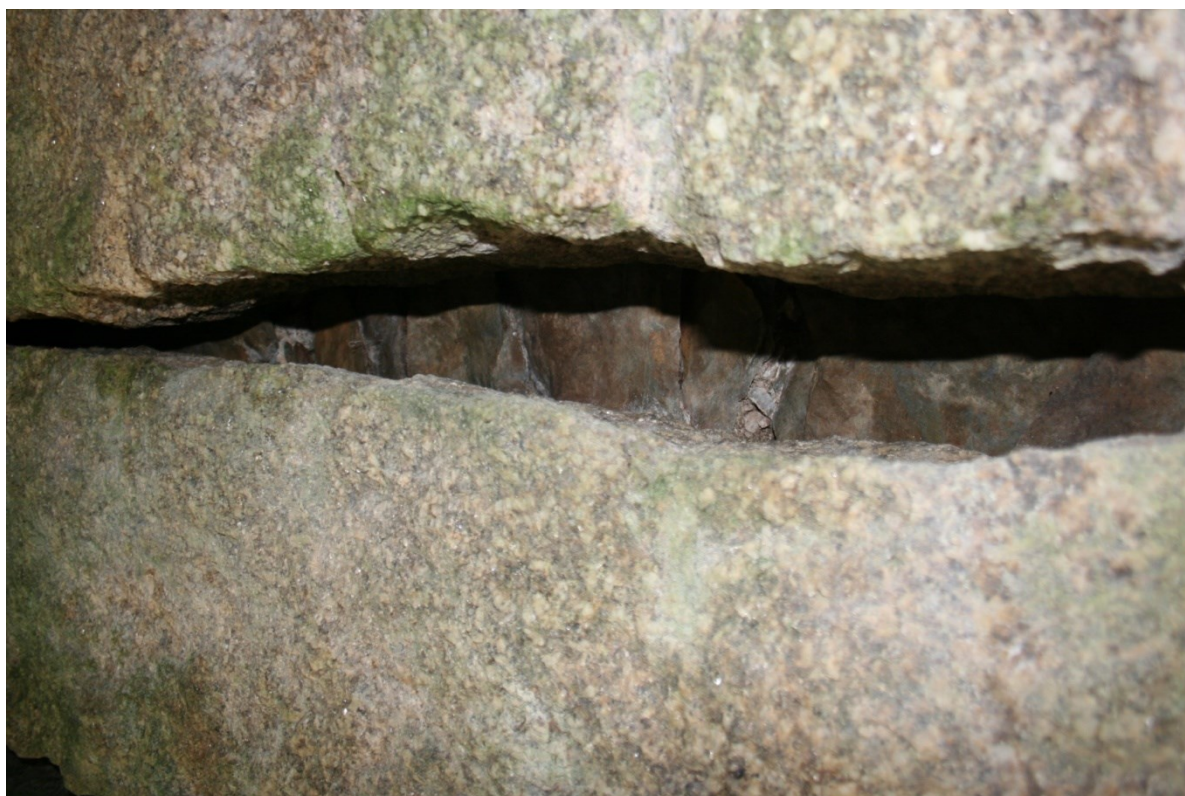
In both upstream and downstream elevations the three perpendicular lintels are visible above the span lintels with rubble walling either side – this is filled with rubble (visible between the lintels from below the bridge, Fig 15) to form the superstructure of the bridge. A low concrete kerb runs either side into which are fixed iron hand rails (Figs 16-18), possibly dating to the first phase of the stone bridge and reused when the concrete kerbs were constructed. Beyond the spans the kerb and rails extend 1.4m to the north and 1.7m to the south. The top of the bridge is surfaced with tarmac. On the southern bank to the east of the bridge a platform suggests the location of a riverside structure, now demolished, although nothing is marked on the maps. A concrete surface above the riverbank and an old pipe emerge into the river at this point.

*Fig 15 Detail of rubble core above span lintels*

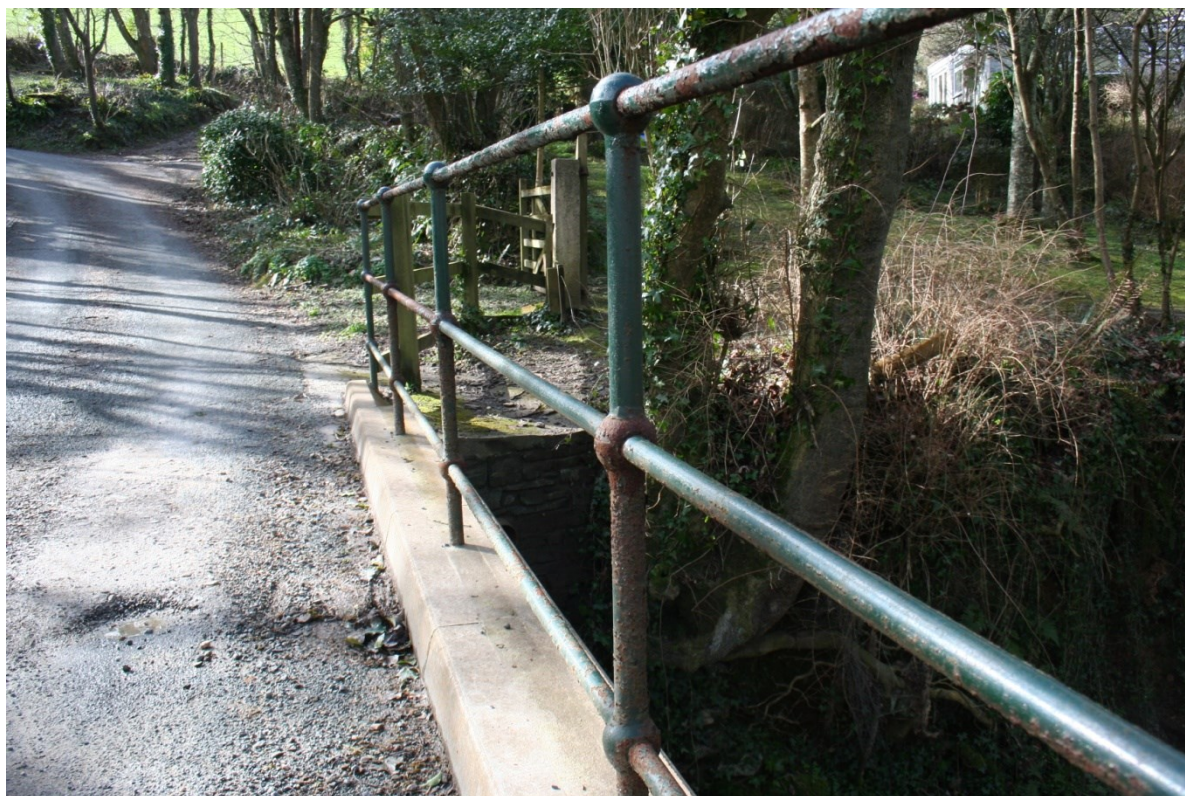
*Fig 18 Detail of iron rails, downstream side*

However, an attempt should be made to leave the outward appearance of the bridge unchanged and the iron railings should be retained as they are a characterful feature in

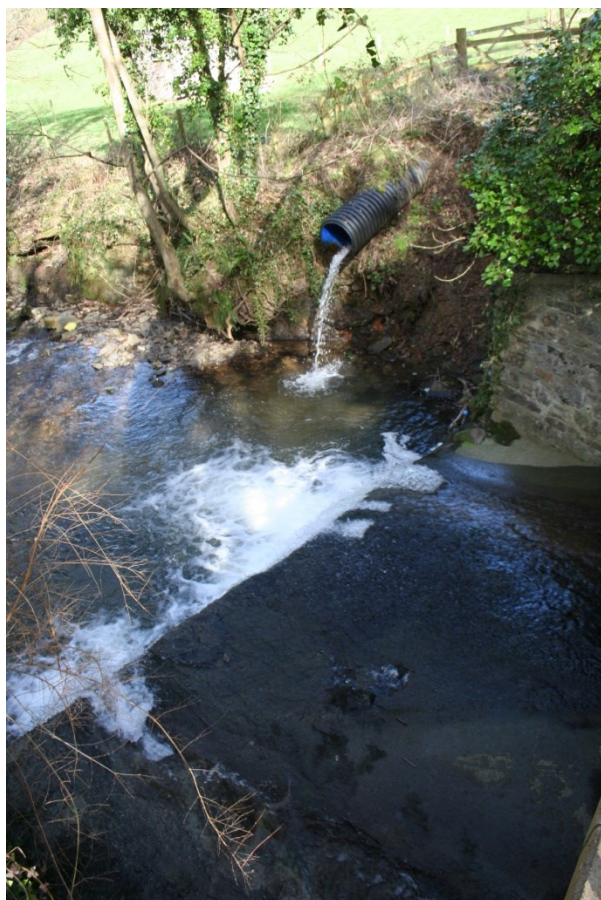
The riverbed beneath the bridge is laid with concrete extending downstream to a weir adjacent to the bridge, although in places the underlying rock is visible where the concrete has eroded/fractured. There is extensive erosion of the riverbank on both the north and the south sides downstream of the weir, with a large drainage pipe issuing into the river on the northern side (Fig 19).

*Fig 19 Weir and pipe, downstream*
