# **Carninney, St Ives, Cornwall**

## **Archaeological Assessment**

<b>Client</b>	<b>Poynton Bradbury Wynter Cole Architects Ltd</b>
<b>Report Number</b>	<b>2015R028</b>
<b>Date</b>	<b>April 2015</b>
<b>Status</b>	<b>Final</b>
<b>Report author</b>	<b>Hayley Goacher BA (Hons) PCIfA</b>
<b>Checked by</b>	<b>Colin Buck/Andy Jones</b>
<b>Approved by</b>	<b>Andrew Young</b>

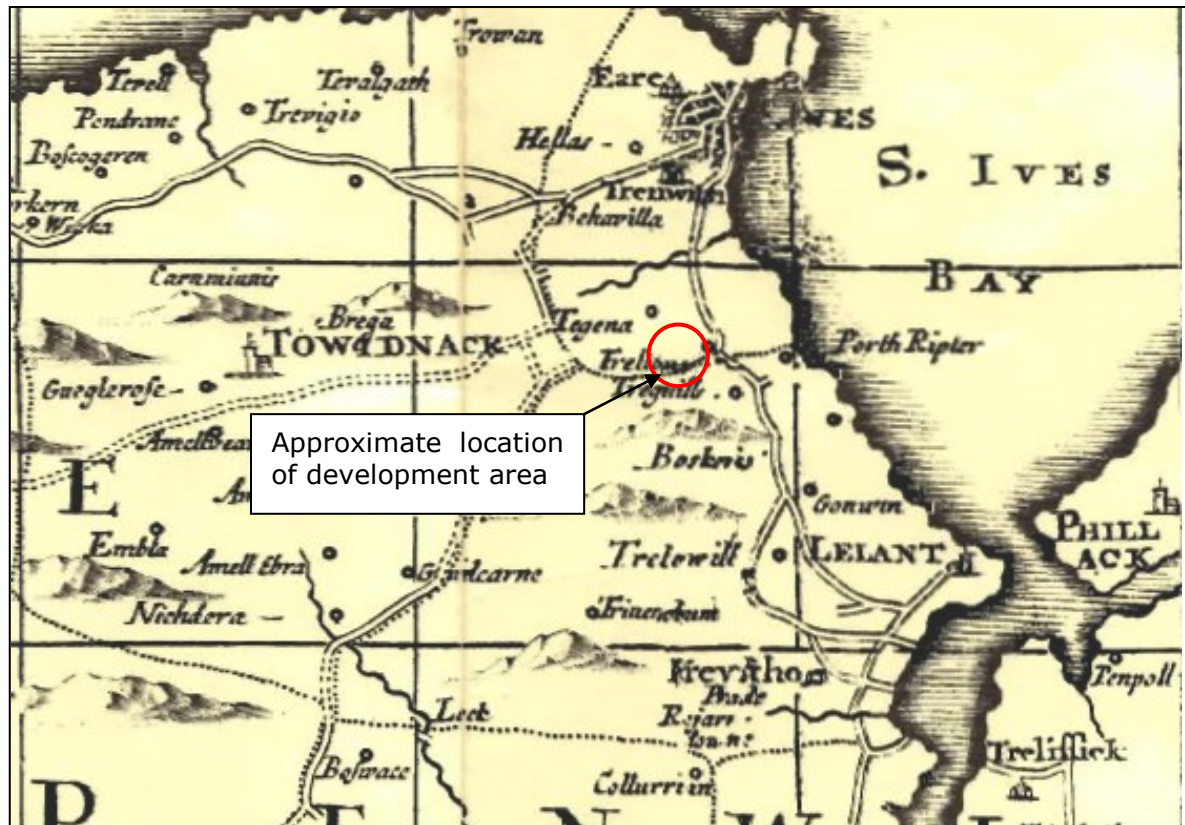
Figure 3: Gascoyne's 1699 Map of Cornwall showing Boskeris and 'Porth Ripter', the name 'Carbis Bay' being a later invention.

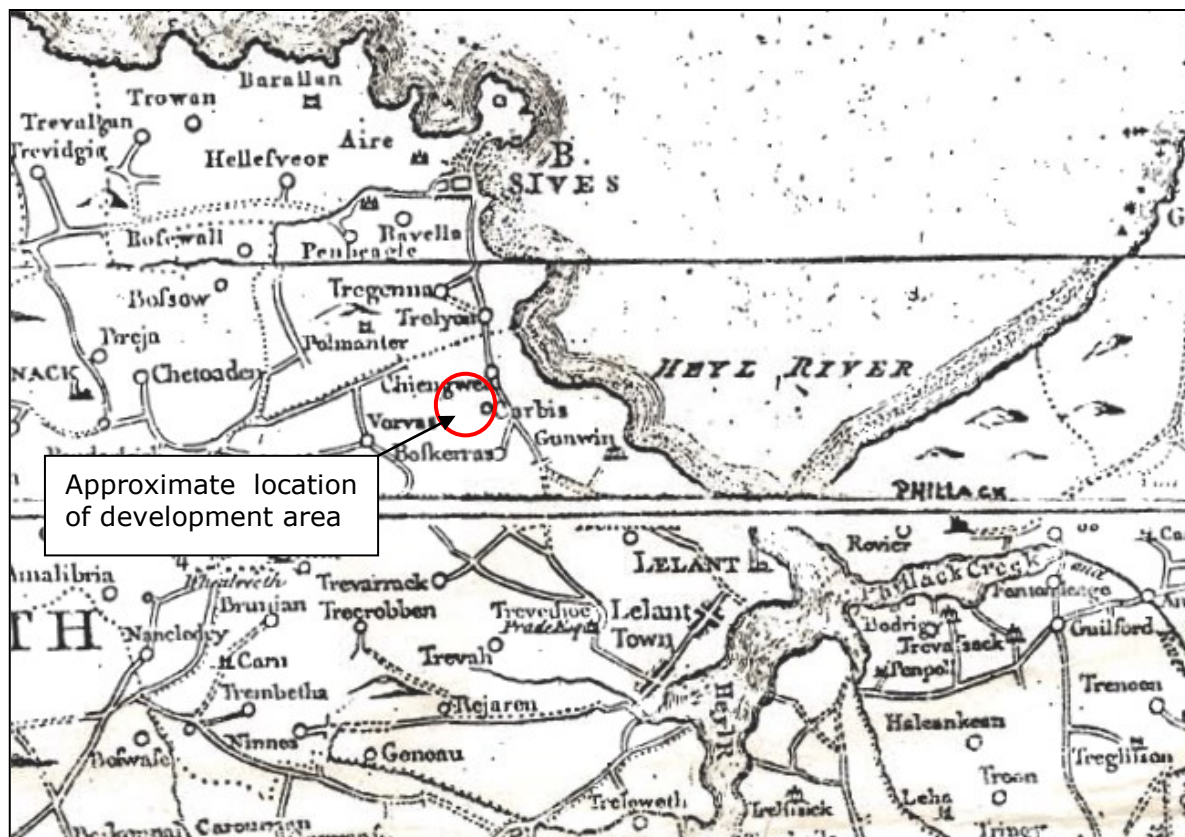
Figure 4: Martyn's 1748 map depicting Chiengweal, Carbis and Boskerres.

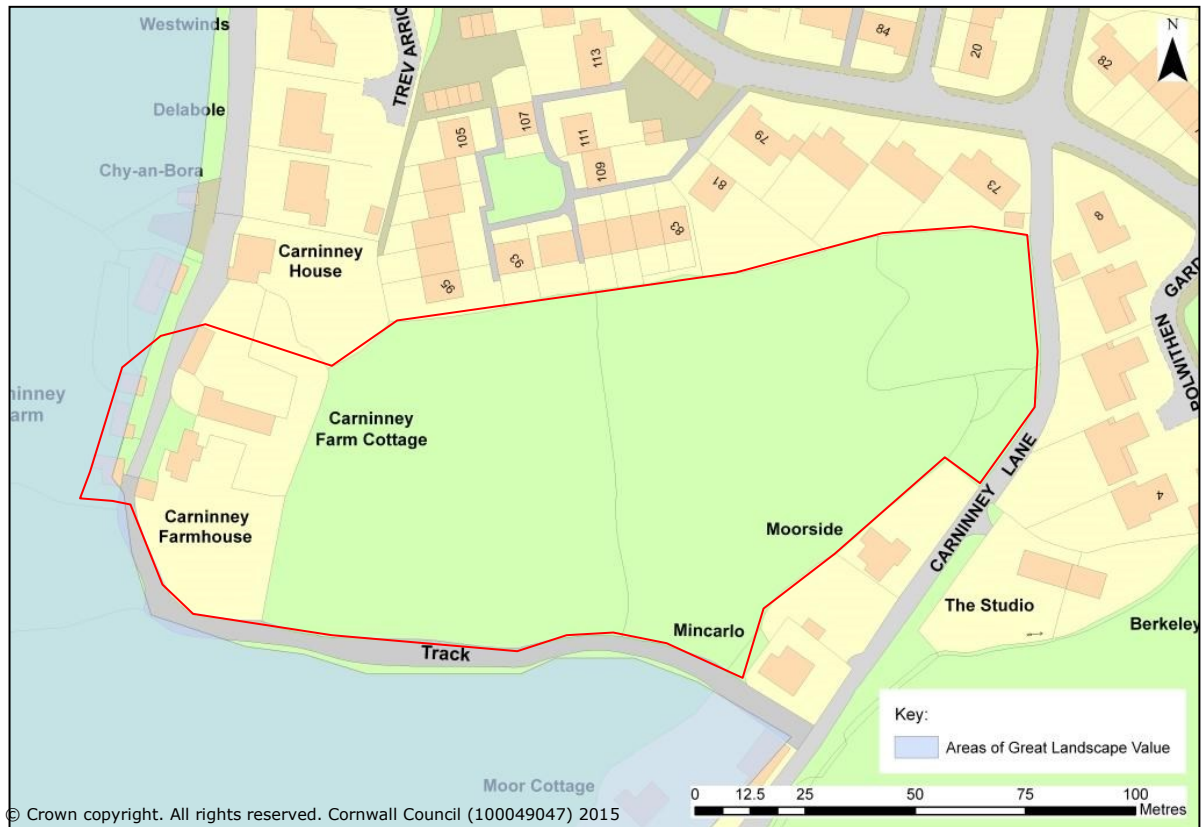
Figure 11: Modern overlay map showing the immediately adjacent Area of Great Landscape Value.

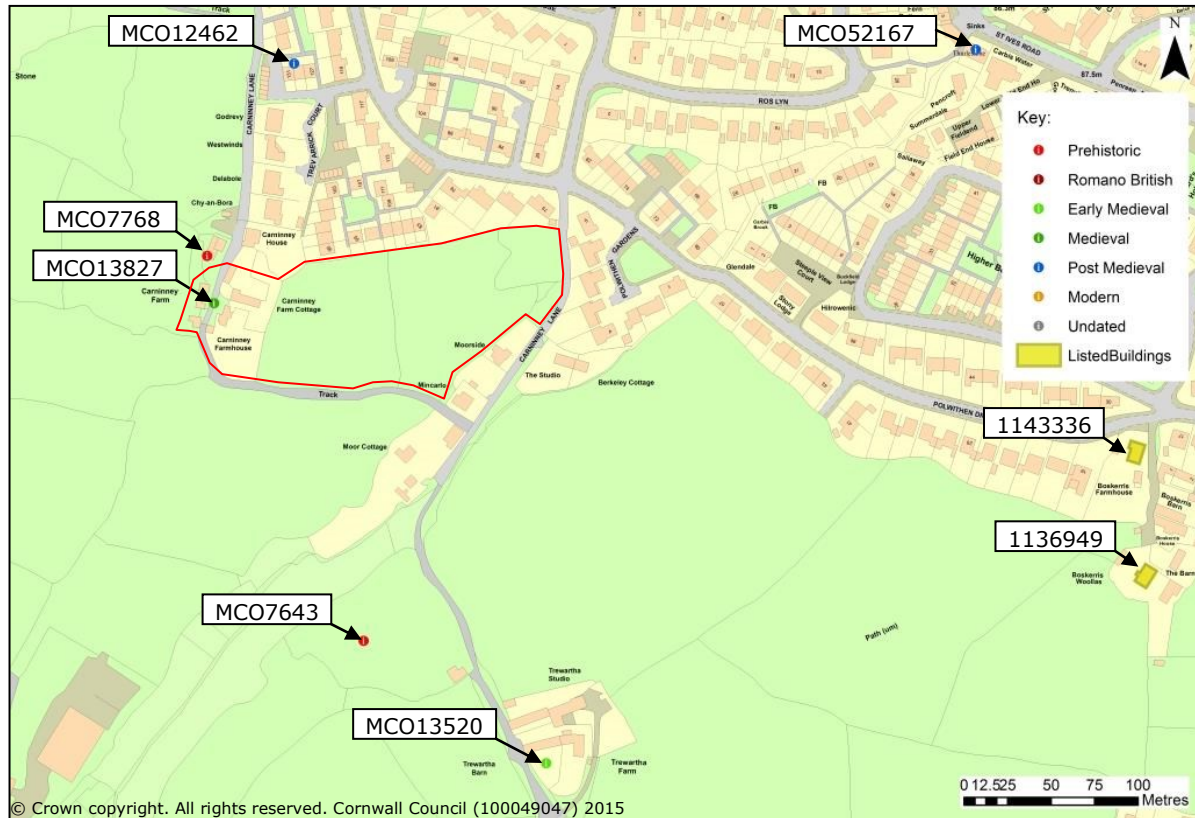
Carninney Farm (MCO13827) is recorded by the HER as a farmstead of medieval origin. The HER also has a reference to a prehistoric round (MCO7768) located immediately

Figure 13: Modern overlay map to show key Listed Buildings and sites recorded in the HER including Carninney Farm and the adjacent possible prehistoric enclosure.

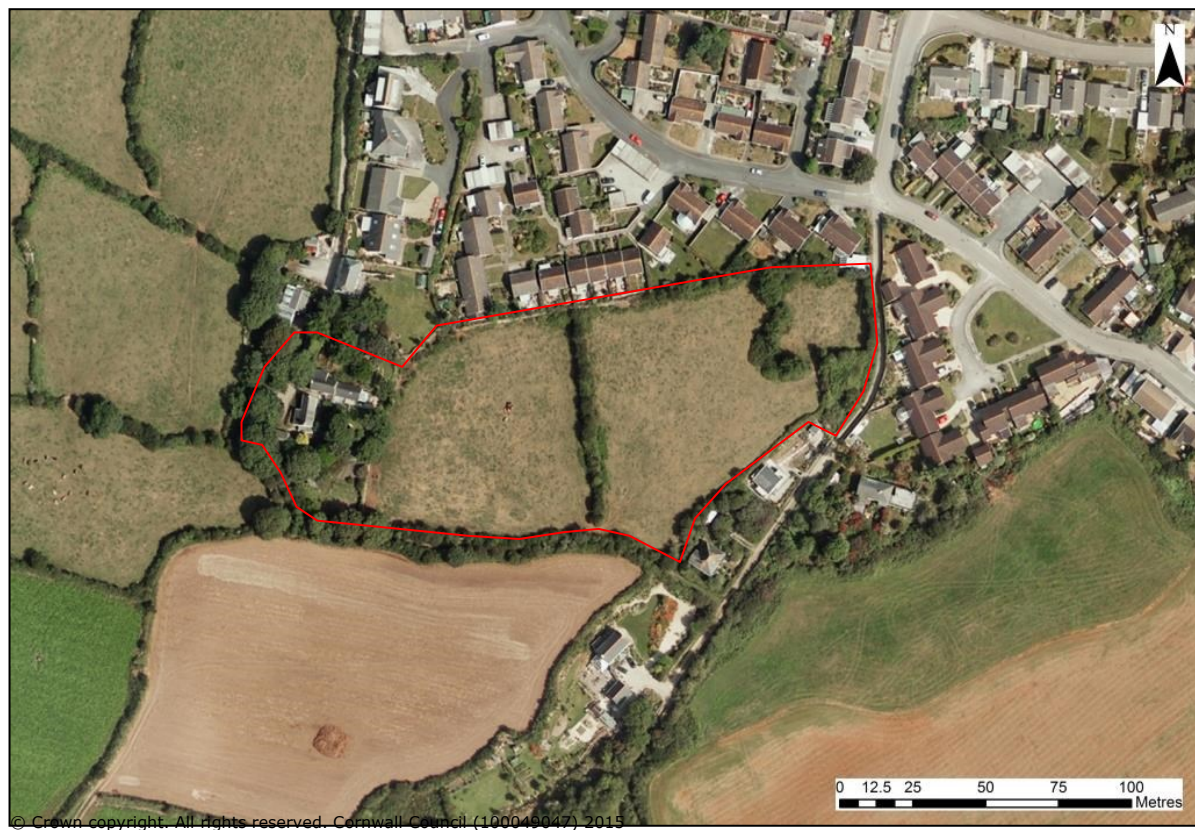
Figure 14: This aerial photograph from 2005 clearly shows the relationship between the fields and farm buildings at Carninney and the modern housing to the north.

Although bordered to the north and east by modern housing, the fields are still situated in quite a rural setting which is also historic in origin. The historically rural setting of the fields will be impacted by the proposed development, though the presence of nearby modern housing means that the integrity of this setting is already compromised (Figs 14 and 16).

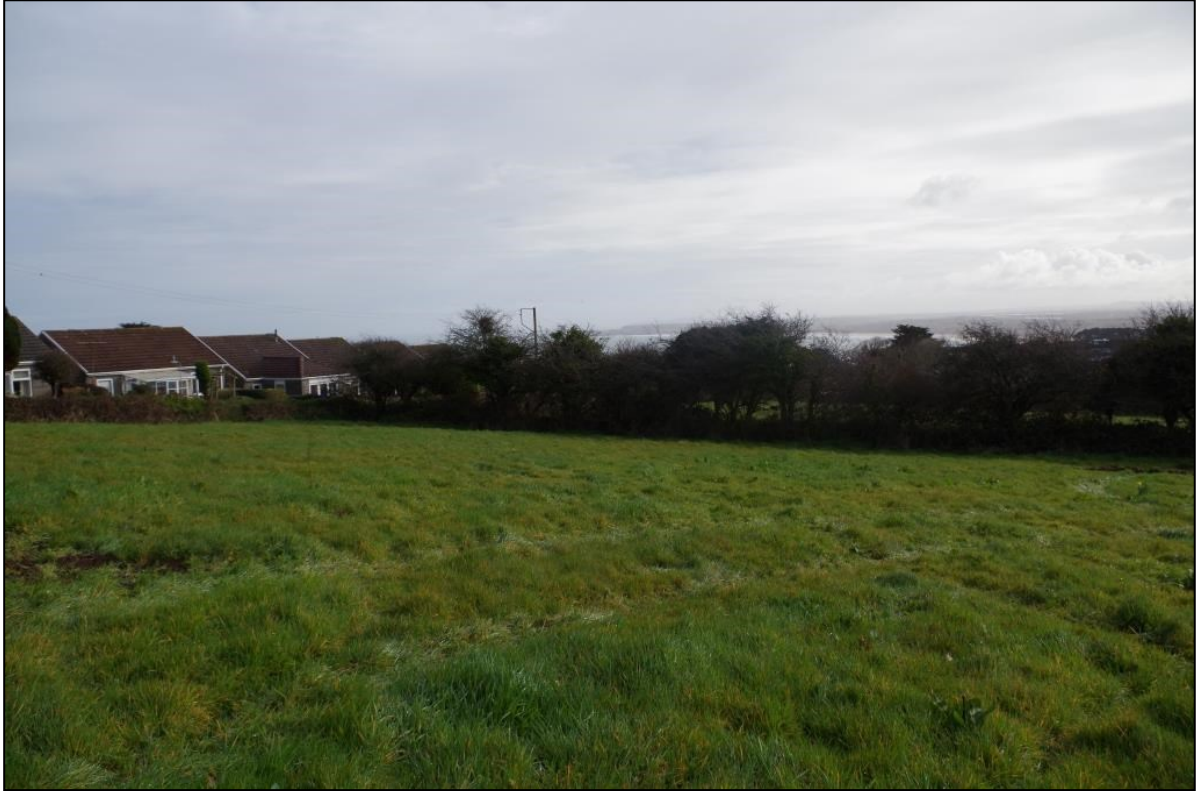
*Figure 15: Field A and the wide ranging view to the northeast including Field B, modern housing and St Ives Bay.*

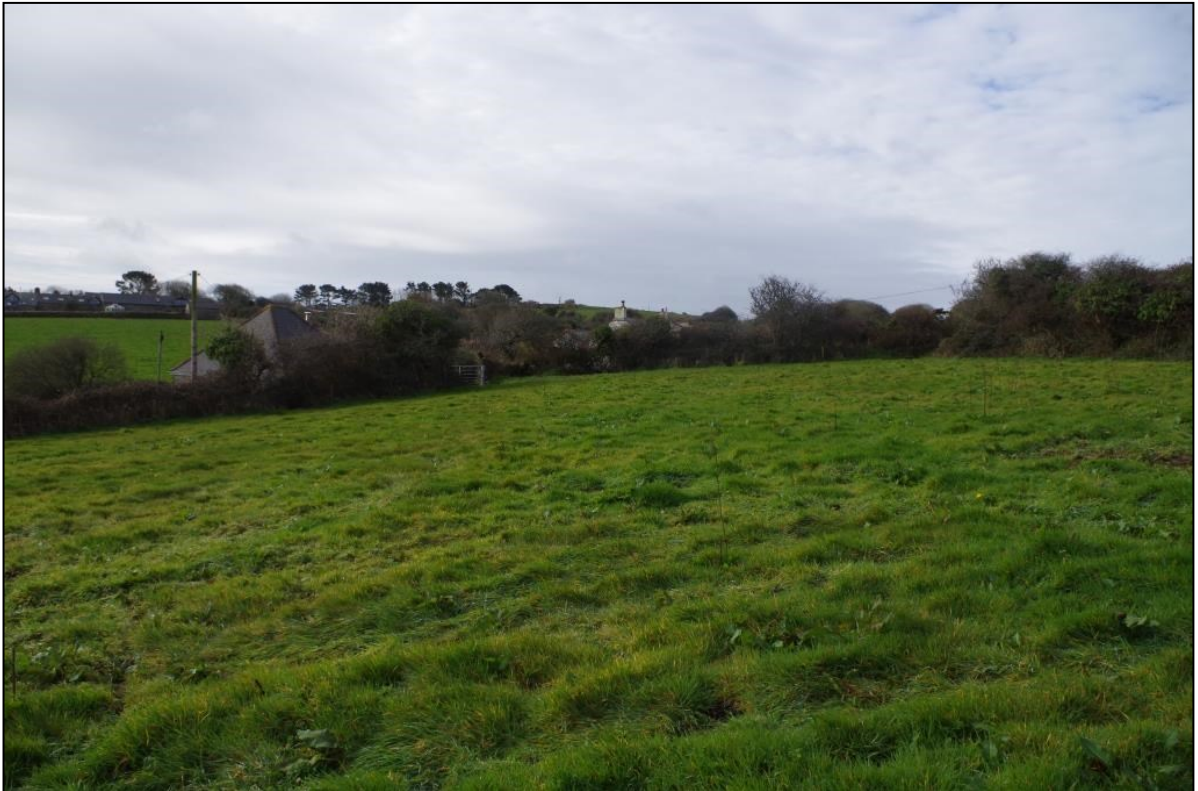
Field B is irregularly shaped though with straight, right-angled boundaries to the north and west (Fig 16). As with Field A, it is enclosed by Cornish hedge boundaries with increasing mixed vegetation extending from the bank to the north and a considerable growth of brambles on the northeast side. The southern boundary adjacent to existing houses has lost the majority of its bank and has been replaced with a fence. Field B slopes down from west to east and has been most recently used as pasture. Similarly the views are of housing and agricultural land with extensive views eastwards. A walkover did not indicate any surviving archaeology on or close to the ground surface.

*Figure 16: The rural view southwest from Field B with the few modern houses in the middle ground and a converted barn in the top left of the image.*

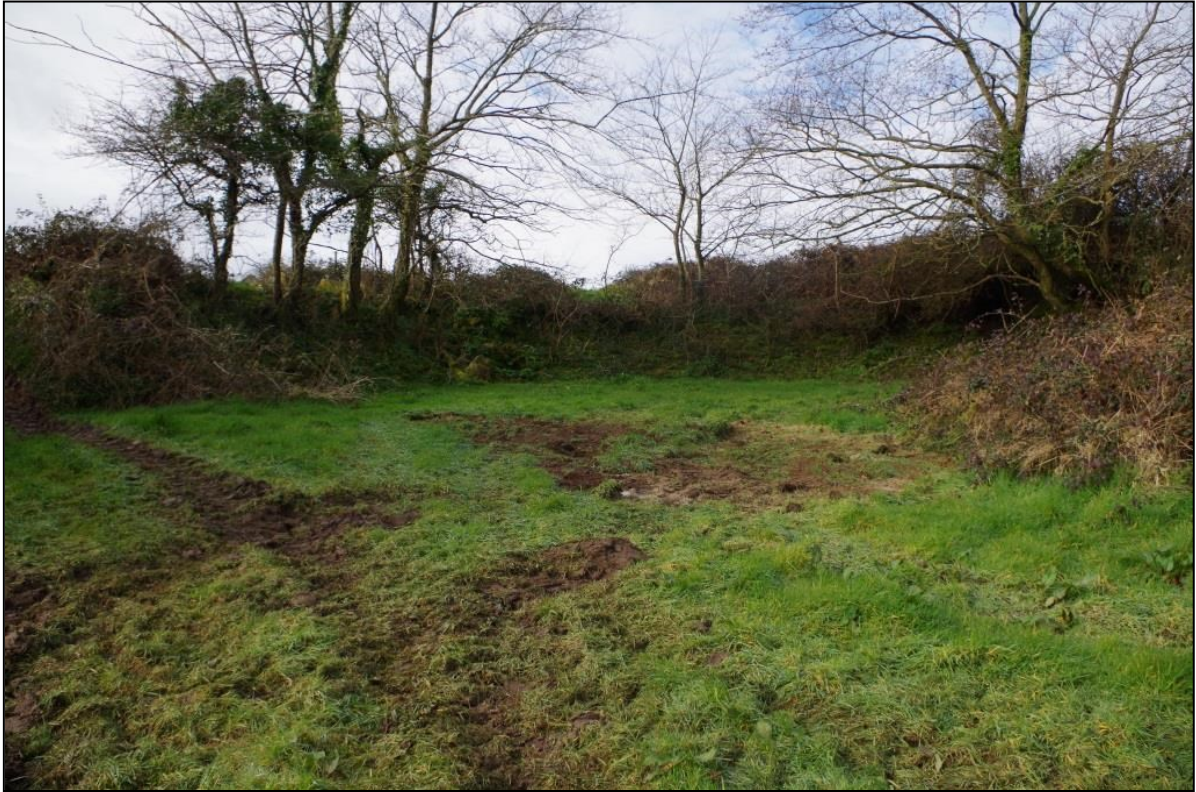
Field C is sub-rectangular and considerably lower than the surrounding fields and is flat (Fig 17). It is bounded by Cornish hedges to the north and east though the western and southern boundaries are stone-faced banks necessitated by the change in level. These banks have considerable mixed vegetation growth including small trees whilst the interior has been taken over by brambles, some of which have been recently cleared. From the centre of Field C there are no views of the surrounding landscape beyond the field boundaries or immediately adjacent housing. The possibility of historic mining or quarrying may have impacted upon its former use and evidence of this may survive below the surface, and may be shown by any Geophysical survey.

*Figure 17: Field C with considerable banks enclosing the field and obscuring views out, particularly to the southwest.*

The change in level and atypical boundaries of Field C suggest uses other than pasture, possibly for mining purposes, or as a quarry for stone to build the farm or even as a stock enclosure (Fig 17). Such activities are not mapped, indicating that any quarrying either pre-dates 1840 or the scale was local, for the farm only. The farm buildings are all constructed using distinctive pink-hued, fine-grained granite most likely to be 'micro-granite', a protrusion of which is known in the area around and to the south of Carbis Bay (British Geological Survey). The possibility of a link between the farmyard and the use of its fields potentially adds significance to site.

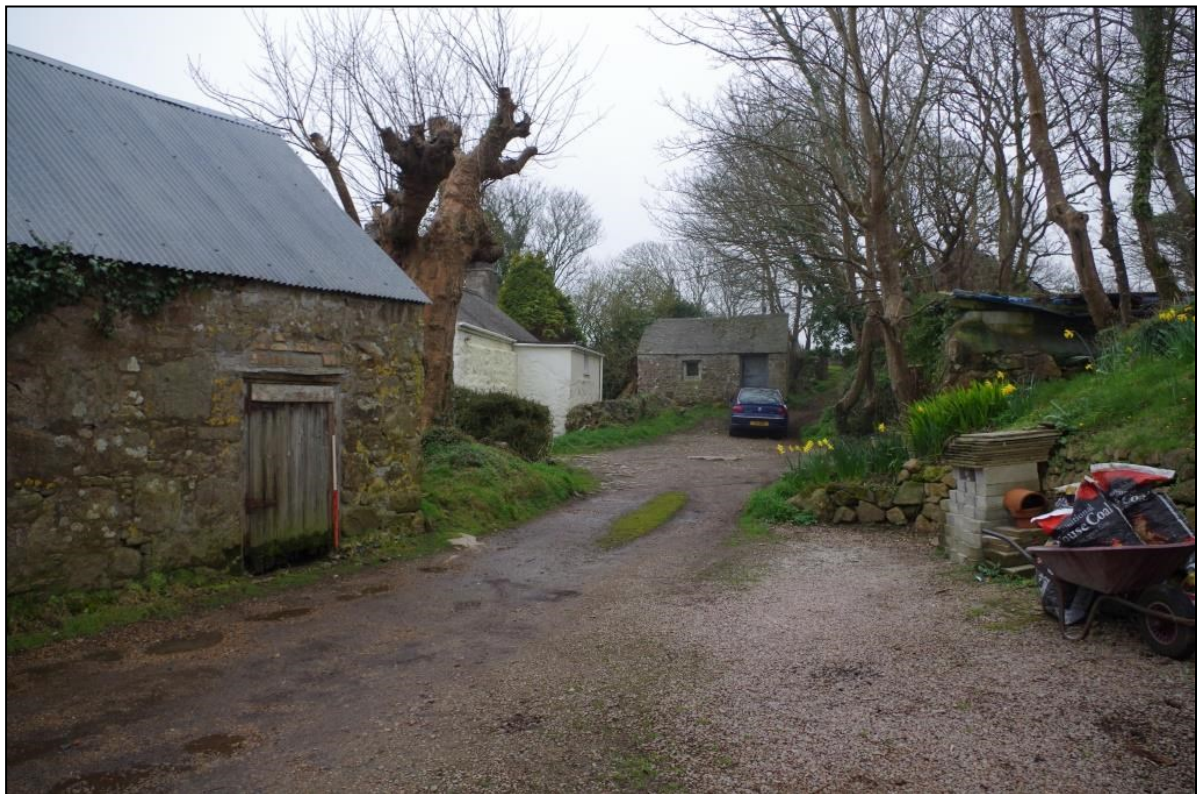
*Figure 18: Carninney Farm yard and Carninney Lane continuing south beyond the yard adjacent to the car with Building 1 in the foreground and Buildings 4 and 6 in the background.*

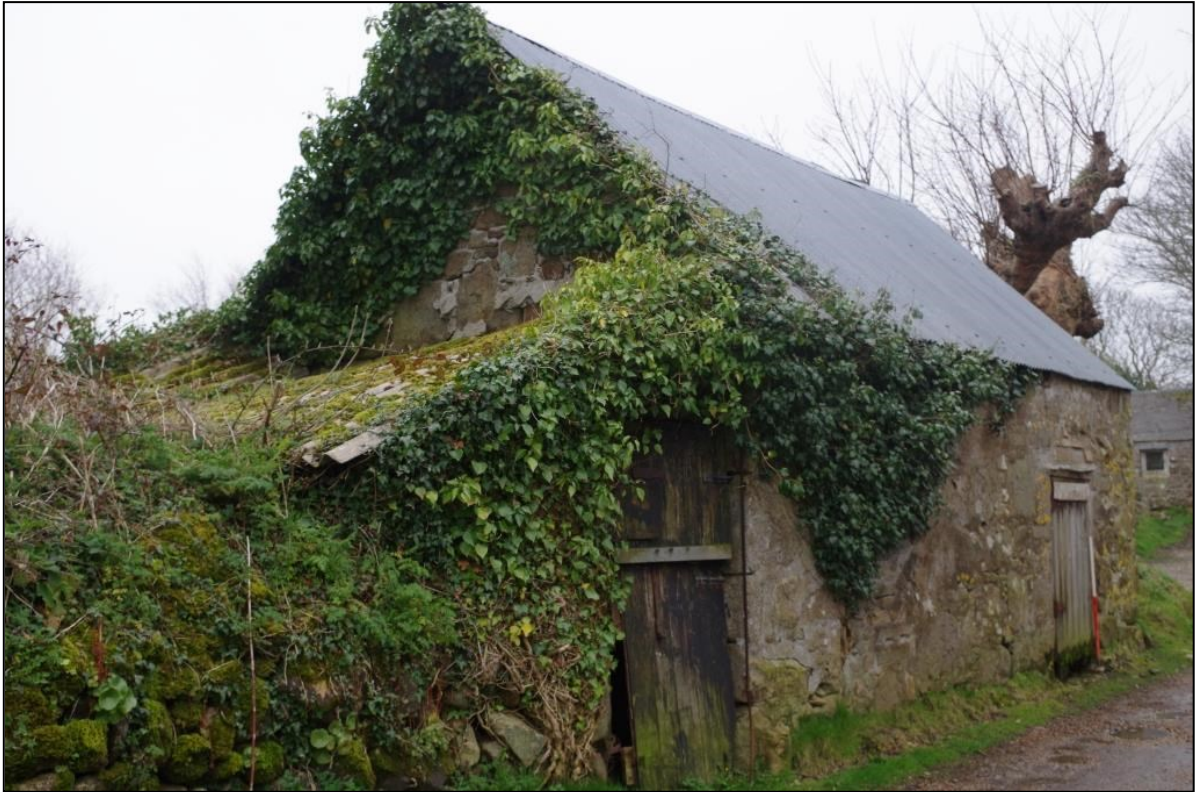
Building 1 is a rectangular single-storey barn aligned northeast-southwest (Fig 19). At the northern end is an abutting lean-to of rubble stone, covered in ivy, with a broken wooden stable door on the west elevation and a corrugated metal roof sloping down from the gable end of the main building. The interior is devoid of any features apart from vegetation debris. Concrete had been used on the top of the walls to support the roof.

Figure 19: The north and west elevations of Building 1. Note the lean-to, steeply pitched roof and blocked opening obscured by ivy.

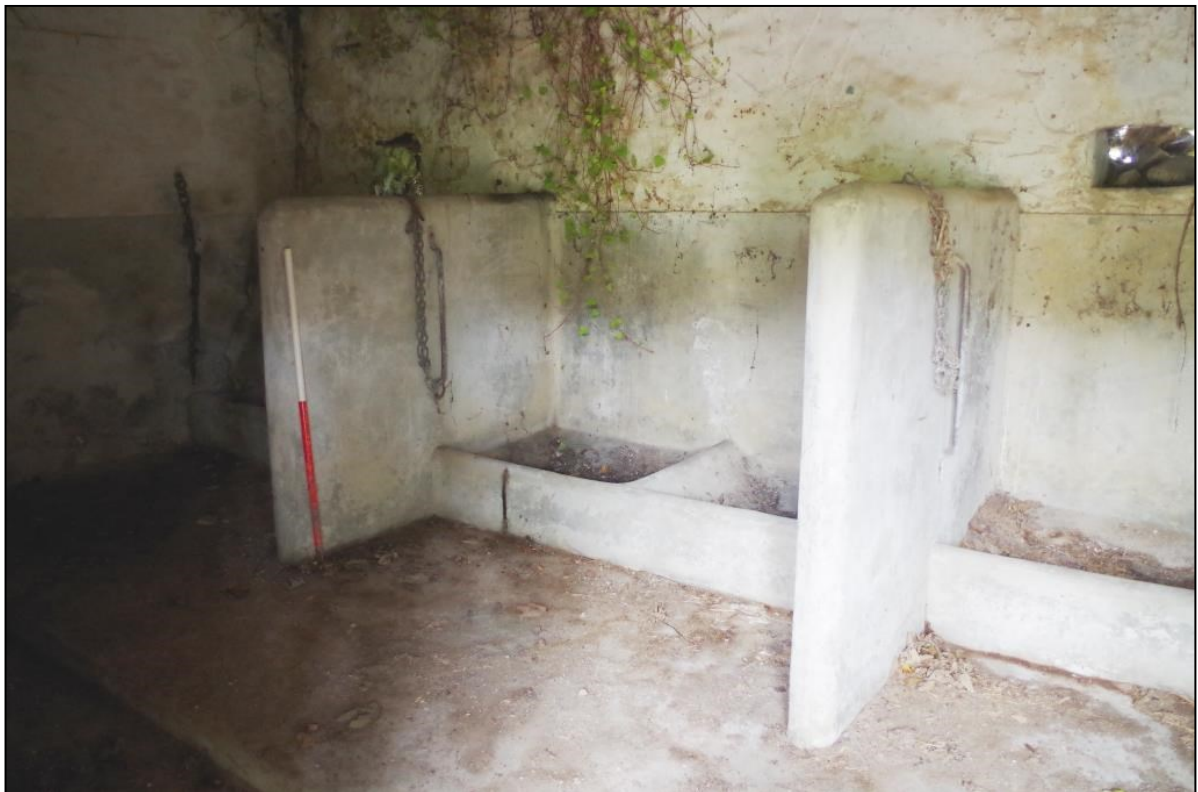
Figure 20: The interior of Building 1 with concrete stalls and floor and a small opening in the east wall.

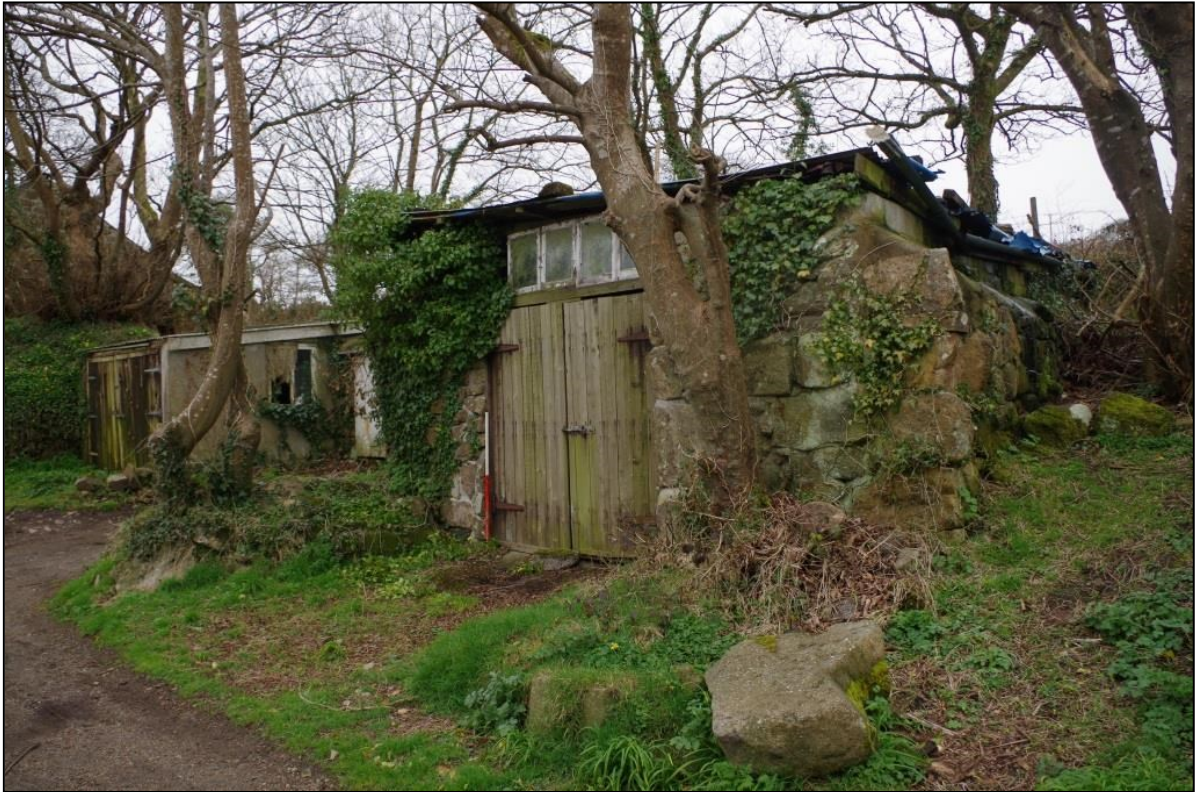
Figure 21: The east and north elevation of Building 2 with a modern doorway and additional walling on the north side.

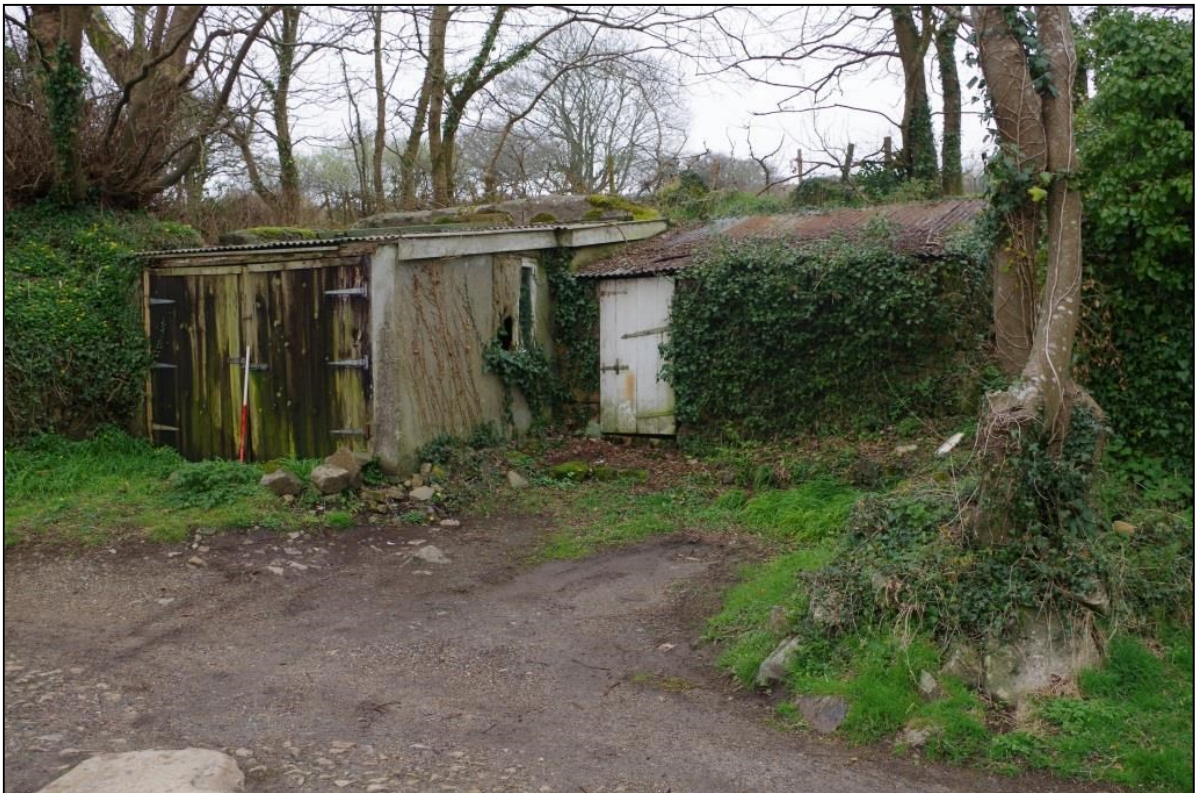
Figure 22: Building 3 looking southwest to show the modern extension and use of concrete and granite.

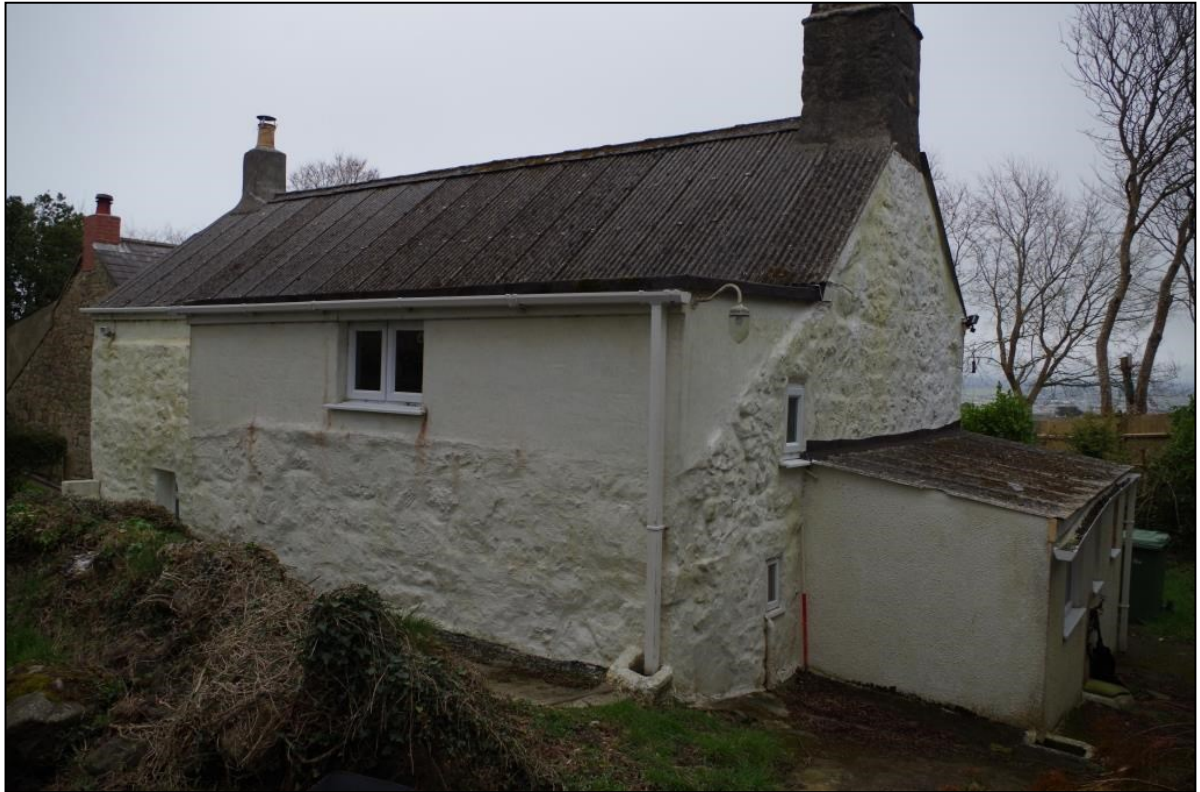
Figure 23: The west and south rear elevations of Building 4 with the modern bathroom extension to the south and partly historic west extension.

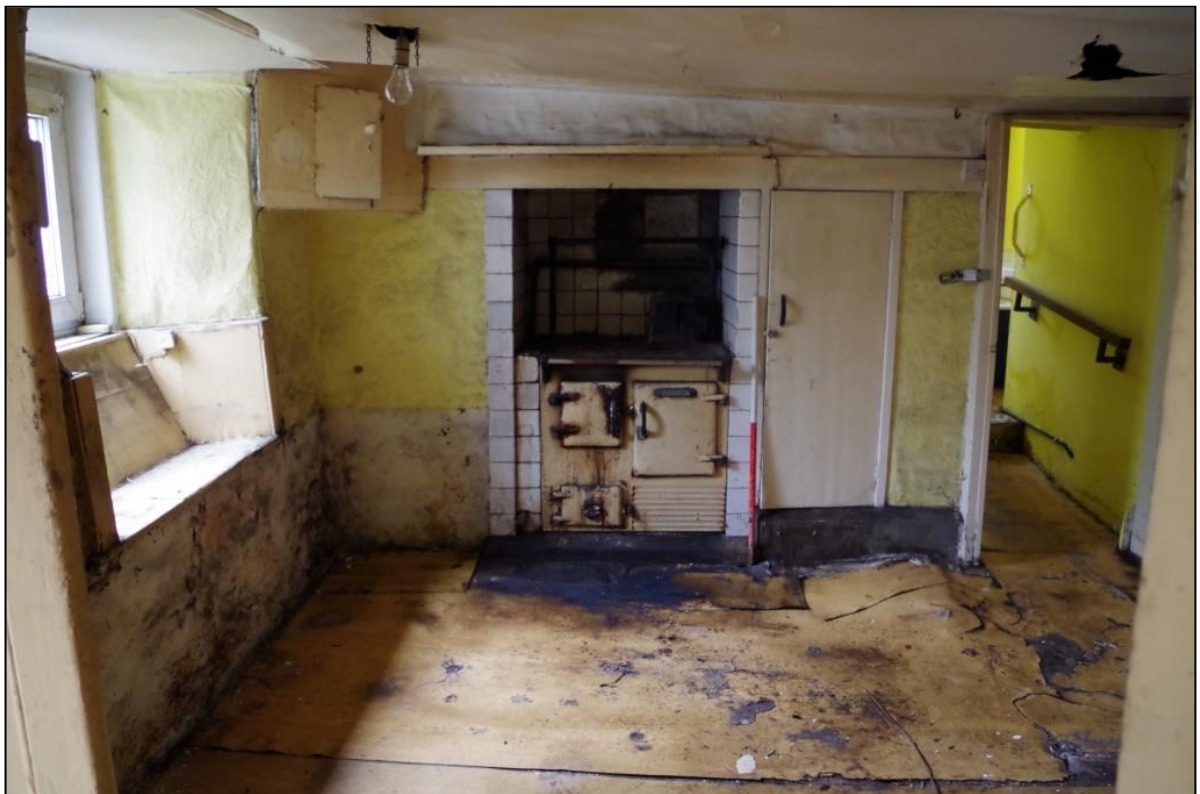
Figure 24: The southern ground floor room of Building 4 with the recessed cooking area. Note also the splayed window, passage to the bathroom and granite steps under the oven.

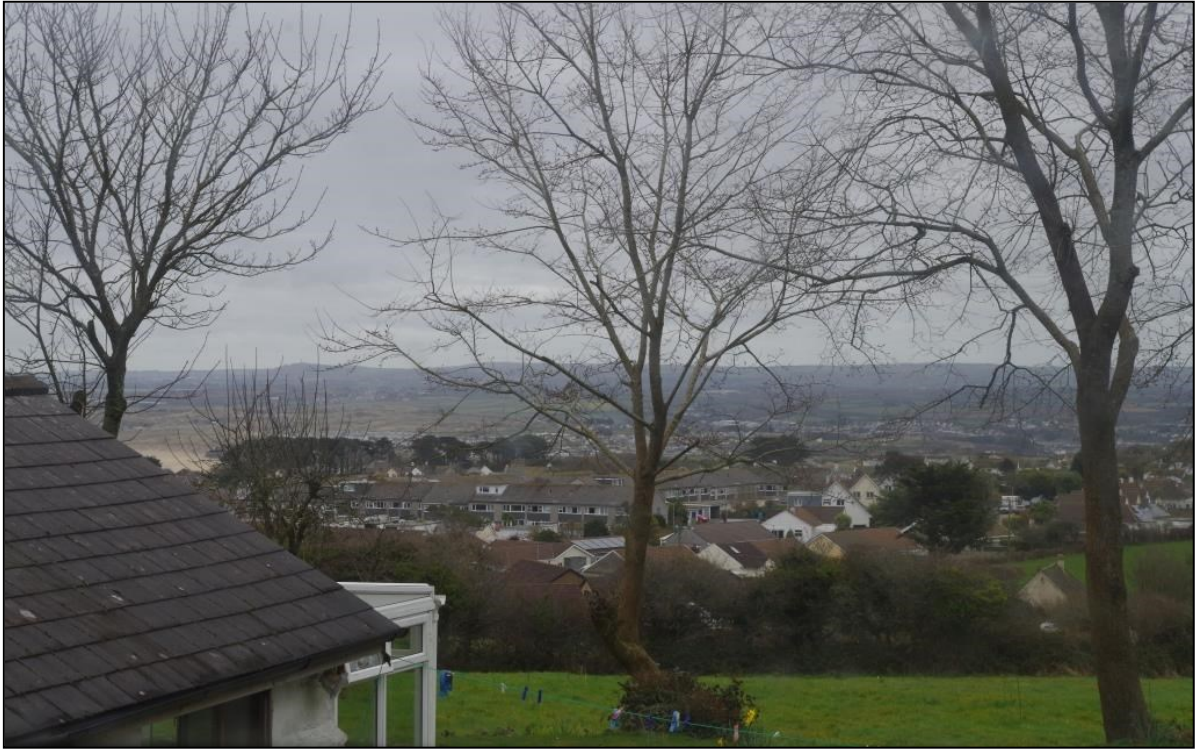
*Figure 25: The view east from the upper floor window of Building 4 over the proposed development area and Carbis Bay housing to St Ives Bay and Carn Brea.*

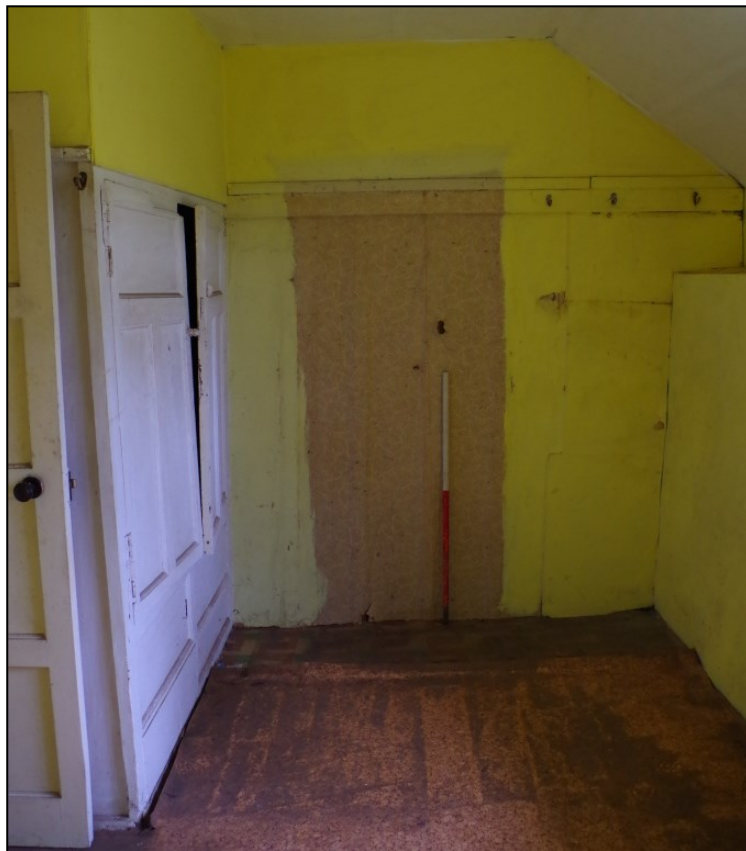
wallpapered and painted, cracks and peeling paper reveal what appears to be a battened wooden insert placed approximately centrally and suggestive of an earlier doorway (Fig 26). The west room has a beam across the length of the ceiling supporting the base of the pitched roof and the edge of the flat roof of the extension. This flat roof only gave a head height of 1.5m. The walls of this room are concrete block, as demonstrated by the narrow wall thickness around the windows in the west and south walls. From the windows in the east wall of the upper floor, extensive views of Carbis Bay, Hayle and the Carn Brea monument can currently be observed.

*Figure 26: The first floor southern room of Building 4 looking north towards the dividing wall. The beige patch helpfully indicates a wood panel that may block a former doorway between the two upper storey rooms.*

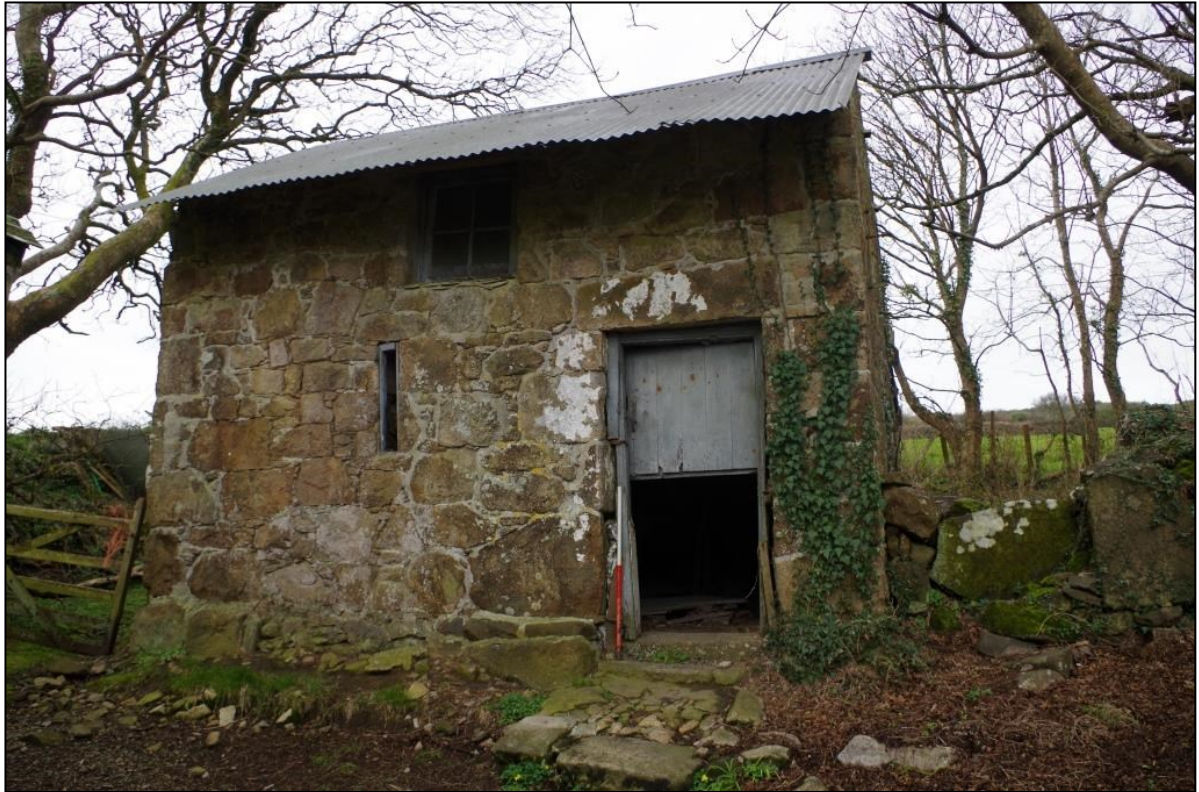
Figure 27: The eastern elevation of Building 5. Note the stable door with cobbled path, slit ventilation on the ground floor and larger window on the upper storey.

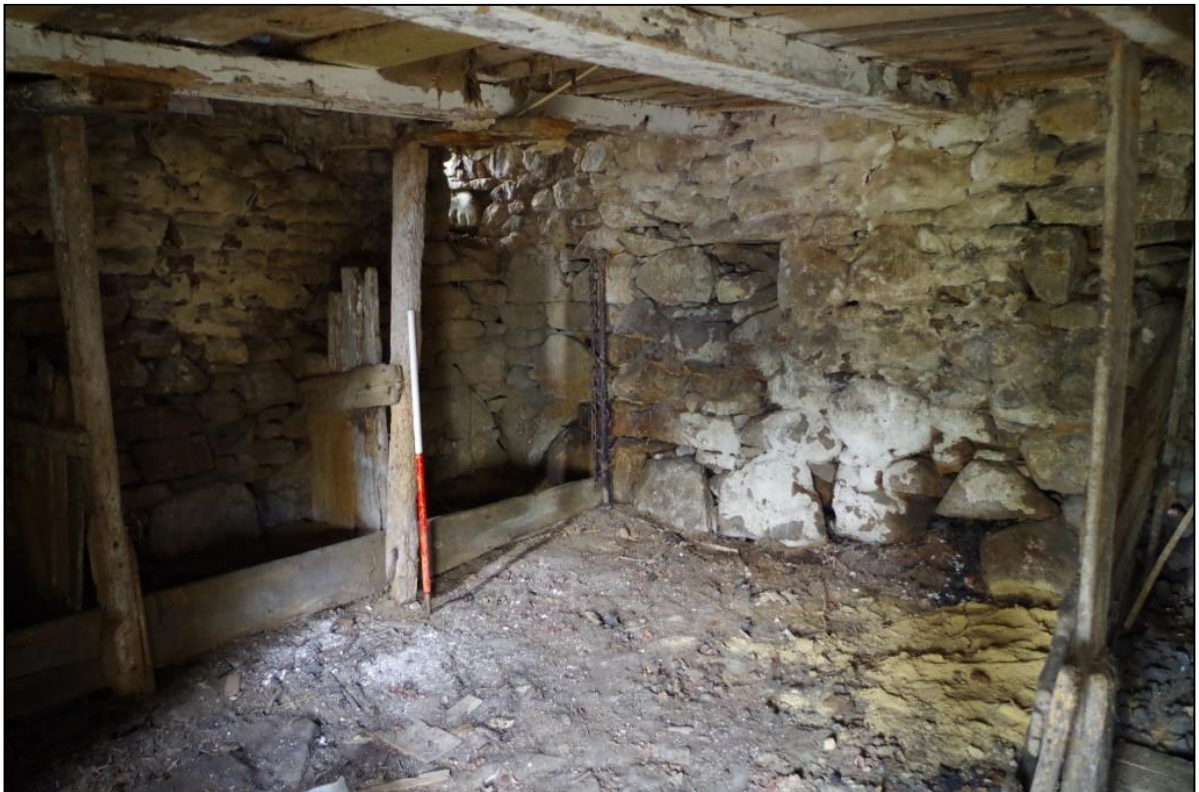
The interior of the building retained some features including three wooden livestock stalls with troughs on the south wall (Fig 28). These have an iron bar and chain at each end. In the northwest corner a wooden partition created an area for coal storage, though it could also have previously been a livestock stall. The wood is considerably decayed with holes and slots suggesting the wood had been reused. The floor is formed of very uneven cobbles covered in vegetation debris.

Figure 28: The interior of Building 5 with wooden stalls, cobble floor and recesses in the rear west wall. At the top of the image the wooden first floor is visible.

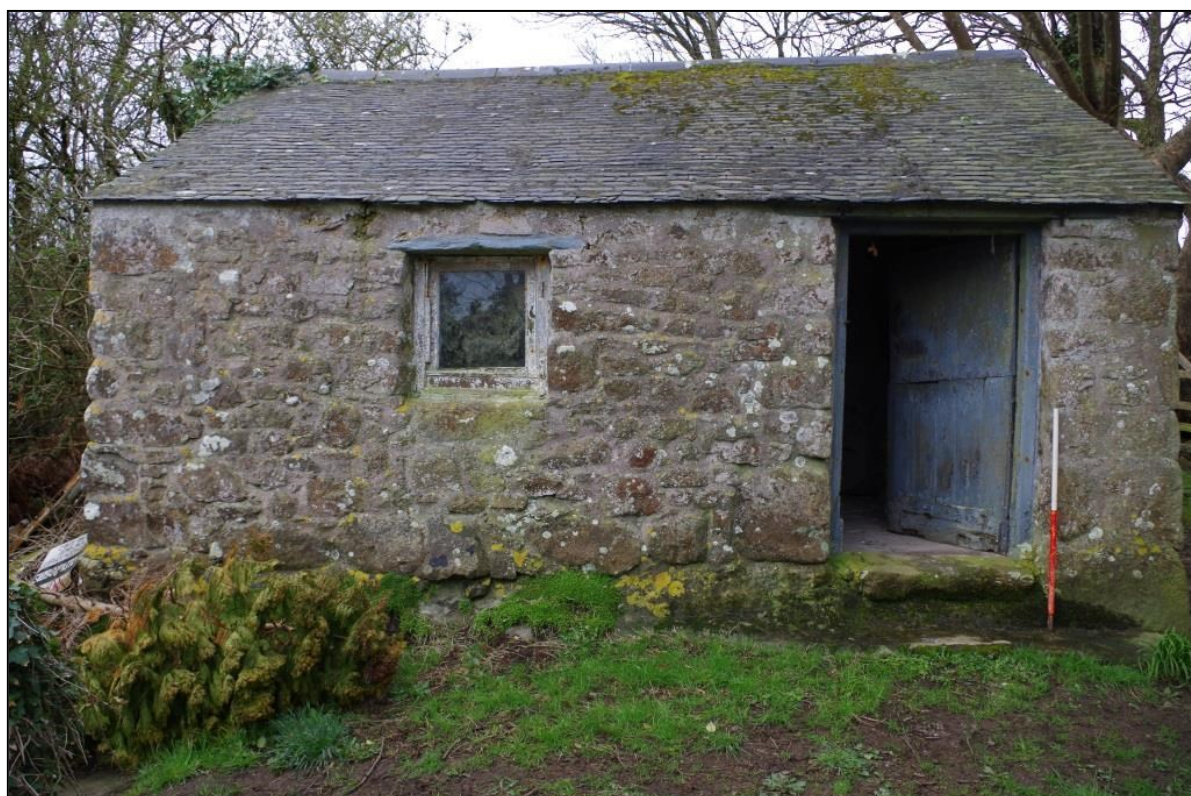
Figure 29: The north elevation of Building 6 with the high threshold step and slate roof.

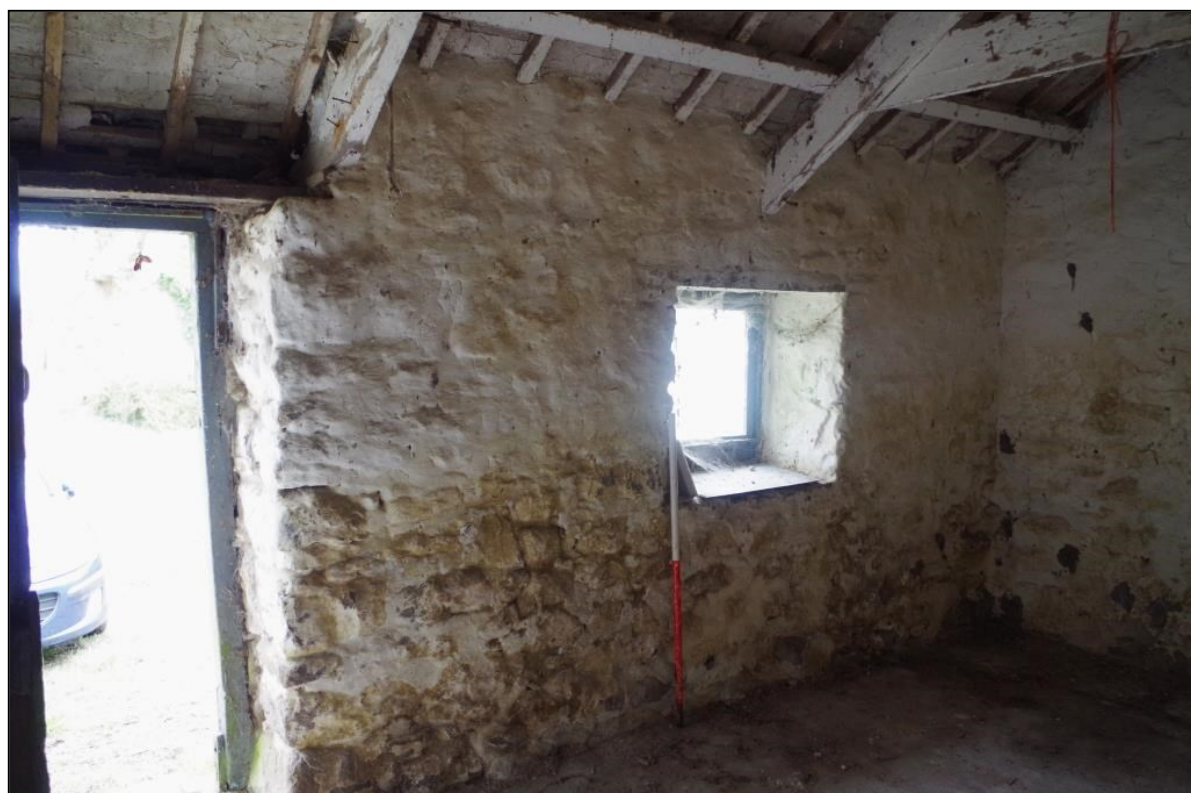
Figure 30: The painted interior of Building 6 with exposed roof and concrete floor.
