Tintagel Castle, Lower Ward Kiosk, Cornwall Archaeological Watching Brief

2015R032

Tintagel Castle, Lower Ward Kiosk.
Archaeological Watching Brief

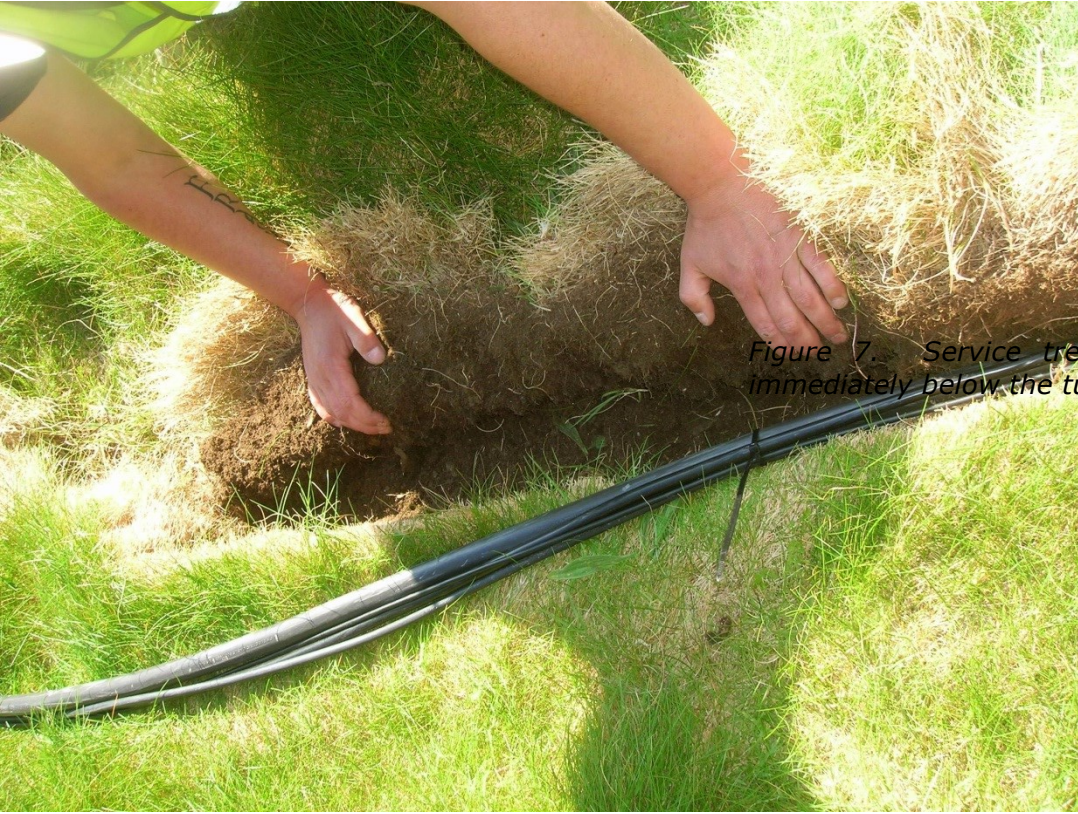
Figure 7. Service trench showing the laying immediately below the turf.

A trench roughly 110m long was dug for the service cables connecting the new kiosk with the visitor centre down in the valley (Fig 3). The turf was cut by knife or spade (Figs 6 and 7) to a depth of about 0.25m (just below root level) and then peeled back to reveal a shallow slot between 0.05m and 0.1m wide into which the cable was inserted. The turf was then replaced.

Throughout the entire length of this trench the depth (Fig 7) was just below the base of the subsoil and roots being cut into grey-brown clay loam. No archaeological features were recorded, and no artefacts recovered (apart from some plastic and sweet wrappers).

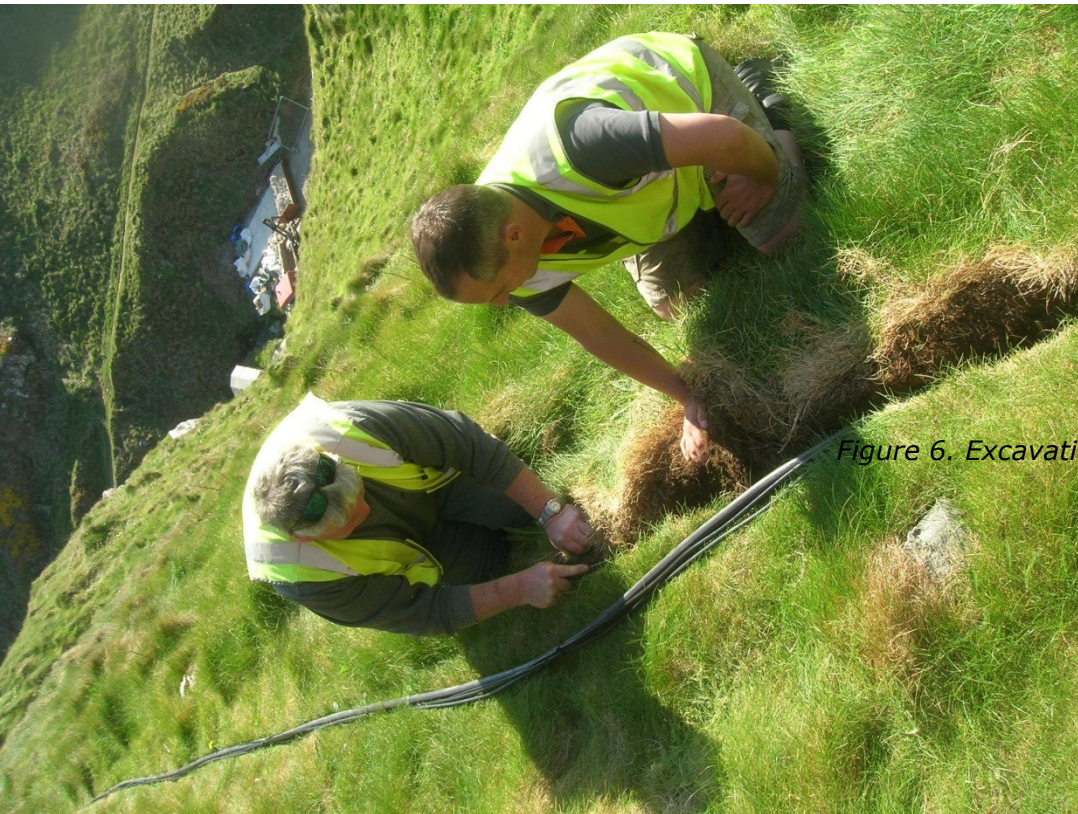
Figure 6. Excavation of Service trench

In April 2015 work on the service cable trench was monitored. The cables were buried at a very shallow level below the ground surface. The turf was cut by knife or spade and then peeled back to reveal a narrow trench into which the cable was inserted with the turf then being replaced (Figs 6 and 7). The underside of the turf, and the exposed soil within the trench were examined for artefacts. A photographic record was made. .

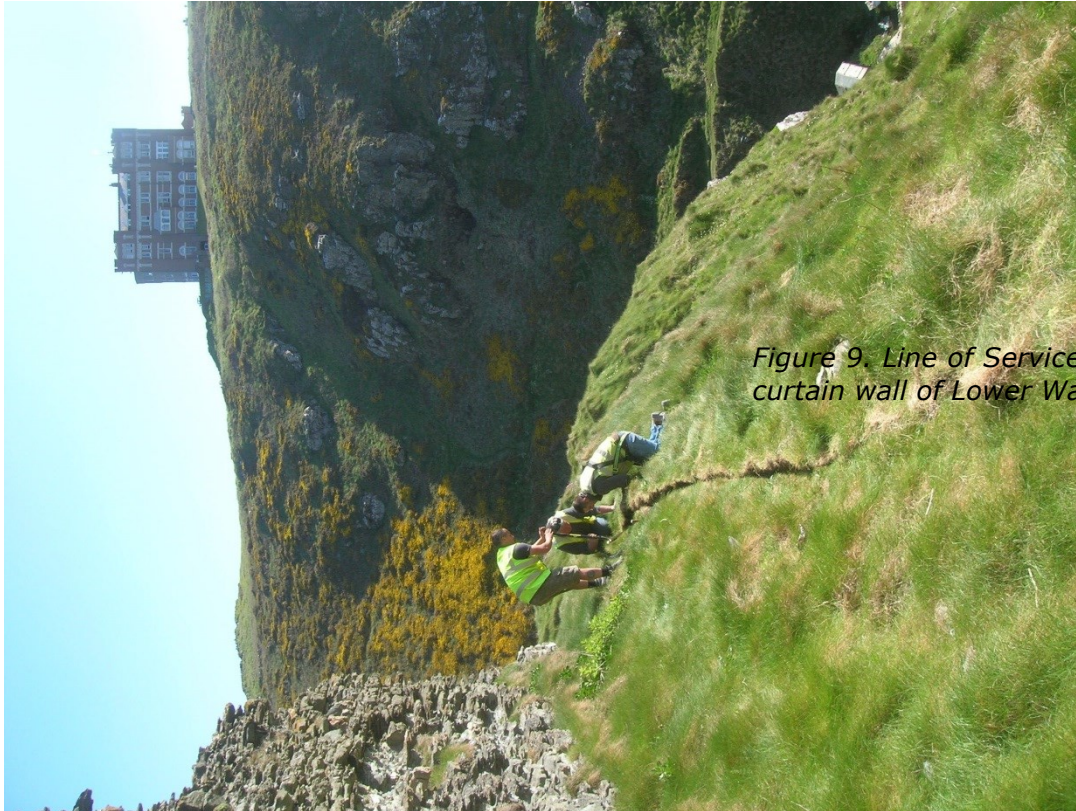
Figure 9. Line of Service cable on path outside of curtain wall of Lower Ward looking north-east.

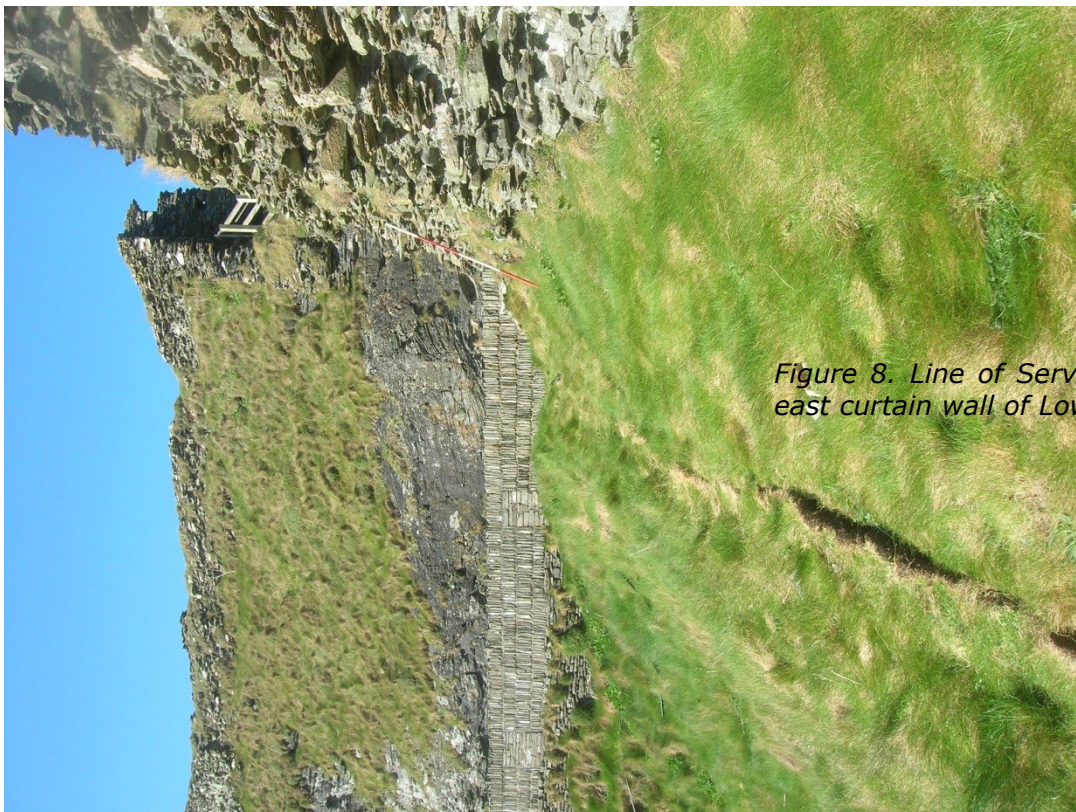
Figure 8. Line of Service cable on path outside east curtain wall of Lower Ward.

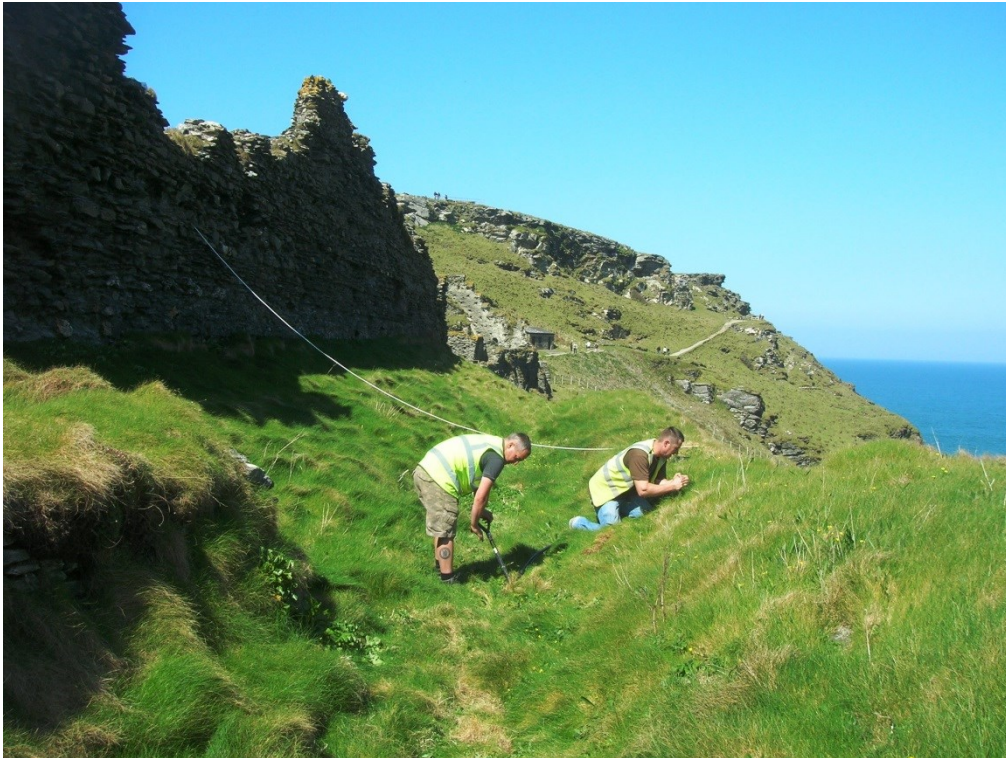
Figure 10. Cutting of service trench in ditch outside north-east curtain wall of Lower Ward.

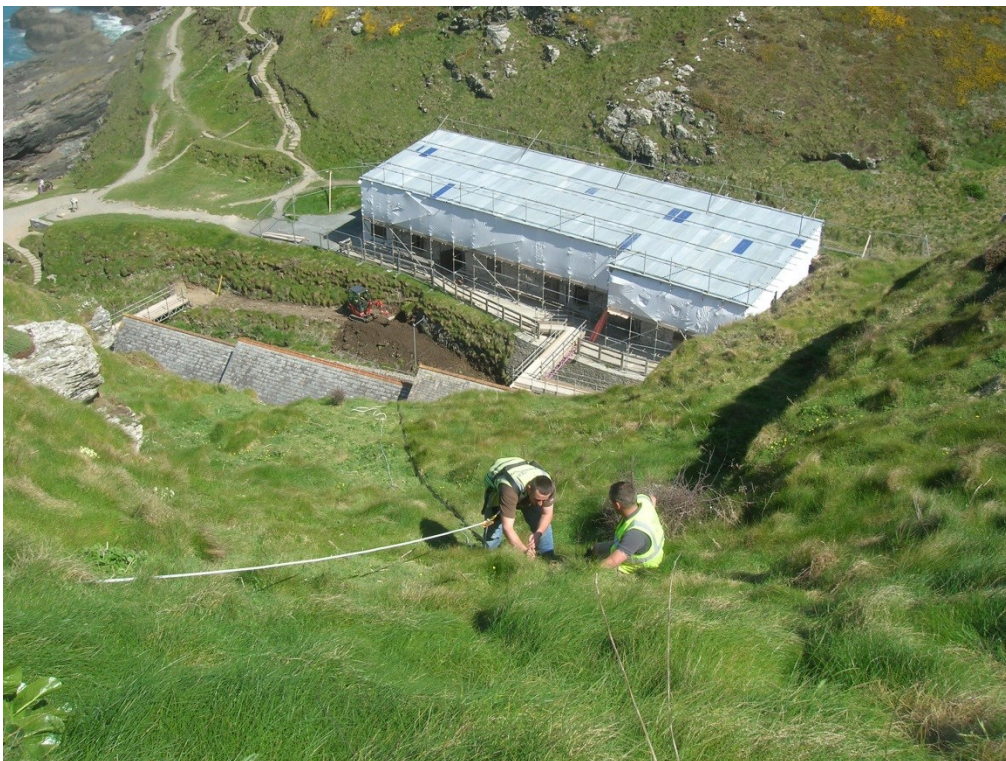
Figure 11. Course of cable trench from the Lower Ward ditch to the visitor centre in the valley below. View looking north-east.

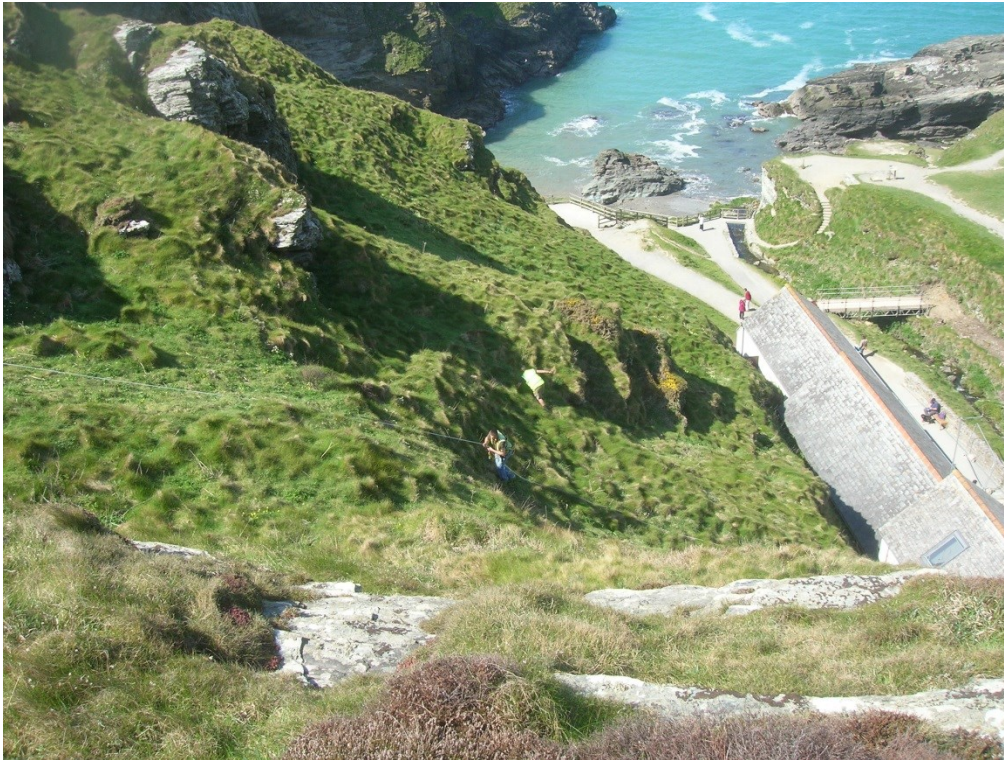
Figure 12. Photograph of the course of the service cable trench down the valley side, clearly showing one, possibly two terraces cut into the valley side.

The trench for the service cabling was only shallow, the depth of which was insufficient to affect any archaeology with the cables being laid immediately below the turf-line. No artefacts were recovered. At the north eastern end of the cable run, as it plunged down the valley side, two possible artificial terraces were observed, one mid slope centered at SX 05190 88964 and one below it, just above the visitor centre at SX 05193 88970 (Fig 12). These resembled the artificial terraces noted on the east-facing sides of Tintagel island being defined by levelled ground and with the rock outcrops deliberately cut to have near vertical faces (though there a possibility that these are slate quarry faces).

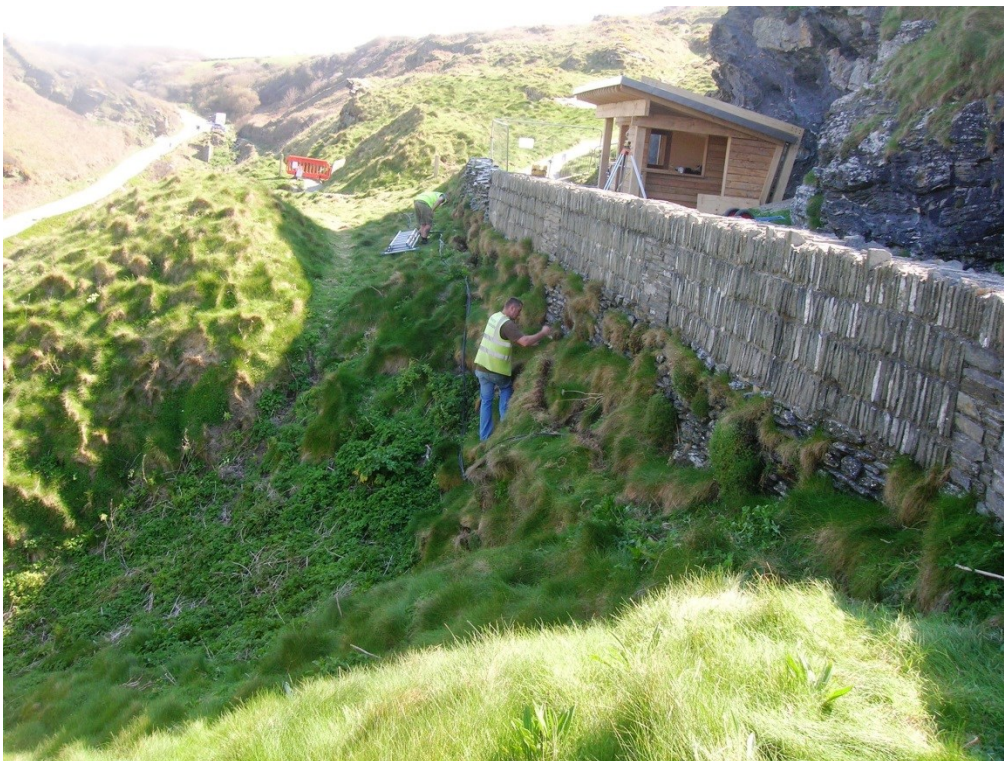
Figure 13. Route of service cable along exterior of barbican wall looking south, south-east.

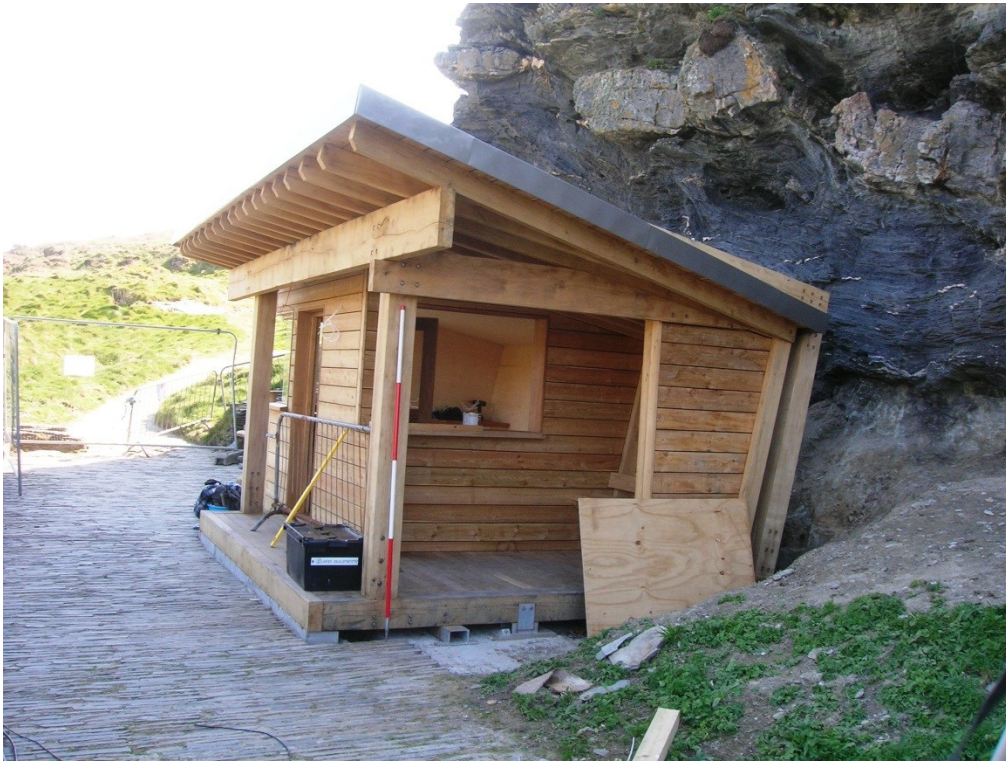
Figure 14. The new visitor kiosk.
