Stepper Point Lobster Hatchery, Padstow, Cornwall Archaeological Assessment

Stepper Point Lobster Hatchery, Padstow, Cornwall

Archaeological Assessment

Client	Dominic Boothroyd, National Lobster Hatchery
Report Number	2015R037
Date	15 June 2015
Status	Final
Report author(s)	Francis Shepherd
Checked by	Charles Johns
Approved by	Andy Jones

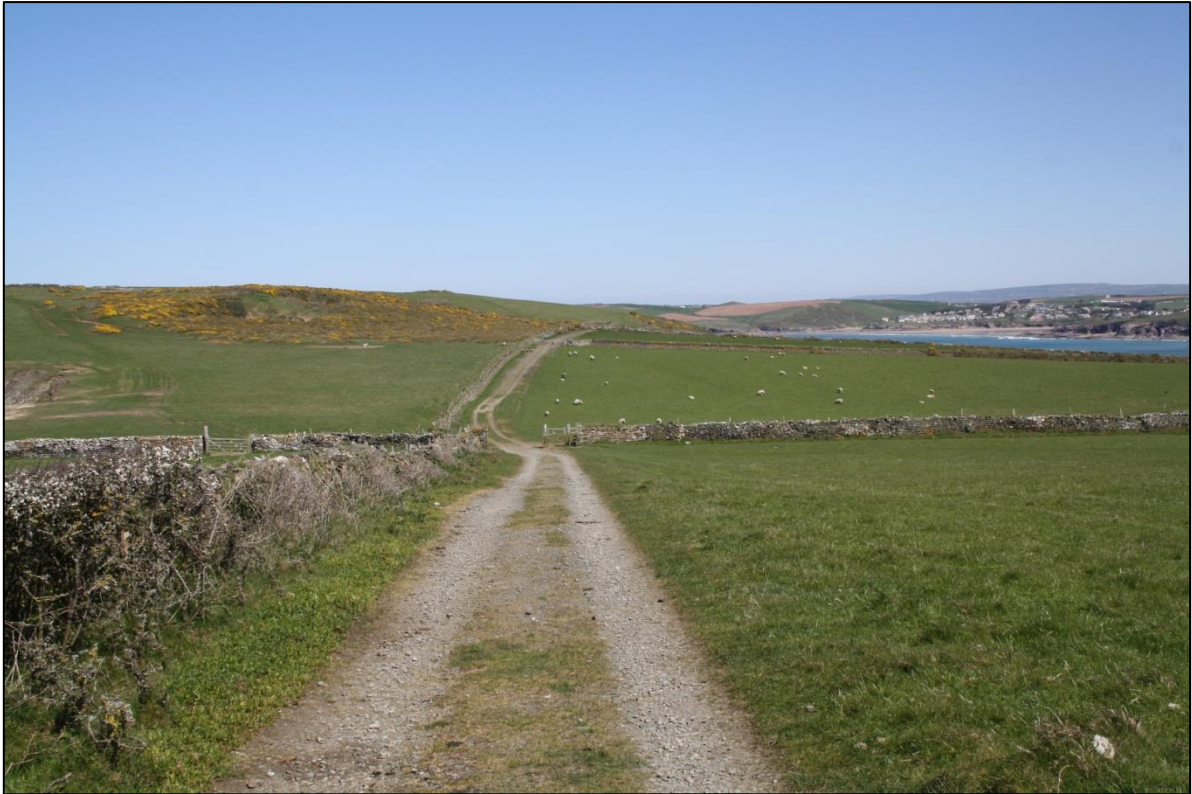
Fig 11 Looking north towards Stepper Point.

The fieldwork demonstrated that all of the existing field boundaries along the access track have been modified in the very recent past presumably to allow the access and egress of modern farming equipment (Fig 12). The track itself has been renewed over time and appears to be of modern construction, apart from the narrow stretch approaching the modern quarry cutting (Fig 11).

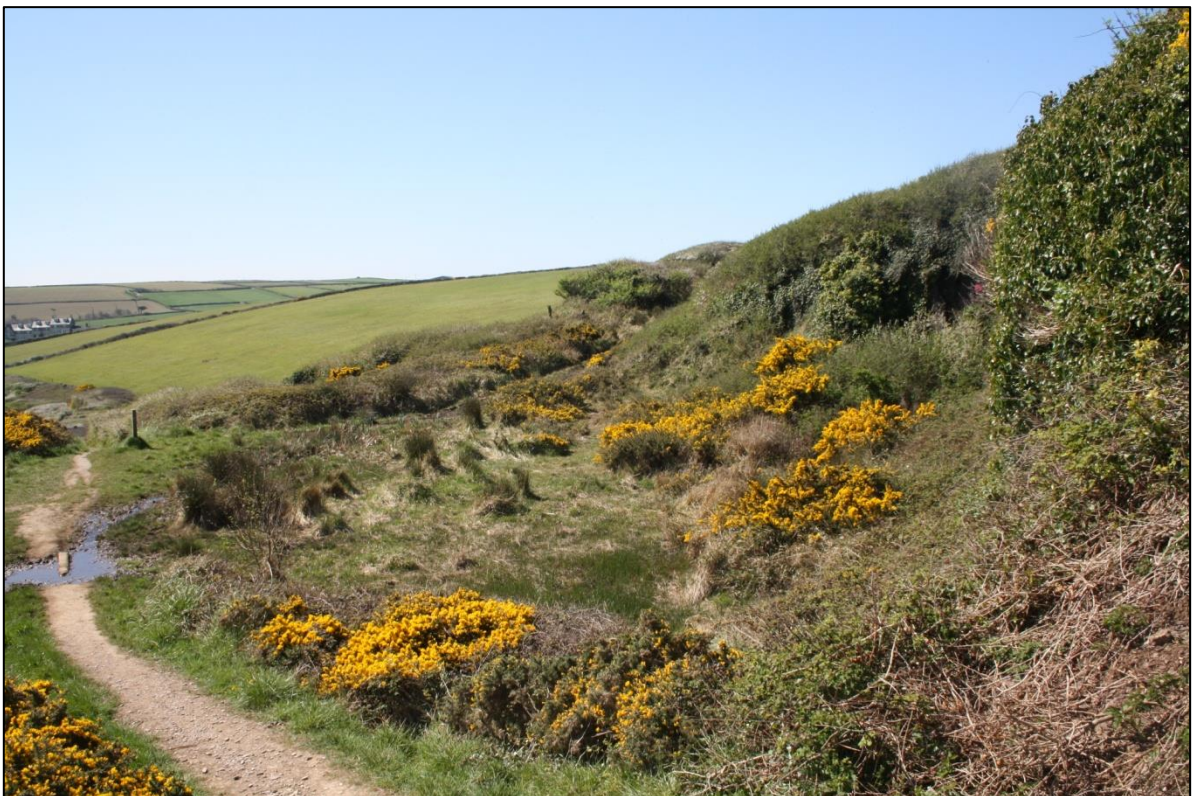
Fig 14 The quarry cutting looking south – note the spring in the foreground.

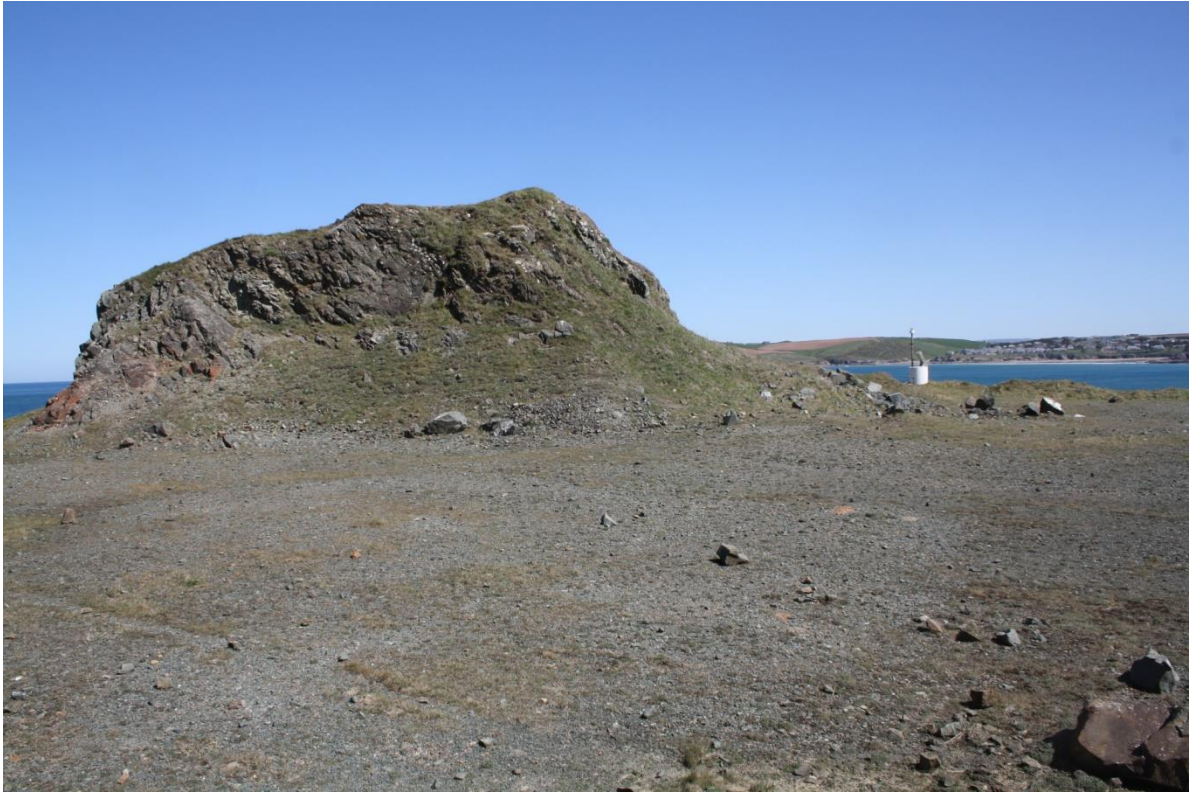
Fig 17 The proposed development site.

When the site was visited no archaeological features were found inside the quarry.

There are no upstanding archaeological features within the footprint of the proposed development and it is unlikely that any will survive below ground. This means that the impact of the proposed development on archaeological remains will be negligible in the quarry area.

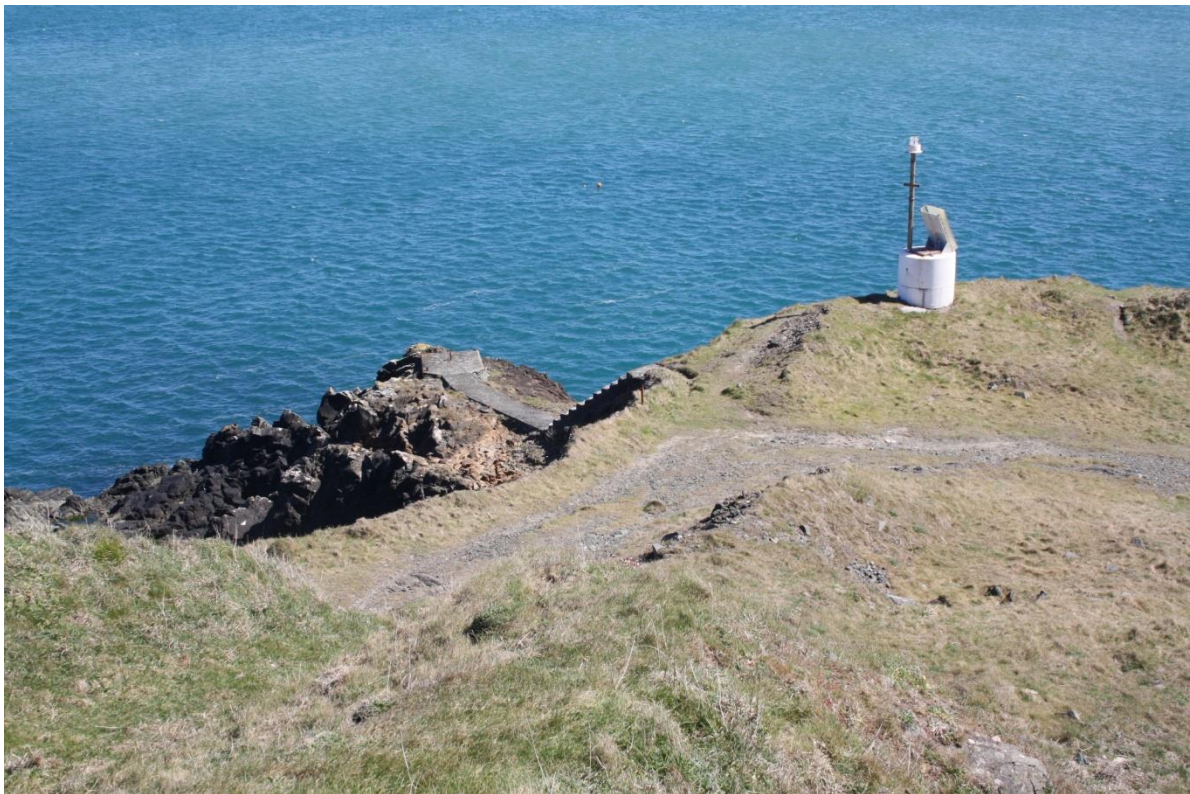
Fig 20 Steps and walkway to the platform – this is likely to have been a predecessor to the modern navigational aid towards the right hand side of the image.
