Dolphin Inn, Grampond, Cornwall Archaeological Watching Brief

**Dolphin Inn,
Grampound, Cornwall**

Archaeological Watching Brief

Client	Mr Tony Bowden (Gilbert and Goode Ltd)
Report Number	2015R039
Date	May 2015
Status	Final
Report	Anna Lawson-Jones
Checked by	Andy Jones
Approved by	Charles Johns

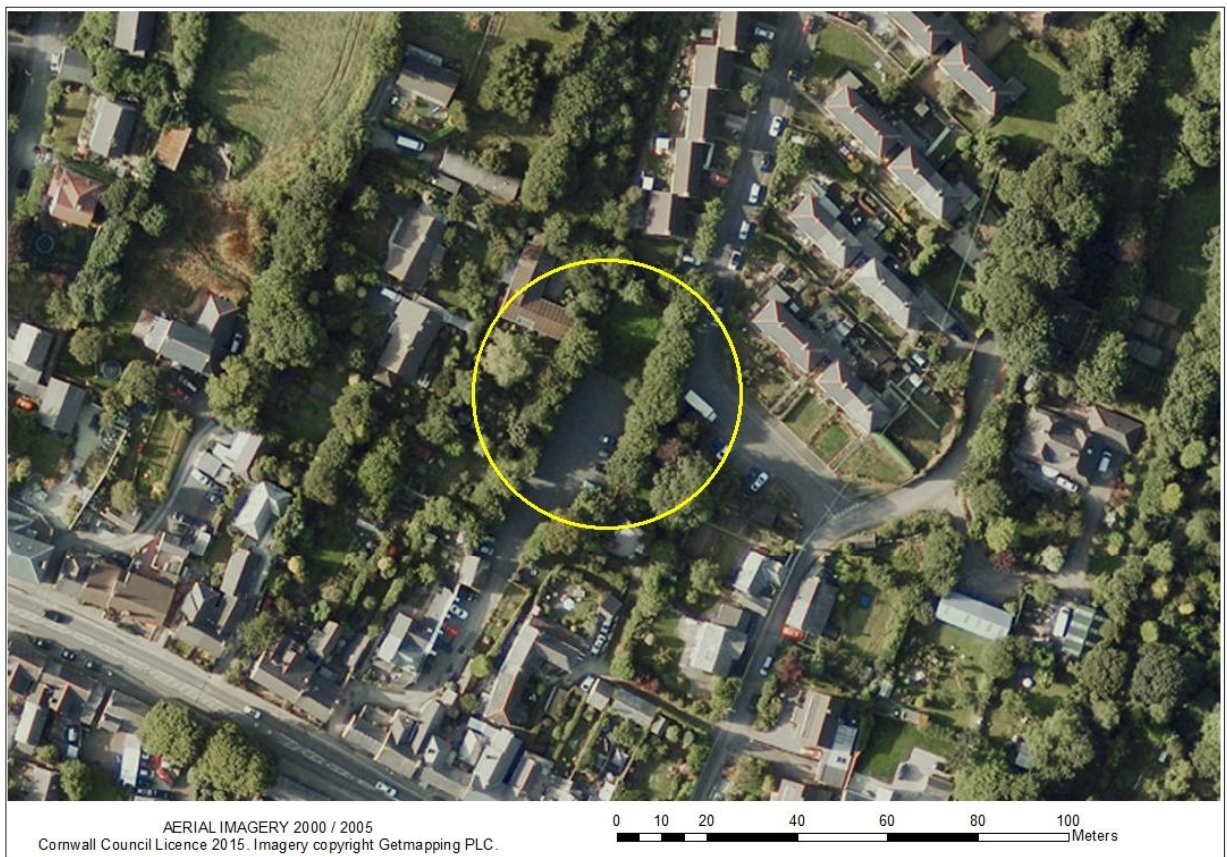
Fig 8 Aerial photograph (2005) showing the site and its immediate area.

Trees run along the eastern and western peripheral historic boundaries of the site as a whole (Fig 8).

There are no Listed Buildings or Scheduled Monuments within the project area, although Grampound as a whole does contain around 53 Listed Buildings (50 of which are Grade II). The vast majority of Listed Buildings are located along Fore Street (Fig 8). Included within these is the Dolphin Inn (DCO14165).

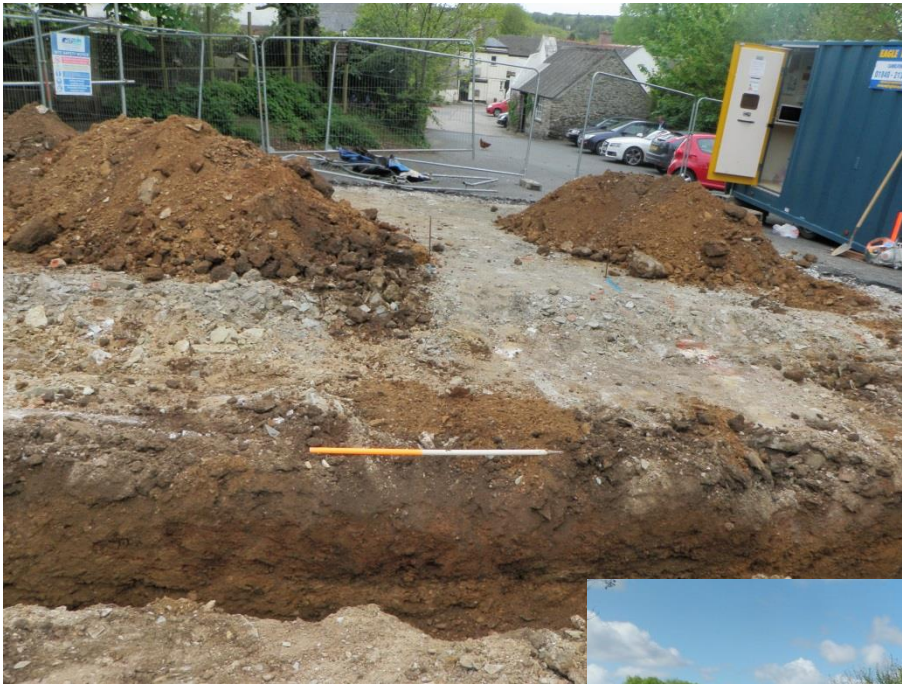
Fig 10 Looking south towards the Dolphin Inn, showing former track [9] in southern house foundation trench.

- [9] – a broad shallow, linear cut running north-south down the site (Fig 10). The feature was sealed by and so predates demolition deposit (2), and cut through both sealed soil (7) and subsoil (10) in to the top of the underlying natural decayed shillet. It had a near flat c 2m wide base with c 45° straight edges, an upper width of 3m and a maximum depth of 0.4m. There was no obvious wheel rutting across the base (although natural at this point was hard). Despite this, the feature does in section resemble a weathered, waterworn track. It is broadly in line with the western side of the Dolphin Inn building itself, and so may have been a continuation of the access route shown running around the inn, linking Fore Street to the plots and fields behind.

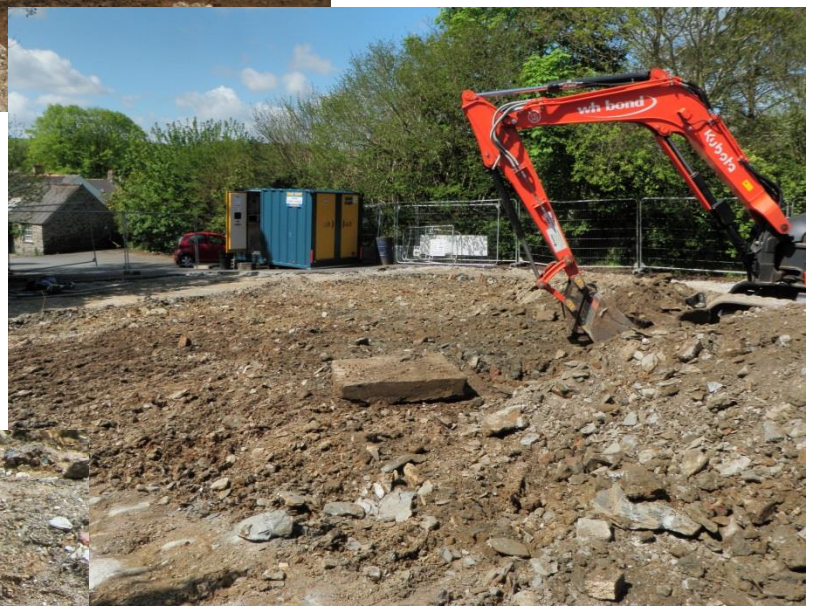
Fig 11 Looking south-west across the southern area showing layer (2) demolition layer.

- (2) - a variably deep post-1900 layer of heavily compressed demolition material composed of concrete blocks, old timbers, occasional cobbles, smashed slate, odd bits of iron and remnant wiring (see Fig 11). All pertain to the 1907 OS mapping which shows probable open animal pens and yard surfacing across the area (Fig 6).

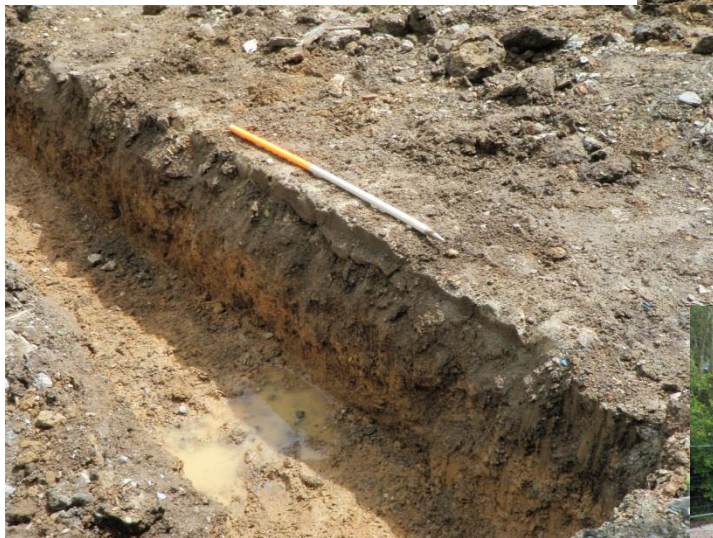
Fig 12 Looking west-south-west, showing wall (4) – above.

- (4) - an east to west running base of brick and concrete walling (see Fig 12). It merged in to form a part of demolition layer (2), and was located on the extreme southern edge of the south-western foundation trench for the southern house.

4	Wall footings	4m long, 0.3m wide and 0.2m deep.	The red brick and concrete remains of an east to west running wall located on the extreme southern edge of the southern house footprint. Remnants of shillet adhered to the northern edge, confirming shillet slab flooring or paving (5).
5	Paving slabs	Up to 0.7m long and 0.2m (max) thick.	Thick, unshaped shillet slabs used for paving or flooring. Most were broken and/or dislodged during demolition, but some appeared to be <i>in situ</i> . None appeared obviously reused from earlier buildings (although it would seem probable that some were!).
6	Remnant garden soil	0.15m deep.	Very compact, dark grey brown silty loam. Moderate to infrequent crushed 0.05m and less sized redbrick and slate pieces, plus occasional plain stone ware (marmalade jar-like) vessels and contemporary glazed domestic ware. Interestingly there was almost no glass, and no marine shells typical of kitchen midden waste. Any meat bones that were present would have long since decayed.

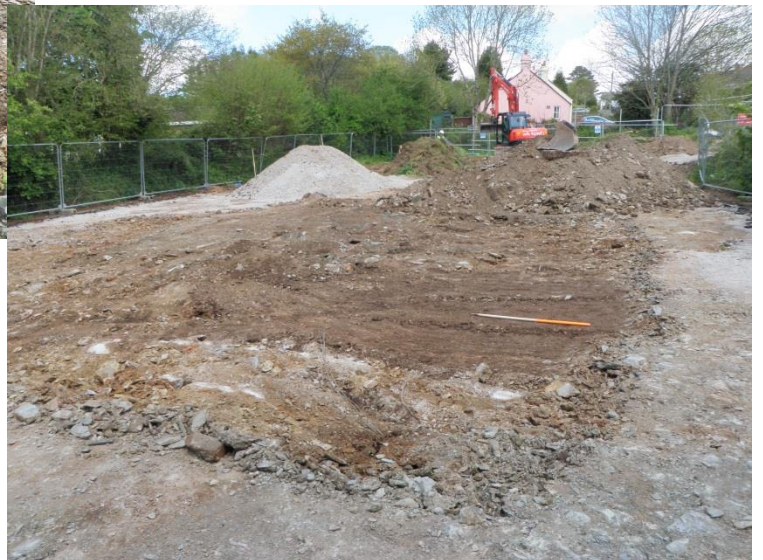
Fig 13 Looking north, showing drain (3) and soil (6) – right.

- (3) - a smashed concrete lined east to west running surface drain with remnants of iron gutter lining was recorded in the southern part of the southern house footprint. It merged in with surrounding demolition layer (2) (see Fig 13).

- (6) - a layer of former (c 1900) topsoil peripheral to the eastern side of the general spread of demolition (2) - Fig 13). It was compacted and contained frequent fragments of coke, red brick, occasional stone ware and post-medieval glazed material - including part of an 18th/19th century Barnstaple ware, internally glazed large domestic/kitchen vessel. This appears to be a contemporary exposed working surface directly associated with the former buildings.

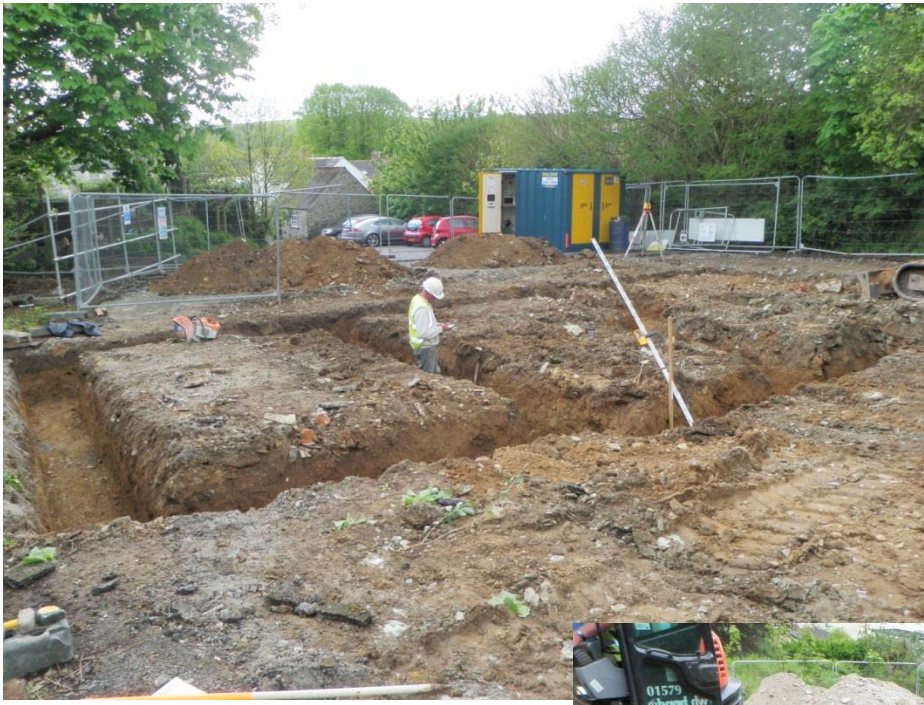
Fig 14 Looking south across the southern house foundation trenches.

The tarmac was largely removed prior to the start of the watching brief. The southern house (see Fig 14), with adjoining garage was positioned centrally within the area, with a separate garage in the north-western corner (for the northern house).

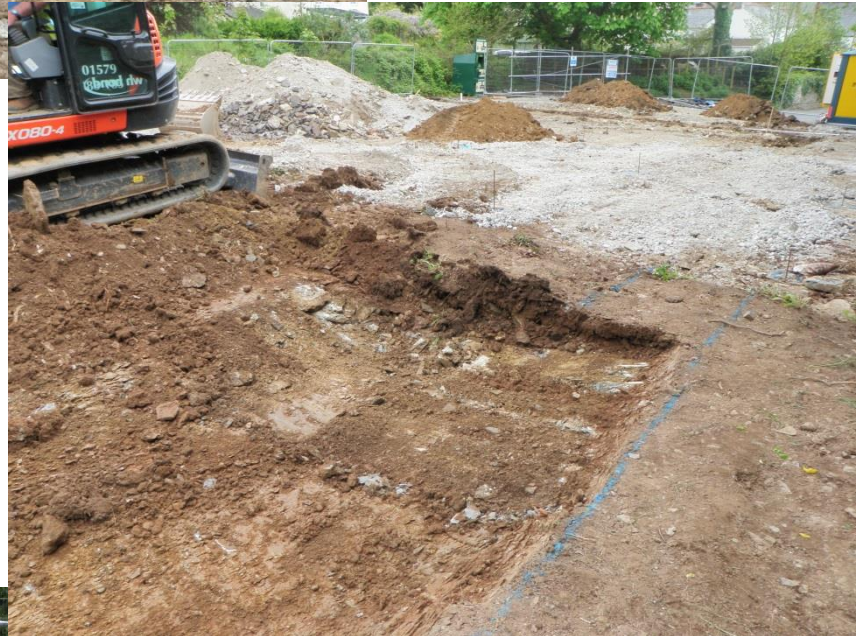
Fig 15 Showing shillet (13) in process of being removed from the northern house area.

- (13) – shillet blocks forming a layer of (hard and softer decaying) shillet located within the southern third of the northern house footprint (see fig 15). This appears to correspond with the northernmost open structure or yard/surface shown on 1907 OS mapping. It did not contain either red brick or concrete, (unlike (2) to the south). The shillet did not reveal any wall footings, etc, and larger slabs did in some instances appear to have been laid horizontally on to (7). The eastern side of this layer was disturbed by wheel rutting caused by the lorries and dumper removing spoil from the site.

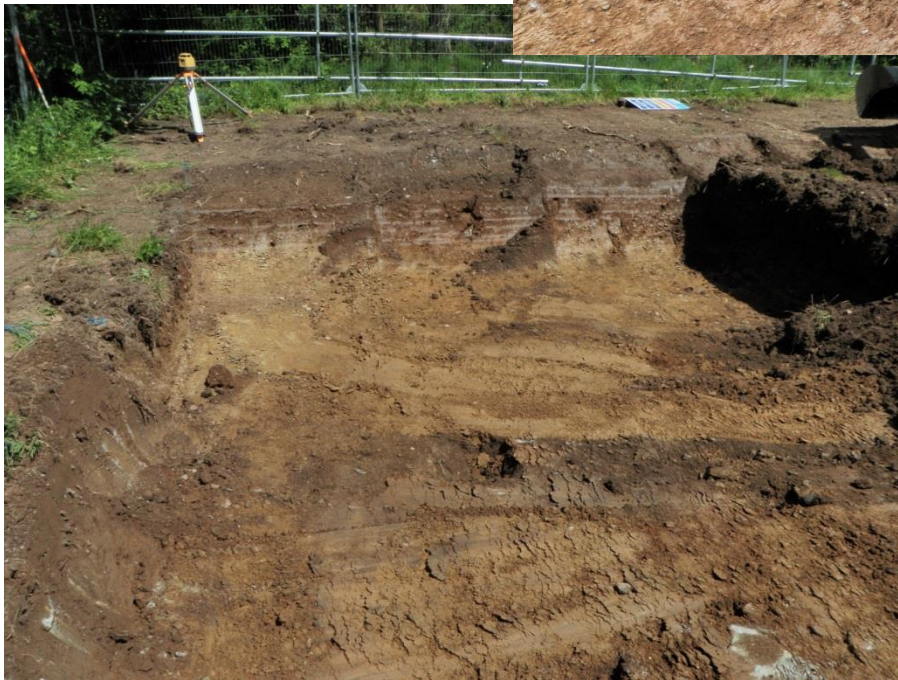
Fig 16 Looking north across the north-western corner of the northern house area, showing modern (14)/[15] running across as a dark streak, shillet (13) in the foreground and the area of track [9] in the section.

14	Pipeline fill	0.5m wide, 0.75m+ deep.	Dark brown loamy, slightly mixed recent pipe trench fill.
15	Foul water pipeline cut	12m+ length, 0.5m wide, 0.75m+ depth.	Linear, machine cut pipe trench with single fill where seen. Pipeline was scheduled for diversion around the southern side of the northern house.
