Porth Navas Quay, Constantine, Cornwall Archaeological Watching Brief

2015R042

Catherine Parkes
BA MCIfA

Duchy of Cornwall

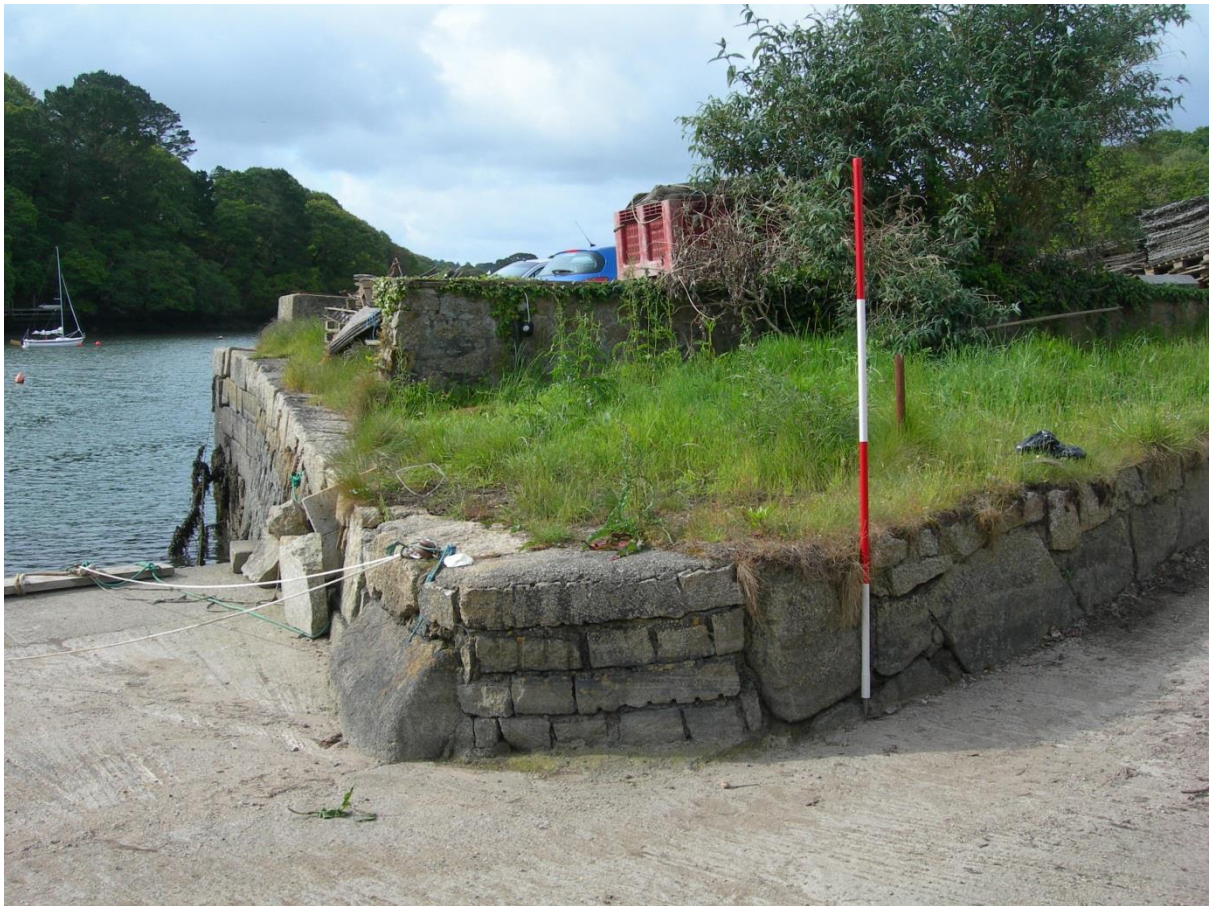
Cover photo	Porth Navas Quay from the north prior to disturbance, showing the modern road and the verge beside it where the work took place, with the Listed quay area behind a later wall built over it, and the creek beyond
Fig 1	Map showing location of the site at Porth Navas on the Helford estuary
Fig 2	Map showing the site relative to the historic quay and the extent of the LB (on the modern map base)
Fig 3	Map showing the site relative to the historic quay and the extent of the LB (on a base combining two layers; the 1:2,500 OS survey of c1880, and modern mapping)
Fig 4	The site, on a roadside verge, seen from the south west, prior to excavation
Fig 5	Detail of the site before excavation, showing the north end of the quay's west face
Fig 6	Works site stripped of turf with the concrete layer 2 exposed, from the north east
Fig 7	Layer 4, the yellowy clay with occasional brick forming the body of the historic quay behind its stone facing, in the centre of the works, seen from the north east

The quay on Porthnavas Creek where the archaeological watching brief took place is thought to date from the mid to late 19th century. It is recorded on the OS map of c1880, but not on the Constantine tithe apportionment survey of c1840 (and not on the schematic but accurate and detailed two-inch scaled drawing made as a preliminary to the first, one-inch OS mapping in the early 19th century). The inner part of the north east side of the quay – that affected by the cesspool works – has a slightly sloping face built of upright rough slabs of shillet or local slate stone with granite quoins and copings. The outer part of the same quay walling is vertical and made entirely of granite blocks (cover photo).

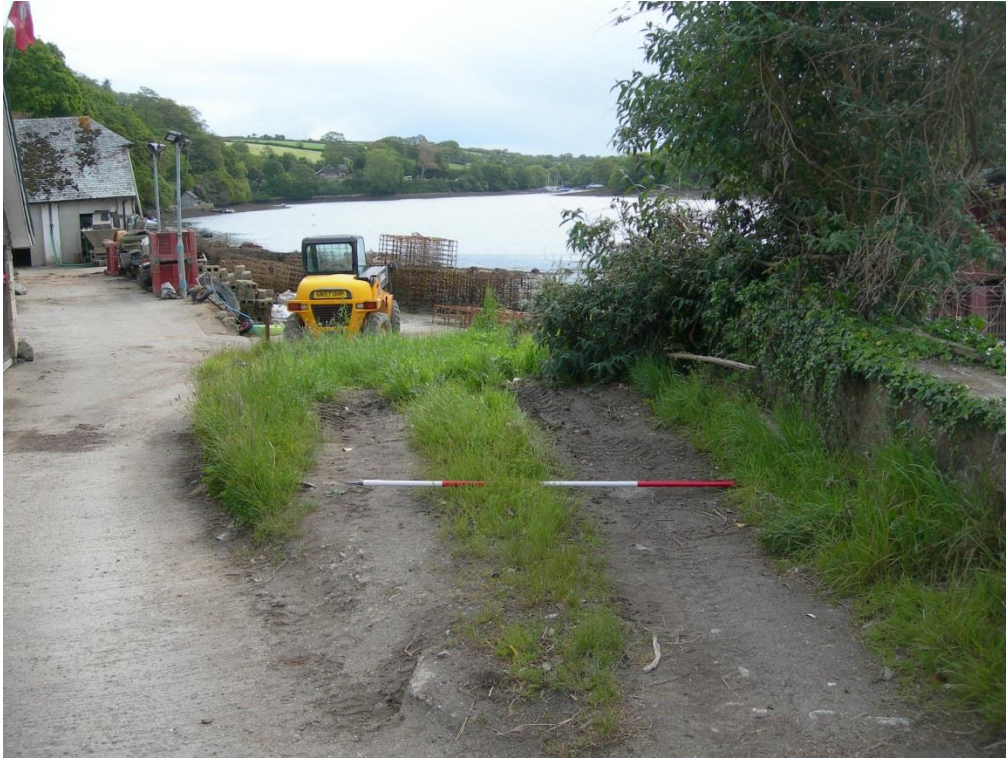
Fig 4 The site, on a roadside verge, seen from the south west, prior to excavation

In the rear ground is the Duchy Oyster Farm, served by the concrete road to the left of the works site. Both the road and its verge lie within the extent of the historic quay, but outside the Listing which protects it, this being defined by the wall to the right.

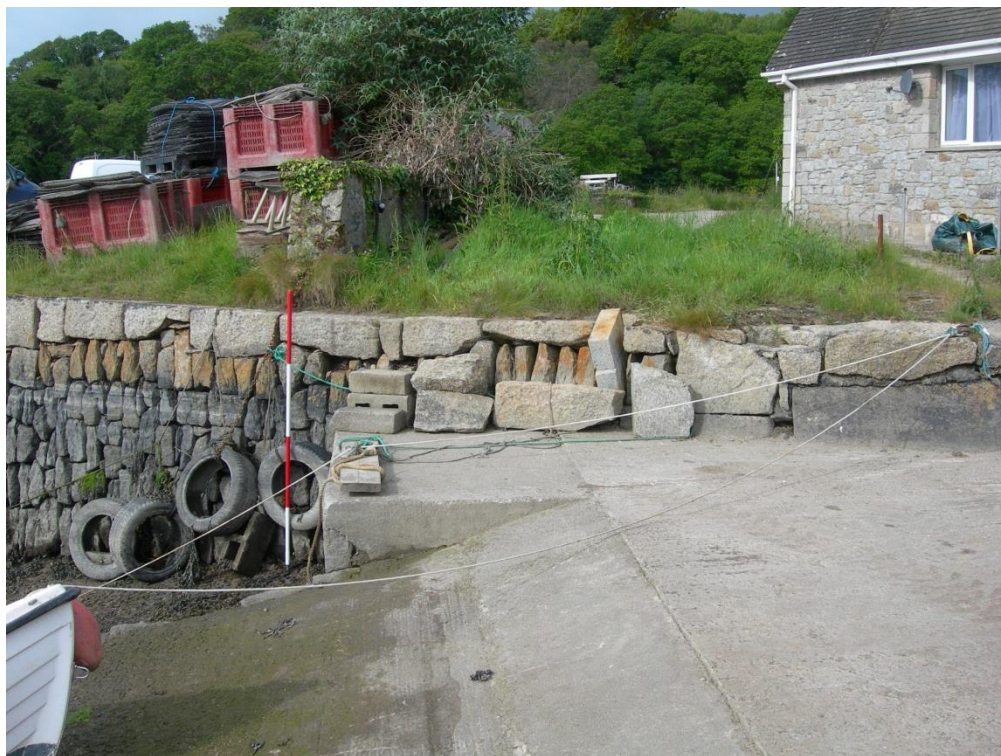
Fig 5 Detail of the site before excavation, showing the north end of the quay's west face

This view shows how the historic quay face extends to the landward side of the wall defining the Listing (above the scale pole), and also shows the location of a recent cable trench running between the quay face (left of a displaced block) and the wall.

- The stone revetment on the north east side of the historic quay was found to extend, maintaining its line, to landward of the later enclosure wall (taken to define the back of the quay for the purpose of Listing - see further under Results and Discussion, below). The excavation, as defined through the planning process, reached to c1.5m from the *front* of the inland, unlisted end of the quay facing. It was therefore guided to avoid potential disturbance to the *rear* of this revetment walling, some of which remained undisturbed whilst other parts showed signs of previous modification (Figs 5 and 8).

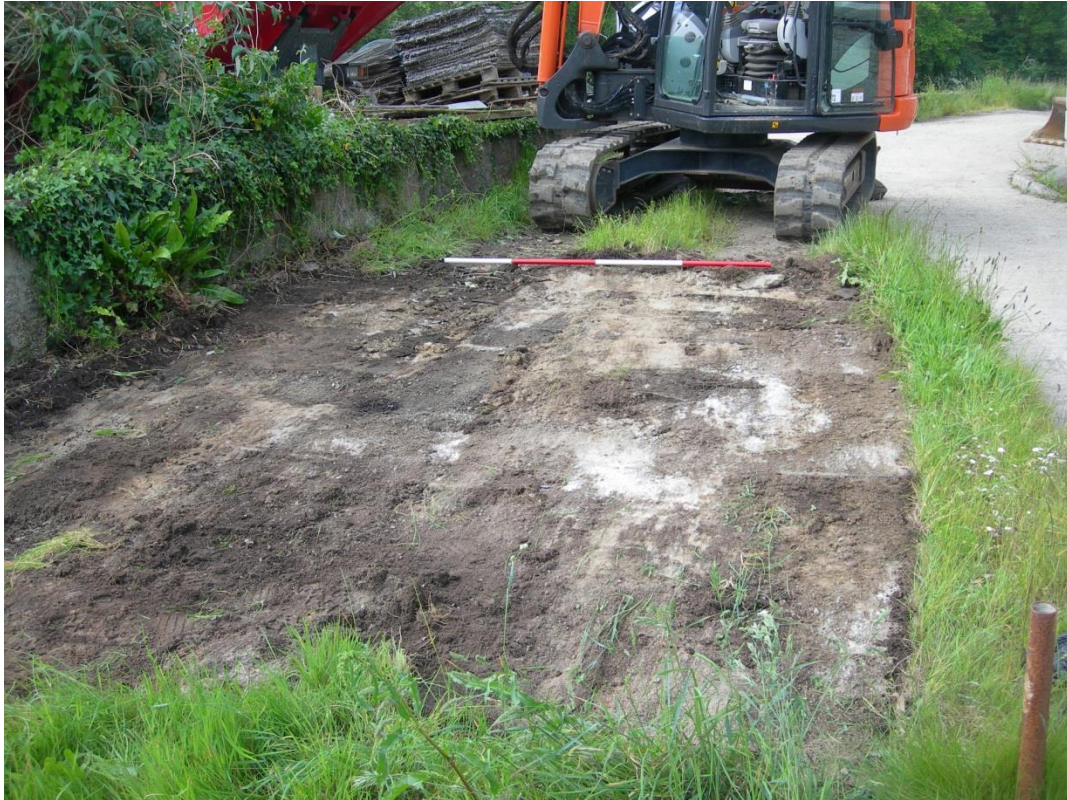
*Fig 6 Works site stripped of turf with the concrete layer 2 exposed, from the north east
The spread of concrete is probably associated with the laying of the roadway alongside.*

and cement mortar is used to turn the quay wall round a corner to the west to line the concrete access road there, slanting over the inland part of the made-up quay ground (cover photo, and Fig 12). This probably dates from the mid-20th century, when the oyster farm base was established a little further up Porthnavas Creek (Fig 4). The concrete in the upper layers of the excavation, with poured concrete towards the north side of it (Figs 6, 7 and 11), may have been deposited when the access road was made up.

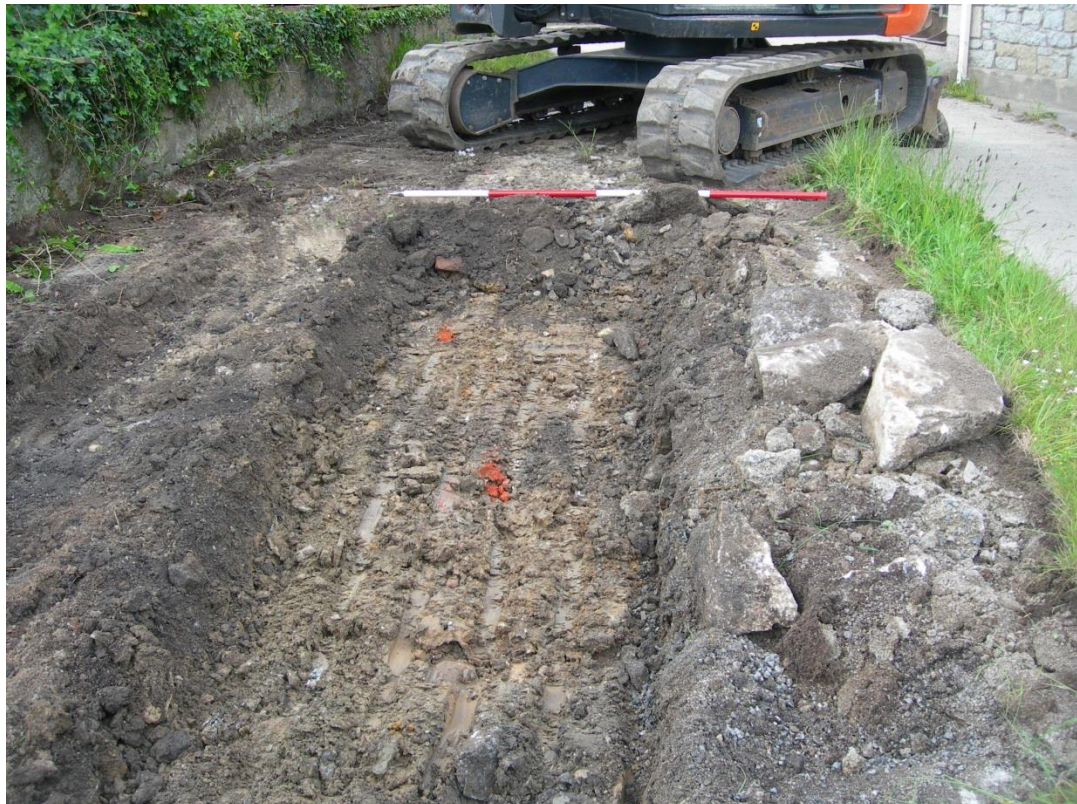
*Fig 7 Layer 4, the yellowy clay with occasional brick laid to form the body of the historic quay behind its stone facing, in the centre of the works, seen from the north east
The concrete to the right is from layer 2, broken and shifted to the edge of the trench.*

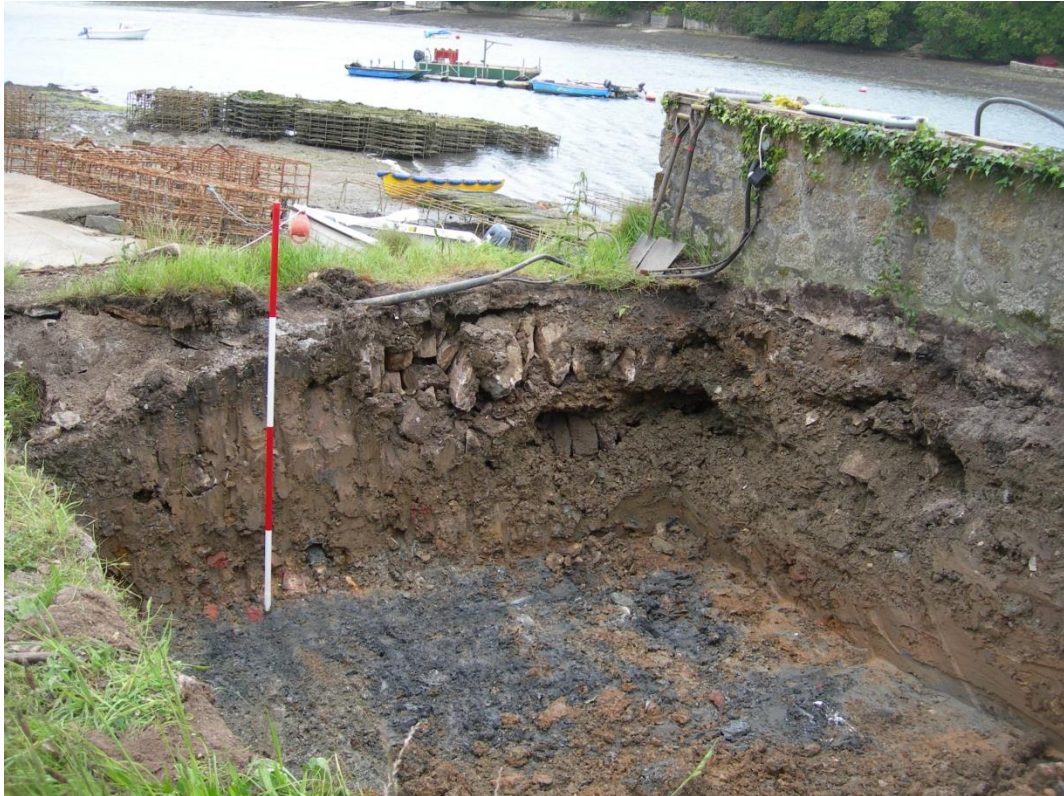
*Fig 8 Basal layer of bluish clay, layer 5, in the eastern corner of the site, from the west
Part of the inner side of the north end (which is outside the Listing) of the stone facing
on the east of the quay can also be seen, some 0.5m to the right of the scale pole; this
part had been previously disturbed to lay the cable, pulled up to the top of the trench.*

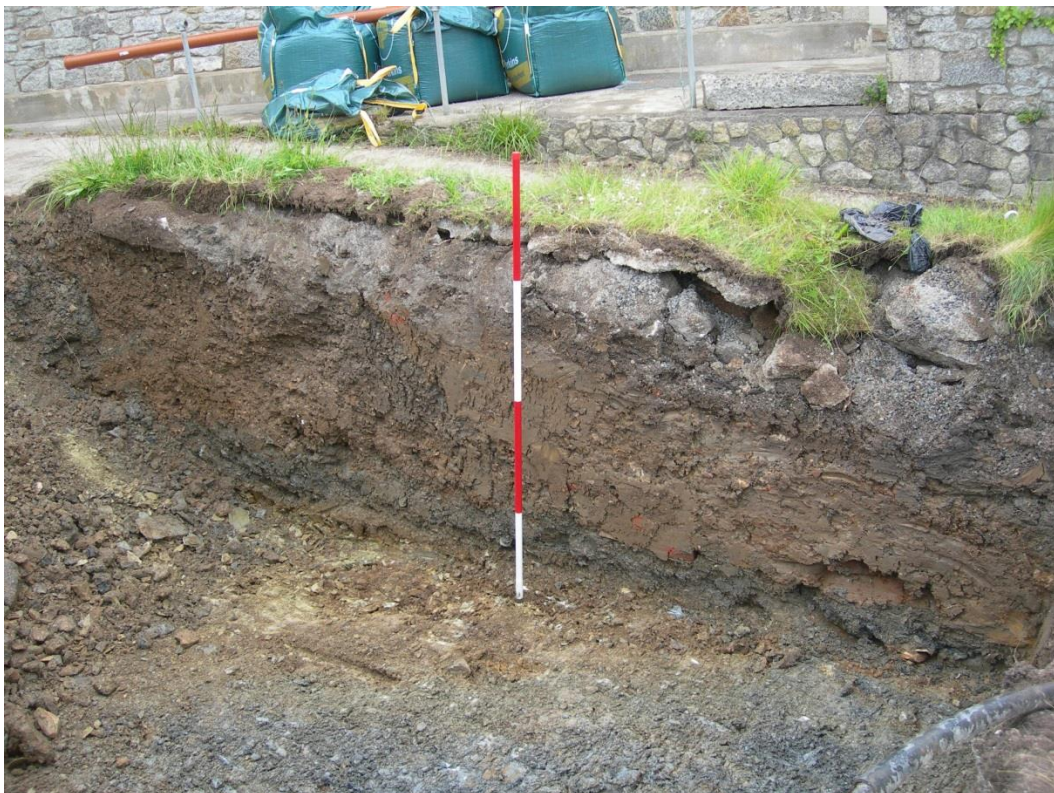
*Fig 9 North west section with natural ochre coloured shillet showing under the basal
grey clay layer 5 and the mass of yellowy brown clay with brick fragments, layer 4*

The watching brief continued to the stage at which the contractors were to proceed to insert a frame and excavate within that to the full depth required (3m or more from surface). At this stage the excavation was at a depth of 1.5-1.6m from surface and had reached natural bedrock over most of its area; part of a layer of grey clay remained, at the base of the made ground behind the quay face in the eastern corner (Fig 9).

The extent and depth of the clay is the most interesting observation of the watching brief, indicating that the whole of the quay ground was made up, behind its stone faces, of this material, its low permeability giving long-term stability to the structure built out into the creek (Fig 9). The core of the quay was built up of two distinct clay deposits, a basal layer spread over stripped natural bedrock, and an upper layer a metre or more thick, incorporating some broken brick consistent with the mid-late 19th century dating of the construction. Also of interest is the presence of shell fragments in both of the layers of clay making up the body of the quay, which may be attributed to oyster fishing and/or processing being carried out at or near the site when the quay was built in the 19th century.

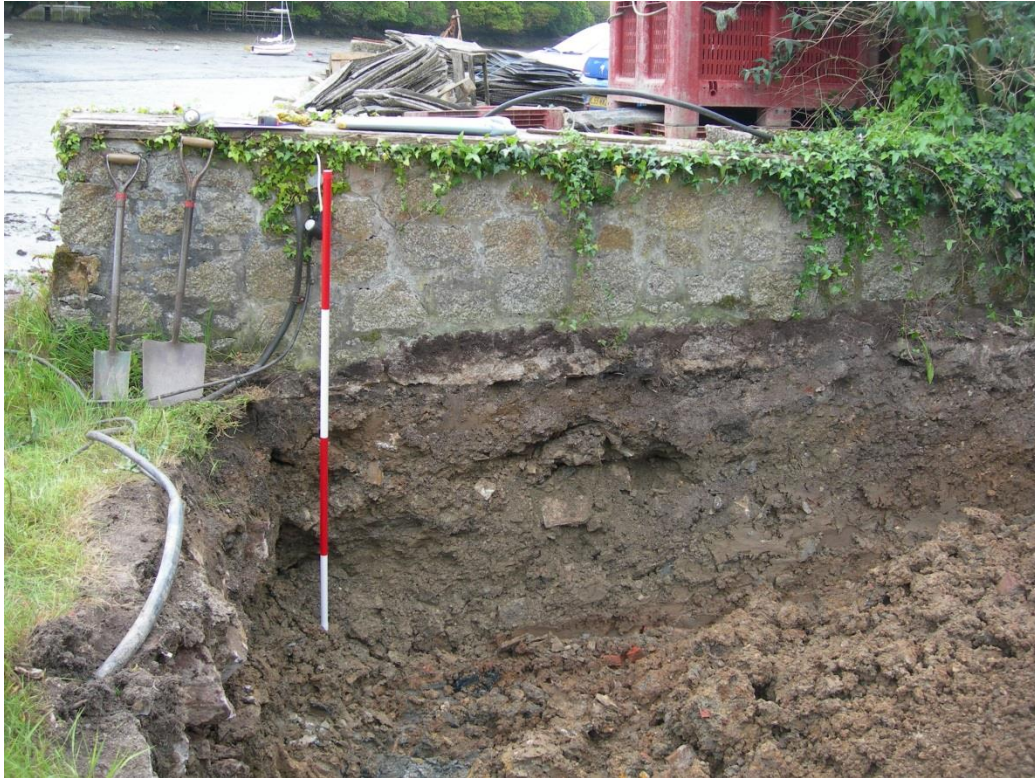
Fig 10 North east end of the landward face of the wall on the historic quay, used to define the Listing, (sited on the clay body of the quay, cut by the works)

Initial examination of the site confirmed that as indicated by map regression, the wall enclosing the waterfront ground on top of the quay (defining the Listed area), is a secondary, 20th century feature. It is only 0.4m wide and 0.6m high including a timber top possibly intended for seating, and made of randomly coursed irregular small granite rubble with narrow drill marks in cement mortar. The watching brief results were consistent with this dating, revealing clay quay fill covering all of the excavated area and continuing under the enclosure wall (Fig 10). The clay also ran under the stones forming the revetment against the access road on north, showing how that road was cut over, rather than behind, the inland part of the quay (Fig 11).

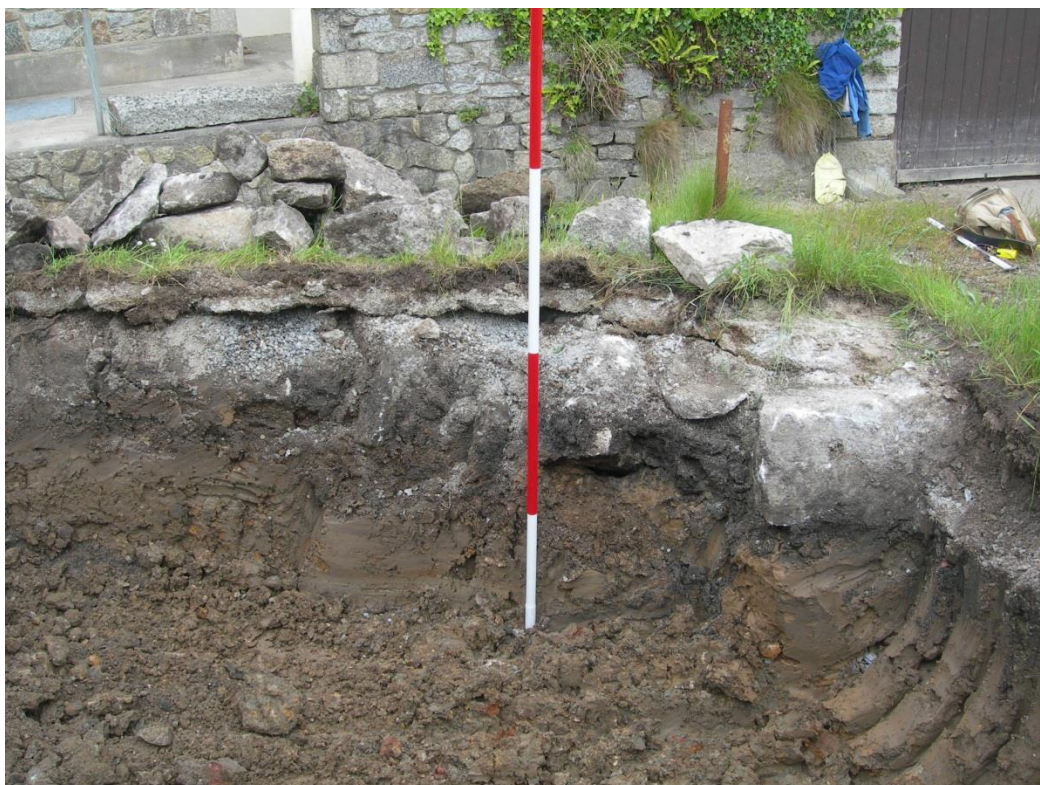
Fig 11 North corner of the works, with large granites bedded on the clay of the quay

The granites line the secondary, concrete road cut over the rear of the quay (between them and the Oyster Boathouse in the rear ground). Some may perhaps have been sourced from the old quay and re-used, while others show modern shaping or drilling. (The front of this revetment appears in Fig 12, and in Fig 13 taken further up the road.)

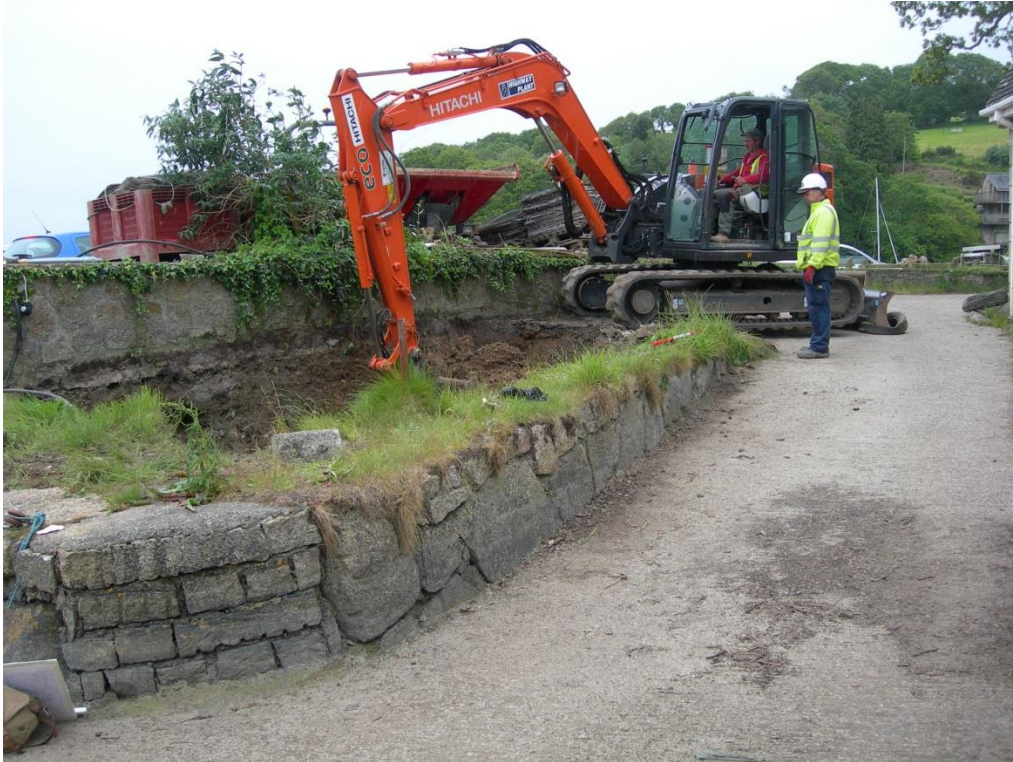
Fig 12 Revetment on the south east of the secondary road cut over the historic quay

The stones' character and drill-marks, cement mortar, and random coursing show that, as indicated by map regression, this road and its walling are relatively recent features.

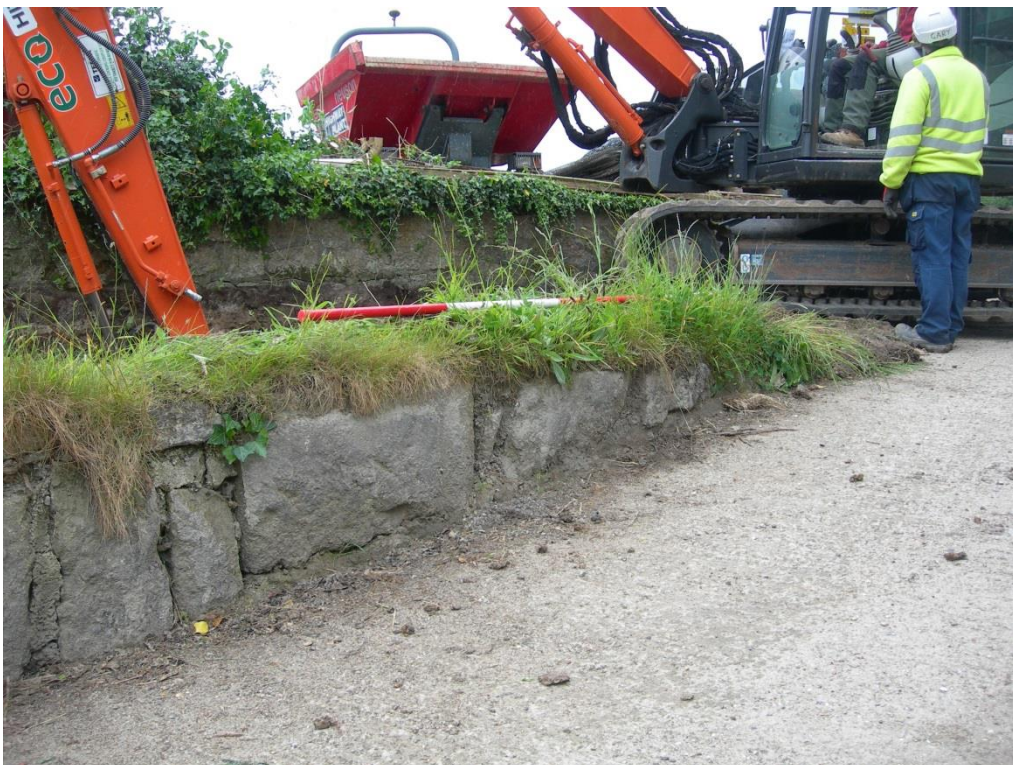
Fig 13 Stones facing the road at the south west end of the north east side of the works

The south west end of the revetment to the road across the rear of the quay, where displacement of several stones was required to accommodate the west corner of the excavation, was formed from single pieces of rubble or re-used shaped granite, mostly around 0.4m across, some up to 0.8m long, with cement mortar (Fig 12). The north east part of this revetment (undisturbed by the excavation) was a little higher as it faced the part of the road rising up onto the historic quay ground, and so incorporated, as well as larger grounders, a course of thin, irregular, split granites. The walling at the corner between the quay wall and the road revetment, on the north of the works site, was made solely of thin granites with frequent narrow drill marks, possibly because it was later trimmed to facilitate turning around it to access a concrete slipway beside it.

These stones, being associated with the road, a recent modification of the quay, were displaced temporarily to admit the west corner of the cesspool unit, and replaced.

- At the south west end of the works site, the width of the roadside area intended for the cesspool proved inadequate to accommodate the excavation area needed by the client. In the direction of the main, enclosed area of the quay, the south eastern long side of the excavation, as agreed through planning, immediately adjoined the (secondary) upstanding enclosure wall, used to define the extent of the Listing. As a result the excavation could not be broadened in that direction without direct adverse impact on the LB. However, an alternative was to accommodate the additional area of excavation on its opposite, north west side, requiring temporary displacement of 2 or 3 large stones (outside the Listing). These stones formed approximately half of the length (2.5m of 5m) of a simple, low revetment to the north east part of the 20th century road to the oyster farm where this was cut across the rear of the quay (Fig 13).

The archaeological officer agreed with the contractors that following the extension of the western corner of the excavation into the edge of the private road, and making good of the ground after insertion of the cesspool unit, the road revetment stones that had been moved would be replaced carefully to their previous setting and orientation by the contractors, as part of the works.

The works had no appreciable impact on the Listed Building or its significance; no early, complex or otherwise highly sensitive features or deposits were uncovered and no artefacts found. The contractors agreed to replace the relatively recent stones revetting the secondary road across the back of the quay following the conclusion of the works.
