Cross House, Padstow, Cornwall Heritage Impact Assessment

Heritage Impact Assessment

Client	Jill Martin
Report Number	2015R050
Date	July 2015
Status	Final
Report author(s)	Jo Sturgess
Checked by	Andy Jones
Approved by	Andrew Young

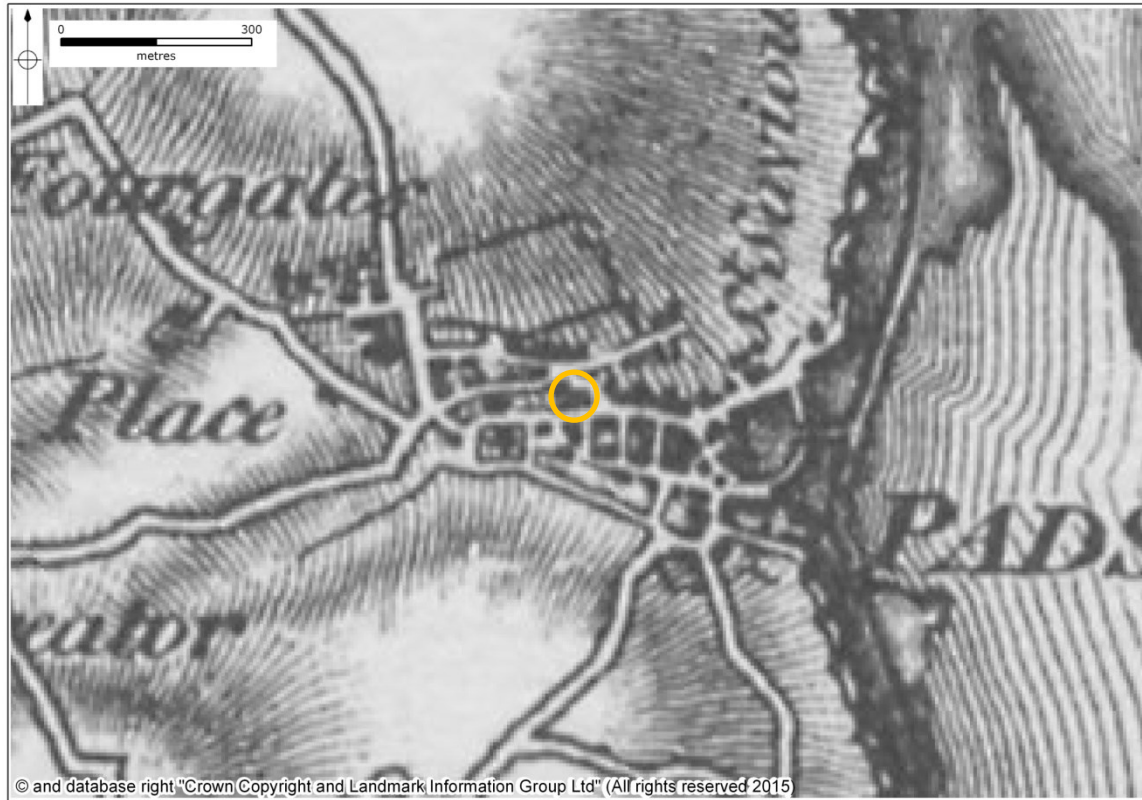
Fig 3 Extract from the OS First Edition One Inch Map c1809.

The earliest map available is the OS First Edition One Inch Map of c1809 (Fig 3). This does not show any detail but clearly indicates that buildings were present on the site at this date and that the road layout has remained unchanged. An Admiralty chart of the harbour dated 1839 (Fig 4) also shows the buildings here but is not detailed enough to show property boundaries and clear extents. The first map to show any clear detail is the Tithe map for the parish of Padstow c1840 (Fig 5). The map shows that by this date the two separate buildings had already been combined to create a single large house. The building is shown as L-shaped, fronting both Church Street to the south and the point where Church Street and Cross Street meet to the east. The map also depicts two small extensions to the rear (the stair projection and a separate building occupying the south-west part of the present kitchen). The accompanying Apportionment describes the property as 'house and yard', the land owner as 'Executors of William Broad (deceased)' and the occupier was William Hugo. The First Edition OS 25 Inch scale map of c1880 (Fig 6) demonstrates that between c1840 and c1880 the house was extended to the rear covering the former external passage between the two earlier extensions and creating the area which is now the kitchen. It appears that a greenhouse was also added at this time up against the back wall of the main part of the house. Interestingly the c1880 OS map labels the property 'Cross House' showing it to be a house of some importance in the town. The Second Edition OS map of c1907 (Fig 7) indicates that at some point between c1880 and c1907 the front porch was added and the part of the house that fronts Church Street was divided off as a separate property again.

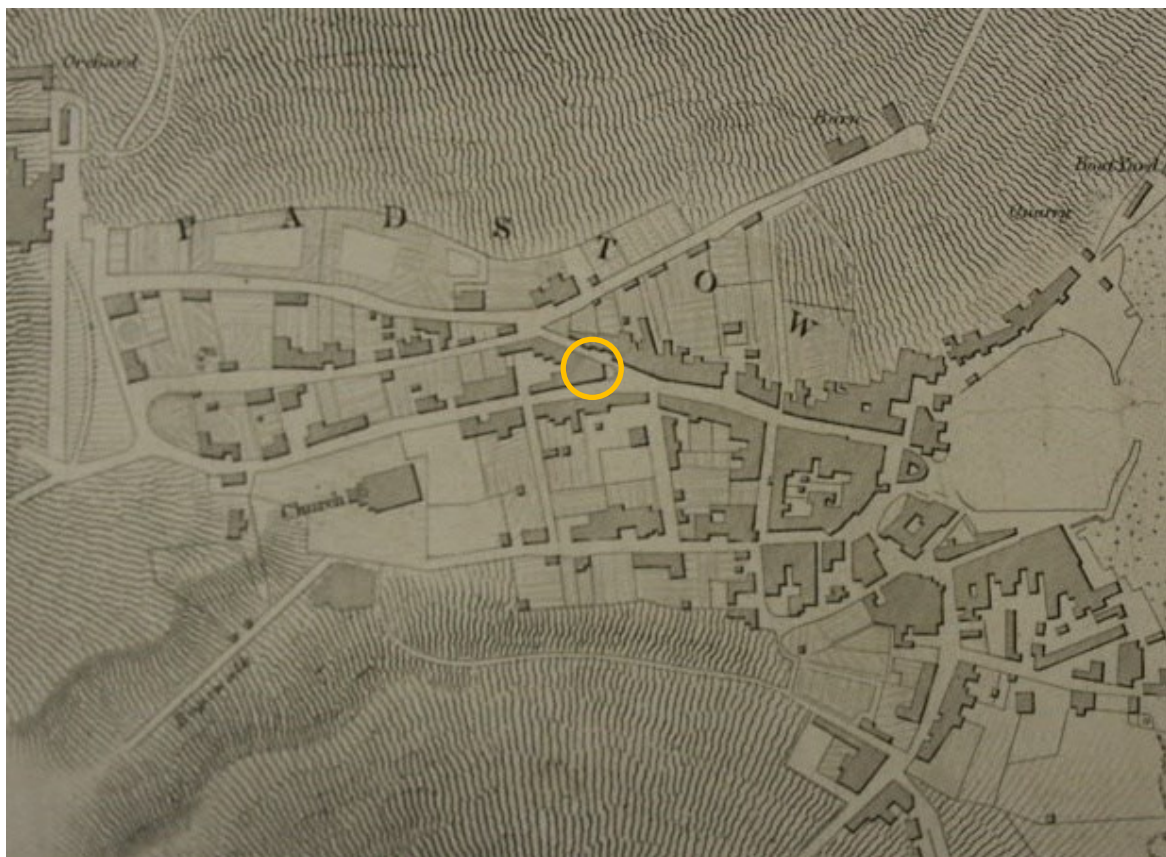
Fig 4 Admiralty chart of the harbour, 1839 (CRO/AD/71/14).

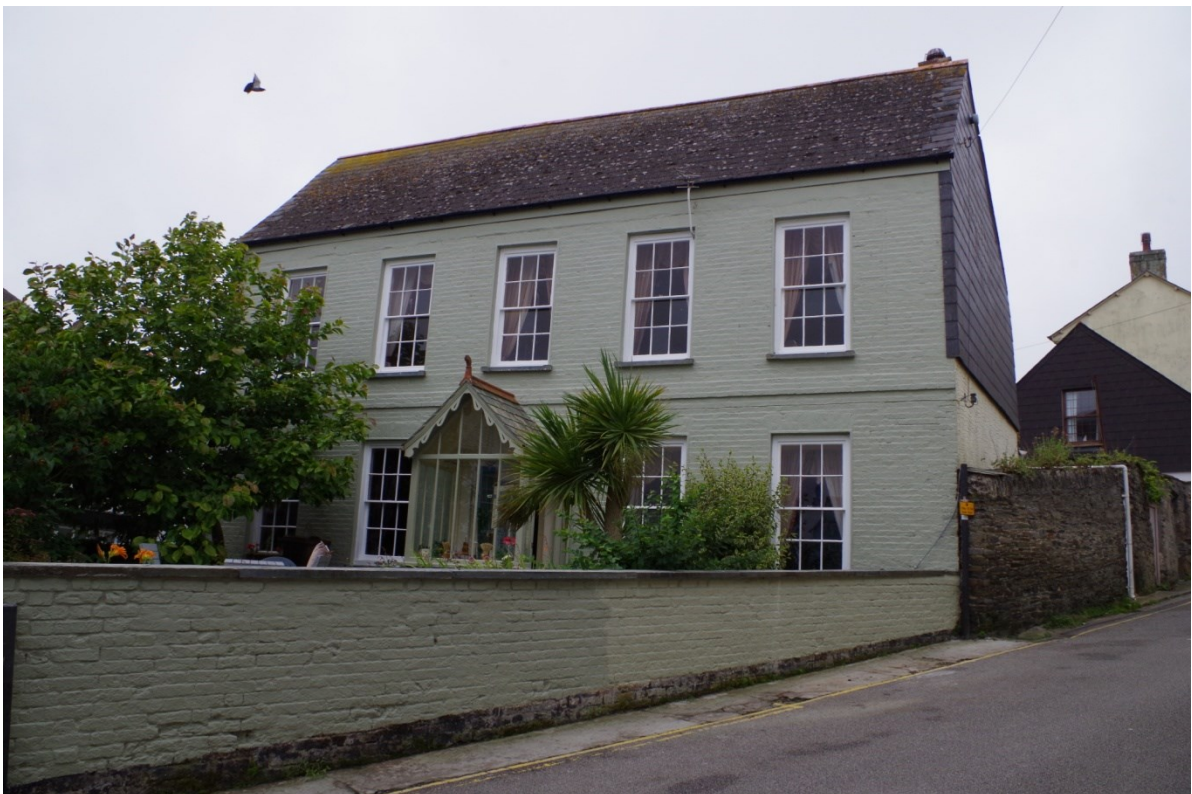
Fig 12 East (front) elevation.

The main part of the house is a gable ended building, aligned north-south, fronting the junction of Cross Street and Church Street. This is also constructed from randomly coursed slate rubble with slate hanging over it at first floor level on the two gables, whilst the rear wall is entirely slate rubble and the front wall appears to have been refaced or rebuilt in brick which sits on a few courses of slate rubble. The front brick wall is stylistically 18th century in date but it seems quite possible that this was added to an existing earlier building.

imposing position on the cross roads with views straight down Duke Street to the harbour and estuary beyond (Fig 11). Its 18th century brick façade can be seen for much of the length of Duke Street and was clearly designed at that time by wealthy owners as a house of importance within the town.

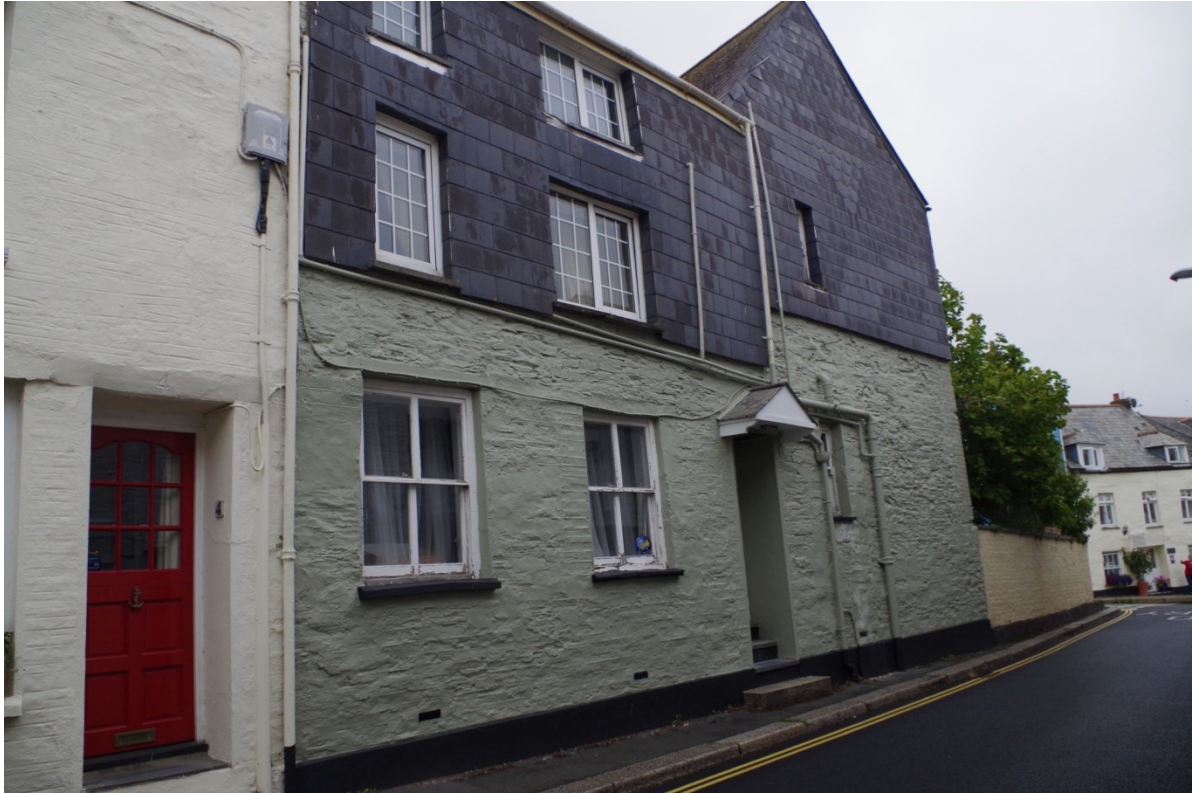
Fig 13 South elevation on Church Street.

The excessive width of the south gable wall of the main part of the building suggests the location of an earlier kitchen fireplace (predating the 18th century remodel) and the cupboard with inserted window opening at the west end of this wall indicates the location of a converted bread oven.

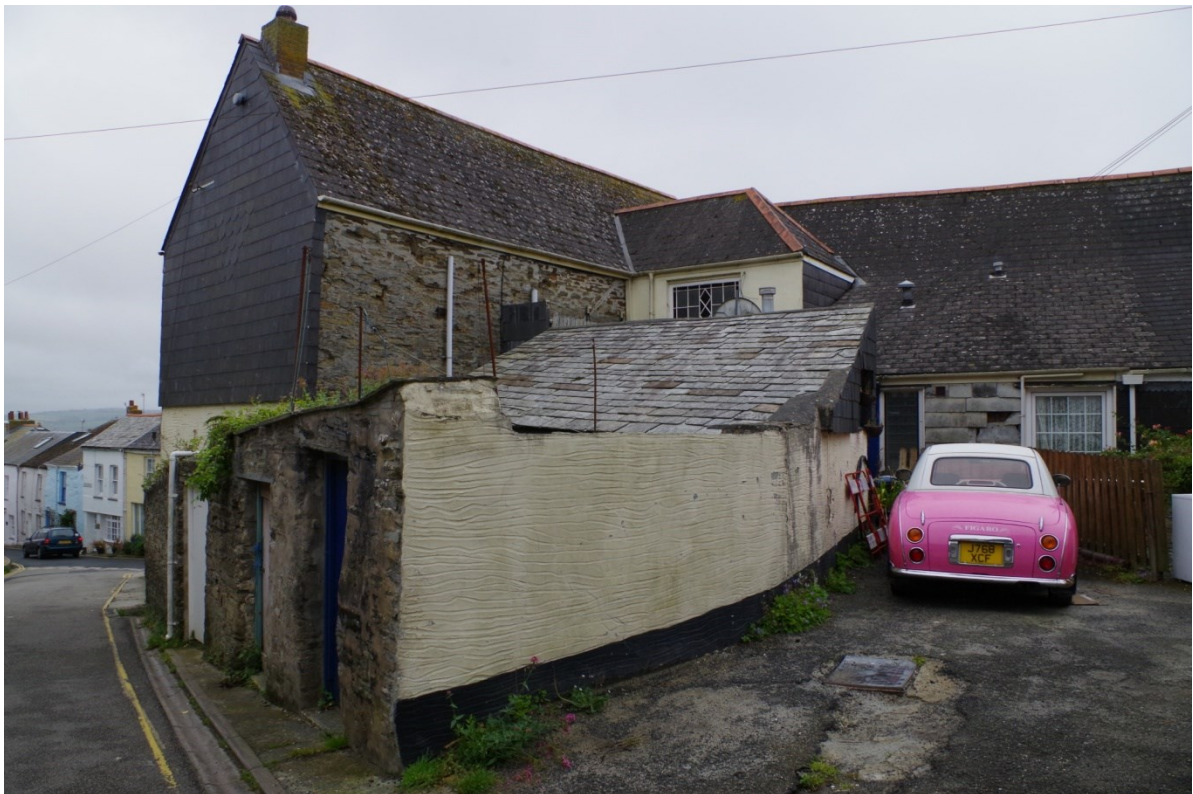
Fig 14 North and west elevations on Cross Street.

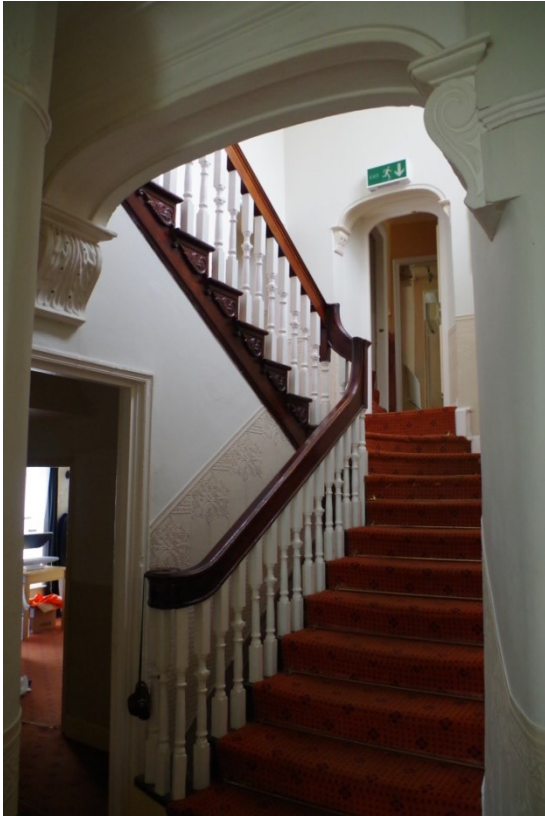
Fig 15 Staircase in projection to rear.

- Another proposal involves the removal of part of the stud wall between the stairs and the corridor leading to the kitchen which is probably part of the 18th century build.

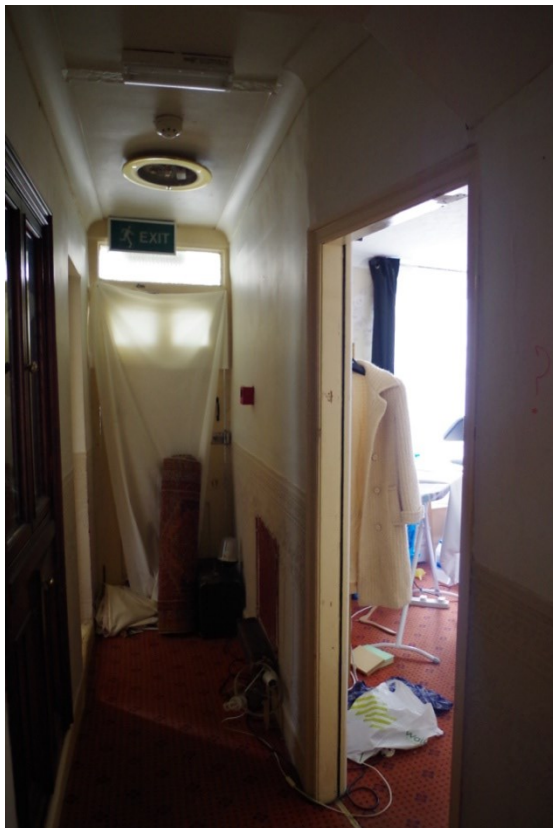
Fig 16 Hallway to east of dining room leading to door onto Church Street.

In the area of the former cottage (present dining room and hallway along its eastern edge) there are two blocked door openings in the north (rear) wall; one centrally set and the other (now a cupboard) adjoining the west party wall. The centrally set door appears to have been the original back door of the property which is likely to have led into a partitioned off hallway crossing the present dining room to an opposing front door. On the present kitchen side of this back door opening two truncated stubs of masonry wall survive which represent the early extensions shown on the c1840 Tithe map (Fig 5). It seems probable that the opening from the stair projection into the former cottage was created during the 18th century remodelling, but the partitioned off hallway at the east end of the former cottage together with the inserted door opening on Church Street are likely to be 19th or early 20th century insertions. The east wall of this hallway would originally have been the east wall of the cottage, and the recessed cupboard in this wall may have been inserted into a former fireplace.

- The proposal to replace the door opening on Church Street with a glazed door of suitable design. This door opening is an insertion but may have been cut through during the 19th century and can be read as part of the historic development of the house.
- A lean-to roof structure with roof lights is proposed to replace the existing 20th century flat roof over the passage that runs along the rear of the kitchen. The proposal will have little impact on historic fabric and little impact visually.

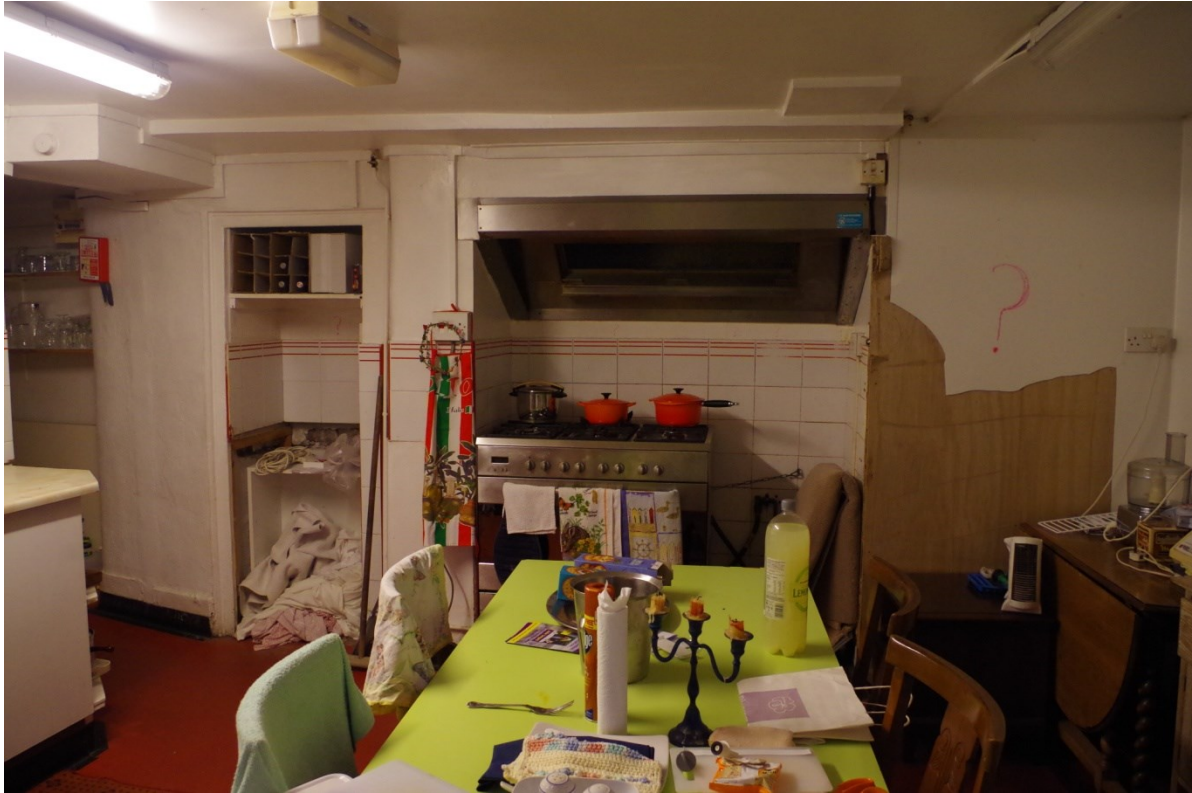
Fig 17 Kitchen looking south, showing rear wall of former cottage.

The former cottage is constructed from randomly coursed slate rubble at ground floor level and is slate hung (probably over stone) at first and second floor level. It seems likely that this part of the house pre-dates the 18th century build or remodelling of the main part. The original rear wall of this cottage is now an internal feature, which has been breached to allow access from the main house and later extensions.

- Re-siting of the kitchen to the existing dining room (former cottage). It is proposed that this will involve the removal of much of the rear wall of the original cottage (dividing wall between the kitchen and dining room). This proposal will have an impact on historic fabric and to some extent, the plan-form of the original cottage. As part of this re-siting it is also proposed that the lath and plaster hall partition wall at the east end of the dining room is removed. This removal would open the ground floor of the cottage to its original eastern extent but at the same time will remove a later historic alteration.
