## Buctor Farm, Tavistock, Devon

### Archaeological Management Plan

<b>Client</b>	<b>Mr D Hutchins</b>
<b>Report Number</b>	<b>2015R055</b>
<b>Date</b>	<b>October2015</b>
<b>Status</b>	<b>Final report</b>
<b>Report author</b>	<b>Colin Buck</b>
<b>Checked by</b>	<b>Andy Jones</b>
<b>Approved by</b>	<b>Andy Young</b>

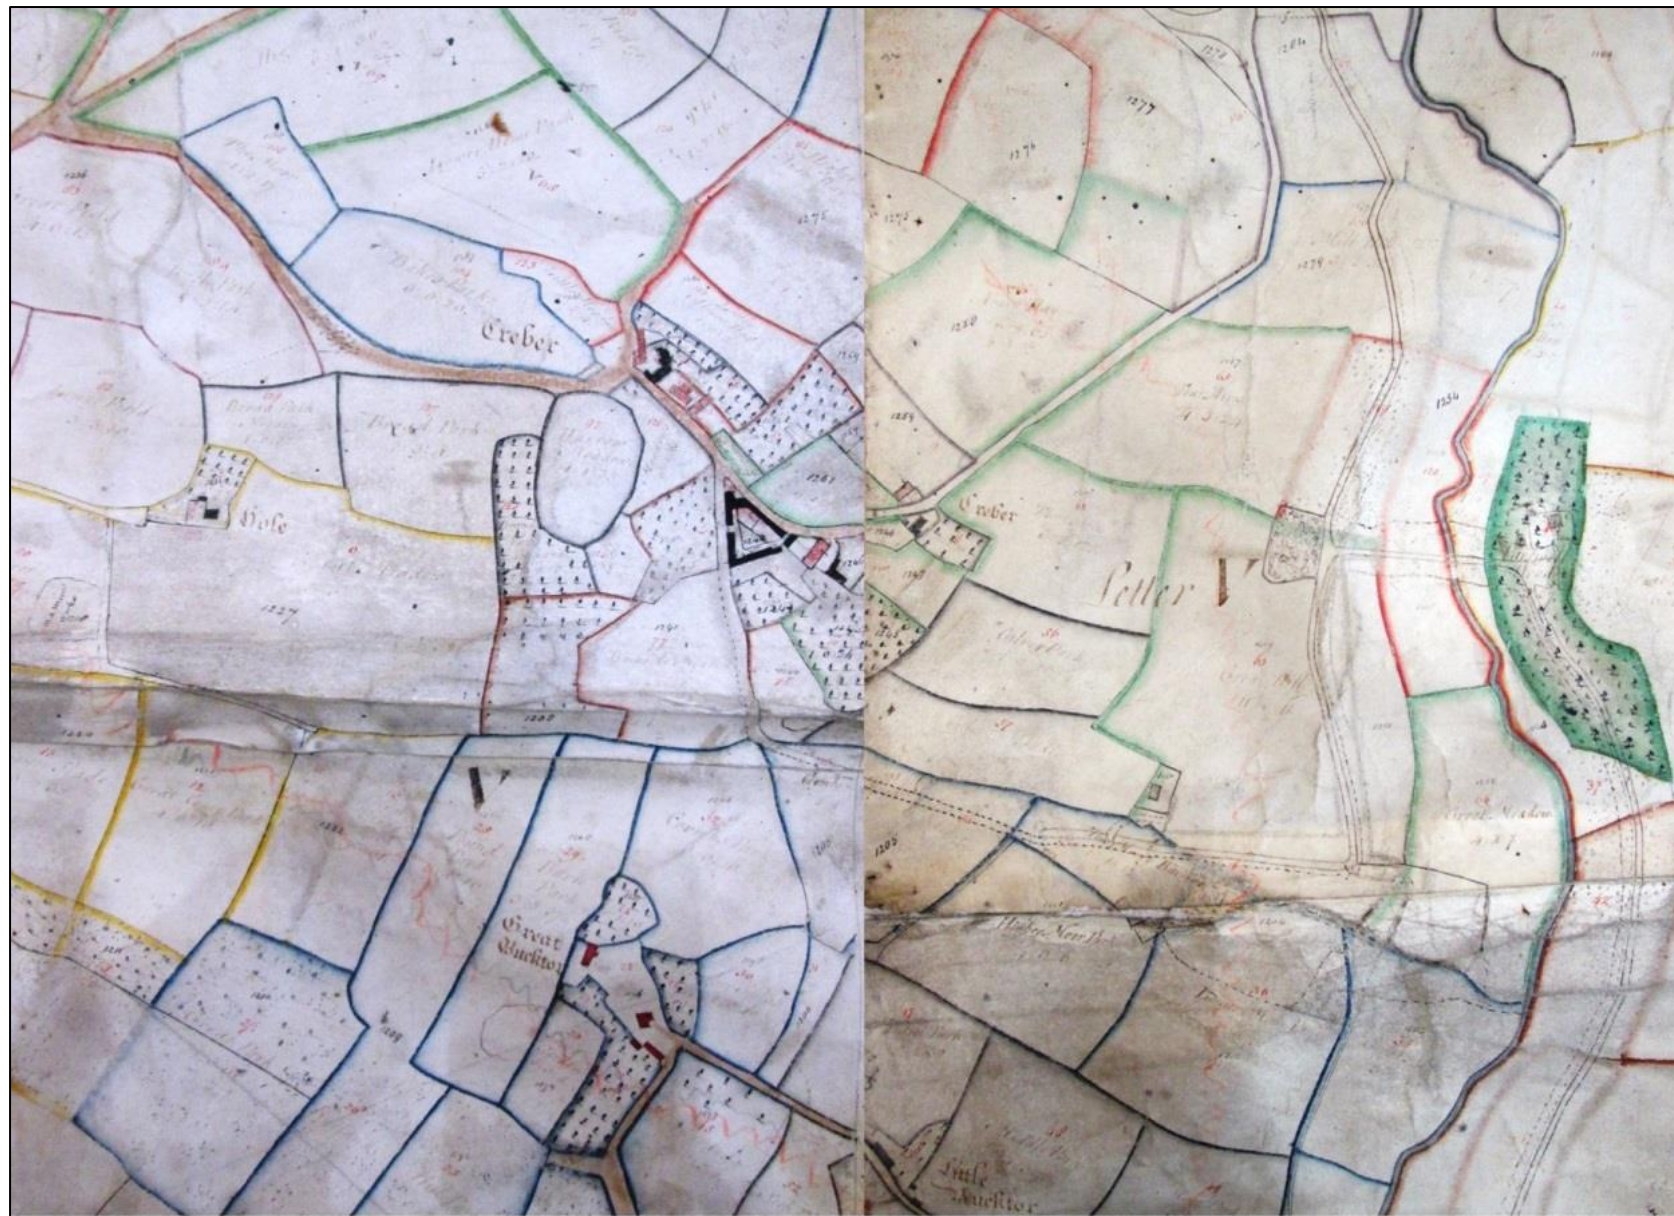
Figure 2 1765 map of the north part of the study area (DHC T1258M/E7).

Donn's map of the study area (see Figs 2 and 3) is the first relatively detailed map that shows the form of the landscape prior to the 19th century enclosure of Luscombe Down to the west and Morwelldown south of Crebor and Hole/Hurlditch. Remnants of medieval strip fields can be seen to have spread out from the smaller infield systems and orchards adjacent to the three main settlements within the study area; Creber originating north west of the site now known as Buctor (Sites 1-3), Great Buctor (Site 5) and Little Buctor (Site 6). The access tracks are also quite visible – many of which are still extant (Sites 13 and 17). Interestingly the Shillamill Manganese mill (Site 15, Fig 3) is shown to good effect, with its leat supply from the north (further up the Lumburn Valley), Bodman (1998), also refers to this site in 1841 as being a Manganese Mill. Unfortunately, this map (DRO T1258ME6/E7, which still has its timber wall hanging supports), has been drawn over with early 19<sup>th</sup> century additions: for example the 1803 Tavistock Canal and mine buildings, and the later c1860s Crebor farm complex of buildings are also blacked out.

In later years, it may well be that the alignment of the Tavistock Canal into its portal, may have utilised an excavated openwork, possibly from the mid/late 18<sup>th</sup> century (extending from known lodes eastwards from the Tamar Valley (ie, Luscombe and Bedford United Lodes, see Fig 8). In fact Figure 2 (1765 map - out of the study area), labels a small site '*Old Mine workings*', indicative of 18<sup>th</sup> century exploitation of tin/copper lodes extending eastwards over Morwelldown to cross the Buctor landscape

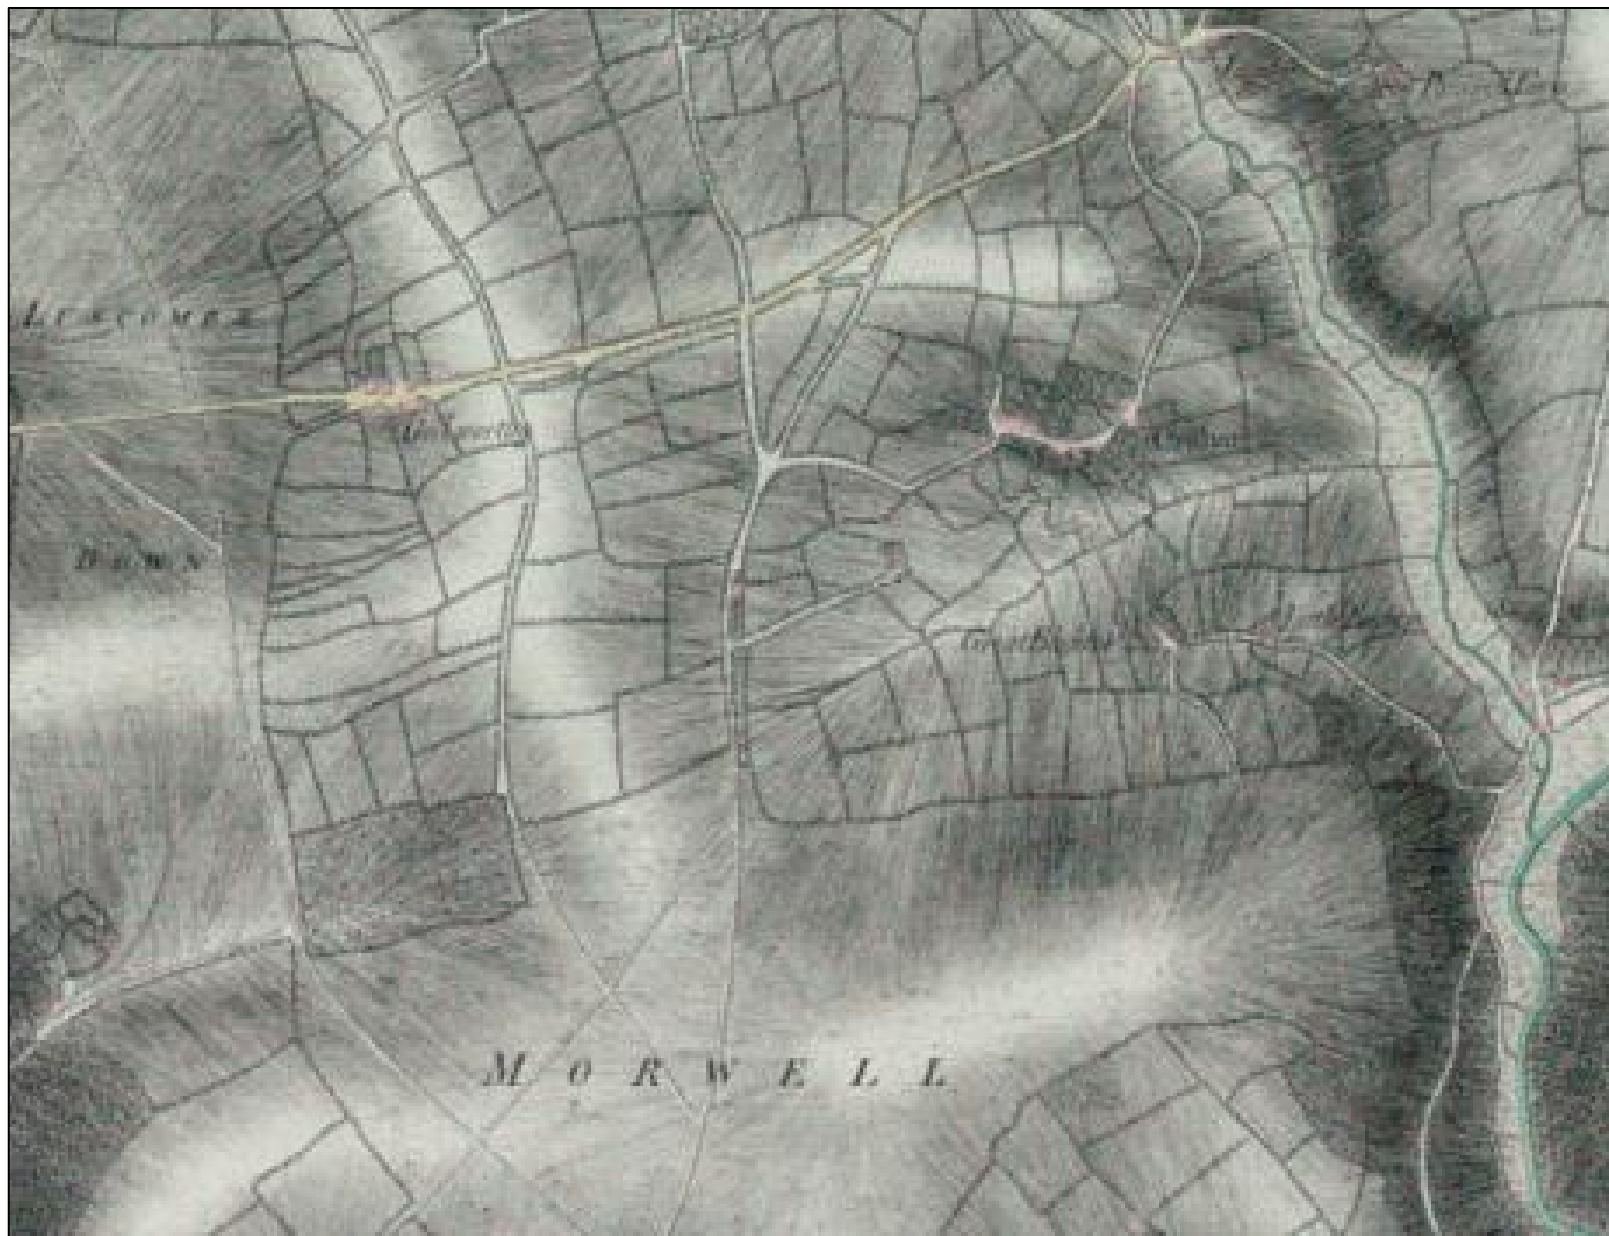
Figure 4 1784-6  
Gardner map of the  
study area (Maps K.  
Top XI 80-80a. By  
permission of the  
British Library).

The Gardner Map of 1784/6 (Fig 4) is the first relatively detailed map to show the form of the late 18<sup>th</sup> century landscape prior to the 19<sup>th</sup> century enclosure of Luscombe and Morwelldown. The landscape character and interrelationships between the upper downland, the medieval strip-field remnants and enclosures, with the valleys of the Lumburn and Tavy are evidenced to good effect. There are no mining-related features shown on this map within the study area.

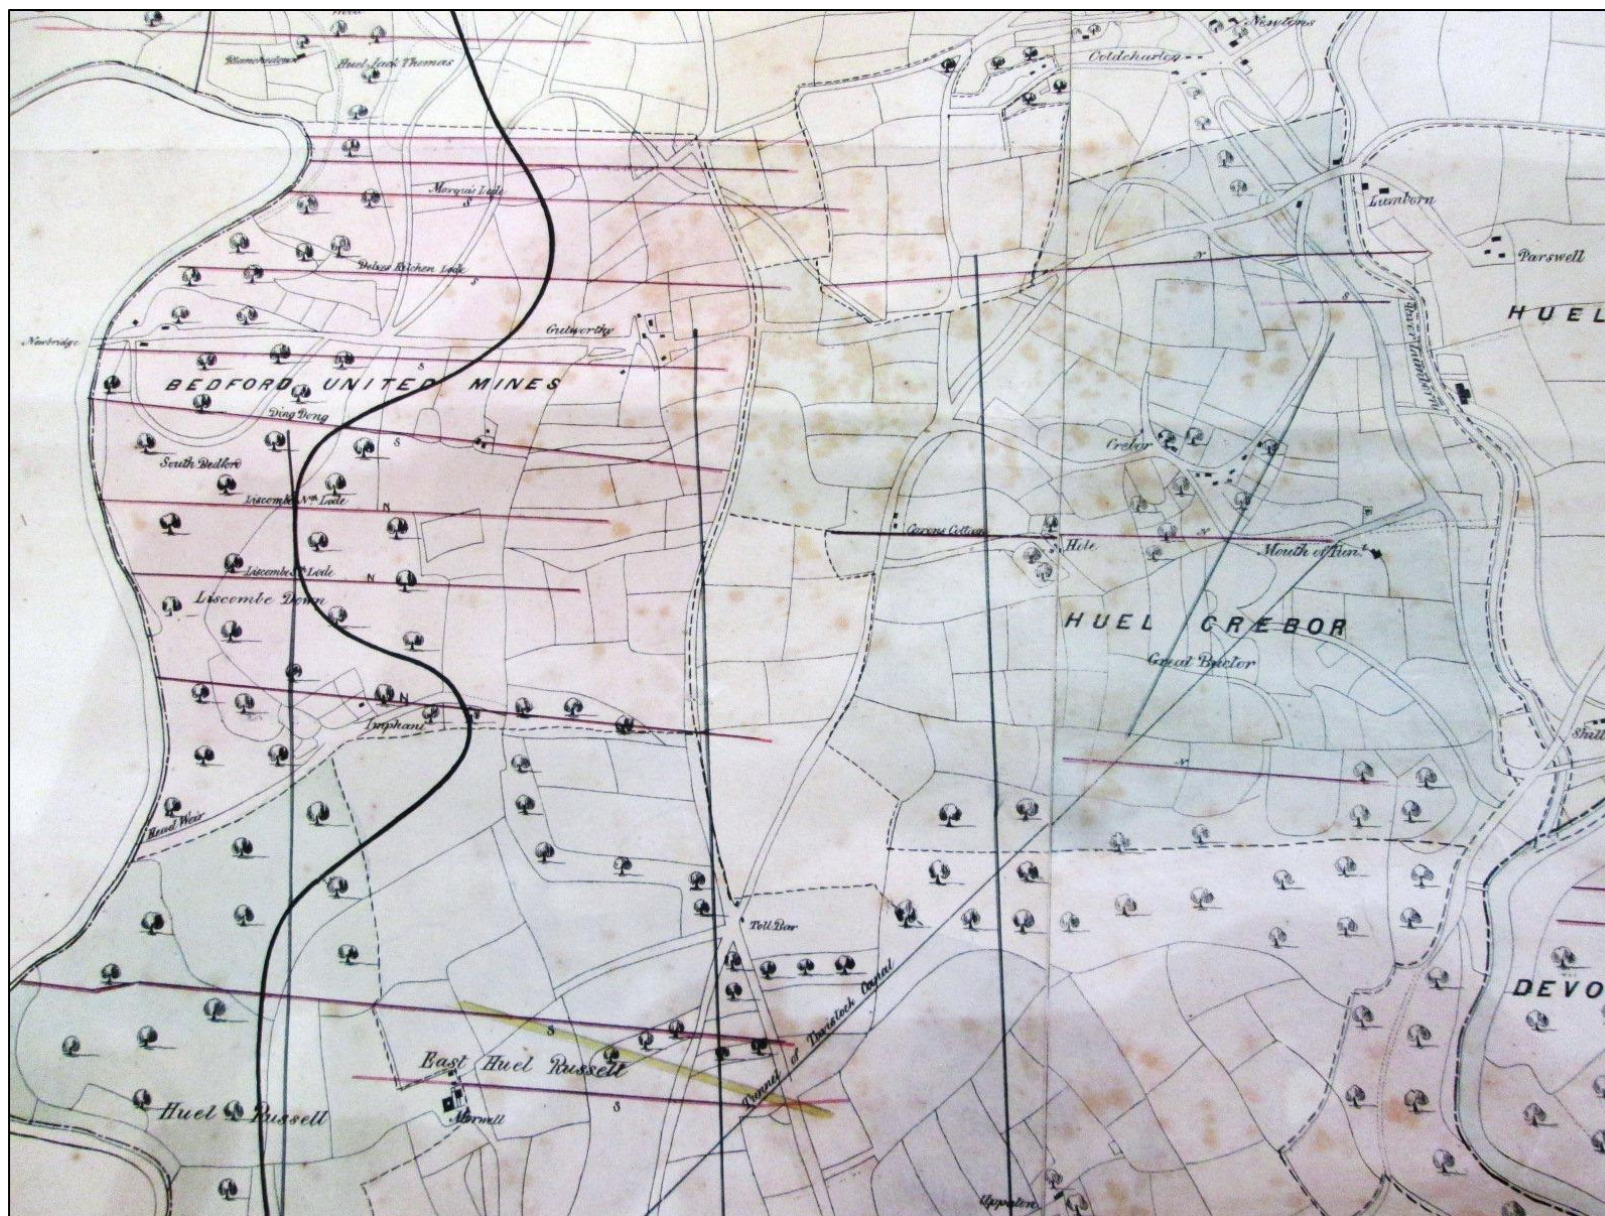
Figure 8 1859 lodes map of the area showing Wheal Crebor and mines/lodes to the west (DHC D1508/E/Tav).

The first detailed mapped information relating to mining is shown on the Symons 1848 lodes and setts map (Fig 7). Primarily copper lodes are shown angling across the landscape (broadly east-west), with mainly north-south cross-courses also shown, often heaving the lodes. Crebor Lode is named as it crosses over the mine, with a cross course intersecting this (Georgina Lode) to the east of Crebor and the west of the tunnel portal. The latter is labelled, and the route of the tunnel shown as it crosses underneath Great Buctor farm settlement. The Tavistock Canal is shown and labelled, as is the Mill Hill section extending north out of the study area. Few shafts are shown but the Agent's House (Site 27) can be seen. Again field systems and access routes (Buctor Lane – Site 13) are present, with a small track (Site 8.1) extending south from Great Buctor uphill to a possible shaft and later quarry (Site 8). The leat to Shillamill manganese mill (Site 15.1) is also shown, with its leat feed from the canal (and possibly via the first water engine placed on the mine). However, the original Shillamill settlement (Site 16), has started to lose evidence of its adjacent fields on the east side of the river (running parallel to the Tavistock Canal, covering evidence of a possible leat – Site 16.1), which ran adjacent to a field boundary (see Fig 2, 1765 Donn's map), to supply the medieval corn mill. Figure 8, the 1859 plan which shows the lodes stretching from the Tamar to the Tavy Valley when compared to the earlier 1848 mapping (Fig 7) reveals an increase in mining activity.

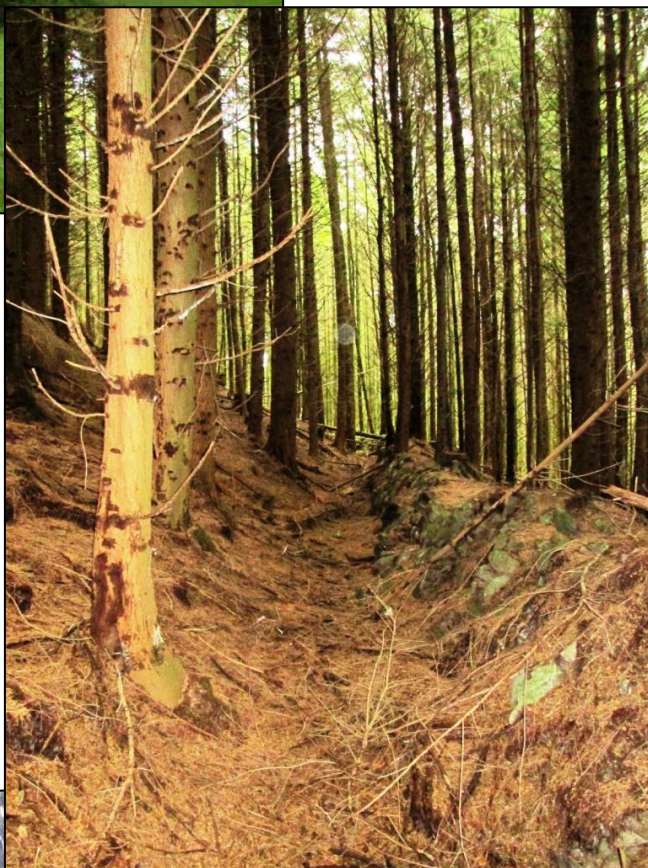
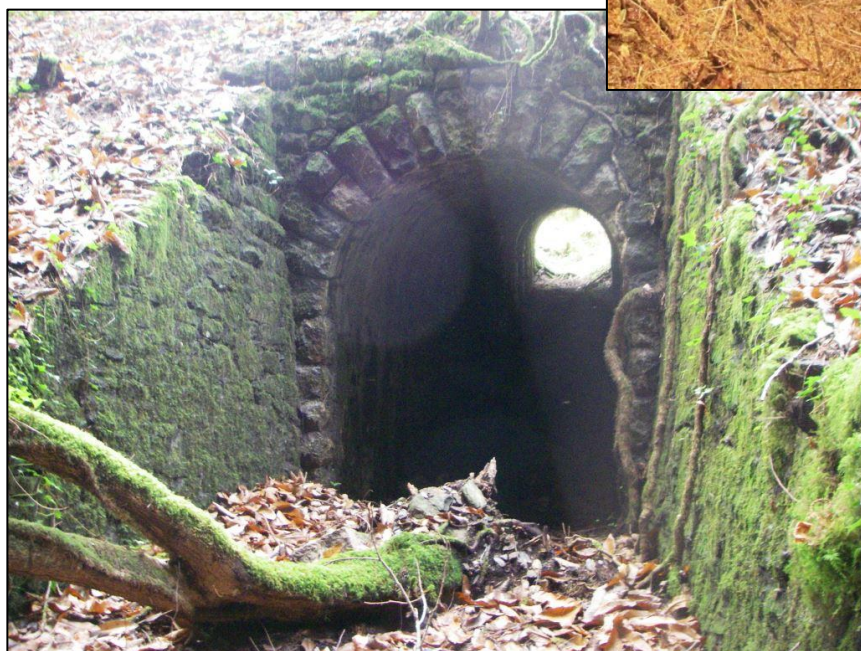
Figure 19 Tunnel  
under railway (Site  
10.1)

The tunnel portal is fully extant. Figure 19 shows the feature from the west side. It is approximately 3m high and 1.9m wide, built of granite stone with arched portals and killas stone interior. The stone has been revetted on both north and south sides of each embankment cutting, on both sides of the disused railway line. A build-up mound of earth and leaf mould slightly restricts visual evidence of both openings, and helps to retain water build within the tunnel.

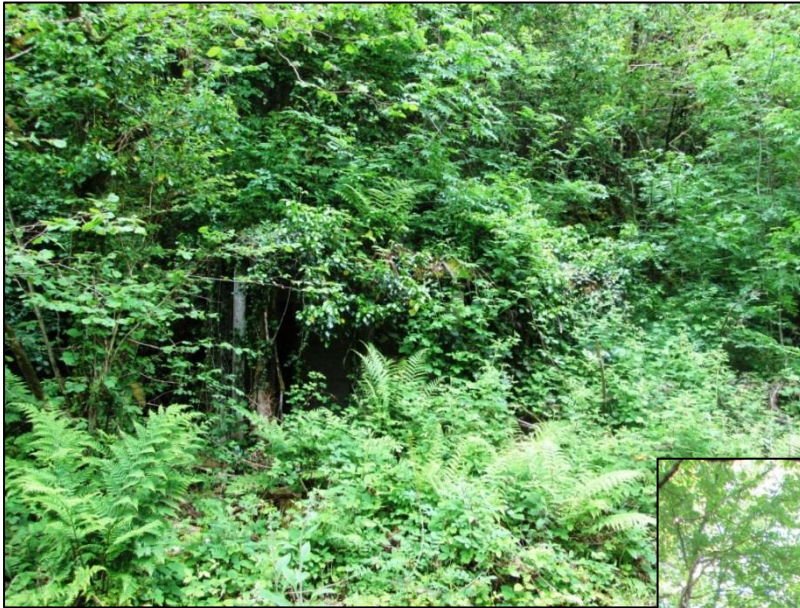
*Figure 20 Permanent Way Hut (Site 11.1, MDV 73001) (© CAU 2015).*

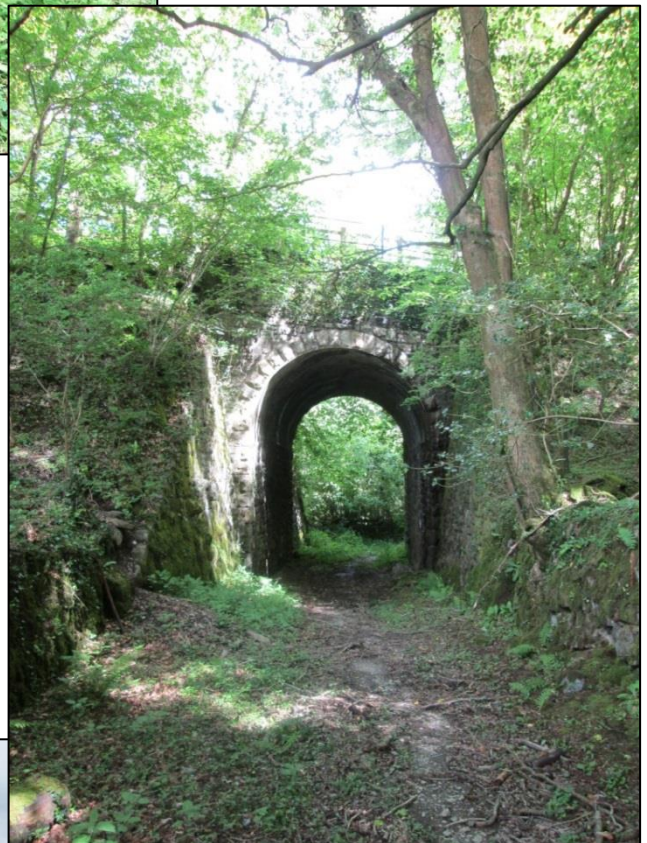
*Figure 21 Buctor Lane Bridge (Site 11.2, MDV 73012) (© CAU 2015)*

Site 11.2: Buctor Lane Bridge (Fig 21) sign states 'Distance from Waterloo – 215 miles, 65 chains'. A single-arch bridge carries the railway over a farm lane. The skew arch is of brick, with cut granite voussoirs, stone abutments, and rusticated masonry wing walls. The parapet is of rubble masonry with an iron handrail. The bridge appears to be in reasonable condition, with some ivy growing on the structure.

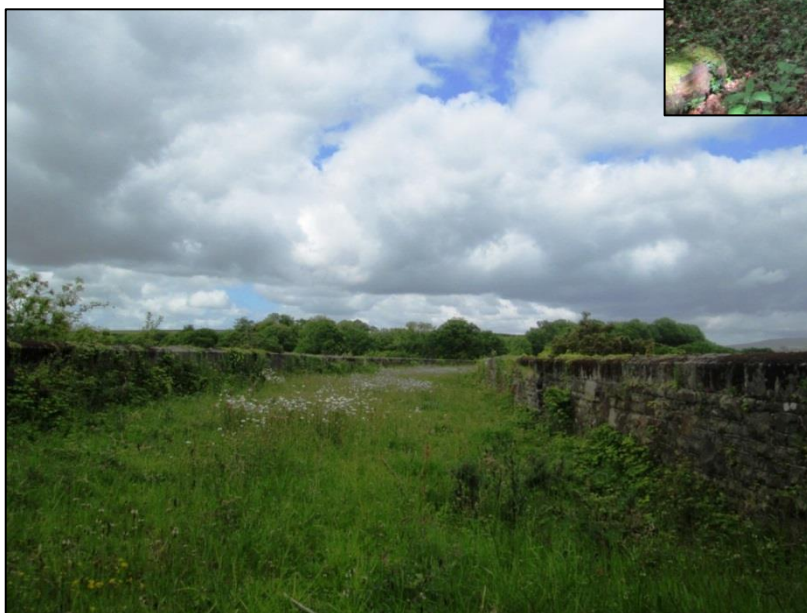
*Figure 22 Shillamill Viaduct track (Site 11.3, MDV 51335) (© CAU 2015).*

Site 11.3: Shillamill Viaduct (Fig 22) was not assessed in detail from its upper trackbed. The viaduct has been closed off from the railway at either end with concrete block walls and a locked steel door at the south, and so could not be inspected as part of this survey. Shillamill Viaduct has twelve 46 foot spans which carry the railway across the Lumburn River and the Tavistock canal. The viaduct was intended to have two additional arches at the south end, but these were replaced by an embankment to dispose of excess material from elsewhere on the line. From the top are excellent views of the Lumburn valley and the Tavistock Canal.

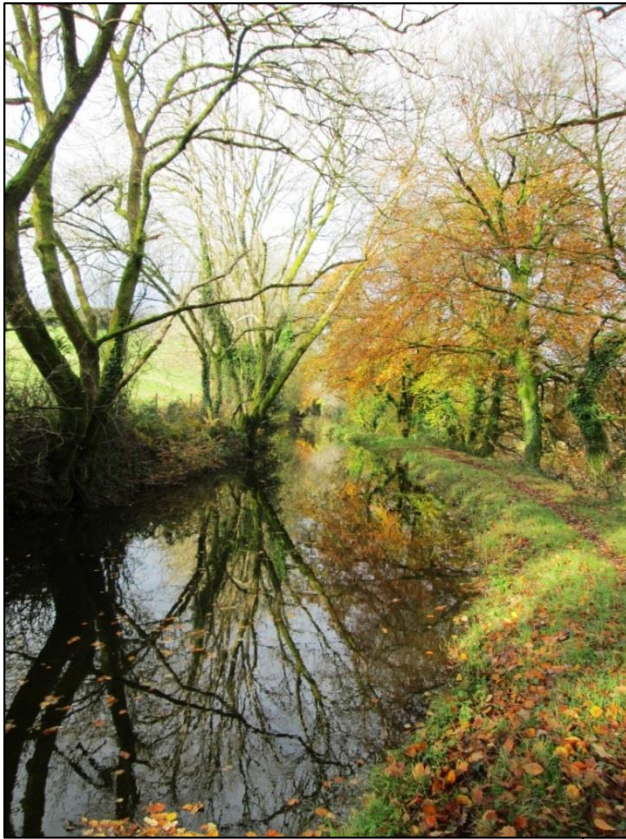
For much of its length the canal's west and north sides (see Fig 24), cuts into both of the Lumburn Valley's east and west sides – revealing bed-rock and forming the bed of the canal. Excess stone material from the rock cut was used to form the rounded profile edge of the east side of the canal – using slate/killas stones set on edge. The tow path was formed along this eastern/southern side. The canal is approximately 4m wide, 0.3m to 0.5m deep, with the east side approximately 0.6m to 0.8m deep from tow path surface to water level. Water slowly flows along the canal, through the tunnel and to the reservoir pond.

*Figure 24 Tavistock Canal (Site 18, MDV 51333) (© CAU 2015).*

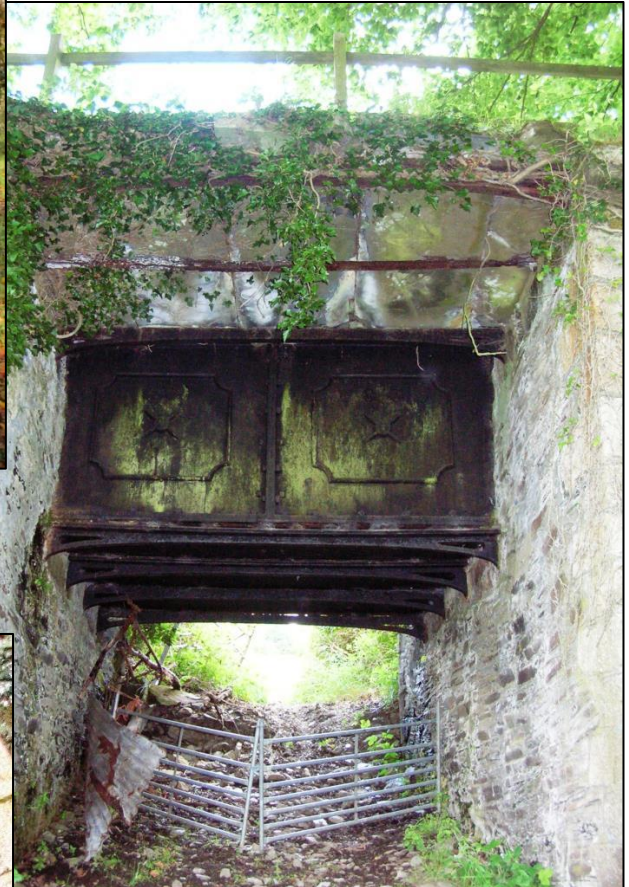
18.1: The bolted sections of the iron trough that carries the canal water over what is now a cattle creep (formerly a road track), extends to either side of the granite quoined masonry, supported by four wrought iron lintels (widening into the masonry sides) set

*Figure 25 Tavistock Canal Bridge Aqueduct (Site 18.1, MDV 73904) (© CAU 2015).*

into the granite masonry (Fig 25). Three other similarly styled lintels provide the support for large slates under the tow path on the south side of the canal. The middle lintel however had rusted to the extent of being ineffectual, and was subsequently replaced with an equivalent (Buck 2013, 11). Unfortunately, the canal has been leaking for a number of years, which has caused the foundation masonry to drop – causing sagging to the entire structure – and causing stone to crack and mortar pointing to crack and dissolve.

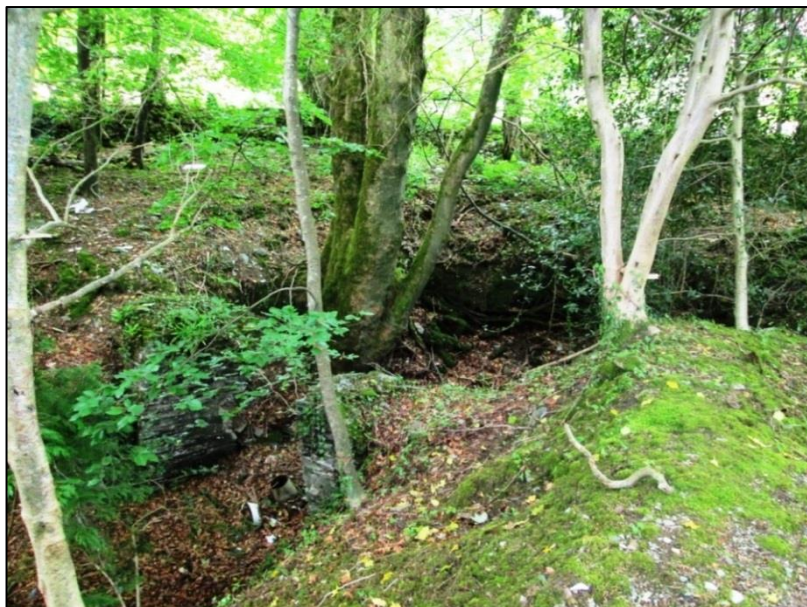
*Figure 27 Kelly's Shaft  
(Site 21, MDV 79918)  
(© CAU 2015).*

The shaft (see Fig 27) is choked at surface (3.5m<sup>2</sup> and 2.5m below ground level), within a wide encircling dry stone hedge (0.7m high and wide). The flat rod slot route to the angle bob masonry is also visible east of the masonry. This measures 3m across its base and is 2m below ground level. The angle bob masonry sides are 2.2m high and 1.2m long, sited between the flat rod slot earthwork and the shaft. The balance bob mounting side walls (Site 21.1) are extant (0.85m internal width, 4m long and 0.6m high), and visible on the east side of the shaft, although the balance bob box to the rear (east end) has gone, presumably demolished when the protective hedge was built around the shaft.

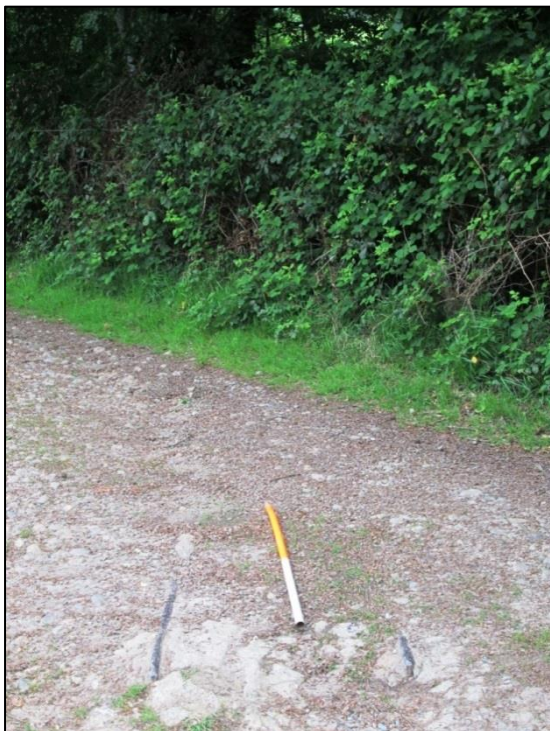
*Figure 30 Tramway remnant in road (Site 25) (© CAU 2015).*

This site should be retained, with a minimal amount of disturbance.

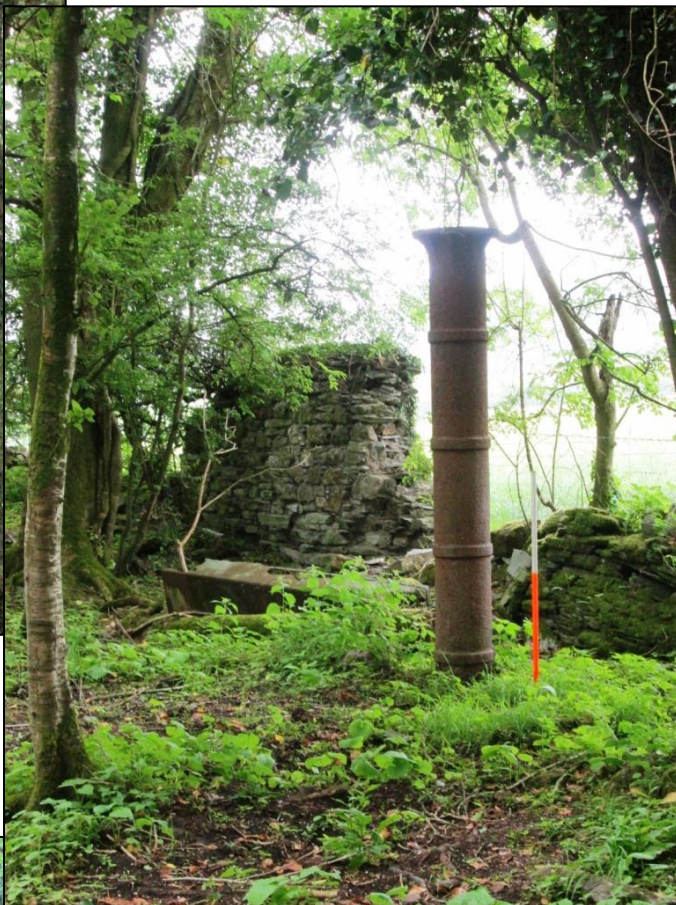
A mound of rubble marks the former site of this building (0.8m above ground level). Its related Saw Pit has wall remnants at the south west corner to a maximum height of 2.4m for a length of 2.8m. In addition, another wall remnant is 1m high for a length of 2.5m – the rest of the building's walls have been robbed. There are two sections of rising main water pipe, each 2.4m long, one of which is standing (Fig 32). These may

Figure 32 Carpenter's Shop/Linhay  
(Site 32) (© CAU 2015).

have been vertical supports for an open fronted part of the yard; a building sited between the saw pit (Site 32.1) and the smith's shop (Site 31).

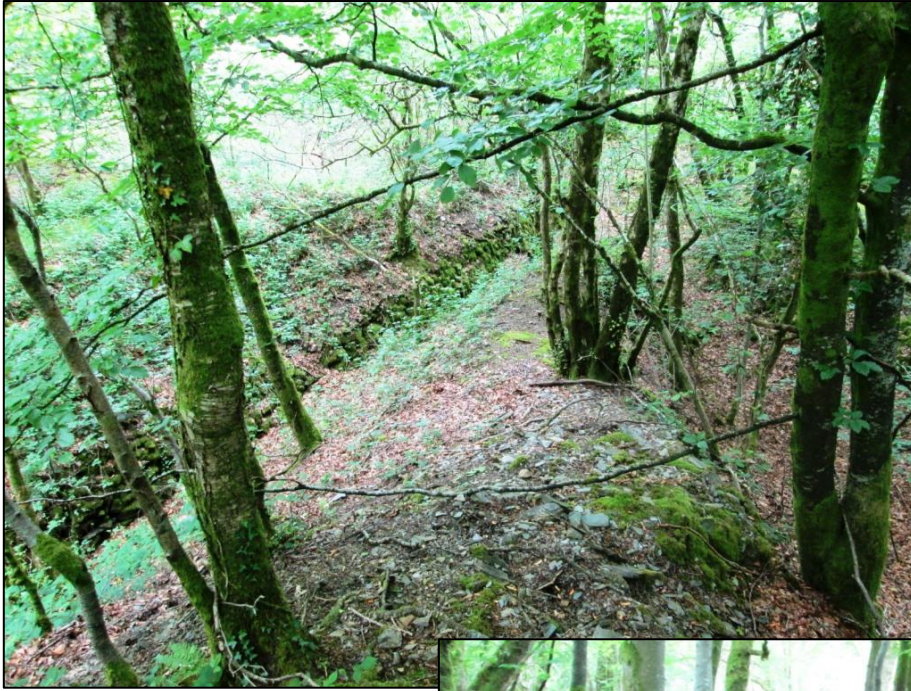
This area has very little evidence of the former spoil tip. During the early decades of the 20<sup>th</sup> century – a programme of re-processing waste tips from mines in the Tamar and Tavy Valley occurred. Advances in ore dressing technology meant that additional ores (tin/copper/wolfram) could be extracted – but some tips (for example this one) focussed on arsenic extraction, the ore from New Eastern Shaft having an arsenic content (see Section 4.2.5, 1893 onwards).

*Figure 34 Site of dressing floors, tramlines (Site 37) (© CAU 2015).*

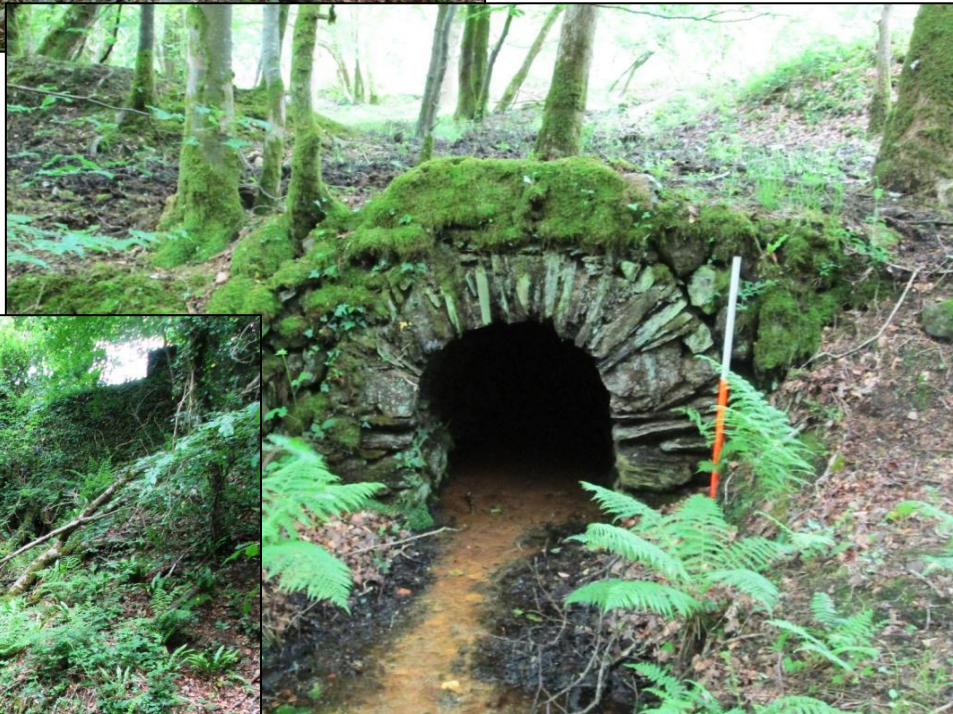
*Figure 35 Adit portal (Site 46) (© CAU 2015).*

The adit portal (Fig 35) is open, with ochreous water issuing. The opening is 0.55m wide, and 0.75m from the internal crown stone arch to water level (0.2m deep).

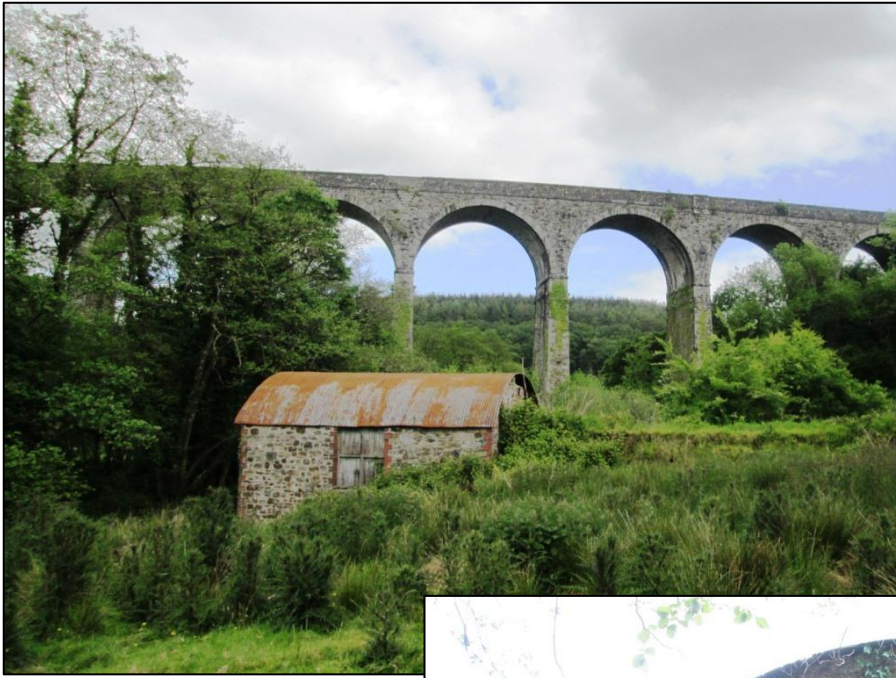
*Figure 37 Pump House - west side (Site 53) (© CAU 2015).*

This building can now be seen to be structurally hazardous. It is recommended that this building is conserved as part of a project of limited structural building remediation and conservation. It is likely that the wall movement is too much to rectify, and that the wall may well need to be dismantled – the foundations stabilised, and the wall rebuilt. If this is beyond the remit of immediate funding, an alternative could be to slow down the wall movement by re-routing the leat away from the building (further to the south – allowing the wall section foundations to stabilise (as the foundations dry out). However, the seasonal winter rains are likely to soften the ground around the building as the water table in the valley floor rise, for at least four to six months per year. In the

short term it is recommended that the building is closed to public access – both to preserve it's (over a century old) intact pump and water wheel – and also to minimise the possibility of collapse to the south west corner of the building onto visitors.

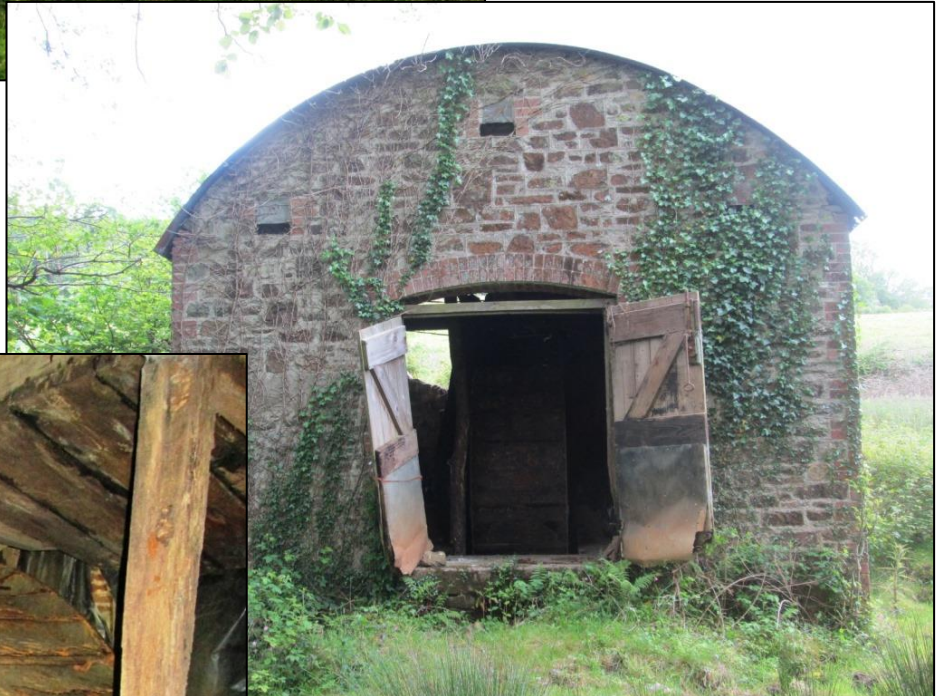
*Figure 38 Pump House north side (Site 53) (© CAU 2015).*

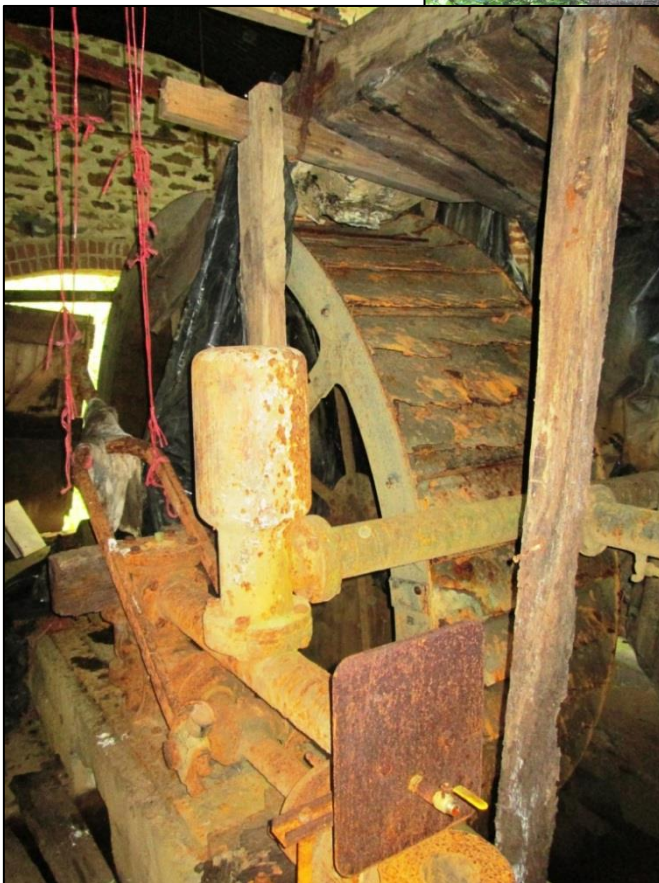
*Figure 39 Pump House - internal view from east (Site 53) (© CAU 2015).*
