Trethosa Solar Farm, St. Stephen in Brannel, Cornwall Archaeological Watching Brief

Archaeological Watching Brief

| Report Number | 2015R060 |
| Date | September 2015 |

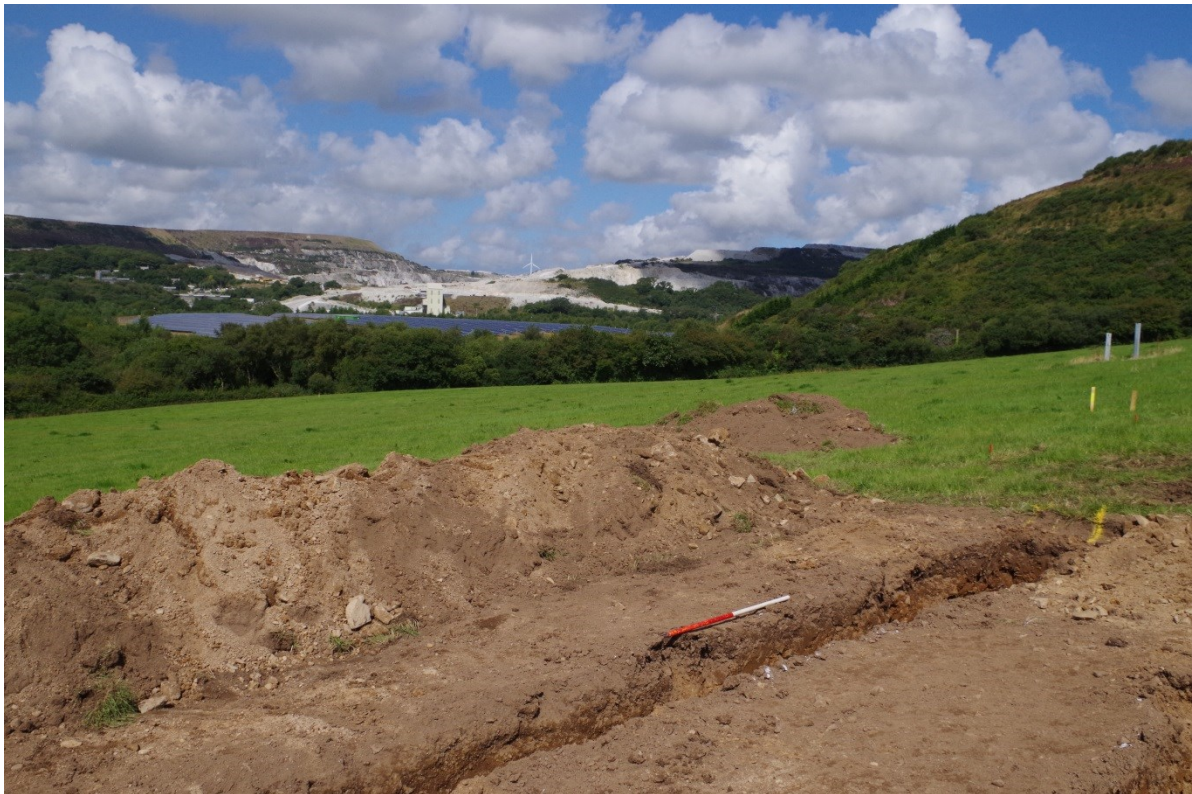
Cover illustration

An excavated cable trench in Field 1 with Melbur china clay pit dominating the landscape north of the site.

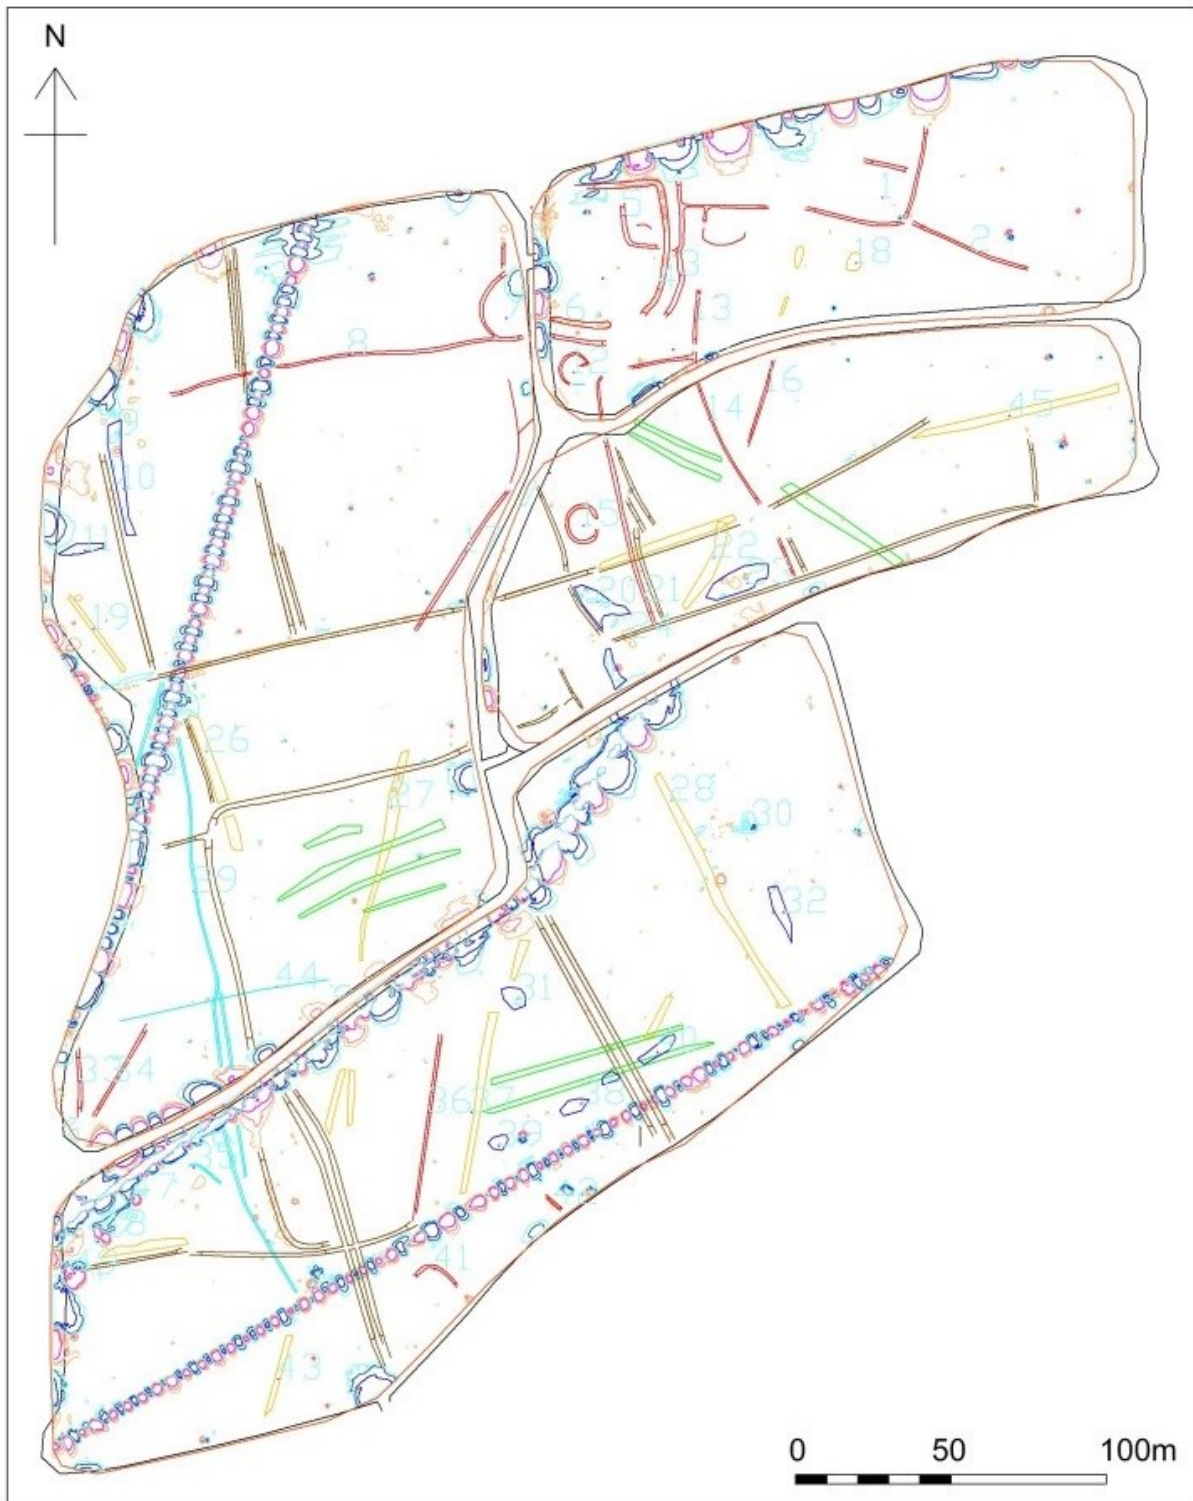
Figure 5. The solar farm site showing the geophysical survey results with the red lines concentrated in the north of the site representing features of probable late prehistoric date.

The geophysical survey results proved to be very clear and not significantly degraded by the effects of modern agriculture (Figure 5). Evidence for ploughed out boundaries which are either documented on archive maps or are clearly additional elements of a post-medieval field system were revealed, particularly in the western part of the survey area. The current cross-contouring field boundaries can be seen in many cases to be those depicted on the 1840 Tithe Map, and these may in part represent fossilised strip field boundaries dating to the immediate post-medieval period. A number of areas of evidence for probable medieval ridge and furrow were also highlighted within the south western part of the survey area.

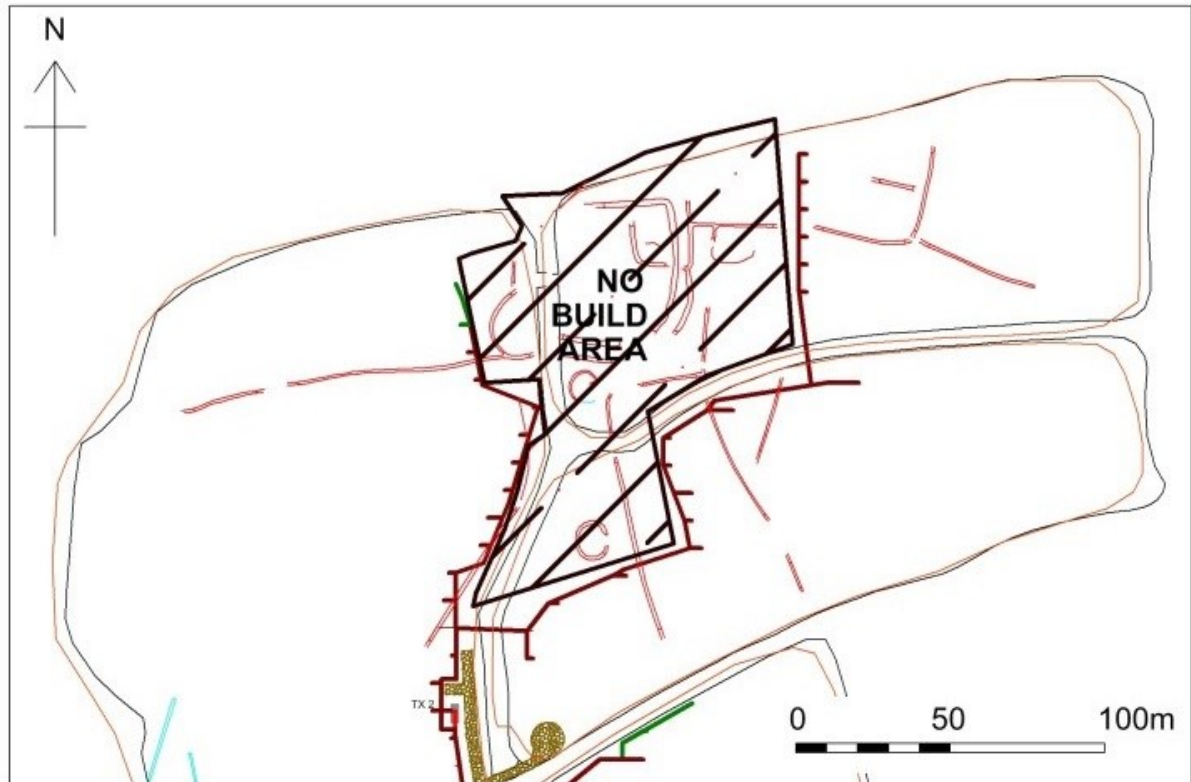
Figure 7. The no build area in the north half of the site, shown overlaid on the geophysical survey results which indicate a probable round or prehistoric enclosure and a pair of round houses to its south.

The most significant features revealed by the geophysical survey lay up against the northern boundary. A sub-square enclosure measuring 44m by 44m in plan defined by an encircling double ditch almost certainly represents a late Iron Age-Romano-British enclosed farmstead of the type known in Cornwall as a round. A number of features are visible within the data set, including a sub-square feature which may represent an associated structure, a shallower ditched sub-circular feature underlying the southwestern corner and a further semi-circular feature to its east. The round also seems to be associated with a possible multi-phase field system which is most clearly defined to the immediate west, south and east of the round. A ring-ditch, possibly a roundhouse, 9.2m in diameter, showed up immediately adjacent to the southern side of the round. Around 56m to the south of the round is a further oval ring-ditch, possibly a house of 9m or 10m across its long access, which has an east-facing opening.

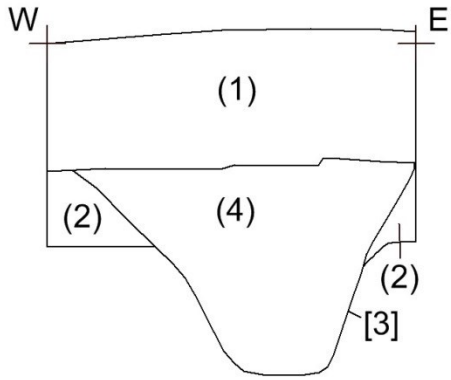
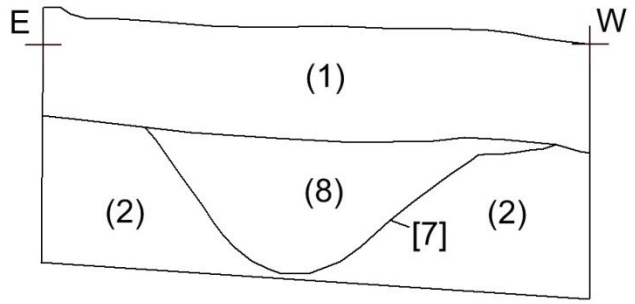
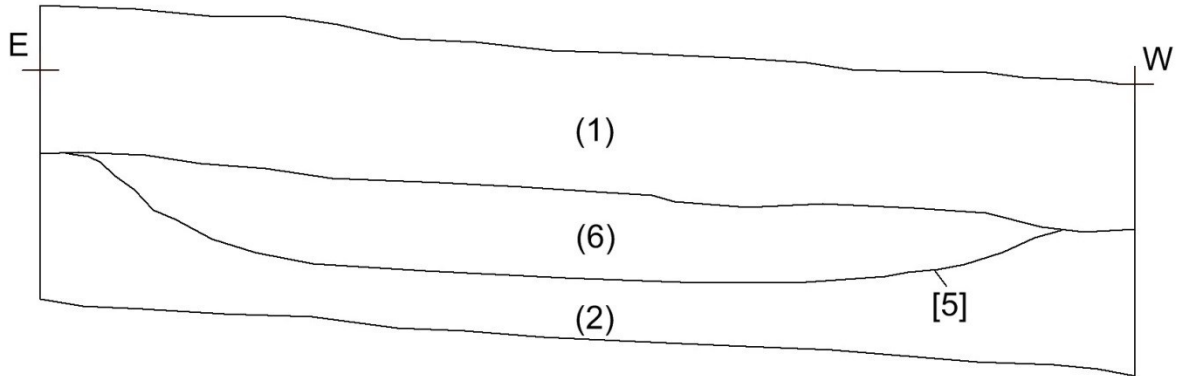
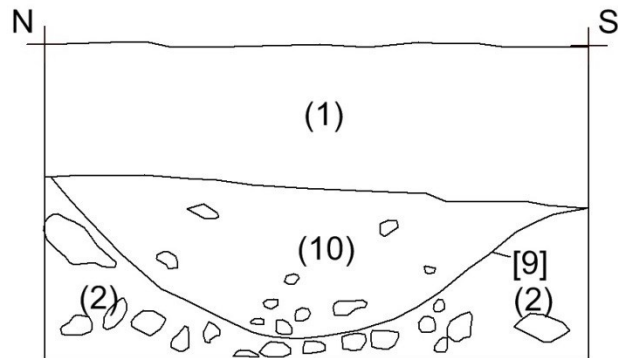
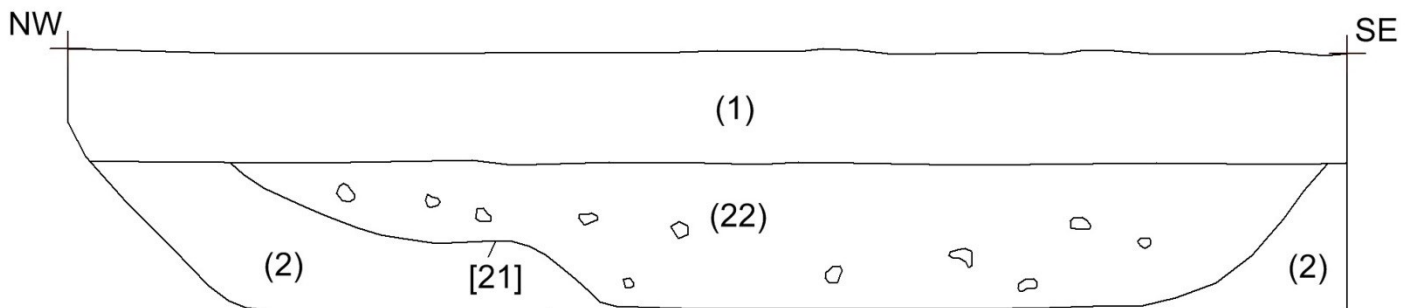
Figure 12. Section drawings of features, from top, [3], [7], [5], [9] and [21], that are likely to be prehistoric in origin.

The remaining features are located closest to the probable round and the no build area and seem likely to correspond to geophysical anomalies that have been interpreted as prehistoric in origin. However the locations of the features in Fields 1 and 3 are offset from the anomalies by up to 5m to the west and 1.5m to the north (Figures 8 and 10). Whilst it is possible that all the recorded archaeological features were not detected by the magnetometry but were close to features that were detected and not found in the ground, it seems more likely that an error, or a compound of smaller errors, has been introduced. Three sets of measurements, each from the solar farm surveyor, the geophysical surveyor and the archaeologist were combined within AutoCad to produce the site plan and at each stage small, but incremental, errors are unfortunately possible. Allowing for this it is very probable that the features and the geophysical anomalies do correspond.

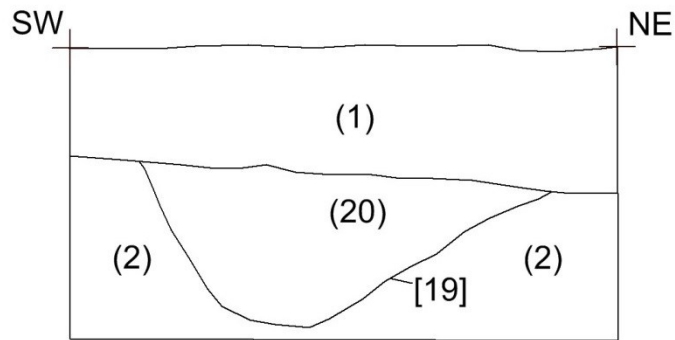
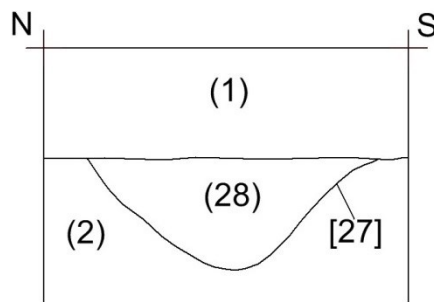
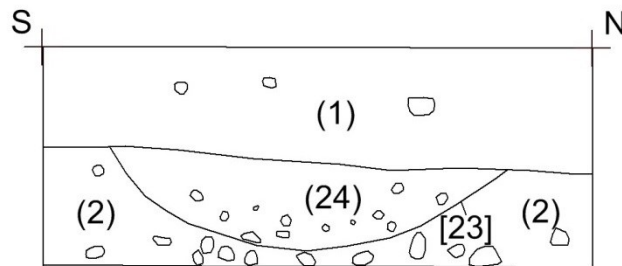
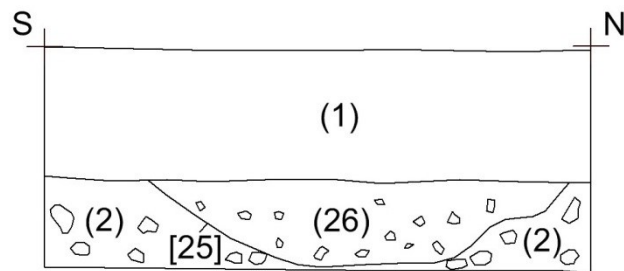
Figure 13. Section drawings of features, from top, [19], [27], [23] and [25], that are likely to be field boundary ditches.

To the east of the trackway a further two features - [19] and [27] - were found in the cable trench leading to the substation (Figures 13 and 20). Feature [19] was 1m east of the substation and its cut was 1.10m wide and 0.40m deep (Figures 13 and 20). The cut had quite steeply sloping sides and a slightly concave base. The fill (20) was an orange-brown silty-clay with frequent gravels and small slate-shale fragments.

In Field 2 features [23] and [25] were comparable to each other but neither was identified by the geophysical survey, probably because their proximity to the fence boundary meant they were obscured by magnetic disturbance (Figures 9 and 17). Their parallel position and orientation approximately aligns them with the prehistoric field system but this is not found to have closely parallel ditches elsewhere in the site. The current north field boundary has been altered to accommodate the mica tip immediately to the north of the site and though depictions on historic maps vary, the Tithe Map in particular suggests that the former boundary was far more sinuous and curved south of its present location. Parallel ditches, usually with a Cornish hedge in the middle, were a common form of medieval and post medieval boundary, as seen at the southern end of the site in features [19] and [27]. It is probable that features [23] and [25] are the double ditches of this former boundary and are medieval or post medieval in date.

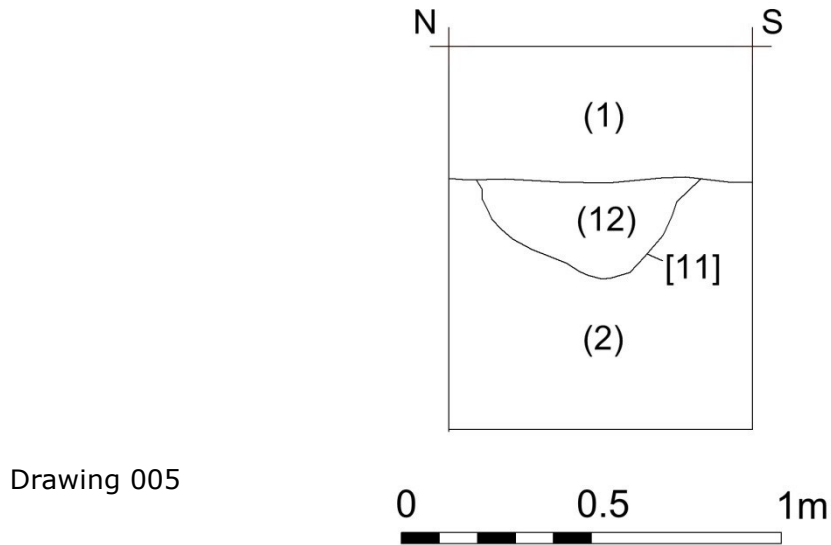
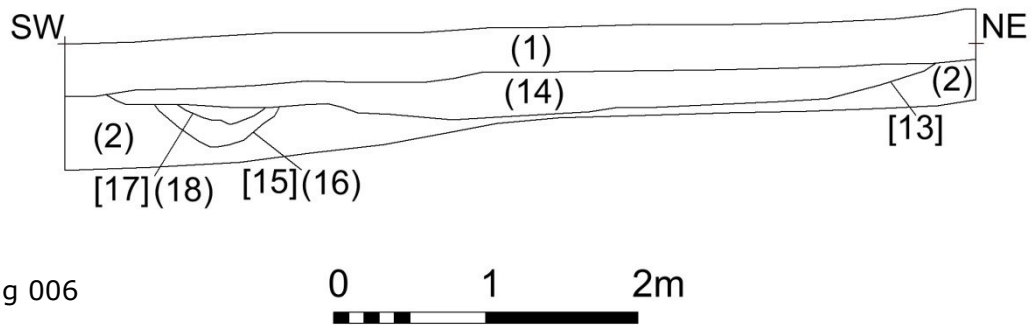
Figure 14. Section drawings of features [11] top, and [13] and [15], bottom, the date and function for which cannot be identified.

Two features - [13] and [15] - were found located at the southern edge of Field 4 where the cable trench turned to the north (Figures 14 and 21). Feature [13] was 5.5m wide and 0.35m deep with a shallow, slightly concave cut. It was filled by (14), a dark grey-brown clayey-silt with occasional gravels and small slate-shale fragments. Cut [13] appeared to cut feature [15], lying between it and the topsoil (1).

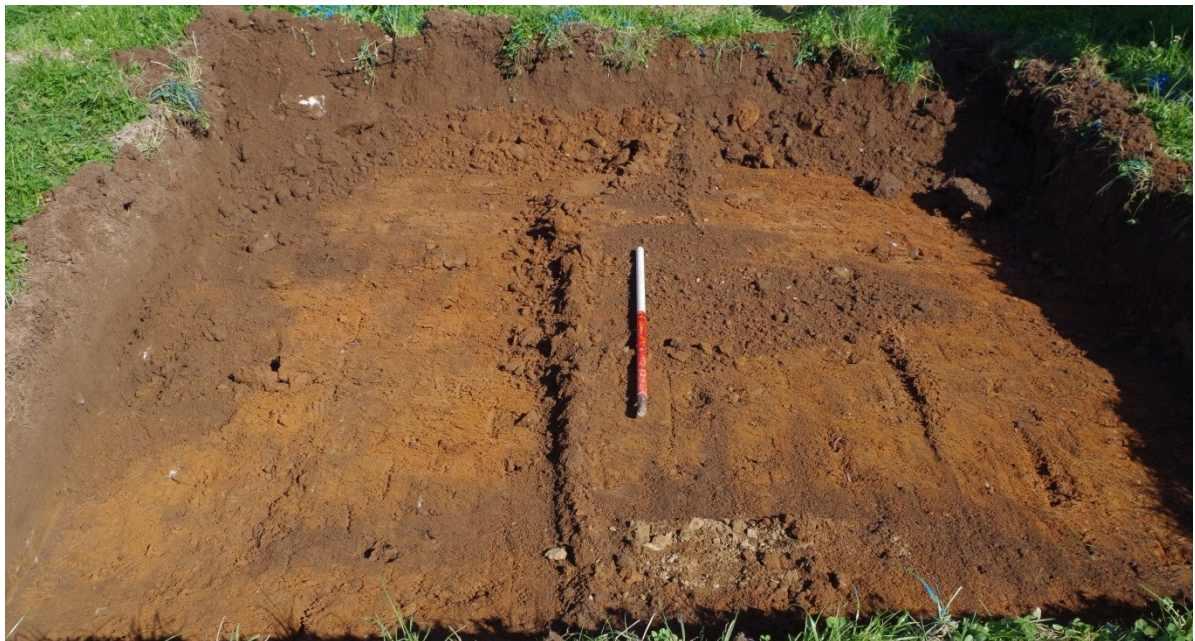
Figure 15. Excavation in Field 4 for the foundations of the substation showing the appearance of the topsoil (1) and subsoil (2) found across the site.

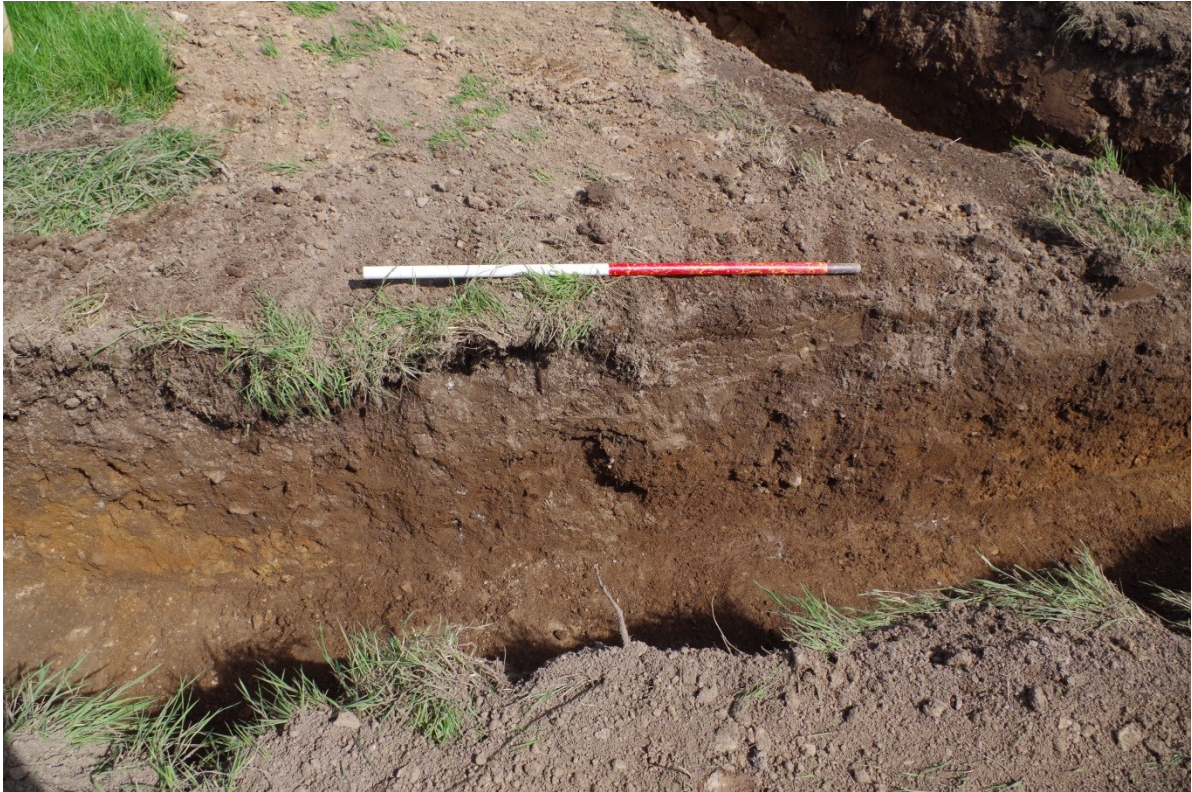
Figure 16. Probable ditch [21] found within a tail trench at the north end of Field 1.

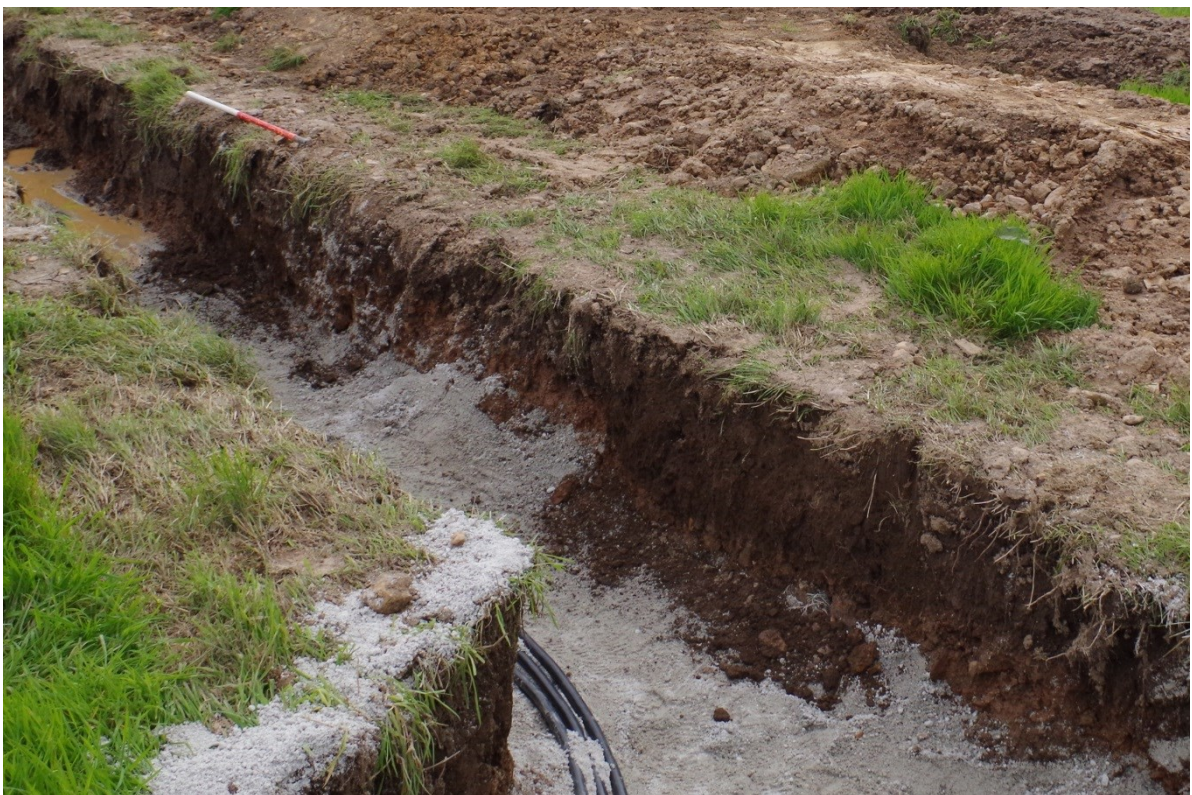
Figure 17. Probable parallel ditches [23], right opposite the black cables, and [25], left under the scale bar, at the northern extent of the cable trenching in Field 2.

Field 2 included the greater part of the no build area across its western half (Figures 7 and 9). The cable trench was located adjacent to the no build area, orientated north-south having cut the boundary from Field 3. At its northern end it turned through 90° to the east and was excavated parallel to the northern boundary. Two features - [23] and [25] were found to the south of the 90° turn (Figures 13 and 17).

Features [23] and [25] were not visible in the extremely wet conditions during which they were first excavated. As the trench dried they became more distinct from the topsoil in particular as the fills (24) and (26) remained wetter than the surrounding soil.

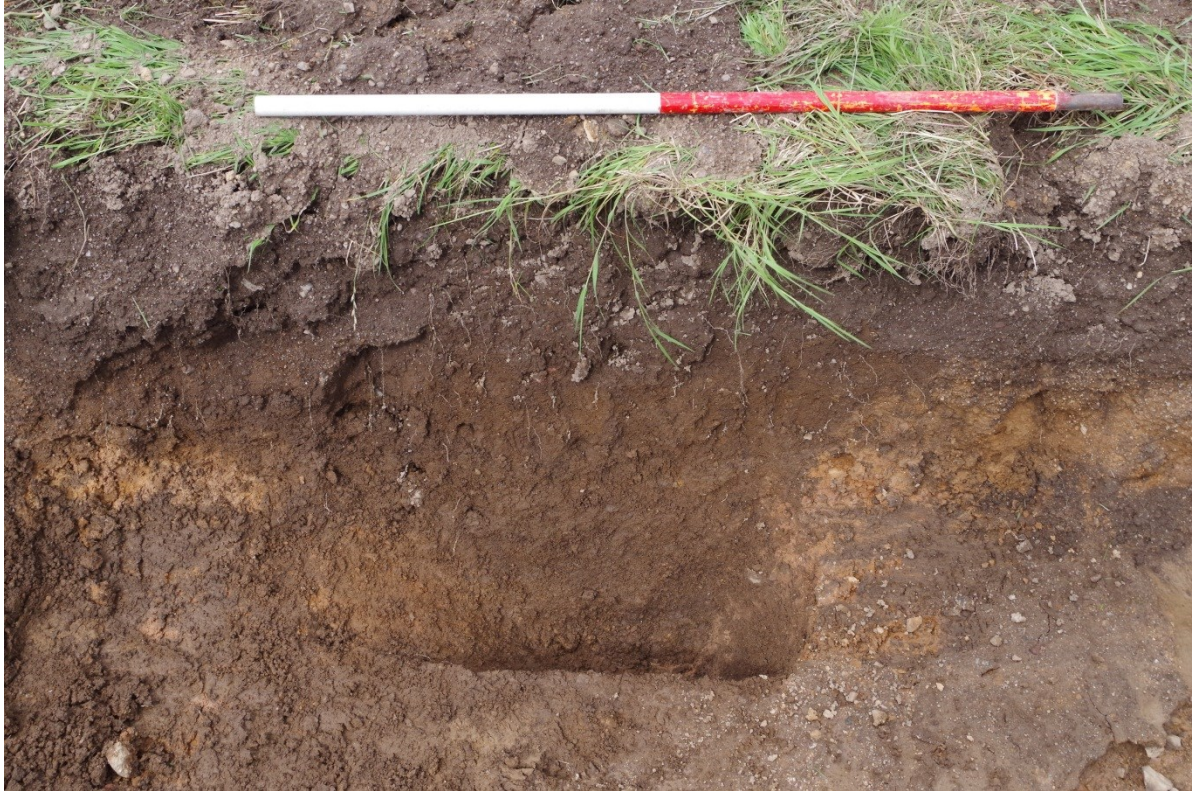
Figure 18. Probable prehistoric ditch [3] close to the no build area in Field 3.

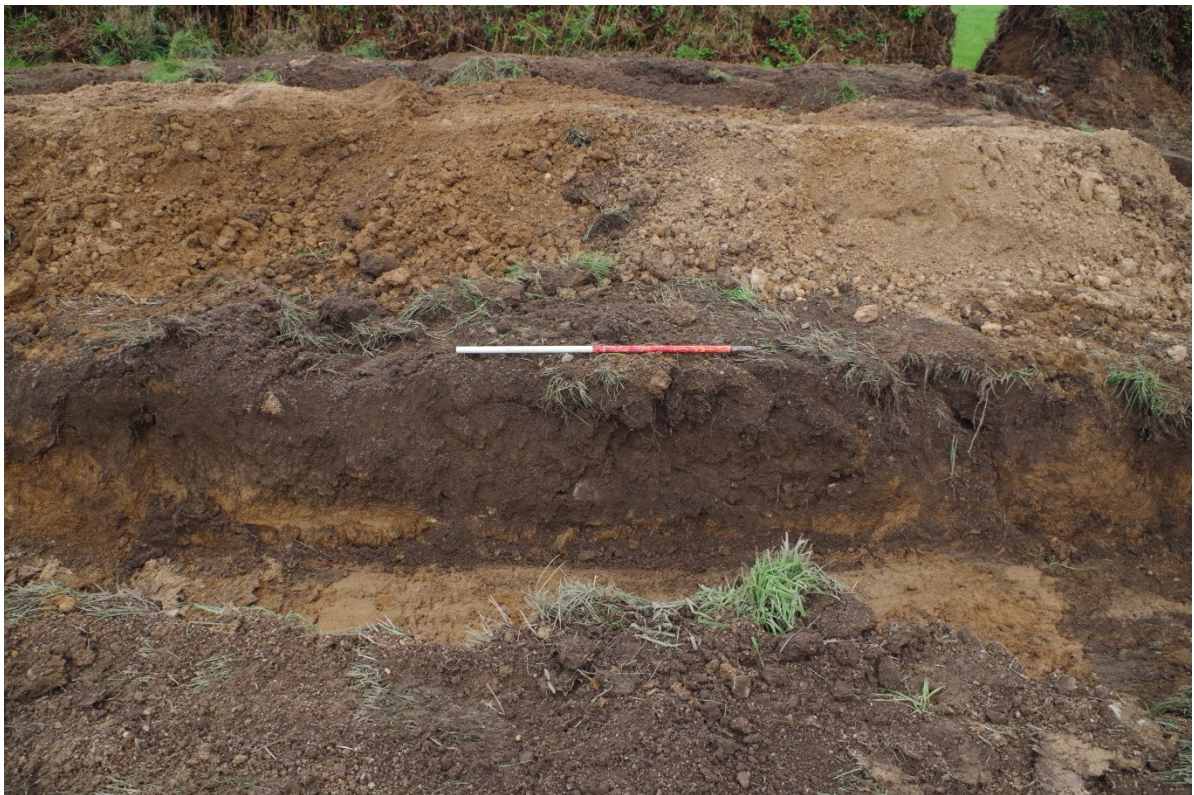
Figure 19. Probable prehistoric ditch [5] in Field 3. Note its greater width compared to [3] above, probably due to the section not cutting the ditch at right angles.

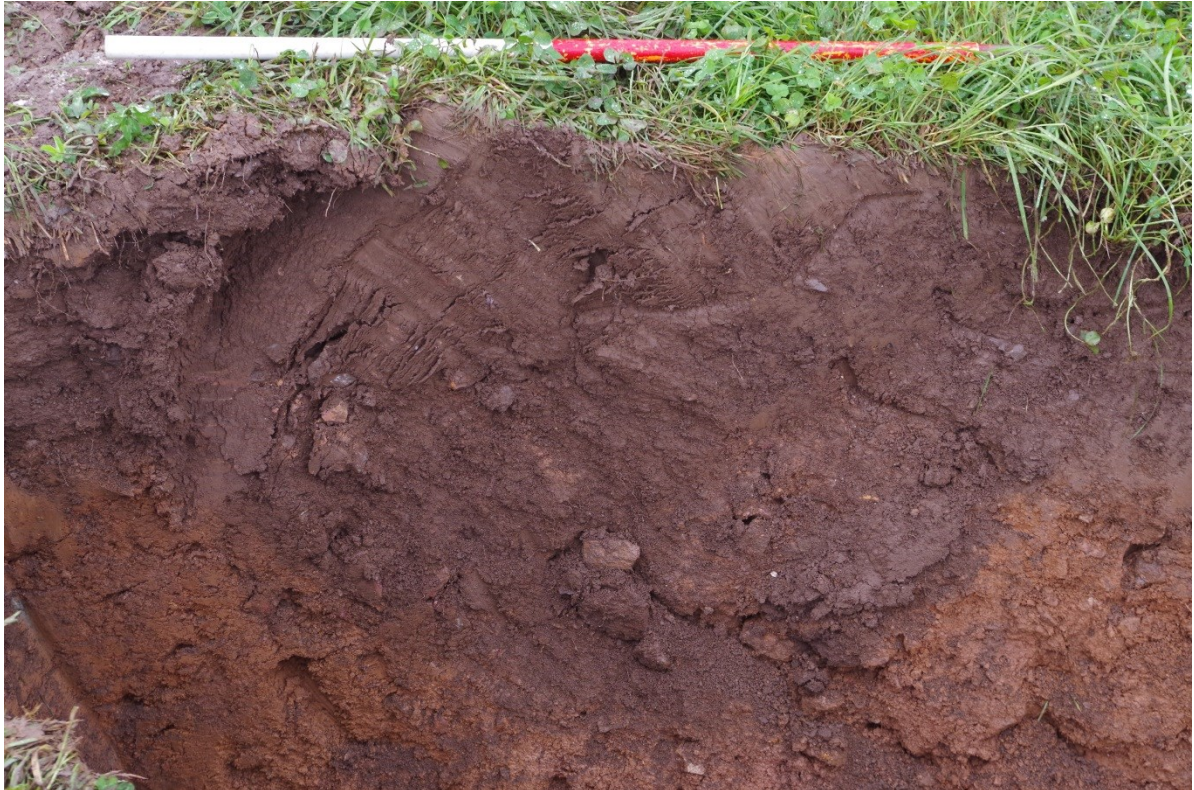
Figure 20. Probable field boundary ditch [19], one of a pair, with [27], to the east of the substation in Field 4.

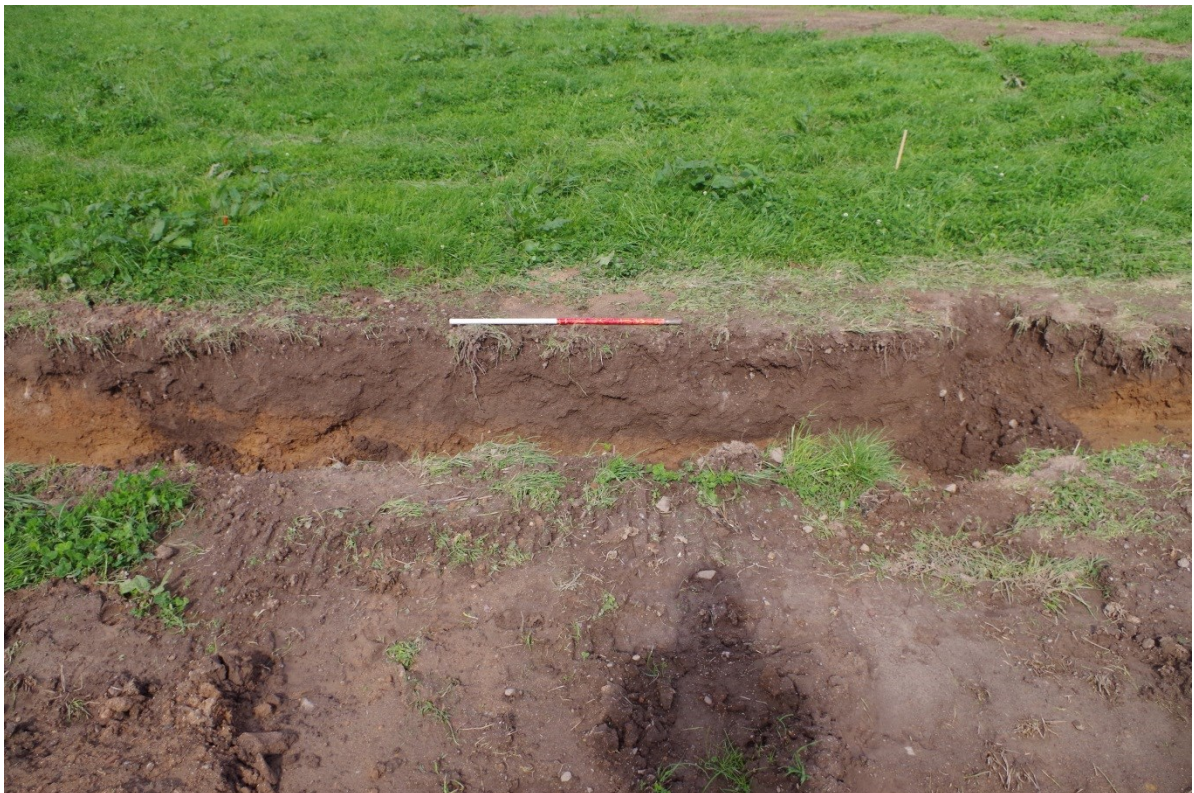
Figure 21. Probable ditch [15], on the left, and wide pipeline ditch [13], to the right, at the southern end of Field 4.

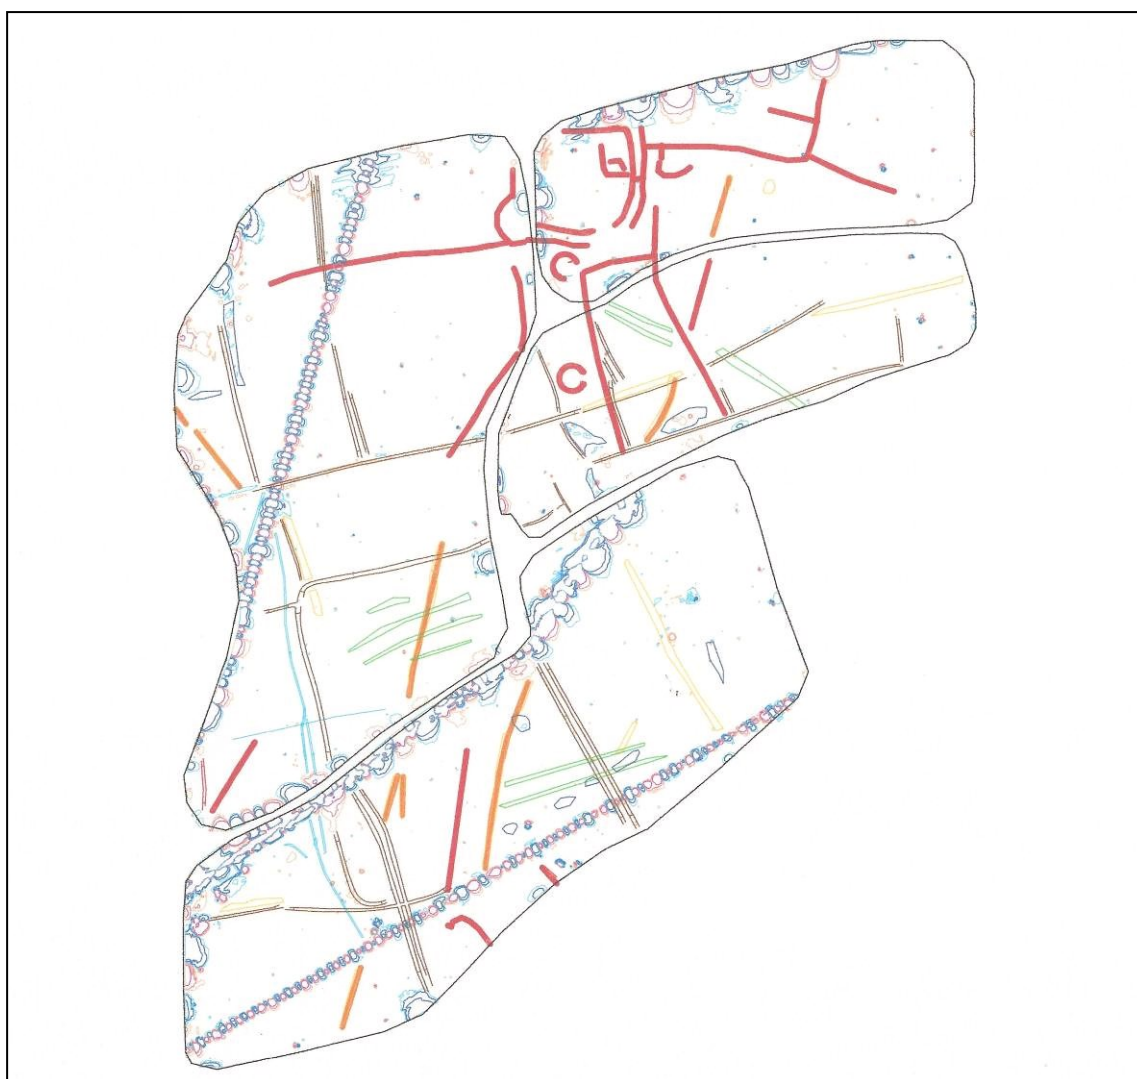
Fig 1. Extract from the interpreted results of the geophysical survey showing (red) probably contemporary late prehistoric boundaries, round and round house sites; (orange) possibly contemporary boundary features.
