St Clare, Penzance, Cornwall Heritage Assessment

St Clare, Penzance, Cornwall

Heritage Assessment

Client	Property Services, Cornwall Council
Report Number	2015R076
Date	December 2015
Status	Final
Report author(s)	Jo Sturgess
Checked by	Andy Jones
Approved by	Andrew Young

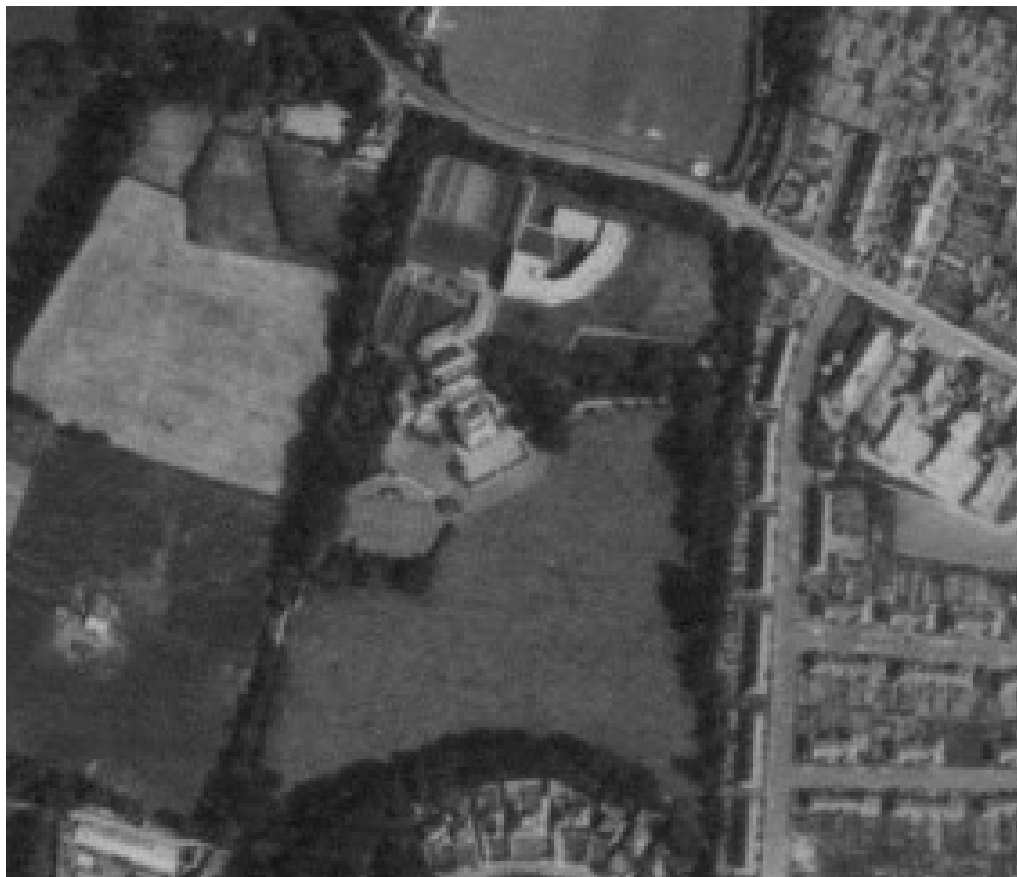
Fig 8 RAF vertical photograph, 1946.

The 1946 RAF aerial photograph (Fig 8) shows pre WWII changes which occurred within the site between c1935 and 1946. In particular it shows the newly completed Quadrangle building (site 20) in the north-eastern part of the site, built in 1938 and opened in 1939 (CRO AD2128/7). It also shows another building (site 47) linking York House to the Quadrangle building. This structure was demolished when the modern council block was constructed (site 14). No other changes within the site are discernable.

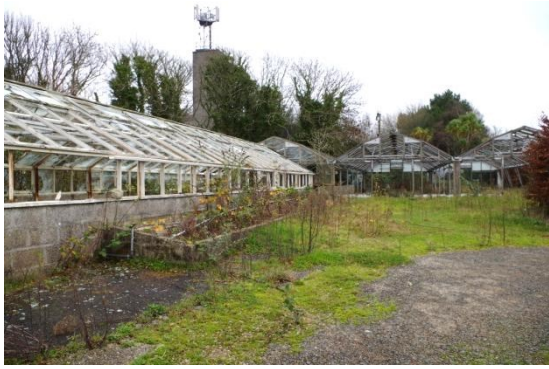
Fig 12 Site 4 looking east.

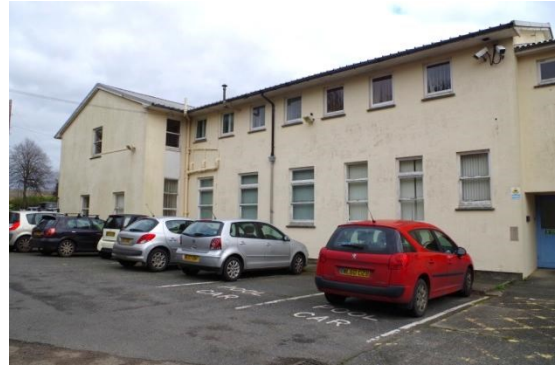
14	46635	30738	Offices	late 20th century	Extant	This range of buildings was built as a link between York House and the Quadrangle block (site 20). It is likely to have been constructed during the 1960s or 1970s either by the school or by the Borough Council who acquired the site in 1970.	Survives intact.	It is recommended that a photographic survey of this range is undertaken if demolition is required.	L

Fig 16 Site 14 looking north-east.

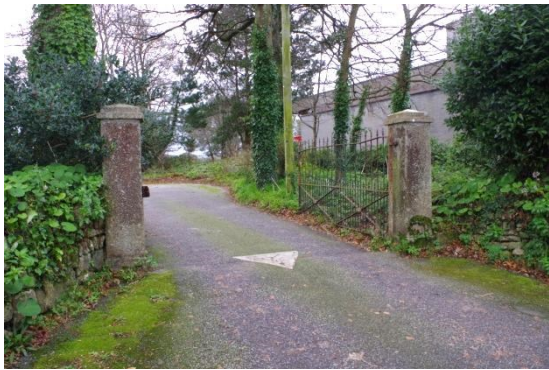
7	46497	30659	Boundary stone	medieval-c1880	Map evidence	A boundary stone is marked on the c1880, c1907 and c1935 OS maps. It was presumably removed when the sports pitches were built in the second half of the 20th century.	Removed.	No recommendations	C
8	46609	30808	Gateposts and gate	19th century	Extant	A pair of square-section, granite gateposts lie either side of the entrance to the east of the fire station. The eastern gatepost has been moved from its original position on the west side of the earlier lane (site 9), and an original decorative iron	Survives intact.	The gateposts and gate should be retained <i>in situ</i> .	C (L)

Fig 13 Site 8 looking south.

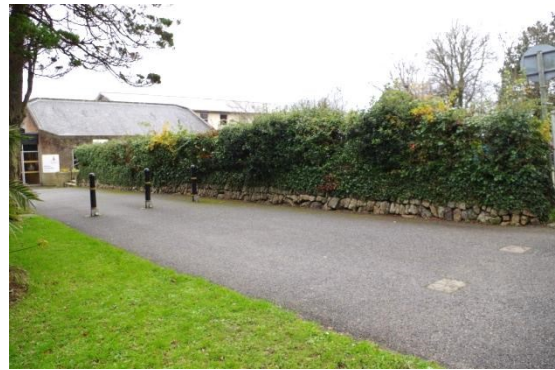
Fig 17 Site 16 looking west.

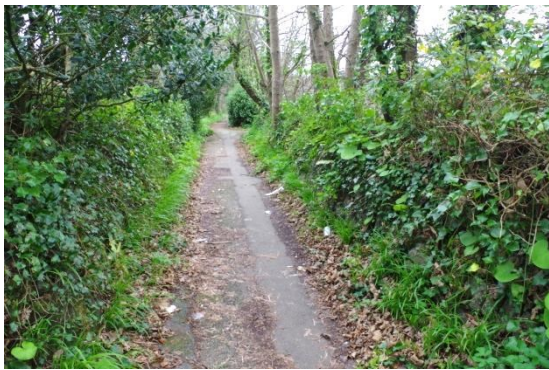
Site	Easting SW	Northing	Monument Type	Date of construction	Form	Description	Condition	Recommendations	Grade
						gate remains <i>in situ</i> on the western post			
9	46576	30706	Lane and banks	medieval-c1840	Extant	This lane defined on either side by stone faced earth banks is an early feature. It is likely to date from at least 1825 but the route may be much earlier. It defines the 19th century property boundary between York House and St Clare's Cottage. The banks stand approximately 0.7m high and are faced with granite and killas rubble. Along the northern section of the lane, adjacent to the fire station, the banks have been removed.	Survives intact to the south of the fire station.	The lane and banks combine to form an early feature. It is recommended that they are retained where possible.	C (L)
10	46584	30720	Driveway	c1825-c1840	Map evidence	A service drive is shown on the c1840 Tithe map leading from the lane (site 9) to the stable block and service quarters at the north-west end of York House. The driveway was removed between c1880 and c1907 when it was replaced by a new service drive (sites 16 and 17). The opening for the driveway, however, through the eastern bank of the lane (site 9) remains <i>in situ</i> .	Does not survive above ground.	It is recommended that any future groundworks in this area are subjected to a programme of archaeological work.	C (L)

Fig 14 Site 9 looking south.

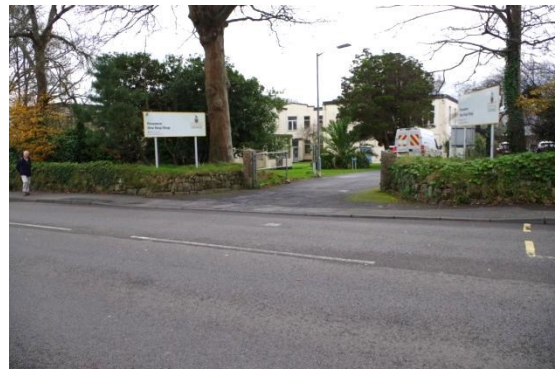
Fig 18 Site 17 looking south.

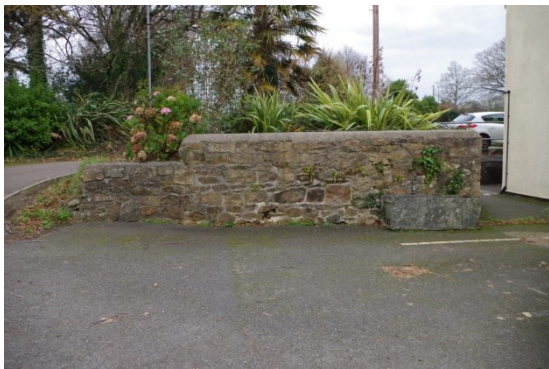
Fig 15 Site 11 looking north.

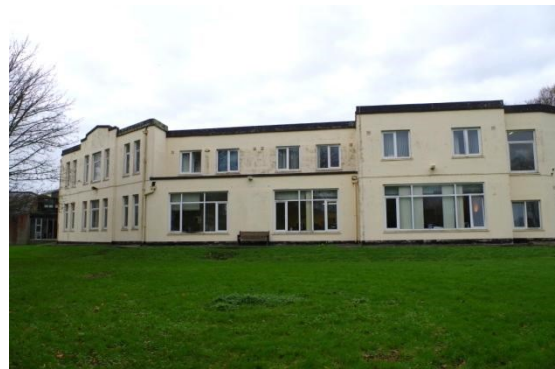
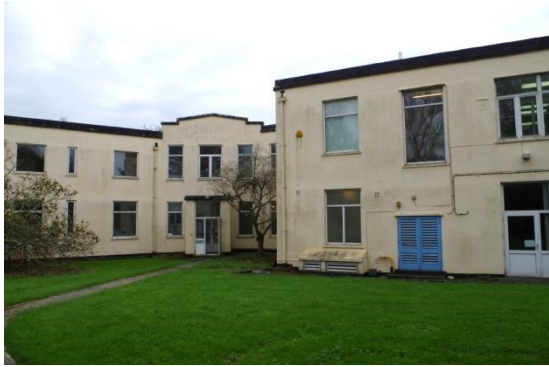
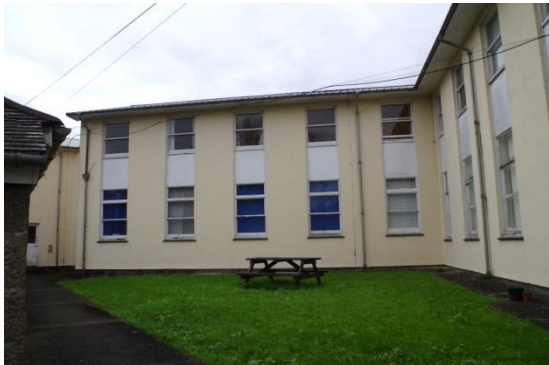
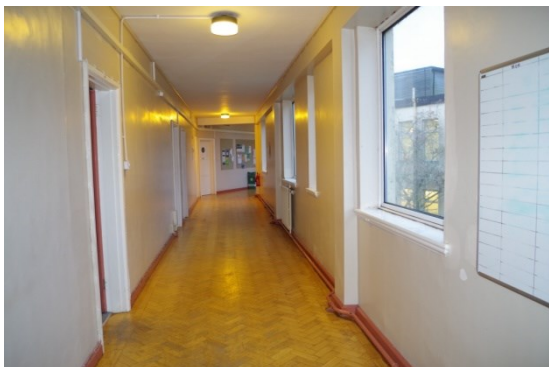
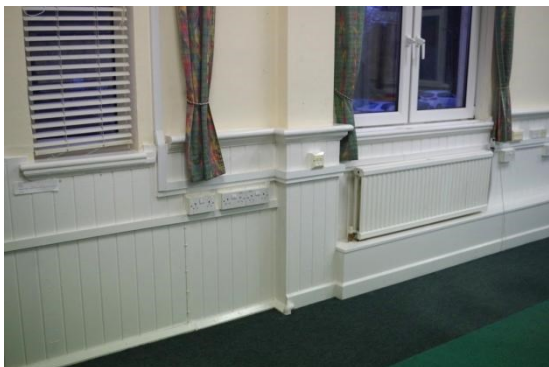
Fig 19 Site 20 looking north-west.

Fig 20 Site 20 looking south-east in quadrangle.

Fig 21 Site 20 looking north in quadrangle at assembly hall.

Fig 22 Site 20 interior corridor.

Fig 23 Site 20 interior panelling and moulded sills.

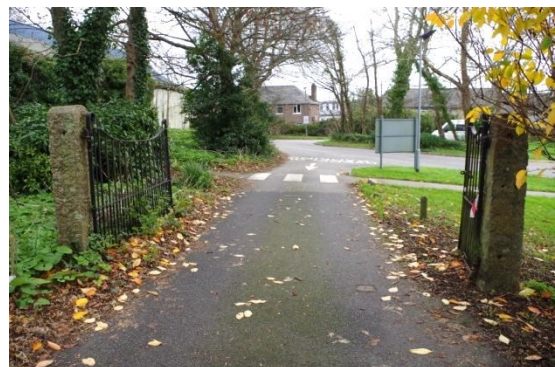
Site	Easting SW	Northing	Monument Type	Date of construction	Form	Description	Condition	Recommendations	Grade
						gardens beyond and the edges are retained by a single course of granite blocks.			
25	46699	30690	Gateposts and gate	19th century	Extant	A pair of square-section, granite gateposts with iron gate, lie either side of the original main drive to York House, just to the south-west of the swimming pool (site 47). These posts are not in their original position and may well have been moved here from an earlier location just to the east of the house adjacent to the remains of the summer house (site 32) as shown on the c1880 OS map. It is unclear when the gateposts and gate were moved.	Survives, but not <i>in situ</i> .	The gateposts and gate should be retained <i>in situ</i> .	C (L)
26	46679	30721	Outbuilding	c1840-c1880	Map evidence	This is the site of a small outbuilding shown on the c1880 OS map as being built against the north-west corner of one of the walled gardens shown on the same map (site 27). This building was removed in 1938 during the construction of the Quadrangle building (site 20).	Removed.	It is recommended that any future groundworks in this area are subjected to a programme of archaeological work.	C (L)

Fig 26 Site 25 looking east.

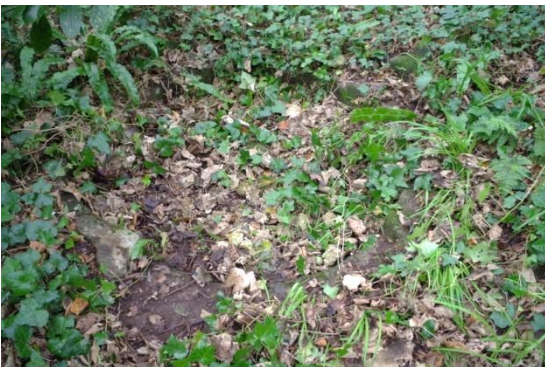
Fig 30 Site 33 looking south.

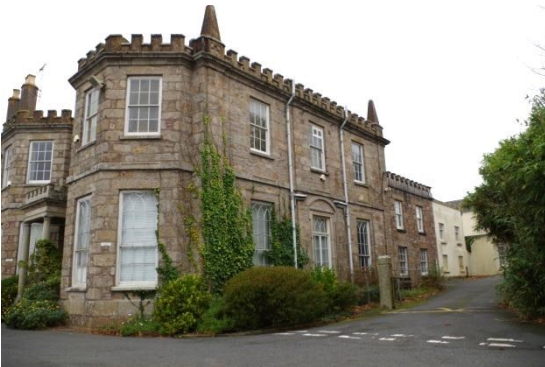
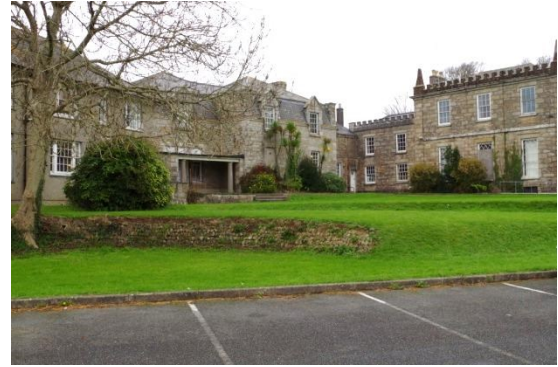
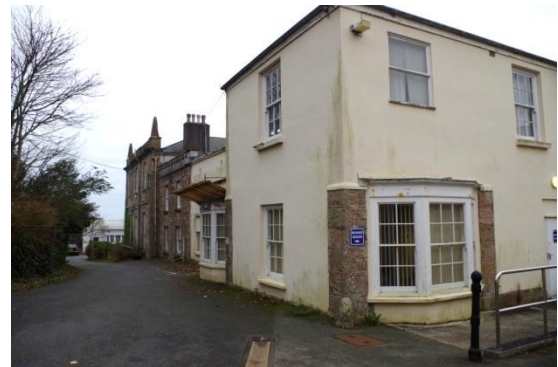
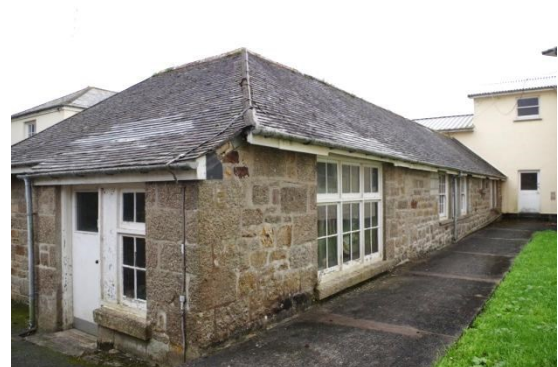
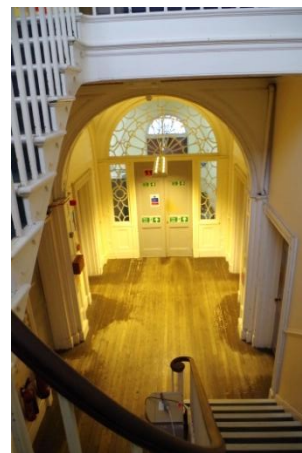
The construction of York House (site 35) began in 1825 for Henry Pope. The Rev. C. V. Le Grice named this house "The Vatican." (Courtney 1878). Henry Pope was a business man who had emigrated to New York, made his fortune there and then returned to Penzance. On his return he bought the land on which York House stands and commissioned its construction. Unfortunately Henry died in 1828 before the completion of his new house, leaving it to his nephew, John Pope Vibert, who was responsible for completing the building work (Courtney 1878). The original architect, responsible for designing York House is currently unknown; however, the inheritor, who completed the building work, John Pope Vibert, was active in Penzance in building works, and was

Fig 31 Sites 34 and 35 looking north-west.

Fig 32 Sites 35, 39 and 42 looking north-east.

Fig 33 Site 35 original stable block looking south.

Fig 34 Site 35 late 19th century stable block looking south-west.

Fig 35 Site 35 entrance hall.

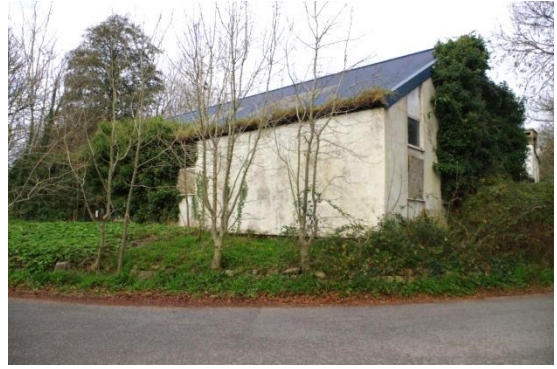
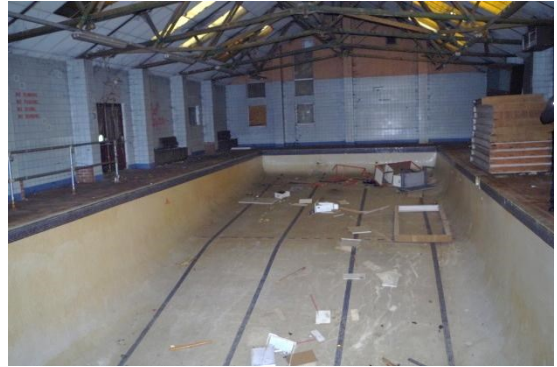
Fig 40 Site 48 looking north-west.

Fig 41 Site 48 interior looking west.

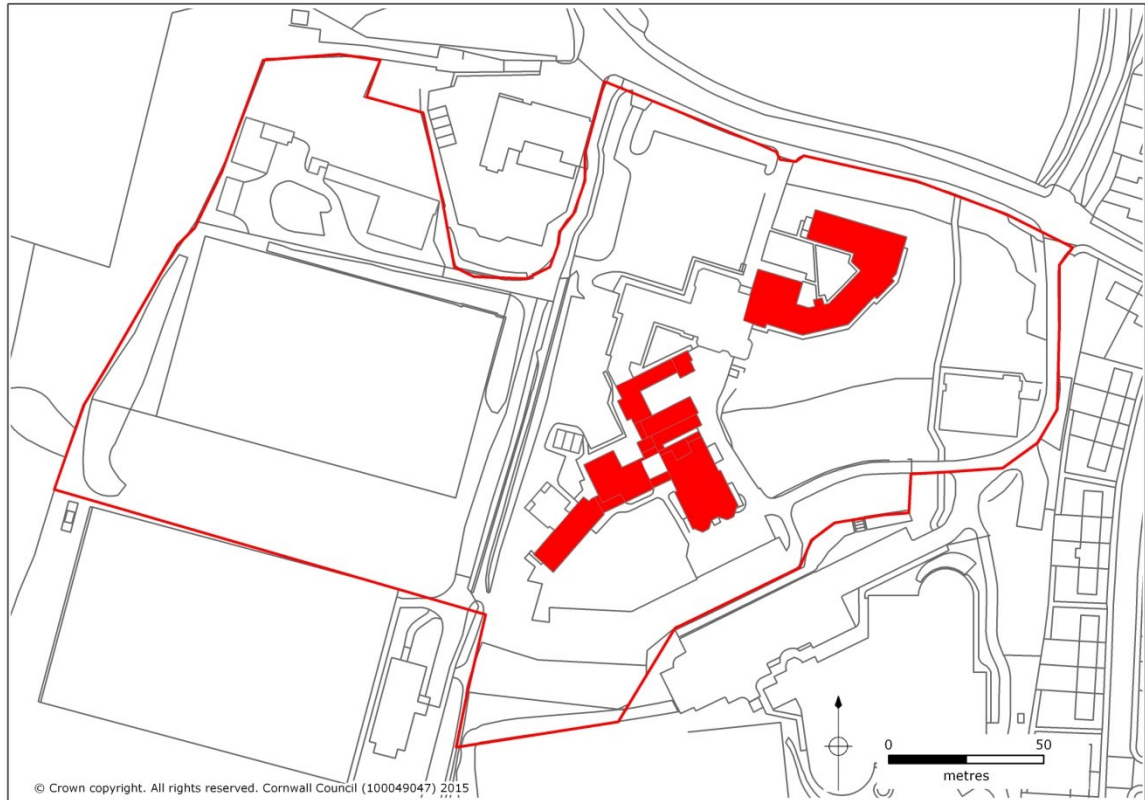
It should be noted that all buildings adjoining the original structure are deemed part of the Listed Building. This, therefore, includes sites 14, 20, 35, 39 and 41 (see Fig 11). However, the modern blocks, post-dating the mid 20th century, are not as significant; these include site 14 and the modern north-western extension of site 41.

Fig 42 Significant parts of the Listed Building (in red).
