Devoran Village Hall, Devoran, Cornwall

Archaeological Watching Brief

Report No: 2015R073
Report Name: Devoran Village Hall, Devoran, Cornwall
Report Author: Ryan Smith

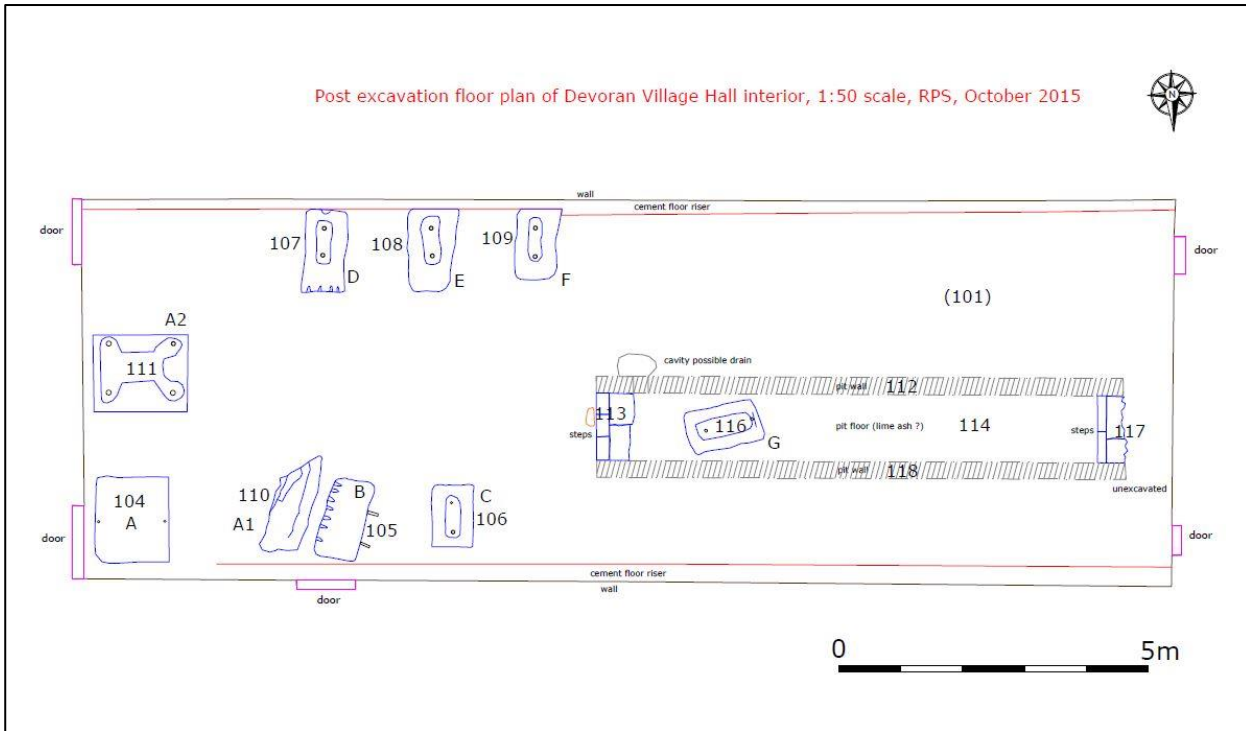
Figure 5: Post excavation plan of Devoran Village Hall, showing inspection pit and large granite blocks or setts.

The eastern end of the room was formed by a raised floor made up of a thin layer of cement 0.05m in depth, which lay around stone A and covered stones A1 and A2 (Fig 5).

In total nine granite stone blocks were revealed along with an intact inspection pit. Each stone was annotated a letter as described within this report. The location of each stone is shown on Figure 5.

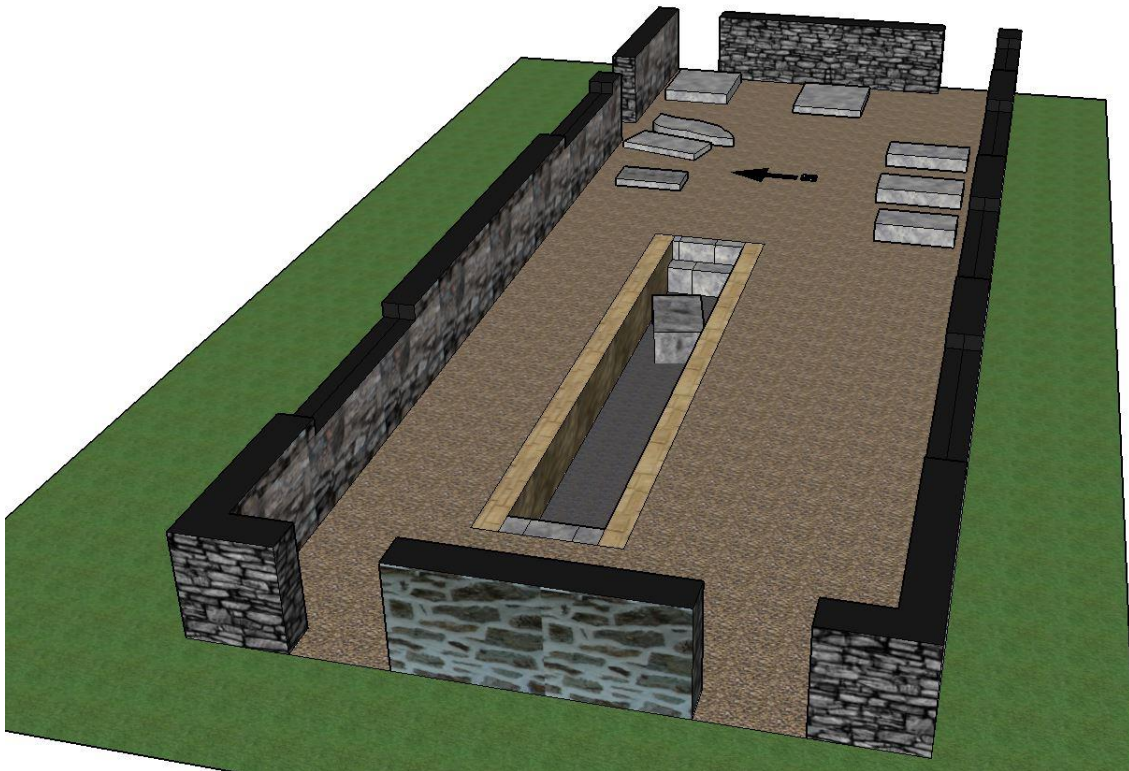
Figure 6: 3d representation of the village hall interior showing the locations of the inspection pit in relation to the granite blocks.

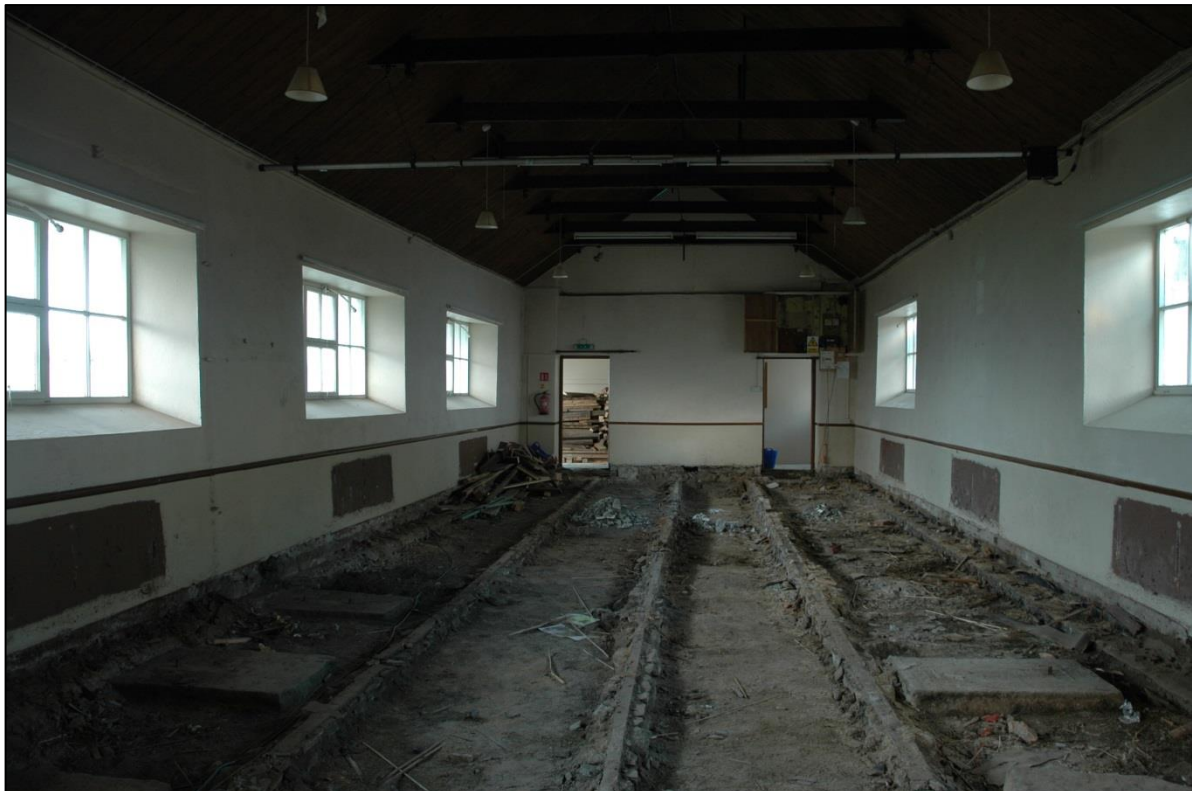
Stone B was a single rectangular block of granite, measuring 1.28m long, 0.7m wide and at least 0.4m thick, which had been dressed on one side. It was not *in situ* and had been tipped onto one side. Protruding from the western face of the block were two metal rods/bolts, measuring 0.03m in diameter and 0.28m in length, approximately 0.53m apart.

Stone C was a single rectangular block of dressed granite, measuring 1.09m long, 0.61m wide. It was *in situ* and protruded 0.2m above the surface of the floor. Two bolt holes measuring 0.025m in diameter, and set 0.49m apart, and a single bolt protruding 0.05m from the stone were recorded in the top of the stone.

Figure 8: View of interior of Devoran Village Hall looking west, showing floor joists and stones B and C.

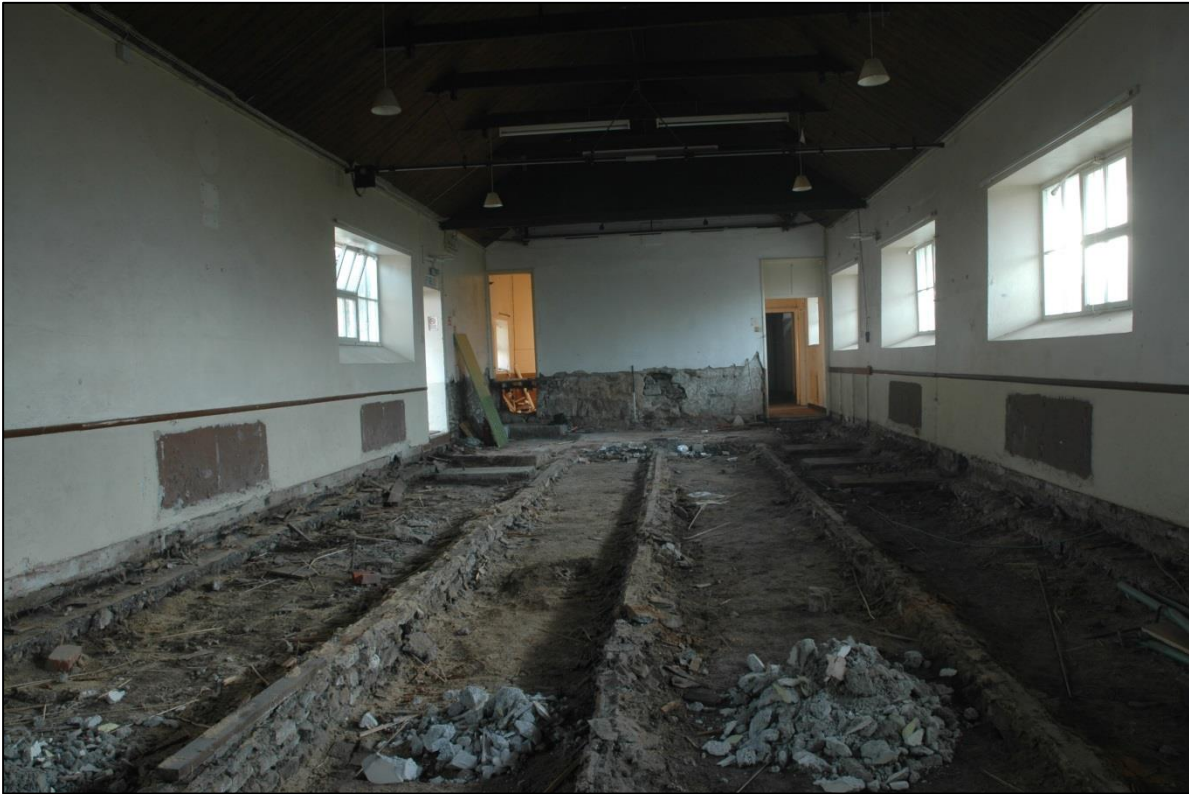
Figure 9: View of the interior of Devoran Village Hall looking east showing floor joists.

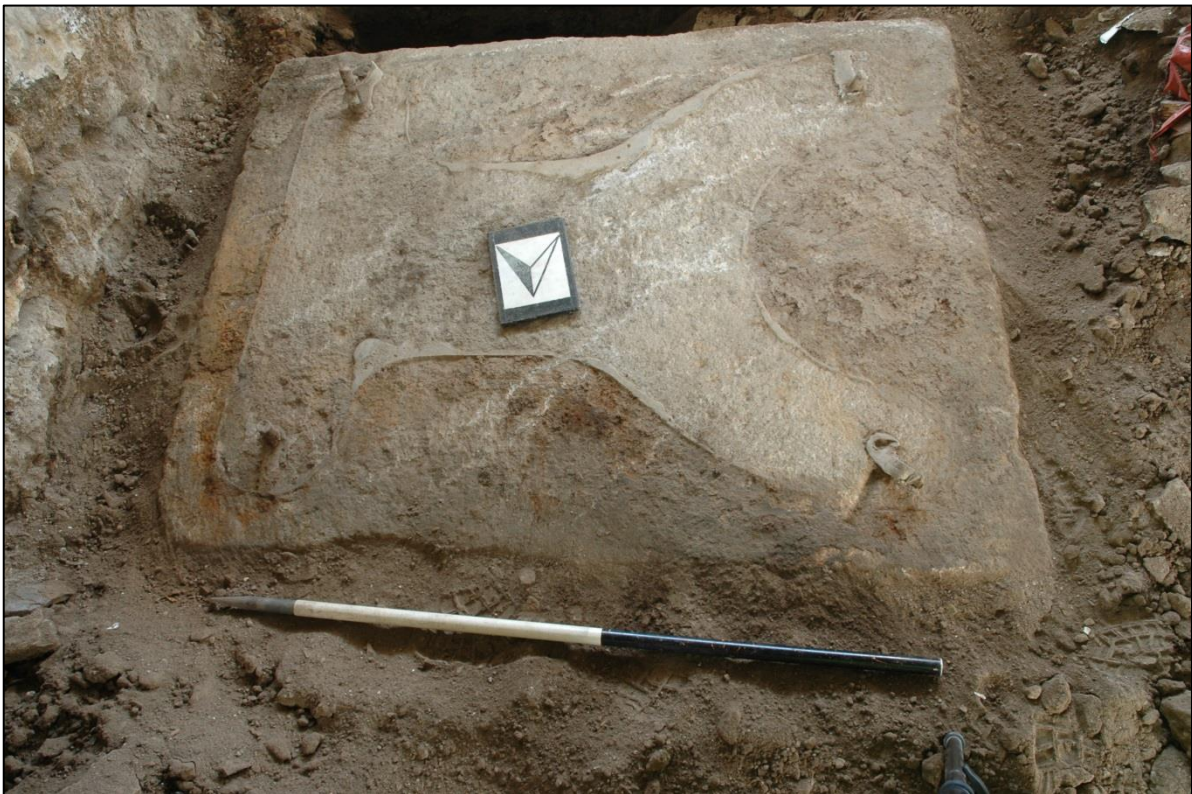
Stone A2 was a single block of dressed granite, measuring 1.53m long, 1.25m wide and 0.3m thick. This stone was notable because of its location close to the eastern wall of the hall and the imprint of the machine it once supported still showing on the surface (Fig 10). Four bolt holes were visible, three of which retained parts of the bolts, one at least protruding 0.1m from the block. The bolts were 0.025m in diameter, 1.3m and 0.76m apart. What appeared to be solder or other metallic material surrounded each of the bolts and continued around the block in a distinct pattern.

Figure 10: View of block A2 located against the east wall, showing the surviving bolts.

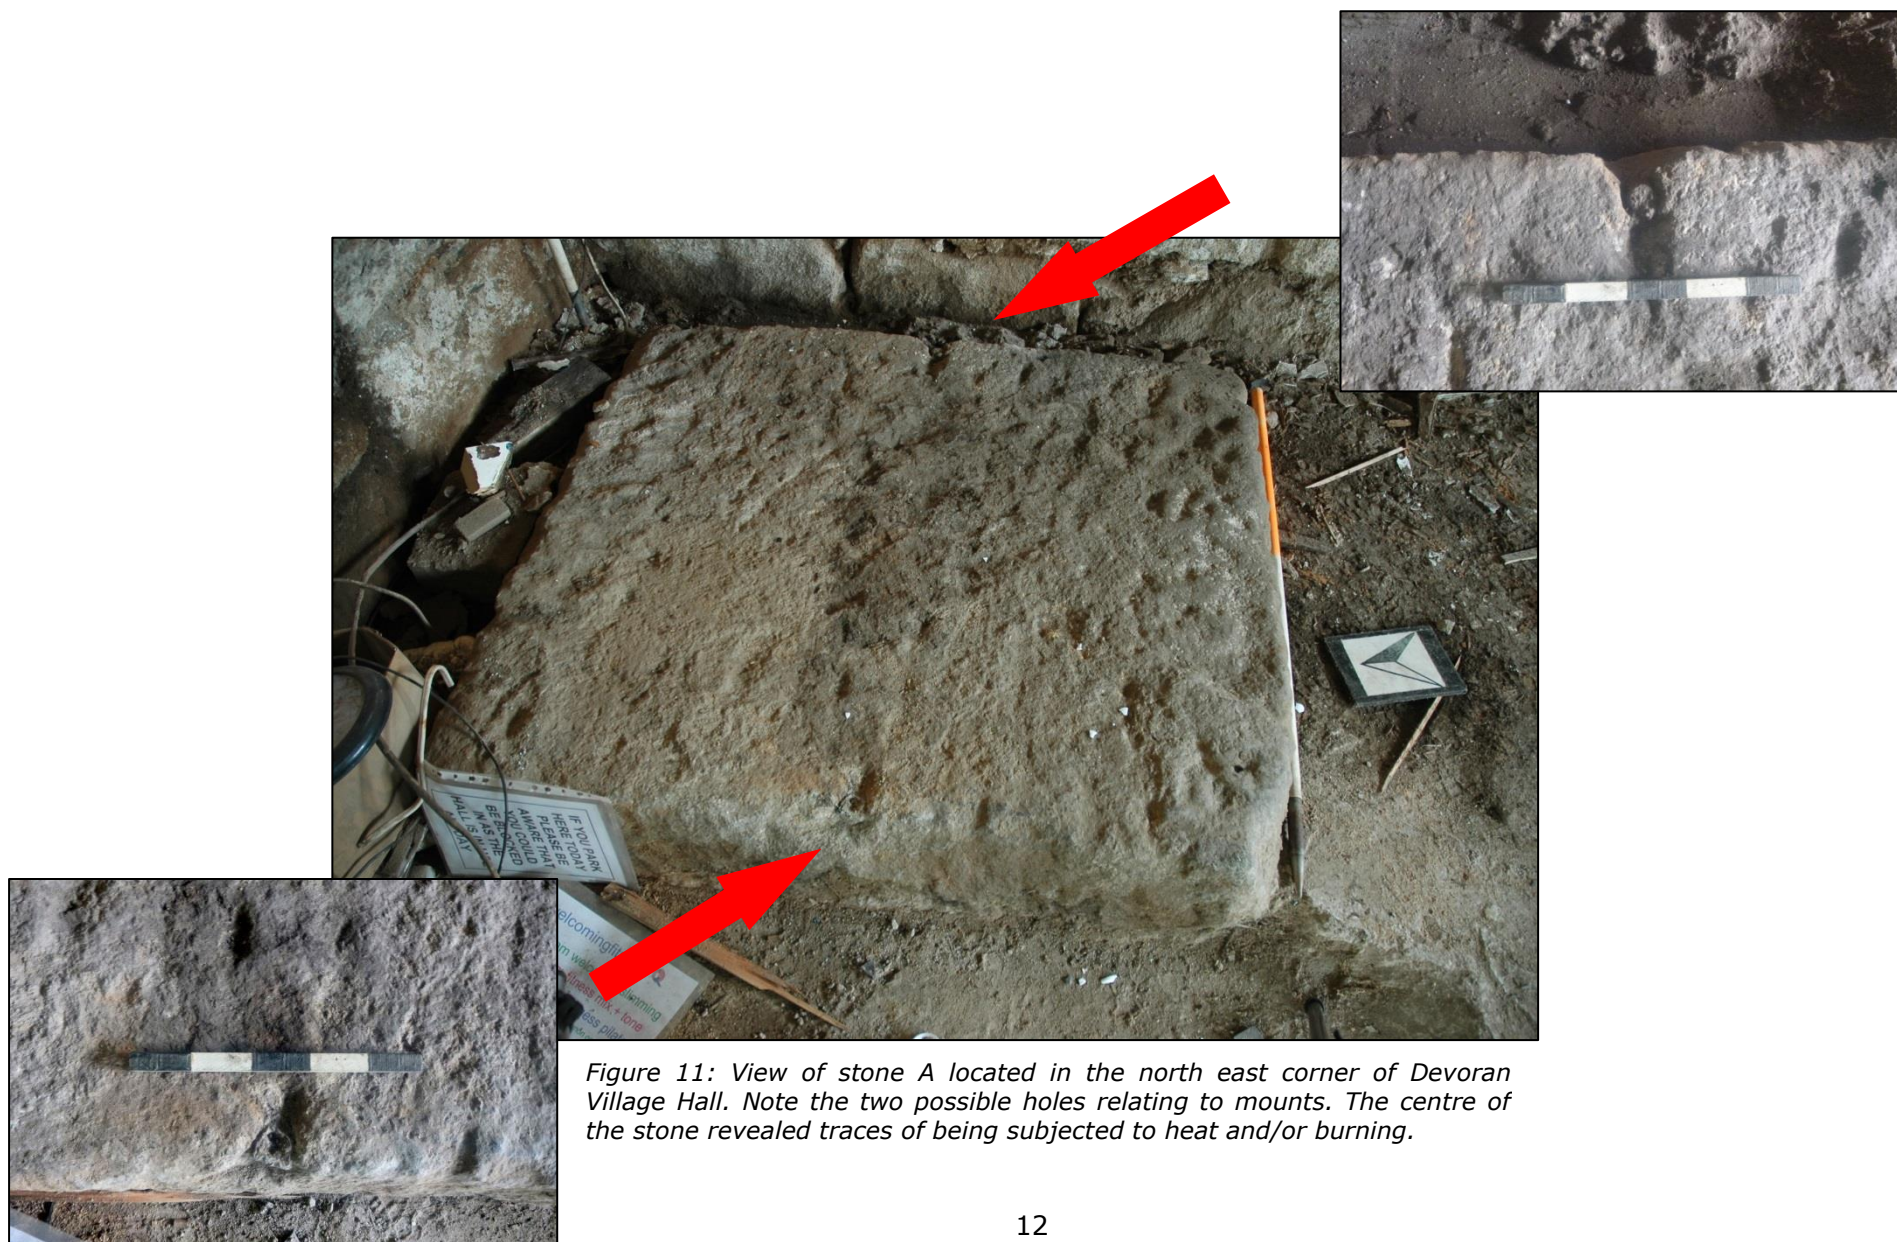
Stone A was a single block of dressed granite, 1.28m long by 1.15m wide and 0.7m thick (Fig 11). Only the surface of the block had actually been dressed. On the surface of the block were two metallic circular indentations almost 0.04m in diameter located on the east and western edges of the block. Between these two indentations appeared to be an area that had been subjected or exposed to burning, this tapered to a narrow line as it approached each of the bolt indentations.

Stone A 104 was visible in 2012 and was briefly examined by Nicholas Johnson and John Smith (CAD Heritage 2012, appendix D). A further examination of the granite block by the author revealed that there were two indentations within the surface of the block along the middle of the eastern and western edges with remnants of metal still visible. Between these two points were indications of heat and a light dusting of charcoal which possibly is evidence for a fire. The depth of the stone was found to be over 0.7m and it was not square, actually angling at 45 degrees in toward the base

from the west side, again supporting the appearance that only the surface of the stone had been dressed and probably *in situ*, although this cannot be substantiated. The north wall appears to have been blocked up, evidenced by a change in the stonework on the exterior almost adjacent to stone A.

Figure 11: View of stone A located in the north east corner of Devoran Village Hall. Note the two possible holes relating to mounts. The centre of the stone revealed traces of being subjected to heat and/or burning.

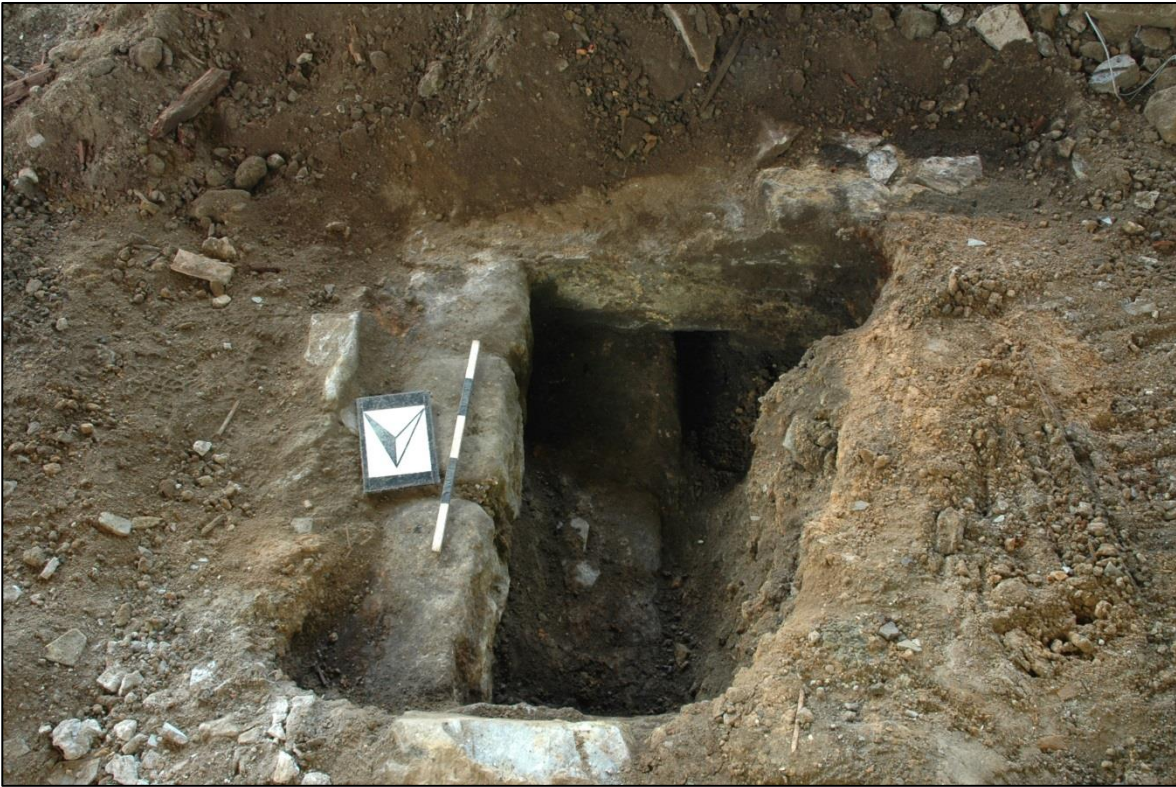
The inspection pit 114 was lined by two walls 112 and 118 which measured approximately 8m long by 1.04m wide and 0.7m deep. The walls were constructed of

slates, bonded together with cement. The stones on the top of the walls were loose and followed the line of the floor joists.

The bottom of the pit was flat at the west end and contained what appeared to be lime ash. There were indications of metal or rust protruding from the floor surface.

At either end of the pit were granite steps 113 (east) and 117 (west). The steps at the eastern end appeared to be made of five granite blocks, three on the upper tier and two on the lower. The upper tier of stones from south to north measured 0.23m wide, 0.3m deep, 0.33m wide, 0.3m deep, 0.4m wide and 0.3m deep. The stone had been laid reasonably level and dropped 0.25m down to the next tier of steps. The tops of each of these stones were smooth in appearance and appeared to have been worn. The lower tier of stones comprised only two blocks of granite, 0.48m wide and 0.37m deep, 0.57m wide and 0.33m deep.

Figure 12: View of east side of inspection pit prior to excavation.

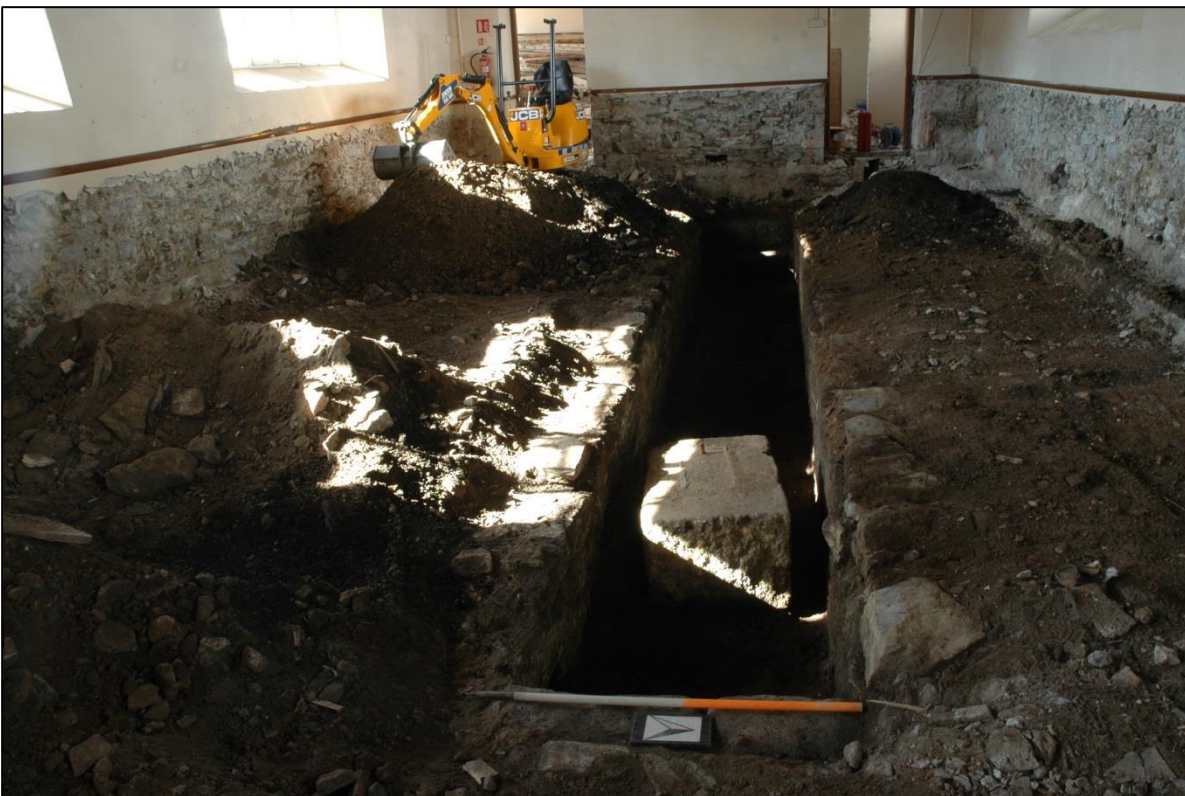
The steps at the western end of the pit comprised four blocks of granite, from south to north upper tier, 0.55m wide, 0.3m deep, 0.45m wide, 0.30m deep, dropping 0.25m to the lower tier of steps. The lower tier of steps from south to north, 0.4m wide, 0.4m deep, 0.6m wide, 0.4m deep, dropping 0.2m to the floor 114.

Located at the eastern end of the inspection pit, in the south side was a hole in the base of the wall. Inspection of the hole revealed that that it extended for at least 0.6m and that it was possibly the remains of a drain.

Figure 13: View of inspection pit after excavation.
